**ENTECH**  
ENGINEERING, INC.

**WASTEWATER STUDY  
RETREAT AT TIMBERRIDGE FILING NO. 4  
PARCEL NO. 52220-00-023  
EL PASO COUNTY, COLORADO**

December 21, 2023

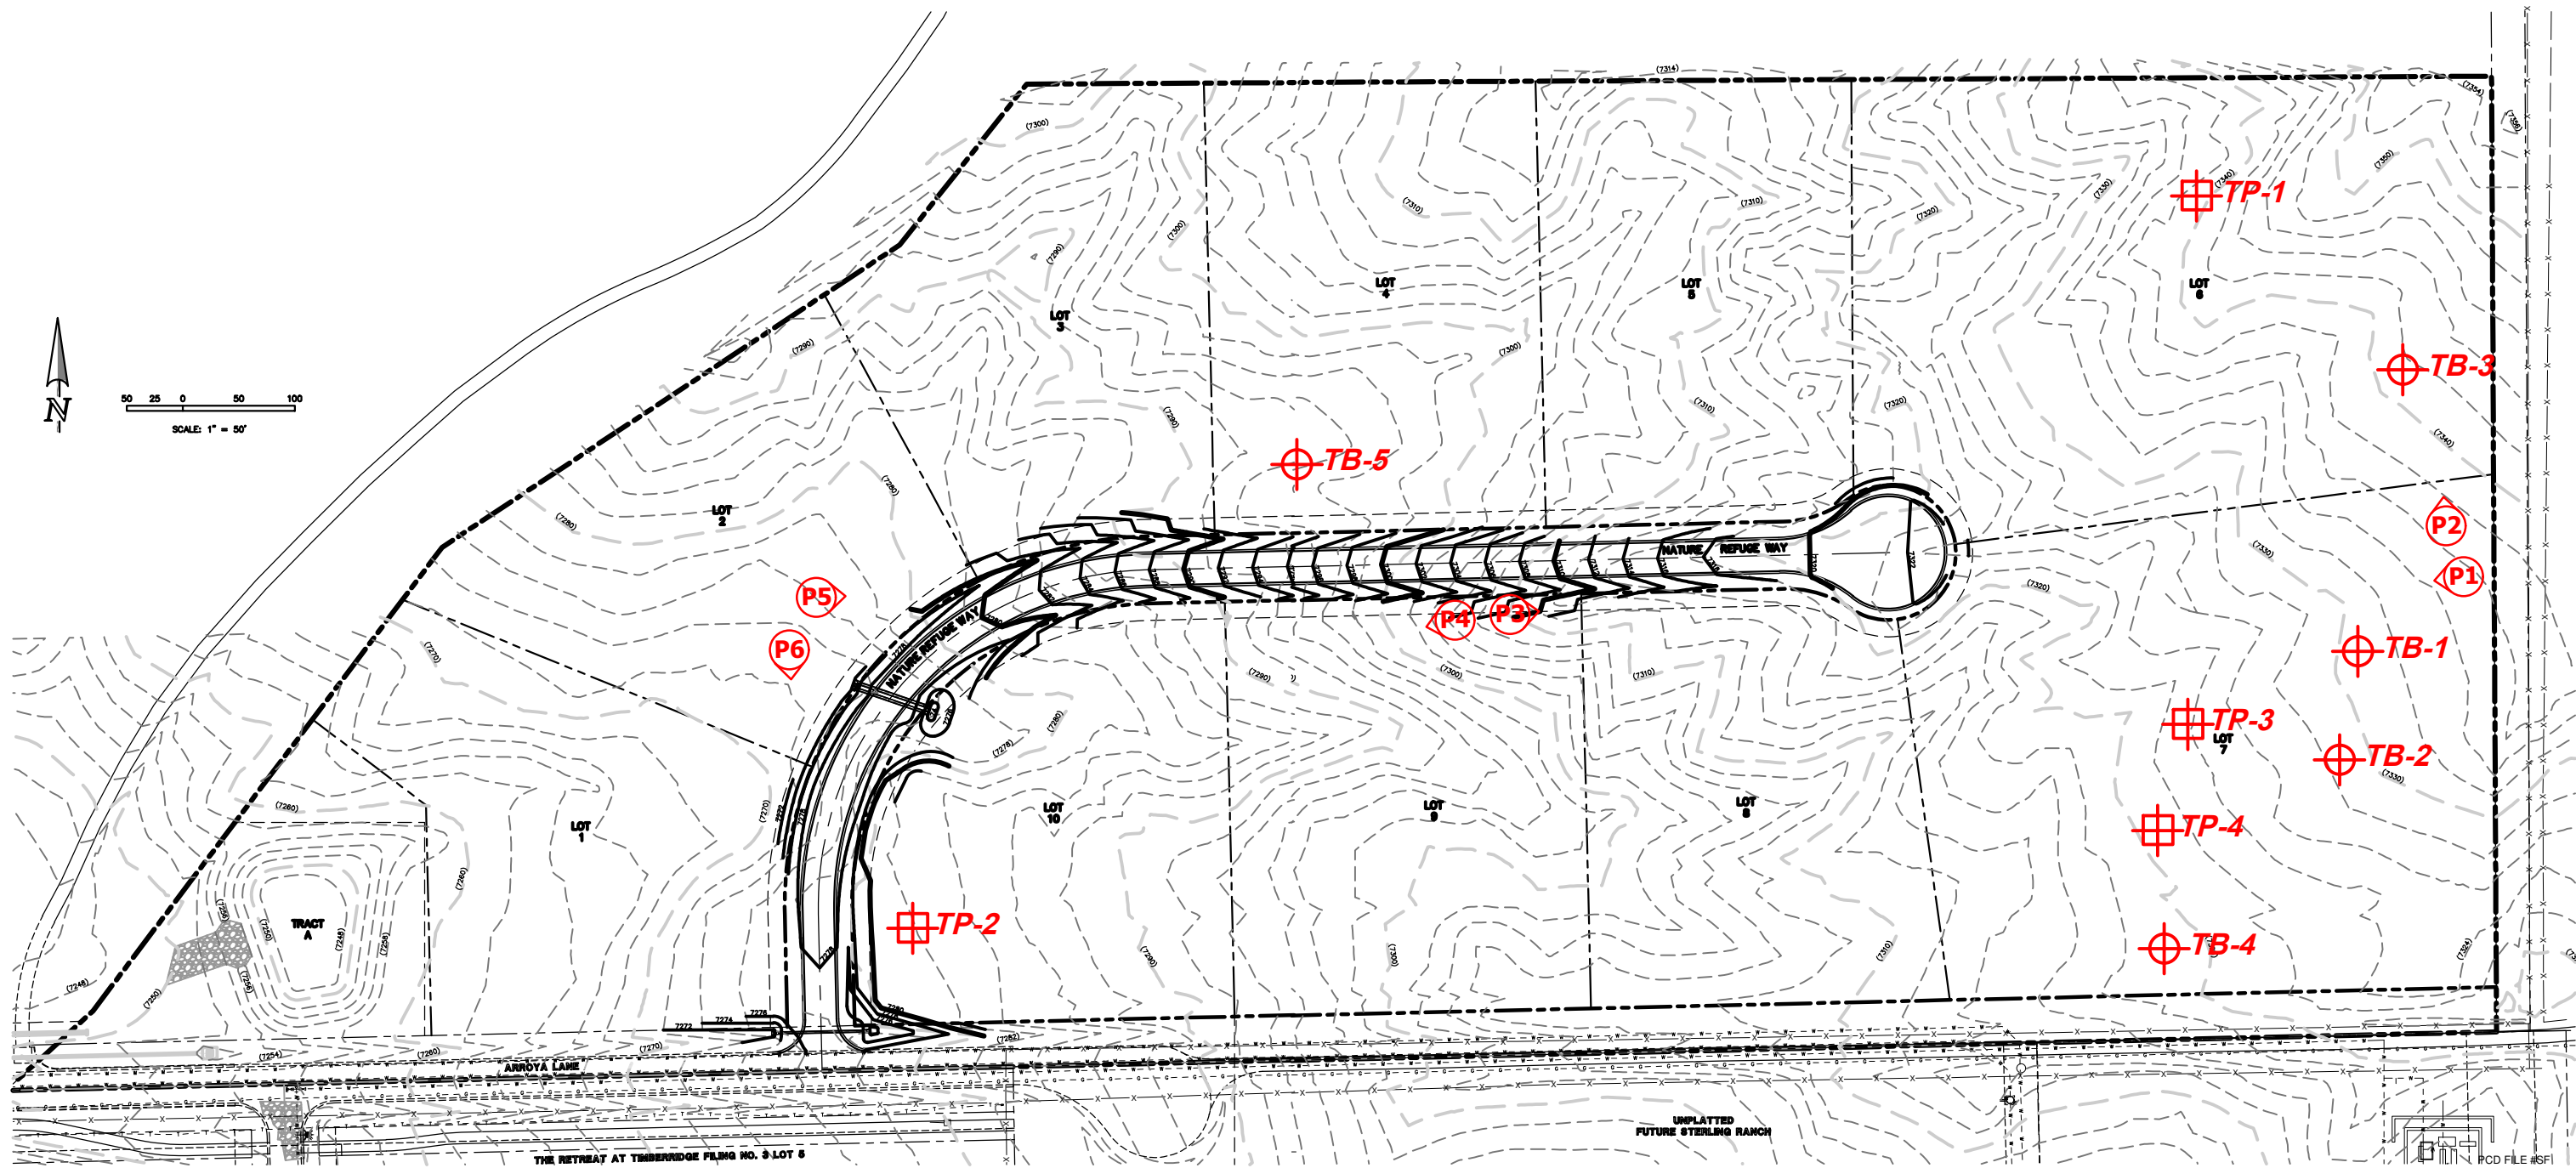
JOB NO.  
231468  
**FIG. 3**

**EXPLORATION AND SITE PLAN**  
 RETREAT AT TIMBERRIDGE FIL. NO. 4  
 EL PASO COUNTY, CO  
 TIMBERRIDGE DEVELOPMENT GROUP, LLC

Ten rural residential 2.5+ acre lots are proposed on the 34.92-acre site. Preliminary grading plans indicate the site grading will be limited to the proposed roadway and detention pond in the southwestern corner of the site. The proposed grading is shown on Exploration and Site Plan presented in Figure 3.

A Geologic Hazard Study was previously performed by Entech Engineering, Inc. for the Retreat at TimberRidge, April 17, 2017 (Reference 1). Test borings and test pits from the previous investigation were utilized for this report. The location of the test borings and test pits are indicated on Figures 3 and 6. Information from the report was used in evaluating the site. The Test Boring and Test Pit Logs are presented in Appendix B, and Summarized on Table B-1. Results of this testing will be discussed later in this report.

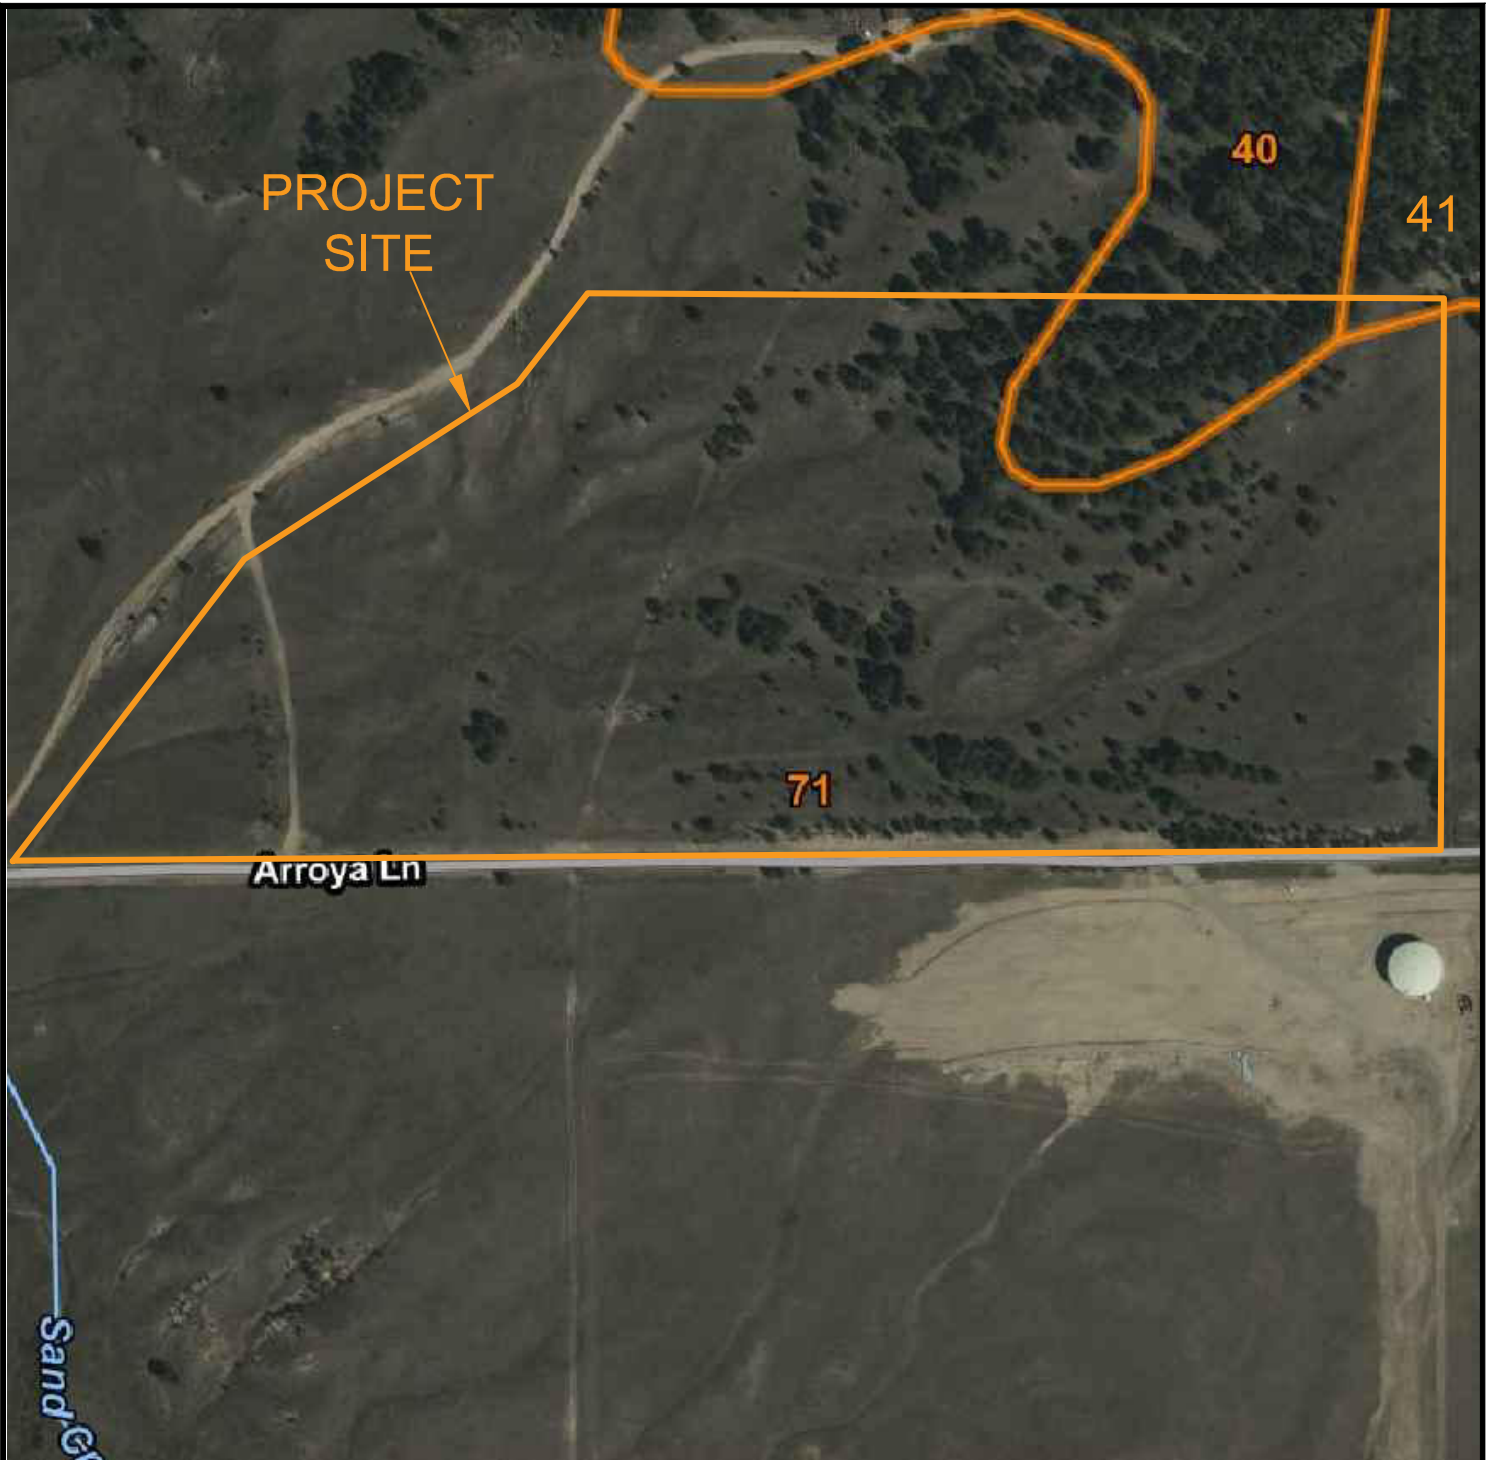
**FIG. 4**

### SOIL SURVEY MAP

The Natural Resource Conservation Service (Reference 2), previously the Soil Conservation Service (Reference 3) has mapped three soil types on the site (Figure 4). In general, the soils classify as gravelly loamy sand and coarse sandy loam. The soils are described as follows:

The Natural Resource Conservation Service (Reference 5), previously the Soil Conservation Service (Reference 6) has been mapped with three soil descriptions. The Soil Survey Map (Reference 5) is presented in Figure 4, and the Soil Survey Descriptions are presented in Appendix D. The soils are described as having slow to rapid percolation rates. The majority of the soils have been described to have moderate permeabilities.

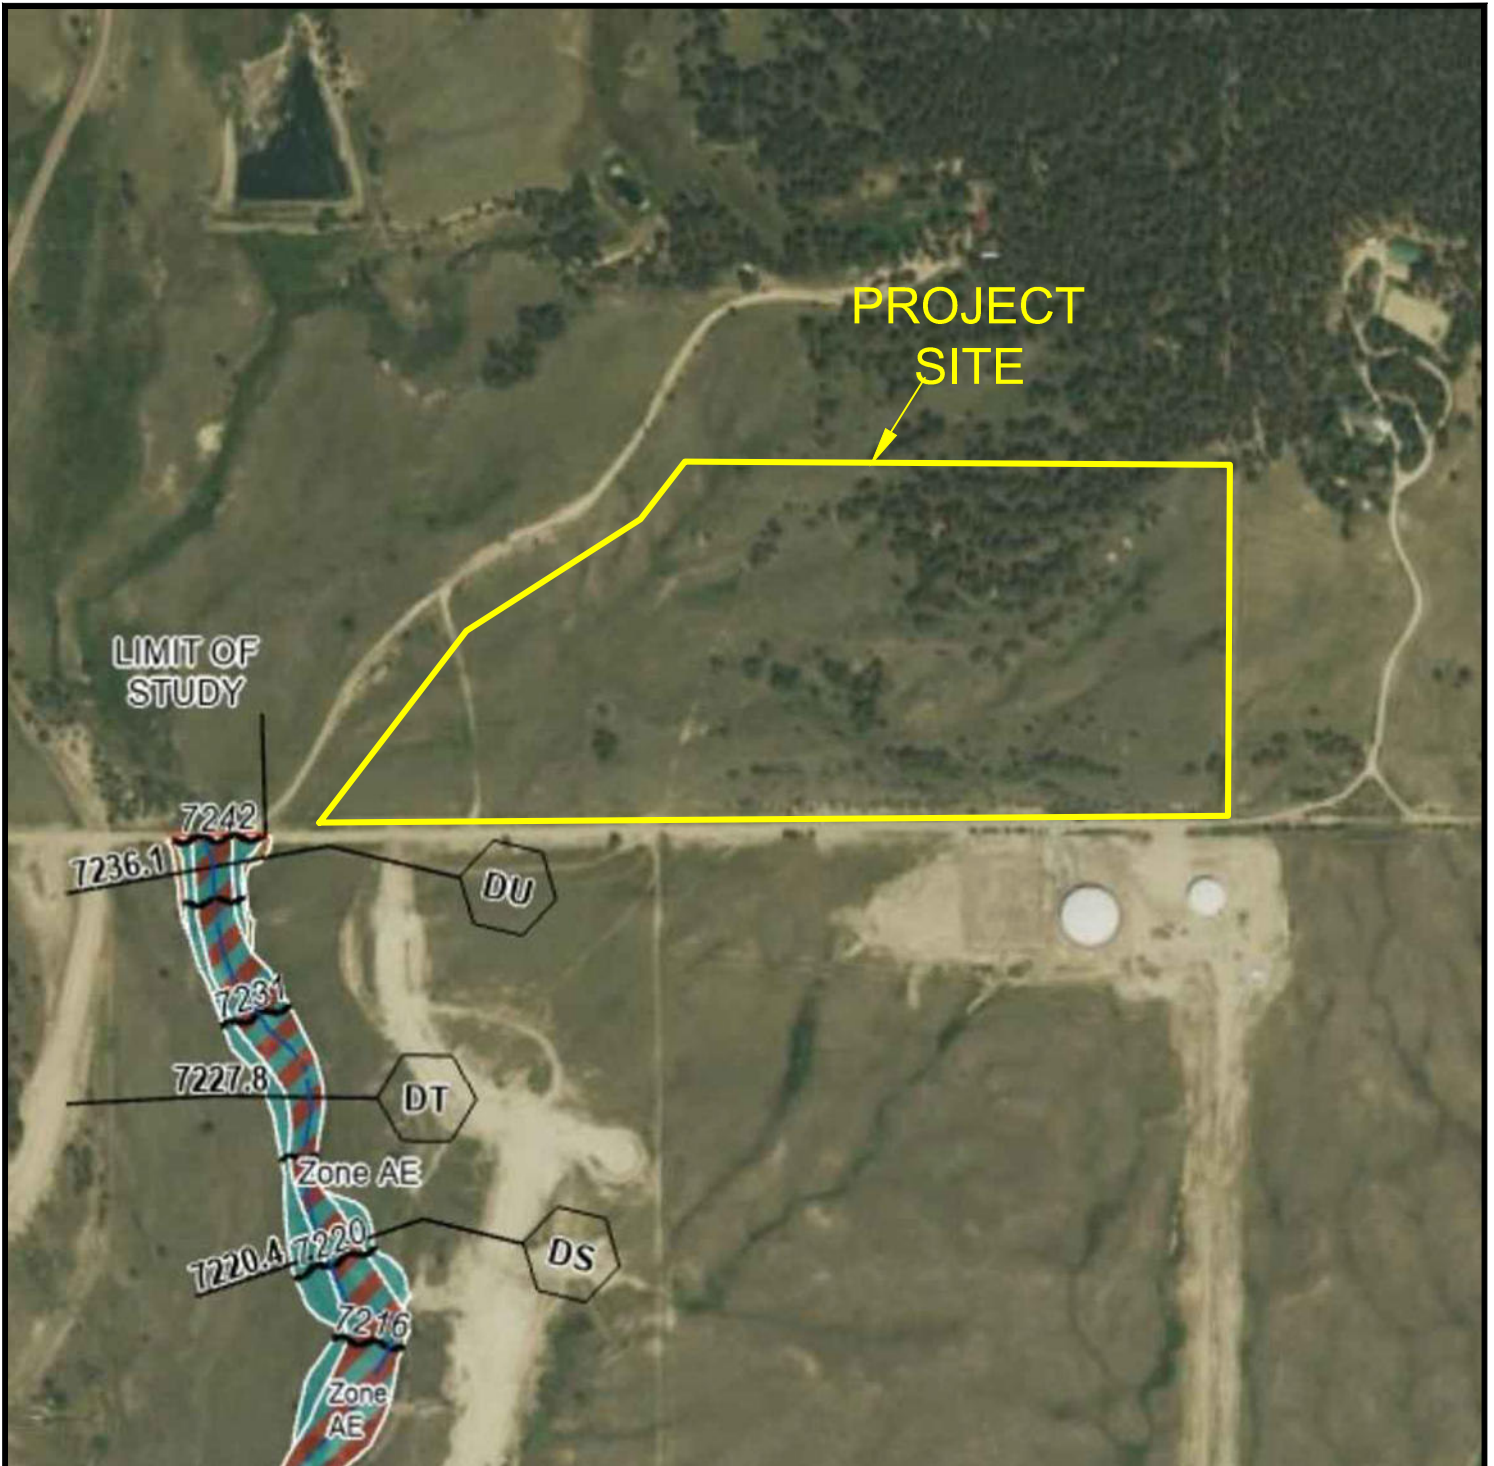
**FIG. 7**

**FEMA FLOODPLAIN MAP**  
 RETREAT AT TIMBERRIDGE FIL. NO. 4  
 EL PASO COUNTY, CO  
 TIMBERRIDGE DEVELOPMENT GROUP, LLC

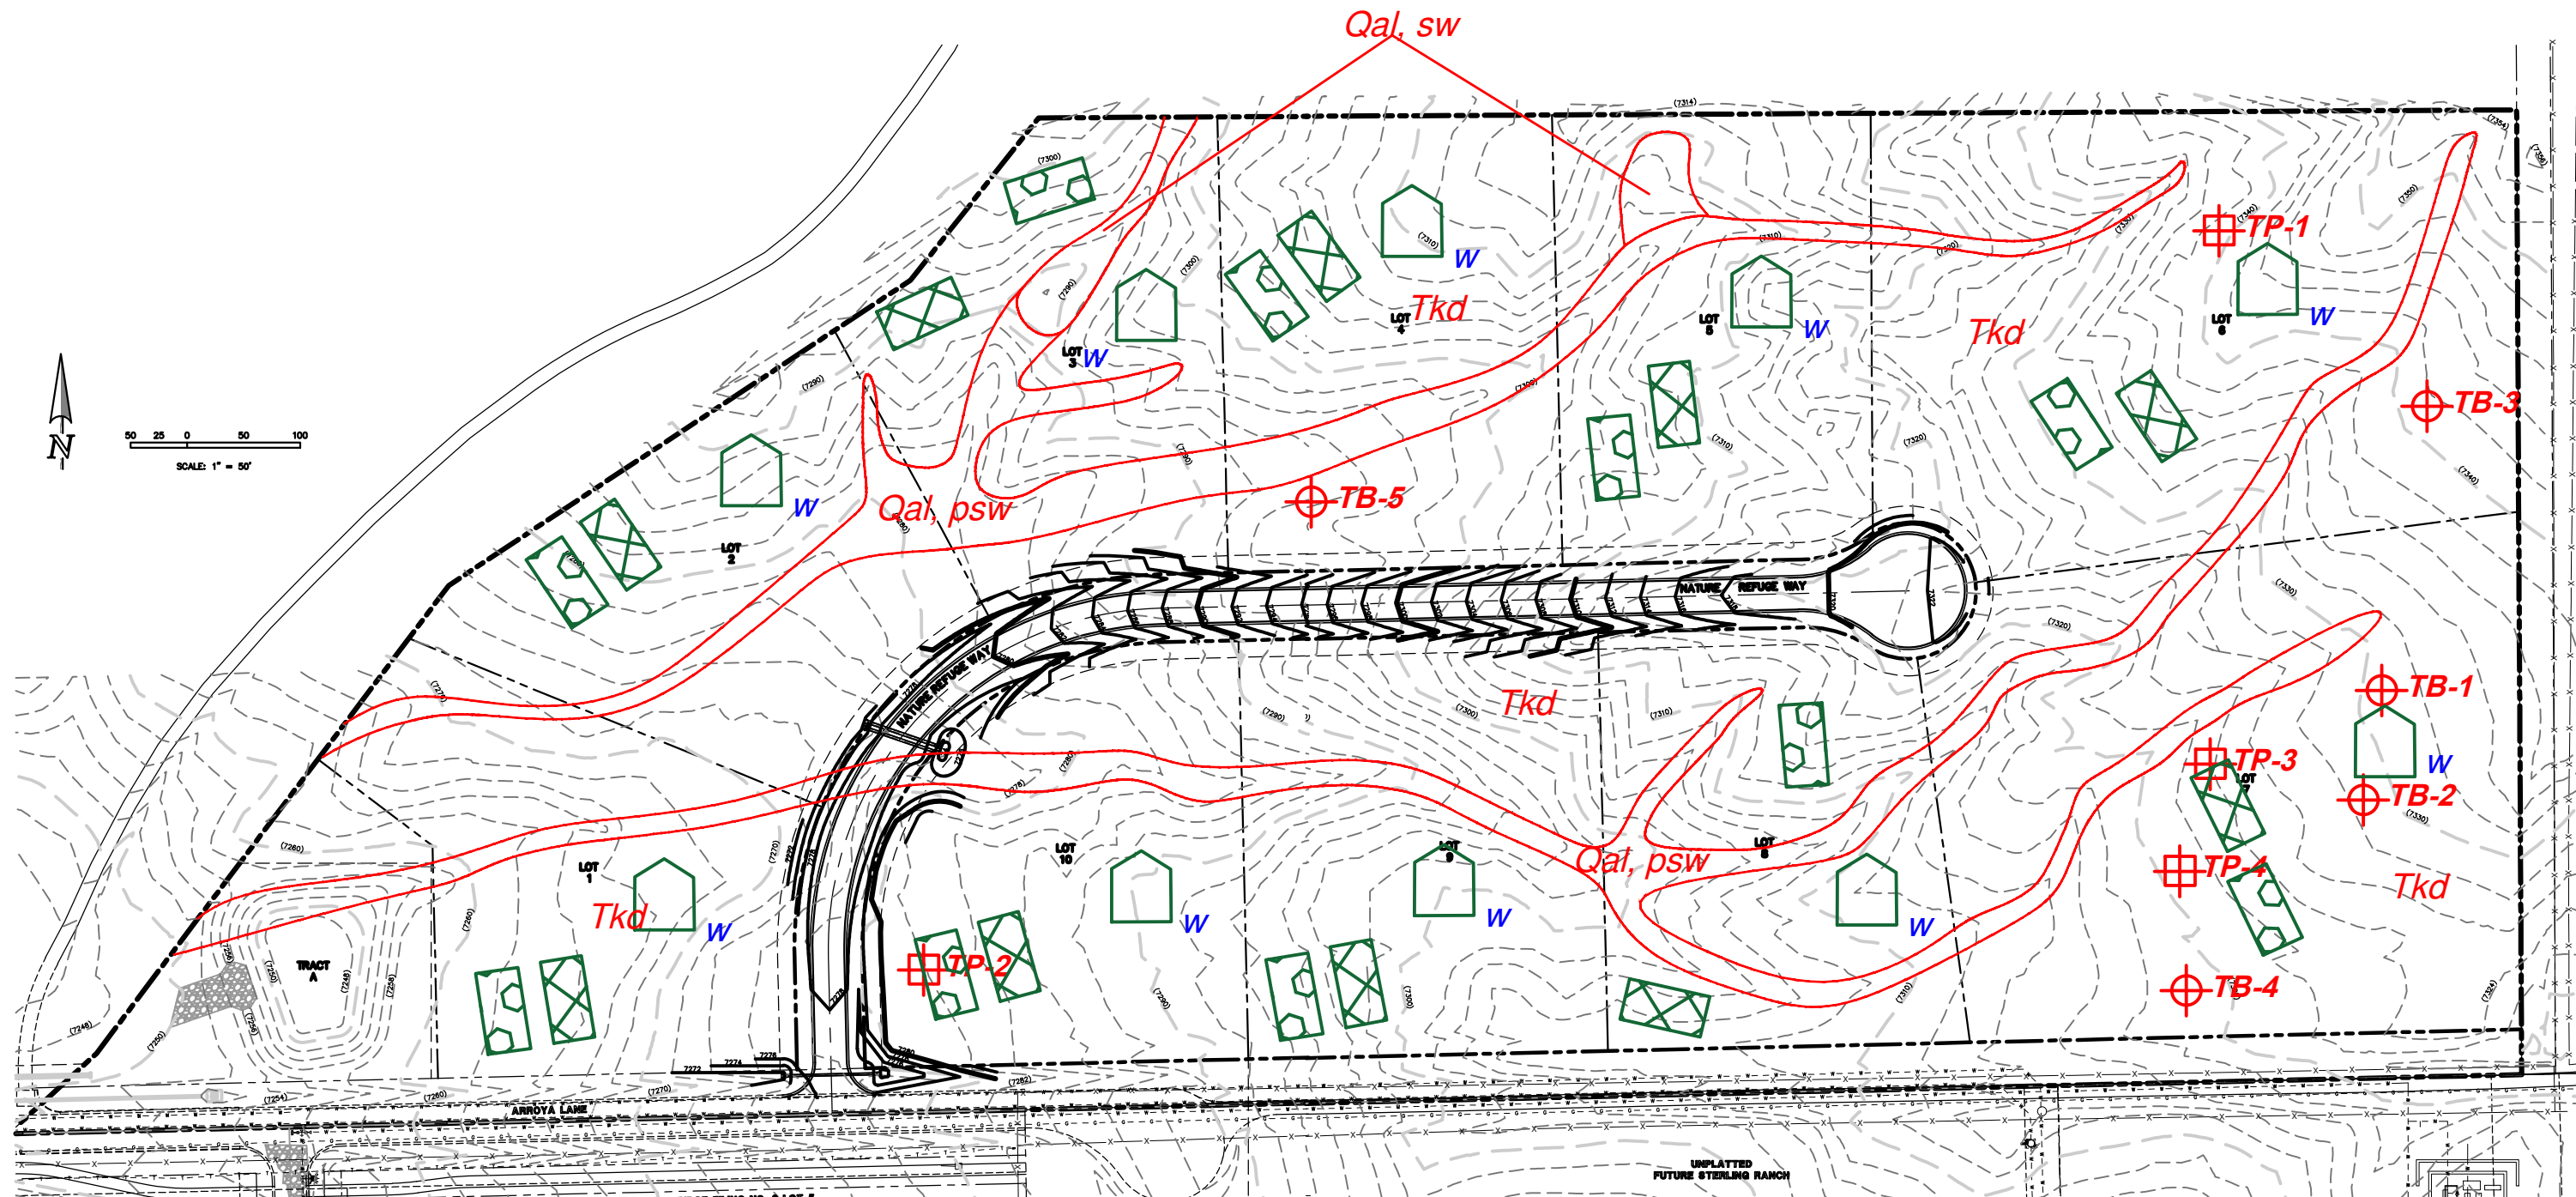
**FIG. 6**

- POSSIBLE OWTS ALTERNATE LOCATION
  - W** \*- WATER WELLS MUST BE A MINIMUM OF 100 FT FROM OWTS ABSORPTION FIELDS

**OWTS SUITABILITY MAP**

The site was evaluated for individual on-site wastewater treatment systems in accordance with the El Paso Land Development Code. Four (4) tactile test pits were previously excavated on the site. The test pits were placed in potential locations of future systems. The approximate locations of the Test Pits are indicated in Figure 3, and on the Septic Suitability Map, Figure 8. Test Pit Logs and Laboratory Test Results in Appendices B and C.

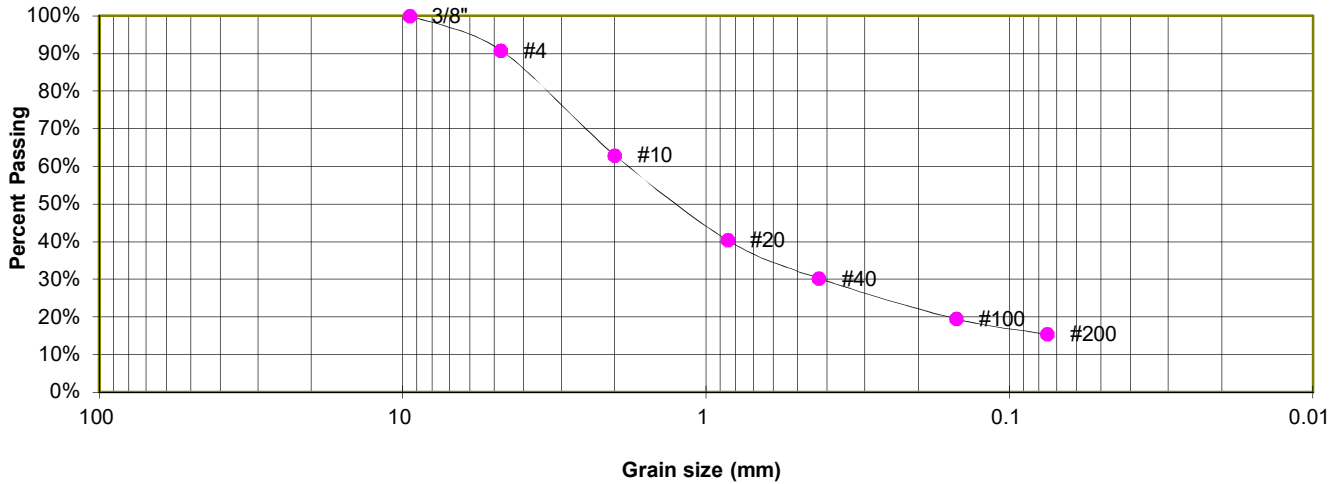
SOIL DESCRIPTION SAND, SILTY  
 SOIL TYPE 1

**GRAIN SIZE ANALYSIS**

U.S. Sieve #	Percent Finer
3"	
1 1/2"	
3/4"	
1/2"	
3/8"	100.0%
4	90.8%
10	63.0%
20	40.4%
40	30.3%
100	19.5%
200	15.4%

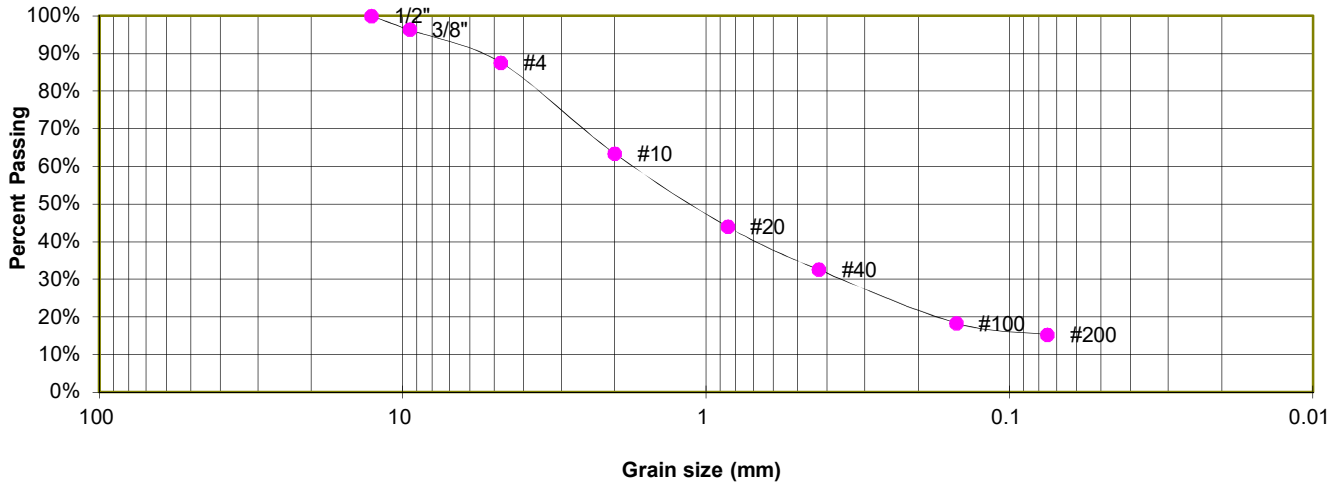
SOIL DESCRIPTION SAND, SILTY  
 SOIL TYPE 1

**GRAIN SIZE ANALYSIS**

U.S. Sieve #	Percent Finer
3"	
1 1/2"	
3/4"	
1/2"	100.0%
3/8"	96.3%
4	87.6%
10	63.4%
20	44.0%
40	32.6%
100	18.4%
200	15.3%

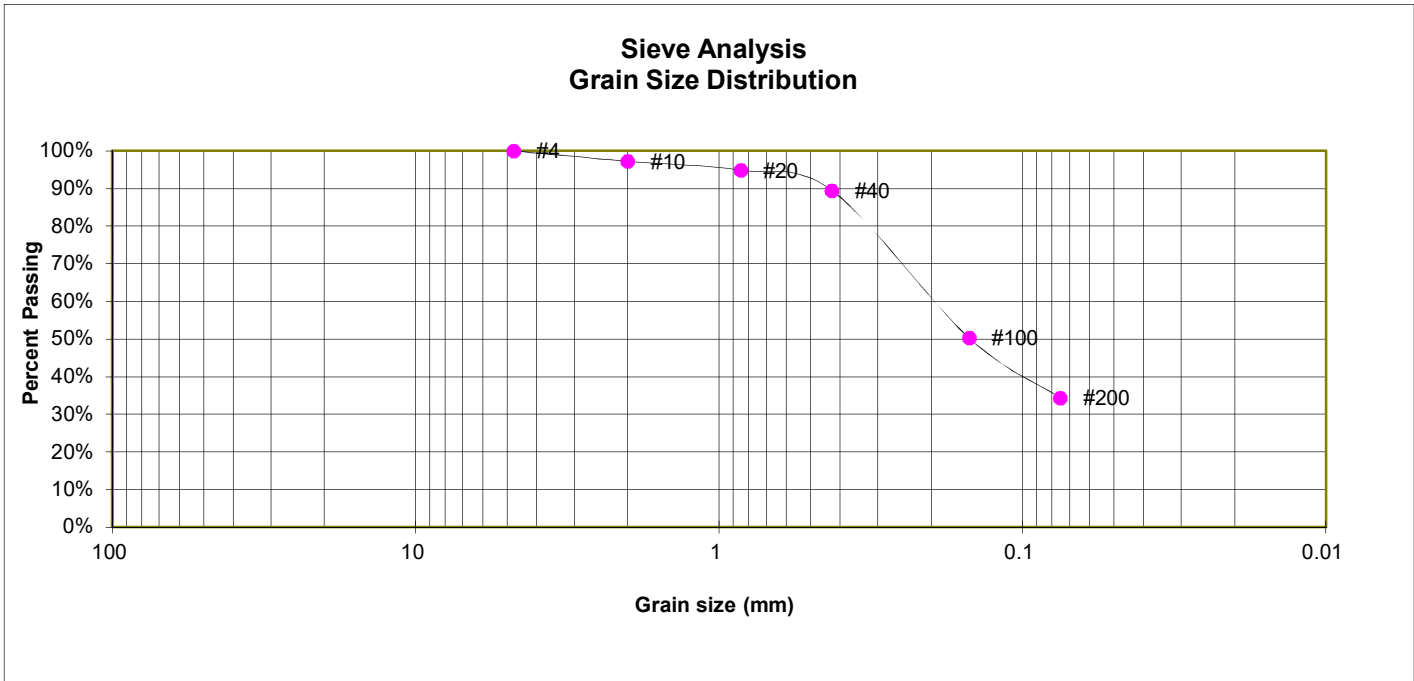
TEST BORING 4  
 DEPTH (FT) 2-3

SOIL DESCRIPTION SAND, CLAYEY  
 SOIL TYPE 1

**GRAIN SIZE ANALYSIS**

U.S. Sieve #	Percent Finer
3"	
1 1/2"	
3/4"	
1/2"	
3/8"	
4	100.0%
10	97.2%
20	94.9%
40	89.5%
100	50.3%
200	34.3%

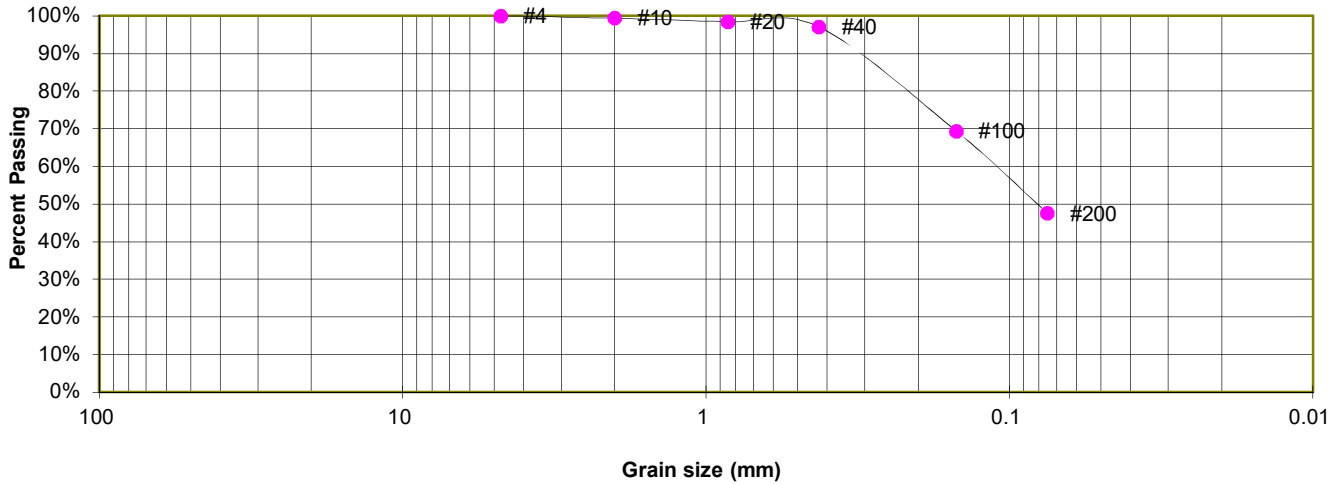
SOIL DESCRIPTION SAND, CLAYEY  
SOIL TYPE 1

**GRAIN SIZE ANALYSIS**

U.S. Sieve #	Percent Finer
3"	
1 1/2"	
3/4"	
1/2"	
3/8"	
4	100.0%
10	99.4%
20	98.4%
40	97.1%
100	69.4%
200	47.6%

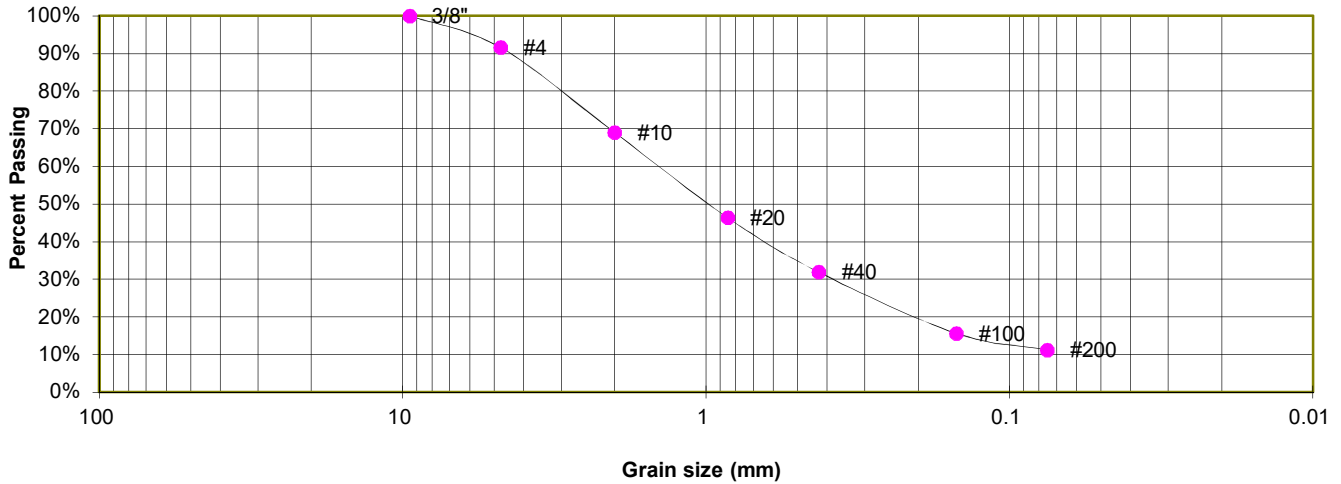
SOIL DESCRIPTION SAND, WITH SILT  
SOIL TYPE 1

#### GRAIN SIZE ANALYSIS

U.S. Sieve #	Percent Finer
3"	
1 1/2"	
3/4"	
1/2"	
3/8"	100.0%
4	91.6%
10	69.0%
20	46.4%
40	31.9%
100	15.7%
200	11.2%

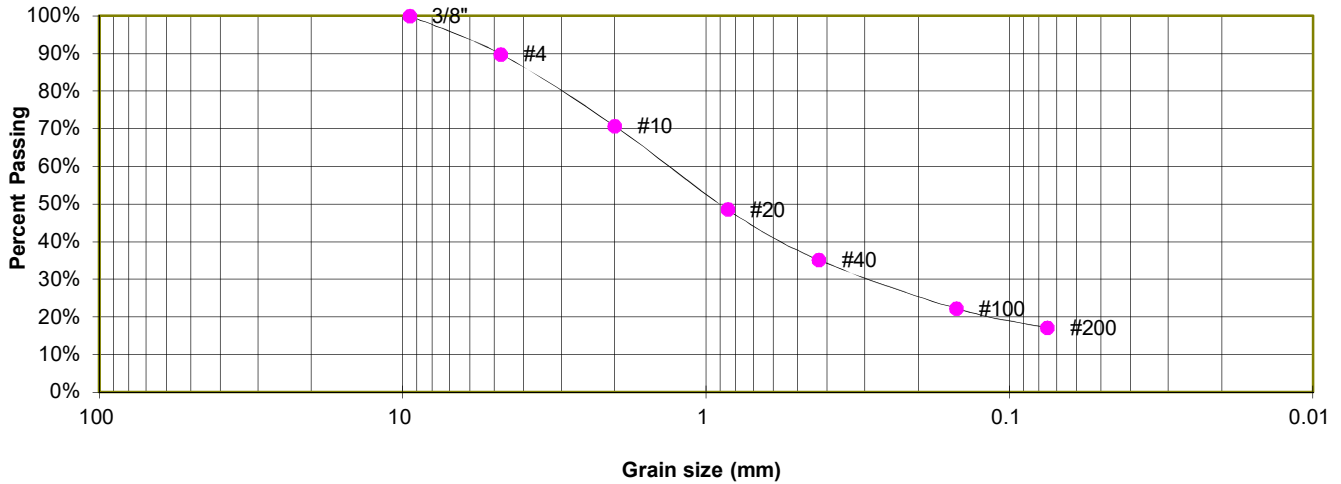
SOIL DESCRIPTION SANDSTONE (SAND, CLAYEY)  
 SOIL TYPE 2

**GRAIN SIZE ANALYSIS**

U.S. Sieve #	Percent Finer
3"	
1 1/2"	
3/4"	
1/2"	
3/8"	100.0%
4	89.9%
10	70.7%
20	48.6%
40	35.1%
100	22.3%
200	17.1%

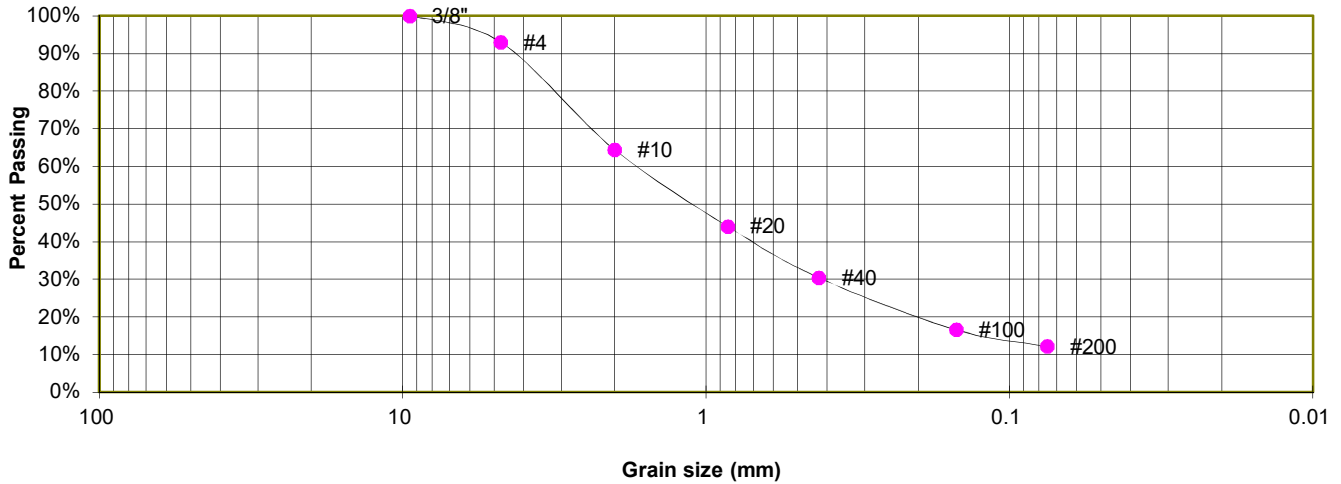
SOIL DESCRIPTION SANDSTONE (SAND, SILTY)  
 SOIL TYPE 2

**GRAIN SIZE ANALYSIS**

U.S. Sieve #	Percent Finer
3"	
1 1/2"	
3/4"	
1/2"	
3/8"	100.0%
4	93.0%
10	64.4%
20	44.1%
40	30.4%
100	16.6%
200	12.1%
