ENTECH
ENGINEERING, INC.

**WASTEWATER STUDY
RETREAT AT TIMBERRIDGE FILING NO. 4
PARCEL NO. 52220-00-023
EL PASO COUNTY, COLORADO**

December 21, 2023

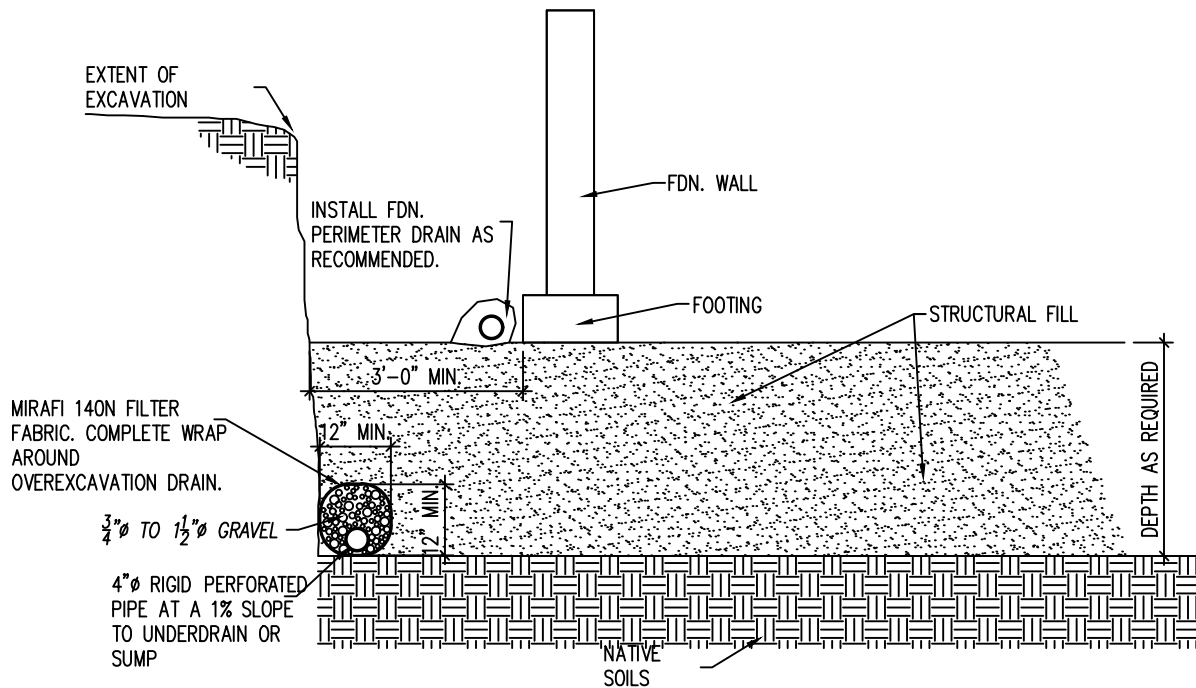
OVEREXCAVATION DRAIN DETAIL
