**SOIL, GEOLOGY, AND GEOLOGIC HAZARD
SPRINGS AT WATERVIEW EAST
SOUTH POWERS BOULEVARD AND BRADLEY ROAD
EL PASO COUNTY, COLORADO**

Dakota Springs Engineering, Inc.
31 North Tejon Street, Suite 500
Colorado Springs, Colorado 80903

April 25, 2017
Revised February 21, 2018

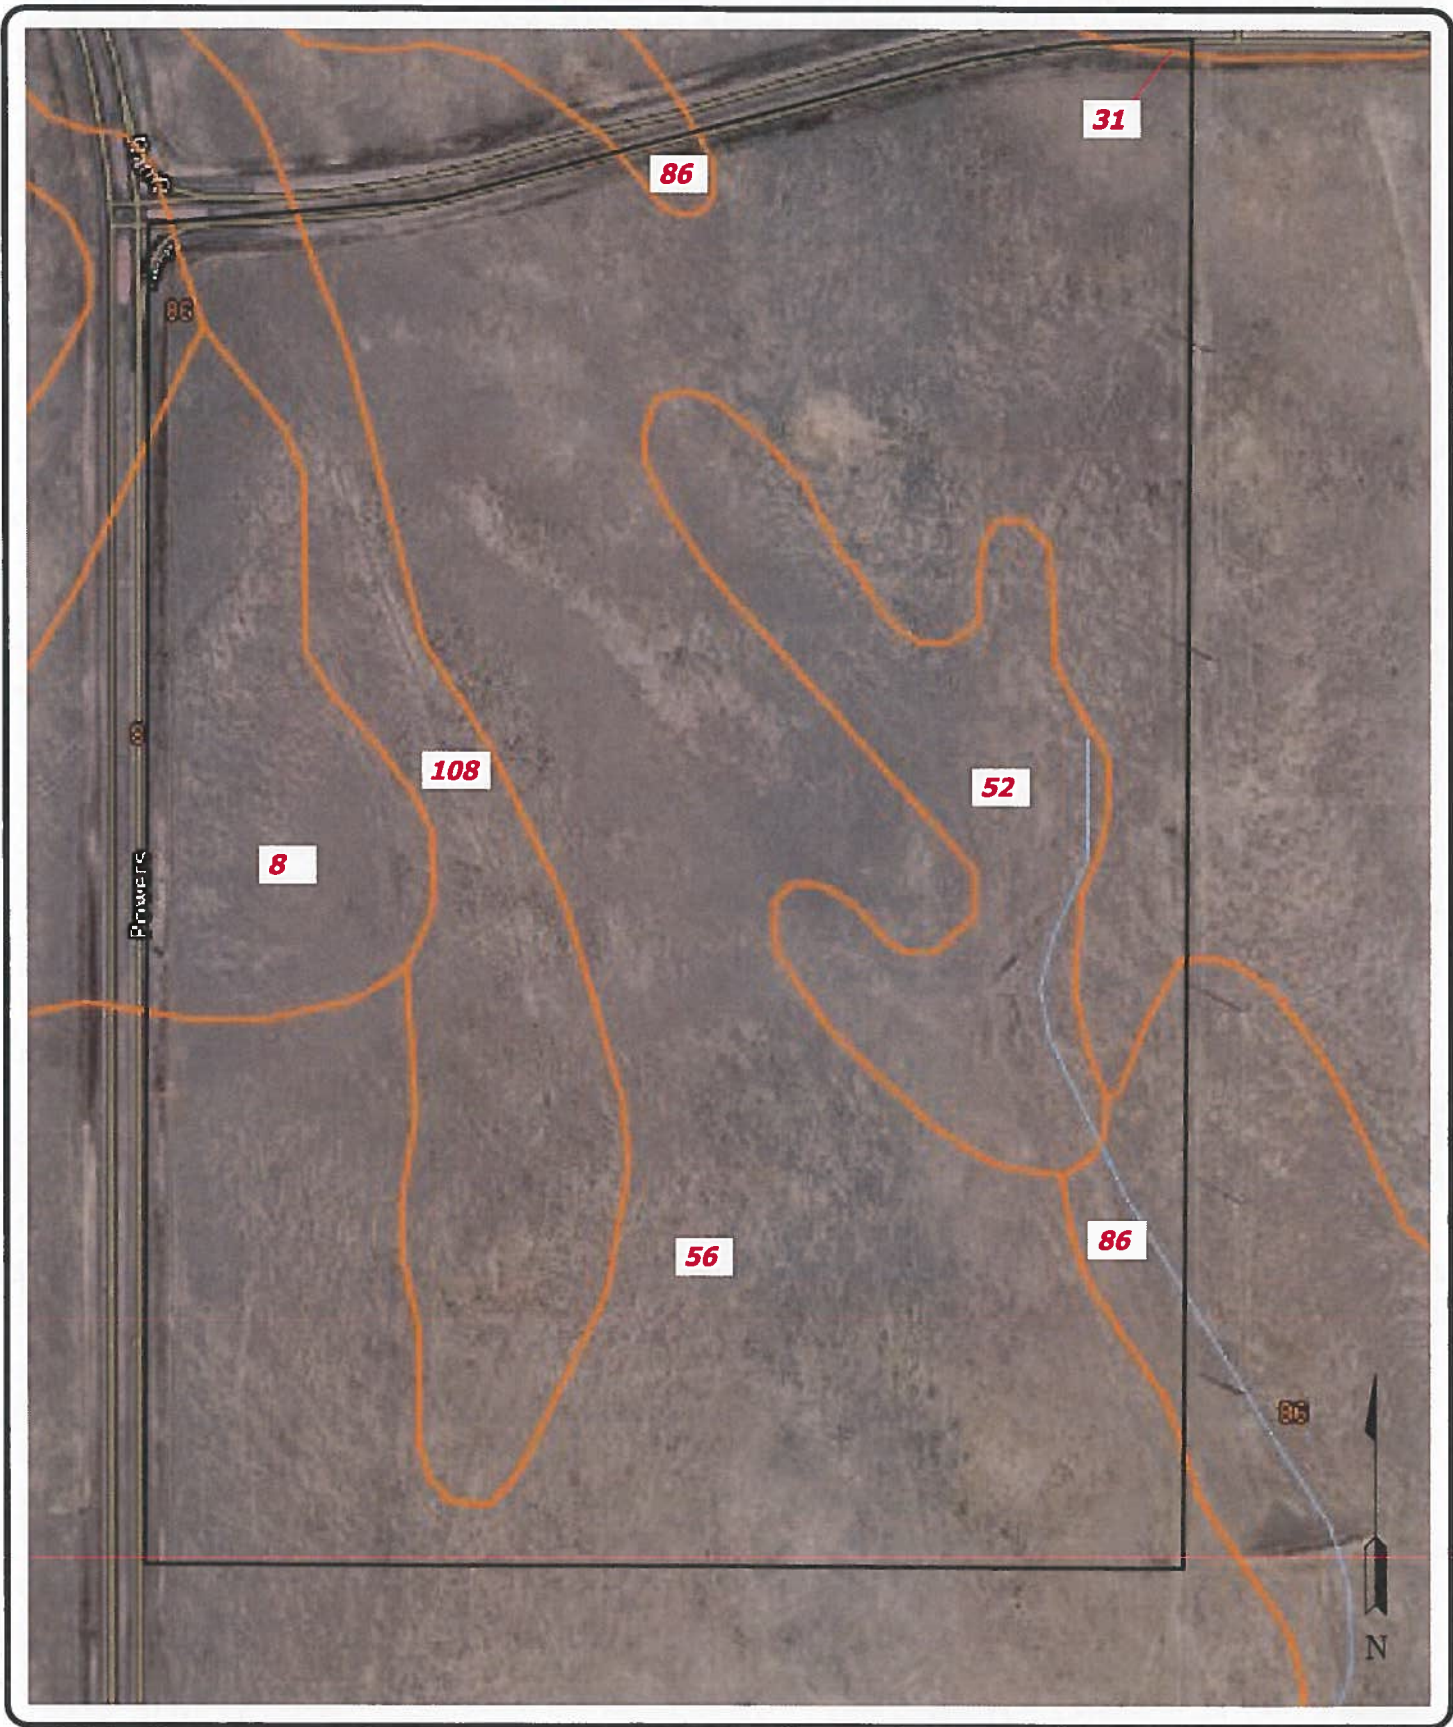
FIG NO.:
 4

SOIL SURVEY MAP
 SPRINGS AT WATERVIEW EAST
 POWERS BOULEVARD AND BRADLEY ROAD
 EL PASO COUNTY, CO.
 FOR: DAKOTA SPRINGS ENGINEERING, INC.
