SOILS AND GEOLOGY REPORT

COUNTRYSIDE SOUTH EL PASO COUNTY, COLORADO

JOB NO. 135524

December 14, 2012

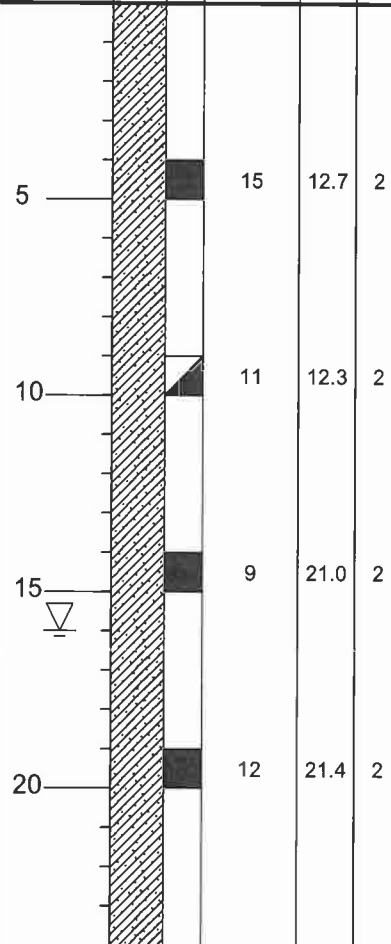
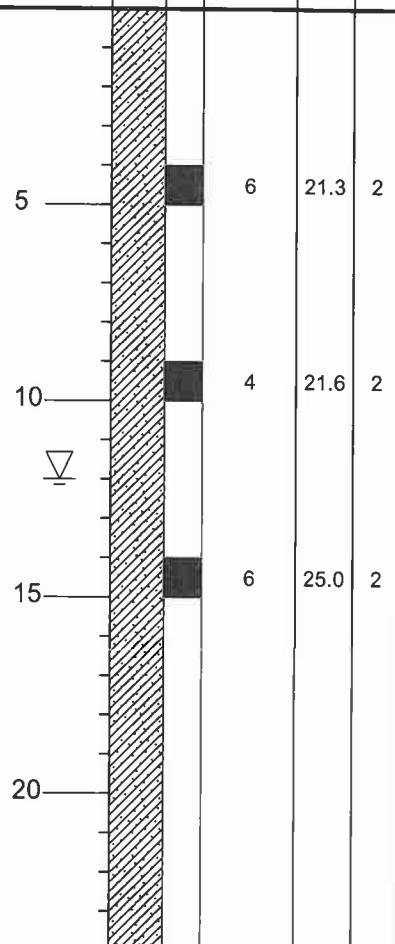
TEST BORING: 31 DATE DRILLED: 11/19/12 REMARKS: GROUNDWATER @ 16.0 ' 11/19/12	DEPTH (FT) SYMBOL SAMPLES BLOWS PER FT. WATER CONTENT % SOIL TYPE	TEST BORING: 32 DATE DRILLED: 11/19/12 REMARKS: GROUNDWATER @ 12.0 ' 11/19/12	DEPTH (FT) SYMBOL SAMPLES BLOWS PER FT. WATER CONTENT % SOIL TYPE
CLAY, SANDY, brown, medium stiff, moist to wet

CLAY TO SANDY CLAY, brown, soft to very stiff, moist

CLAYSTONE, brown to grey, firm, moist to wet

Groundwater was observed in six of the test borings at depths ranging from depths of 7 feet to 16 feet below the existing ground surface at the time of field exploration. Fluctuations in groundwater and subsurface moisture conditions may occur due to variations in rainfall and other factors not readily apparent at this time. In addition, development on the property and adjacent properties may also affect groundwater levels.

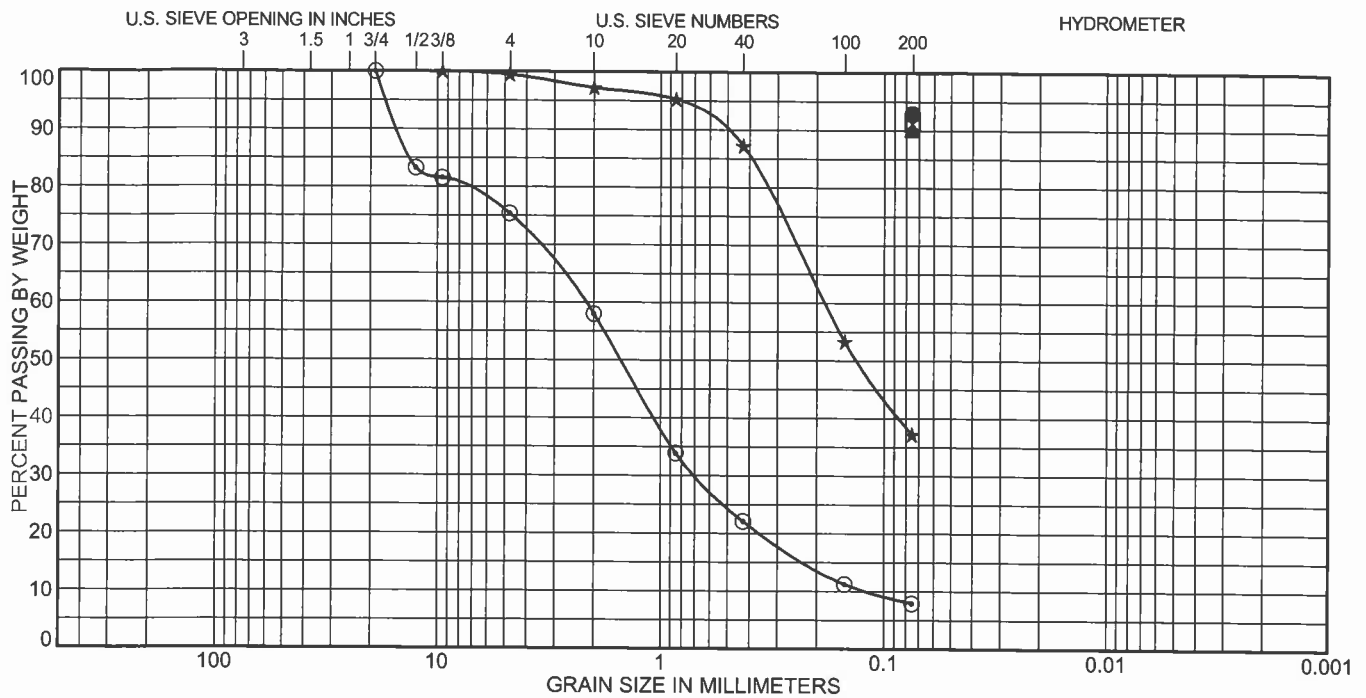
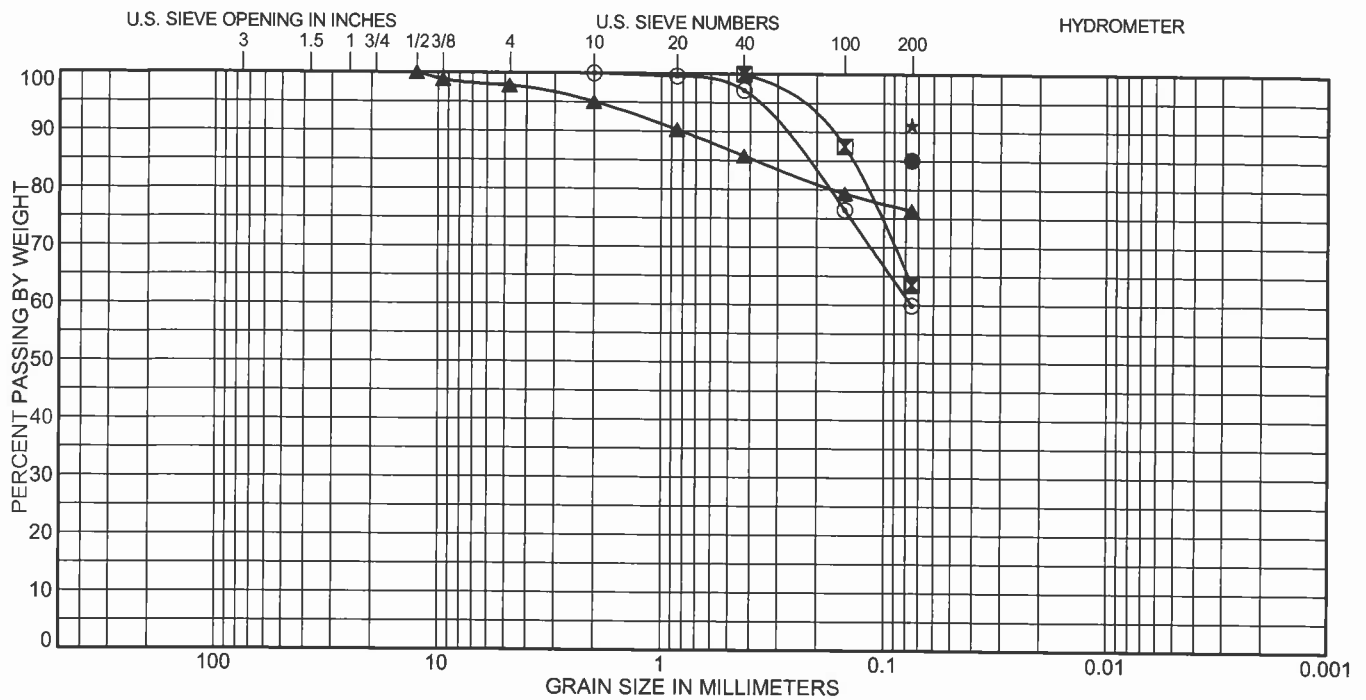
FIGURE No. 23

COBBLES	GRAVEL		SAND			SILT OR CLAY
	coarse	fine	coarse	medium	fine

Test Boring	Depth (ft)	Classification	LL	PL	PI	Cc	Cu
● 4	9.0	LEAN CLAY(CL)	31	15	16		
⊠ 5	9.0	SANDY LEAN CLAY(CL)	26	14	12		
▲ 6	19.0	LEAN CLAY with SAND(CL)	32	21	11		
★ 7	9.0	LEAN CLAY(CL)	49	17	32		
⊙ 8	9.0	SANDY LEAN CLAY(CL)	28	15	13

Test Boring	Depth (ft)	%Gravel	%Sand	%Silt	%Clay
● 4	9.0			85.1	
⊠ 5	9.0	0.0	36.5	63.5	
▲ 6	19.0	2.2	21.4	76.4	
★ 7	9.0			91.2	
⊙ 8	9.0	0.0	40.1	59.9

Soil laboratory testing was performed as part of this investigation. The laboratory tests included moisture content, dry density, grain-size analyses, Atterberg Limits and Swell/Consolidation tests. A Summary of Laboratory Test Results is presented in Figure 21. Soils Classification Data is presented in Figures 22 through 28. Swell/Consolidation Test Results are presented in Figures 29 through 38.

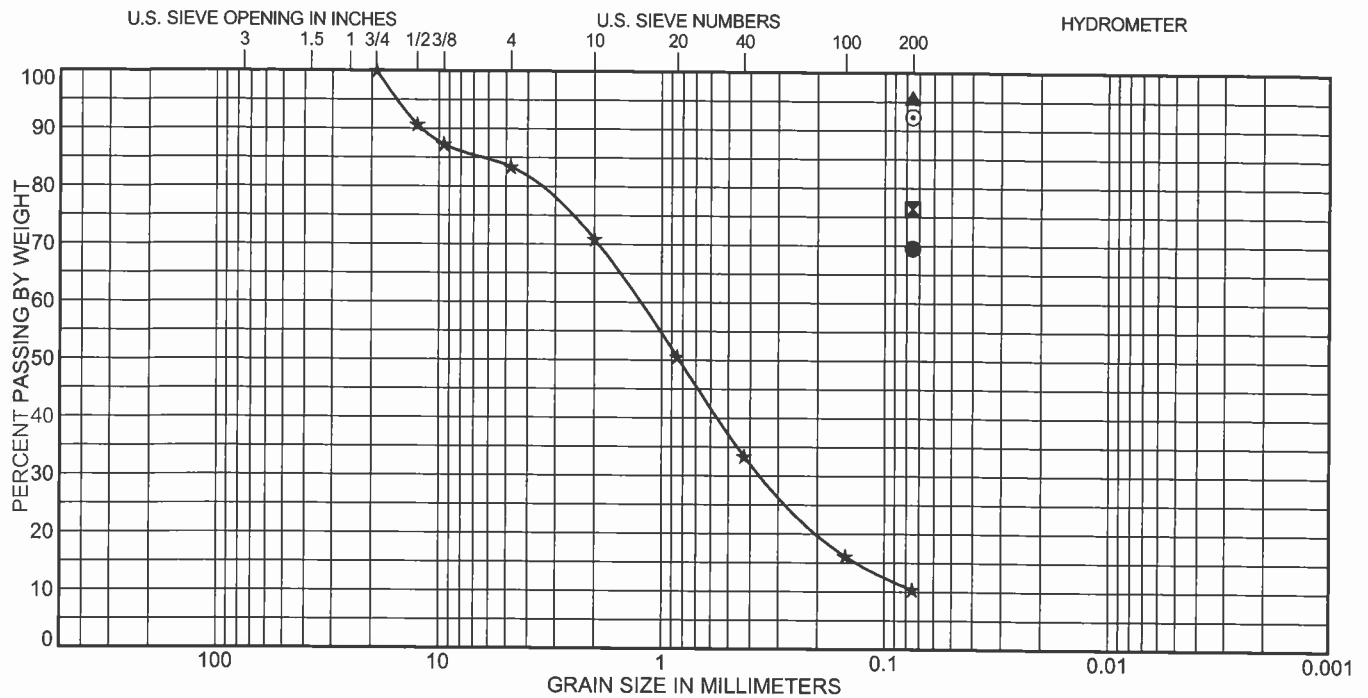
FIGURE No. 24

COBBLES	GRAVEL		SAND			SILT OR CLAY
	coarse	fine	coarse	medium	fine

Test Boring	Depth (ft)	Classification	LL	PL	PI	Cc	Cu
● 8	14.0	SANDY LEAN CLAY(CL)	28	16	12		
☒ 9	9.0	LEAN CLAY with SAND(CL)	39	23	16		
▲ 10	4.0	LEAN CLAY(CL)	29	17	12		
★ 10	29.0	WELL-GRADED SAND with SILT and GRAVEL(SW-SM)	NP	NP	NP	1.3	17.6
⊙ 11	4.0	LEAN CLAY(CL)	46	23	23

Test Boring	Depth (ft)	%Gravel	%Sand	%Silt	%Clay
● 8	14.0			69.5	
☒ 9	9.0			76.4	
▲ 10	4.0			95.7	
★ 10	29.0	16.6	73.0	10.4	
⊙ 11	4.0			92.3

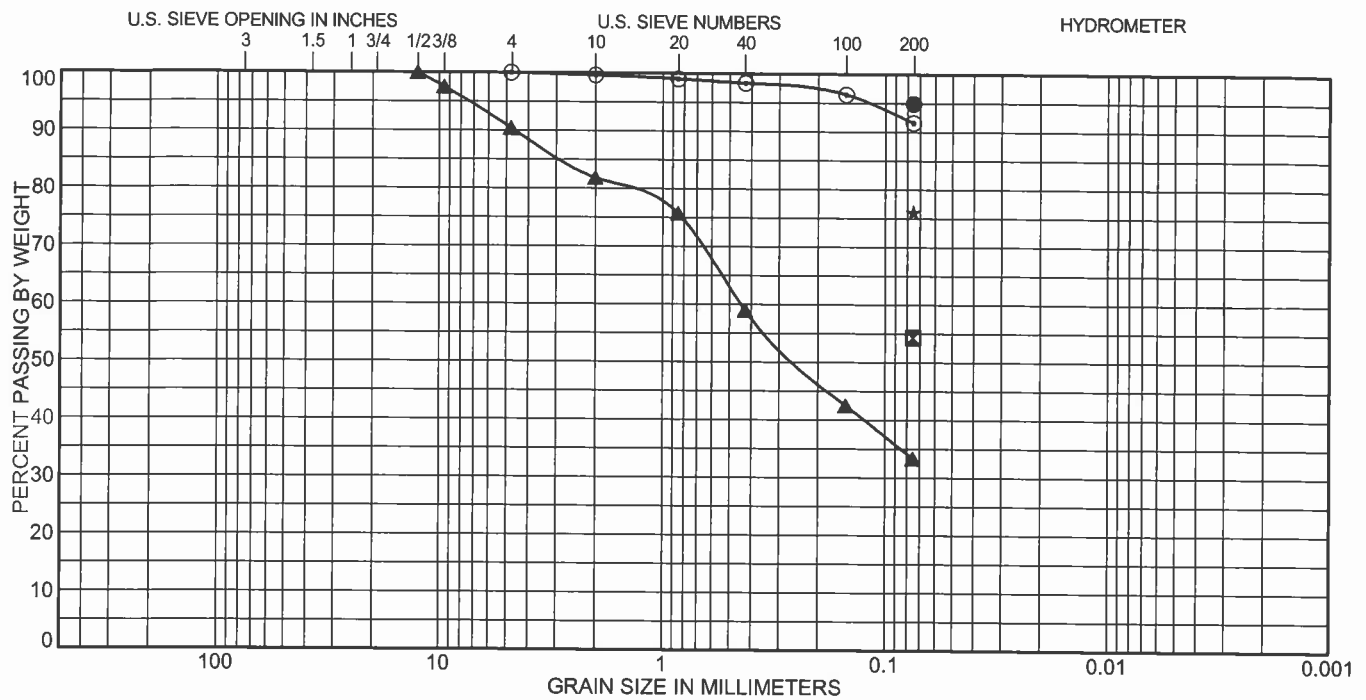
FIGURE No. 25

COBBLES	GRAVEL		SAND			SILT OR CLAY
	coarse	fine	coarse	medium	fine

Test Boring	Depth (ft)	Classification	LL	PL	PI	Cc	Cu
● 12	9.0						
☒ 14	4.0	SANDY SILT (ML)	NP	NP	NP		
▲ 14	9.0	CLAYEY SAND (SC)	32	19	13		
★ 15	9.0	LEAN CLAY with SAND (CL)	31	15	16		
⊙ 16	9.0	SILT (ML)	NP	NP	NP

Test Boring	Depth (ft)	%Gravel	%Sand	%Silt	%Clay
● 12	9.0			94.9	
☒ 14	4.0			54.3	
▲ 14	9.0	9.6	57.1	33.3	
★ 15	9.0			76.1	
⊙ 16	9.0	0.0	8.4	91.6

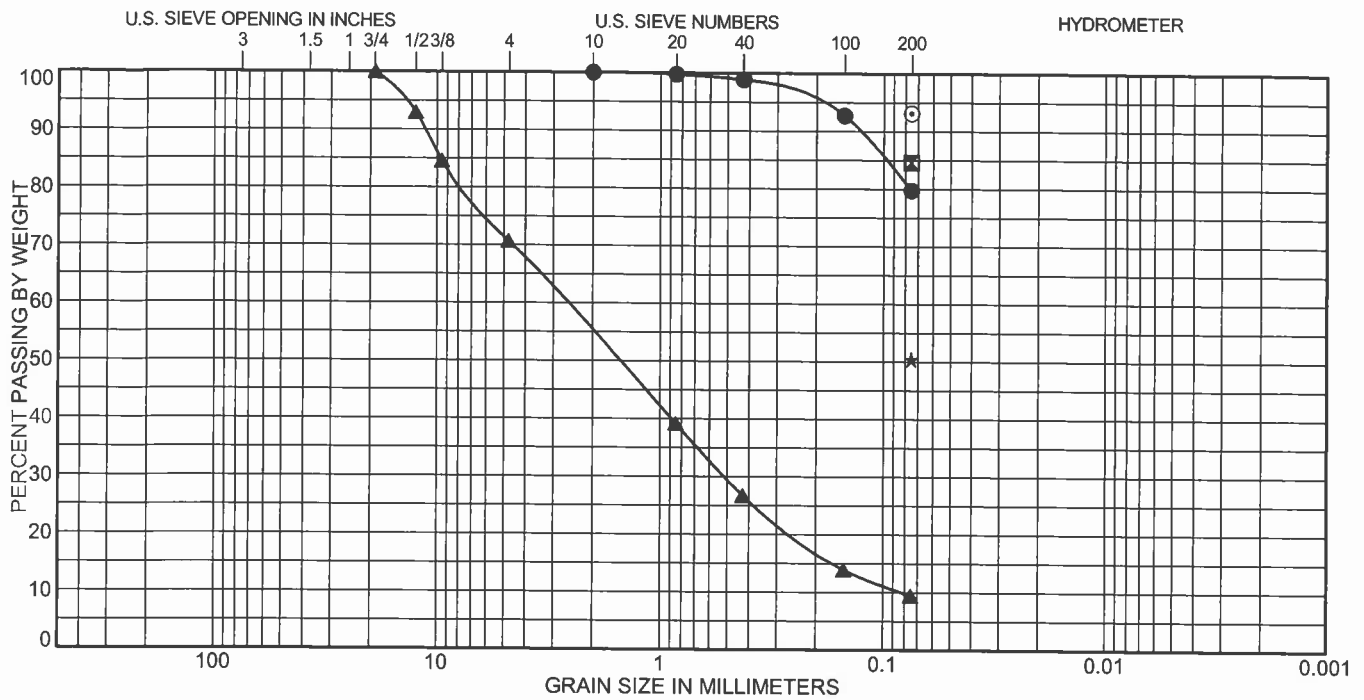
FIGURE No. 26

COBBLES	GRAVEL		SAND			SILT OR CLAY
	coarse	fine	coarse	medium	fine

Test Boring	Depth (ft)	Classification	LL	PL	PI	Cc	Cu
● 17	9.0	LEAN CLAY with SAND(CL)	39	16	23		
☒ 20	4.0	LEAN CLAY with SAND(CL)	46	23	23		
▲ 20	29.0	WELL-GRADED SAND with SILT and GRAVEL(SW-SM)	NP	NP	NP	1.2	32.4
★ 21	9.0	SANDY LEAN CLAY(CL)	27	12	15		
⊙ 22	4.0	LEAN CLAY(CL)	41	15	26

Test Boring	Depth (ft)	%Gravel	%Sand	%Silt	%Clay
● 17	9.0	0.0	20.3	79.7	
☒ 20	4.0			84.6	
▲ 20	29.0	29.3	61.2	9.4	
★ 21	9.0			50.4	
⊙ 22	4.0			93.1

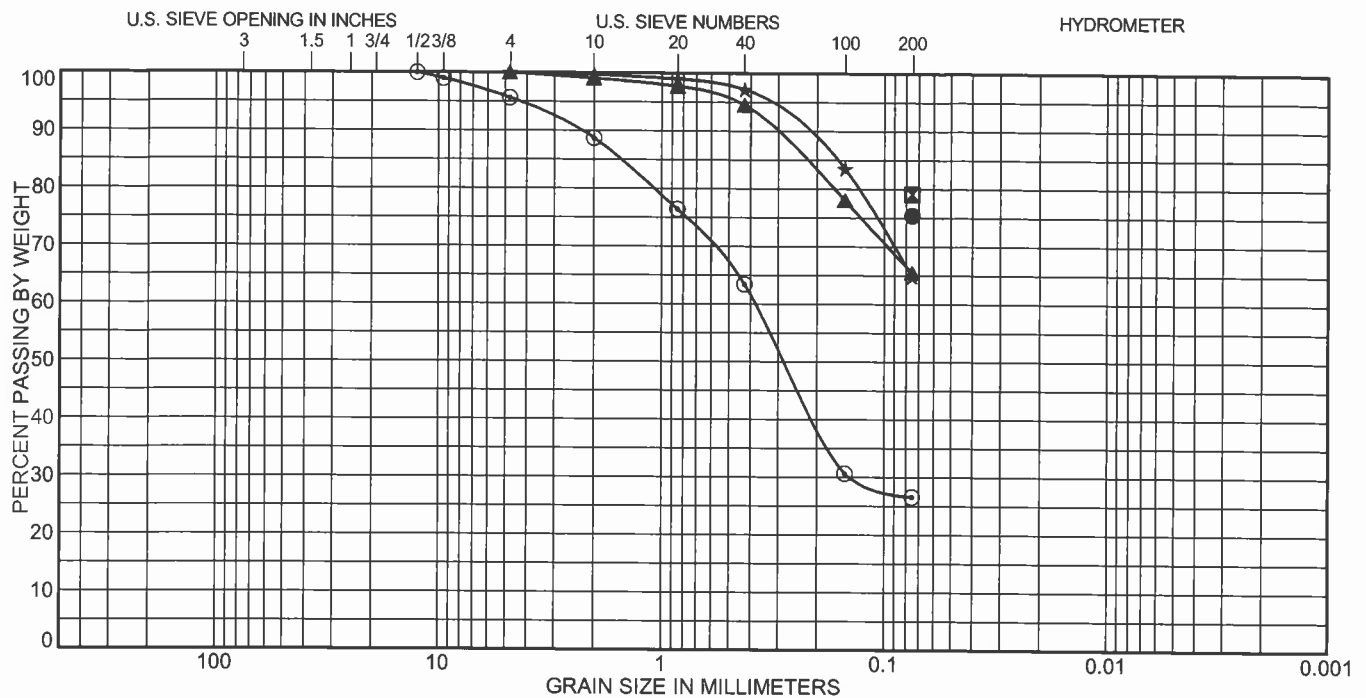
FIGURE No. 27

COBBLES	GRAVEL		SAND			SILT OR CLAY
	coarse	fine	coarse	medium	fine

Test Boring	Depth (ft)	Classification	LL	PL	PI	Cc	Cu
● 24	9.0	LEAN CLAY with SAND(CL)	32	18	14		
☒ 25	9.0	LEAN CLAY with SAND(CL)	49	18	31		
▲ 26	9.0	SANDY LEAN CLAY(CL)	37	15	22		
★ 26	14.0	SANDY LEAN CLAY(CL)	28	17	11		
⊙ 27	14.0	CLAYEY SAND(SC)	23	13	10

Test Boring	Depth (ft)	%Gravel	%Sand	%Silt	%Clay
● 24	9.0			75.4	
☒ 25	9.0			79.1	
▲ 26	9.0	0.0	34.5	65.5	
★ 26	14.0	0.0	35.2	64.8	
⊙ 27	14.0	4.4	69.1	26.6

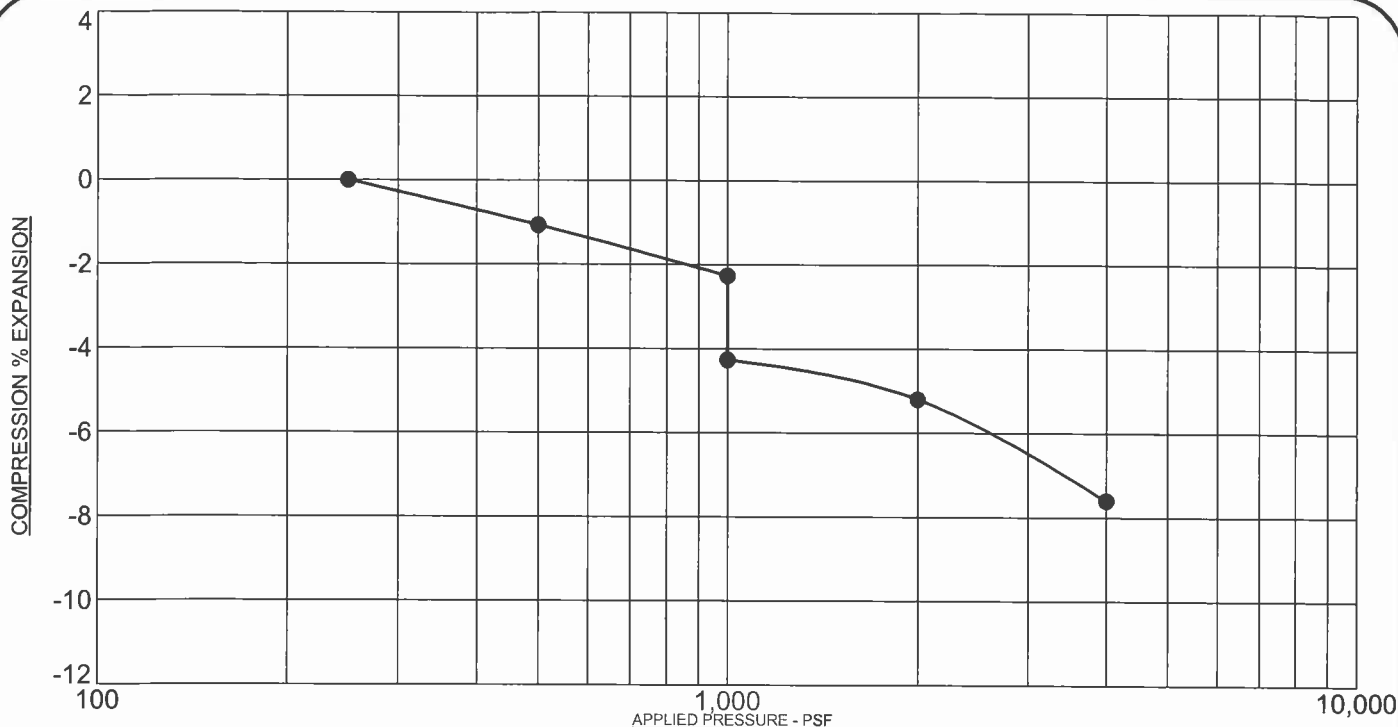
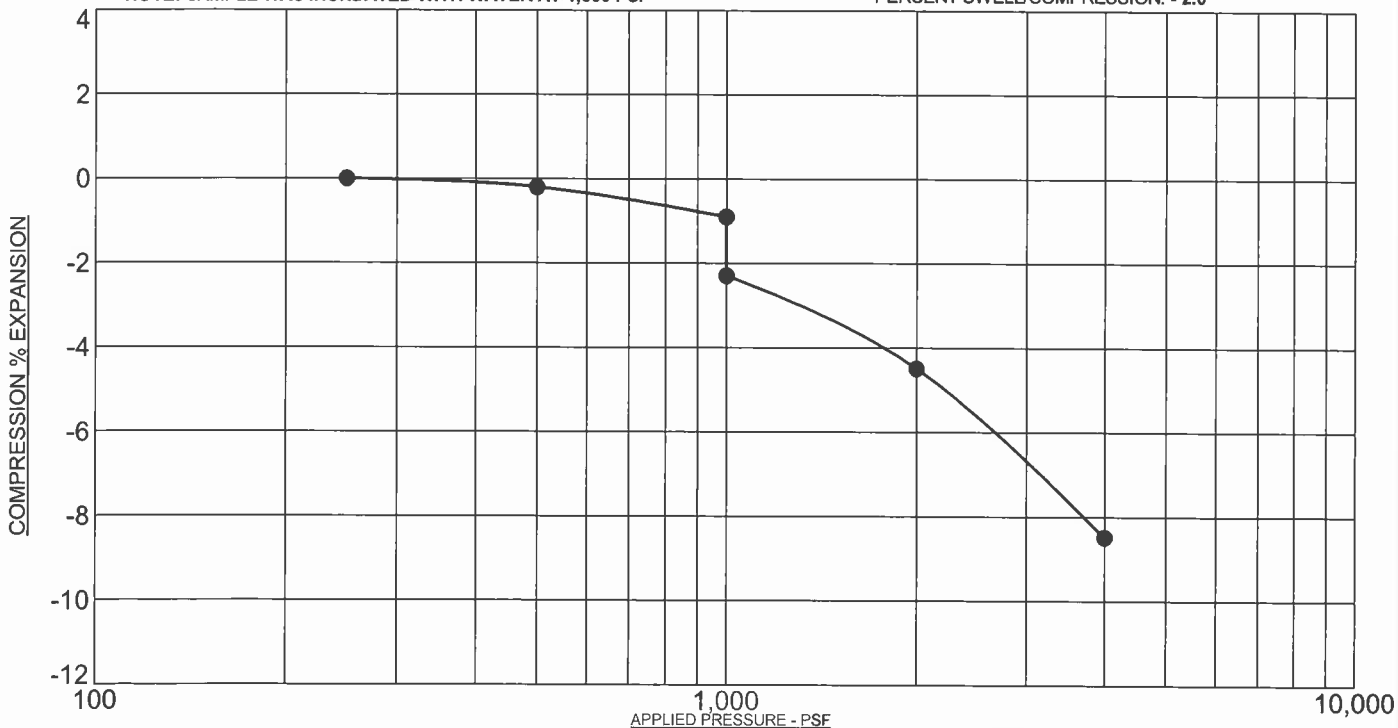
FIGURE No. 29

PROJECT: Countryside South El Paso County, Colorado
 RMG SOIL TYPE: 2
 SAMPLE DESCRIPTION: CLAY
 NOTE: SAMPLE WAS INUNDATED WITH WATER AT 1,000 PSF

SAMPLE LOCATION: 1 @ 4 FT
 NATURAL DRY UNIT WEIGHT: 112.0 PCF
 NATURAL MOISTURE CONTENT: 12.9%
 PERCENT SWELL/COMPRESSION: - 2.0

SAMPLE LOCATION: 3 @ 4 FT
 NATURAL DRY UNIT WEIGHT: 91.3 PCF
 NATURAL MOISTURE CONTENT: 13.1%
 PERCENT SWELL/COMPRESSION: - 1.4

SWELL/CONSOLIDATION TEST RESULTS

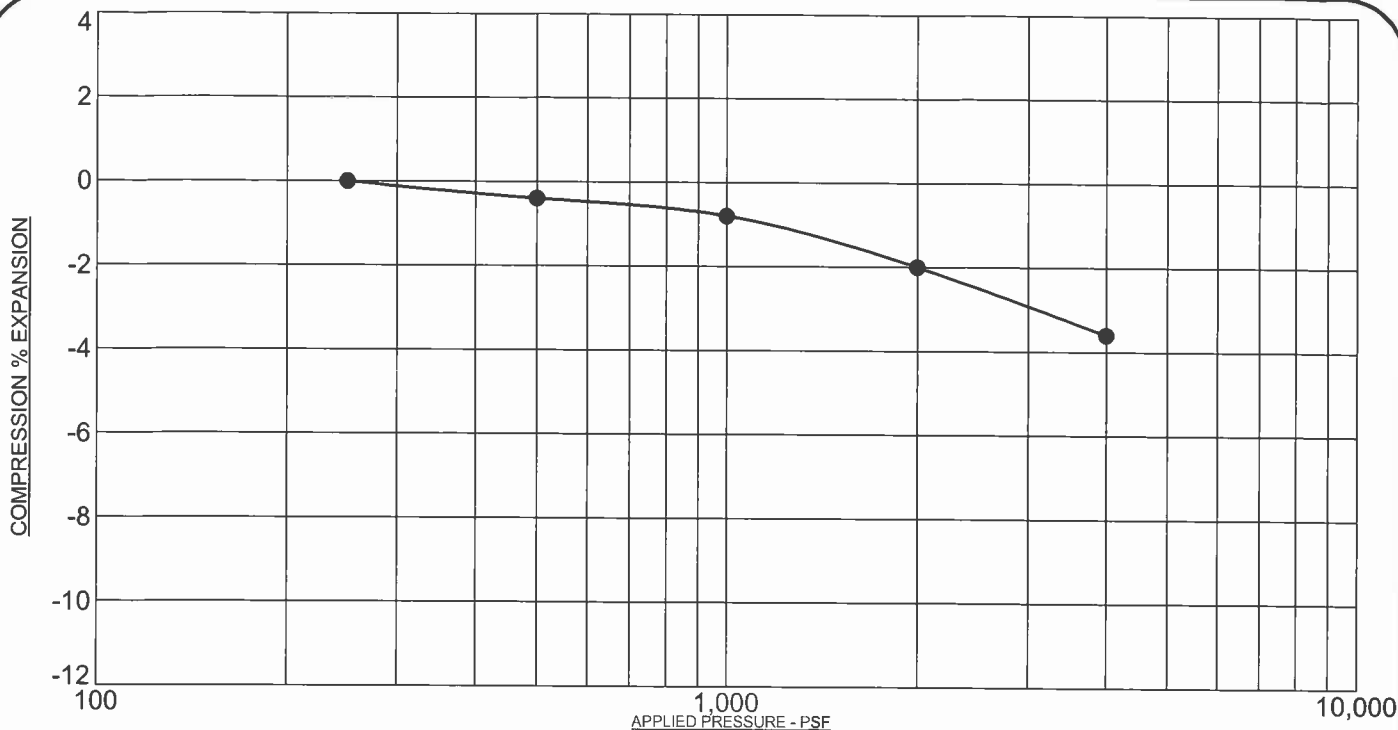
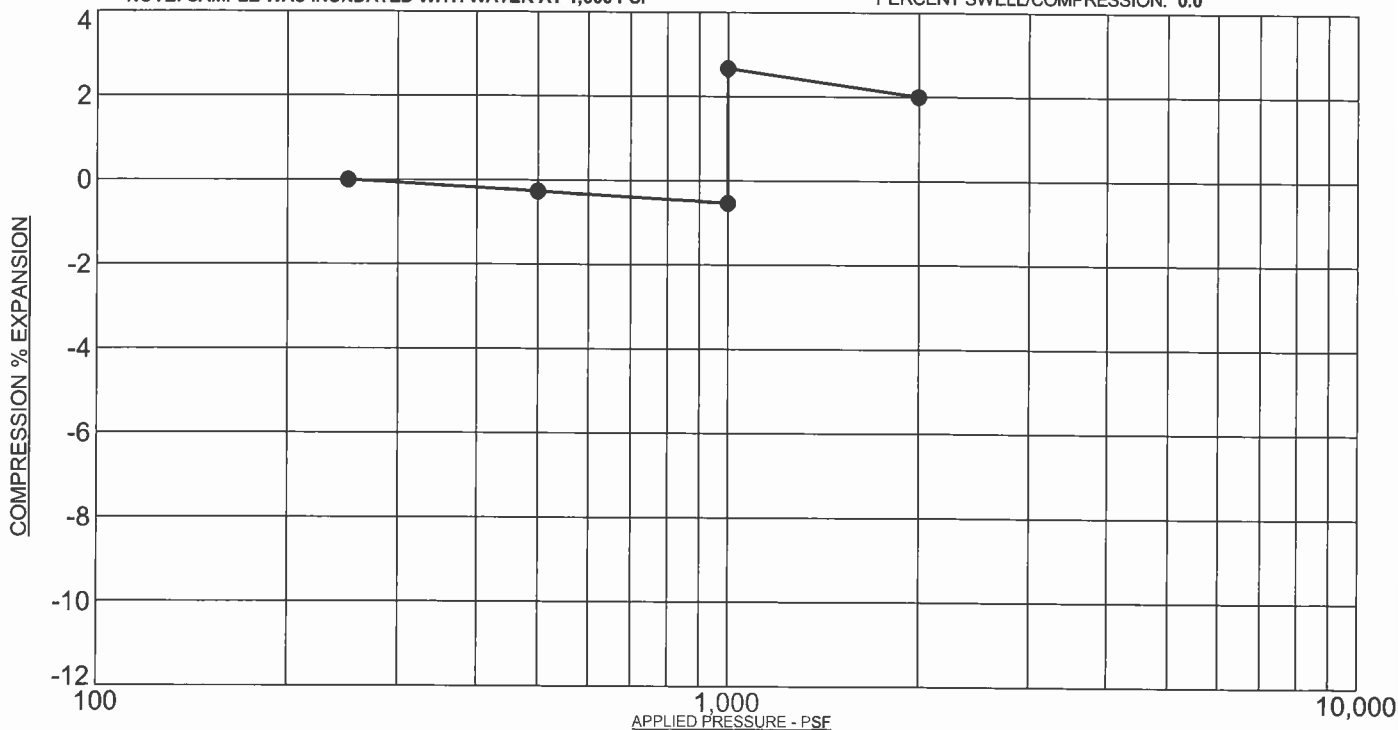
FIGURE No. 30

PROJECT: Countryside South El Paso County, Colorado
 RMG SOIL TYPE: 2
 SAMPLE DESCRIPTION: SANDY CLAY
 NOTE: SAMPLE WAS INUNDATED WITH WATER AT 1,000 PSF

SAMPLE LOCATION: 4 @ 9 FT
 NATURAL DRY UNIT WEIGHT: 109.5 PCF
 NATURAL MOISTURE CONTENT: 13.5%
 PERCENT SWELL/COMPRESSION: 0.0

SAMPLE LOCATION: 7 @ 9 FT
 NATURAL DRY UNIT WEIGHT: 115.1 PCF
 NATURAL MOISTURE CONTENT: 12.1%
 PERCENT SWELL/COMPRESSION: 3.2

SWELL/CONSOLIDATION TEST RESULTS

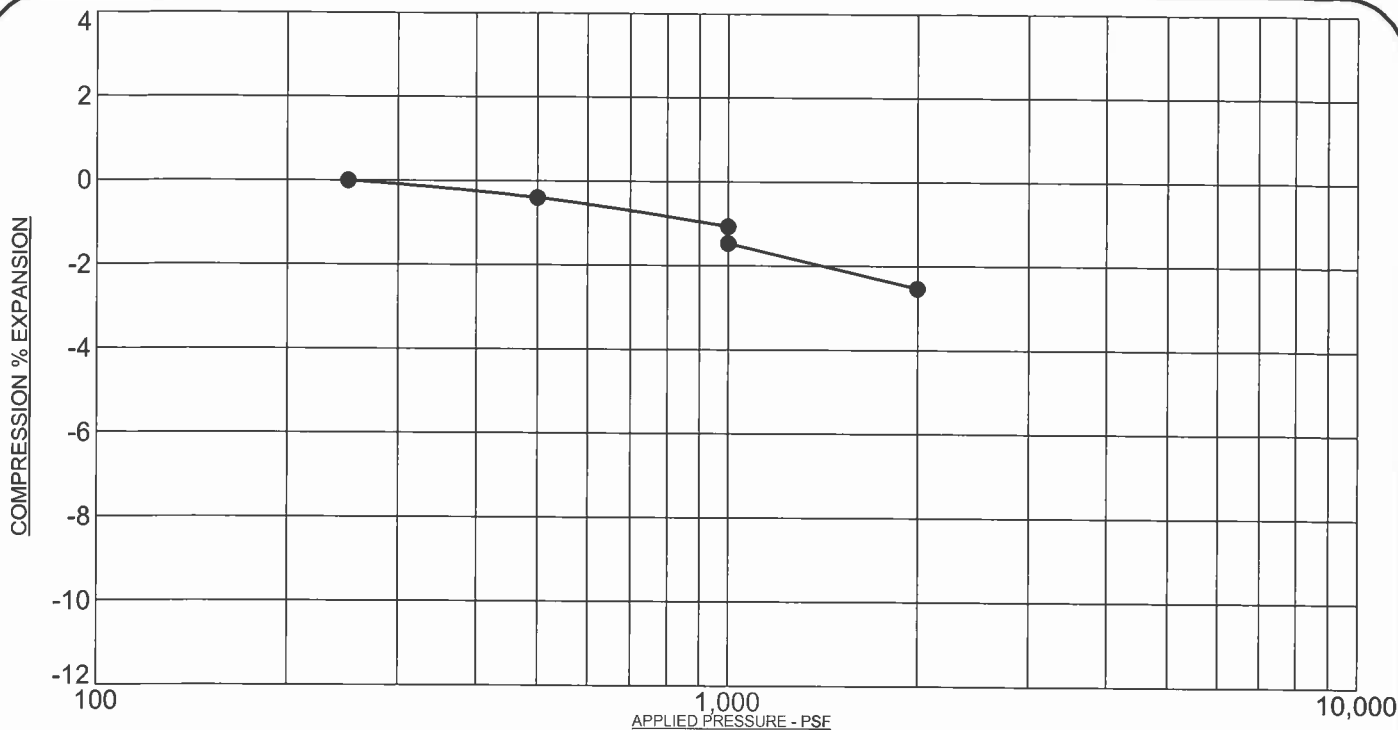
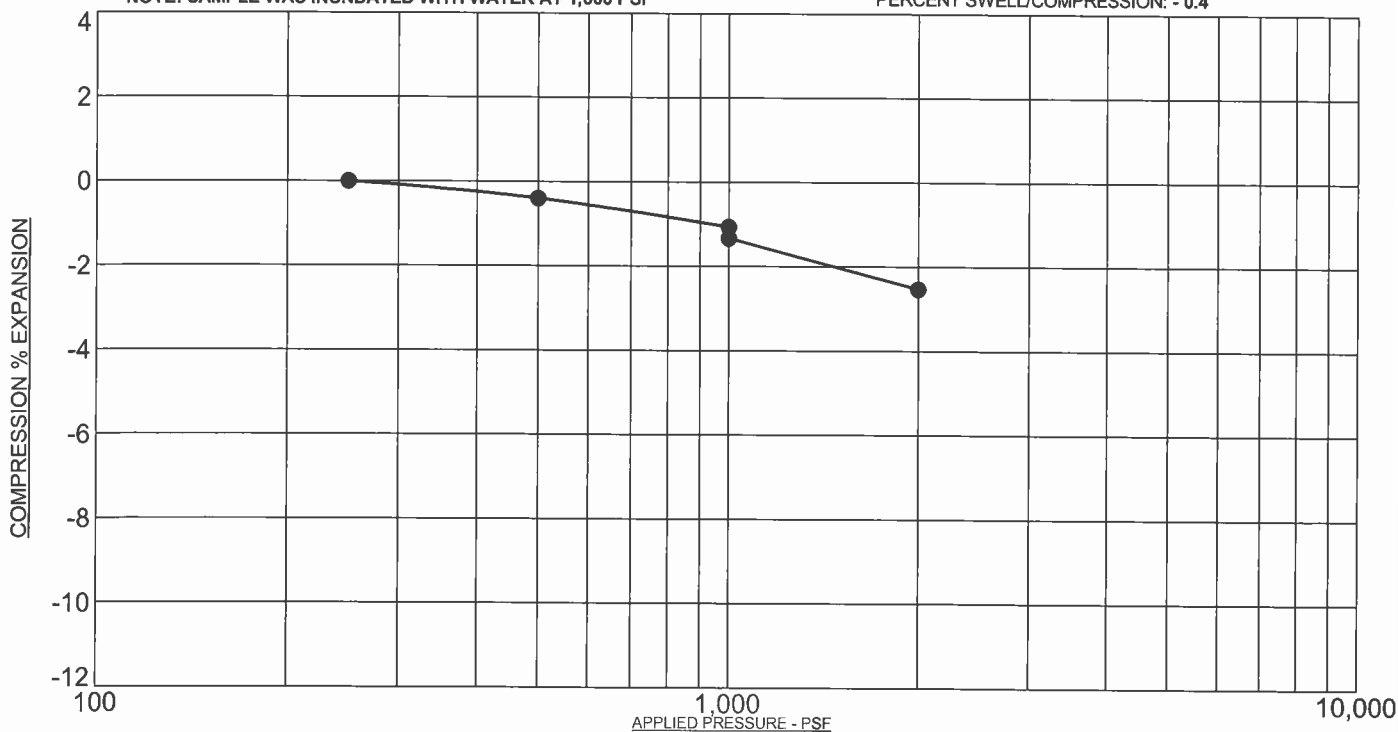
FIGURE No. 31

PROJECT: Countryside South El Paso County, Colorado
 RMG SOIL TYPE: 2
 SAMPLE DESCRIPTION: SANDY CLAY
 NOTE: SAMPLE WAS INUNDATED WITH WATER AT 1,000 PSF

SAMPLE LOCATION: 8 @ 14 FT
 NATURAL DRY UNIT WEIGHT: 110.3 PCF
 NATURAL MOISTURE CONTENT: 14.8%
 PERCENT SWELL/COMPRESSION: - 0.4

SAMPLE LOCATION: 9 @ 9 FT
 NATURAL DRY UNIT WEIGHT: 103.2 PCF
 NATURAL MOISTURE CONTENT: 20.8%
 PERCENT SWELL/COMPRESSION: - 0.3

SWELL/CONSOLIDATION TEST RESULTS

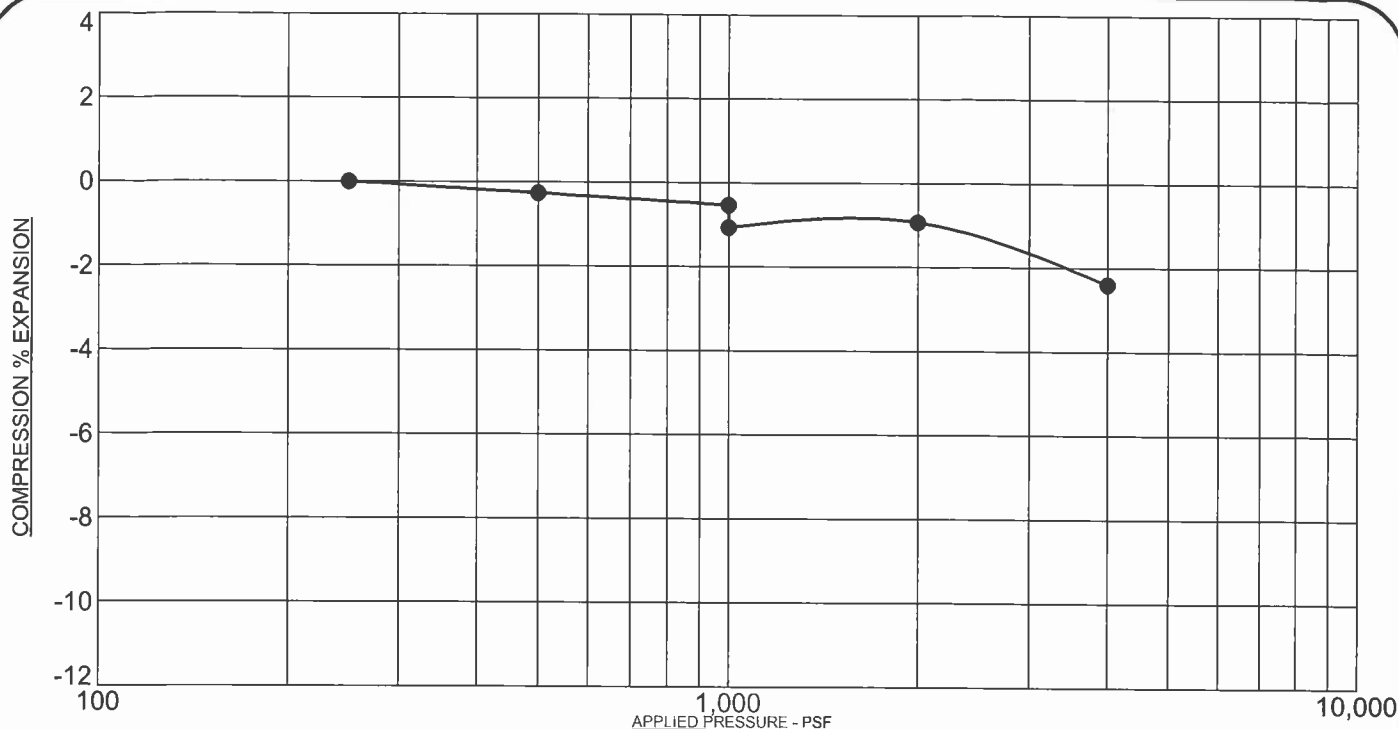
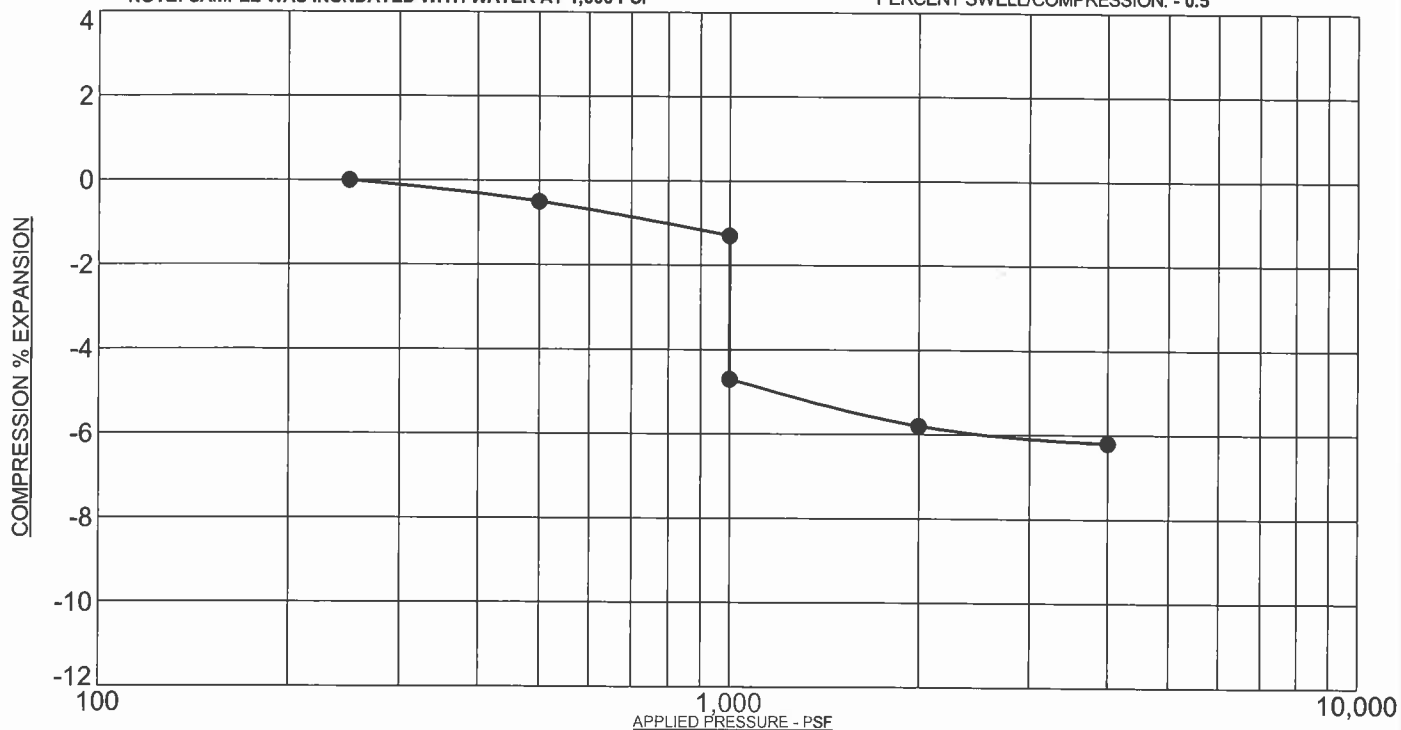
FIGURE No. 32

PROJECT: Countryside South El Paso County, Colorado
 RMG SOIL TYPE: 2
 SAMPLE DESCRIPTION: CLAY
 NOTE: SAMPLE WAS INUNDATED WITH WATER AT 1,000 PSF

SAMPLE LOCATION: 10 @ 4 FT
 NATURAL DRY UNIT WEIGHT: 106.9 PCF
 NATURAL MOISTURE CONTENT: 11.0%
 PERCENT SWELL/COMPRESSION: - 0.5

PROJECT: Countryside South El Paso County, Colorado
 RMG SOIL TYPE: 2
 SAMPLE DESCRIPTION: SANDY CLAY
 NOTE: SAMPLE WAS INUNDATED WITH WATER AT 1,000 PSF

SAMPLE LOCATION: 11 @ 4 FT
 NATURAL DRY UNIT WEIGHT: 86.7 PCF
 NATURAL MOISTURE CONTENT: 14.4%
 PERCENT SWELL/COMPRESSION: - 3.4

SWELL/CONSOLIDATION TEST RESULTS

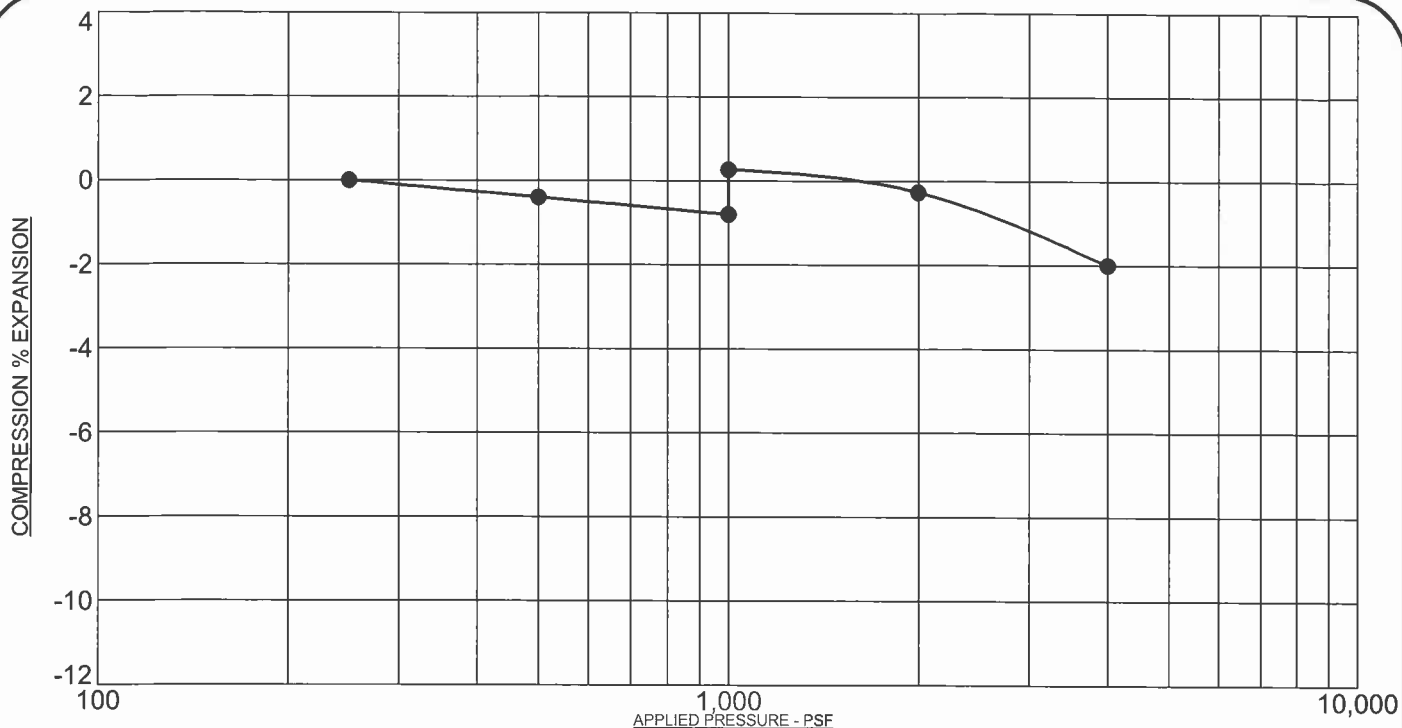
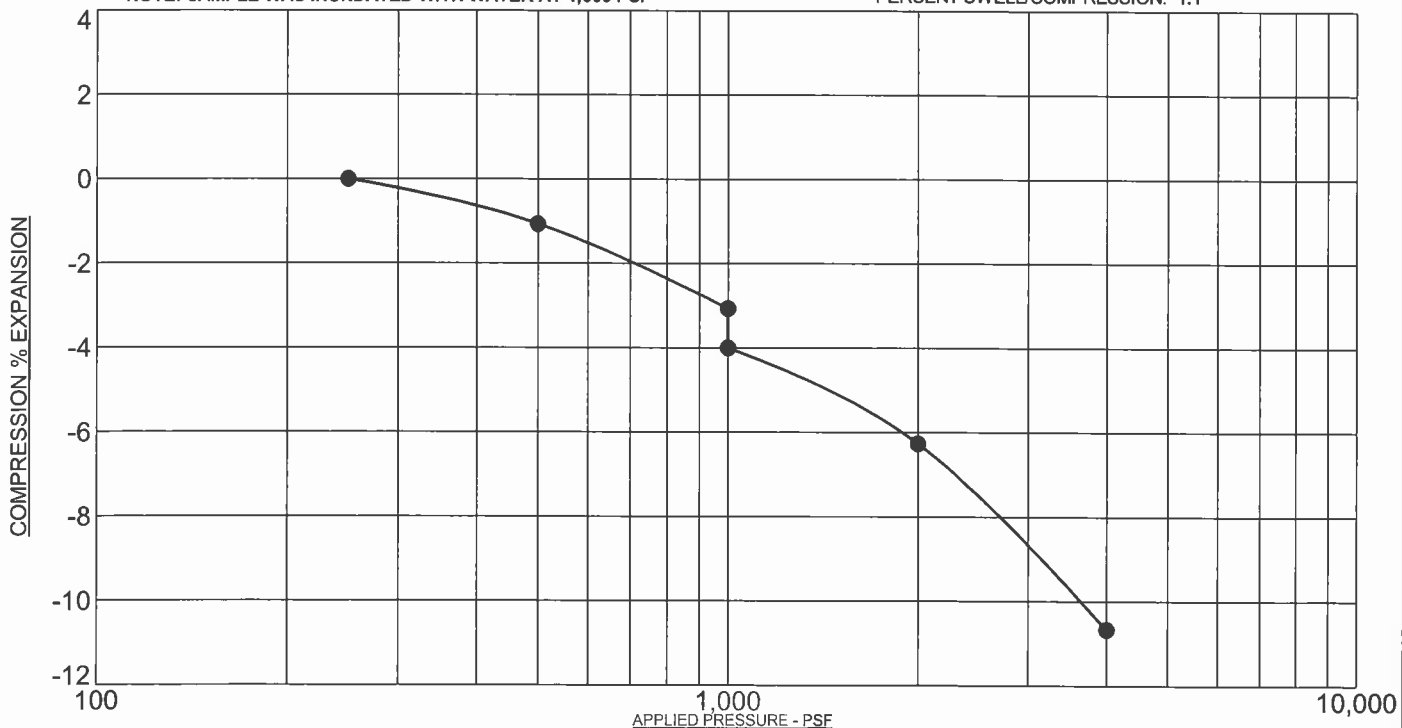
FIGURE No. 33

PROJECT: Countryside South El Paso County, Colorado
 RMG SOIL TYPE: 2
 SAMPLE DESCRIPTION: SANDY CLAY
 NOTE: SAMPLE WAS INUNDATED WITH WATER AT 1,000 PSF

SAMPLE LOCATION: 12 @ 9 FT
 NATURAL DRY UNIT WEIGHT: 105.6 PCF
 NATURAL MOISTURE CONTENT: 20.3%
 PERCENT SWELL/COMPRESSION: 1.1

PROJECT: Countryside South El Paso County, Colorado
 RMG SOIL TYPE: 2
 SAMPLE DESCRIPTION: CLAY
 NOTE: SAMPLE WAS INUNDATED WITH WATER AT 1,000 PSF

SAMPLE LOCATION: 13 @ 14 FT
 NATURAL DRY UNIT WEIGHT: 94.2 PCF
 NATURAL MOISTURE CONTENT: 27.1%
 PERCENT SWELL/COMPRESSION: - 0.9

SWELL/CONSOLIDATION TEST RESULTS

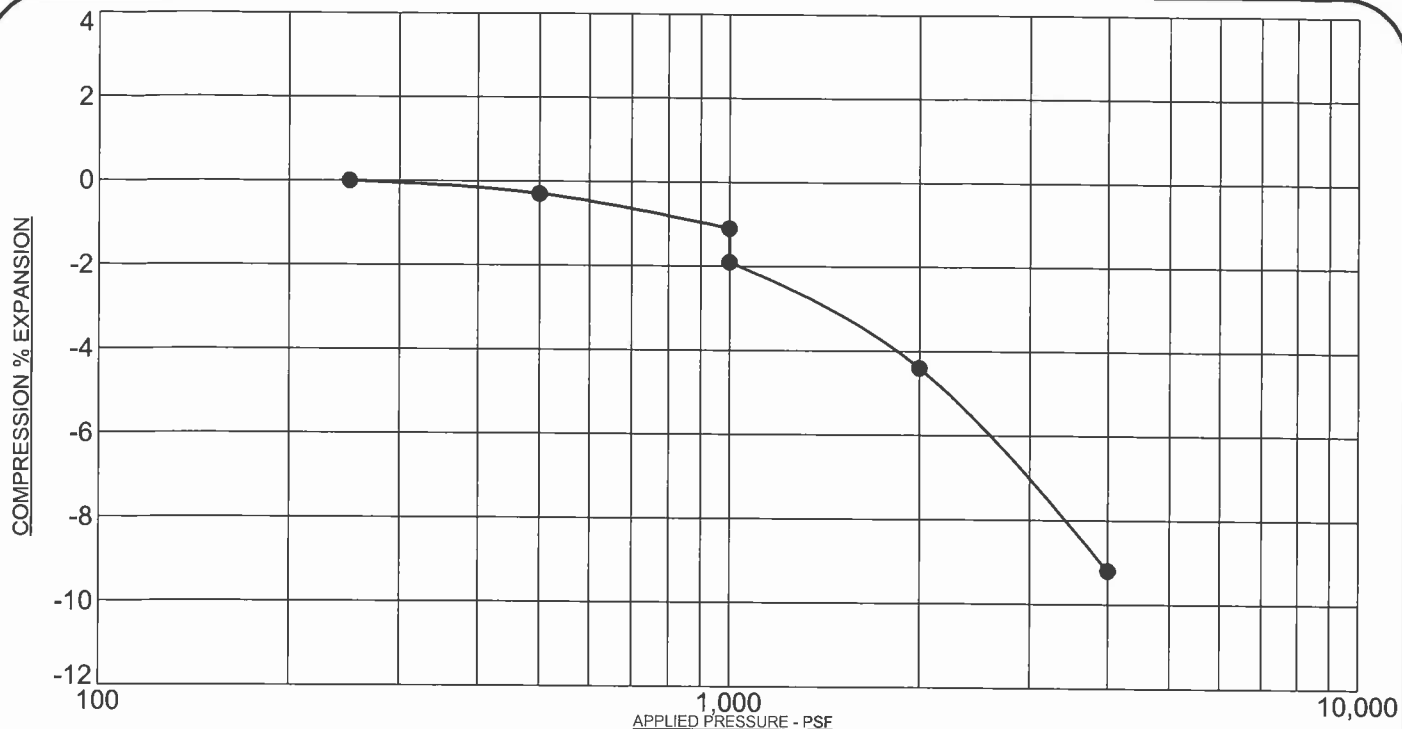
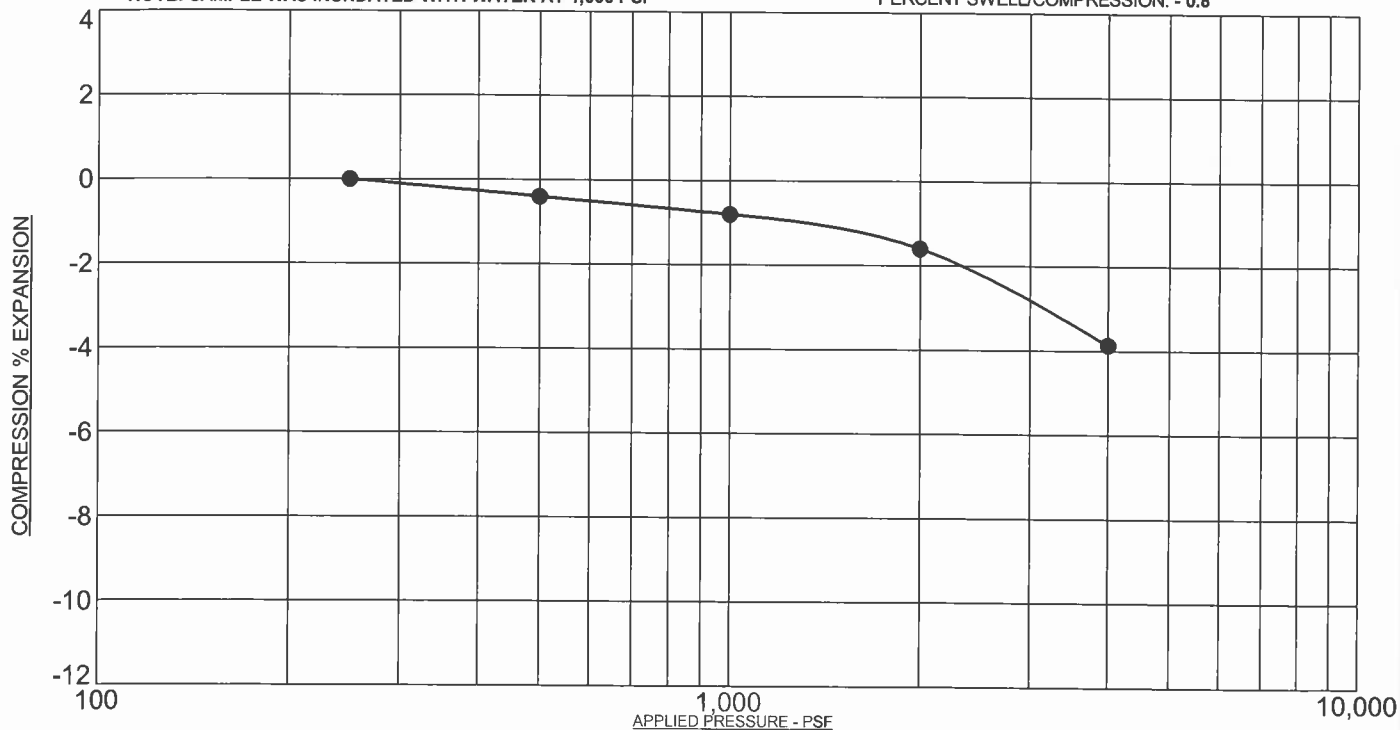
FIGURE No. 34

PROJECT: Countryside South El Paso County, Colorado
 RMG SOIL TYPE: 2
 SAMPLE DESCRIPTION: SANDY CLAY
 NOTE: SAMPLE WAS INUNDATED WITH WATER AT 1,000 PSF

SAMPLE LOCATION: 15 @ 4 FT
 NATURAL DRY UNIT WEIGHT: 87.2 PCF
 NATURAL MOISTURE CONTENT: 15.0%
 PERCENT SWELL/COMPRESSION: - 0.8

SAMPLE LOCATION: 18 @ 9 FT
 NATURAL DRY UNIT WEIGHT: 103.9 PCF
 NATURAL MOISTURE CONTENT: 17.4%
 PERCENT SWELL/COMPRESSION: 0.0

SWELL/CONSOLIDATION TEST RESULTS

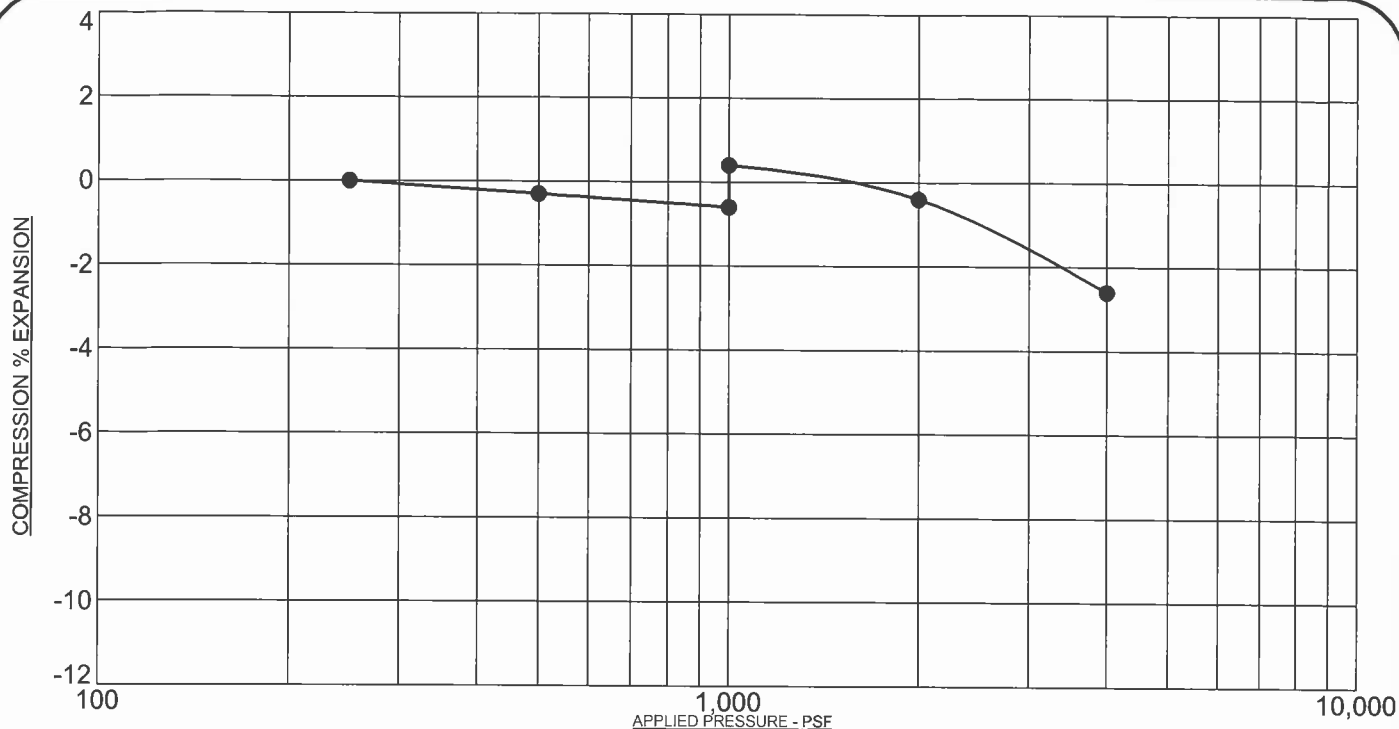
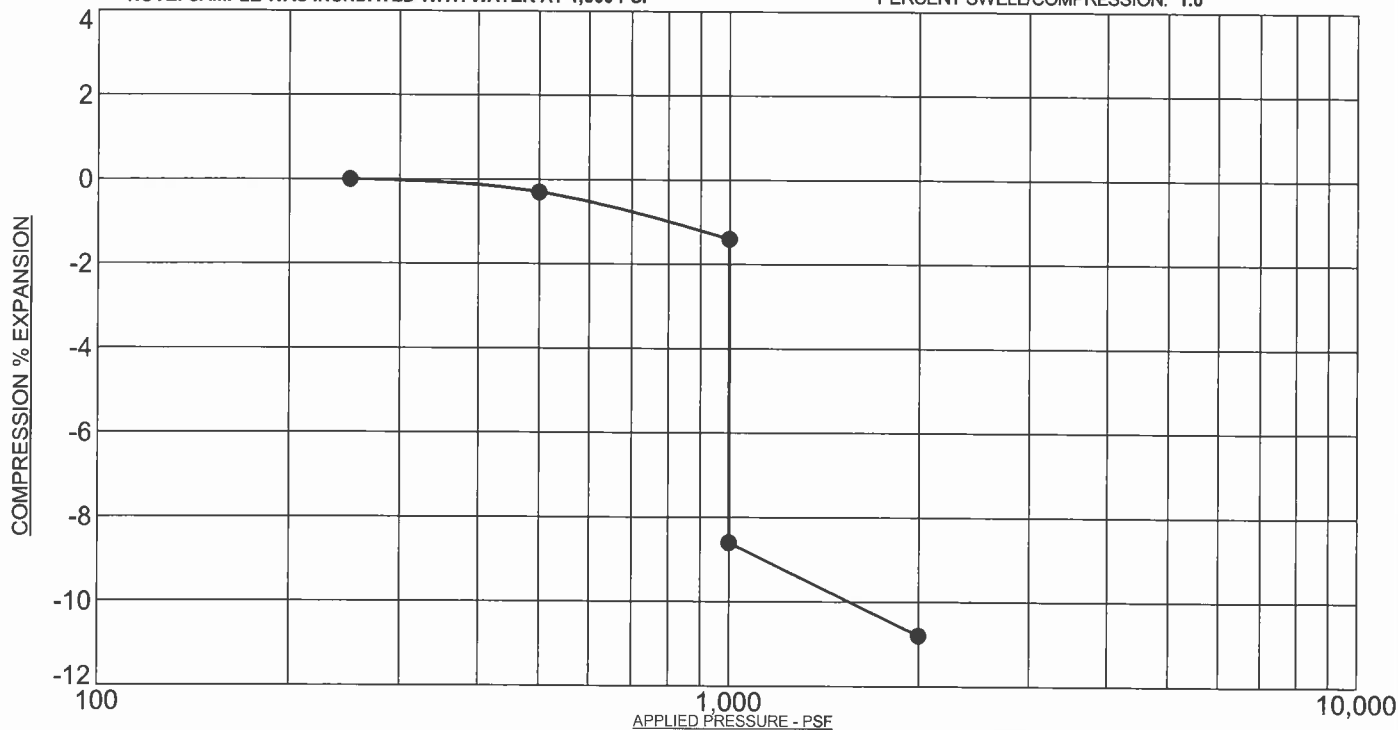
FIGURE No. 35

PROJECT: Countryside South El Paso County, Colorado
 RMG SOIL TYPE: 2
 SAMPLE DESCRIPTION: SANDY CLAY
 NOTE: SAMPLE WAS INUNDATED WITH WATER AT 1,000 PSF

SAMPLE LOCATION: 20 @ 4 FT
 NATURAL DRY UNIT WEIGHT: 101.8 PCF
 NATURAL MOISTURE CONTENT: 14.8%
 PERCENT SWELL/COMPRESSION: 1.0

SAMPLE LOCATION: 21 @ 9 FT
 NATURAL DRY UNIT WEIGHT: 90.6 PCF
 NATURAL MOISTURE CONTENT: 9.0%
 PERCENT SWELL/COMPRESSION: -7.2

SWELL/CONSOLIDATION TEST RESULTS
