SOILS AND GEOLOGY REPORT

COUNTRYSIDE SOUTH EL PASO COUNTY, COLORADO

JOB NO. 135524

December 14, 2012

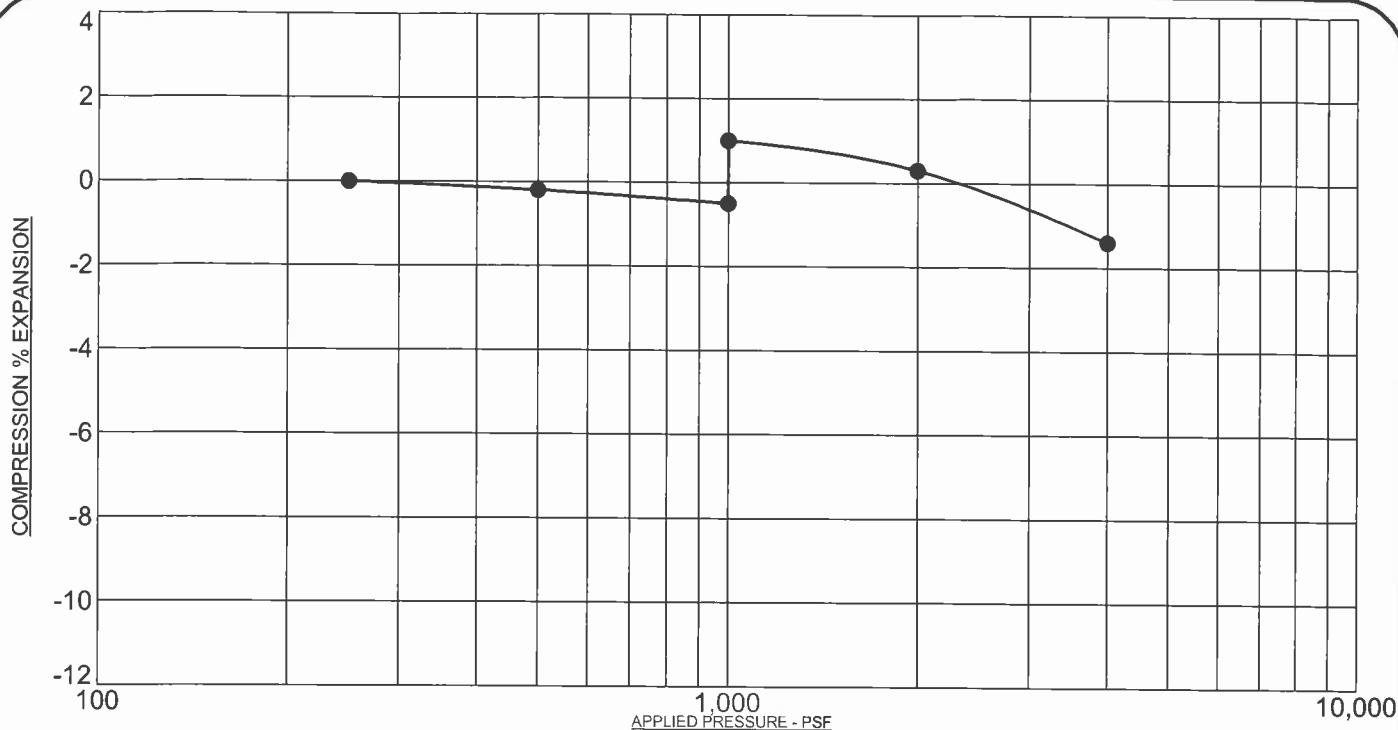
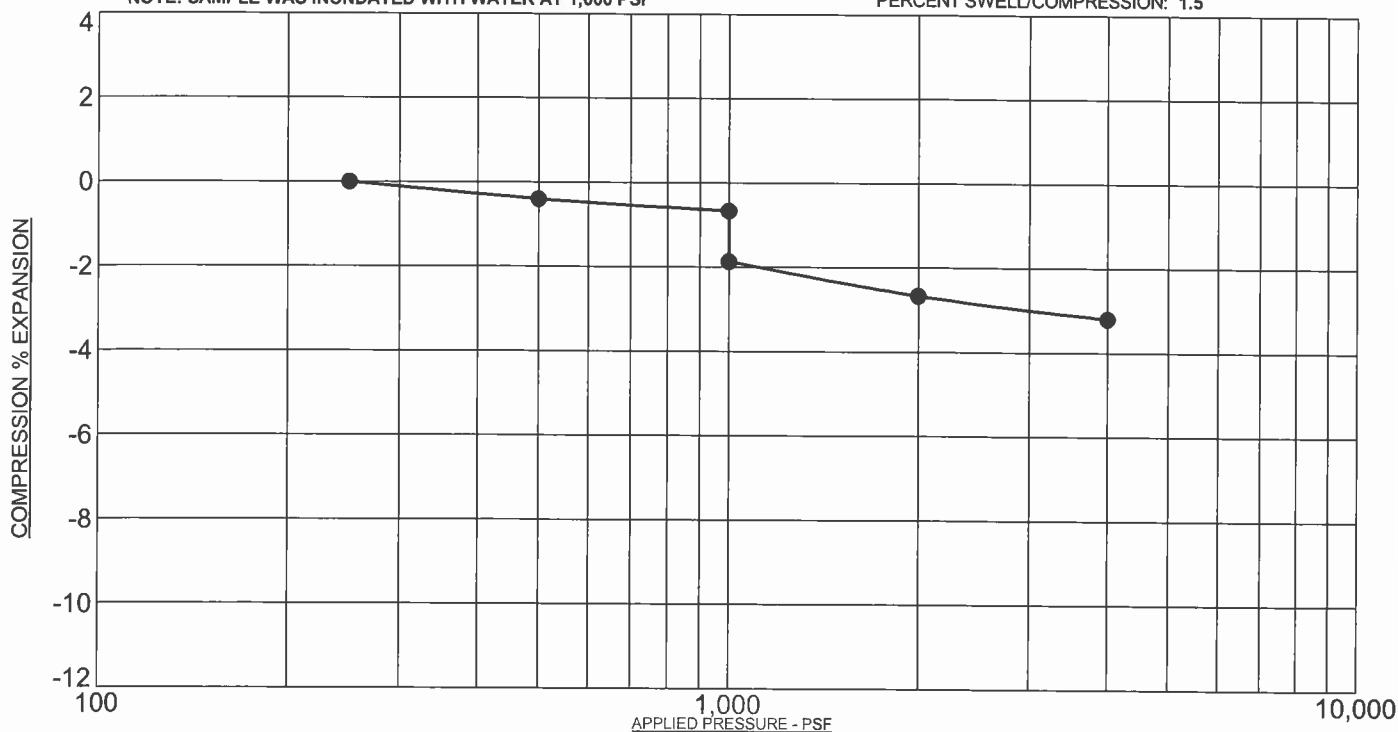
FIGURE No. 36

PROJECT: Countryside South El Paso County, Colorado
 RMG SOIL TYPE: 2
 SAMPLE DESCRIPTION: SANDY CLAY
 NOTE: SAMPLE WAS INUNDATED WITH WATER AT 1,000 PSF

SAMPLE LOCATION: 22 @ 4 FT
 NATURAL DRY UNIT WEIGHT: 103.4 PCF
 NATURAL MOISTURE CONTENT: 15.1%
 PERCENT SWELL/COMPRESSION: 1.5

SAMPLE LOCATION: 23 @ 14 FT
 NATURAL DRY UNIT WEIGHT: 105.3 PCF
 NATURAL MOISTURE CONTENT: 8.6%
 PERCENT SWELL/COMPRESSION: - 1.2

SWELL/CONSOLIDATION TEST RESULTS

Soil laboratory testing was performed as part of this investigation. The laboratory tests included moisture content, dry density, grain-size analyses, Atterberg Limits and Swell/Consolidation tests. A Summary of Laboratory Test Results is presented in Figure 21. Soils Classification Data is presented in Figures 22 through 28. Swell/Consolidation Test Results are presented in Figures 29 through 38.

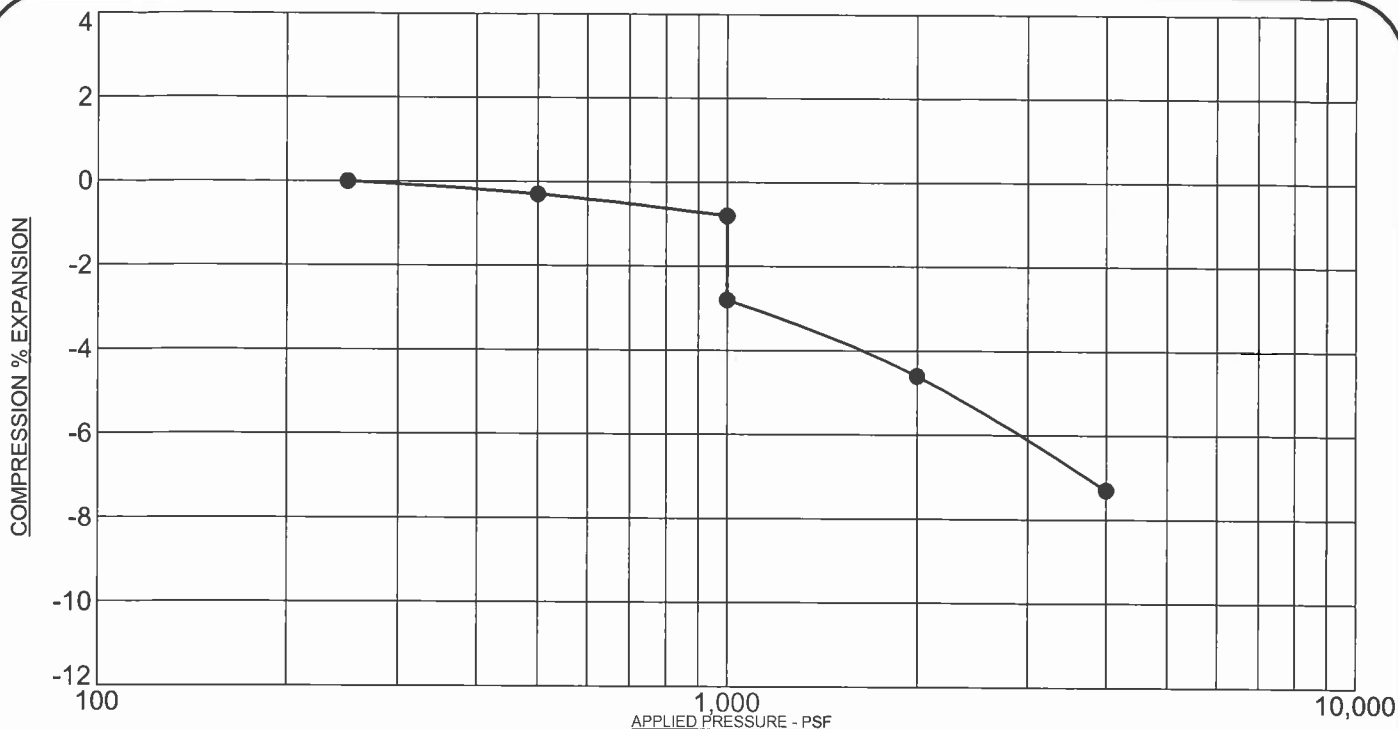
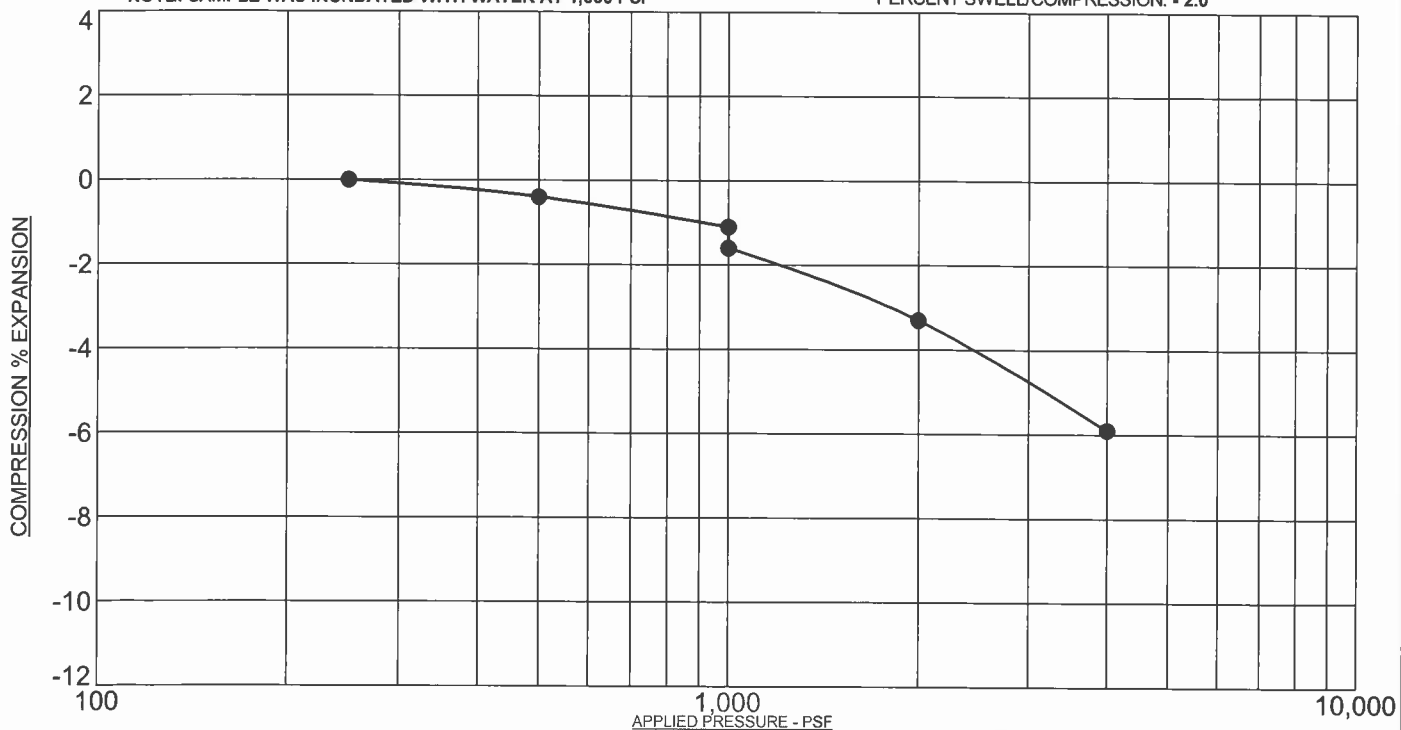
FIGURE No. 37

PROJECT: Countryside South El Paso County, Colorado
 RMG SOIL TYPE: 2
 SAMPLE DESCRIPTION: SANDY CLAY
 NOTE: SAMPLE WAS INUNDATED WITH WATER AT 1,000 PSF

SAMPLE LOCATION: 24 @ 9 FT
 NATURAL DRY UNIT WEIGHT: 93.0 PCF
 NATURAL MOISTURE CONTENT: 11.0%
 PERCENT SWELL/COMPRESSION: - 2.0

PROJECT: Countryside South El Paso County, Colorado
 RMG SOIL TYPE: 2
 SAMPLE DESCRIPTION: CLAY
 NOTE: SAMPLE WAS INUNDATED WITH WATER AT 1,000 PSF

SAMPLE LOCATION: 29 @ 9 FT
 NATURAL DRY UNIT WEIGHT: 99.4 PCF
 NATURAL MOISTURE CONTENT: 23.8%
 PERCENT SWELL/COMPRESSION: - 0.5

SWELL/CONSOLIDATION TEST RESULTS

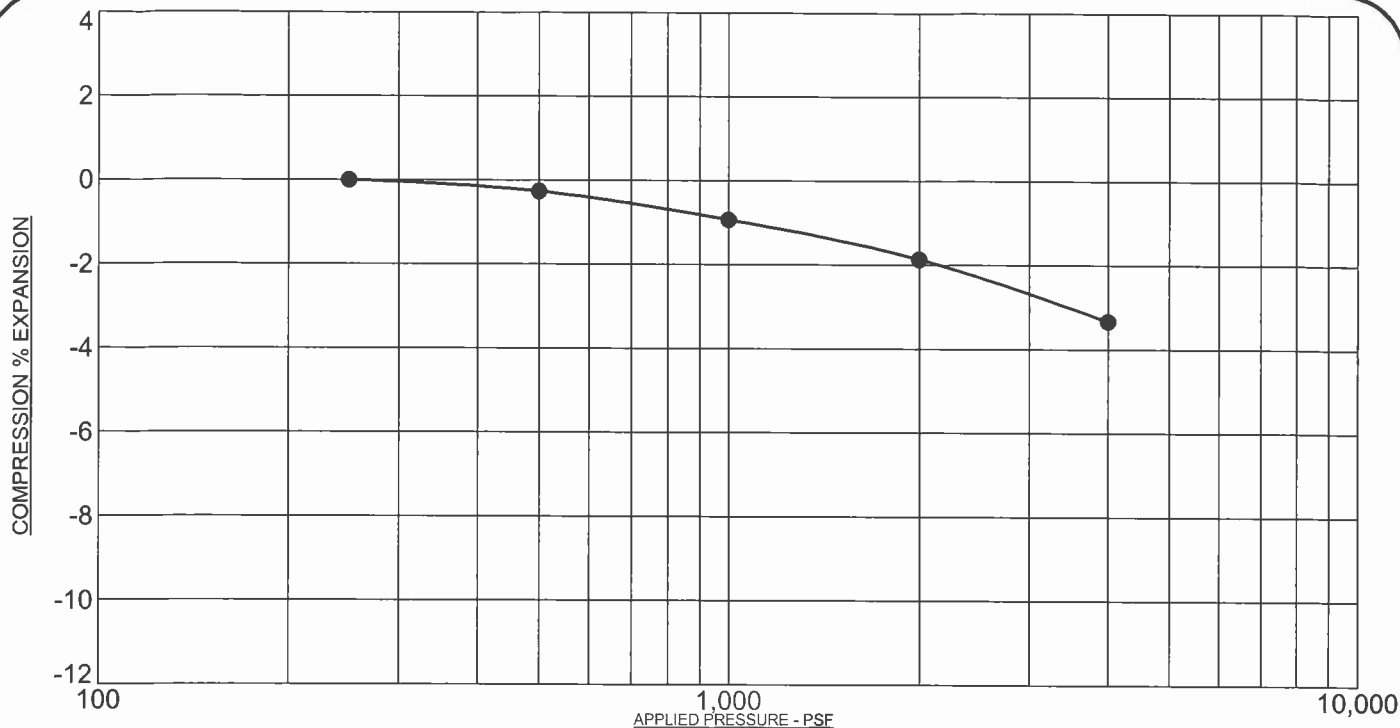
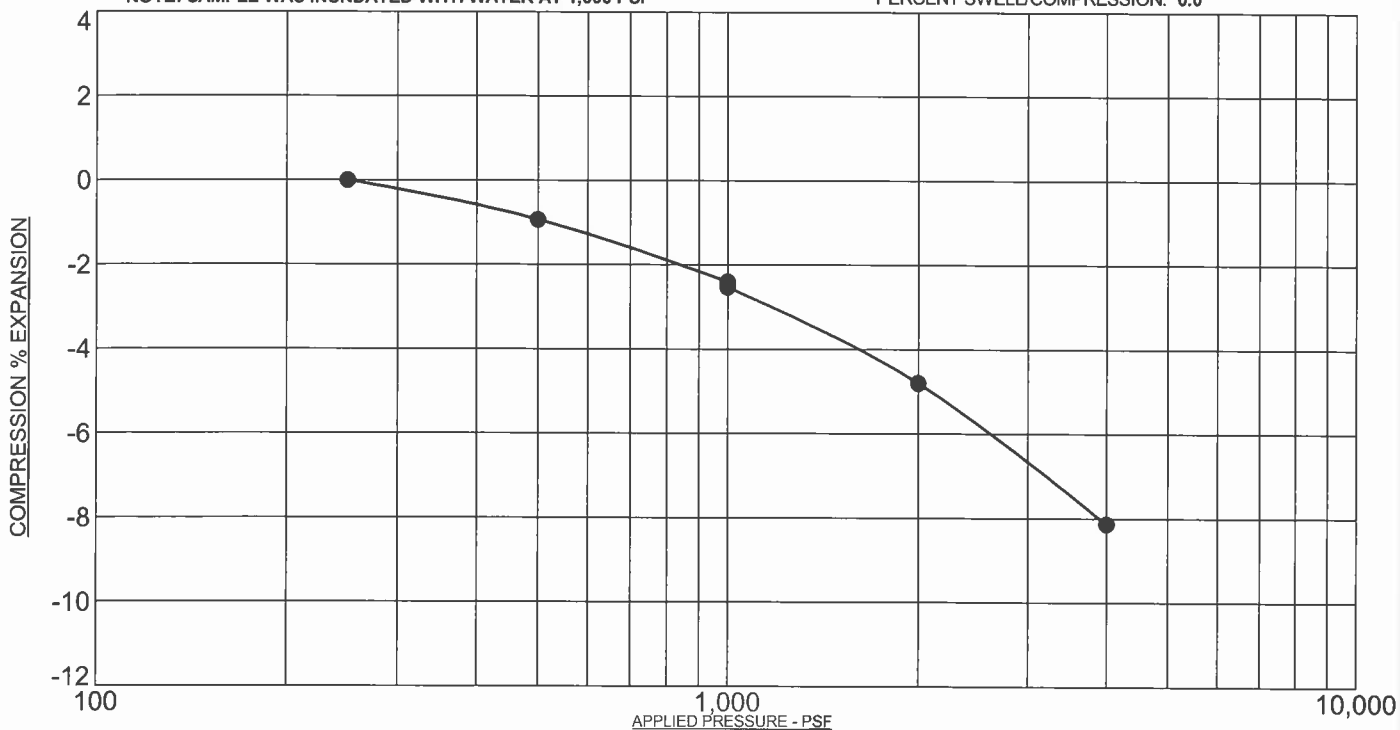
FIGURE No. 38

PROJECT: Countryside South El Paso County, Colorado
 RMG SOIL TYPE: 2
 SAMPLE DESCRIPTION: SANDY CLAY
 NOTE: SAMPLE WAS INUNDATED WITH WATER AT 1,000 PSF

SAMPLE LOCATION: 30 @ 4 FT
 NATURAL DRY UNIT WEIGHT: 113.4 PCF
 NATURAL MOISTURE CONTENT: 15.7%
 PERCENT SWELL/COMPRESSION: 0.0

PROJECT: Countryside South El Paso County, Colorado
 RMG SOIL TYPE: 2
 SAMPLE DESCRIPTION: CLAY TO SANDY CLAY
 NOTE: SAMPLE WAS INUNDATED WITH WATER AT 1,000 PSF

SAMPLE LOCATION: 32 @ 14 FT
 NATURAL DRY UNIT WEIGHT: 99.1 PCF
 NATURAL MOISTURE CONTENT: 25.0%
 PERCENT SWELL/COMPRESSION: - 0.1

SWELL/CONSOLIDATION TEST RESULTS

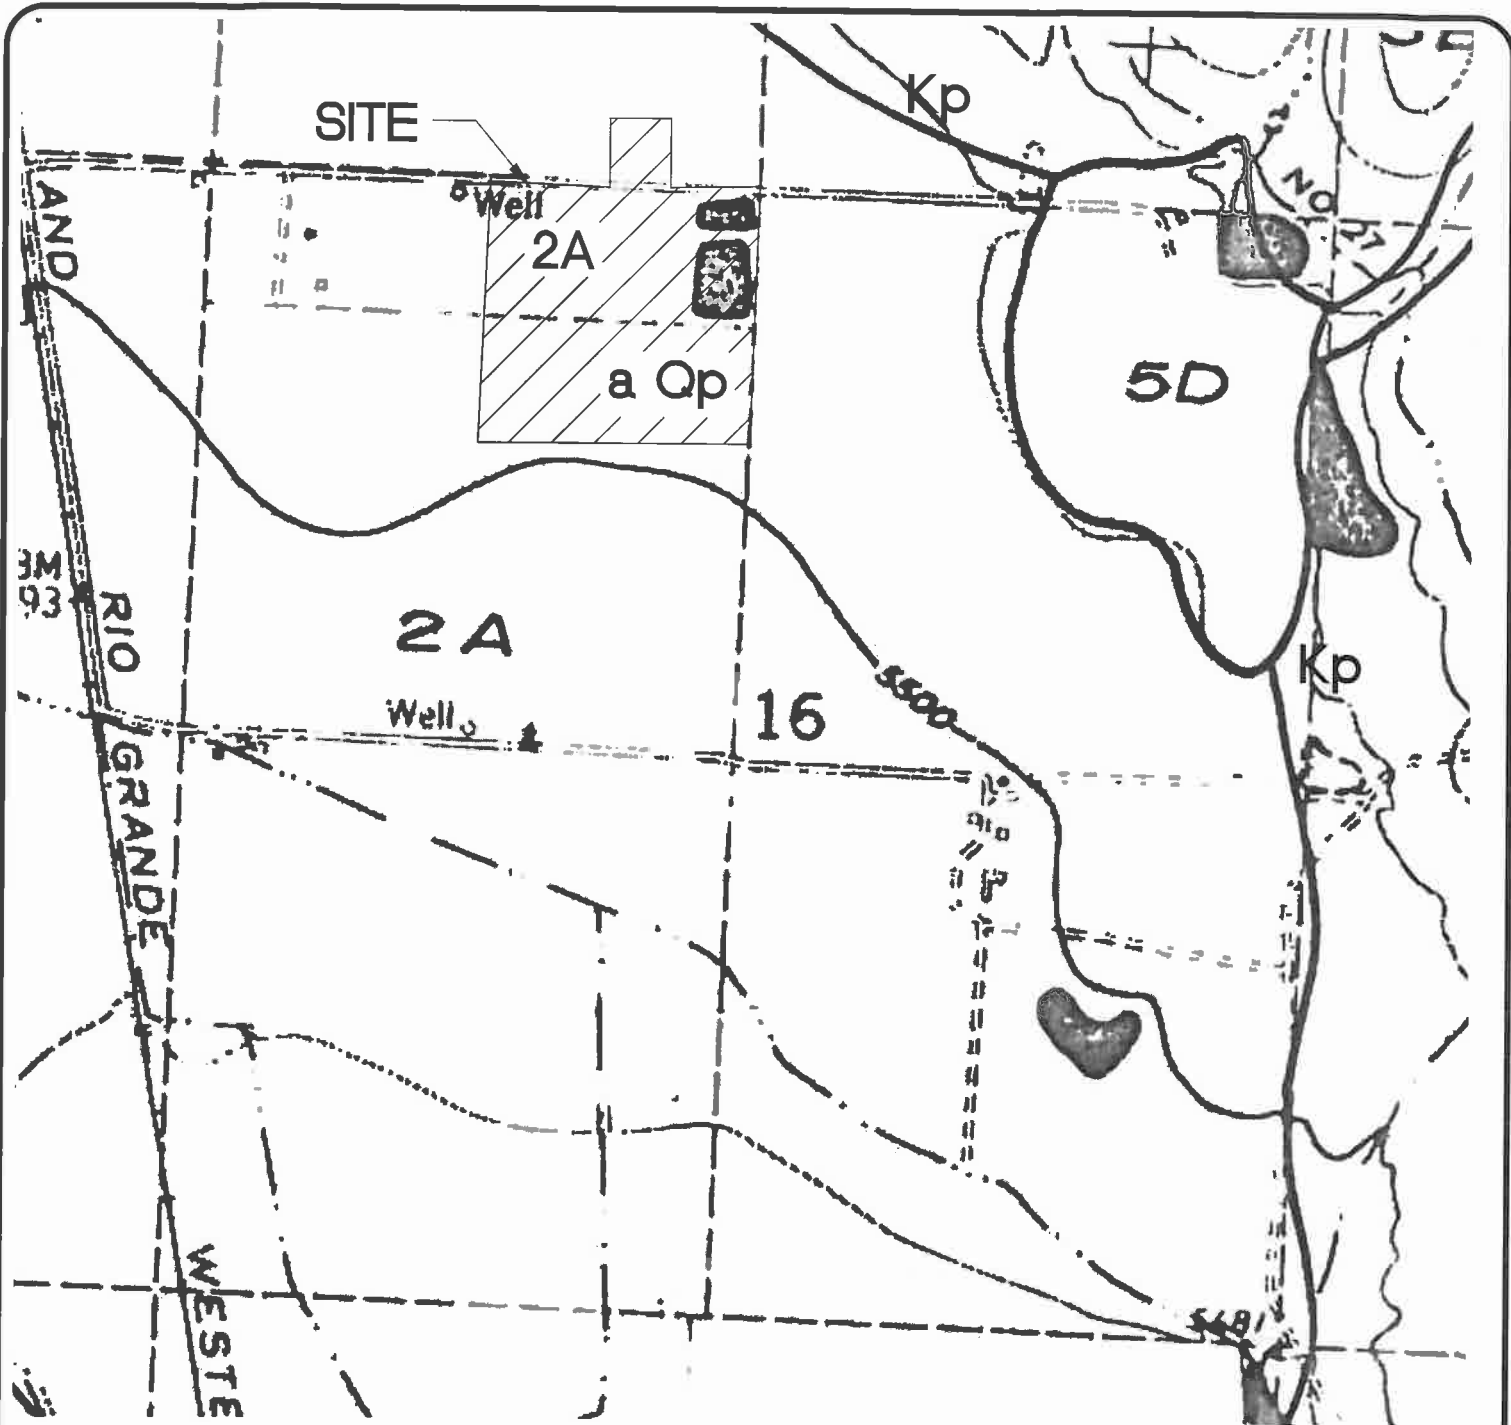
FIG No. 39

a Qp - Piney Creek Alluvium (Upper Holocene)

In general, the geology at the site consists of stream deposits and alluvium soils. A General Engineering Geology Map is presented in Figure 39. One geologic unit and one environmental engineering unit were mapped at the site as:
