**ENTECH**  
ENGINEERING, INC.

**PRELIMINARY SOIL, GEOLOGY, GEOLOGIC HAZARD,  
AND WASTEWATER STUDY,  
WINSOME SUBDIVISION  
PARCEL NO. 51000-00-493  
17480 MERIDIAN ROAD NORTH  
EL PASO COUNTY, COLORADO**

October 2, 2018  
Revised January 11, 2019

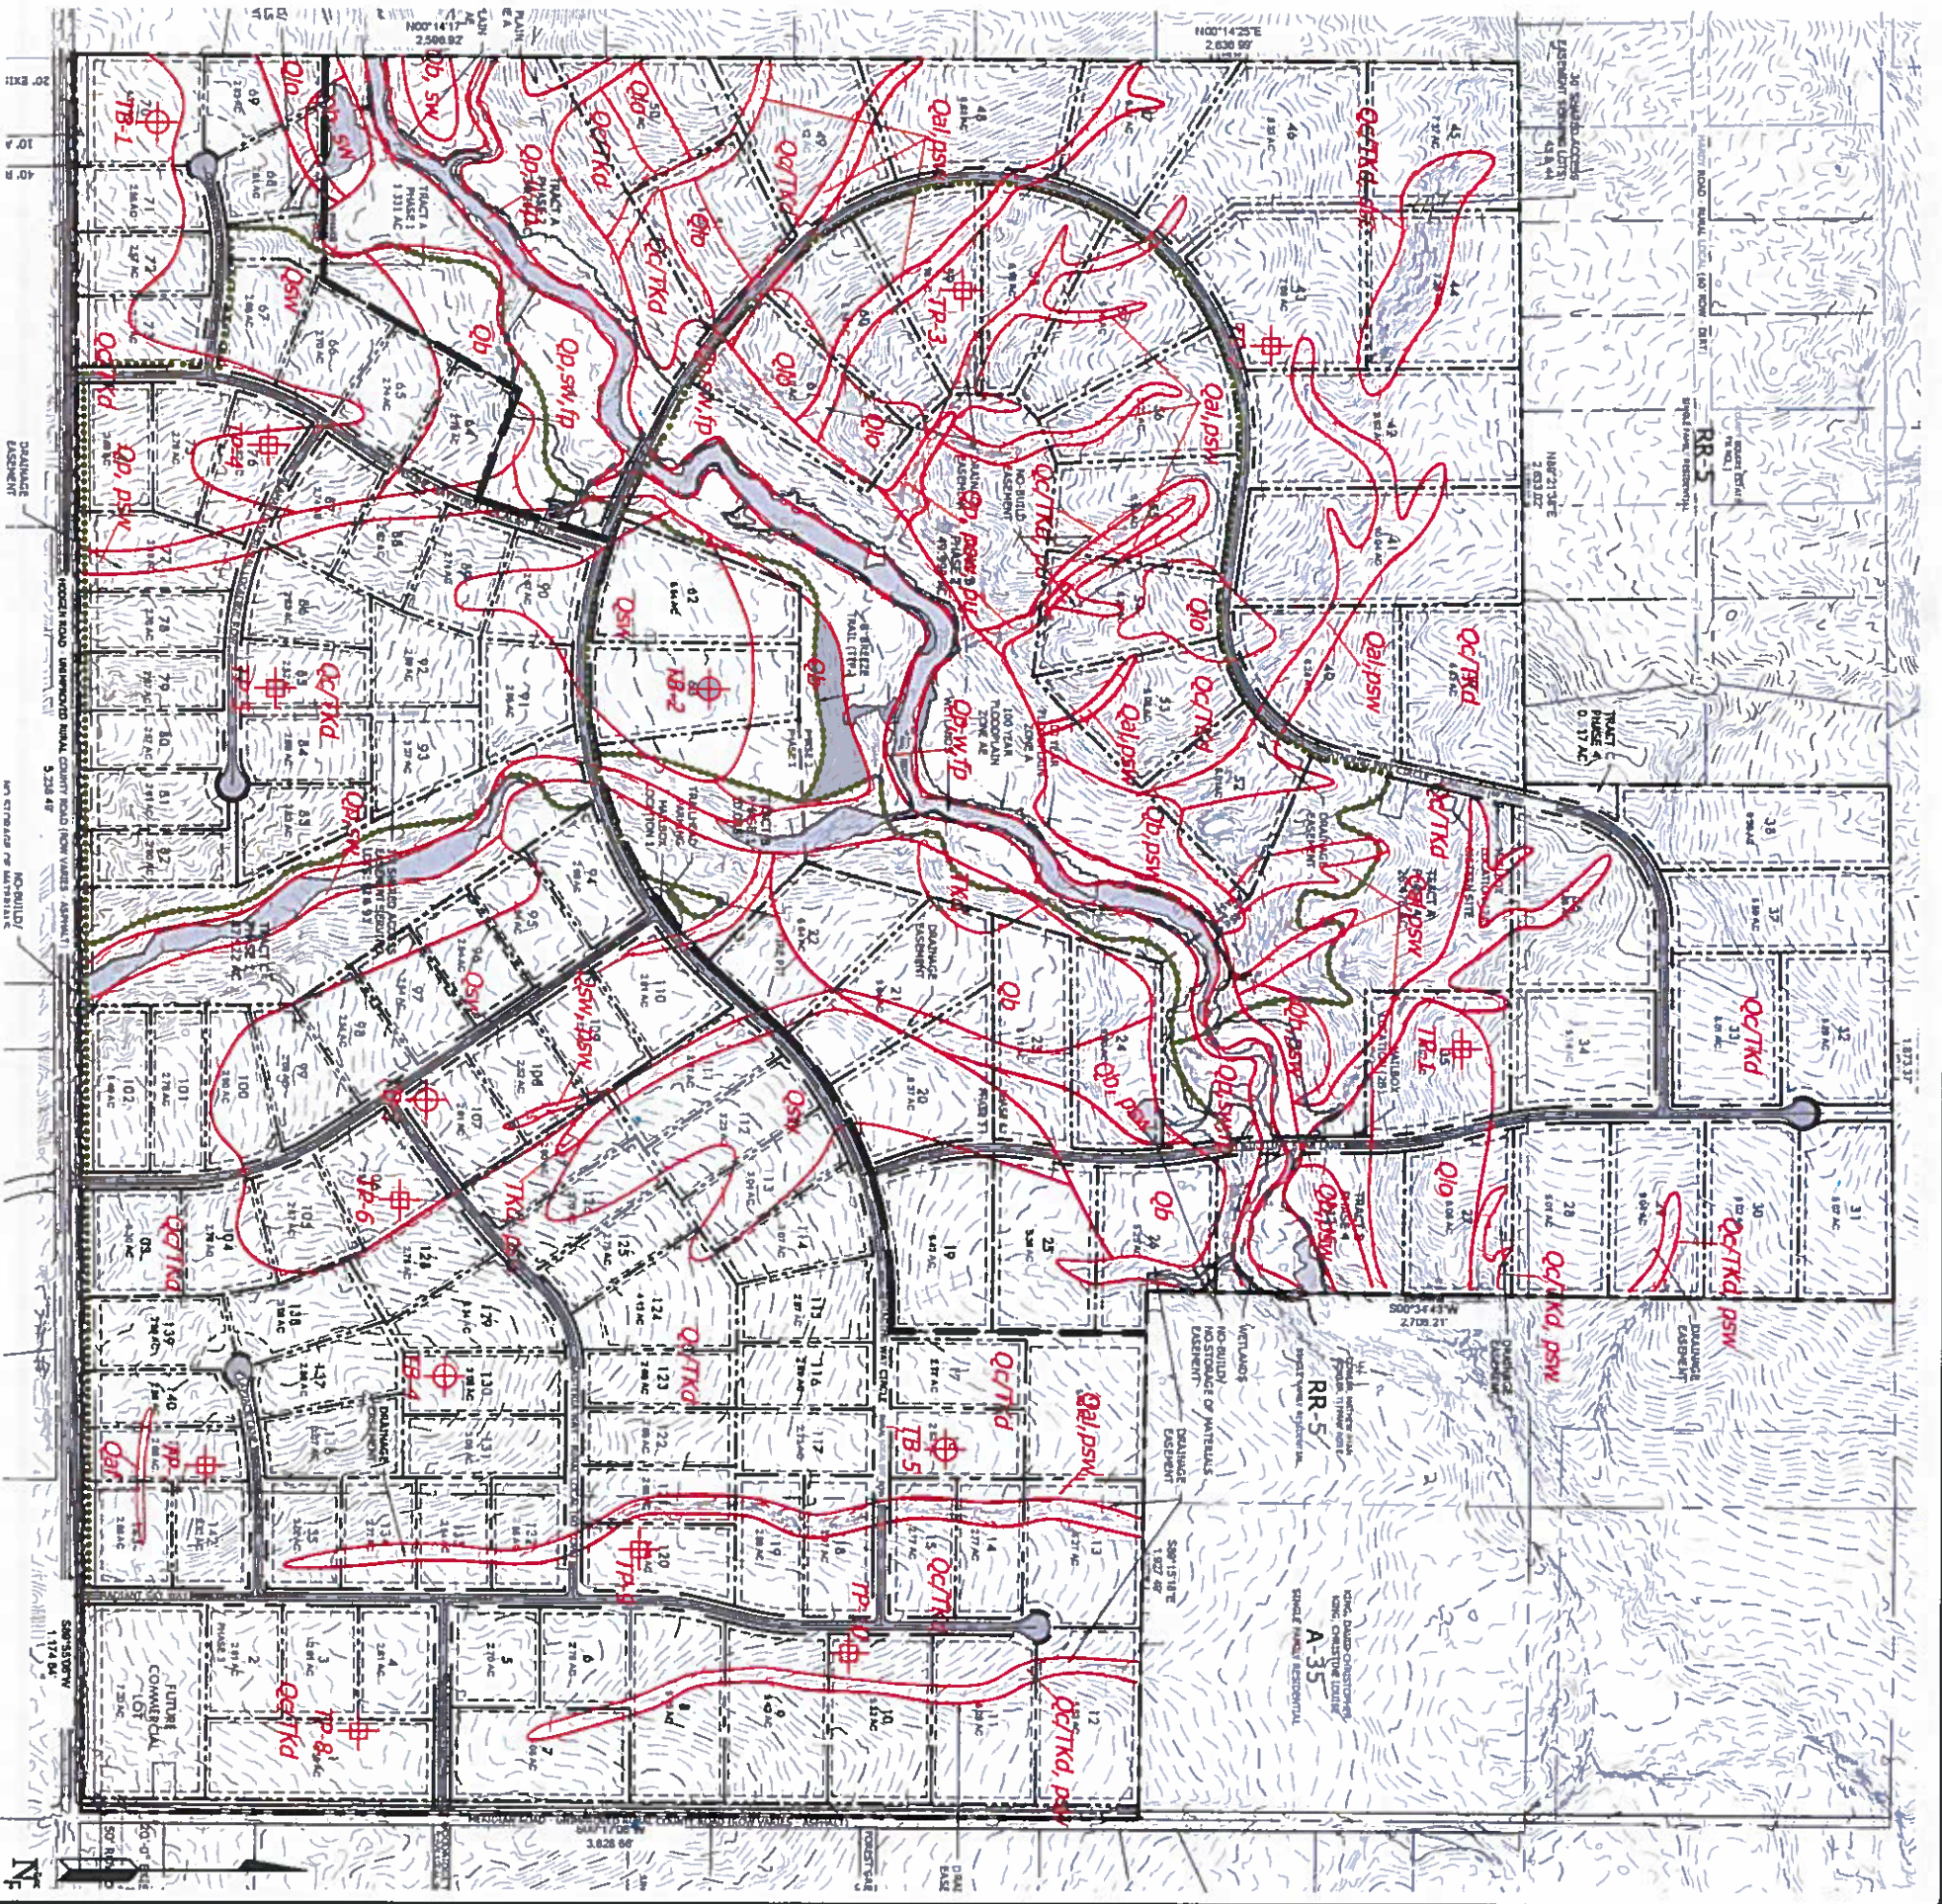
**GEOLOGY/ENGINEERING GEOLOGY MAP**  
**WINSOME SUBDIVISION**  
 17480 MERIDIAN ROAD NORTH  
 EL PASO COUNTY, CO.  
 FOR: PROTERRA PROPERTIES, LLC

- dsc - downslope creep area
  - fp - floodplain
  - pu - potentially unstable slope
  - psw - potentially seasonal shallow groundwater area
  - sw - seasonal shallow groundwater area

- w - flowing water
  - ⊕ - approximate test boring location
  - ⊕ - approximate test pit location

As mentioned previously, detailed mapping has been performed on this site to produce an Geology/Engineering Geology Map (Figure 6). This map shows the location of various geologic conditions of which the developers should be cognizant during the planning, design and construction stages of the project. These hazards and the recommended mitigation techniques are as follows:

The majority of the slopes in the building areas on site are gently to moderately sloping and do not exhibit any past or potential unstable slopes or landslides. However, the steeply sloping areas along the drainage in the central portion of the site have been identified as potentially unstable slopes. Additionally, areas of downslope creep have been mapped on the site. These areas are identified on the Geology/Engineering Geology Map, Figure 6. The recommendations for these areas are as follows:

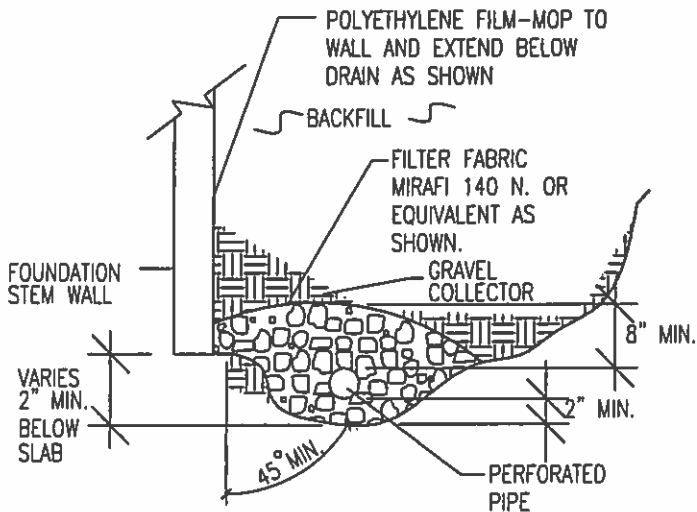
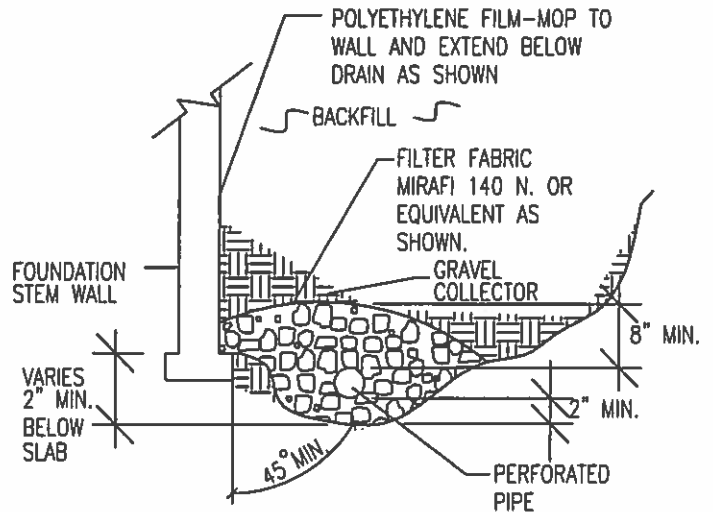
-GRAVEL SIZE IS RELATED TO DIAMETER OF PIPE PERFORATIONS-85% GRAVEL GREATER THAN 2x PERFORATION DIAMETER.

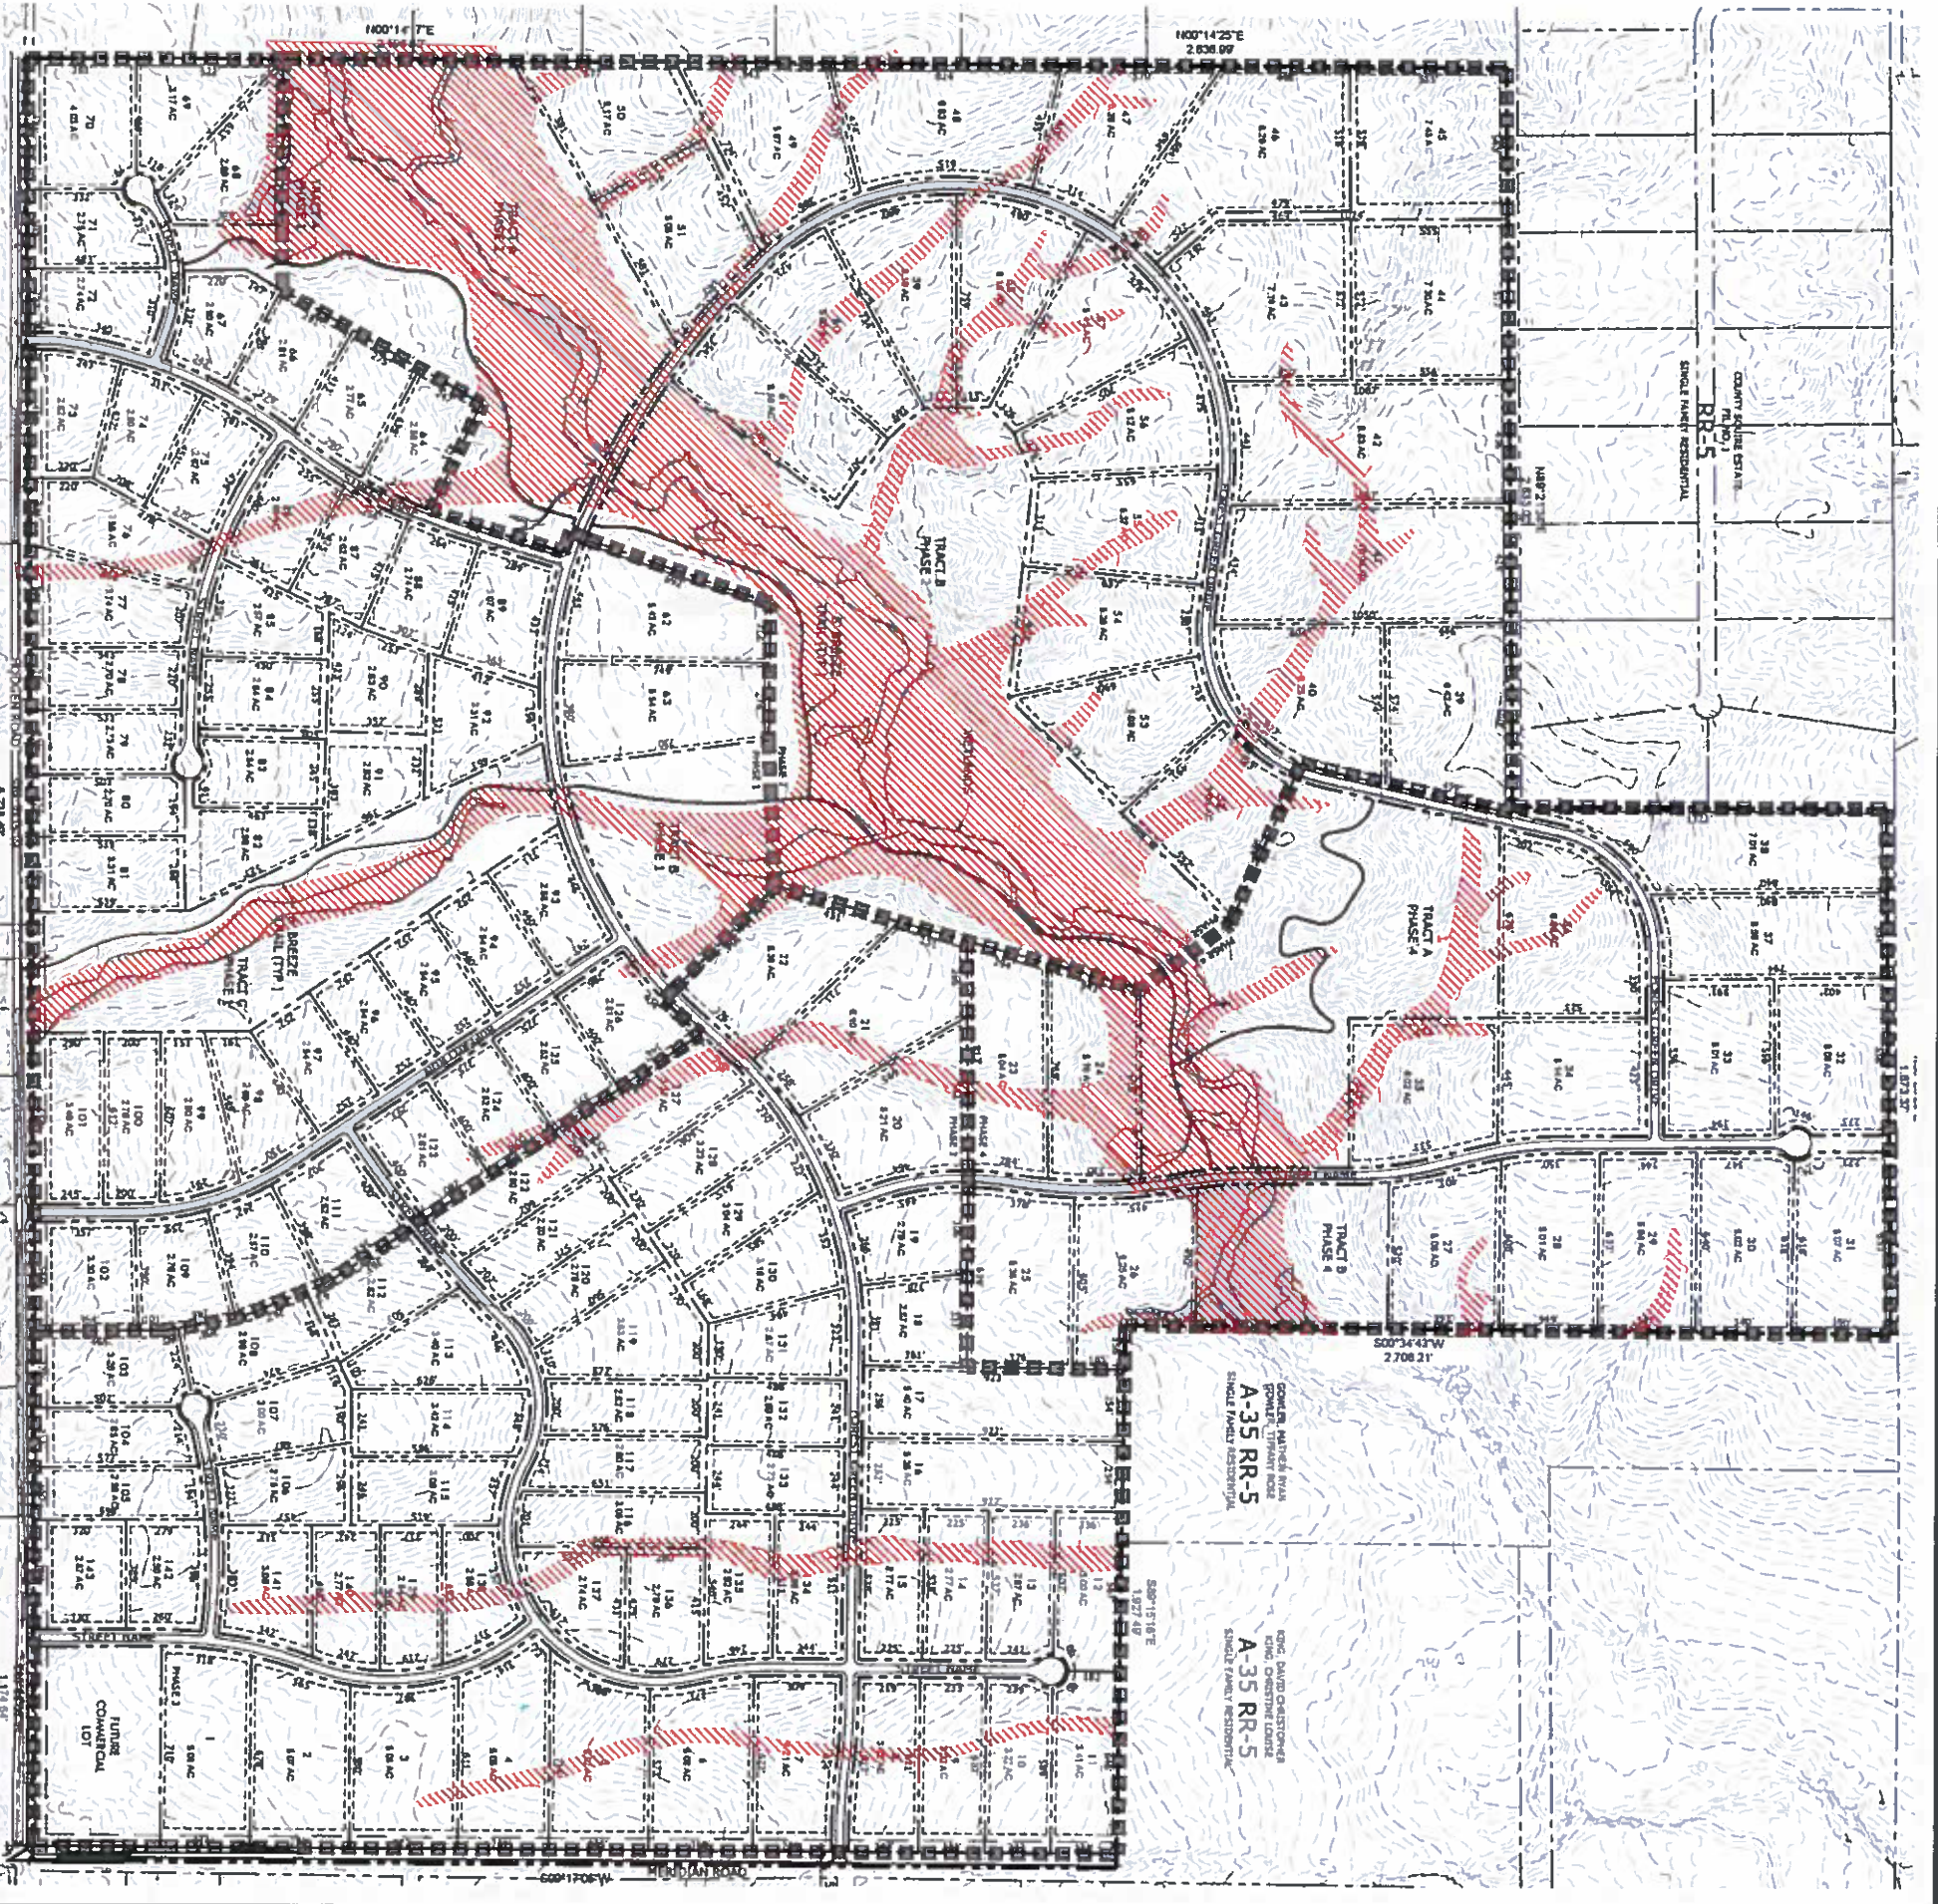
SEPTIC SUITABILITY MAP  
 WINSOME SUBDIVISION  
 17480 MERIDIAN ROAD NORTH  
 EL PASO COUNTY, CO.  
 FOR: PROTERRA PROPERTIES, LLC

- AREAS THAT ARE NOT SUITABLE FOR ON-SITE WASTE WATER TREATMENT SYSTEMS
- \* WATER WELLS MUST BE A MINIMUM OF 100 FT FROM OWTS ABSORPTION FIELDS

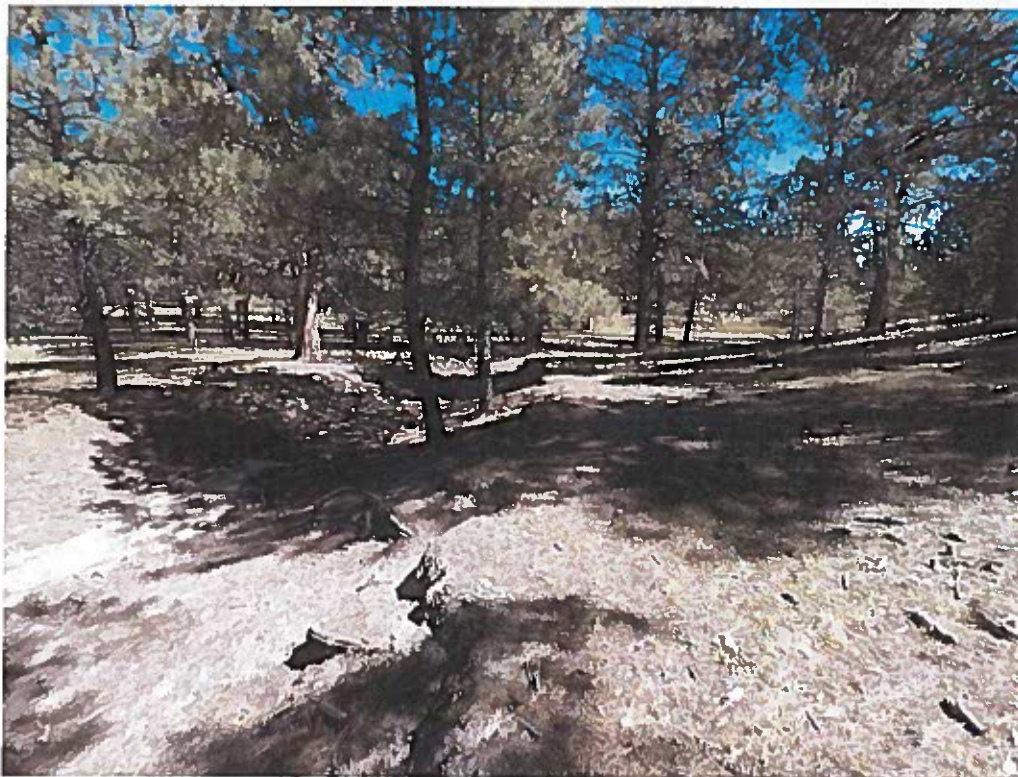
**Looking east along drainage in the northern portion of the site.**

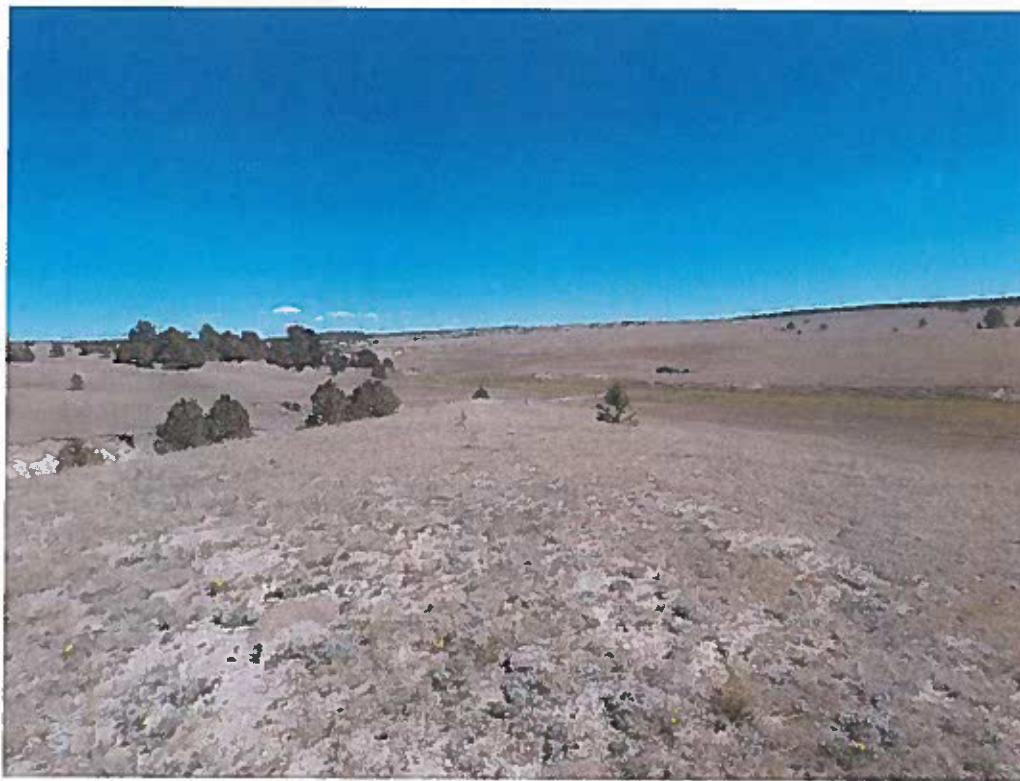
**Looking east towards  
W. Kiowa Creek in the  
central portion of the  
site.**

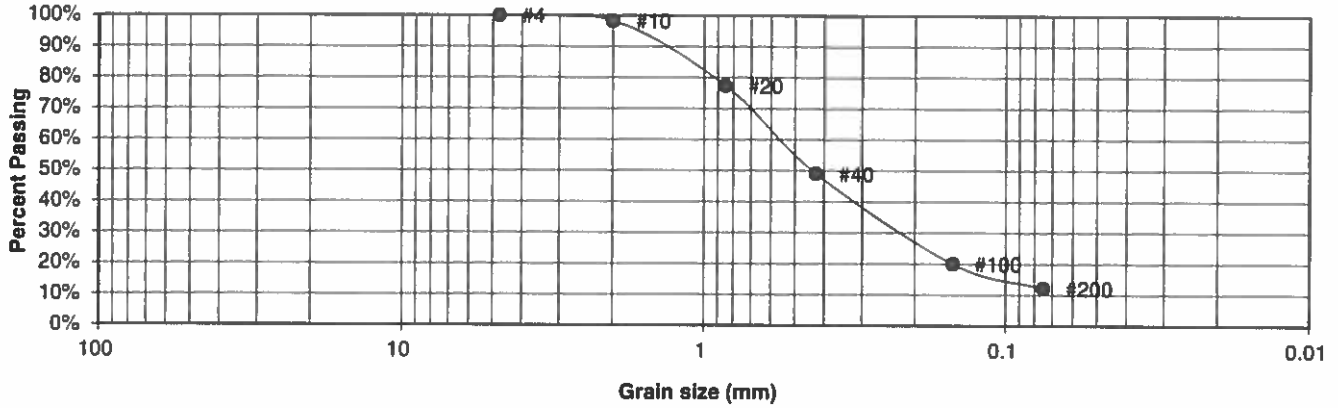
**Sieve Analysis  
Grain Size Distribution**

U.S. Sieve #	Percent Finer
3"	
1 1/2"	
3/4"	
1/2"	
3/8"	
4	100.0%
10	98.3%
20	77.4%
40	49.0%
100	20.0%
200	12.1%

**Atterberg Limits**  
 Plastic Limit NP  
 Liquid Limit NV  
 Plastic Index NP

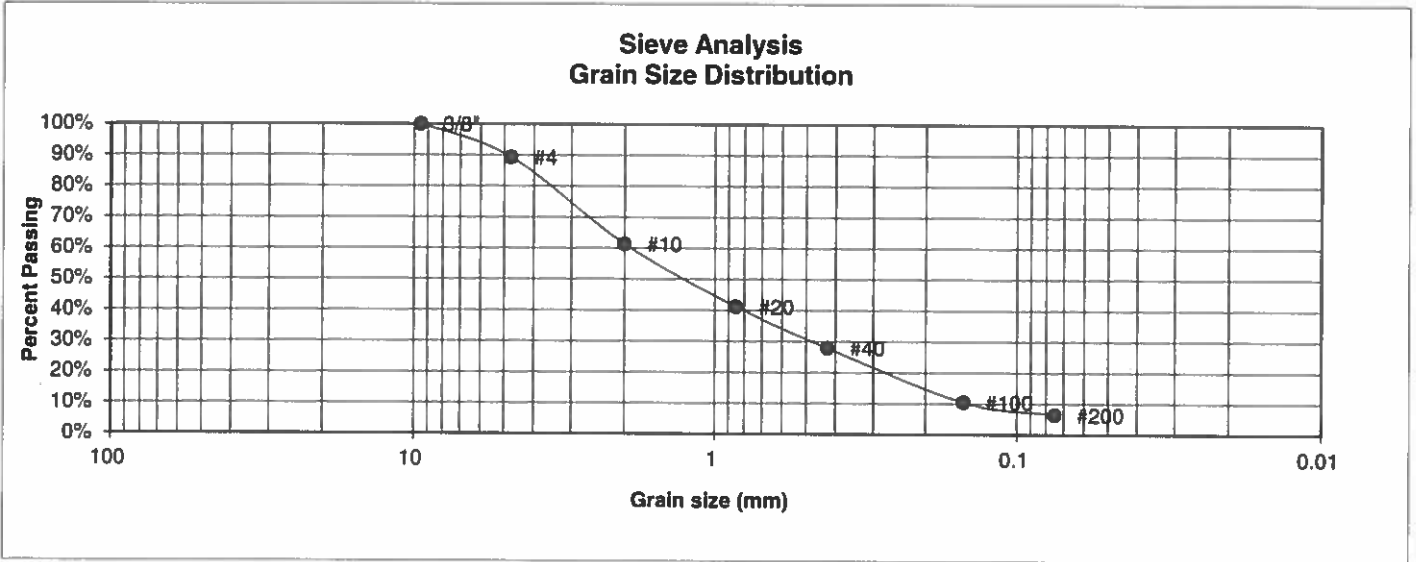
<b>UNIFIED CLASSIFICATION</b>	SM-SW	<b>CLIENT</b>	PROTERRA PROPERTIES
<b>SOIL TYPE #</b>	1	<b>PROJECT</b>	WINSOME SUBDIVISION
<b>TEST BORING #</b>	3	<b>JOB NO.</b>	181459
<b>DEPTH (FT)</b>	10	<b>TEST BY</b>	BL

U.S. Sieve #	Percent Finer
3"	
1 1/2"	
3/4"	
1/2"	
3/8"	100.0%
4	89.3%
10	61.3%
20	41.2%
40	27.9%
100	10.5%
200	6.5%

Soil Type 1 is a slightly silty to silty and clayey sand (SM-SW, SM, SC). This material was encountered in the test borings and in nine of the test pits. The sand was encountered at depths ranging from the existing surface to 12 to 15 feet bgs and extended to the termination of the Test Boring Nos. 2, 3 and 5 (20 feet). These soils were encountered at loose to medium dense states and at dry to moist conditions. Samples tested had 7 to 34 percent of the soil sized particles passing the No. 200 Sieve. Atterberg Limits Testing resulted in the sand being non-plastic. FHA Swell Testing on a sample of the sand resulted in an expansion of 30 psf, indicating a low expansion potential.

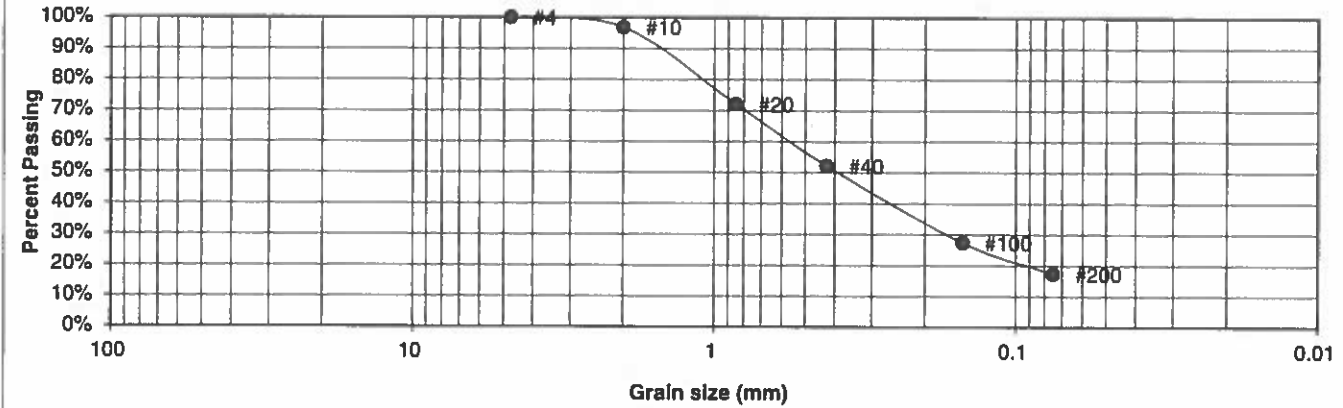
**Sieve Analysis  
Grain Size Distribution**

U.S. Sieve #	Percent Finer
3"	
1 1/2"	
3/4"	
1/2"	
3/8"	
4	100.0%
10	96.9%
20	72.1%
40	52.2%
100	27.4%
200	17.3%

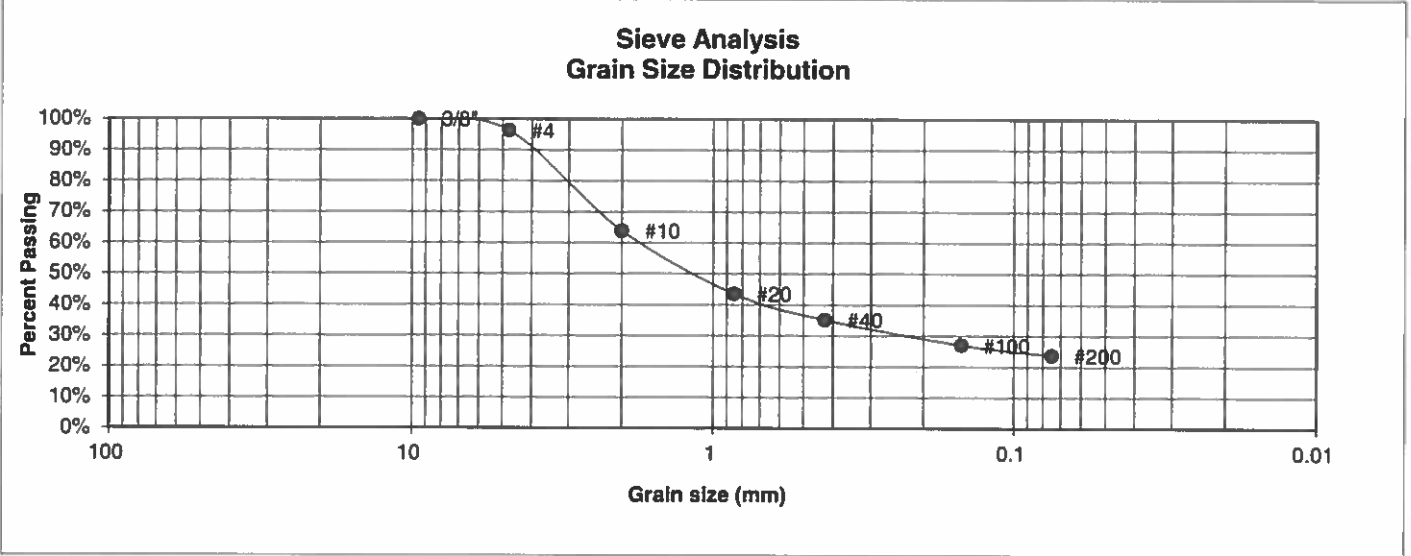
FIG NO.:  
C-3

<b>UNIFIED CLASSIFICATION</b>	SM	<b>CLIENT</b>	PROTERRA PROPERTIES
<b>SOIL TYPE #</b>	1	<b>PROJECT</b>	WINSOME SUBDIVISION
<b>TEST BORING #</b>	TP-3	<b>JOB NO.</b>	181459
<b>DEPTH (FT)</b>	2-3	<b>TEST BY</b>	BL

<u>U.S. Sieve #</u>	<u>Percent Finer</u>
3"	
1 1/2"	
3/4"	
1/2"	
3/8"	100.0%
4	96.3%
10	63.9%
20	43.5%
40	35.2%
100	27.0%
200	23.7%

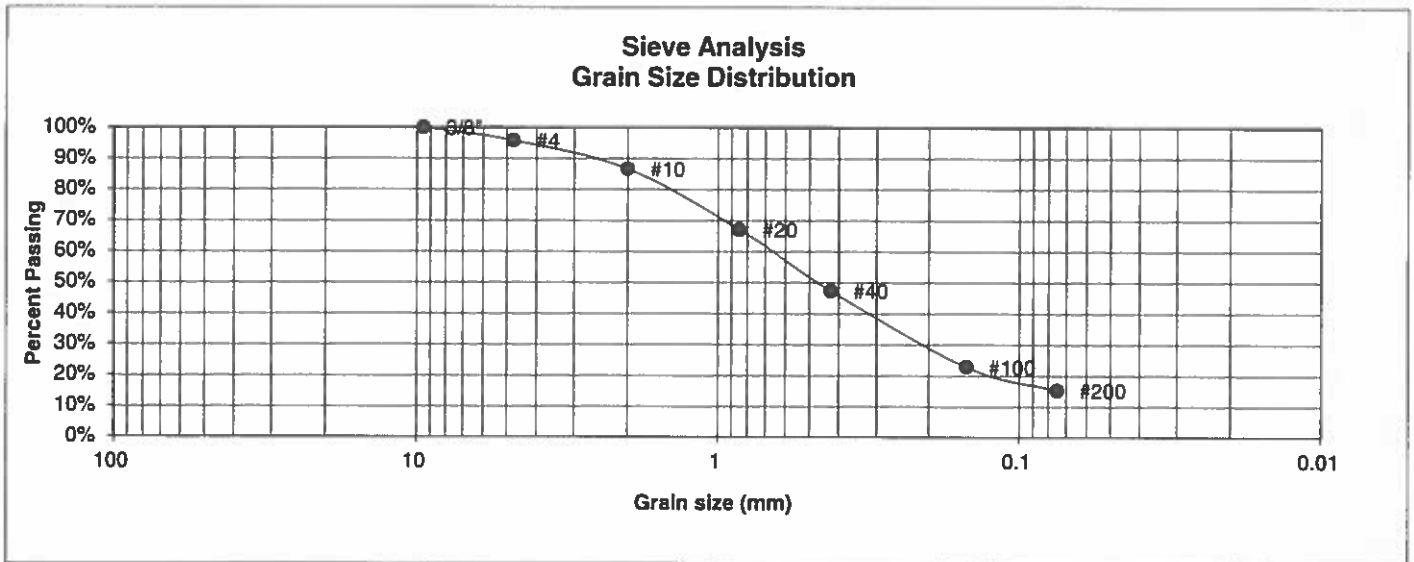
FIG NO.:  
C-4

<b>UNIFIED CLASSIFICATION</b>	SM	<b>CLIENT</b>	PROTERRA PROPERTIES
<b>SOIL TYPE #</b>	1	<b>PROJECT</b>	WINSOME SUBDIVISION
<b>TEST BORING #</b>	TP-4	<b>JOB NO.</b>	181459
<b>DEPTH (FT)</b>	5-6	<b>TEST BY</b>	BL

U.S. Sieve #	Percent Finer
3"	
1 1/2"	
3/4"	
1/2"	
3/8"	100.0%
4	95.8%
10	86.7%
20	67.2%
40	47.4%
100	22.9%
200	15.3%

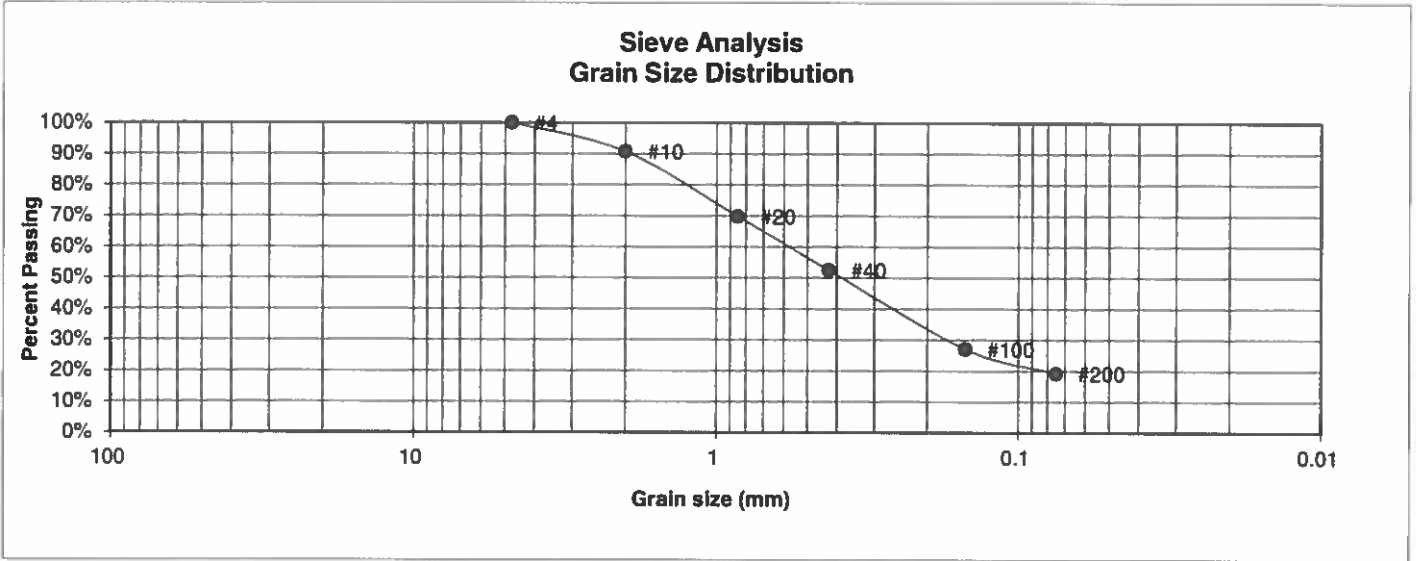
FIG NO.:  
6-5

<b>UNIFIED CLASSIFICATION</b>	SM	<b>CLIENT</b>	PROTERRA PROPERTIES
<b>SOIL TYPE #</b>	1	<b>PROJECT</b>	WINSOME SUBDIVISION
<b>TEST BORING #</b>	TP-5	<b>JOB NO.</b>	181459
<b>DEPTH (FT)</b>	2-3	<b>TEST BY</b>	BL

U.S. Sieve #	Percent Finer
3"	
1 1/2"	
3/4"	
1/2"	
3/8"	
4	100.0%
10	90.8%
20	69.8%
40	52.5%
100	27.1%
200	19.2%

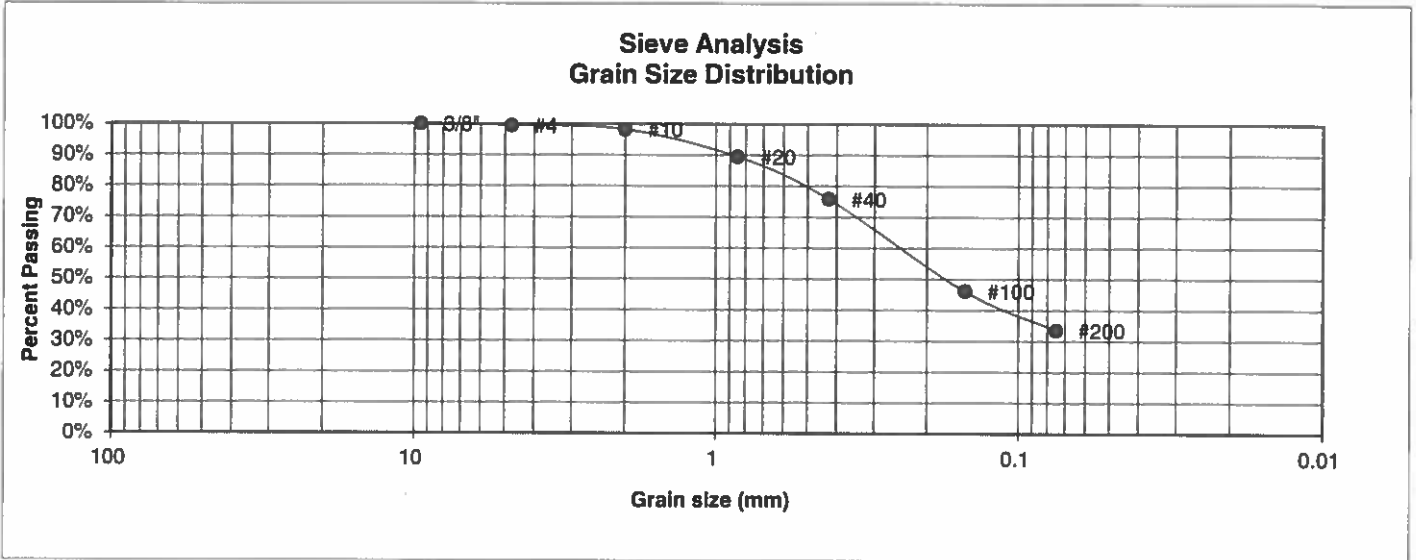
FIG NO.:  
C-6

<b>UNIFIED CLASSIFICATION</b>	SM	<b>CLIENT</b>	PROTERRA PROPERTIES
<b>SOIL TYPE #</b>	1	<b>PROJECT</b>	WINSOME SUBDIVISION
<b>TEST BORING #</b>	TP-7	<b>JOB NO.</b>	181459
<b>DEPTH (FT)</b>	2-3	<b>TEST BY</b>	BL

U.S. Sieve #	Percent Finer
3"	
1 1/2"	
3/4"	
1/2"	
3/8"	100.0%
4	99.5%
10	98.3%
20	89.5%
40	75.8%
100	46.1%
200	33.5%

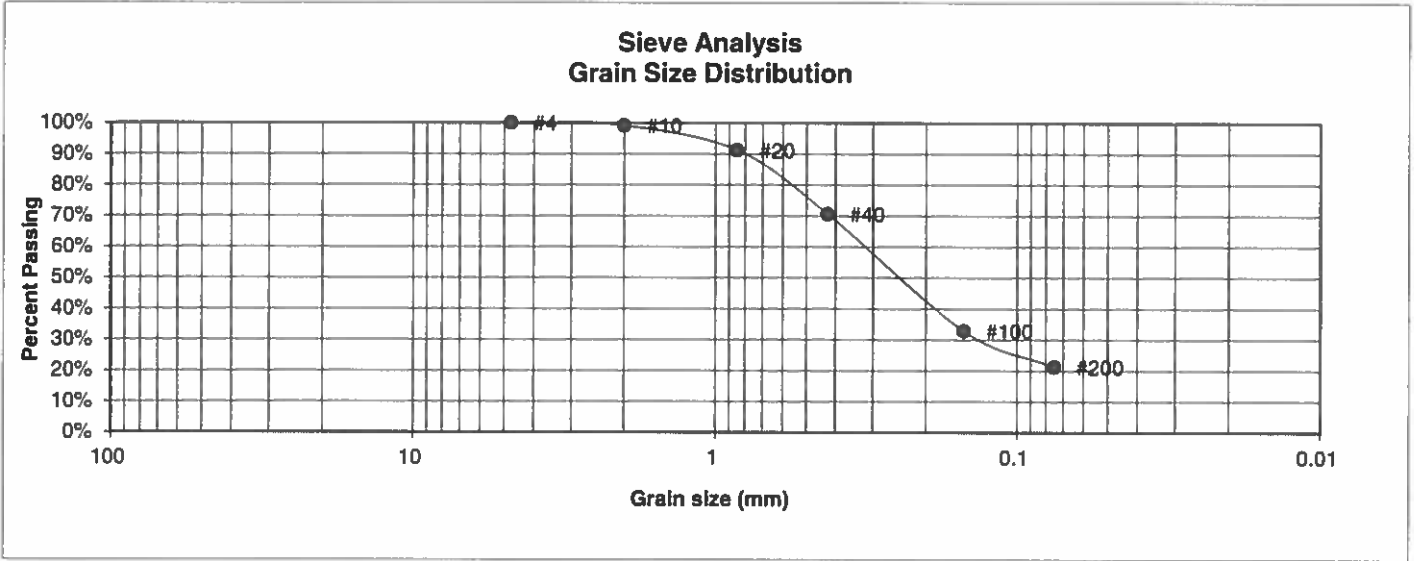
6-7

<b>UNIFIED CLASSIFICATION</b>	SM	<b>CLIENT</b>	PROTERRA PROPERTIES
<b>SOIL TYPE #</b>	1	<b>PROJECT</b>	WINSOME SUBDIVISION
<b>TEST BORING #</b>	TP-9	<b>JOB NO.</b>	181459
<b>DEPTH (FT)</b>	5-6	<b>TEST BY</b>	BL

U.S. Sieve #	Percent Finer
3"	
1 1/2"	
3/4"	
1/2"	
3/8"	
4	100.0%
10	99.2%
20	91.2%
40	70.6%
100	32.9%
200	21.3%

<b>Swell</b>	
Moisture at start	12.7%
Moisture at finish	22.9%
Moisture increase	10.1%
Initial dry density (pcf)	98
Swell (psf)	30

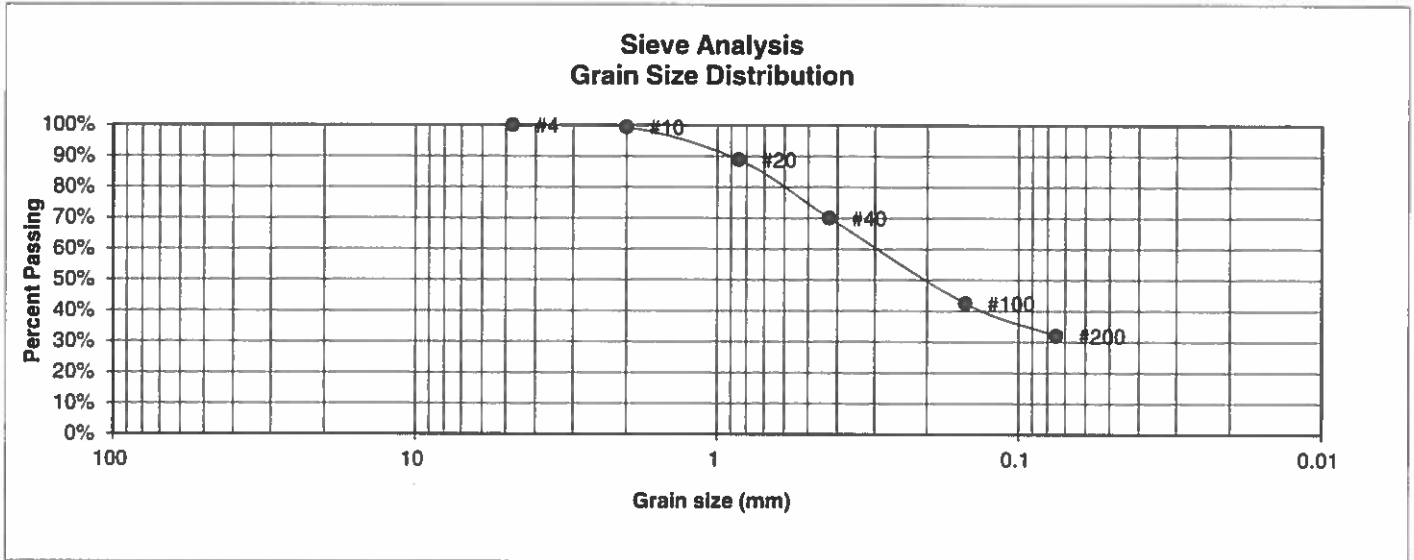
FIG NO:  
L-8

<b>UNIFIED CLASSIFICATION</b>	SM	<b>CLIENT</b>	PROTERRA PROPERTIES
<b>SOIL TYPE #</b>	1	<b>PROJECT</b>	WINSOME SUBDIVISION
<b>TEST BORING #</b>	TP-10	<b>JOB NO.</b>	181459
<b>DEPTH (FT)</b>	2-3	<b>TEST BY</b>	BL

U.S. Sieve #	Percent Finer
3"	
1 1/2"	
3/4"	
1/2"	
3/8"	
4	100.0%
10	99.4%
20	88.9%
40	70.0%
100	42.6%
200	32.0%

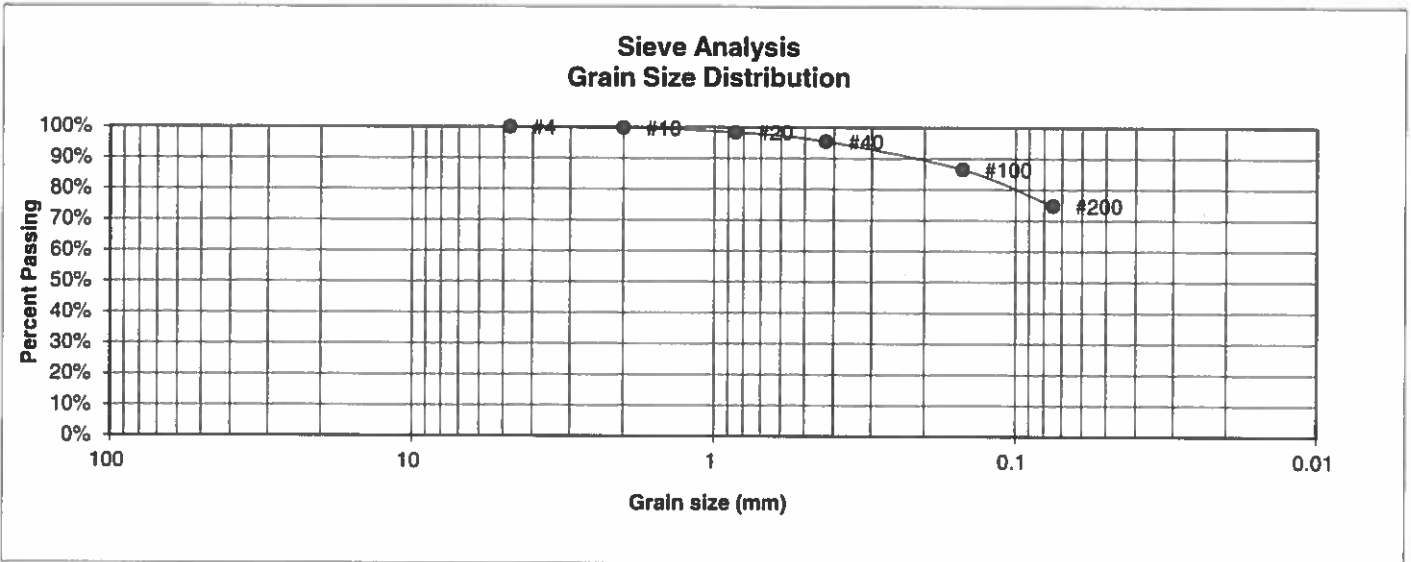
L-9

<b>UNIFIED CLASSIFICATION</b>	CL	<b>CLIENT</b>	PROTERRA PROPERTIES
<b>SOIL TYPE #</b>	2	<b>PROJECT</b>	WINSOME SUBDIVISION
<b>TEST BORING #</b>	TP-1	<b>JOB NO.</b>	181459
<b>DEPTH (FT)</b>	5-6	<b>TEST BY</b>	BL

U.S. Sieve #	Percent Finer
3"	
1 1/2"	
3/4"	
1/2"	
3/8"	
4	100.0%
10	99.8%
20	98.4%
40	95.4%
100	86.5%
200	74.8%

Atterberg Limits	
Plastic Limit	20
Liquid Limit	30
Plastic Index	10

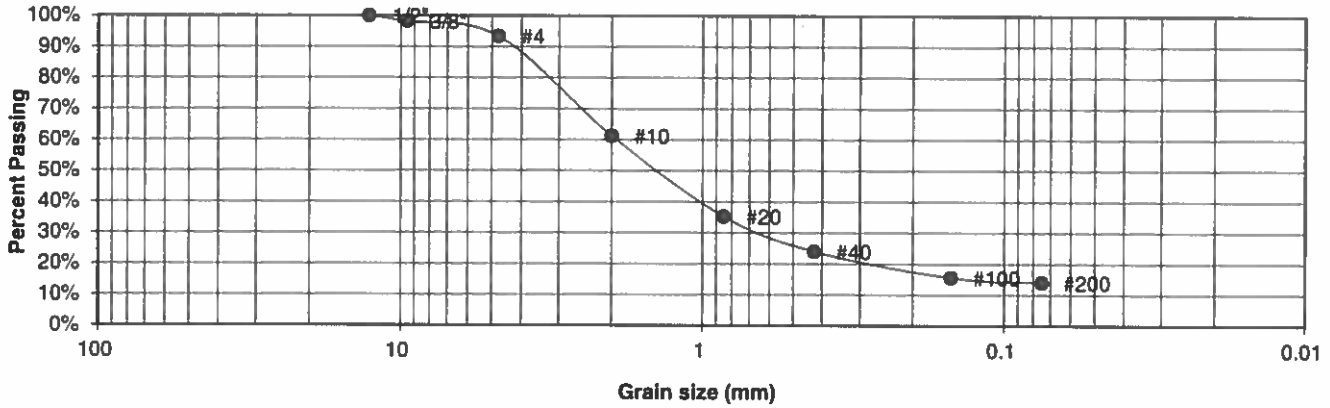
**Sieve Analysis  
Grain Size Distribution**

<b>UNIFIED CLASSIFICATION</b>	SM	<b>CLIENT</b>	PROTERRA PROPERTIES
<b>SOIL TYPE #</b>	3	<b>PROJECT</b>	WINSOME SUBDIVISION
<b>TEST BORING #</b>	TP-2	<b>JOB NO.</b>	181459
<b>DEPTH (FT)</b>	5-6	<b>TEST BY</b>	BL

U.S. Sieve #	Percent Finer
3"	
1 1/2"	
3/4"	
1/2"	100.0%
3/8"	98.2%
4	93.4%
10	61.2%
20	35.3%
40	24.0%
100	15.6%
200	14.0%

Atterberg Limits	
Plastic Limit	21
Liquid Limit	30
Plastic Index	9

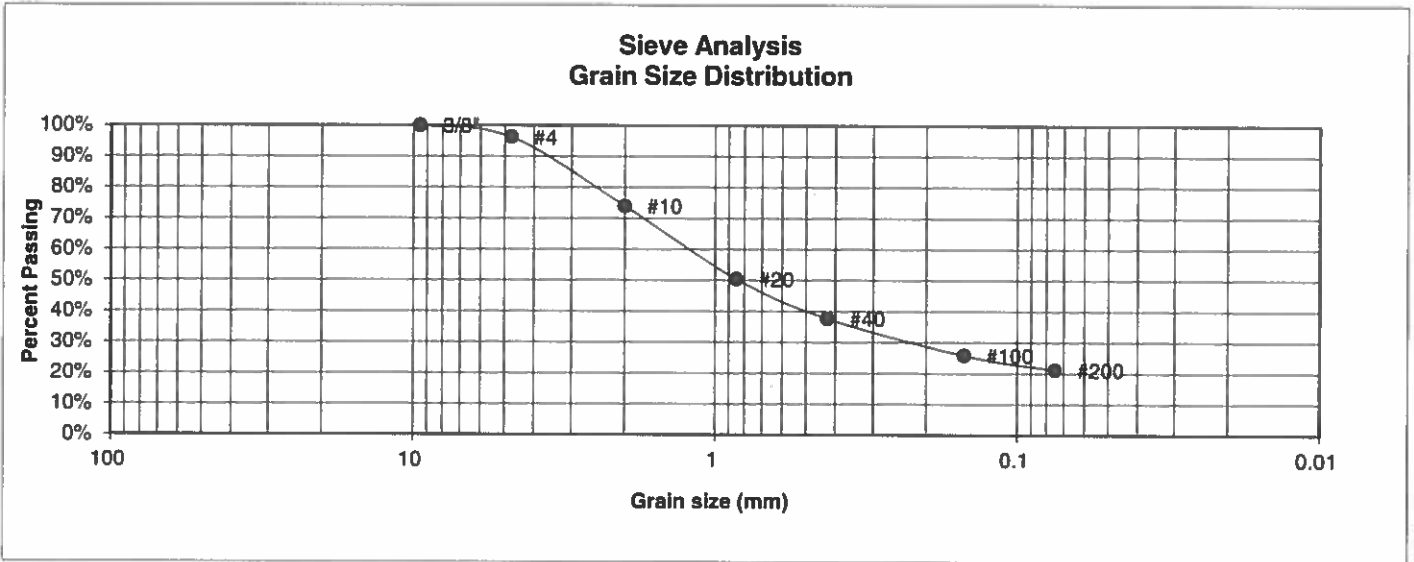
FIG NO.:  
C-11

<b>UNIFIED CLASSIFICATION</b>	SC	<b>CLIENT</b>	PROTERRA PROPERTIES
<b>SOIL TYPE #</b>	3	<b>PROJECT</b>	WINSOME SUBDIVISION
<b>TEST BORING #</b>	TP-8	<b>JOB NO.</b>	181459
<b>DEPTH (FT)</b>	5-6	<b>TEST BY</b>	BL

<u>U.S. Sieve #</u>	<u>Percent Finer</u>
3"	
1 1/2"	
3/4"	
1/2"	
3/8"	100.0%
4	96.2%
10	74.0%
20	50.4%
40	37.7%
100	25.8%
200	21.1%

<u>Atterberg Limits</u>	
Plastic Limit	19
Liquid Limit	33
Plastic Index	14

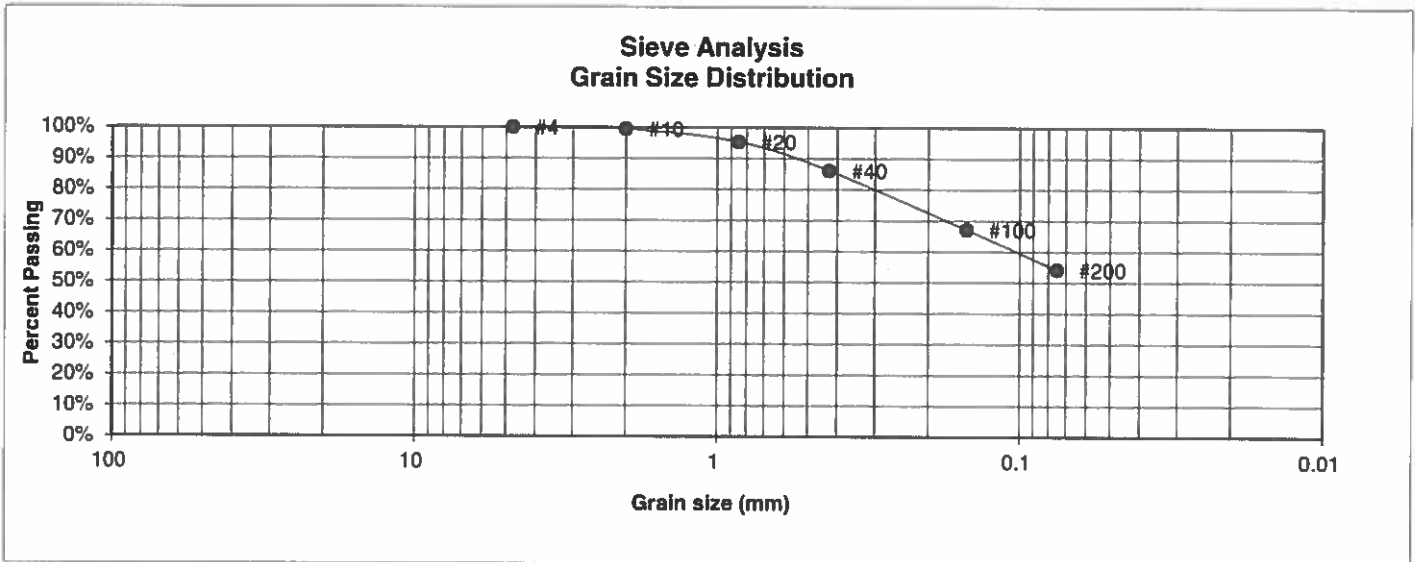
FIG NO.:  
C-12

<b>UNIFIED CLASSIFICATION</b>	CL-SC	<b>CLIENT</b>	PROTERRA PROPERTIES
<b>SOIL TYPE #</b>	3	<b>PROJECT</b>	WINSOME SUBDIVISION
<b>TEST BORING #</b>	TP-6	<b>JOB NO.</b>	181459
<b>DEPTH (FT)</b>	5-6	<b>TEST BY</b>	BL

U.S. Sieve #	Percent Finer
3"	
1 1/2"	
3/4"	
1/2"	
3/8"	
4	100.0%
10	99.5%
20	95.4%
40	86.1%
100	67.1%
200	54.2%

Moisture at start	8.4%
Moisture at finish	20.4%
Moisture increase	12.0%
Initial dry density (pcf)	101
Swell (psf)	350

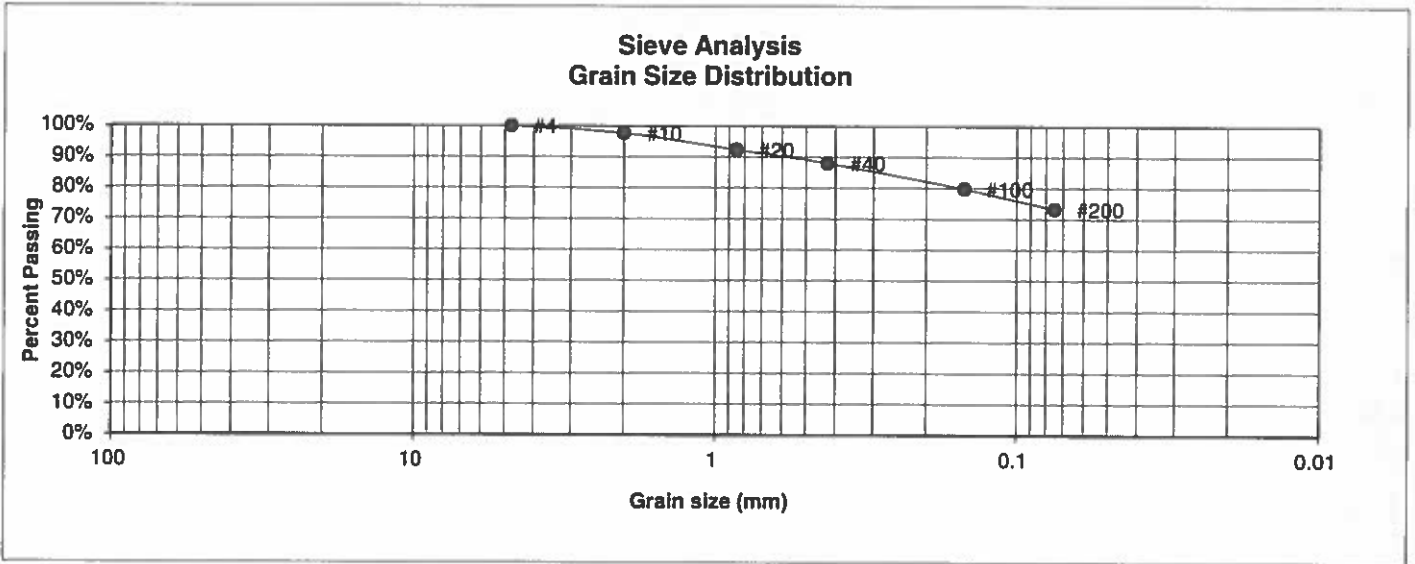
FIG NO.:  
C-19

<b>UNIFIED CLASSIFICATION</b>	CL	<b>CLIENT</b>	PROTERRA PROPERTIES
<b>SOIL TYPE #</b>	4	<b>PROJECT</b>	WINSOME SUBDIVISION
<b>TEST BORING #</b>	1	<b>JOB NO.</b>	181459
<b>DEPTH (FT)</b>	15	<b>TEST BY</b>	BL

U.S. Sieve #	Percent Finer
3"	
1 1/2"	
3/4"	
1/2"	
3/8"	
4	100.0%
10	97.7%
20	92.3%
40	88.0%
100	79.8%
200	73.2%

Atterberg Limits	
Plastic Limit	22
Liquid Limit	35
Plastic Index	13
