**ENTECH**  
ENGINEERING, INC.

**PRELIMINARY SOIL, GEOLOGY, GEOLOGIC HAZARD,  
AND WASTEWATER STUDY,  
WINSOME SUBDIVISION  
PARCEL NO. 51000-00-493  
17480 MERIDIAN ROAD NORTH  
EL PASO COUNTY, COLORADO**

October 2, 2018  
Revised January 11, 2019

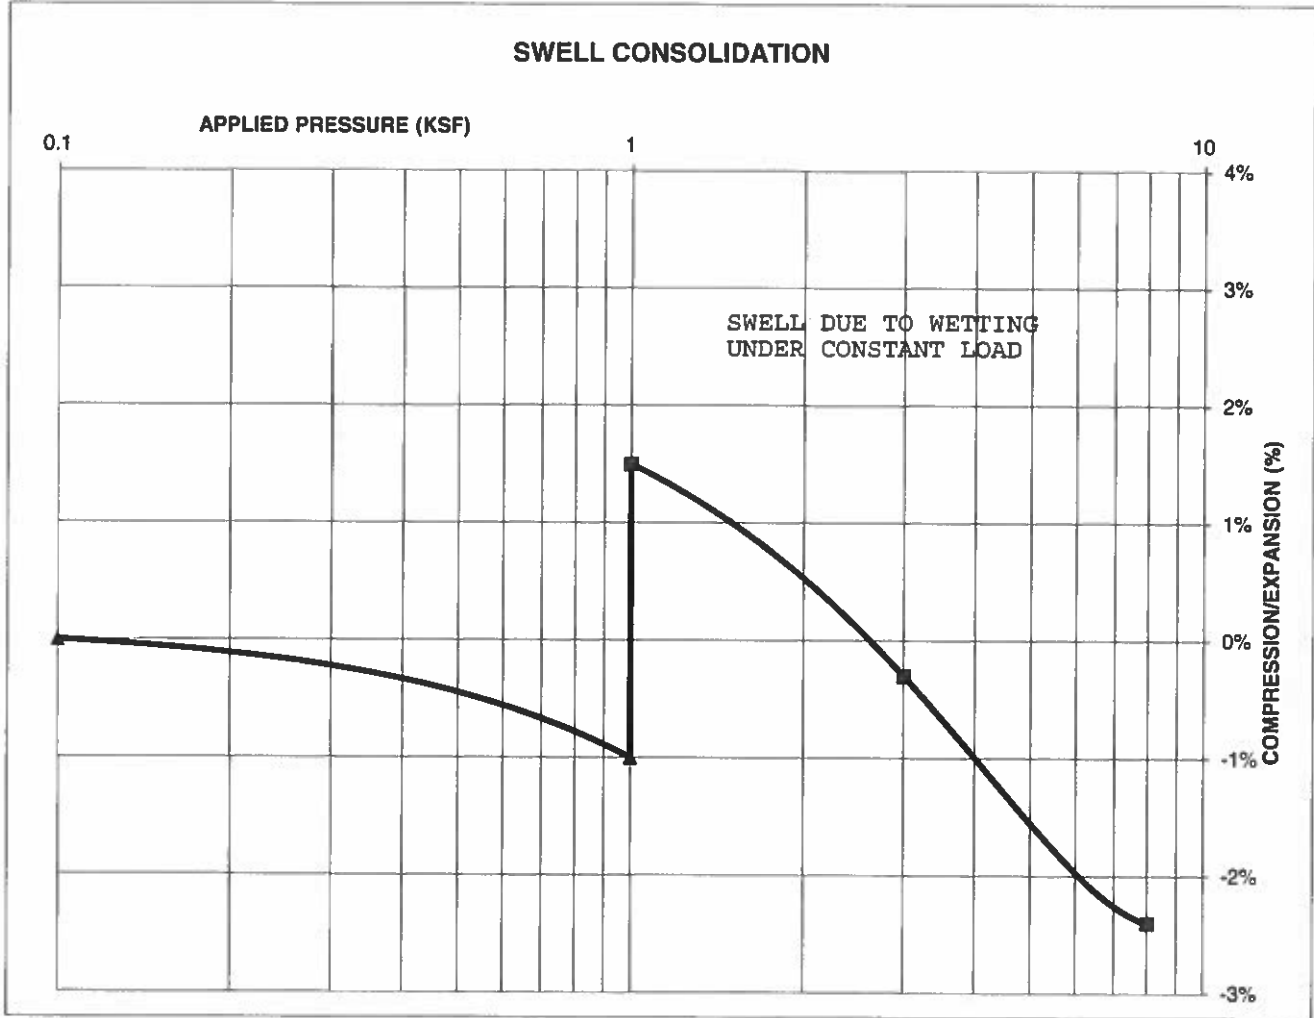
TEST BORING #	1	DEPTH(ft)	15
DESCRIPTION	CL	SOIL TYPE	4
NATURAL UNIT DRY WEIGHT (PCF)			120
NATURAL MOISTURE CONTENT			13.4%
SWELL/CONSOLIDATION (%)			2.5%
