SOILS AND GEOLOGY STUDY

**Winslow Drive
Estates at Cathedral Pines
El Paso County, Colorado**

JOB NO. 187749

June 24, 2022

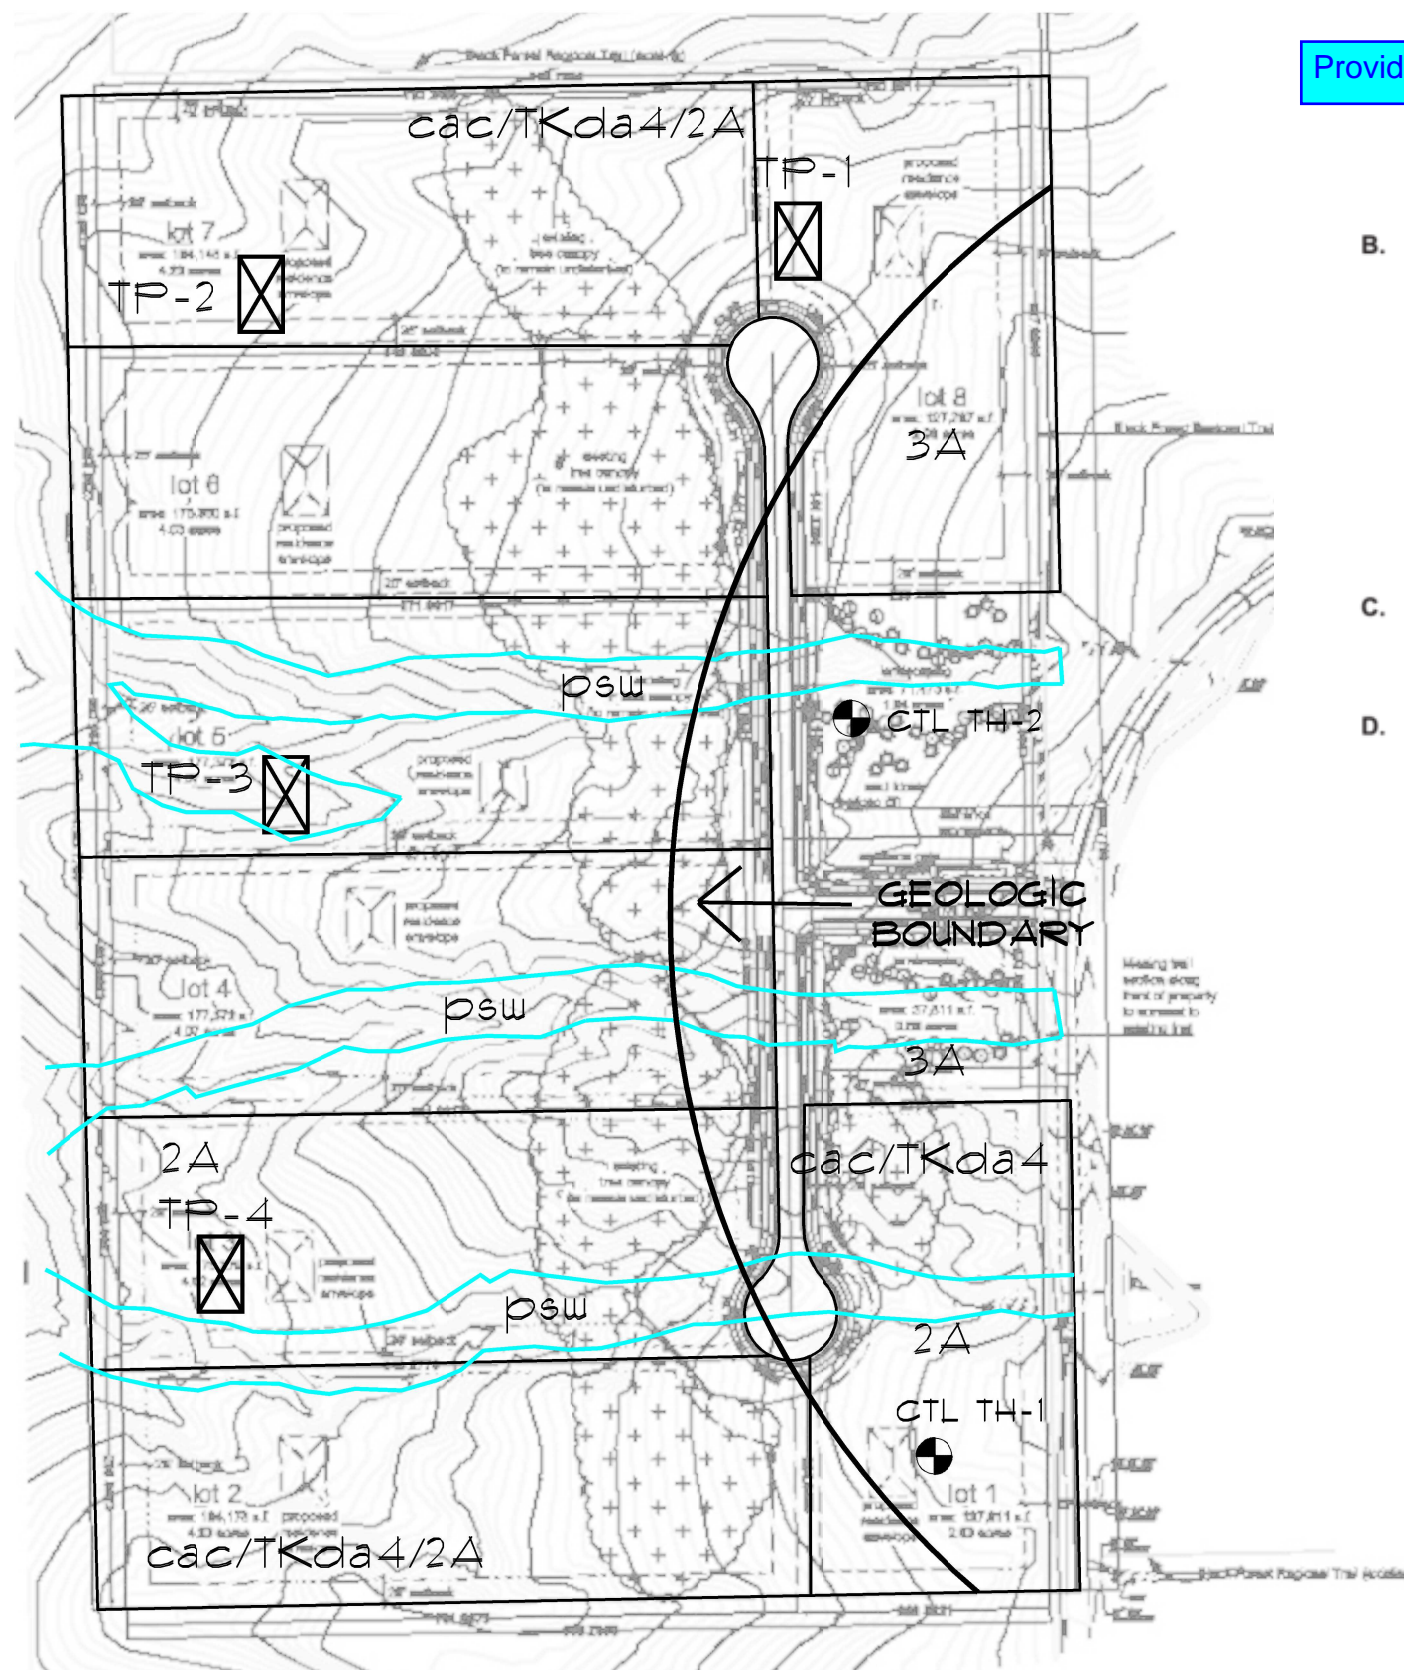
⊗ DENOTES APPROXIMATE LOCATION OF TEST PITS OBSERVED BY RMG FOR THIS STUDY

⊙ DENOTES APPROXIMATE LOCATION OF TEST HOLES PERFORMED BY CTL THOMPSON, PROJECT NO. CS11101-105 DATED MAY 2, 2008

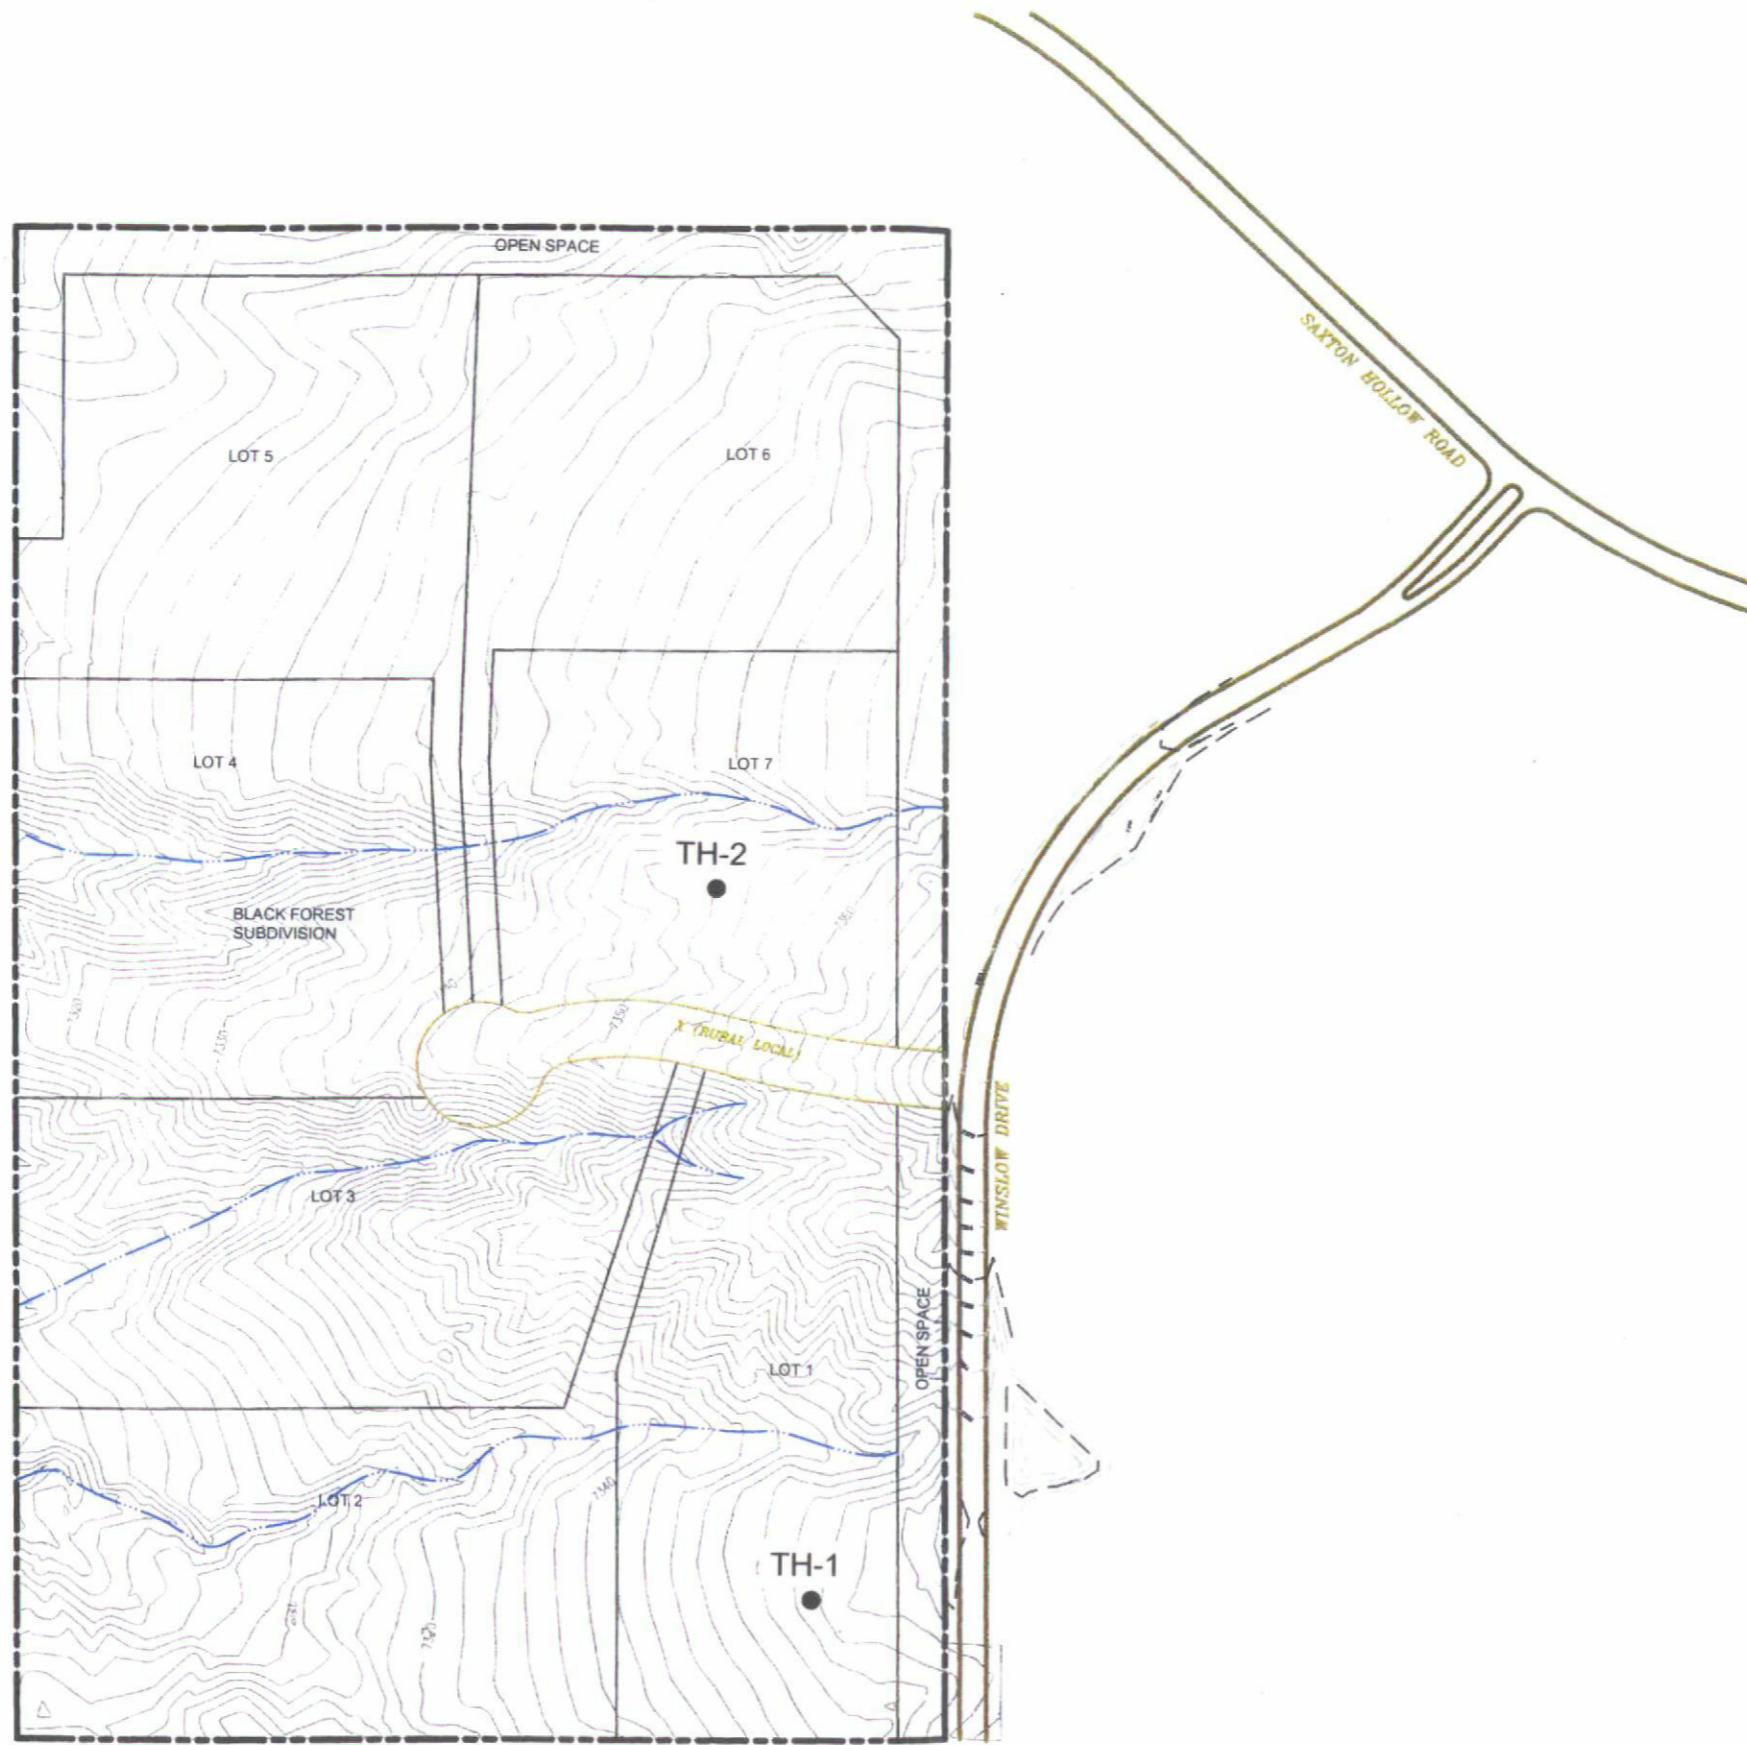
**Location of
Exploratory
Borings**

- TH-1 INDICATES APPROXIMATE LOCATION OF EXPLORATORY BORING.
- INDICATES APPROXIMATE LOCATION OF PROPERTY BOUNDARY.
- - - INDICATES EXISTING TOPOGRAPHY.
- ~ ~ ~ INDICATES INTERMITTENT DRAINAGES.

The approximately 35-acre Winslow Drive Parcel site is located west of Winslow Drive and north of Darr Drive in El Paso County, Colorado. The parcel is zoned Rural Residential. The general shape and location of the site are shown on Fig. 1.

Subsurface conditions for the property were explored by drilling two very widely-spaced borings at the approximate locations presented on Fig. 1. Boring locations were limited to areas accessible through the trees from Winslow Drive. Graphic logs of the conditions found in our borings are presented on Fig. 4.

Septic system locations should avoid the minor drainages and steeper slopes. The intermittent drainages swales are identified on Fig. 1.

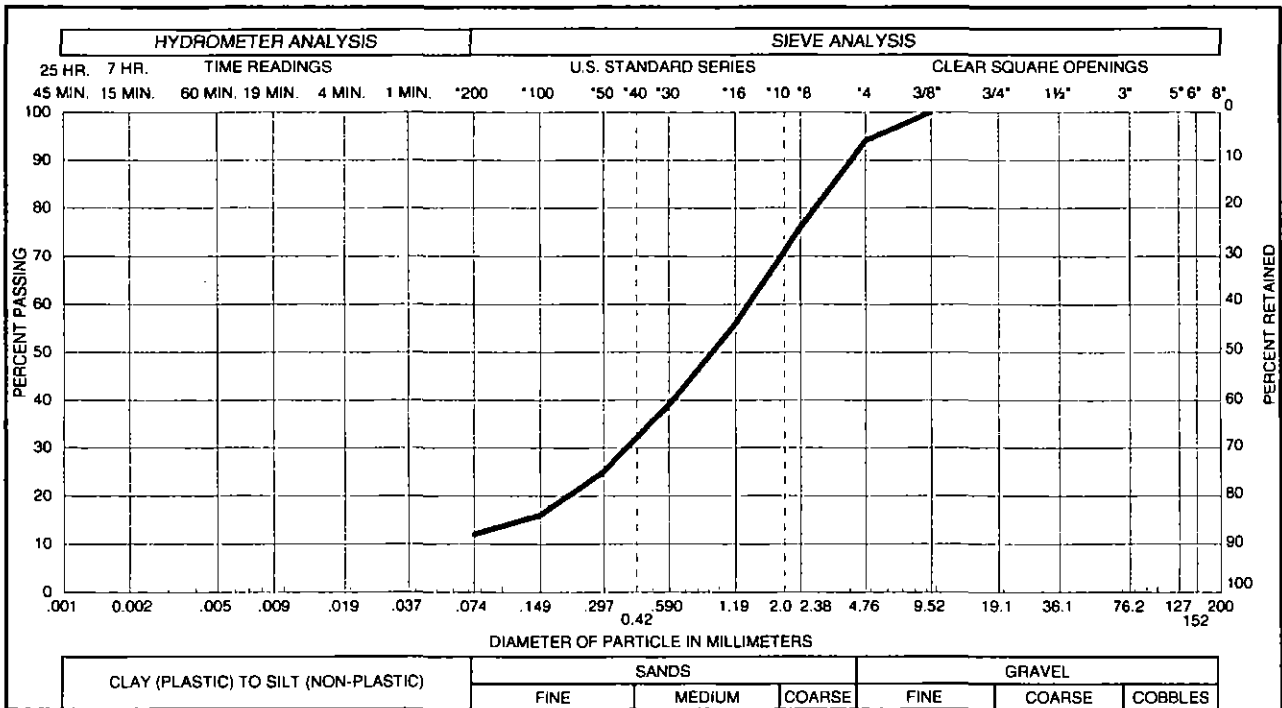
Sample of SANDSTONE, SILTY GRAVEL 6 % SAND 82 %
 From TH - 2 AT 4 FEET SILT & CLAY 12 % LIQUID LIMIT %
 PLASTICITY INDEX %
