SOILS AND GEOLOGY STUDY

**Winslow Drive
Estates at Cathedral Pines
El Paso County, Colorado**

JOB NO. 187749

**June 24, 2022
Revised July 21, 2023**

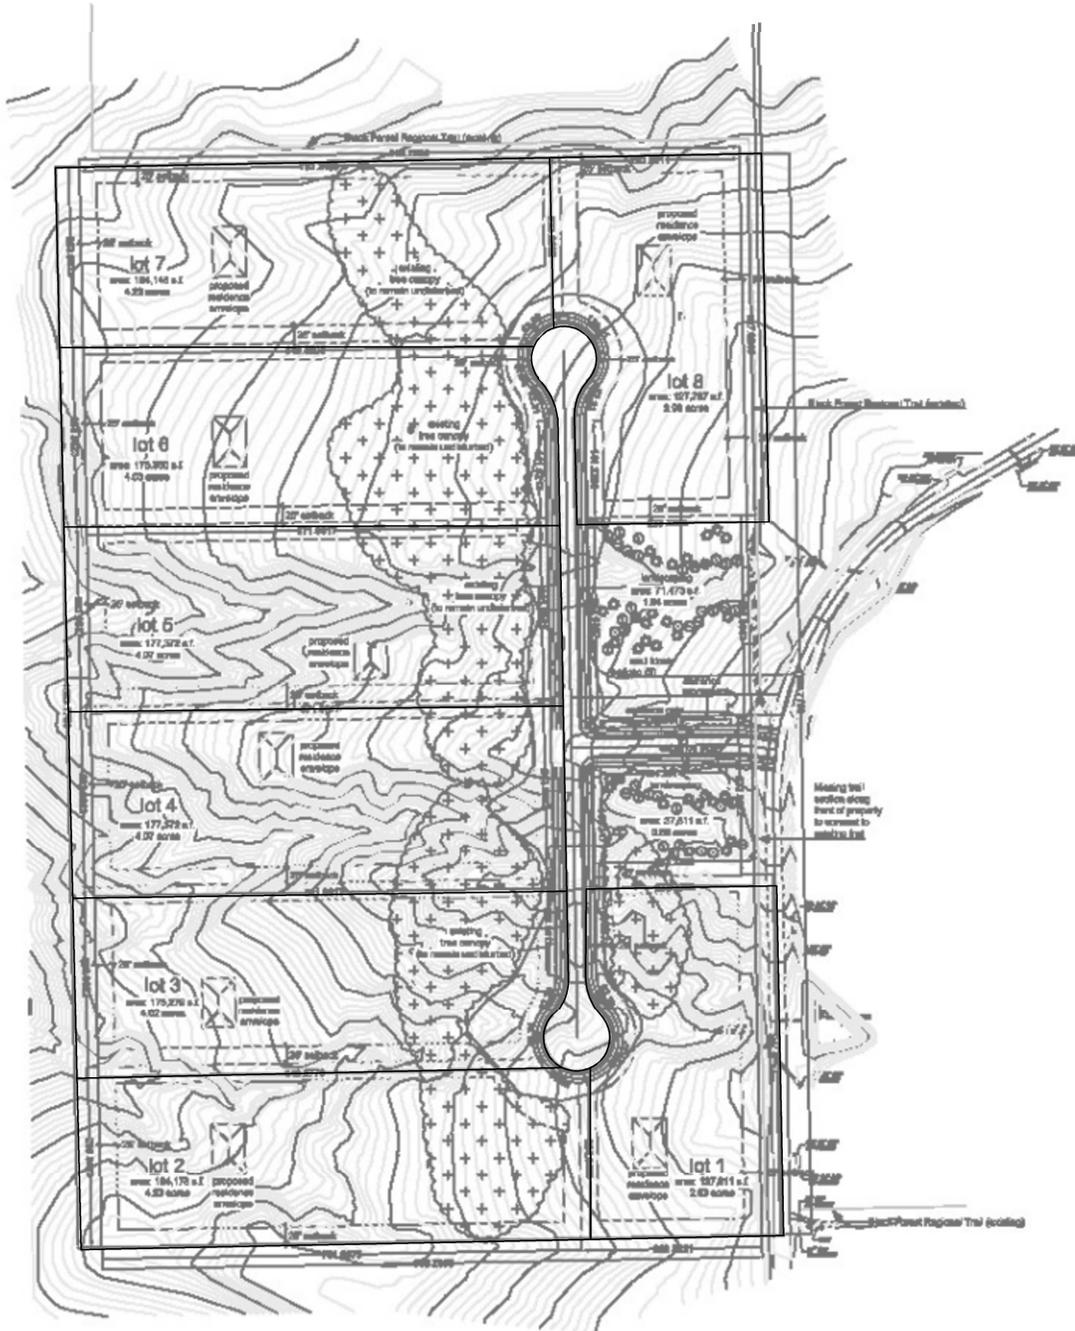
FIG No. 2

The site consists of approximately 35 acres of undeveloped land. It is our understanding the existing 35 acres is to be subdivided into a total of eight new lots, which are to range between approximately 2.93 and 4.23 acres. There are no existing structures on the site. The Proposed Lot Layout is presented in Figure 2.

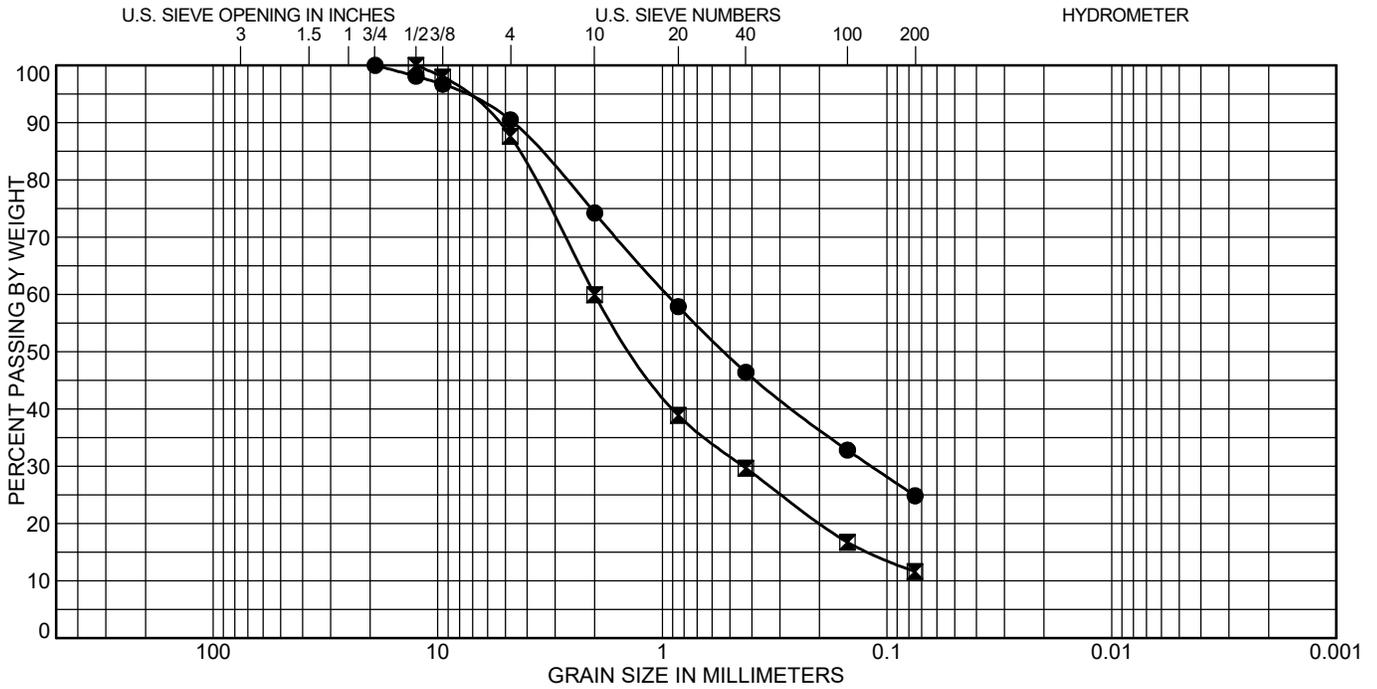
FIGURE No. 9

COBBLES	GRAVEL		SAND			SILT OR CLAY
	coarse	fine	coarse	medium	fine

Test Boring	Depth (ft)	Classification	LL	PL	PI
● 1	4.0	SILTY SAND(SM)	NP	NP	NP
☒ 2	14.0	WELL-GRADED SAND with SILT(SW-SM)	NP	NP	NP

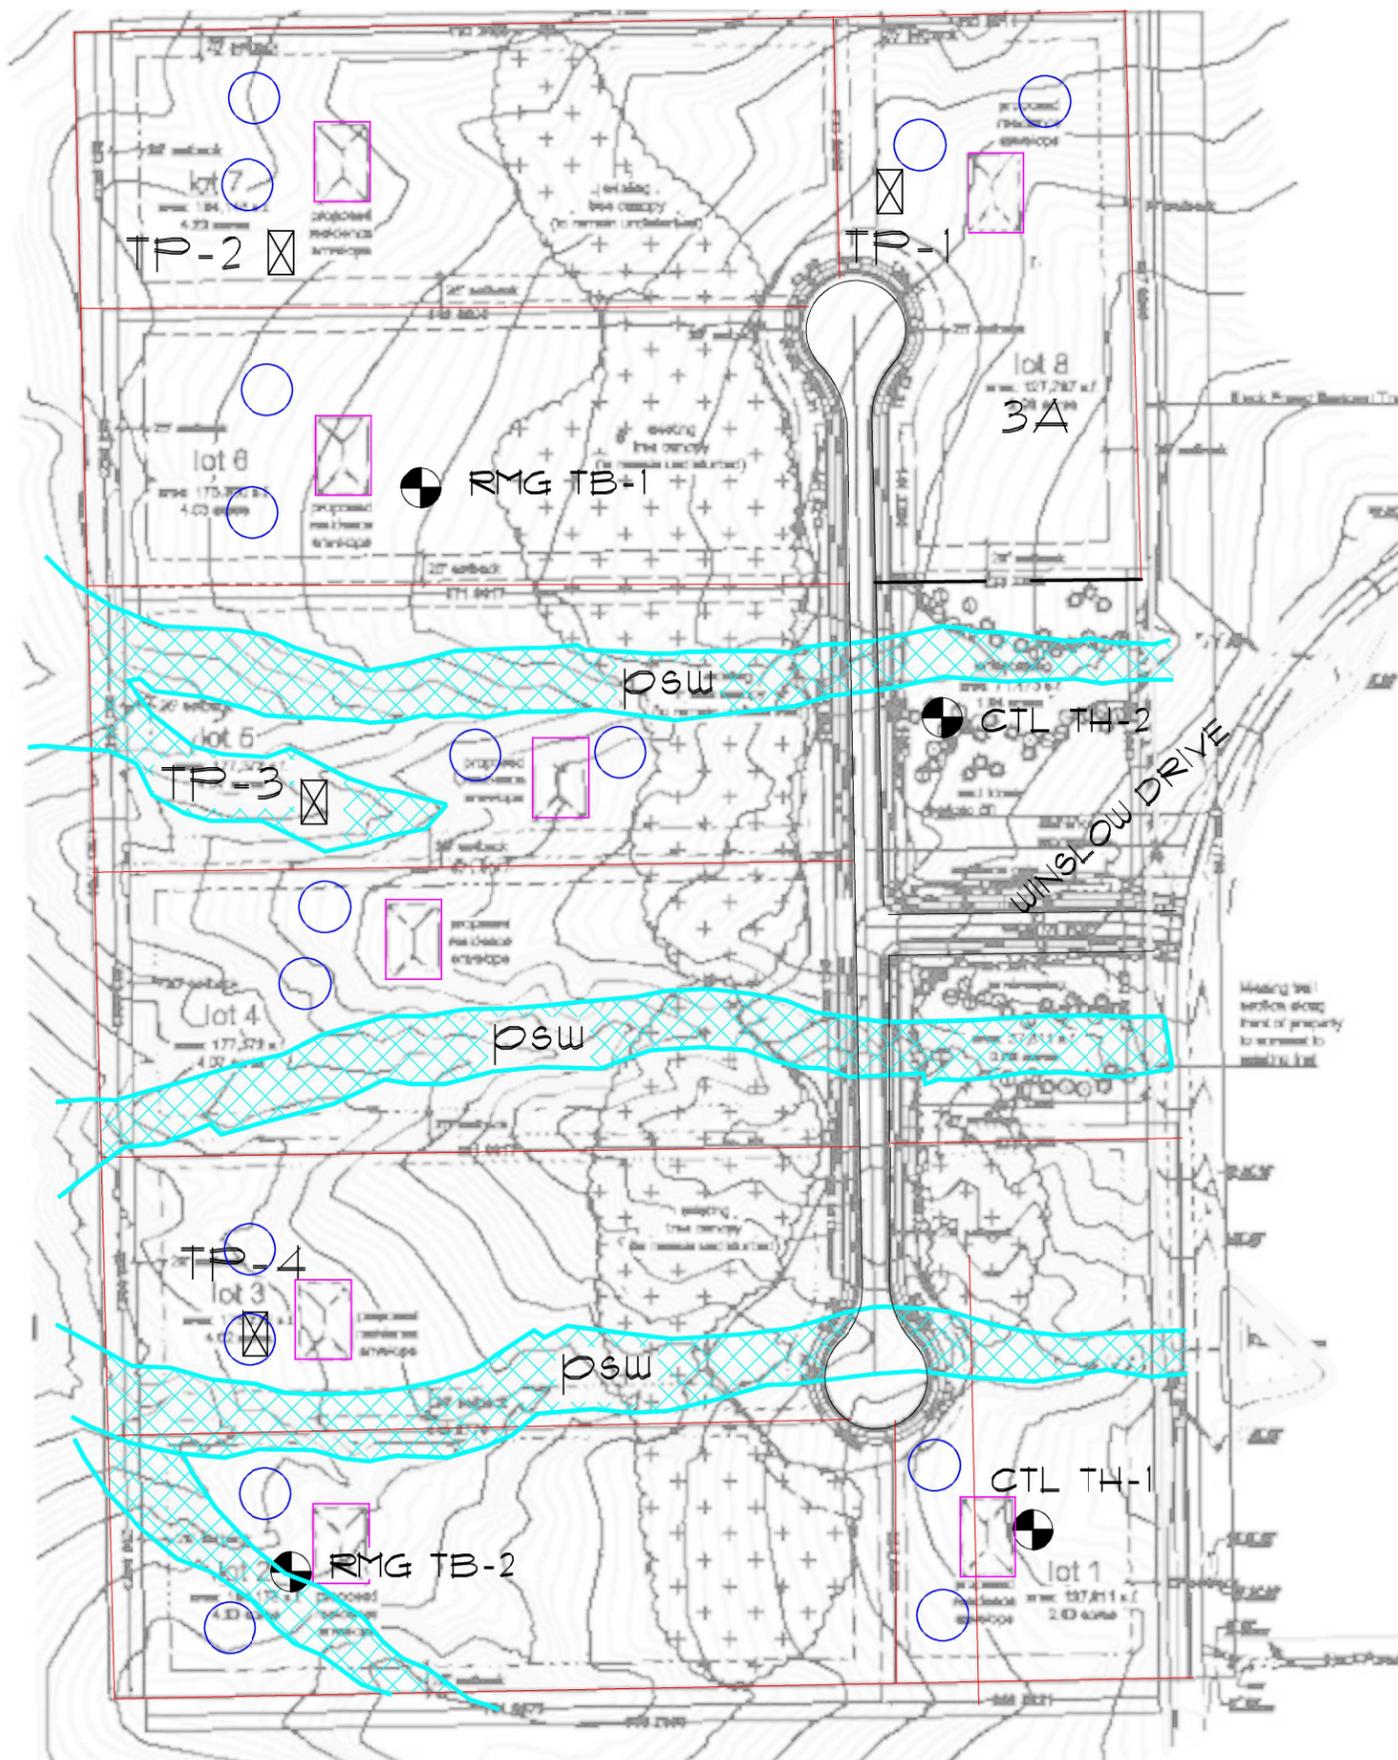
FIG-10

Geologic Conditions

TKda4 - Dawson Formation Facies Unit Four

Based on our site reconnaissance on March 21, 2022 and USGS 2019 topographic map of the Black Forest Quadrangle, the site generally slopes down from east to west with an elevation difference of approximately 52 feet across the site. There are three minor drainages that cross the site, from east to the west, as well as numerous smaller drainage swales that flow into the minor drainages. The drainages generally have moderately-defined channels and the majority of storm runoff is anticipated to be in the form of sheet flows along the lower portions of the drainage swales. The drainages discharge into Black Squirrel Creek approximately ¼ to ½-mile west of the site. The water levels in the drainage channel areas are anticipated to vary dependent upon local precipitation events. The drainage channel features can be seen in Figure 10, Engineering and Geology Map.

The CTL test holes and RMG test borings are located on the Engineering and Geology Map, Figure 10. Additional descriptions of the findings from both CTL and RMG are included below.

- Each treatment area shall be designed to insure the OWTS does not fall within the restricted areas, potentially seasonally wet, as identified on the Engineering and Geology Map, Figure 10.

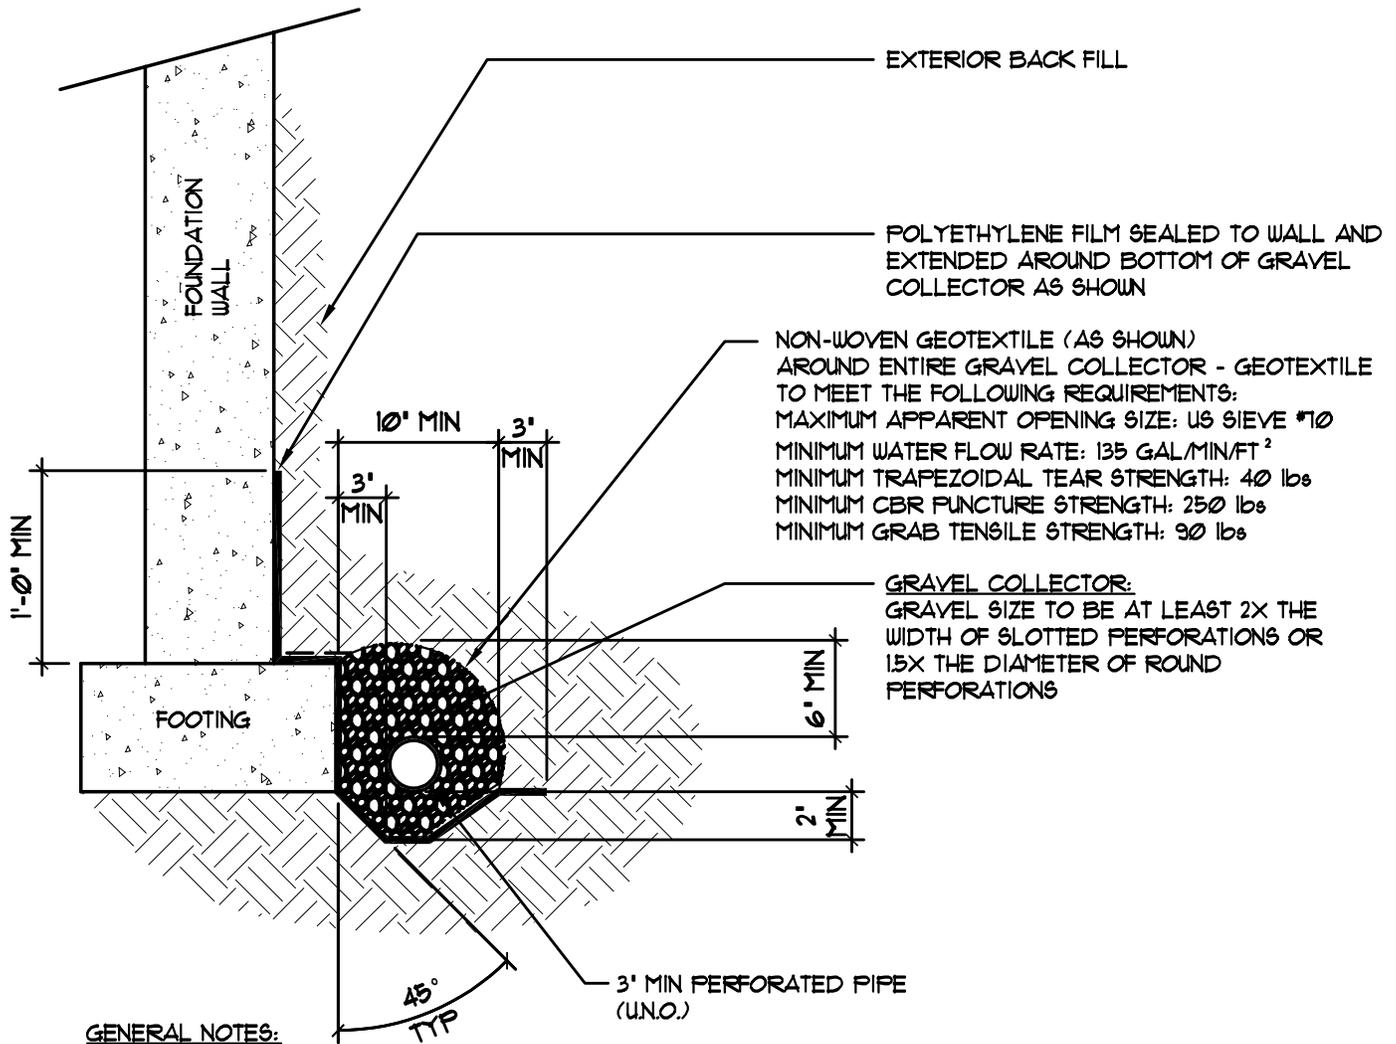
FIG No. 13

1. BOTTOM OF DRAIN PIPE SHALL BE AT OR BELOW BOTTOM OF FOOTING AT ALL LOCATIONS
2. ALL DRAIN PIPE SHALL BE PERFORATED PLASTIC, WITH THE EXCEPTION OF THE DISCHARGE PORTION WHICH SHALL BE SOLID, NON-PERFORATED PIPE.

3. DRAIN PIPE SHALL HAVE POSITIVE FALL THROUGHOUT.
4. DRAIN PIPE SHALL BE PROVIDED WITH A FREE GRAVITY OUTFALL, IF POSSIBLE. IF A GRAVITY OUTFALL CANNOT BE ACHIEVED, THEN A SUMP PIT AND PUMP SHALL BE USED. THE OUTFALL SHOULD EXTEND PAST BACKFILL ZONES AND DISCHARGE TO A LOCATION THAT IS GRADED TO DIRECT WATER OFF-SITE.

PERIMETER DRAIN

trench, if applicable. Perimeter drains help prevent the intrusion of water into areas below grade. A typical perimeter drain detail is presented in Figure 13. Additionally, if groundwater was encountered within 4 to 6 feet below the bottom of foundation components an underslab drain may also be recommended. An underslab drain detail is presented in Figure 14.

In addition to the previously identified mitigation alternatives, surface and subsurface drainage systems should be considered. Exterior, perimeter foundation drains should be installed around below-grade habitable or storage spaces. A typical perimeter drain detail is presented in Figure 13. Surface water should be efficiently removed from the building area to prevent ponding and infiltration into the subsurface soil.

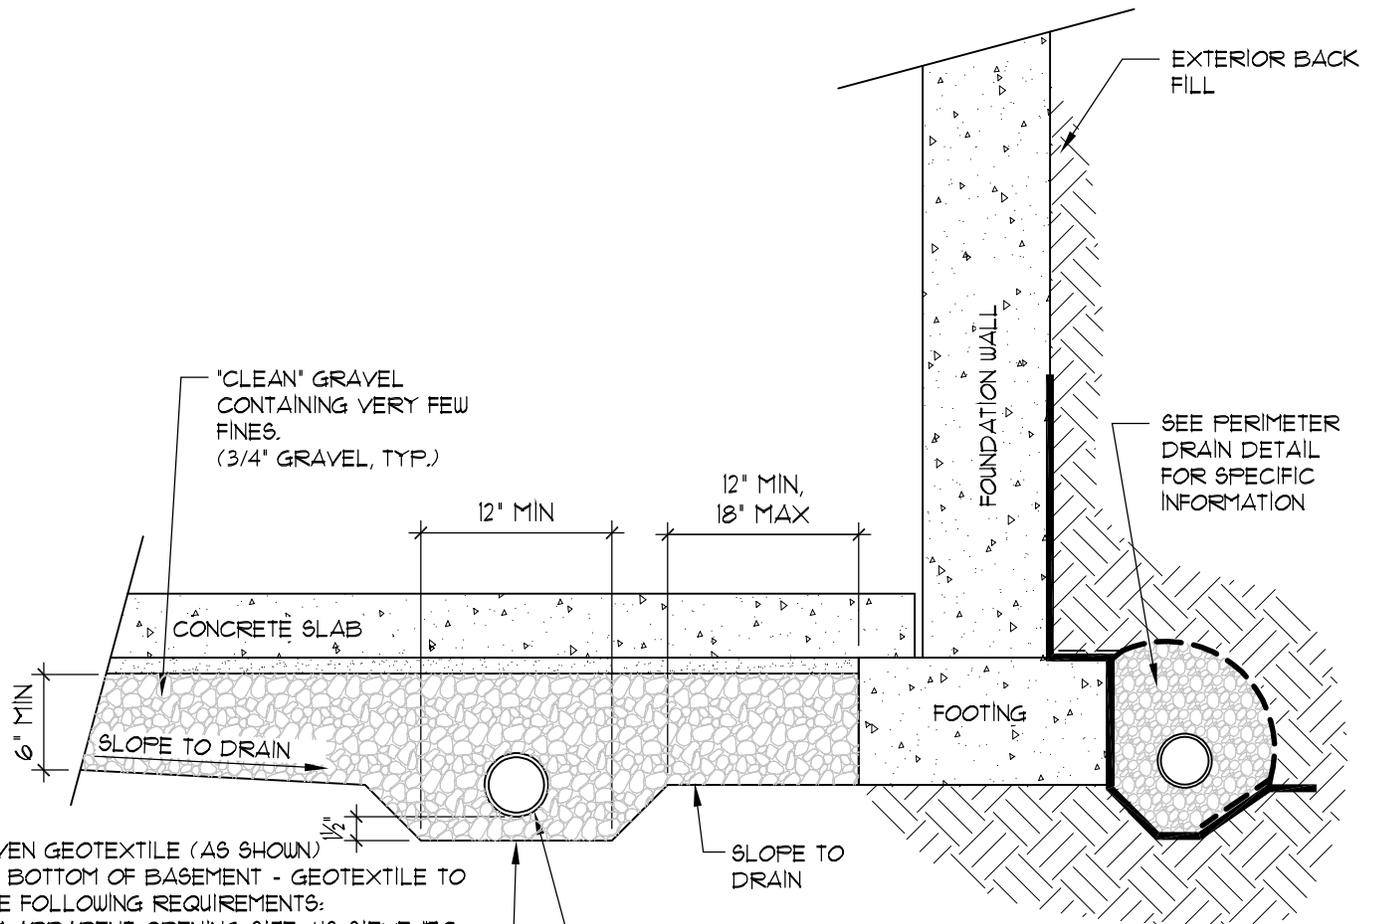
NON-WOVEN GEOTEXTILE (AS SHOWN) ACROSS BOTTOM OF BASEMENT - GEOTEXTILE TO MEET THE FOLLOWING REQUIREMENTS:
 MAXIMUM APPARENT OPENING SIZE: US SIEVE #10
 MINIMUM WATER FLOW RATE: 135 GAL/MIN/FT²
 MINIMUM TRAPEZOIDAL TEAR STRENGTH: 40 lbs
 MINIMUM CBR PUNCTURE STRENGTH: 250 lbs
 MINIMUM GRAB TENSILE STRENGTH: 90 lbs

3' DIAMETER RIGID PERFORATED PIPE CONNECTED TO A SUITABLE GRAVITY OUTFALL SUCH AS AN UNDERDRAIN LOCATED IN THE UTILITY TRENCH IN THE STREET WITH A MIN. GRADE OF PIPE = 15%. IF A FREE GRAVITY OUTFALL CANNOT BE ACHIEVED, A SUMP PIT AND PUMP SHOULD BE PROVIDED.

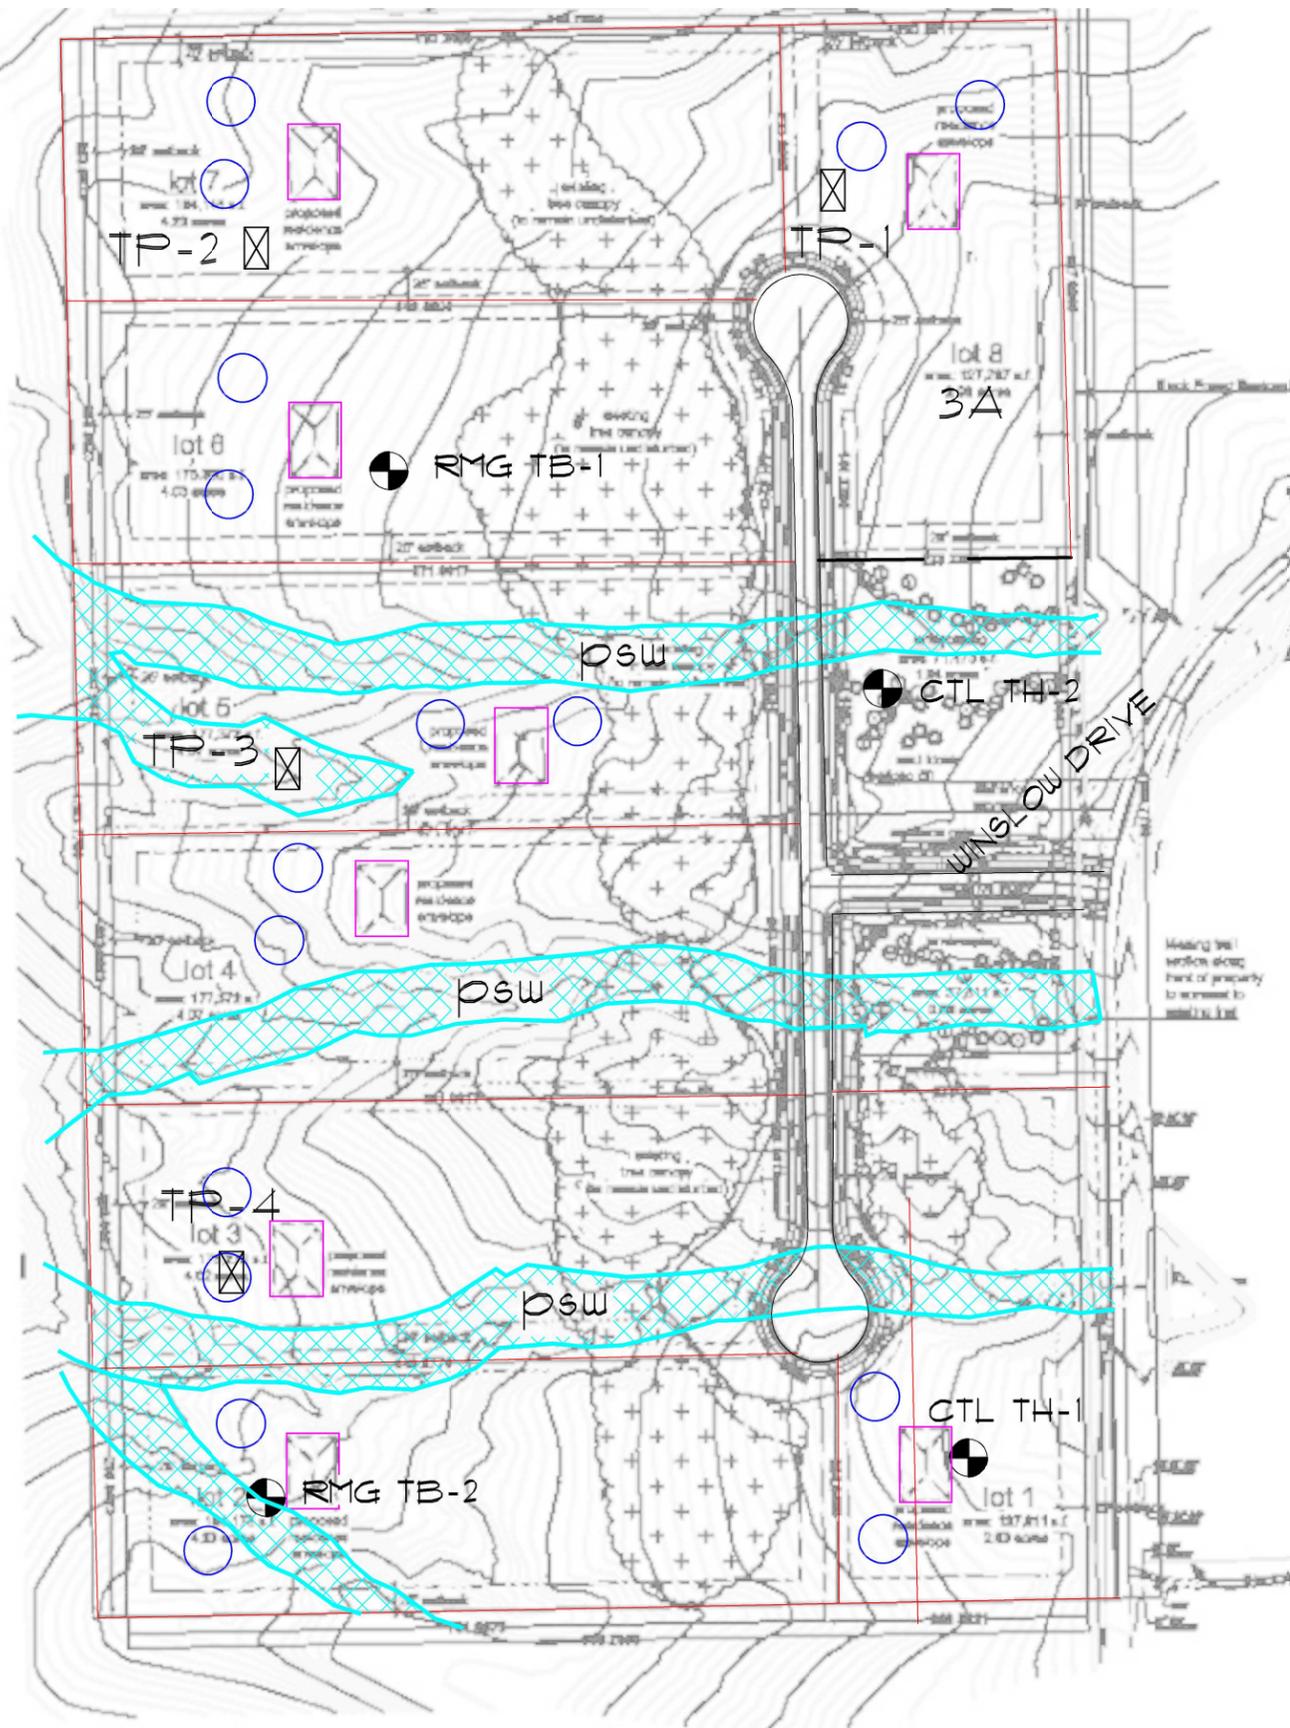
SHEET No. FIG-6

- DENOTES APPROXIMATE LOCATION OF FUTURE RESIDENCE
- DENOTES APPROXIMATE LOCATION OF ONSITE WASTEWATER TREATMENT SYSTEMS (OWTS). THE SELECTED LOCATIONS ARE FOR ILLUSTRATION ONLY. IF ALL SETBACK REQUIREMENTS ARE MET FOR EACH LOT, THERE ARE NO RESTRICTIONS ON THE PLACEMENT OF THE INDIVIDUAL OWTS.
- psw - Potentially Seasonally Wet area. Should be avoided with proper placement of residence and OWTS
- DENOTES APPROXIMATE LOCATION OF TEST PITS OBSERVED BY RMG FOR THIS STUDY
- DENOTES APPROXIMATE LOCATION OF TEST HOLES PERFORMED BY CTL THOMPSON, PROJECT NO. CS17101-105 DATED MAY 2, 2008
- DENOTES APPROXIMATE LOCATION OF TEST BORINGS PERFORMED BY RMG FOR THIS STUDY

SEPTIC SUITABILITY

Personnel of RMG performed a soil evaluation to include four 8-foot deep test pits, on March 31, 2022 (Test Pit TP-1 through TP-4), utilizing the visual and tactile method for the evaluation of the site soils. The test pits were excavated in areas that appeared most likely to be used for residential construction. The Test Pit Logs are presented in Figures 4 and 5. A Septic Suitability Map is presented in Figure 6.

Neither groundwater nor bedrock (limiting layers) were encountered in the RMG test pits. However, groundwater was encountered in our test boring TB-2 at 5 feet and bedrock was encountered at depths of 3 and 6 feet in our test borings. TB-2 was located near a drainage to verify the depth of groundwater, this area has been mapped as *psw – potentially seasonally wet* and should be avoided when placing the OWTS for each lot. This area is shown on the Septic Suitability Map, Figure 6.

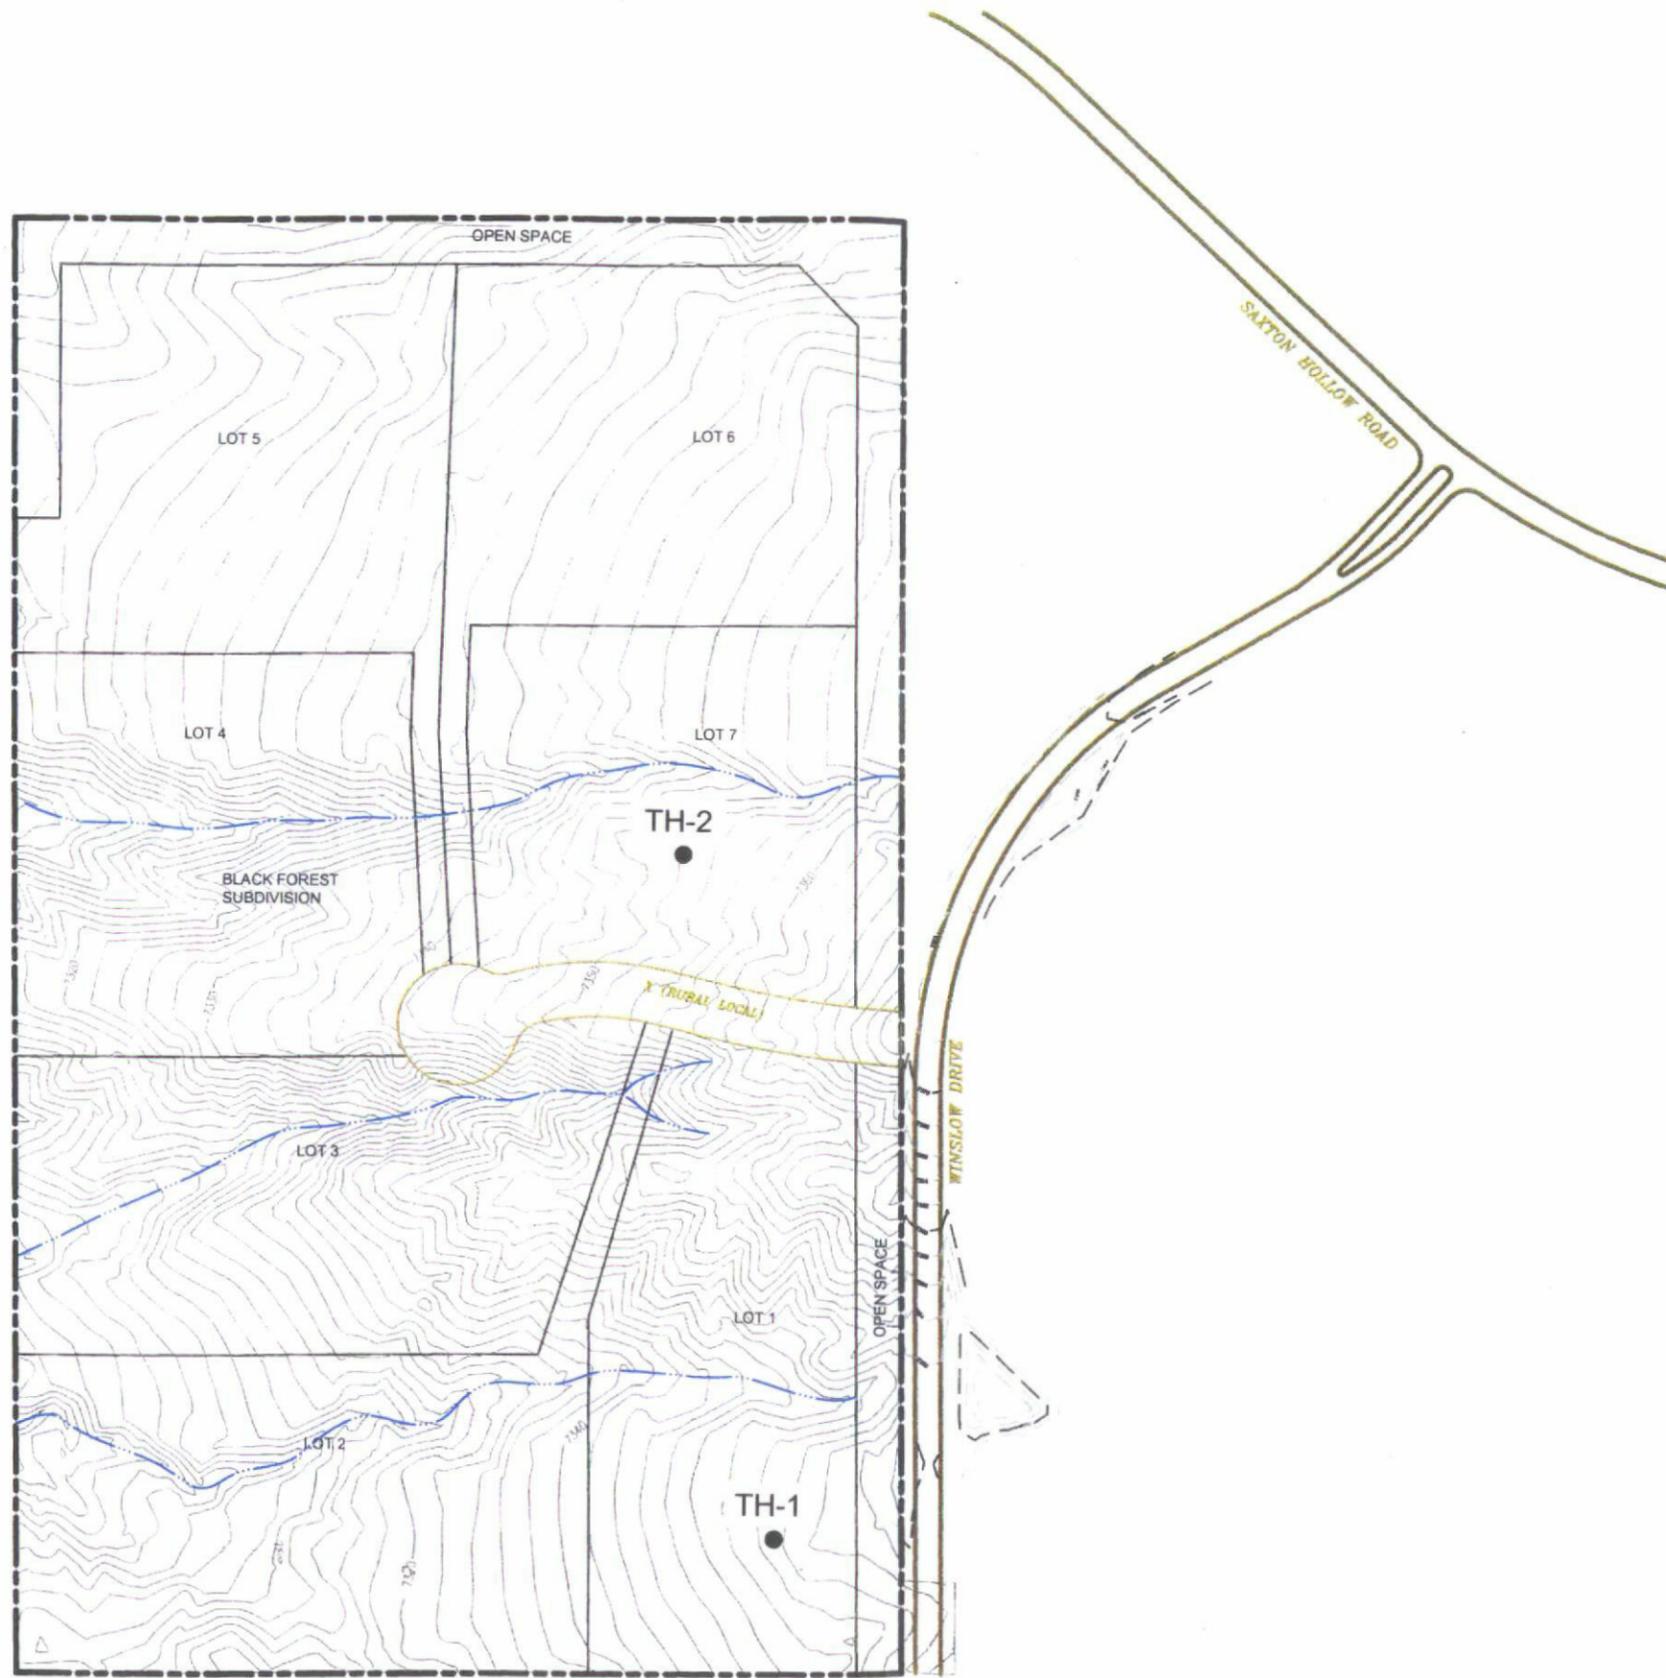
- LEGEND:**
- TH-1 ● INDICATES APPROXIMATE LOCATION OF EXPLORATORY BORING.
 - INDICATES APPROXIMATE LOCATION OF PROPERTY BOUNDARY.
 - - - INDICATES EXISTING TOPOGRAPHY.
 - ~ ~ ~ INDICATES INTERMITTENT DRAINAGES.

**Location of
 Exploratory
 Borings**

FIG. 1 – LOCATION OF EXPLORATORY BORINGS AND PERCOLATION TESTS

Septic system locations should avoid the minor drainages and steeper slopes. The intermittent drainages swales are identified on Fig. 1.

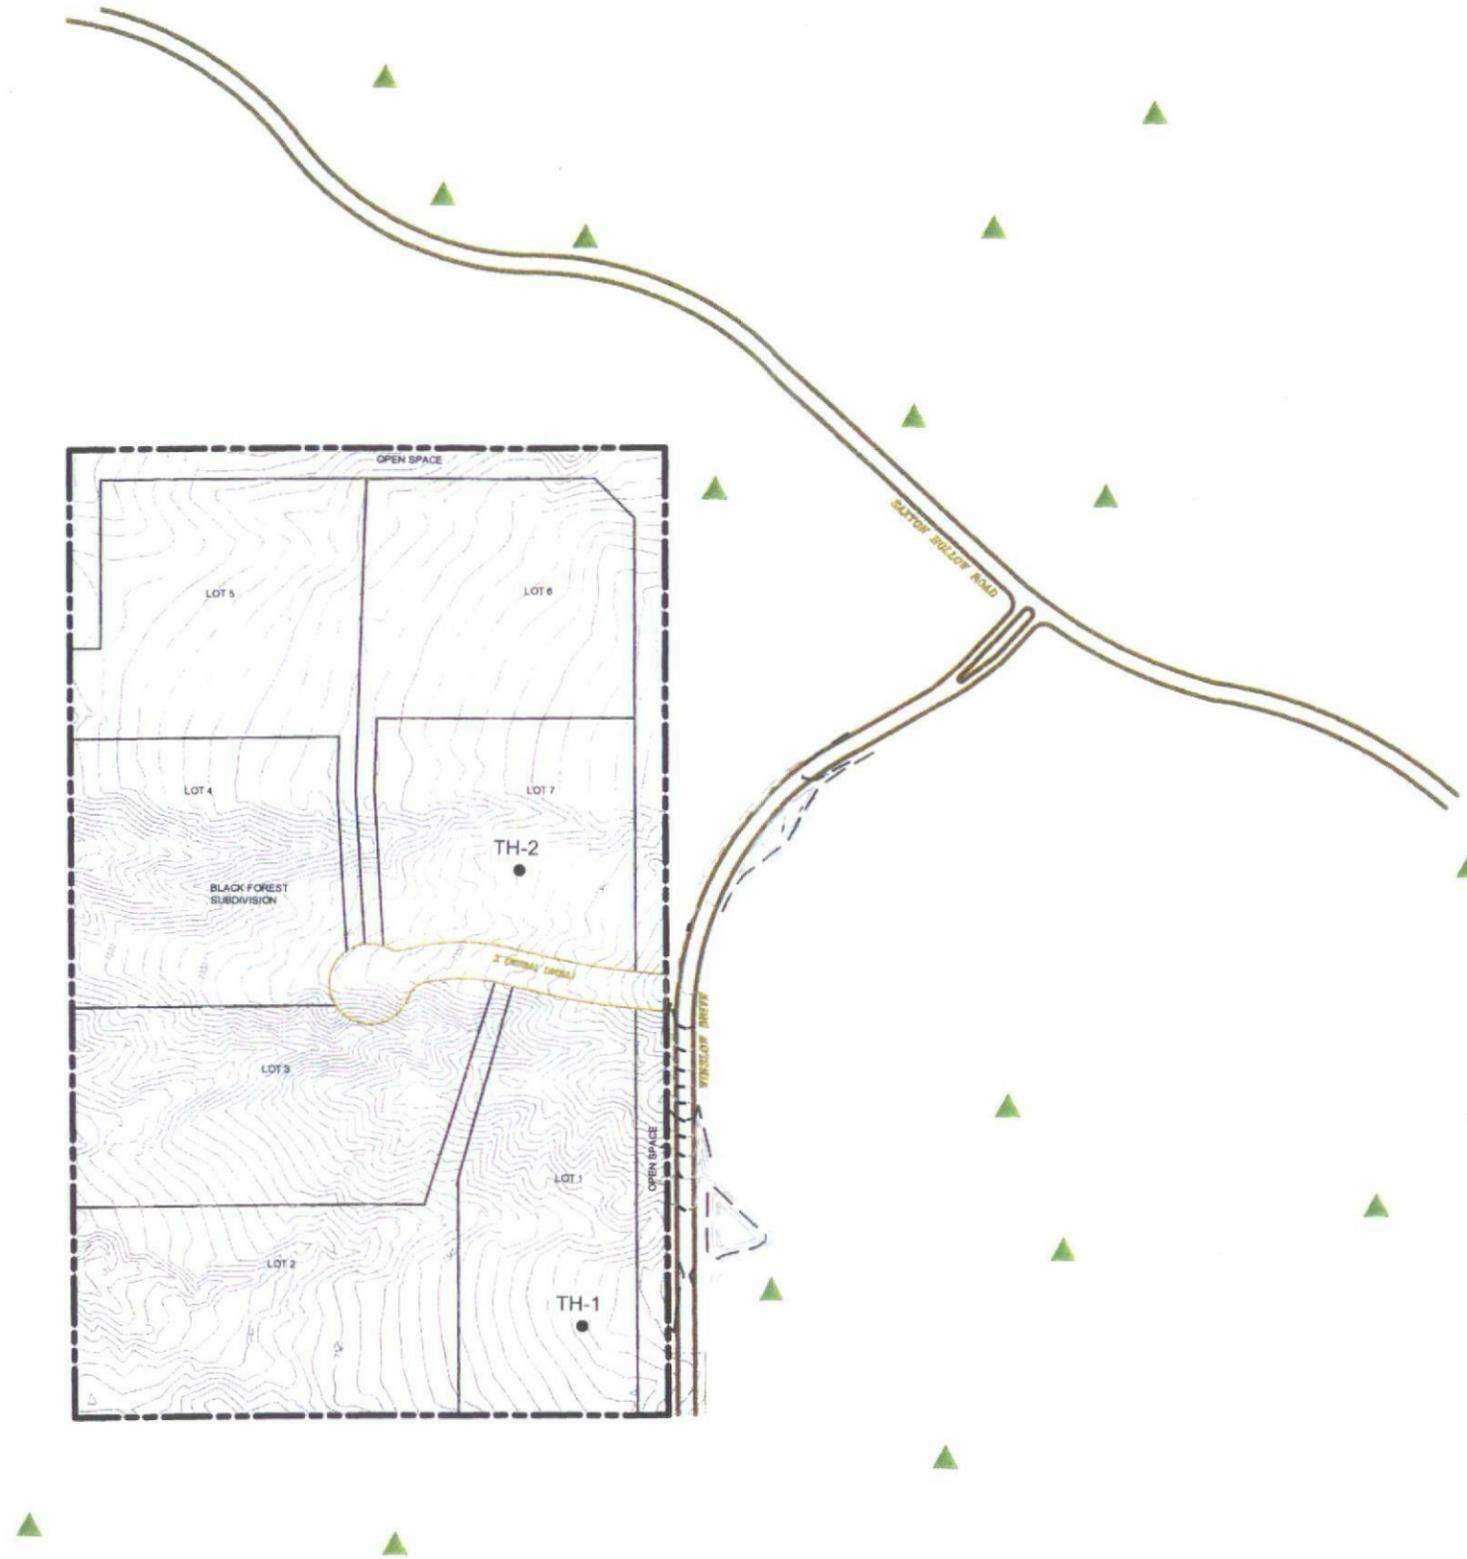
- TH-1 INDICATES APPROXIMATE LOCATION OF EXPLORATORY BORING.
- INDICATES APPROXIMATE LOCATION OF PROPERTY BOUNDARY.
- - - - INDICATES EXISTING TOPOGRAPHY.
- ▲ INDICATES APPROXIMATE LOCATION OF EXISTING WELL.

**Existing
 Well
 Locations**

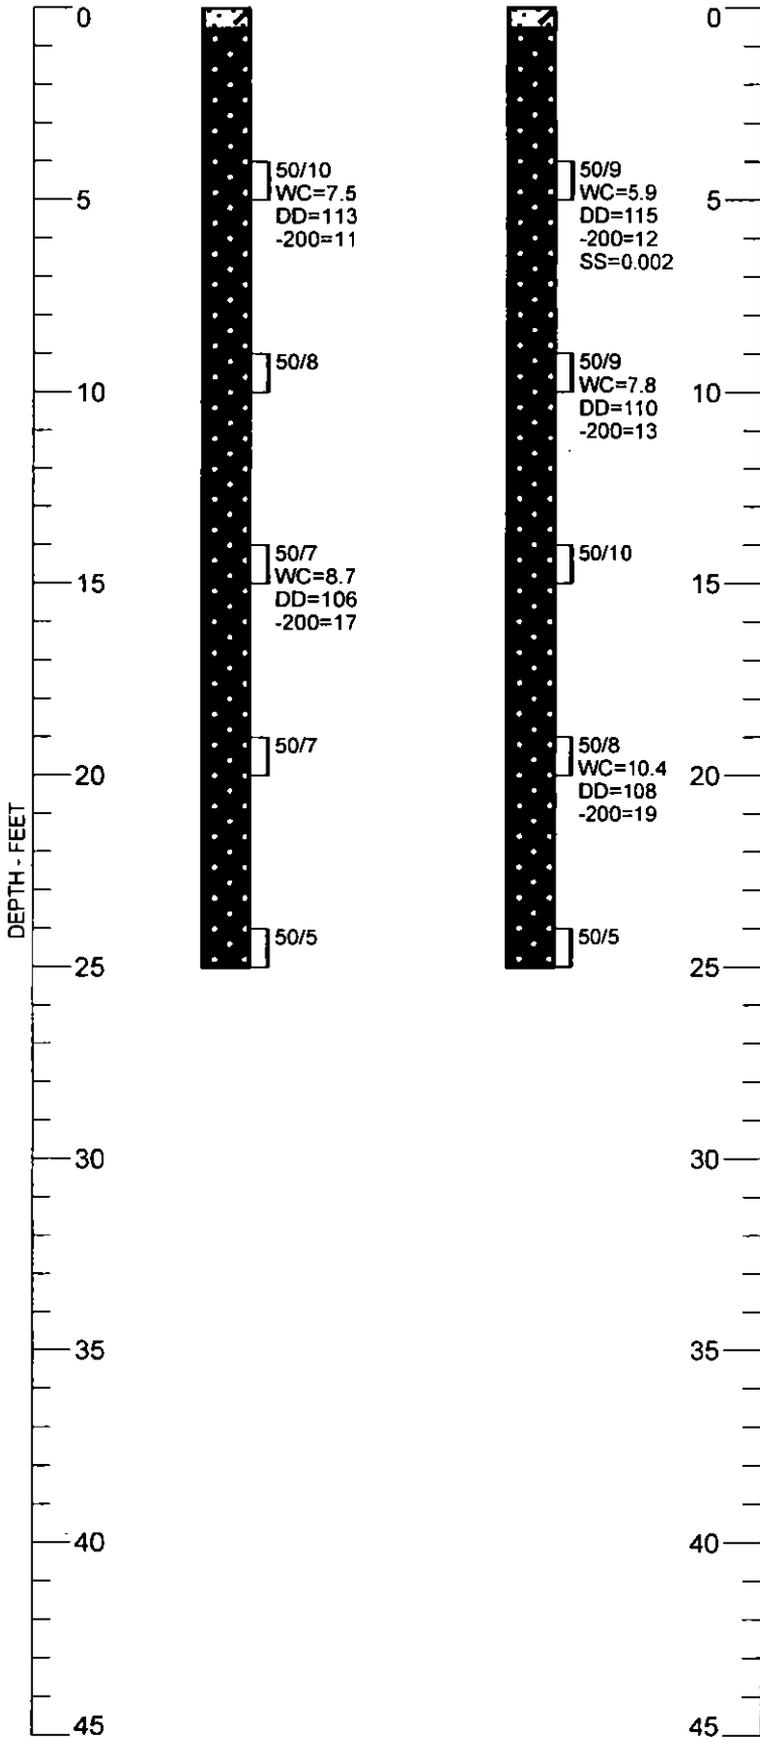
DRIVE SAMPLE. THE SYMBOL 50/10 INDICATES 50 BLOWS OF A 140-POUND HAMMER FALLING 30 INCHES WERE REQUIRED TO DRIVE A 2.5-INCH O.D. SAMPLER 10 INCHES.

1. THE BORINGS WERE DRILLED APRIL 18, 2008 USING A 4-INCH DIAMETER, CONTINUOUS-FLIGHT AUGER AND A CME-45, TRUCK-MOUNTED DRILL RIG.
2. THESE LOGS ARE SUBJECT TO THE EXPLANATIONS, LIMITATIONS, AND CONCLUSIONS AS CONTAINED IN THIS REPORT.
3. GROUND WATER WAS NOT ENCOUNTERED IN THE EXPLORATORY BORINGS DURING THIS INVESTIGATION.
4. WC - INDICATES MOISTURE CONTENT. (%)
 DD - INDICATES DRY DENSITY. (PCF)
 -200 - INDICATES PASSING NO. 200 SIEVE. (%)
 SS - INDICATES WATER-SOLUBLE SULFATE CONTENT. (%)

Summary Logs of Exploratory Borings

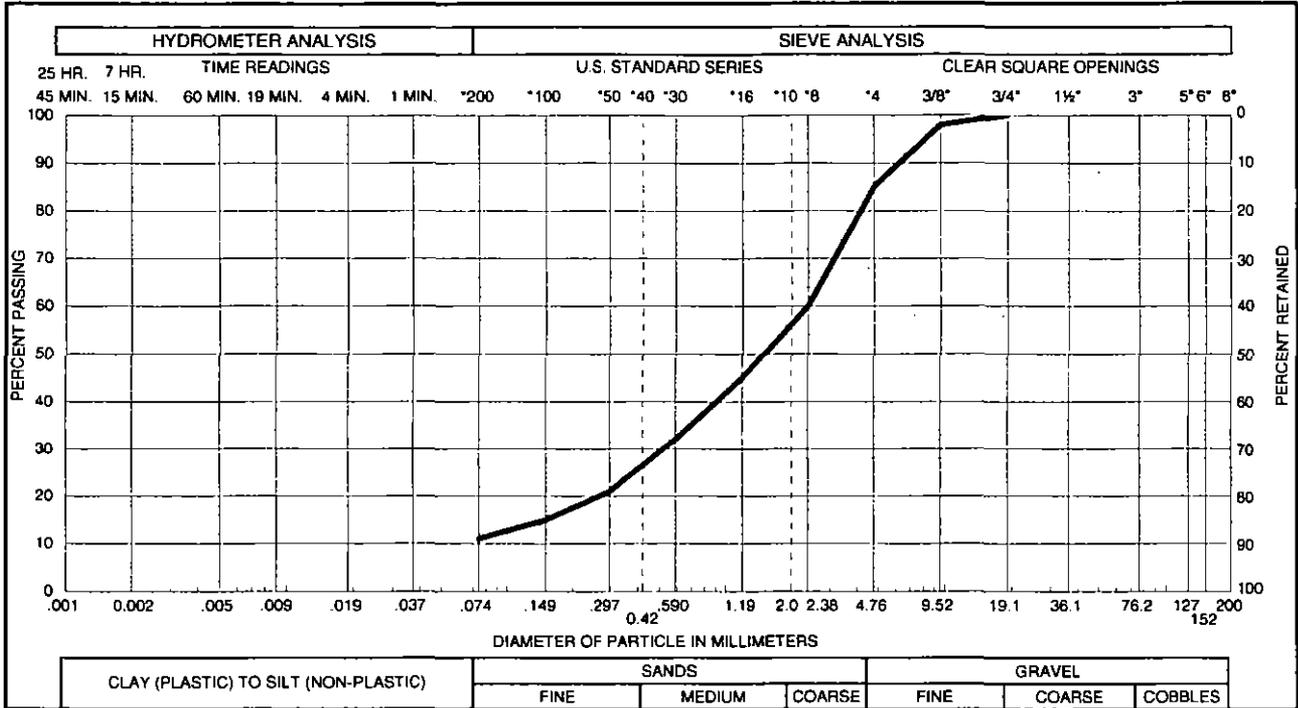
Sample of SANDSTONE, SL. SILTY, GRAVELLY GRAVEL 15 % SAND 74 %
 From TH - 1 AT 4 FEET SILT & CLAY 11 % LIQUID LIMIT %
 PLASTICITY INDEX %

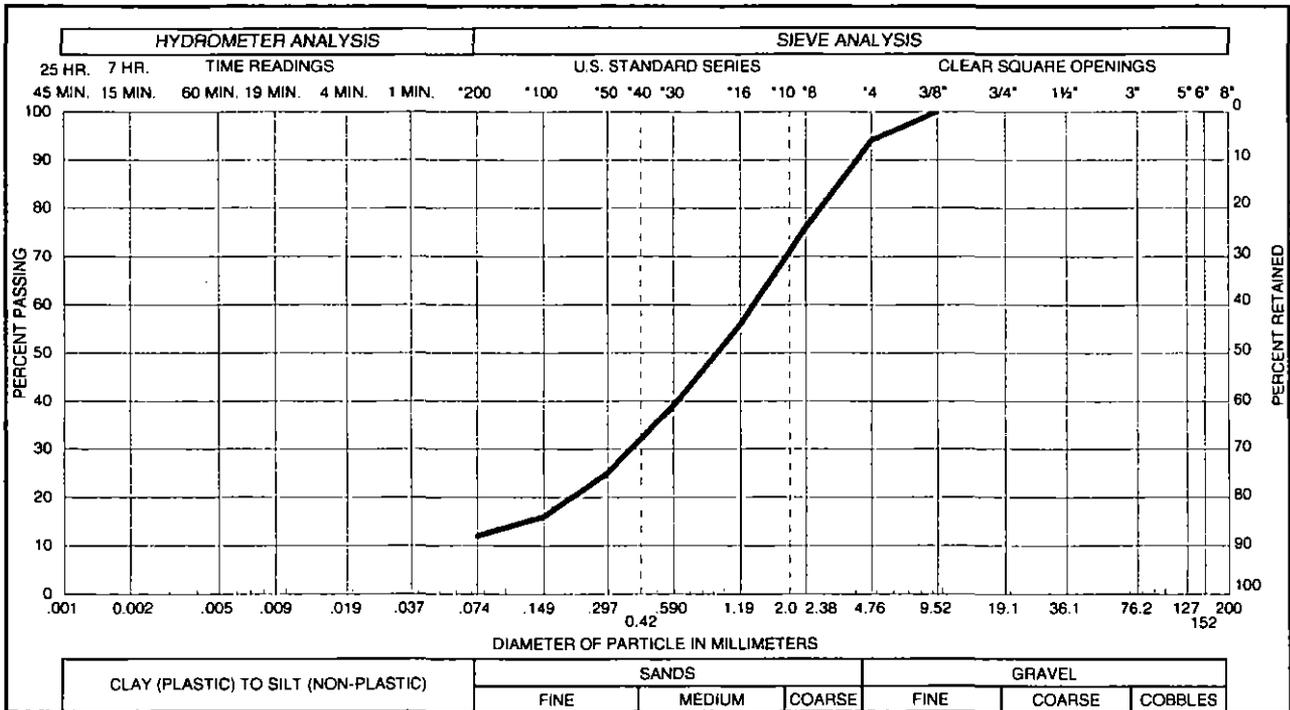
Sample of SANDSTONE, SILTY GRAVEL 6 % SAND 82 %
 From TH - 2 AT 4 FEET SILT & CLAY 12 % LIQUID LIMIT %
 PLASTICITY INDEX %
