**ENTECH**  
ENGINEERING, INC.

**SOIL, GEOLOGY, & WASTEWATER STUDY  
THE RETREAT AT TIMBERRIDGE, FILING 2  
VOLLMER ROAD AND ARROYA LANE  
EL PASO COUNTY, COLORADO**

April 26, 2021

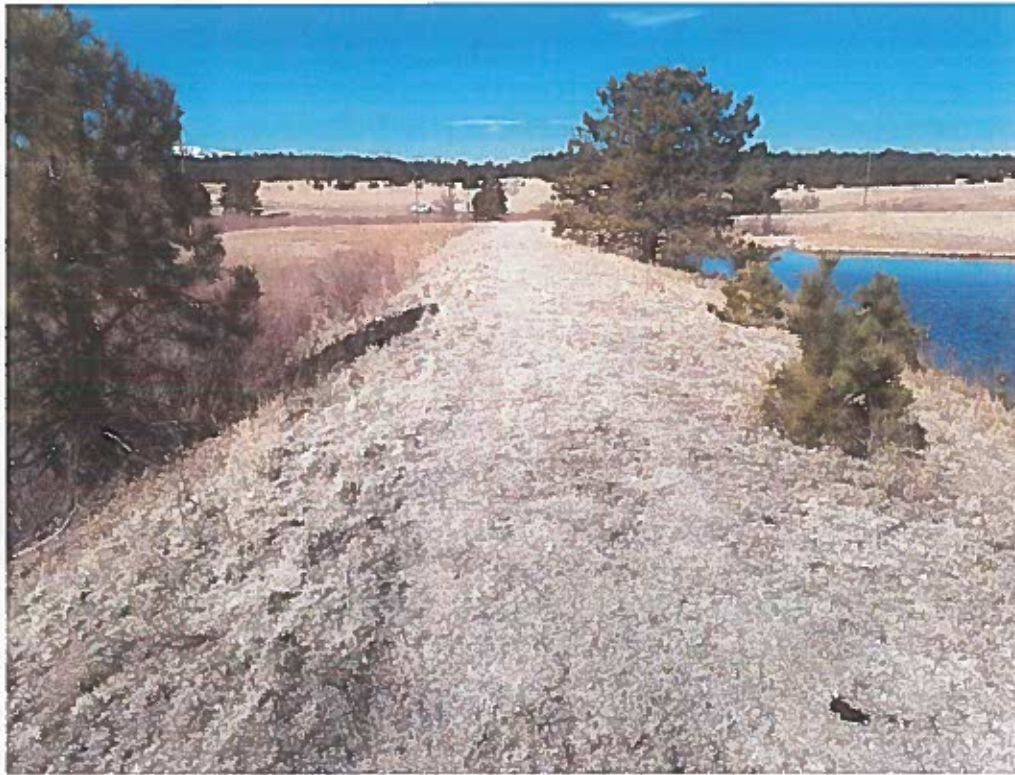
**Looking west along  
the crest of the dam in  
the northern portion of  
the site.**

These are recent man-made fill deposits associated with the two dams located across the site. One of the dams is located north of Arroya Lane and is not within the proposed developed area. One dam is located on the eastern side of Parcel C. It is anticipated that this dam will be removed and filled during the site grading process. At the time of the investigation the condition of the dams was observed, and appeared to be in good condition.

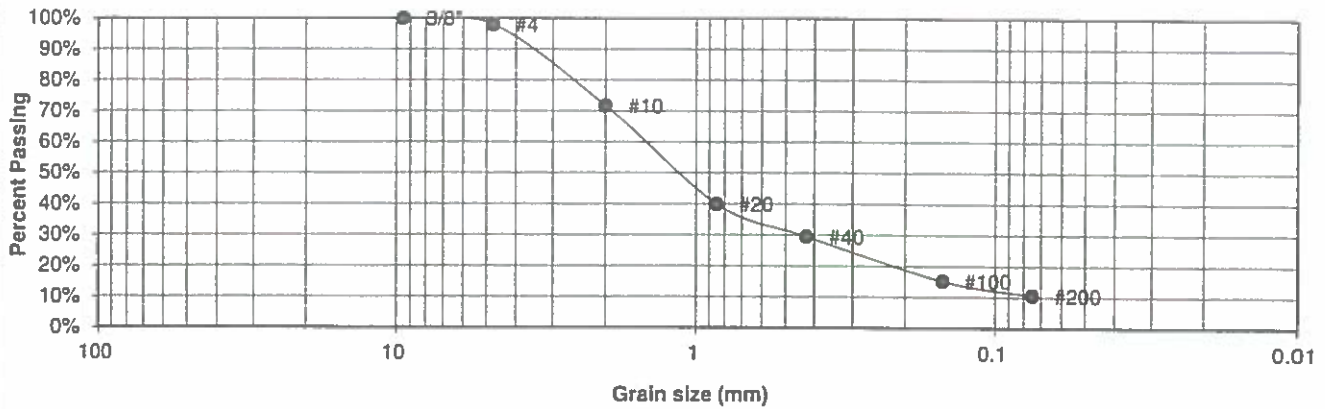
**Sieve Analysis  
Grain Size Distribution**

<u>UNIFIED CLASSIFICATION</u>	SM-SW	<u>CLIENT</u>	ARROYA INVESTMENTS
<u>SOIL TYPE #</u>	1	<u>PROJECT</u>	THE RETREAT AT TIMBER RIDGE
<u>TEST BORING #</u>	5	<u>JOB NO.</u>	170020
<u>DEPTH (FT)</u>	2-3	<u>TEST BY</u>	BL

<u>U.S. Sieve #</u>	<u>Percent Finer</u>
3"	
1 1/2"	
3/4"	
1/2"	
3/8"	100.0%
4	97.9%
10	71.7%
20	40.0%
40	29.4%
100	15.2%
200	10.5%

Soil Type 1 silty to slightly silty sand and very clayey sand (SM-SW, SM, SC), encountered in all of Test Borings at the existing ground surface and extending to depths ranging from 1 foot to 17 feet bgs. These soils were encountered at loose to dense states and at moist conditions. The majority of the soils were encountered and medium dense states. Samples tested had 9 to 41 percent passing the No. 200 Sieve. Atterberg Limits Testing resulted in the sand being non-plastic. Sulfate testing resulted in less than 0.01 to 0.01 percent sulfate by weight indicating the sand exhibits negligible potential for below grade concrete degradation.

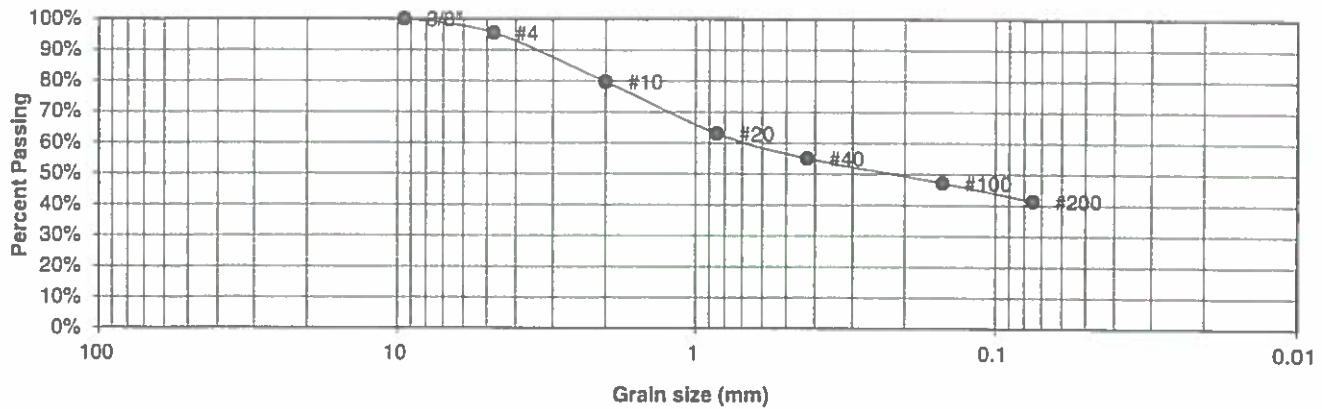
### Sieve Analysis Grain Size Distribution

<u>UNIFIED CLASSIFICATION</u>	SC	<u>CLIENT</u>	ARROYA INVESTMENTS
<u>SOIL TYPE #</u>	1	<u>PROJECT</u>	THE RETREAT AT TIMBER RIDGE
<u>TEST BORING #</u>	6	<u>JOB NO.</u>	170020
<u>DEPTH (FT)</u>	5	<u>TEST BY</u>	BL

<u>U.S. Sieve #</u>	<u>Percent Finer</u>
3"	
1 1/2"	
3/4"	
1/2"	
3/8"	100.0%
#4	95.6%
#10	79.8%
#20	63.1%
#40	55.1%
#100	47.2%
#200	41.3%

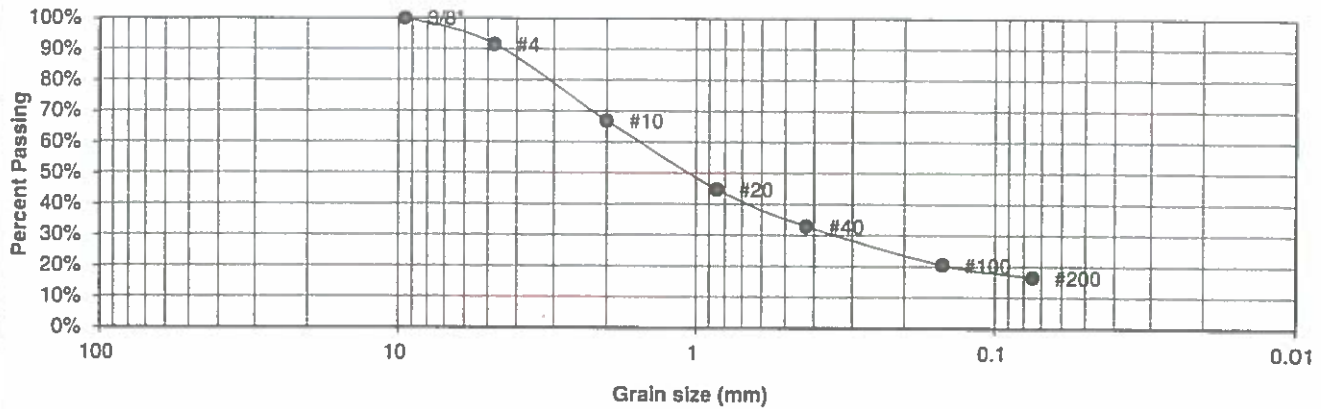
**Sieve Analysis  
Grain Size Distribution**

UNIFIED CLASSIFICATION	SM	CLIENT	ARROYA INVESTMENTS
SOIL TYPE #	1	PROJECT	THE RETREAT AT TIMBER RIDGE
TEST BORING #	11	JOB NO.	170020
DEPTH (FT)	5	TEST BY	BL

U.S. Sieve #	Percent Finer
3"	
1 1/2"	
3/4"	
1/2"	
3/8"	100.0%
4	91.5%
10	66.9%
20	44.8%
40	32.9%
100	20.5%
200	16.5%

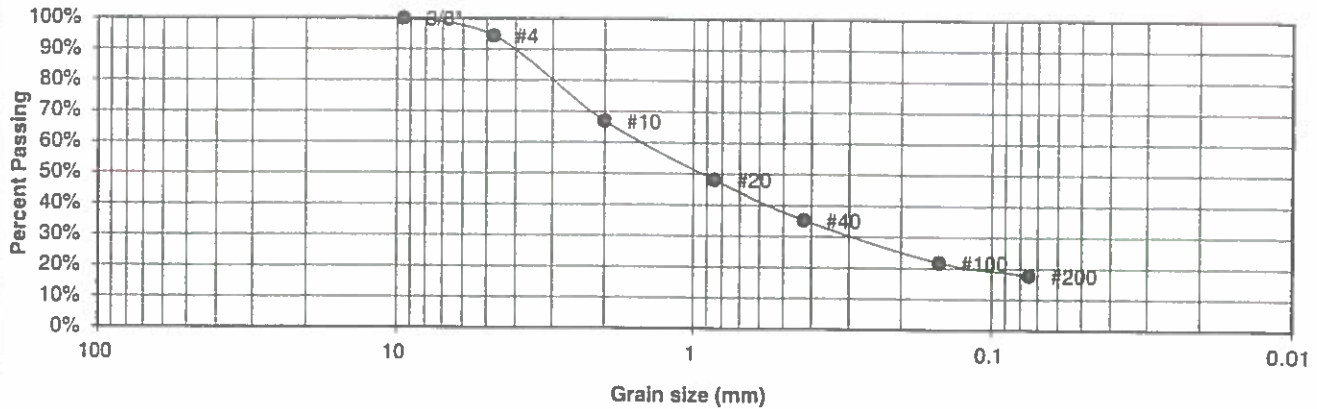
UNIFIED CLASSIFICATION	SM	CLIENT	ARROYA INVESTMENTS
SOIL TYPE #	1	PROJECT	THE RETREAT AT TIMBER RIDGE
TEST BORING #	13	JOB NO.	170020
DEPTH (FT)	2-3	TEST BY	BL

U.S. Sieve #	Percent Finer
3"	
1 1/2"	
3/4"	
1/2"	
3/8"	100.0%
4	94.4%
10	67.0%
20	48.2%
40	35.2%
100	21.8%
200	17.8%

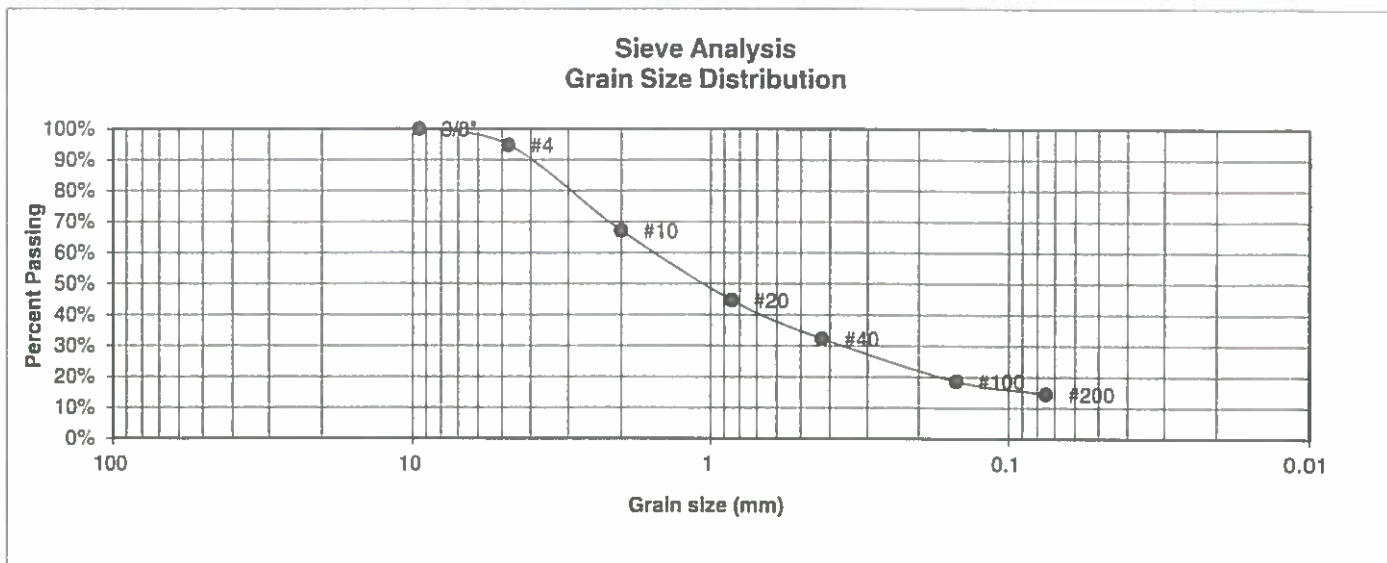
FIG NO.:  
C-4

<u>UNIFIED CLASSIFICATION</u>	SM	<u>CLIENT</u>	ARROYA INVESTMENTS
<u>SOIL TYPE #</u>	1	<u>PROJECT</u>	THE RETREAT AT TIMBER RIDGE
<u>TEST BORING #</u>	9	<u>JOB NO.</u>	170020
<u>DEPTH (FT)</u>	2-3	<u>TEST BY</u>	BL

<u>U.S. Sieve #</u>	<u>Percent Finer</u>
3"	
1 1/2"	
3/4"	
1/2"	
3/8"	100.0%
4	94.8%
10	67.2%
20	44.7%
40	32.3%
100	18.6%
200	14.6%

<u>Atterberg Limits</u>	
Plastic Limit	NP
Liquid Limit	NV
Plastic Index	NP

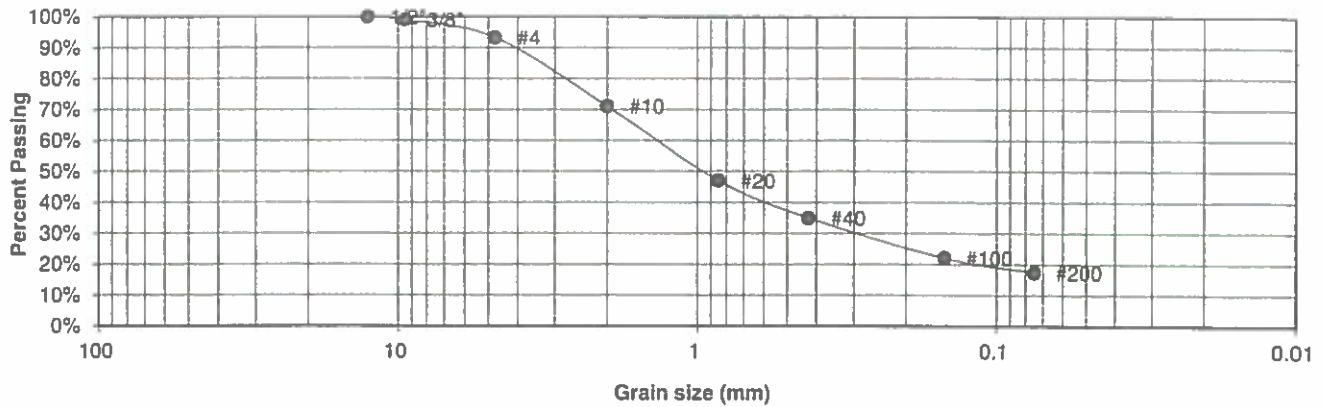
<u>UNIFIED CLASSIFICATION</u>	SM	<u>CLIENT</u>	ARROYA INVESTMENTS
<u>SOIL TYPE #</u>	1	<u>PROJECT</u>	THE RETREAT AT TIMBER RIDGE
<u>TEST BORING #</u>	10	<u>JOB NO.</u>	170020
<u>DEPTH (FT)</u>	5	<u>TEST BY</u>	BL

<u>U.S. Sieve #</u>	<u>Percent Finer</u>
3"	
1 1/2"	
3/4"	
1/2"	100.0%
3/8"	99.1%
4	93.3%
10	71.0%
20	47.0%
40	35.0%
100	22.0%
200	17.4%

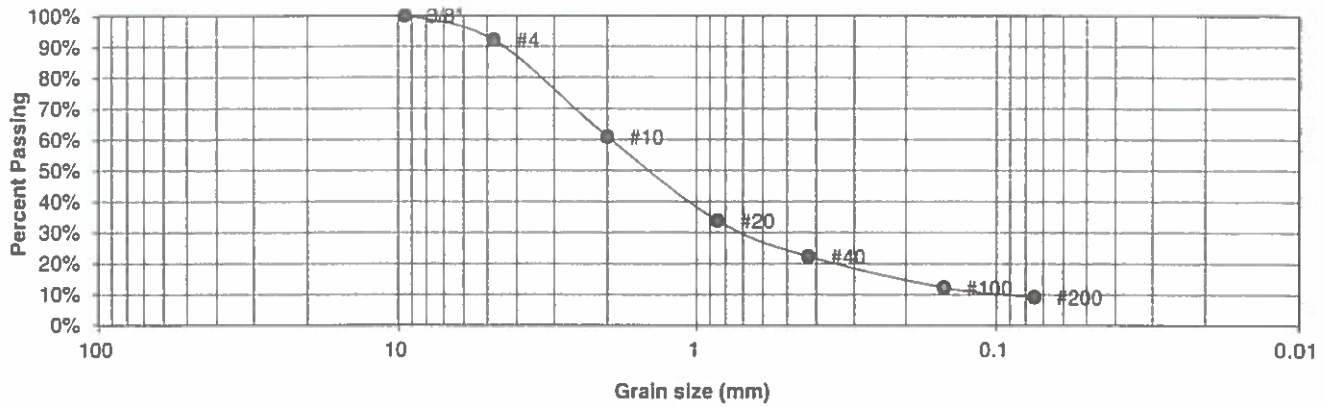
<u>UNIFIED CLASSIFICATION</u>	SM-SW	<u>CLIENT</u>	ARROYA INVESTMENTS
<u>SOIL TYPE #</u>	1	<u>PROJECT</u>	THE RETREAT AT TIMBER RIDGE
<u>TEST BORING #</u>	2	<u>JOB NO.</u>	170020
<u>DEPTH (FT)</u>	10	<u>TEST BY</u>	BL

<u>U.S. Sieve #</u>	<u>Percent Finer</u>
3"	
1 1/2"	
3/4"	
1/2"	
3/8"	100.0%
4	92.1%
10	60.9%
20	33.9%
40	22.3%
100	12.3%
200	9.2%

<u>Atterberg Limits</u>	
Plastic Limit	NP
Liquid Limit	NV
Plastic Index	NP

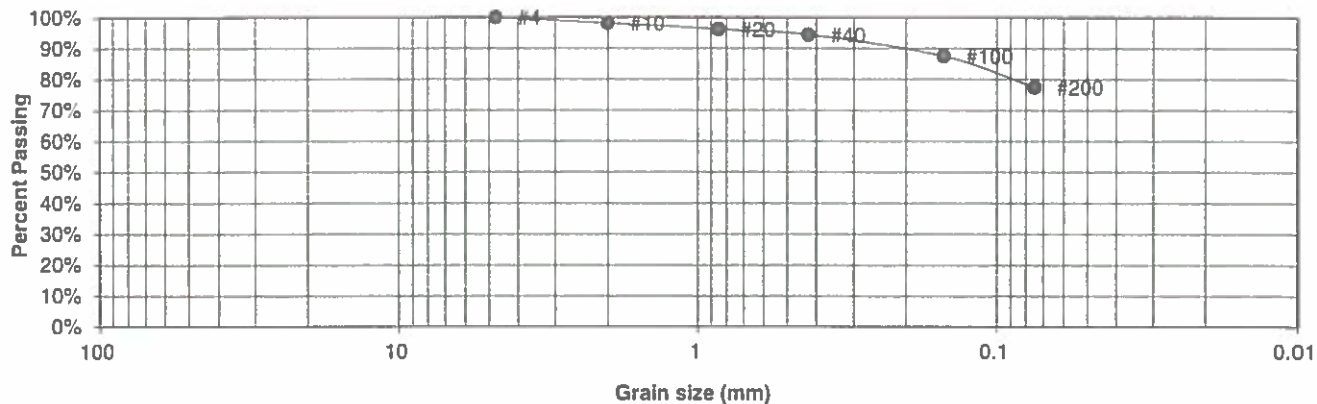
<u>UNIFIED CLASSIFICATION</u>	CL	<u>CLIENT</u>	ARROYA INVESTMENTS
<u>SOIL TYPE #</u>	2	<u>PROJECT</u>	THE RETREAT AT TIMBER RIDGE
<u>TEST BORING #</u>	1	<u>JOB NO.</u>	170020
<u>DEPTH (FT)</u>	2-3	<u>TEST BY</u>	BL

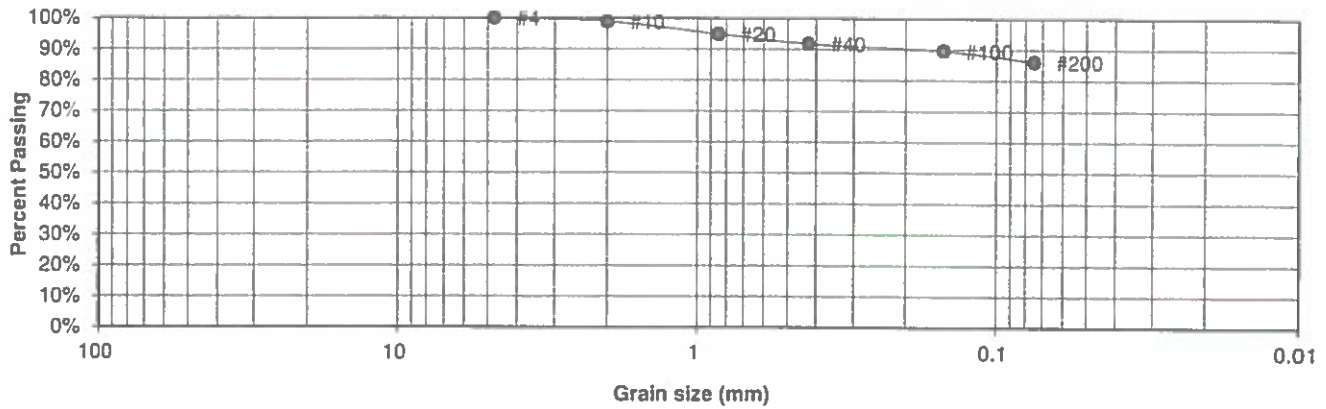
<u>UNIFIED CLASSIFICATION</u>	CL	<u>CLIENT</u>	ARROYA INVESTMENTS
<u>SOIL TYPE #</u>	2	<u>PROJECT</u>	THE RETREAT AT TIMBER RIDGE
<u>TEST BORING #</u>	2	<u>JOB NO.</u>	170020
<u>DEPTH (FT)</u>	4	<u>TEST BY</u>	BL

<u>U.S. Sieve #</u>	<u>Percent Finer</u>
3"	
1 1/2"	
3/4"	
1/2"	
3/8"	
4	100.0%
10	98.9%
20	94.9%
40	91.8%
100	89.6%
200	86.1%

<u>Swell</u>	
Moisture at start	15.9%
Moisture at finish	24.9%
Moisture increase	9.0%
Initial dry density (pcf)	99
Swell (psf)	1520

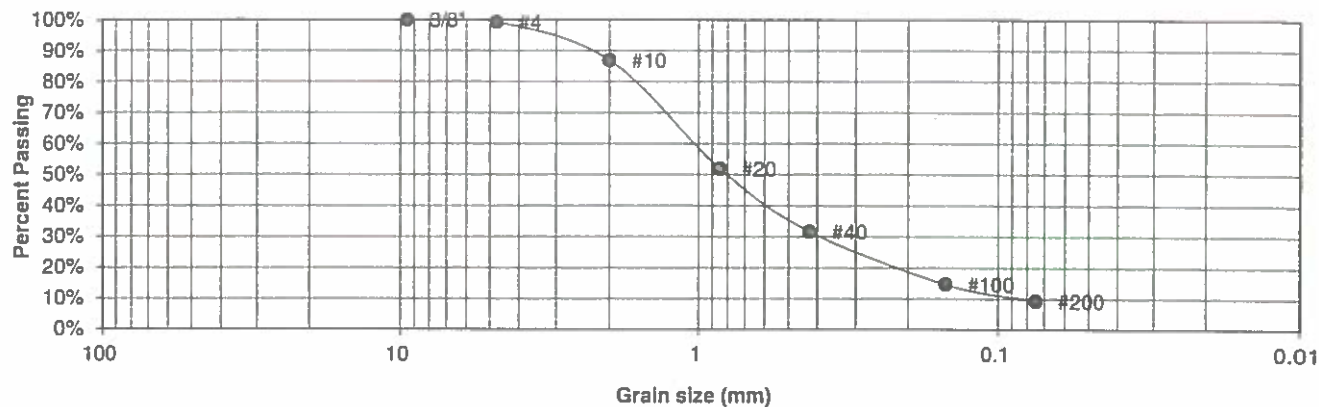
<u>UNIFIED CLASSIFICATION</u>	SM-SW	<u>CLIENT</u>	ARROYA INVESTMENTS
<u>SOIL TYPE #</u>	3	<u>PROJECT</u>	THE RETREAT AT TIMBER RIDGE
<u>TEST BORING #</u>	1	<u>JOB NO.</u>	170020
<u>DEPTH (FT)</u>	10	<u>TEST BY</u>	BL

<u>U.S. Sieve #</u>	<u>Percent Finer</u>
3"	
1 1/2"	
3/4"	
1/2"	
3/8"	100.0%
4	99.3%
10	87.0%
20	52.0%
40	31.6%
100	14.7%
200	9.3%

<u>Atterberg Limits</u>	
Plastic Limit	NP
Liquid Limit	NV
Plastic Index	NP

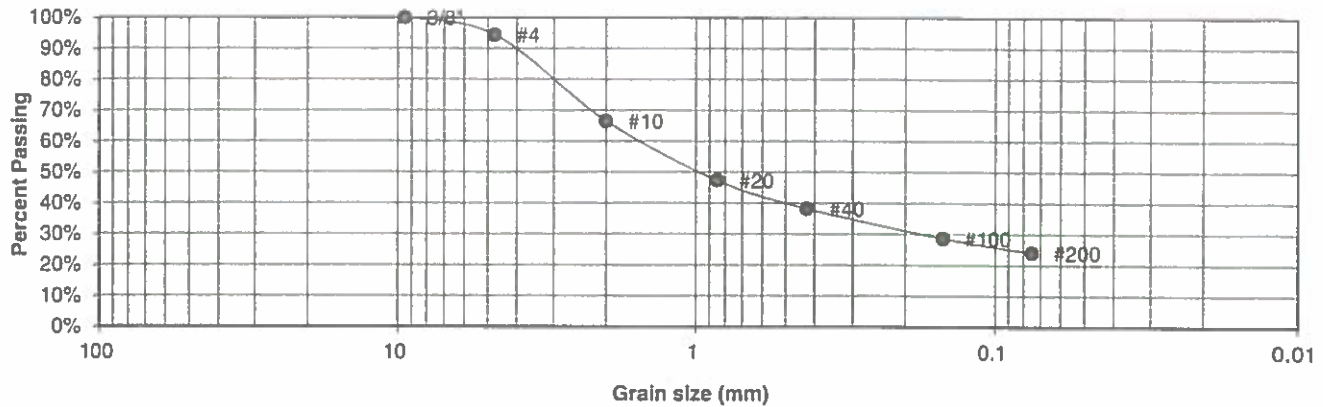
<u>UNIFIED CLASSIFICATION</u>	SM	<u>CLIENT</u>	ARROYA INVESTMENTS
<u>SOIL TYPE #</u>	3	<u>PROJECT</u>	THE RETREAT AT TIMBER RIDGE
<u>TEST BORING #</u>	3	<u>JOB NO.</u>	170020
<u>DEPTH (FT)</u>	5	<u>TEST BY</u>	BL

<u>U.S. Sieve #</u>	<u>Percent Finer</u>
3"	
1 1/2"	
3/4"	
1/2"	
3/8"	100.0%
4	94.4%
10	66.5%
20	47.4%
40	38.2%
100	28.7%
200	24.0%

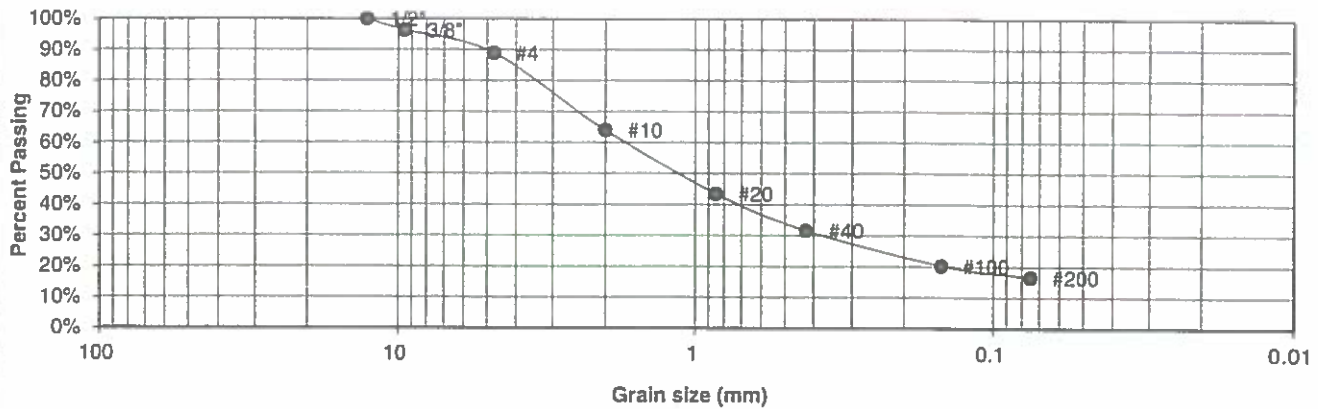
<u>UNIFIED CLASSIFICATION</u>	SM	<u>CLIENT</u>	ARROYA INVESTMENTS
<u>SOIL TYPE #</u>	3	<u>PROJECT</u>	THE RETREAT AT TIMBER RIDGE
<u>TEST BORING #</u>	7	<u>JOB NO.</u>	170020
<u>DEPTH (FT)</u>	20	<u>TEST BY</u>	BL

<u>U.S. Sieve #</u>	<u>Percent Finer</u>
3"	
1 1/2"	
3/4"	
1/2"	100.0%
3/8"	96.3%
4	88.9%
10	64.0%
20	43.5%
40	31.6%
100	20.3%
200	16.6%

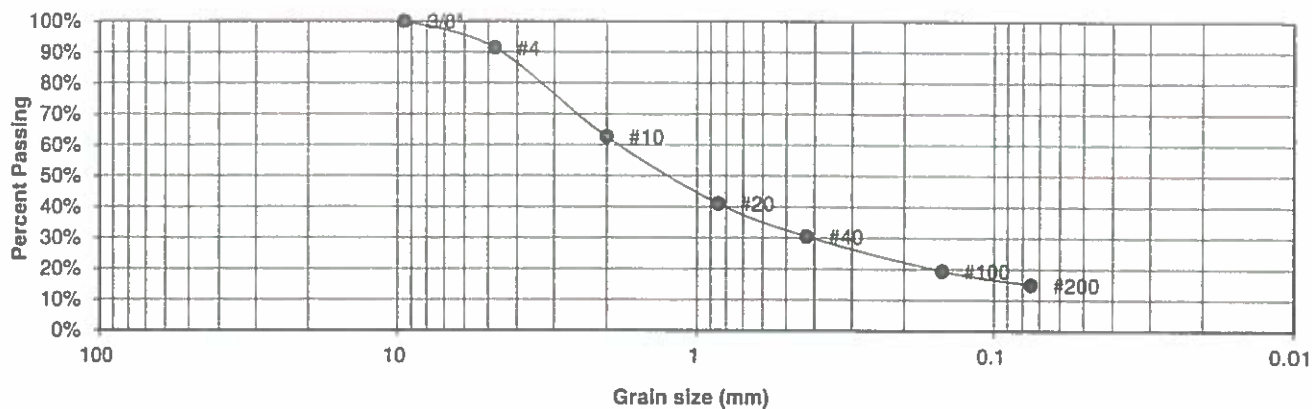
<u>UNIFIED CLASSIFICATION</u>	SM	<u>CLIENT</u>	ARROYA INVESTMENTS
<u>SOIL TYPE #</u>	3	<u>PROJECT</u>	THE RETREAT AT TIMBER RIDGE
<u>TEST BORING #</u>	8	<u>JOB NO.</u>	170020
<u>DEPTH (FT)</u>	5	<u>TEST BY</u>	BL

<u>U.S. Sieve #</u>	<u>Percent Finer</u>
3"	
1 1/2"	
3/4"	
1/2"	
3/8"	100.0%
4	91.3%
10	62.6%
20	41.1%
40	30.5%
100	19.4%
200	14.9%

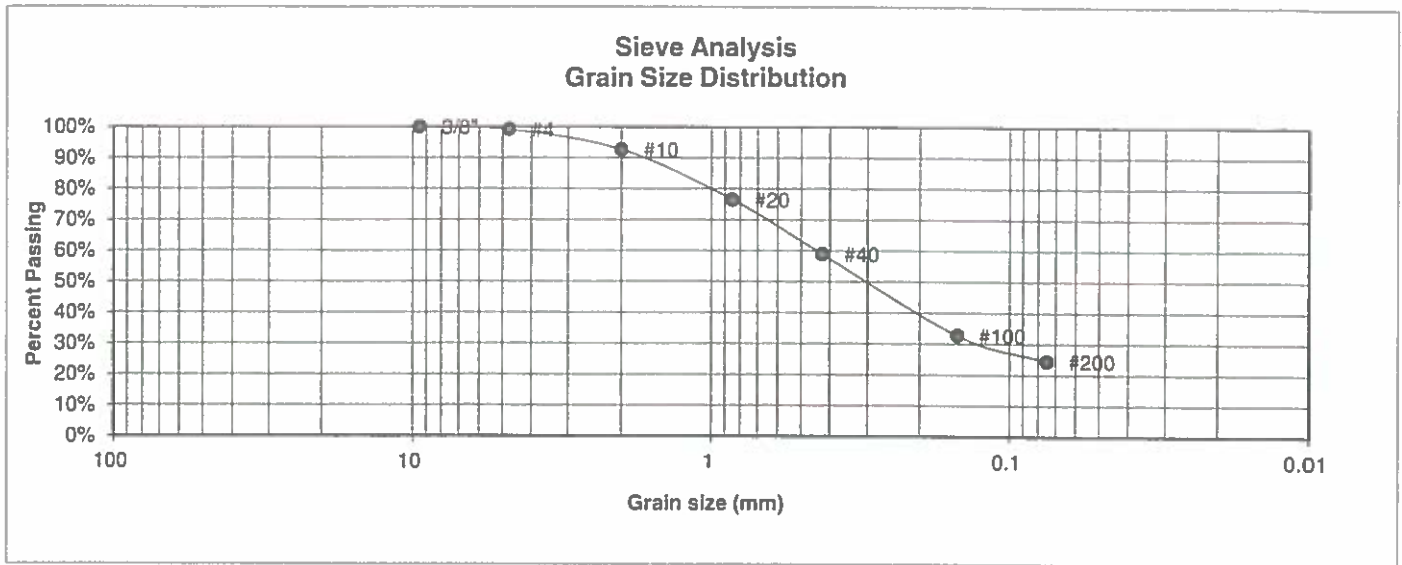
C-13

<u>UNIFIED CLASSIFICATION</u>	SC	<u>CLIENT</u>	ARROYA INVESTMENTS
<u>SOIL TYPE #</u>	3	<u>PROJECT</u>	THE RETREAT AT TIMBER RIDGE
<u>TEST BORING #</u>	12	<u>JOB NO.</u>	170020
<u>DEPTH (FT)</u>	10	<u>TEST BY</u>	BL

<u>U.S. Sieve #</u>	<u>Percent Finer</u>
3"	
1 1/2"	
3/4"	
1/2"	
3/8"	100.0%
4	99.1%
10	92.7%
20	76.5%
40	58.9%
100	32.7%
200	24.4%

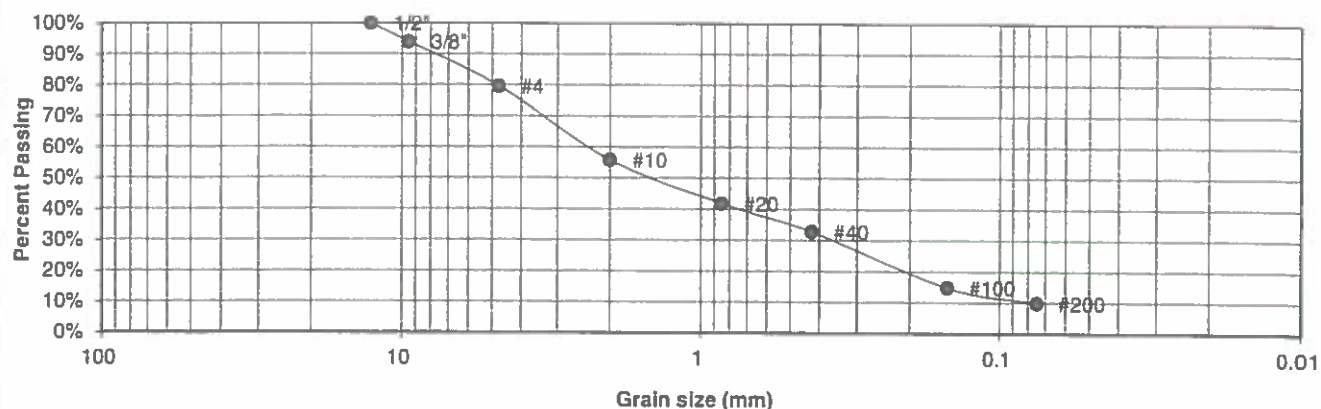
<u>UNIFIED CLASSIFICATION</u>	SM-SW	<u>CLIENT</u>	ARROYA INVESTMENTS
<u>SOIL TYPE #</u>	3	<u>PROJECT</u>	THE RETREAT AT TIMBER RIDGE
<u>TEST BORING #</u>	9	<u>JOB NO.</u>	170020
<u>DEPTH (FT)</u>	15	<u>TEST BY</u>	BL

<u>U.S. Sieve #</u>	<u>Percent Finer</u>
3"	
1 1/2"	
3/4"	
1/2"	100.0%
3/8"	93.9%
4	79.6%
10	55.8%
20	41.8%
40	32.8%
100	14.8%
200	9.9%

<u>Atterberg Limits</u>	
Plastic Limit	NP
Liquid Limit	NV
Plastic Index	NP

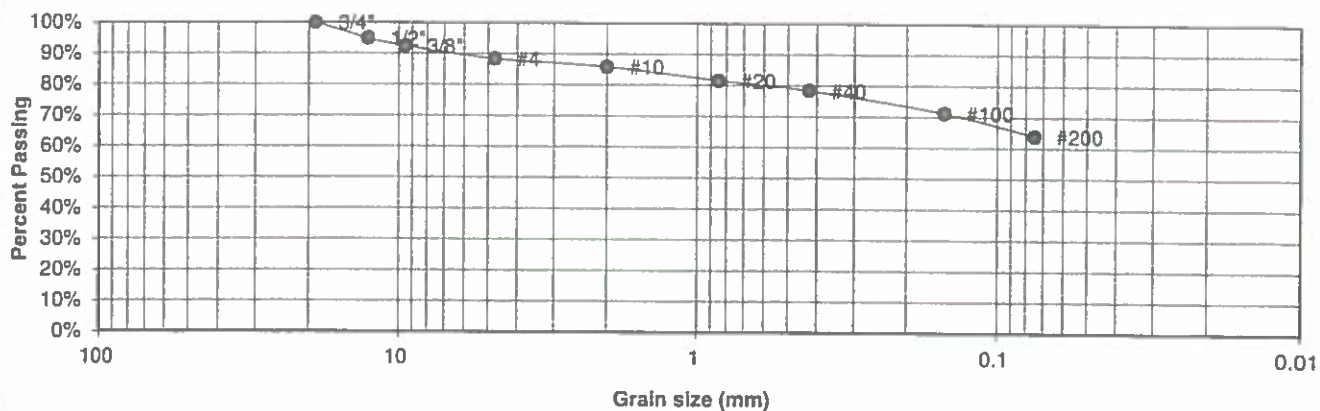
UNIFIED CLASSIFICATION	CL	CLIENT	ARROYA INVESTMENTS
SOIL TYPE #	4	PROJECT	THE RETREAT AT TIMBER RIDGE
TEST BORING #	4	JOB NO.	170020
DEPTH (FT)	15	TEST BY	BL

U.S. Sieve #	Percent Finer
3"	
1 1/2"	
3/4"	100.0%
1/2"	94.9%
3/8"	92.5%
4	88.4%
10	85.9%
20	81.5%
40	78.4%
100	71.3%
200	63.9%

Atterberg	
Limits	
Plastic Limit	24
Liquid Limit	44
Plastic Index	20

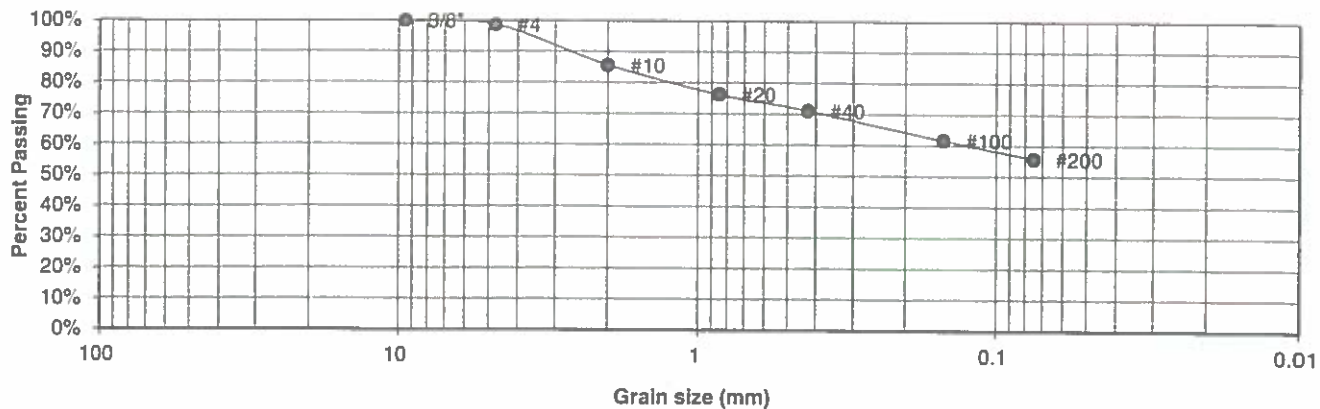
<u>UNIFIED CLASSIFICATION</u>	CL	<u>CLIENT</u>	ARROYA INVESTMENTS
<u>SOIL TYPE #</u>	4	<u>PROJECT</u>	THE RETREAT AT TIMBER RIDGE
<u>TEST BORING #</u>	5	<u>JOB NO.</u>	170020
<u>DEPTH (FT)</u>	10	<u>TEST BY</u>	BL

<u>U.S. Sieve #</u>	<u>Percent Finer</u>
3"	
1 1/2"	
3/4"	
1/2"	
3/8"	100.0%
4	98.6%
10	85.6%
20	76.2%
40	71.0%
100	61.6%
200	55.7%

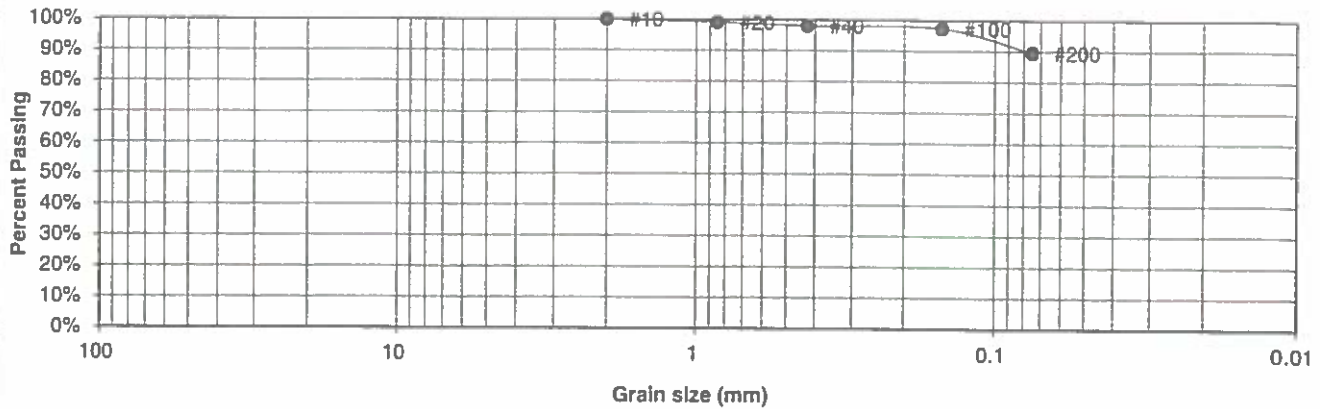
<u>UNIFIED CLASSIFICATION</u>	CL	<u>CLIENT</u>	ARROYA INVESTMENTS
<u>SOIL TYPE #</u>	4	<u>PROJECT</u>	THE RETREAT AT TIMBER RIDGE
<u>TEST BORING #</u>	7	<u>JOB NO.</u>	170020
<u>DEPTH (FT)</u>	15	<u>TEST BY</u>	BL

<u>U.S. Sieve #</u>	<u>Percent Finer</u>
3"	
1 1/2"	
3/4"	
1/2"	
3/8"	
4	
10	100.0%
20	99.1%
40	98.1%
100	97.3%
200	89.5%

<u>Atterberg Limits</u>	
Plastic Limit	26
Liquid Limit	47
Plastic Index	21

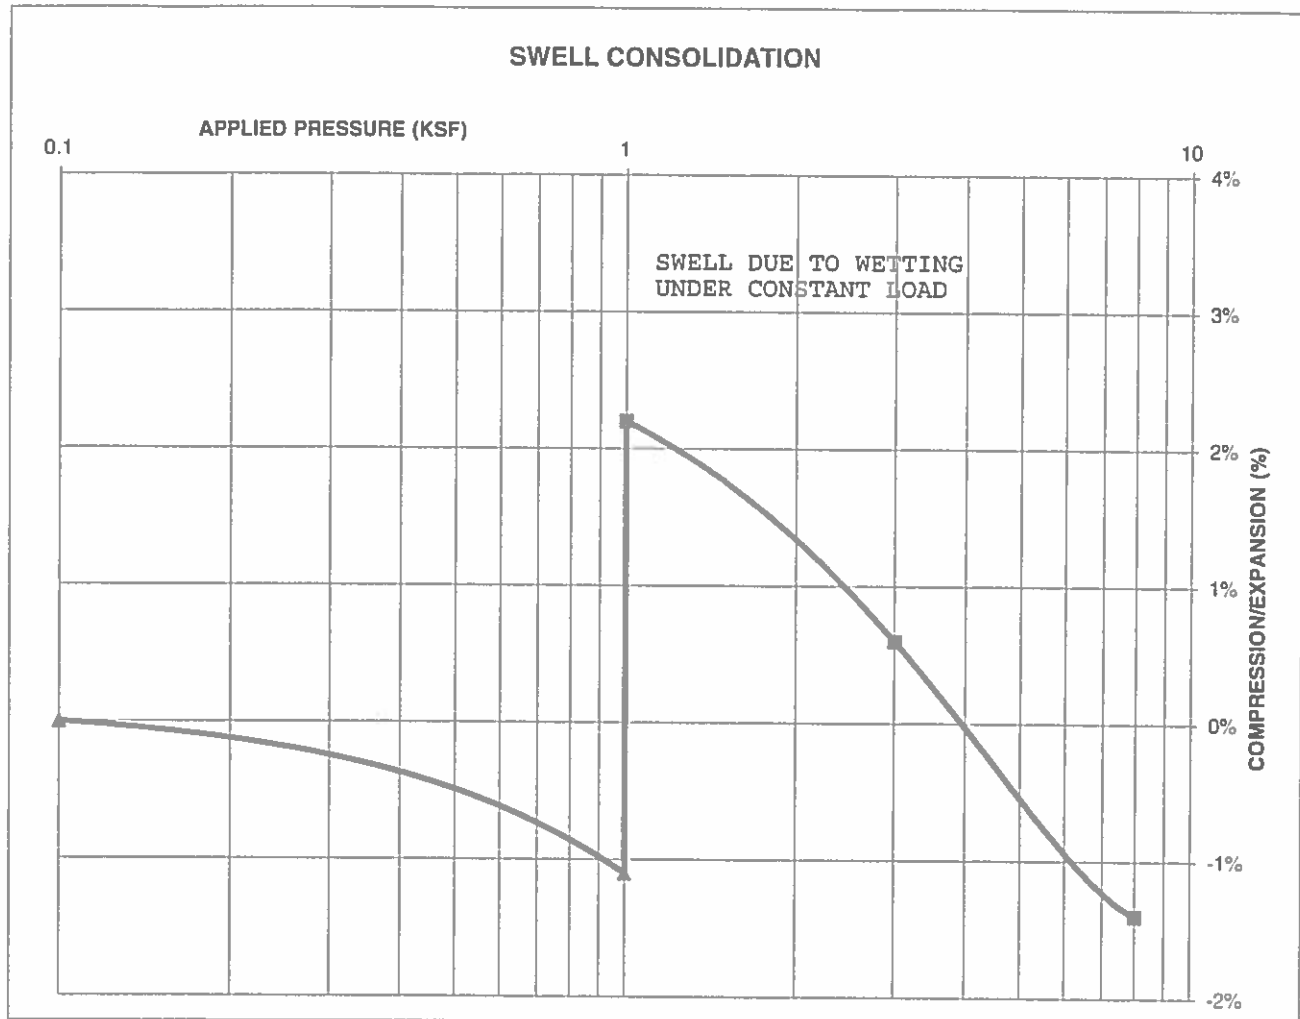
TEST BORING #	4	DEPTH(ft)	15
DESCRIPTION	CL	SOIL TYPE	4
NATURAL UNIT DRY WEIGHT (PCF)			109
NATURAL MOISTURE CONTENT			19.9%
SWELL/CONSOLIDATION (%)			3.3%

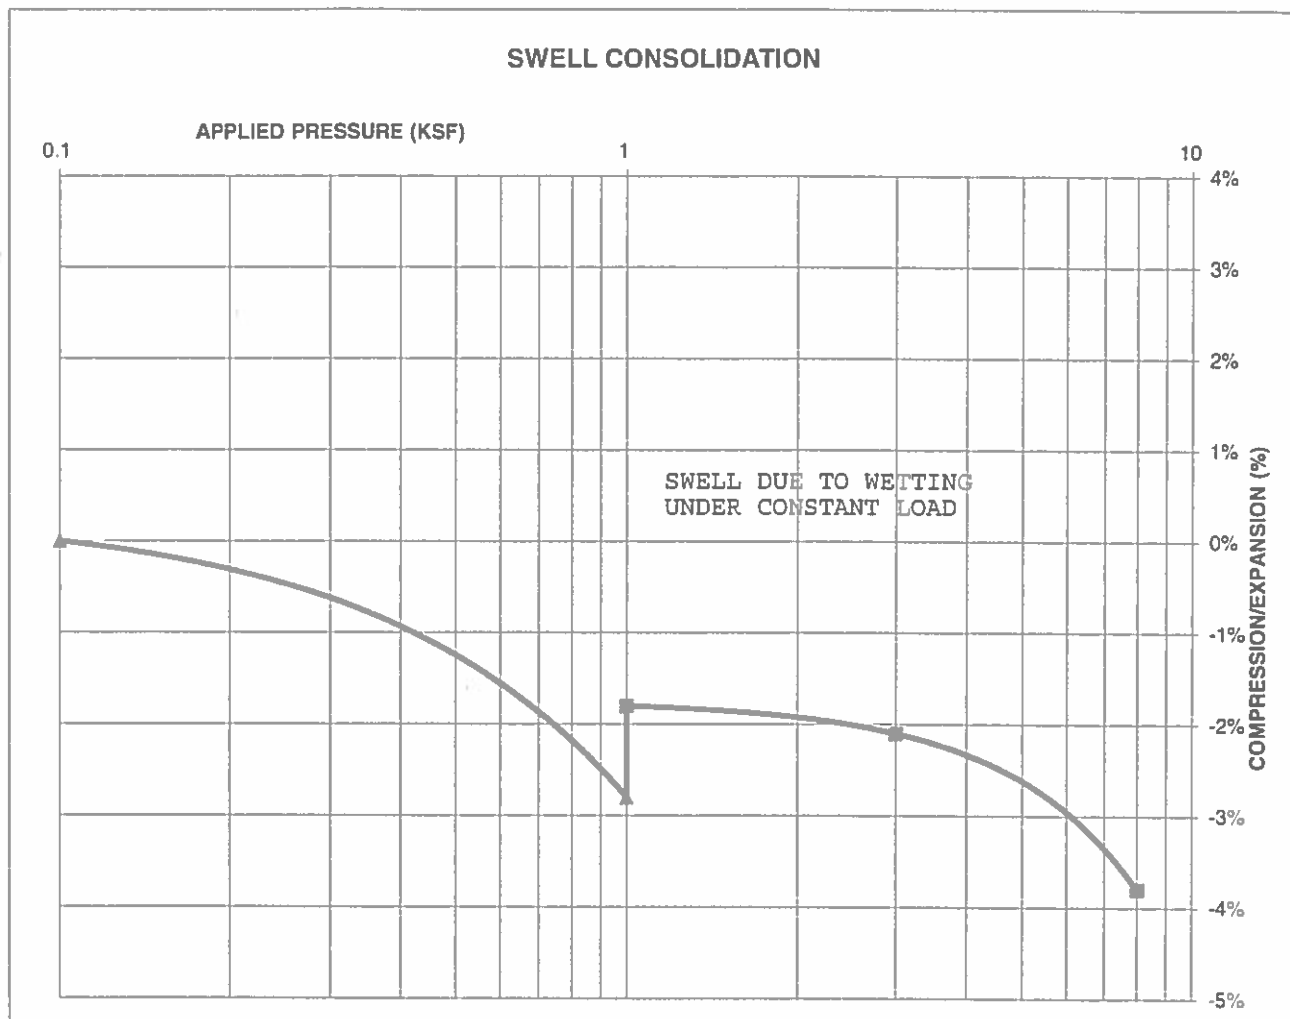
TEST BORING #	5	DEPTH(ft)	10
DESCRIPTION	CL	SOIL TYPE	4
NATURAL UNIT DRY WEIGHT (PCF)	111		
NATURAL MOISTURE CONTENT	17.8%		
SWELL/CONSOLIDATION (%)	1.0%

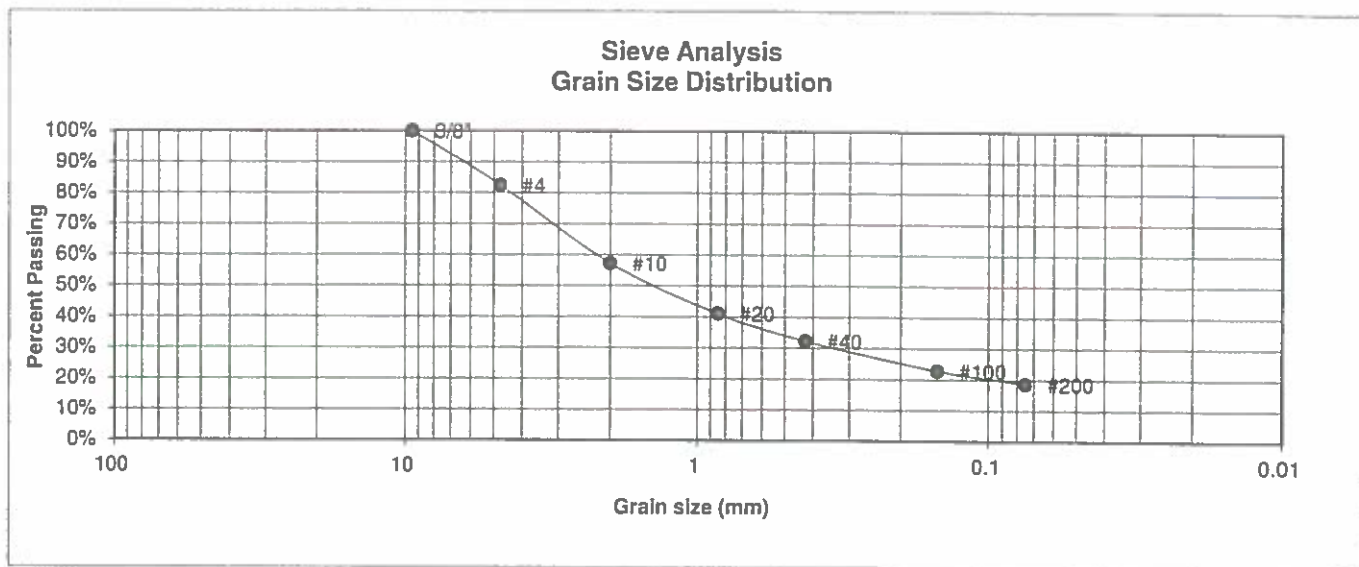
C-21

BORING NO.	TP-2	UNIFIED CLASSIFICATION	SM	TEST BY	BL
DEPTH(ft)	3	AASHTO CLASSIFICATION		JOB NO.	170020
CLIENT	ARROYA INVESTMENTS				
PROJECT	THE RETREAT AT TIMBER RIDGE

U.S. Sieve #	Percent Finer
3"	
1 1/2"	
3/4"	
1/2"	
3/8"	100.0%
4	82.5%
10	57.3%
20	41.0%
40	32.3%
100	22.9%
200	18.7%

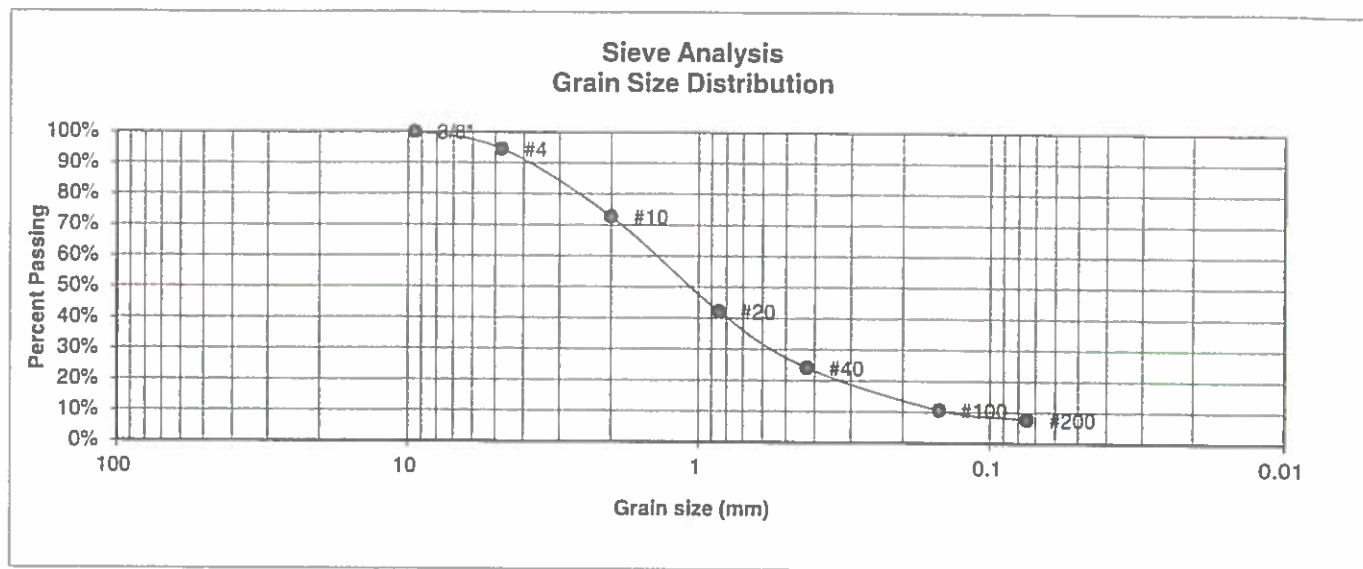
FIG NO.:  
C-22

BORING NO.	TP-4	UNIFIED CLASSIFICATION	SM-SW	TEST BY	BL
DEPTH(ft)	4	AASHTO CLASSIFICATION		JOB NO.	170020
CLIENT	ARROYA INVESTMENTS				
PROJECT	THE RETREAT AT TIMBER RIDGE

U.S. Sieve #	Percent Finer
3"	
1 1/2"	
3/4"	
1/2"	
3/8"	100.0%
4	94.6%
10	72.7%
20	42.2%
40	24.1%
100	10.6%
200	7.7%

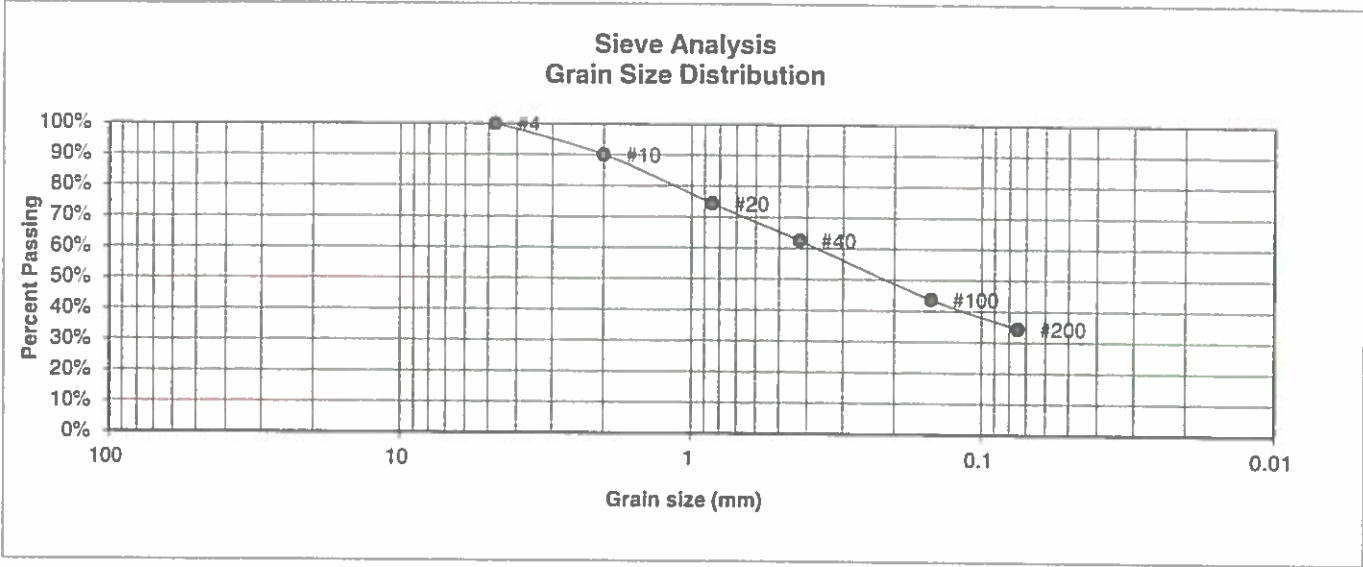
C-23

BORING NO.	TP-5	UNIFIED CLASSIFICATION	SC	TEST BY	BL
DEPTH(ft)	7-8	AASHTO CLASSIFICATION		JOB NO.	170020
CLIENT	ARROYA INVESTMENTS				
PROJECT	THE RETREAT AT TIMBER RIDGE

U.S. Sieve #	Percent Finer
3"	
1 1/2"	
3/4"	
1/2"	
3/8"	
4	100.0%
10	90.1%
20	74.4%
40	62.5%
100	43.8%
200	34.4%

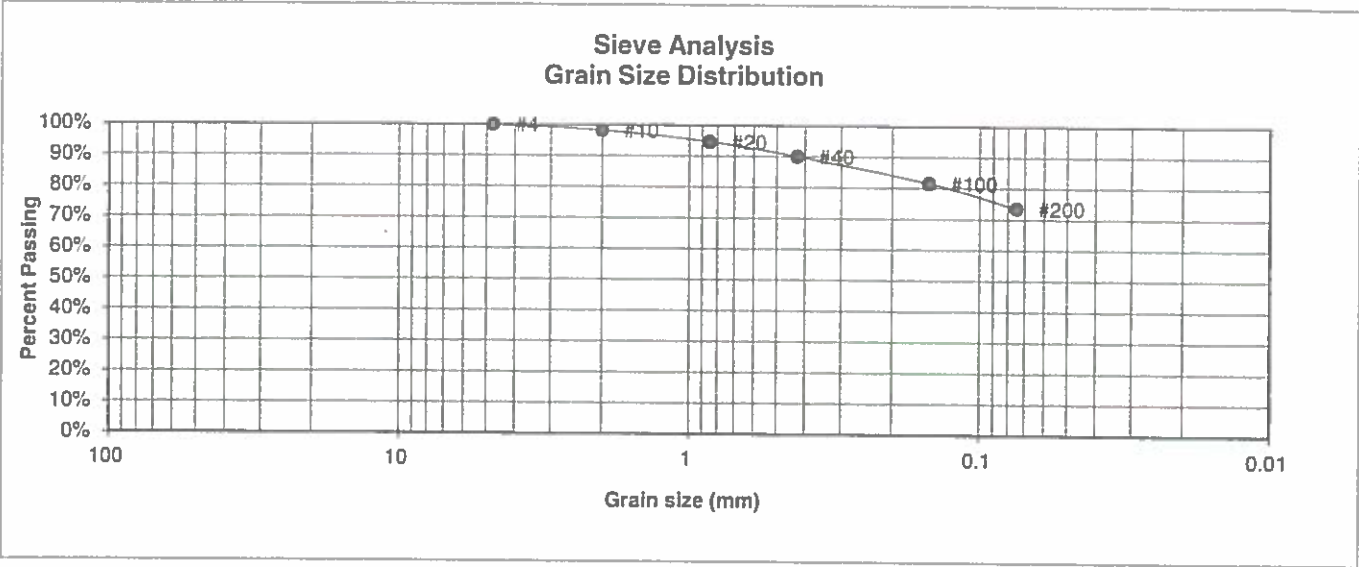
FIG NO.:  
 C-24

BORING NO.	TP-6	UNIFIED CLASSIFICATION	CL	TEST BY	BL
DEPTH(ft)	2	AASHTO CLASSIFICATION		JOB NO.	170020
CLIENT	ARROYA INVESTMENTS				
PROJECT	THE RETREAT AT TIMBER RIDGE

U.S. Sieve #	Percent Finer	Atterberg Limits
3"		Plastic Limit
1 1/2"		Liquid Limit
3/4"		Plastic Index
1/2"		
3/8"		
4	100.0%	<u>Swell</u>
10	98.3%	Moisture at start
20	94.7%	Moisture at finish
40	90.0%	Moisture increase
100	81.6%	Initial dry density (pcf)
200	73.6%	Swell (psf)
