Re: **Geologic Hazard Review – Revised No-Build Line**  
4619 Redstone Ridge Road – Guest House  
El Paso County, Colorado  
Entech Job No. 260429

4619 REDSTONE RIDGE ROAD - GUEST HOUSE  
COLORADO CENTRAL BUILDERS, INC.

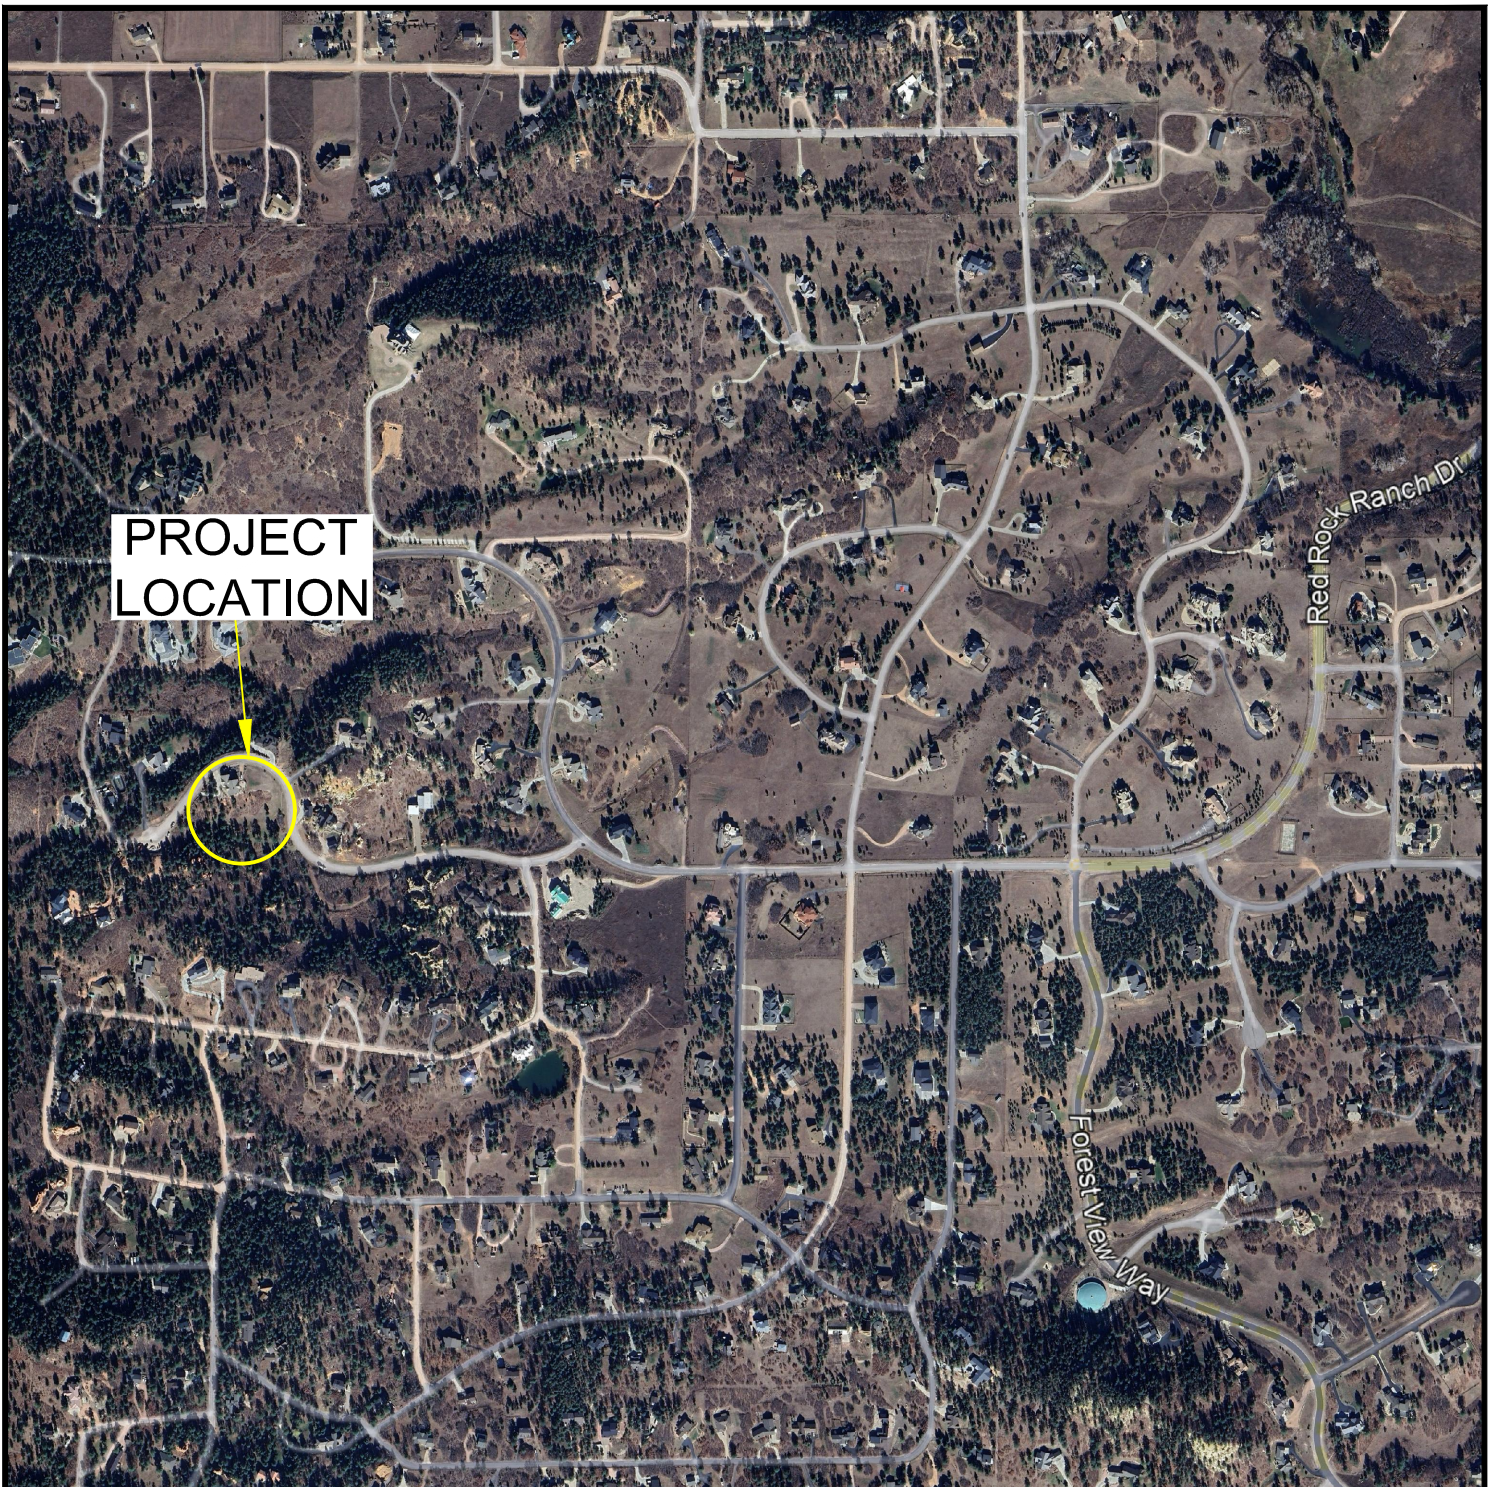
FIG. 1

## VICINITY MAP

As requested, personnel of Entech Engineering, Inc. (Entech) have investigated the above-referenced site to evaluate the conditions with respect to geology and geologic hazards affecting the proposed revised no-build line on the lot. The proposed project is to consist of the construction of guest house in the southeastern portion of the lot. The location of the site is shown in the Vicinity Map, Figure 1, and the USGS Topography Map in Figure 2.

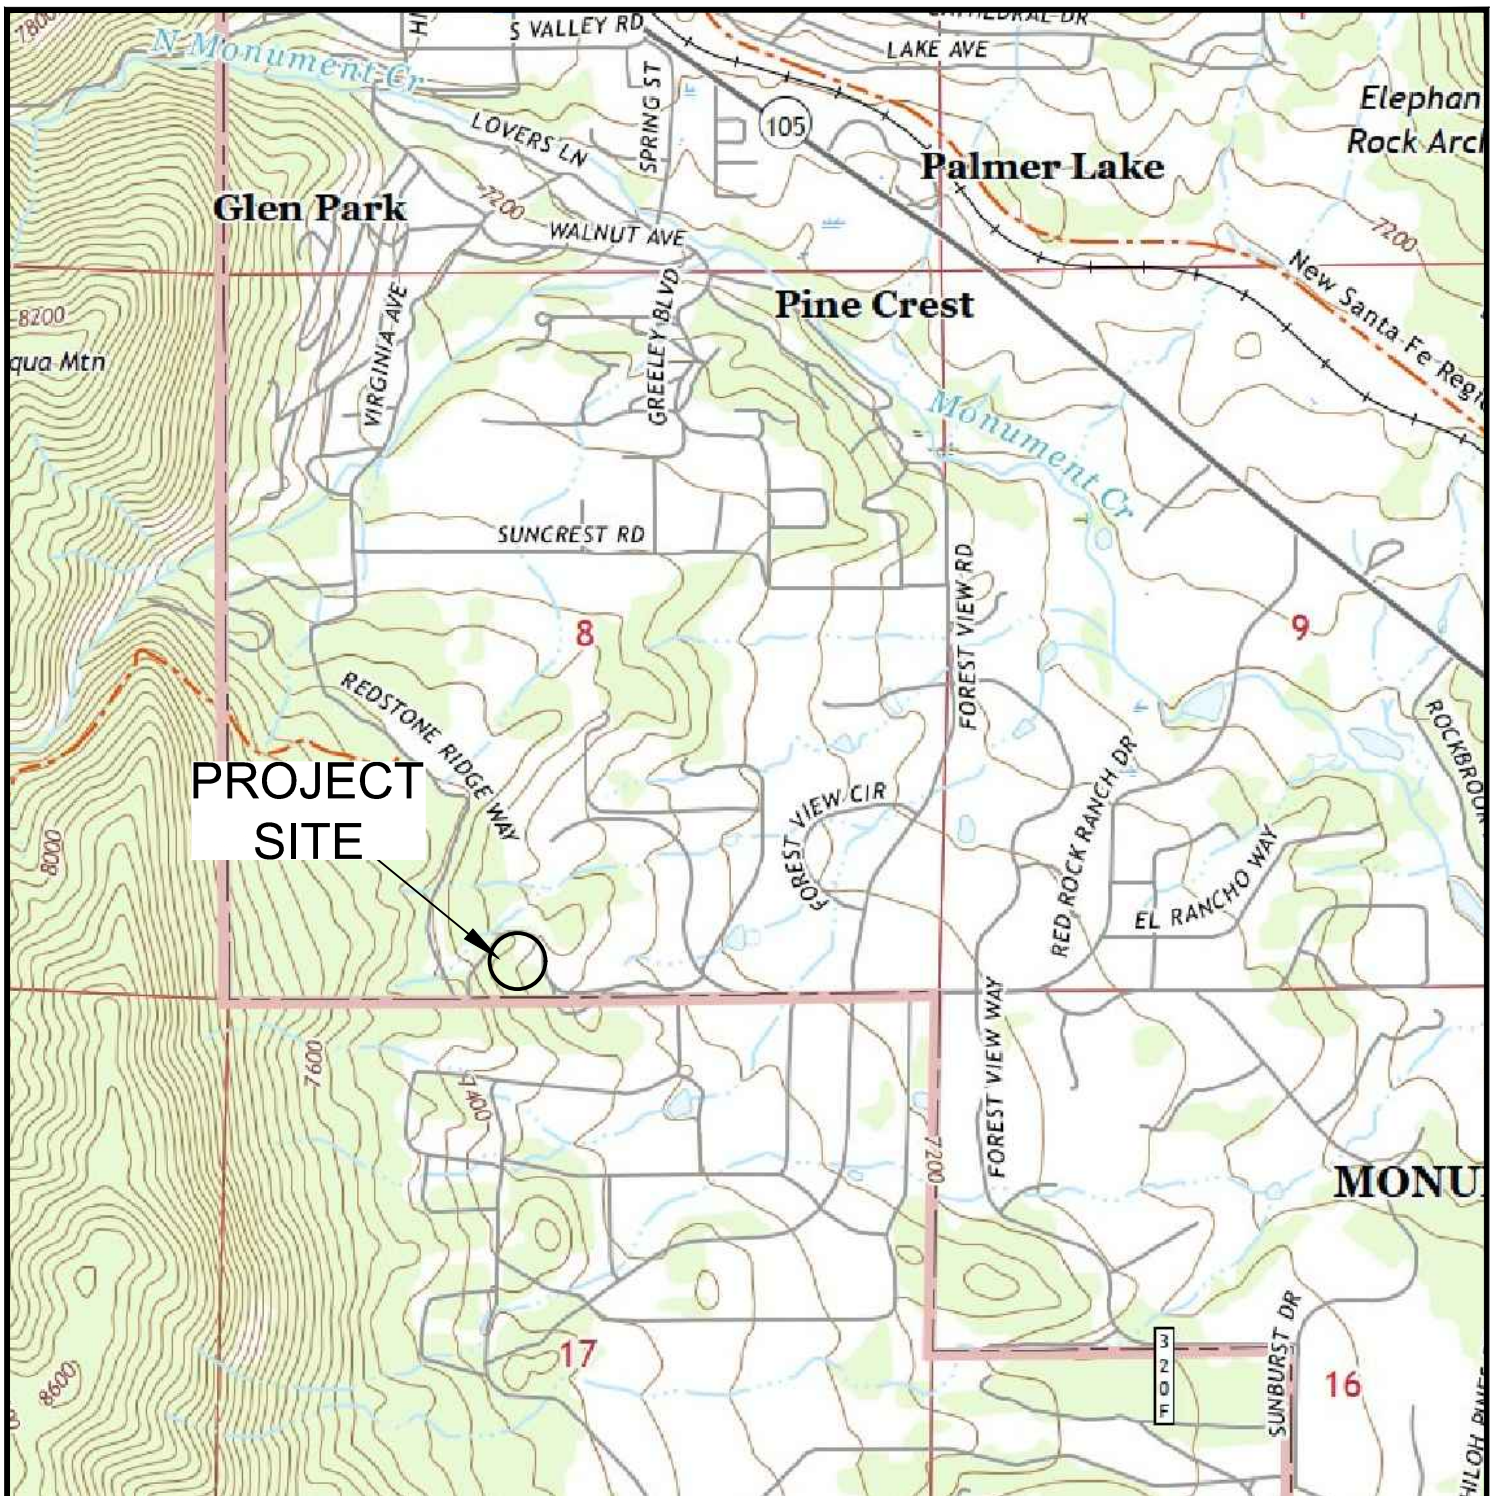
## USGS TOPOGRAPHY MAP

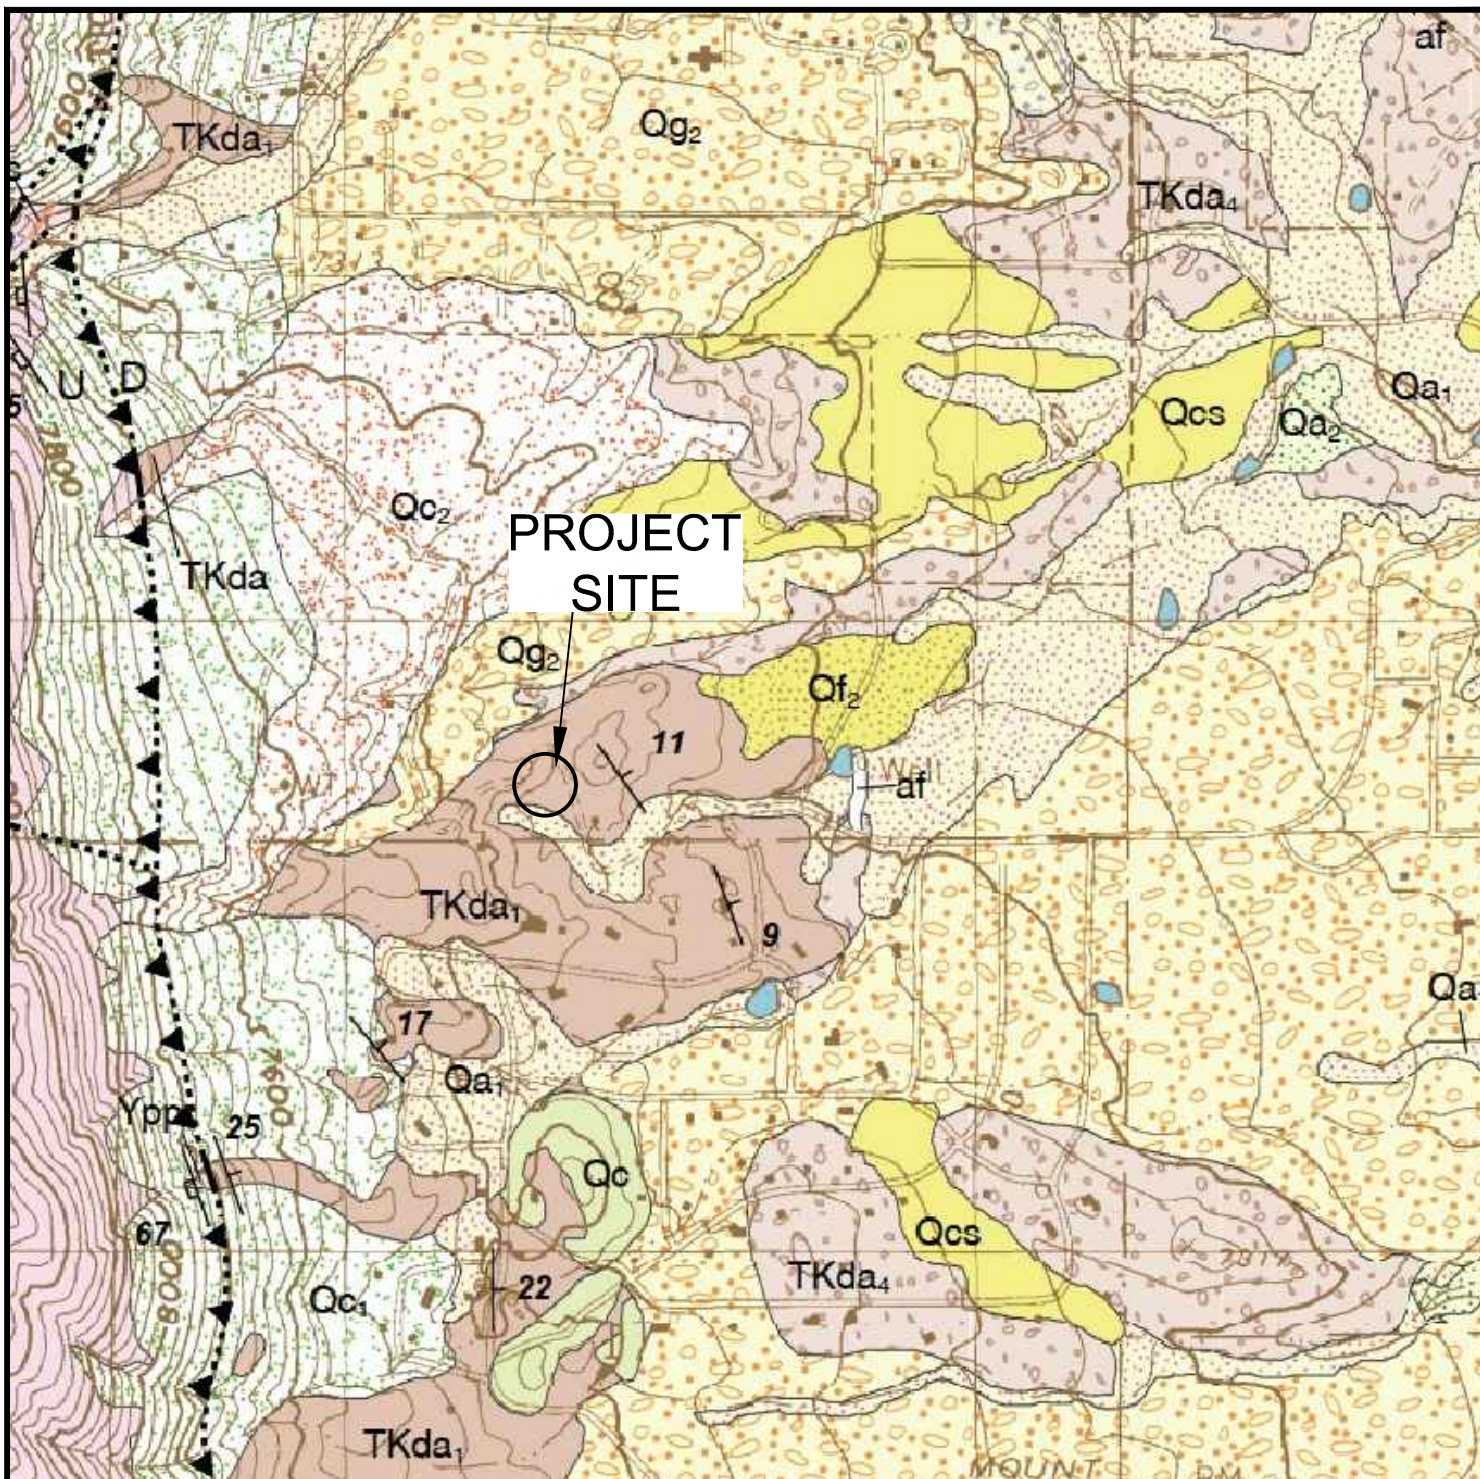
FIG. 4

**GEOLOGIC MAP OF THE PALMER  
LAKE QUADRANGLE**  
4619 REDSTONE RIDGE ROAD - GUEST HOUSE  
CENTRAL COLORADO BUILDERS, INC.

The geology of the site was evaluated using, the referenced previous investigation, the results of the test borings completed by Entech, the *Geologic Map of the Palmer Lake Quadrangle*, distributed by the Colorado Geological Survey in 2007 (Reference 3, Figure 4), and site-specific mapping of the site. The Geology/Engineering Geology Map prepared for the site is presented in Figure 5.

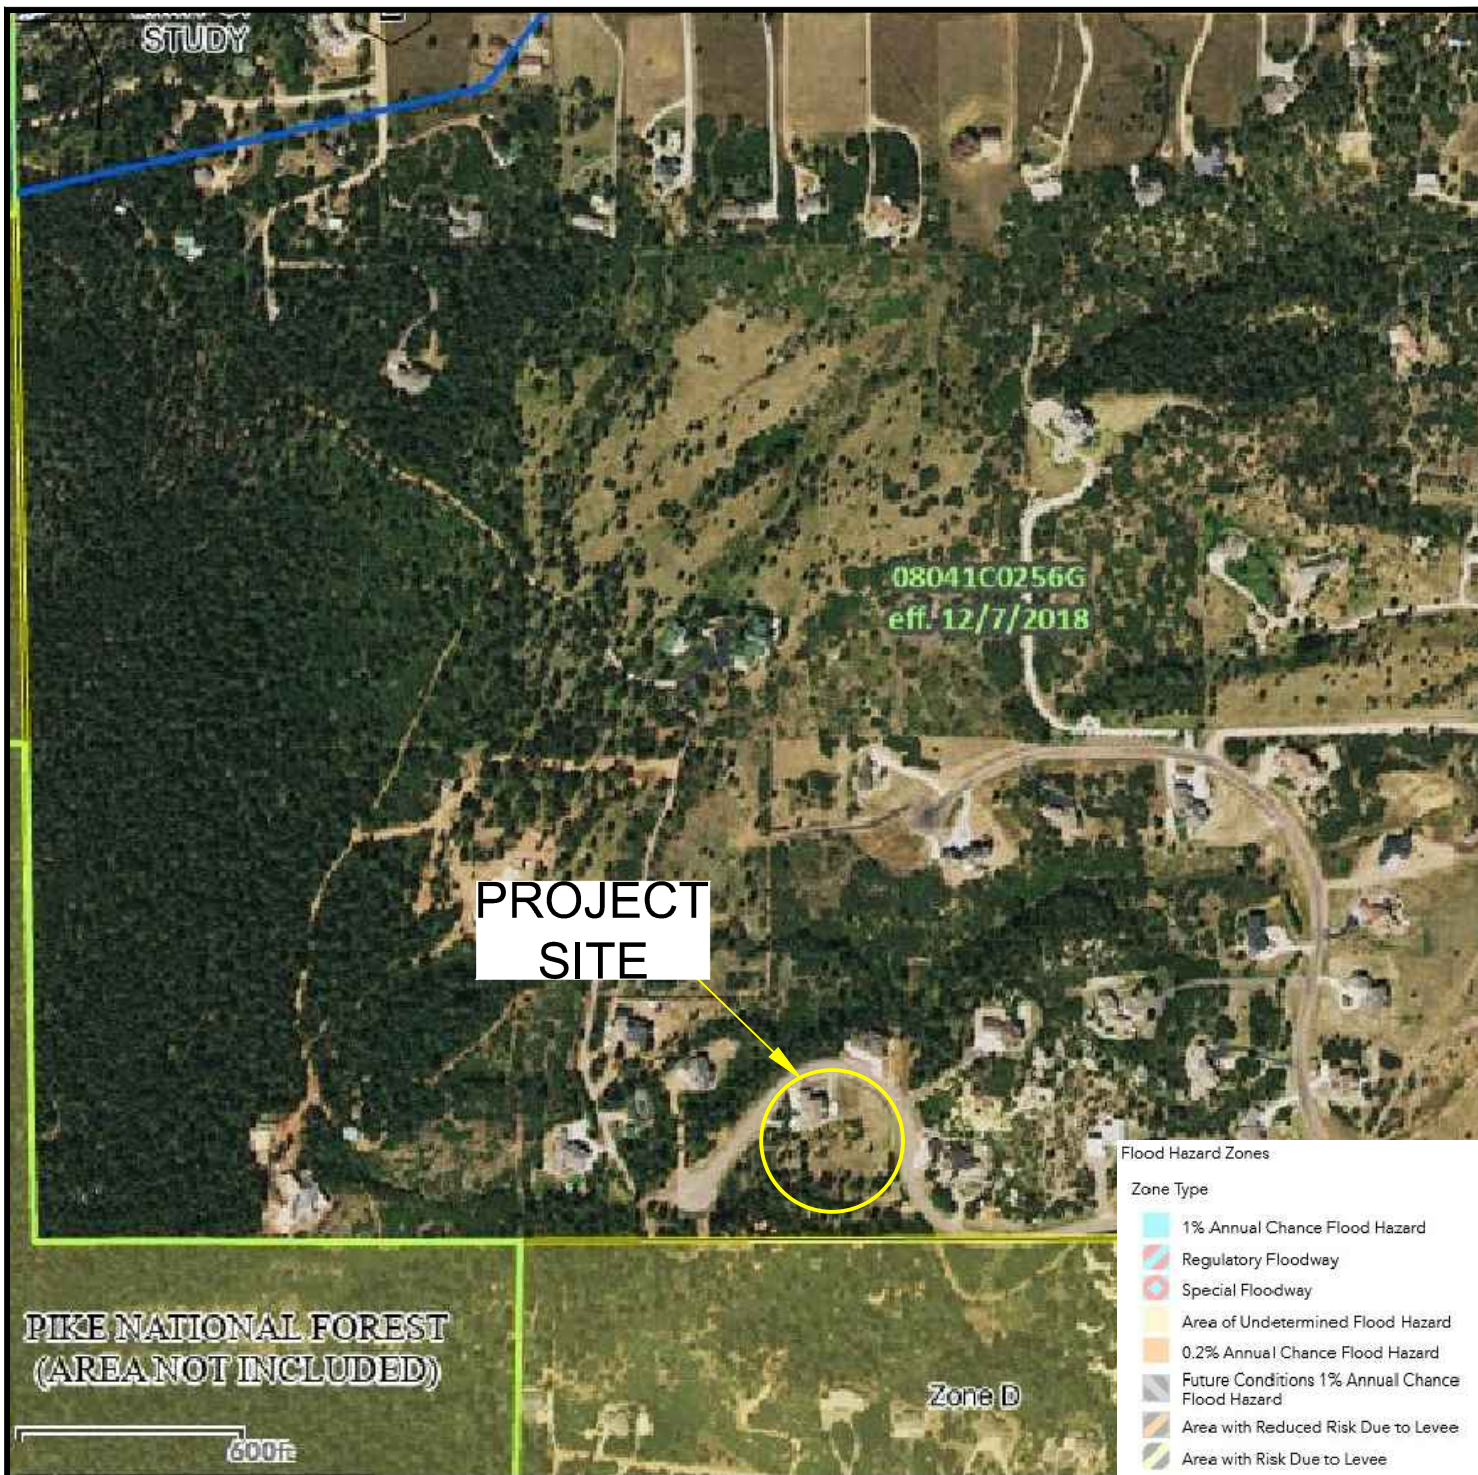
## FEMA FLOODPLAIN MAP

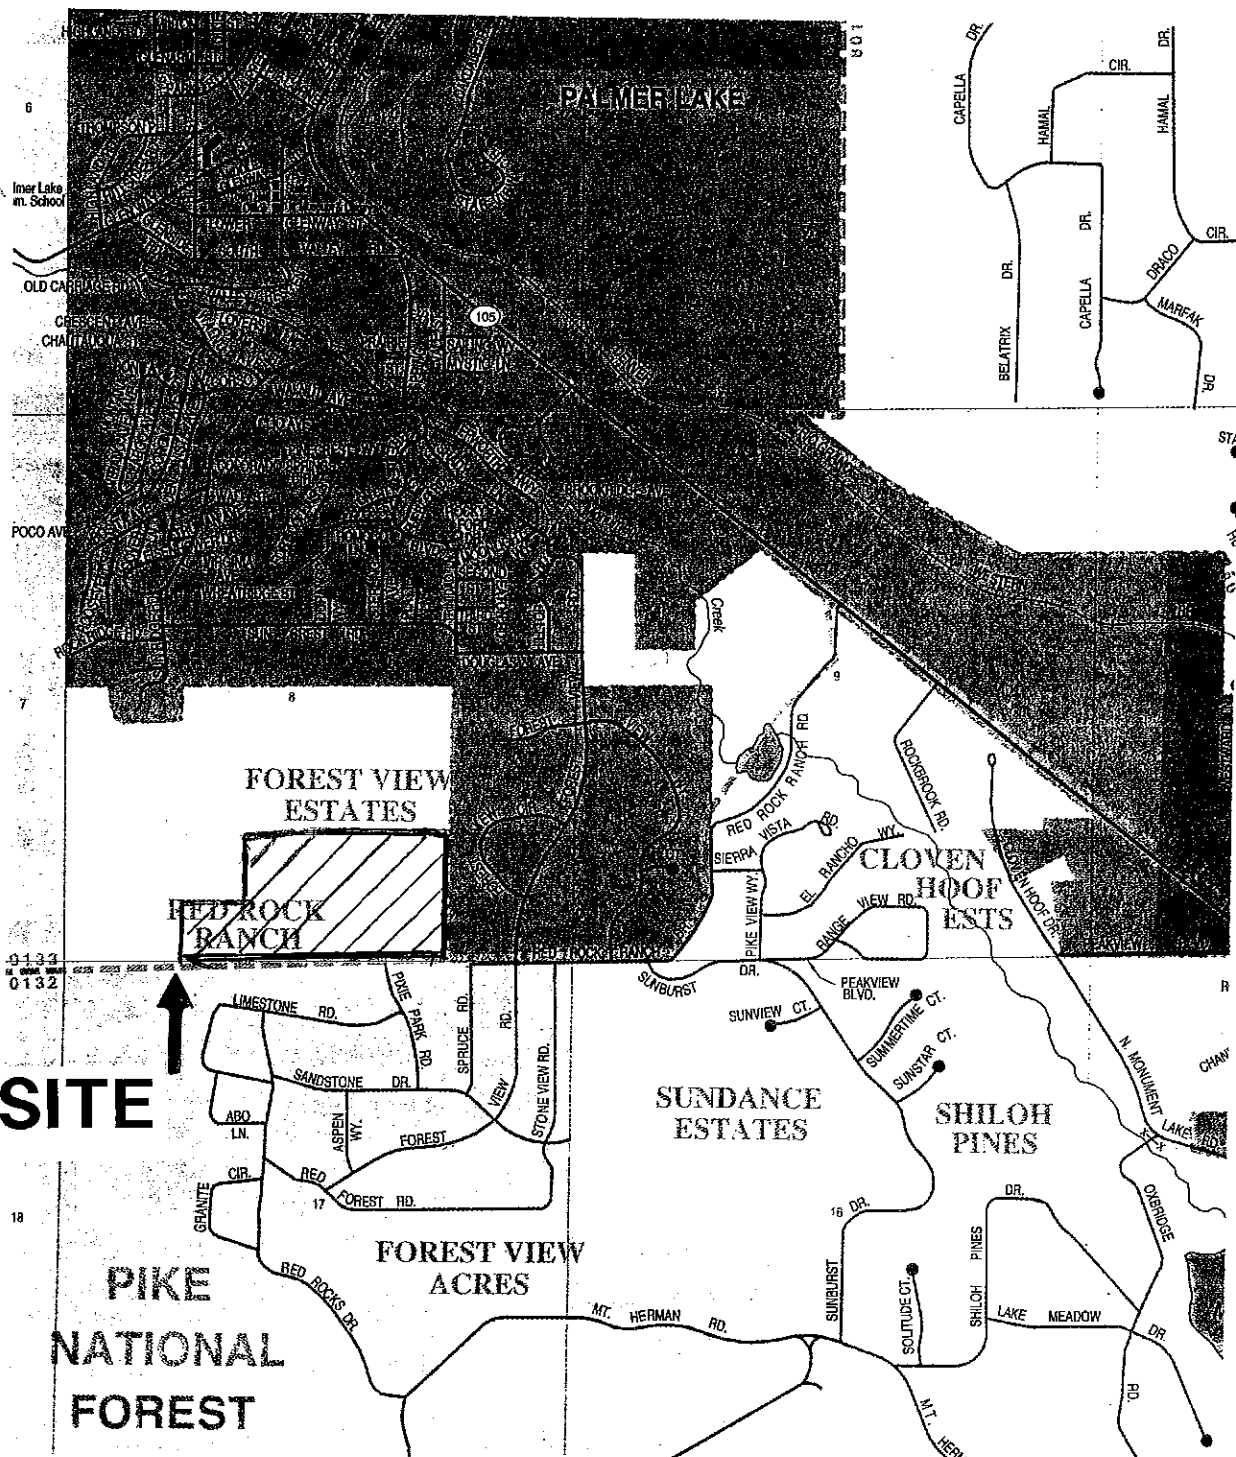
1

### VICINITY MAP

The site is located in the S½ of Section 8, Township 11 South, Range 67 West of the 6<sup>th</sup> Principal Meridian in El Paso County, Colorado. The site is located south of Palmer Lake, Colorado, northwest of the intersection of Red Rock Ranch Drive and Spruce Road. The location of the site is as shown on the Vicinity Map, Figure 1.

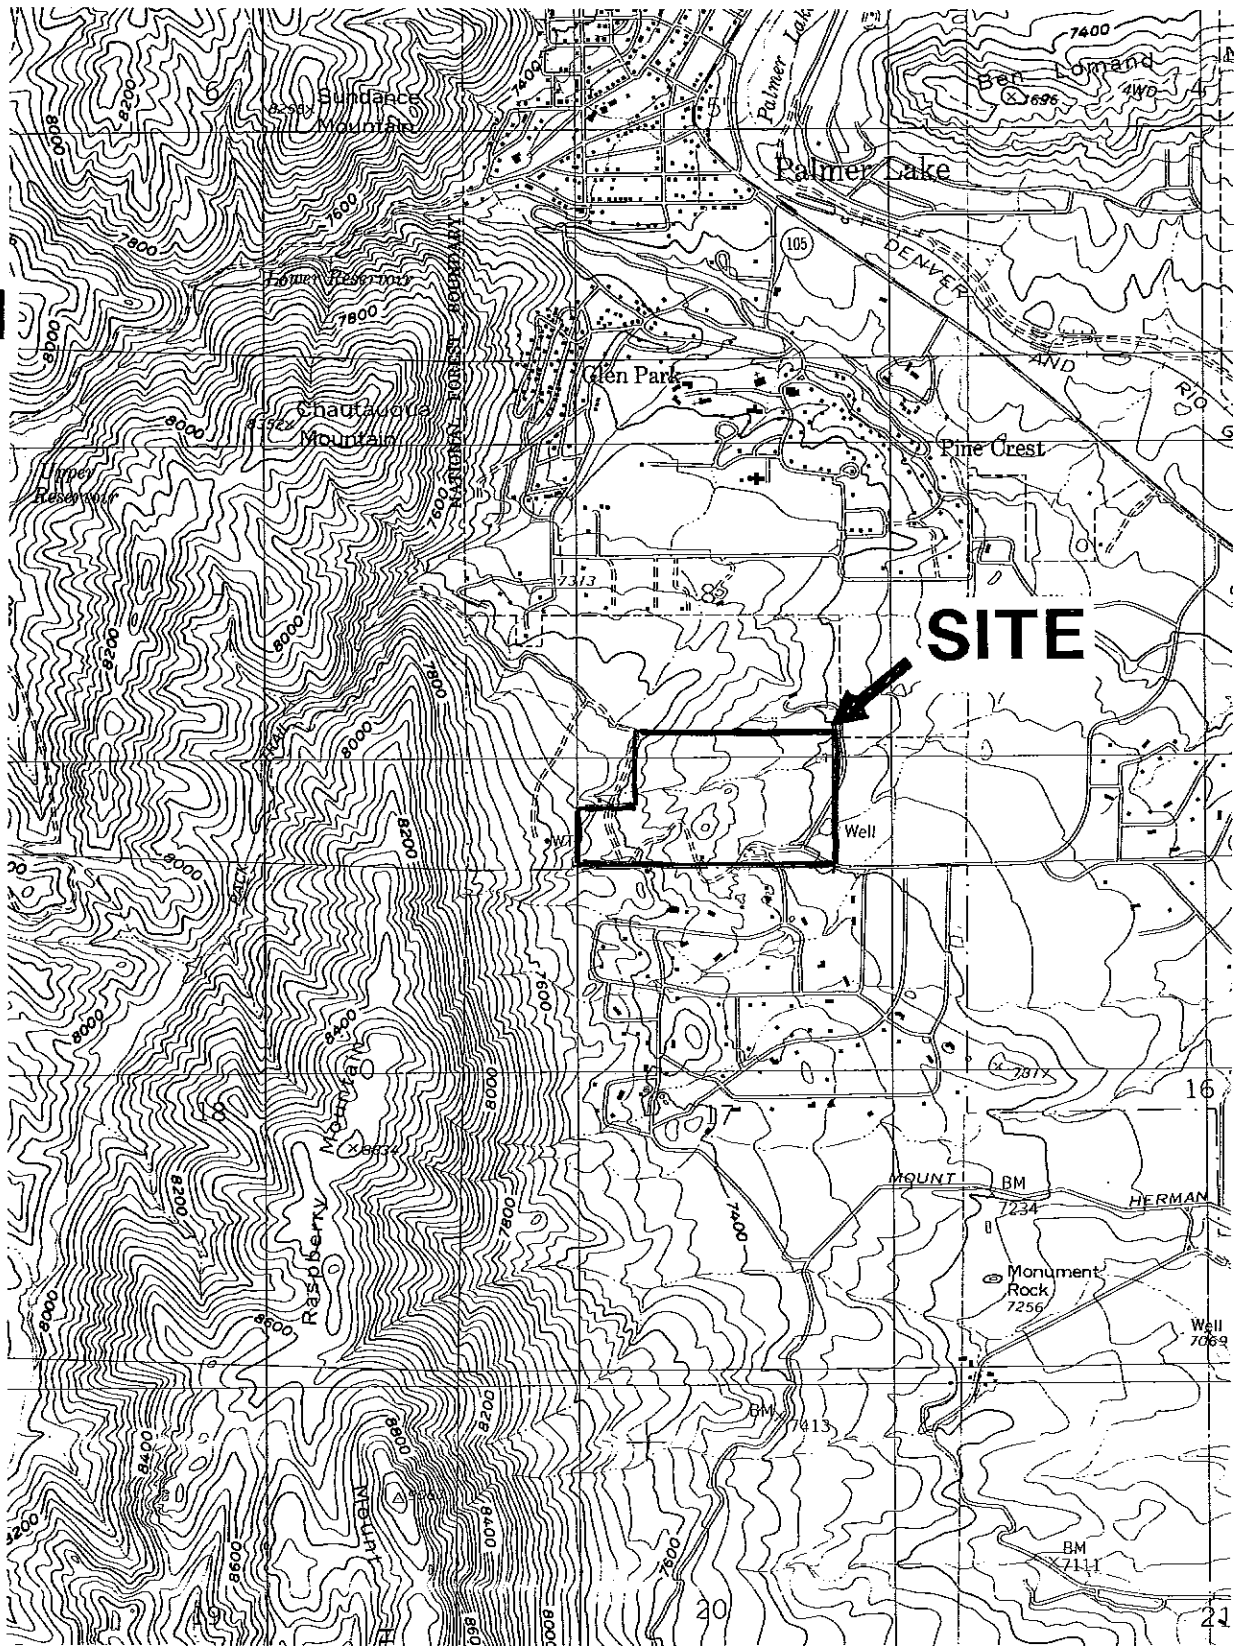
2

USGS MAP

The topography of the site is gently to steeply sloping generally to the east. The site boundaries are indicated on the USGS Map, Figure 2. Previous land uses have included grazing and pasture land. The site contains low grasses, dense scrub oak and Ponderosa Pines. The drainages on site trend in easterly to northeasterly directions. No water was observed flowing in these drainages at the time of this investigation. Areas of ponded water exist behind several small earthen dams on the site. The site photographs are included in Appendix A. The locations and directions of the photographs are indicated on Figure 3.

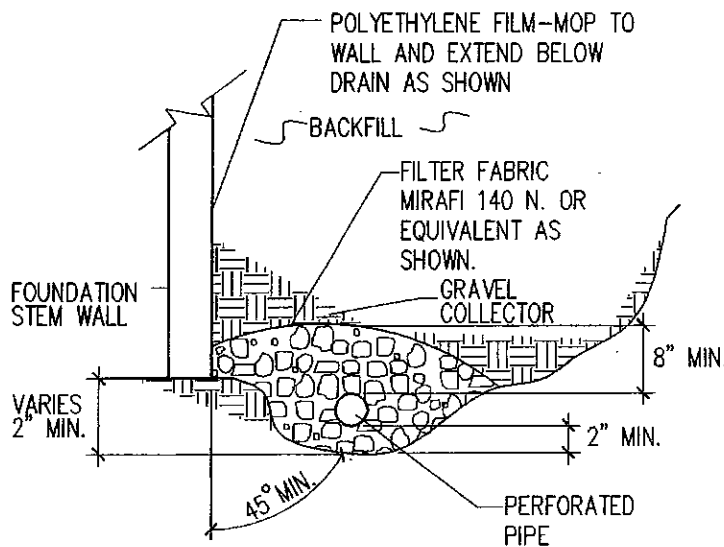
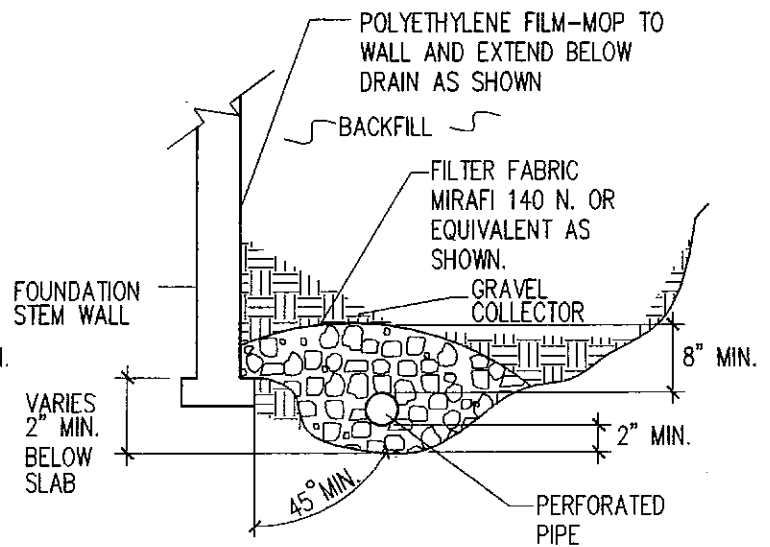
—GRAVEL SIZE IS RELATED TO DIAMETER OF PIPE PERFORATIONS—85% GRAVEL GREATER THAN 2x PERFORATION DIAMETER.

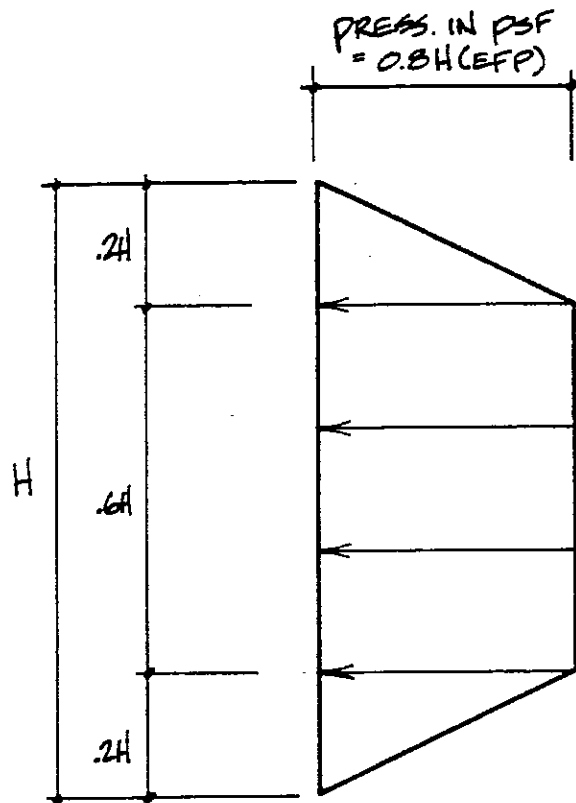
13

PRESSURE DISTRIBUTION

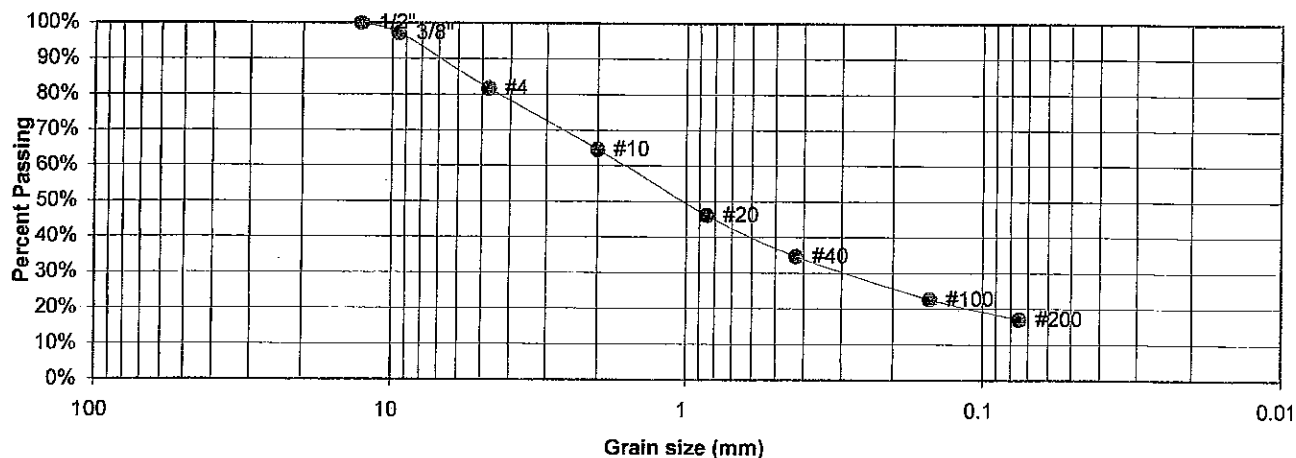
### Sieve Analysis Grain Size Distribution

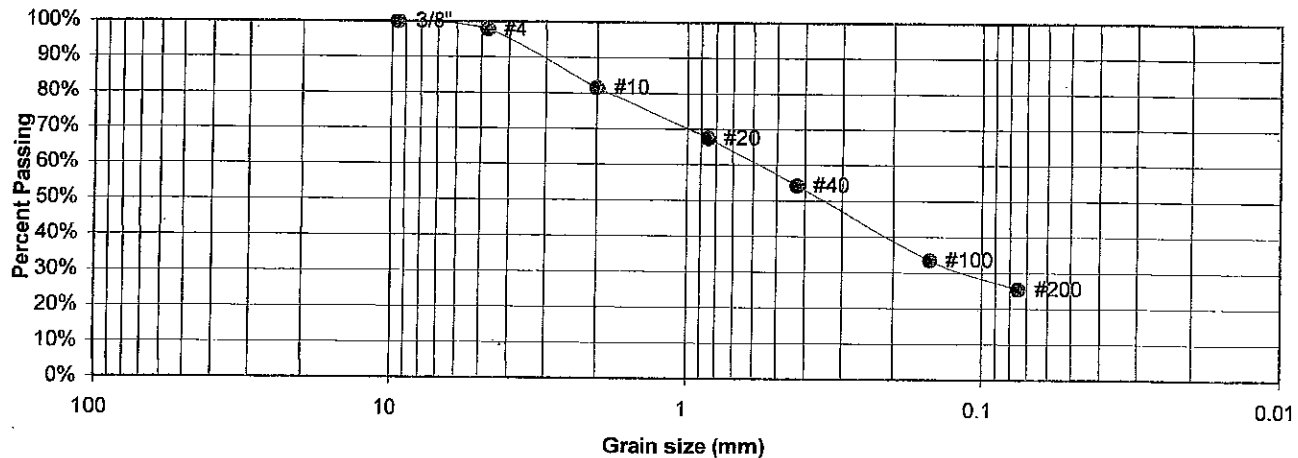
### Sieve Analysis Grain Size Distribution

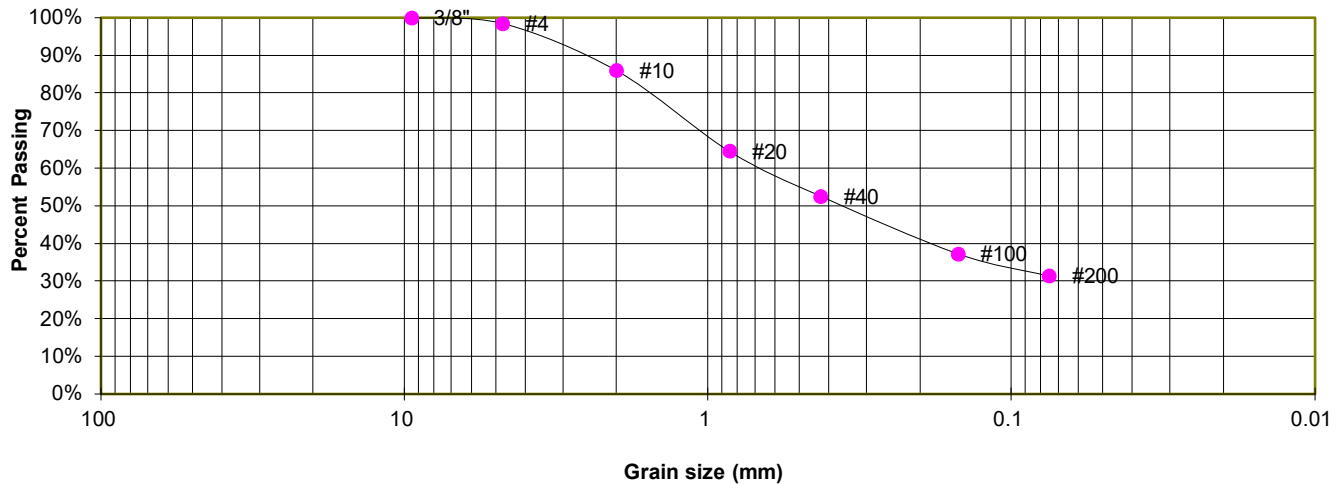
SOIL DESCRIPTION SAND, CLAYEY

### Sieve Analysis Grain Size Distribution

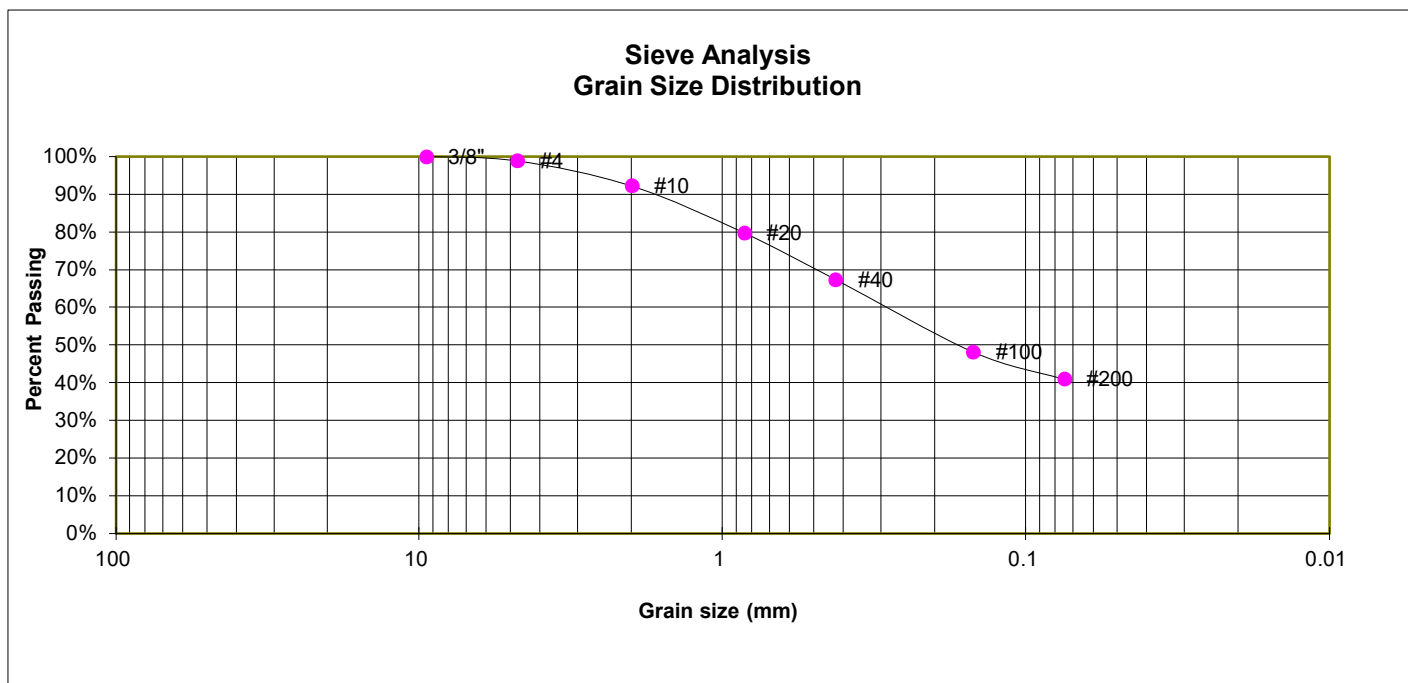
| DEPTH (FT) | 10 |

| SOIL DESCRIPTION | SANDSTONE (SAND, CLAYEY) |

#### **GRAIN SIZE ANALYSIS**

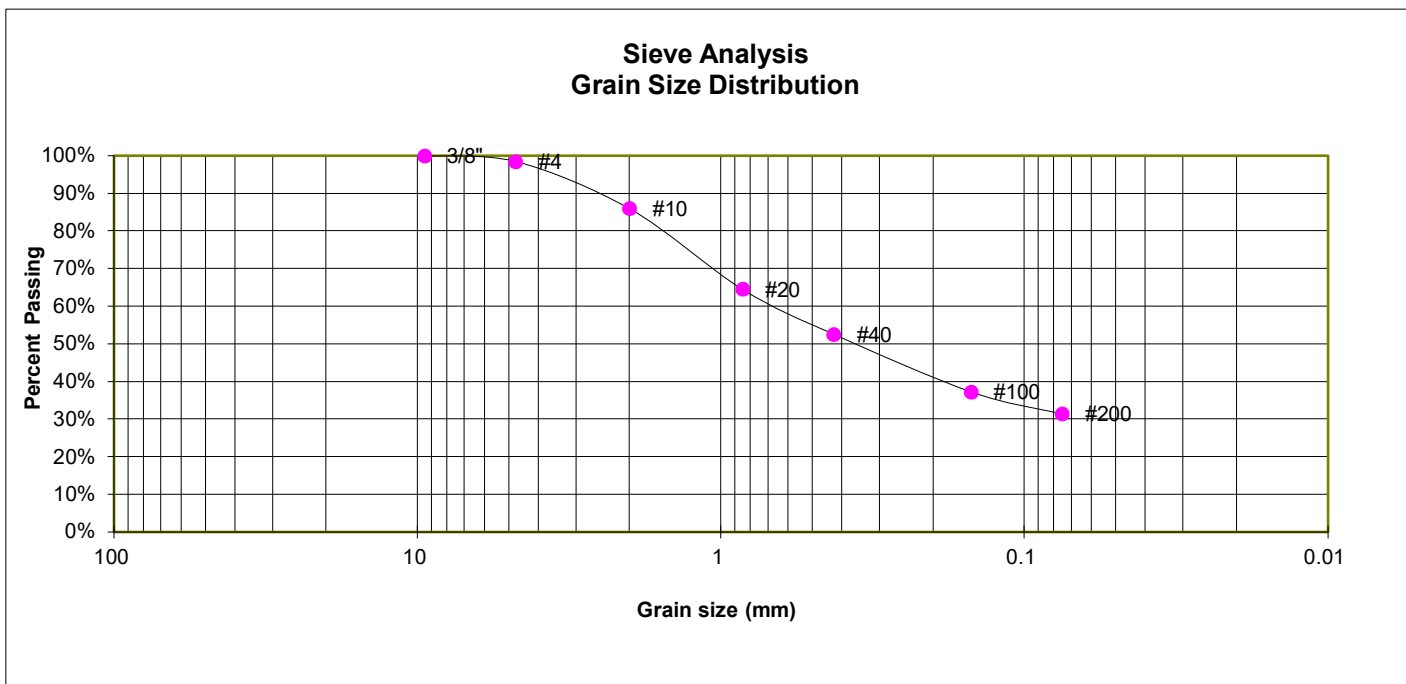
| DEPTH (FT) | 2-3 |

| SOIL DESCRIPTION | SAND, CLAYEY |

#### GRAIN SIZE ANALYSIS

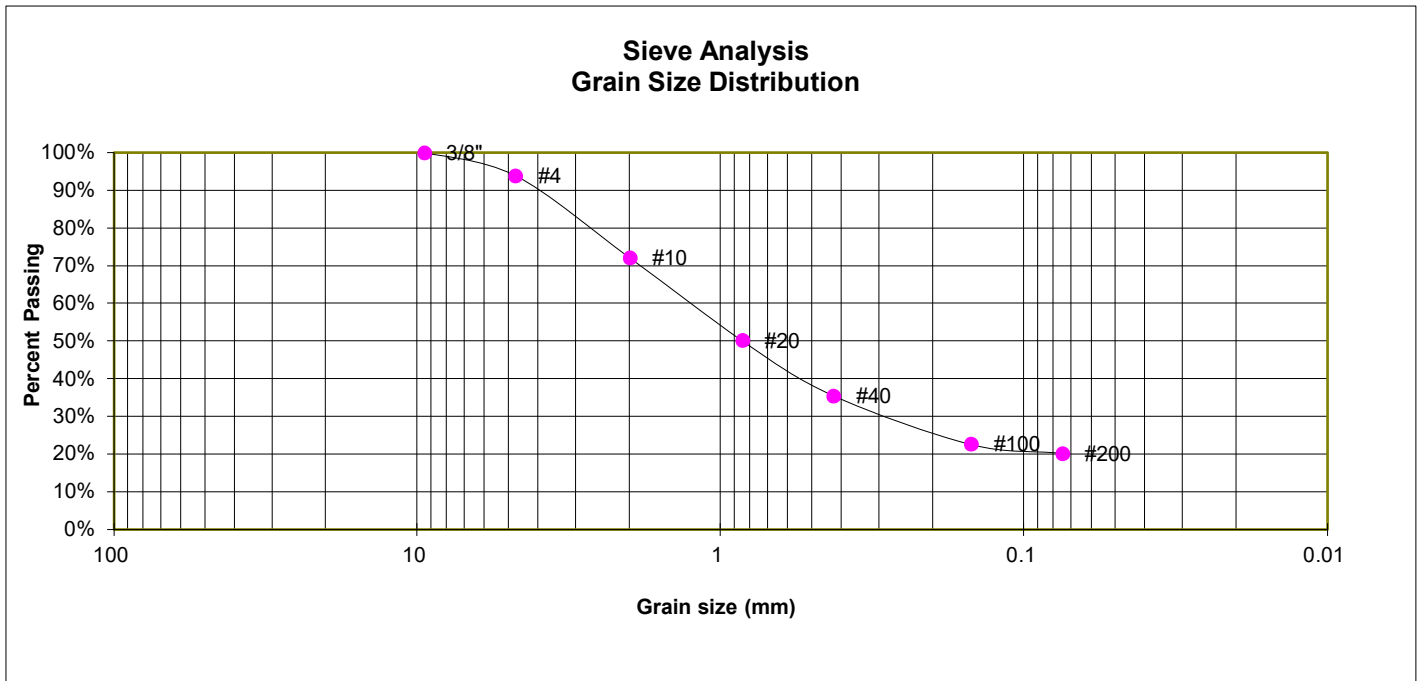
TEST BORING 2  
DEPTH (FT) 5

SOIL DESCRIPTION SAND, CLAYEY

**GRAIN SIZE ANALYSIS**

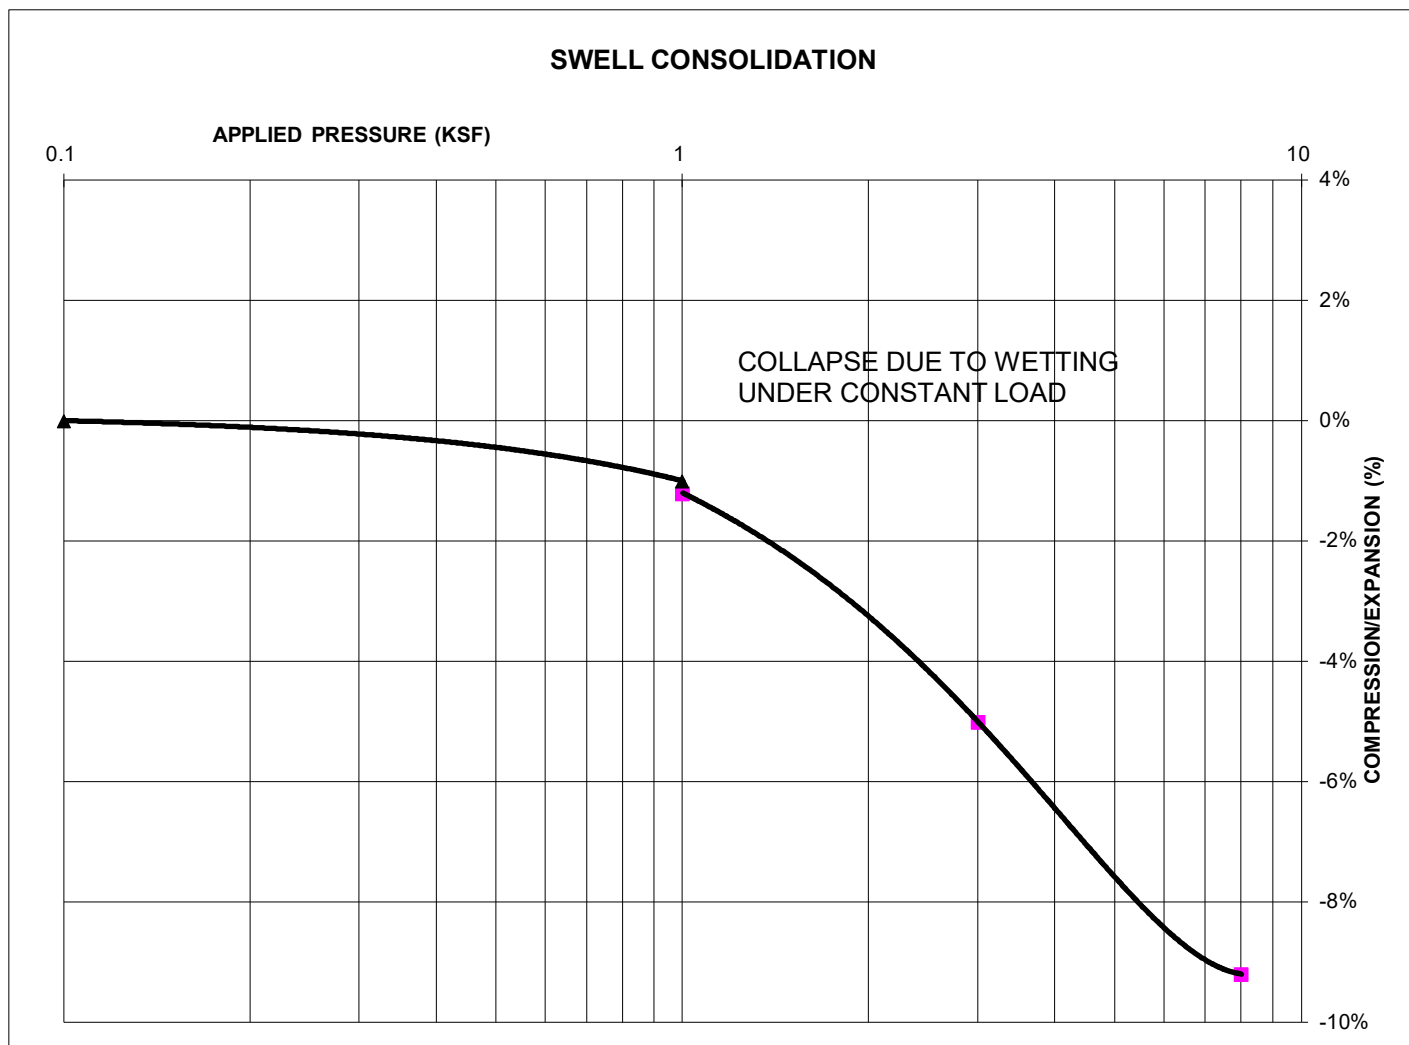
**FIG. 8**

**SWELL/COLLAPSE TEST RESULTS**

NATURAL UNIT DRY WEIGHT (PCF): 95  
NATURAL MOISTURE CONTENT: 18.1%  
SWELL/COLLAPSE (%): -0.2%

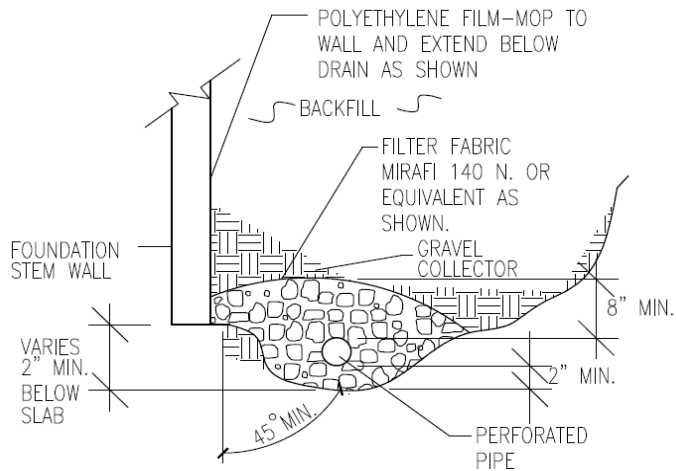
-GRAVEL SIZE IS RELATED TO DIAMETER OF PIPE PERFORATIONS-85% GRAVEL GREATER THAN 2x PERFORATION DIAMETER.

A subsurface perimeter drain is recommended for all useable space below grade (areas where the interior slab or bottom of the crawlspace is below the exterior grade). A typical perimeter drain detail is included with this report in Figure 9.
