**WASTEWATER REPORT  
LATIGO TRAILS FILINGS 9 AND 10, 78 LOTS  
SOUTHWEST OF EASTONVILLE ROAD  
AND LATIGO BOULEVARD  
EL PASO COUNTY, COLORADO**

Project No. CS19409-115

October 7, 2021  
Revised March 31, 2022

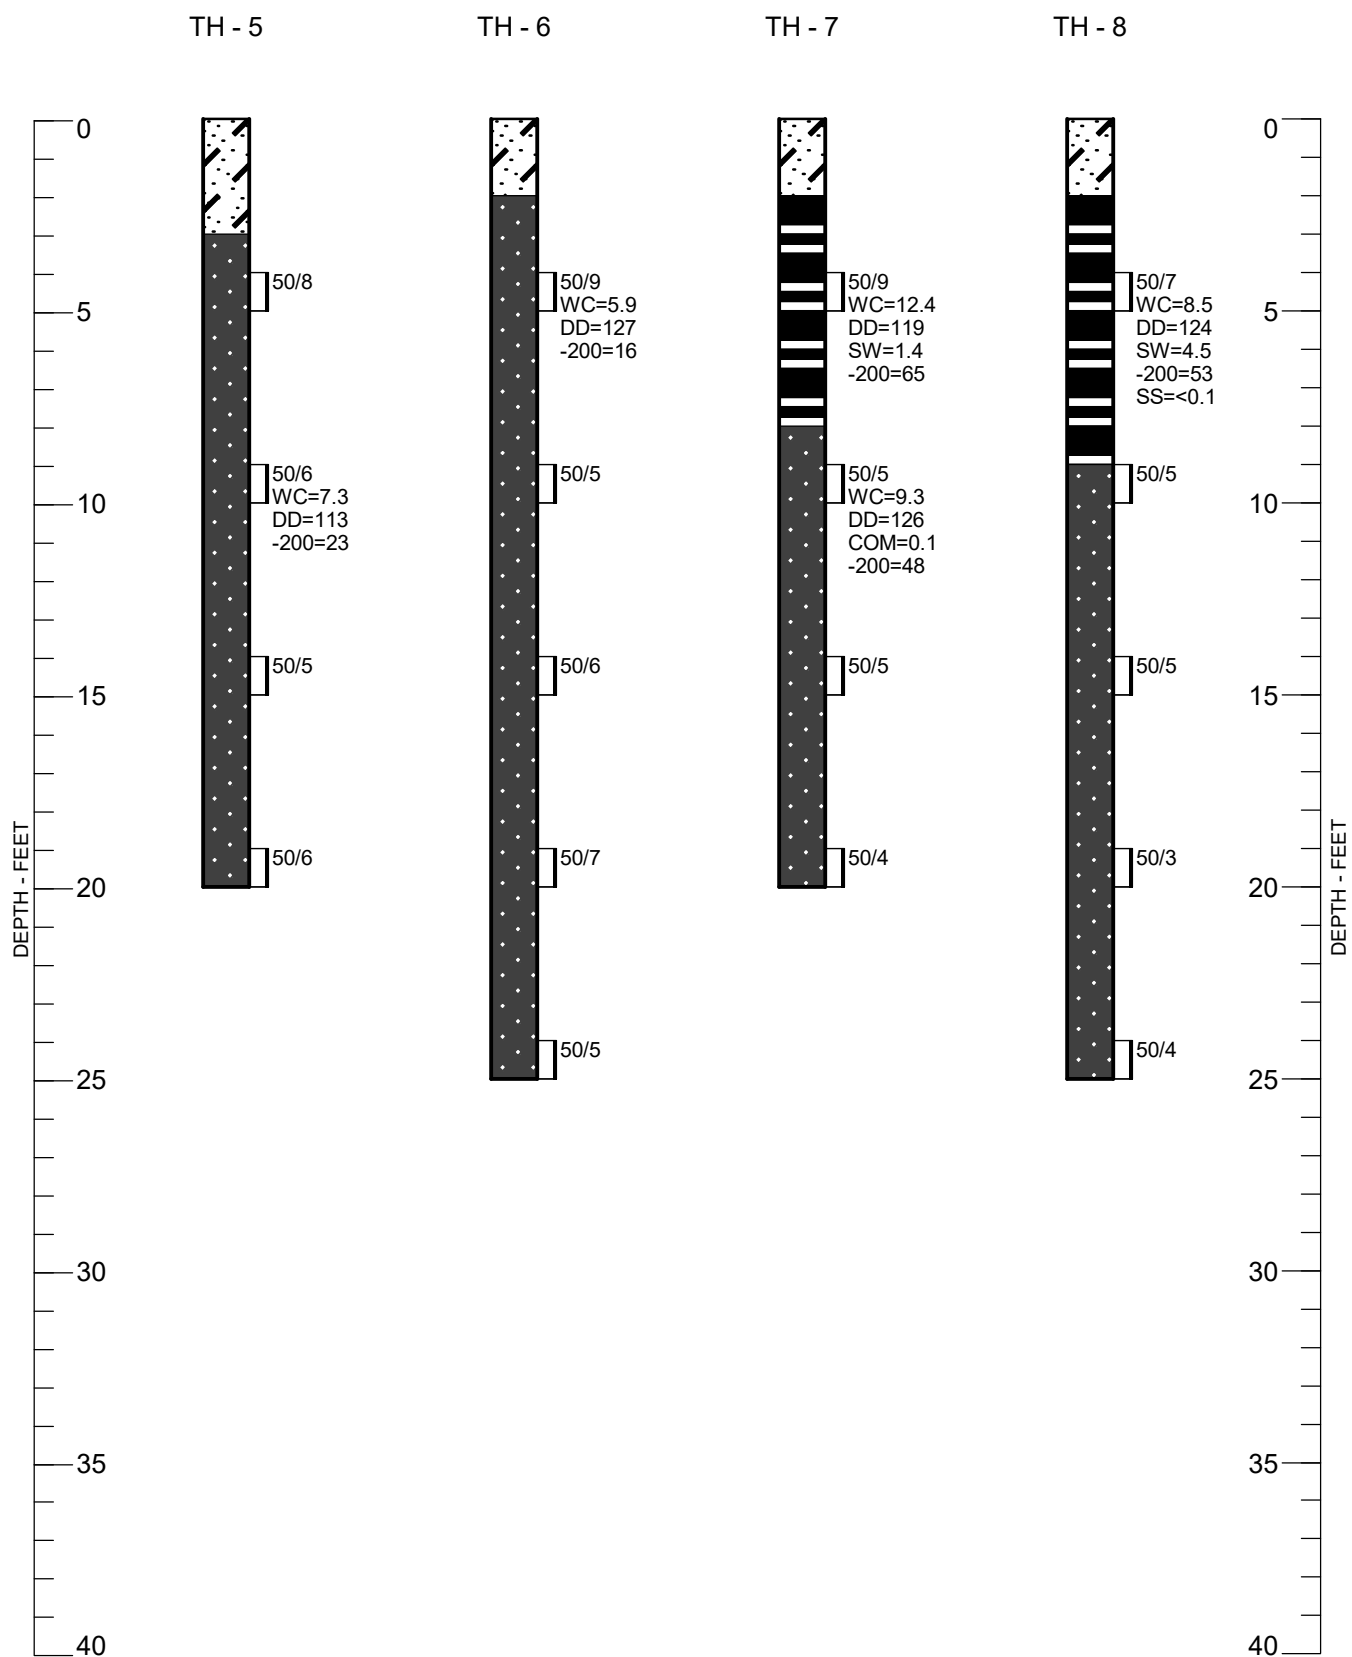
### **SUMMARY LOGS OF EXPLORATORY BORINGS**

1. THE BORINGS WERE DRILLED JUNE 14, 21, 22, AND 23 2021 USING A 4-INCH DIAMETER, CONTINUOUS-FLIGHT AUGER AND A CME-45, TRUCK-MOUNTED DRILL RIG.
2. THESE LOGS ARE SUBJECT TO THE EXPLANATIONS, LIMITATIONS, AND CONCLUSIONS AS CONTAINED IN THIS REPORT.
3. WC - INDICATES MOISTURE CONTENT. (%)  
DD - INDICATES DRY DENSITY. (PCF)  
SW - INDICATES SWELL WHEN WETTED UNDER APPROXIMATE OVERBURDEN PRESSURE. (%)  
COM - INDICATES COMPRESSION WHEN WETTED UNDER APPROXIMATE OVERBURDEN PRESSURE. (%)  
-200 - INDICATES PASSING NO. 200 SIEVE. (%)  
SS - INDICATES WATER-SOLUBLE SULFATE CONTENT. (%)

The soils encountered in our test pits consisted predominantly of Type 1 sand and loamy sand and Type 2 sandy loam with localized areas of silty clay loam and sandy clay. Bedrock was identified in fourteen of our test pits at depths between 2 and 9 feet. It is noted that bedrock was identified in our borings at depths of 1 to 3 feet; however, the borings were drilled for the purpose of geotechnical engineering and the methodology for determining bedrock for OWTS purposes differs slightly. The observations in the test pits were generally relied upon for this report. The near surface bedrock was typically sandstone with some shallow claystone beds in the southeastern portion of Filing 9. The soil and bedrock layers encountered in our test pits are summarized below in Table A. Our boring logs are presented in Appendix A.
