**WASTEWATER REPORT  
LATIGO TRAILS FILINGS 9 AND 10, 78 LOTS  
SOUTHWEST OF EASTONVILLE ROAD  
AND LATIGO BOULEVARD  
EL PASO COUNTY, COLORADO**

Project No. CS19409-115

October 7, 2021  
Revised March 31, 2022  
Revised June 16, 2022

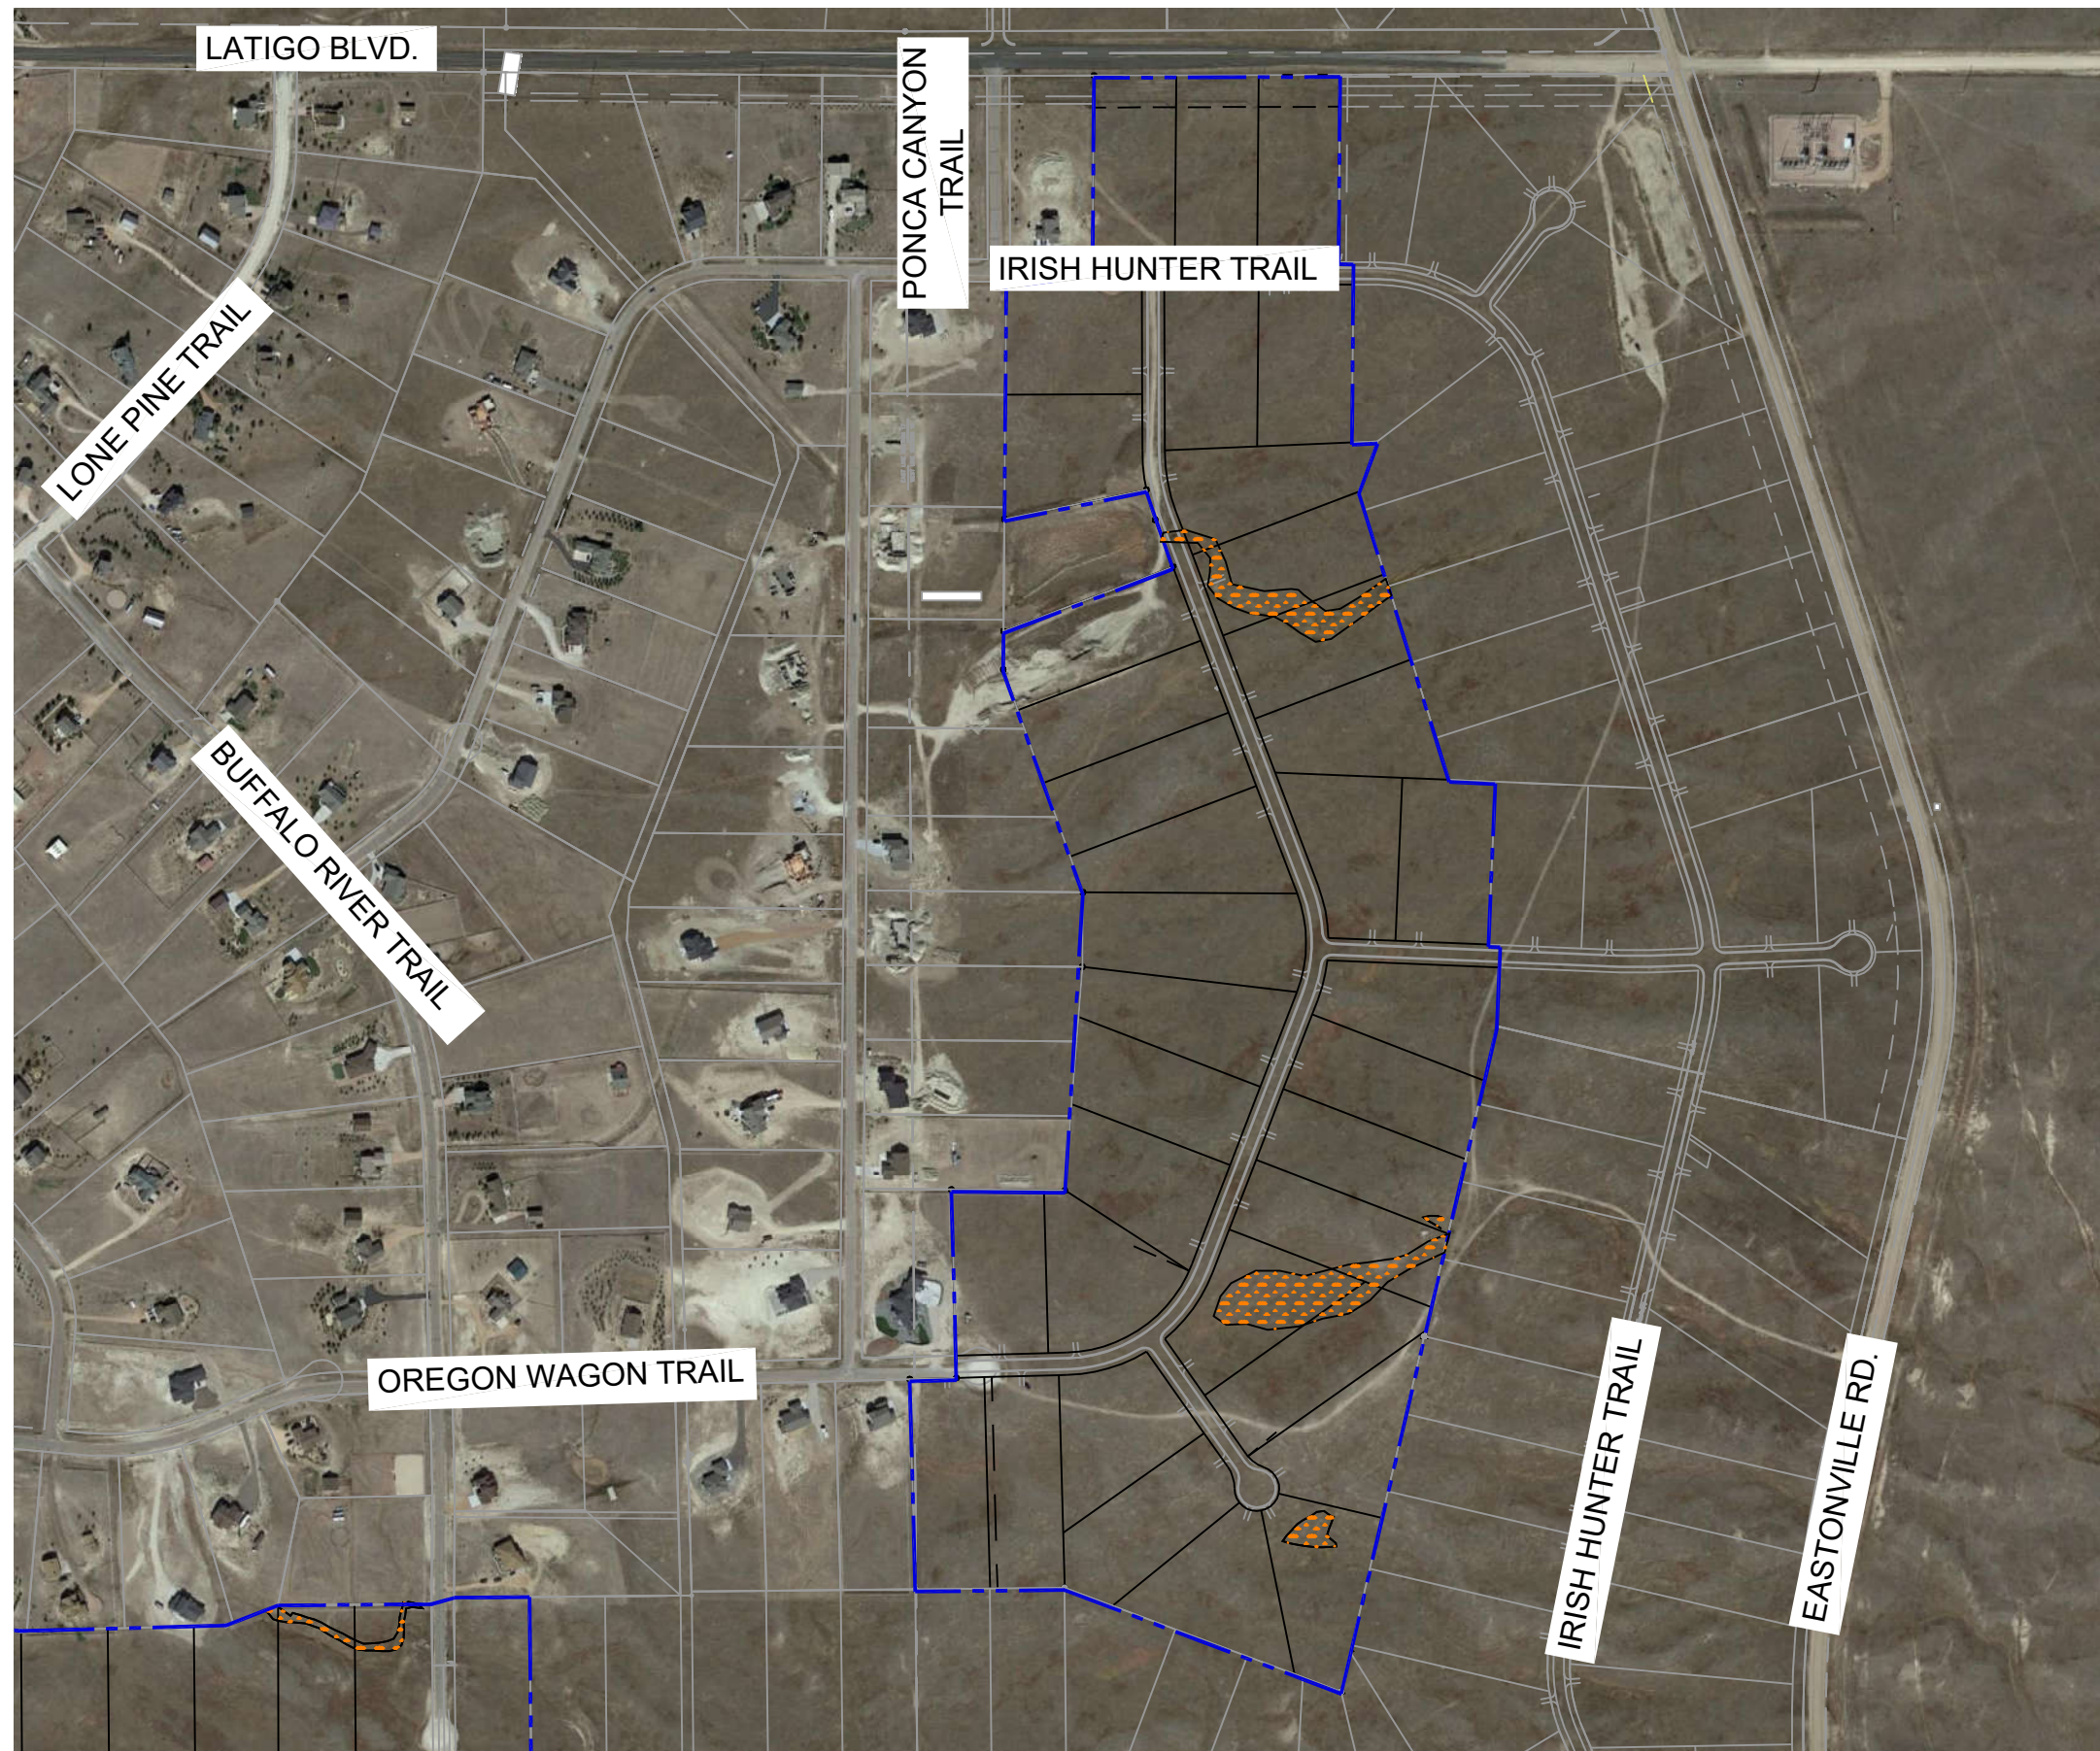
FILING 10  
SEPTIC  
SUITABILITY  
MAP

AREAS WHERE SEPTIC SYSTEMS ARE NOT RECOMMENDED.

FIGS. 2 and 3 – SEPTIC SUITABILITY MAPS

Drainages and seasonally moist areas currently identified on the site have been noted on Figs. 2 and 3 as areas where septic systems are not recommended.

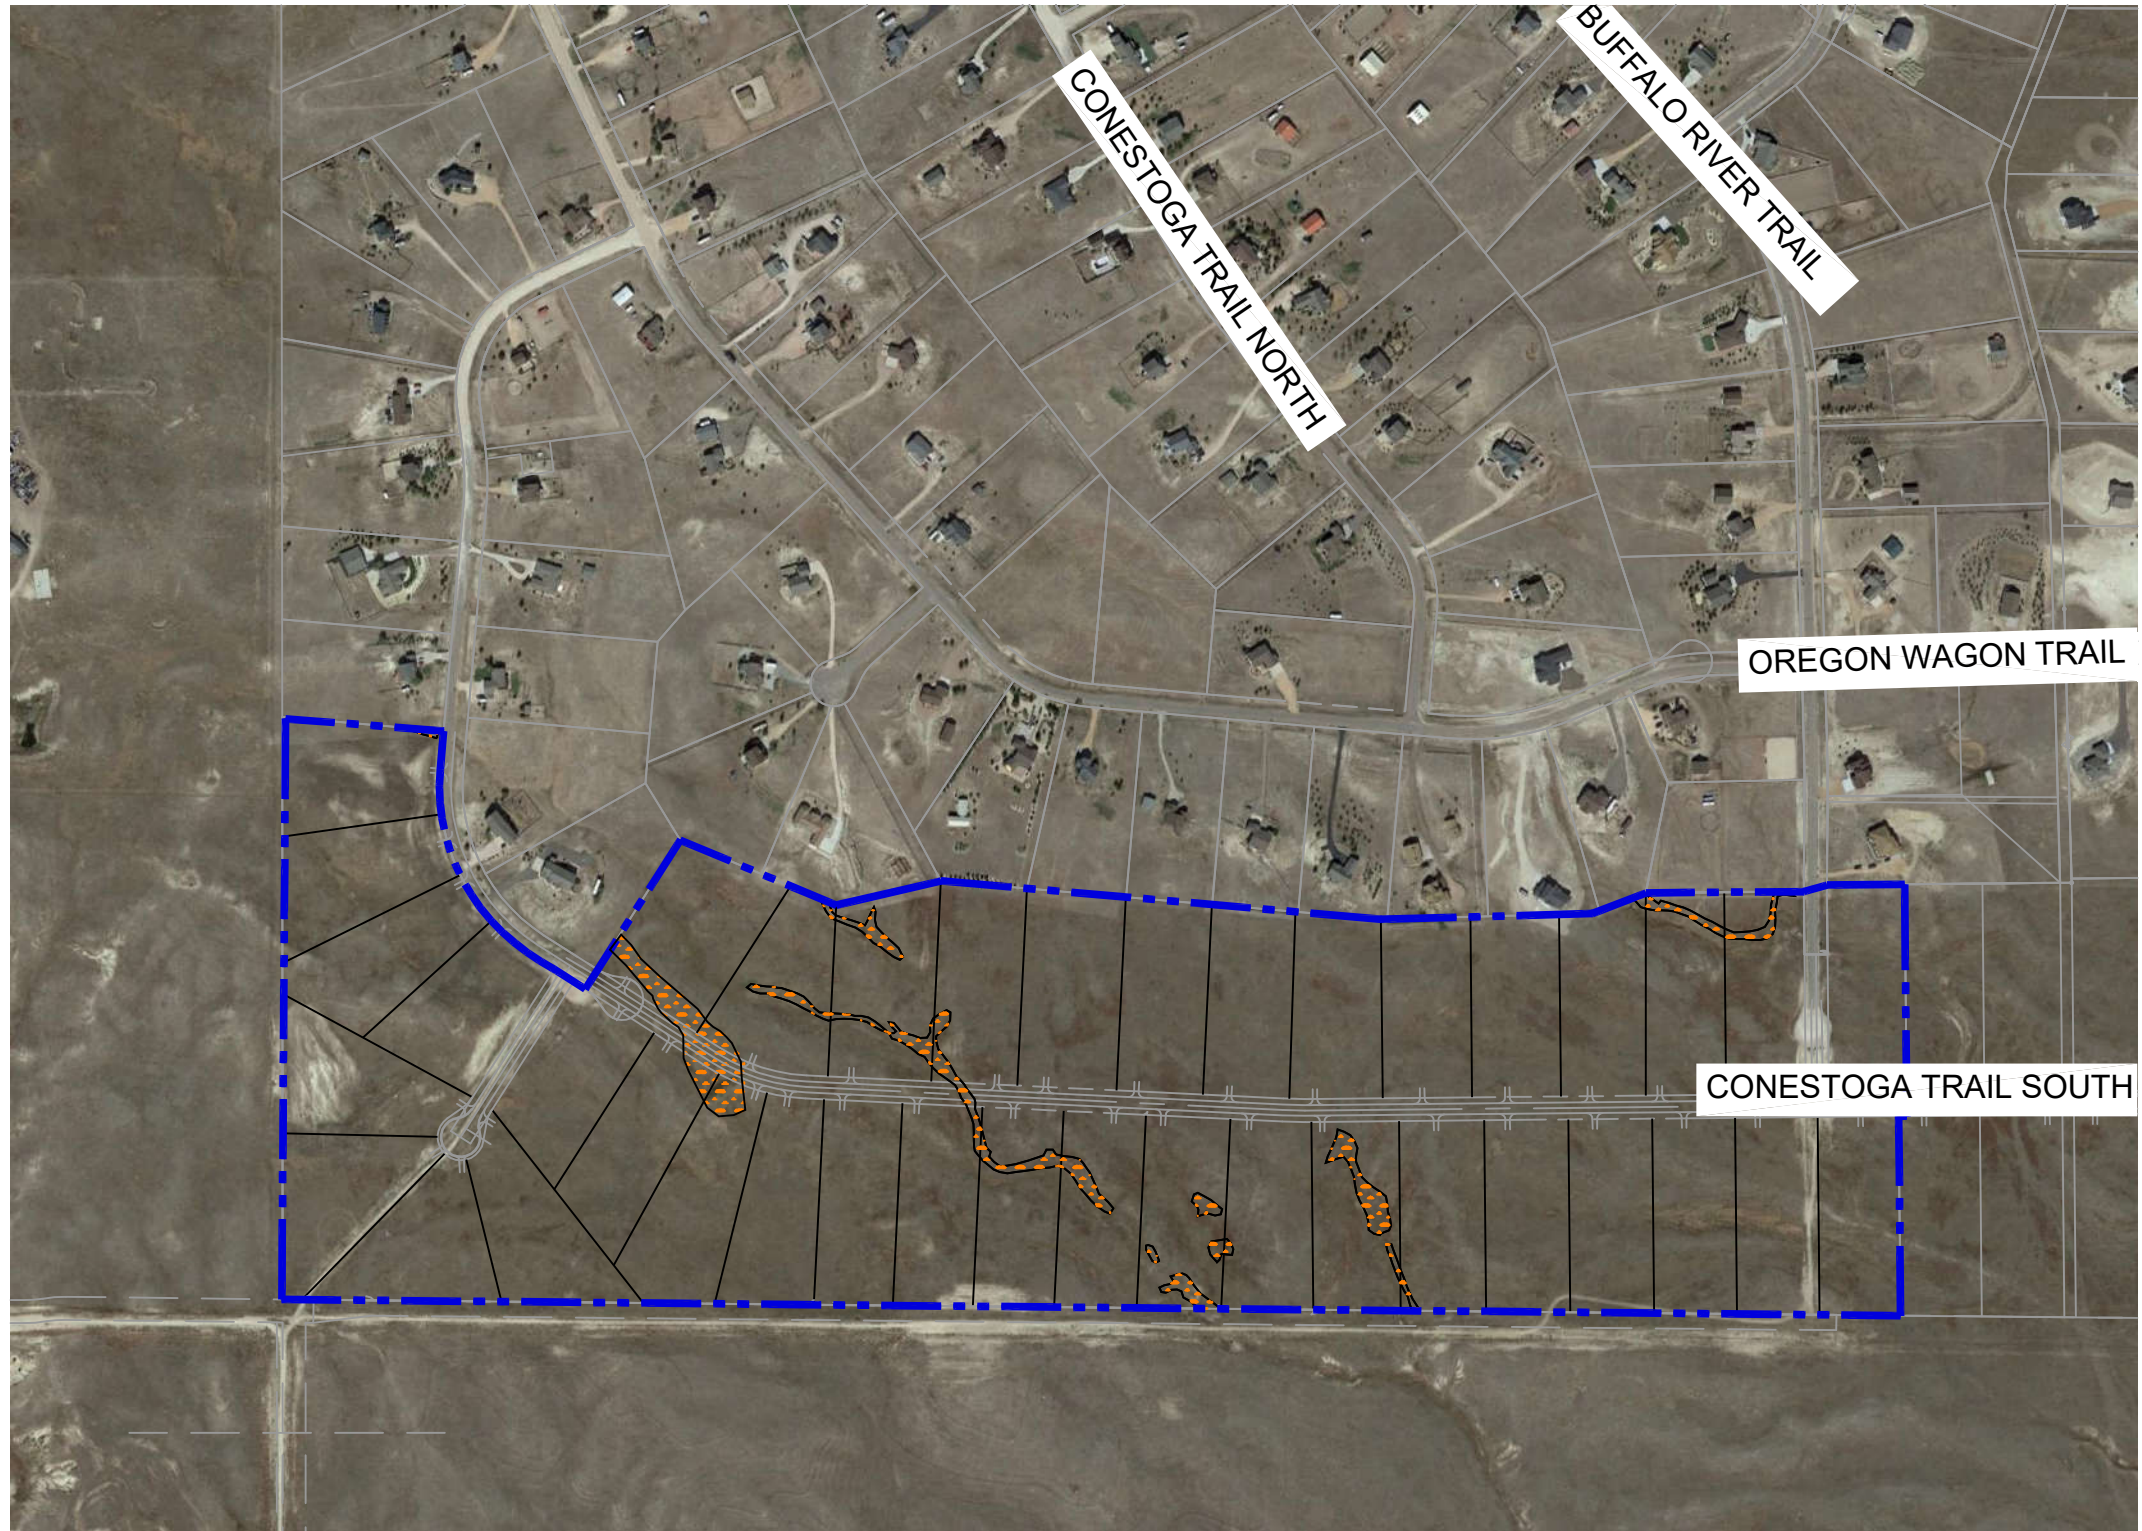
FIG. 3

AREA WHERE SEPTIC SYSTEMS ARE NOT RECOMMENDED.
-

FILING 9  
SEPTIC  
SUITABILITY  
MAP

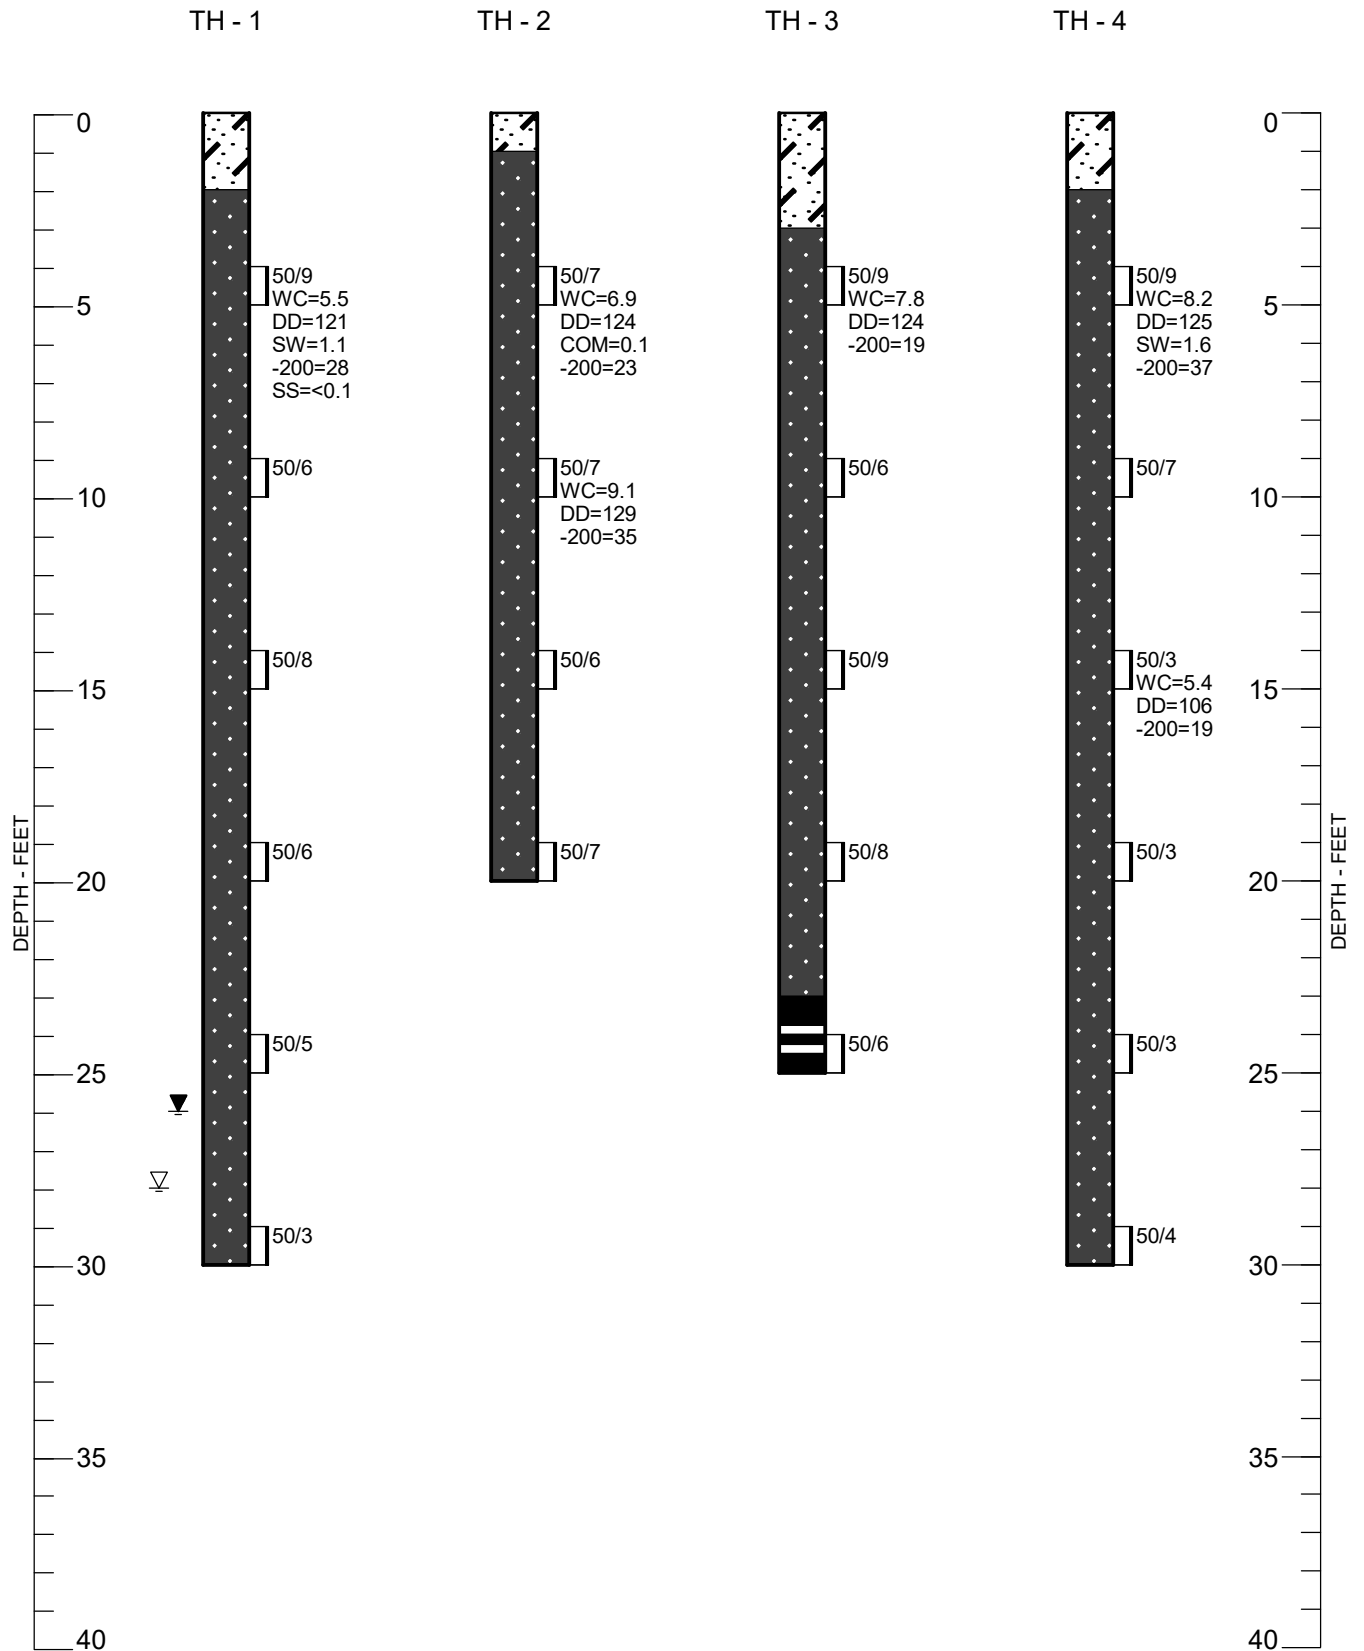
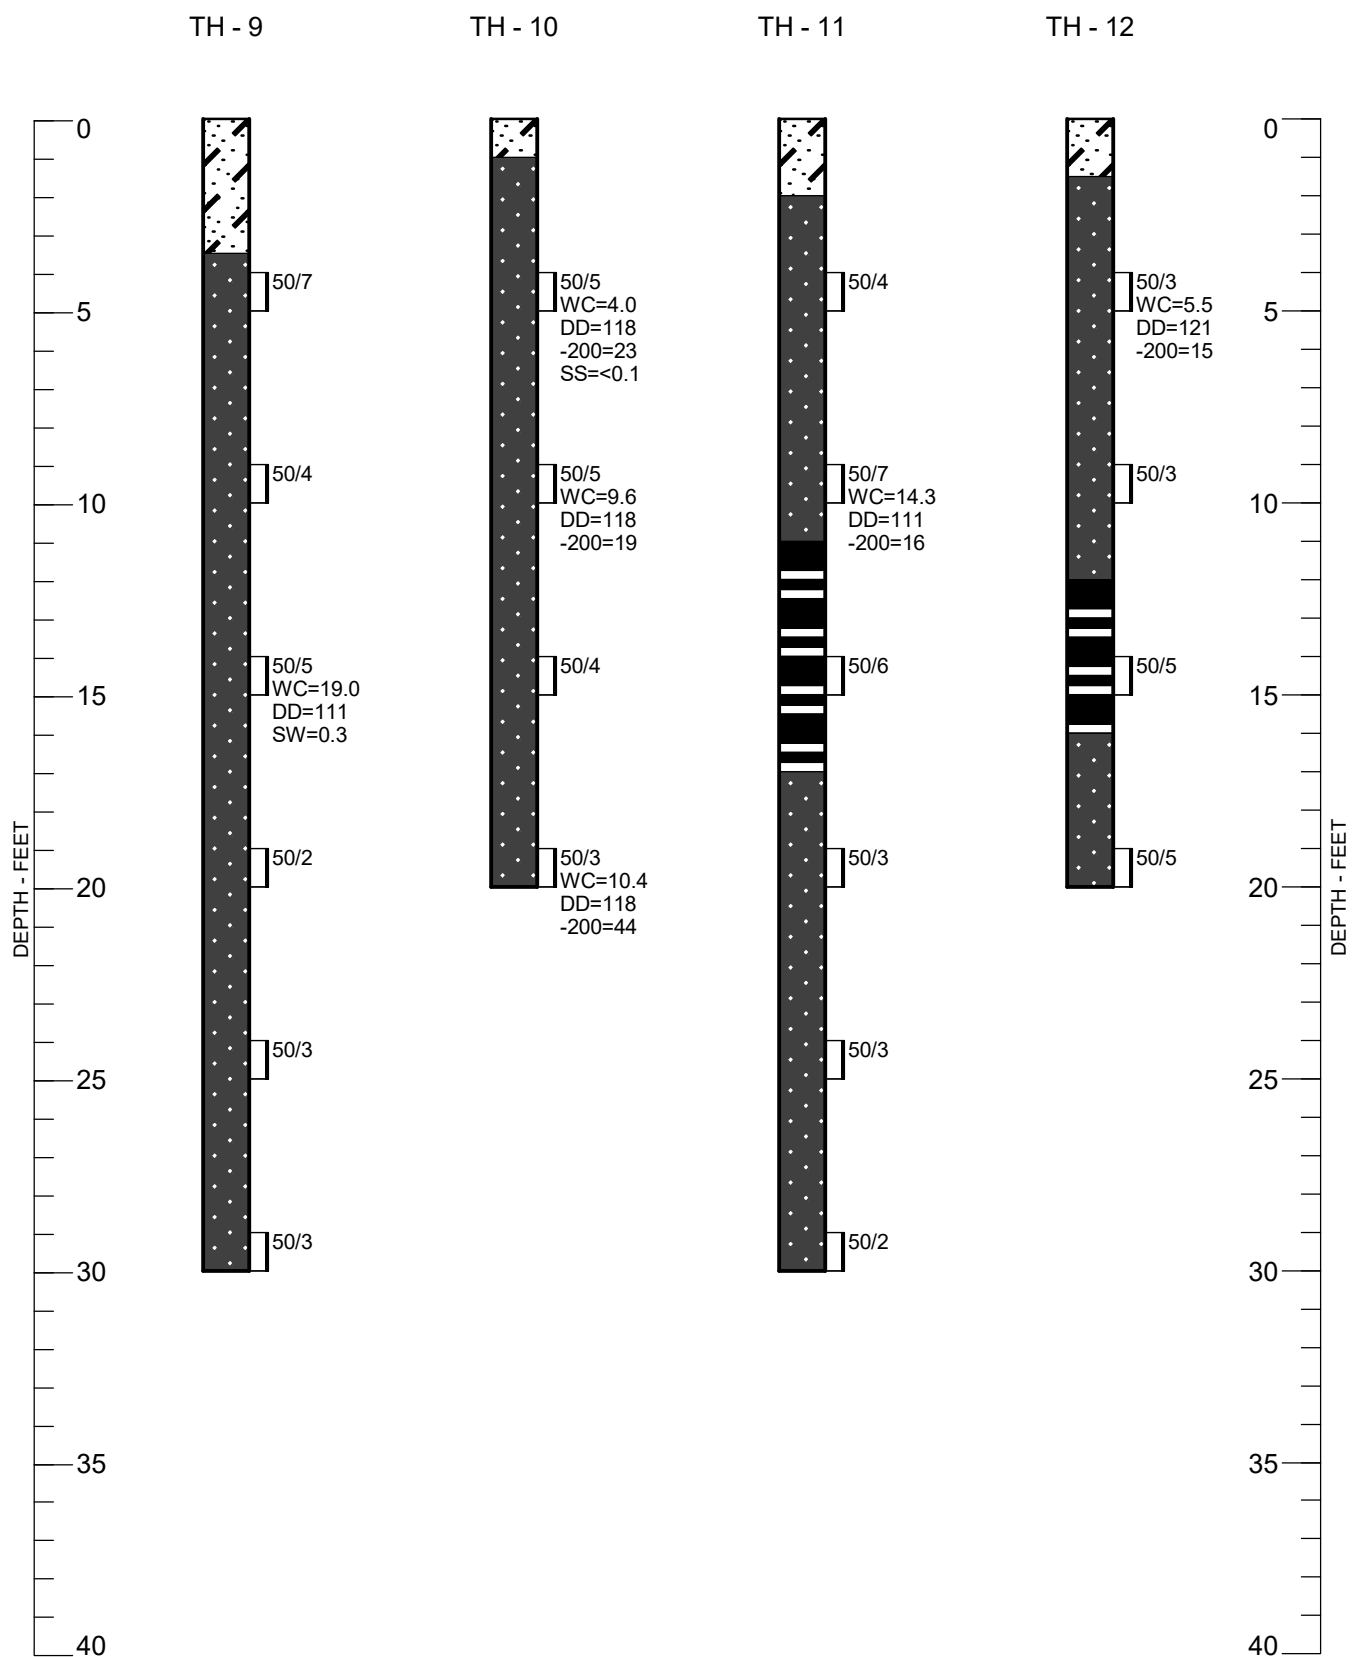
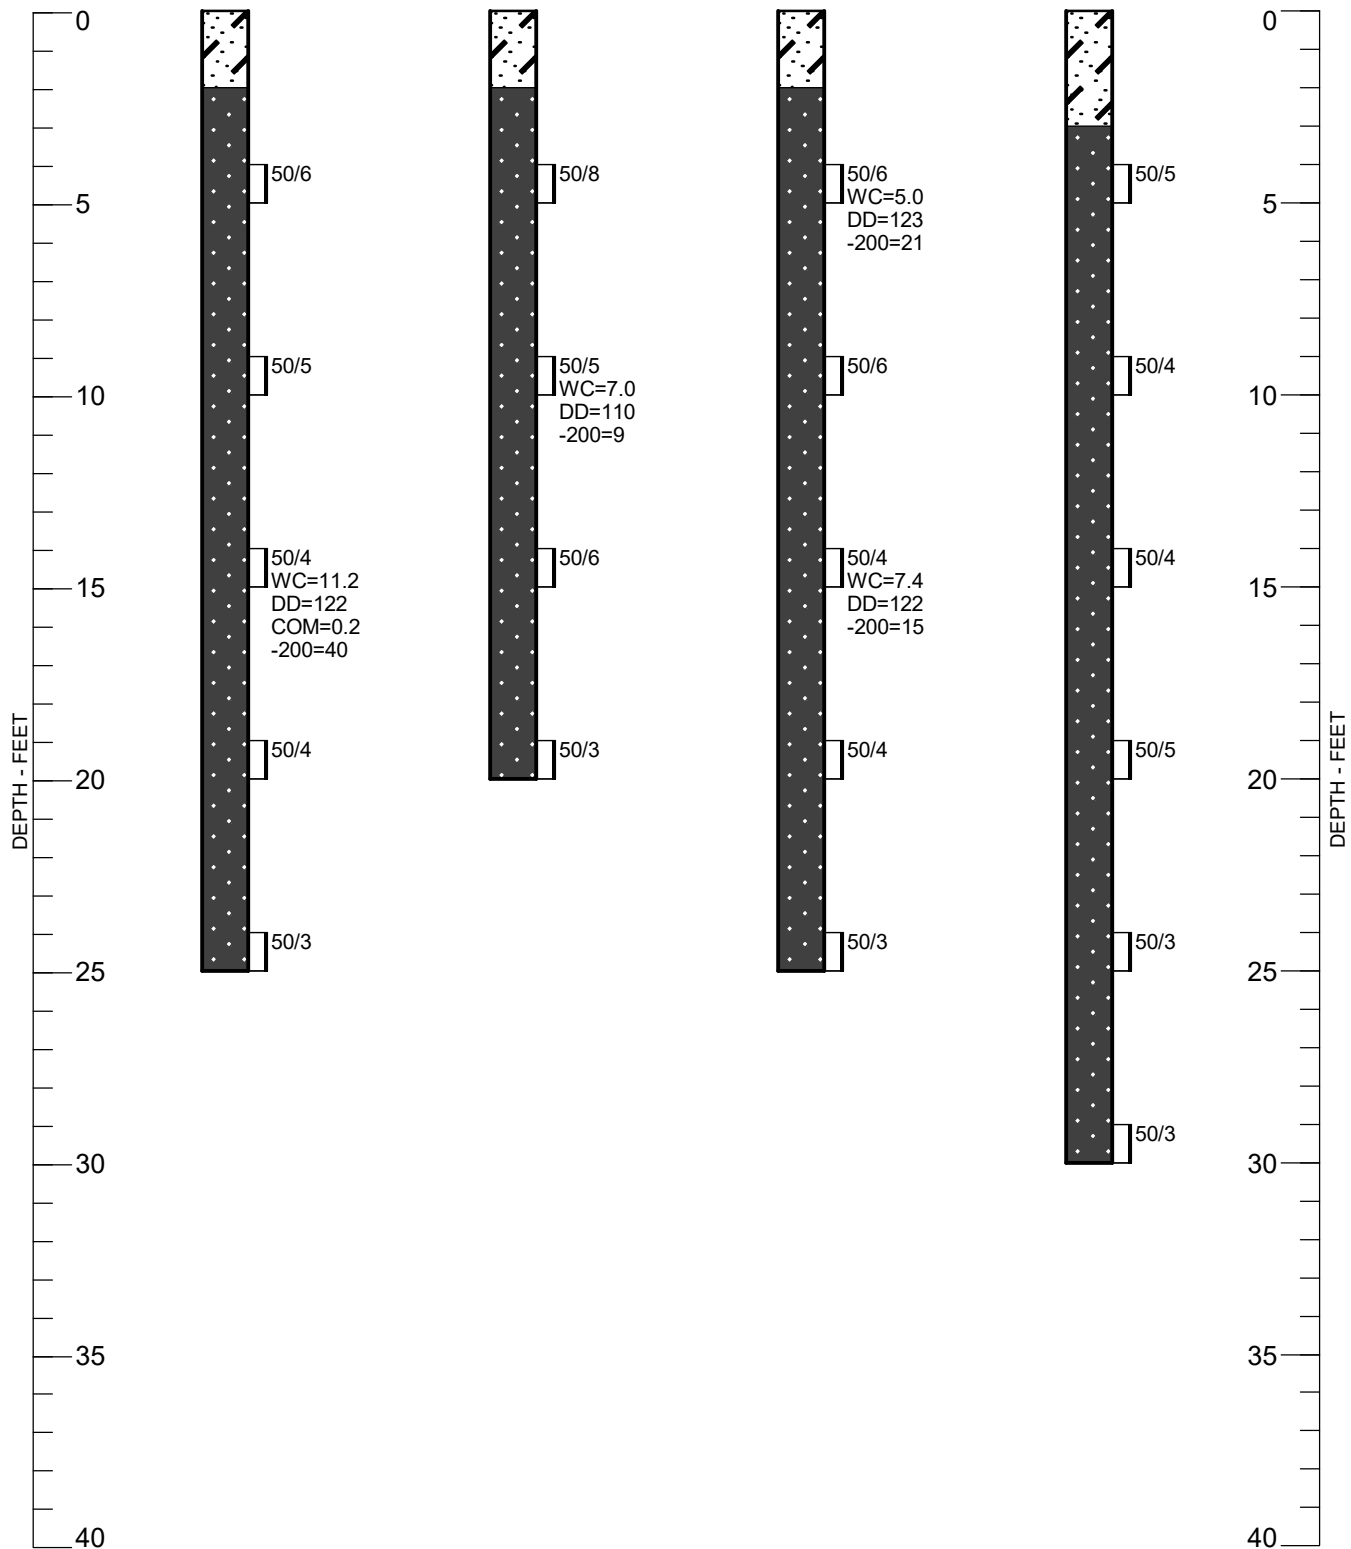
### **SUMMARY LOGS OF EXPLORATORY BORINGS**

1. THE BORINGS WERE DRILLED JUNE 14, 21, 22, AND 23 2021 USING A 4-INCH DIAMETER, CONTINUOUS-FLIGHT AUGER AND A CME-45, TRUCK-MOUNTED DRILL RIG.
2. THESE LOGS ARE SUBJECT TO THE EXPLANATIONS, LIMITATIONS, AND CONCLUSIONS AS CONTAINED IN THIS REPORT.
3. WC - INDICATES MOISTURE CONTENT. (%)  
DD - INDICATES DRY DENSITY. (PCF)  
SW - INDICATES SWELL WHEN WETTED UNDER APPROXIMATE OVERBURDEN PRESSURE. (%)  
COM - INDICATES COMPRESSION WHEN WETTED UNDER APPROXIMATE OVERBURDEN PRESSURE. (%)  
-200 - INDICATES PASSING NO. 200 SIEVE. (%)  
SS - INDICATES WATER-SOLUBLE SULFATE CONTENT. (%)

The soils encountered in our test pits consisted predominantly of Type 1 sand and loamy sand and Type 2 sandy loam with localized areas of silty clay loam and sandy clay. Bedrock was identified in fourteen of our test pits at depths between 2 and 9 feet. It is noted that bedrock was identified in our borings at depths of 1 to 3 feet; however, the borings were drilled for the purpose of geotechnical engineering and the methodology for determining bedrock for OWTS purposes differs slightly. The observations in the test pits were generally relied upon for this report. The near surface bedrock was typically sandstone with some shallow claystone beds in the southeastern portion of Filing 10. The soil and bedrock layers encountered in our test pits are summarized below in Table A. Our boring logs are presented in Appendix A.

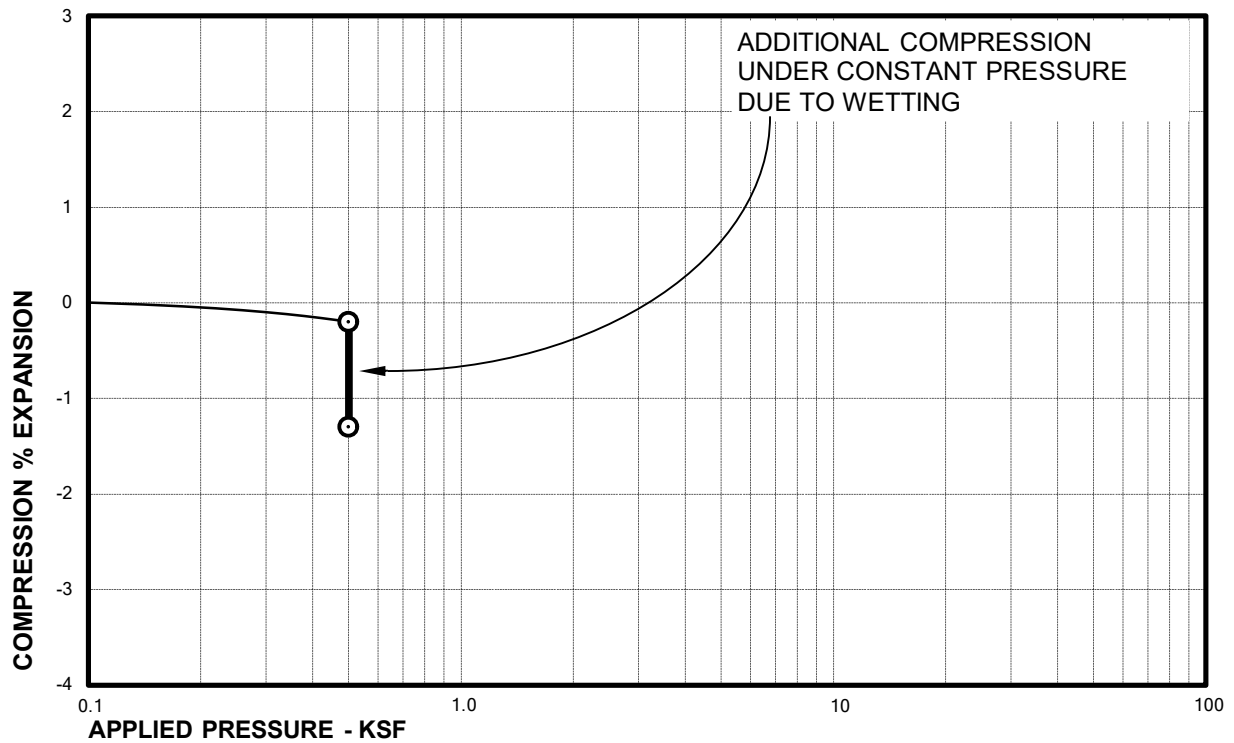
Sample of SANDSTONE, CLAYEY  
From TH-1 AT 4 FEET

DRY UNIT WEIGHT= 121 PCF  
MOISTURE CONTENT= 5.5 %

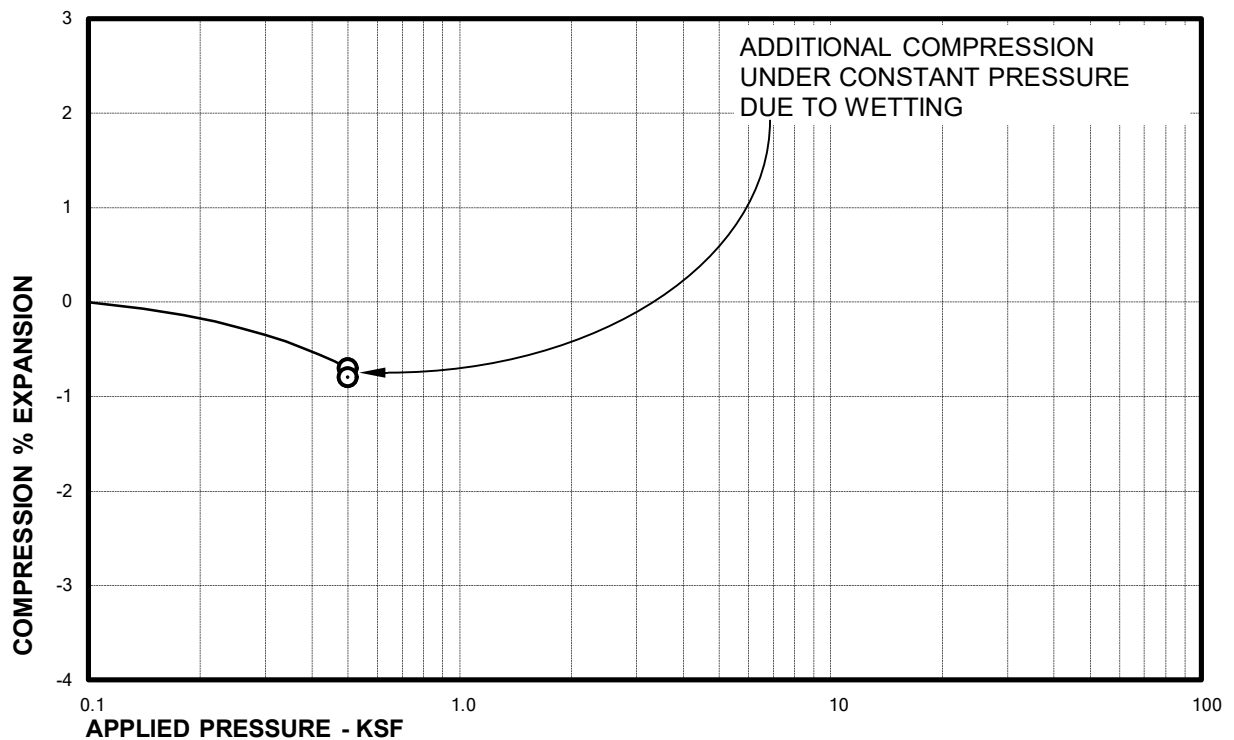
Sample of SANDSTONE, SILTY  
From TH-2 AT 4 FEET

DRY UNIT WEIGHT= 124 PCF  
MOISTURE CONTENT= 6.9 %

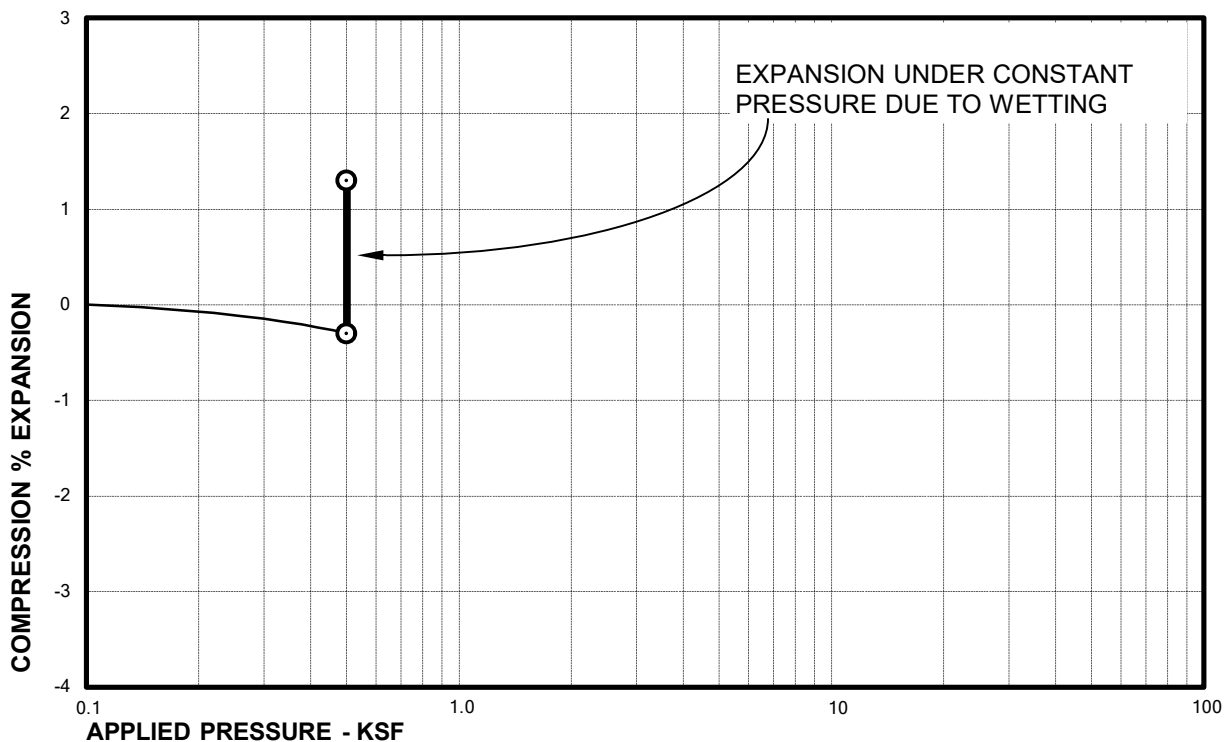
Sample of SANDSTONE, VERY CLAYEY  
From TH-4 AT 4 FEET

DRY UNIT WEIGHT= 125 PCF  
MOISTURE CONTENT= 8.2 %

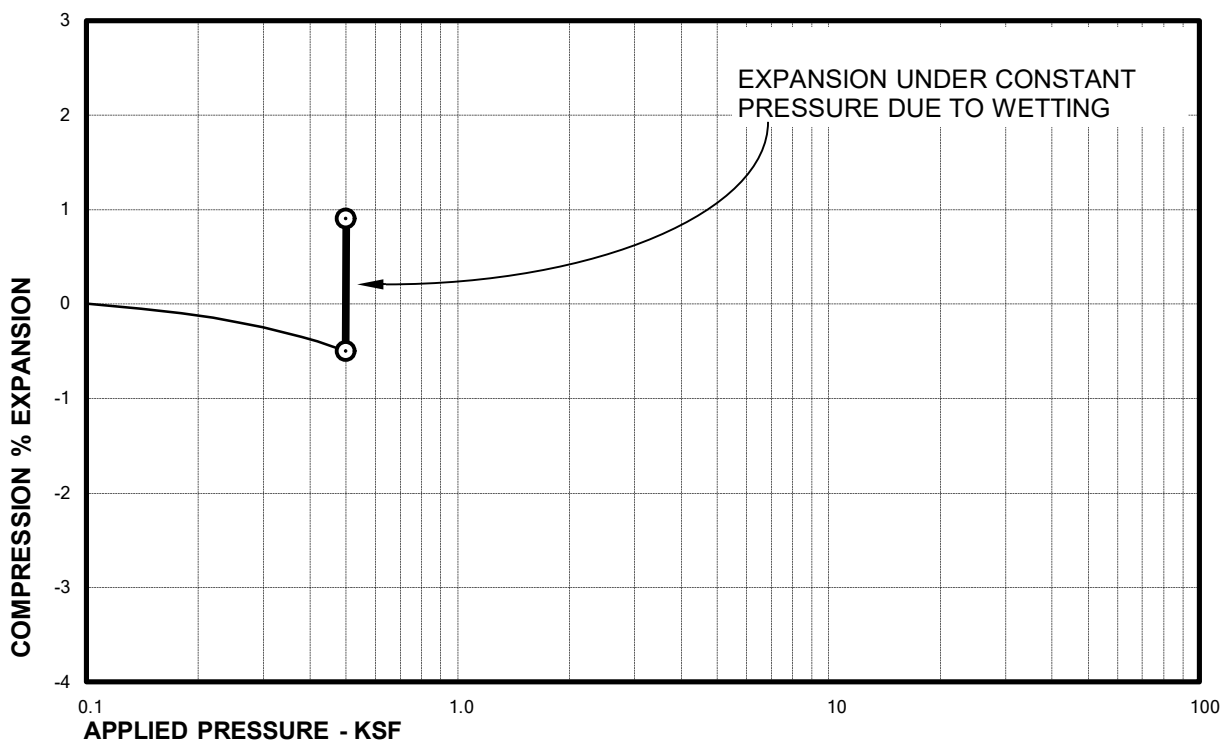
Sample of CLAYSTONE, SANDY  
From TH-7 AT 4 FEET

DRY UNIT WEIGHT= 119 PCF  
MOISTURE CONTENT= 12.4 %

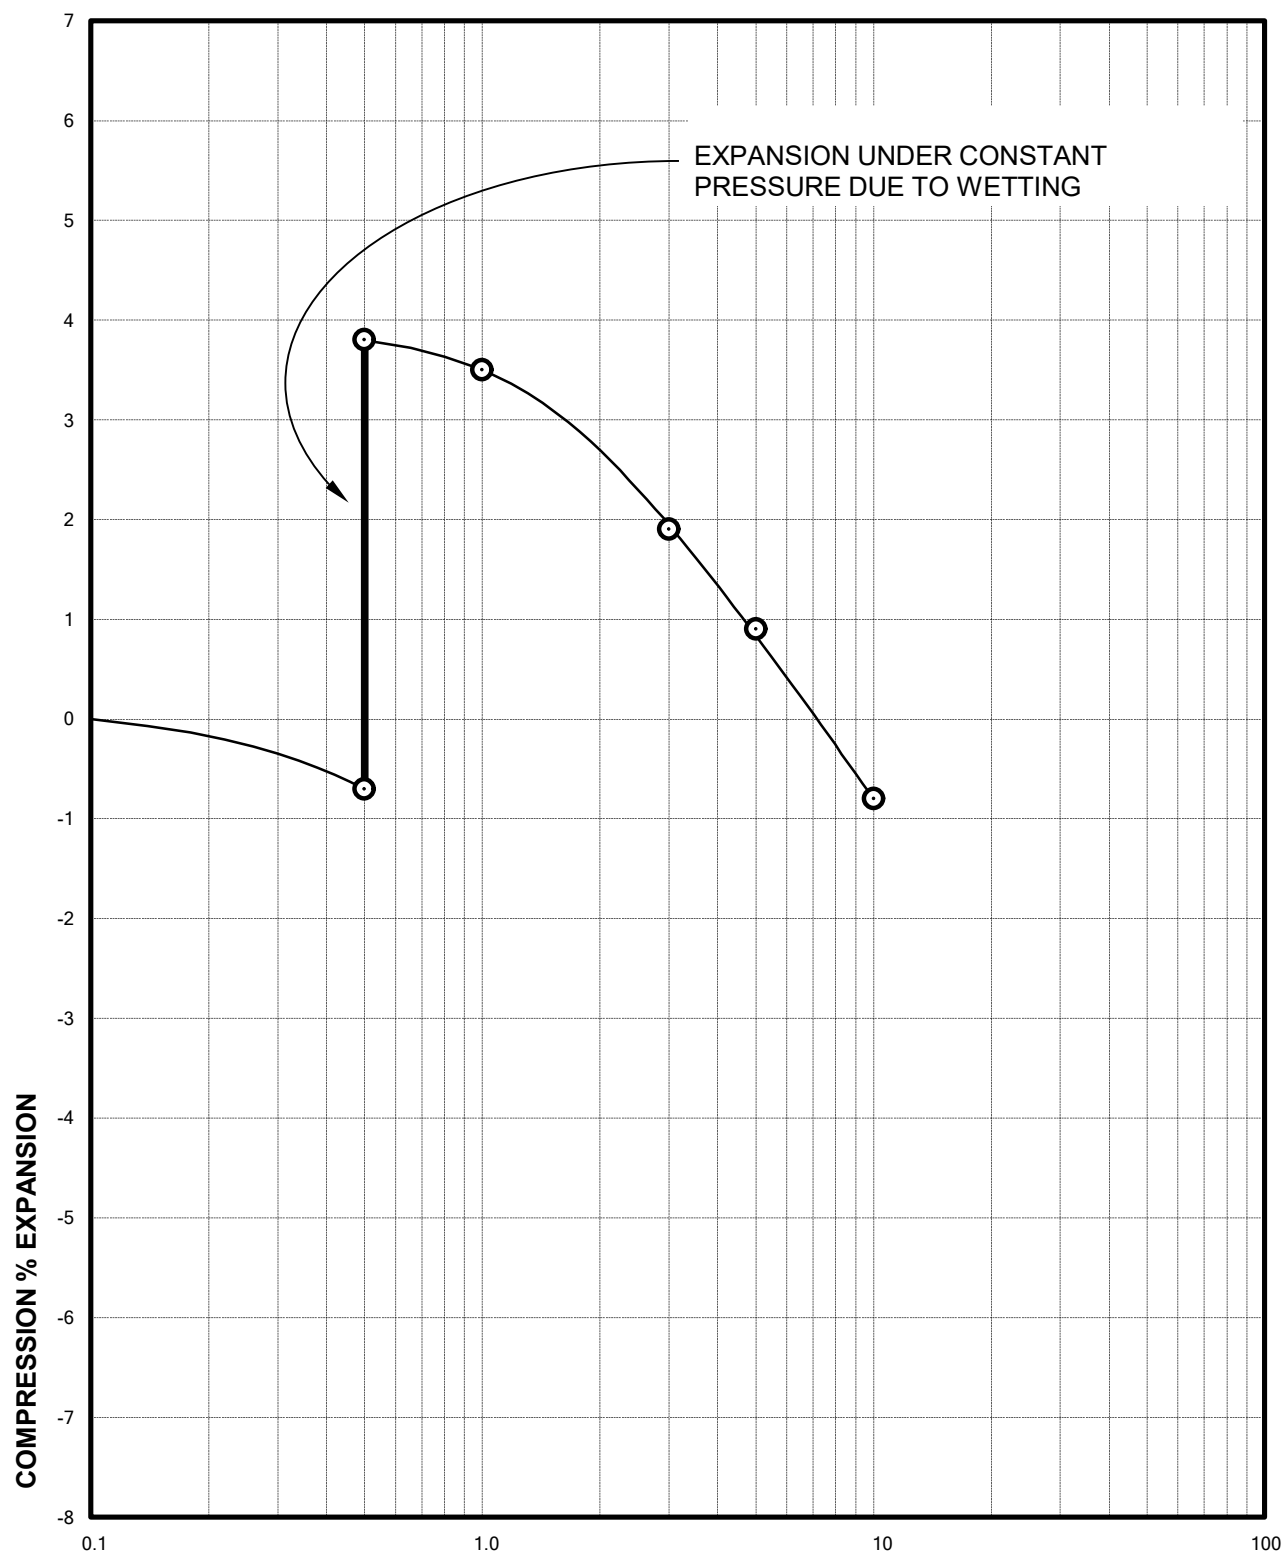
**APPLIED PRESSURE - KSF**  
Sample of CLAYSTONE, VERY SANDY  
From TH-8 AT 4 FEET

DRY UNIT WEIGHT= 124 PCF  
MOISTURE CONTENT= 8.5 %

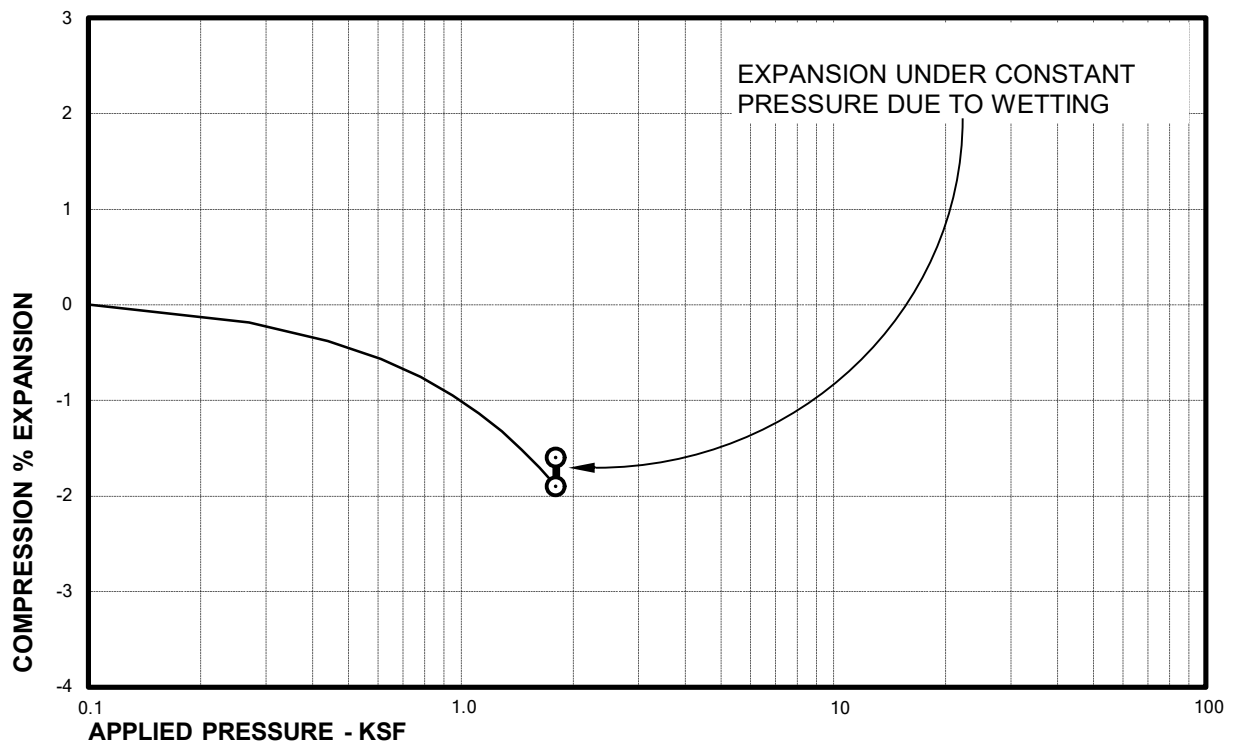
Sample of SANDSTONE, VERY CLAYEY  
From TH-9 AT 14 FEET

DRY UNIT WEIGHT= 111 PCF  
MOISTURE CONTENT= 19.0 %

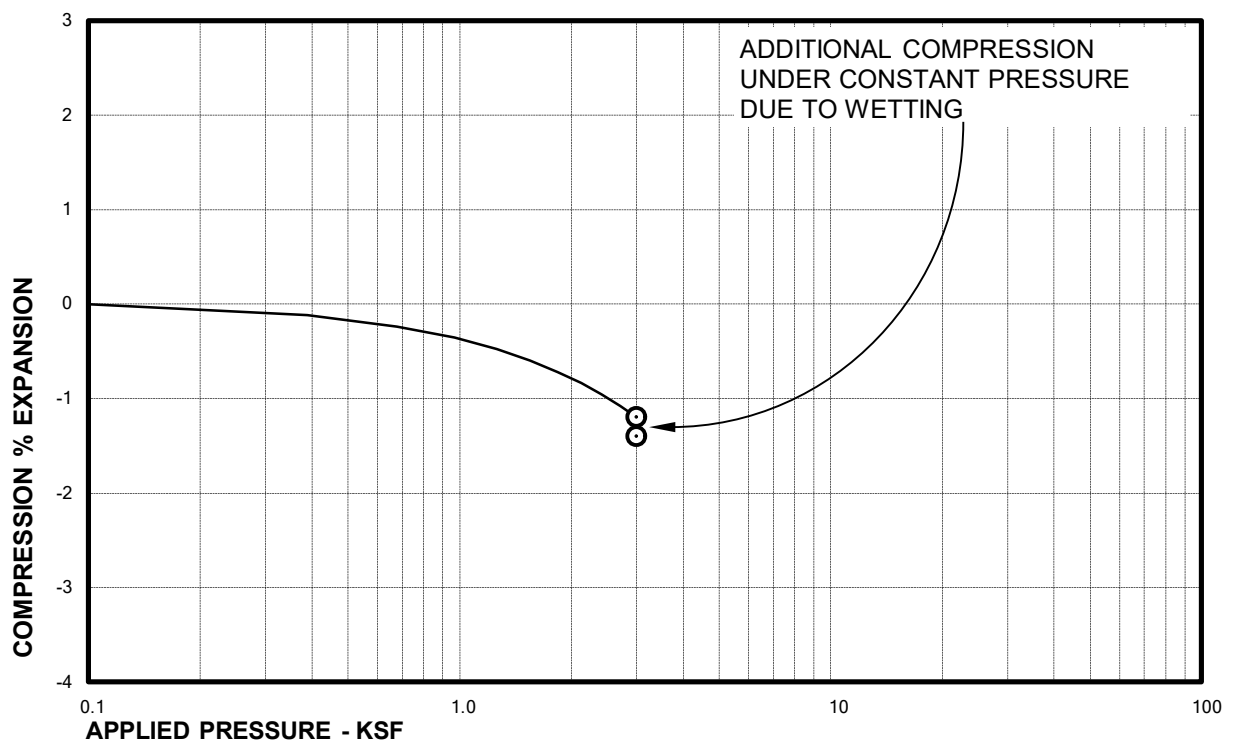
Sample of SANDSTONE, CLAYEY  
From TH-11 AT 24 FEET

DRY UNIT WEIGHT= 111 PCF  
MOISTURE CONTENT= 14.3 %

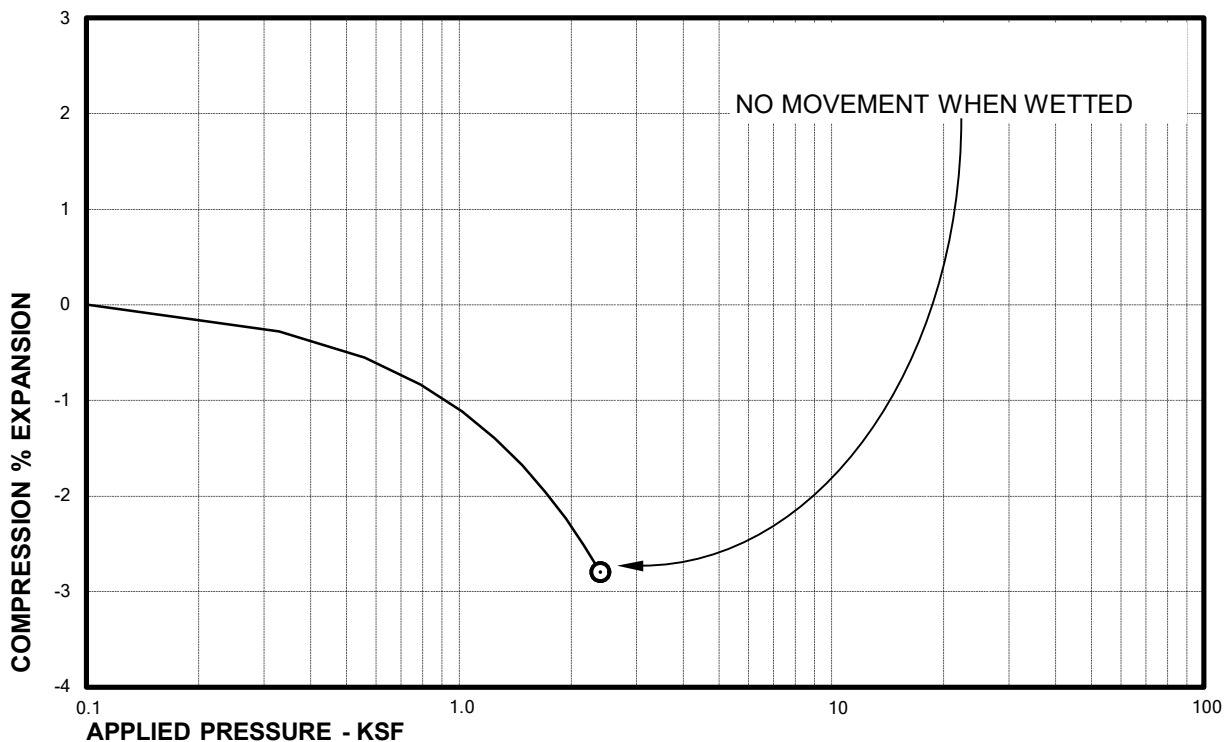
Sample of SANDSTONE  
From TH-17 AT 19 FEET

DRY UNIT WEIGHT= 121 PCF  
MOISTURE CONTENT= 12.5 %
