**WASTEWATER REPORT  
LATIGO TRAILS FILINGS 9 AND 10, 78 LOTS  
SOUTHWEST OF EASTONVILLE ROAD  
AND LATIGO BOULEVARD  
EL PASO COUNTY, COLORADO**

Project No. CS19409-115

October 7, 2021  
Revised March 31, 2022  
Revised June 16, 2022

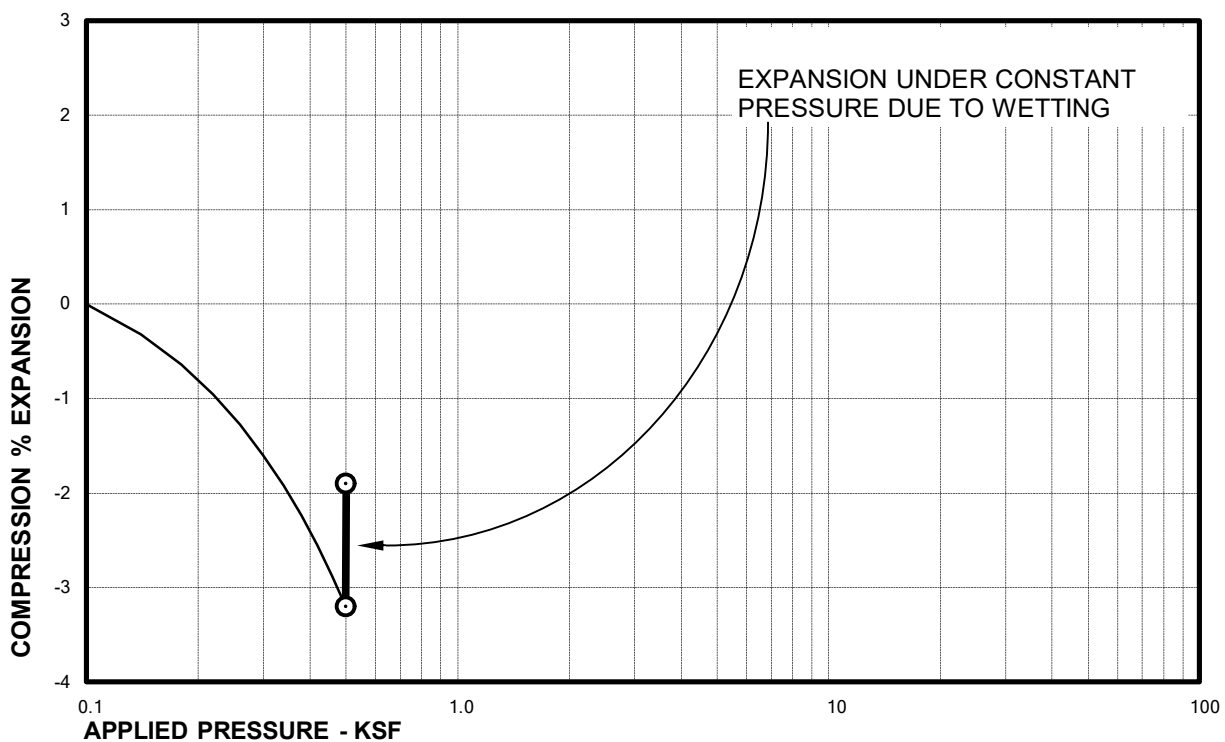
Sample of SANDSTONE, VERY CLAYEY  
From TH-18 AT 4 FEET

DRY UNIT WEIGHT= 124 PCF  
MOISTURE CONTENT= 9.7 %

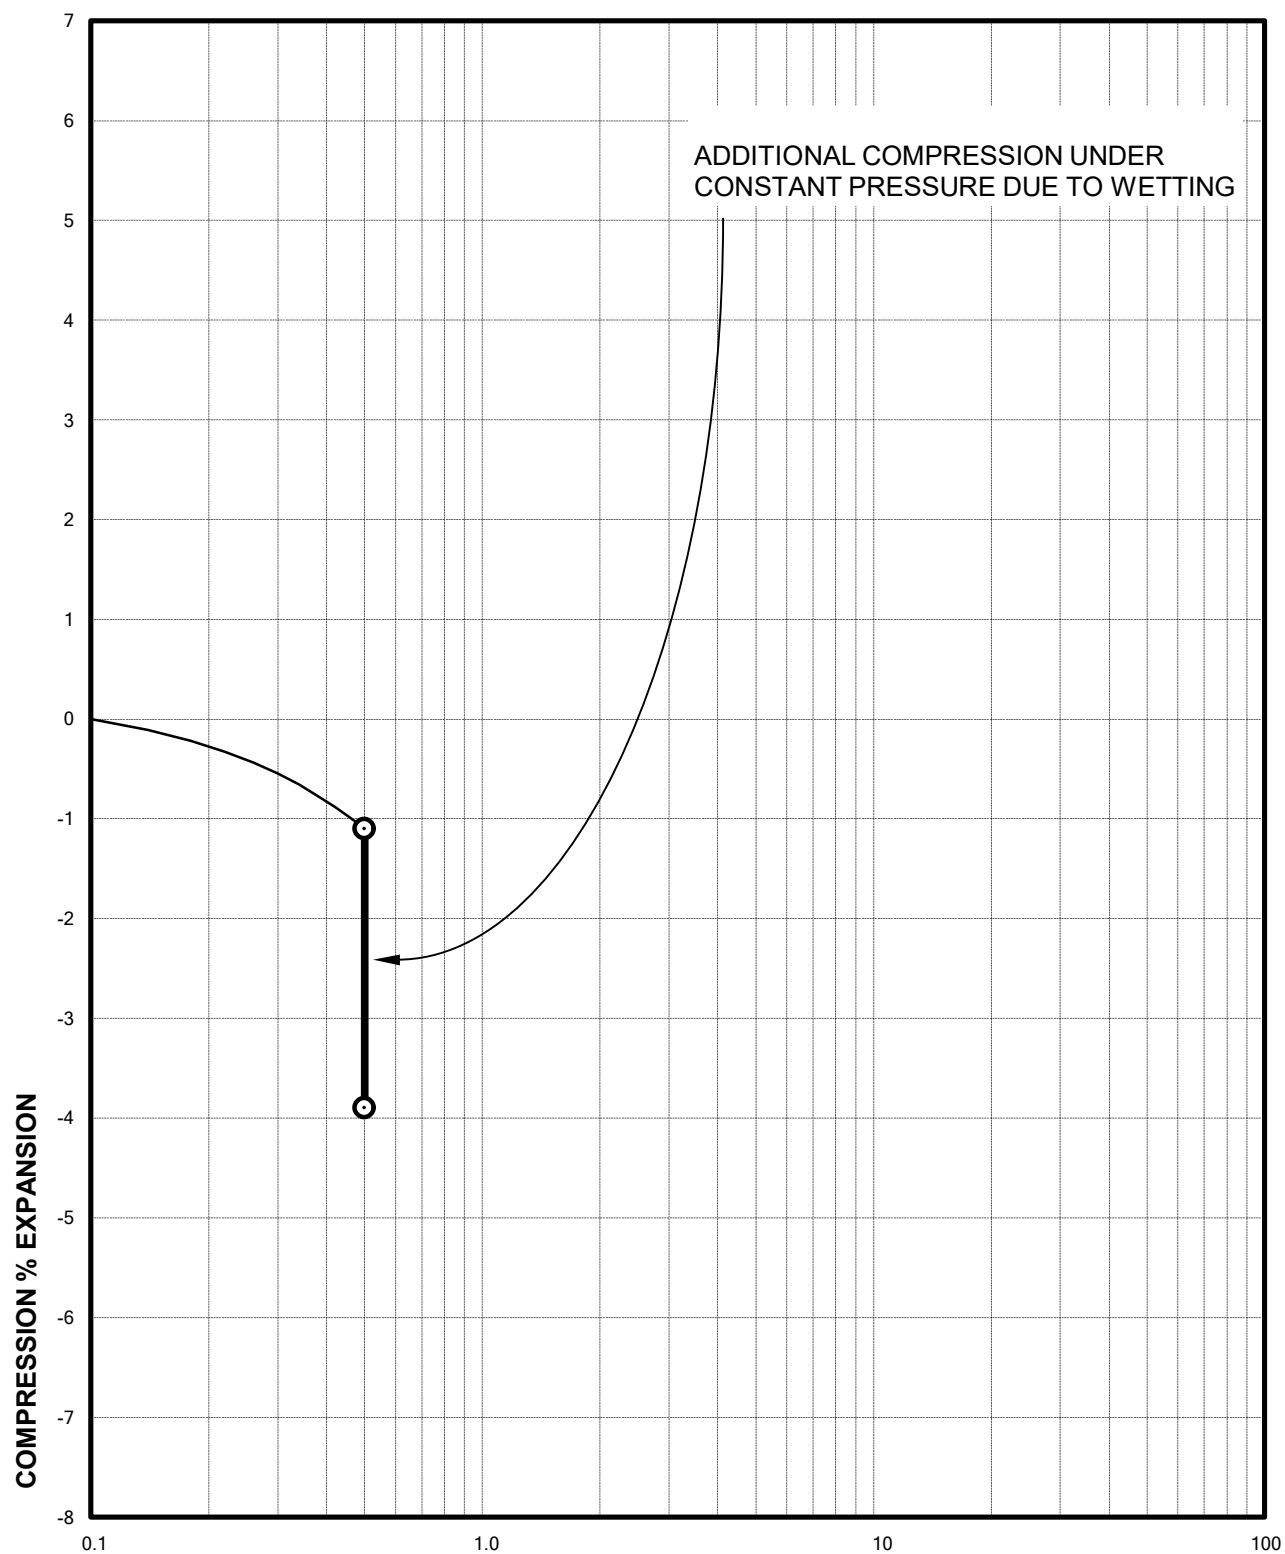
**APPLIED PRESSURE - KSF**  
Sample of CLAYSTONE, VERY SANDY  
From TH-19 AT 4 FEET

DRY UNIT WEIGHT= 104 PCF  
MOISTURE CONTENT= 10.5 %

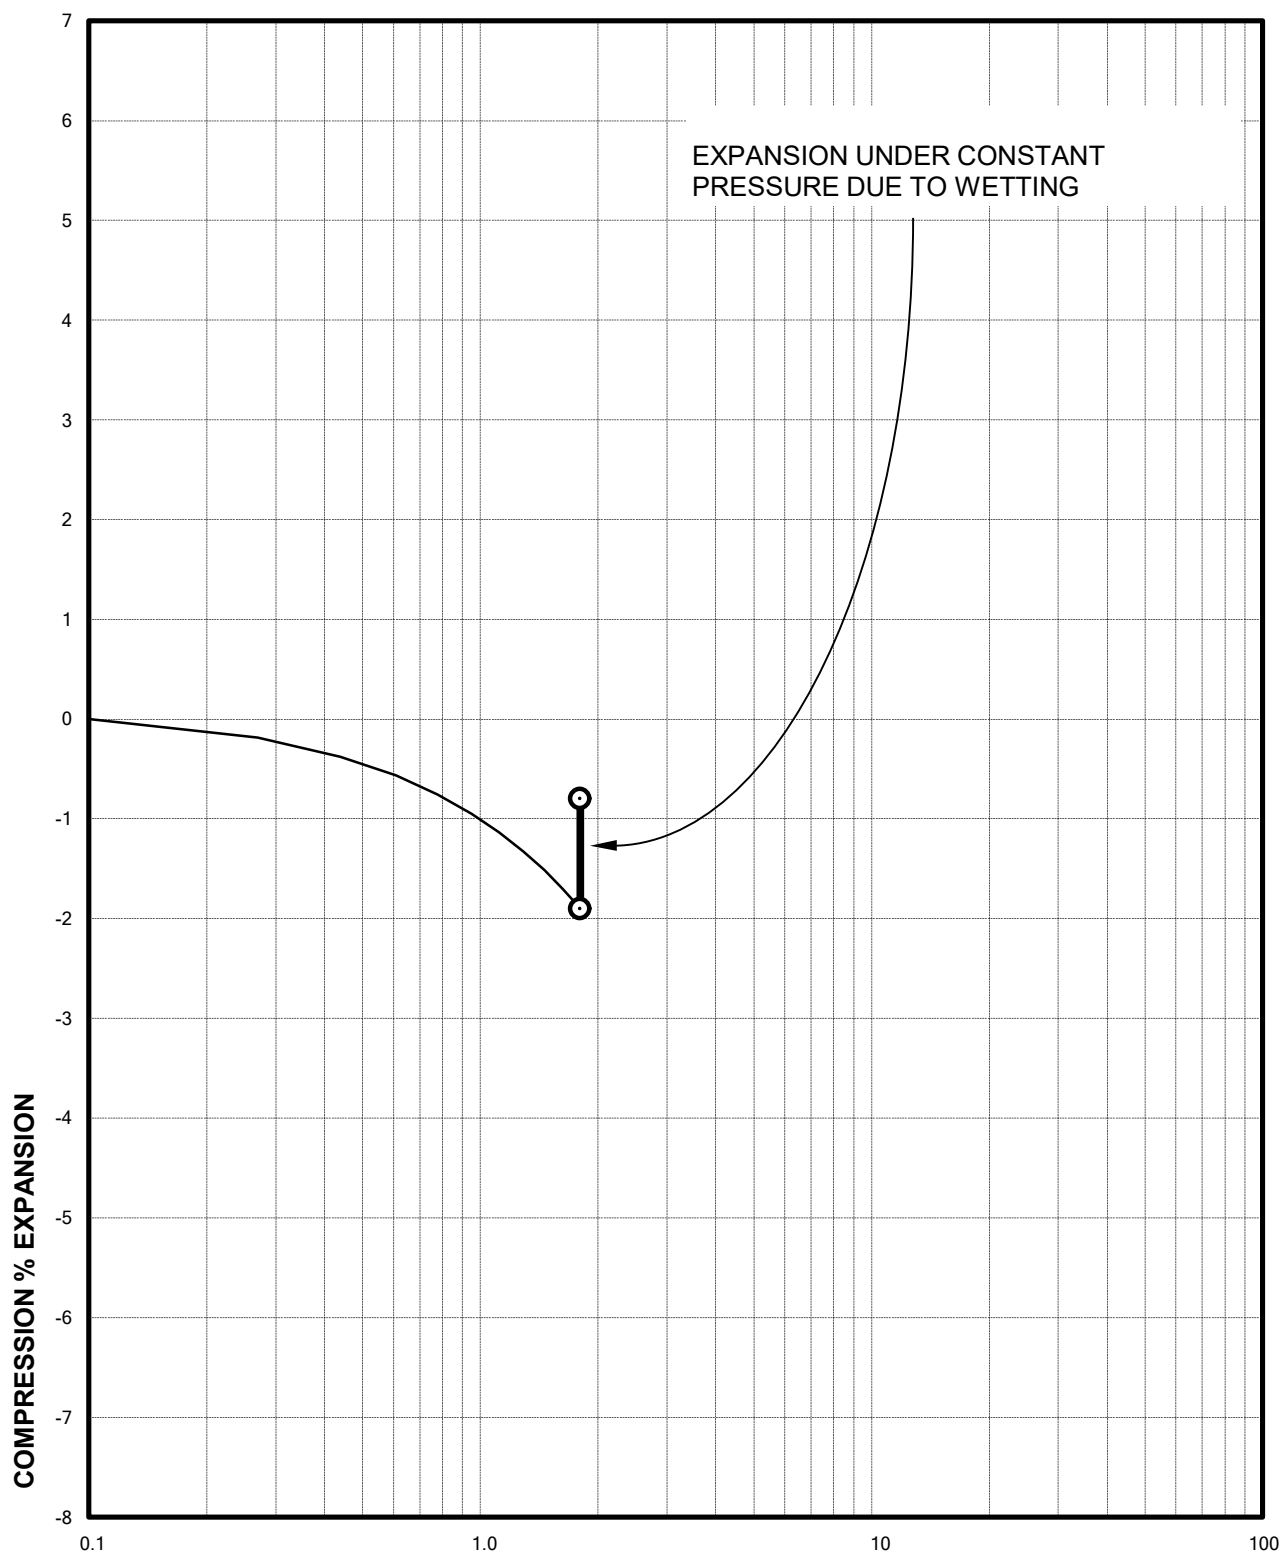
**APPLIED PRESSURE - KSF**  
Sample of SANDSTONE, CLAYEY  
From TH-20 AT 14 FEET

DRY UNIT WEIGHT= 121 PCF  
MOISTURE CONTENT= 12.0 %

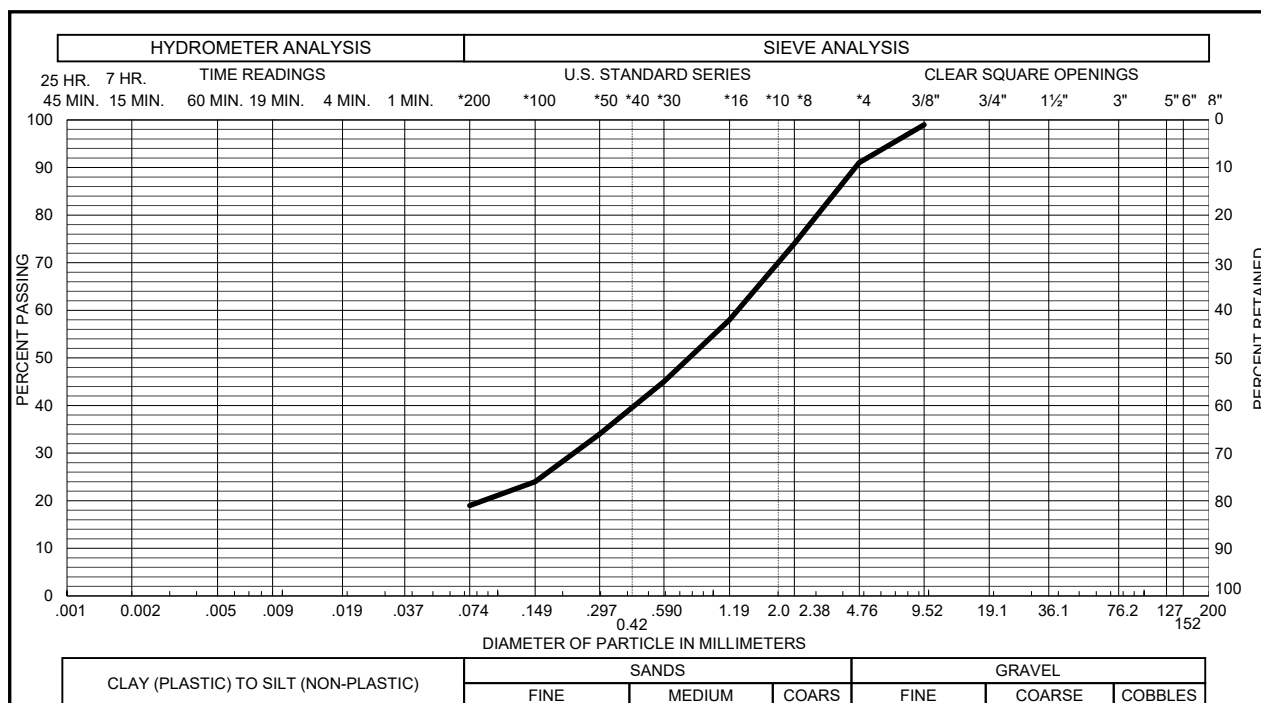
Sample of SANDSTONE, SILTY GRAVEL 9 % SAND 72 %  
From TH - 4 AT 14 FEET SILT & CLAY 19 % LIQUID LIMIT      %  
PLASTICITY INDEX      %

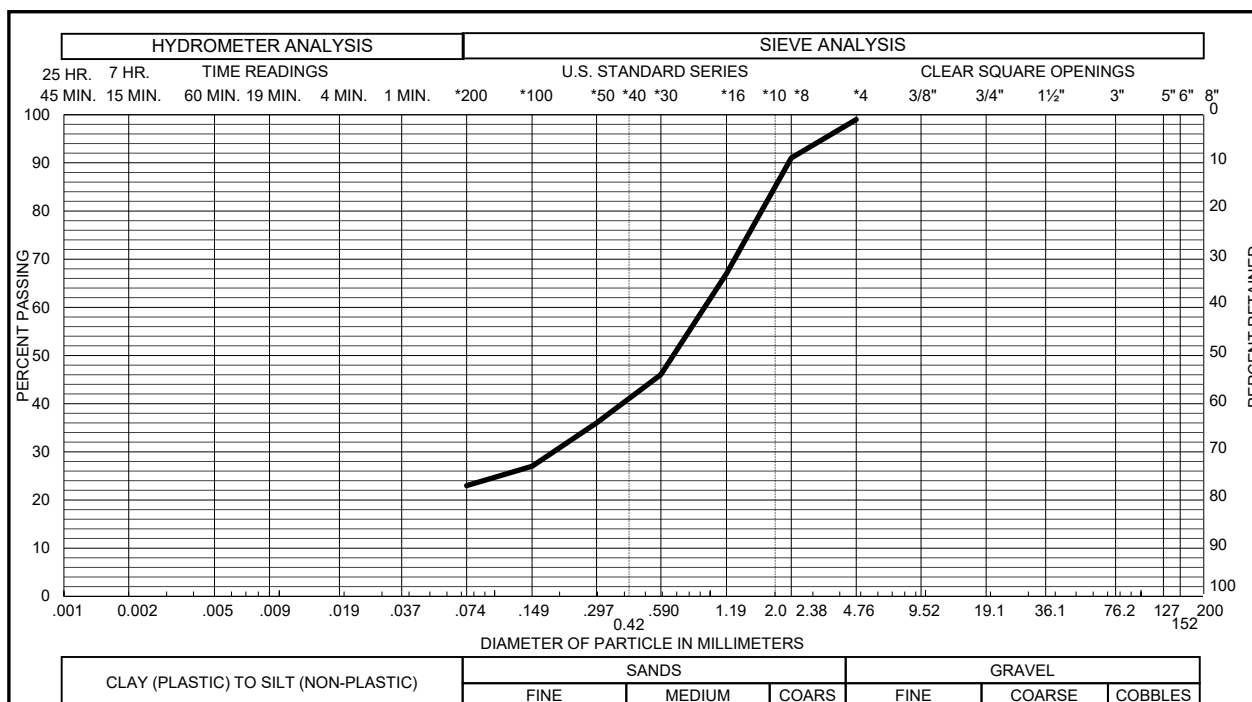
Sample of SANDSTONE, SILTY GRAVEL 1 % SAND 76 %  
From TH - 5 AT 9 FEET SILT & CLAY 23 % LIQUID LIMIT      %  
PLASTICITY INDEX      %

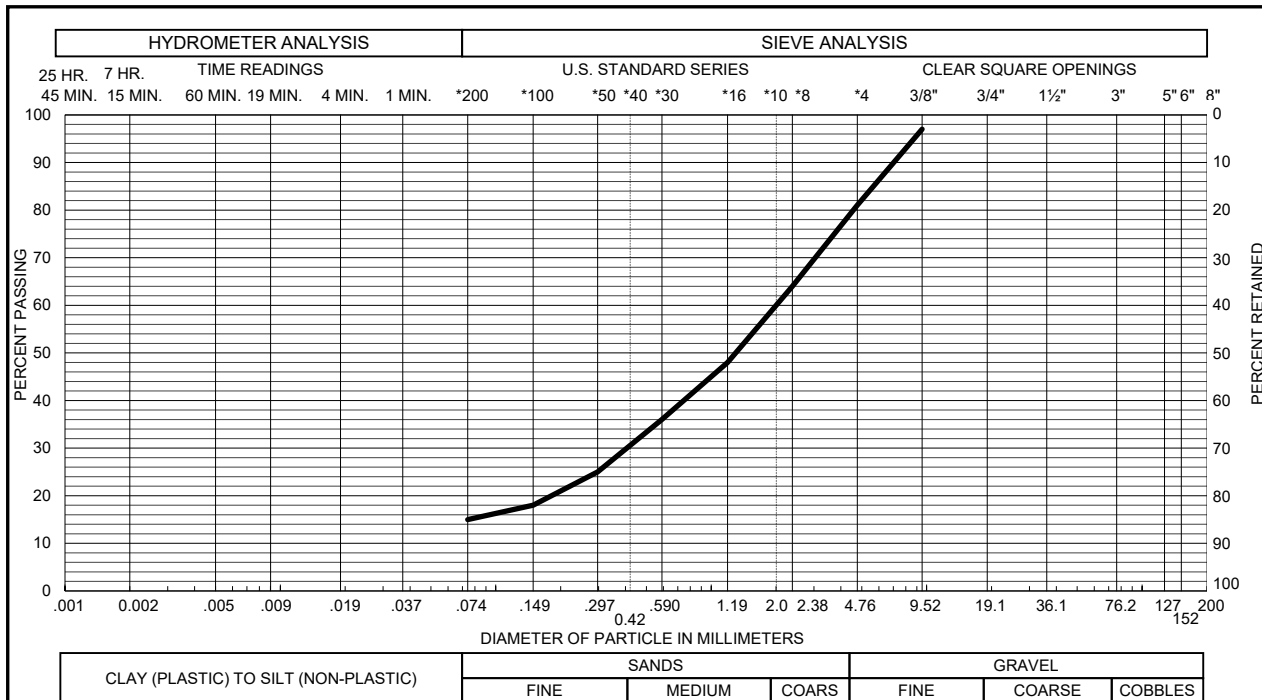
Sample of SANDSTONE, SILTY GRAVEL 19 % SAND 66 %  
From TH - 12 AT 4 FEET SILT & CLAY 15 % LIQUID LIMIT      %  
PLASTICITY INDEX      %

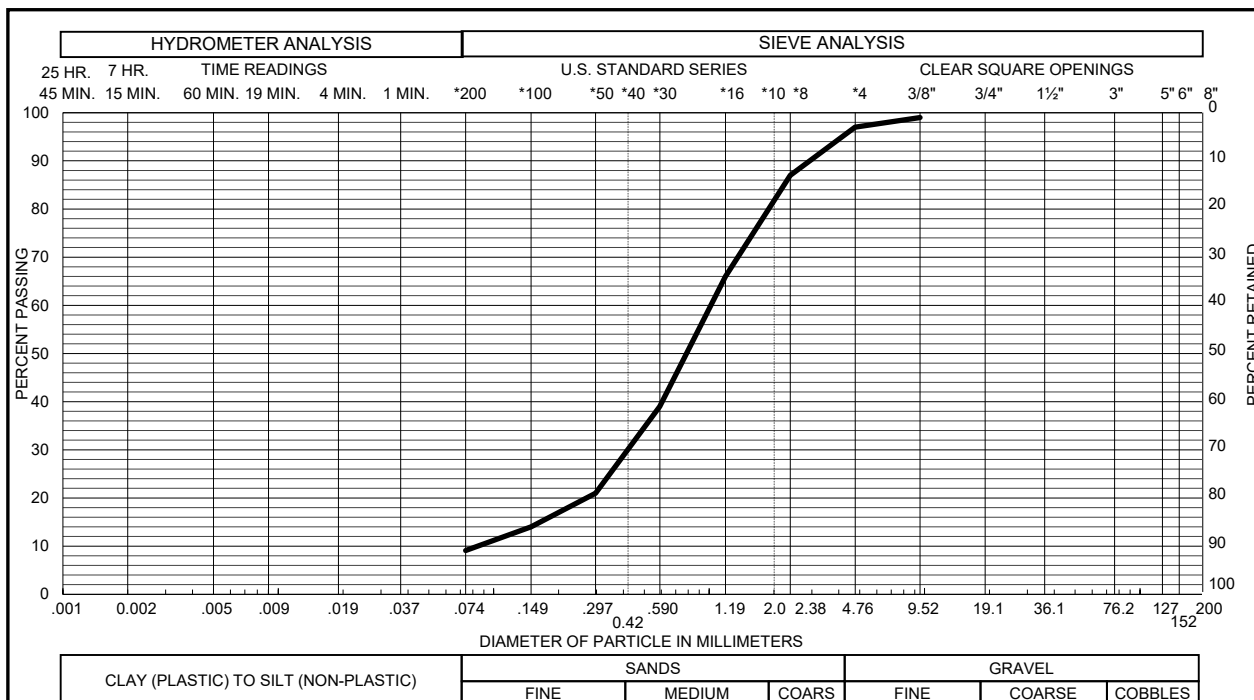
Sample of SANDSTONE, SLIGHTLY SILTY GRAVEL 3 % SAND 88 %  
From TH - 14 AT 9 FEET SILT & CLAY 9 % LIQUID LIMIT      %  
PLASTICITY INDEX      %
