**ROCKY MOUNTAIN GROUP
EMPLOYEE OWNED**

Job No. 175706

Re: Response to Colorado Geological Survey and El Paso County Review Comments
The Ridge at Lorson Ranch
Fontaine Bl
The Ridge at Lorson Ranch
El Paso County, Colorado

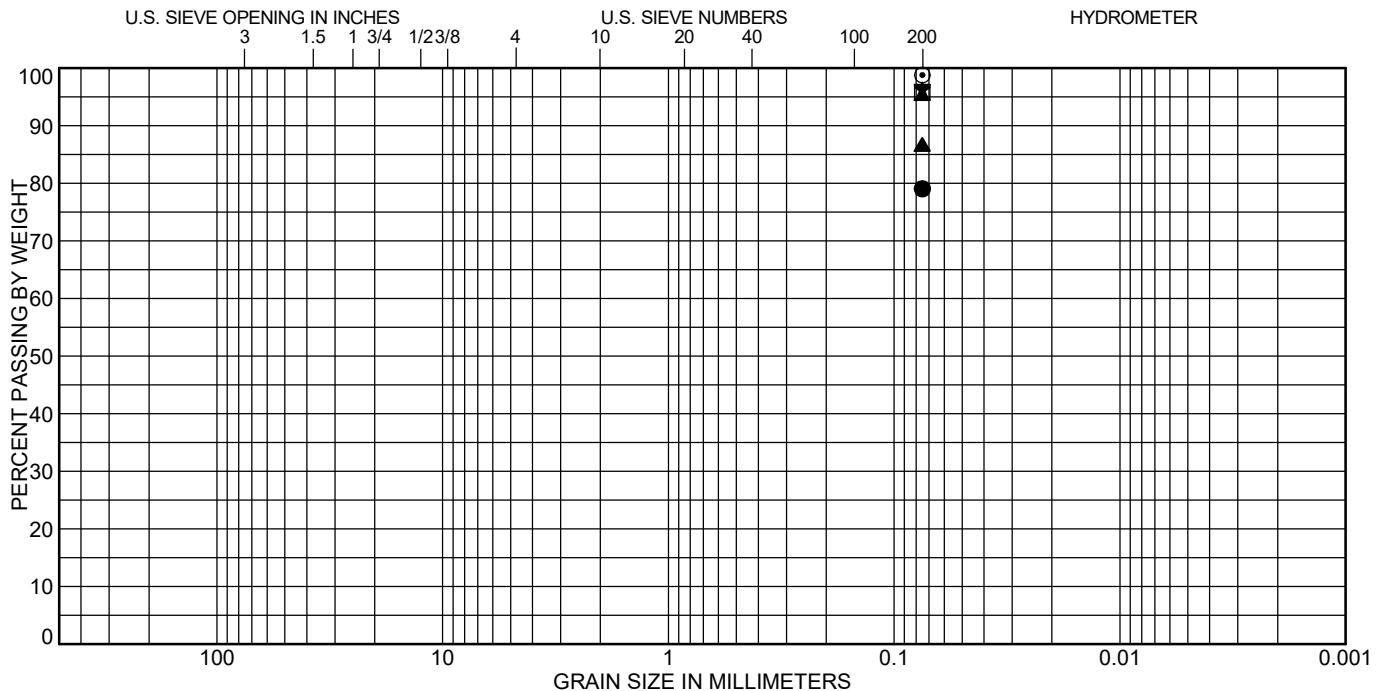
FIGURE No. 73

Test Boring	Depth (ft)	Classification	LL	PL	PI
● D-1	14.0	LEAN CLAY with SAND(CL)	41	15	26
☒ D-2	19.0	LEAN CLAY(CL)	43	14	29
▲ D-7	4.0	LEAN CLAY(CL)	42	17	25
★ D-8	9.0	FAT CLAY(CH)	55	18	37
⊙ D-17	14.0	LEAN CLAY(CL)	49	12	37

Soil laboratory testing was performed as part of this investigation. The laboratory tests included moisture content, dry density, grain-size analyses, Atterberg Limits and Swell/Consolidation tests. A Summary of Laboratory Test Results is presented in Figure 72 (13 pages). Soil Classification Data is presented in Figures 73 through 81. Swell/Consolidation Test Results are presented in Figures 82 through 143. Laboratory testing was not performed on the 13 preliminary test borings.

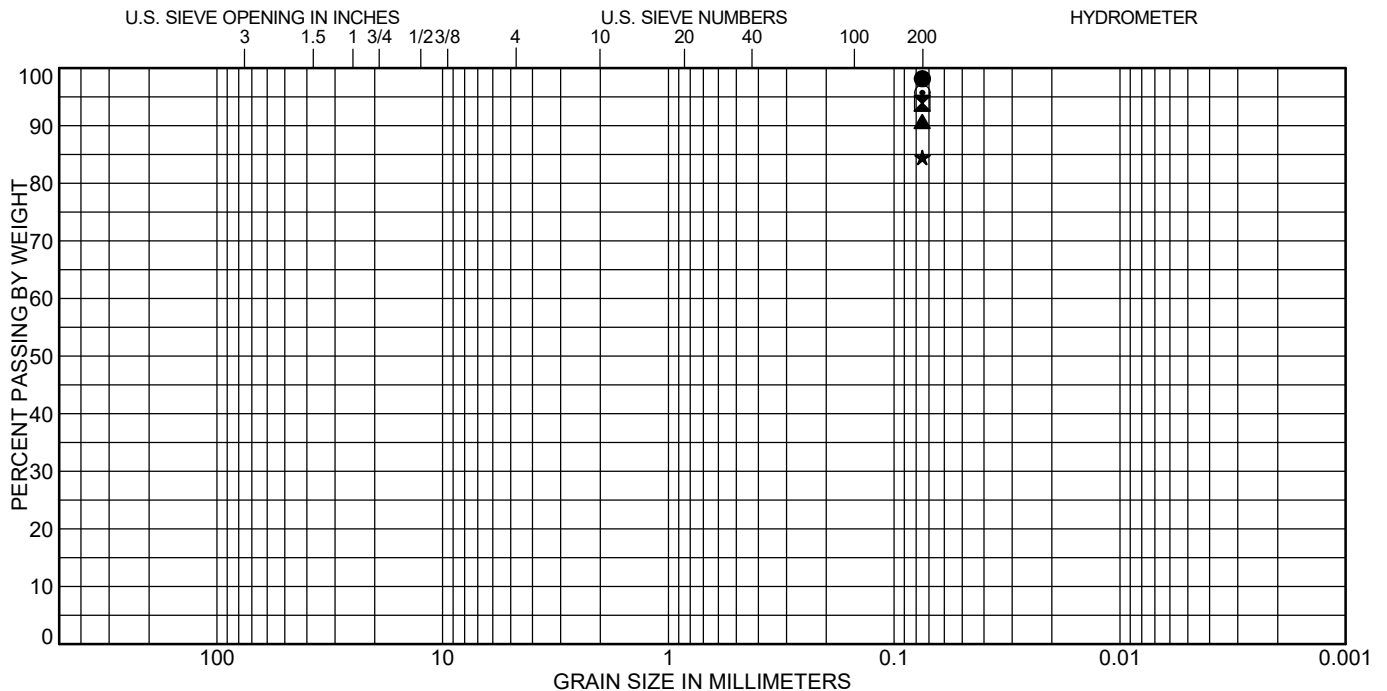
FIGURE No. 74

Test Boring	Depth (ft)	Classification	LL	PL	PI
● D-23	19.0	LEAN CLAY(CL)	45	19	26
☒ D-26	9.0	LEAN CLAY(CL)	46	15	31
▲ D-27	14.0	LEAN CLAY(CL)	43	16	27
★ D-30	9.0	LEAN CLAY with SAND(CL)	39	14	25
⊙ D-34	14.0	FAT CLAY(CH)	54	17	37

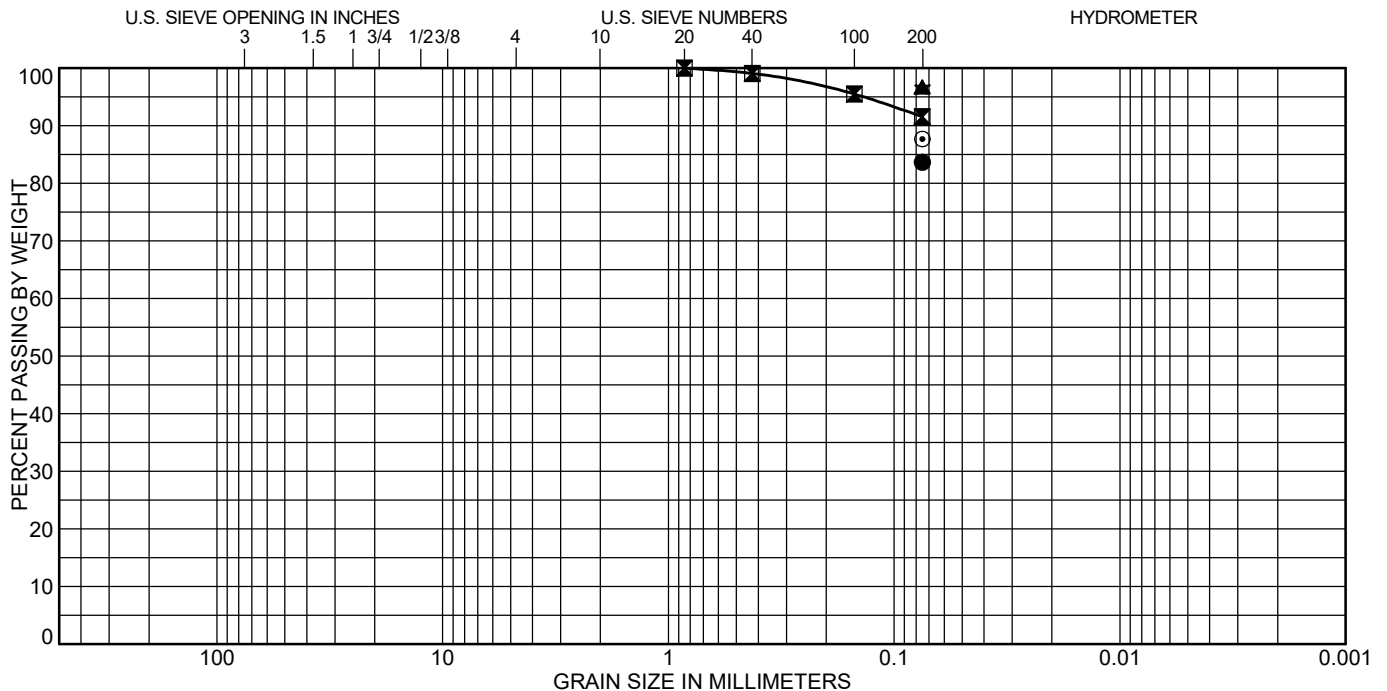
FIGURE No. 75

Test Boring	Depth (ft)	Classification	LL	PL	PI
● D-40	4.0	LEAN CLAY with SAND(CL)	38	14	24
⊠ D-43	9.0	FAT CLAY(CH)	52	18	34
▲ D-47	14.0	FAT CLAY(CH)	56	18	38
★ D-51	14.0	FAT CLAY(CH)	55	17	38
⊙ D-57	14.0	LEAN CLAY(CL)	48	16	32

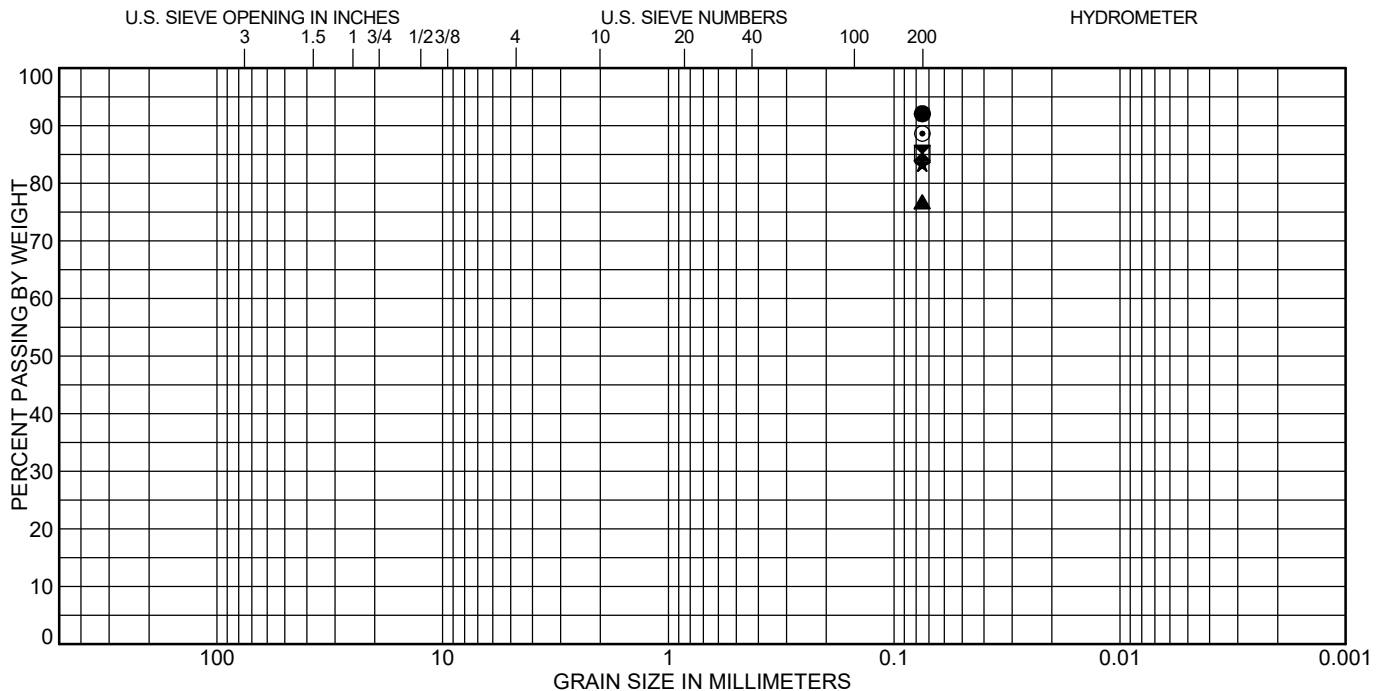
FIGURE No. 76

Test Boring	Depth (ft)	Classification				LL	PL	PI
● D-63	9.0	LEAN CLAY(CL)				43	14	29
☒ D-67	4.0	FAT CLAY(CH)				70	24	46
▲ F-1	9.0	LEAN CLAY with SAND(CL)				36	14	22
★ F-2	9.0	LEAN CLAY with SAND(CL)				40	13	27
⊙ F-6	14.0	LEAN CLAY(CL)				38	14	24
Test Boring	Depth (ft)	%Gravel	%Sand	%Silt	%Clay			
● D-63	9.0			92.1				
☒ D-67	4.0			85.2				
▲ F-1	9.0			76.8				
★ F-2	9.0			83.3				
⊙ F-6	14.0			88.6

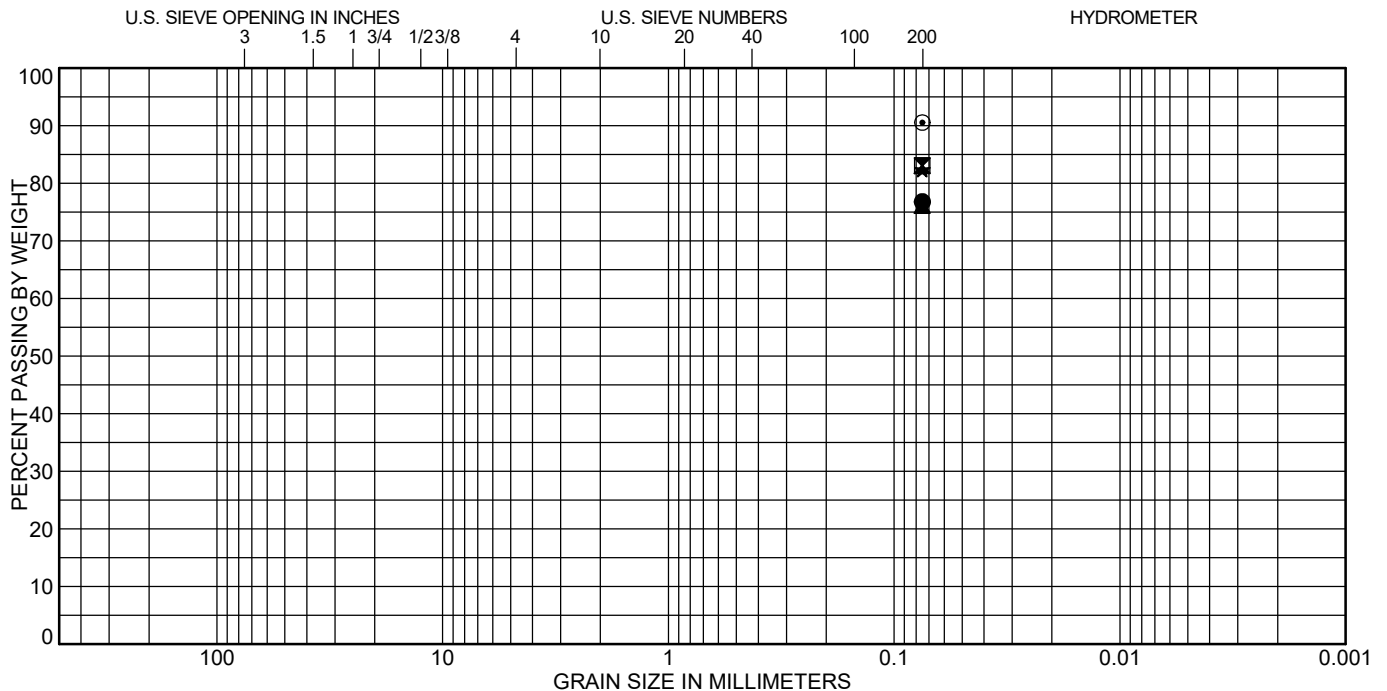
FIGURE No. 77

Test Boring	Depth (ft)	Classification				LL	PL	PI
● F-9	9.0							
☒ F-11	19.0	LEAN CLAY with SAND(CL)				42	16	26
▲ F-12	9.0	LEAN CLAY with SAND(CL)				35	13	22
★ F-16	9.0	LEAN CLAY with SAND(CL)				42	14	28
⊙ F-18	14.0	LEAN CLAY(CL)				42	17	25
Test Boring	Depth (ft)	%Gravel	%Sand	%Silt	%Clay			
● F-9	9.0			76.8				
☒ F-11	19.0			83.0				
▲ F-12	9.0			76.0				
★ F-16	9.0			82.4				
⊙ F-18	14.0			90.5

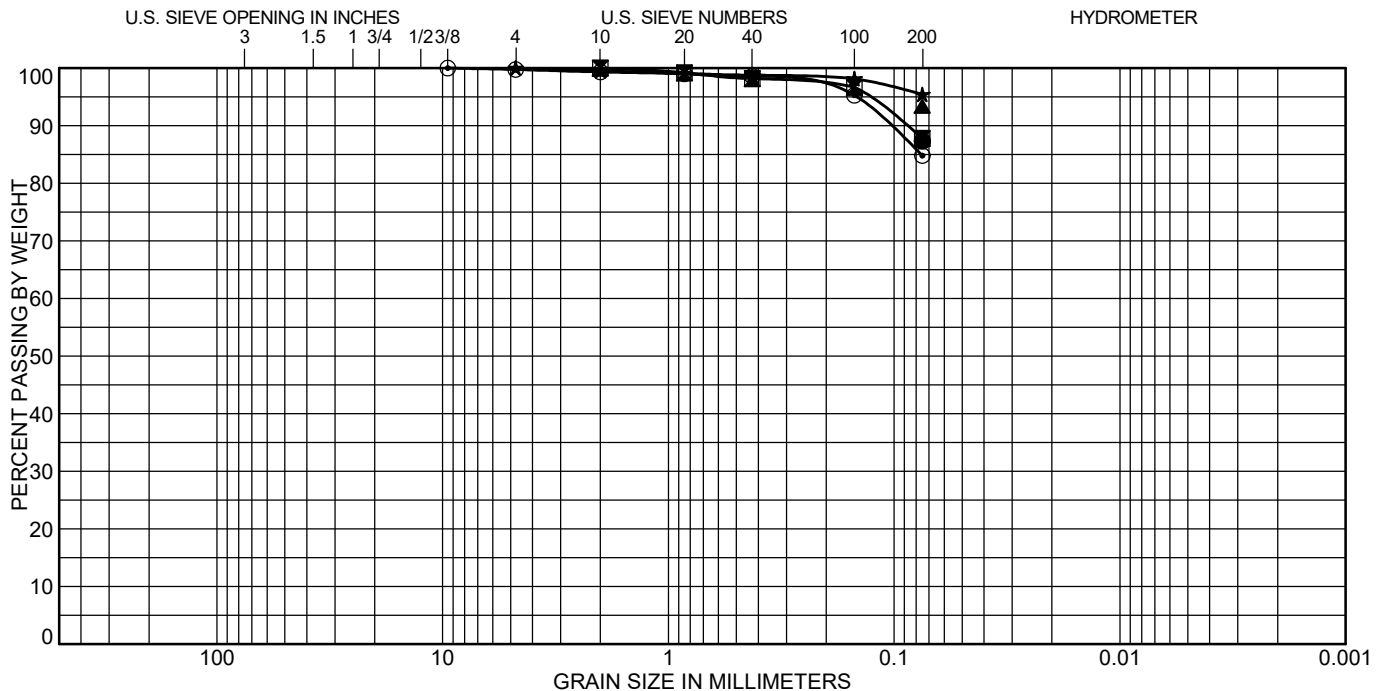
FIGURE No. 78

Test Boring	Depth (ft)	Classification			LL	PL	PI
● F-22	9.0	LEAN CLAY(CL)			43	18	25
☒ F-25	14.0	LEAN CLAY(CL)			47	16	31
▲ F-28	24.0	LEAN CLAY(CL)			46	17	29
★ F-30	14.0	LEAN CLAY(CL)			46	18	28
⊙ F-34	19.0	LEAN CLAY with SAND(CL)			47	15	32
Test Boring	Depth (ft)	%Gravel	%Sand	%Silt	%Clay		
● F-22	9.0			87.3			
☒ F-25	14.0	0.0	12.2	87.8			
▲ F-28	24.0			93.4			
★ F-30	14.0	0.0	4.6	95.4			
⊙ F-34	19.0	0.3	14.9	84.8

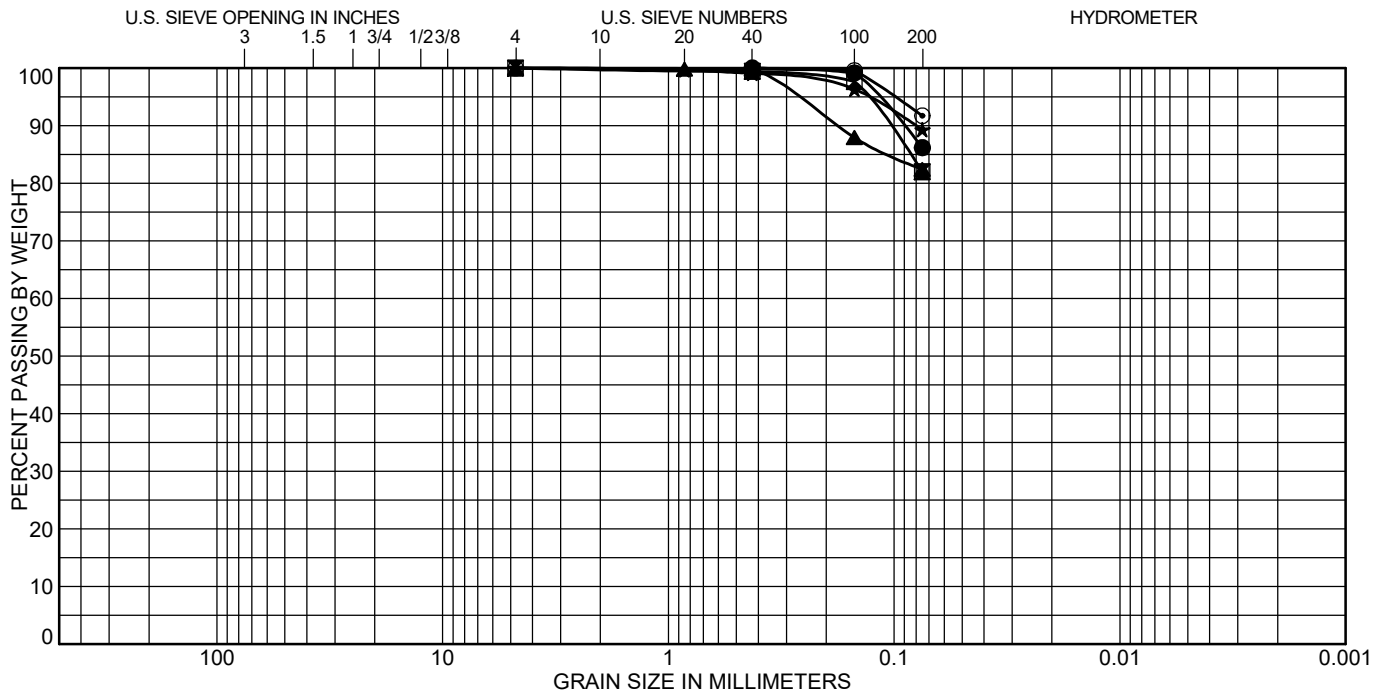
FIGURE No. 79

Test Boring	Depth (ft)	Classification	LL	PL	PI
● F-38	4.0				
☒ H-1	14.0	LEAN CLAY with SAND(CL)	47	15	32
▲ H-6	9.0	LEAN CLAY with SAND(CL)	38	13	25
★ H-9	4.0	LEAN CLAY(CL)	46	14	32
⊙ H-11	9.0	LEAN CLAY(CL)	39	16	23

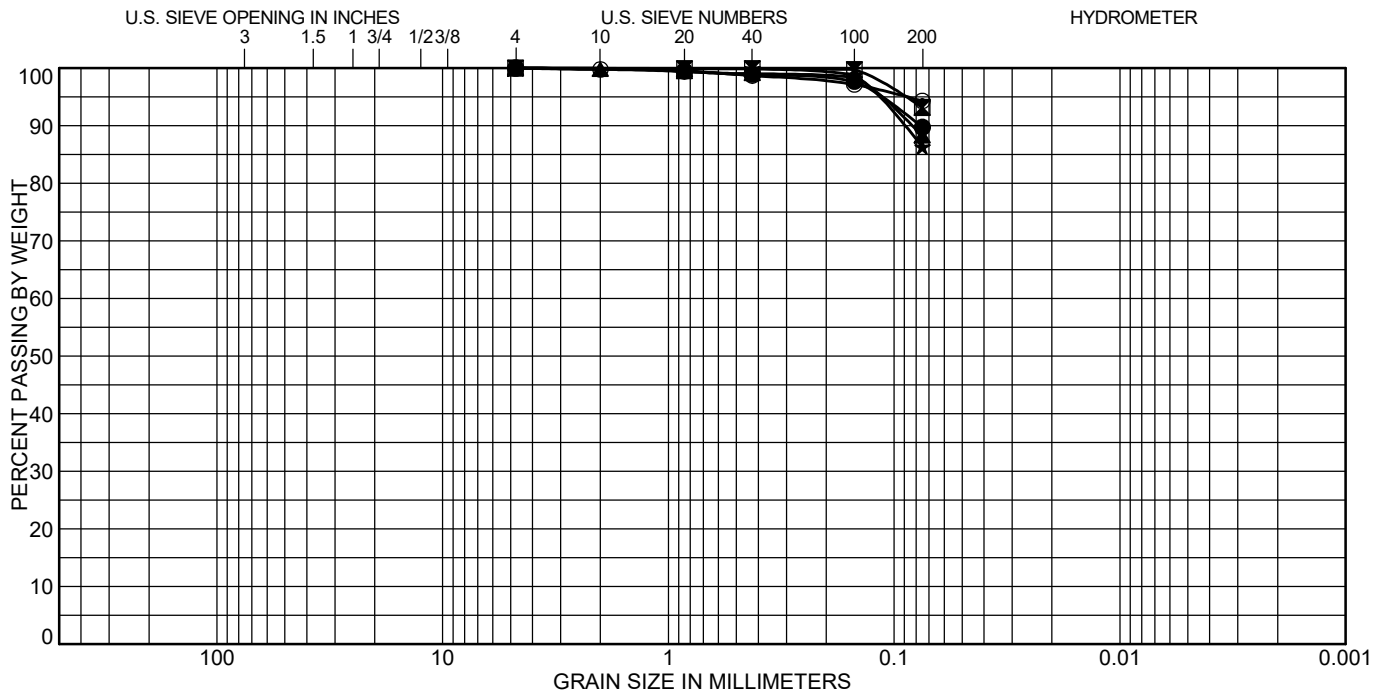
FIGURE No. 80

Test Boring	Depth (ft)	Classification	LL	PL	PI
● H-12	19.0	LEAN CLAY(CL)	47	17	30
☒ H-15	14.0	LEAN CLAY(CL)	47	14	33
▲ H-17	4.0	LEAN CLAY(CL)	43	15	28
★ H-19	9.0	LEAN CLAY(CL)	35	15	20
⊙ H-20	14.0	LEAN CLAY(CL)	49	17	32

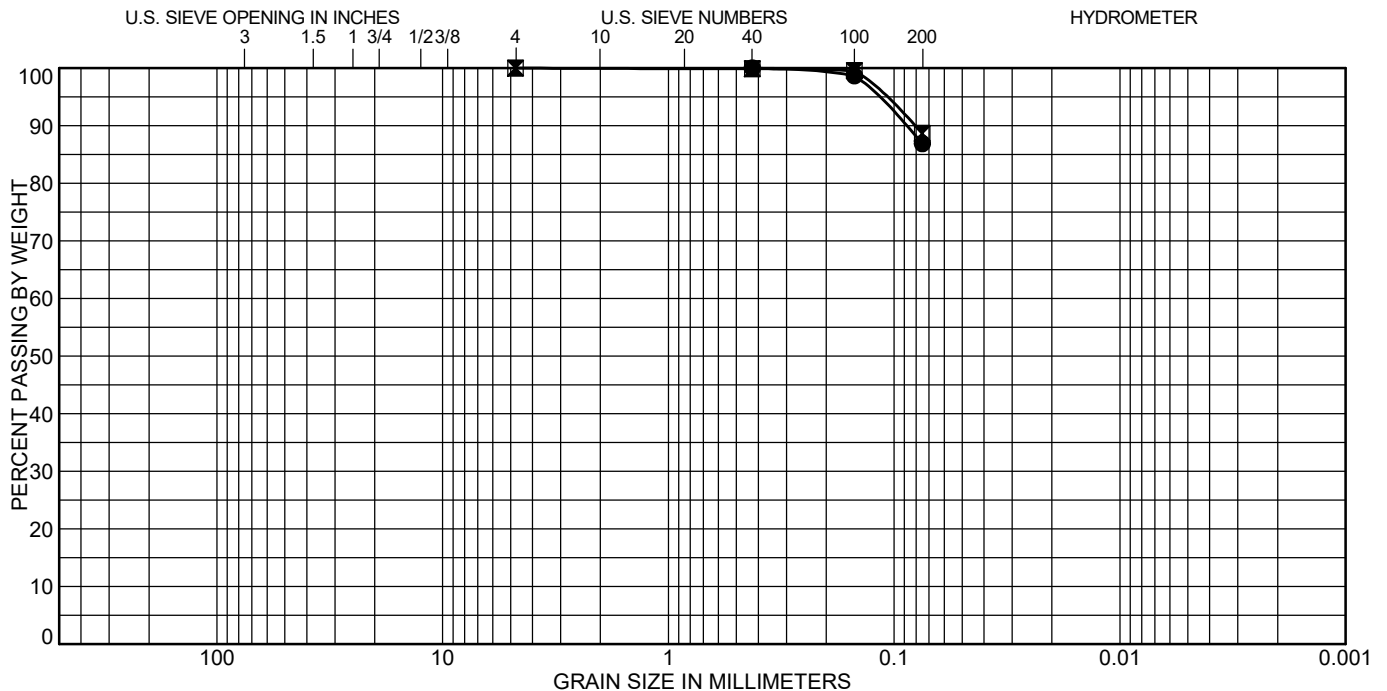
FIGURE No. 81

Test Boring	Depth (ft)	Classification	LL	PL	PI
● H-22	9.0	LEAN CLAY(CL)	37	14	23
☒ H-24	9.0	LEAN CLAY(CL)	35	14	21

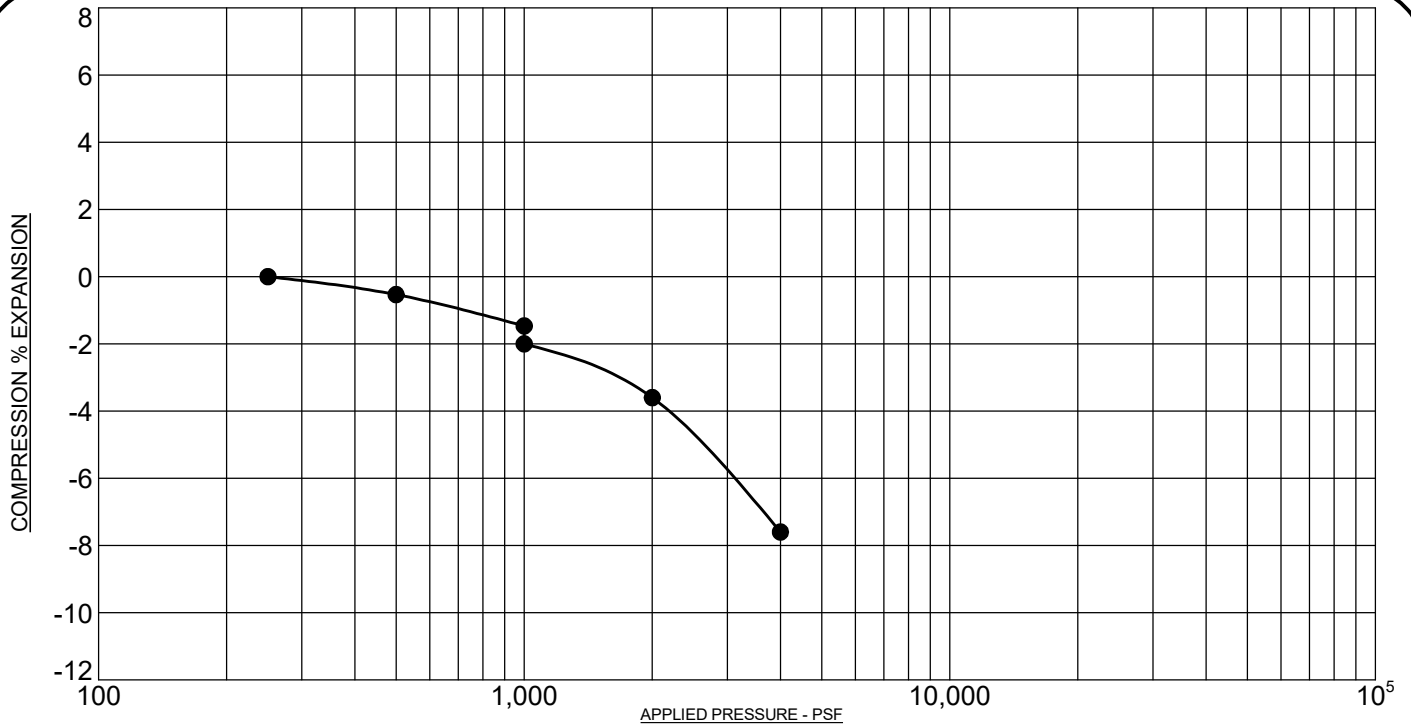
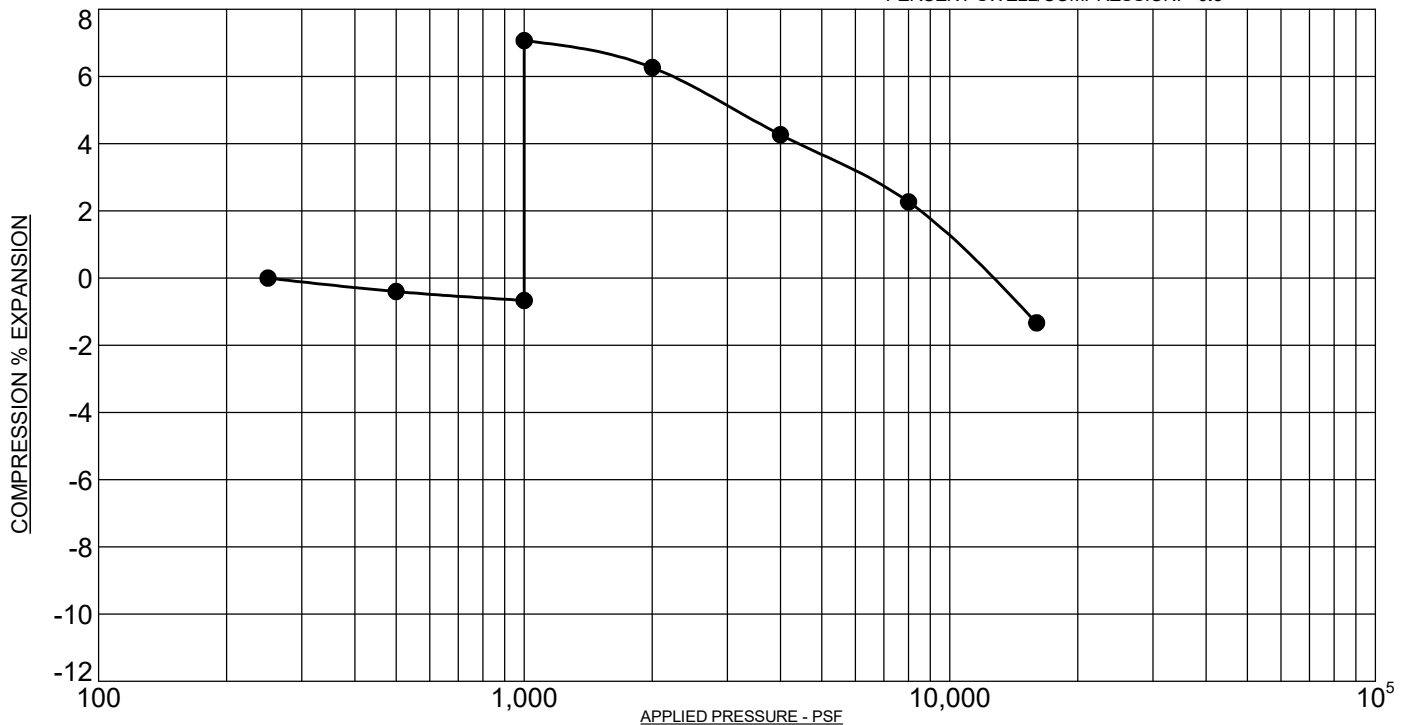
FIGURE No. 82

PROJECT: **The Ridge at Lorson Ranch El Paso County, Colorado**
 SAMPLE DESCRIPTION: **CLAYSTONE, SANDY**
 NOTE: **SAMPLE WAS INUNDATED WITH WATER AT 1,000 PSF**

SAMPLE LOCATION: **D-1 @ 14 FT**
 NATURAL DRY UNIT WEIGHT: **102.8 PCF**
 NATURAL MOISTURE CONTENT: **10.6%**
 PERCENT SWELL/COMPRESSION: **- 0.5**

SAMPLE LOCATION: **D-2 @ 19 FT**
 NATURAL DRY UNIT WEIGHT: **112.2 PCF**
 NATURAL MOISTURE CONTENT: **8.9%**
 PERCENT SWELL/COMPRESSION: **7.7**

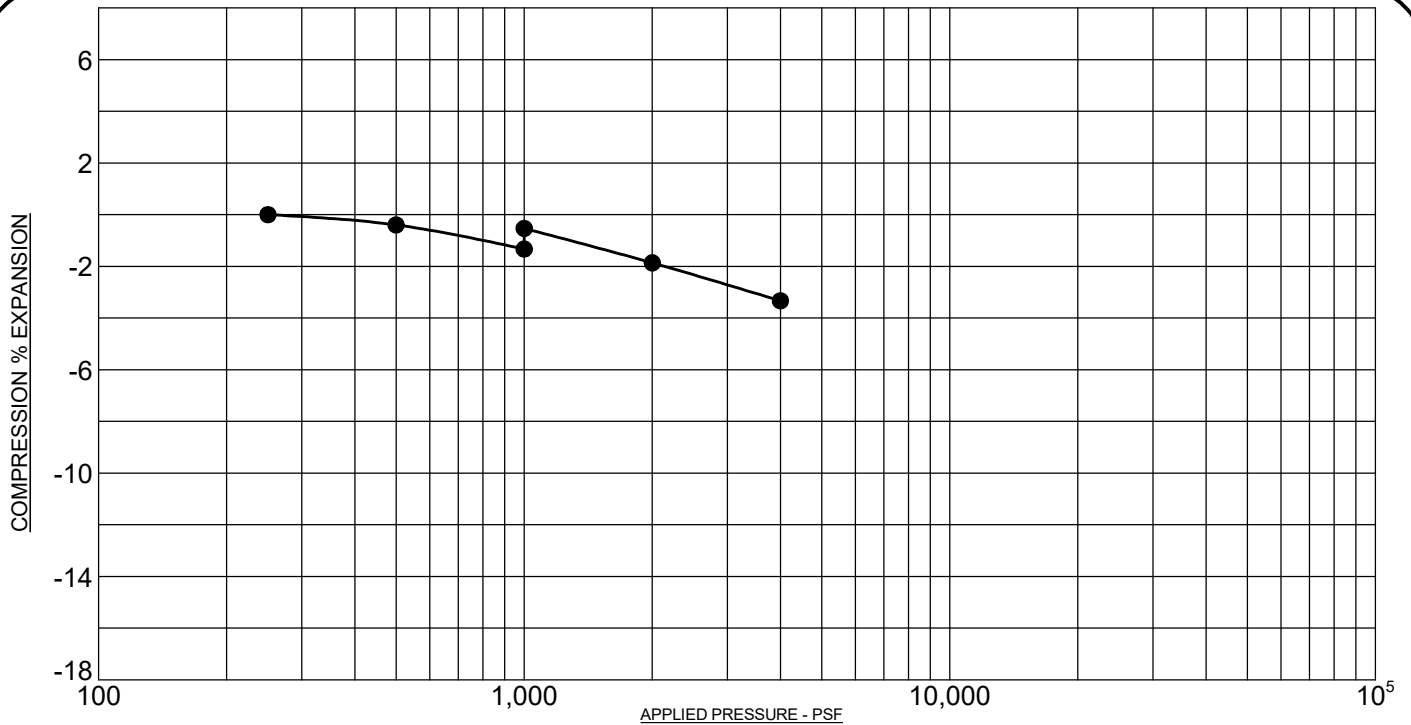
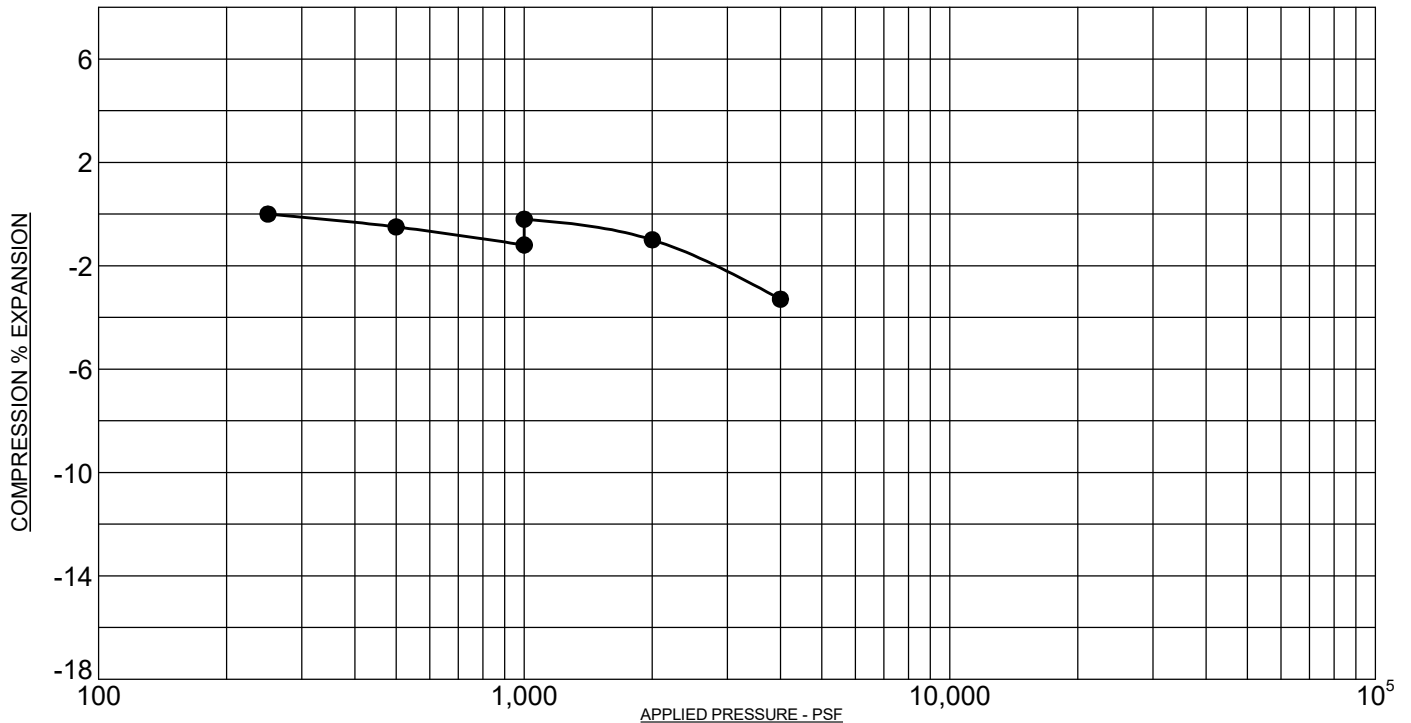
FIGURE No. 83

PROJECT: **The Ridge at Lorson Ranch El Paso County, Colorado**
 SAMPLE DESCRIPTION: **CLAYSTONE, SANDY**
 NOTE: **SAMPLE WAS INUNDATED WITH WATER AT 1,000 PSF**

SAMPLE LOCATION: **D-3 @ 4 FT**
 NATURAL DRY UNIT WEIGHT: **125.5 PCF**
 NATURAL MOISTURE CONTENT: **10.8%**
 PERCENT SWELL/COMPRESSION: **0.8**

SAMPLE LOCATION: **D-6 @ 9 FT**
 NATURAL DRY UNIT WEIGHT: **110.0 PCF**
 NATURAL MOISTURE CONTENT: **7.7%**
 PERCENT SWELL/COMPRESSION: **1.0**

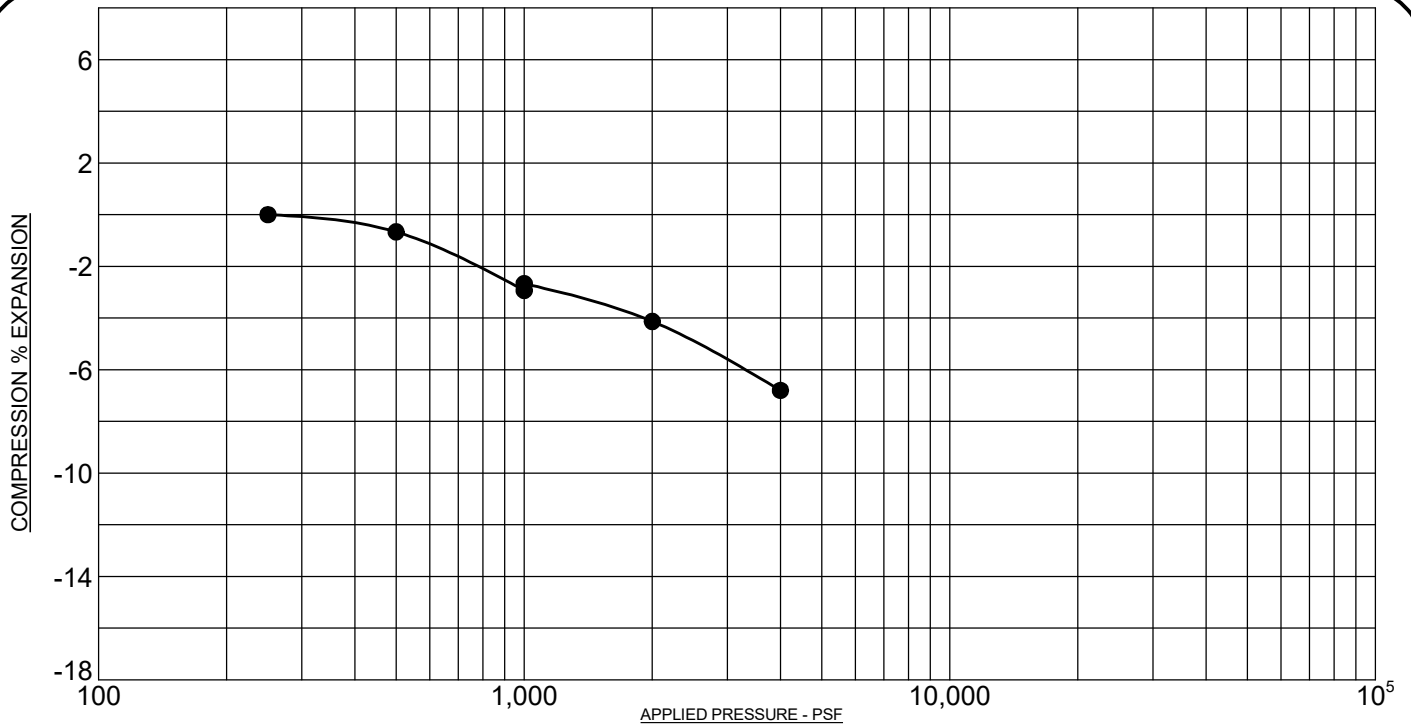
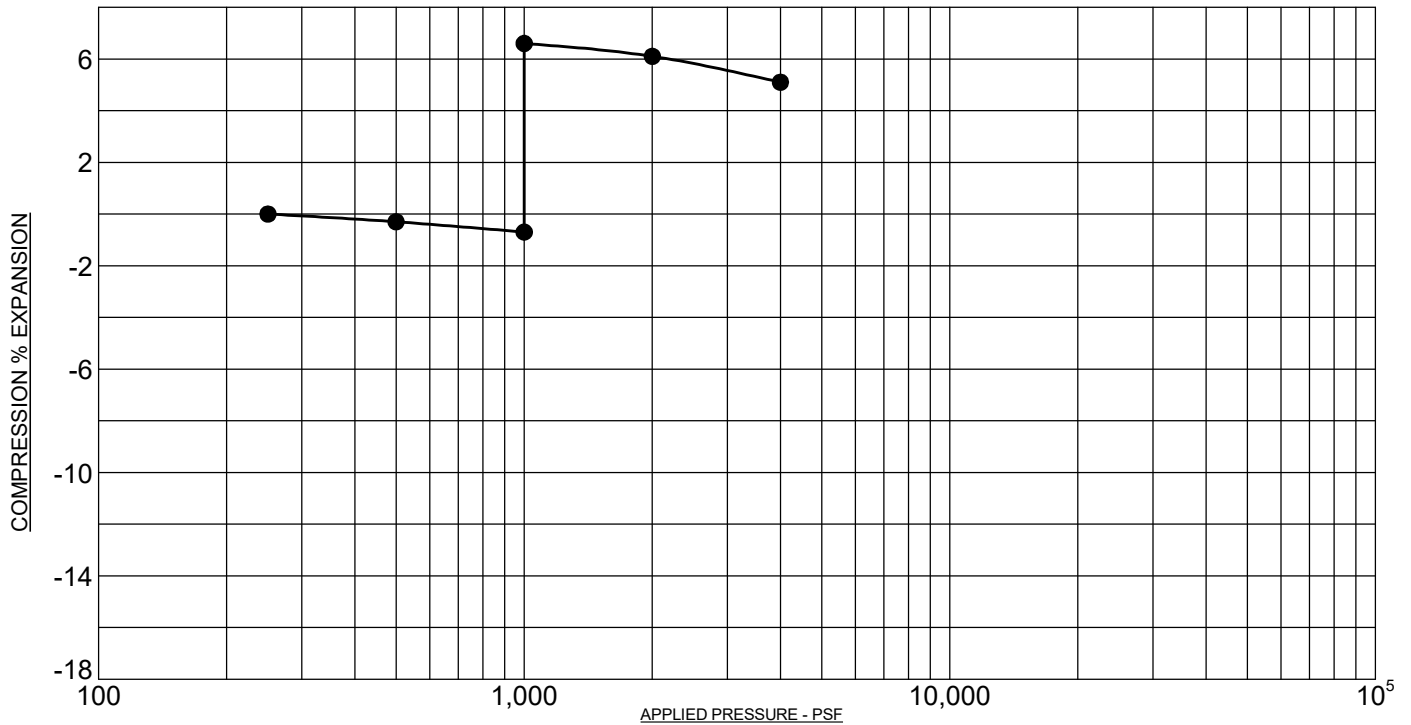
FIGURE No. 84

PROJECT: **The Ridge at Lorson Ranch El Paso County, Colorado**
 SAMPLE DESCRIPTION: **CLAYSTONE, SANDY**
 NOTE: **SAMPLE WAS INUNDATED WITH WATER AT 1,000 PSF**

SAMPLE LOCATION: **D-7 @ 4 FT**
 NATURAL DRY UNIT WEIGHT: **106.1 PCF**
 NATURAL MOISTURE CONTENT: **10.9%**
 PERCENT SWELL/COMPRESSION: **0.3**

SAMPLE LOCATION: **D-8 @ 9 FT**
 NATURAL DRY UNIT WEIGHT: **122.8 PCF**
 NATURAL MOISTURE CONTENT: **13.3%**
 PERCENT SWELL/COMPRESSION: **7.3**

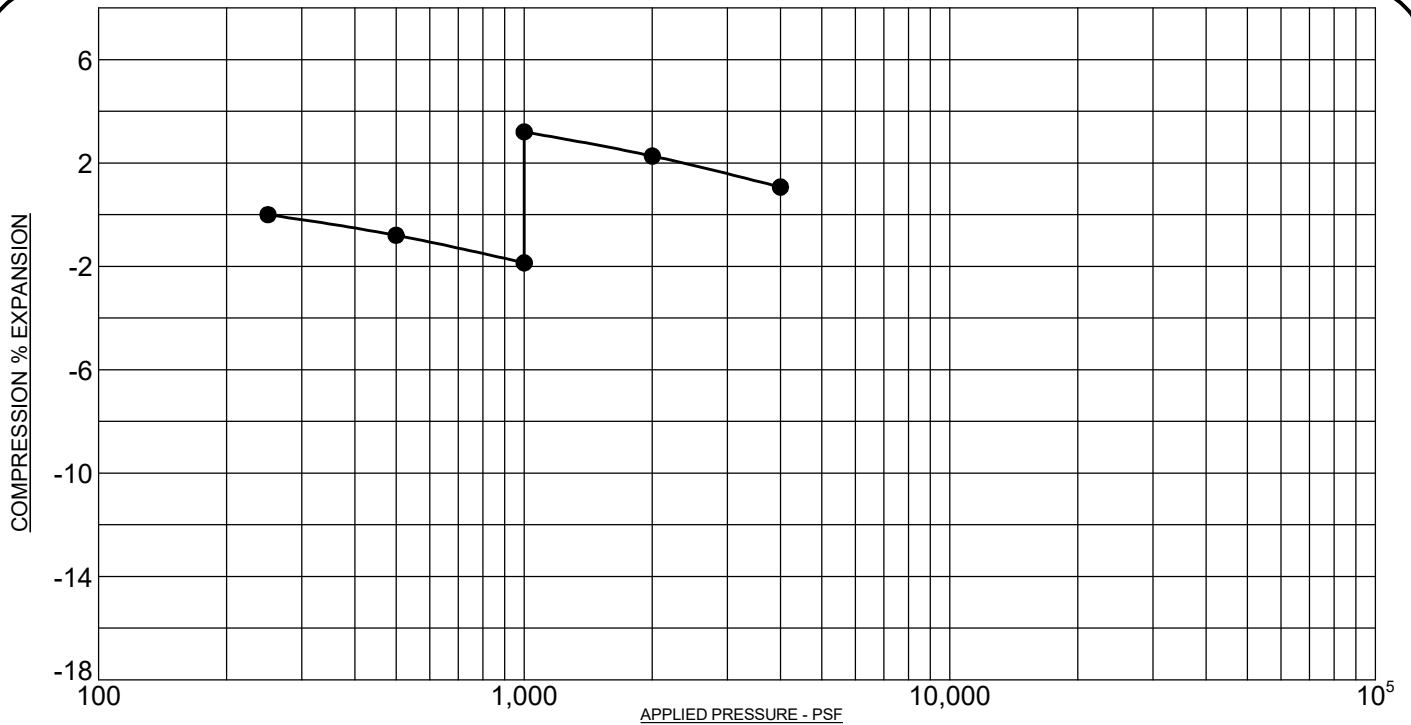
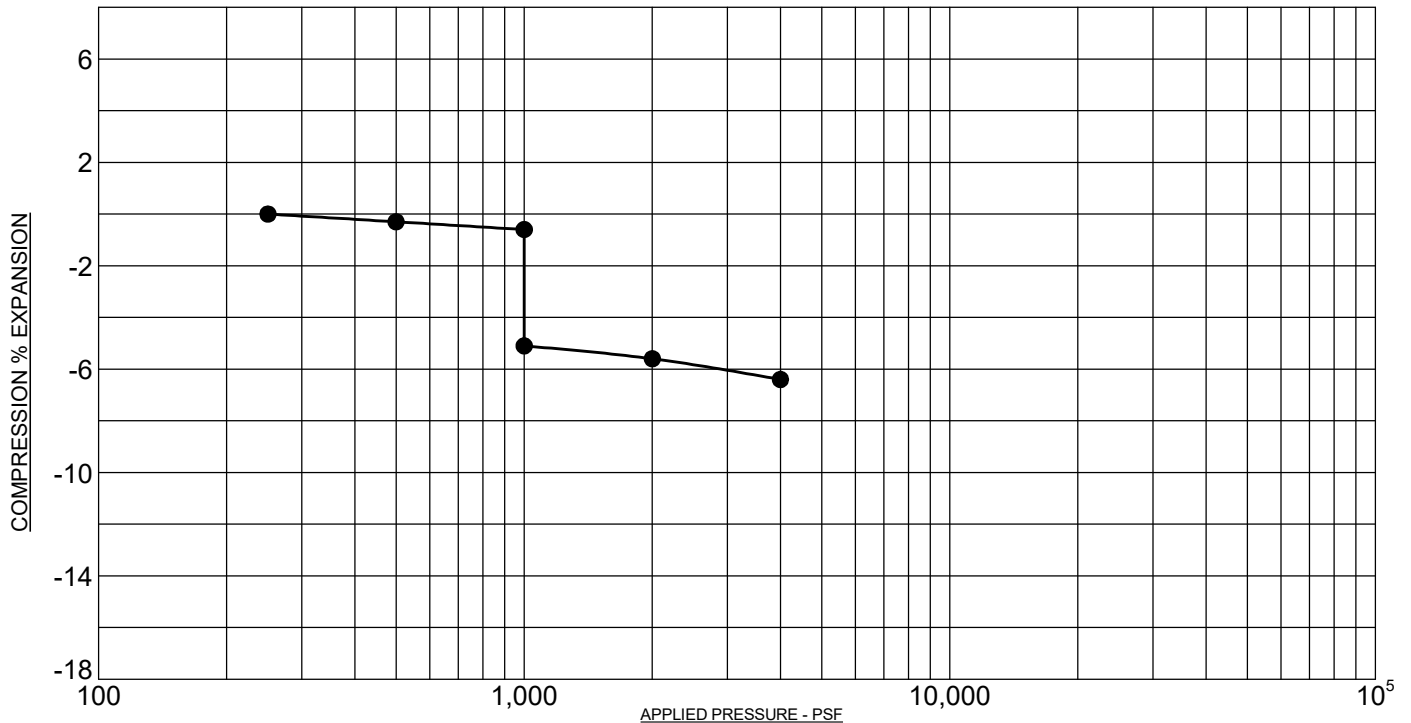
FIGURE No. 85

PROJECT: **The Ridge at Lorson Ranch El Paso County, Colorado**
 SAMPLE DESCRIPTION: **CLAYSTONE, SANDY**
 NOTE: **SAMPLE WAS INUNDATED WITH WATER AT 1,000 PSF**

SAMPLE LOCATION: **D-9 @ 9 FT**
 NATURAL DRY UNIT WEIGHT: **PCF**
 NATURAL MOISTURE CONTENT: **12.8%**
 PERCENT SWELL/COMPRESSION: **5.1**

SAMPLE LOCATION: **D-10 @ 9 FT**
 NATURAL DRY UNIT WEIGHT: **120.2 PCF**
 NATURAL MOISTURE CONTENT: **16.0%**
 PERCENT SWELL/COMPRESSION: **- 4.5**

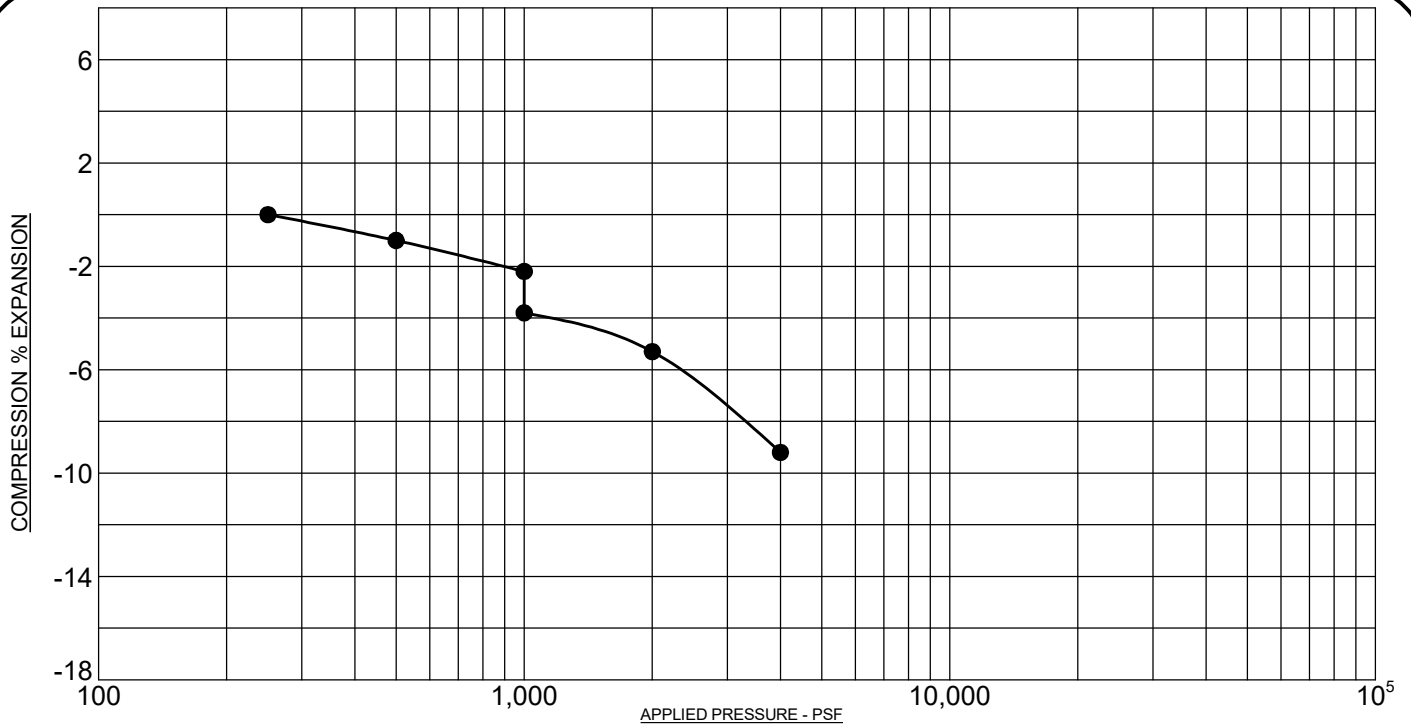
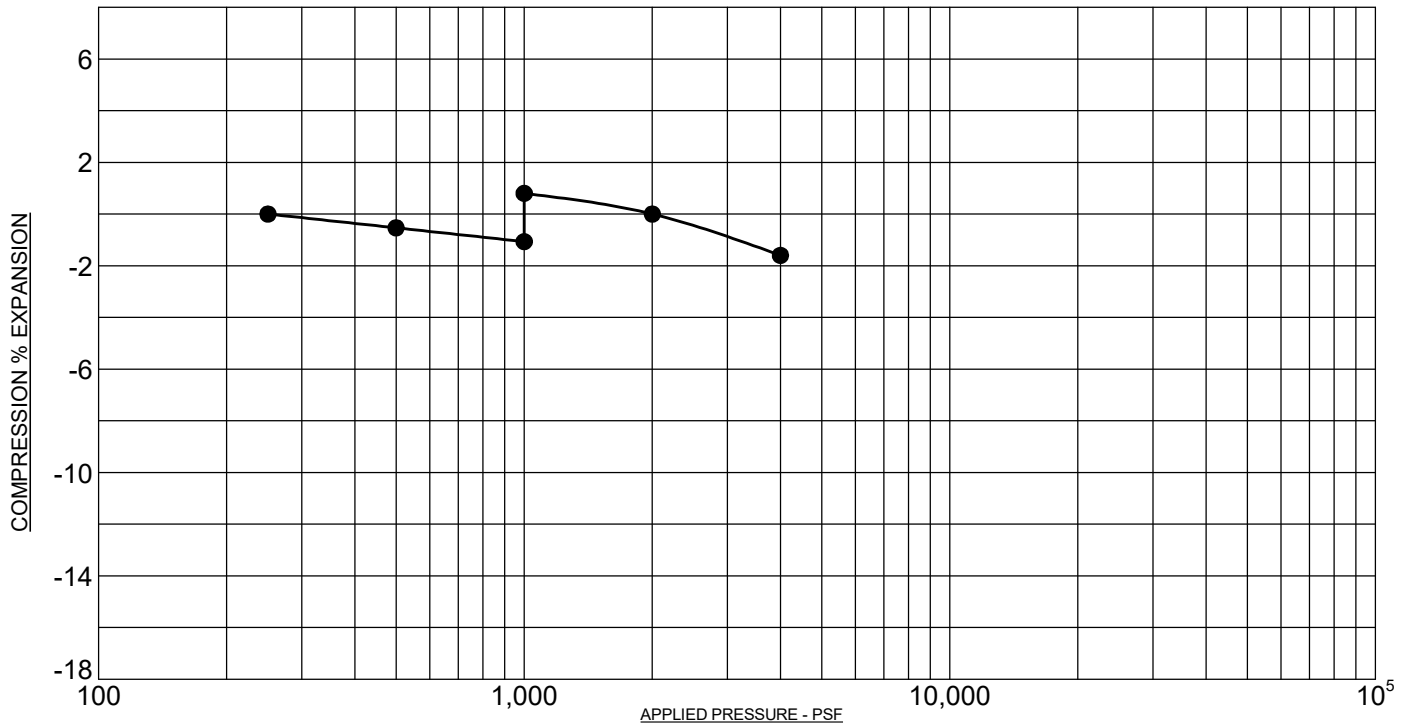
FIGURE No. 86

PROJECT: **The Ridge at Lorson Ranch El Paso County, Colorado**
 SAMPLE DESCRIPTION: **CLAYSTONE, SANDY**
 NOTE: **SAMPLE WAS INUNDATED WITH WATER AT 1,000 PSF**

SAMPLE LOCATION: **D-11 @ 9 FT**
 NATURAL DRY UNIT WEIGHT: **98.3 PCF**
 NATURAL MOISTURE CONTENT: **11.2%**
 PERCENT SWELL/COMPRESSION: **- 1.6**

SAMPLE LOCATION: **D-12 @ 9 FT**
 NATURAL DRY UNIT WEIGHT: **PCF**
 NATURAL MOISTURE CONTENT: **9.6%**
 PERCENT SWELL/COMPRESSION: **1.9**

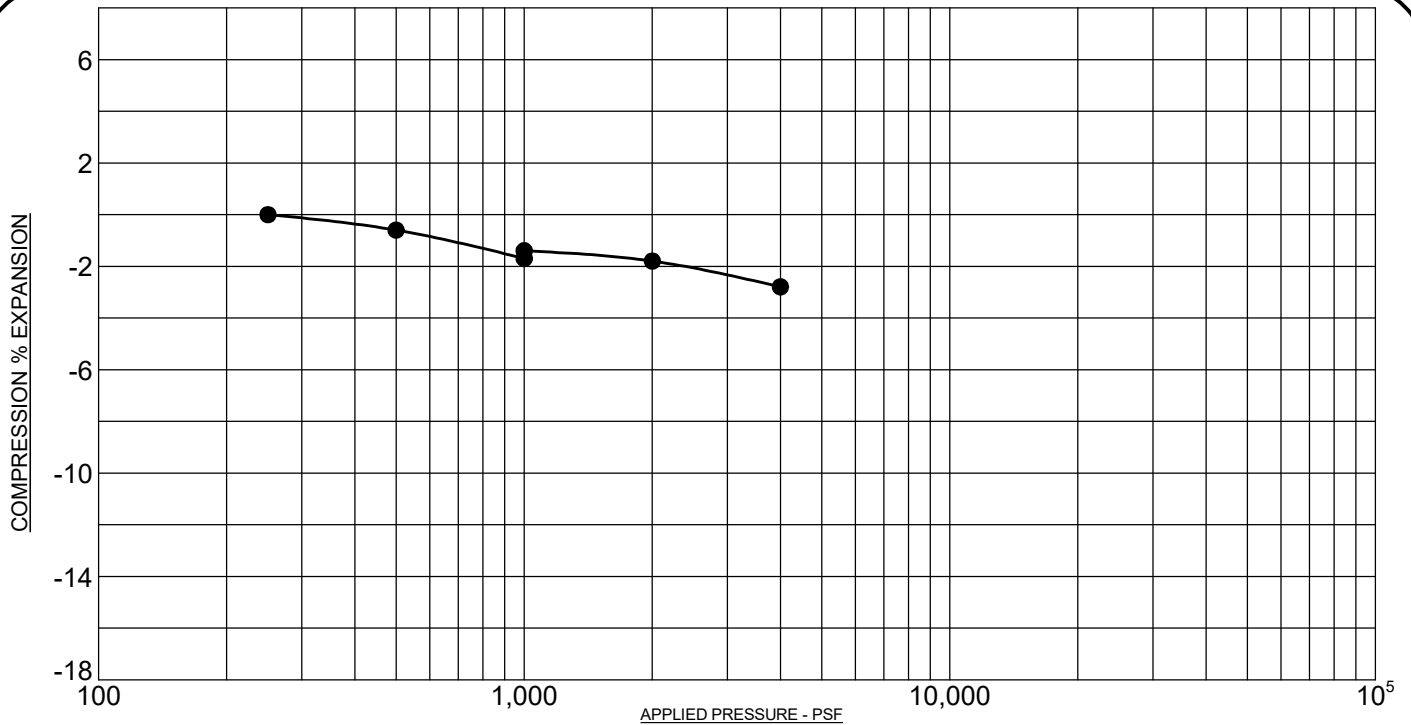
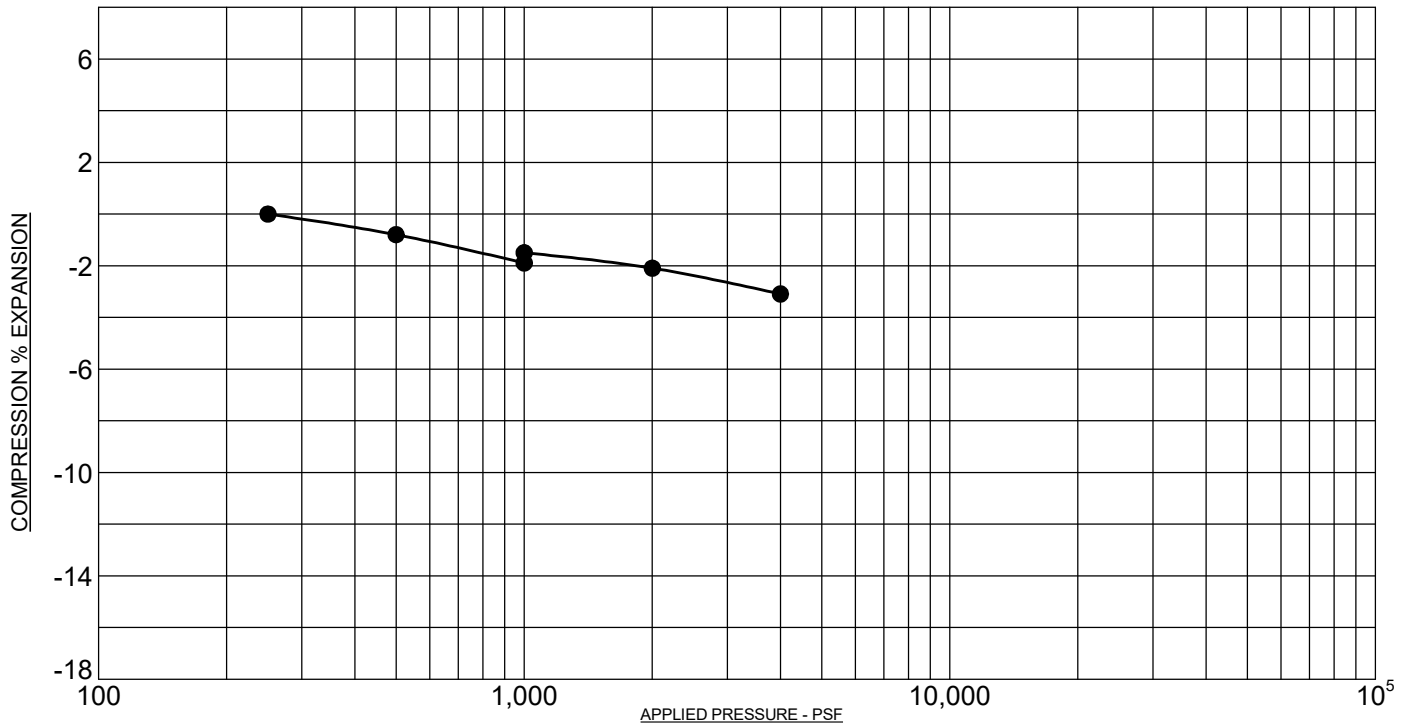
FIGURE No. 87

PROJECT: **The Ridge at Lorson Ranch El Paso County, Colorado**
 SAMPLE DESCRIPTION: **CLAYSTONE, SANDY**
 NOTE: **SAMPLE WAS INUNDATED WITH WATER AT 1,000 PSF**

SAMPLE LOCATION: **D-13 @ 14 FT**
 NATURAL DRY UNIT WEIGHT: **120.3 PCF**
 NATURAL MOISTURE CONTENT: **10.5%**
 PERCENT SWELL/COMPRESSION: **0.3**

SAMPLE LOCATION: **D-14 @ 9 FT**
 NATURAL DRY UNIT WEIGHT: **125.0 PCF**
 NATURAL MOISTURE CONTENT: **8.8%**
 PERCENT SWELL/COMPRESSION: **0.4**
