**ROCKY MOUNTAIN GROUP
EMPLOYEE OWNED**

Job No. 175706

Re: Response to Colorado Geological Survey and El Paso County Review Comments
The Ridge at Lorson Ranch
Fontaine Bl
The Ridge at Lorson Ranch
El Paso County, Colorado

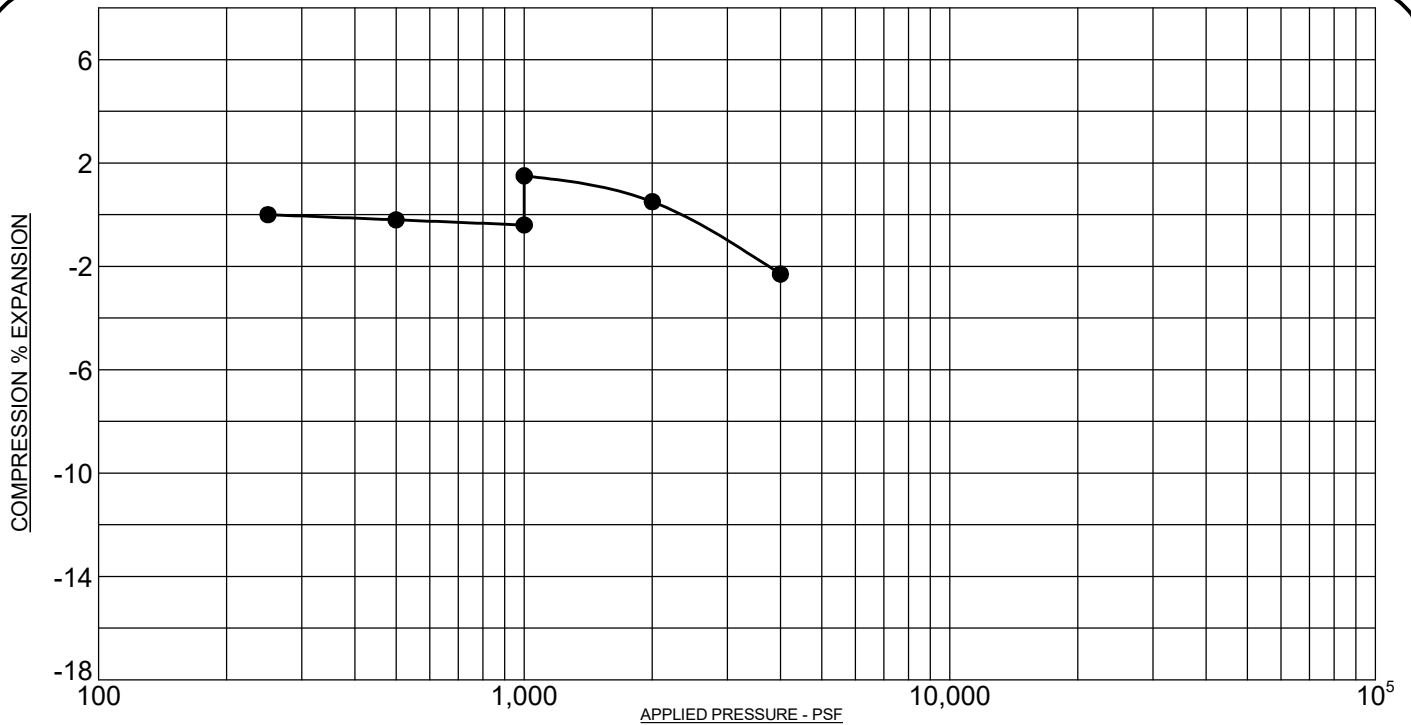
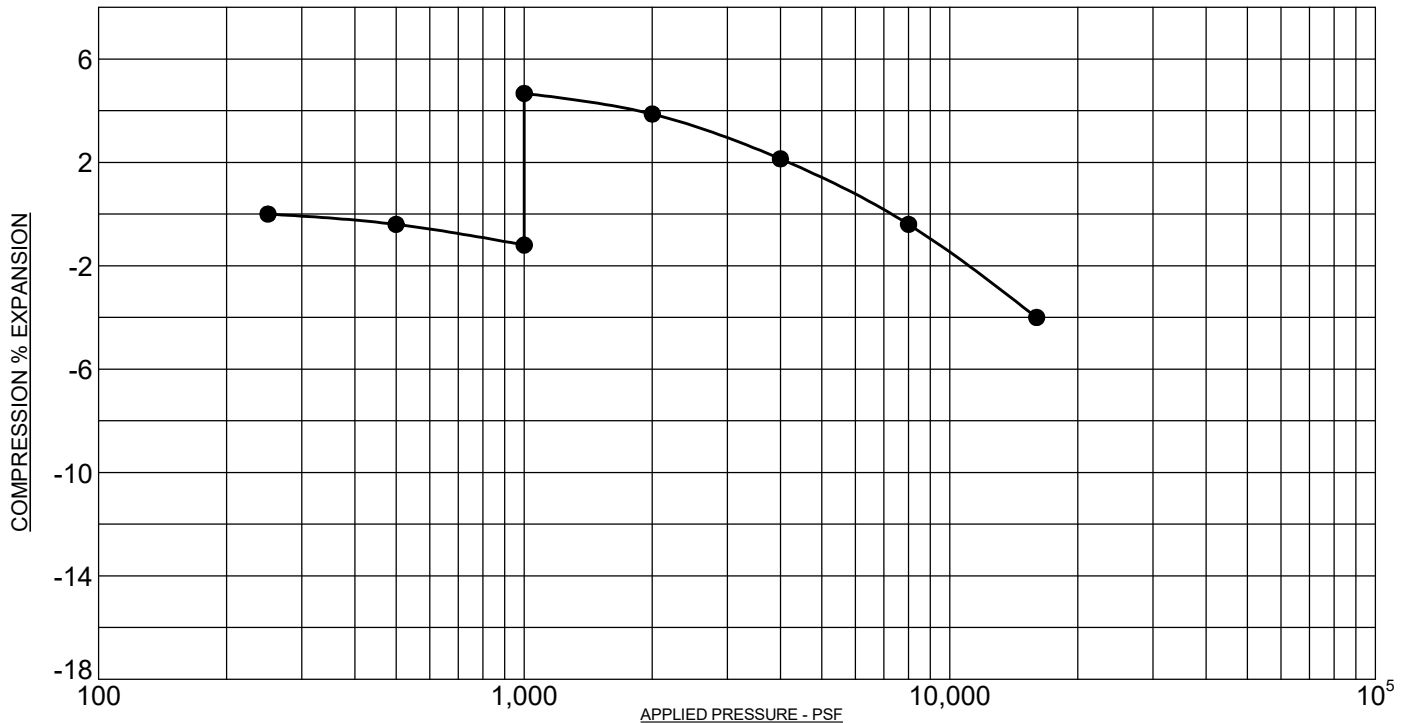
FIGURE No. 88

PROJECT: **The Ridge at Lorson Ranch El Paso County, Colorado**
 SAMPLE DESCRIPTION: **CLAY, SANDY**
 NOTE: **SAMPLE WAS INUNDATED WITH WATER AT 1,000 PSF**

SAMPLE LOCATION: **D-15 @ 4 FT**
 NATURAL DRY UNIT WEIGHT: **107.3 PCF**
 NATURAL MOISTURE CONTENT: **7.4%**
 PERCENT SWELL/COMPRESSION: **1.9**

PROJECT: **The Ridge at Lorson Ranch El Paso County, Colorado**
 SAMPLE DESCRIPTION: **CLAYSTONE, SANDY**
 NOTE: **SAMPLE WAS INUNDATED WITH WATER AT 1,000 PSF**

SAMPLE LOCATION: **D-17 @ 14 FT**
 NATURAL DRY UNIT WEIGHT: **137.0 PCF**
 NATURAL MOISTURE CONTENT: **11.5%**
 PERCENT SWELL/COMPRESSION: **5.9**

Soil laboratory testing was performed as part of this investigation. The laboratory tests included moisture content, dry density, grain-size analyses, Atterberg Limits and Swell/Consolidation tests. A Summary of Laboratory Test Results is presented in Figure 72 (13 pages). Soil Classification Data is presented in Figures 73 through 81. Swell/Consolidation Test Results are presented in Figures 82 through 143. Laboratory testing was not performed on the 13 preliminary test borings.

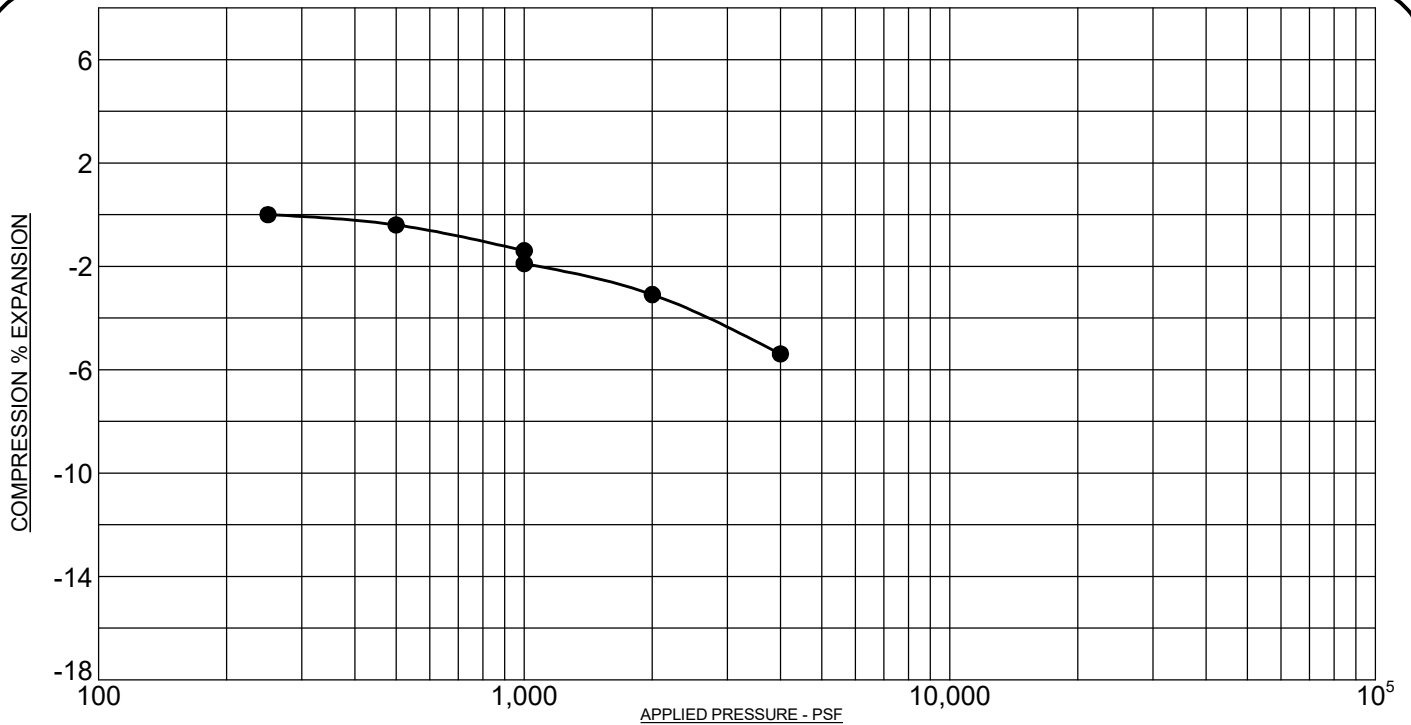
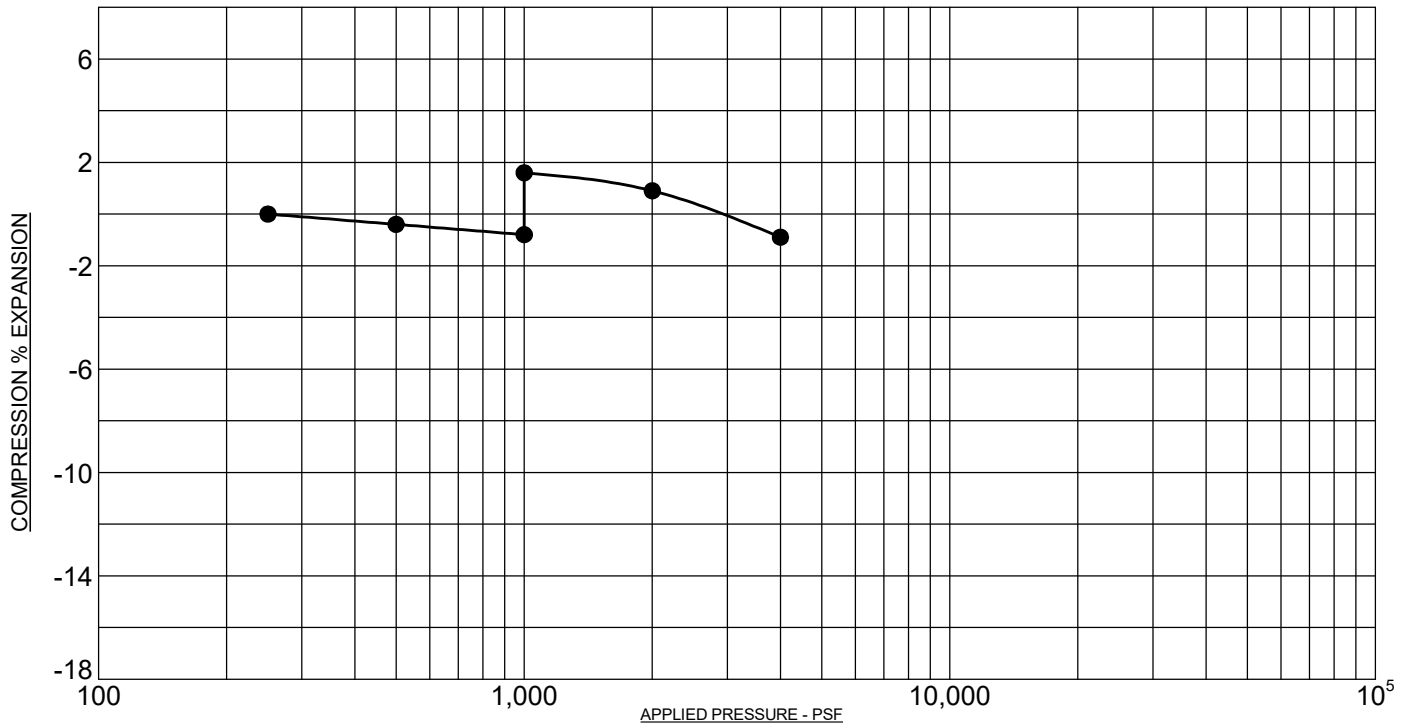
FIGURE No. 89

PROJECT: **The Ridge at Lorson Ranch El Paso County, Colorado**
 SAMPLE DESCRIPTION: **CLAYSTONE, SANDY**
 NOTE: **SAMPLE WAS INUNDATED WITH WATER AT 1,000 PSF**

SAMPLE LOCATION: **D-19 @ 14 FT**
 NATURAL DRY UNIT WEIGHT: **99.8 PCF**
 NATURAL MOISTURE CONTENT: **14.6%**
 PERCENT SWELL/COMPRESSION: **- 0.5**

PROJECT: **The Ridge at Lorson Ranch El Paso County, Colorado**
 SAMPLE DESCRIPTION: **CLAY, SANDY**
 NOTE: **SAMPLE WAS INUNDATED WITH WATER AT 1,000 PSF**

SAMPLE LOCATION: **D-20 @ 9 FT**
 NATURAL DRY UNIT WEIGHT: **115.6 PCF**
 NATURAL MOISTURE CONTENT: **11.3%**
 PERCENT SWELL/COMPRESSION: **2.4**

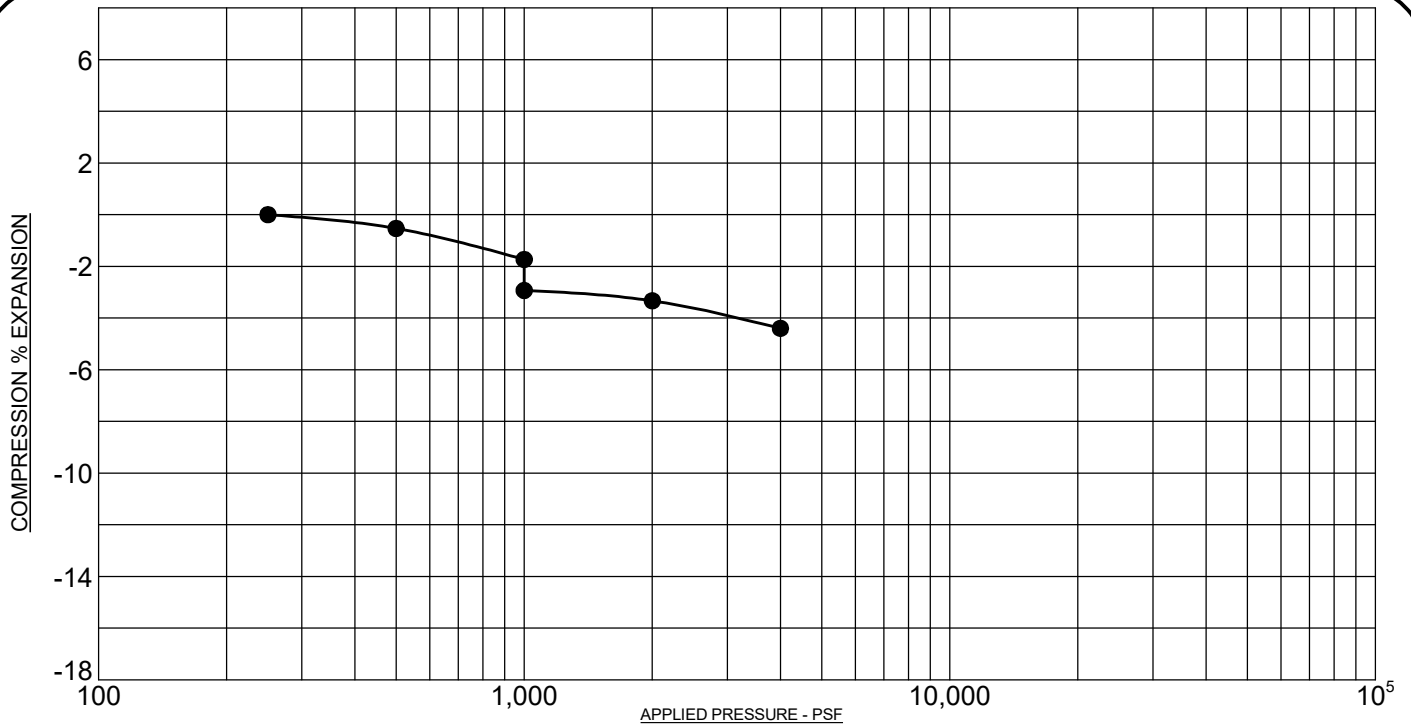
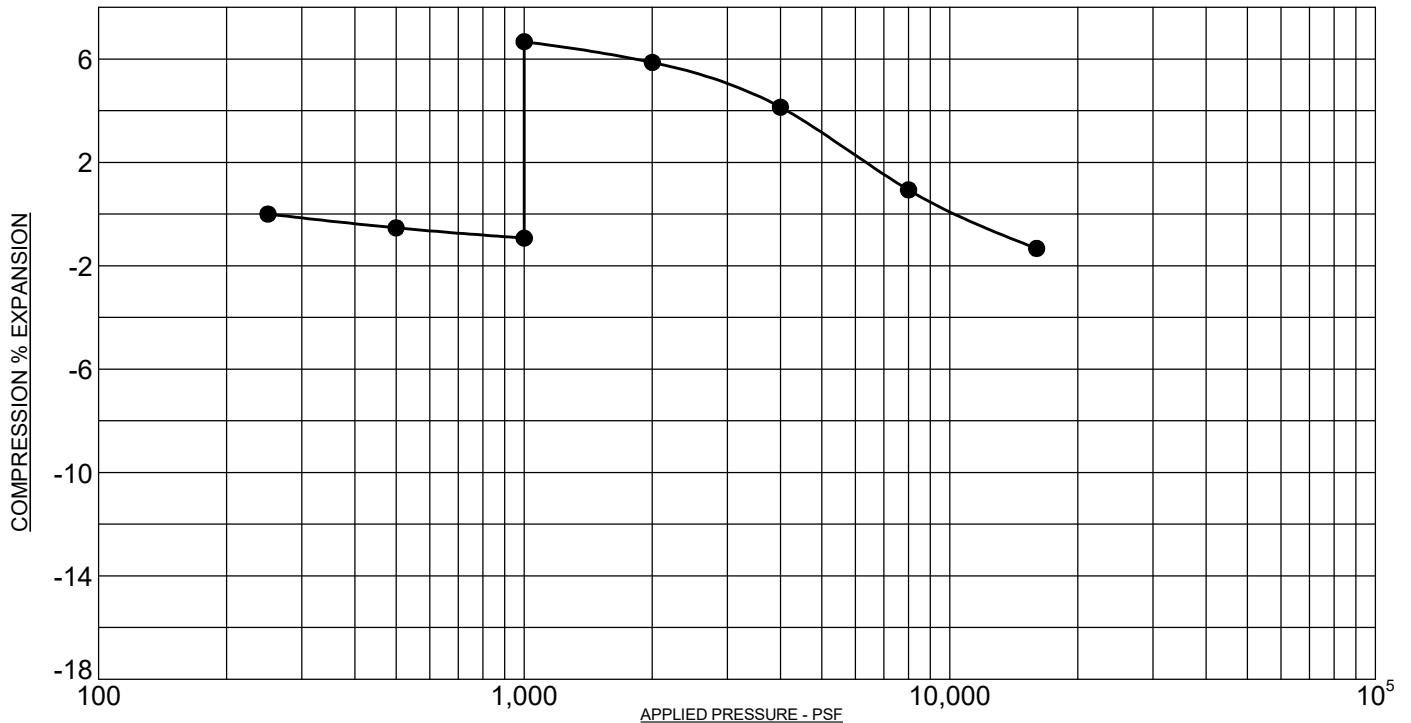
FIGURE No. 90

PROJECT: **The Ridge at Lorson Ranch El Paso County, Colorado**
 SAMPLE DESCRIPTION: **CLAYSTONE, SANDY**
 NOTE: **SAMPLE WAS INUNDATED WITH WATER AT 1,000 PSF**

SAMPLE LOCATION: **D-22 @ 9 FT**
 NATURAL DRY UNIT WEIGHT: **123.6 PCF**
 NATURAL MOISTURE CONTENT: **12.2%**
 PERCENT SWELL/COMPRESSION: **- 1.2**

SAMPLE LOCATION: **D-23 @ 19 FT**
 NATURAL DRY UNIT WEIGHT: **116.3 PCF**
 NATURAL MOISTURE CONTENT: **10.6%**
 PERCENT SWELL/COMPRESSION: **7.6**

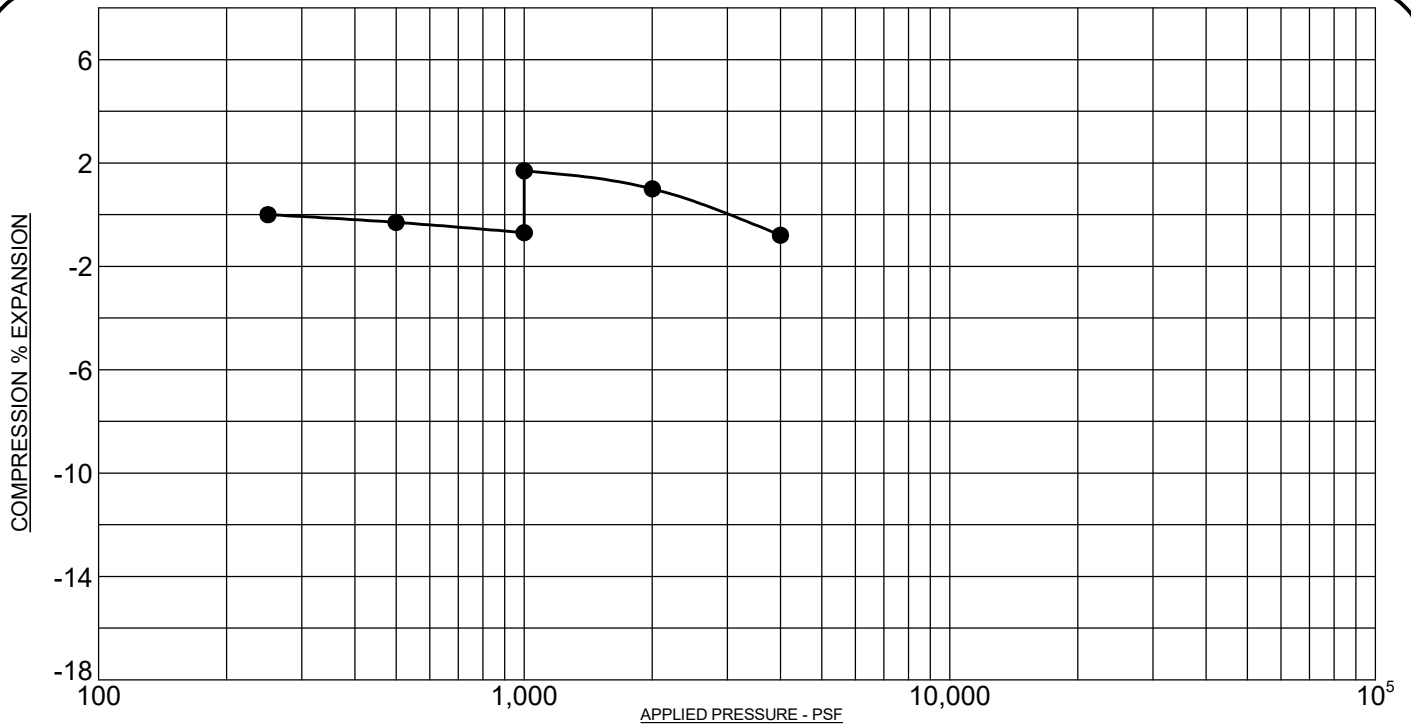
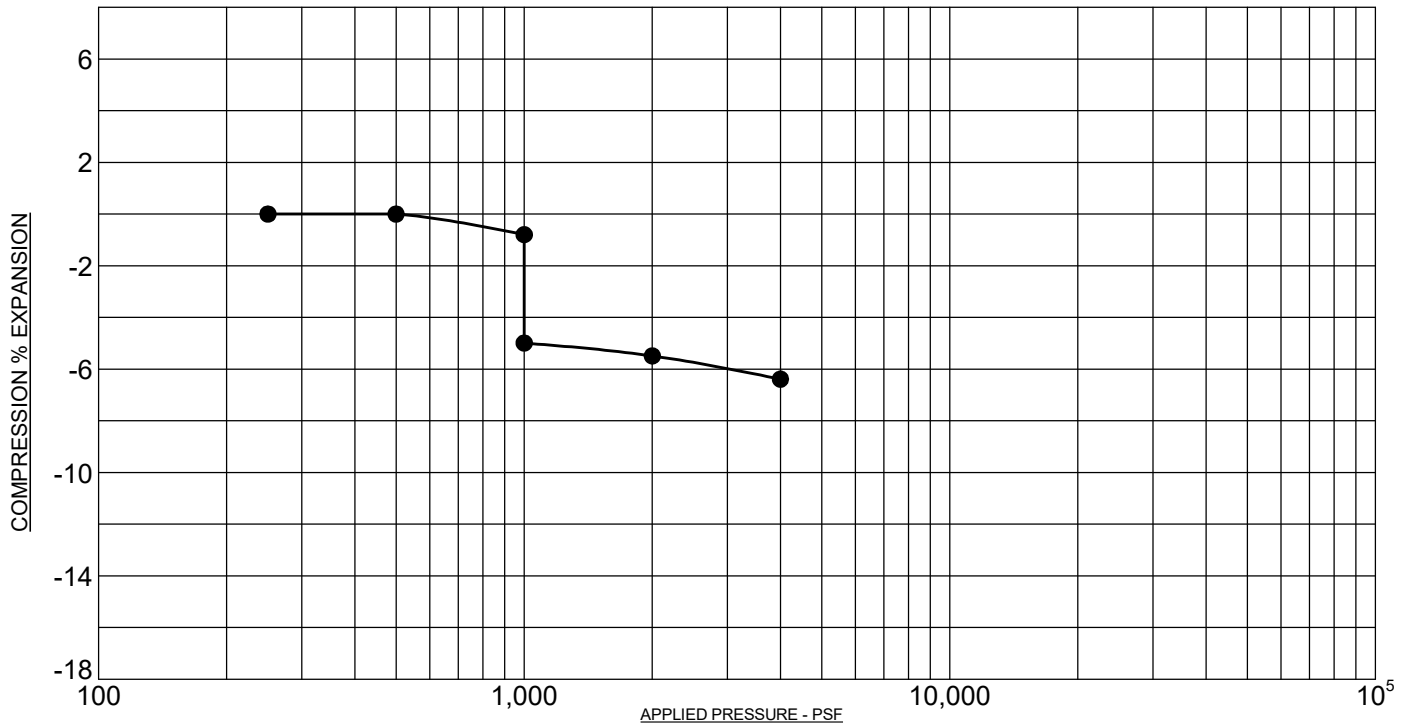
FIGURE No. 91

PROJECT: **The Ridge at Lorson Ranch El Paso County, Colorado**
 SAMPLE DESCRIPTION: **CLAYSTONE, SANDY**
 NOTE: **SAMPLE WAS INUNDATED WITH WATER AT 1,000 PSF**

SAMPLE LOCATION: **D-24 @ 4 FT**
 NATURAL DRY UNIT WEIGHT: **PCF**
 NATURAL MOISTURE CONTENT: **14.4%**
 PERCENT SWELL/COMPRESSION: **2.4**

PROJECT: **The Ridge at Lorson Ranch El Paso County, Colorado**
 SAMPLE DESCRIPTION: **CLAYSTONE, SANDY**
 NOTE: **SAMPLE WAS INUNDATED WITH WATER AT PSF**

SAMPLE LOCATION: **D-25 @ 14 FT**
 NATURAL DRY UNIT WEIGHT: **124.1 PCF**
 NATURAL MOISTURE CONTENT: **10.8%**
 PERCENT SWELL/COMPRESSION: **- 4.2**

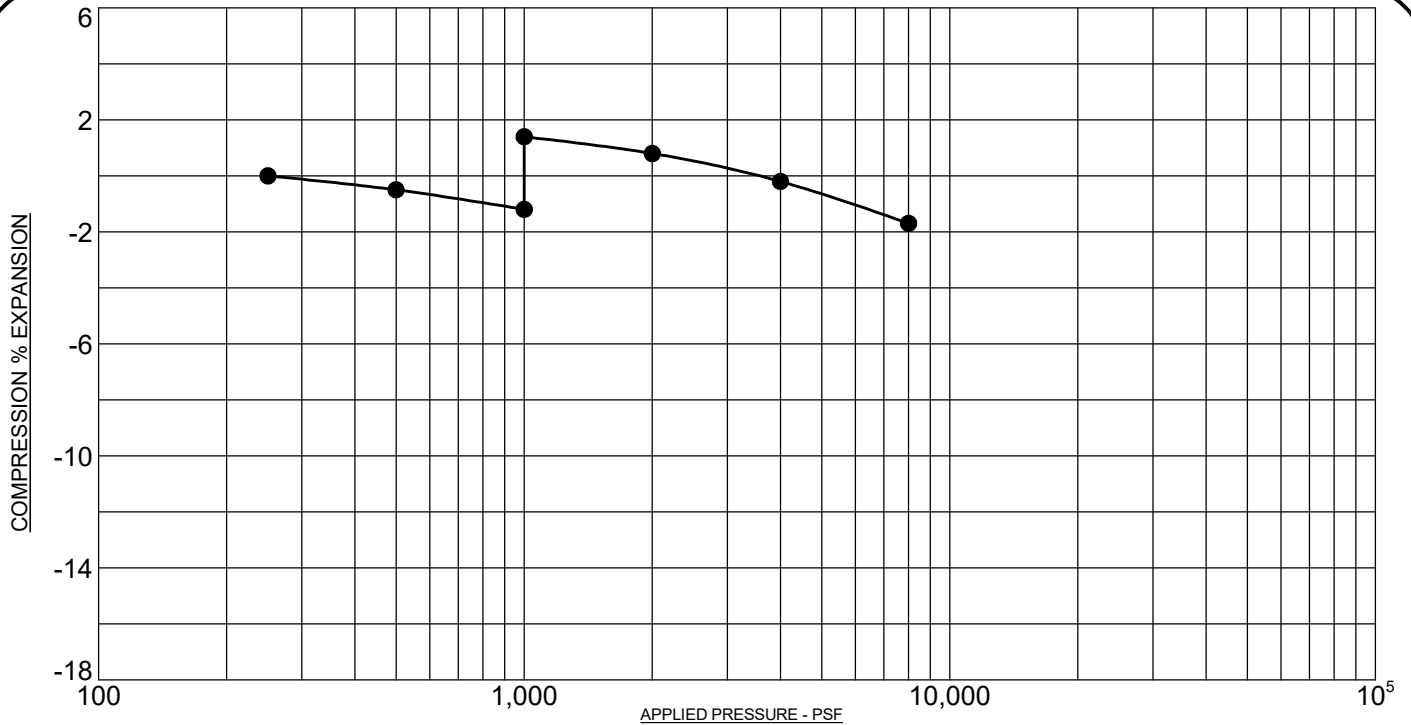
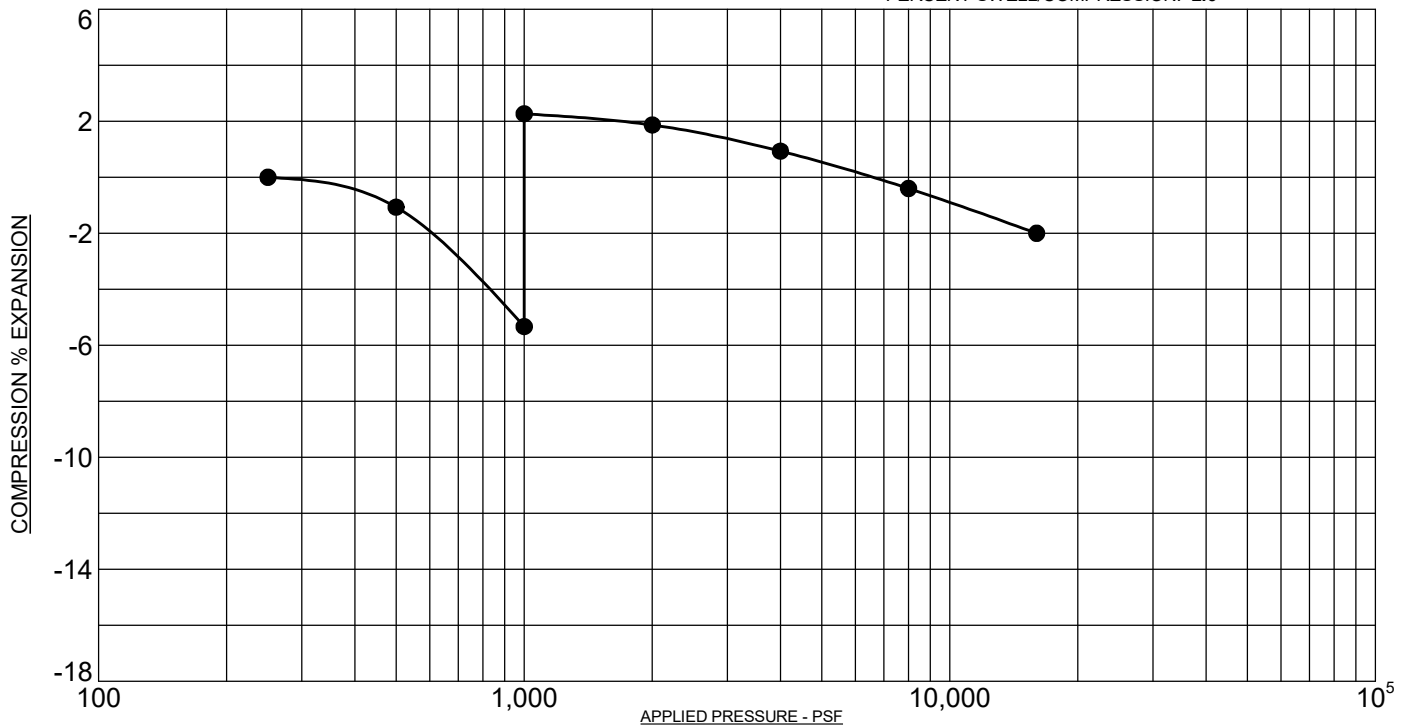
FIGURE No. 92

PROJECT: **The Ridge at Lorson Ranch El Paso County, Colorado**
 SAMPLE DESCRIPTION: **CLAYSTONE, SANDY**
 NOTE: **SAMPLE WAS INUNDATED WITH WATER AT 1,000 PSF**

SAMPLE LOCATION: **D-27 @ 14 FT**
 NATURAL DRY UNIT WEIGHT: **120.3 PCF**
 NATURAL MOISTURE CONTENT: **13.8%**
 PERCENT SWELL/COMPRESSION: **2.6**

SAMPLE LOCATION: **D-28 @ 9 FT**
 NATURAL DRY UNIT WEIGHT: **121.2 PCF**
 NATURAL MOISTURE CONTENT: **14.1%**
 PERCENT SWELL/COMPRESSION: **7.6**

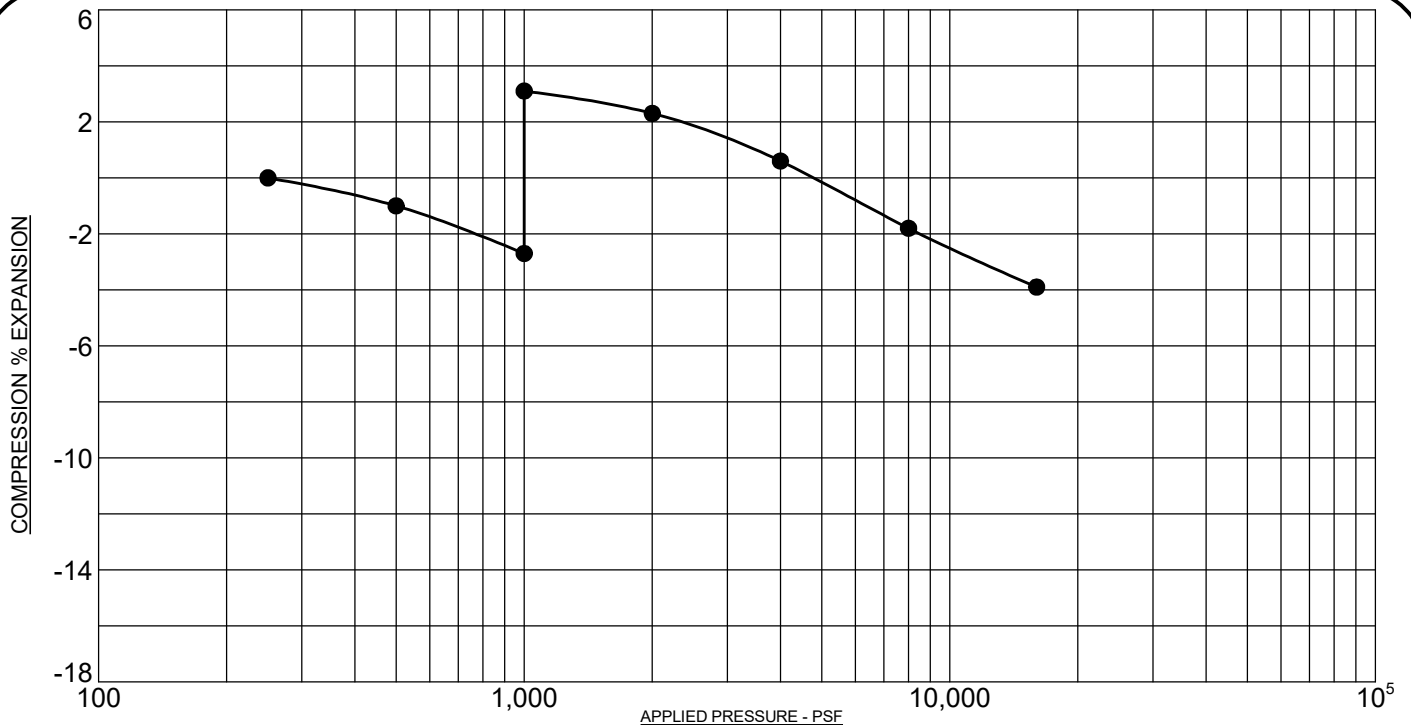
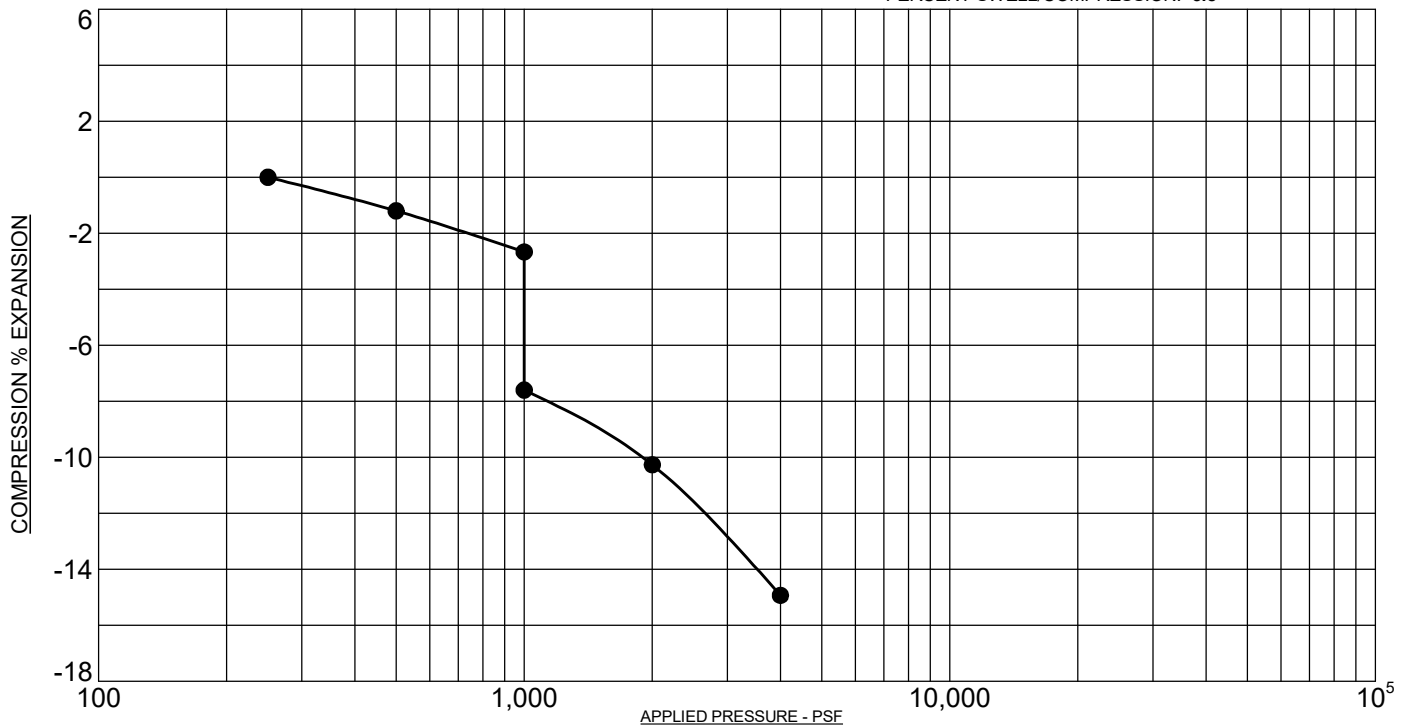
PROJECT: **The Ridge at Lorson Ranch El Paso County, Colorado**
 SAMPLE DESCRIPTION: **CLAYSTONE, SANDY**
 NOTE: **SAMPLE WAS INUNDATED WITH WATER AT 1,000 PSF**

SAMPLE LOCATION: **D-29 @ 9 FT**
 NATURAL DRY UNIT WEIGHT: **116.6 PCF**
 NATURAL MOISTURE CONTENT: **11.1%**
 PERCENT SWELL/COMPRESSION: **5.8**

SAMPLE LOCATION: **D-30 @ 9 FT**
 NATURAL DRY UNIT WEIGHT: **97.8 PCF**
 NATURAL MOISTURE CONTENT: **9.0%**
 PERCENT SWELL/COMPRESSION: **- 4.9**

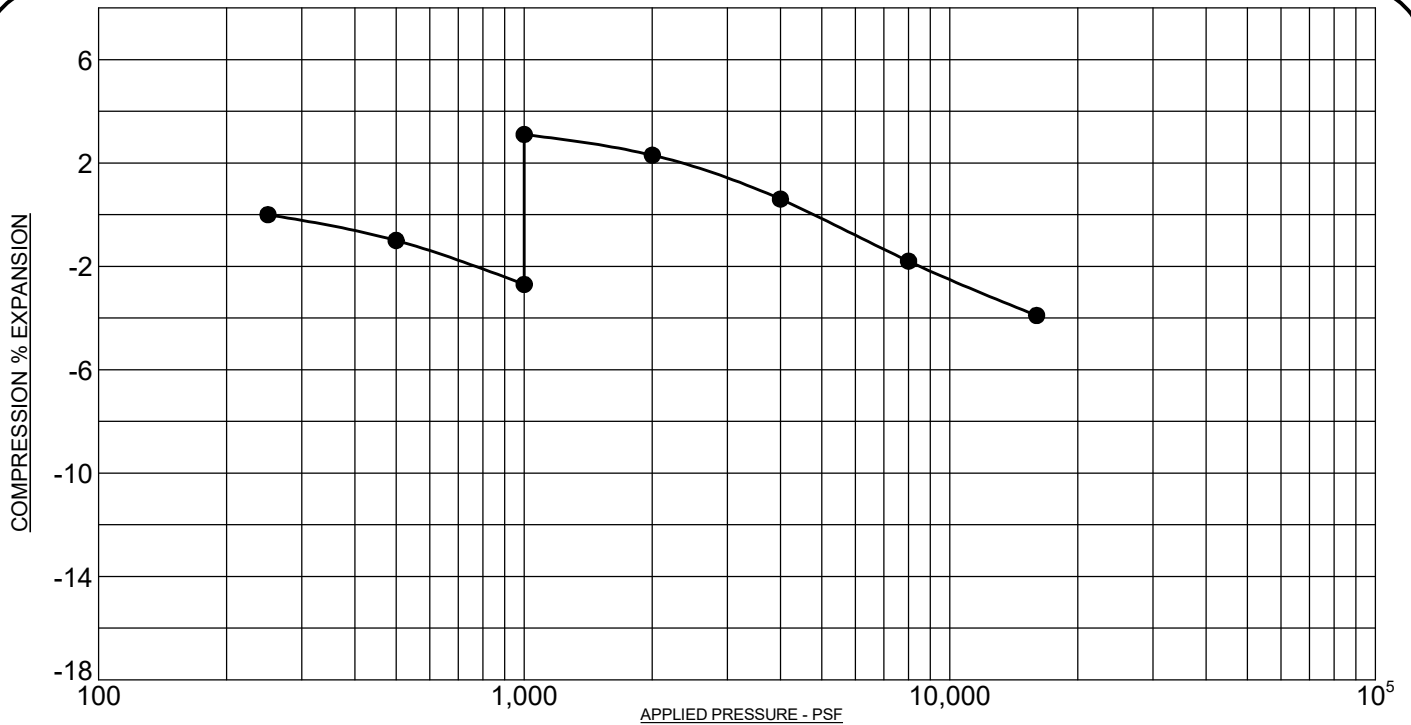
FIGURE No. 93

PROJECT: **The Ridge at Lorson Ranch El Paso County, Colorado**
 SAMPLE DESCRIPTION: **CLAYSTONE, SANDY**
 NOTE: **SAMPLE WAS INUNDATED WITH WATER AT 1,000 PSF**

SAMPLE LOCATION: **D-29 @ 9 FT**
 NATURAL DRY UNIT WEIGHT: **116.6 PCF**
 NATURAL MOISTURE CONTENT: **11.1%**
 PERCENT SWELL/COMPRESSION: **5.8**

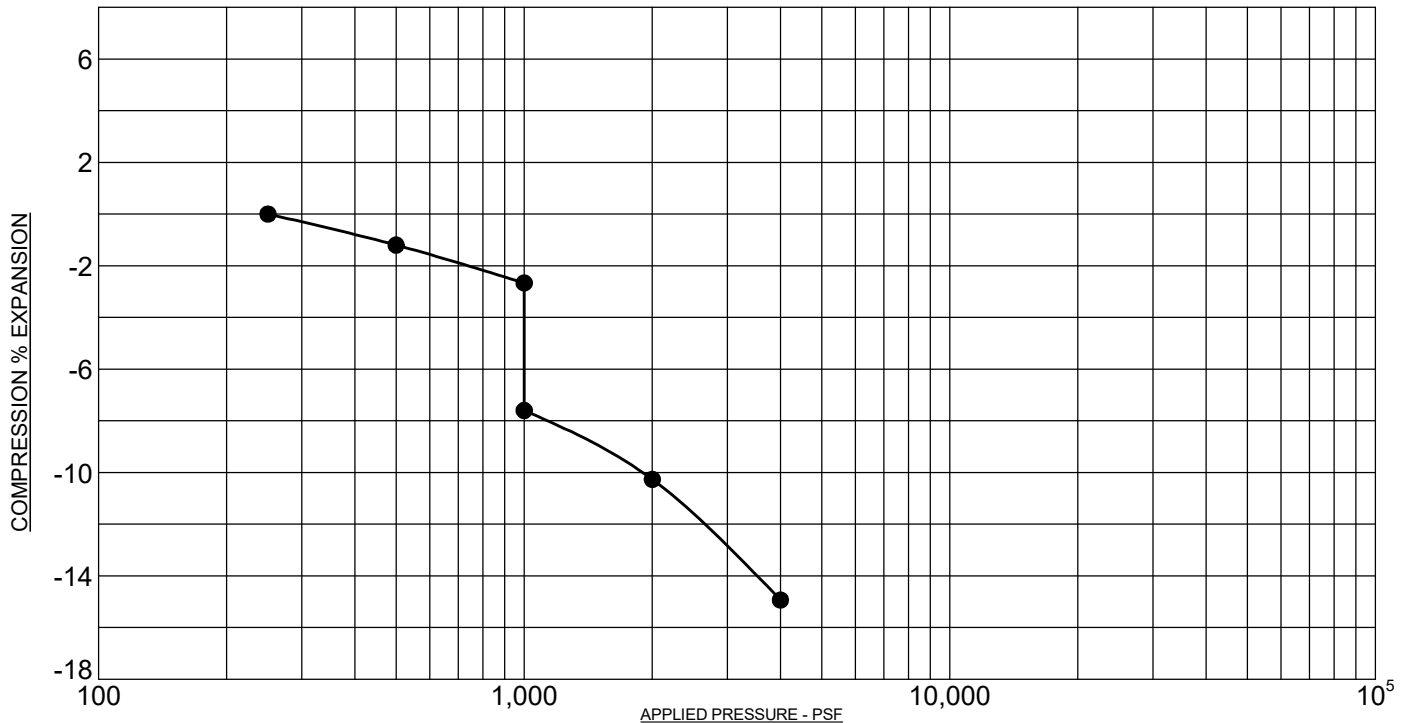
PROJECT: **The Ridge at Lorson Ranch El Paso County, Colorado**
 SAMPLE DESCRIPTION: **CLAYSTONE, SANDY**
 NOTE: **SAMPLE WAS INUNDATED WITH WATER AT 1,000 PSF**

SAMPLE LOCATION: **D-30 @ 9 FT**
 NATURAL DRY UNIT WEIGHT: **97.8 PCF**
 NATURAL MOISTURE CONTENT: **9.0%**
 PERCENT SWELL/COMPRESSION: **- 4.9**

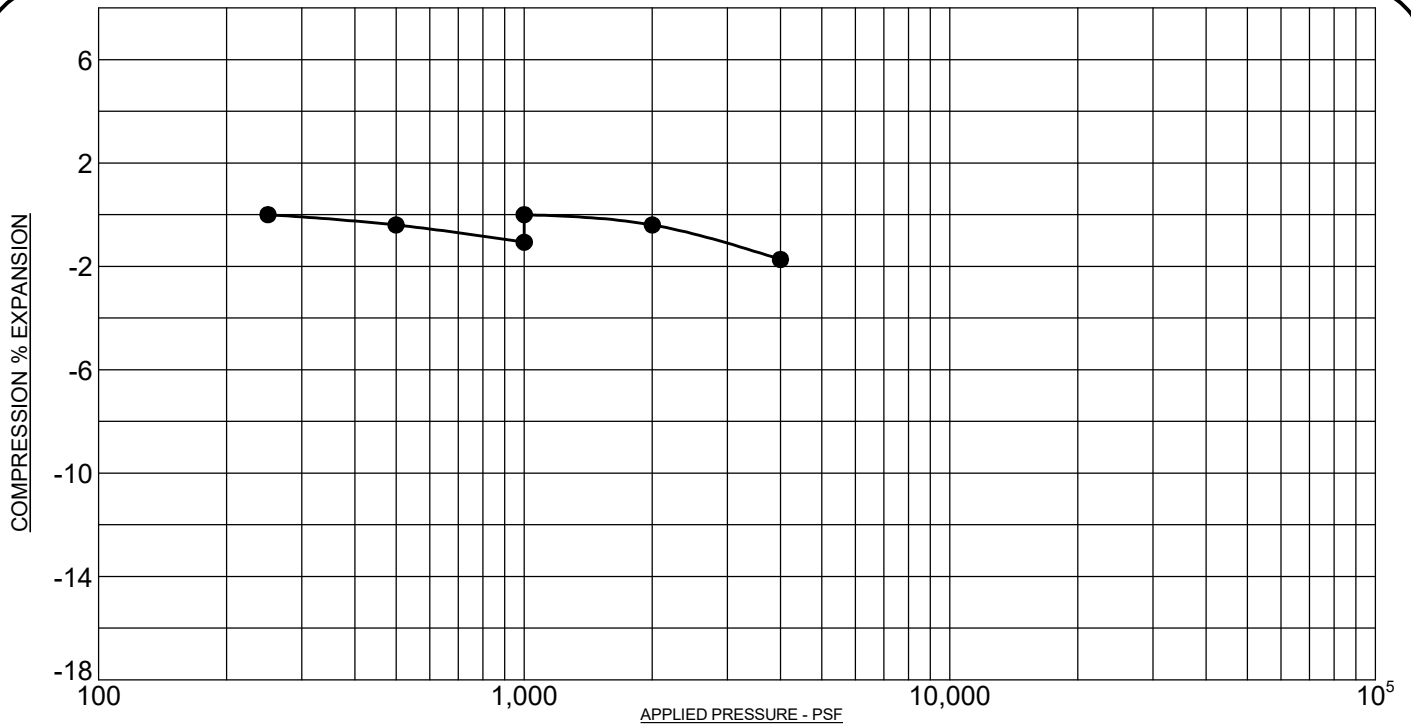
FIGURE No. 93

PROJECT: **The Ridge at Lorson Ranch El Paso County, Colorado**
 SAMPLE DESCRIPTION: **CLAYSTONE, SANDY**
 NOTE: **SAMPLE WAS INUNDATED WITH WATER AT 1,000 PSF**

SAMPLE LOCATION: **D-31 @ 9 FT**
 NATURAL DRY UNIT WEIGHT: **120.9 PCF**
 NATURAL MOISTURE CONTENT: **11.3%**
 PERCENT SWELL/COMPRESSION: **1.1**

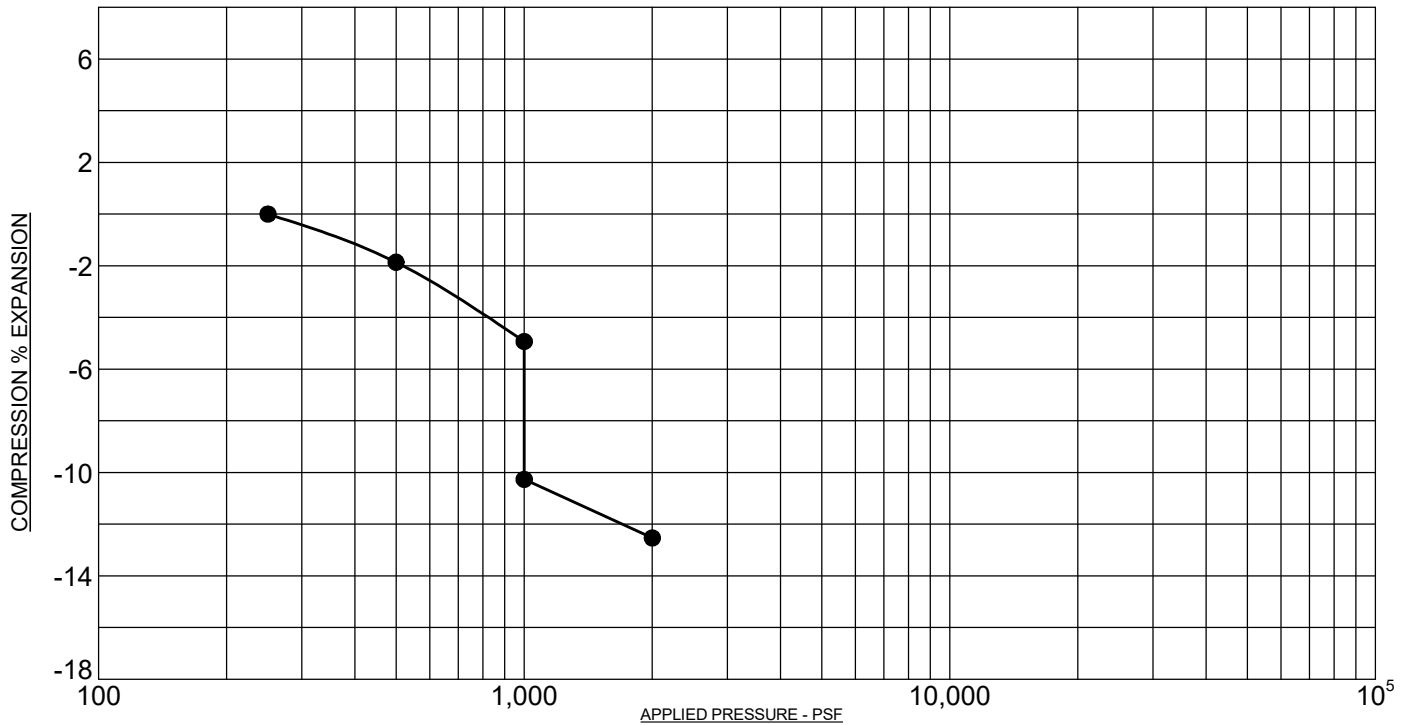
PROJECT: **The Ridge at Lorson Ranch El Paso County, Colorado**
 SAMPLE DESCRIPTION: **CLAYSTONE, SANDY**
 NOTE: **SAMPLE WAS INUNDATED WITH WATER AT 1,000 PSF**

SAMPLE LOCATION: **D-32 @ 19 FT**
 NATURAL DRY UNIT WEIGHT: **105.6 PCF**
 NATURAL MOISTURE CONTENT: **12.1%**
 PERCENT SWELL/COMPRESSION: **- 5.3**

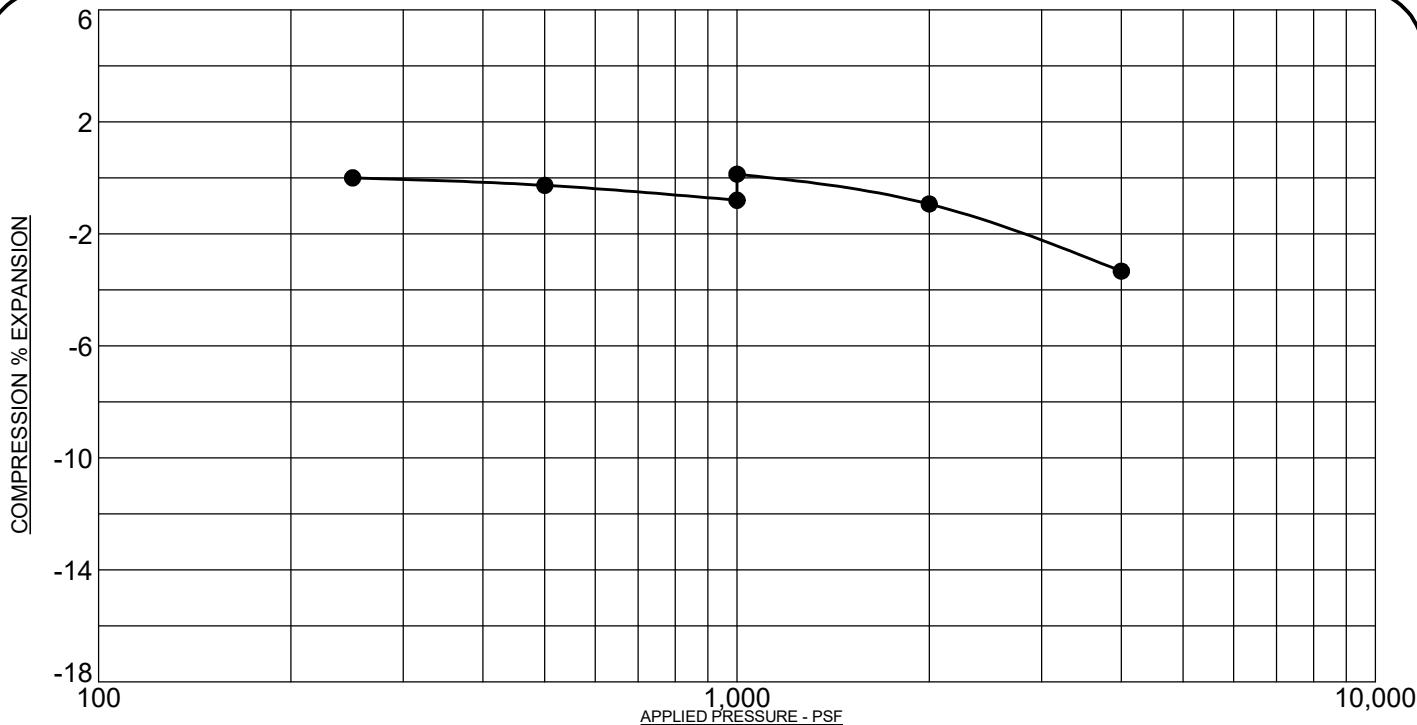
FIGURE No. 94

PROJECT: **The Ridge at Lorson Ranch El Paso County, Colorado**
 SAMPLE DESCRIPTION: **CLAYSTONE, SANDY**
 NOTE: **SAMPLE WAS INUNDATED WITH WATER AT 1,000 PSF**

SAMPLE LOCATION: **D-33 @ 14 FT**
 NATURAL DRY UNIT WEIGHT: **118.4 PCF**
 NATURAL MOISTURE CONTENT: **10.1%**
 PERCENT SWELL/COMPRESSION: **0.9**

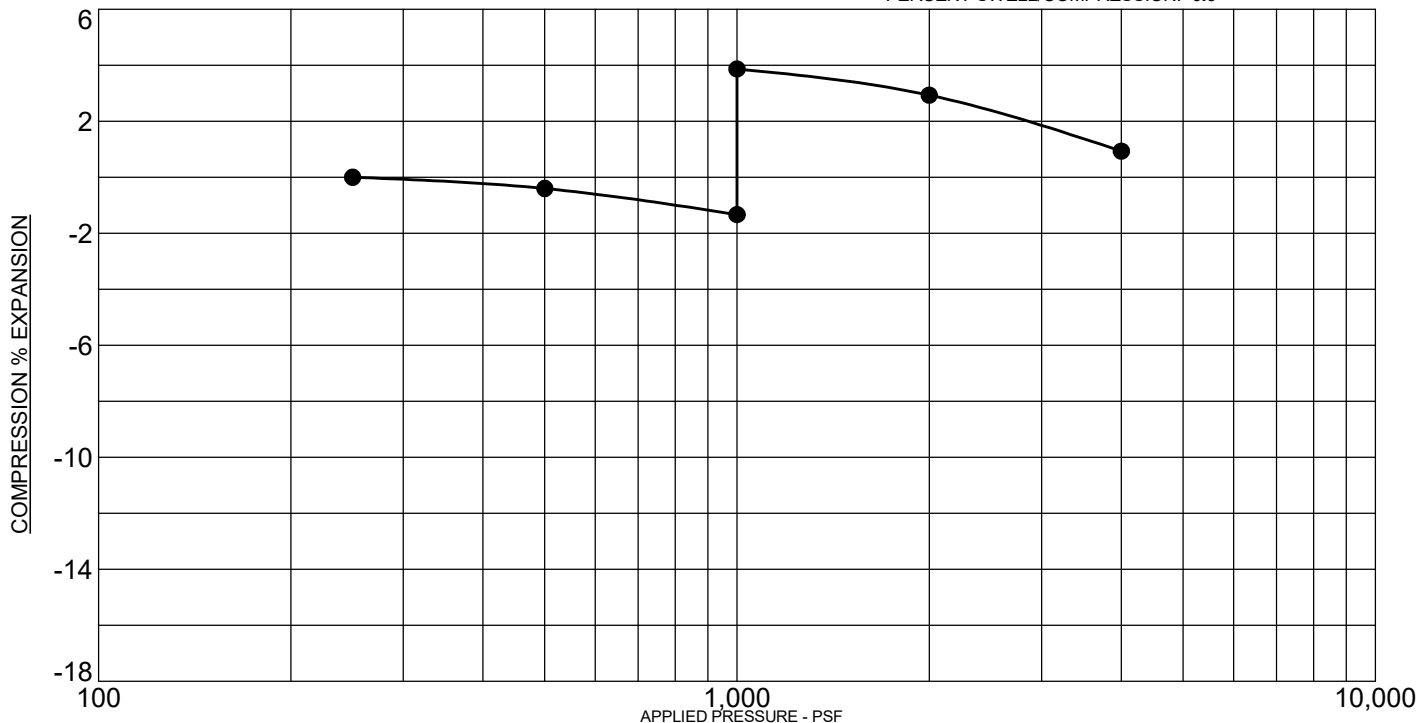
PROJECT: **The Ridge at Lorson Ranch El Paso County, Colorado**
 SAMPLE DESCRIPTION: **CLAYSTONE, SANDY**
 NOTE: **SAMPLE WAS INUNDATED WITH WATER AT 1,000 PSF**

SAMPLE LOCATION: **D-34 @ 14 FT**
 NATURAL DRY UNIT WEIGHT: **112.5 PCF**
 NATURAL MOISTURE CONTENT: **13.2%**
 PERCENT SWELL/COMPRESSION: **5.2**

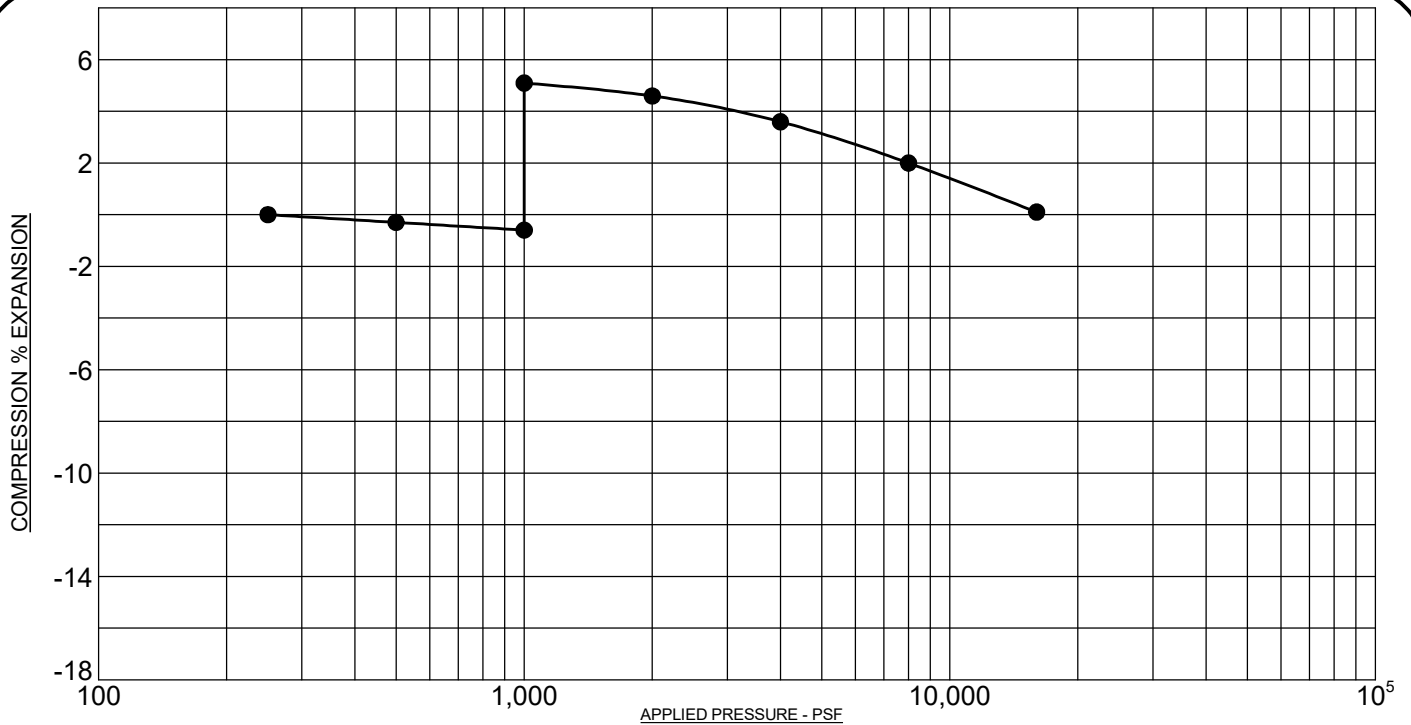
FIGURE No. 95

PROJECT: **The Ridge at Lorson Ranch El Paso County, Colorado**
 SAMPLE DESCRIPTION: **CLAYSTONE, SANDY**
 NOTE: **SAMPLE WAS INUNDATED WITH WATER AT 1,000 PSF**

SAMPLE LOCATION: **D-35 @ 19 FT**
 NATURAL DRY UNIT WEIGHT: **PCF**
 NATURAL MOISTURE CONTENT: **15.9%**
 PERCENT SWELL/COMPRESSION: **5.7**

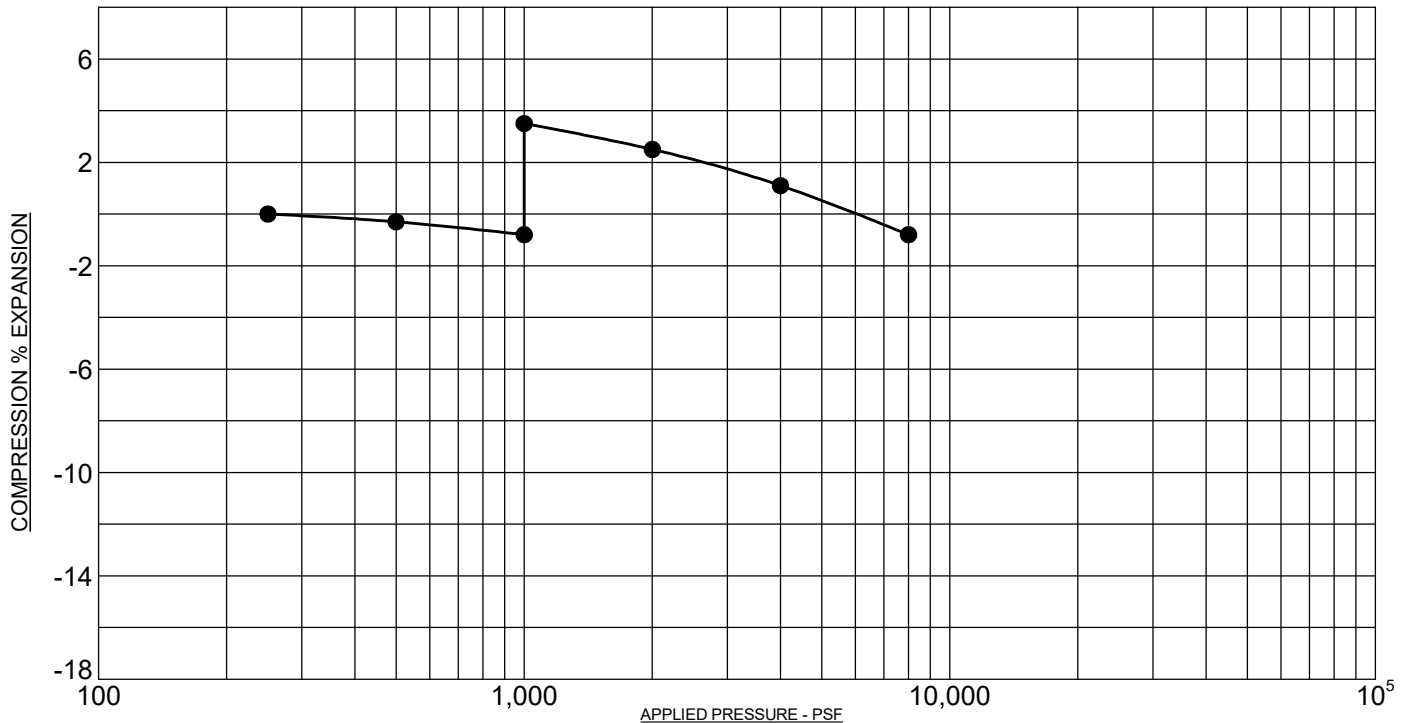
PROJECT: **The Ridge at Lorson Ranch El Paso County, Colorado**
 SAMPLE DESCRIPTION: **CLAYSTONE, SANDY**
 NOTE: **SAMPLE WAS INUNDATED WITH WATER AT 1,000 PSF**

SAMPLE LOCATION: **D-36 @ 19 FT**
 NATURAL DRY UNIT WEIGHT: **107.5 PCF**
 NATURAL MOISTURE CONTENT: **21.2%**
 PERCENT SWELL/COMPRESSION: **4.3**
