**ROCKY MOUNTAIN GROUP
EMPLOYEE OWNED**

Job No. 175706

Re: Response to Colorado Geological Survey and El Paso County Review Comments
The Ridge at Lorson Ranch
Fontaine Bl
The Ridge at Lorson Ranch
El Paso County, Colorado

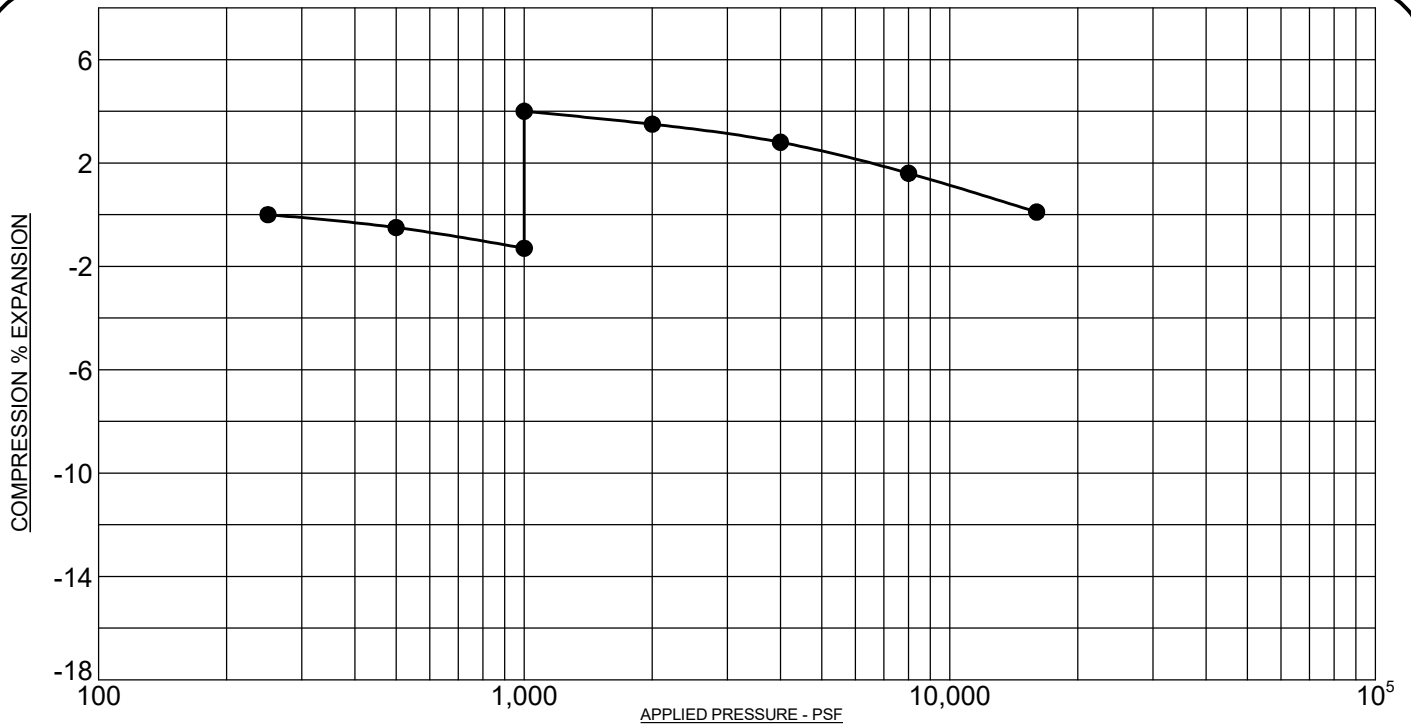
FIGURE No. 96

PROJECT: **The Ridge at Lorson Ranch El Paso County, Colorado**
 SAMPLE DESCRIPTION: **CLAYSTONE, SANDY**
 NOTE: **SAMPLE WAS INUNDATED WITH WATER AT 1,000 PSF**

SAMPLE LOCATION: **D-37 @ 14 FT**
 NATURAL DRY UNIT WEIGHT: **122.3 PCF**
 NATURAL MOISTURE CONTENT: **13.6%**
 PERCENT SWELL/COMPRESSION: **5.3**

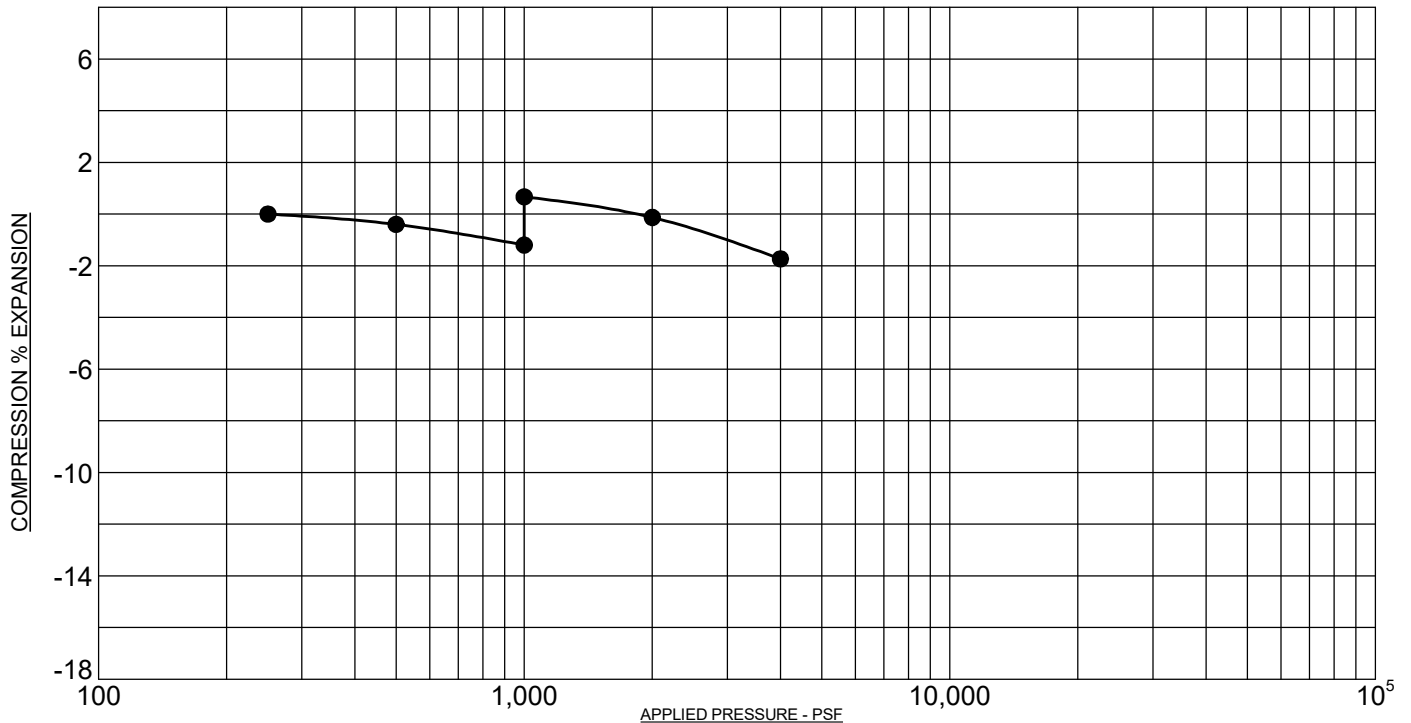
PROJECT: **The Ridge at Lorson Ranch El Paso County, Colorado**
 SAMPLE DESCRIPTION: **CLAYSTONE, SANDY**
 NOTE: **SAMPLE WAS INUNDATED WITH WATER AT 1,000 PSF**

SAMPLE LOCATION: **D-38 @ 19 FT**
 NATURAL DRY UNIT WEIGHT: **PCF**
 NATURAL MOISTURE CONTENT: **15.2%**
 PERCENT SWELL/COMPRESSION: **1.9**

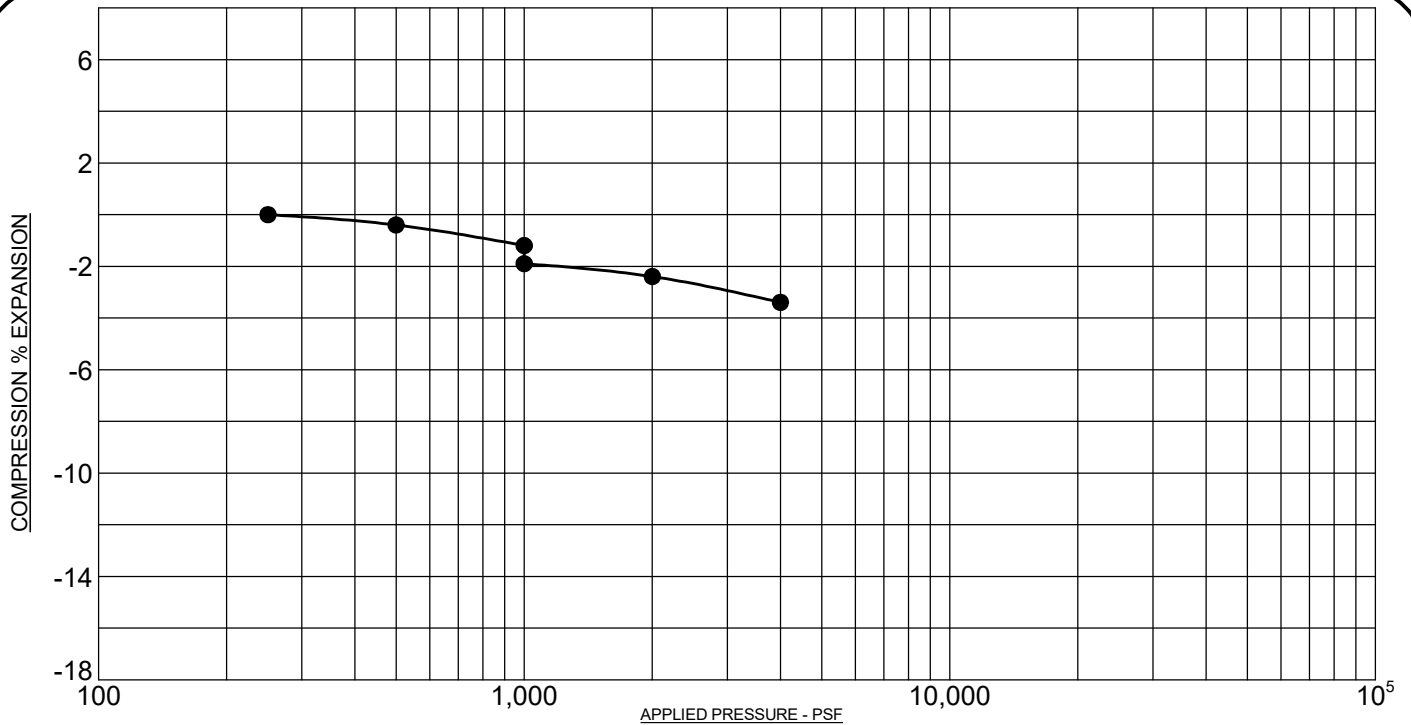
FIGURE No. 97

PROJECT: **The Ridge at Lorson Ranch El Paso County, Colorado**
 SAMPLE DESCRIPTION: **CLAYSTONE, SANDY**
 NOTE: **SAMPLE WAS INUNDATED WITH WATER AT 1,000 PSF**

SAMPLE LOCATION: **D-39 @ 9 FT**
 NATURAL DRY UNIT WEIGHT: **118.3 PCF**
 NATURAL MOISTURE CONTENT: **10.7%**
 PERCENT SWELL/COMPRESSION: **- 0.7**

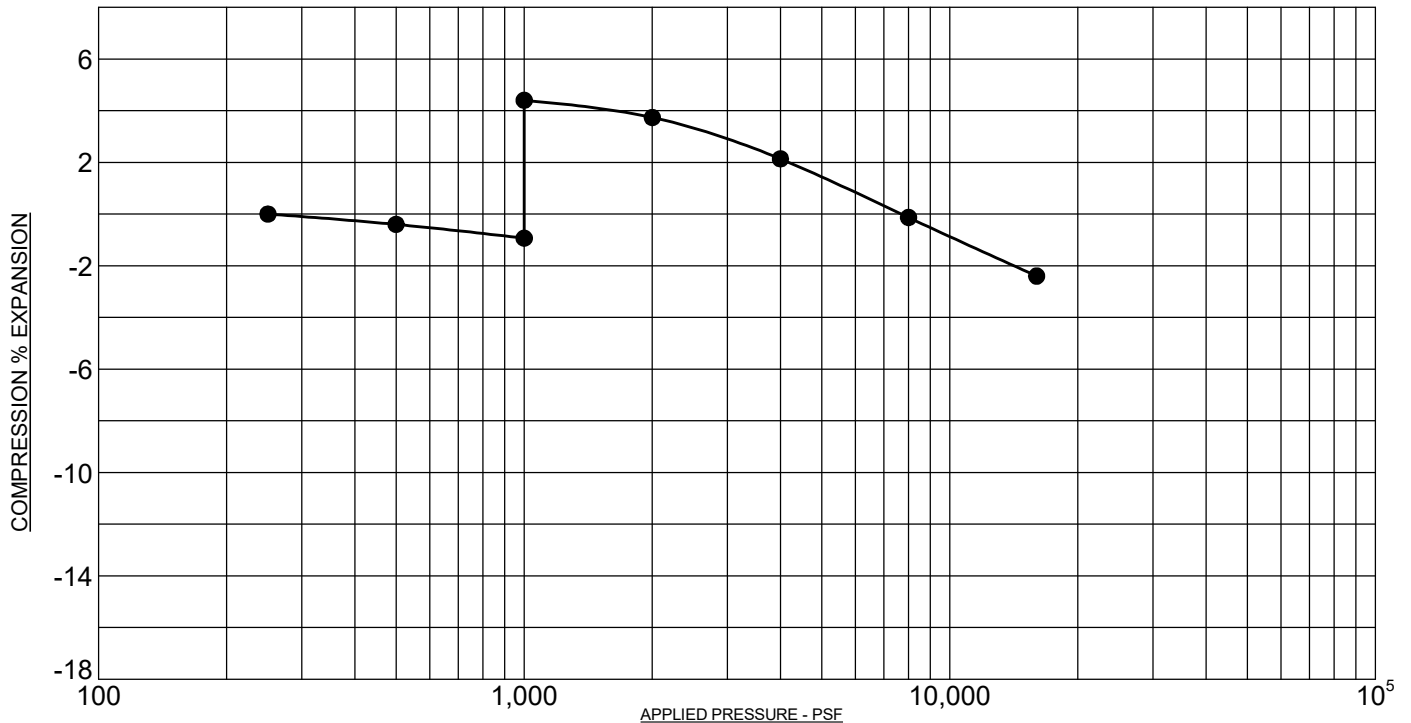
PROJECT: **The Ridge at Lorson Ranch El Paso County, Colorado**
 SAMPLE DESCRIPTION: **CLAYSTONE, SANDY**
 NOTE: **SAMPLE WAS INUNDATED WITH WATER AT 1,000 PSF**

SAMPLE LOCATION: **D-41 @ 9 FT**
 NATURAL DRY UNIT WEIGHT: **PCF**
 NATURAL MOISTURE CONTENT: **49.3%**
 PERCENT SWELL/COMPRESSION: **5.3**

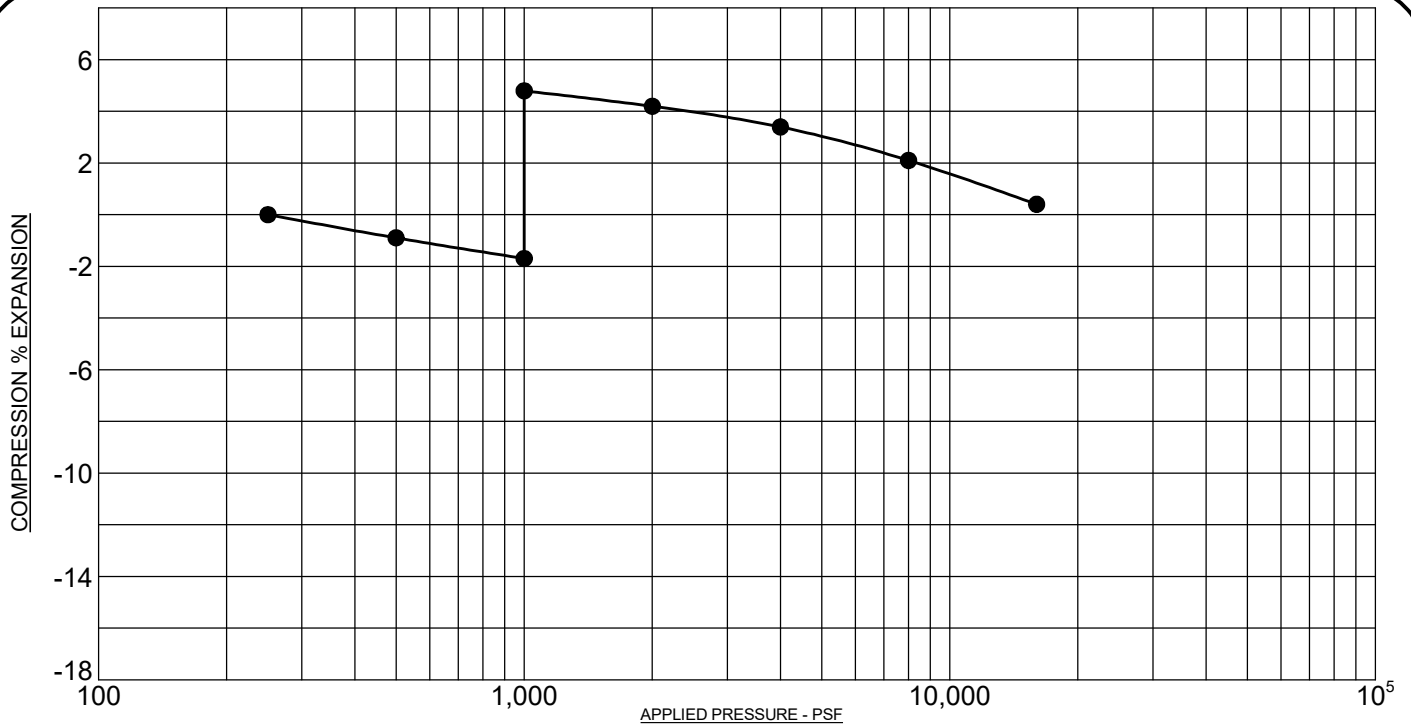
FIGURE No. 98

PROJECT: **The Ridge at Lorson Ranch El Paso County, Colorado**
 SAMPLE DESCRIPTION: **CLAYSTONE, SANDY**
 NOTE: **SAMPLE WAS INUNDATED WITH WATER AT 1,000 PSF**

SAMPLE LOCATION: **D-42 @ 4 FT**
 NATURAL DRY UNIT WEIGHT: **PCF**
 NATURAL MOISTURE CONTENT: **14.0%**
 PERCENT SWELL/COMPRESSION: **6.5**

The noted moisture values have been corrected. The results of the laboratory tests performed on boring D-42 were presented in the previous report referenced above.

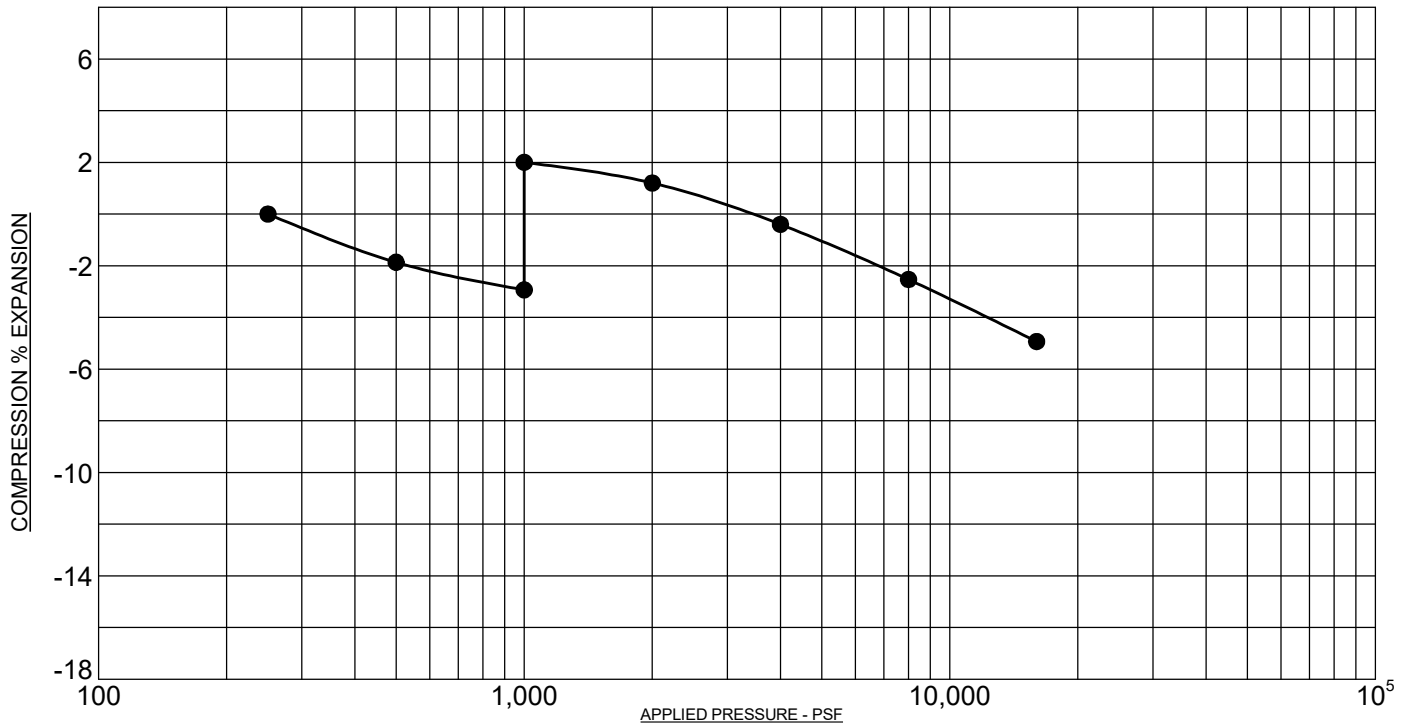
PROJECT: **The Ridge at Lorson Ranch El Paso County, Colorado**
 SAMPLE DESCRIPTION: **CLAYSTONE, SANDY**
 NOTE: **SAMPLE WAS INUNDATED WITH WATER AT 1,000 PSF**

SAMPLE LOCATION: **D-43 @ 9 FT**
 NATURAL DRY UNIT WEIGHT: **PCF**
 NATURAL MOISTURE CONTENT: **13.5%**
 PERCENT SWELL/COMPRESSION: **4.9**

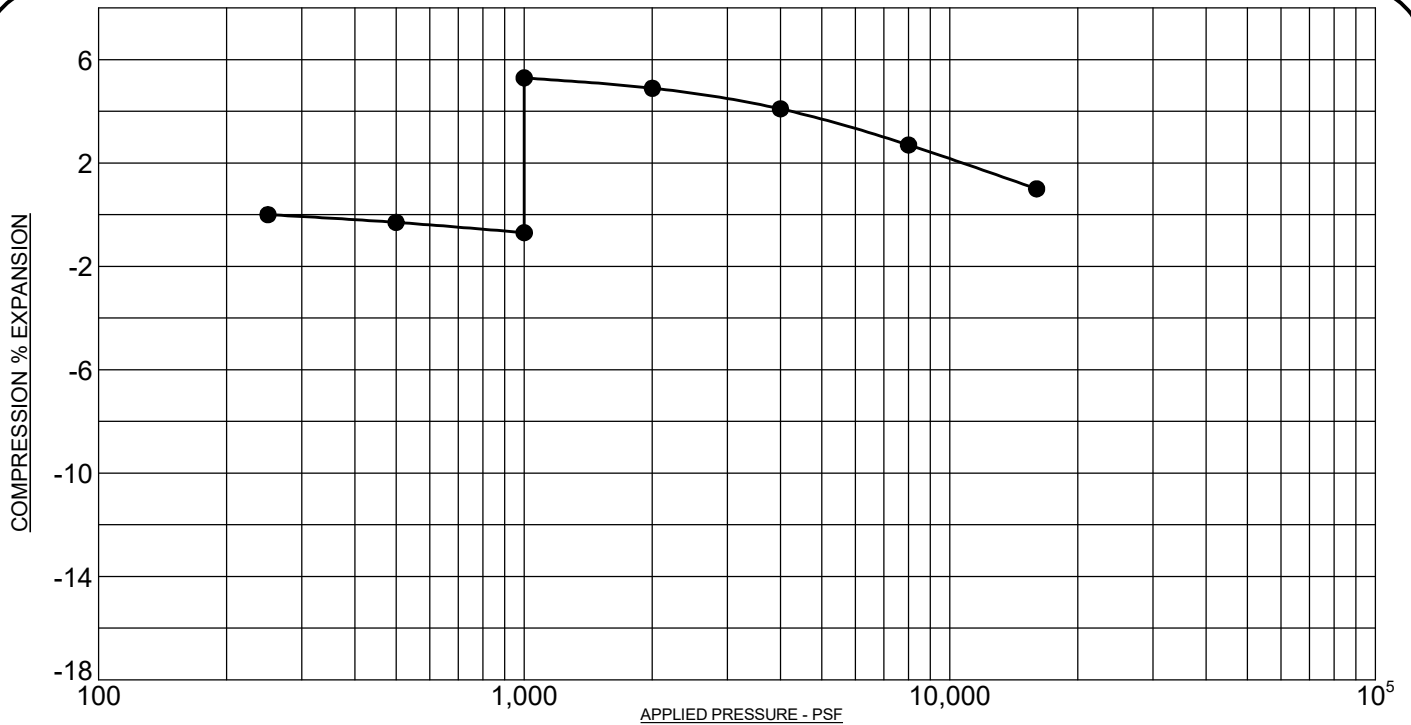
FIGURE No. 99

PROJECT: **The Ridge at Lorson Ranch El Paso County, Colorado**
 SAMPLE DESCRIPTION: **CLAYSTONE, SANDY**
 NOTE: **SAMPLE WAS INUNDATED WITH WATER AT 1,000 PSF**

SAMPLE LOCATION: **D-44 @ 4 FT**
 NATURAL DRY UNIT WEIGHT: **PCF**
 NATURAL MOISTURE CONTENT: **11.7%**
 PERCENT SWELL/COMPRESSION: **6.0**

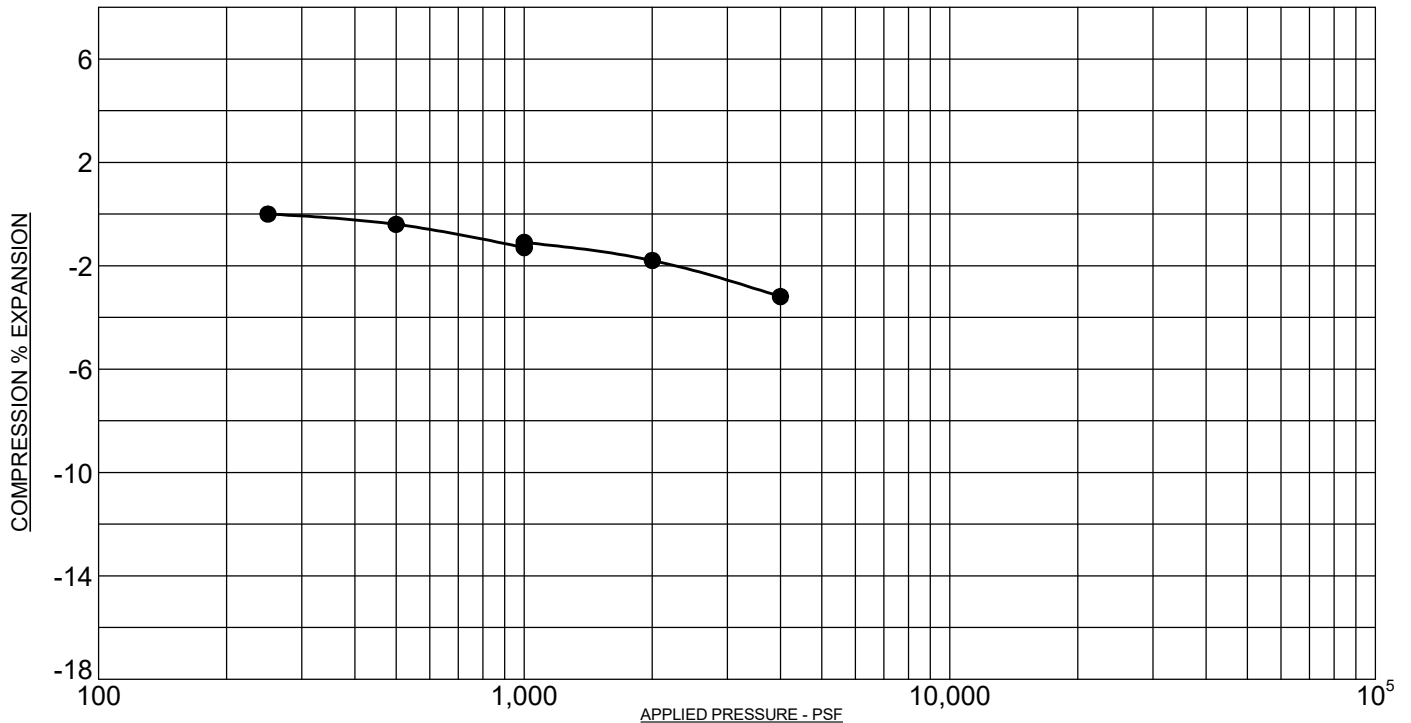
PROJECT: **The Ridge at Lorson Ranch El Paso County, Colorado**
 SAMPLE DESCRIPTION: **CLAYSTONE, SANDY**
 NOTE: **SAMPLE WAS INUNDATED WITH WATER AT 1,000 PSF**

SAMPLE LOCATION: **D-45 @ 24 FT**
 NATURAL DRY UNIT WEIGHT: **79.0 PCF**
 NATURAL MOISTURE CONTENT: **16.2%**
 PERCENT SWELL/COMPRESSION: **0.2**

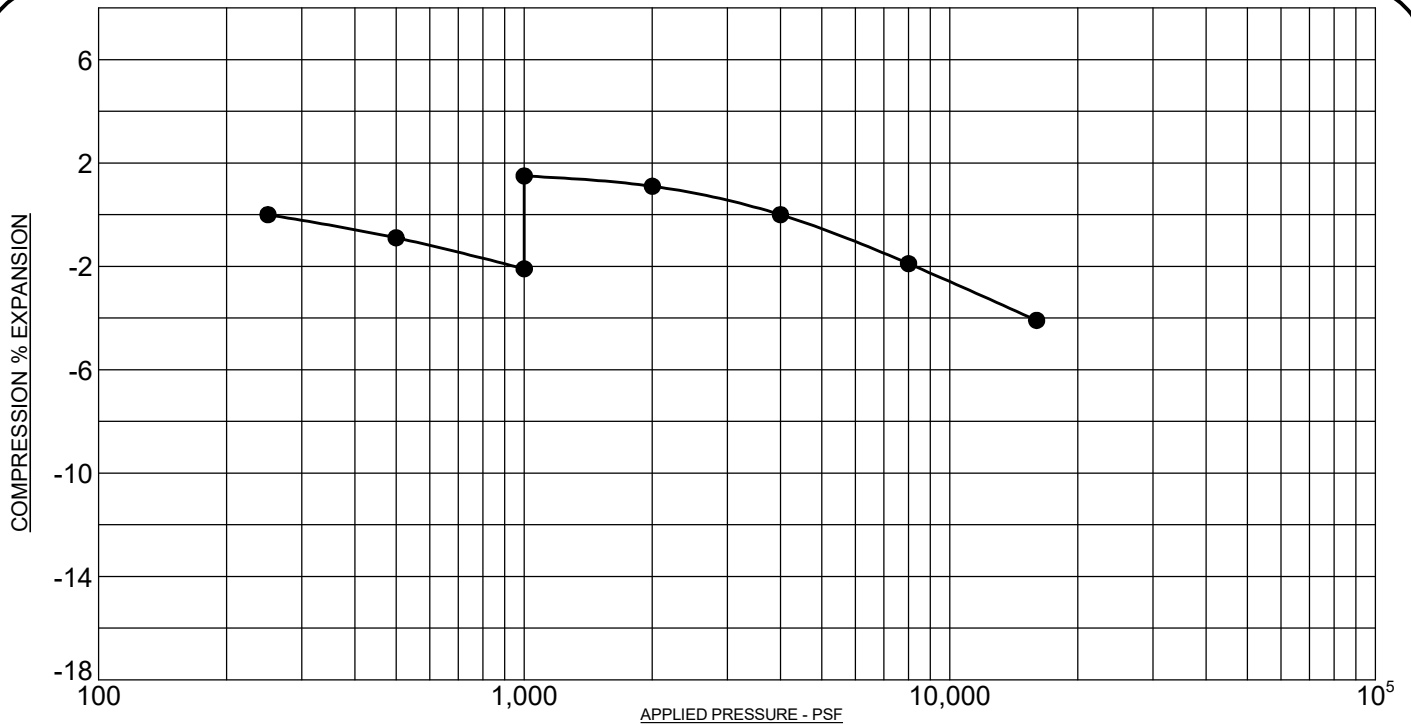
FIGURE No. 100

PROJECT: **The Ridge at Lorson Ranch El Paso County, Colorado**
 SAMPLE DESCRIPTION: **CLAYSTONE, SANDY**
 NOTE: **SAMPLE WAS INUNDATED WITH WATER AT 1,000 PSF**

SAMPLE LOCATION: **D-46 @ 9 FT**
 NATURAL DRY UNIT WEIGHT: **119.7 PCF**
 NATURAL MOISTURE CONTENT: **9.7%**
 PERCENT SWELL/COMPRESSION: **3.6**

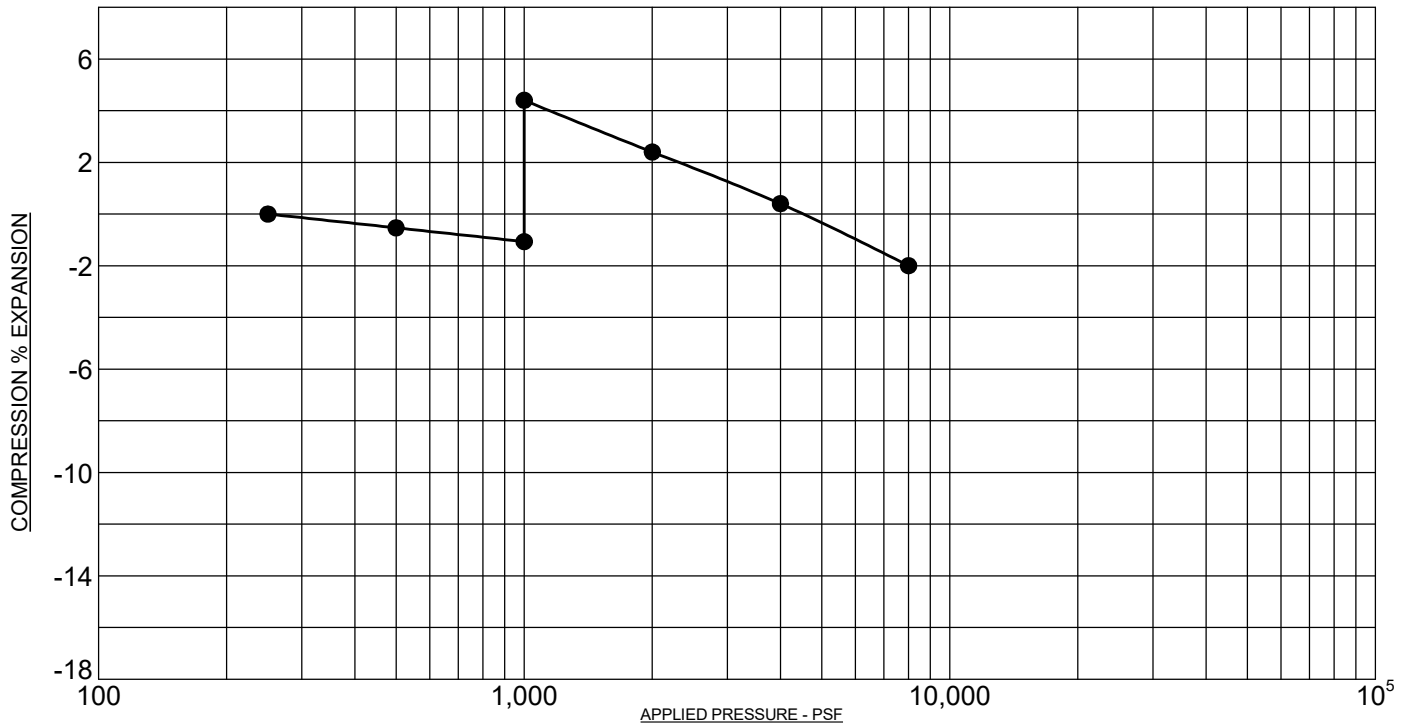
PROJECT: **The Ridge at Lorson Ranch El Paso County, Colorado**
 SAMPLE DESCRIPTION: **CLAYSTONE, SANDY**
 NOTE: **SAMPLE WAS INUNDATED WITH WATER AT 1,000 PSF**

SAMPLE LOCATION: **D-47 @ 19 FT**
 NATURAL DRY UNIT WEIGHT: **116.2 PCF**
 NATURAL MOISTURE CONTENT: **16.4%**
 PERCENT SWELL/COMPRESSION: **5.5**

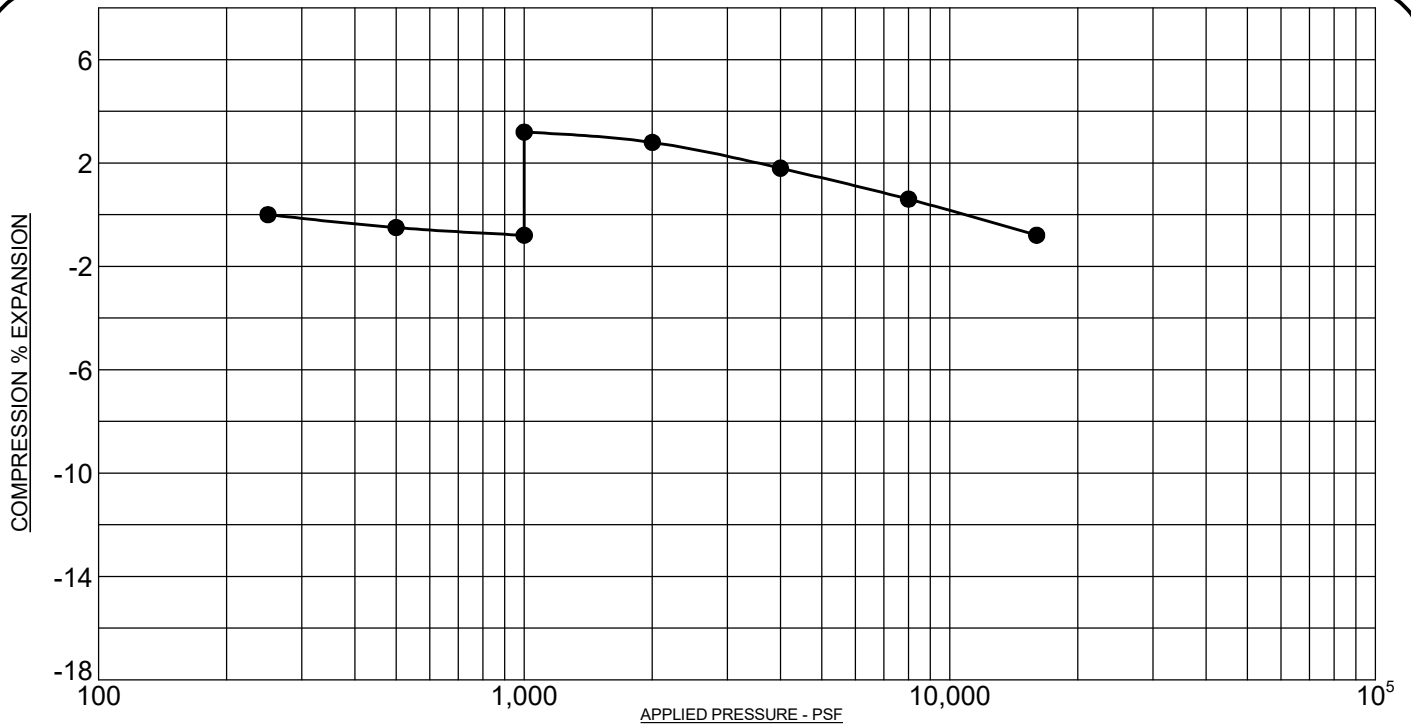
FIGURE No. 101

PROJECT: **The Ridge at Lorson Ranch El Paso County, Colorado**
 SAMPLE DESCRIPTION: **CLAYSTONE, SANDY**
 NOTE: **SAMPLE WAS INUNDATED WITH WATER AT 1,000 PSF**

SAMPLE LOCATION: **D-48 @ 14 FT**
 NATURAL DRY UNIT WEIGHT: **117.7 PCF**
 NATURAL MOISTURE CONTENT: **11.4%**
 PERCENT SWELL/COMPRESSION: **4.0**

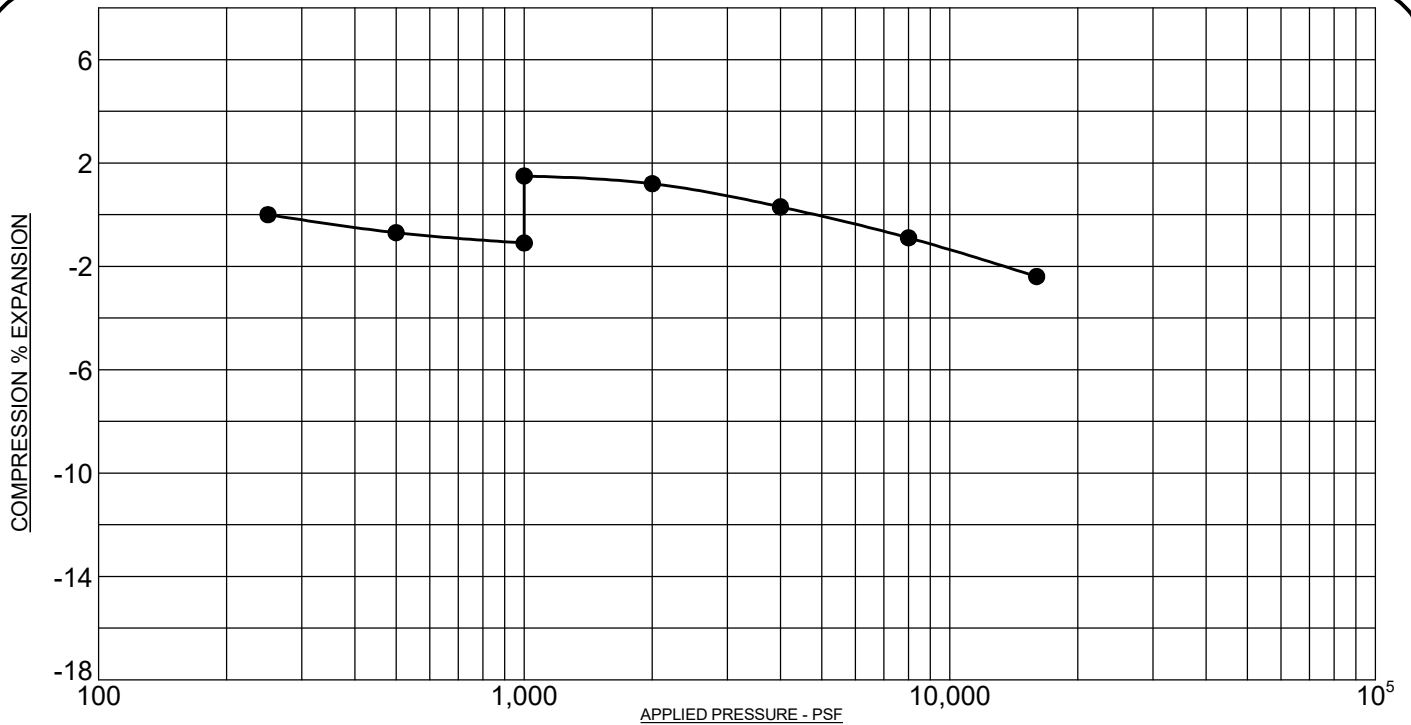
FIGURE No. 102

PROJECT: **The Ridge at Lorson Ranch El Paso County, Colorado**
 SAMPLE DESCRIPTION: **CLAY, SANDY**
 NOTE: **SAMPLE WAS INUNDATED WITH WATER AT 1,000 PSF**

SAMPLE LOCATION: **D-51 @ 14 FT**
 NATURAL DRY UNIT WEIGHT: **121.8 PCF**
 NATURAL MOISTURE CONTENT: **12.1%**
 PERCENT SWELL/COMPRESSION: **2.6**

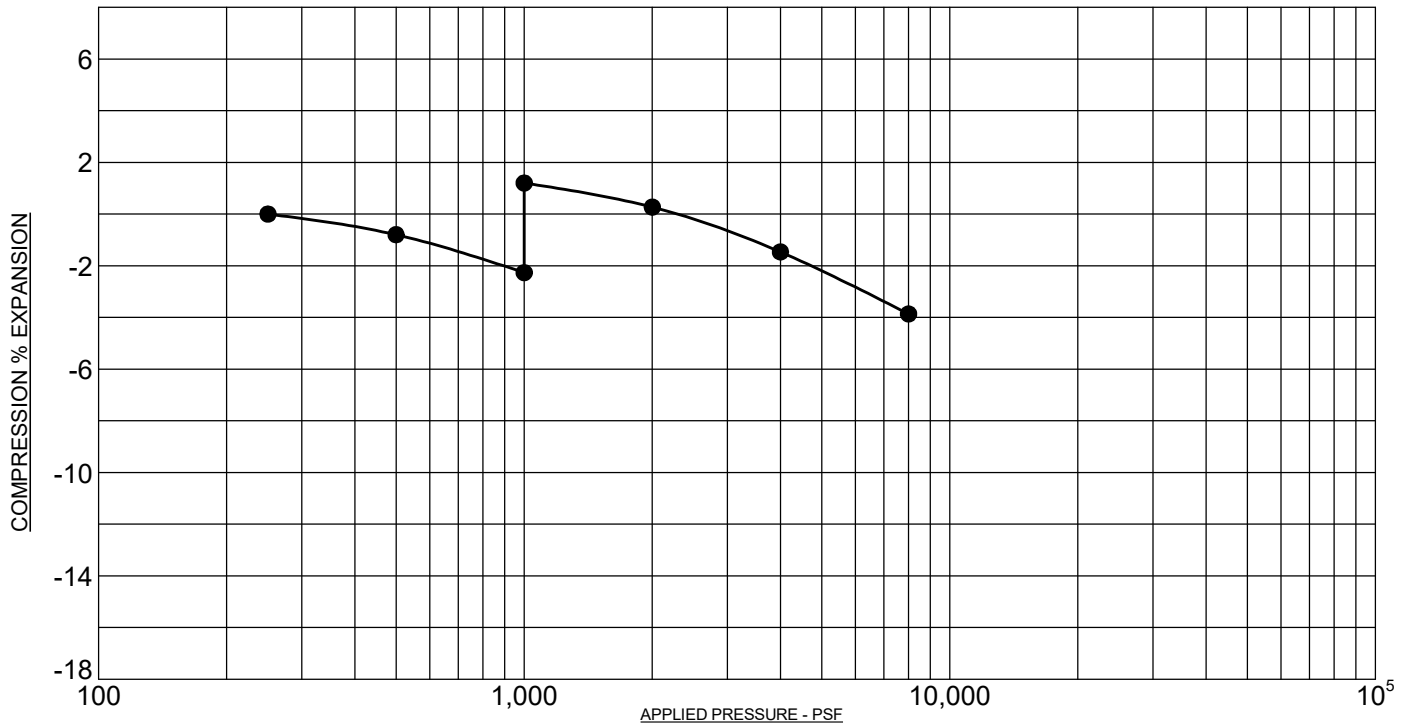
PROJECT: **The Ridge at Lorson Ranch El Paso County, Colorado**
 SAMPLE DESCRIPTION: **CLAY, SANDY**
 NOTE: **SAMPLE WAS INUNDATED WITH WATER AT 1,000 PSF**

SAMPLE LOCATION: **D-52 @ 9 FT**
 NATURAL DRY UNIT WEIGHT: **126.0 PCF**
 NATURAL MOISTURE CONTENT: **10.2%**
 PERCENT SWELL/COMPRESSION: **3.5**

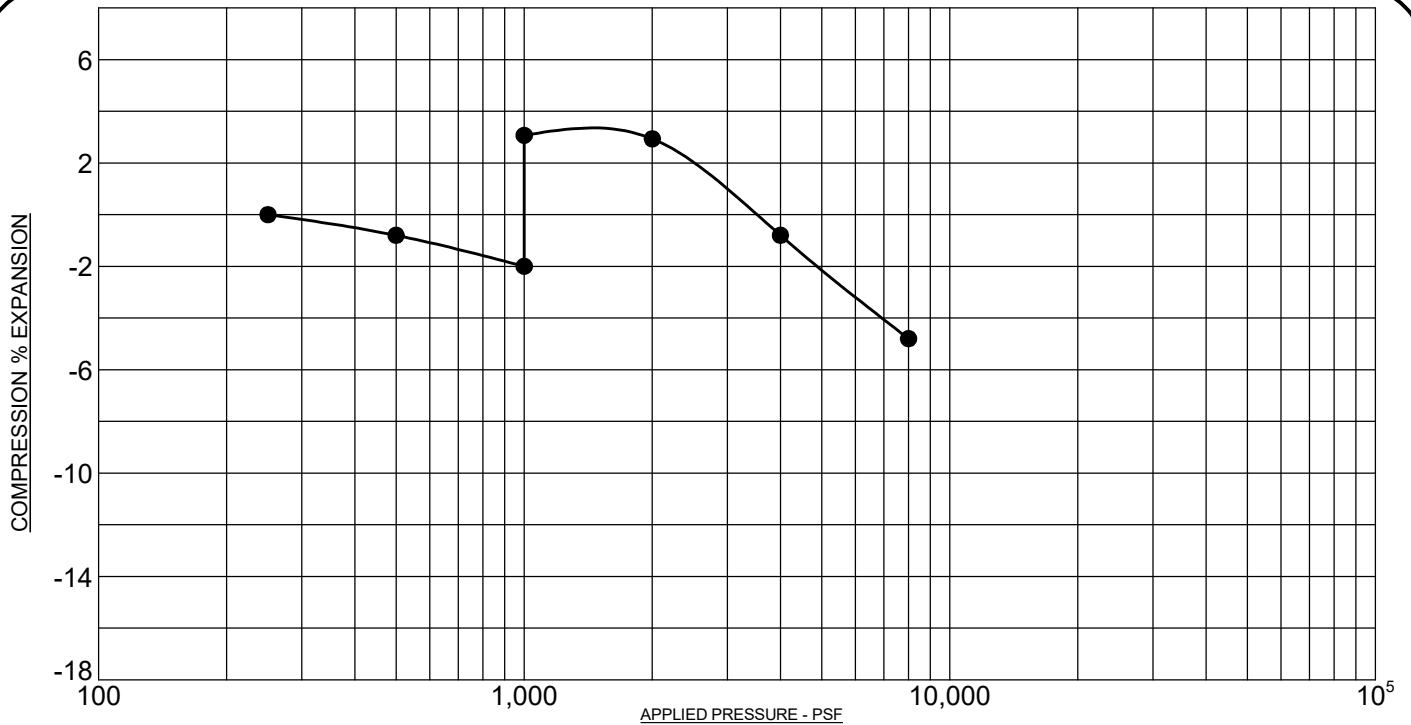
FIGURE No. 103

PROJECT: **The Ridge at Lorson Ranch El Paso County, Colorado**
 SAMPLE DESCRIPTION: **CLAY, SANDY**
 NOTE: **SAMPLE WAS INUNDATED WITH WATER AT 1,000 PSF**

SAMPLE LOCATION: **D-53 @ 4 FT**
 NATURAL DRY UNIT WEIGHT: **109.9 PCF**
 NATURAL MOISTURE CONTENT: **11.3%**
 PERCENT SWELL/COMPRESSION: **5.1**

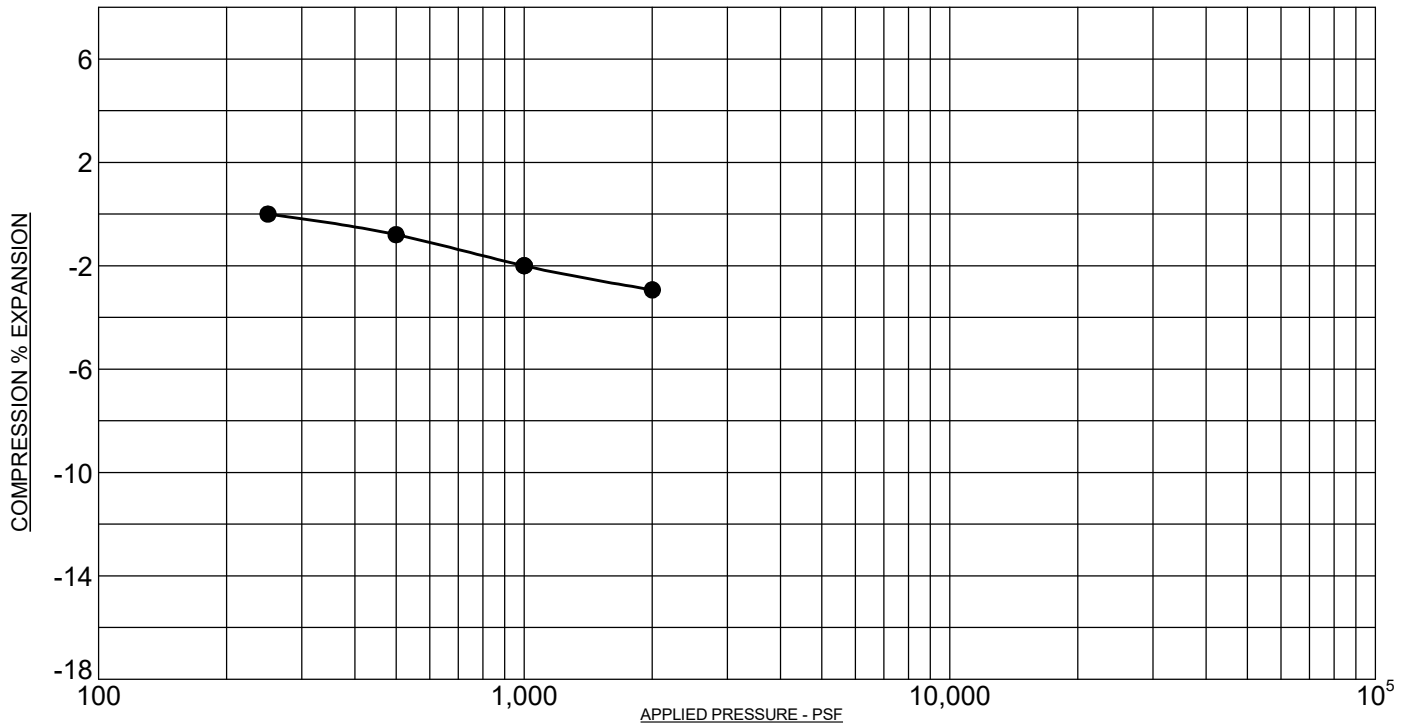
PROJECT: **The Ridge at Lorson Ranch El Paso County, Colorado**
 SAMPLE DESCRIPTION: **CLAY, SANDY**
 NOTE: **SAMPLE WAS INUNDATED WITH WATER AT 1,000 PSF**

SAMPLE LOCATION: **D-54 @ FT**
 NATURAL DRY UNIT WEIGHT: **105.9 PCF**
 NATURAL MOISTURE CONTENT: **19.6%**
 PERCENT SWELL/COMPRESSION: **0.0**

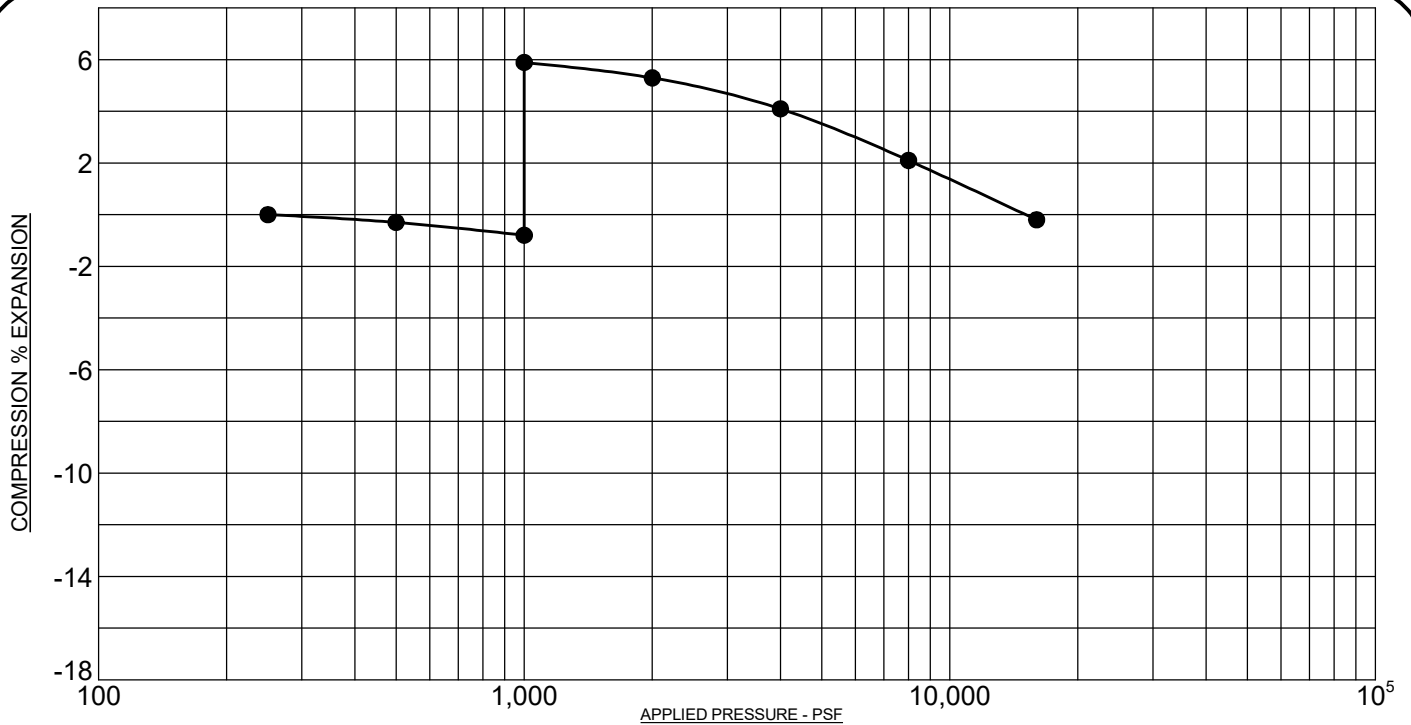
FIGURE No. 104

PROJECT: **The Ridge at Lorson Ranch El Paso County, Colorado**
 SAMPLE DESCRIPTION: **CLAYSTONE, SANDY**
 NOTE: **SAMPLE WAS INUNDATED WITH WATER AT 1,000 PSF**

SAMPLE LOCATION: **D-55 @ 9 FT**
 NATURAL DRY UNIT WEIGHT: **110.8 PCF**
 NATURAL MOISTURE CONTENT: **15.8%**
 PERCENT SWELL/COMPRESSION: **6.7**

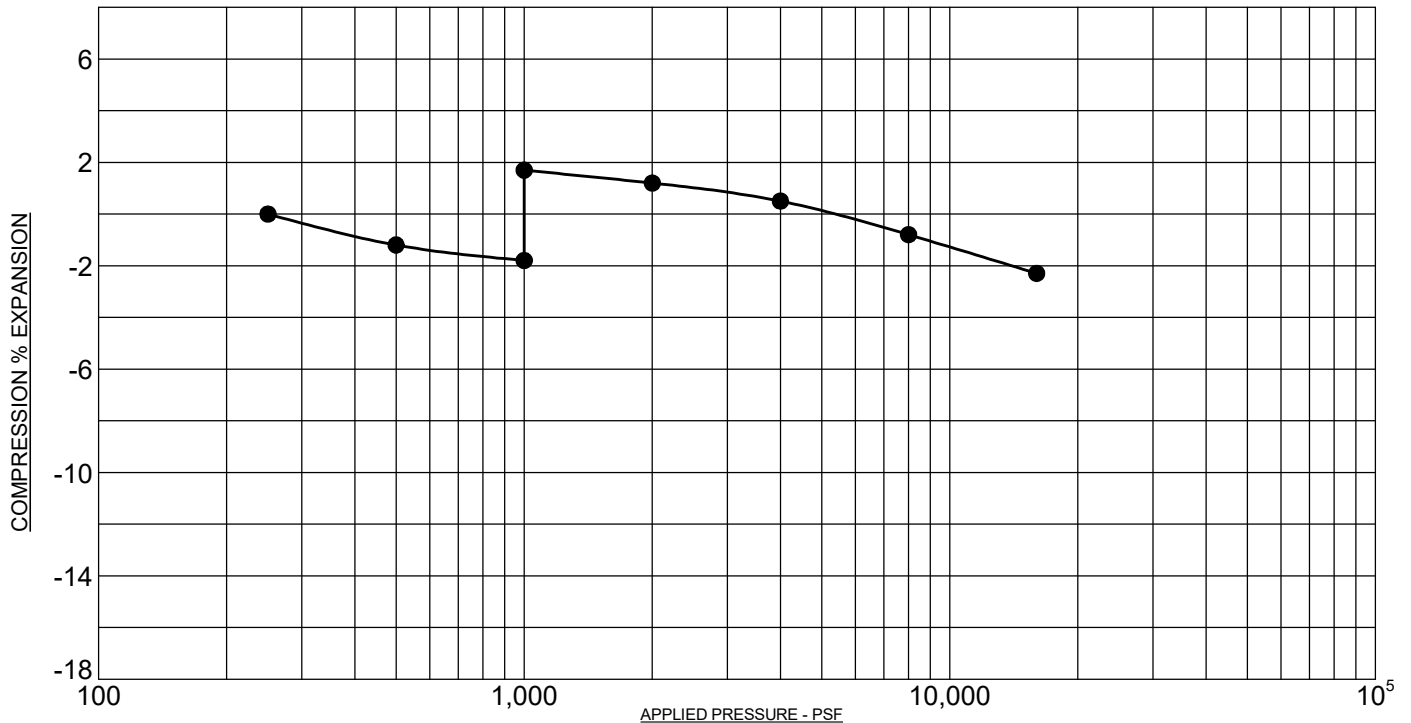
PROJECT: **The Ridge at Lorson Ranch El Paso County, Colorado**
 SAMPLE DESCRIPTION: **CLAYSTONE, SANDY**
 NOTE: **SAMPLE WAS INUNDATED WITH WATER AT 1,000 PSF**

SAMPLE LOCATION: **D-56 @ 9 FT**
 NATURAL DRY UNIT WEIGHT: **121.4 PCF**
 NATURAL MOISTURE CONTENT: **12.9%**
 PERCENT SWELL/COMPRESSION: **3.5**

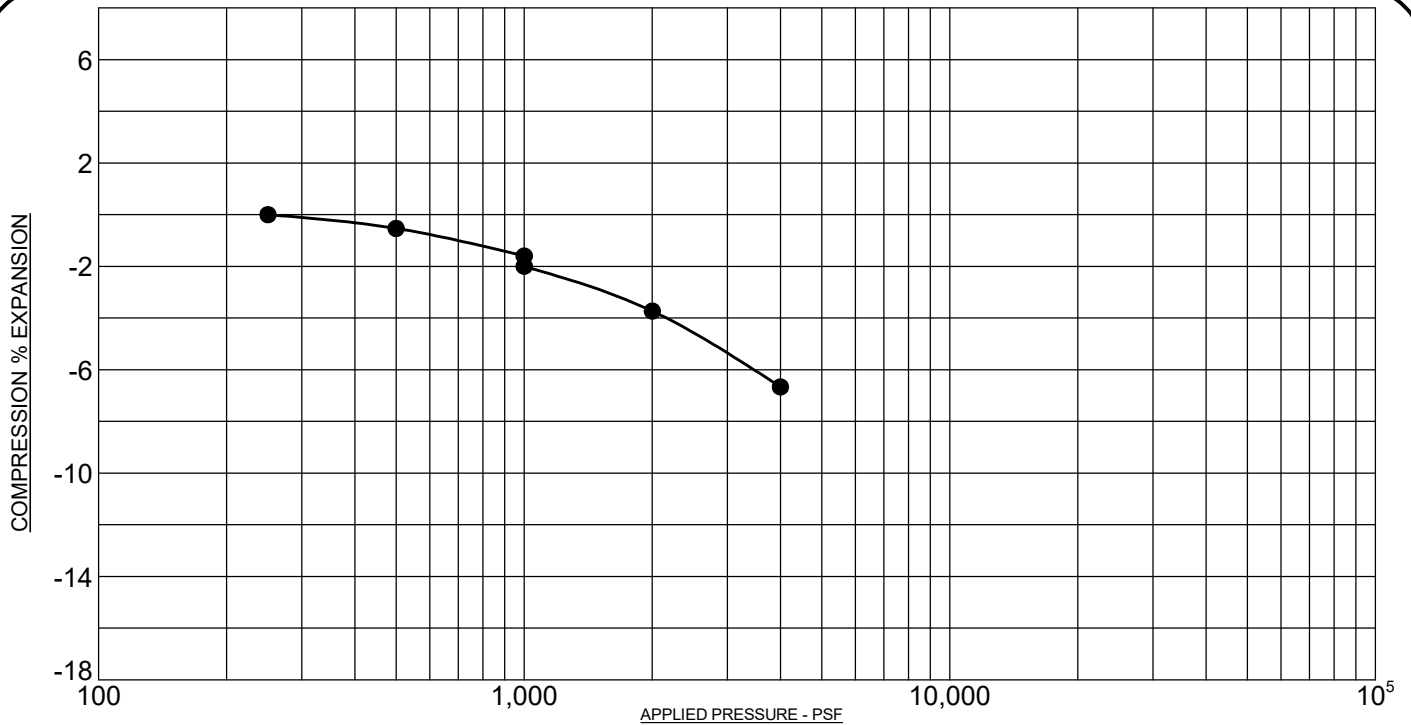
FIGURE No. 105

PROJECT: **The Ridge at Lorson Ranch El Paso County, Colorado**
 SAMPLE DESCRIPTION: **CLAYSTONE, SANDY**
 NOTE: **SAMPLE WAS INUNDATED WITH WATER AT 1,000 PSF**

SAMPLE LOCATION: **D-57 @ 14 FT**
 NATURAL DRY UNIT WEIGHT: **109.4 PCF**
 NATURAL MOISTURE CONTENT: **13.8%**
 PERCENT SWELL/COMPRESSION: **- 0.4**

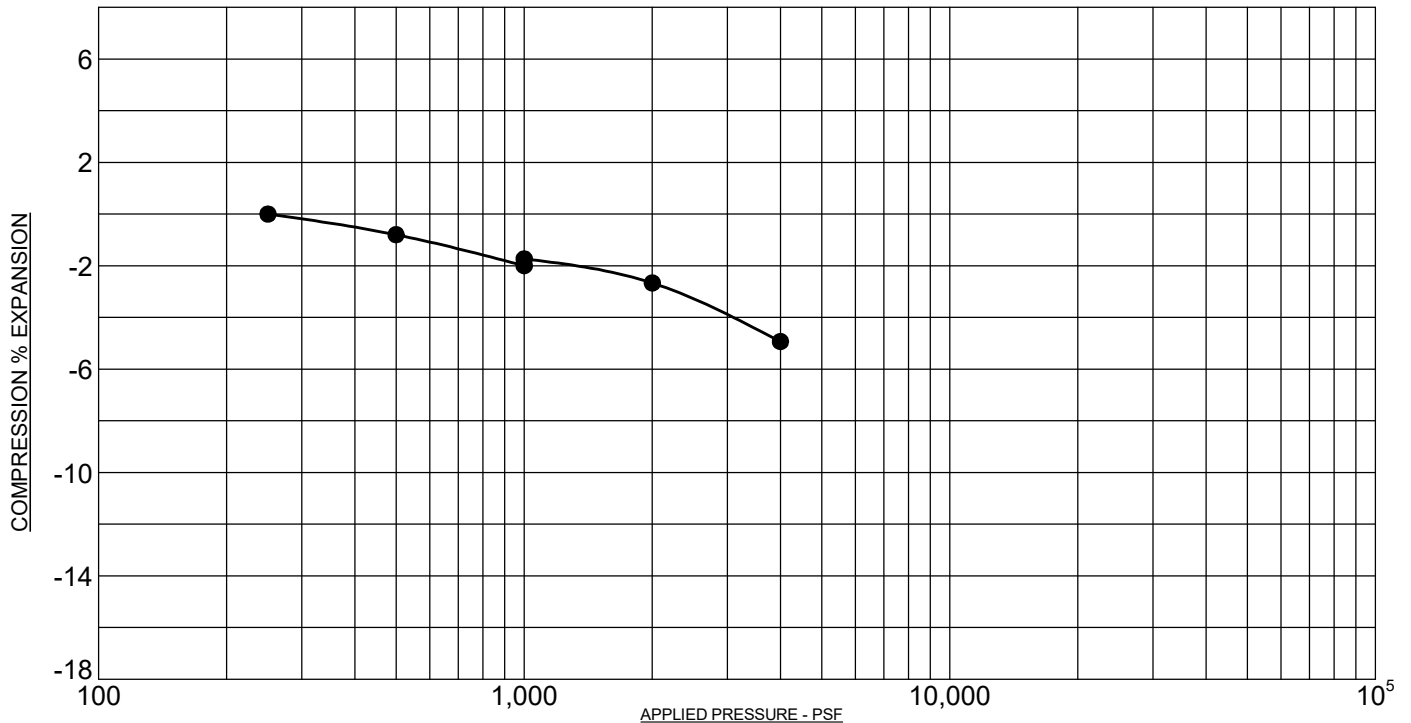
PROJECT: **The Ridge at Lorson Ranch El Paso County, Colorado**
 SAMPLE DESCRIPTION: **CLAYSTONE, SANDY**
 NOTE: **SAMPLE WAS INUNDATED WITH WATER AT 1,000 PSF**

SAMPLE LOCATION: **D-58 @ 9 FT**
 NATURAL DRY UNIT WEIGHT: **108.0 PCF**
 NATURAL MOISTURE CONTENT: **11.0%**
 PERCENT SWELL/COMPRESSION: **0.3**

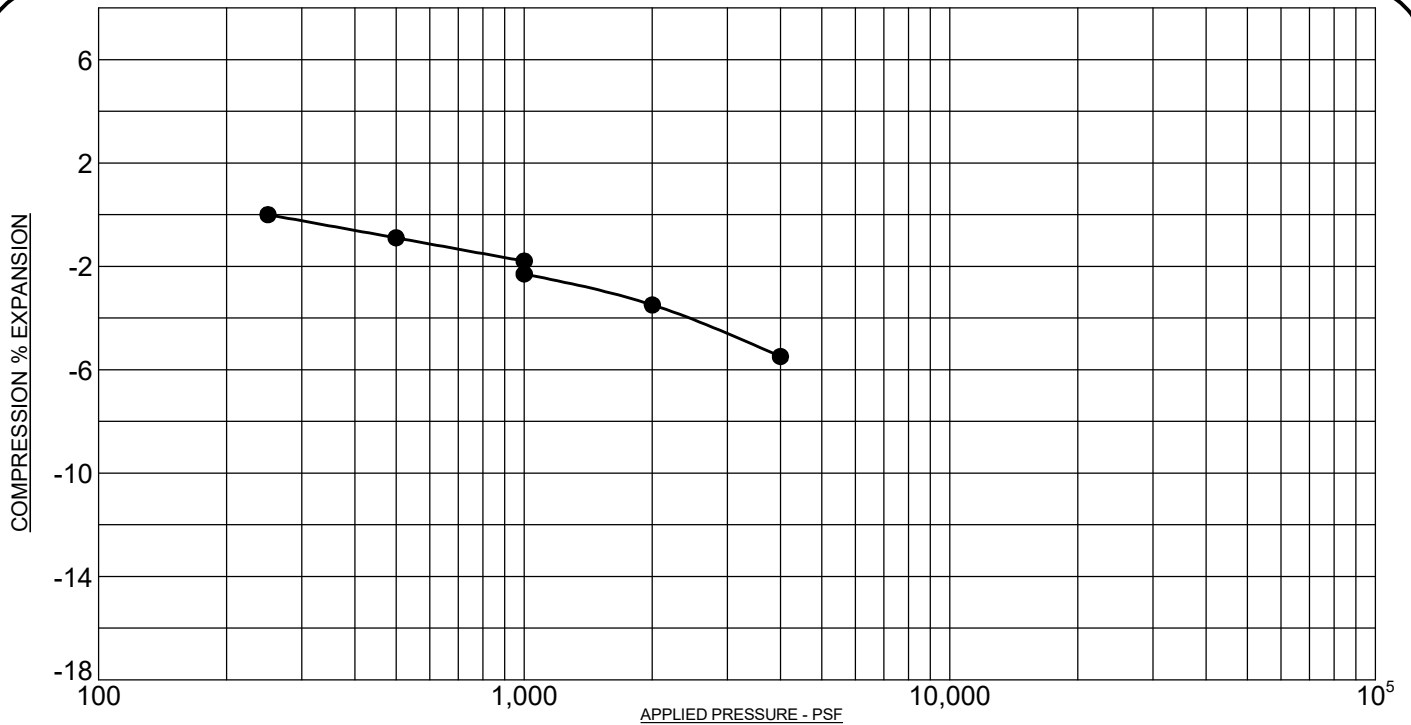
FIGURE No. 106

PROJECT: **The Ridge at Lorson Ranch El Paso County, Colorado**
 SAMPLE DESCRIPTION: **CLAYSTONE, SANDY**
 NOTE: **SAMPLE WAS INUNDATED WITH WATER AT 1,000 PSF**

SAMPLE LOCATION: **D-59 @ 4 FT**
 NATURAL DRY UNIT WEIGHT: **107.5 PCF**
 NATURAL MOISTURE CONTENT: **11.1%**
 PERCENT SWELL/COMPRESSION: **- 0.5**
