**ROCKY MOUNTAIN GROUP
EMPLOYEE OWNED**

Job No. 175706

Re: Response to Colorado Geological Survey and El Paso County Review Comments
The Ridge at Lorson Ranch
Fontaine Bl
The Ridge at Lorson Ranch
El Paso County, Colorado

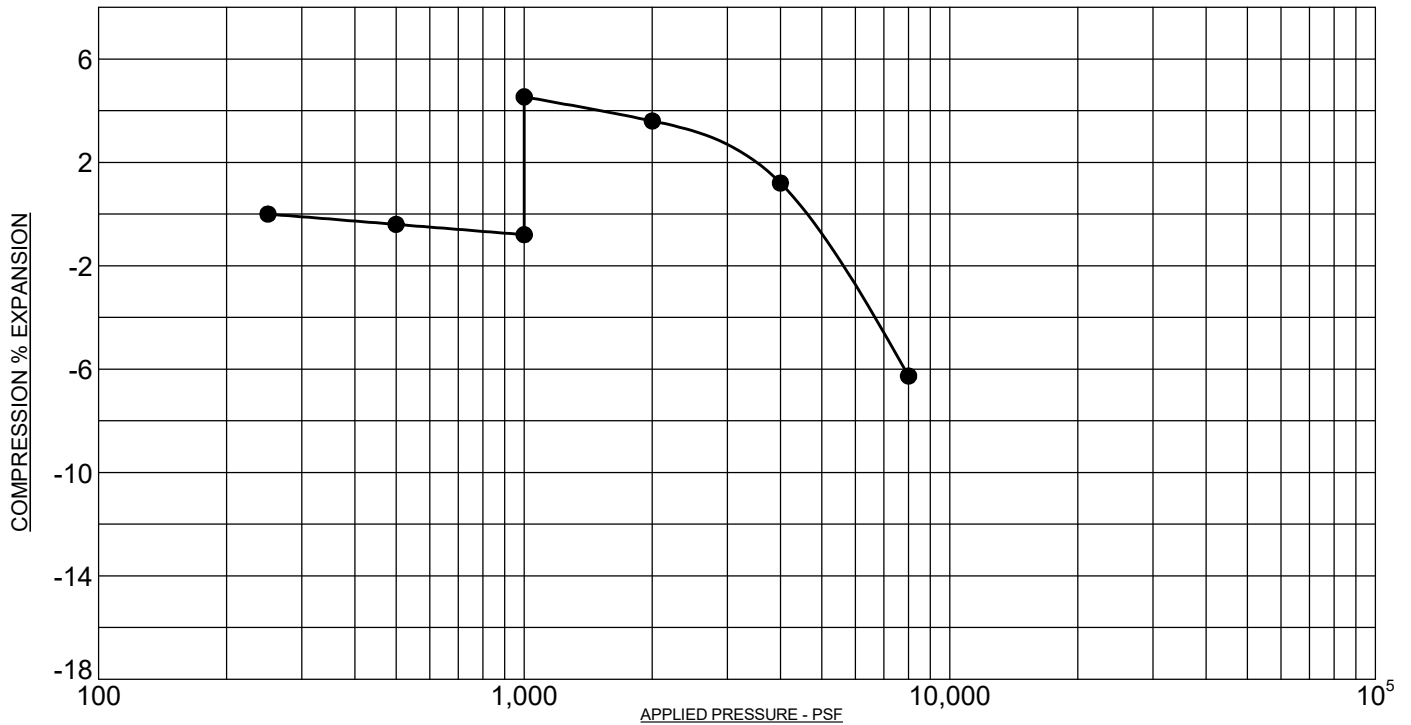
PROJECT: **The Ridge at Lorson Ranch El Paso County, Colorado**
 SAMPLE DESCRIPTION: **CLAYSTONE, SANDY**
 NOTE: **SAMPLE WAS INUNDATED WITH WATER AT 1,000 PSF**

SAMPLE LOCATION: **D-60 @ 9 FT**
 NATURAL DRY UNIT WEIGHT: **116.2 PCF**
 NATURAL MOISTURE CONTENT: **11.6%**
 PERCENT SWELL/COMPRESSION: **5.3**

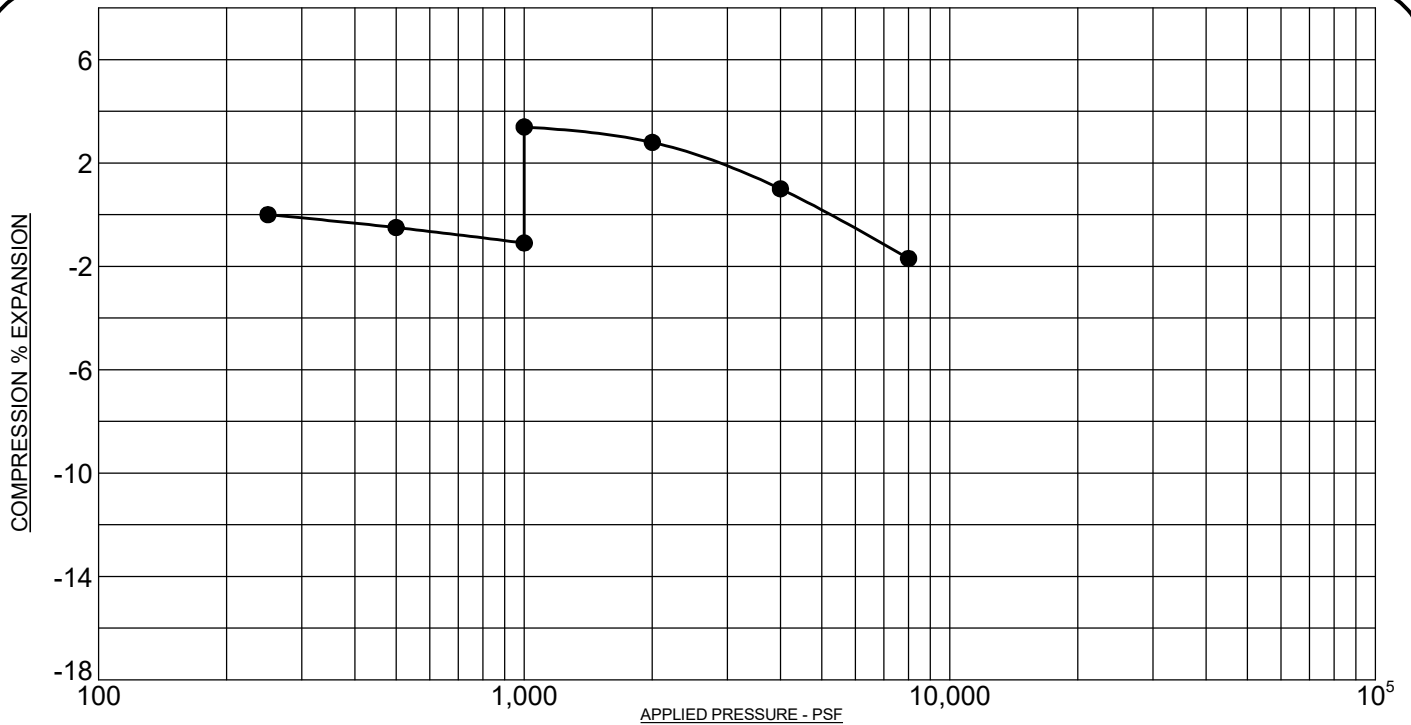
FIGURE No. 107

PROJECT: **The Ridge at Lorson Ranch El Paso County, Colorado**
 SAMPLE DESCRIPTION: **CLAYSTONE, SANDY**
 NOTE: **SAMPLE WAS INUNDATED WITH WATER AT 1,000 PSF**

SAMPLE LOCATION: **D-61 @ 4 FT**
 NATURAL DRY UNIT WEIGHT: **106.6 PCF**
 NATURAL MOISTURE CONTENT: **14.1%**
 PERCENT SWELL/COMPRESSION: **4.5**

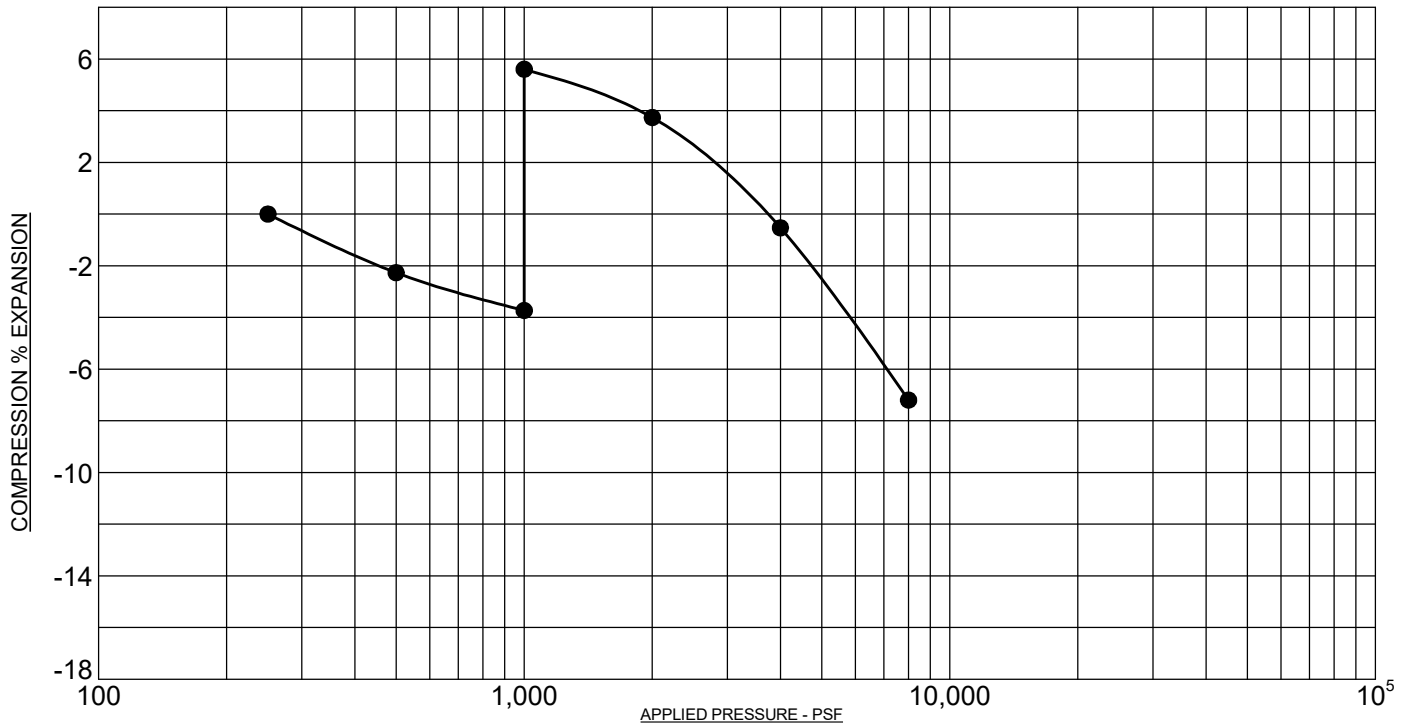
PROJECT: **The Ridge at Lorson Ranch El Paso County, Colorado**
 SAMPLE DESCRIPTION: **CLAYSTONE, SANDY**
 NOTE: **SAMPLE WAS INUNDATED WITH WATER AT 1,000 PSF**

SAMPLE LOCATION: **D-62 @ 14 FT**
 NATURAL DRY UNIT WEIGHT: **121.0 PCF**
 NATURAL MOISTURE CONTENT: **13.5%**
 PERCENT SWELL/COMPRESSION: **9.3**

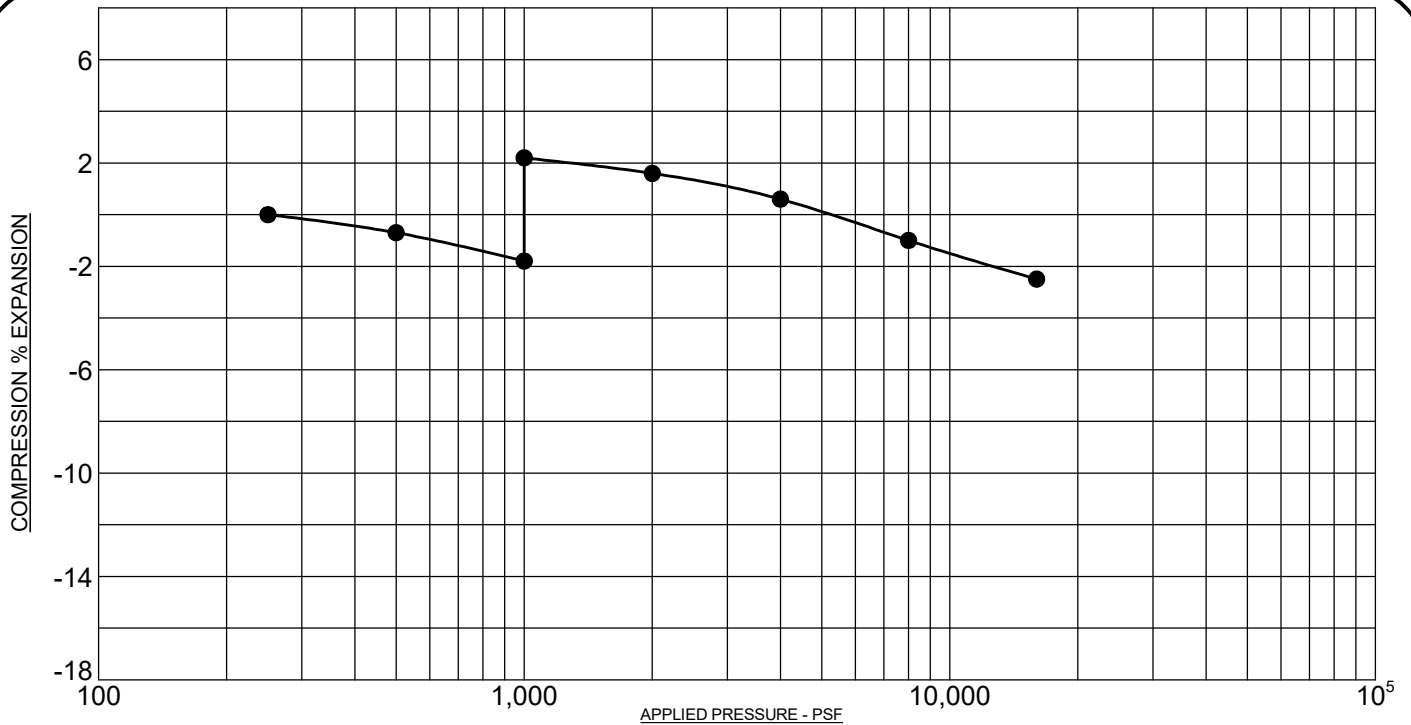
FIGURE No. 108

PROJECT: **The Ridge at Lorson Ranch El Paso County, Colorado**
 SAMPLE DESCRIPTION: **CLAYSTONE, SANDY**
 NOTE: **SAMPLE WAS INUNDATED WITH WATER AT 1,000 PSF**

SAMPLE LOCATION: **D-63 @ 9 FT**
 NATURAL DRY UNIT WEIGHT: **124.2 PCF**
 NATURAL MOISTURE CONTENT: **9.8%**
 PERCENT SWELL/COMPRESSION: **4.0**

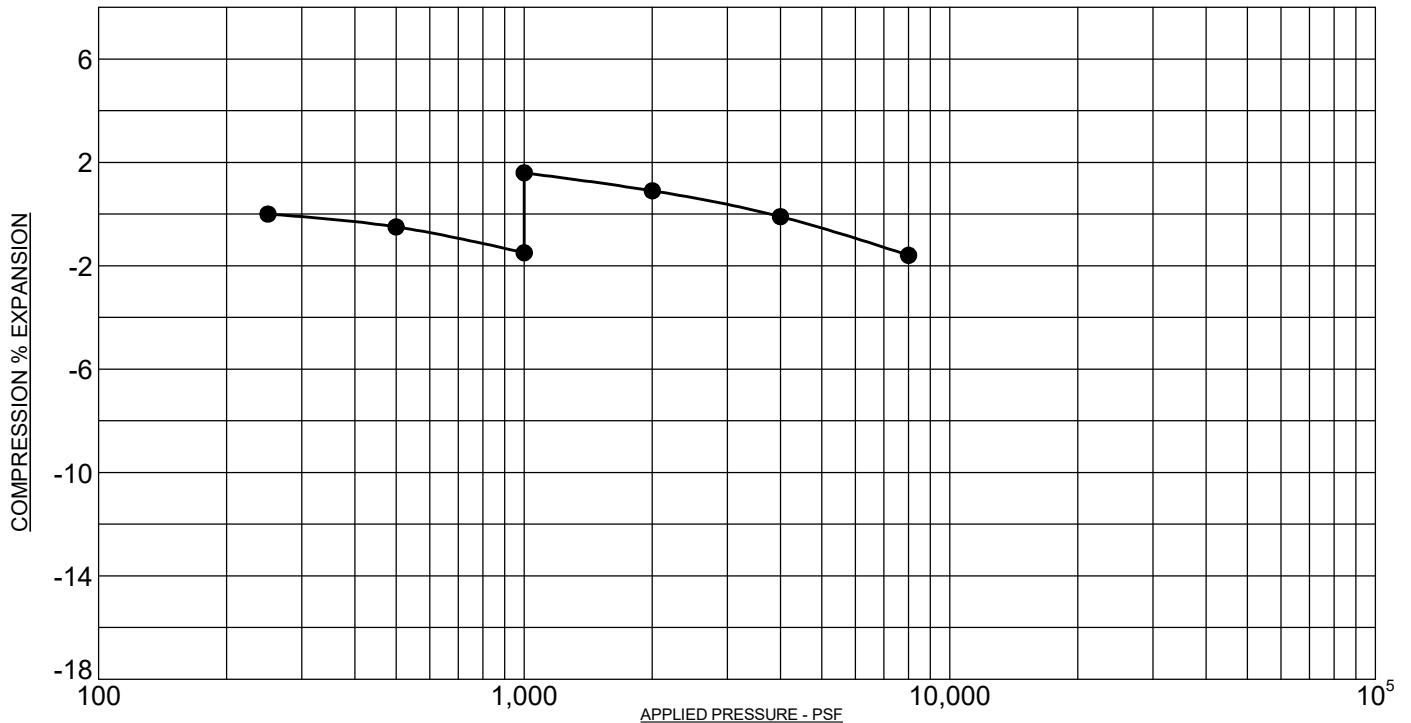
PROJECT: **The Ridge at Lorson Ranch El Paso County, Colorado**
 SAMPLE DESCRIPTION: **CLAYSTONE, SANDY**
 NOTE: **SAMPLE WAS INUNDATED WITH WATER AT 1,000 PSF**

SAMPLE LOCATION: **D-65 @ 14 FT**
 NATURAL DRY UNIT WEIGHT: **82.8 PCF**
 NATURAL MOISTURE CONTENT: **18.9%**
 PERCENT SWELL/COMPRESSION: **3.1**

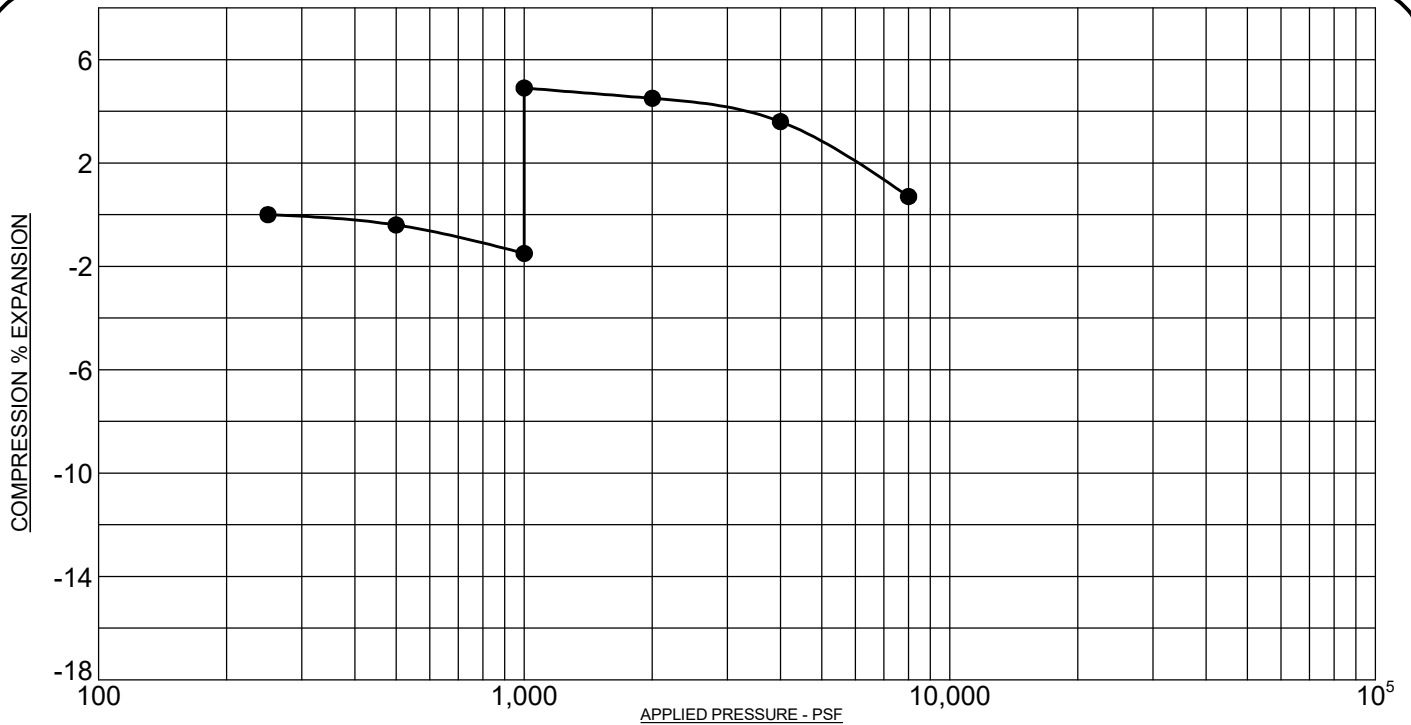
FIGURE No. 109

PROJECT: **The Ridge at Lorson Ranch El Paso County, Colorado**
 SAMPLE DESCRIPTION: **CLAY, SANDY**
 NOTE: **SAMPLE WAS INUNDATED WITH WATER AT 1,000 PSF**

SAMPLE LOCATION: **D-66 @ 4 FT**
 NATURAL DRY UNIT WEIGHT: **114.1 PCF**
 NATURAL MOISTURE CONTENT: **11.6%**
 PERCENT SWELL/COMPRESSION: **6.4**

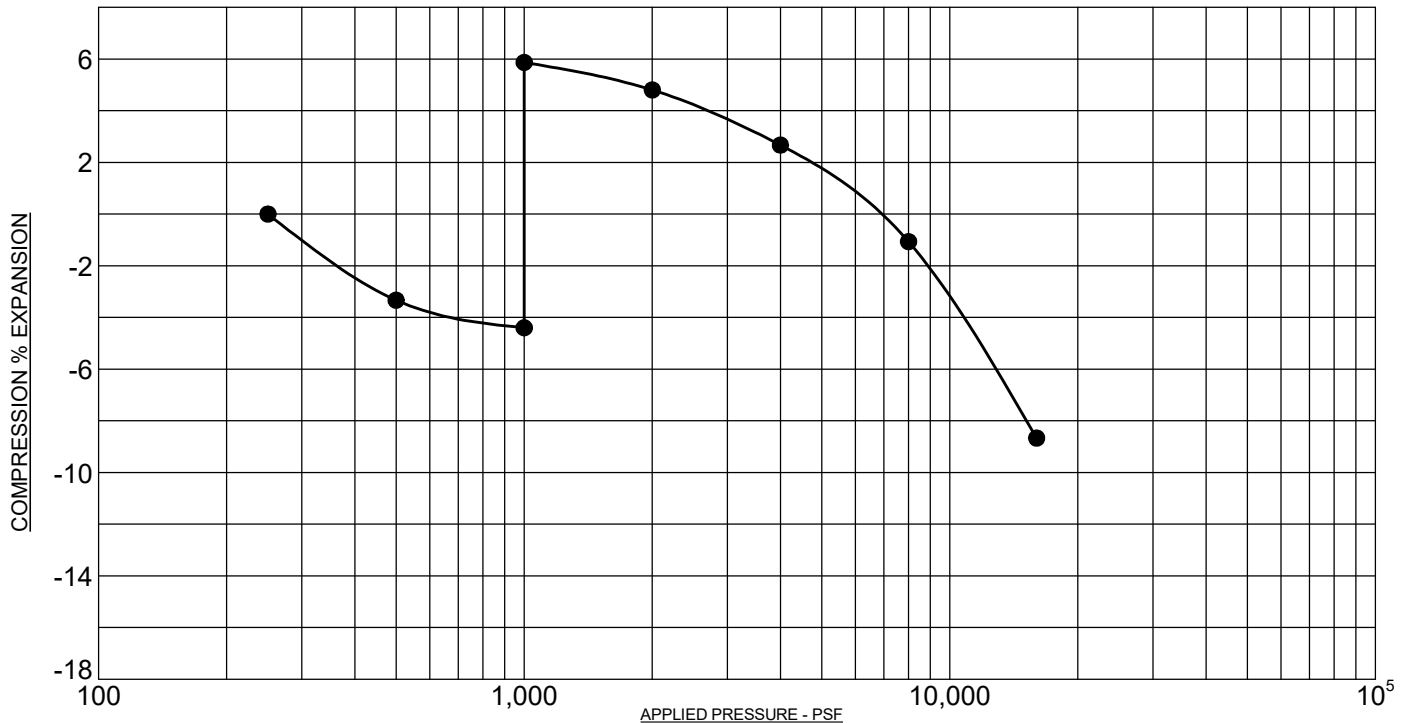
PROJECT: **The Ridge at Lorson Ranch El Paso County, Colorado**
 SAMPLE DESCRIPTION: **CLAYSTONE, SANDY**
 NOTE: **SAMPLE WAS INUNDATED WITH WATER AT 1,000 PSF**

SAMPLE LOCATION: **D-67 @ 4 FT**
 NATURAL DRY UNIT WEIGHT: **PCF**
 NATURAL MOISTURE CONTENT: **16.6%**
 PERCENT SWELL/COMPRESSION: **10.3**

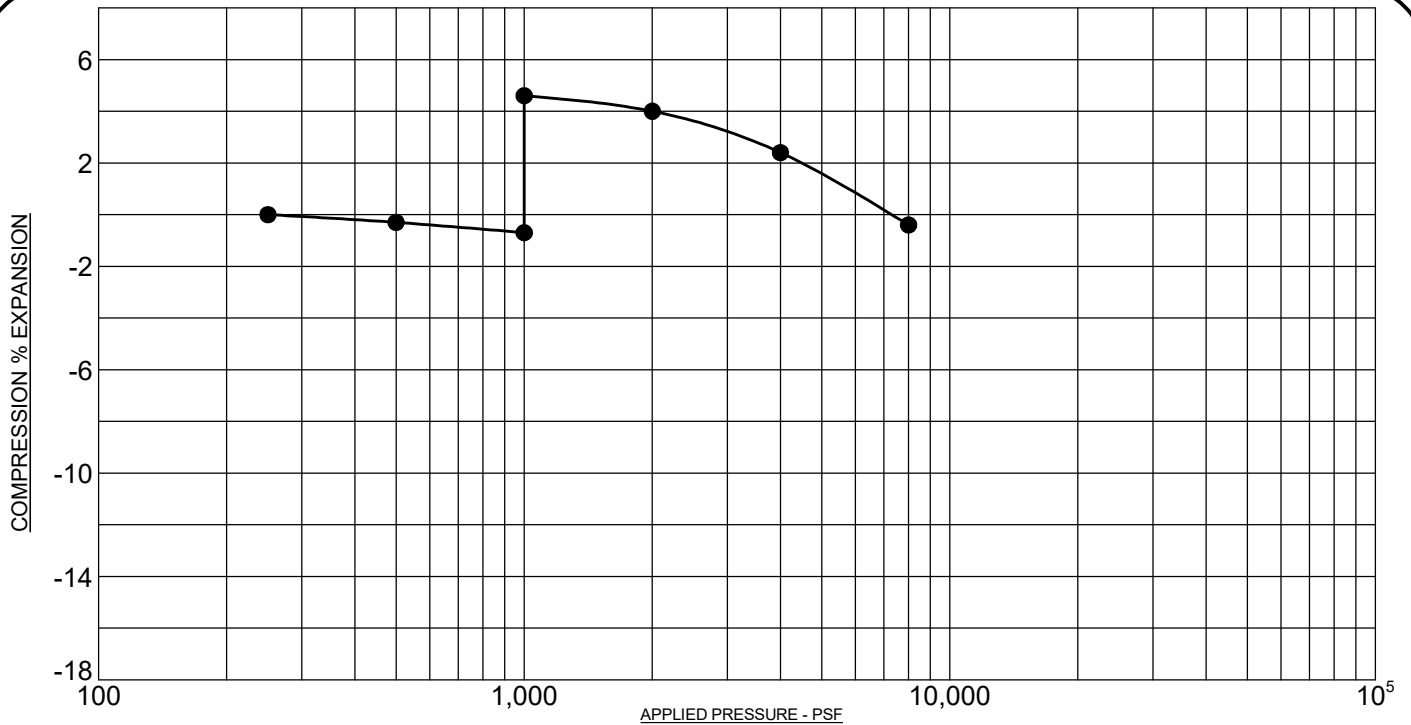
FIGURE No. 110

PROJECT: **The Ridge at Lorson Ranch El Paso County, Colorado**
 SAMPLE DESCRIPTION: **CLAYSTONE, SANDY**
 NOTE: **SAMPLE WAS INUNDATED WITH WATER AT 1,000 PSF**

SAMPLE LOCATION: **D-68 @ 14 FT**
 NATURAL DRY UNIT WEIGHT: **116.0 PCF**
 NATURAL MOISTURE CONTENT: **10.9%**
 PERCENT SWELL/COMPRESSION: **5.3**

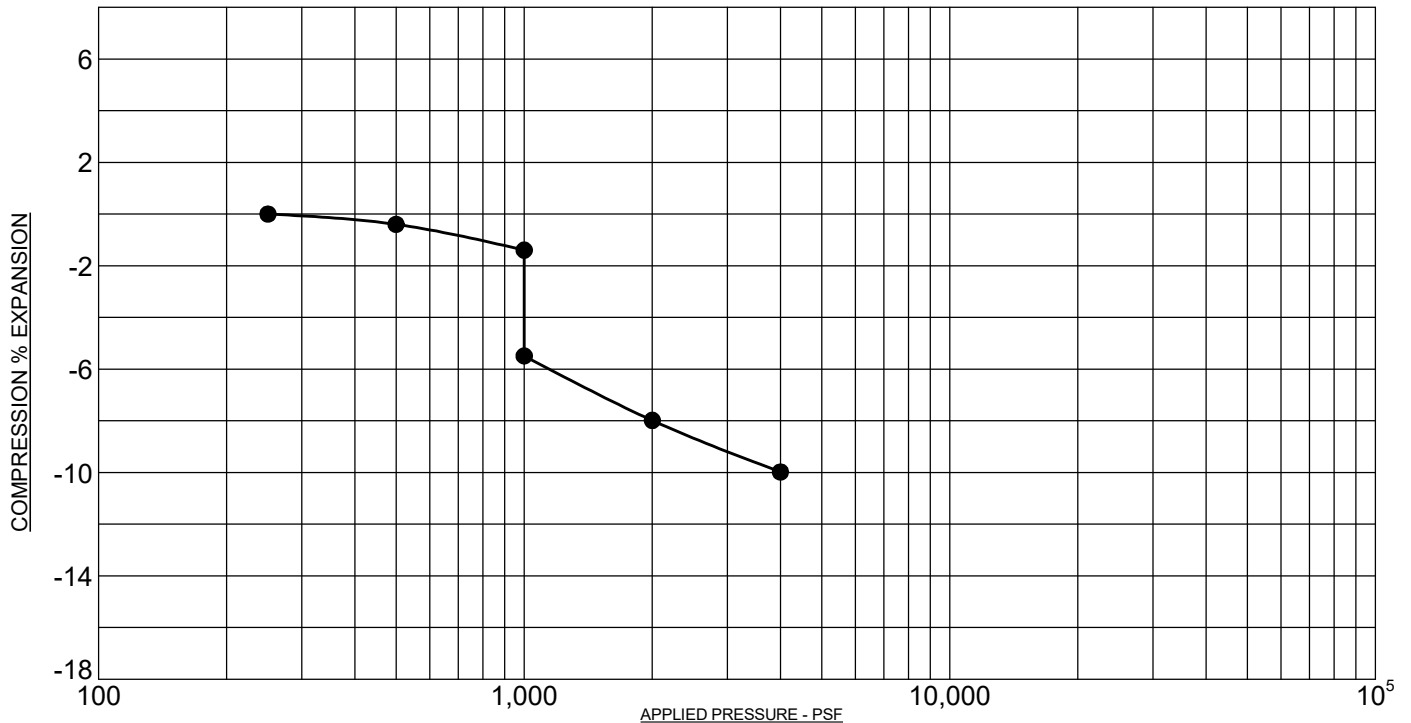
PROJECT: **The Ridge at Lorson Ranch El Paso County, Colorado**
 SAMPLE DESCRIPTION: **CLAYSTONE, SANDY**
 NOTE: **SAMPLE WAS INUNDATED WITH WATER AT 1,000 PSF**

SAMPLE LOCATION: **D-69 @ 14 FT**
 NATURAL DRY UNIT WEIGHT: **PCF**
 NATURAL MOISTURE CONTENT: **9.4%**
 PERCENT SWELL/COMPRESSION: **- 4.1**

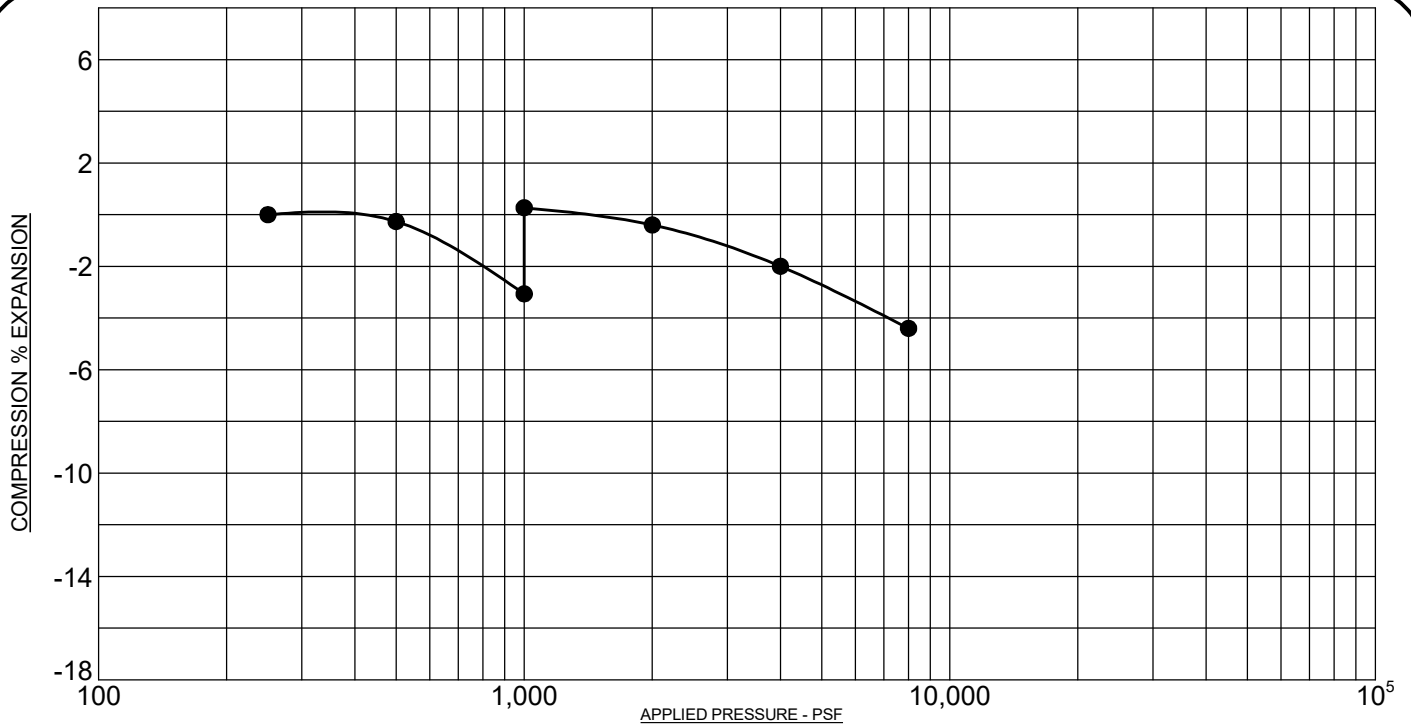
FIGURE No. 111

PROJECT: **The Ridge at Lorson Ranch El Paso County, Colorado**
 SAMPLE DESCRIPTION: **CLAYSTONE, SANDY**
 NOTE: **SAMPLE WAS INUNDATED WITH WATER AT 1,000 PSF**

SAMPLE LOCATION: **D-70 @ 9 FT**
 NATURAL DRY UNIT WEIGHT: **PCF**
 NATURAL MOISTURE CONTENT: **10.8%**
 PERCENT SWELL/COMPRESSION: **3.3**

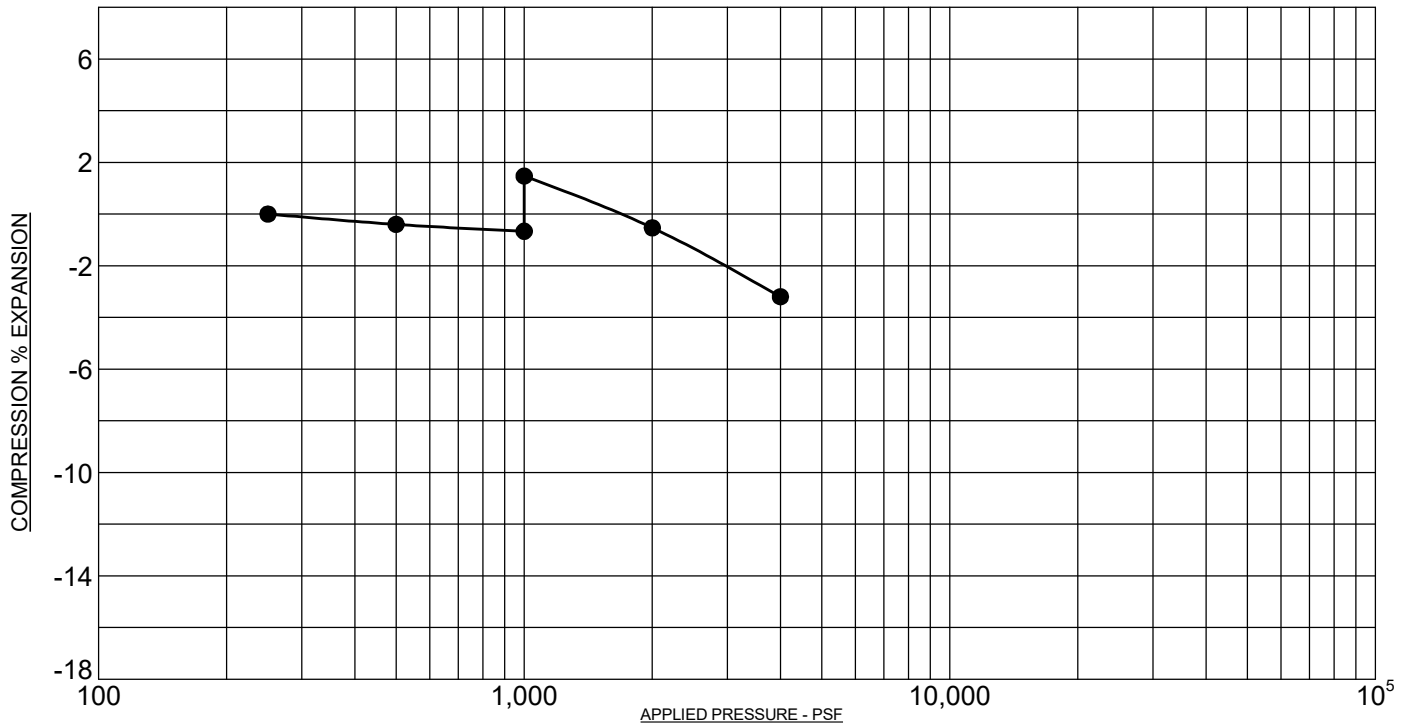
PROJECT: **The Ridge at Lorson Ranch El Paso County, Colorado**
 SAMPLE DESCRIPTION: **CLAYSTONE, SANDY**
 NOTE: **SAMPLE WAS INUNDATED WITH WATER AT 1,000 PSF**

SAMPLE LOCATION: **F-1 @ 9 FT**
 NATURAL DRY UNIT WEIGHT: **110.5 PCF**
 NATURAL MOISTURE CONTENT: **12.9%**
 PERCENT SWELL/COMPRESSION: **2.1**

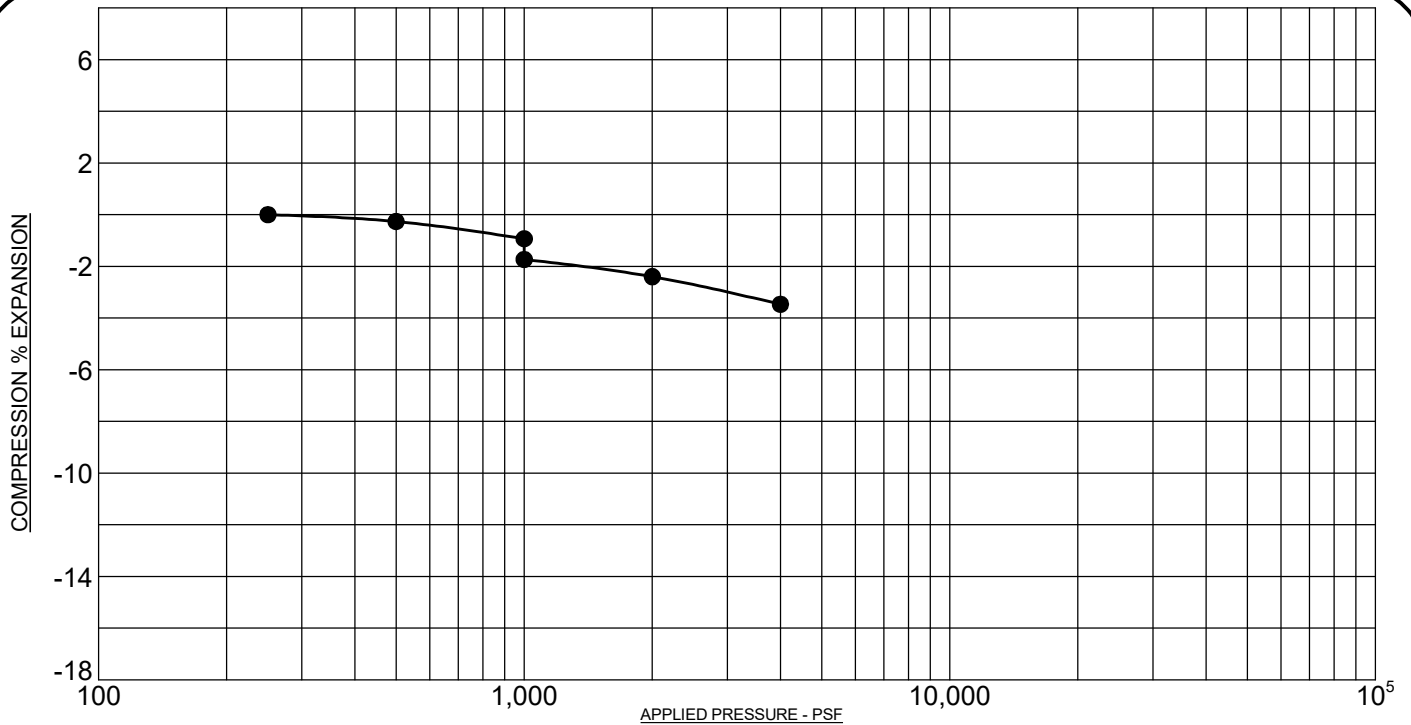
PROJECT: **The Ridge at Lorson Ranch El Paso County, Colorado**
 SAMPLE DESCRIPTION: **CLAYSTONE, SANDY**
 NOTE: **SAMPLE WAS INUNDATED WITH WATER AT 1,000 PSF**

SAMPLE LOCATION: **F-2 @ 9 FT**
 NATURAL DRY UNIT WEIGHT: **107.7 PCF**
 NATURAL MOISTURE CONTENT: **9.4%**
 PERCENT SWELL/COMPRESSION: **- 0.8**

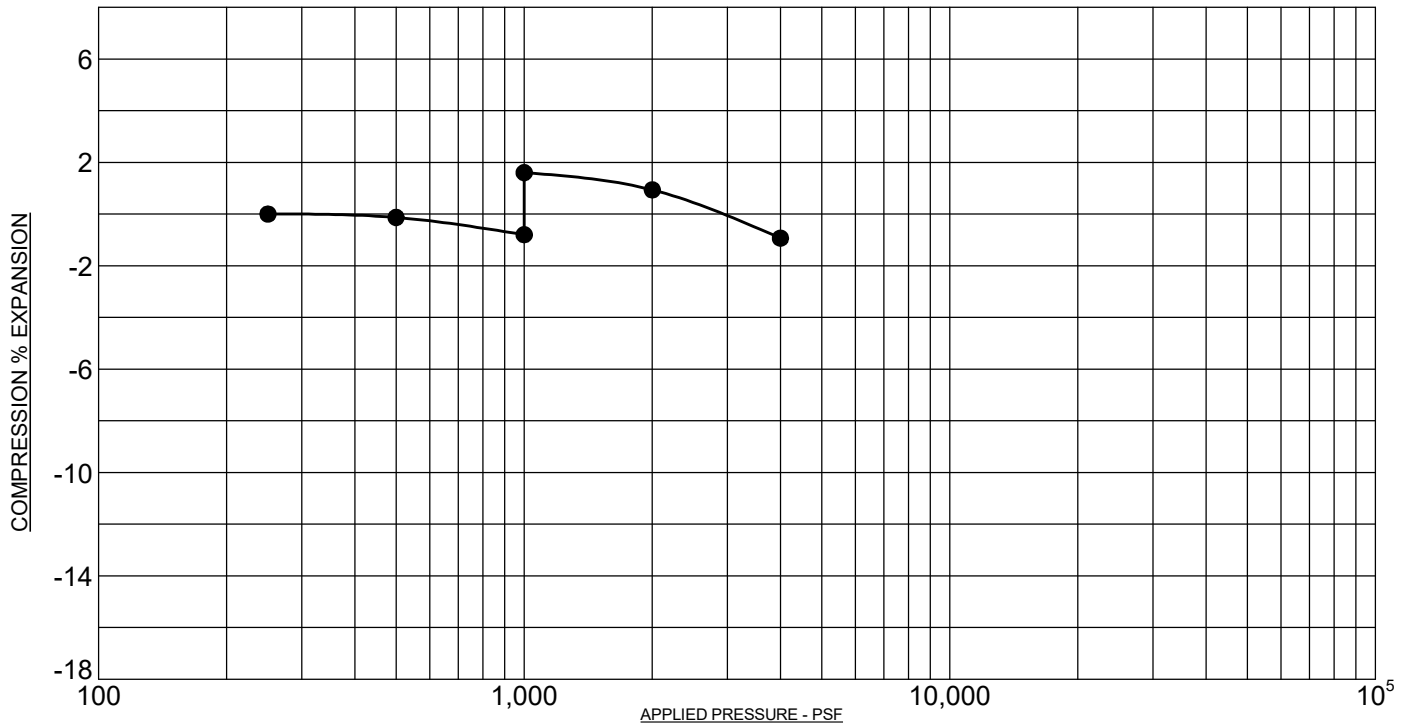
PROJECT: **The Ridge at Lorson Ranch El Paso County, Colorado**
 SAMPLE DESCRIPTION: **CLAYSTONE, SANDY**
 NOTE: **SAMPLE WAS INUNDATED WITH WATER AT 1,000 PSF**

SAMPLE LOCATION: **F-3 @ 14 FT**
 NATURAL DRY UNIT WEIGHT: **111.7 PCF**
 NATURAL MOISTURE CONTENT: **10.0%**
 PERCENT SWELL/COMPRESSION: **2.4**

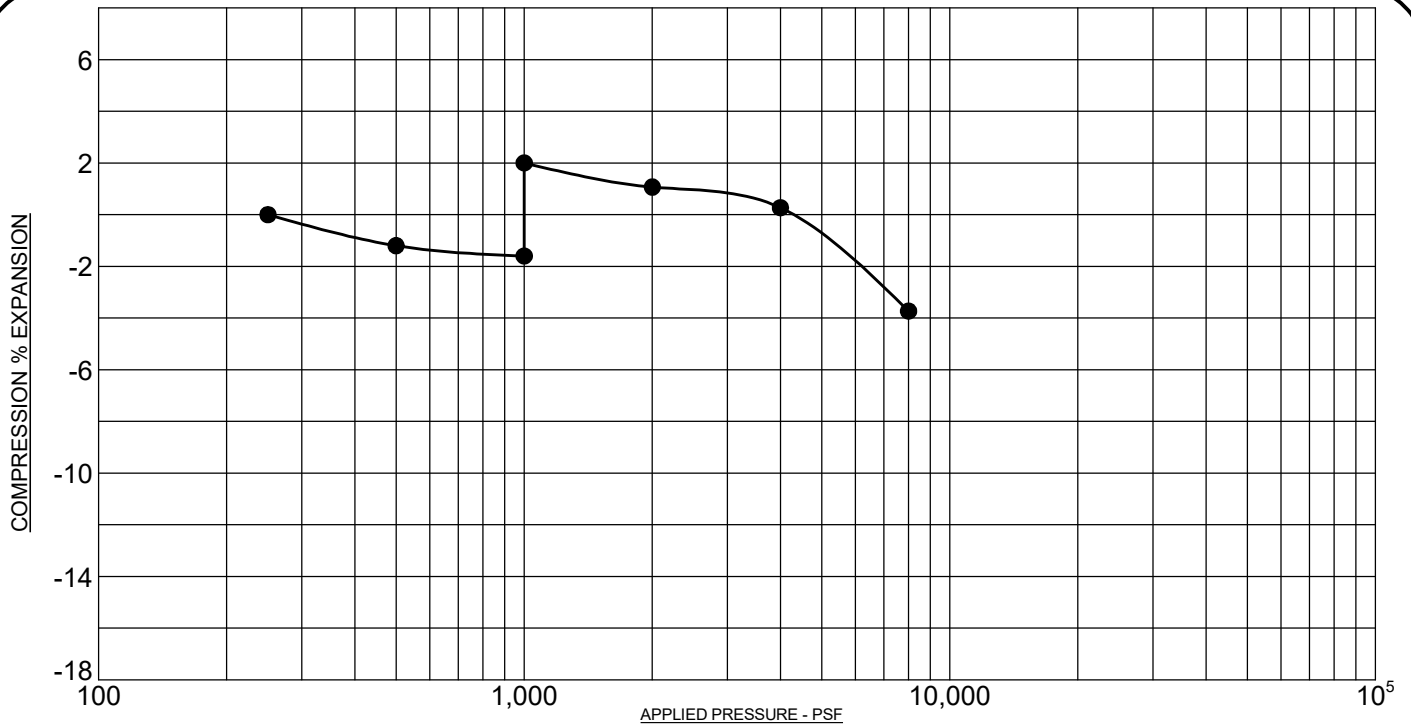
PROJECT: **The Ridge at Lorson Ranch El Paso County, Colorado**
 SAMPLE DESCRIPTION: **CLAYSTONE, SANDY**
 NOTE: **SAMPLE WAS INUNDATED WITH WATER AT 1,000 PSF**

SAMPLE LOCATION: **F-4 @ 9 FT**
 NATURAL DRY UNIT WEIGHT: **124.3 PCF**
 NATURAL MOISTURE CONTENT: **8.9%**
 PERCENT SWELL/COMPRESSION: **3.6**

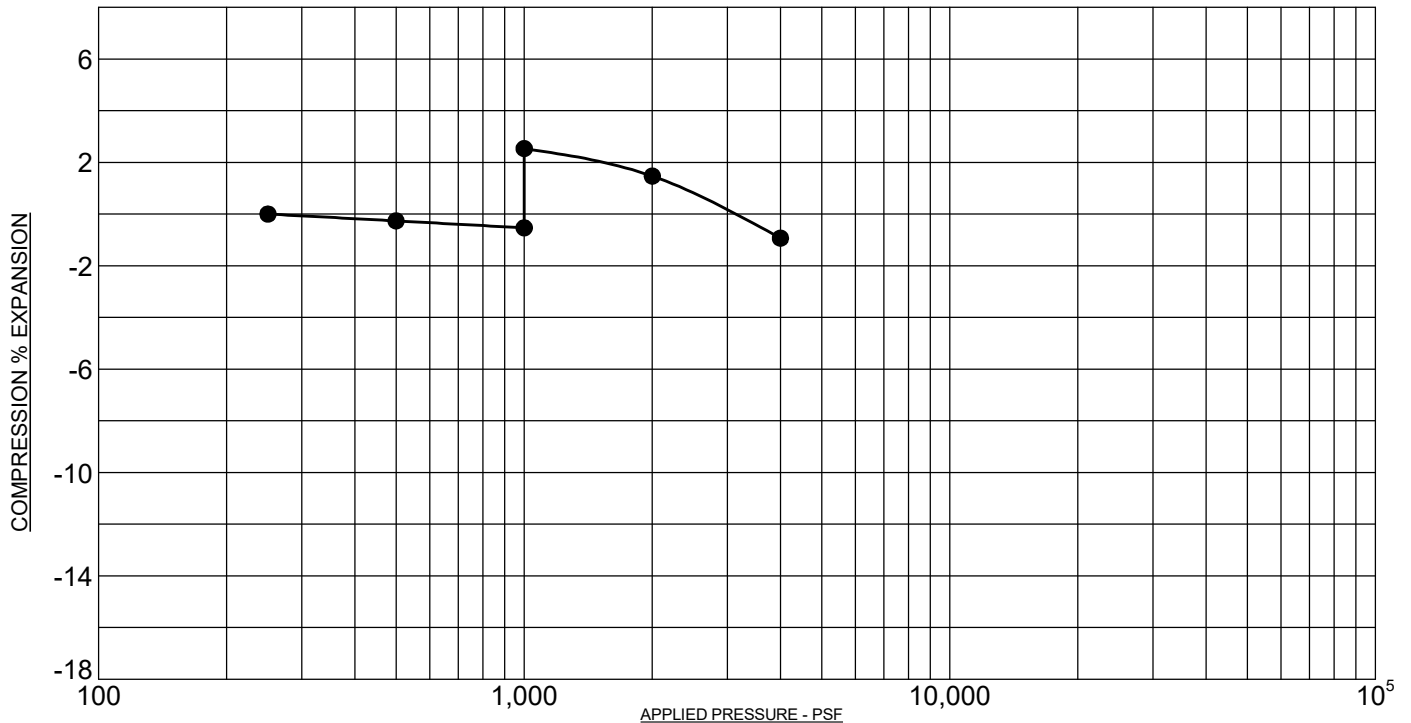
PROJECT: **The Ridge at Lorson Ranch El Paso County, Colorado**
 SAMPLE DESCRIPTION: **CLAYSTONE, SANDY**
 NOTE: **SAMPLE WAS INUNDATED WITH WATER AT 1,000 PSF**

SAMPLE LOCATION: **F-5 @ 9 FT**
 NATURAL DRY UNIT WEIGHT: **114.2 PCF**
 NATURAL MOISTURE CONTENT: **9.7%**
 PERCENT SWELL/COMPRESSION: **3.1**

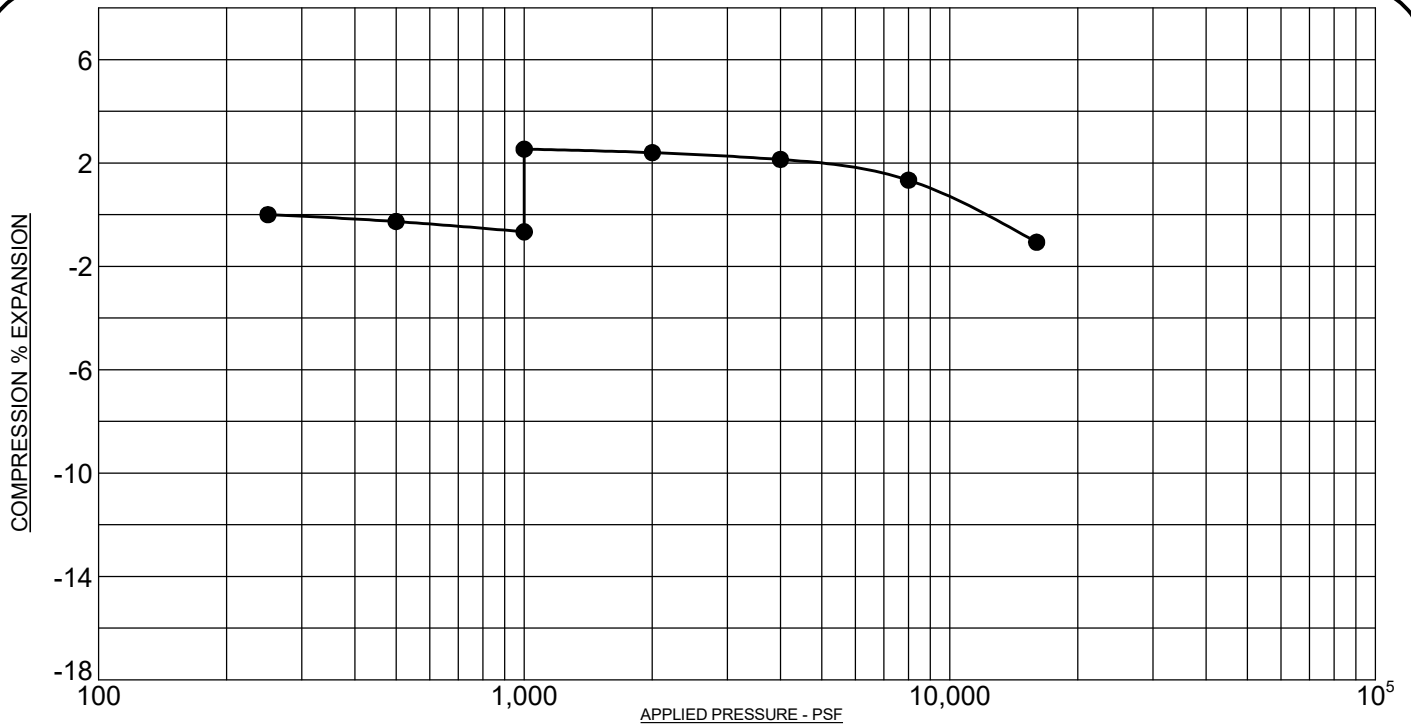
PROJECT: **The Ridge at Lorson Ranch El Paso County, Colorado**
 SAMPLE DESCRIPTION: **CLAYSTONE, SANDY**
 NOTE: **SAMPLE WAS INUNDATED WITH WATER AT 1,000 PSF**

SAMPLE LOCATION: **F-6 @ 14 FT**
 NATURAL DRY UNIT WEIGHT: **126.9 PCF**
 NATURAL MOISTURE CONTENT: **8.9%**
 PERCENT SWELL/COMPRESSION: **3.2**

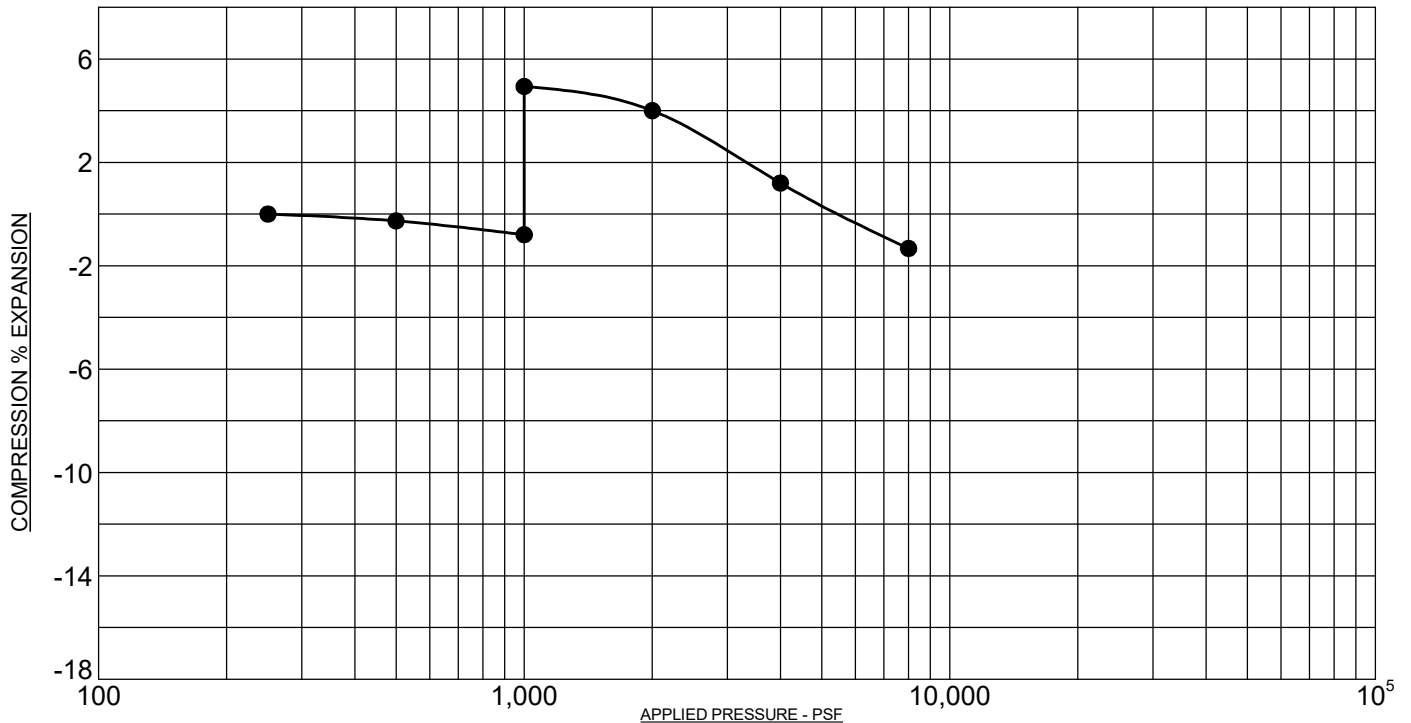
PROJECT: **The Ridge at Lorson Ranch El Paso County, Colorado**
 SAMPLE DESCRIPTION: **CLAYSTONE, SANDY**
 NOTE: **SAMPLE WAS INUNDATED WITH WATER AT 1,000 PSF**

SAMPLE LOCATION: **F-7 @ 9 FT**
 NATURAL DRY UNIT WEIGHT: **128.3 PCF**
 NATURAL MOISTURE CONTENT: **7.3%**
 PERCENT SWELL/COMPRESSION: **5.7**

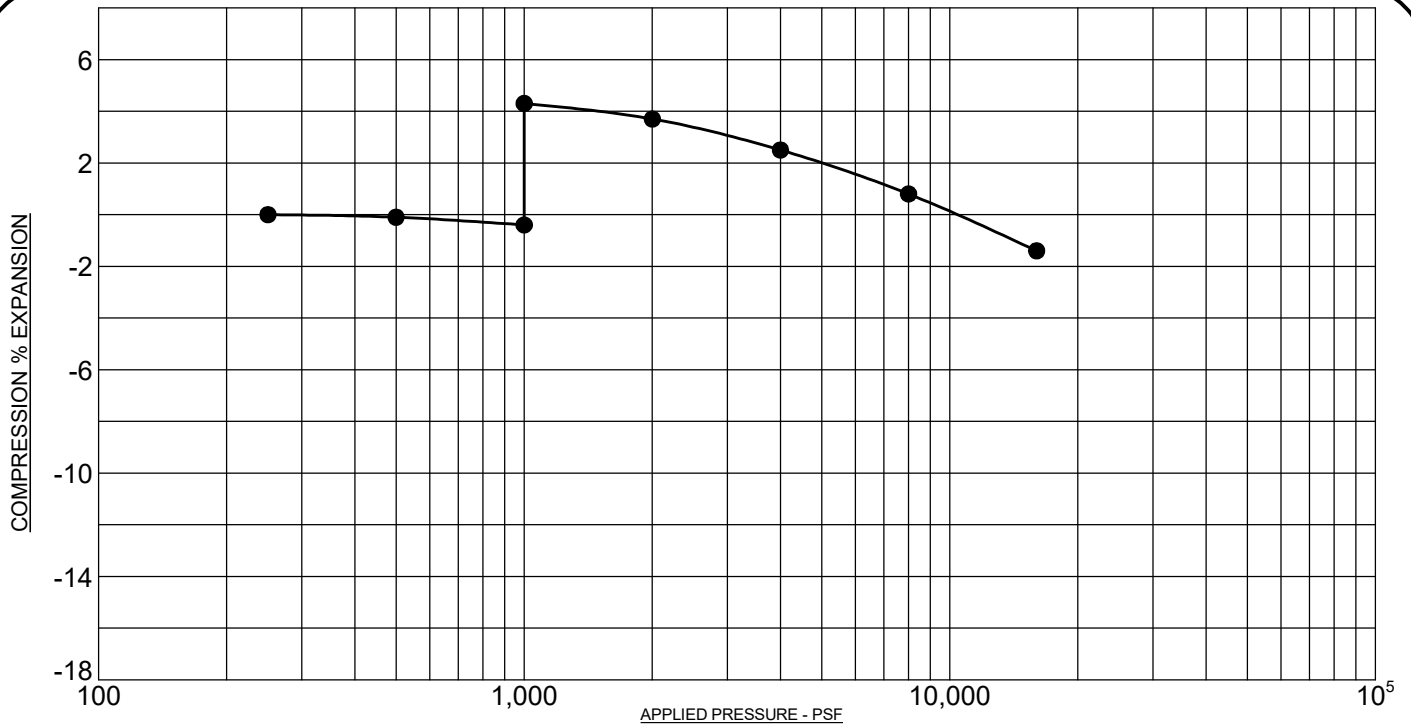
PROJECT: **The Ridge at Lorson Ranch El Paso County, Colorado**
 SAMPLE DESCRIPTION: **CLAYSTONE, SANDY**
 NOTE: **SAMPLE WAS INUNDATED WITH WATER AT 1,000 PSF**

SAMPLE LOCATION: **F-8 @ 14 FT**
 NATURAL DRY UNIT WEIGHT: **115.5 PCF**
 NATURAL MOISTURE CONTENT: **17.0%**
 PERCENT SWELL/COMPRESSION: **4.7**

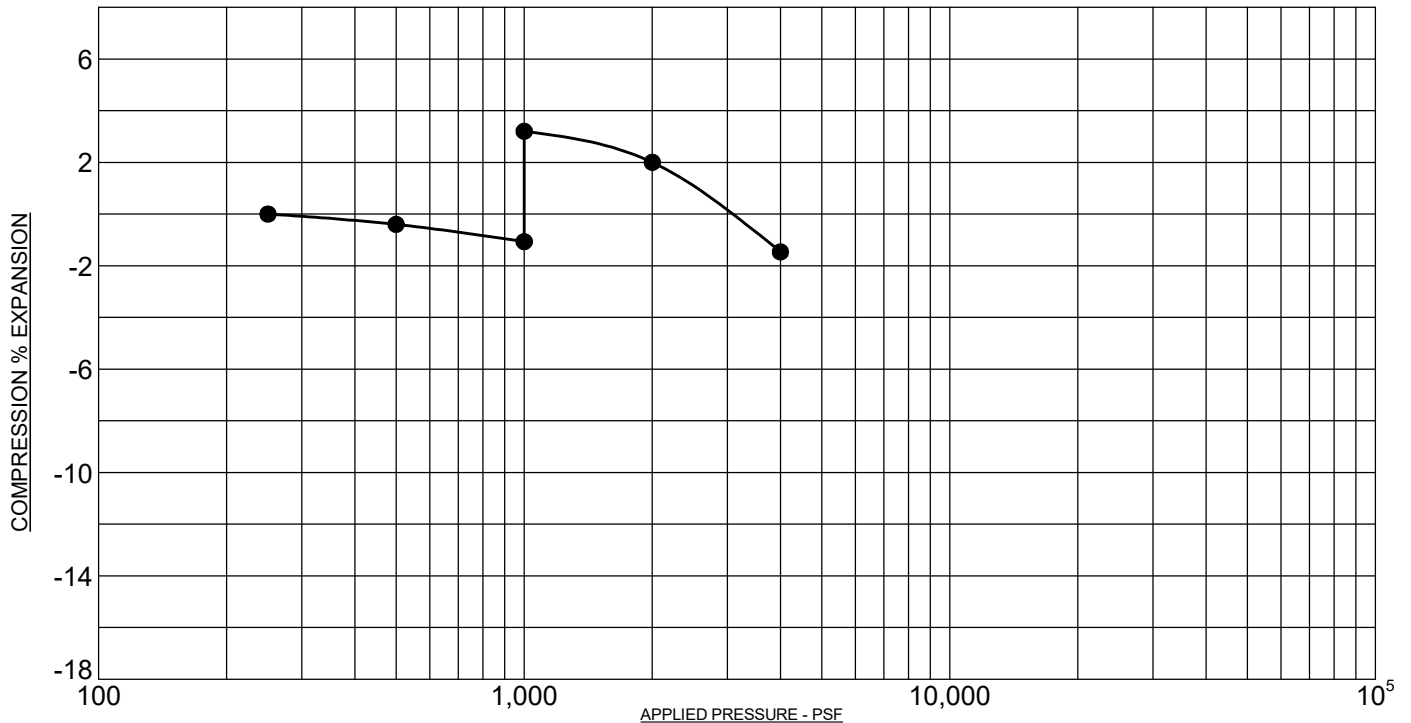
PROJECT: **The Ridge at Lorson Ranch El Paso County, Colorado**
 SAMPLE DESCRIPTION: **CLAYSTONE, SANDY**
 NOTE: **SAMPLE WAS INUNDATED WITH WATER AT 1,000 PSF**

SAMPLE LOCATION: **F-9 @ 14 FT**
 NATURAL DRY UNIT WEIGHT: **112.3 PCF**
 NATURAL MOISTURE CONTENT: **11.0%**
 PERCENT SWELL/COMPRESSION: **4.3**

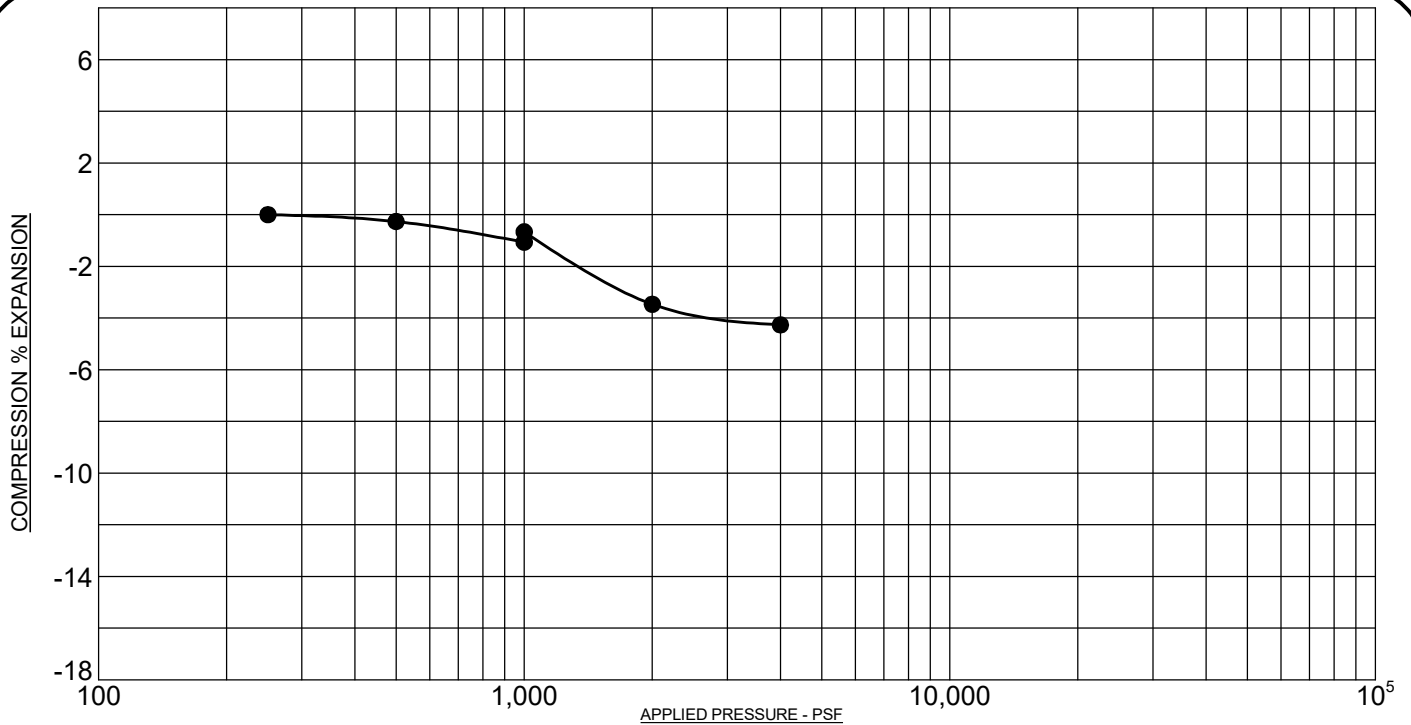
PROJECT: **The Ridge at Lorson Ranch El Paso County, Colorado**
 SAMPLE DESCRIPTION: **CLAYSTONE, SANDY**
 NOTE: **SAMPLE WAS INUNDATED WITH WATER AT 1,000 PSF**

SAMPLE LOCATION: **F-10 @ 9 FT**
 NATURAL DRY UNIT WEIGHT: **122.0 PCF**
 NATURAL MOISTURE CONTENT: **11.4%**
 PERCENT SWELL/COMPRESSION: **0.4**
