**ROCKY MOUNTAIN GROUP
EMPLOYEE OWNED**

Job No. 175706

Re: Response to Colorado Geological Survey and El Paso County Review Comments
The Ridge at Lorson Ranch
Fontaine Bl
The Ridge at Lorson Ranch
El Paso County, Colorado

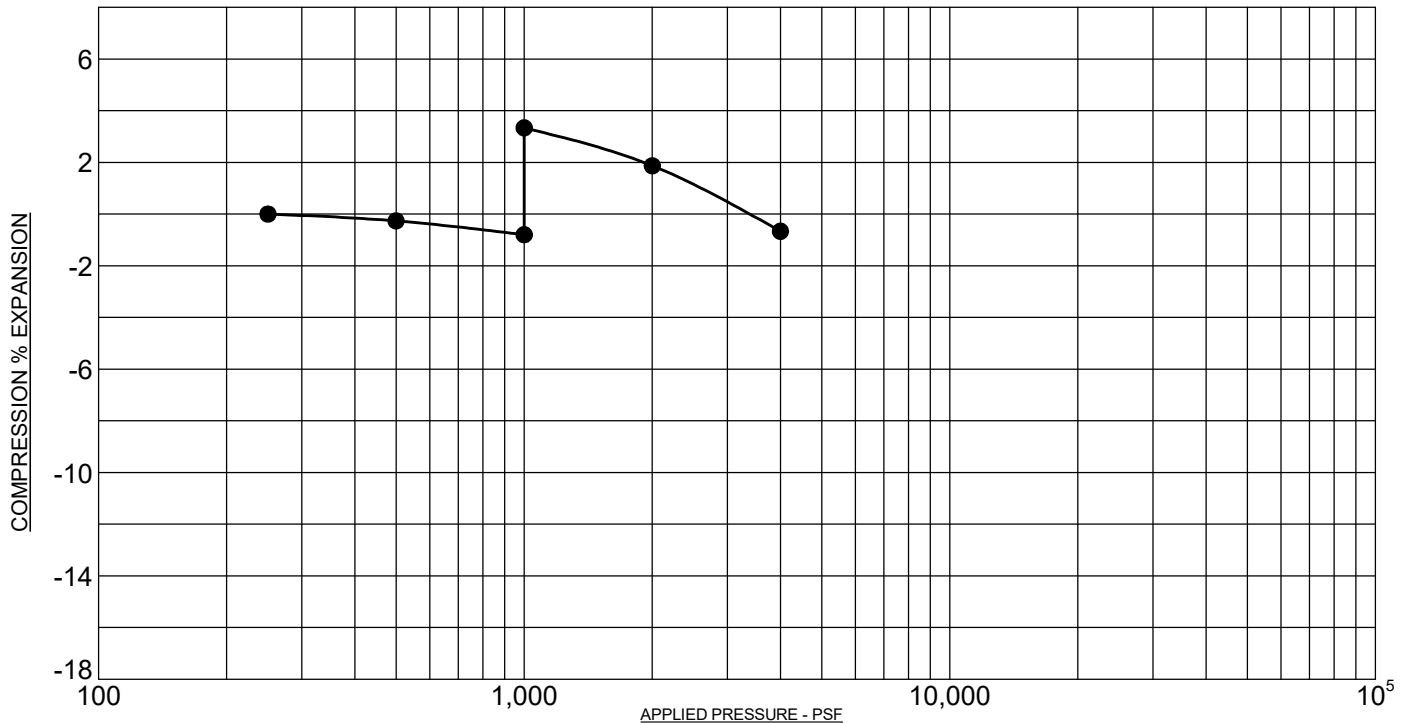
PROJECT: **The Ridge at Lorson Ranch El Paso County, Colorado**
 SAMPLE DESCRIPTION: **CLAYSTONE, SANDY**
 NOTE: **SAMPLE WAS INUNDATED WITH WATER AT 1,000 PSF**

SAMPLE LOCATION: **F-11 @ 19 FT**
 NATURAL DRY UNIT WEIGHT: **122.8 PCF**
 NATURAL MOISTURE CONTENT: **10.8%**
 PERCENT SWELL/COMPRESSION: **4.1**

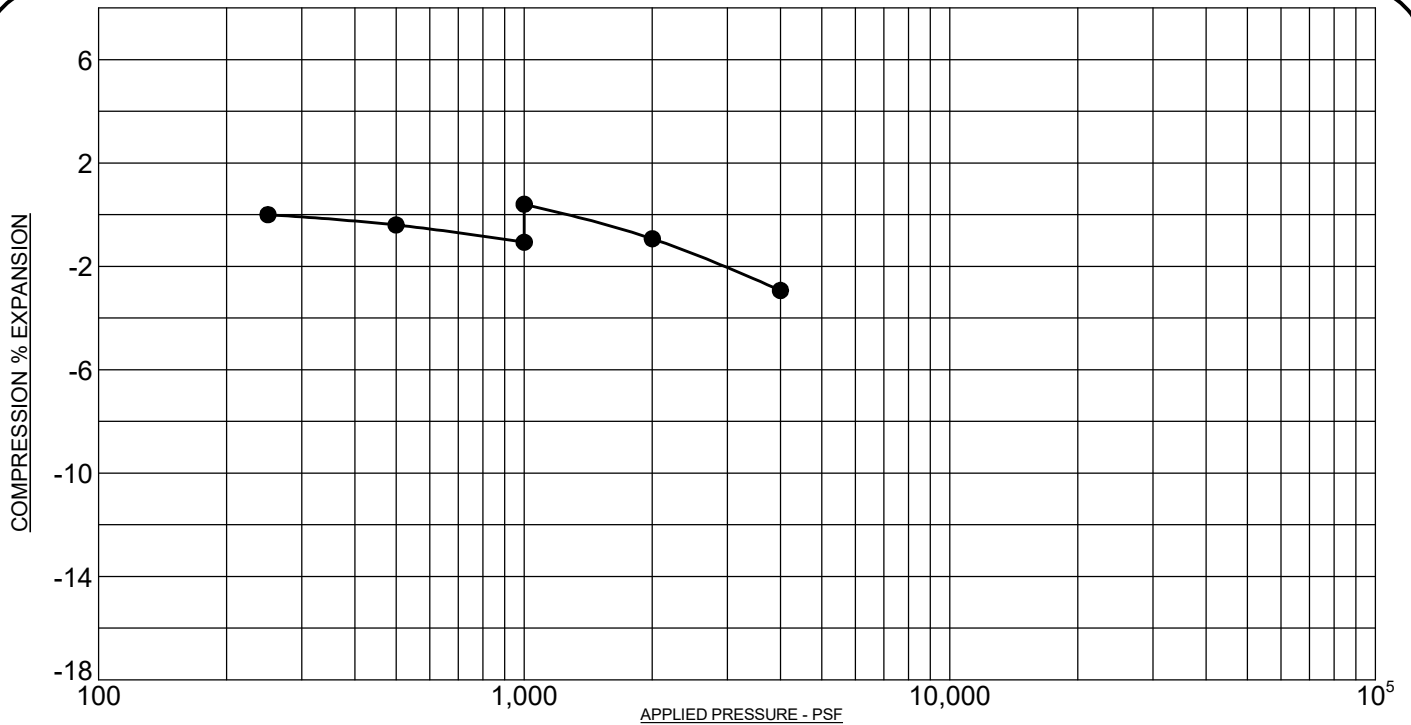
PROJECT: **The Ridge at Lorson Ranch El Paso County, Colorado**
 SAMPLE DESCRIPTION: **CLAYSTONE, SANDY**
 NOTE: **SAMPLE WAS INUNDATED WITH WATER AT 1,000 PSF**

SAMPLE LOCATION: **F-12 @ 9 FT**
 NATURAL DRY UNIT WEIGHT: **116.0 PCF**
 NATURAL MOISTURE CONTENT: **9.2%**
 PERCENT SWELL/COMPRESSION: **1.5**

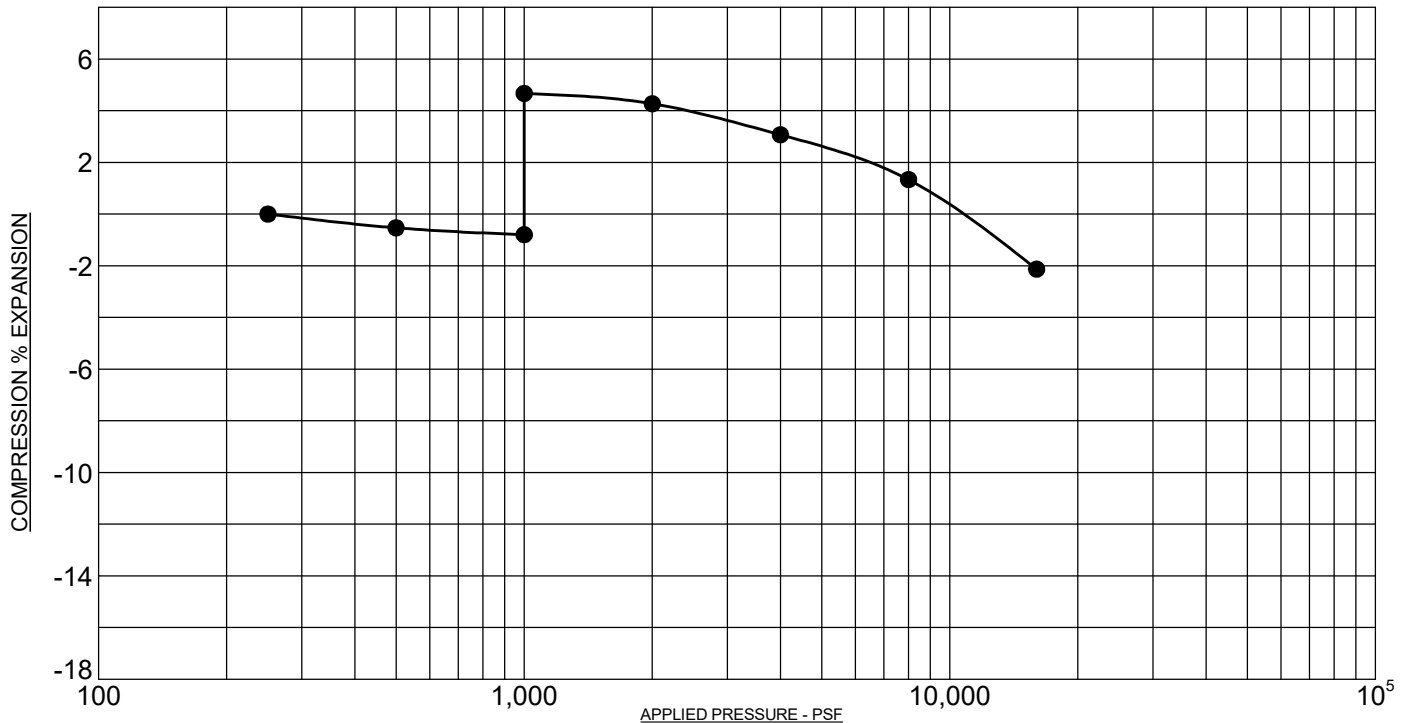
PROJECT: **The Ridge at Lorson Ranch El Paso County, Colorado**
 SAMPLE DESCRIPTION: **CLAYSTONE, SANDY**
 NOTE: **SAMPLE WAS INUNDATED WITH WATER AT 1,000 PSF**

SAMPLE LOCATION: **F-13 @ 9 FT**
 NATURAL DRY UNIT WEIGHT: **127.4 PCF**
 NATURAL MOISTURE CONTENT: **8.2%**
 PERCENT SWELL/COMPRESSION: **5.5**

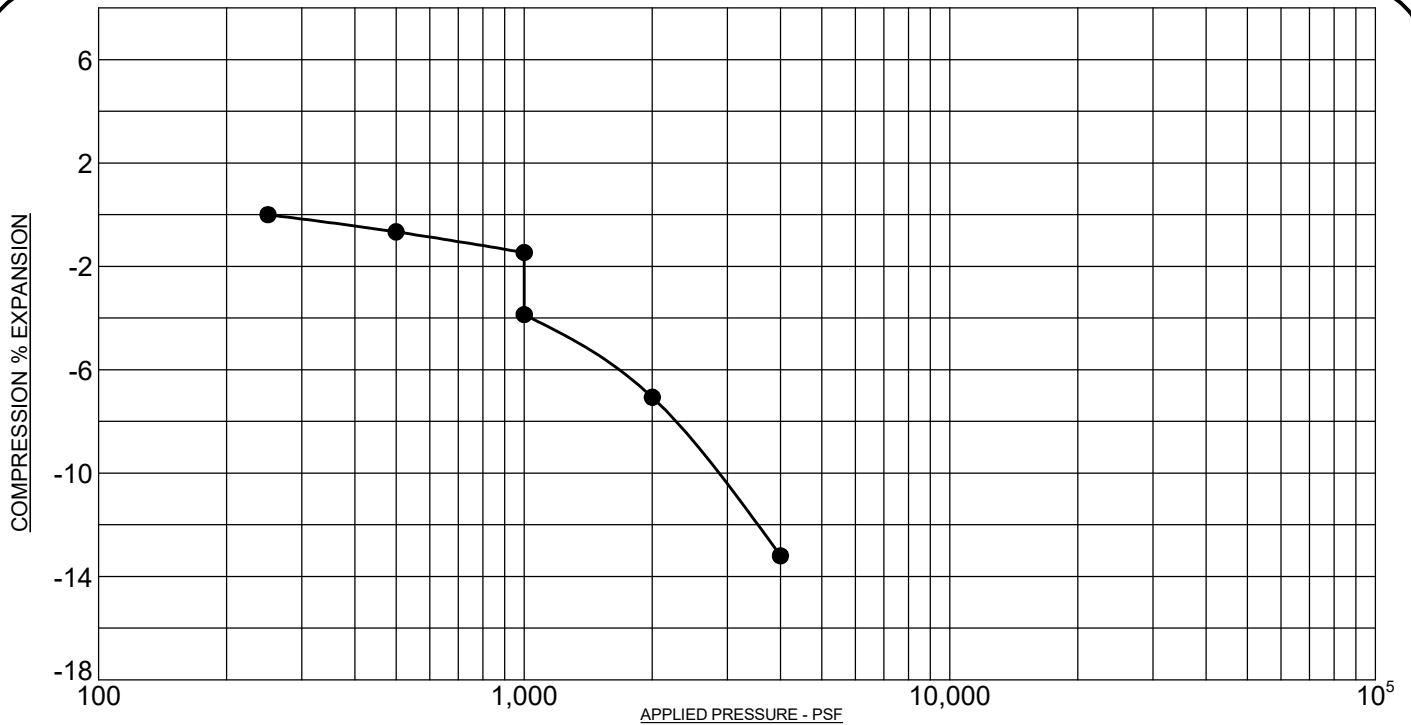
PROJECT: **The Ridge at Lorson Ranch El Paso County, Colorado**
 SAMPLE DESCRIPTION: **CLAYSTONE, SANDY**
 NOTE: **SAMPLE WAS INUNDATED WITH WATER AT 1,000 PSF**

SAMPLE LOCATION: **F-14 @ 14 FT**
 NATURAL DRY UNIT WEIGHT: **94.0 PCF**
 NATURAL MOISTURE CONTENT: **9.7%**
 PERCENT SWELL/COMPRESSION: **- 2.4**

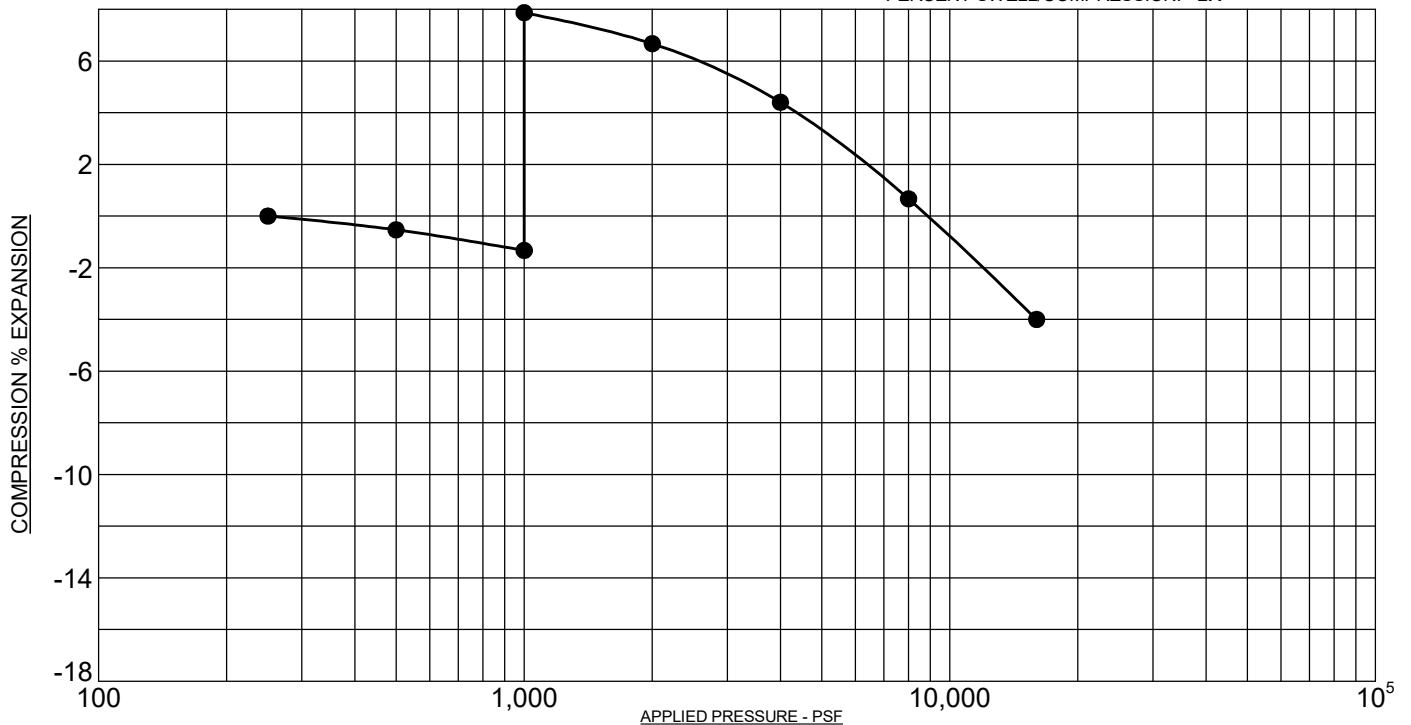
PROJECT: **The Ridge at Lorson Ranch El Paso County, Colorado**
 SAMPLE DESCRIPTION: **CLAYSTONE, SANDY**
 NOTE: **SAMPLE WAS INUNDATED WITH WATER AT 1,000 PSF**

SAMPLE LOCATION: **F-15 @ 14 FT**
 NATURAL DRY UNIT WEIGHT: **126.6 PCF**
 NATURAL MOISTURE CONTENT: **13.2%**
 PERCENT SWELL/COMPRESSION: **9.2**

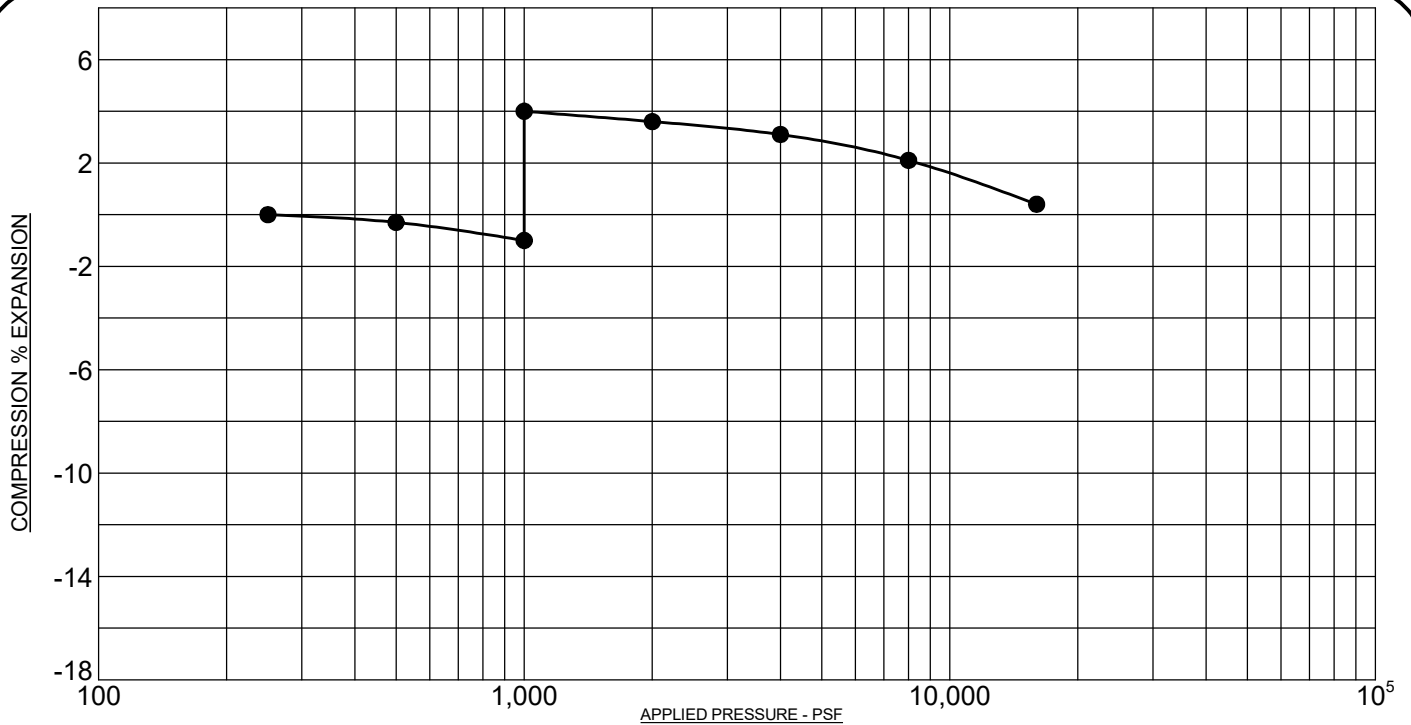
PROJECT: **The Ridge at Lorson Ranch El Paso County, Colorado**
 SAMPLE DESCRIPTION: **CLAYSTONE, SANDY**
 NOTE: **SAMPLE WAS INUNDATED WITH WATER AT 1,000 PSF**

SAMPLE LOCATION: **F-16 @ 9 FT**
 NATURAL DRY UNIT WEIGHT: **127.6 PCF**
 NATURAL MOISTURE CONTENT: **10.3%**
 PERCENT SWELL/COMPRESSION: **5.0**

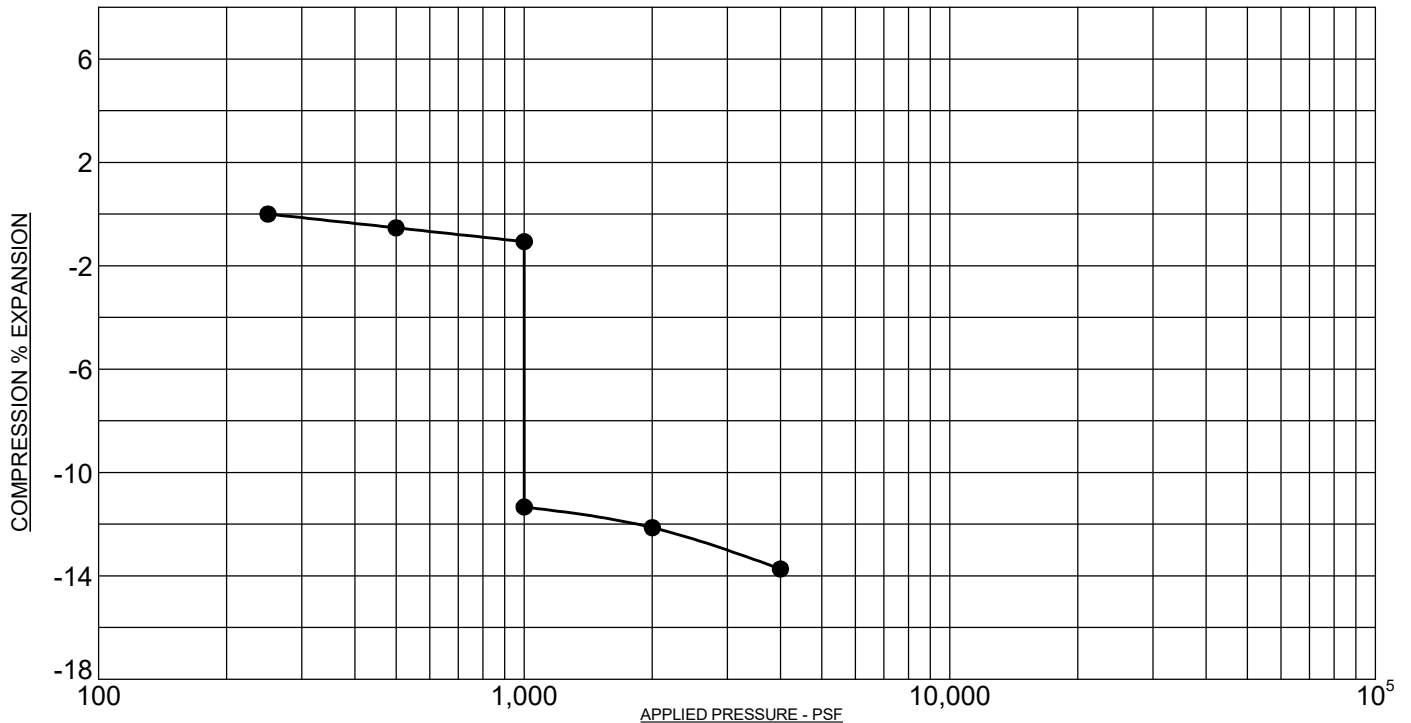
PROJECT: **The Ridge at Lorson Ranch El Paso County, Colorado**
 SAMPLE DESCRIPTION: **CLAYSTONE, SANDY**
 NOTE: **SAMPLE WAS INUNDATED WITH WATER AT 1,000 PSF**

SAMPLE LOCATION: **F-17 @ 14 FT**
 NATURAL DRY UNIT WEIGHT: **124.1 PCF**
 NATURAL MOISTURE CONTENT: **10.9%**
 PERCENT SWELL/COMPRESSION: **- 10.3**

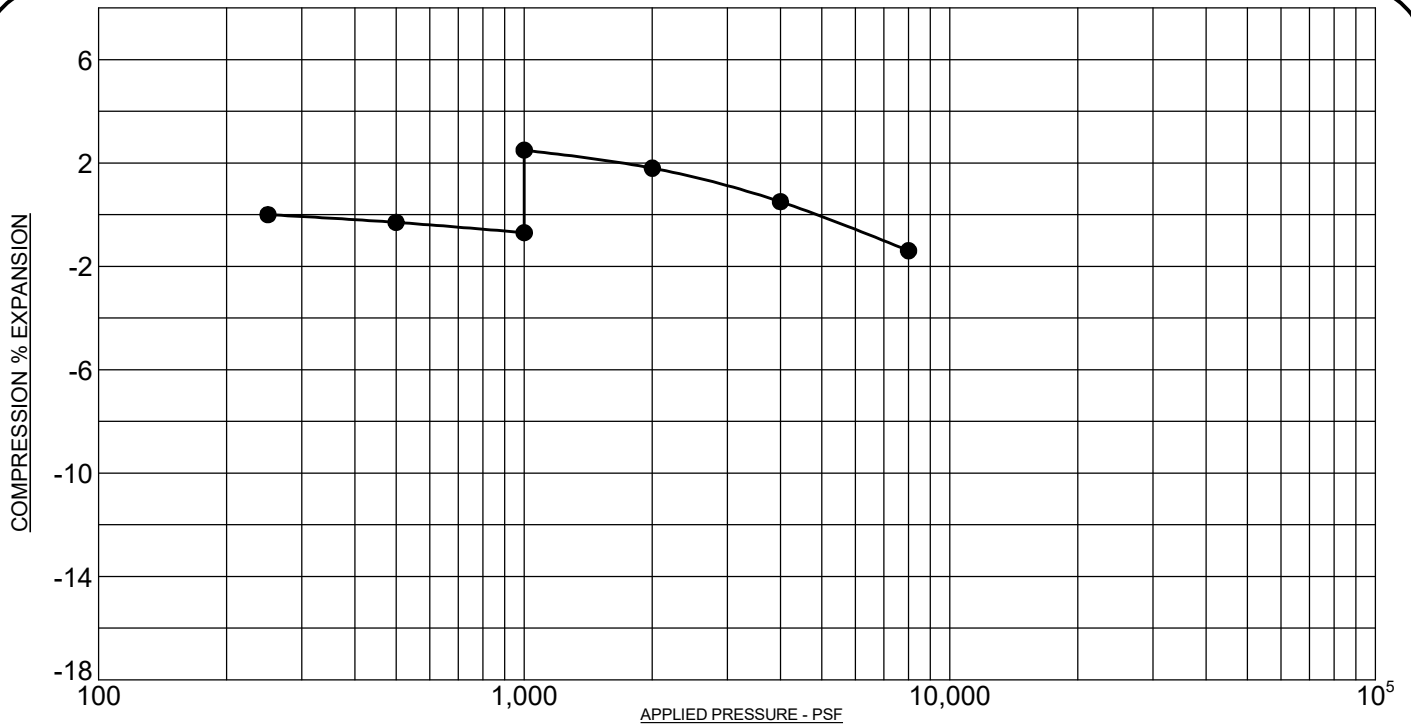
PROJECT: **The Ridge at Lorson Ranch El Paso County, Colorado**
 SAMPLE DESCRIPTION: **CLAYSTONE, SANDY**
 NOTE: **SAMPLE WAS INUNDATED WITH WATER AT 1,000 PSF**

SAMPLE LOCATION: **F-18 @ 14 FT**
 NATURAL DRY UNIT WEIGHT: **117.0 PCF**
 NATURAL MOISTURE CONTENT: **11.7%**
 PERCENT SWELL/COMPRESSION: **3.2**

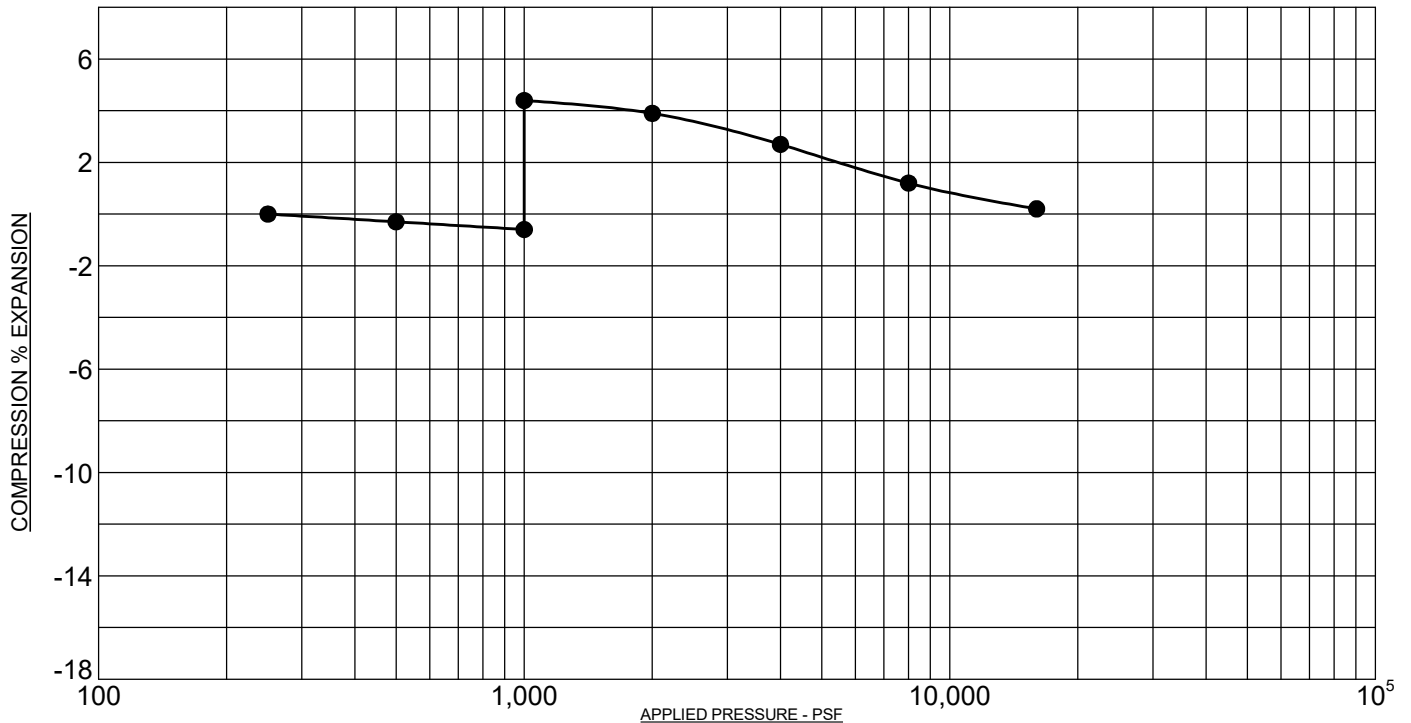
PROJECT: **The Ridge at Lorson Ranch El Paso County, Colorado**
 SAMPLE DESCRIPTION: **CLAYSTONE, SANDY**
 NOTE: **SAMPLE WAS INUNDATED WITH WATER AT 1,000 PSF**

SAMPLE LOCATION: **F-19 @ 14 FT**
 NATURAL DRY UNIT WEIGHT: **122.0 PCF**
 NATURAL MOISTURE CONTENT: **8.9%**
 PERCENT SWELL/COMPRESSION: **5.0**

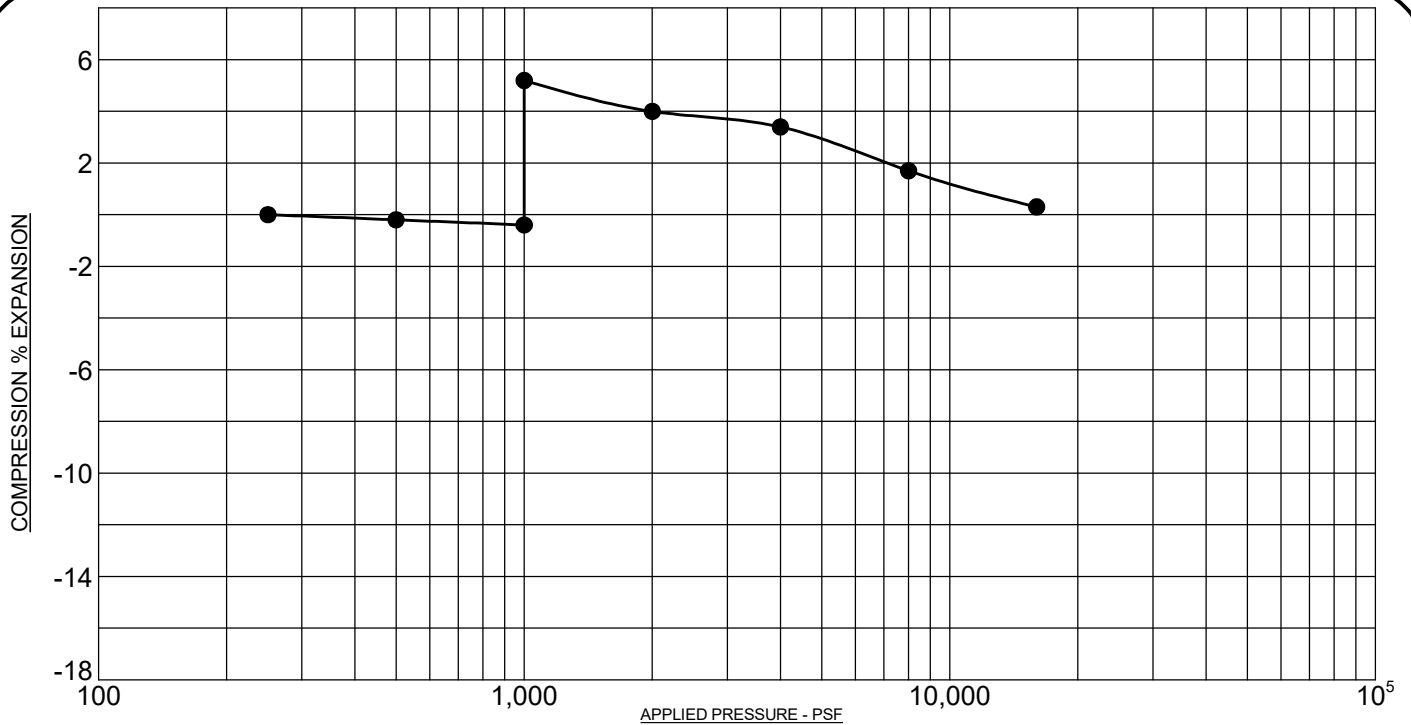
PROJECT: **The Ridge at Lorson Ranch El Paso County, Colorado**
 SAMPLE DESCRIPTION: **CLAYSTONE, SANDY**
 NOTE: **SAMPLE WAS INUNDATED WITH WATER AT 1,000 PSF**

SAMPLE LOCATION: **F-20 @ 9 FT**
 NATURAL DRY UNIT WEIGHT: **118.8 PCF**
 NATURAL MOISTURE CONTENT: **7.7%**
 PERCENT SWELL/COMPRESSION: **5.6**

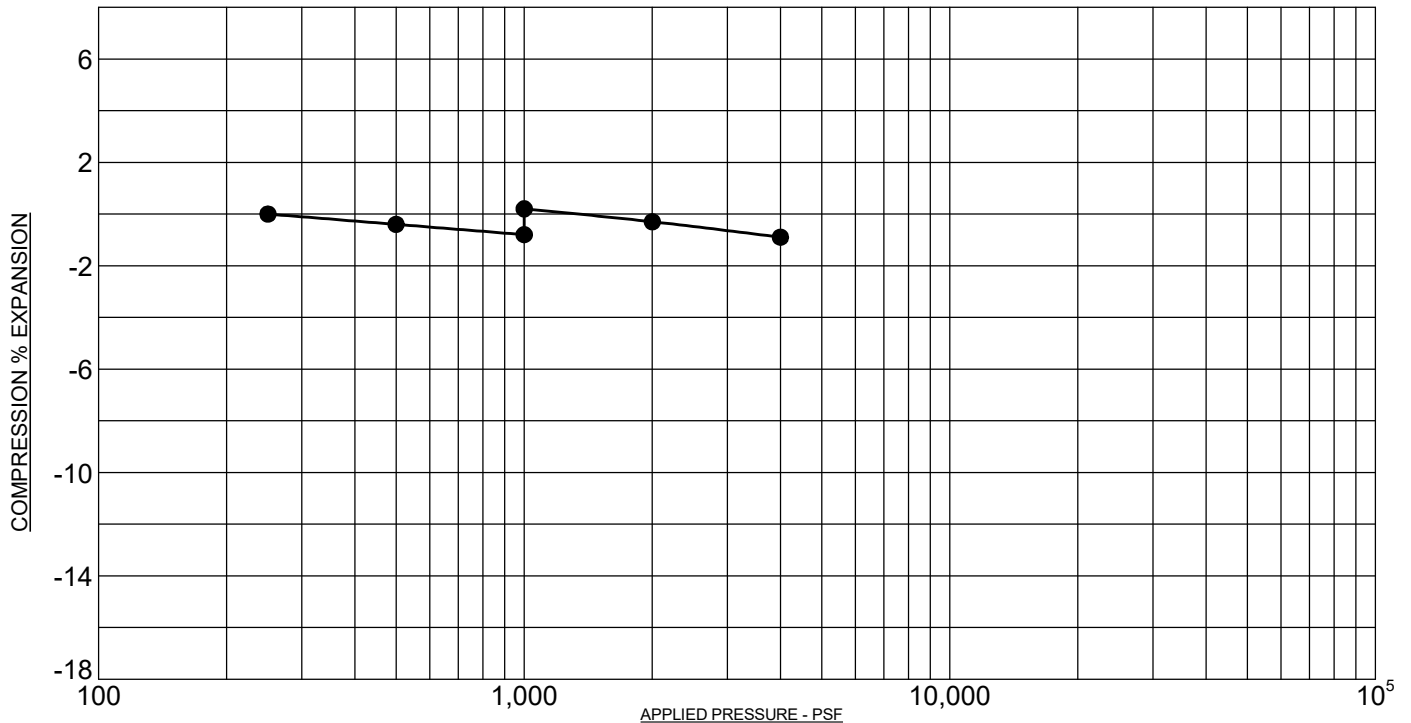
PROJECT: **The Ridge at Lorson Ranch El Paso County, Colorado**
 SAMPLE DESCRIPTION: **CLAYSTONE, SANDY**
 NOTE: **SAMPLE WAS INUNDATED WITH WATER AT 1,000 PSF**

SAMPLE LOCATION: **F-21 @ 19 FT**
 NATURAL DRY UNIT WEIGHT: **119.7 PCF**
 NATURAL MOISTURE CONTENT: **10.7%**
 PERCENT SWELL/COMPRESSION: **1.0**

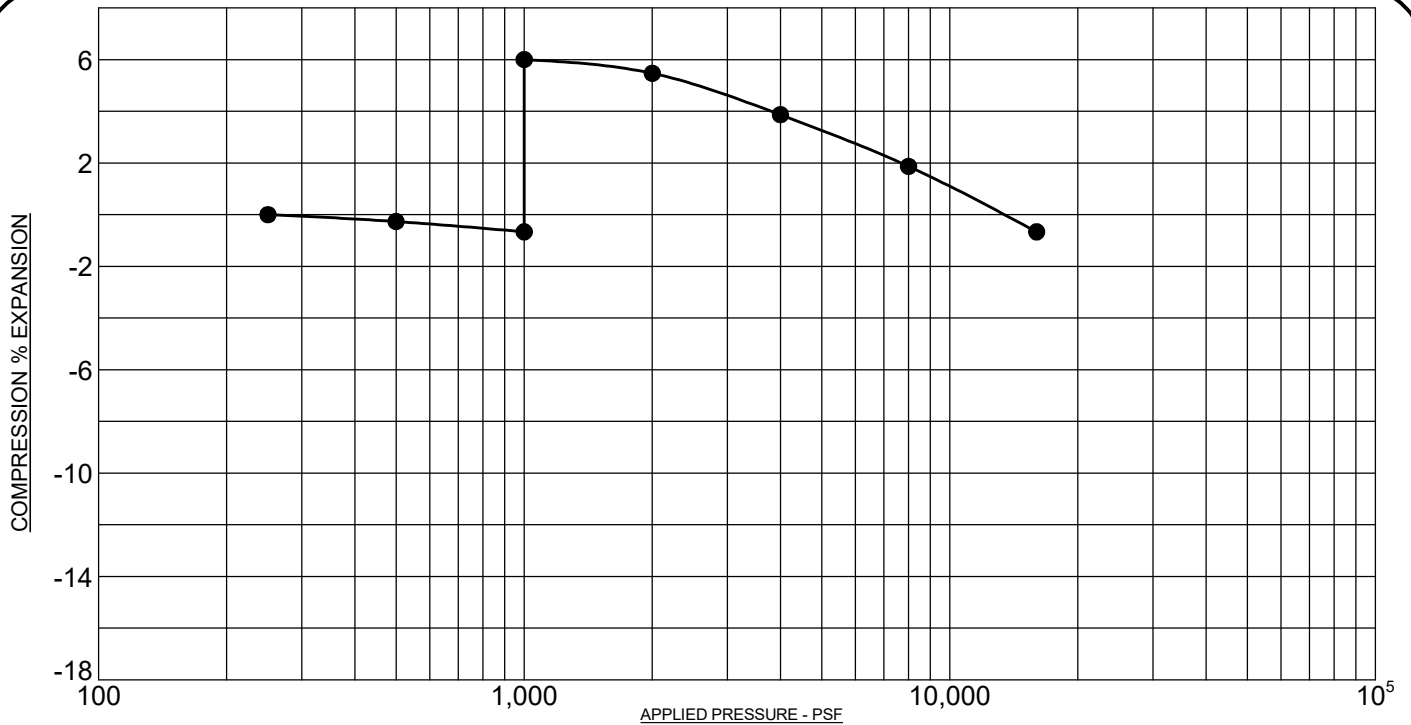
PROJECT: **The Ridge at Lorson Ranch El Paso County, Colorado**
 SAMPLE DESCRIPTION: **CLAYSTONE, SANDY**
 NOTE: **SAMPLE WAS INUNDATED WITH WATER AT 1,000 PSF**

SAMPLE LOCATION: **F-22 @ 9 FT**
 NATURAL DRY UNIT WEIGHT: **97.3 PCF**
 NATURAL MOISTURE CONTENT: **9.3%**
 PERCENT SWELL/COMPRESSION: **6.7**

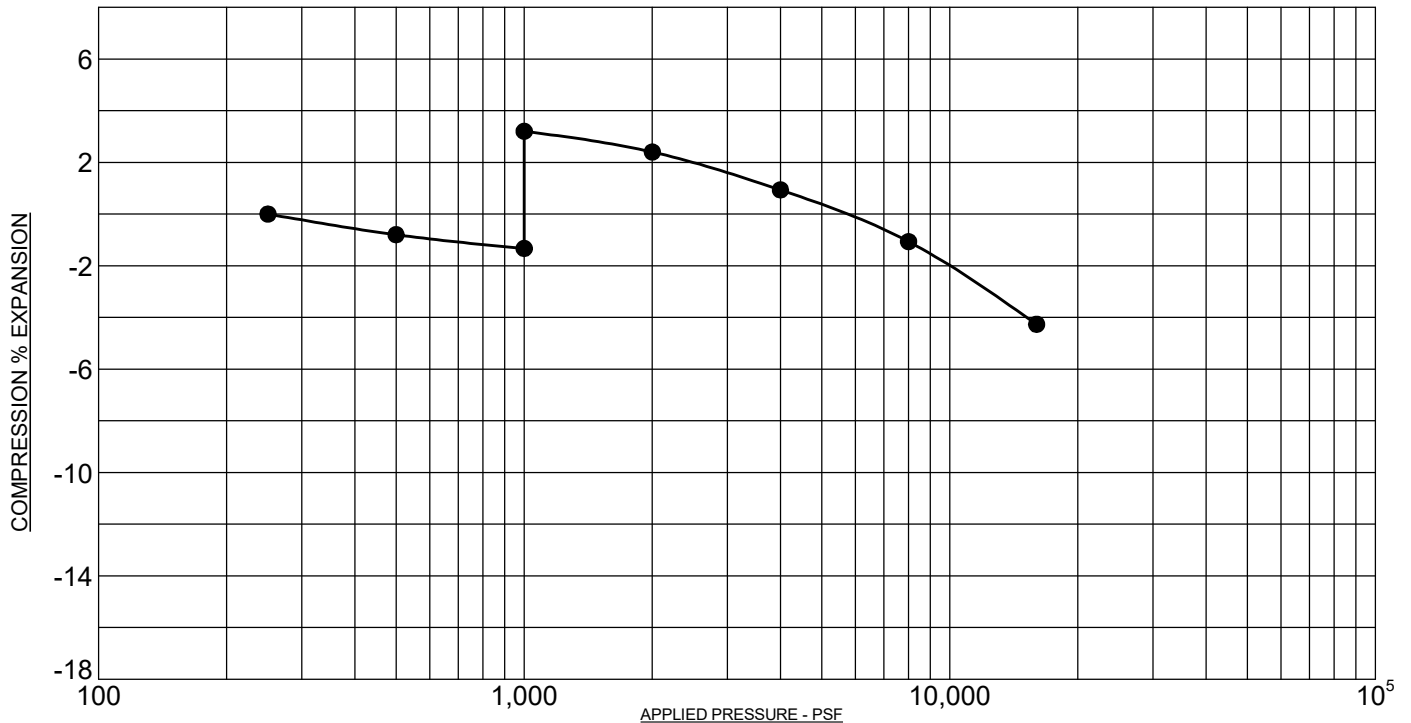
PROJECT: **The Ridge at Lorson Ranch El Paso County, Colorado**
 SAMPLE DESCRIPTION: **CLAYSTONE, SANDY**
 NOTE: **SAMPLE WAS INUNDATED WITH WATER AT 1,000 PSF**

SAMPLE LOCATION: **F-24 @ 9 FT**
 NATURAL DRY UNIT WEIGHT: **120.9 PCF**
 NATURAL MOISTURE CONTENT: **9.8%**
 PERCENT SWELL/COMPRESSION: **4.5**

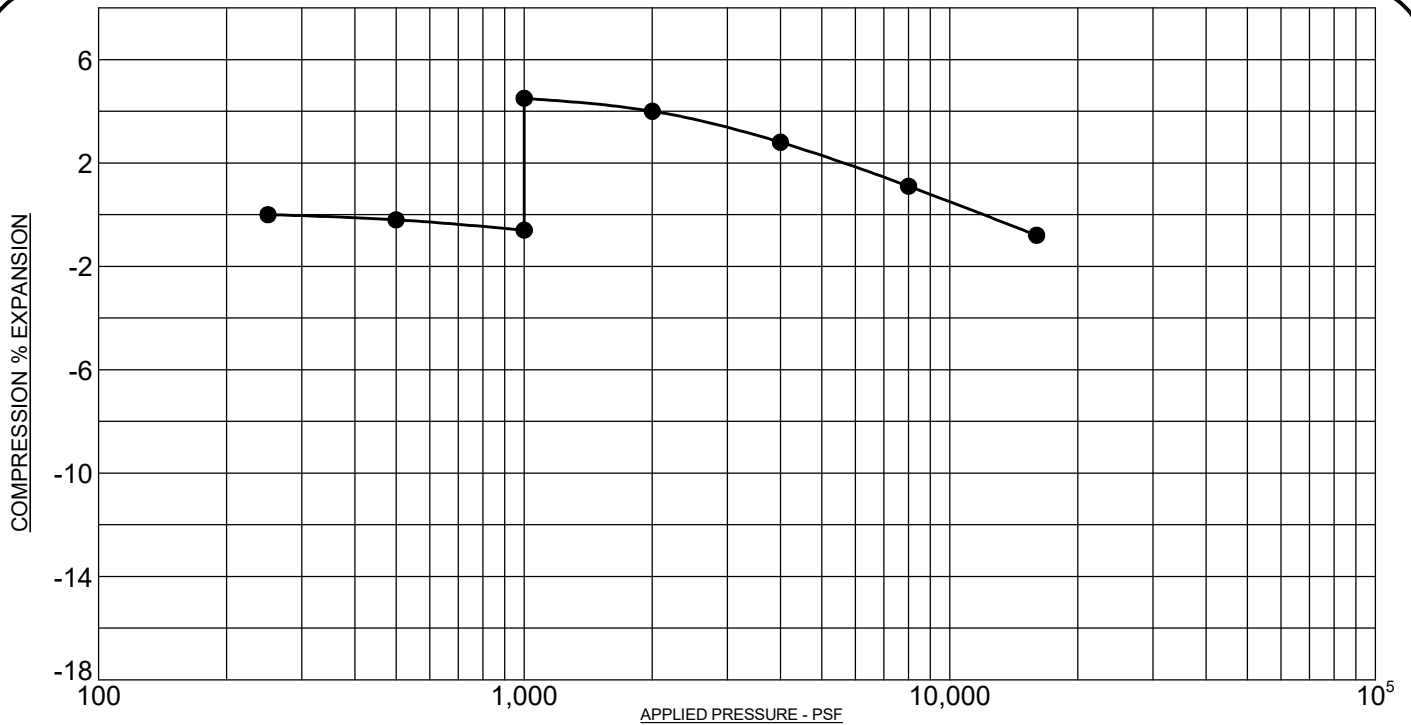
PROJECT: **The Ridge at Lorson Ranch El Paso County, Colorado**
 SAMPLE DESCRIPTION: **CLAYSTONE, SANDY**
 NOTE: **SAMPLE WAS INUNDATED WITH WATER AT 1,000 PSF**

SAMPLE LOCATION: **F-25 @ 14 FT**
 NATURAL DRY UNIT WEIGHT: **PCF**
 NATURAL MOISTURE CONTENT: **12.0%**
 PERCENT SWELL/COMPRESSION: **5.1**

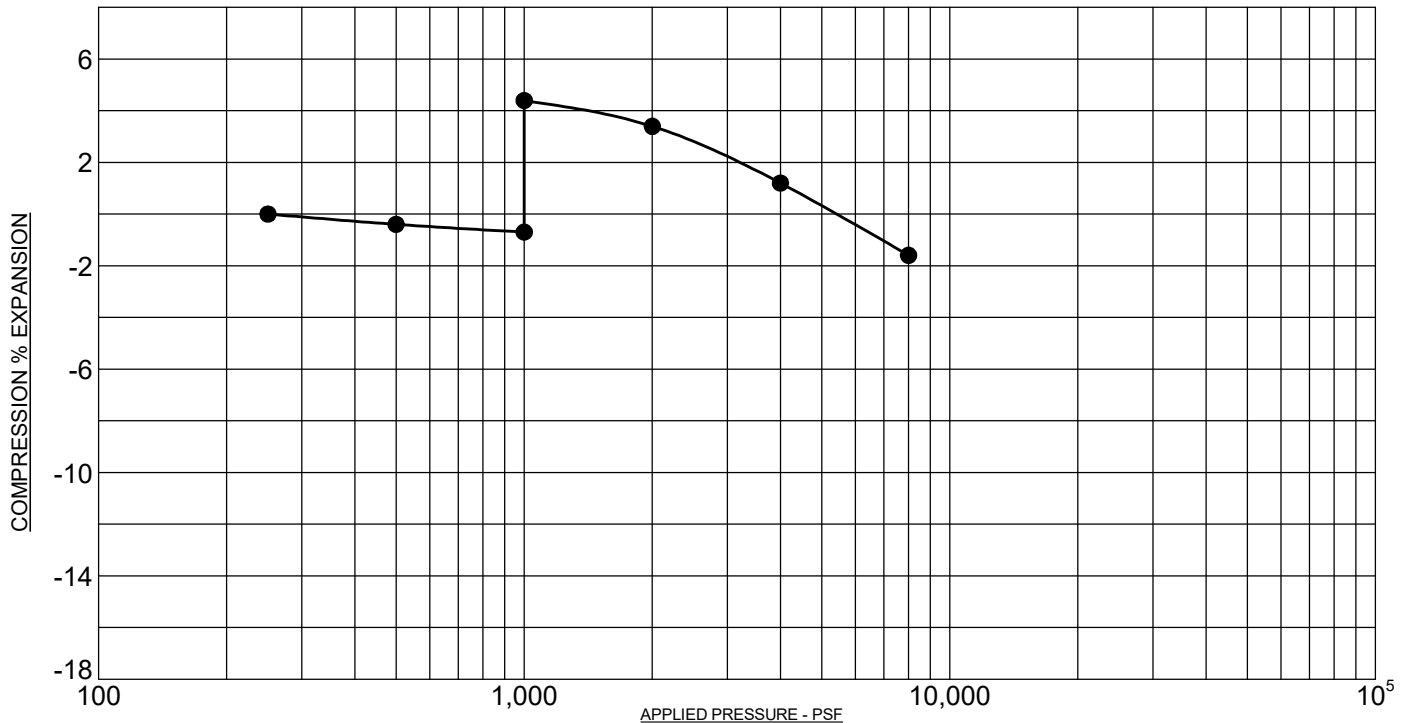
PROJECT: **The Ridge at Lorson Ranch El Paso County, Colorado**
 SAMPLE DESCRIPTION: **CLAYSTONE, SANDY**
 NOTE: **SAMPLE WAS INUNDATED WITH WATER AT 1,000 PSF**

SAMPLE LOCATION: **F-26 @ 9 FT**
 NATURAL DRY UNIT WEIGHT: **PCF**
 NATURAL MOISTURE CONTENT: **9.9%**
 PERCENT SWELL/COMPRESSION: **5.1**

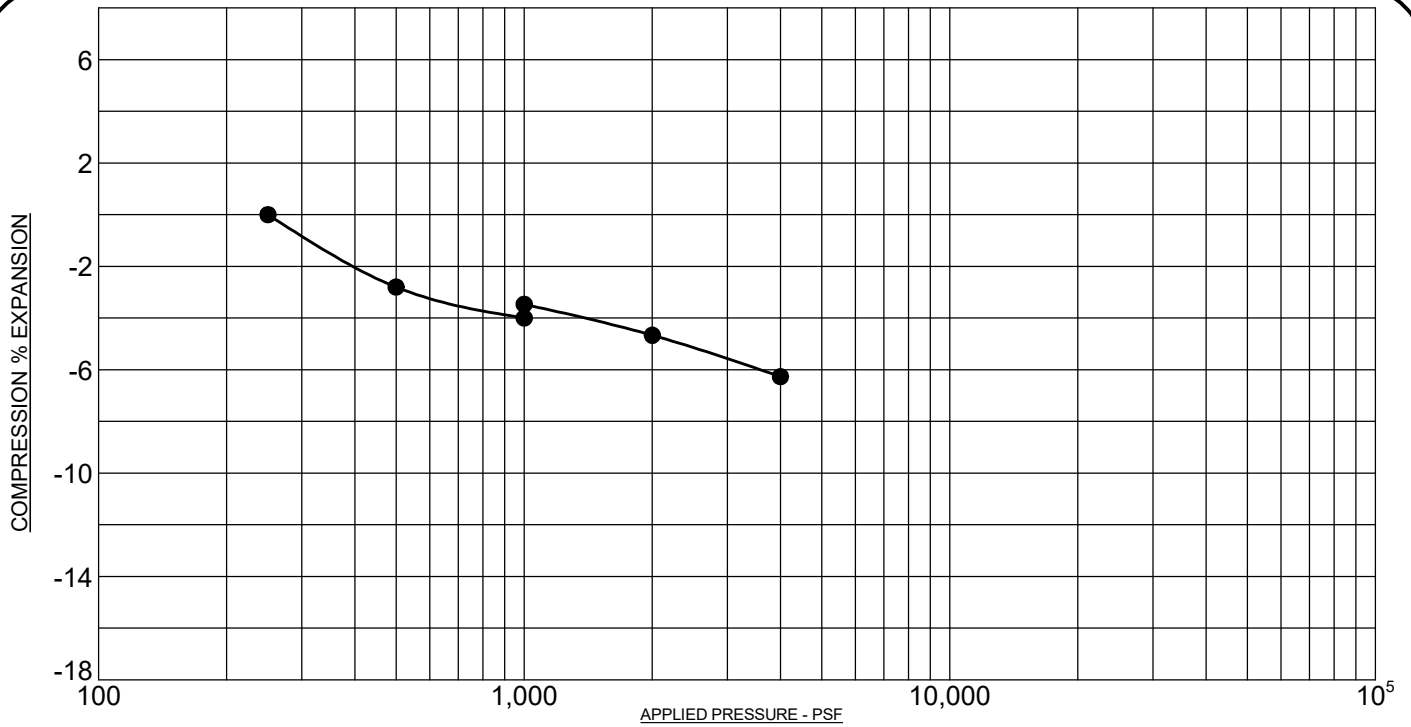
PROJECT: **The Ridge at Lorson Ranch El Paso County, Colorado**
 SAMPLE DESCRIPTION: **CLAYSTONE, SANDY**
 NOTE: **SAMPLE WAS INUNDATED WITH WATER AT 1,000 PSF**

SAMPLE LOCATION: **F-27 @ 14 FT**
 NATURAL DRY UNIT WEIGHT: **111.6 PCF**
 NATURAL MOISTURE CONTENT: **14.6%**
 PERCENT SWELL/COMPRESSION: **0.5**

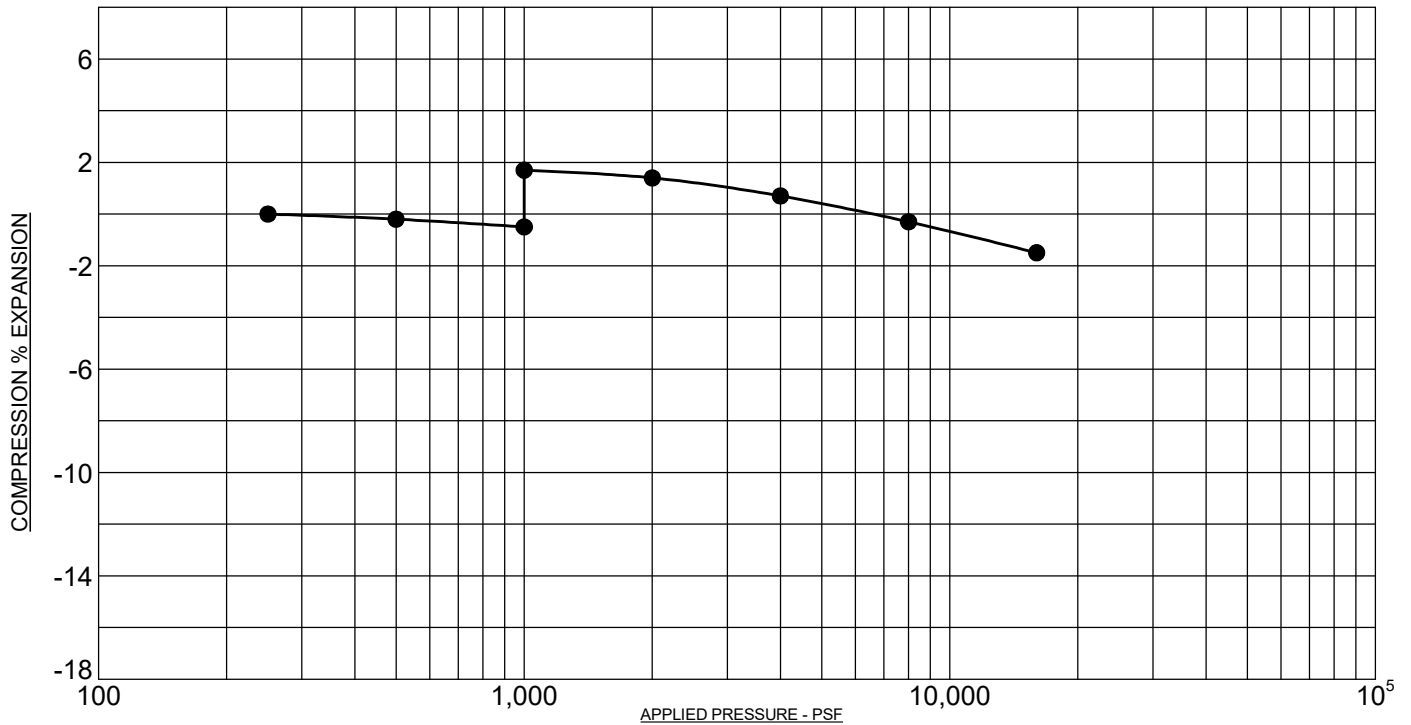
PROJECT: **The Ridge at Lorson Ranch El Paso County, Colorado**
 SAMPLE DESCRIPTION: **CLAYSTONE, SANDY**
 NOTE: **SAMPLE WAS INUNDATED WITH WATER AT 1,000 PSF**

SAMPLE LOCATION: **F-28 @ 9 FT**
 NATURAL DRY UNIT WEIGHT: **90.9 PCF**
 NATURAL MOISTURE CONTENT: **14.2%**
 PERCENT SWELL/COMPRESSION: **2.2**

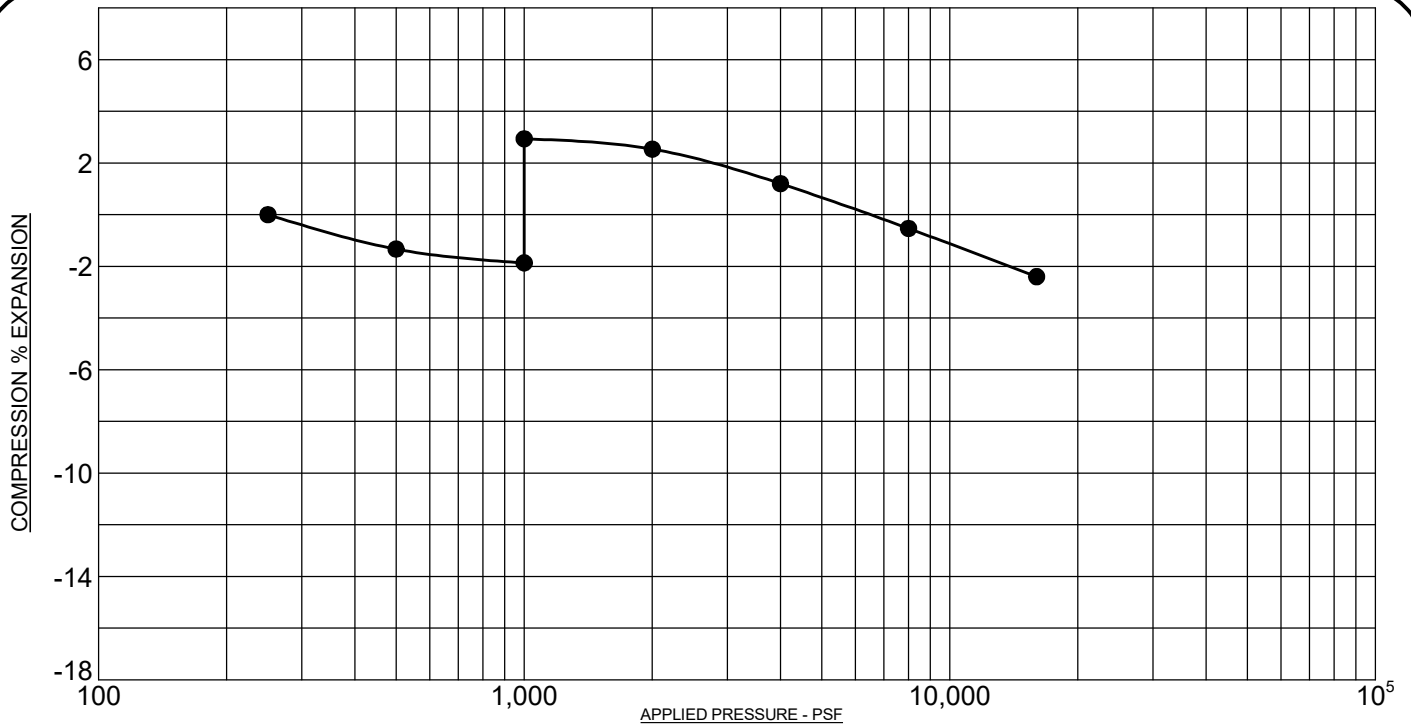
PROJECT: **The Ridge at Lorson Ranch El Paso County, Colorado**
 SAMPLE DESCRIPTION: **CLAYSTONE, SANDY**
 NOTE: **SAMPLE WAS INUNDATED WITH WATER AT 1,000 PSF**

SAMPLE LOCATION: **F-29 @ 9 FT**
 NATURAL DRY UNIT WEIGHT: **120.8 PCF**
 NATURAL MOISTURE CONTENT: **11.9%**
 PERCENT SWELL/COMPRESSION: **4.8**

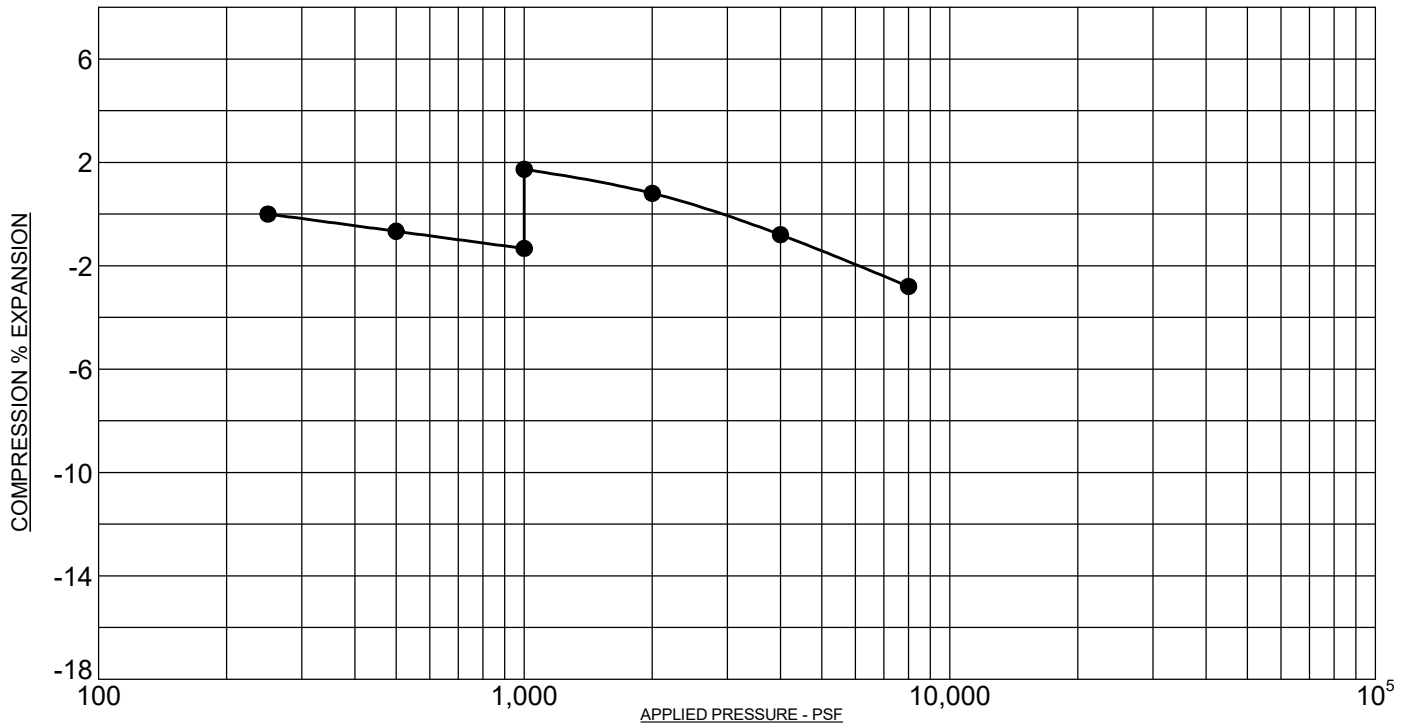
PROJECT: **The Ridge at Lorson Ranch El Paso County, Colorado**
 SAMPLE DESCRIPTION: **CLAYSTONE, SANDY**
 NOTE: **SAMPLE WAS INUNDATED WITH WATER AT 1,000 PSF**

SAMPLE LOCATION: **F-30 @ 14 FT**
 NATURAL DRY UNIT WEIGHT: **115.0 PCF**
 NATURAL MOISTURE CONTENT: **11.7%**
 PERCENT SWELL/COMPRESSION: **3.1**

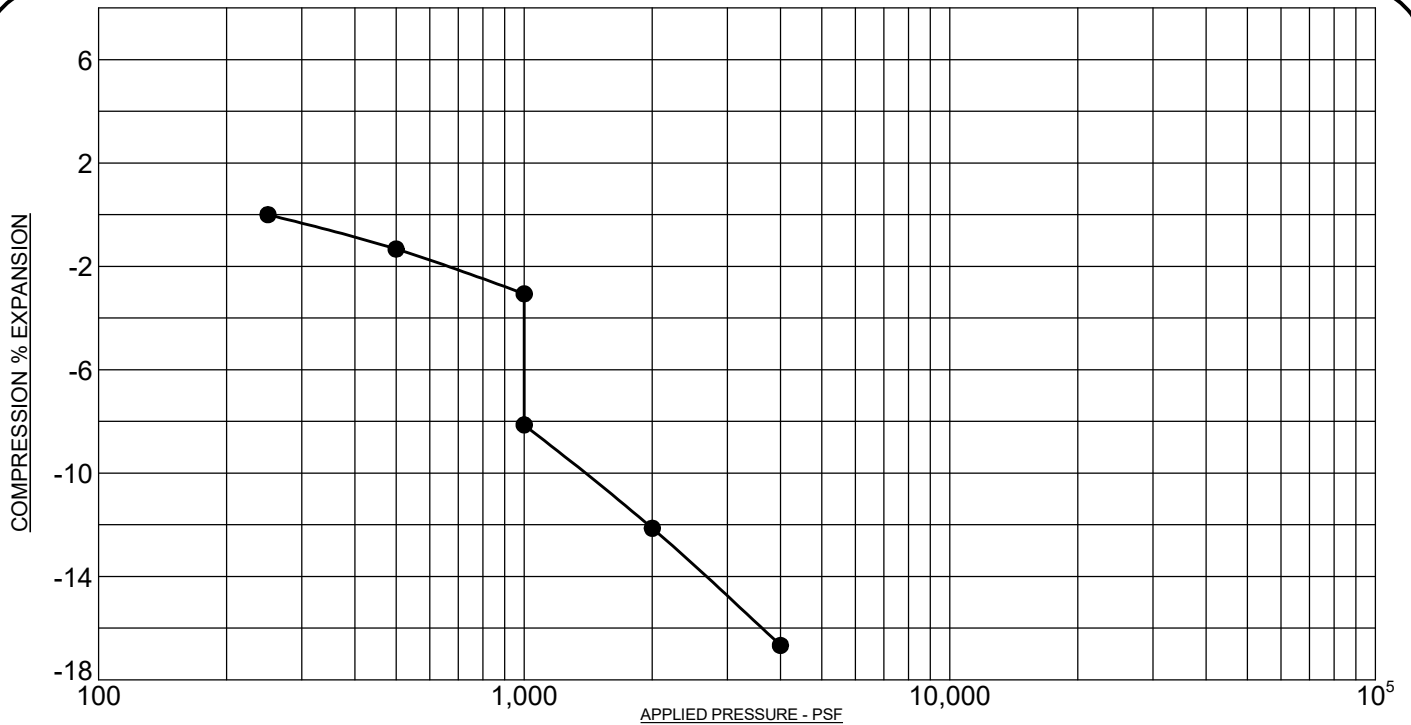
PROJECT: **The Ridge at Lorson Ranch El Paso County, Colorado**
 SAMPLE DESCRIPTION: **CLAYSTONE, SANDY**
 NOTE: **SAMPLE WAS INUNDATED WITH WATER AT 1,000 PSF**

SAMPLE LOCATION: **F-31 @ 9 FT**
 NATURAL DRY UNIT WEIGHT: **90.8 PCF**
 NATURAL MOISTURE CONTENT: **13.1%**
 PERCENT SWELL/COMPRESSION: **- 5.1**
