**ROCKY MOUNTAIN GROUP
EMPLOYEE OWNED**

Job No. 175706

Re: Response to Colorado Geological Survey and El Paso County Review Comments
The Ridge at Lorson Ranch
Fontaine Bl
The Ridge at Lorson Ranch
El Paso County, Colorado

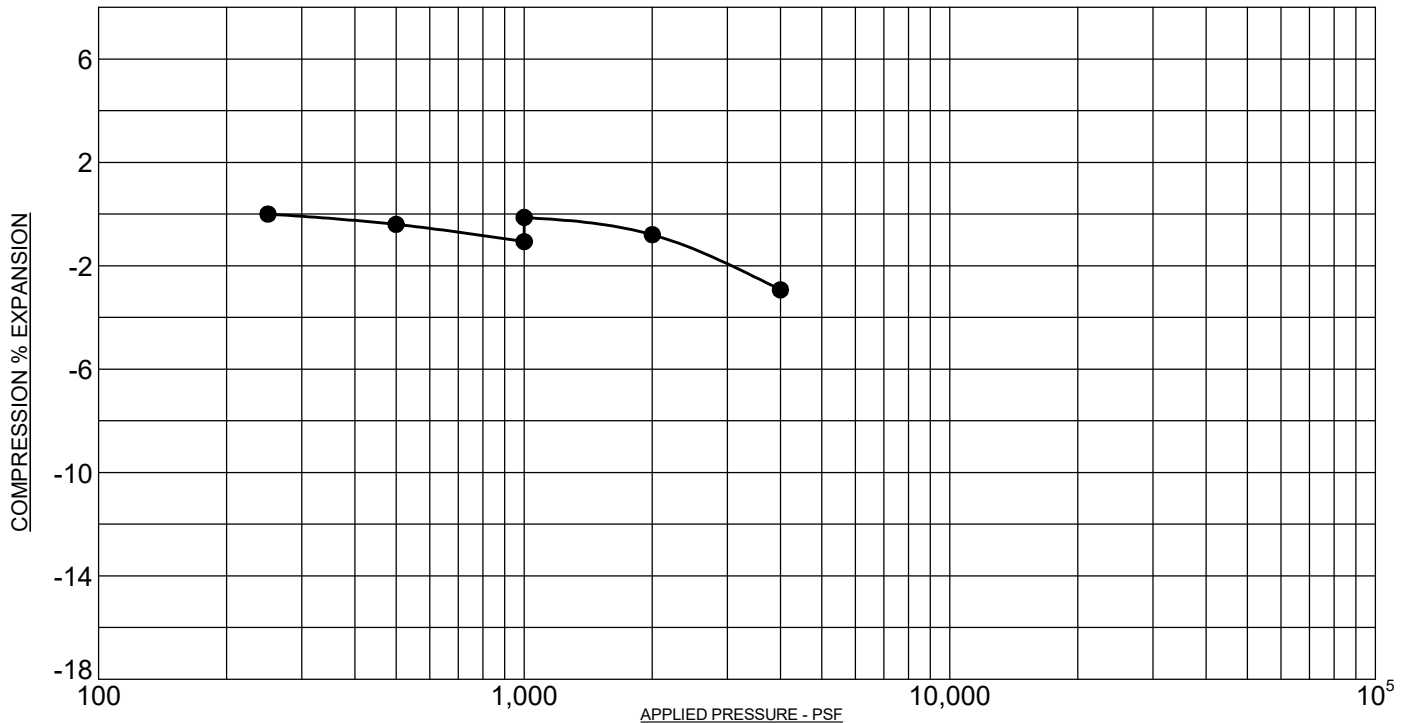
PROJECT: **The Ridge at Lorson Ranch El Paso County, Colorado**
 SAMPLE DESCRIPTION: **CLAYSTONE, SANDY**
 NOTE: **SAMPLE WAS INUNDATED WITH WATER AT 1,000 PSF**

SAMPLE LOCATION: **F-32 @ 4 FT**
 NATURAL DRY UNIT WEIGHT: **112.8 PCF**
 NATURAL MOISTURE CONTENT: **8.3%**
 PERCENT SWELL/COMPRESSION: **0.9**

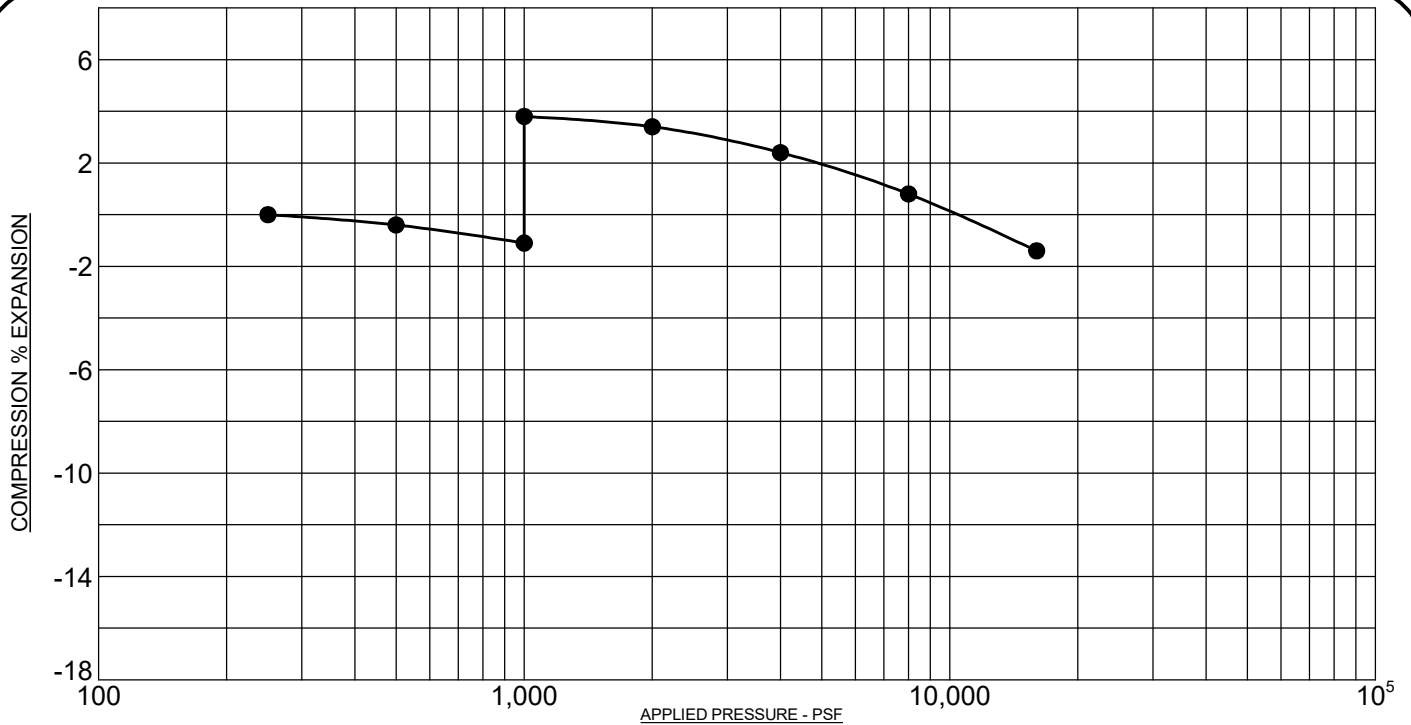
PROJECT: **The Ridge at Lorson Ranch El Paso County, Colorado**
 SAMPLE DESCRIPTION: **CLAYSTONE, SANDY**
 NOTE: **SAMPLE WAS INUNDATED WITH WATER AT 1,000 PSF**

SAMPLE LOCATION: **F-33 @ 19 FT**
 NATURAL DRY UNIT WEIGHT: **PCF**
 NATURAL MOISTURE CONTENT: **10.0%**
 PERCENT SWELL/COMPRESSION: **4.9**

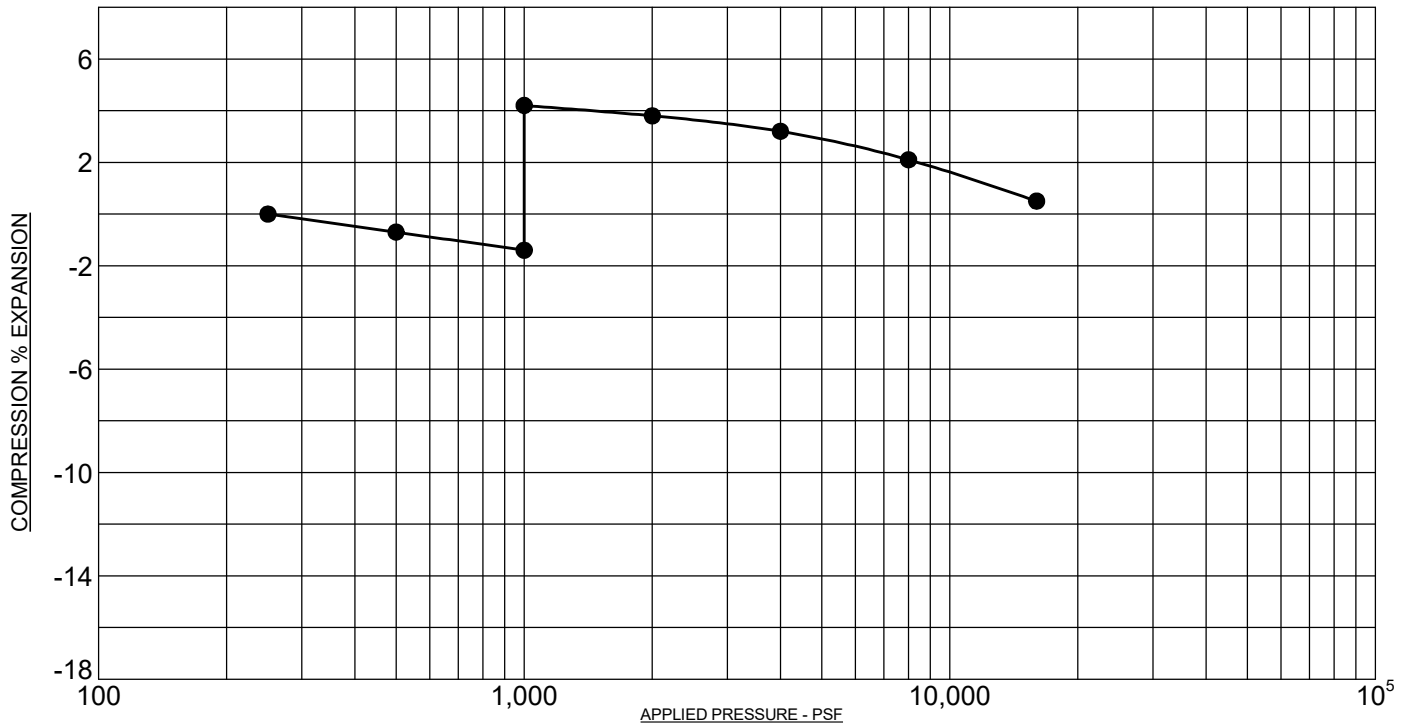
PROJECT: **The Ridge at Lorson Ranch El Paso County, Colorado**
 SAMPLE DESCRIPTION: **CLAYSTONE, SANDY**
 NOTE: **SAMPLE WAS INUNDATED WITH WATER AT 1,000 PSF**

SAMPLE LOCATION: **F-34 @ 19 FT**
 NATURAL DRY UNIT WEIGHT: **PCF**
 NATURAL MOISTURE CONTENT: **11.3%**
 PERCENT SWELL/COMPRESSION: **5.6**

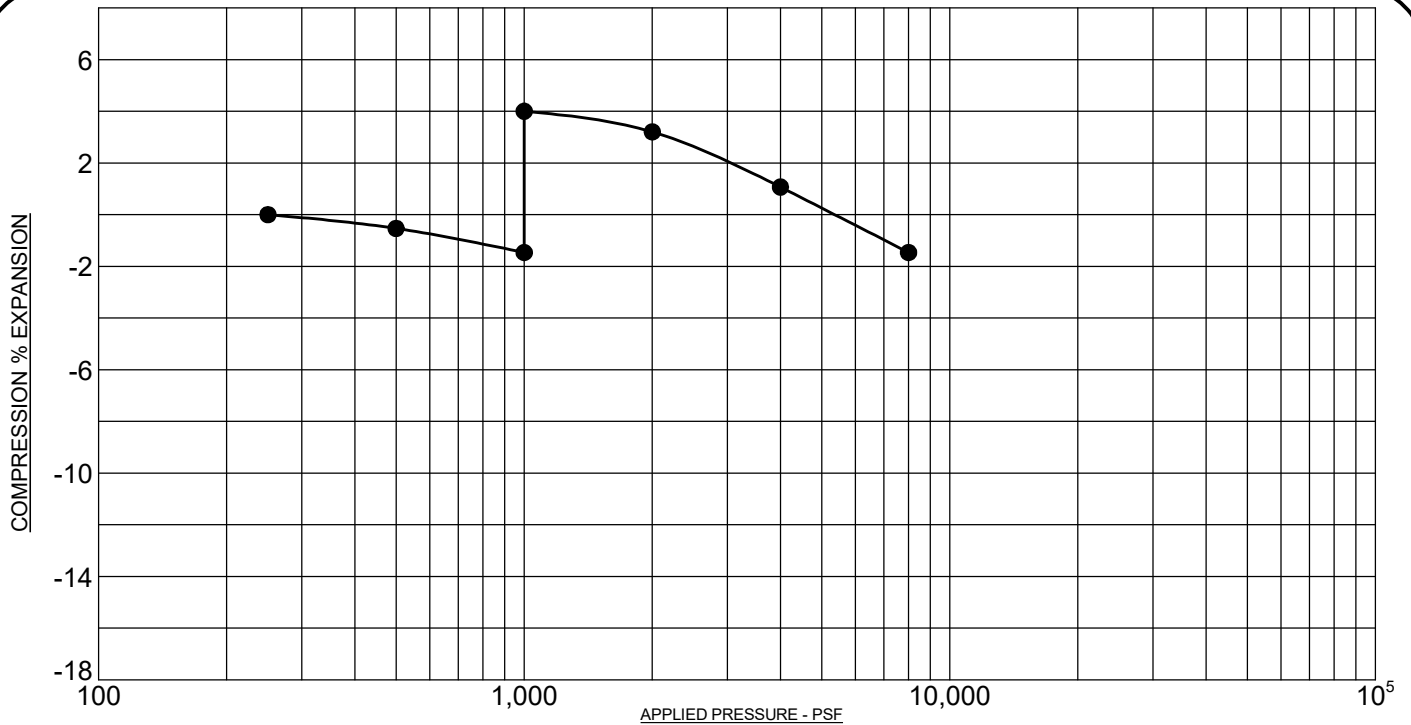
PROJECT: **The Ridge at Lorson Ranch El Paso County, Colorado**
 SAMPLE DESCRIPTION: **CLAYSTONE, SANDY**
 NOTE: **SAMPLE WAS INUNDATED WITH WATER AT 1,000 PSF**

SAMPLE LOCATION: **F-35 @ 14 FT**
 NATURAL DRY UNIT WEIGHT: **PCF**
 NATURAL MOISTURE CONTENT: **9.8%**
 PERCENT SWELL/COMPRESSION: **5.5**

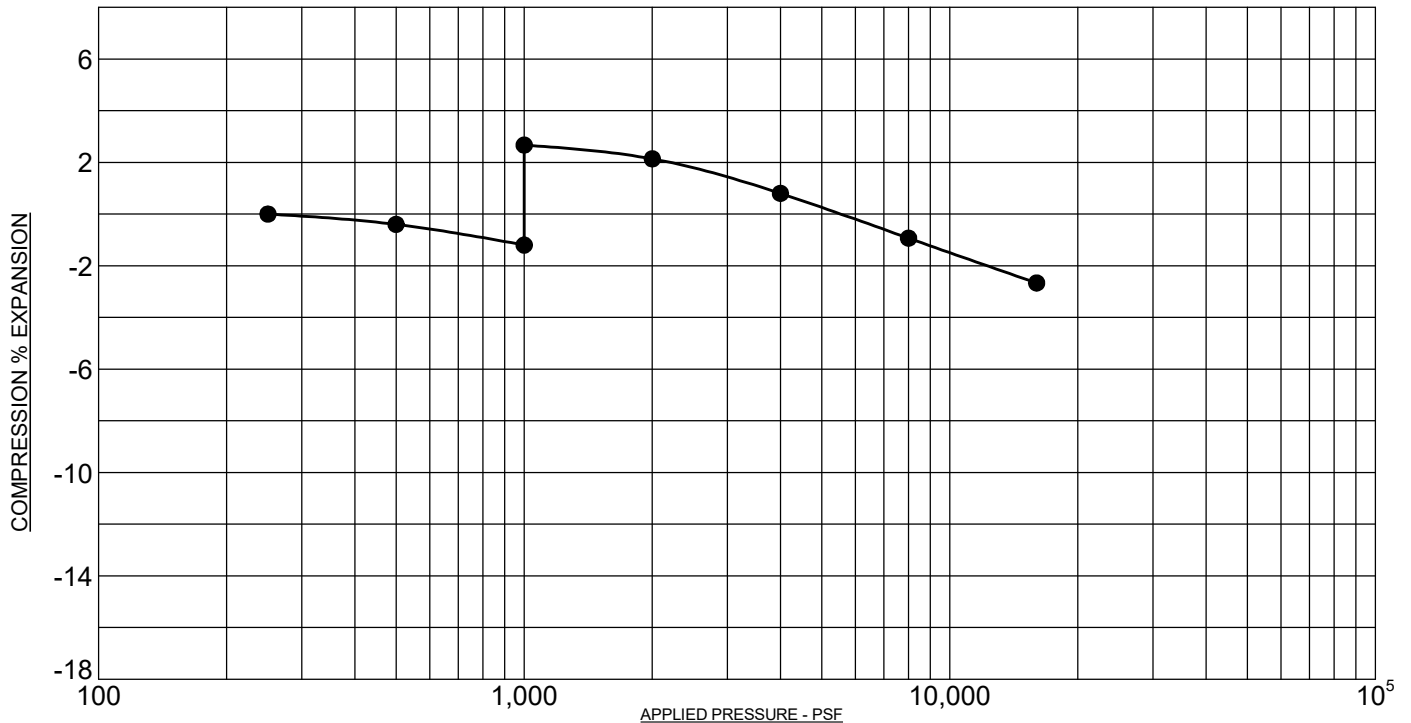
PROJECT: **The Ridge at Lorson Ranch El Paso County, Colorado**
 SAMPLE DESCRIPTION: **CLAYSTONE, SANDY**
 NOTE: **SAMPLE WAS INUNDATED WITH WATER AT 1,000 PSF**

SAMPLE LOCATION: **F-36 @ 14 FT**
 NATURAL DRY UNIT WEIGHT: **PCF**
 NATURAL MOISTURE CONTENT: **11.5%**
 PERCENT SWELL/COMPRESSION: **3.9**

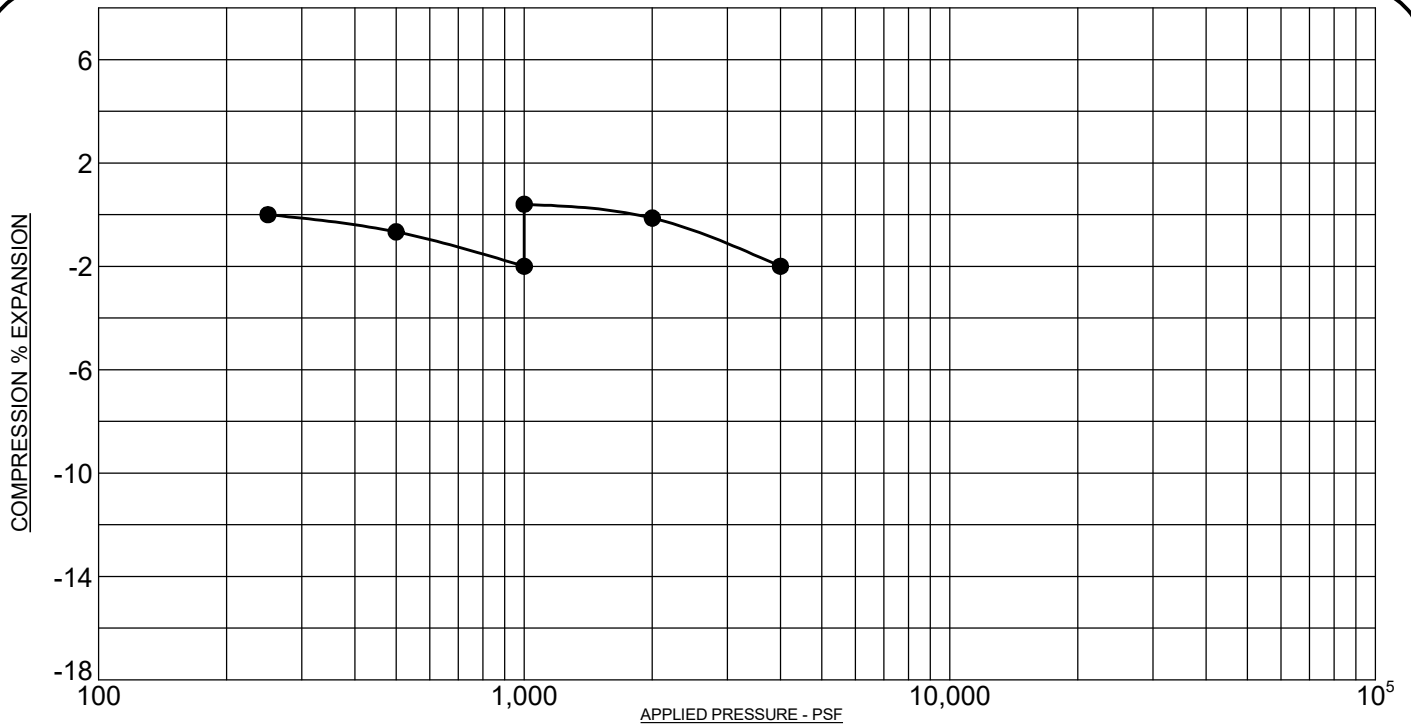
PROJECT: **The Ridge at Lorson Ranch El Paso County, Colorado**
 SAMPLE DESCRIPTION: **CLAY, SANDY**
 NOTE: **SAMPLE WAS INUNDATED WITH WATER AT 1,000 PSF**

SAMPLE LOCATION: **F-37 @ 9 FT**
 NATURAL DRY UNIT WEIGHT: **PCF**
 NATURAL MOISTURE CONTENT: **11.6%**
 PERCENT SWELL/COMPRESSION: **2.4**

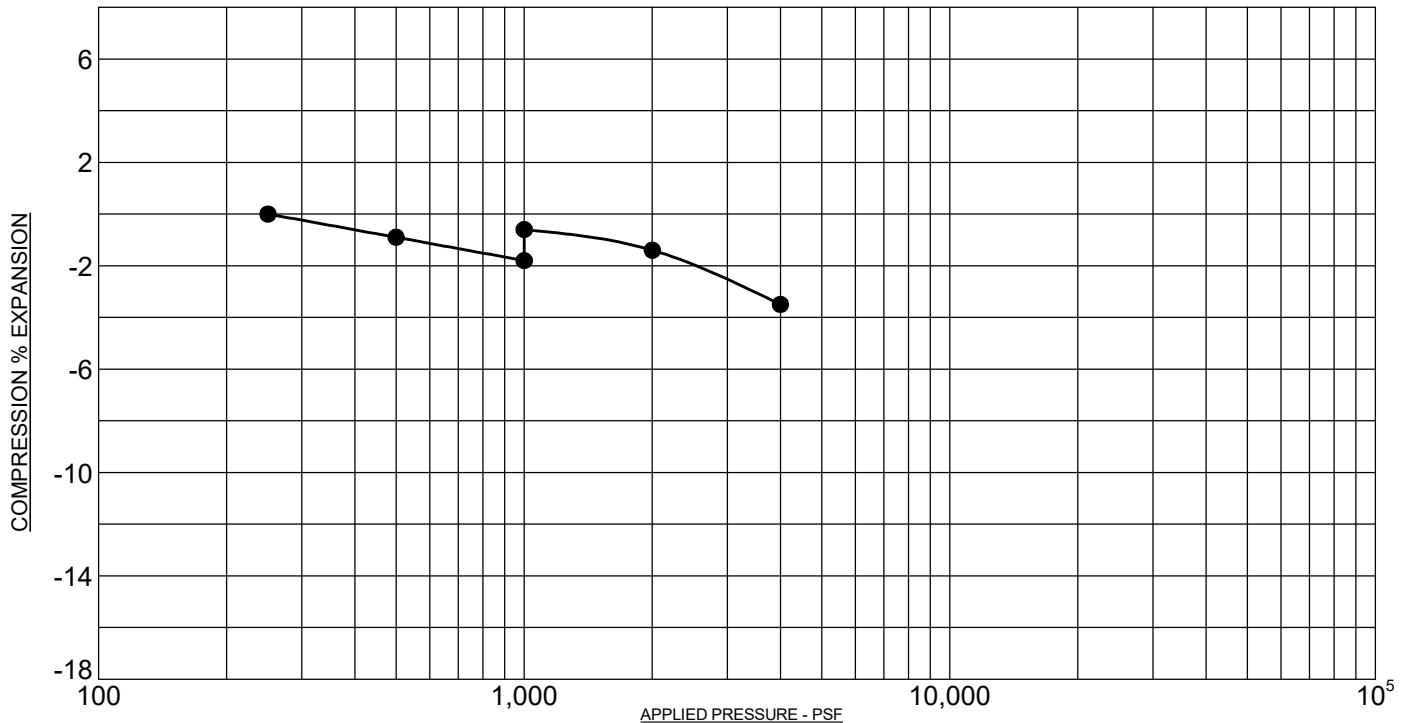
PROJECT: **The Ridge at Lorson Ranch El Paso County, Colorado**
 SAMPLE DESCRIPTION: **CLAYSTONE, SANDY**
 NOTE: **SAMPLE WAS INUNDATED WITH WATER AT 1,000 PSF**

SAMPLE LOCATION: **F-38 @ 4 FT**
 NATURAL DRY UNIT WEIGHT: **PCF**
 NATURAL MOISTURE CONTENT: **7.7%**
 PERCENT SWELL/COMPRESSION: **1.2**

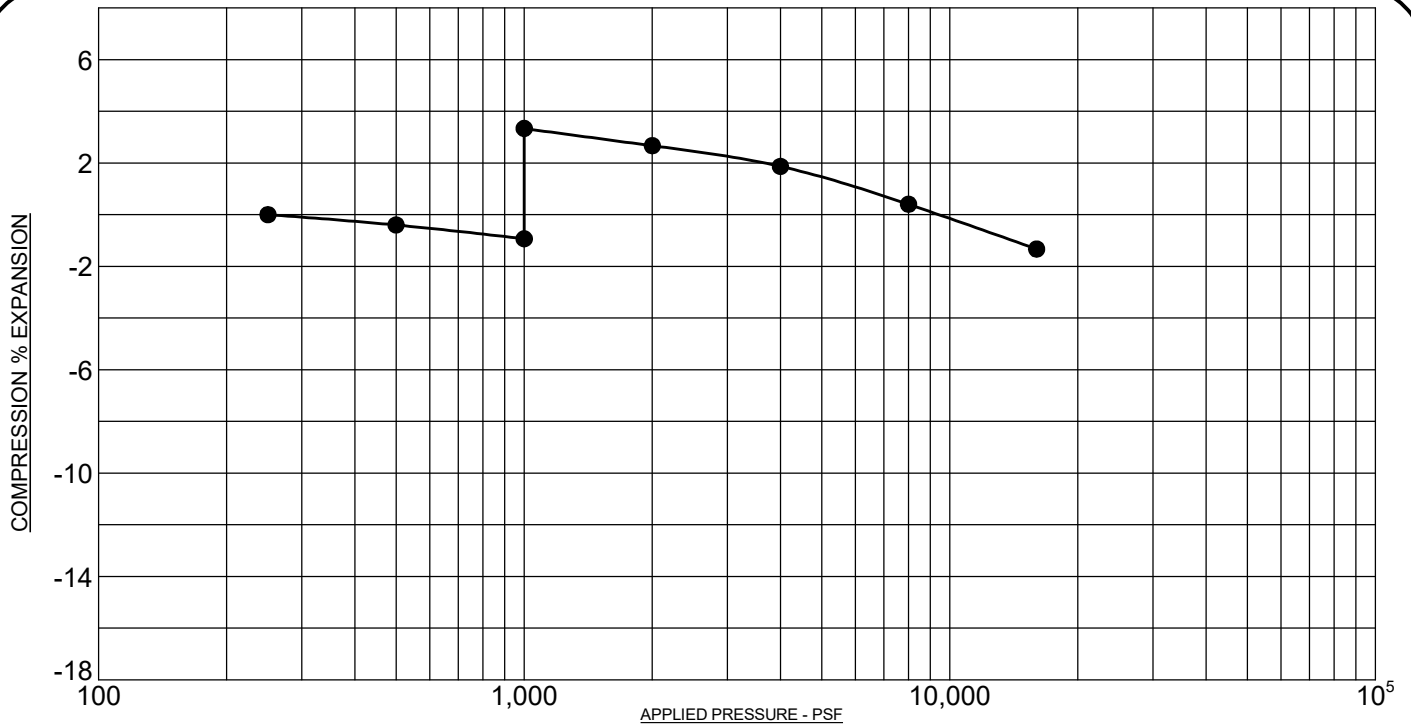
PROJECT: **The Ridge at Lorson Ranch El Paso County, Colorado**
 SAMPLE DESCRIPTION: **CLAYSTONE, SANDY**
 NOTE: **SAMPLE WAS INUNDATED WITH WATER AT 1,000 PSF**

SAMPLE LOCATION: **F-39 @ 9 FT**
 NATURAL DRY UNIT WEIGHT: **116.2 PCF**
 NATURAL MOISTURE CONTENT: **15.0%**
 PERCENT SWELL/COMPRESSION: **4.3**

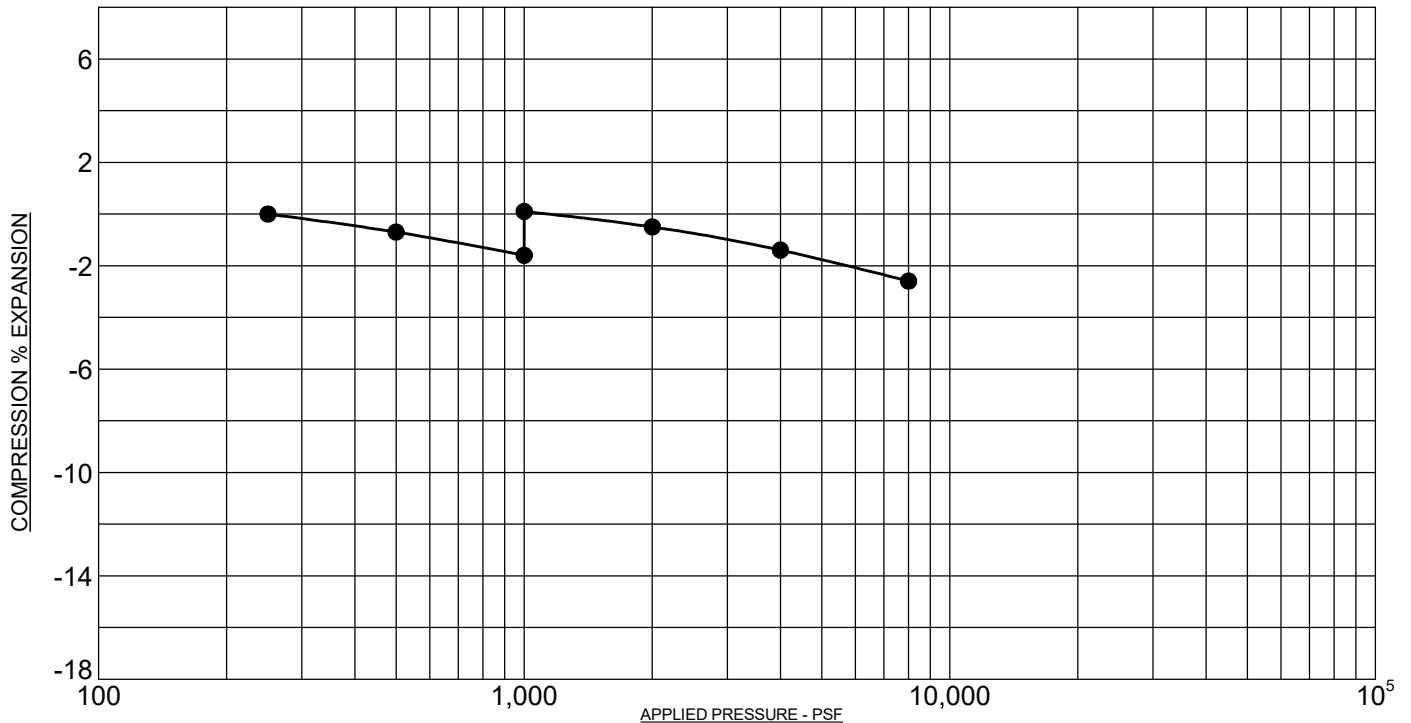
PROJECT: **The Ridge at Lorson Ranch El Paso County, Colorado**
 SAMPLE DESCRIPTION: **CLAYSTONE, SANDY**
 NOTE: **SAMPLE WAS INUNDATED WITH WATER AT 1,000 PSF**

SAMPLE LOCATION: **H-1 @ 14 FT**
 NATURAL DRY UNIT WEIGHT: **118.7 PCF**
 NATURAL MOISTURE CONTENT: **15.0%**
 PERCENT SWELL/COMPRESSION: **1.7**

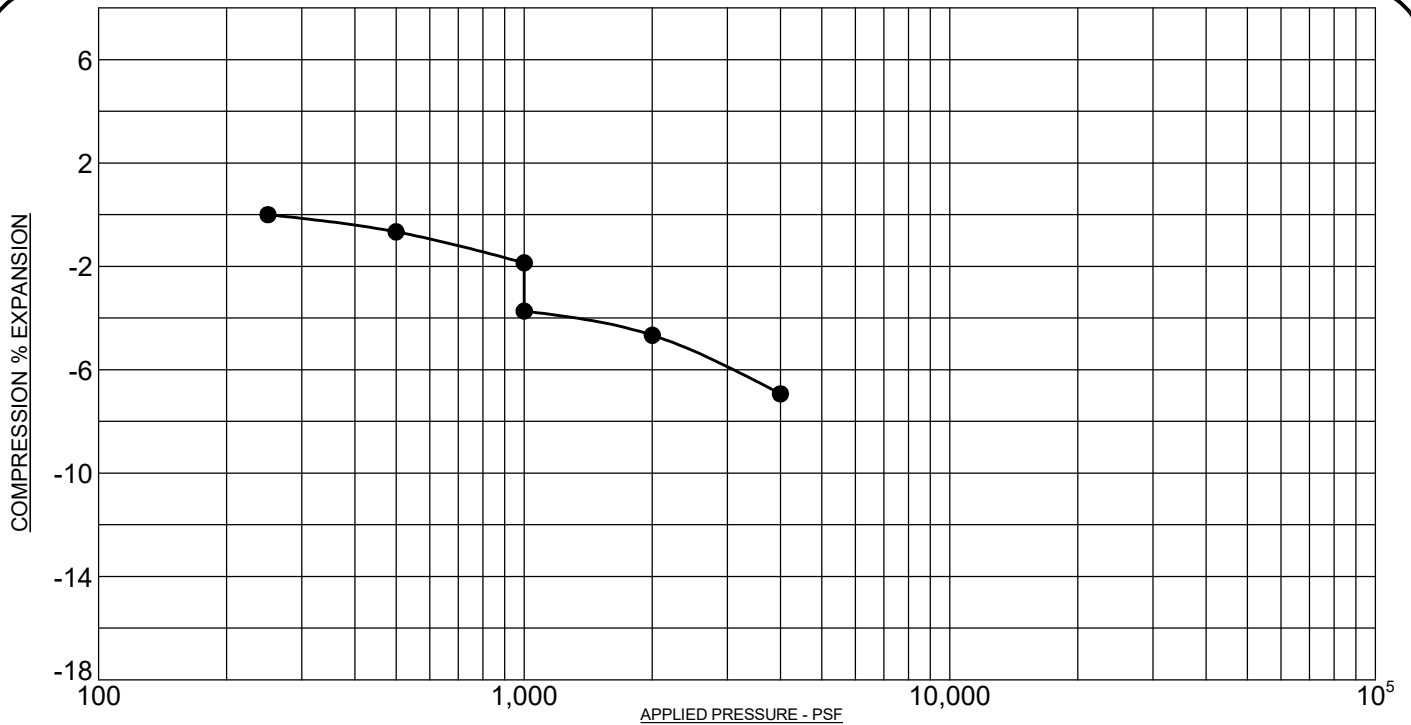
PROJECT: **The Ridge at Lorson Ranch El Paso County, Colorado**
 SAMPLE DESCRIPTION: **CLAYSTONE, SANDY**
 NOTE: **SAMPLE WAS INUNDATED WITH WATER AT 1,000 PSF**

SAMPLE LOCATION: **H-2 @ 9 FT**
 NATURAL DRY UNIT WEIGHT: **102.8 PCF**
 NATURAL MOISTURE CONTENT: **15.0%**
 PERCENT SWELL/COMPRESSION: **- 1.9**

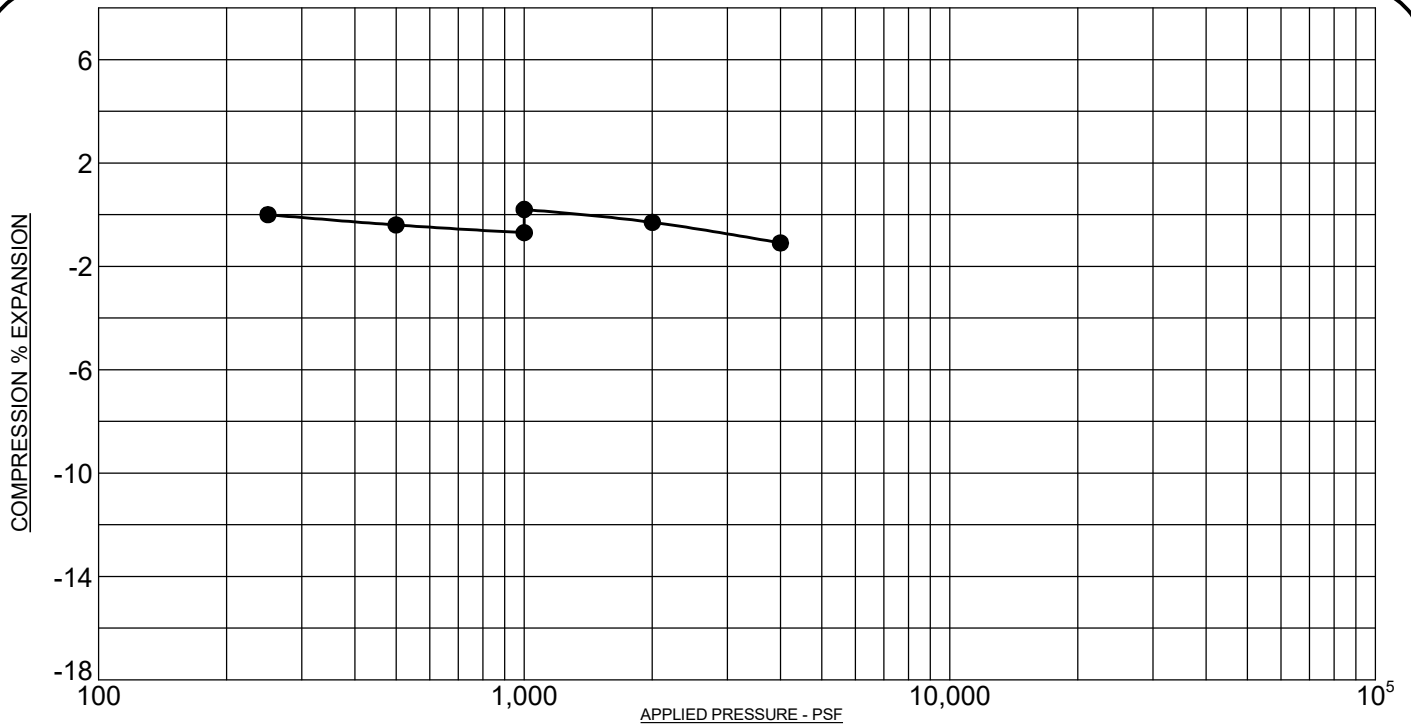
PROJECT: **The Ridge at Lorson Ranch El Paso County, Colorado**
 SAMPLE DESCRIPTION: **CLAYSTONE, SANDY**
 NOTE: **SAMPLE WAS INUNDATED WITH WATER AT 1000 PSF**

SAMPLE LOCATION: **H-4 @ 14 FT**
 NATURAL DRY UNIT WEIGHT: **81.5 PCF**
 NATURAL MOISTURE CONTENT: **15.5%**
 PERCENT SWELL/COMPRESSION: **0.9**

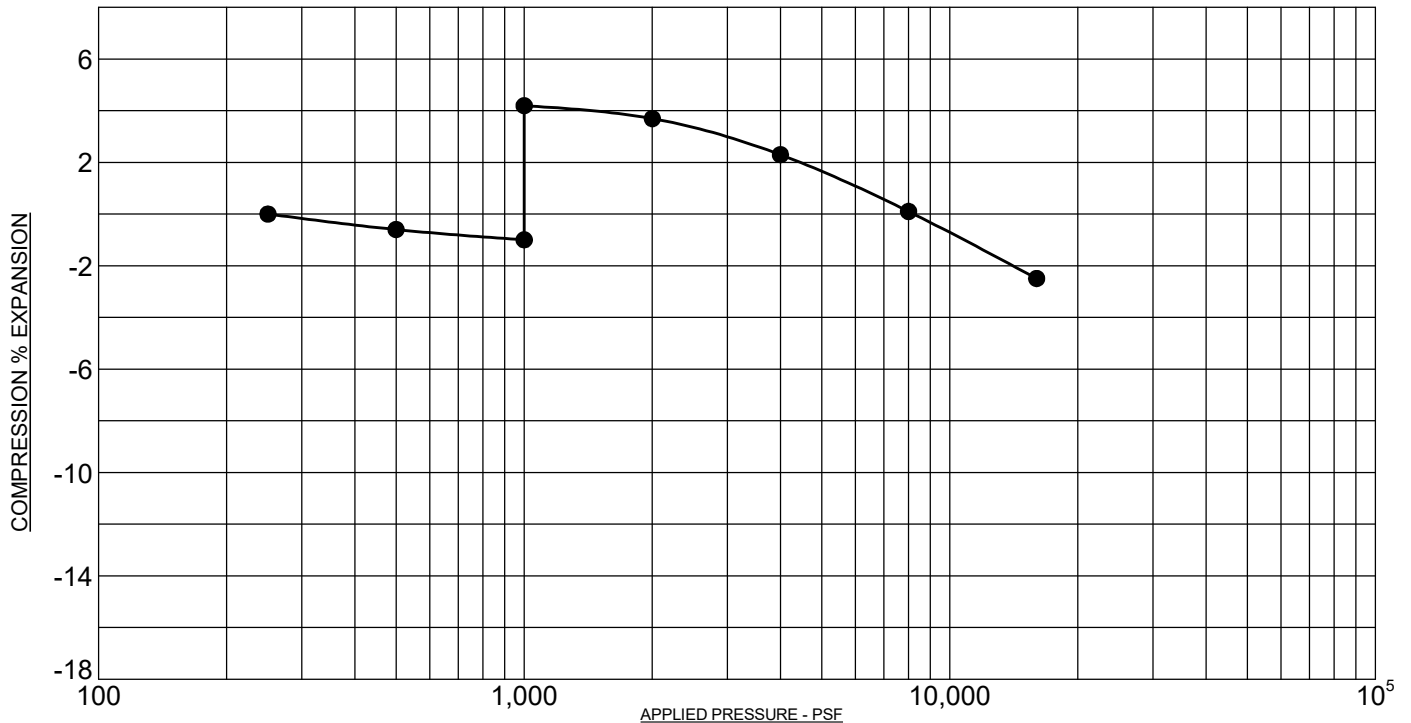
PROJECT: **The Ridge at Lorson Ranch El Paso County, Colorado**
 SAMPLE DESCRIPTION: **CLAY, SANDY**
 NOTE: **SAMPLE WAS INUNDATED WITH WATER AT 1000 PSF**

SAMPLE LOCATION: **H-6 @ 9 FT**
 NATURAL DRY UNIT WEIGHT: **109.9 PCF**
 NATURAL MOISTURE CONTENT: **15.0%**
 PERCENT SWELL/COMPRESSION: **5.2**

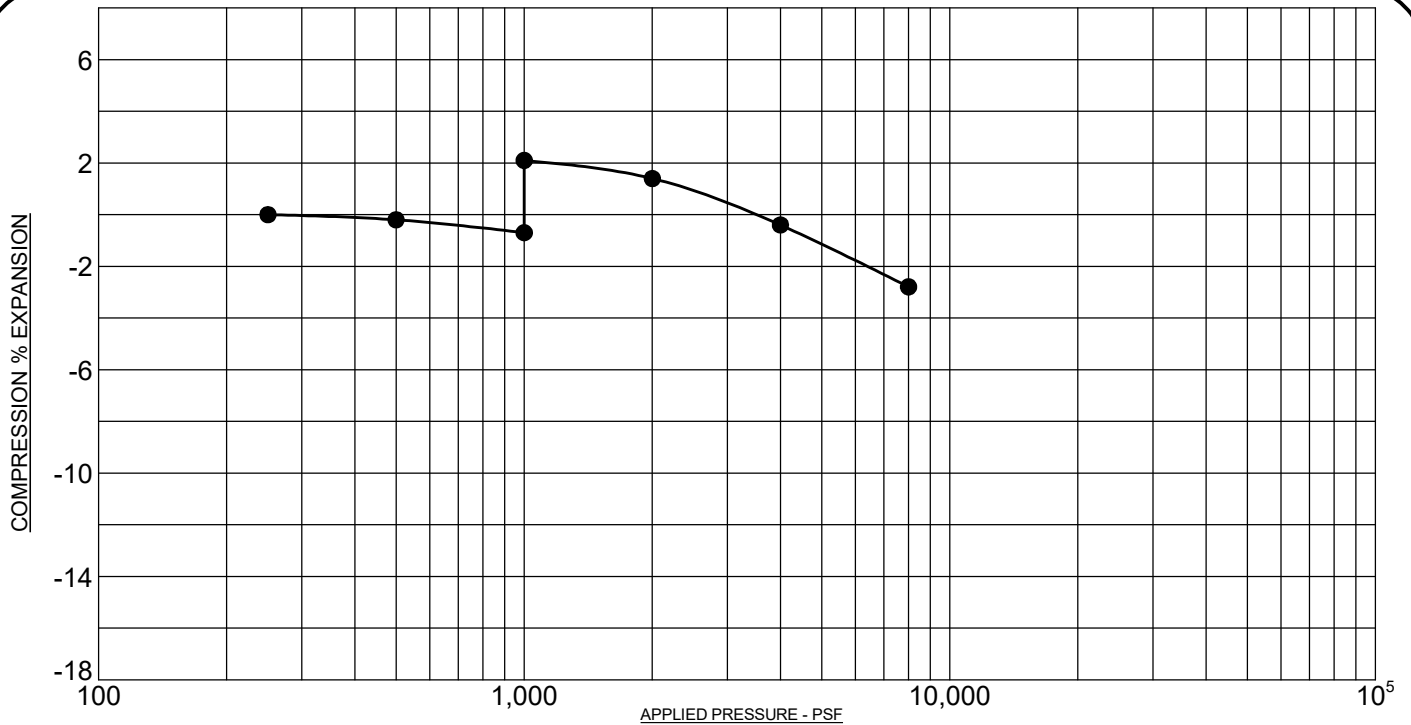
PROJECT: **The Ridge at Lorson Ranch El Paso County, Colorado**
 SAMPLE DESCRIPTION: **CLAYSTONE, SANDY**
 NOTE: **SAMPLE WAS INUNDATED WITH WATER AT 1,000 PSF**

SAMPLE LOCATION: **H-7 @ 24 FT**
 NATURAL DRY UNIT WEIGHT: **PCF**
 NATURAL MOISTURE CONTENT: **%**
 PERCENT SWELL/COMPRESSION: **2.8**

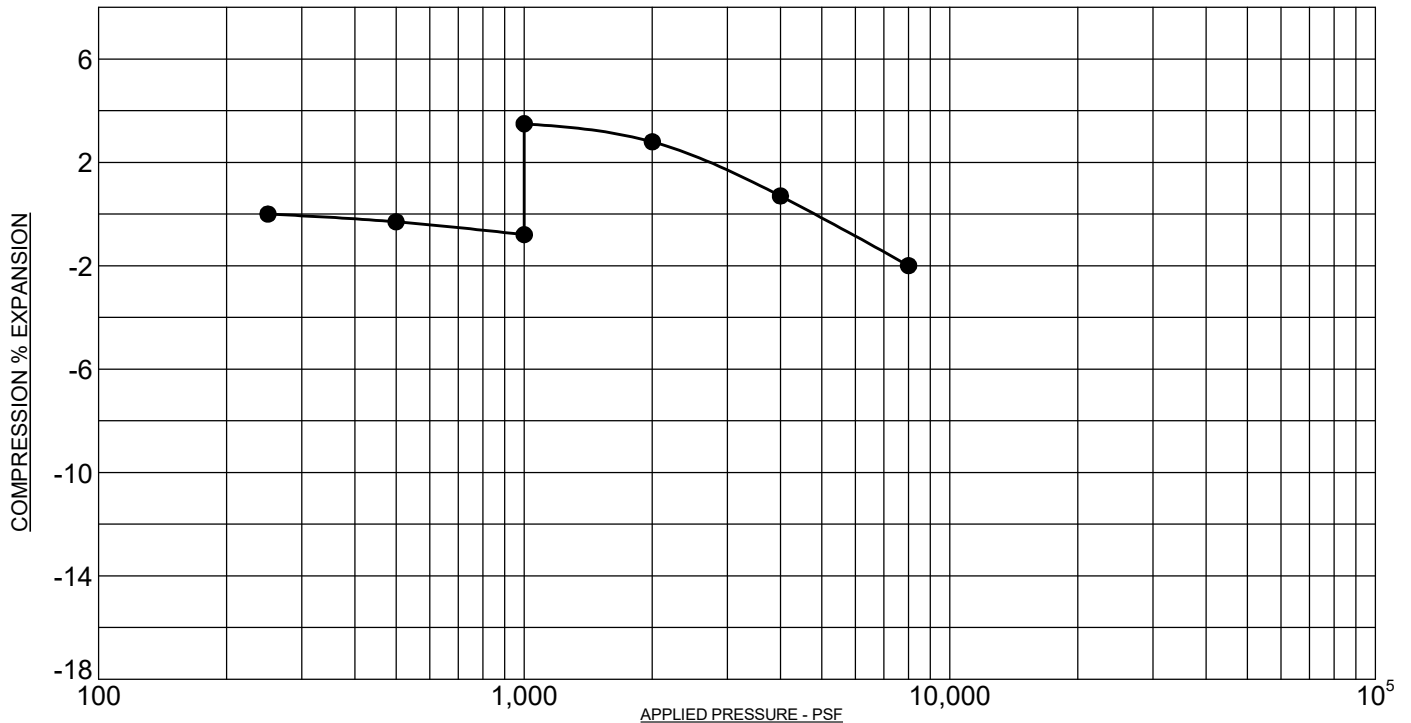
PROJECT: **The Ridge at Lorson Ranch El Paso County, Colorado**
 SAMPLE DESCRIPTION: **CLAYSTONE, SANDY**
 NOTE: **SAMPLE WAS INUNDATED WITH WATER AT 1,000 PSF**

SAMPLE LOCATION: **H-8 @ 14 FT**
 NATURAL DRY UNIT WEIGHT: **107.2 PCF**
 NATURAL MOISTURE CONTENT: **15.0%**
 PERCENT SWELL/COMPRESSION: **4.3**

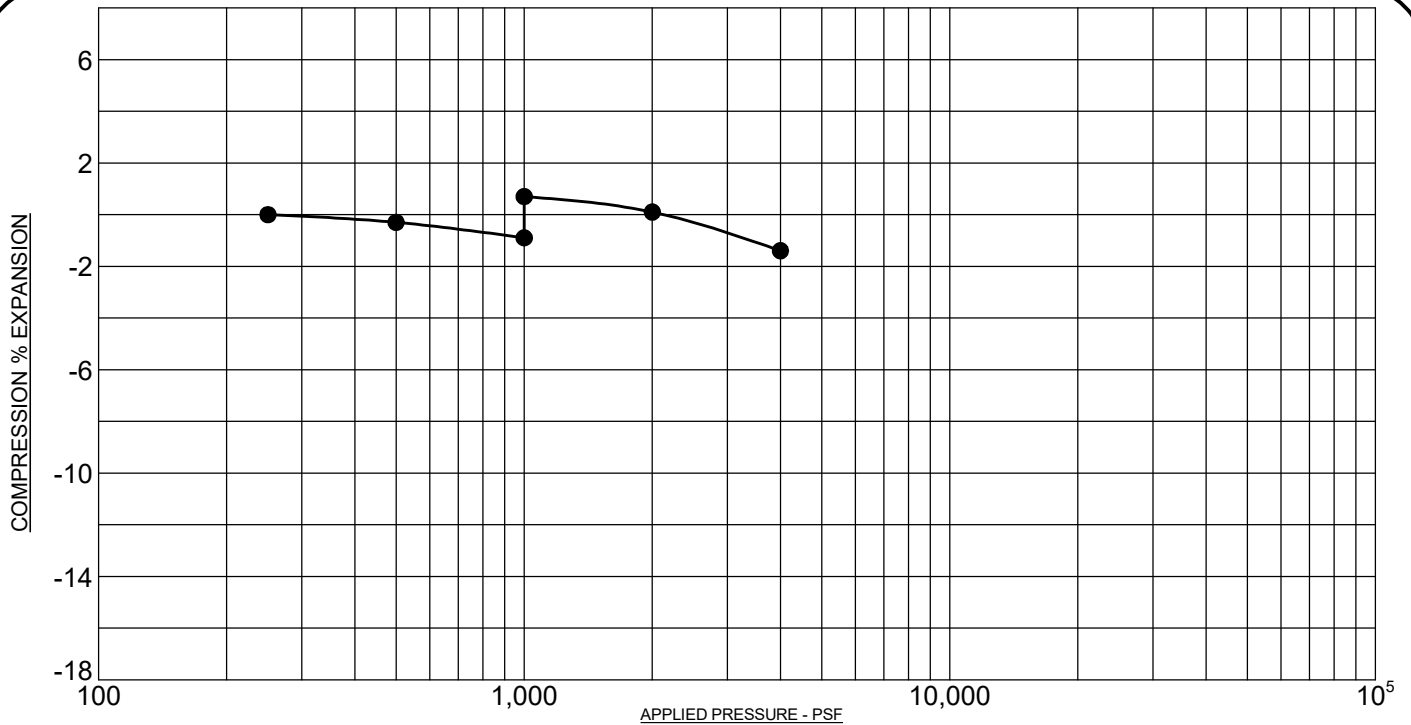
PROJECT: **The Ridge at Lorson Ranch El Paso County, Colorado**
 SAMPLE DESCRIPTION: **CLAYSTONE, SANDY**
 NOTE: **SAMPLE WAS INUNDATED WITH WATER AT 1,000 PSF**

SAMPLE LOCATION: **H-9 @ 4 FT**
 NATURAL DRY UNIT WEIGHT: **114.1 PCF**
 NATURAL MOISTURE CONTENT: **15.0%**
 PERCENT SWELL/COMPRESSION: **1.6**

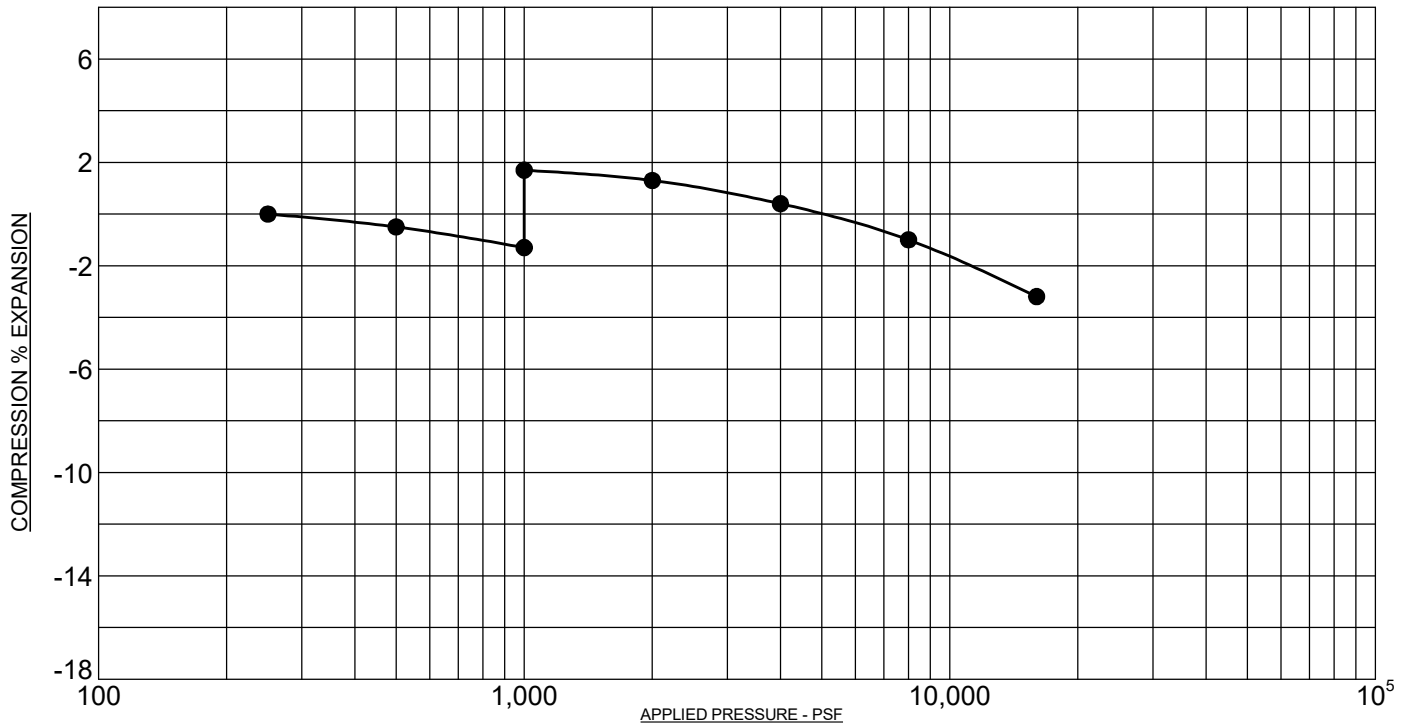
PROJECT: **The Ridge at Lorson Ranch El Paso County, Colorado**
 SAMPLE DESCRIPTION: **CLAYSTONE, SANDY**
 NOTE: **SAMPLE WAS INUNDATED WITH WATER AT 1,000 PSF**

SAMPLE LOCATION: **H-10 @ 4 FT**
 NATURAL DRY UNIT WEIGHT: **112.3 PCF**
 NATURAL MOISTURE CONTENT: **14.4%**
 PERCENT SWELL/COMPRESSION: **3.0**

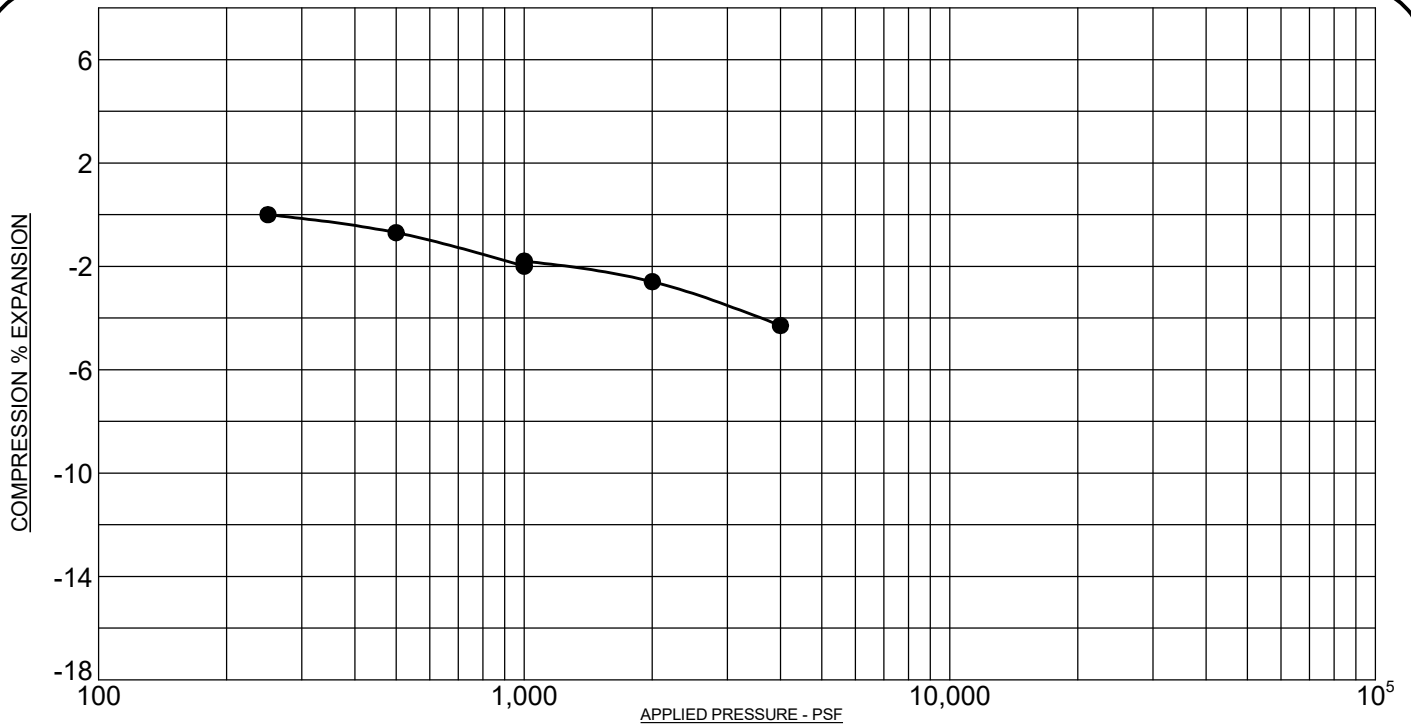
PROJECT: **The Ridge at Lorson Ranch El Paso County, Colorado**
 SAMPLE DESCRIPTION: **CLAY, SANDY**
 NOTE: **SAMPLE WAS INUNDATED WITH WATER AT 1,000 PSF**

SAMPLE LOCATION: **H-11 @ 9 FT**
 NATURAL DRY UNIT WEIGHT: **101.2 PCF**
 NATURAL MOISTURE CONTENT: **9.9%**
 PERCENT SWELL/COMPRESSION: **0.2**

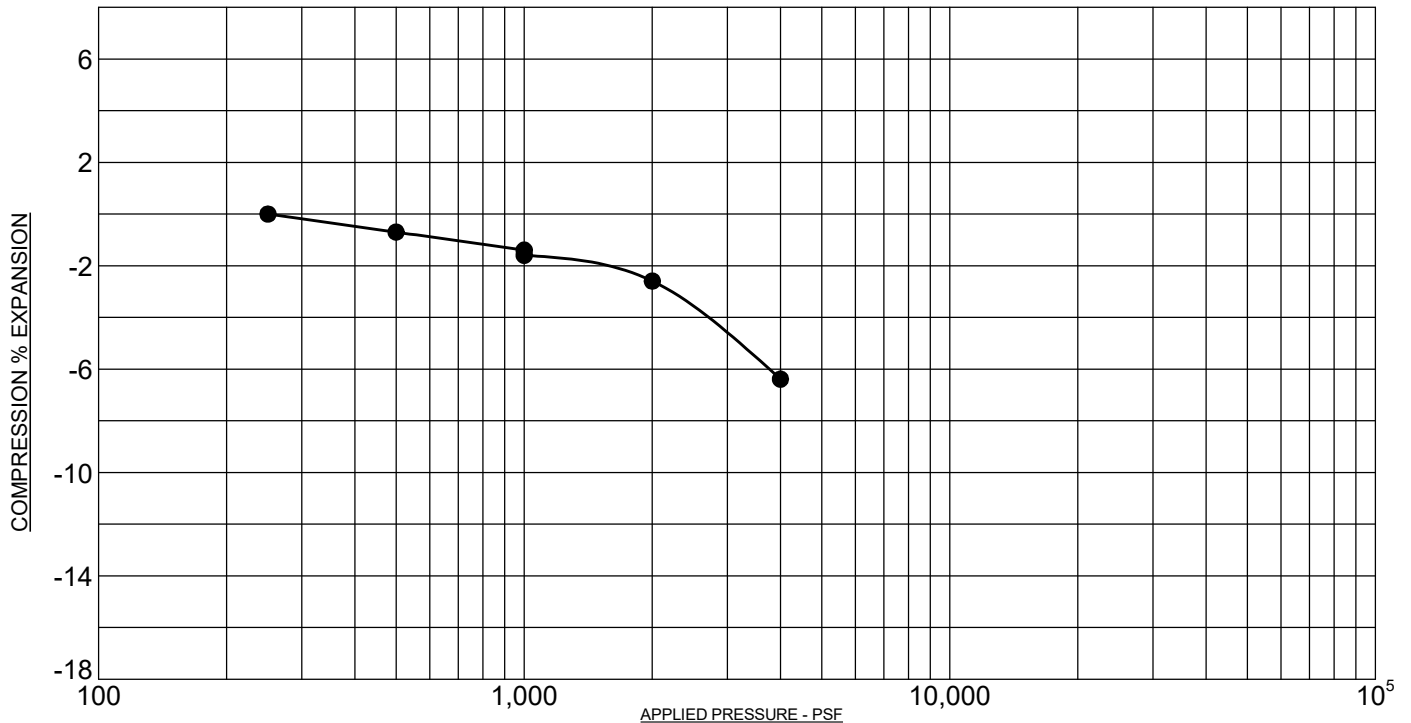
PROJECT: **The Ridge at Lorson Ranch El Paso County, Colorado**
 SAMPLE DESCRIPTION: **CLAYSTONE, SANDY**
 NOTE: **SAMPLE WAS INUNDATED WITH WATER AT 1,000 PSF**

SAMPLE LOCATION: **H-12 @ 19 FT**
 NATURAL DRY UNIT WEIGHT: **106.9 PCF**
 NATURAL MOISTURE CONTENT: **15.6%**
 PERCENT SWELL/COMPRESSION: **- 0.2**

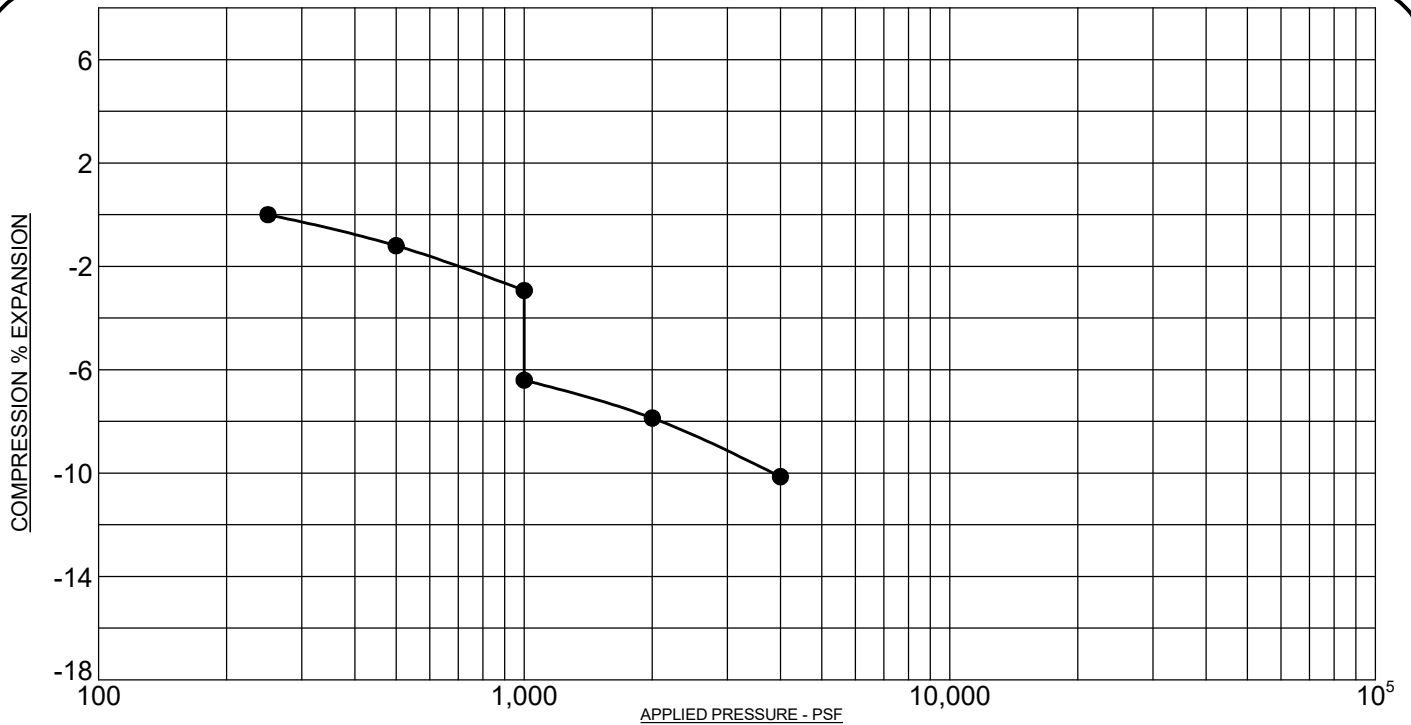
PROJECT: **The Ridge at Lorson Ranch El Paso County, Colorado**
 SAMPLE DESCRIPTION: **CLAYSTONE, SANDY**
 NOTE: **SAMPLE WAS INUNDATED WITH WATER AT 1,000 PSF**

SAMPLE LOCATION: **H-13 @ 9 FT**
 NATURAL DRY UNIT WEIGHT: **110.5 PCF**
 NATURAL MOISTURE CONTENT: **9.7%**
 PERCENT SWELL/COMPRESSION: **- 3.5**

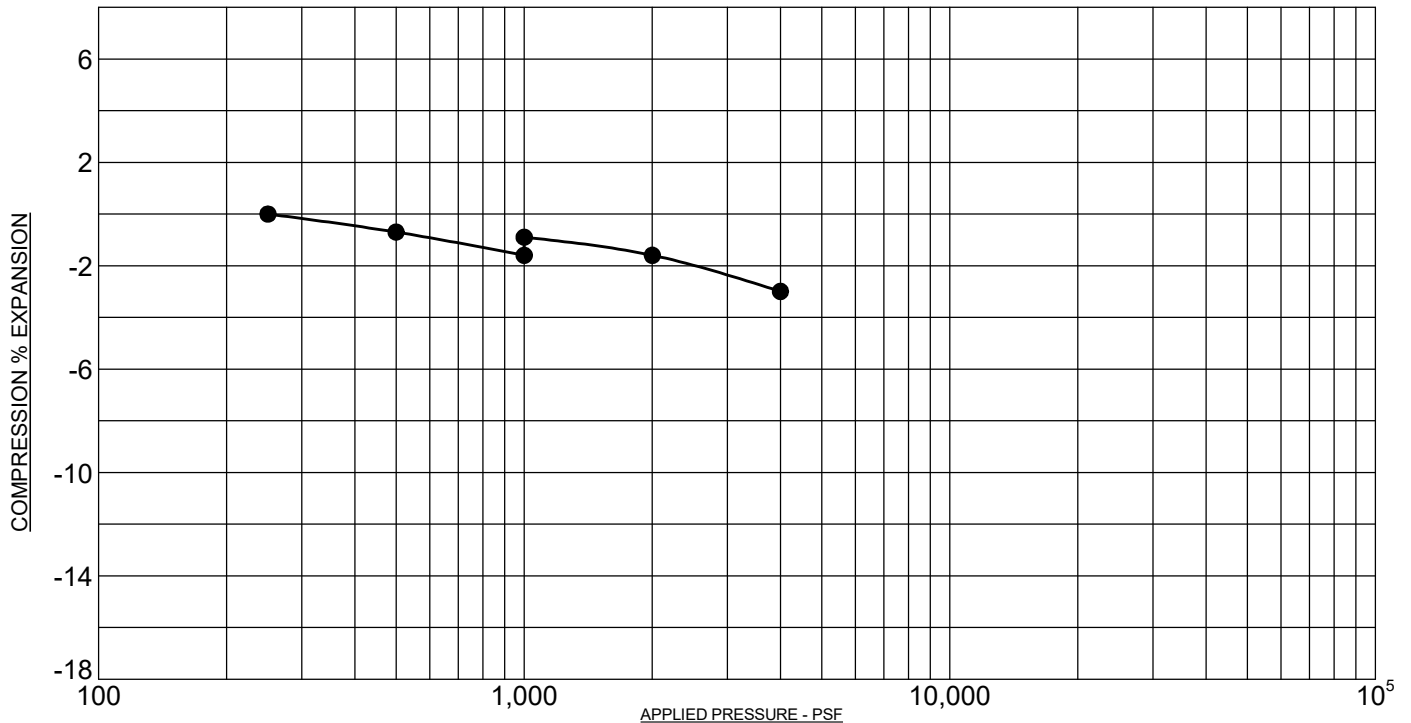
PROJECT: **The Ridge at Lorson Ranch El Paso County, Colorado**
 SAMPLE DESCRIPTION: **CLAYSTONE, SANDY**
 NOTE: **SAMPLE WAS INUNDATED WITH WATER AT 1,000 PSF**

SAMPLE LOCATION: **H-14 @ 14 FT**
 NATURAL DRY UNIT WEIGHT: **107.8 PCF**
 NATURAL MOISTURE CONTENT: **15.5%**
 PERCENT SWELL/COMPRESSION: **0.7**
