**ROCKY MOUNTAIN GROUP
EMPLOYEE OWNED**

Job No. 175706

Re: Response to Colorado Geological Survey and El Paso County Review Comments
The Ridge at Lorson Ranch
Fontaine Bl
The Ridge at Lorson Ranch
El Paso County, Colorado

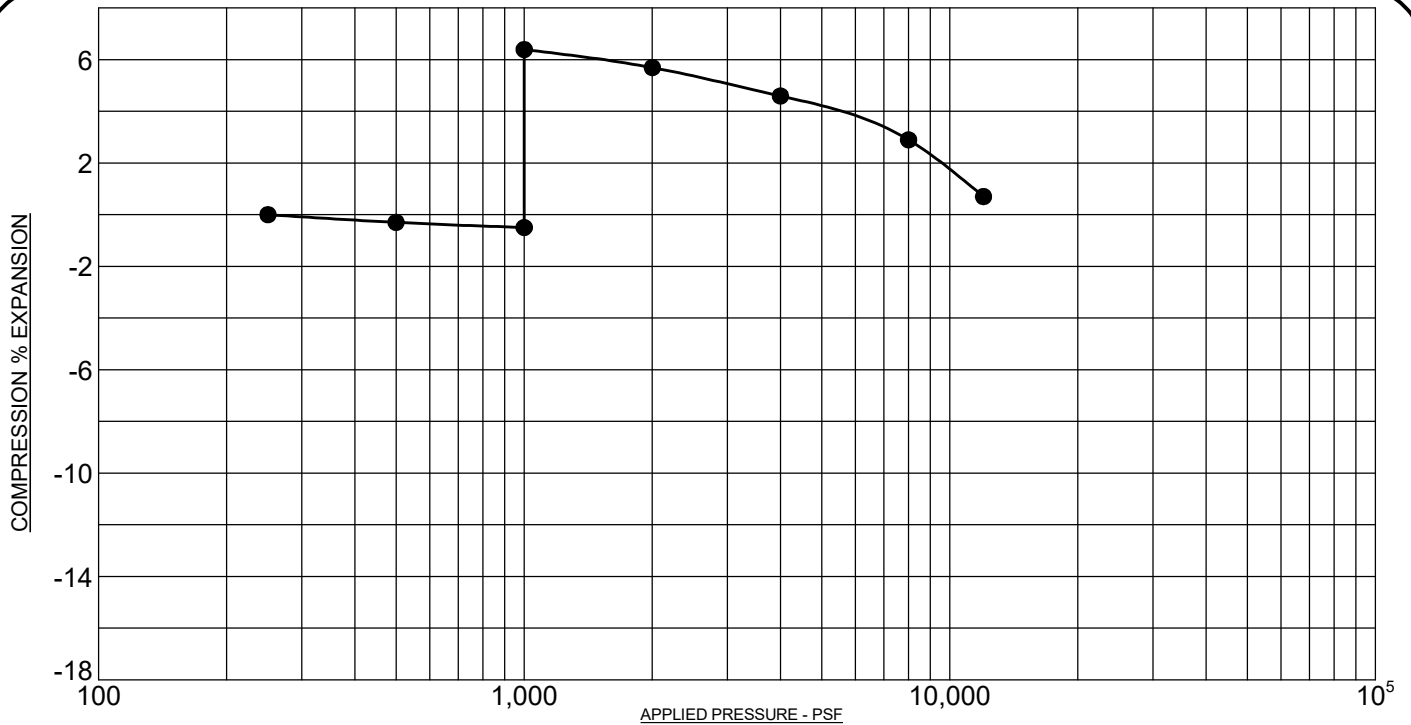
PROJECT: **The Ridge at Lorson Ranch El Paso County, Colorado**
 SAMPLE DESCRIPTION: **CLAYSTONE, SANDY**
 NOTE: **SAMPLE WAS INUNDATED WITH WATER AT 1,000 PSF**

SAMPLE LOCATION: **H-15 @ 14 FT**
 NATURAL DRY UNIT WEIGHT: **122.1 PCF**
 NATURAL MOISTURE CONTENT: **12.0%**
 PERCENT SWELL/COMPRESSION: **6.9**

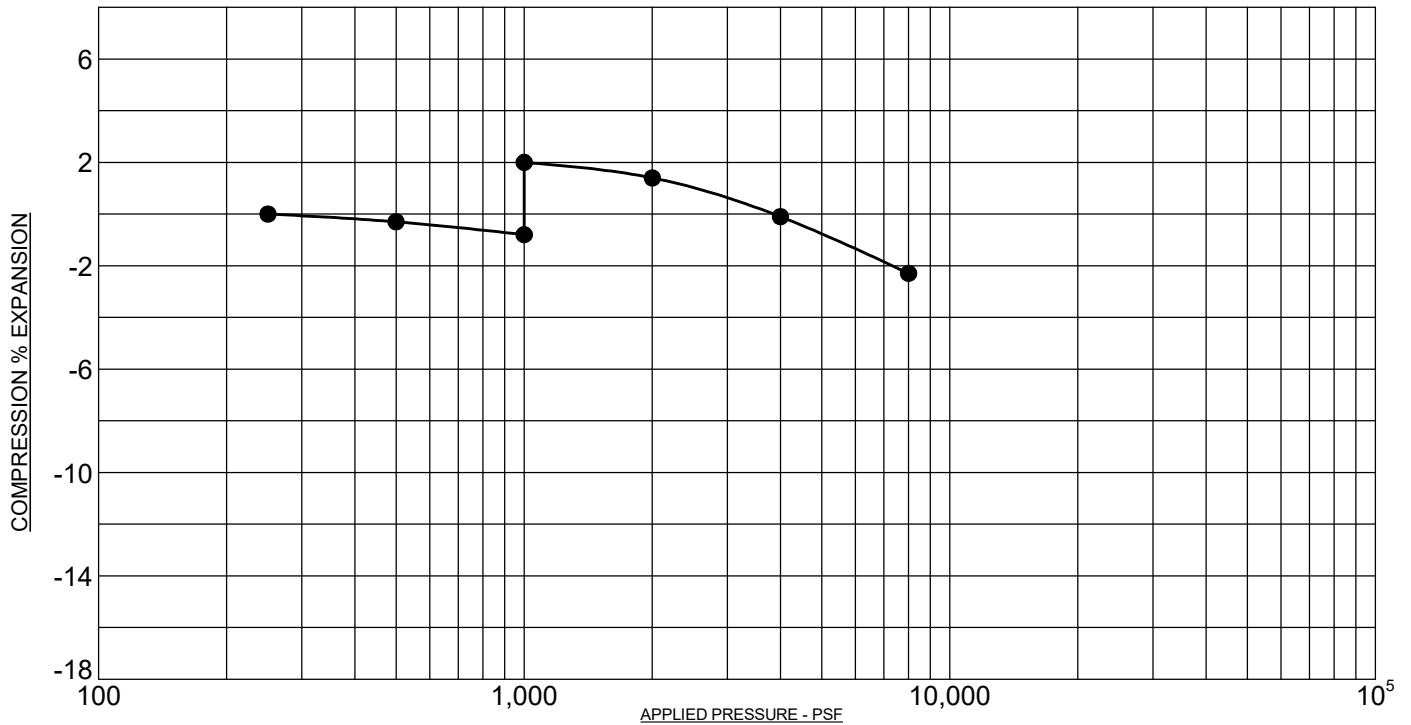
PROJECT: **The Ridge at Lorson Ranch El Paso County, Colorado**
 SAMPLE DESCRIPTION: **CLAY, SANDY**
 NOTE: **SAMPLE WAS INUNDATED WITH WATER AT 1,000 PSF**

SAMPLE LOCATION: **H-16 @ 24 FT**
 NATURAL DRY UNIT WEIGHT: **113.7 PCF**
 NATURAL MOISTURE CONTENT: **15.5%**
 PERCENT SWELL/COMPRESSION: **2.8**

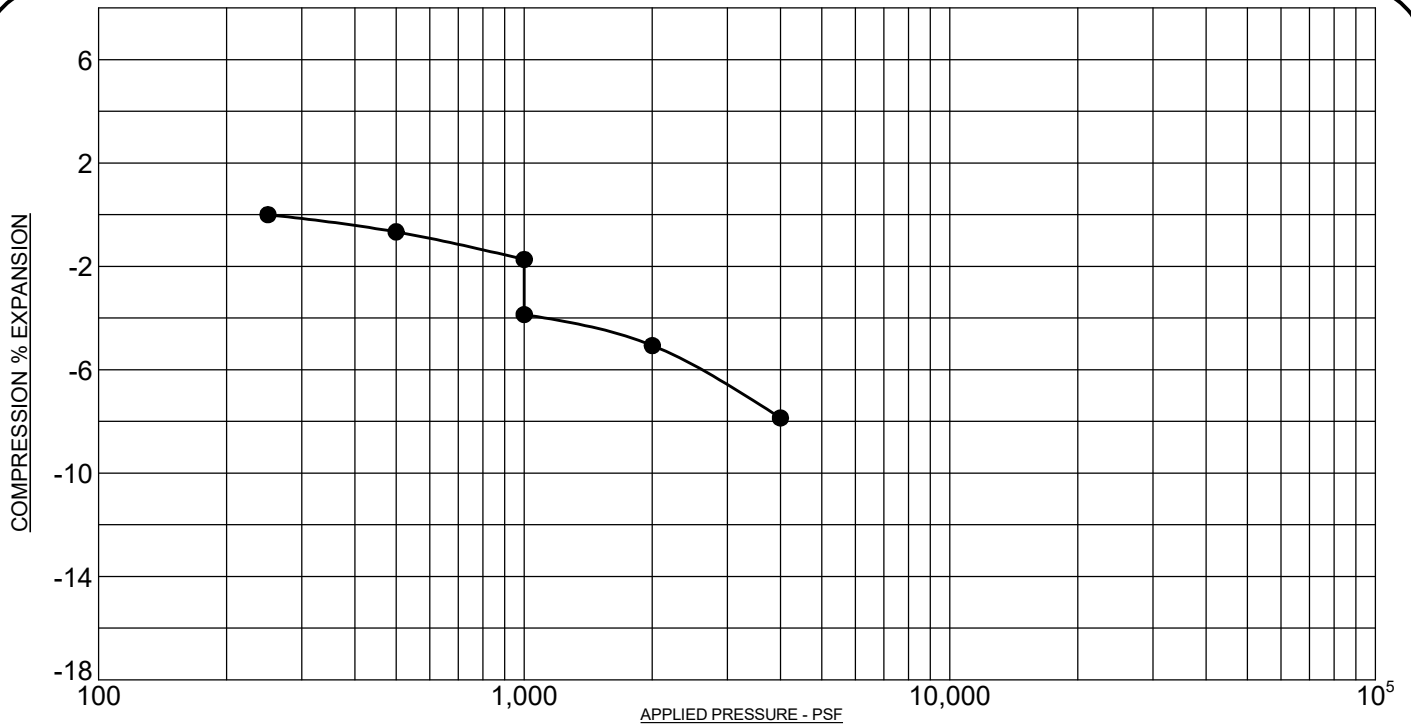
PROJECT: **The Ridge at Lorson Ranch El Paso County, Colorado**
 SAMPLE DESCRIPTION: **CLAYSTONE, SANDY**
 NOTE: **SAMPLE WAS INUNDATED WITH WATER AT 1,000 PSF**

SAMPLE LOCATION: **H-18 @ 9 FT**
 NATURAL DRY UNIT WEIGHT: **106.2 PCF**
 NATURAL MOISTURE CONTENT: **9.7%**
 PERCENT SWELL/COMPRESSION: **- 2.1**

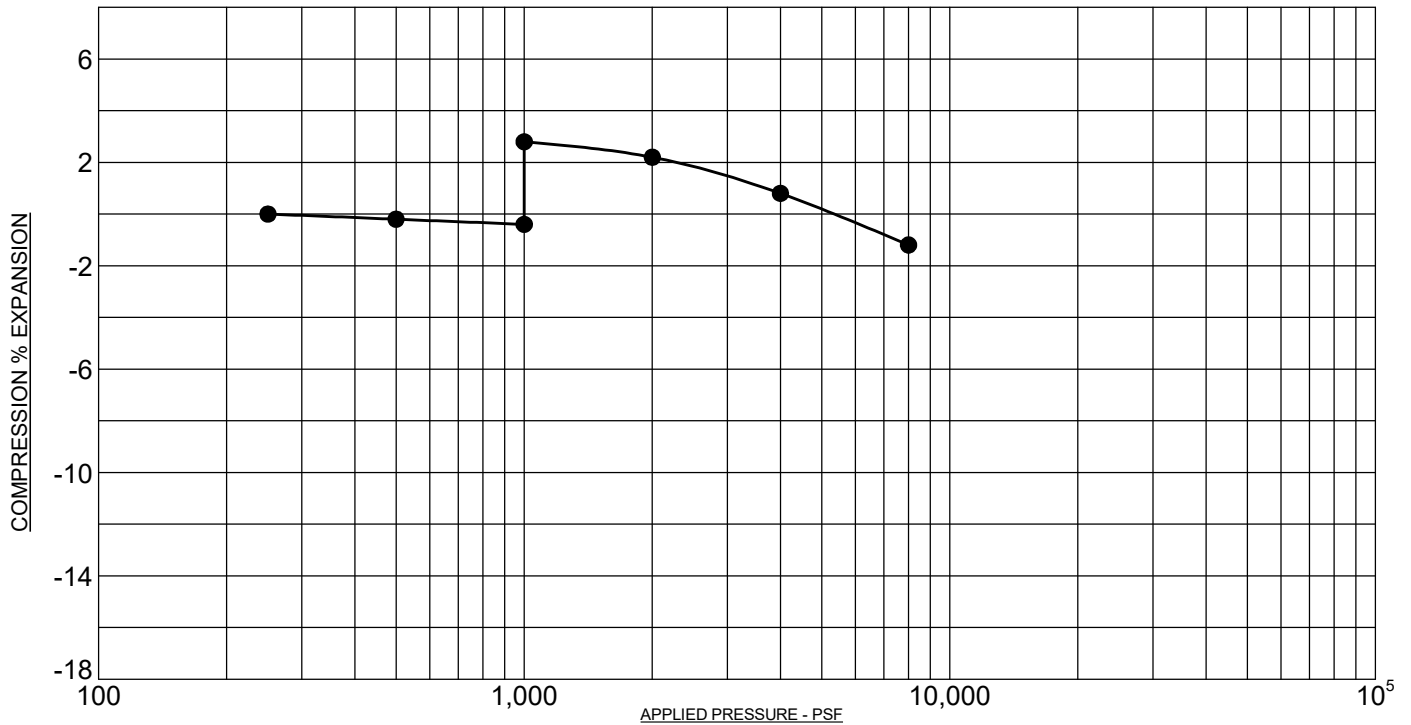
PROJECT: **The Ridge at Lorson Ranch El Paso County, Colorado**
 SAMPLE DESCRIPTION: **CLAYSTONE, SANDY**
 NOTE: **SAMPLE WAS INUNDATED WITH WATER AT 1,000 PSF**

SAMPLE LOCATION: **H-19 @ 9 FT**
 NATURAL DRY UNIT WEIGHT: **112.6 PCF**
 NATURAL MOISTURE CONTENT: **8.5%**
 PERCENT SWELL/COMPRESSION: **3.2**

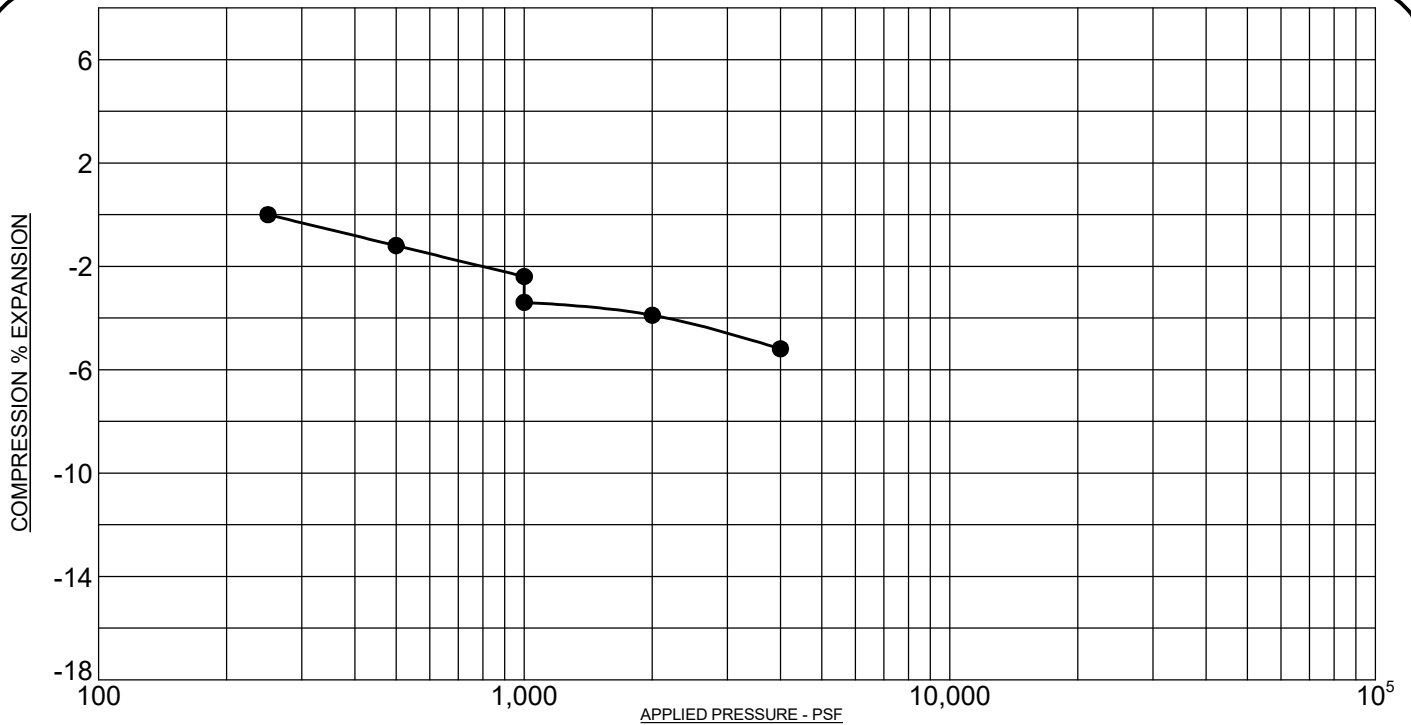
PROJECT: **The Ridge at Lorson Ranch El Paso County, Colorado**
 SAMPLE DESCRIPTION: **CLAYSTONE, SANDY**
 NOTE: **SAMPLE WAS INUNDATED WITH WATER AT 1,000 PSF**

SAMPLE LOCATION: **H-20 @ 14 FT**
 NATURAL DRY UNIT WEIGHT: **110.1 PCF**
 NATURAL MOISTURE CONTENT: **12.7%**
 PERCENT SWELL/COMPRESSION: **- 1.0**

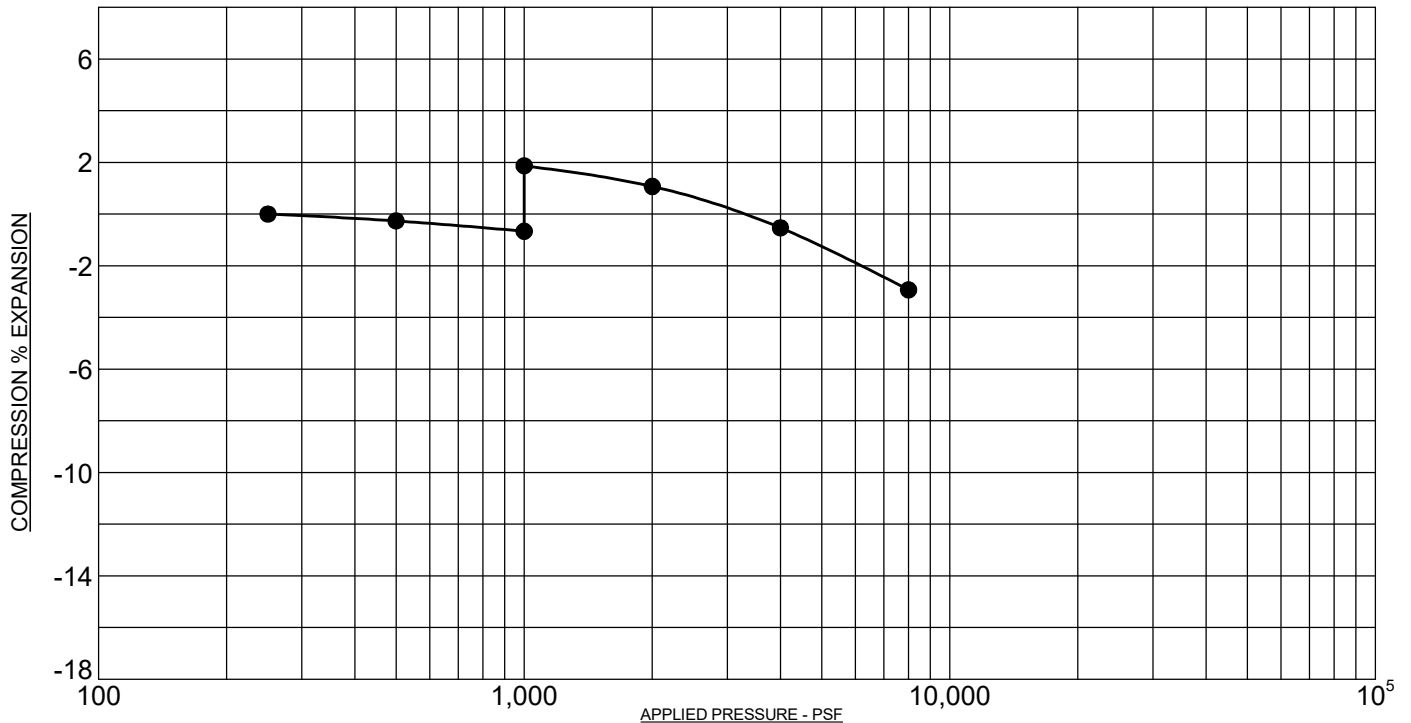
PROJECT: **The Ridge at Lorson Ranch El Paso County, Colorado**
 SAMPLE DESCRIPTION: **CLAYSTONE, SANDY**
 NOTE: **SAMPLE WAS INUNDATED WITH WATER AT 1,000 PSF**

SAMPLE LOCATION: **H-21 @ 24 FT**
 NATURAL DRY UNIT WEIGHT: **120.2 PCF**
 NATURAL MOISTURE CONTENT: **11.3%**
 PERCENT SWELL/COMPRESSION: **2.5**

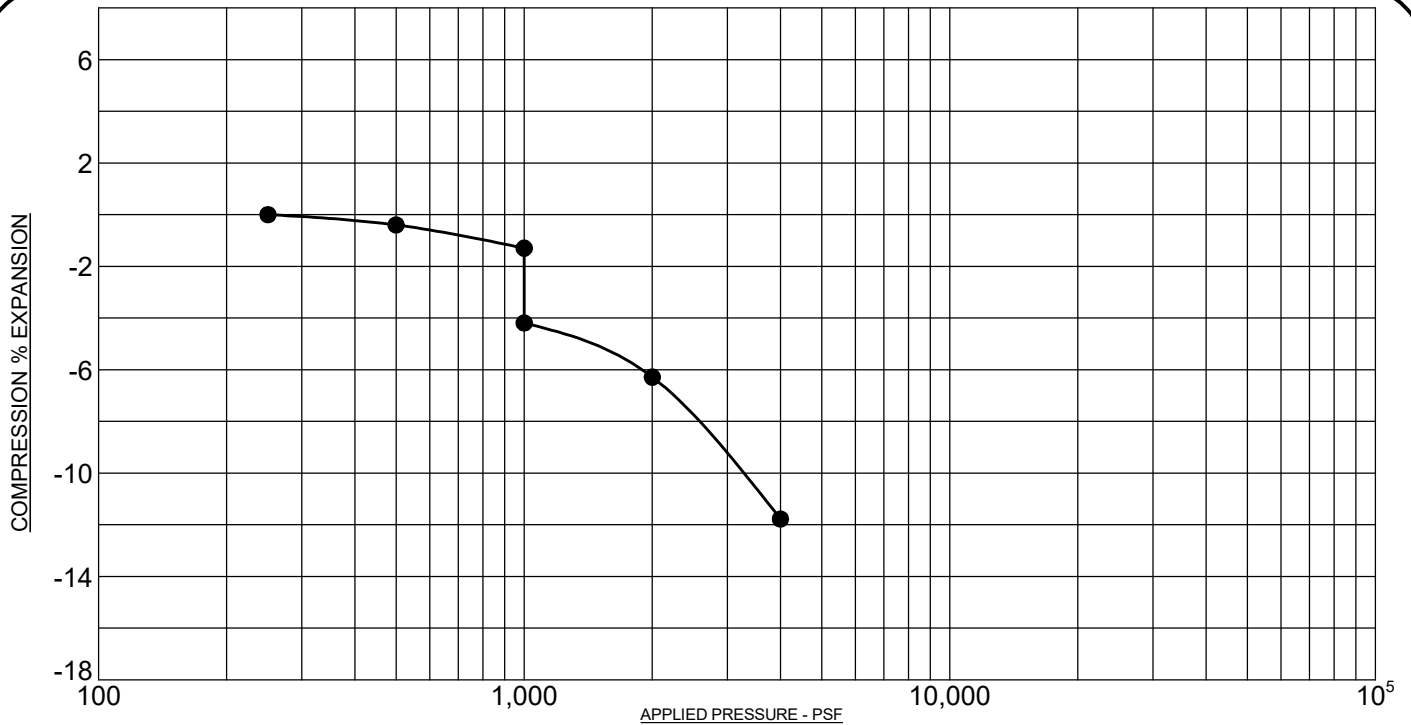
PROJECT: **The Ridge at Lorson Ranch El Paso County, Colorado**
 SAMPLE DESCRIPTION: **CLAYSTONE, SANDY**
 NOTE: **SAMPLE WAS INUNDATED WITH WATER AT 1,000 PSF**

SAMPLE LOCATION: **H-22 @ 9 FT**
 NATURAL DRY UNIT WEIGHT: **95.3 PCF**
 NATURAL MOISTURE CONTENT: **8.8%**
 PERCENT SWELL/COMPRESSION: **- 2.9**

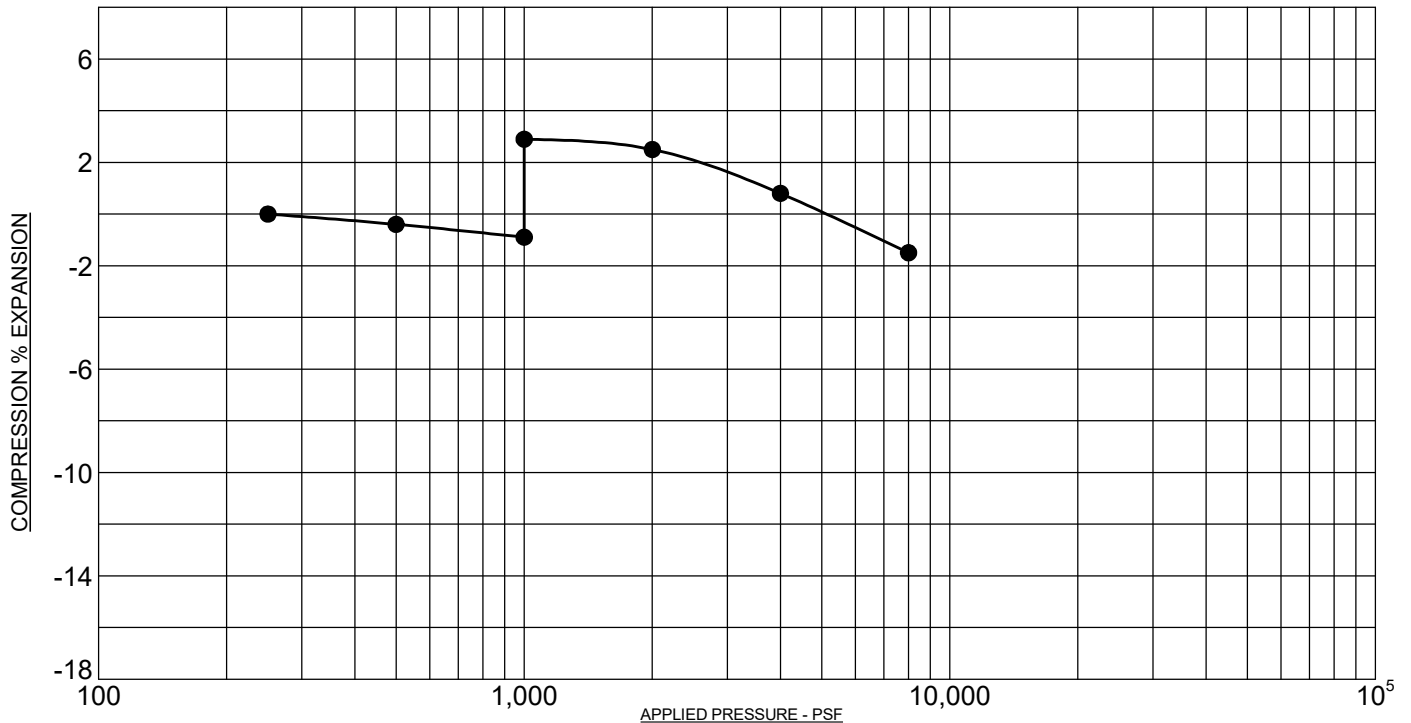
PROJECT: **The Ridge at Lorson Ranch El Paso County, Colorado**
 SAMPLE DESCRIPTION: **CLAY, SANDY**
 NOTE: **SAMPLE WAS INUNDATED WITH WATER AT 1,000 PSF**

SAMPLE LOCATION: **H-23 @ 14 FT**
 NATURAL DRY UNIT WEIGHT: **117.6 PCF**
 NATURAL MOISTURE CONTENT: **8.6%**
 PERCENT SWELL/COMPRESSION: **3.8**

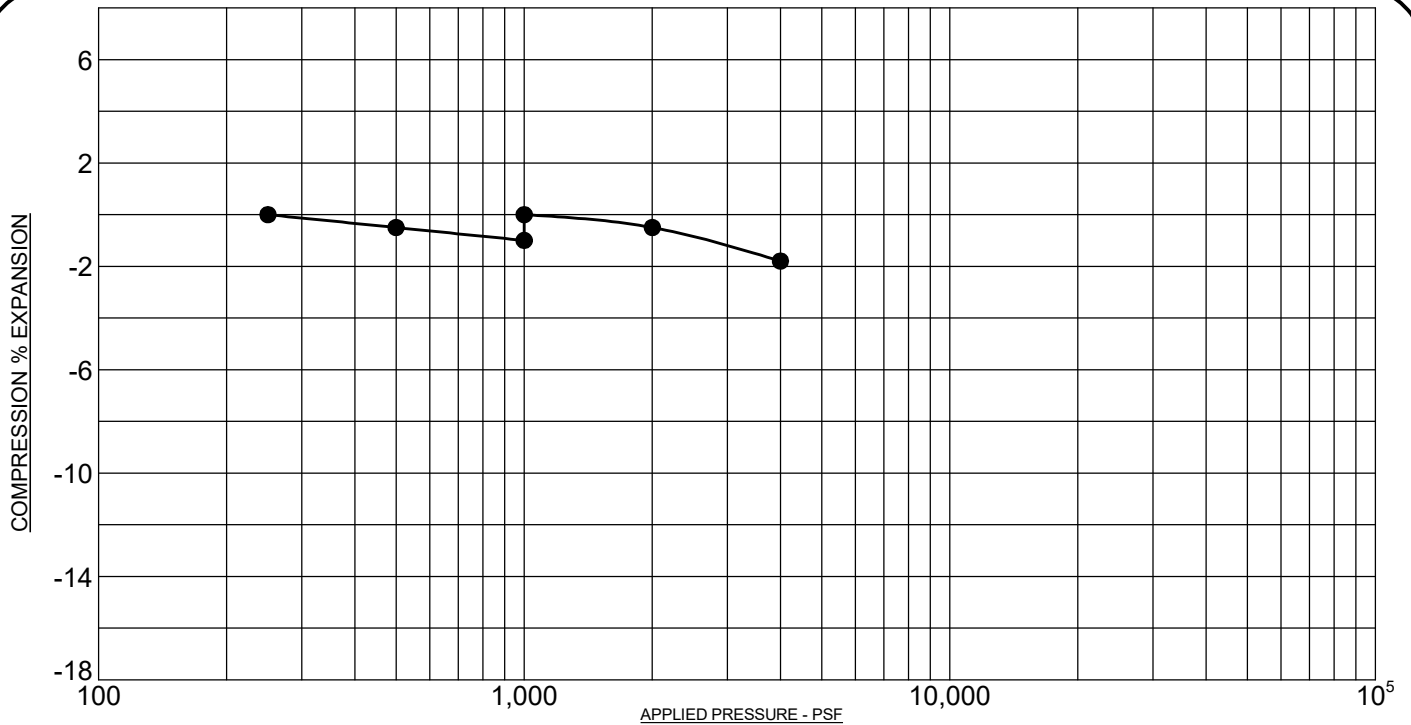
PROJECT: **The Ridge at Lorson Ranch El Paso County, Colorado**
 SAMPLE DESCRIPTION: **CLAY, SANDY**
 NOTE: **SAMPLE WAS INUNDATED WITH WATER AT 1,000 PSF**

SAMPLE LOCATION: **H-24 @ 9 FT**
 NATURAL DRY UNIT WEIGHT: **114.1 PCF**
 NATURAL MOISTURE CONTENT: **8.7%**
 PERCENT SWELL/COMPRESSION: **1.0**

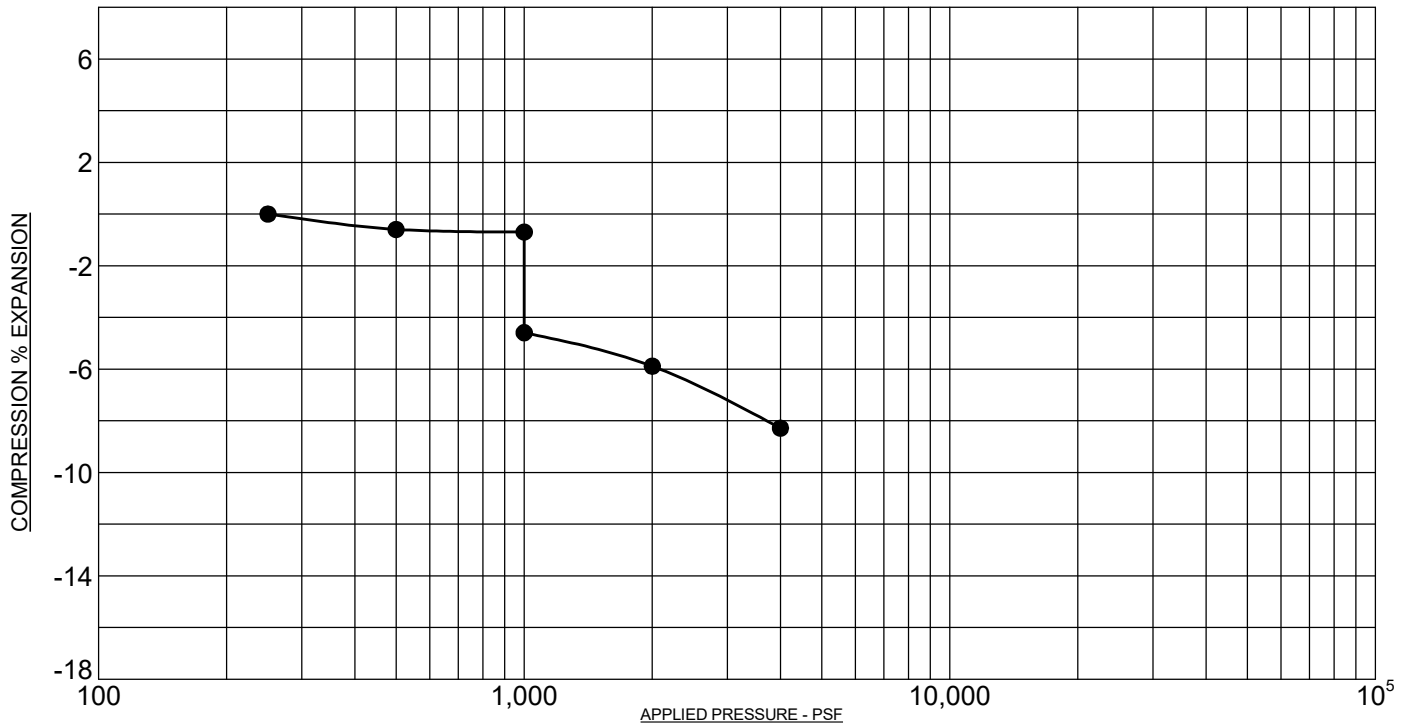
PROJECT: **The Ridge at Lorson Ranch El Paso County, Colorado**
 SAMPLE DESCRIPTION: **CLAYSTONE, SANDY**
 NOTE: **SAMPLE WAS INUNDATED WITH WATER AT 1,000 PSF**

SAMPLE LOCATION: **H-25 @ 4 FT**
 NATURAL DRY UNIT WEIGHT: **106.3 PCF**
 NATURAL MOISTURE CONTENT: **11.0%**
 PERCENT SWELL/COMPRESSION: **- 3.9**
