RE: Meridian Service Metropolitan District
Well Sites 5, 7 & 8
SDP Submittal – Drainage Report
Addresses
Well Site 5: 10511 Rainbow Bridge Drive
Well Site 7: 10810 Eastonville Road
Well Site 8: 11496 Eastonville Road

The intention of the applicant is to construct three buildings (one at each well site) to house electrical gear.

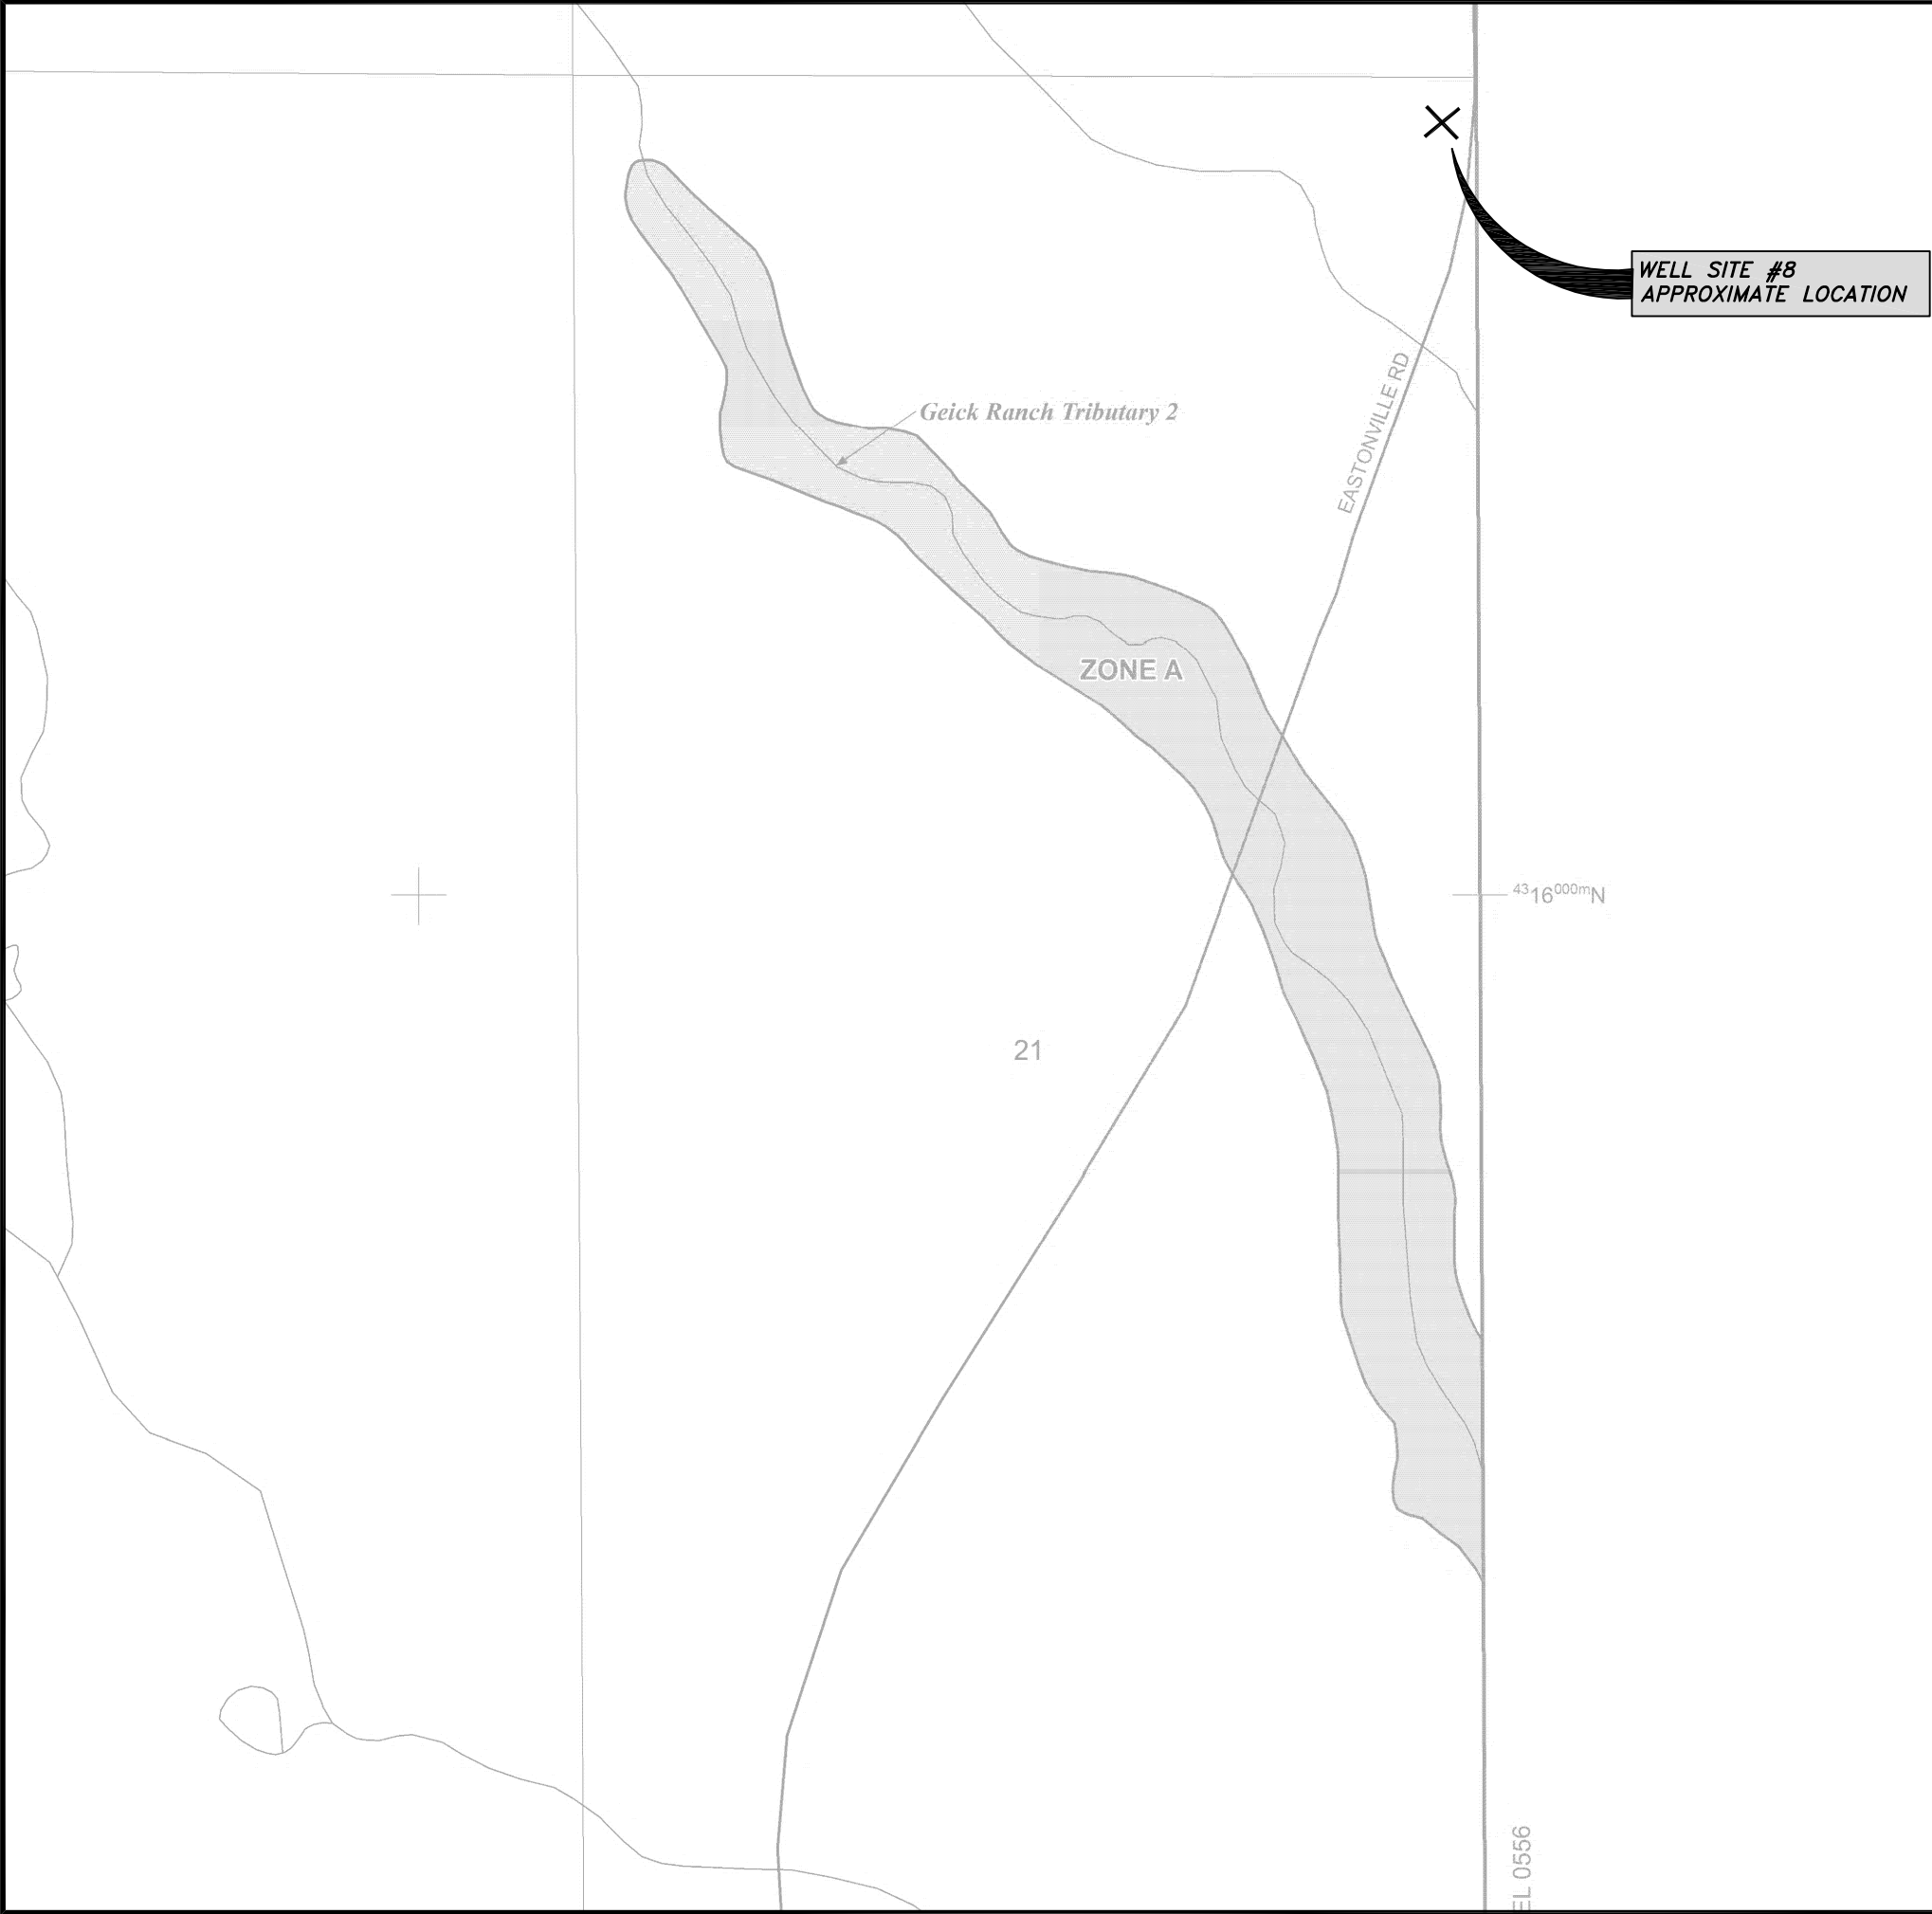
J:\JDS-Hydro\Project Files\151 Meridian Service Metropolitan District\15148 Well Site 5-7-8 Drawings\Working\Well Site 8\15148_WS8_Fema.dwg 2020/11/23 12:22 PM By: Shelby Gatlin

SPECIAL FLOOD HAZARD AREAS (SFHAS) SUBJECT TO INUNDATION BY THE 1% ANNUAL CHANCE FLOOD

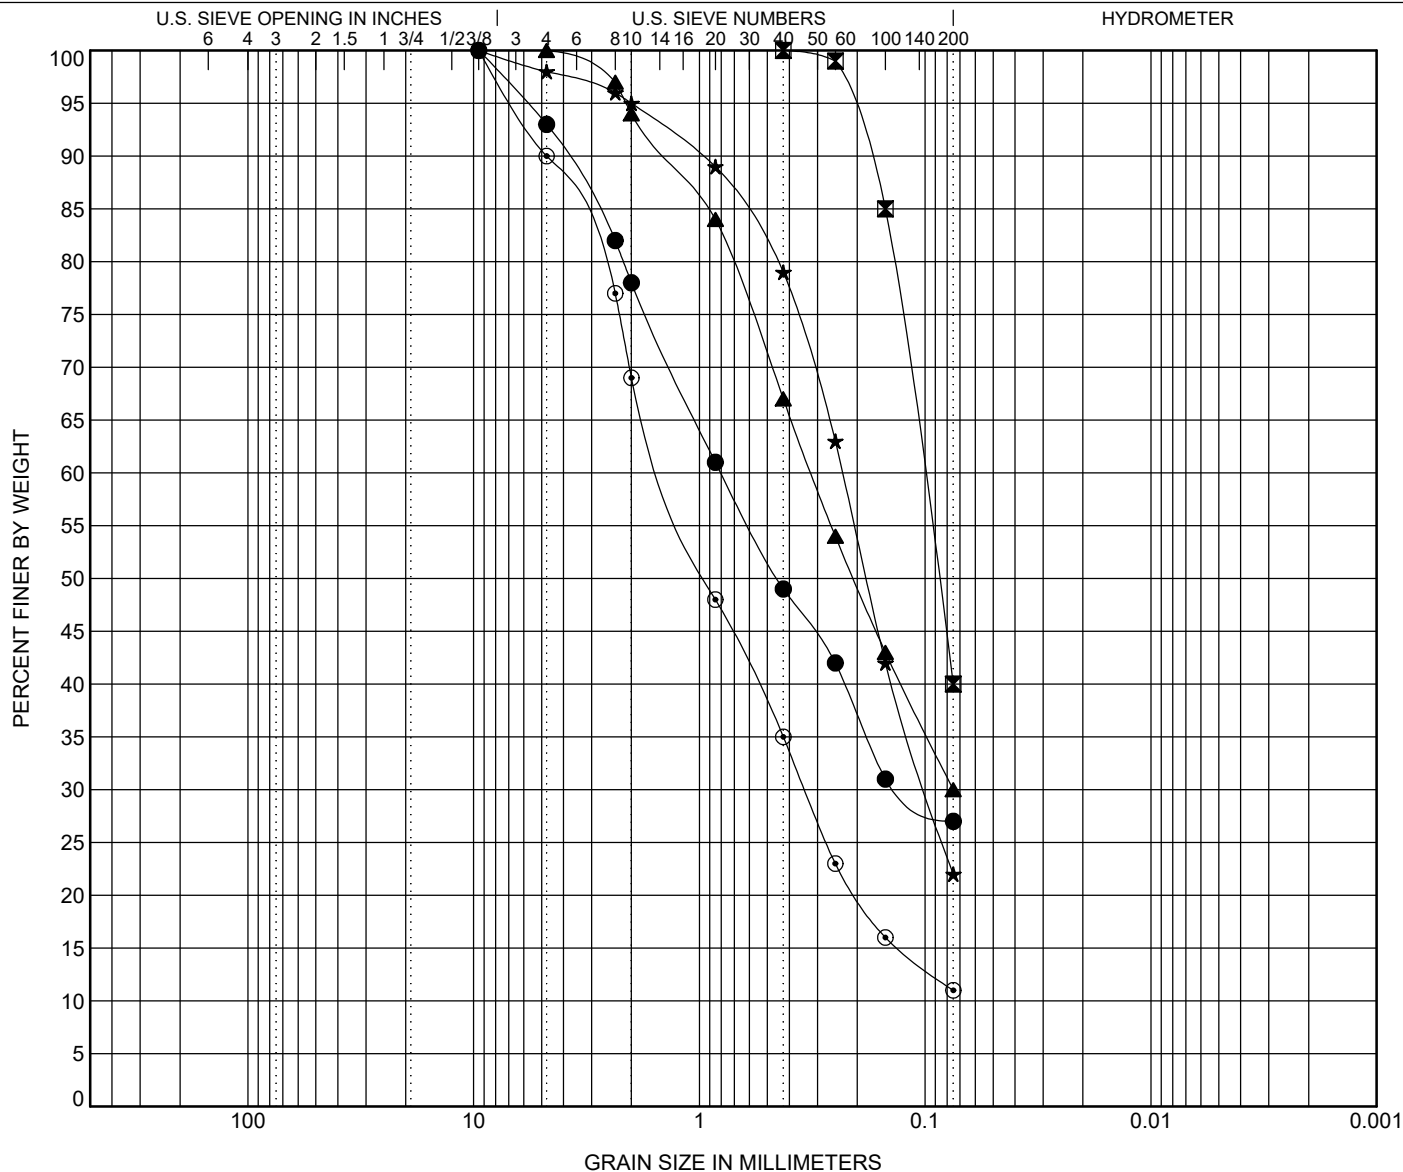
COBBLES	GRAVEL		SAND			SILT OR CLAY
	coarse	fine	coarse	medium	fine

BOREHOLE	DEPTH	Classification					LL	PL	PI	Cc	Cu
● Well Site #5	4.0	CLAYEY SAND(SC)					25	16	9		
☒ Well Site #5	9.0	SILTY SAND(SM)					NP	NP	NP		
▲ Well Site #5	14.0	CLAYEY SAND(SC)					29	21	8		
★ Well Site #7	4.0	SILTY SAND(SM)					NP	NP	NP		
⊙ Well Site #7	7.0	WELL-GRADED SAND with SILT(SW-SM)					NP	NP	NP	1.28	21.23
BOREHOLE	DEPTH	D100	D60	D30	D10	%Gravel	%Sand	%Silt		%Clay	
● Well Site #5	4.0	9.5	0.802	0.126		7.0	66.0	27.0			
☒ Well Site #5	9.0	0.425	0.102			0.0	60.0	40.0			
▲ Well Site #5	14.0	4.75	0.319	0.075		0.0	70.0	30.0			
★ Well Site #7	4.0	9.5	0.232	0.099		2.0	76.0	22.0			
⊙ Well Site #7	7.0	9.5	1.386	0.341		10.0	79.0	11.0

- Description and Identification of Soils (Visual-Manual Procedure)
- Classification of Soils for Engineering Purposes
- Moisture Content and Unit Weight of Soils
- Sieve Analysis
- Liquid Limit, Plastic Limit, and Plasticity Index of Soils

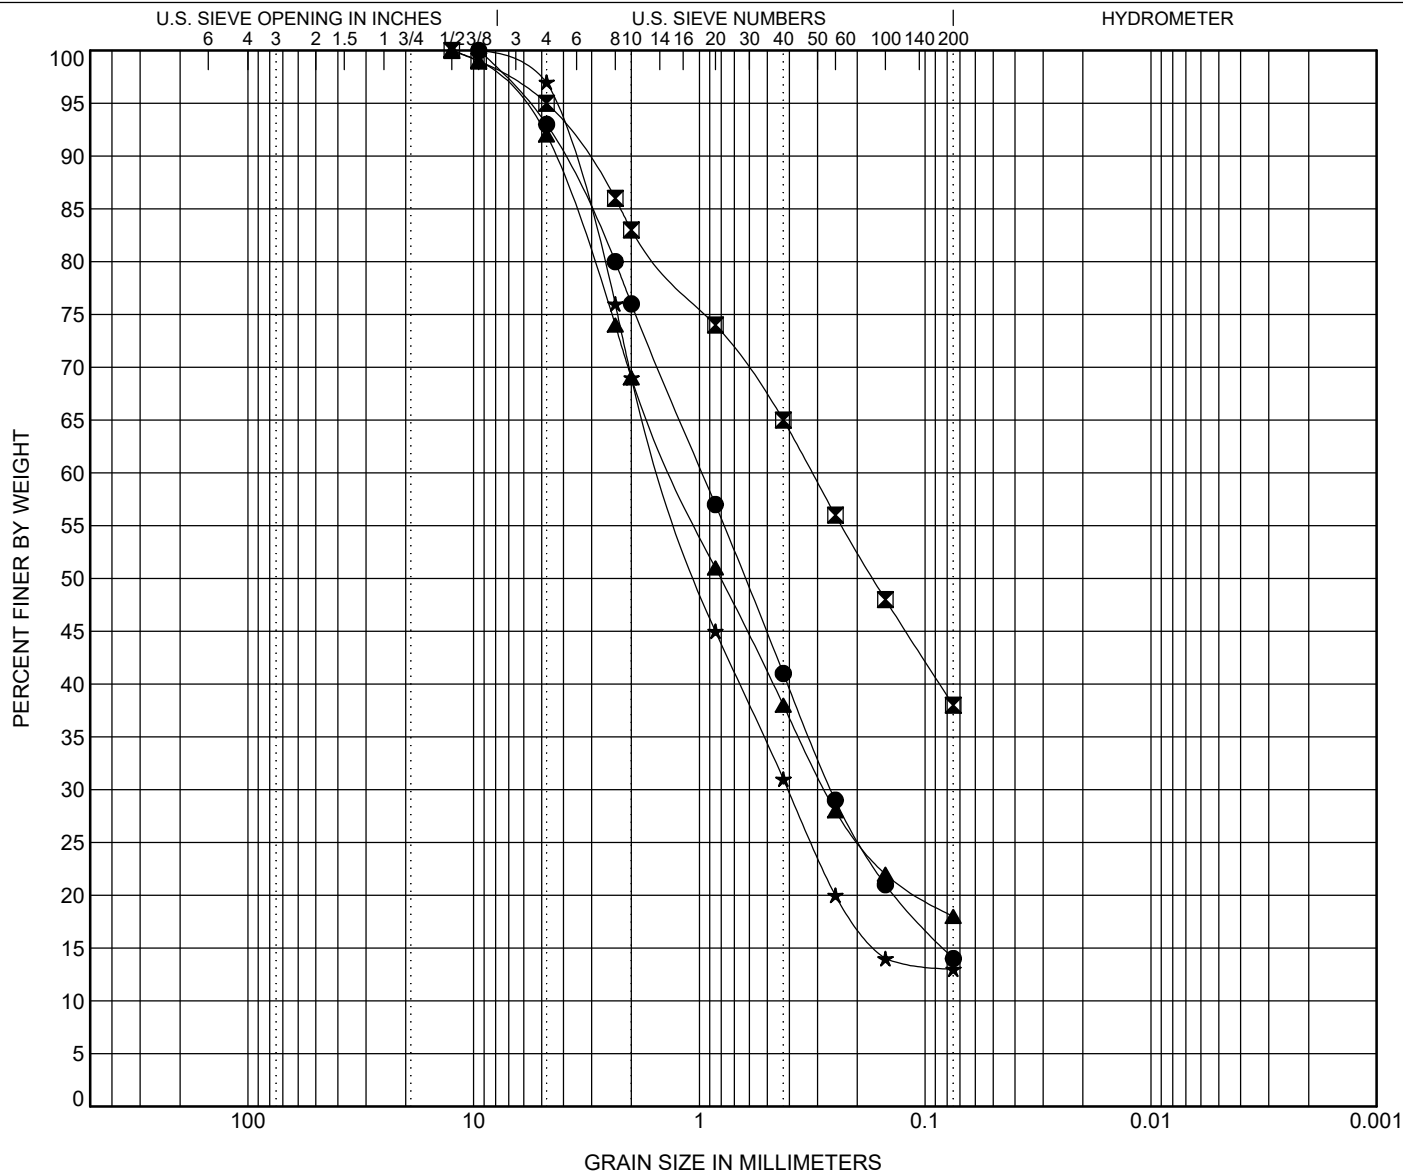
COBBLES	GRAVEL		SAND			SILT OR CLAY
	coarse	fine	coarse	medium	fine

BOREHOLE	DEPTH	Classification					LL	PL	PI	Cc	Cu
● Well Site #7	9.0	SILTY SAND(SM)					NP	NP	NP		
■ Well Site #7	19.0	CLAYEY SAND(SC)					42	14	28		
▲ Well Site #8	4.0	CLAYEY SAND(SC)					26	18	8		
★ Well Site #8	9.0	CLAYEY SAND(SC)					29	19	10		
BOREHOLE	DEPTH	D100	D60	D30	D10	%Gravel	%Sand	%Silt		%Clay	
● Well Site #7	9.0	9.5	0.973	0.261		7.0	79.0	14.0			
■ Well Site #7	19.0	12.5	0.316			5.0	57.0	38.0			
▲ Well Site #8	4.0	12.5	1.304	0.278		8.0	74.0	18.0			
★ Well Site #8	9.0	9.5	1.451	0.405		3.0	84.0	13.0

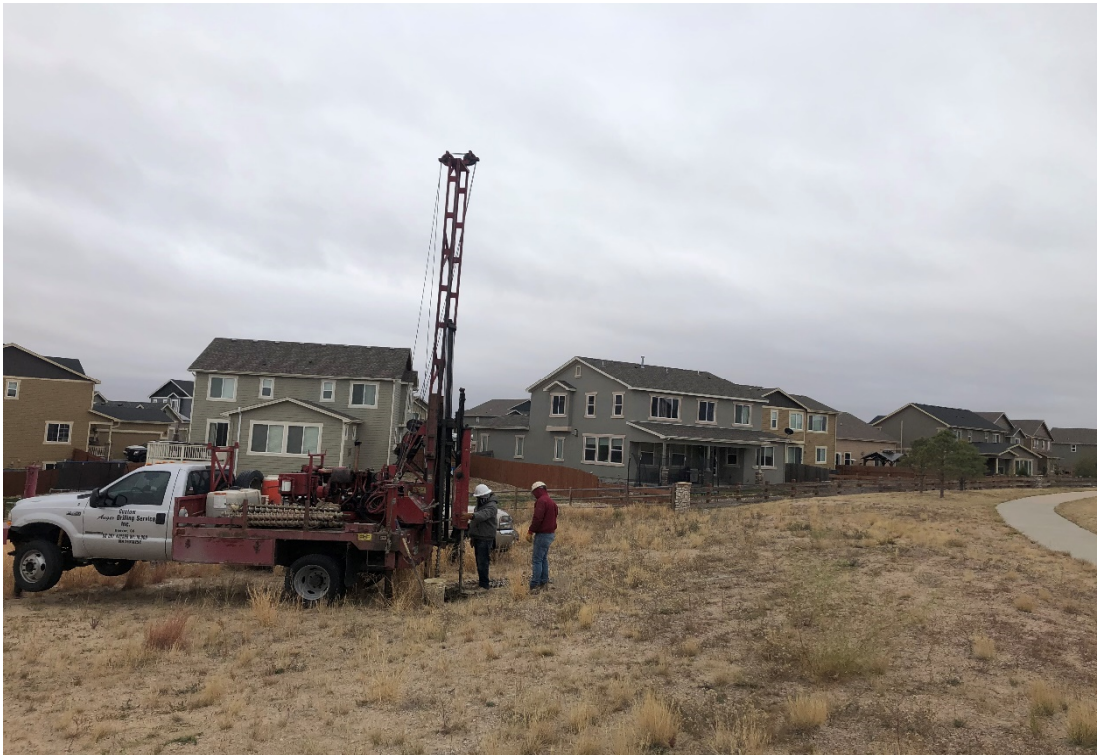
DRILLING WELL SITE #5- LOOKING SOUTHEAST

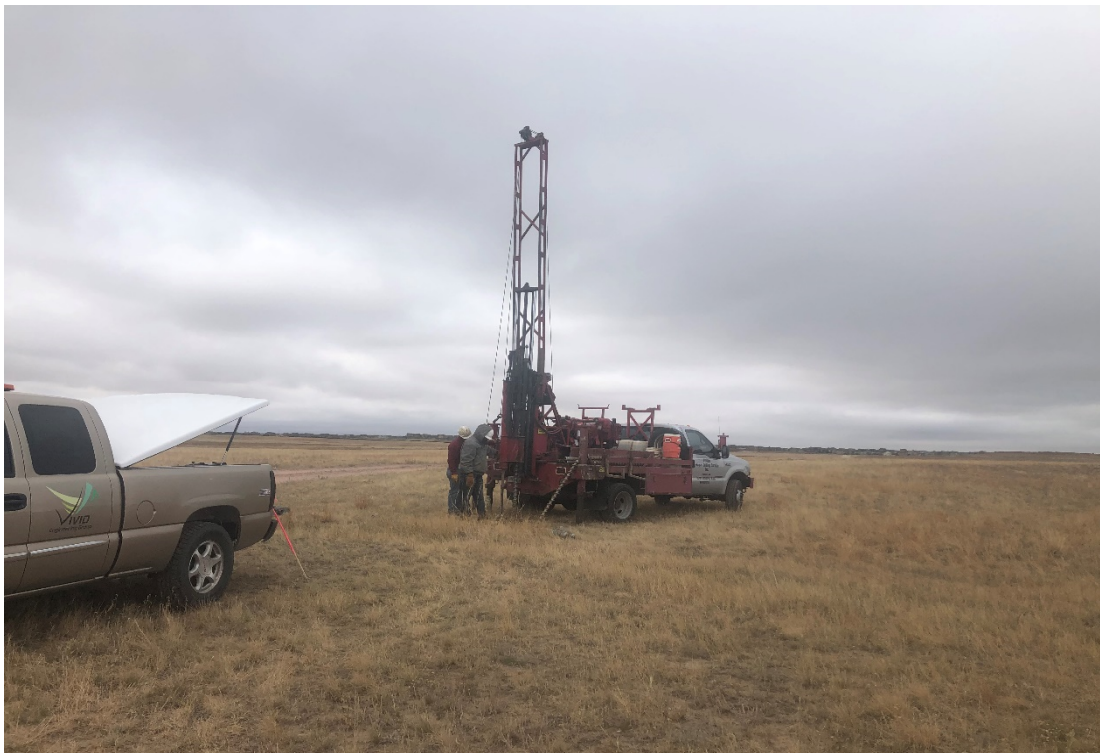
DRILLING WELL SITE #7 - LOOKING SOUTHWEST

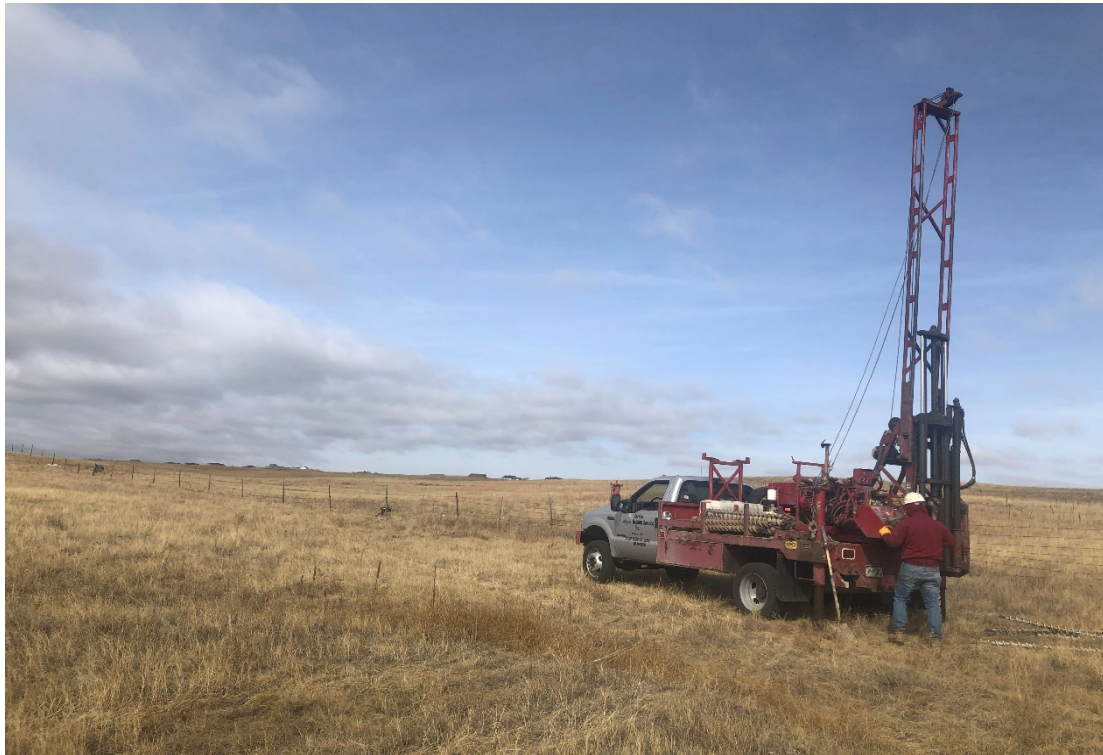
DRILLING WELL SITE #8- LOOKING NORTHWEST
