**ENTECH**  
ENGINEERING, INC.

**SOIL, GEOLOGY, AND GEOLOGIC HAZARD STUDY  
COPPER CHASE AND STERLING RANCH FILING NO. 2  
EL PASO COUNTY, COLORADO**

February 10, 2020  
Revised September 25, 2020

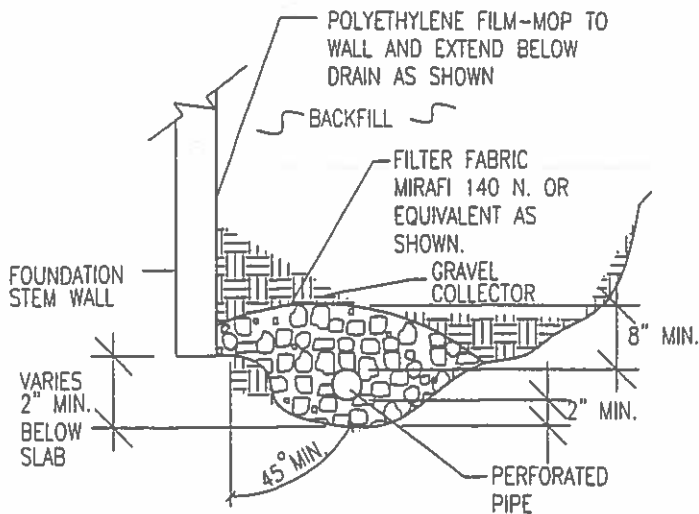
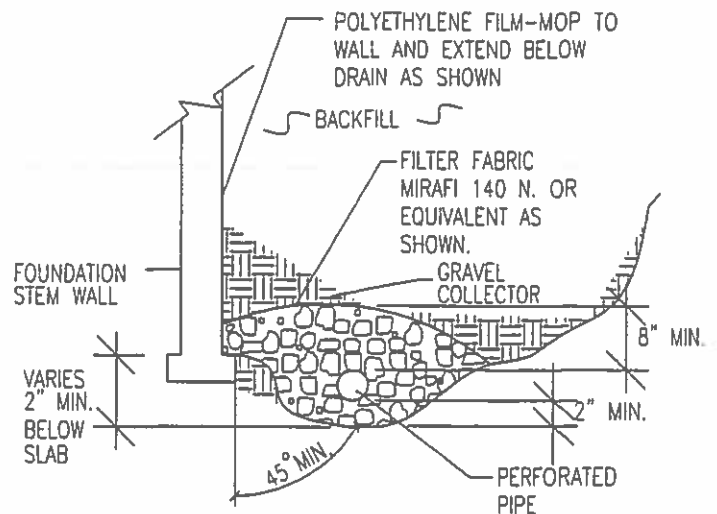
FIG NO.:  
9

-GRAVEL SIZE IS RELATED TO DIAMETER OF PIPE PERFORATIONS-85% GRAVEL GREATER THAN 2x PERFORATION DIAMETER.

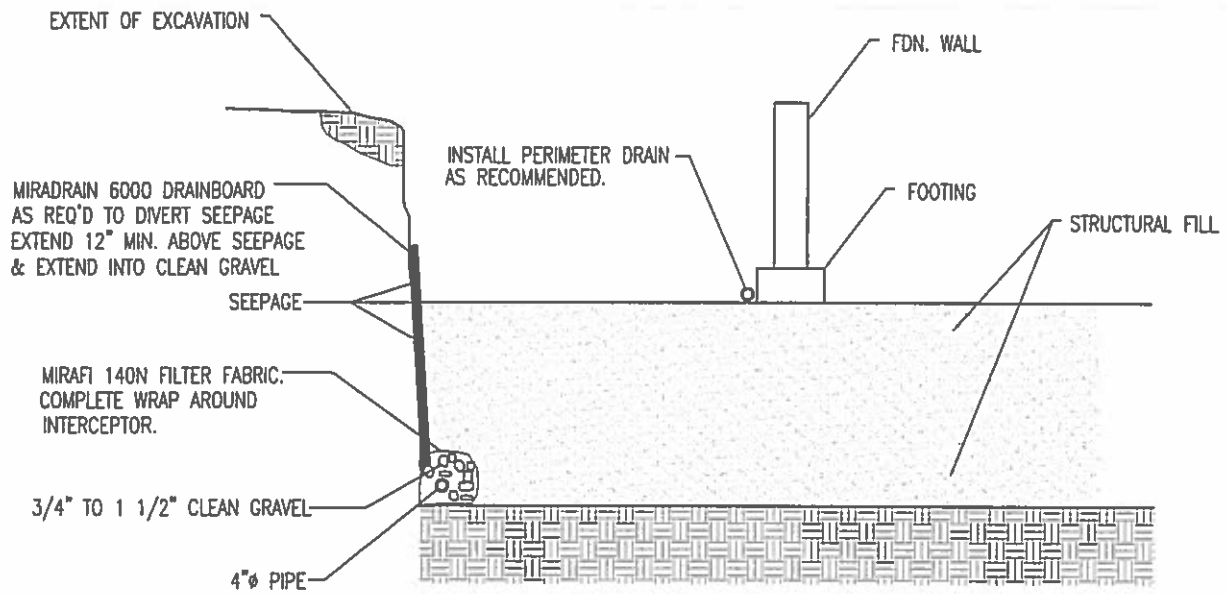
## INTERCEPTOR DRAIN DETAIL

NOTE:  
 EXTEND INTERCEPTOR DRAIN TO DAYLIGHT

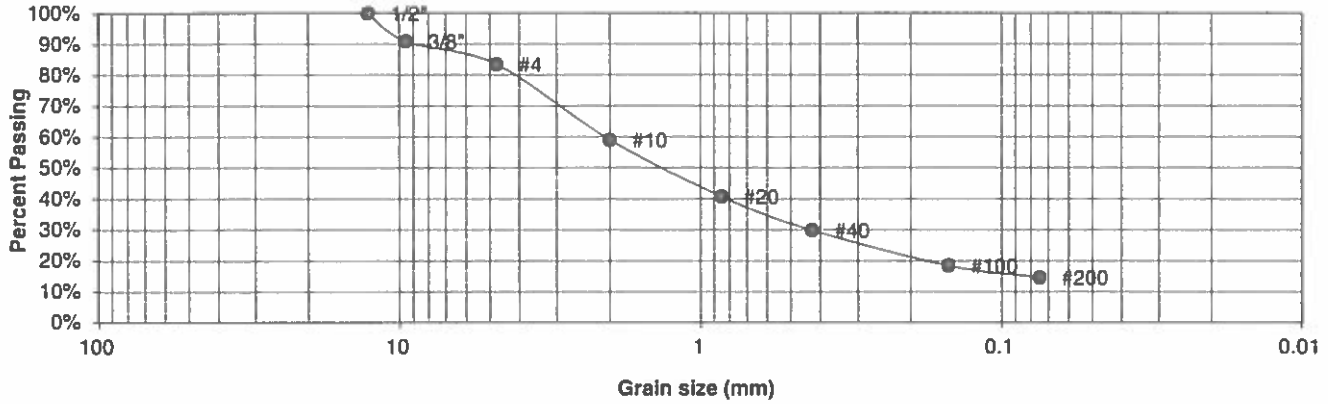
FIG NO.:  
C-1

<b>UNIFIED CLASSIFICATION</b>	SM	<b>CLIENT</b>	MORLEY-BENTLEY INVEST.
<b>SOIL TYPE #</b>	1A	<b>PROJECT</b>	STERLING RANCH, F-2
<b>TEST BORING #</b>	1	<b>JOB NO.</b>	191088
<b>DEPTH (FT)</b>	2-3	<b>TEST BY</b>	BL

**Sieve Analysis  
Grain Size Distribution**

U.S. Sieve #	Percent Finer
3"	
1 1/2"	
3/4"	
1/2"	100.0%
3/8"	90.9%
4	83.4%
10	59.0%
20	40.7%
40	29.9%
100	18.4%
200	14.6%

Atterberg Limits	
Plastic Limit	NP
Liquid Limit	NV
Plastic Index	NP

Soil Type 1A was classified as a silty sand fill (SM). The sand fill was encountered in Test Boring No. 1 at the existing ground surface and extending to 4 feet bgs. Standard Penetration Testing on the fill resulted in a N-Value of 8 bpf, indicating loose states. Water content and grain size testing resulted in a water content of 7 percent with approximately 15 percent of the soil size particles passing the No 200 sieve. Atterberg limits testing resulted in non-plastic results.

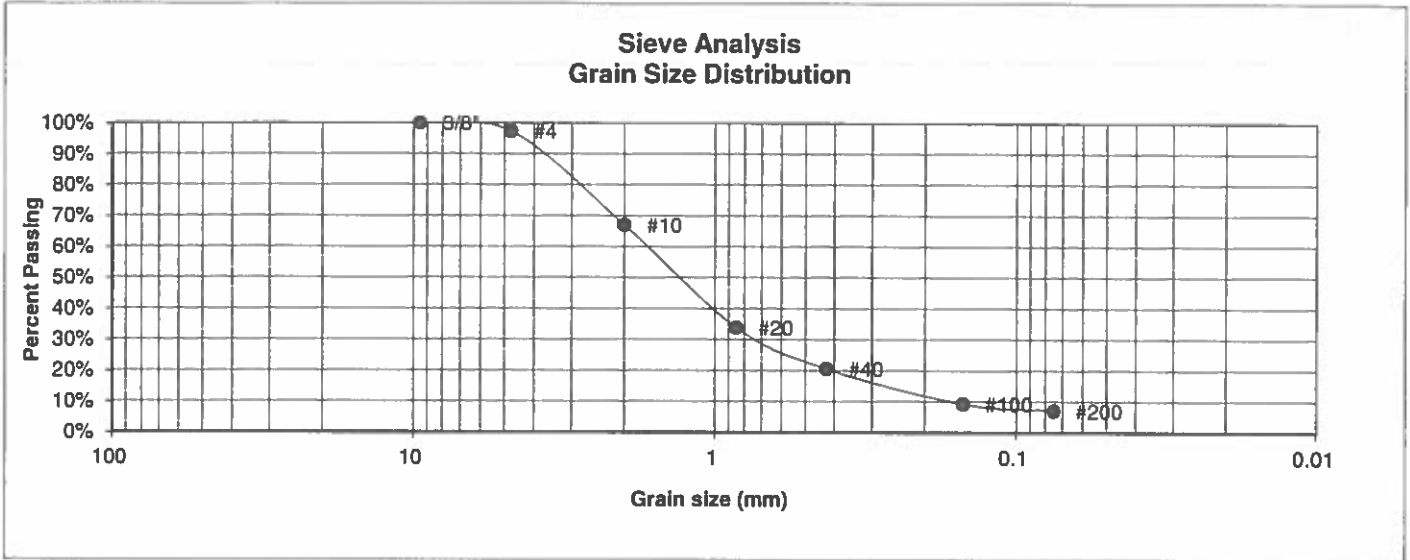
JOB NO: 191088  
FIG NO: C-2

<u>UNIFIED CLASSIFICATION</u>	SM-SW	<u>CLIENT</u>	MORLEY-BENTLEY INVEST.
<u>SOIL TYPE #</u>	1	<u>PROJECT</u>	STERLING RANCH, F-2
<u>TEST BORING #</u>	3	<u>JOB NO.</u>	191088
<u>DEPTH (FT)</u>	2-3	<u>TEST BY</u>	BL

U.S. Sieve #	Percent Finer
3"	
1 1/2"	
3/4"	
1/2"	
3/8"	100.0%
4	97.3%
10	67.0%
20	33.8%
40	20.5%
100	9.2%
200	7.1%

Atterberg Limits	
Plastic Limit	
Liquid Limit	
Plastic Index	
Swell	
Moisture at start	4.7%
Moisture at finish	18.7%
Moisture increase	14.0%
Initial dry density (pcf)	94
Swell (psf)	30

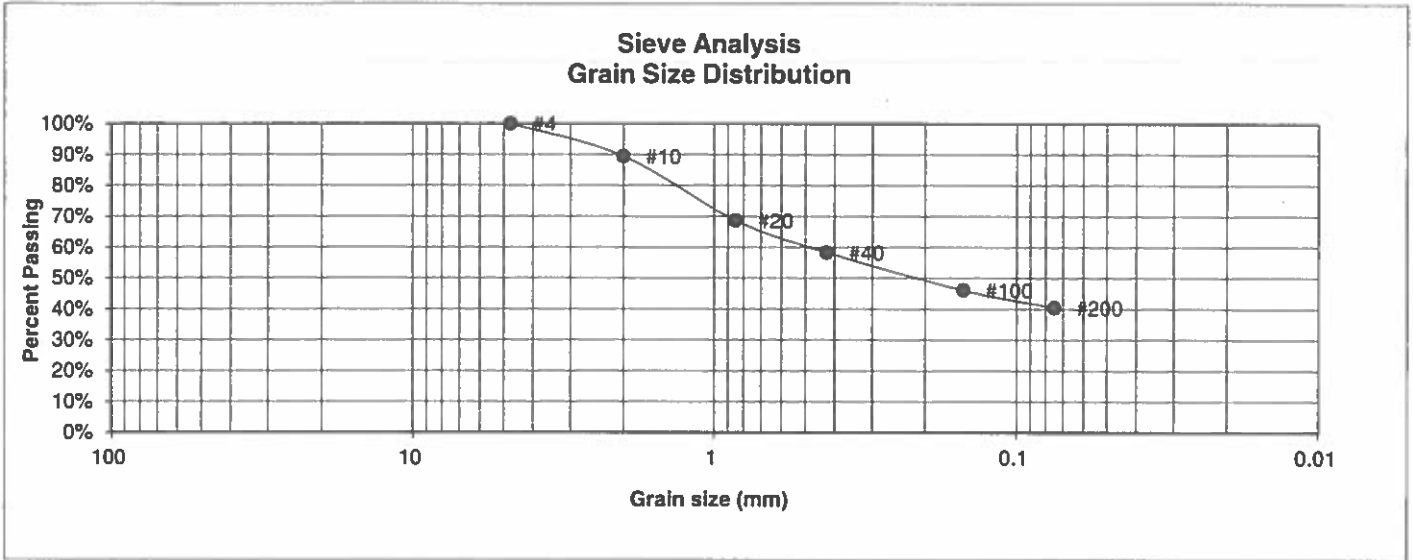
FIG NO.:  
*C-3*

<u>UNIFIED CLASSIFICATION</u>	SC	<u>CLIENT</u>	MORLEY-BENTLEY INVEST.
<u>SOIL TYPE #</u>	2	<u>PROJECT</u>	STERLING RANCH, F-2
<u>TEST BORING #</u>	1	<u>JOB NO.</u>	191088
<u>DEPTH (FT)</u>	10	<u>TEST BY</u>	BL

<u>U.S. Sieve #</u>	<u>Percent Finer</u>
3"	
1 1/2"	
3/4"	
1/2"	
3/8"	
4	100.0%
10	89.5%
20	68.7%
40	58.3%
100	46.2%
200	40.4%

<u>Atterberg Limits</u>	
Plastic Limit	14
Liquid Limit	25
Plastic Index	11

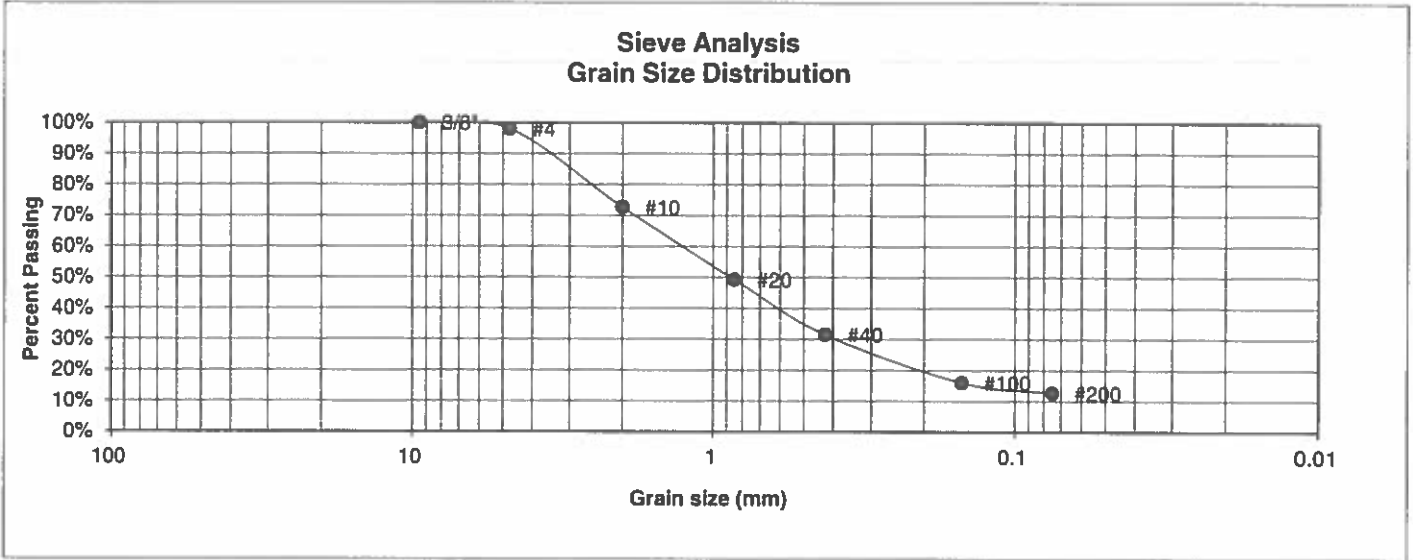
FIG NO.:  
C-4

<b>UNIFIED CLASSIFICATION</b>	SM	<b>CLIENT</b>	MORLEY-BENTLEY INVEST.
<b>SOIL TYPE #</b>	2	<b>PROJECT</b>	STERLING RANCH, F-2
<b>TEST BORING #</b>	2	<b>JOB NO.</b>	191088
<b>DEPTH (FT)</b>	10	<b>TEST BY</b>	BL

U.S. Sieve #	Percent Finer
3"	
1 1/2"	
3/4"	
1/2"	
3/8"	100.0%
4	98.0%
10	72.7%
20	49.3%
40	31.5%
100	16.0%
200	12.7%

Atterberg Limits	
Plastic Limit	NP
Liquid Limit	NV
Plastic Index	NP

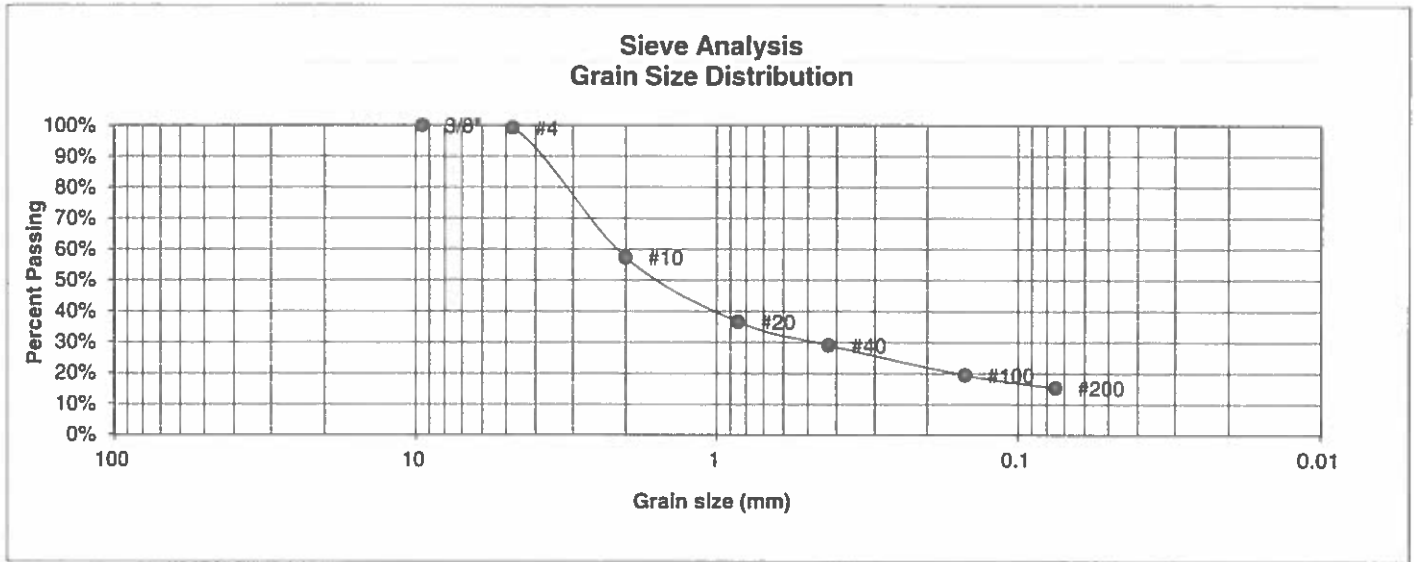
FIG NO:  
*C-5*

<u>UNIFIED CLASSIFICATION</u>	SM	<u>CLIENT</u>	MORLEY-BENTLEY INVEST.
<u>SOIL TYPE #</u>	2	<u>PROJECT</u>	STERLING RANCH, F-2
<u>TEST BORING #</u>	4	<u>JOB NO.</u>	191088
<u>DEPTH (FT)</u>	5	<u>TEST BY</u>	BL

<u>U.S. Sieve #</u>	<u>Percent Finer</u>
3"	
1 1/2"	
3/4"	
1/2"	
3/8"	100.0%
4	99.2%
10	57.4%
20	36.7%
40	29.1%
100	19.5%
200	15.3%

Atterberg Limits  
 Plastic Limit  
 Liquid Limit  
 Plastic Index

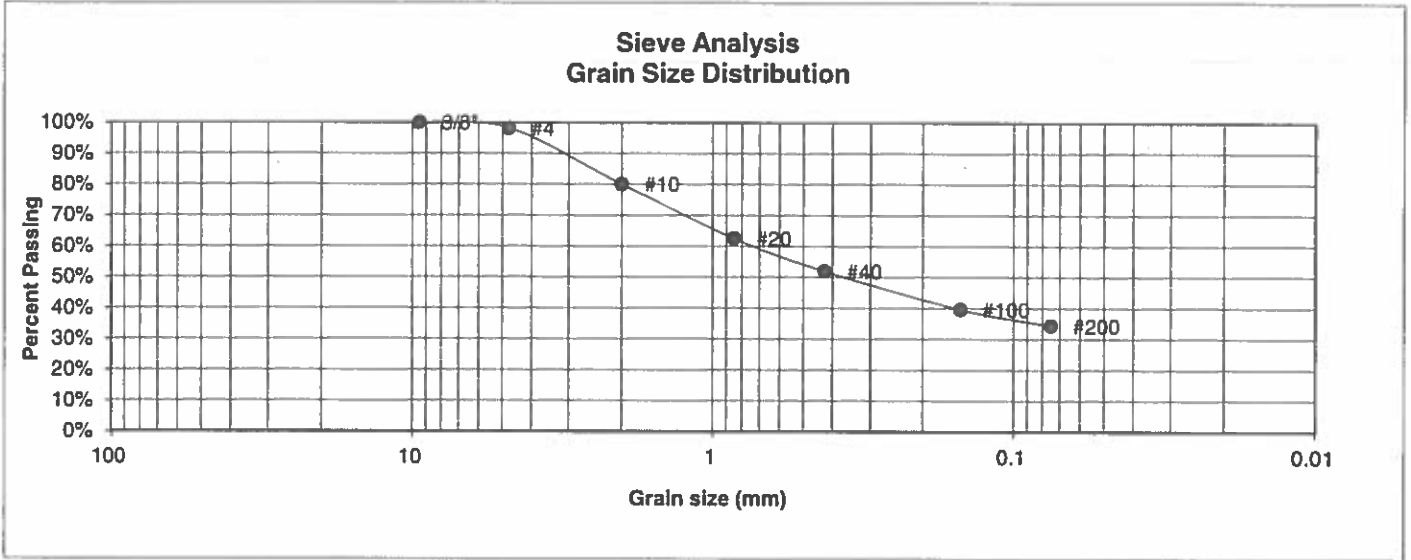
<u>UNIFIED CLASSIFICATION</u>	SC	<u>CLIENT</u>	MORLEY-BENTLEY INVEST.
<u>SOIL TYPE #</u>	2	<u>PROJECT</u>	STERLING RANCH, F-2
<u>TEST BORING #</u>	4	<u>JOB NO.</u>	191088
<u>DEPTH (FT)</u>	15	<u>TEST BY</u>	BL

U.S. Sieve #	Percent Finer
3"	
1 1/2"	
3/4"	
1/2"	
3/8"	100.0%
4	98.2%
10	80.1%
20	62.5%
40	52.0%
100	39.6%
200	34.3%

Atterberg Limits	
Plastic Limit	20
Liquid Limit	30
Plastic Index	10

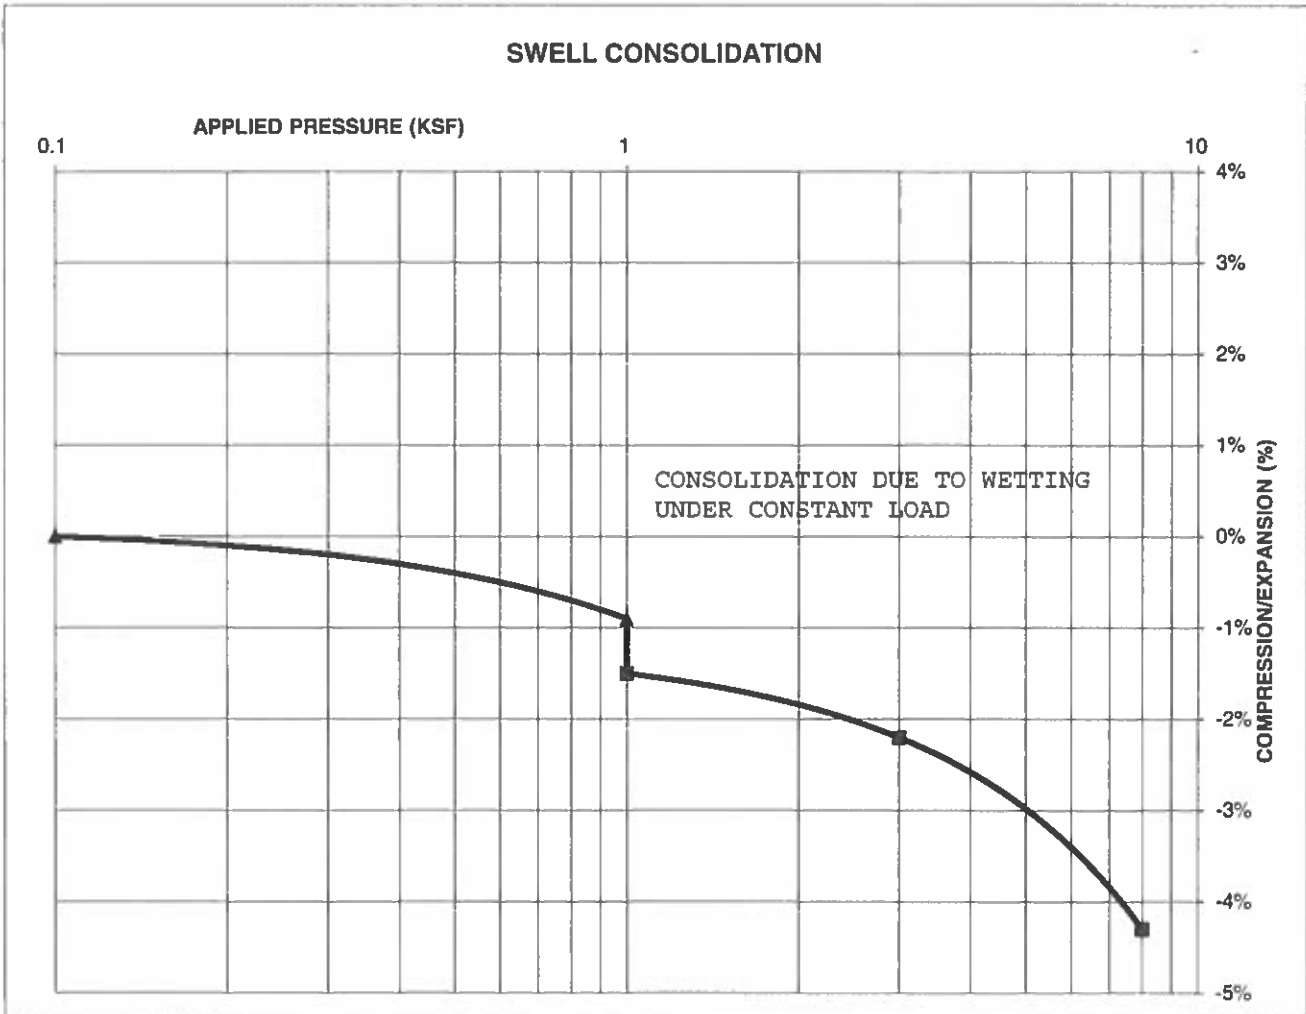
TEST BORING #	1	DEPTH(ft)	10
DESCRIPTION	SC	SOIL TYPE	2
NATURAL UNIT DRY WEIGHT (PCF)			132
NATURAL MOISTURE CONTENT			7.3%
SWELL/CONSOLIDATION (%)			-0.6%

JOB NO. 191088  
CLIENT MORLEY-BENTLEY INVEST.  
PROJECT STERLING RANCH, F-2

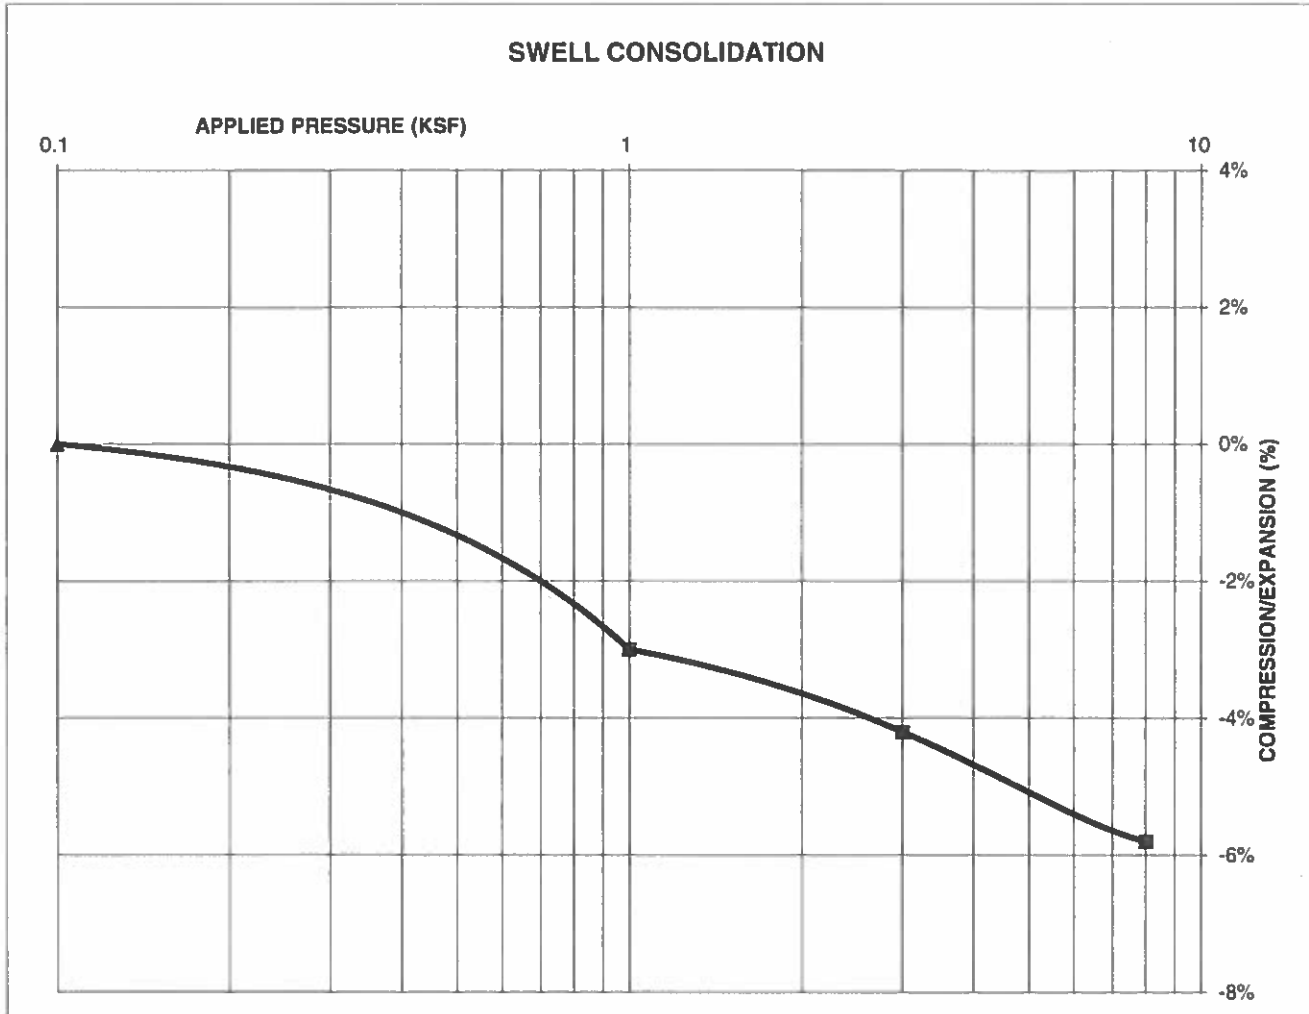
TEST BORING #	4	DEPTH(ft)	15
DESCRIPTION	SC	SOIL TYPE	2
NATURAL UNIT DRY WEIGHT (PCF)			103
NATURAL MOISTURE CONTENT			22.8%
SWELL/CONSOLIDATION (%)			0.0%

JOB NO. 191088  
CLIENT MORLEY-BENTLEY INVEST.  
PROJECT STERLING RANCH, F-2

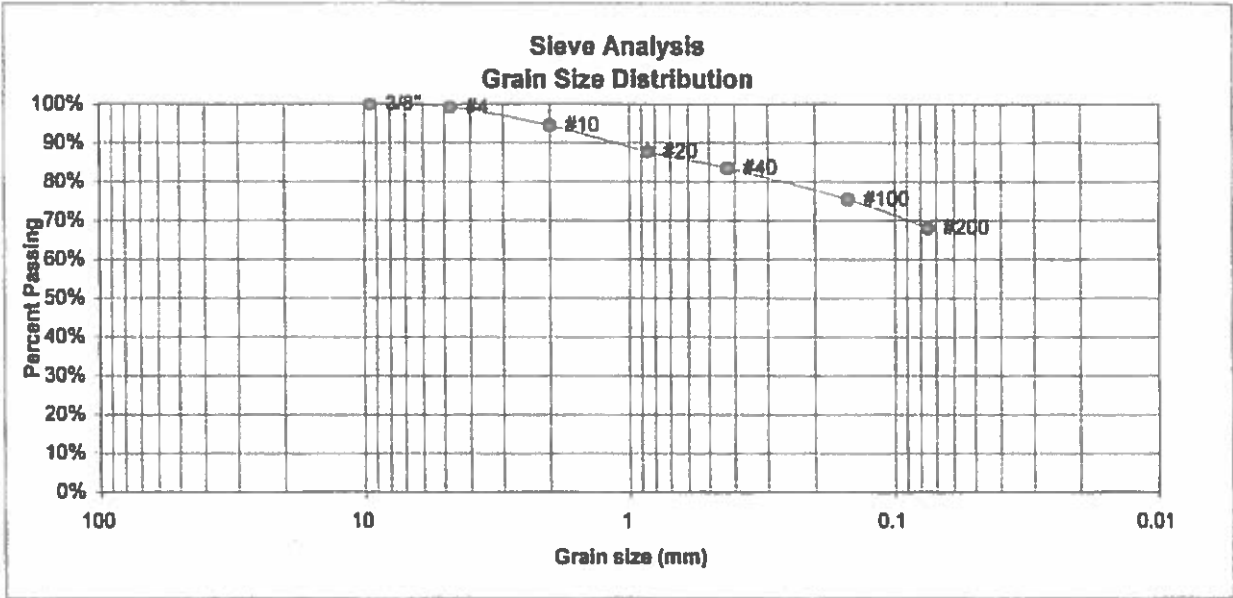
FIG NO.:  
D-1

<b>UNIFIED CLASSIFICATION</b>	CL	<b>CLIENT</b>	MORLEY BENTLEY
<b>SOIL TYPE #</b>	4	<b>PROJECT</b>	STERLING RANCH
<b>TEST BORING #</b>	1	<b>JOB NO.</b>	82556
<b>DEPTH (FT)</b>	5	<b>TEST BY</b>	DG

U.S. Sieve #	Percent Finer
3"	
1 1/2"	
3/4"	
1/2"	
3/8"	100.0%
4	99.2%
10	94.4%
20	87.7%
40	83.5%
100	75.5%
200	68.1%

**Atterberg Limits**  
 Plastic Limit  
 Liquid Limit  
 Plastic Index

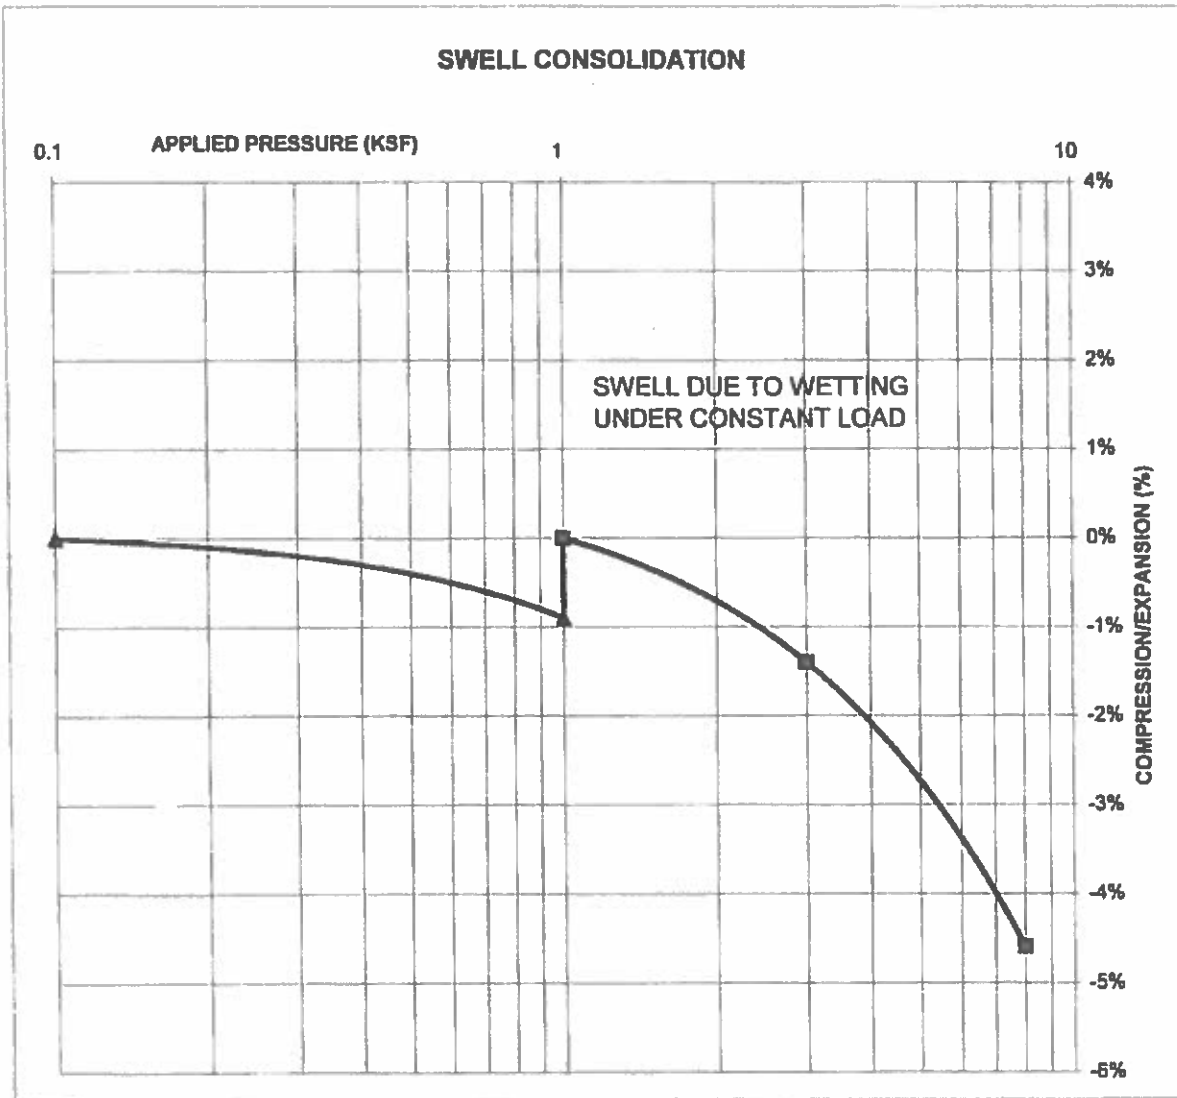
**SWELL CONSOLIDATION  
 TEST RESULTS**

TEST BORING #	1	DEPTH(FT)	5
DESCRIPTION	CL	SOIL TYPE	4
NATURAL UNIT DRY WEIGHT (PCF)			118
NATURAL MOISTURE CONTENT			13.4%
SWELL/CONSOLIDATION (%)			0.9%

JOB NO. 82556  
CLIENT MORLEY BENTLEY  
PROJECT STERLING RANCH
