Job No. 185657

Re: Response to Colorado Geological Survey
Creekside at Lorson Ranch, Filing No. 2
El Paso County, Colorado

RMG – Rocky Mountain Group previously prepared the *Soil and Geology Study* (RMG Job. No. 185657, dated February 21, 2022) for the proposed planned unit development to consist of 38 single-family units on approximately 6.01 acres at Lorson Boulevard and Trappe Drive. The report was reviewed by personnel of the Colorado Geological Survey (CGS), and comments (dated May 24, 2022) were provided. RMG has prepared this document in response to those review comments.

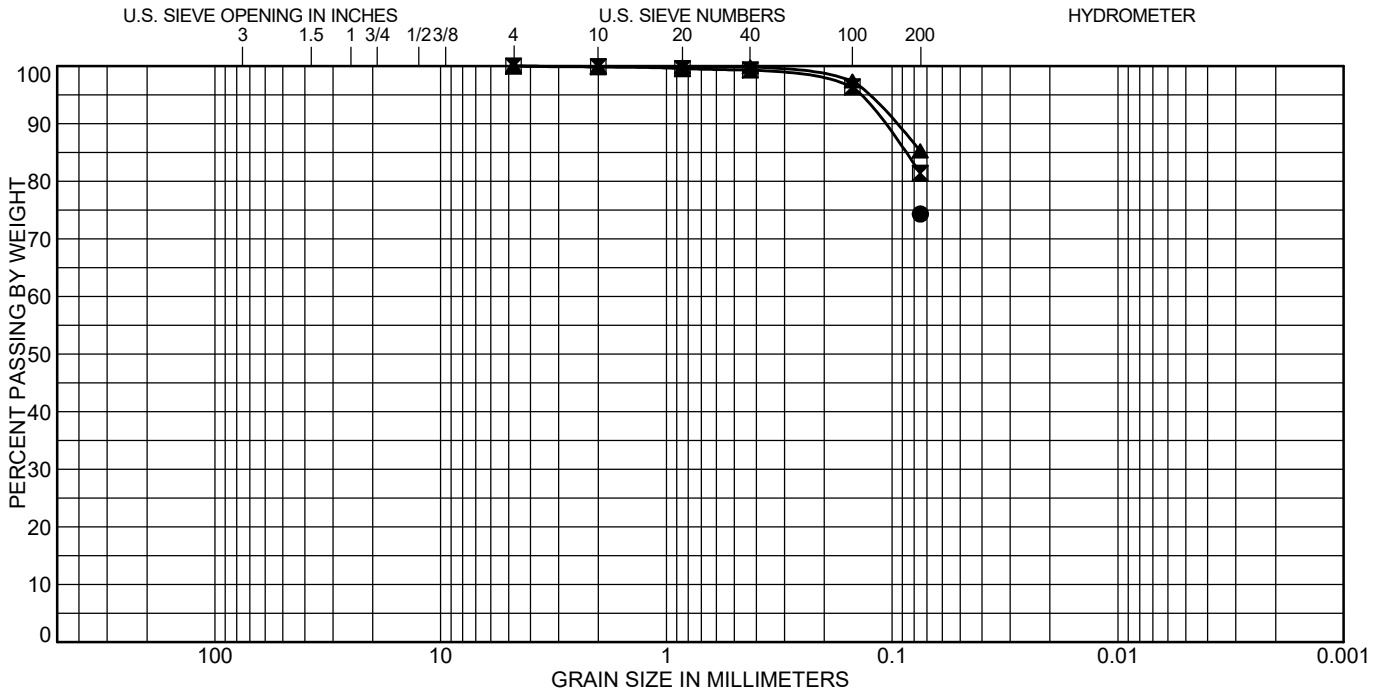
FIGURE No. 7

| COBBLES | GRAVEL | | SAND | | | SILT OR CLAY |

Soil laboratory testing was performed as part of this investigation. The laboratory tests included moisture content, dry density, grain-size analyses, Atterberg Limits and Swell/Consolidation tests. A Summary of Laboratory Test Results is presented in Figure 6. Soils Classification Data is presented in Figure 7. Swell/Consolidation Test Results are presented in Figures 8 and 9.

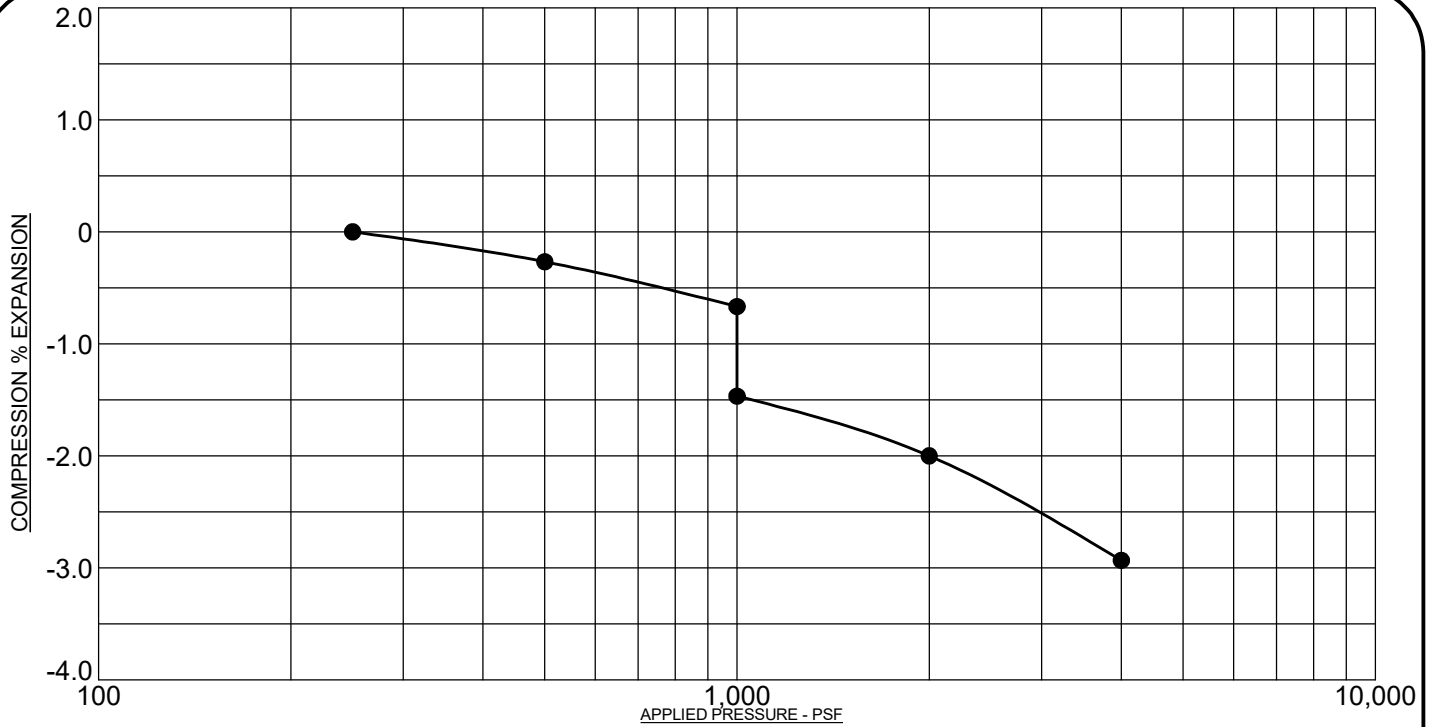
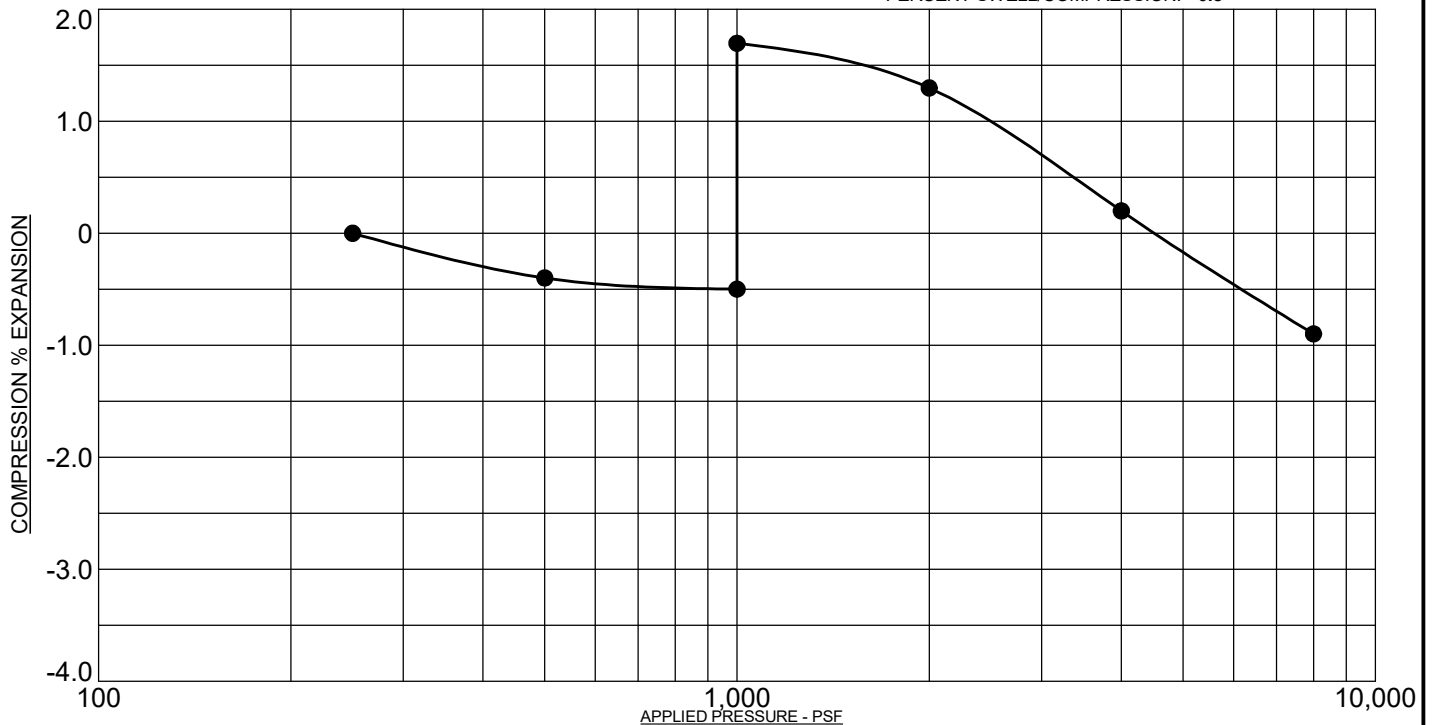
FIGURE No. 8

PROJECT: Creekside at Lorson Ranch, Filing No. 2 El Paso County, Colorado
 SAMPLE DESCRIPTION: FILL: CLAY, SANDY
 NOTE: SAMPLE WAS INUNDATED WITH WATER AT 1,000 PSF

SAMPLE LOCATION: 1 @ 4 FT
 NATURAL DRY UNIT WEIGHT: 116.9 PCF
 NATURAL MOISTURE CONTENT: 13.1%
 PERCENT SWELL/COMPRESSION: - 0.8

PROJECT: Creekside at Lorson Ranch, Filing No. 2 El Paso County, Colorado
 SAMPLE DESCRIPTION: CLAYSTONE, SANDY
 NOTE: SAMPLE WAS INUNDATED WITH WATER AT 1,000 PSF

SAMPLE LOCATION: 1 @ 14 FT
 NATURAL DRY UNIT WEIGHT: 116.2 PCF
 NATURAL MOISTURE CONTENT: 16.8%
 PERCENT SWELL/COMPRESSION: 2.2

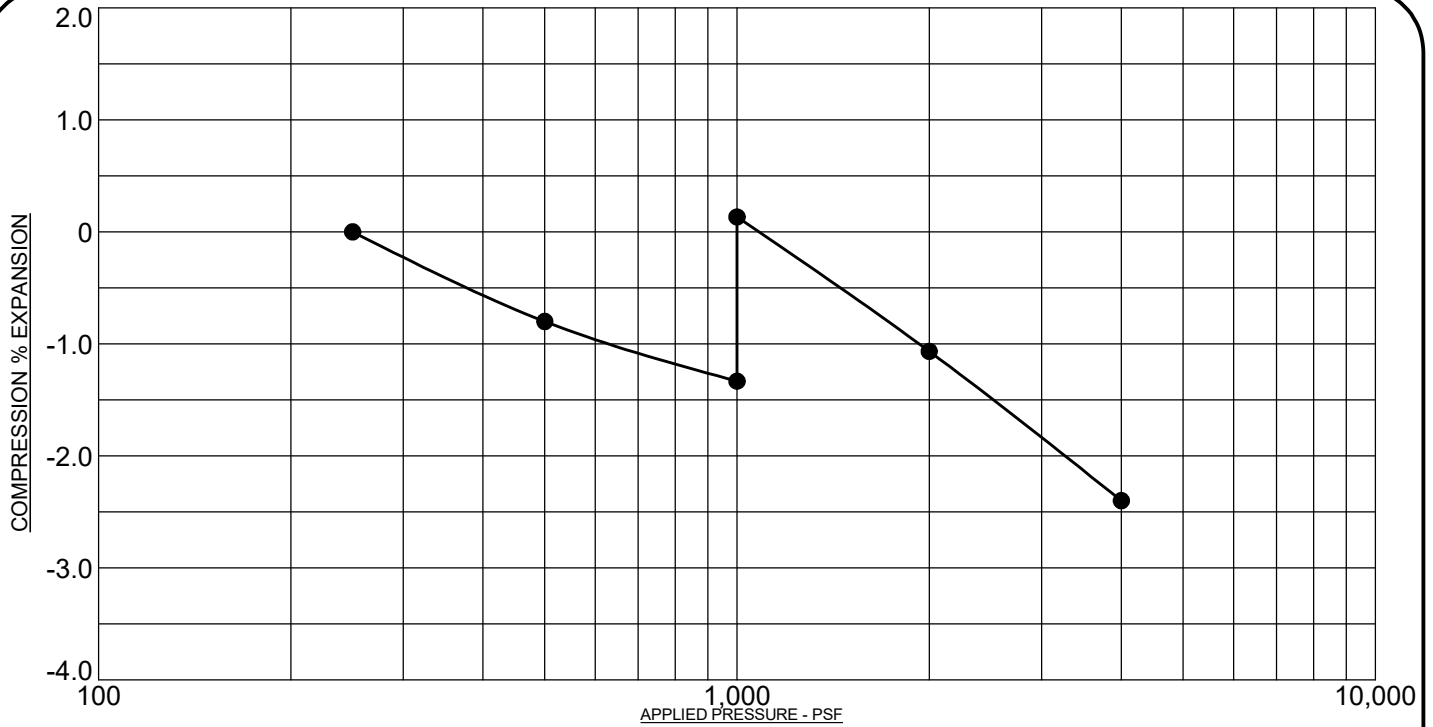
FIGURE No. 9

PROJECT: **Creekside at Lorson Ranch, Filing No. 2 El Paso County, Colorado**
 SAMPLE DESCRIPTION: **FILL: CLAY, SANDY**
 NOTE: **SAMPLE WAS INUNDATED WITH WATER AT 1,000 PSF**

SAMPLE LOCATION: **3 @ 14 FT**
 NATURAL DRY UNIT WEIGHT: **116.2 PCF**
 NATURAL MOISTURE CONTENT: **12.2%**
 PERCENT SWELL/COMPRESSION: **1.5**

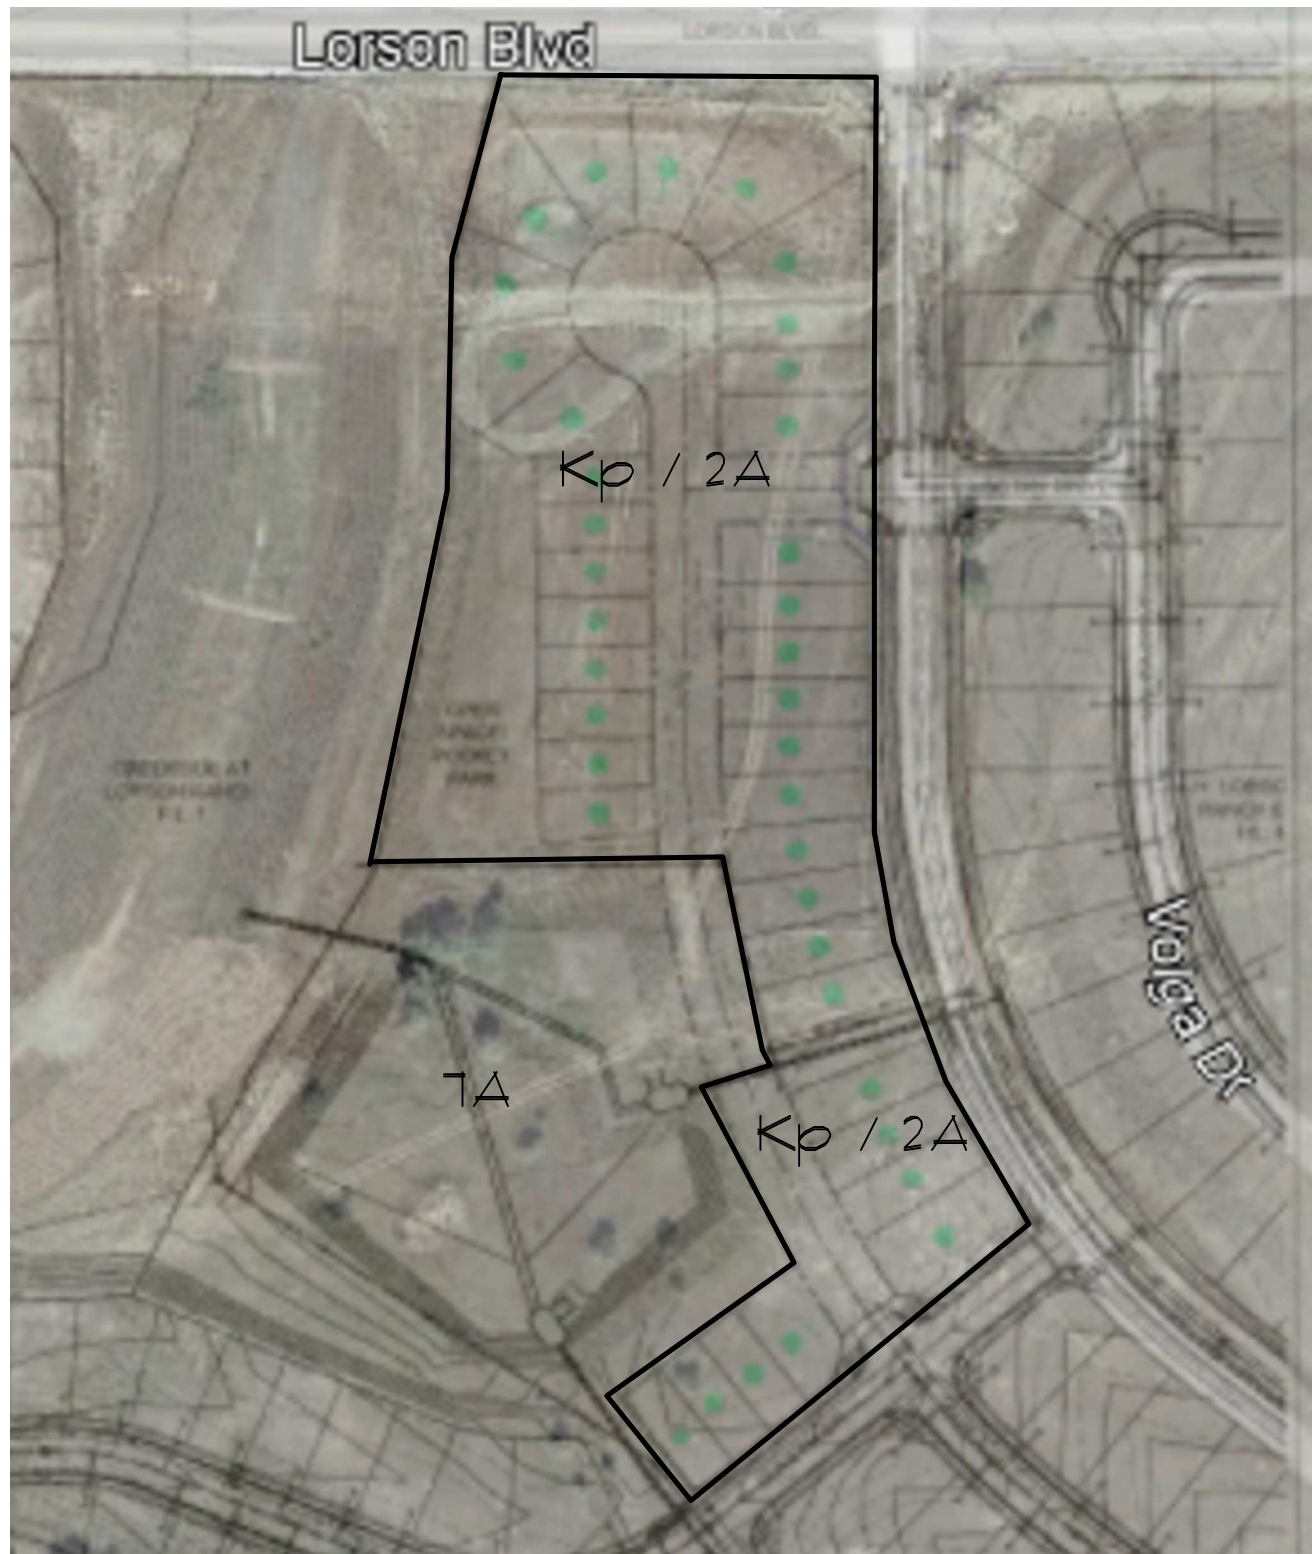
SHEET No.
FIG-10

GENERAL GEOLOGY

- *Kp - Pierre Shale (Upper Cretaceous)* - Predominately siltstone and claystone. Contains sandstone and sandy shale near top and bottom of the formation. Sandstone and shale were not encountered in the test borings performed for this investigation. Claystone bedrock was encountered in one test boring at a depth of 14 feet.

ENGINEERING
GEOLOGY MAP

Based on our field observations, the USDA map, and the Geologic Map of the Pueblo 1 degree x 2 degrees quadrangle, south-central Colorado an interpreted geologic map of significant surficial deposits and features was mapped for the site. The identified geologic conditions affecting the development are presented in the Engineering and Geology Map, Figure 10.

The Engineering Geology is presented in the Engineering and Geology Map, Figure 10.

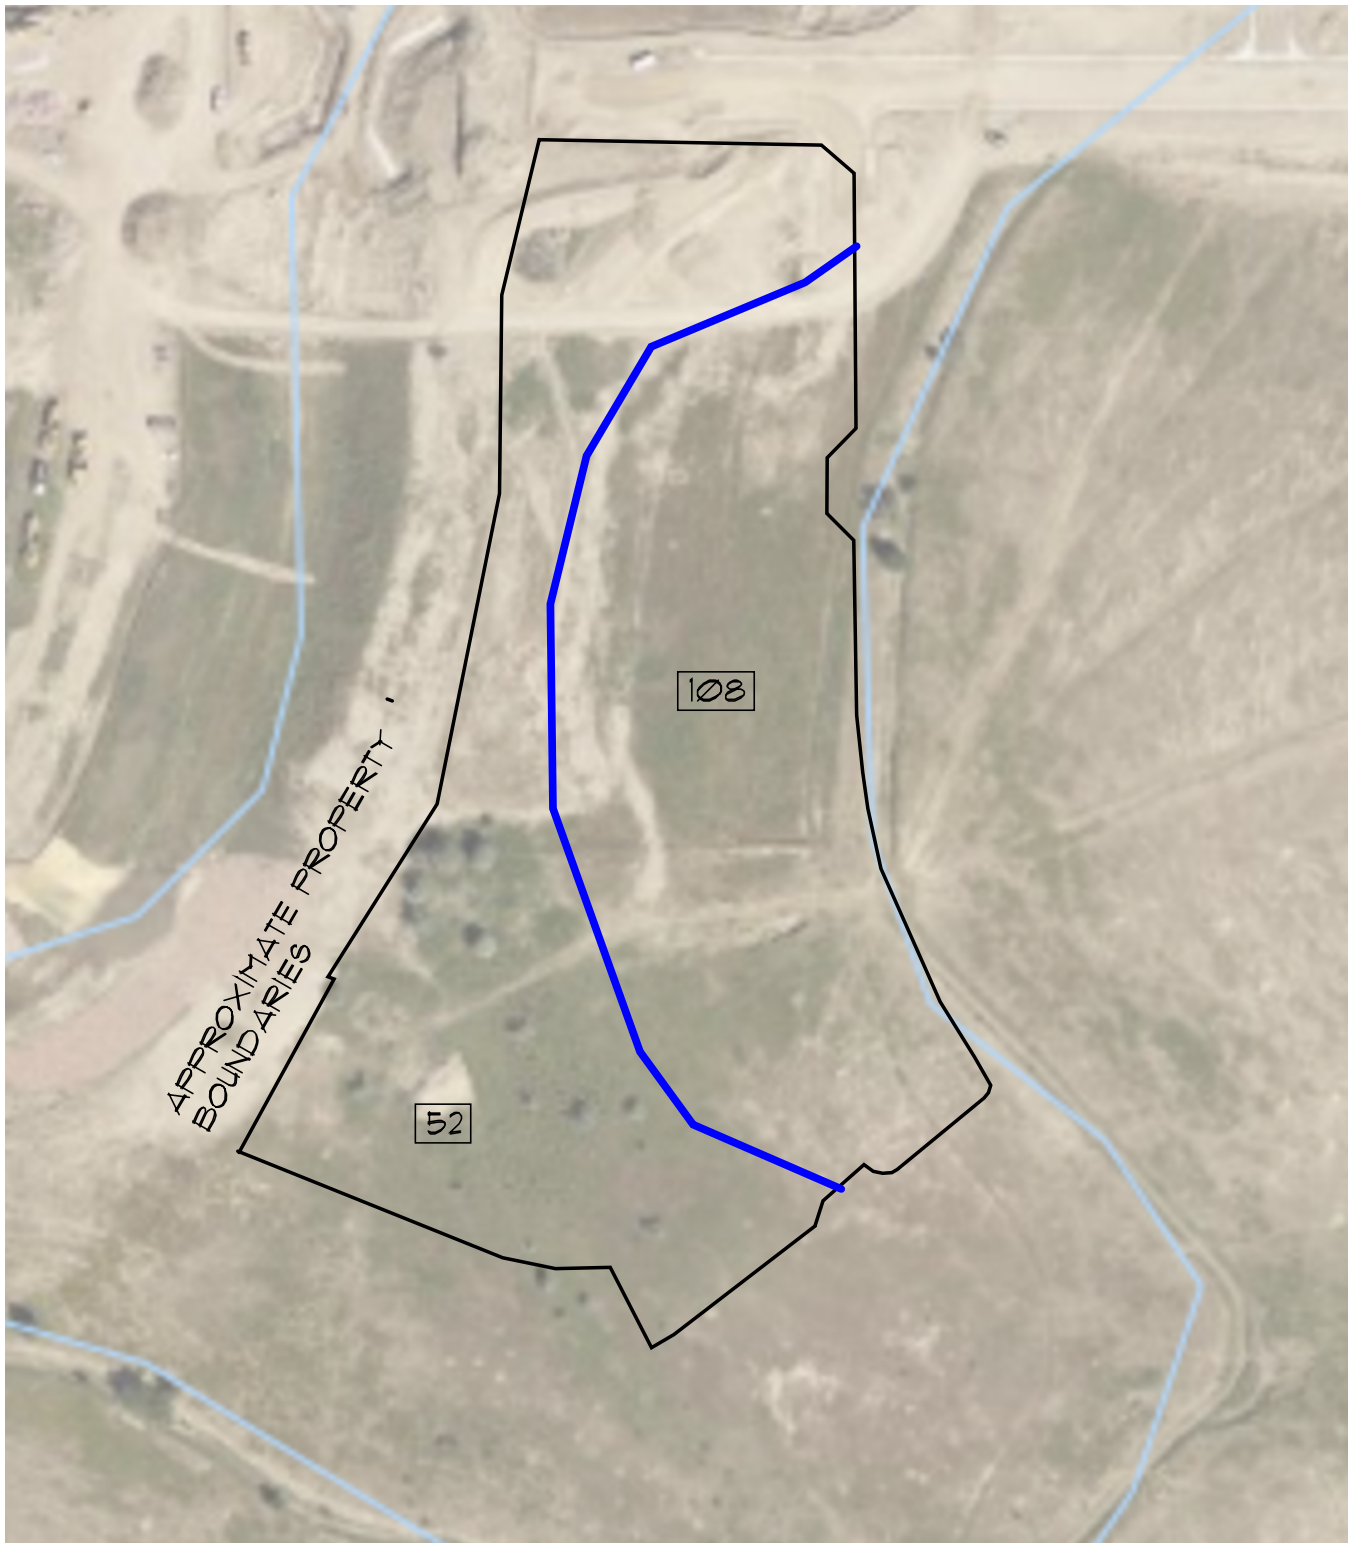
FIG No. 11

APPROXIMATE PROPERTY
BOUNDARIES

The USDA Soil Survey Map is presented in Figure 11.
