**ENTECH**  
ENGINEERING, INC.

**SOIL, GEOLOGY, AND GEOLOGIC HAZARD STUDY  
STERLING RANCH PHASE 2  
AND STERLING RANCH FILING NO. 3  
EL PASO COUNTY, COLORADO**

June 25, 2020  
Revised March 3, 2021  
Revised May 4, 2021

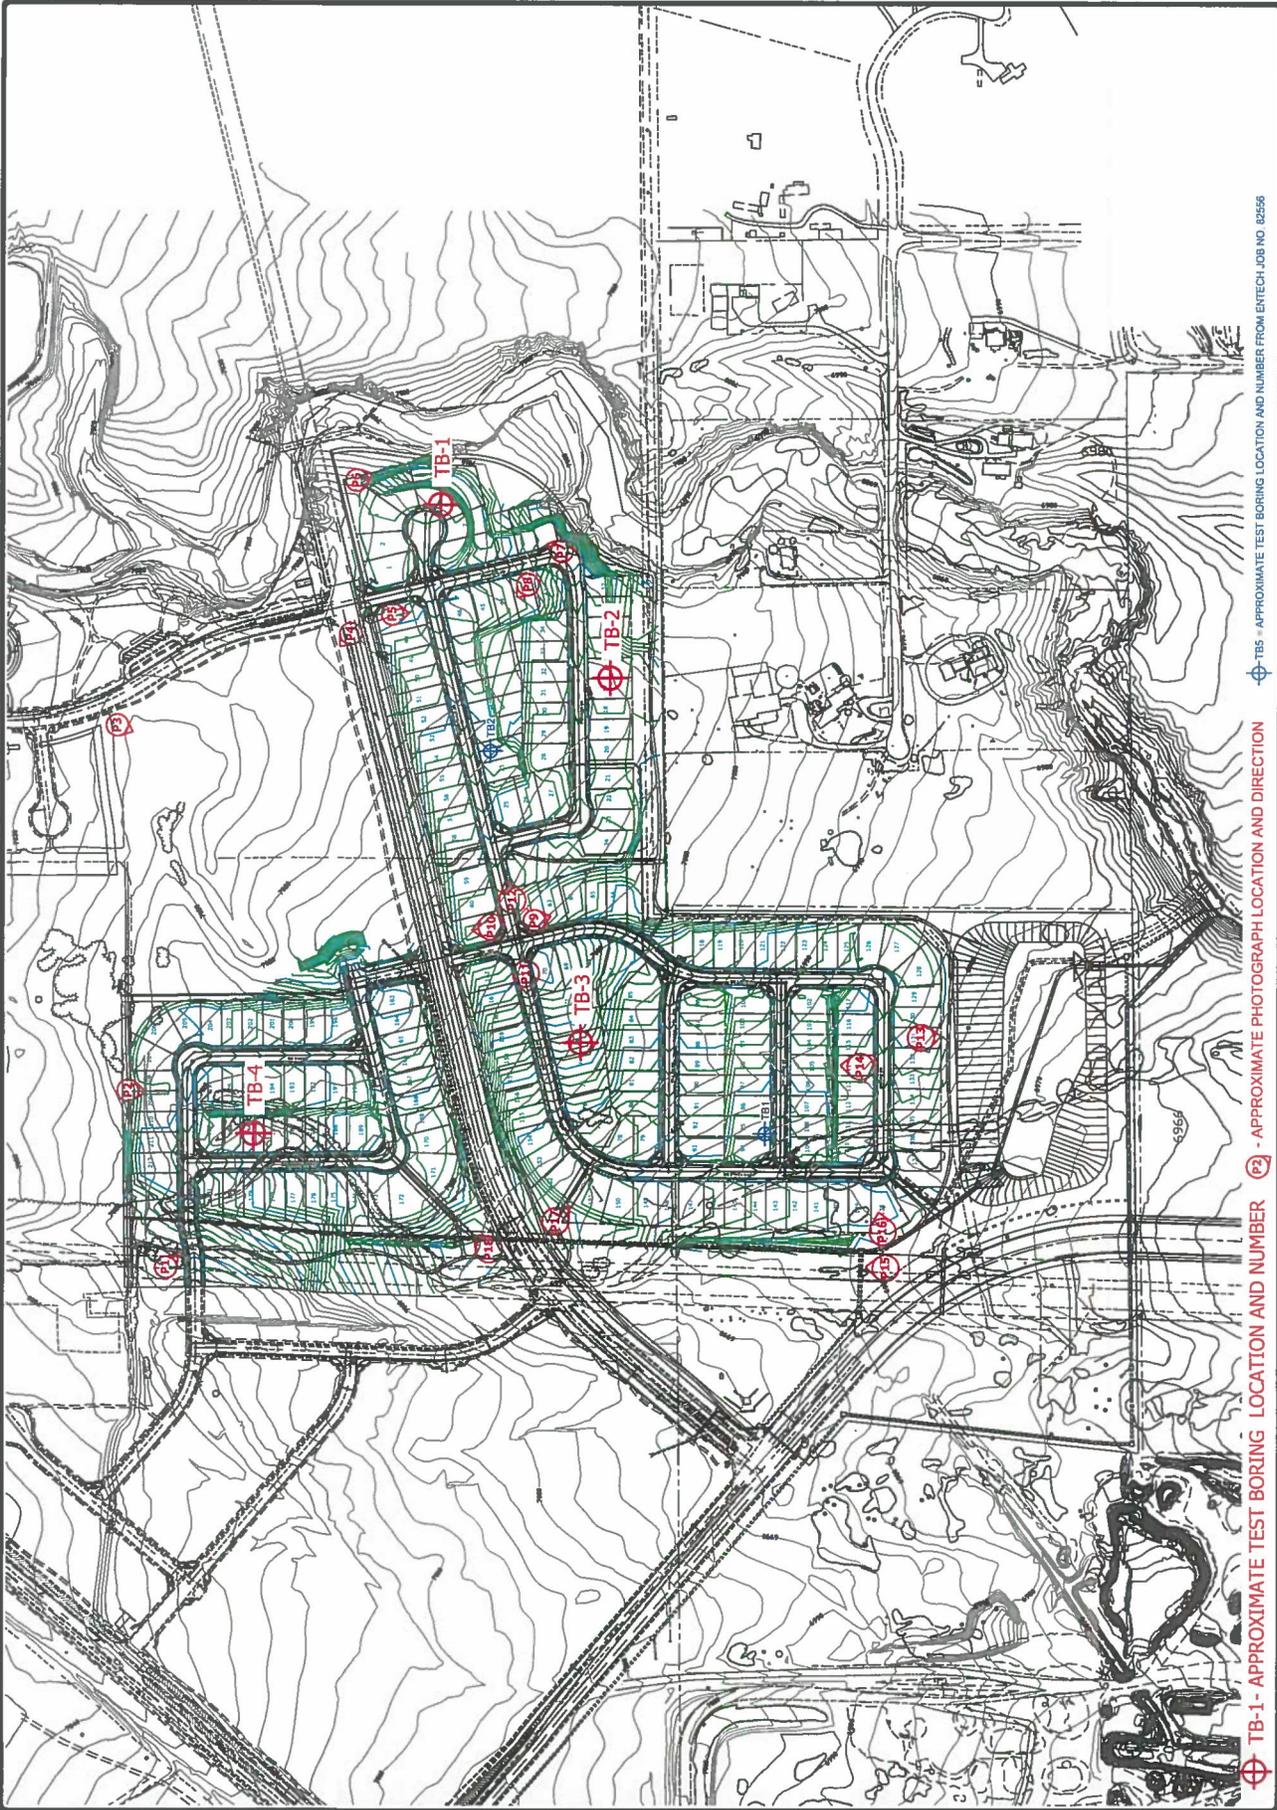
**TEST BORING LOCATION MAP**  
STERLING RANCH PHASE 2 & F3  
EL PASO, COLORADO  
FOR: MORLEY-BENTLY INVESTMENTS

TB-1 - APPROXIMATE TEST BORING LOCATION AND NUMBER   
 TB-2 - APPROXIMATE PHOTOGRAPH LOCATION AND DIRECTION   
 TB-3 - APPROXIMATE TEST BORING LOCATION AND NUMBER   
 TB-4 - APPROXIMATE TEST BORING LOCATION AND NUMBER   
 TB-5 - APPROXIMATE TEST BORING LOCATION AND NUMBER FROM ENTECH JOB NO. 82556

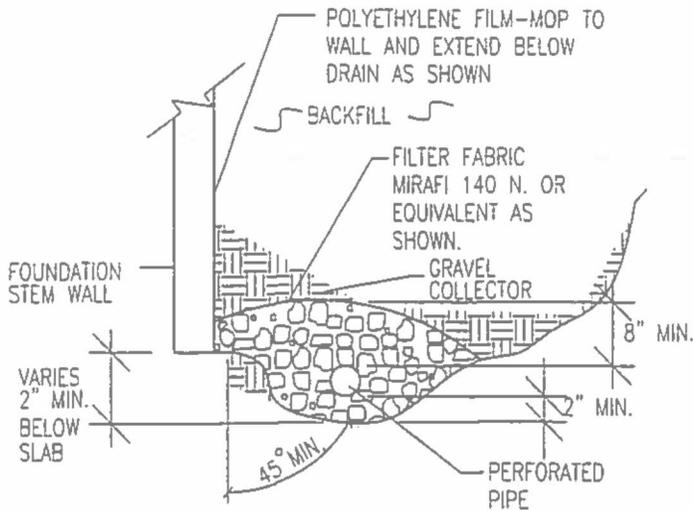
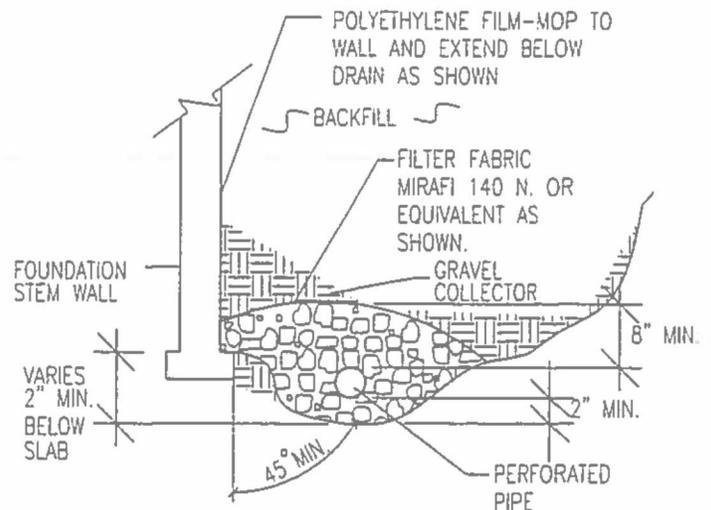
JOB NO.:  
191089  
FIG NO.:  
9

-GRAVEL SIZE IS RELATED TO DIAMETER OF PIPE PERFORATIONS-85% GRAVEL GREATER THAN 2x PERFORATION DIAMETER.

Areas of seasonal and potentially seasonal shallow groundwater have been mapped in the drainage area along the western boundary of the site. This area will be regraded and drainage piped to the south, however, structures immediately adjacent to the drainage area may experience higher water levels during periods of high moisture. Additionally, shallow groundwater was encountered west of the site after precipitation events due to runoff from the north that backed up in permeable sands overlying the bedrock. According to the grading plan the drainage area is to be filled and regraded and drainage from the north collected and piped to a detention pond south of the site. All soft or organic soils should be removed prior to fill placement. Unstable soils may be encountered where excavations approach the groundwater level. Shallow groundwater areas may also affect utility installation. Geo-grids or shotrock may be necessary to stabilize excavations. Foundations should be kept as high as possible. Foundations in or adjacent to seasonal or potentially seasonal shallow groundwater areas may require drains to control seepage within the foundation zone. Typical drain details are presented

in Figures 9 through 11. Where basements are considered, interceptor and underslab drains may be necessary. Additional investigation is recommended after grading and the storm sewer is installed to evaluate groundwater conditions.

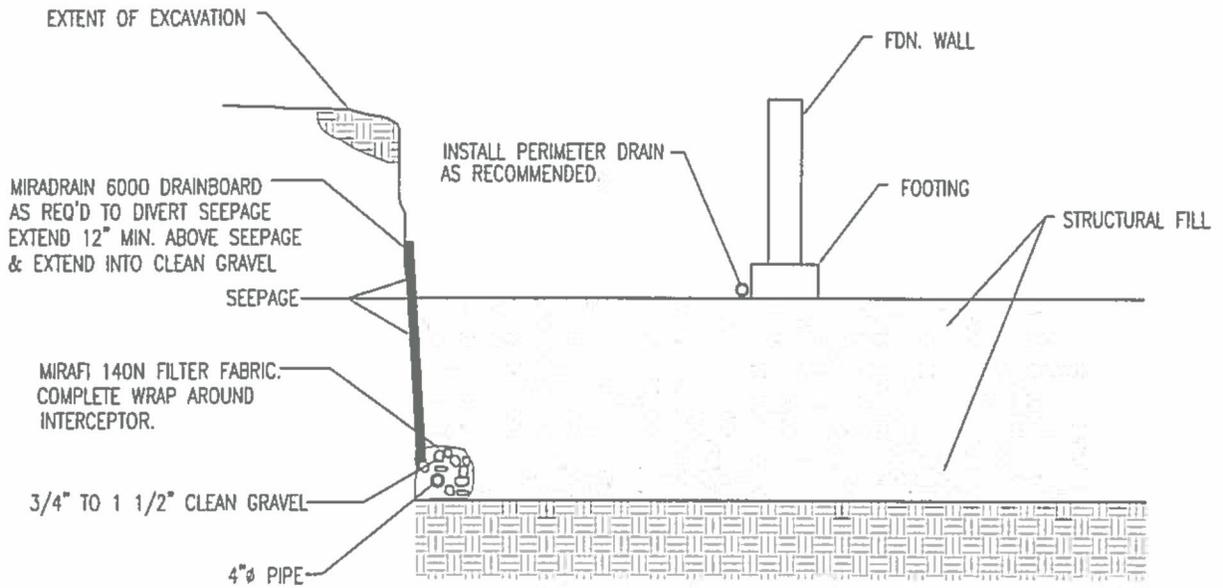
INTERCEPTOR DRAIN DETAIL  
N.T.S.

NOTE:  
EXTEND INTERCEPTOR DRAIN TO DAYLIGHT

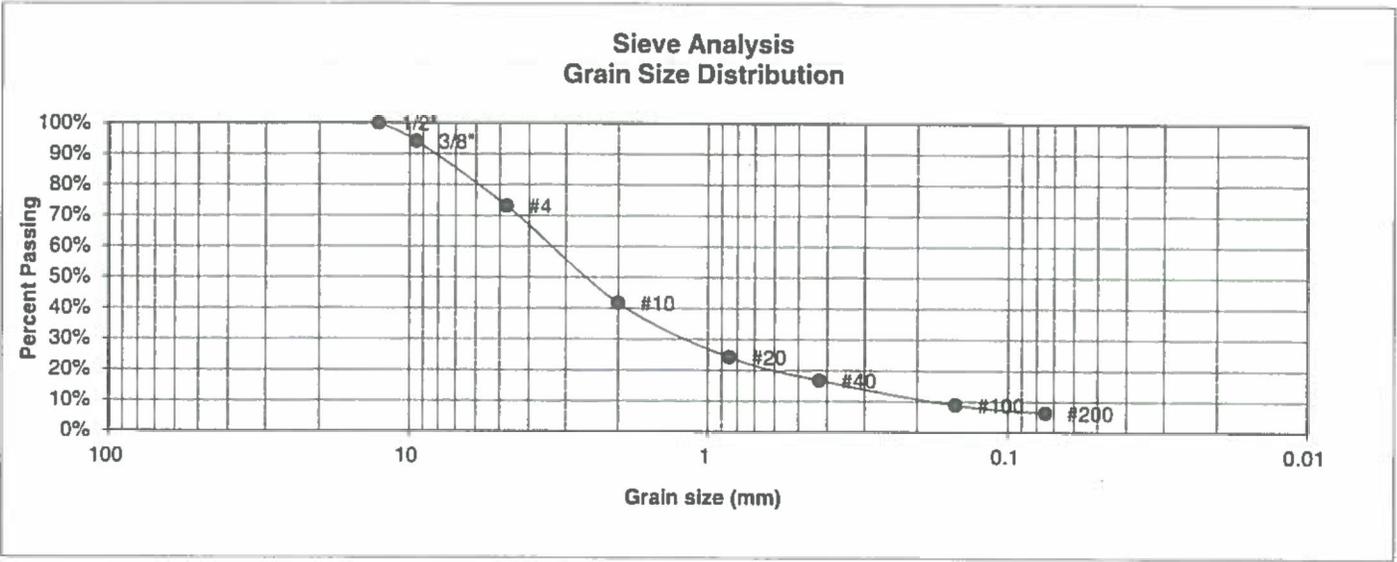
FIG NO.:  
C-1

<b>UNIFIED CLASSIFICATION</b>	SM-SW	<b>CLIENT</b>	MORLEY-BENTLEY INVEST.
<b>SOIL TYPE #</b>	1	<b>PROJECT</b>	STERLING RANCH, P2, F3
<b>TEST BORING #</b>	1	<b>JOB NO.</b>	191089
<b>DEPTH (FT)</b>	2-3	<b>TEST BY</b>	BL

U.S. Sieve #	Percent Finer
3"	
1 1/2"	
3/4"	
1/2"	100.0%
3/8"	94.1%
4	73.2%
10	41.7%
20	24.3%
40	16.8%
100	8.9%
200	6.4%

Atterberg Limits	
Plastic Limit	NP
Liquid Limit	NV
Plastic Index	NP

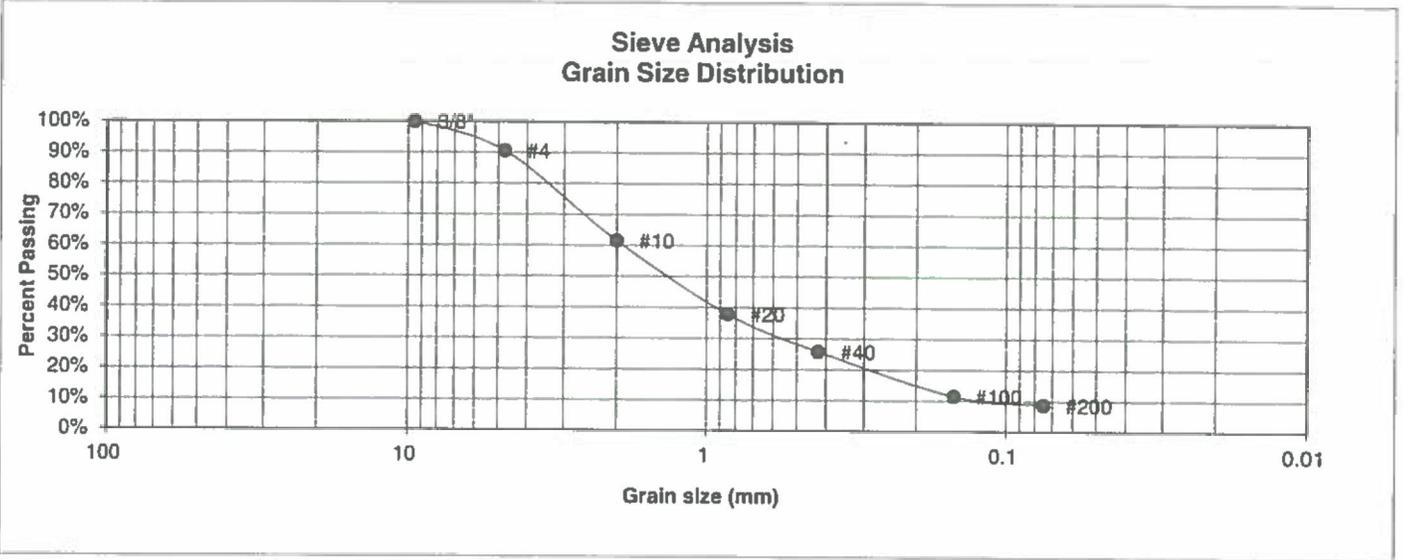
FIG NO.:  
G-2

<b>UNIFIED CLASSIFICATION</b>	SM-SW	<b>CLIENT</b>	MORLEY-BENTLEY INVEST.
<b>SOIL TYPE #</b>	1	<b>PROJECT</b>	STERLING RANCH, P2, F3
<b>TEST BORING #</b>	2	<b>JOB NO.</b>	191089
<b>DEPTH (FT)</b>	5	<b>TEST BY</b>	BL

U.S. Sieve #	Percent Finer
3"	
1 1/2"	
3/4"	
1/2"	
3/8"	100.0%
4	90.5%
10	61.5%
20	37.8%
40	25.8%
100	11.5%
200	8.7%

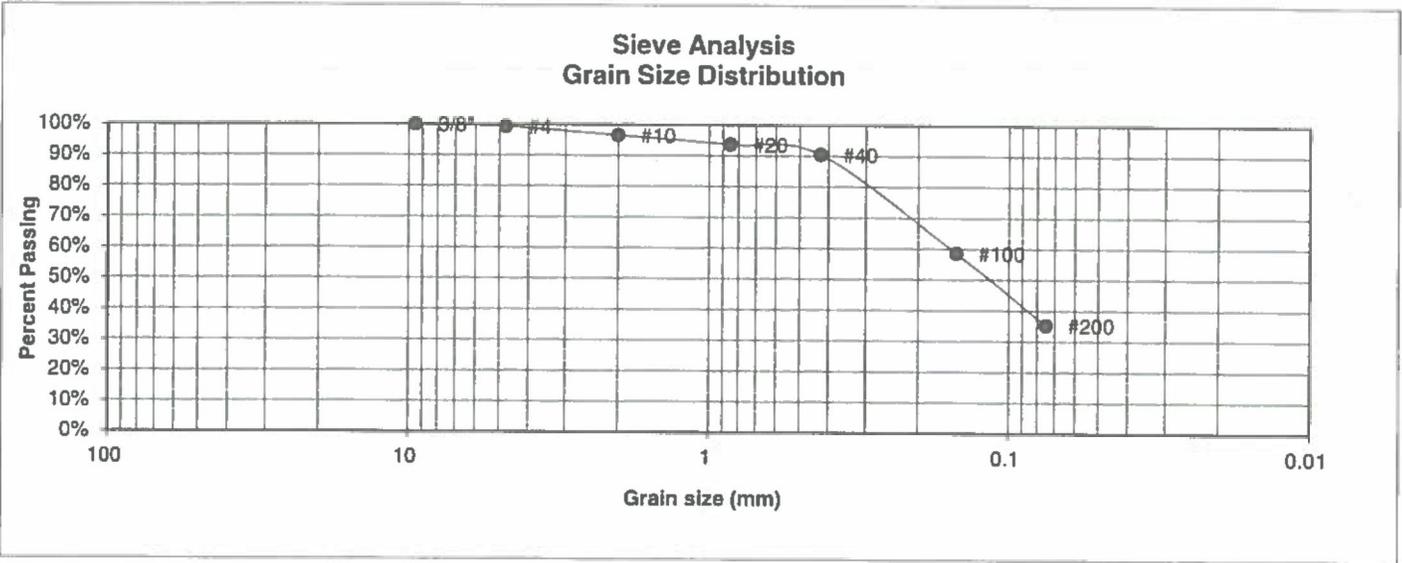
FIG NO.:  
C-3

<u>UNIFIED CLASSIFICATION</u>	SM	<u>CLIENT</u>	MORLEY-BENTLEY INVEST.
<u>SOIL TYPE #</u>	1	<u>PROJECT</u>	STERLING RANCH, P2, F3
<u>TEST BORING #</u>	3	<u>JOB NO.</u>	191089
<u>DEPTH (FT)</u>	10	<u>TEST BY</u>	BL

U.S. Sieve #	Percent Finer
3"	
1 1/2"	
3/4"	
1/2"	
3/8"	100.0%
4	99.3%
10	96.6%
20	93.6%
40	90.4%
100	58.6%
200	35.3%

<u>Atterberg Limits</u>	
Plastic Limit	NP
Liquid Limit	NV
Plastic Index	NP

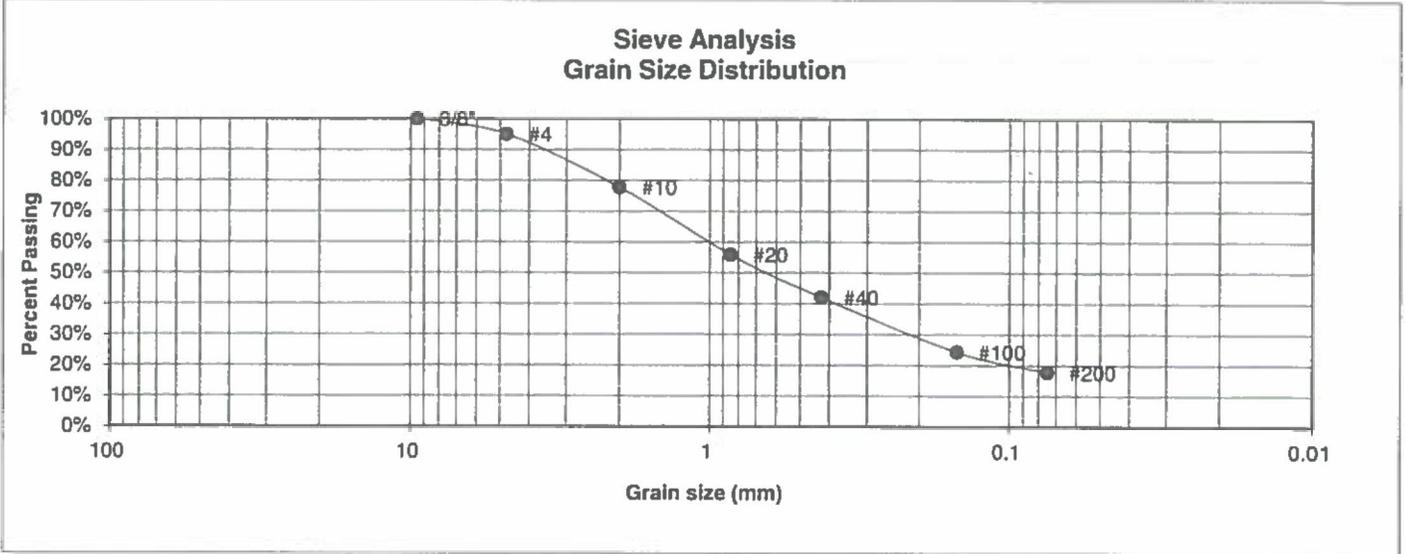
FIG NO.:  
C-4

<u>UNIFIED CLASSIFICATION</u>	SM	<u>CLIENT</u>	MORLEY-BENTLEY INVEST.
<u>SOIL TYPE #</u>	1	<u>PROJECT</u>	STERLING RANCH, P2, F3
<u>TEST BORING #</u>	4	<u>JOB NO.</u>	191089
<u>DEPTH (FT)</u>	2-3	<u>TEST BY</u>	BL

<u>U.S. Sieve #</u>	<u>Percent Finer</u>
3"	
1 1/2"	
3/4"	
1/2"	
3/8"	100.0%
4	95.0%
10	77.8%
20	55.9%
40	42.0%
100	24.3%
200	17.8%

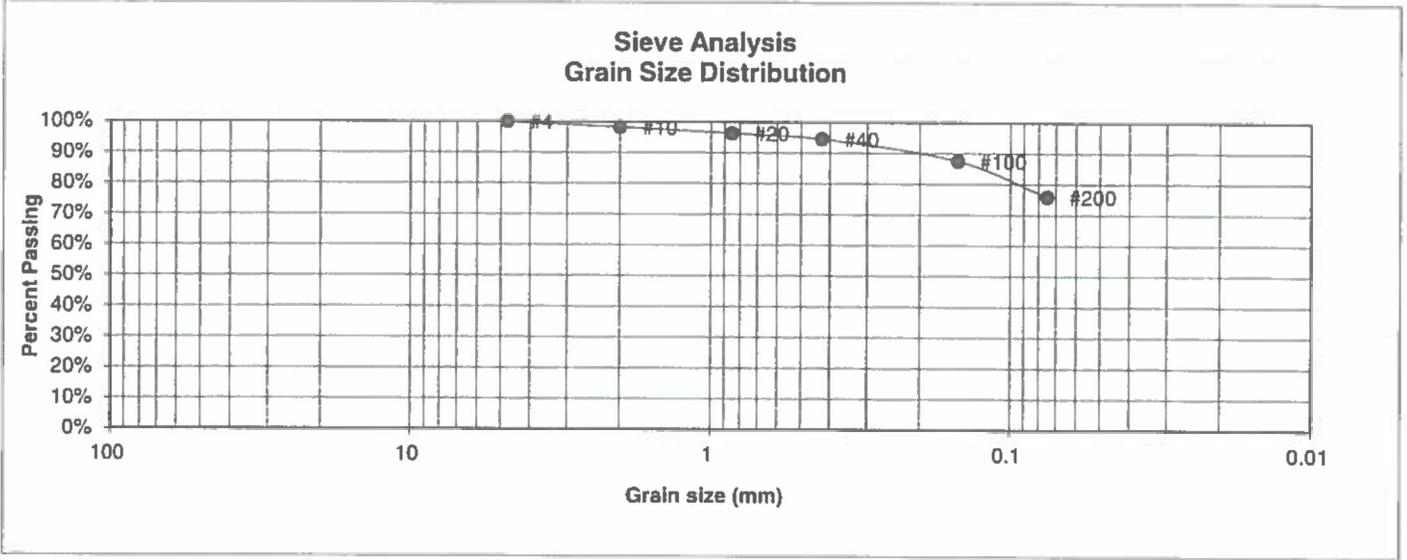
FIG NO:  
C-5

<u>UNIFIED CLASSIFICATION</u>	CL	<u>CLIENT</u>	MORLEY-BENTLEY INVEST.
<u>SOIL TYPE #</u>	2	<u>PROJECT</u>	STERLING RANCH, P2, F3
<u>TEST BORING #</u>	4	<u>JOB NO.</u>	191089
<u>DEPTH (FT)</u>	5	<u>TEST BY</u>	BL

<u>U.S. Sieve #</u>	<u>Percent Finer</u>
3"	
1 1/2"	
3/4"	
1/2"	
3/8"	
4	100.0%
10	98.3%
20	96.3%
40	94.5%
100	87.5%
200	75.9%

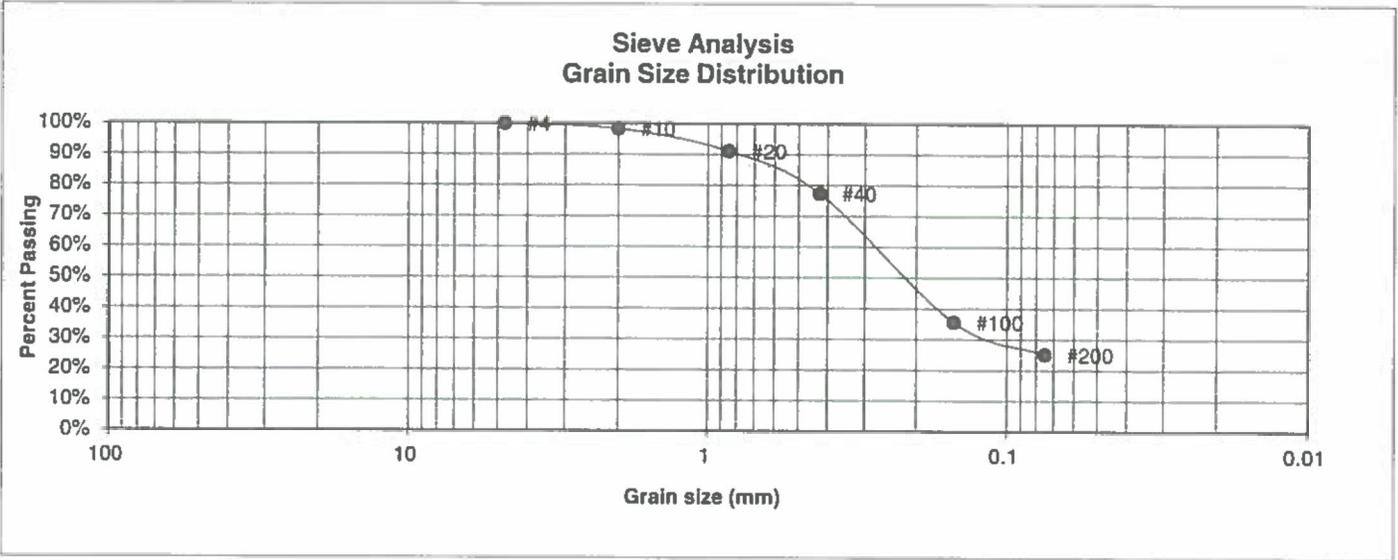
FIG NO.:  
C-6

<u>UNIFIED CLASSIFICATION</u>	SM	<u>CLIENT</u>	MORLEY-BENTLEY INVEST.
<u>SOIL TYPE #</u>	3	<u>PROJECT</u>	STERLING RANCH, P2, F3
<u>TEST BORING #</u>	2	<u>JOB NO.</u>	191089
<u>DEPTH (FT)</u>	10	<u>TEST BY</u>	BL

<u>U.S. Sieve #</u>	<u>Percent Finer</u>
3"	
1 1/2"	
3/4"	
1/2"	
3/8"	
4	100.0%
10	98.3%
20	91.1%
40	77.3%
100	35.6%
200	25.1%

<u>Atterberg Limits</u>	
Plastic Limit	NP
Liquid Limit	NV
Plastic Index	NP

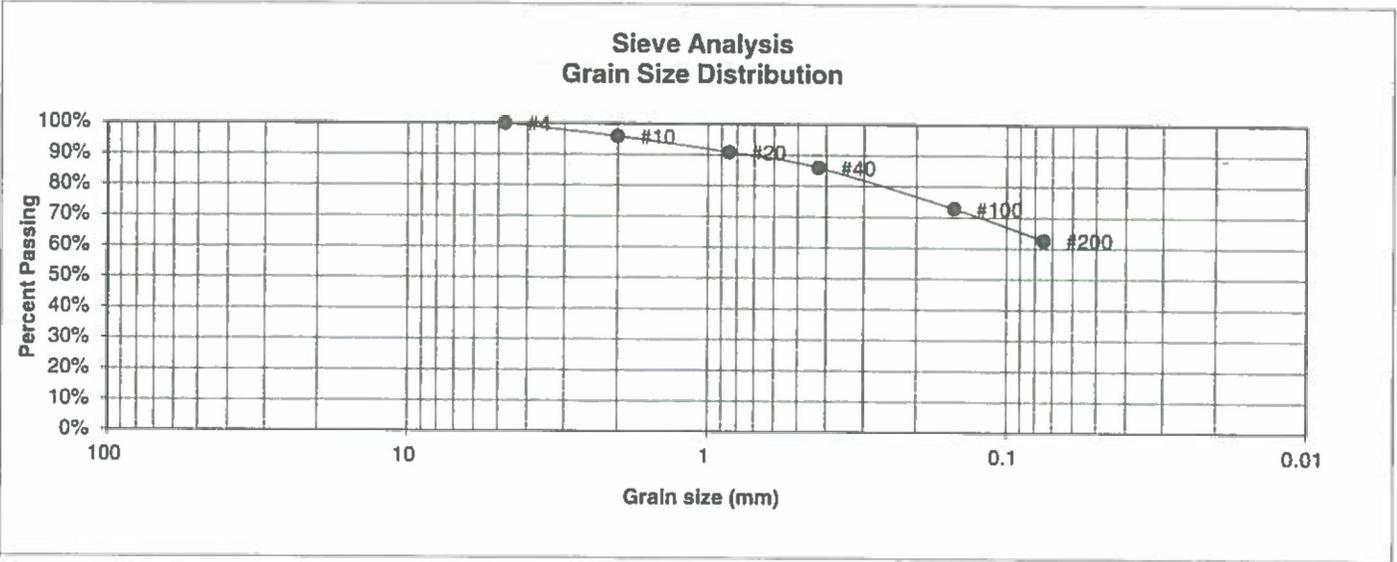
<u>UNIFIED CLASSIFICATION</u>	CL	<u>CLIENT</u>	MORLEY-BENTLEY INVEST.
<u>SOIL TYPE #</u>	4	<u>PROJECT</u>	STERLING RANCH, P2, F3
<u>TEST BORING #</u>	3	<u>JOB NO.</u>	191089
<u>DEPTH (FT)</u>	20	<u>TEST BY</u>	BL

<u>U.S. Sieve #</u>	<u>Percent Finer</u>
3"	
1 1/2"	
3/4"	
1/2"	
3/8"	
4	100.0%
10	95.9%
20	90.9%
40	86.0%
100	72.8%
200	62.7%

<u>Atterberg Limits</u>	
Plastic Limit	20
Liquid Limit	32
Plastic Index	12

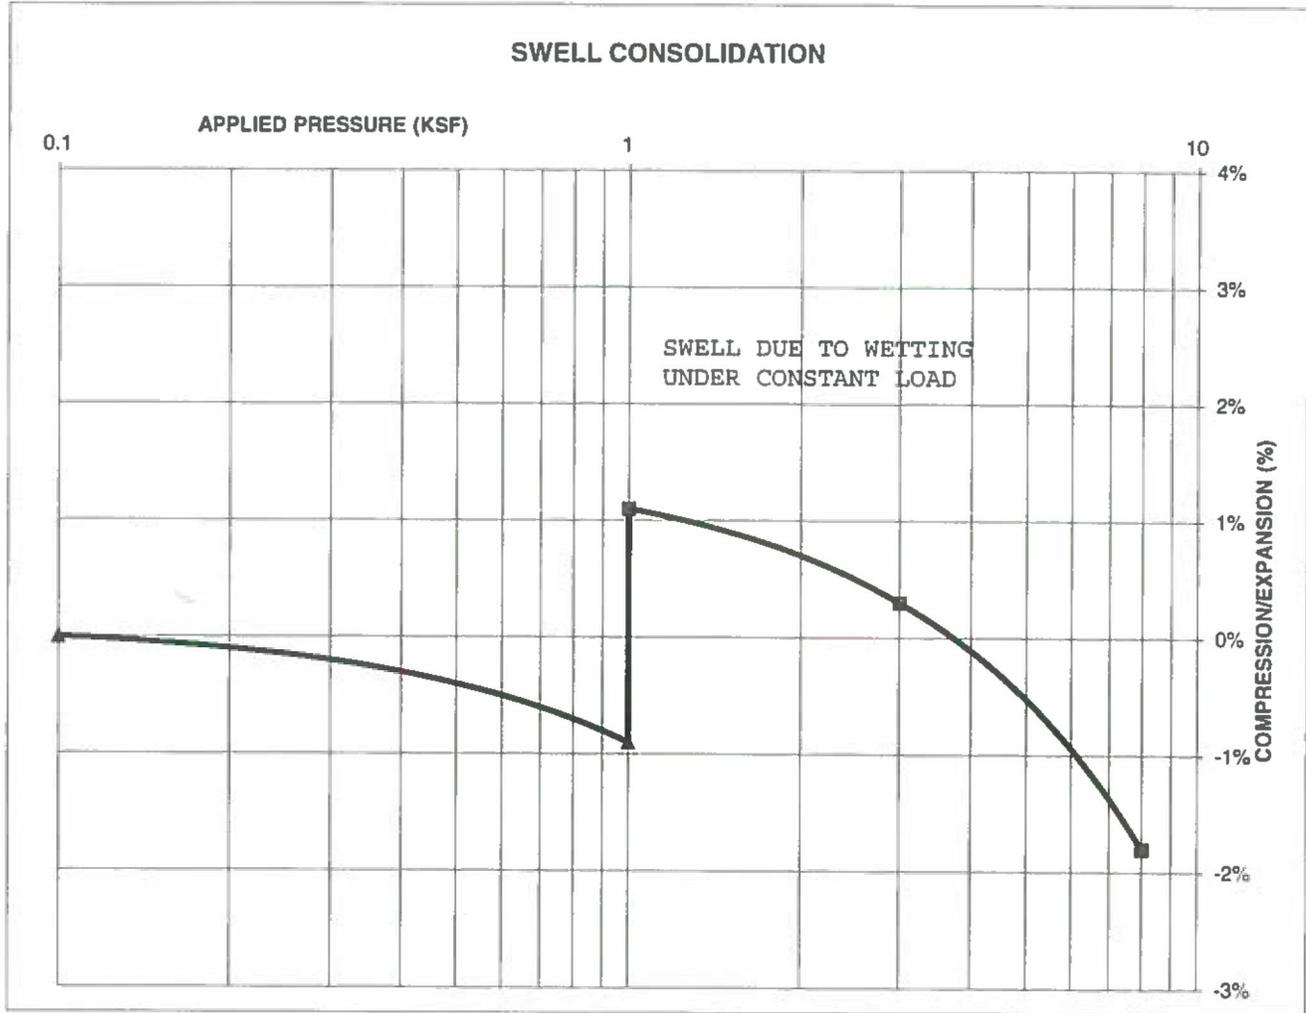
TEST BORING #	4	DEPTH(ft)	5
DESCRIPTION	CL	SOIL TYPE	2
NATURAL UNIT DRY WEIGHT (PCF)			113
NATURAL MOISTURE CONTENT			12.5%
SWELL/CONSOLIDATION (%)			2.0%

JOB NO. 191089  
 CLIENT MORLEY-BENTLEY INVEST.  
 PROJECT STERLING RANCH, P2, F3

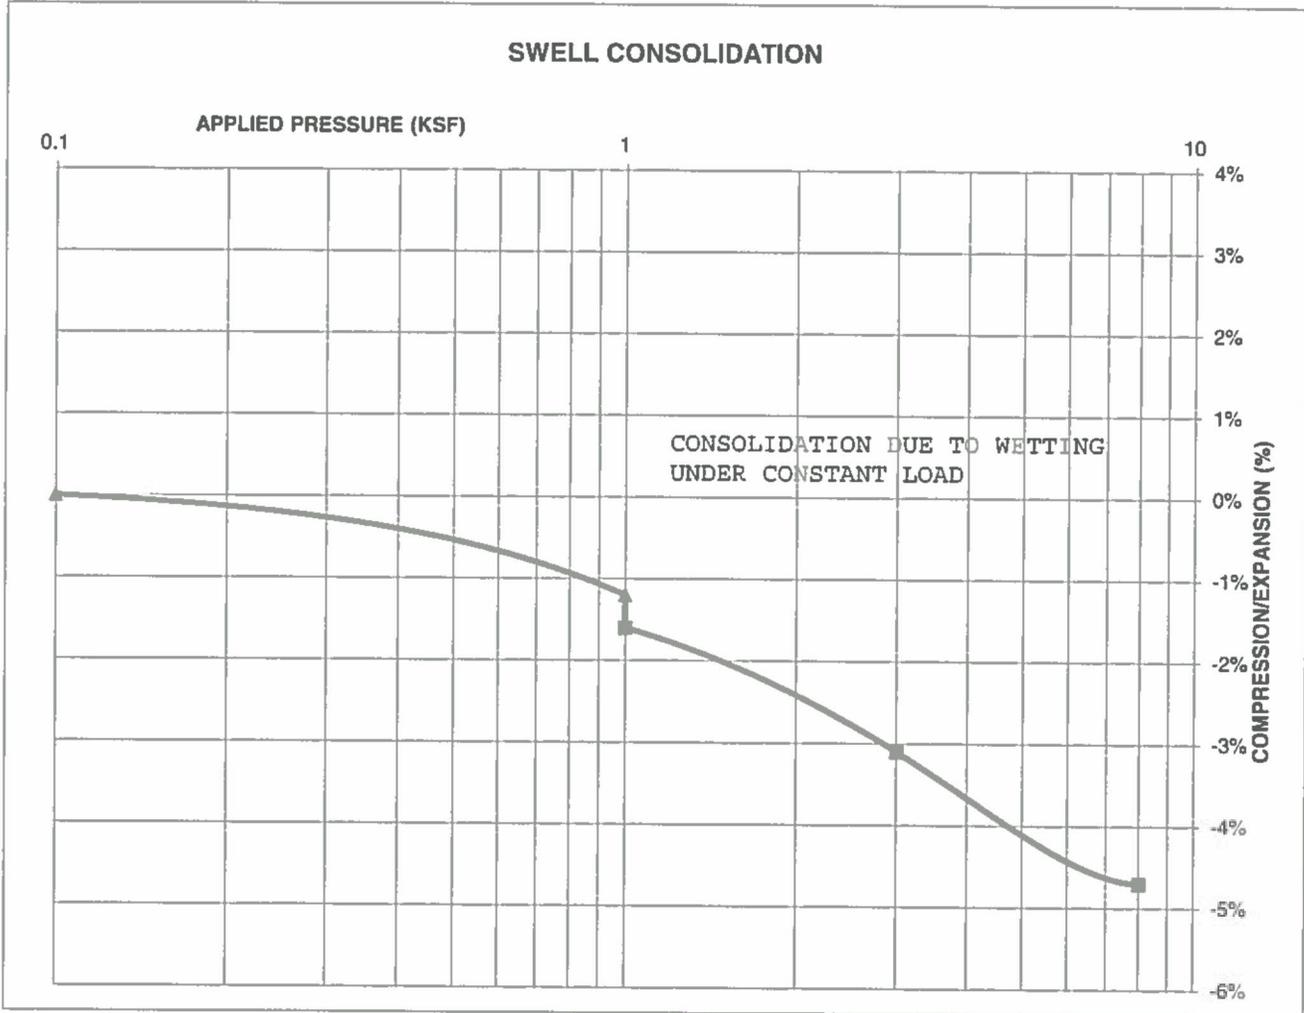
TEST BORING #	3	DEPTH(ft)	20
DESCRIPTION	CL	SOIL TYPE	4
NATURAL UNIT DRY WEIGHT (PCF)			121
NATURAL MOISTURE CONTENT			6.4%
SWELL/CONSOLIDATION (%)			-0.4%

JOB NO. 191089  
 CLIENT MORLEY-BENTLEY INVEST.  
 PROJECT STERLING RANCH, P2, F3
