## **SOILS AND GEOLOGY STUDY**

**10805 Milan Road  
EPC Schedule No. 6224000011  
El Paso County, Colorado**

**JOB NO. 180317**

**February 4, 2021**

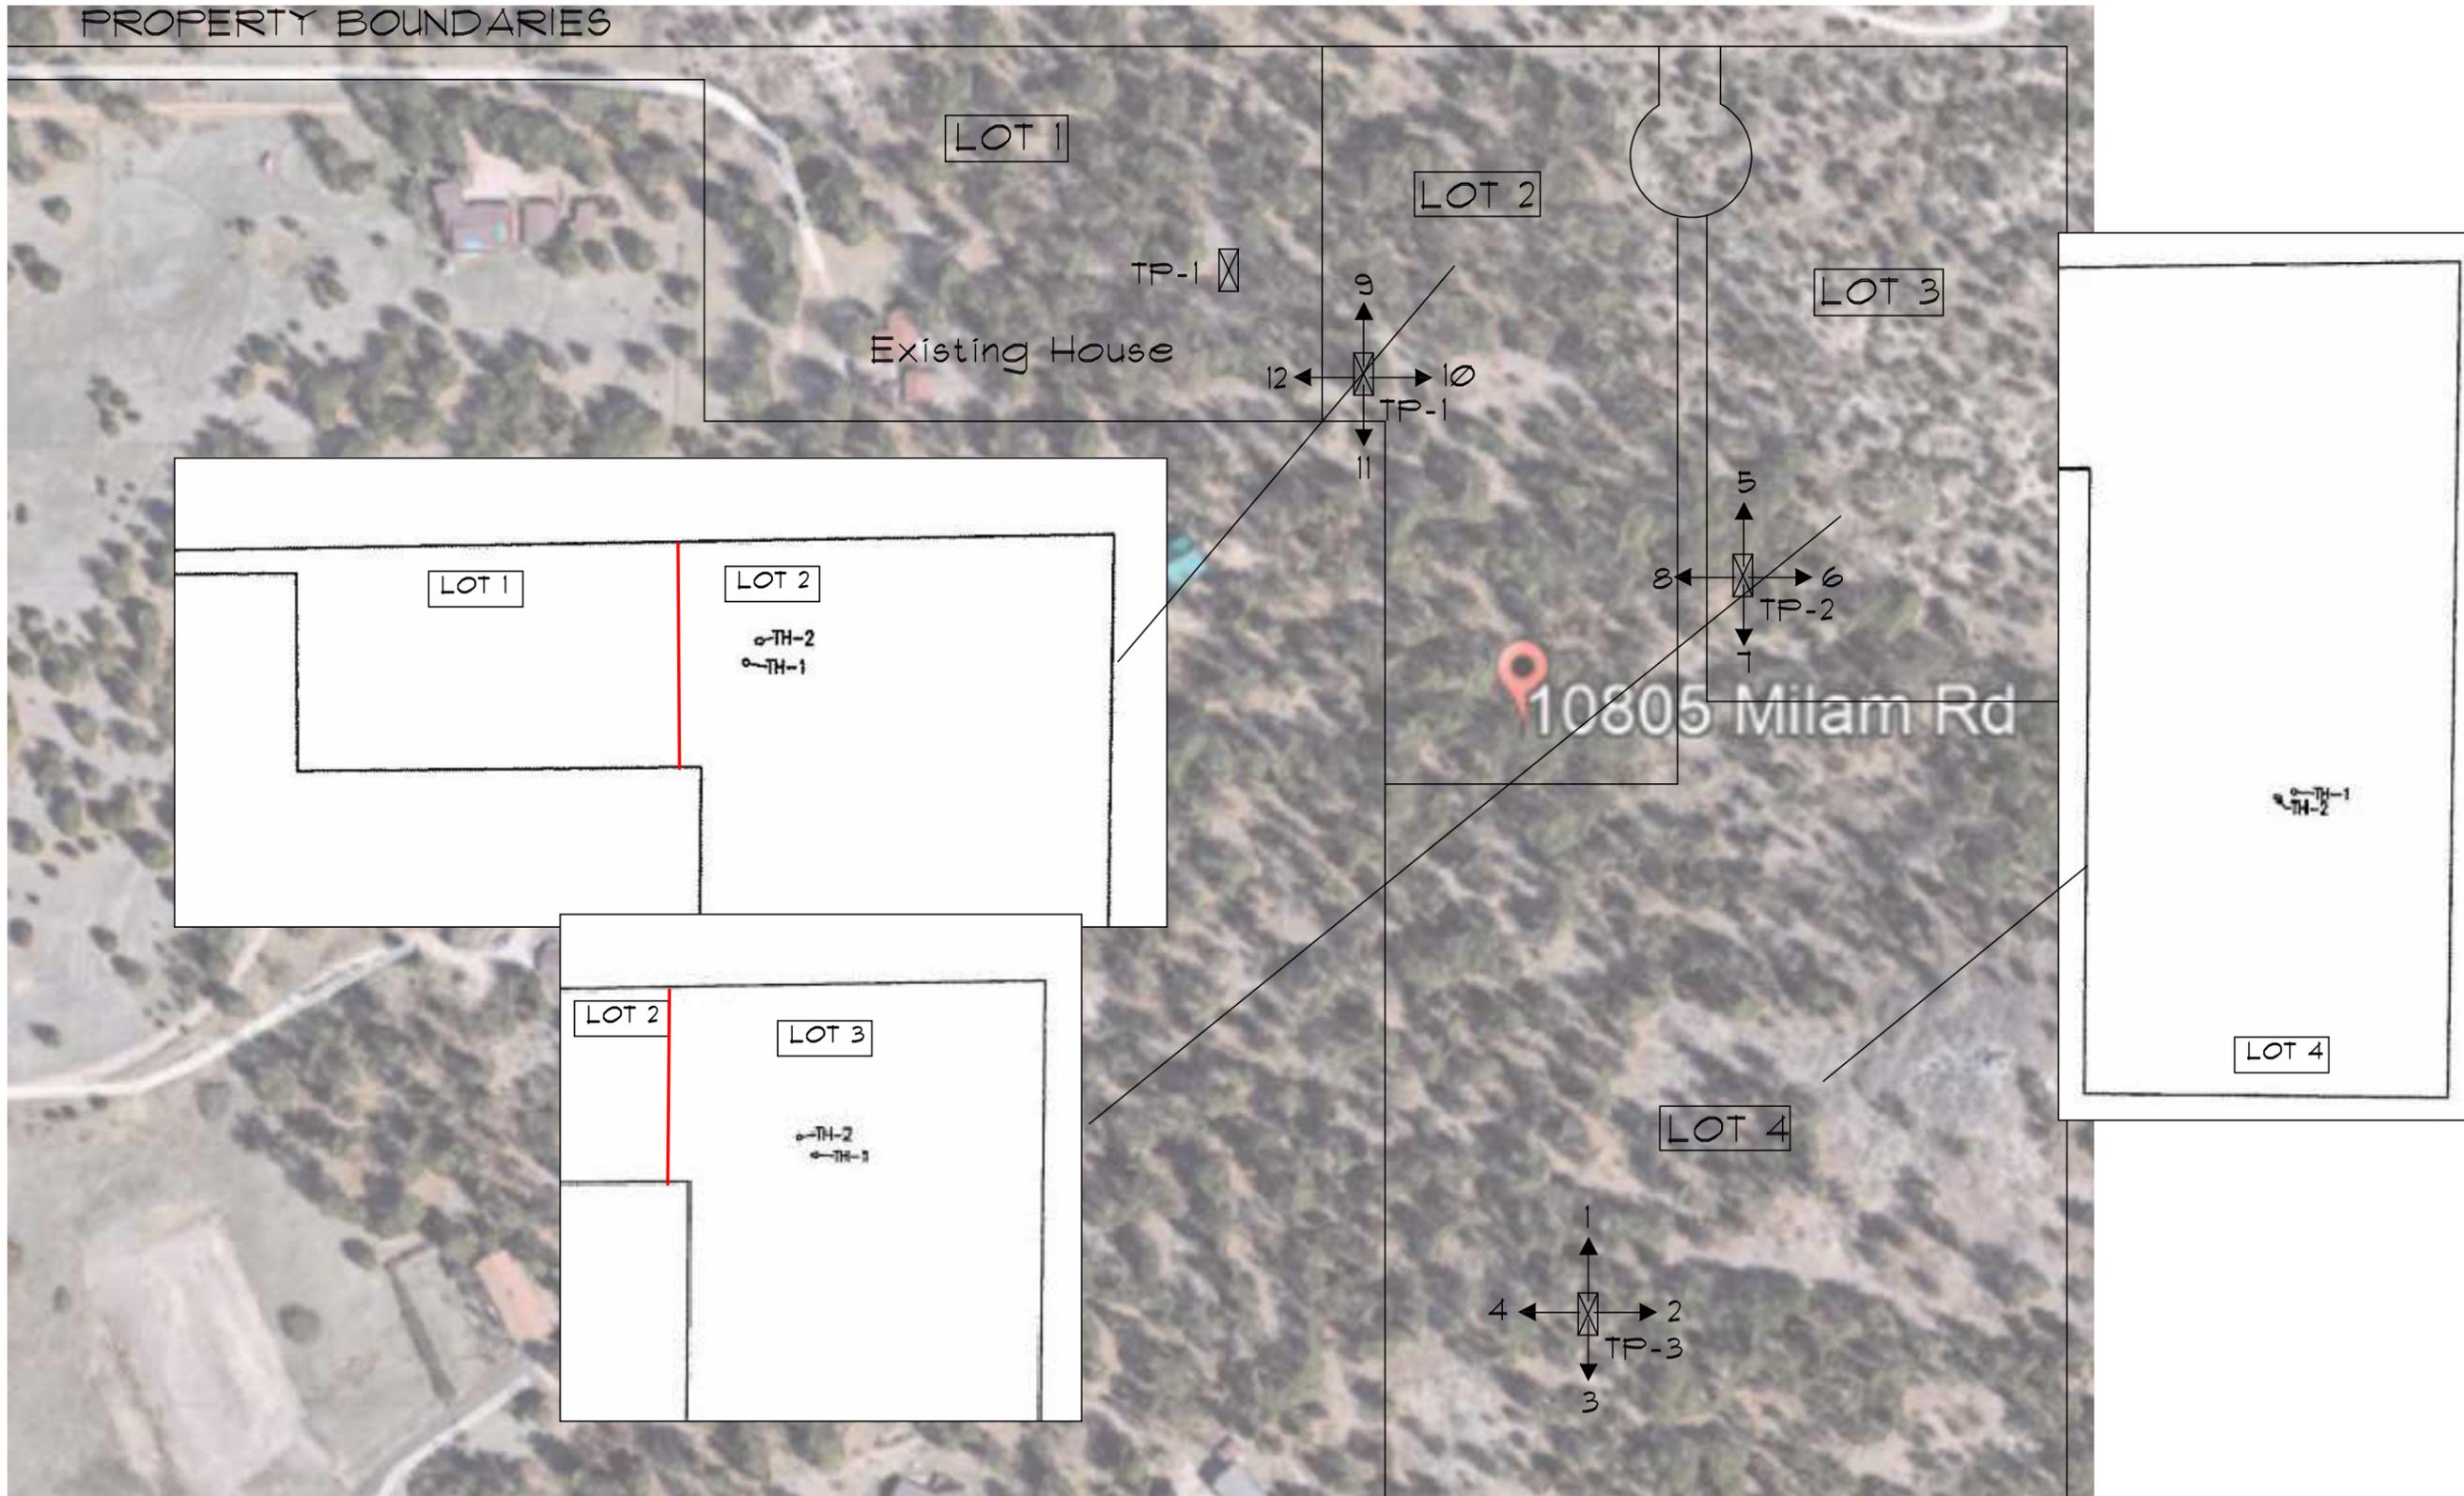
PROPERTY BOUNDARIES

Access to Lot 1 will remain from Milam Road. Access to Lots 2, 3, and 4 will be from the creation of a new cul-de-sac that is to extend south from Sierra Ridge Trail. The Proposed Lot Layout, Figure 2, presents the general boundaries of our investigation. The subject site includes all four proposed Lots.

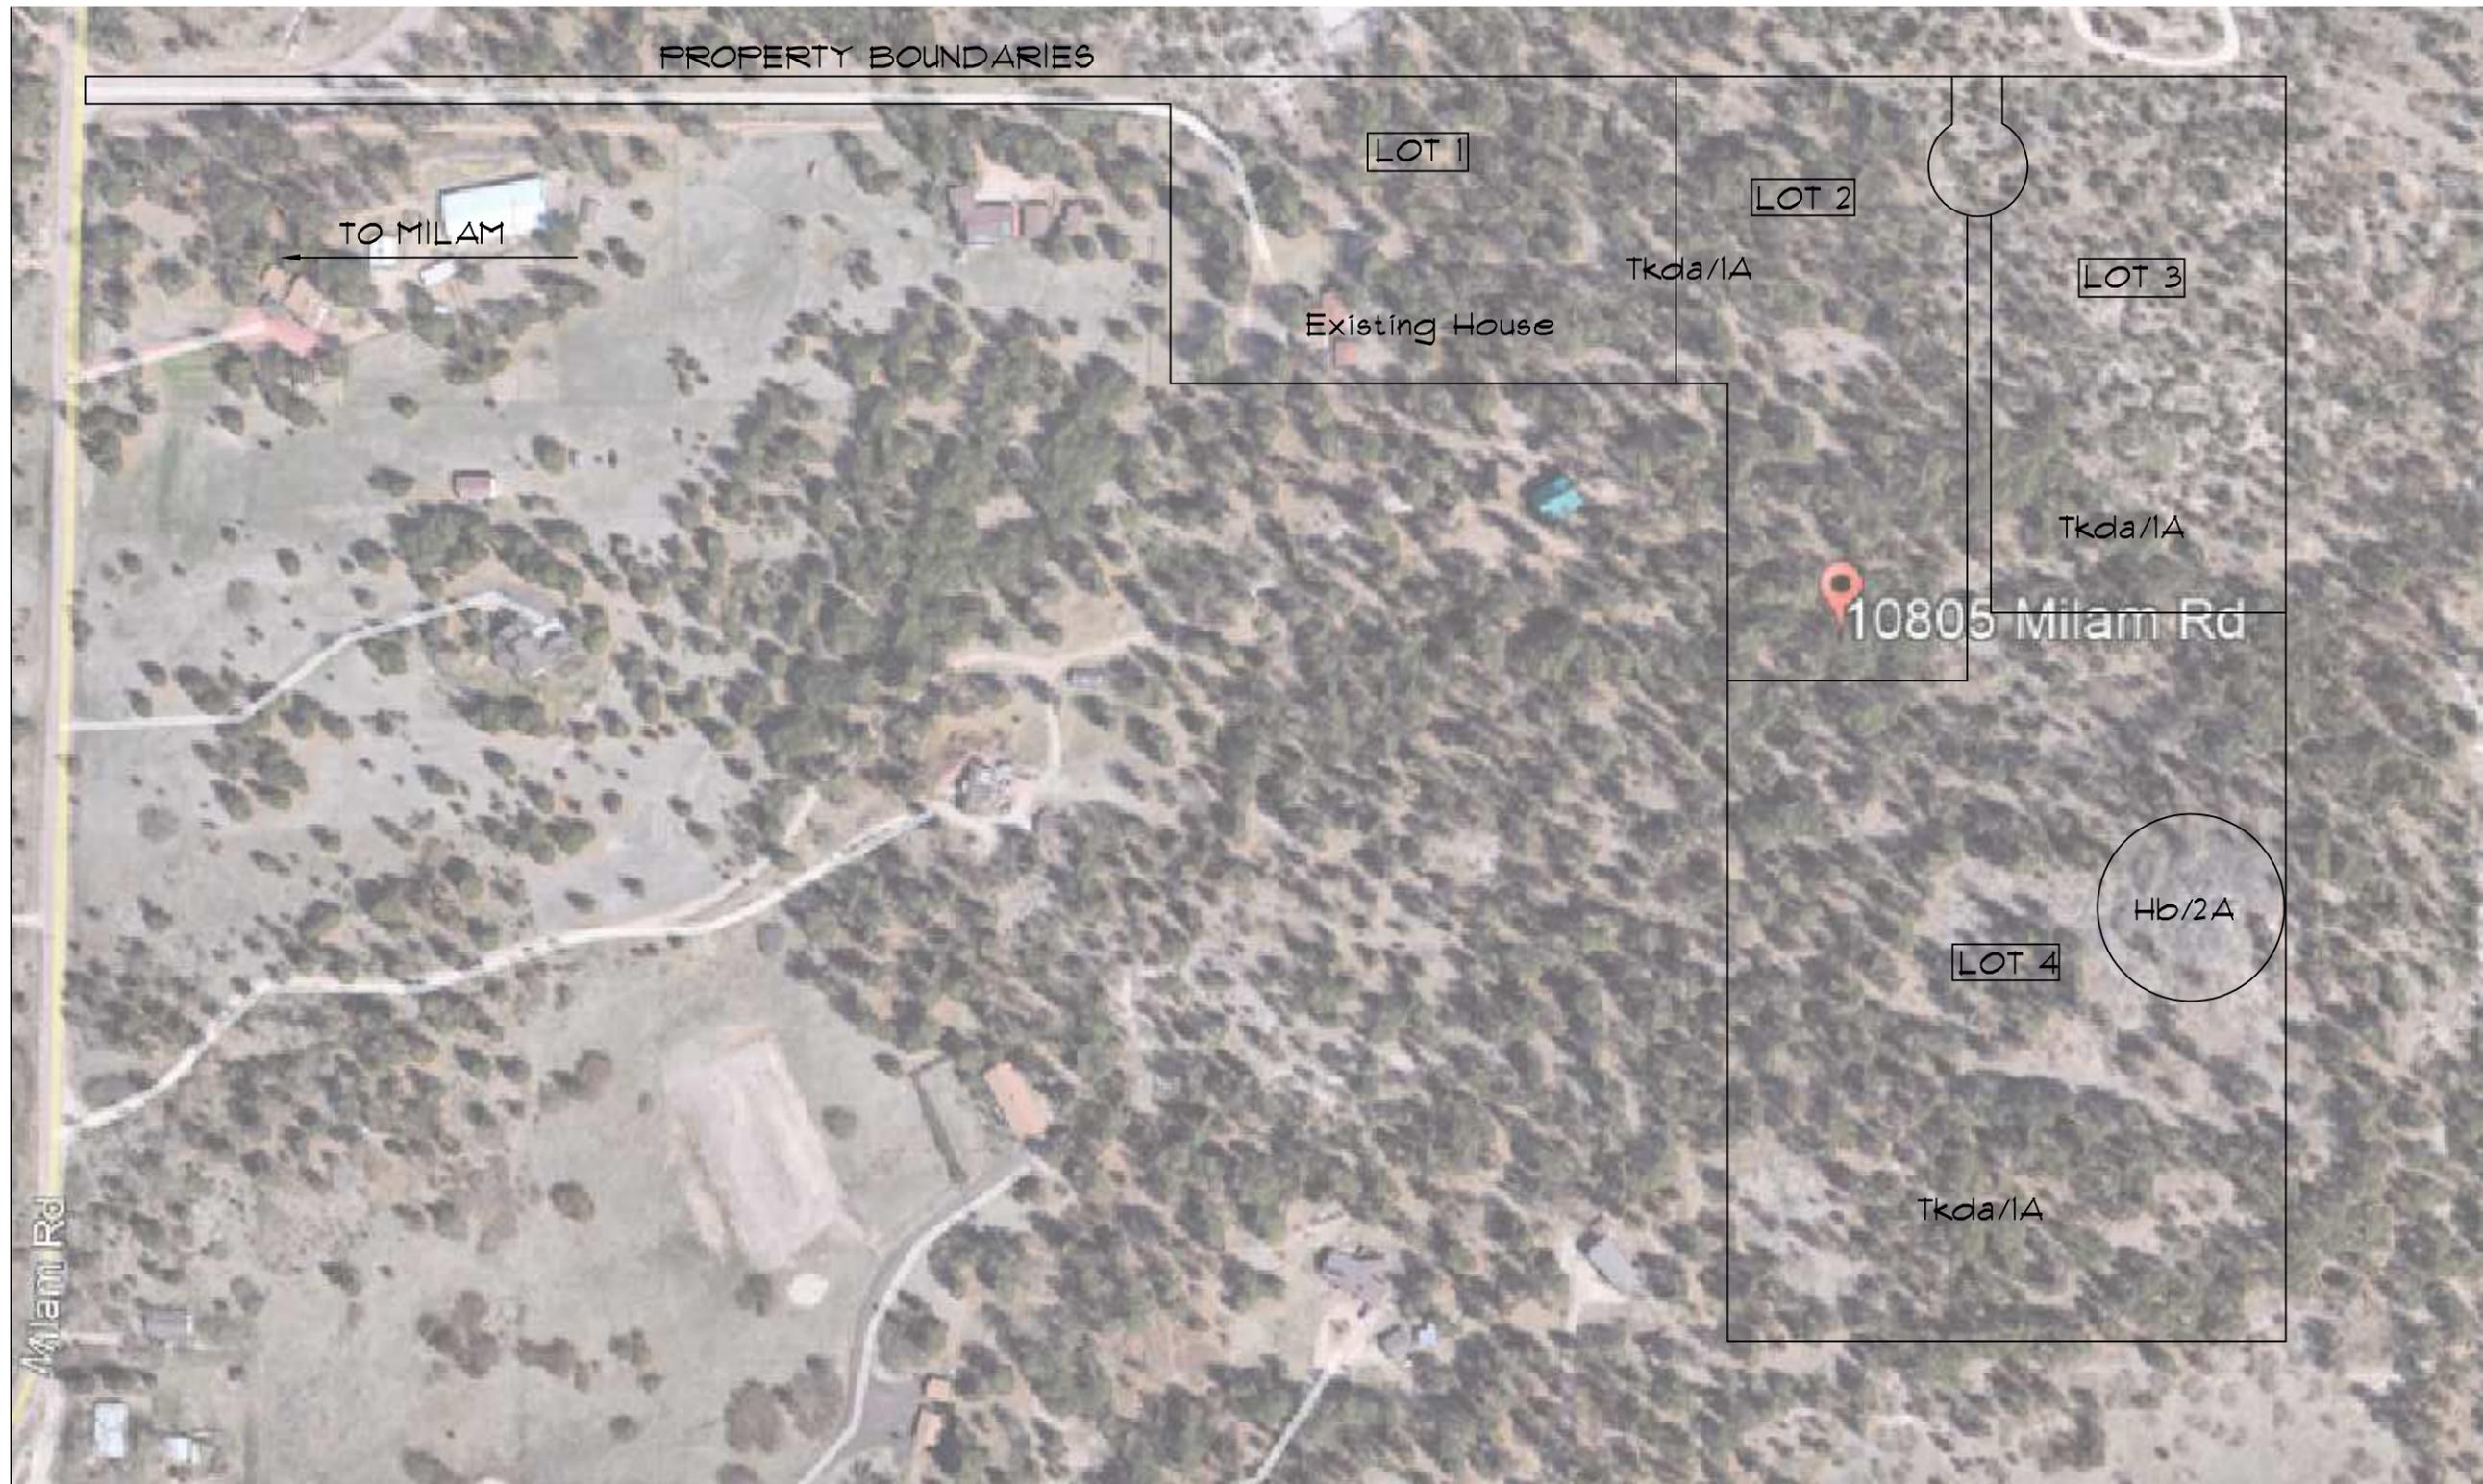
SHEET No.  
**FIG-6**

Geologic

- *TKda - Dawson Formation* - The Dawson Formation underlies the entire site. *Tkda* typically is light gray to tan and typically consists of arkose, arkosic conglomerate, sandstone and interbedded gray claystone seams. The residual soils overlying this formation were derived from the in-situ weathering of the bedrock materials on-site and typically weather to brown or reddish brown.
- *hb* - sandstone outcropping

ENGINEERING AND GEOLOGY MAP

The locations of Geoquest, LLC's test borings and RMG's test pits are presented on the Engineering and Geology Map, Figure 6.

Personnel of RMG performed a soil evaluation on December 9, 2020 that included one 5-foot deep test pit on each of Lots 2, 3, and 4, utilizing the visual and tactile method for evaluation of the site soils. The test pits were excavated in areas on each Lot that appeared most likely to be used for residential construction. Test pits were terminated at 5-foot depth due to a limiting layer of sandstone bedrock. Evidence of seasonally high groundwater was not observed in the test pits. The soils were evaluated to determine the soil types and structure. The approximate locations of the test pits are presented in the Engineering and Geology Map, Figure 6.

identified geologic conditions affecting the development are presented in the Engineering and Geology Map, Figure 6.

The sandstone with low to moderate clay content was encountered in all the test borings and test pits, based on the blow counts encountered at the time of Geoquest LLC's drilling and RMG's observation of Test Pit excavations, it is anticipated the bedrock can be dug with standard excavating equipment. The sandstone knoll with its steep slopes is depicted on the Engineering and Geology Map, Figure 6.

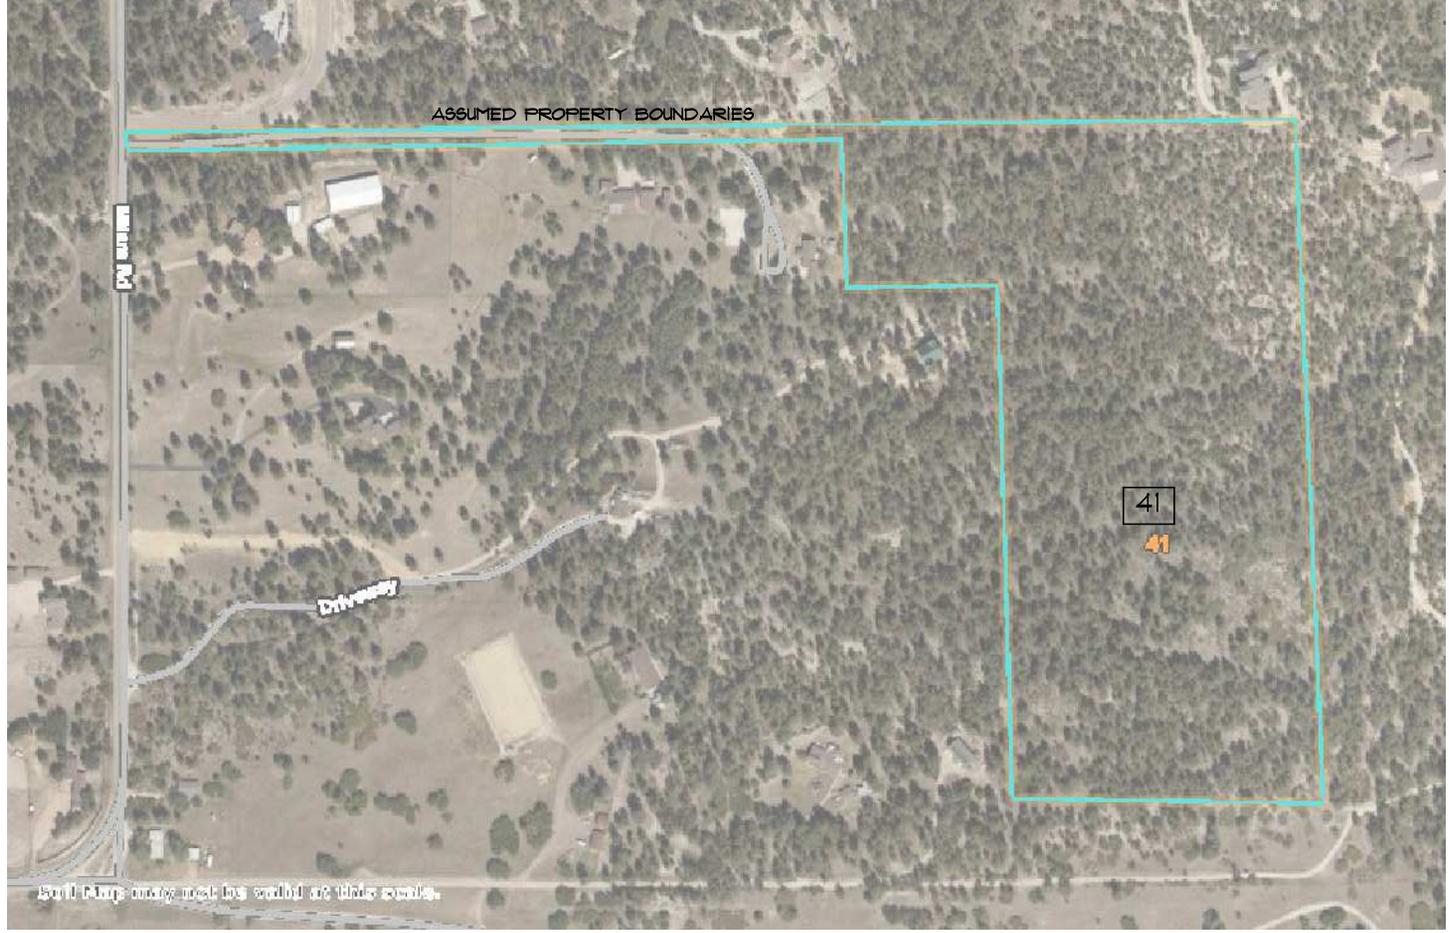
FIG No. 7

NOT TO SCALE  
 BASE MAP PROVIDED BY: USDA

41- KETTLE GRAVELLY SAND LOAM, 8 TO 40% SLOPES

The USDA Soil Survey Map is presented in Figure 7.

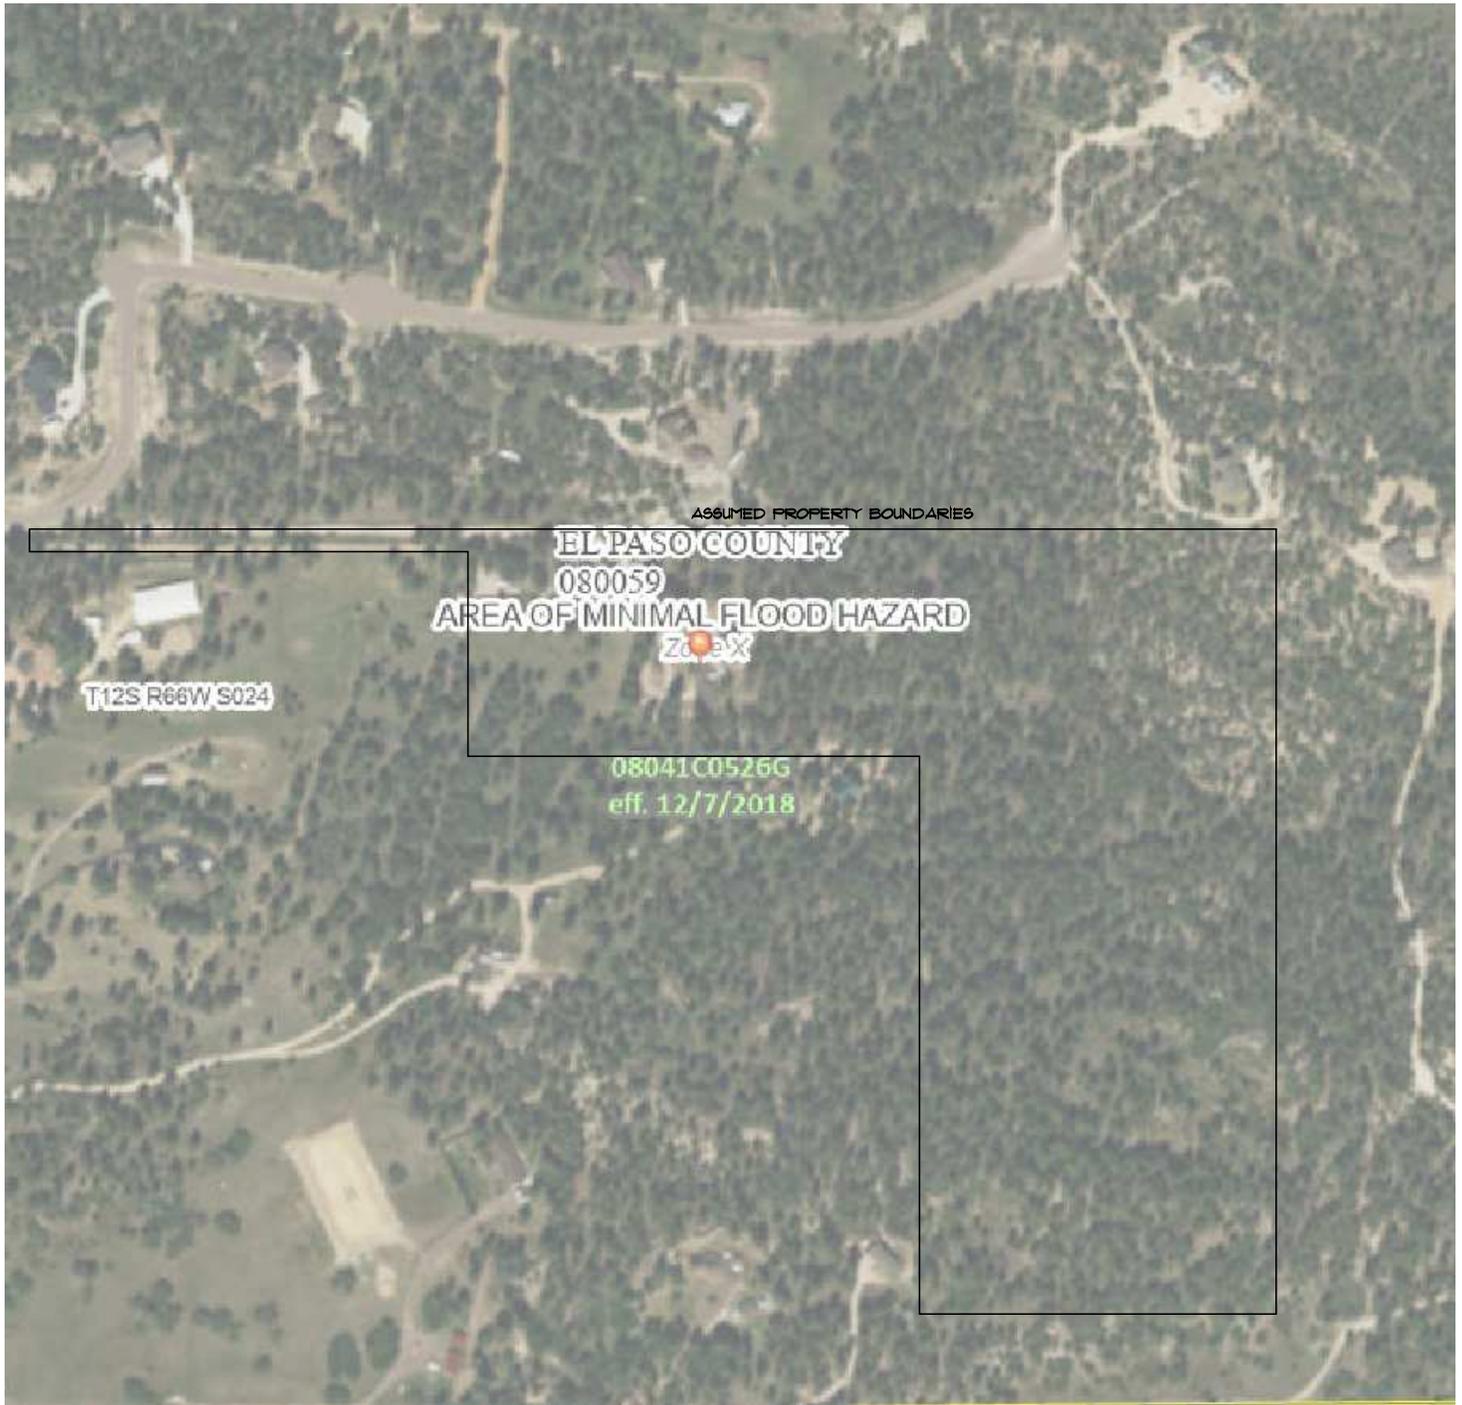
FIG No. 9

NOT TO SCALE  
 BASE MAP PROVIDED BY: CGS

Based on review of the Federal Emergency Management Agency (FEMA) Community Panel No. 08041C0526G, the online ArcGIS Pikes Peak Regional Floodplain Map, the entire site lies outside of mapped 100-year and 500-year floodplains. The FEMA Map is presented in Figure 9.

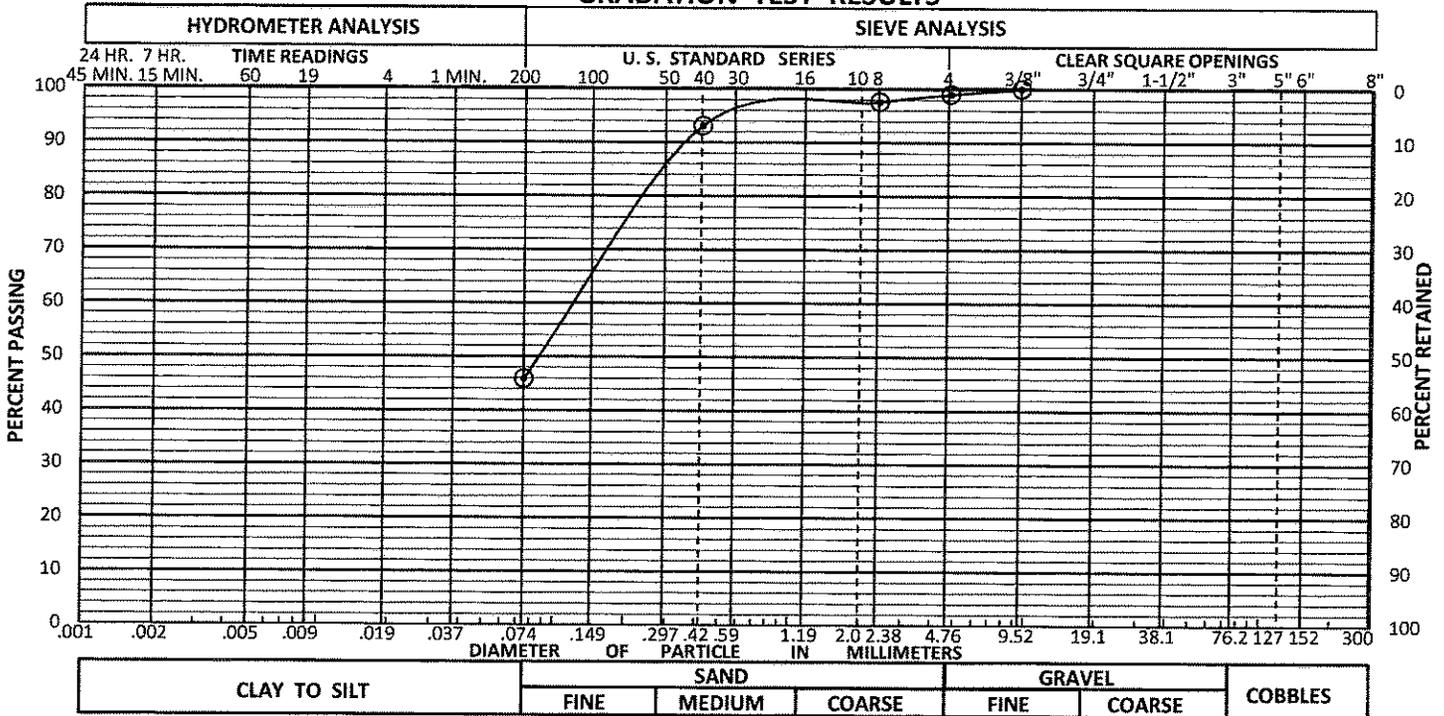
# GEOQUEST LLC GRADATION TEST RESULTS

CLAY TO SILT	SAND			GRAVEL		COBBLES
	FINE	MEDIUM	COARSE	FINE	COARSE	
<b>CLASSIFICATION</b> <u>SC</u>	<b>NOTES: 11.8 % Moisture Content</b>					
GRAVEL <u>1.0 %</u>	LL = <u>27.7</u>					
SAND <u>53.2 %</u>	PL = <u>19.8</u>					
FINES <u>45.8 %</u>	PI = <u>7.9</u>					
SAMPLE # <u>1</u> HOLE # <u>TH-1</u> DEPTH <u>12</u> FEET

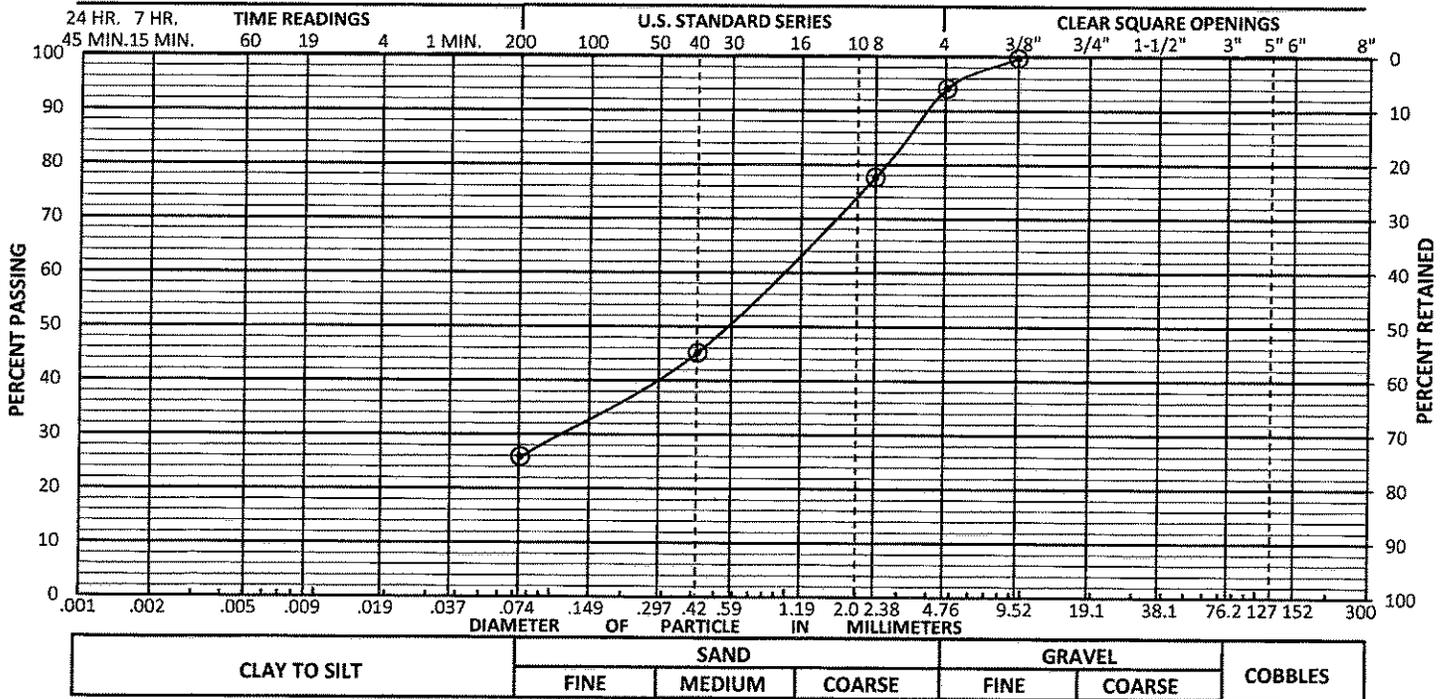
CLAY TO SILT	SAND			GRAVEL		COBBLES
	FINE	MEDIUM	COARSE	FINE	COARSE	
<b>CLASSIFICATION</b> <u>SM</u>	<b>NOTES: 4.9 % Moisture Content</b>					
GRAVEL <u>5.9 %</u>						
SAND <u>68.3 %</u>						
FINES <u>25.8 %</u>						
SAMPLE # <u>1</u> HOLE # <u>TH-2</u> DEPTH <u>4</u> FEET						
Job #: 17-0144 By: MJ 11/4/2020

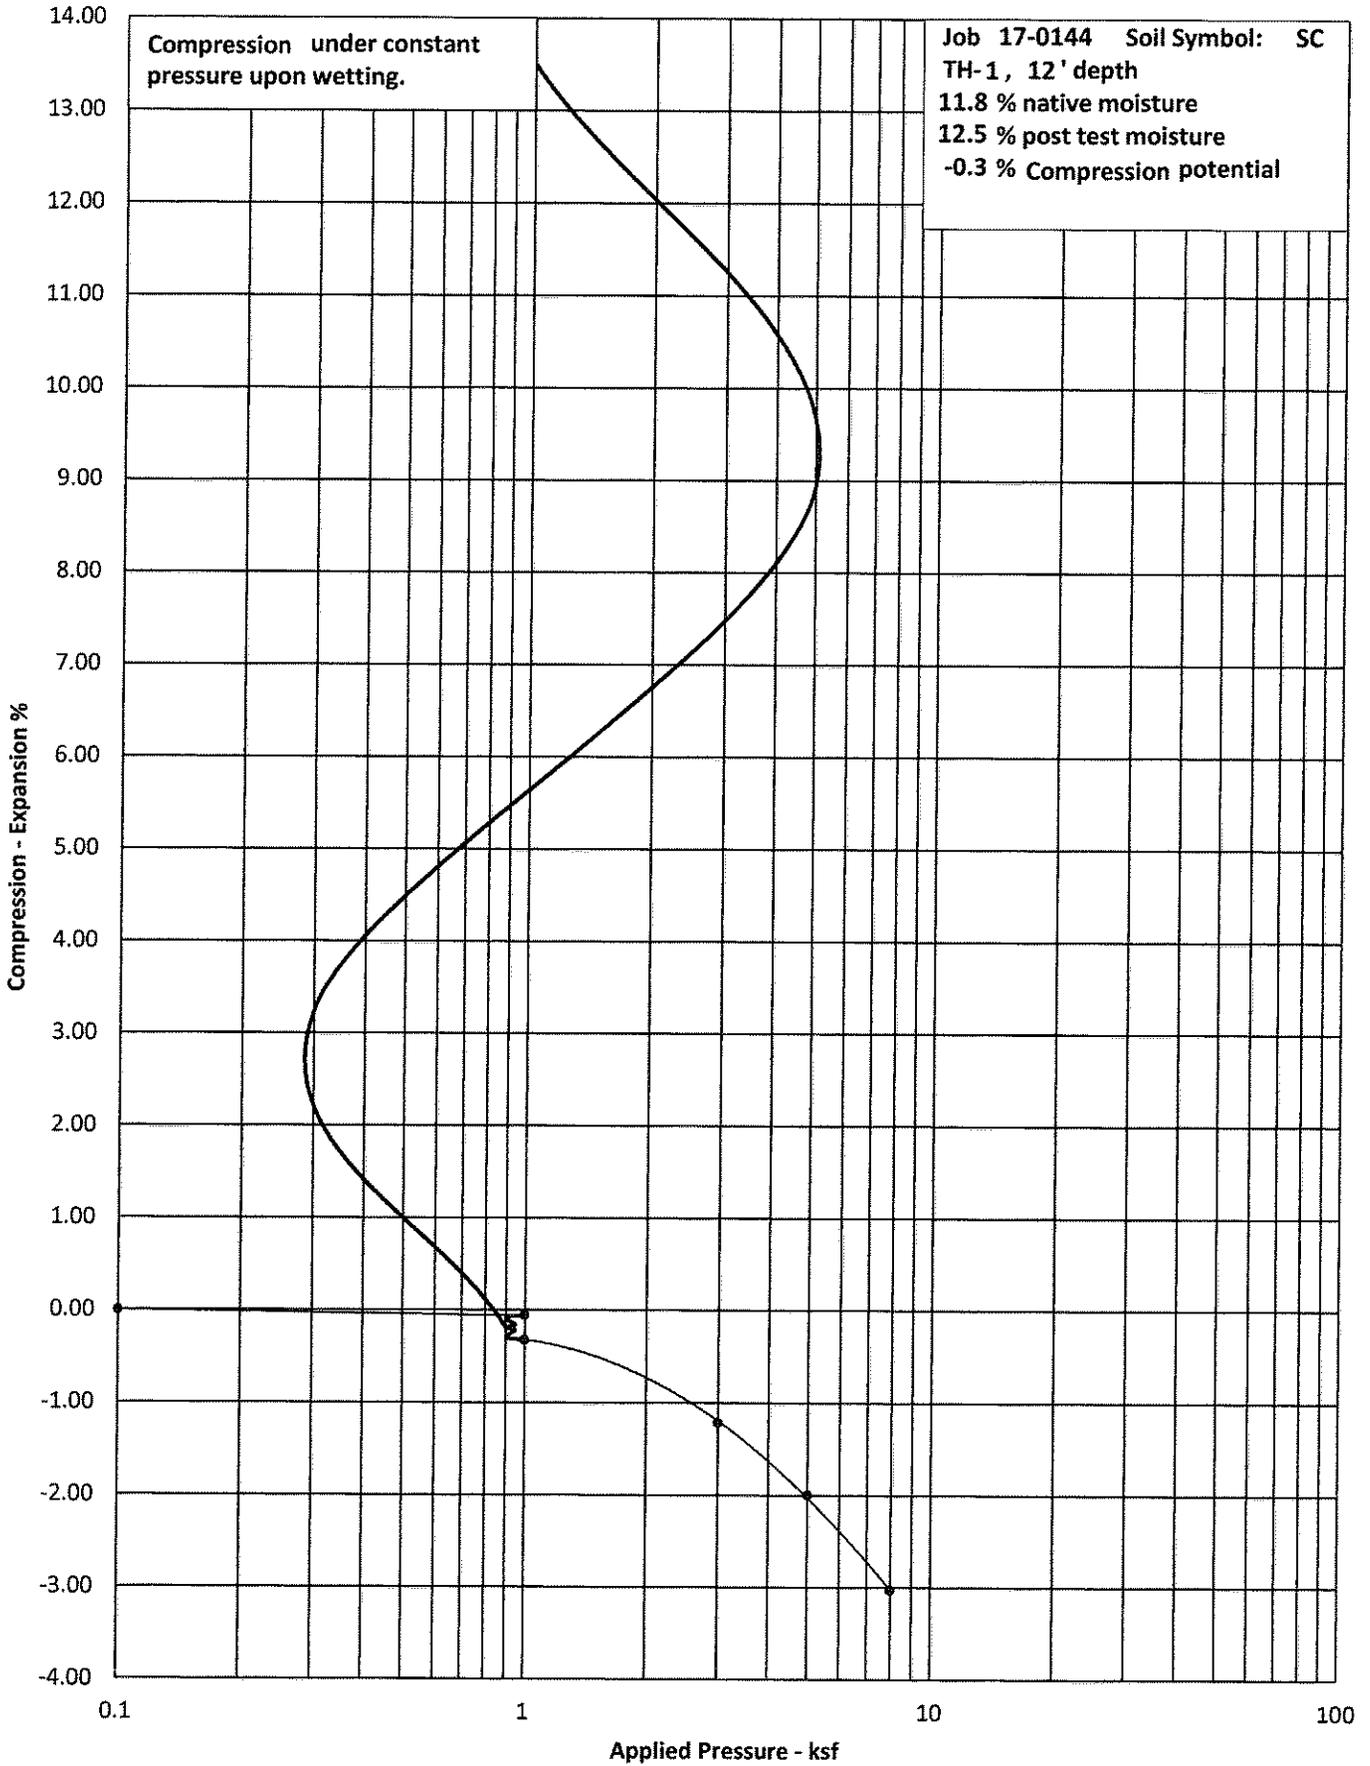
GEOQUEST LLC  
SWELL-CONSOLIDATION TEST RESULTS

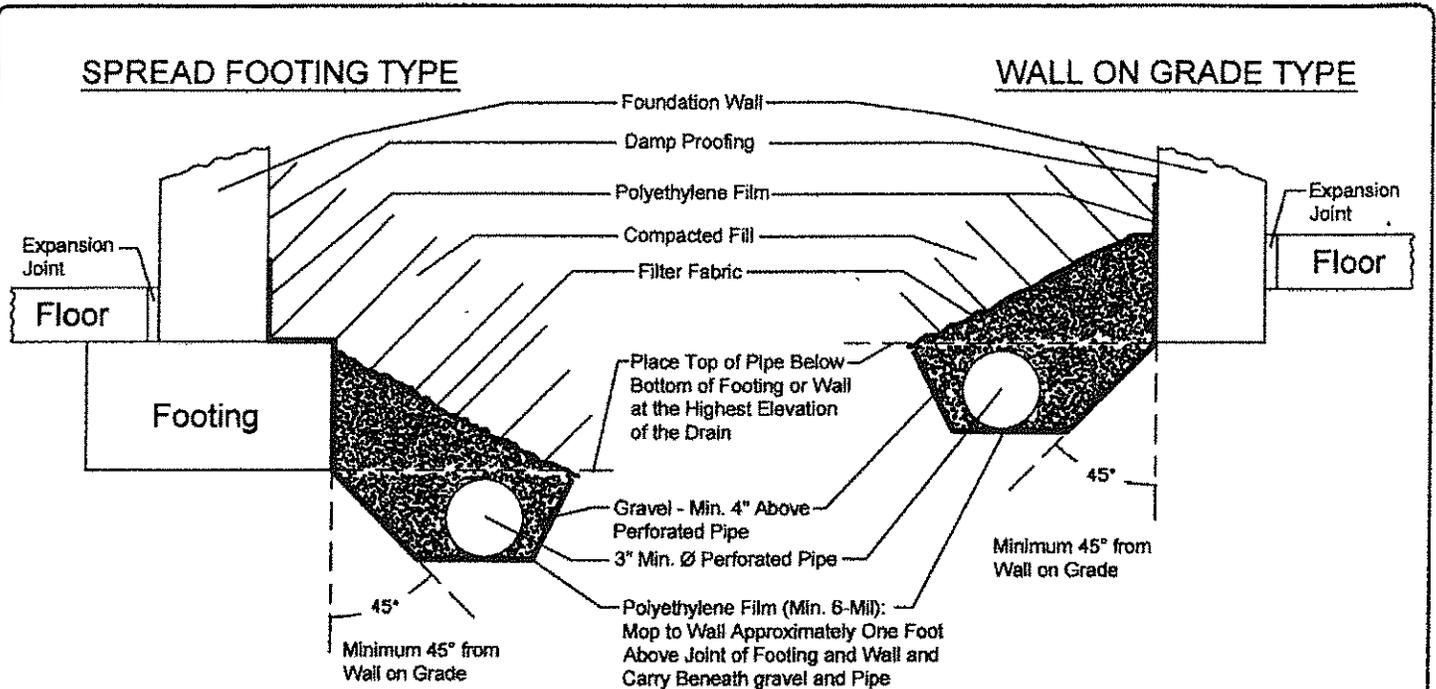
## EXTERIOR DRAIN DETAIL

1. Gravel to be Not More Than 1-1/2" and Not Less Than 1/2" Diameter.
2. Perforated Pipe Diameter Varies With Expected Seepage. 3"Ø and 4"Ø are Most Common. ABS and PVC are Most Common Materials for Pipe. We approve the use of an "EZ Flow Drainage System" by Infiltrator. All specifications in this drain detail are still applicable.

3. Pipe to be Laid out in a Minimum Slope of 1" in 10'.
4. Gravity Outfall is Desired if Possible. Portion of Pipe in Area Not Drained Shall be Non-Perforated. Daylight Must be Maintained Clear of Debris in Order to Function Properly.

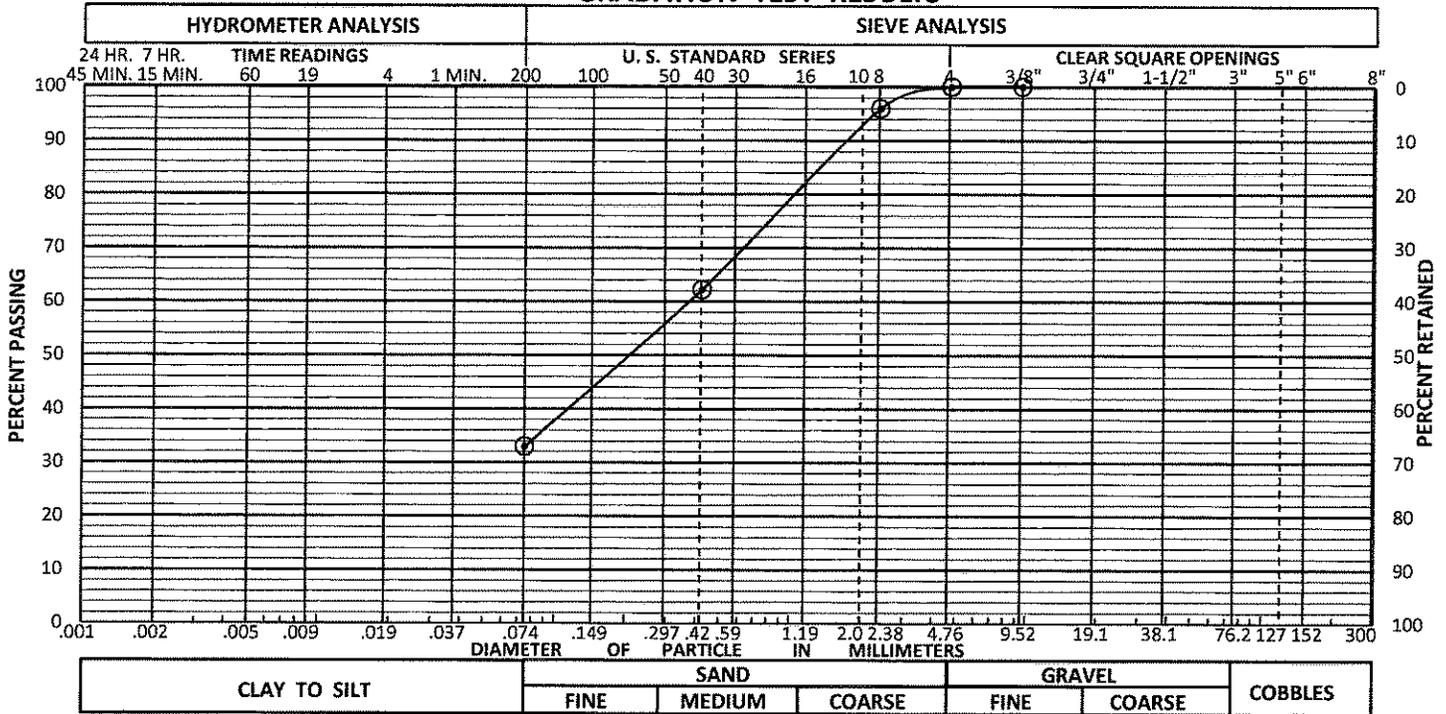
# GEOQUEST LLC GRADATION TEST RESULTS

CLASSIFICATION SC  
 GRAVEL 0.0 %  
 SAND 67.1 %  
 FINES 32.9 %

NOTES: 11.7 % Moisture Content

SAMPLE # 1 HOLE # TH-1 DEPTH 12 FEET

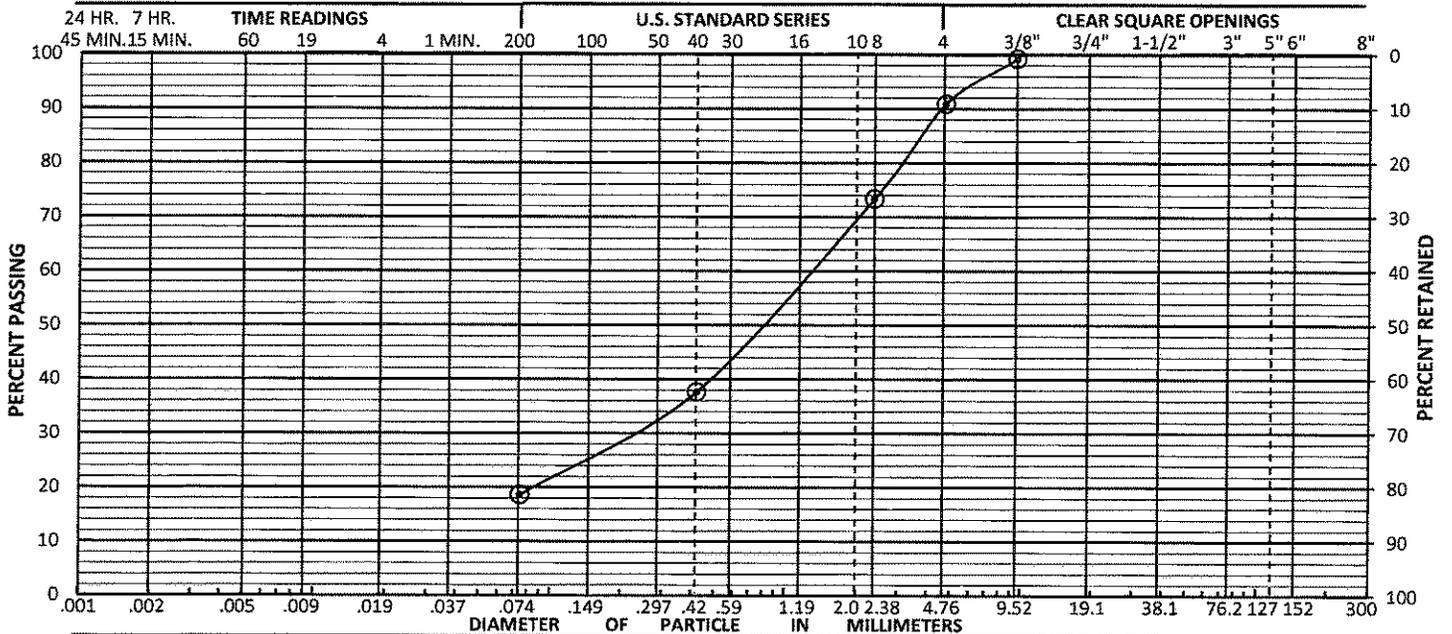
CLASSIFICATION SM  
 GRAVEL 9.2 %  
 SAND 72.2 %  
 FINES 18.6 %

NOTES: 3.1 % Moisture Content

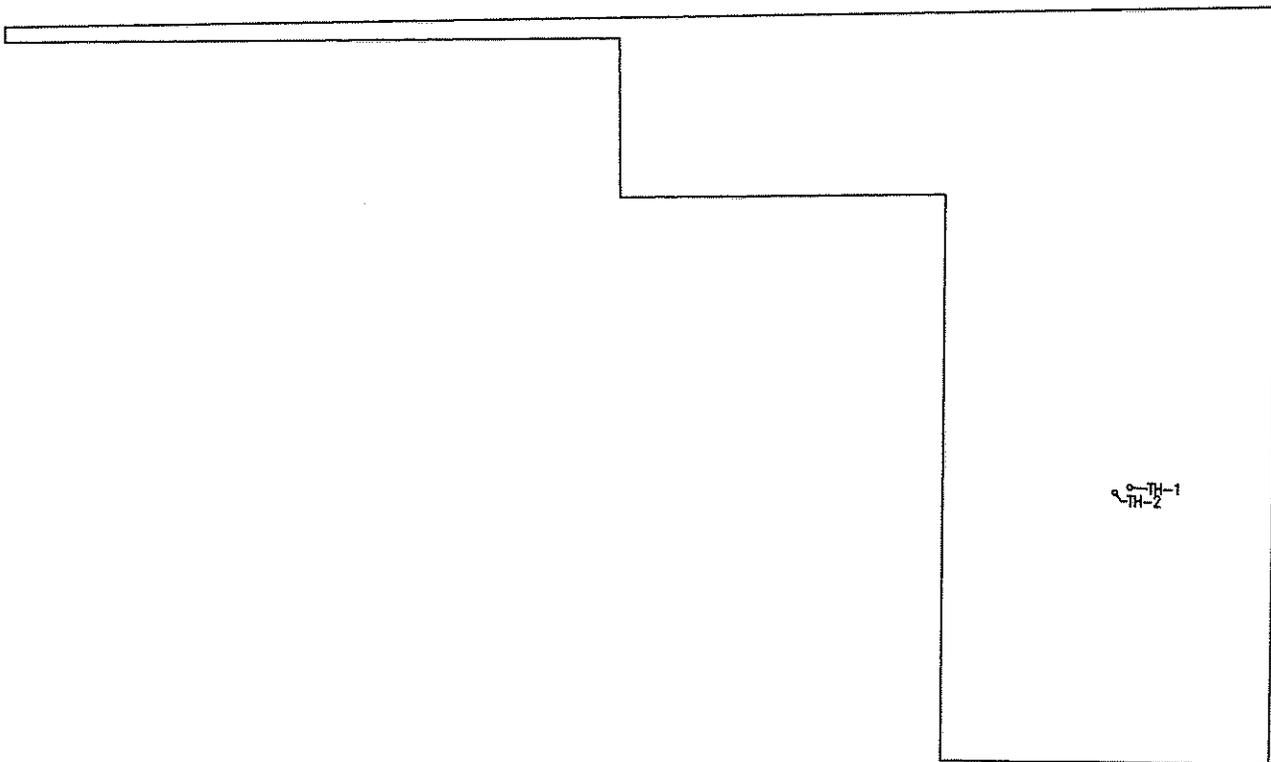
Lot 2  
10805 Milam Rd.  
El Paso County  
Colorado  
Job #20-1216

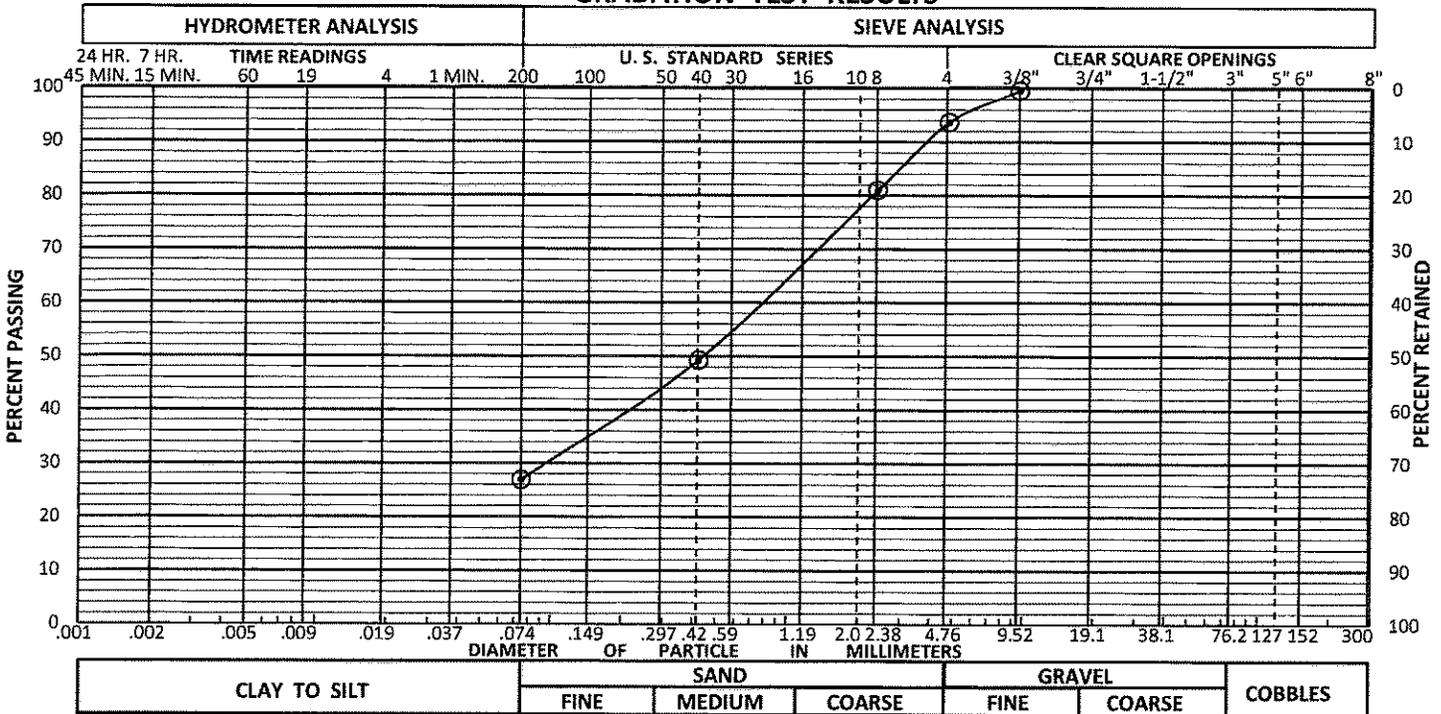
# GEOQUEST LLC GRADATION TEST RESULTS

CLASSIFICATION SM  
 GRAVEL 6.4 %  
 SAND 66.7 %  
 FINES 26.9 %

NOTES: 5.6 % Moisture Content

SAMPLE # 1 HOLE # TH-1 DEPTH 3 FEET

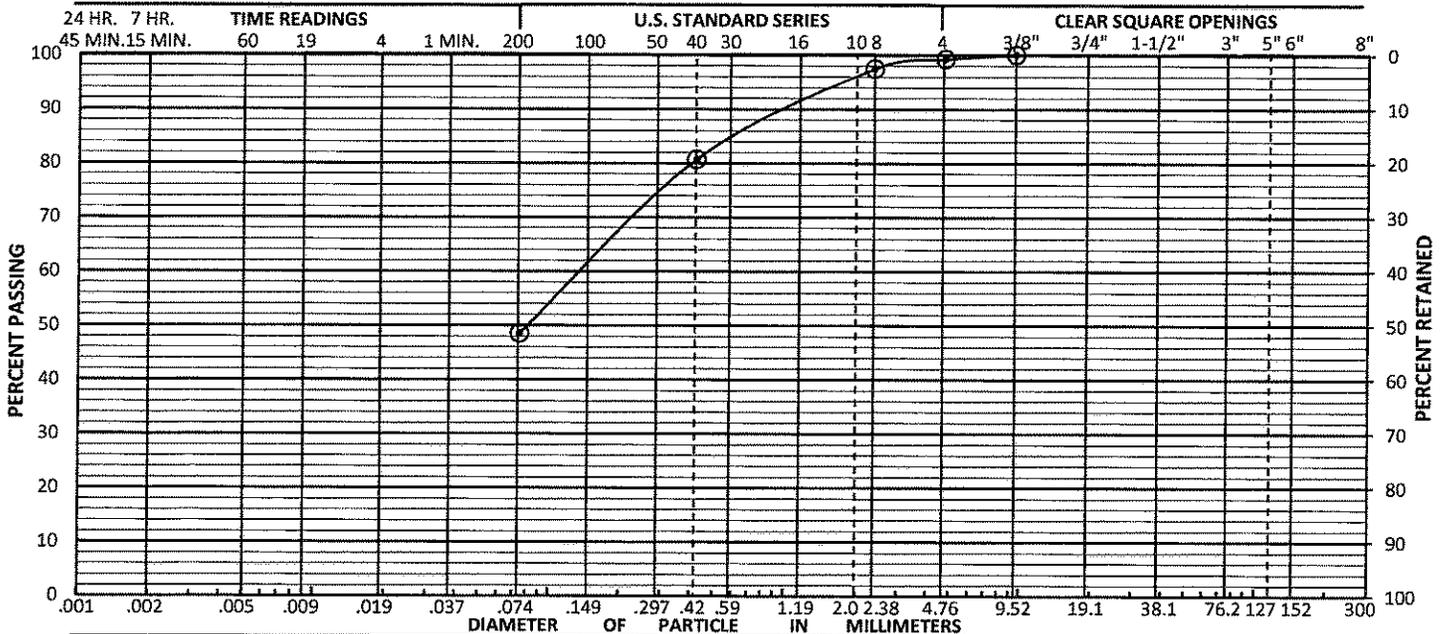
CLASSIFICATION SC  
 GRAVEL 0.8 %  
 SAND 50.7 %  
 FINES 48.5 %

NOTES: 10.3 % Moisture Content
