## **SOILS AND GEOLOGY STUDY**

**10805 Milan Road  
EPC Schedule No. 6224000011  
El Paso County, Colorado**

**JOB NO. 180317**

**February 4, 2021**

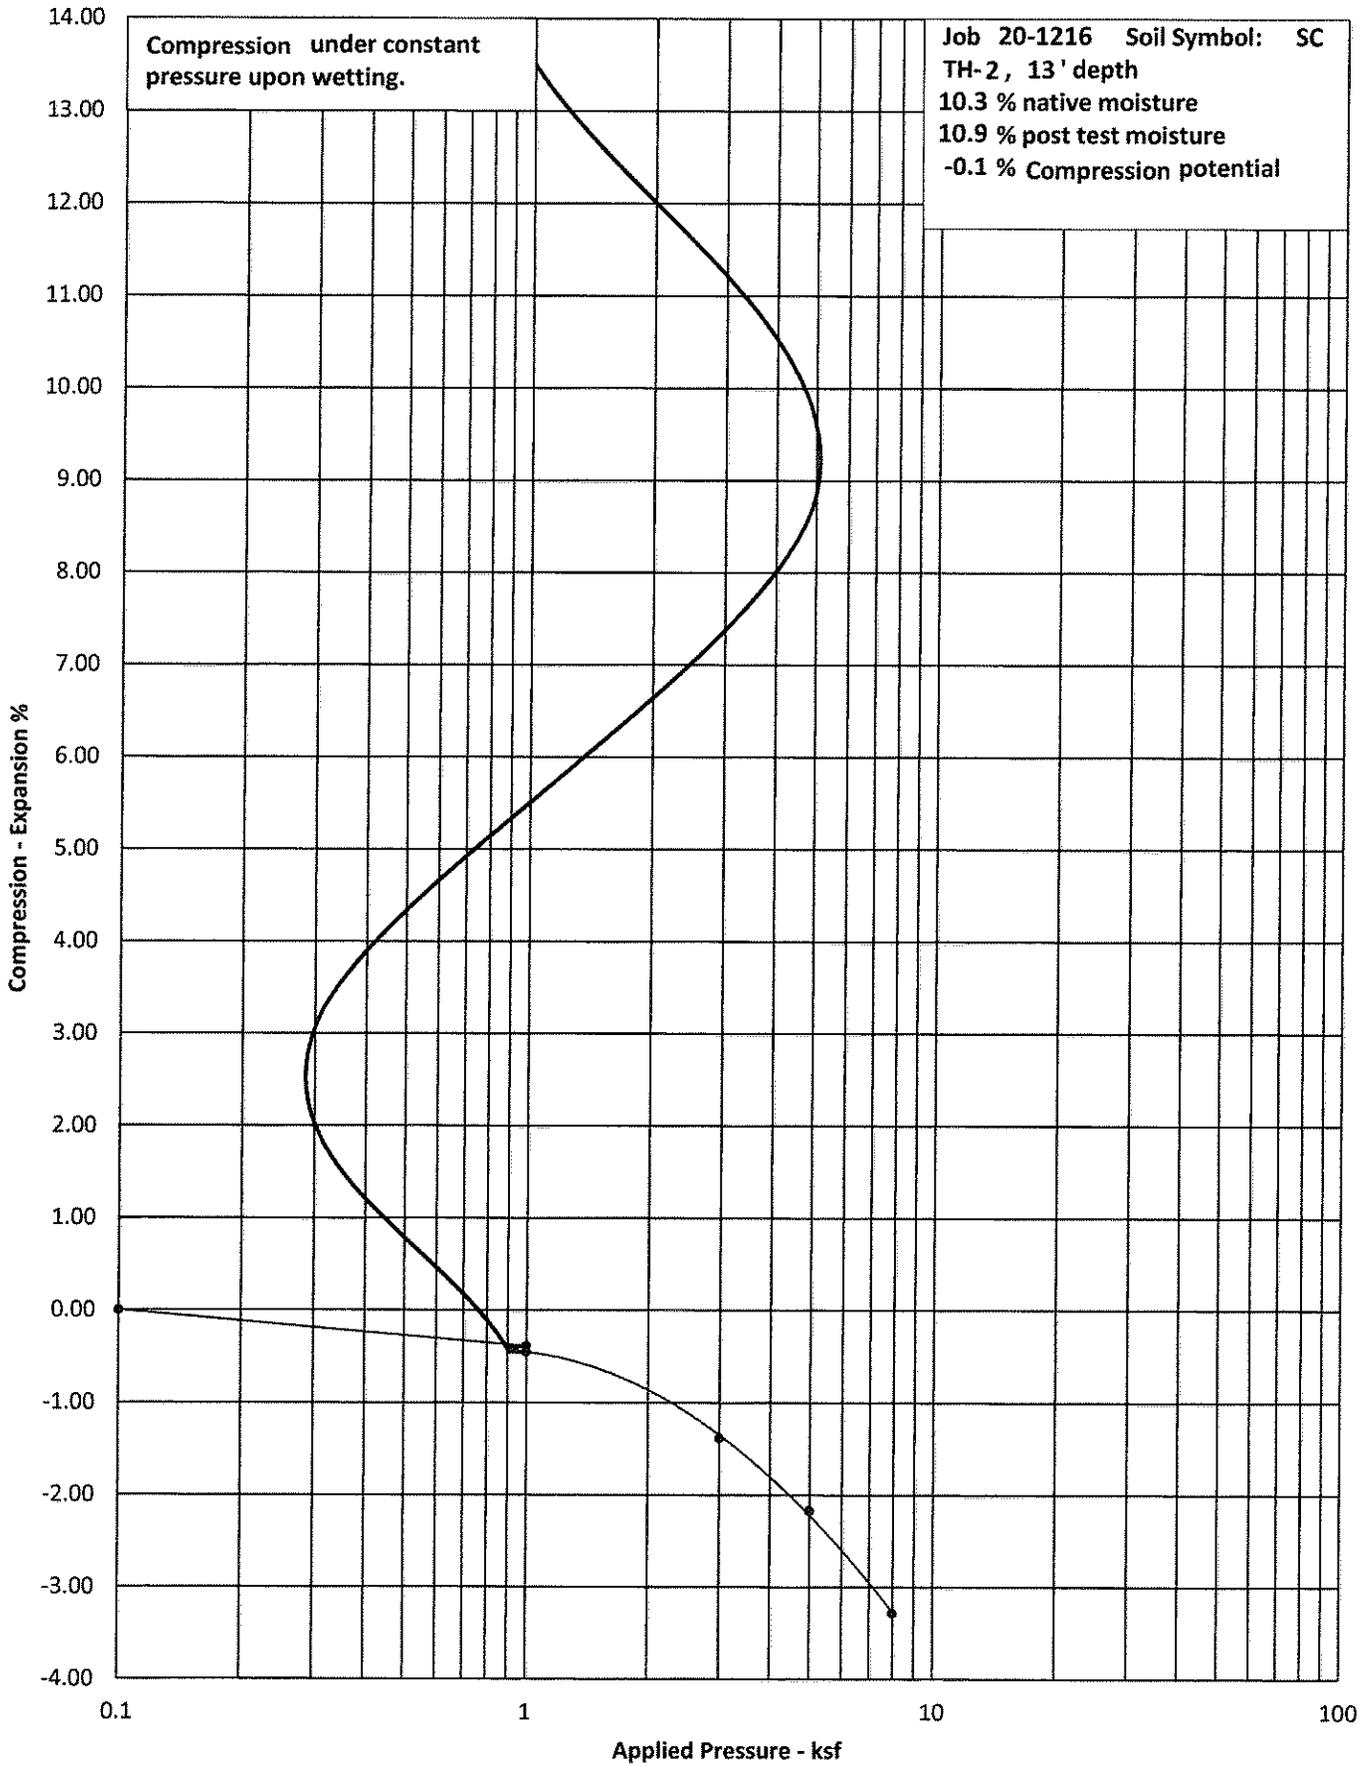
GEOQUEST LLC  
SWELL-CONSOLIDATION TEST RESULTS

Job 20-1216 Soil Symbol: SC  
TH-2, 13' depth  
10.3 % native moisture  
10.9 % post test moisture  
-0.1 % Compression potential

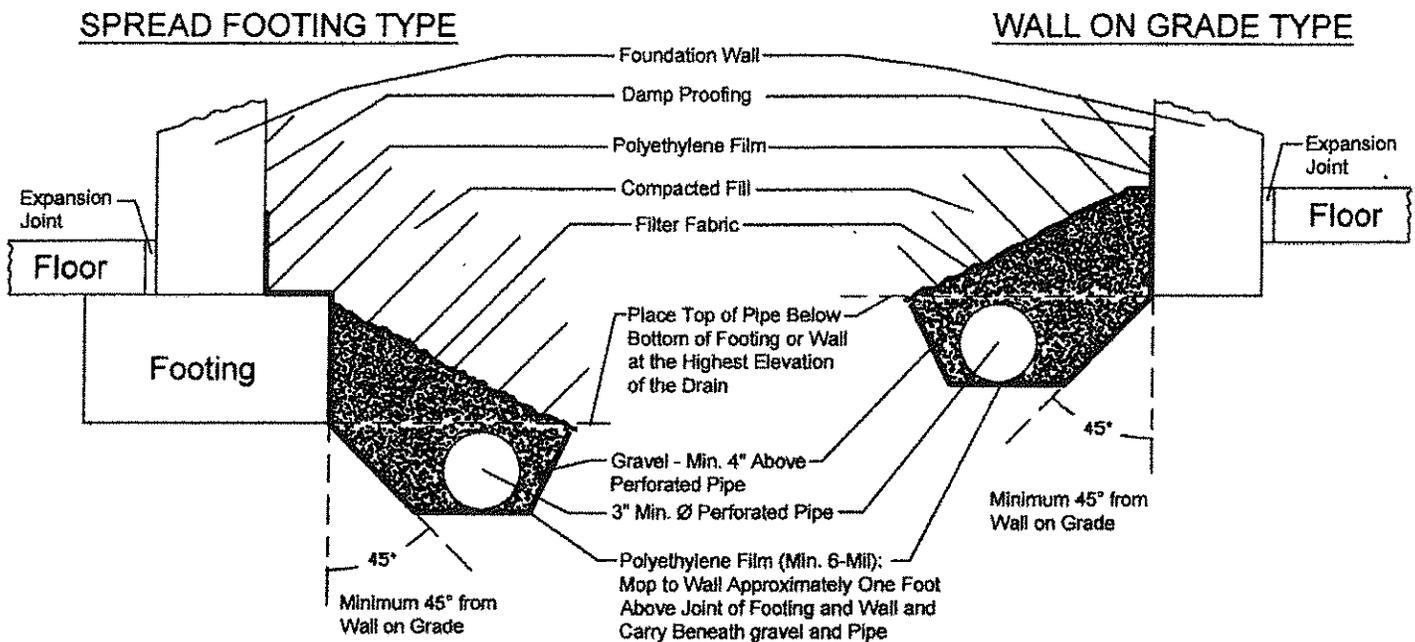
## EXTERIOR DRAIN DETAIL

1. Gravel to be Not More Than 1-1/2" and Not Less Than 1/2" Diameter.
2. Perforated Pipe Diameter Varies With Expected Seepage. 3"Ø and 4"Ø are Most Common. ABS and PVC are Most Common Materials for Pipe. We approve the use of an "EZ Flow Drainage System" by Infiltrator. All specifications in this drain detail are still applicable.

3. Pipe to be Laid out in a Minimum Slope of 1" in 10'.
4. Gravity Outfall is Desired if Possible. Portion of Pipe in Area Not Drained Shall be Non-Perforated. Daylight Must be Maintained Clear of Debris in Order to Function Properly.
