## PAVEMENT DESIGN REPORT

**Copper Chase at Sterling Ranch, Filing No. 1  
Phase 2  
El Paso County, Colorado**

**JOB NO. 193596-2**

**June 4, 2024**

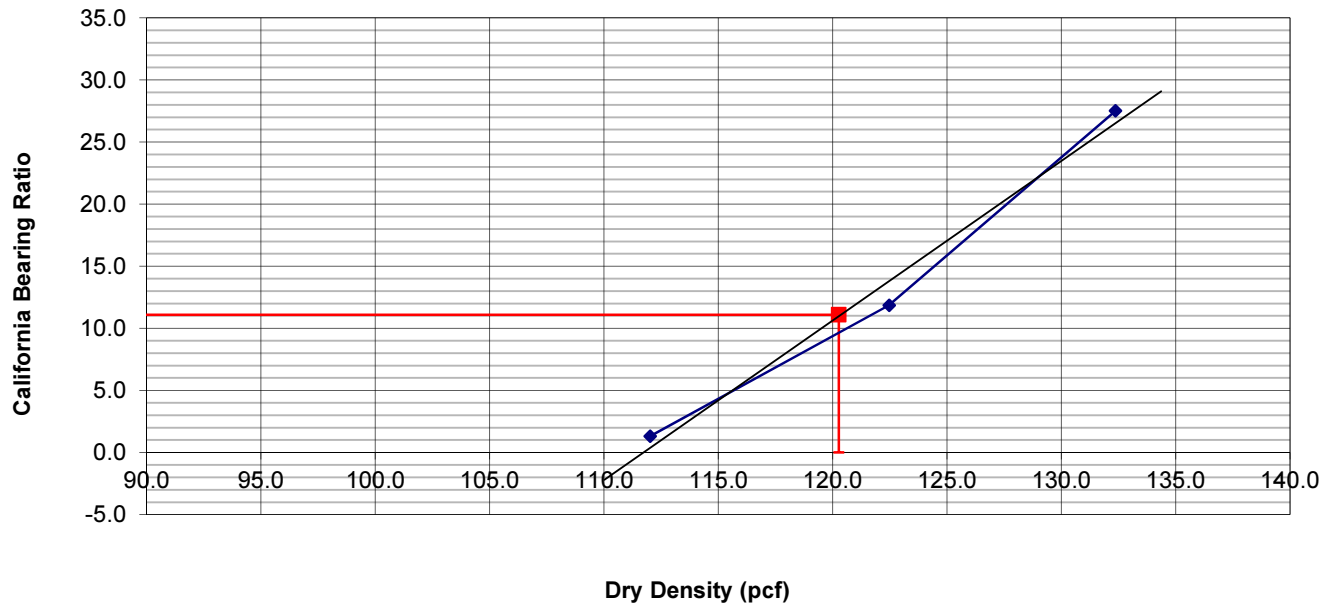
Project: Copper Chase at Sterling Ranch, Filing No. 1, Phase II  
 Job No.: 193596  
 AASHTO Classification" A-7-6  
 Sample Number: CBR  
 Sample Location: Combined Bulk Sample  
 Soil Description: Clayey Sand

10 blows/lift	25 blows/lift	56 blows/lift
Corrected California Bearing Ratio	1.3	11.9	27.5
Dry Density (pcf)	112.0	122.5	132.4
Percent Compaction	88	97	105
Percent Moisture After Soaking	13.0	10.7	10.4
Percent Expansion (+) / Compression (-)	0.0%	0.1%	0.2%
Surcharge Weight (lbs)	12.60	12.60	12.60

<b>California Bearing Ratio</b>	<b>11.1</b>
Dry Density (pcf)	126.6
Percent Compaction	95%
Target Dry Density	120.3
Compaction Test Method	ASTM D-1557
Condition of sample	Soaked

A combined bulk sample of A-6 soil was tested to determine the optimum moisture-density relationship in accordance with ASTM D-698 (Standard Proctor compaction test). California Bearing Ratio, CBR tests were performed at varying densities with moisture content near optimum. At 95% of the maximum Standard Proctor density, the CBR of the bulk sample was 1.24. The Moisture-Density Relation Curve is presented in Figure 12. The CBR Test Results are presented in Figures 13 and 14.
