PAVEMENT DESIGN REPORT

**Copper Chase at Sterling Ranch, Filing No. 1
Phase 2
El Paso County, Colorado**

JOB NO. 193596-2

June 4, 2024

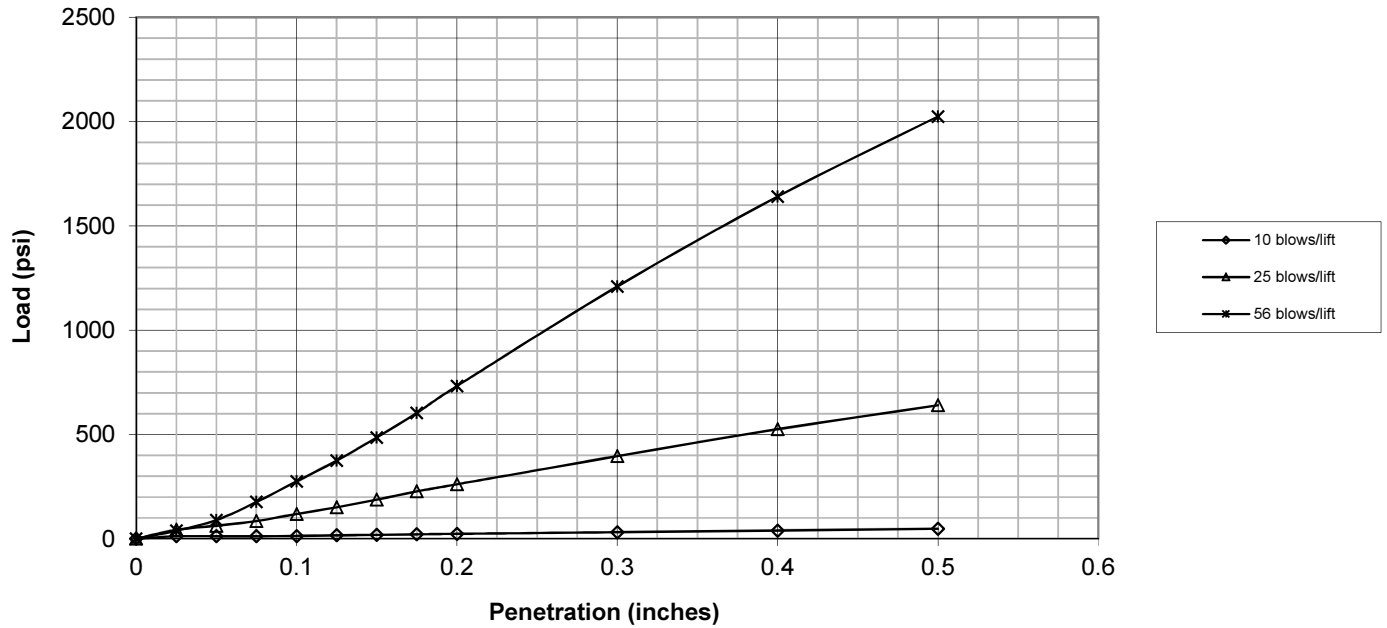
Project: Copper Chase at Sterling Ranch, Filing No. 1, Phase II
 Job No.: 193596
 AASHTO Classification: A-7-6
 Sample Number: CBR
 Sample Location: Combined Bulk Sample
 Soil Description: Clayey Sand

10 blows/lift	25 blows/lift	56 blows/lift
Penetration (in)	Load (psi)	Load (psi)	Load (psi)
0.000	0.0	0.0	0.0
0.025	11.8	42.3	38.3
0.050	11.8	62.1	89.7
0.075	11.8	85.0	176.0
0.100	13.1	118.6	275.1
0.125	16.5	150.8	374.2
0.150	18.5	187.5	485.4
0.175	21.2	227.1	603.3
0.200	23.5	261.0	732.0
0.300	31.2	395.7	1209.4
0.400	39.0	525.4	1641.0
0.500	47.4	640.0	2024.7

Corrected Penetration (in)	Corrected Load (psi)
10 blows/lift	0.100	1.3
25 blows/lift	0.100	11.9
56 blows/lift	0.100	27.5

A combined bulk sample of A-6 soil was tested to determine the optimum moisture-density relationship in accordance with ASTM D-698 (Standard Proctor compaction test). California Bearing Ratio, CBR tests were performed at varying densities with moisture content near optimum. At 95% of the maximum Standard Proctor density, the CBR of the bulk sample was 1.24. The Moisture-Density Relation Curve is presented in Figure 12. The CBR Test Results are presented in Figures 13 and 14.

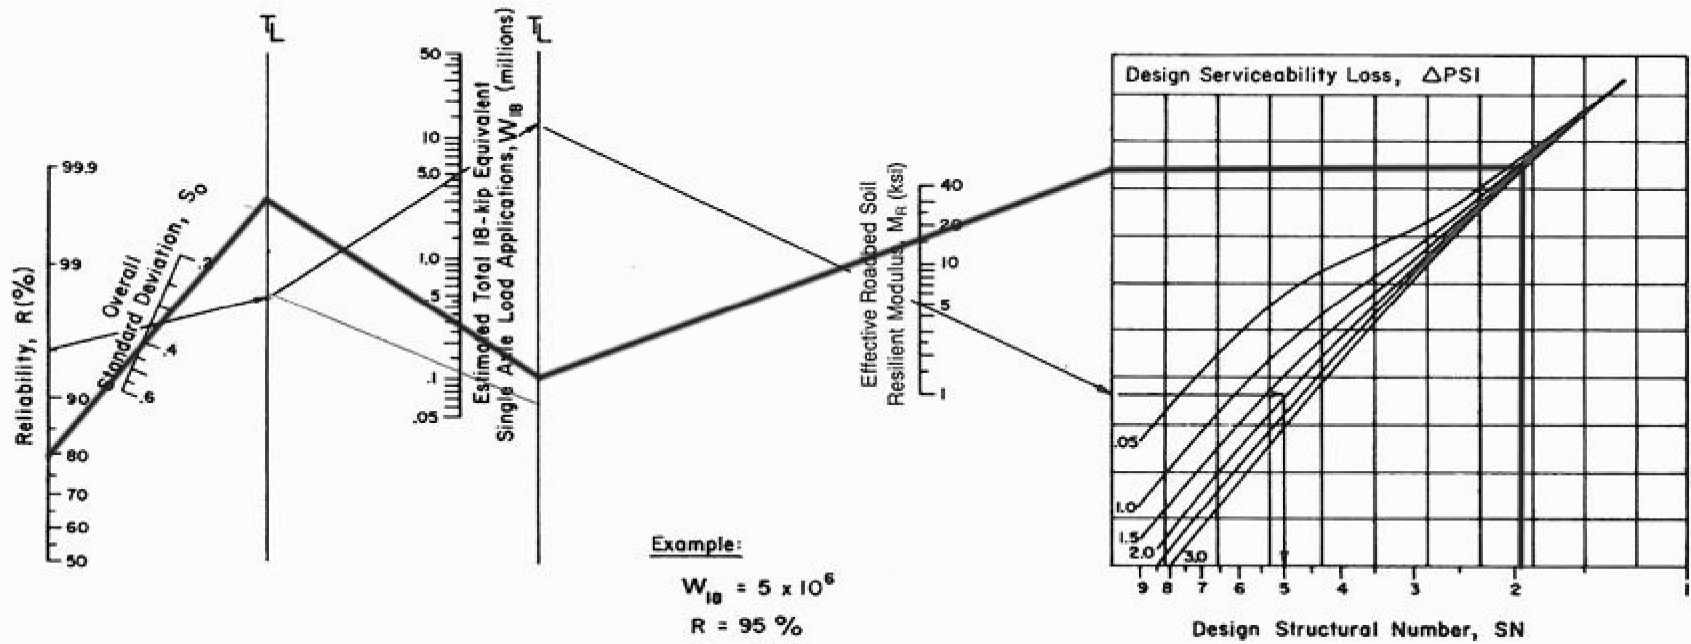
NOMOGRAPH SOLVES:

$$\log_{10} W_{18} = z_R * S_o + 9.36 * \log_{10}(SN+1) - 0.20 + \frac{\log_{10} \left[\frac{\Delta PSI}{4.2 - 1.5} \right]}{0.40 + \frac{1094}{(SN+1)^{5.19}}} + 2.32 * \log_{10} M_R - 8.07$$

Example:

$W_{18} = 5 \times 10^6$

1993 AASHTO Empirical Equation for Flexible Pavements
