PAVEMENT DESIGN REPORT

Copper Chase at Sterling Ranch, Filing No. 1 Phase 1 El Paso County, Colorado

JOB NO. 193596

February 26, 2024

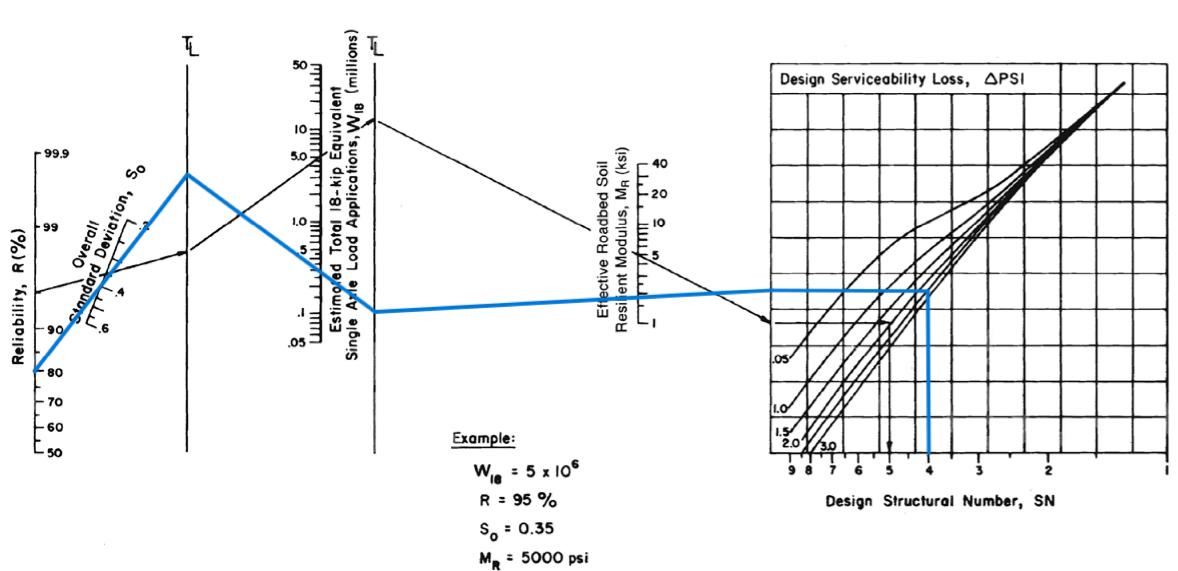
NOMOGRAPH SOLVES: $\log_{10} \frac{\Delta \text{ PSI}}{4.2 - 1.5} + 2.32 \log_{10} M_R - 8.07$ $\log_{10} 18 = Z_R * S_0 + 9.36 \log_{10} (\text{SN+1}) - 0.20 + \frac{\log_{10} A_R}{(\text{SN+1})^{5.19}} + 2.32 \log_{10} M_R - 8.07$

ΔPSI = 1.9

Solution: SN = 5.0

Urban Local Roads Nomograph
