PAVEMENT DESIGN REPORT

**Copper Chase at Sterling Ranch, Filing No. 1
Phase 2
El Paso County, Colorado**

JOB NO. 193596-2

**June 4, 2024
Revised: July 9, 2024**

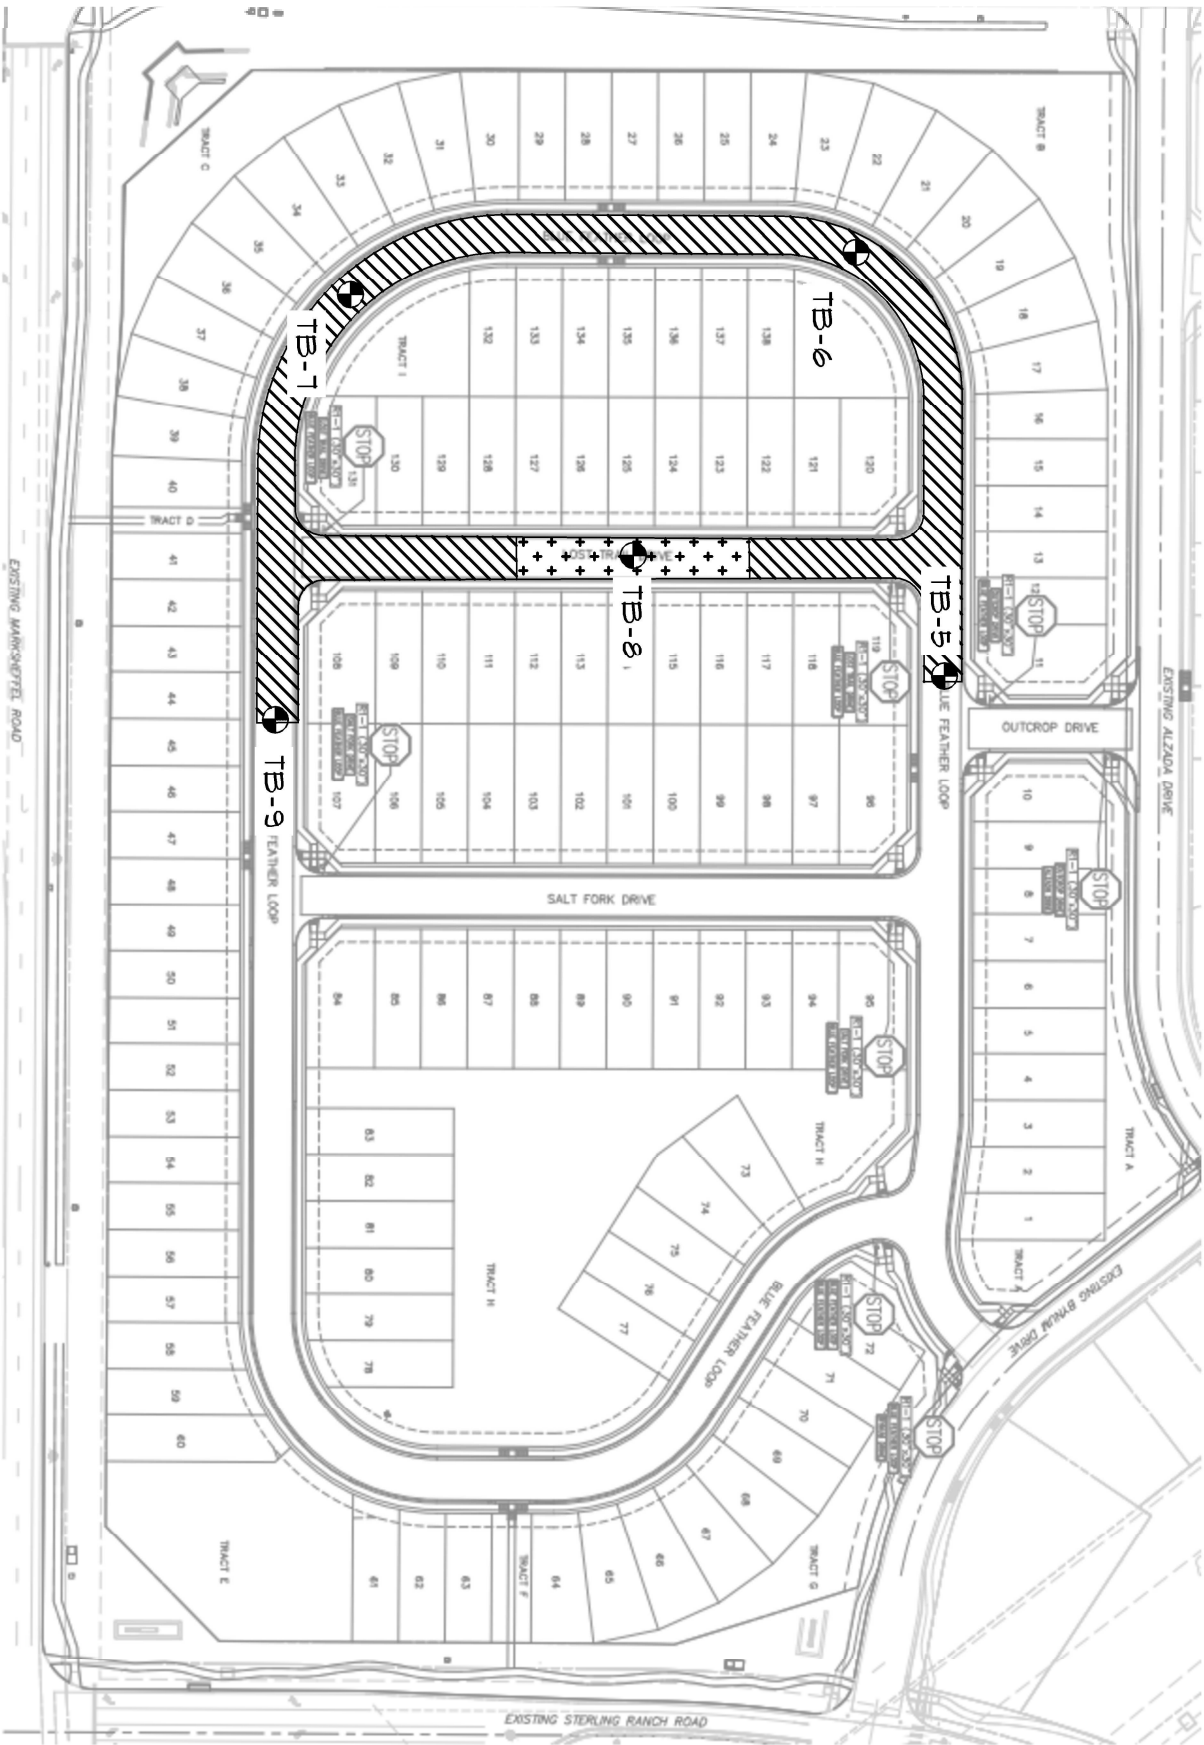
SHEET No.
FIG-2.1

TEST BORING
LAYOUT PLAN

INDICATES AREAS INCLUDED IN THIS REPORT
WHERE SOIL MITIGATIONS ARE NOT ANTICIPATED.

INDICATES AREAS INCLUDED IN THIS
REPORT WHERE OVEREXCAVATION AND
REPLACEMENT OF CLAYSTONE IS
ANTICIPATED.

DENOTES LOTS WHERE TEST
BORINGS WERE PERFORMED

The subsurface conditions on the site were investigated by drilling five exploratory test borings. The approximate locations of the test borings are presented in the Test Boring Location Plan, Figure 2.1.

The PDCM notes that mitigation measures may be required for expansive soils, shallow ground water, subgrade instability, etc. Based on the AASHTO classification for the soils in this subdivision, the claystone subgrade soils evaluated for this pavement design can be expected to be expansive and need to be removed and replaced. Groundwater or wet and unstable soils were not encountered in the borings. Therefore, special mitigation will be necessary for selected portion of roadway, consisting of the removal and replacement of claystone bedrock within 24 inches of structural fill as indicated below and on Figure 2.1.

Claystone with swell potential above 2.0 percent are prone to heaving upon wetting. We recommend that claystone within pavement boundaries in the vicinity of TB-8 (as shown on Figure 2.1) be removed to a depth of at least 24 inches below the bottom of the ABC layer and disposed of. The exposed soil should be proofrolled with a heavy pneumatic-tired vehicle to a firm and unyielding condition. After proofrolling, backfill with 24-inches of granular on-site soil installed in 8-inch loose lifts and compacted to 95 percent of the Standard Proctor value as determined by ASTM D-1557.

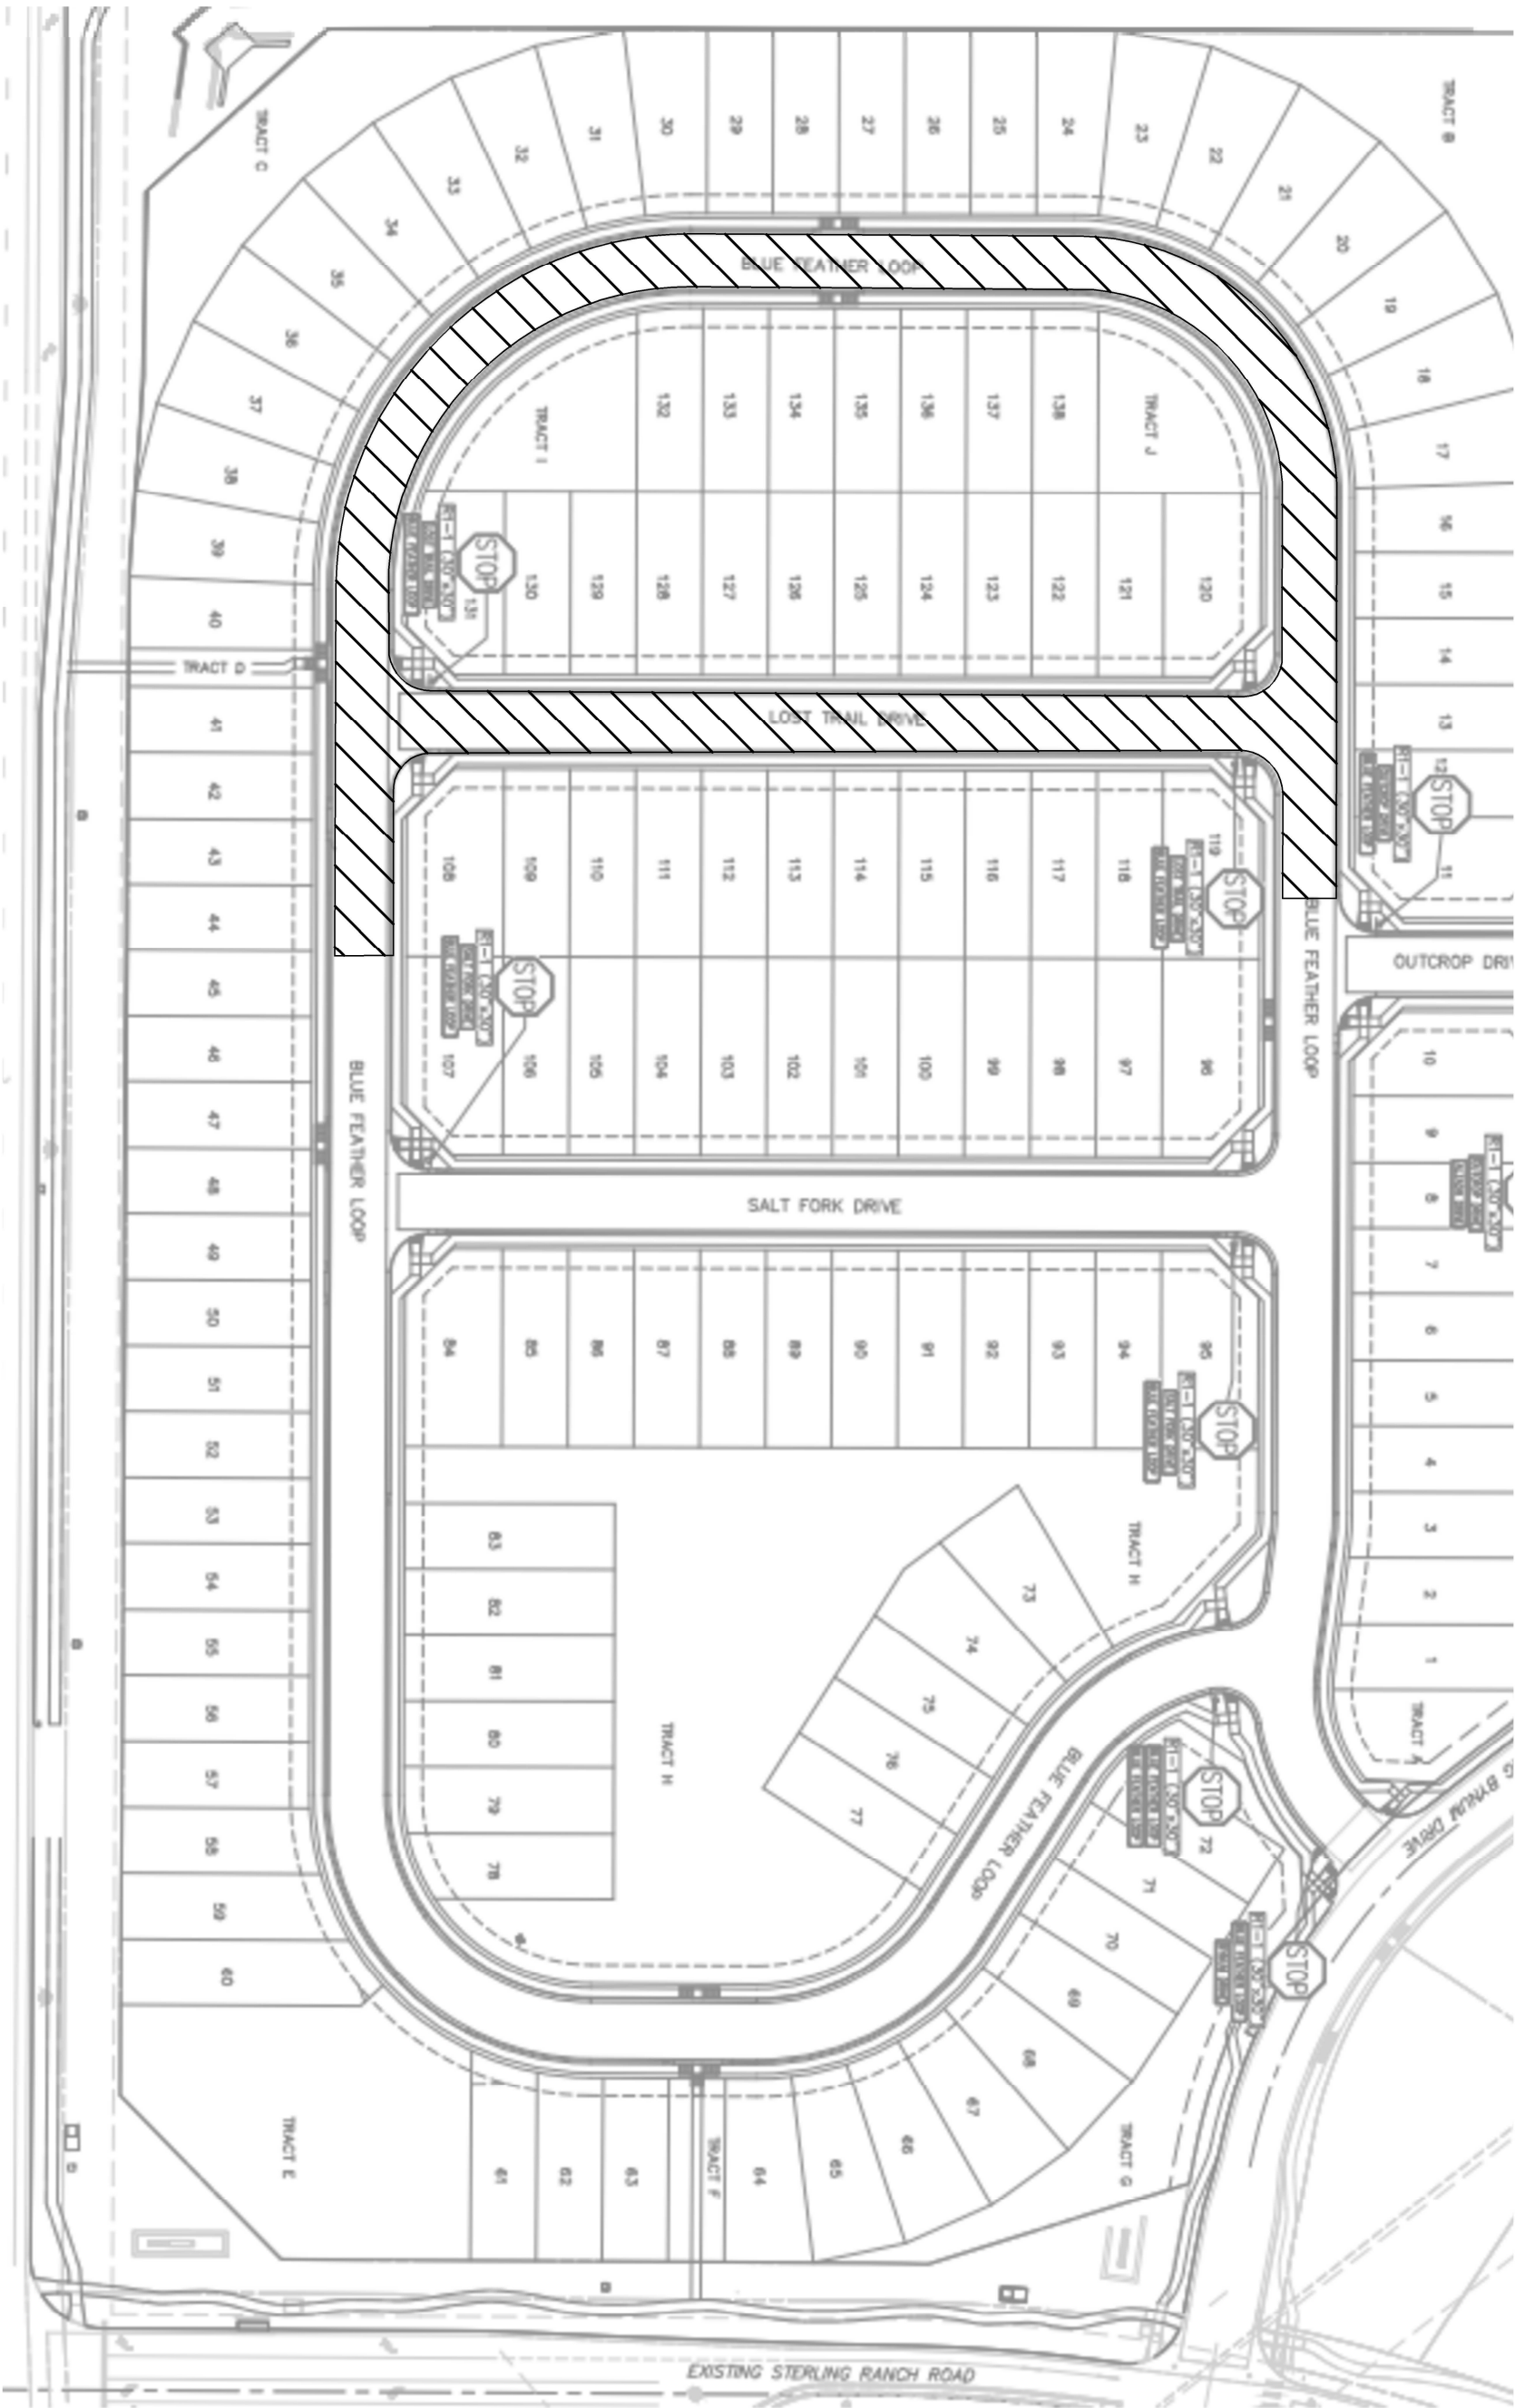
Urban Local: Lost Trail Drive
and Blue Feather Loop
ESAL - 292,000

PAVEMENT
RECOMMENDATIONS

Based on the design calculations, the recommended pavement sections are presented below and on Figure 2.2.

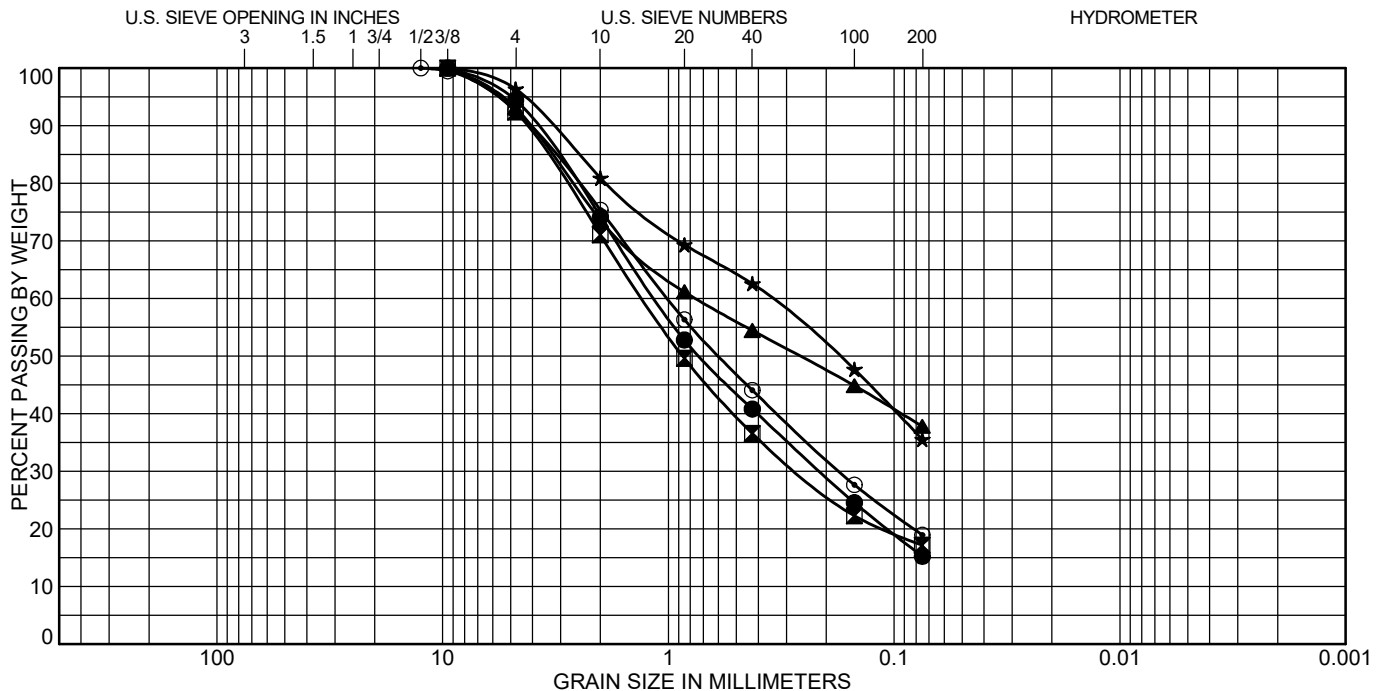
FIGURE No. 8

COBBLES	GRAVEL		SAND			SILT OR CLAY
	coarse	fine	coarse	medium	fine

Test Boring	Depth (ft)	Classification			LL	PL	PI
● 5	0.0	CLAYEY SAND(SC)			33	15	18
☒ 5	2.0	CLAYEY SAND(SC)			35	18	17
▲ 6	0.0	CLAYEY SAND(SC)			41	16	25
★ 6	2.0						
⊙ 7	0.0	CLAYEY SAND(SC)			31	17	14
Test Boring	Depth (ft)	%Gravel	%Sand	%Silt	%Clay		
● 5	0.0	5.6	79.2	15.2			
☒ 5	2.0	7.6	75.2	17.2			
▲ 6	0.0	6.9	55.3	37.8			
★ 6	2.0	3.6	60.8	35.5			
⊙ 7	0.0	7.4	73.7	18.9

The moisture content for the recovered samples was obtained in the laboratory. Grain-size analysis and Atterberg Limits tests were performed on selected samples for purposes of classification and to develop pertinent engineering properties. A Summary of Laboratory Test Results is presented in Figure 7. Soil Classification Data are presented in Figures 8 and 9. Swell/Consolidation test results are presented in Figures 10 and 11.

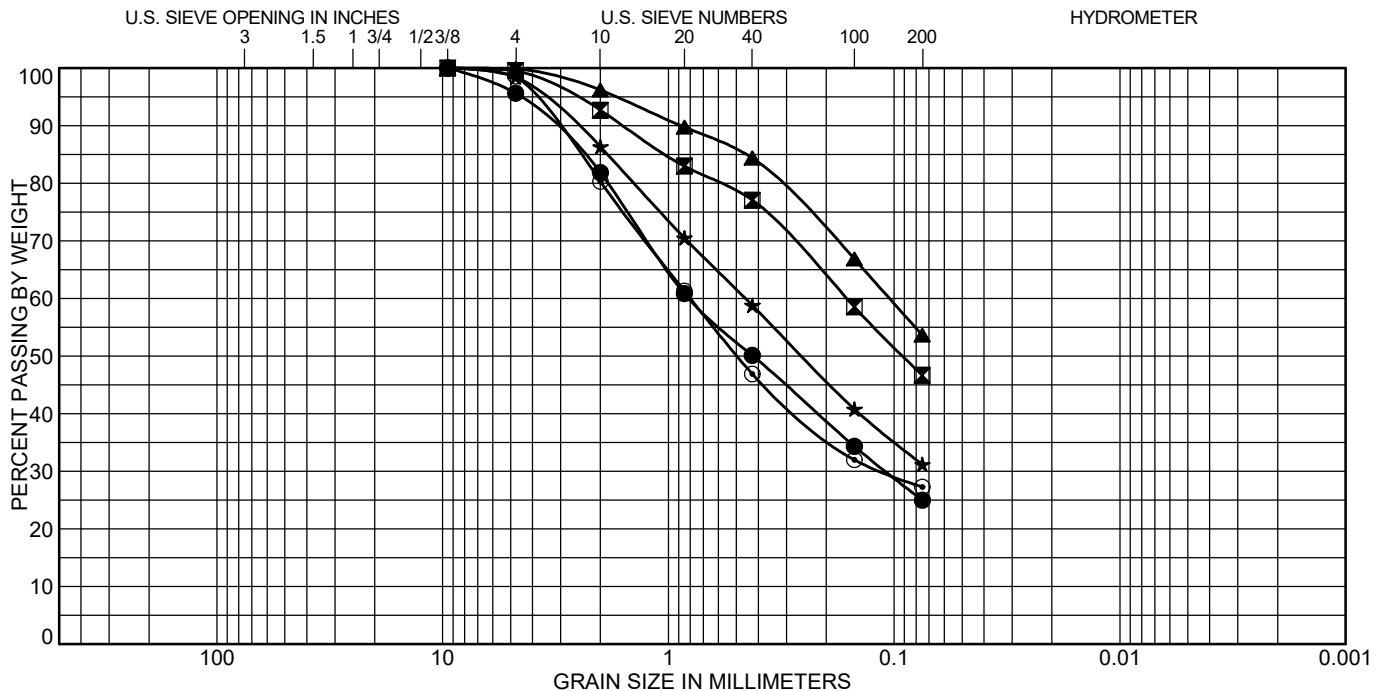
COBBLES	GRAVEL		SAND			SILT OR CLAY
	coarse	fine	coarse	medium	fine

Test Boring	Depth (ft)	Classification				LL	PL	PI
● 7	2.0	CLAYEY SAND(SC)				31	16	15
☒ 8	0.0	CLAYEY SAND(SC)				42	15	27
▲ 8	2.0	SANDY LEAN CLAY(CL)				37	14	23
★ 9	0.0	CLAYEY SAND(SC)				34	14	20
⊙ 9	2.0	CLAYEY SAND(SC)				34	16	18
Test Boring	Depth (ft)	%Gravel	%Sand	%Silt	%Clay			
● 7	2.0	4.4	70.7	25.0				
☒ 8	0.0	0.5	52.9	46.7				
▲ 8	2.0	0.1	46.3	53.6				
★ 9	0.0	1.6	67.3	31.2				
⊙ 9	2.0	1.4	71.3	27.3

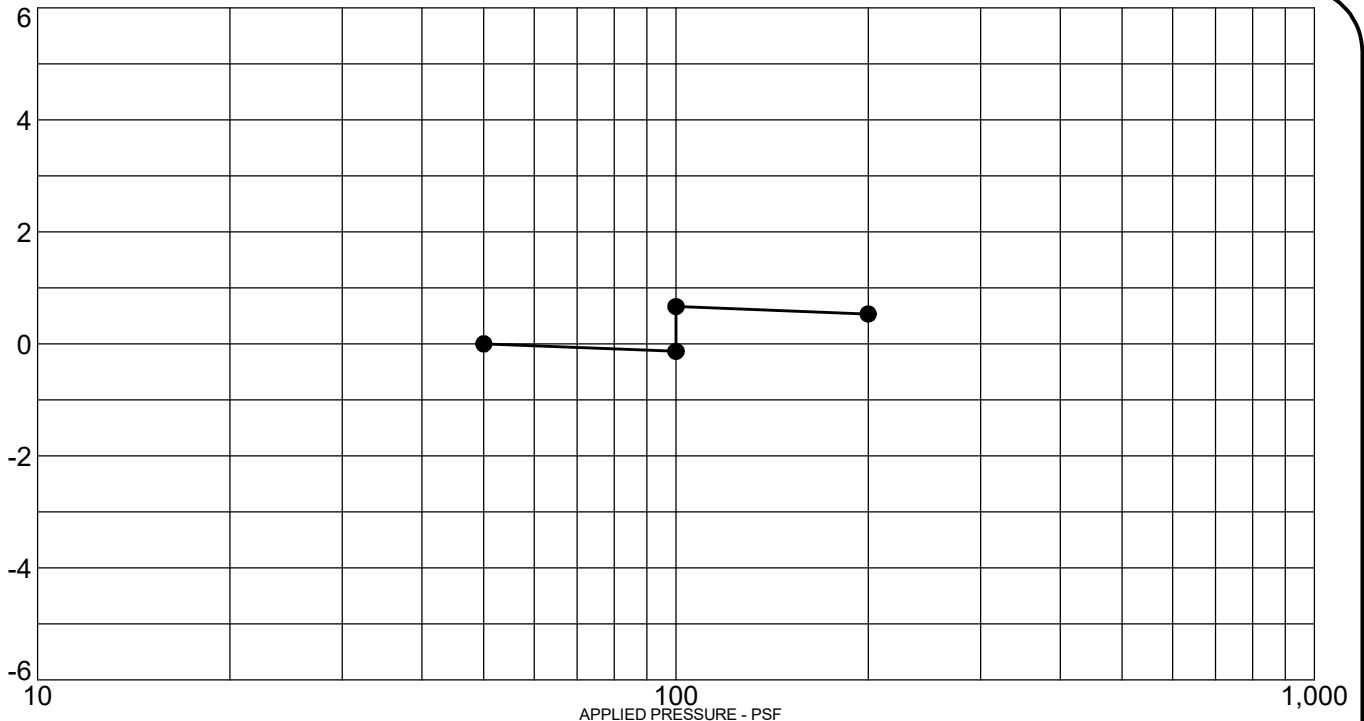
PROJECT: Copper Chase at Sterling Ranch, Filing No. 1, El Paso County, Colorado
 SAMPLE DESCRIPTION: SANDSTONE, CLAYEY
 NOTE: SAMPLE WAS INUNDATED WITH WATER AT 100 PSF

SAMPLE LOCATION: 6 @ 2 FT
 NATURAL DRY UNIT WEIGHT: 106.8 PCF
 NATURAL MOISTURE CONTENT: 13.8%
 PERCENT SWELL/COMPRESSION: 0.8

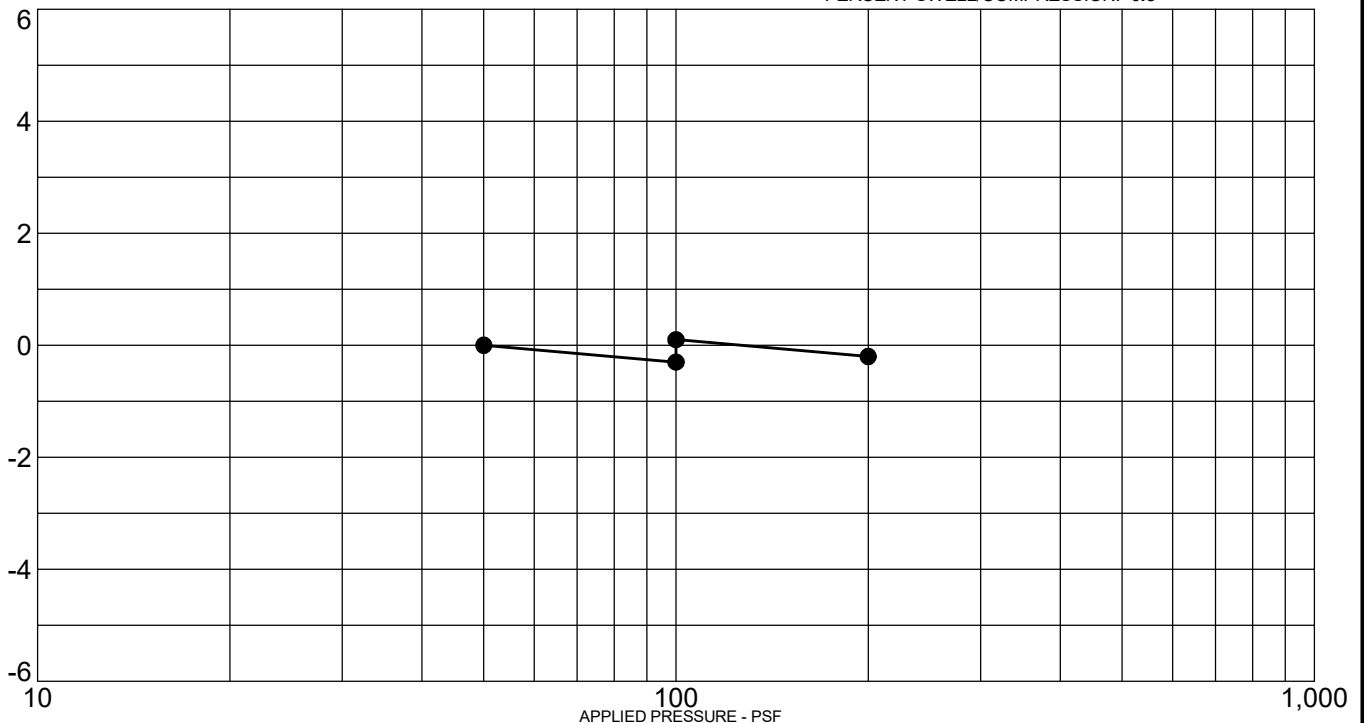
PROJECT: Copper Chase at Sterling Ranch, Filing No. 1, El Paso County, Colorado
 SAMPLE DESCRIPTION: SANDSTONE, CLAYEY
 NOTE: SAMPLE WAS INUNDATED WITH WATER AT 100 PSF

SAMPLE LOCATION: 6 @ 4 FT
 NATURAL DRY UNIT WEIGHT: 106.6 PCF
 NATURAL MOISTURE CONTENT: 20.9%
 PERCENT SWELL/COMPRESSION: 0.4

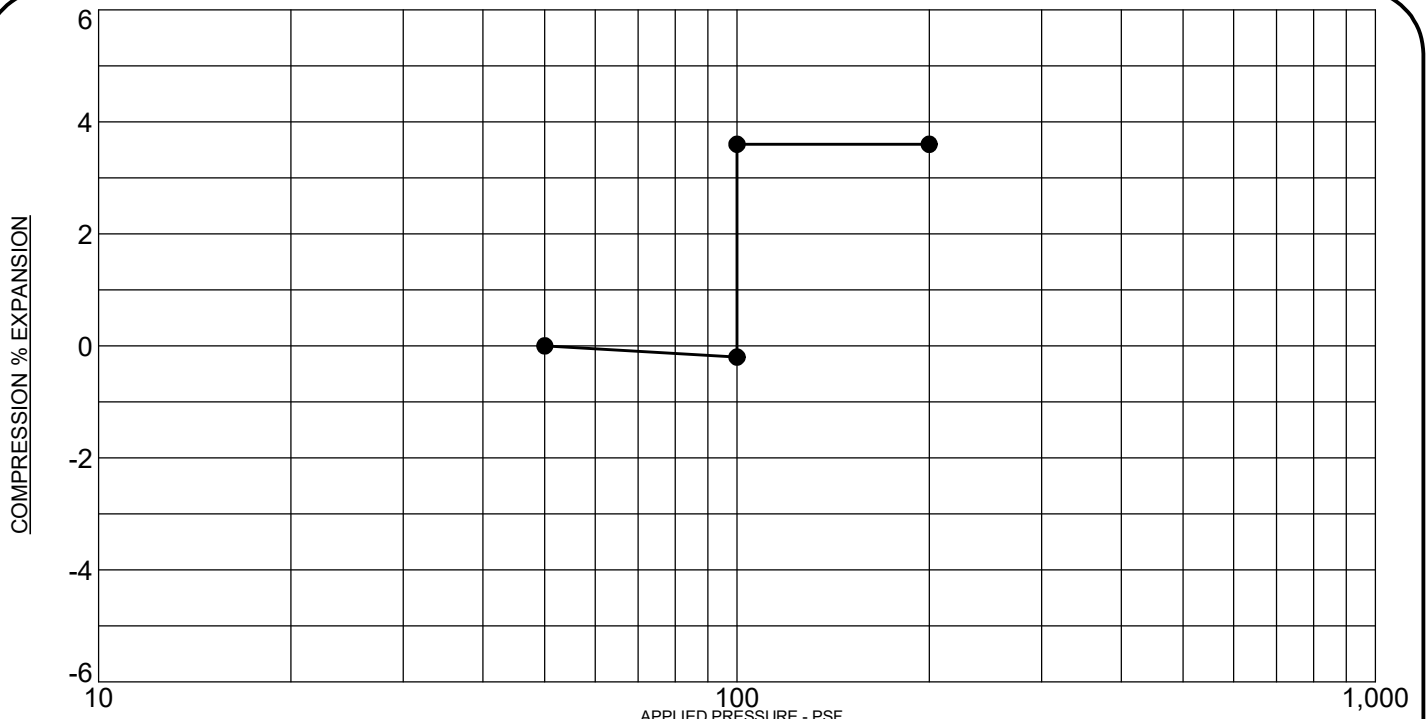
PROJECT: Copper Chase at Sterling Ranch, Filing No. 1, El Paso County, Colorado
 SAMPLE DESCRIPTION: CLAYSTONE, SANDY,
 NOTE: SAMPLE WAS INUNDATED WITH WATER AT 100 PSF

SAMPLE LOCATION: 8 @ 2 FT
 NATURAL DRY UNIT WEIGHT: 113.6 PCF
 NATURAL MOISTURE CONTENT: 14.1%
 PERCENT SWELL/COMPRESSION: 3.8

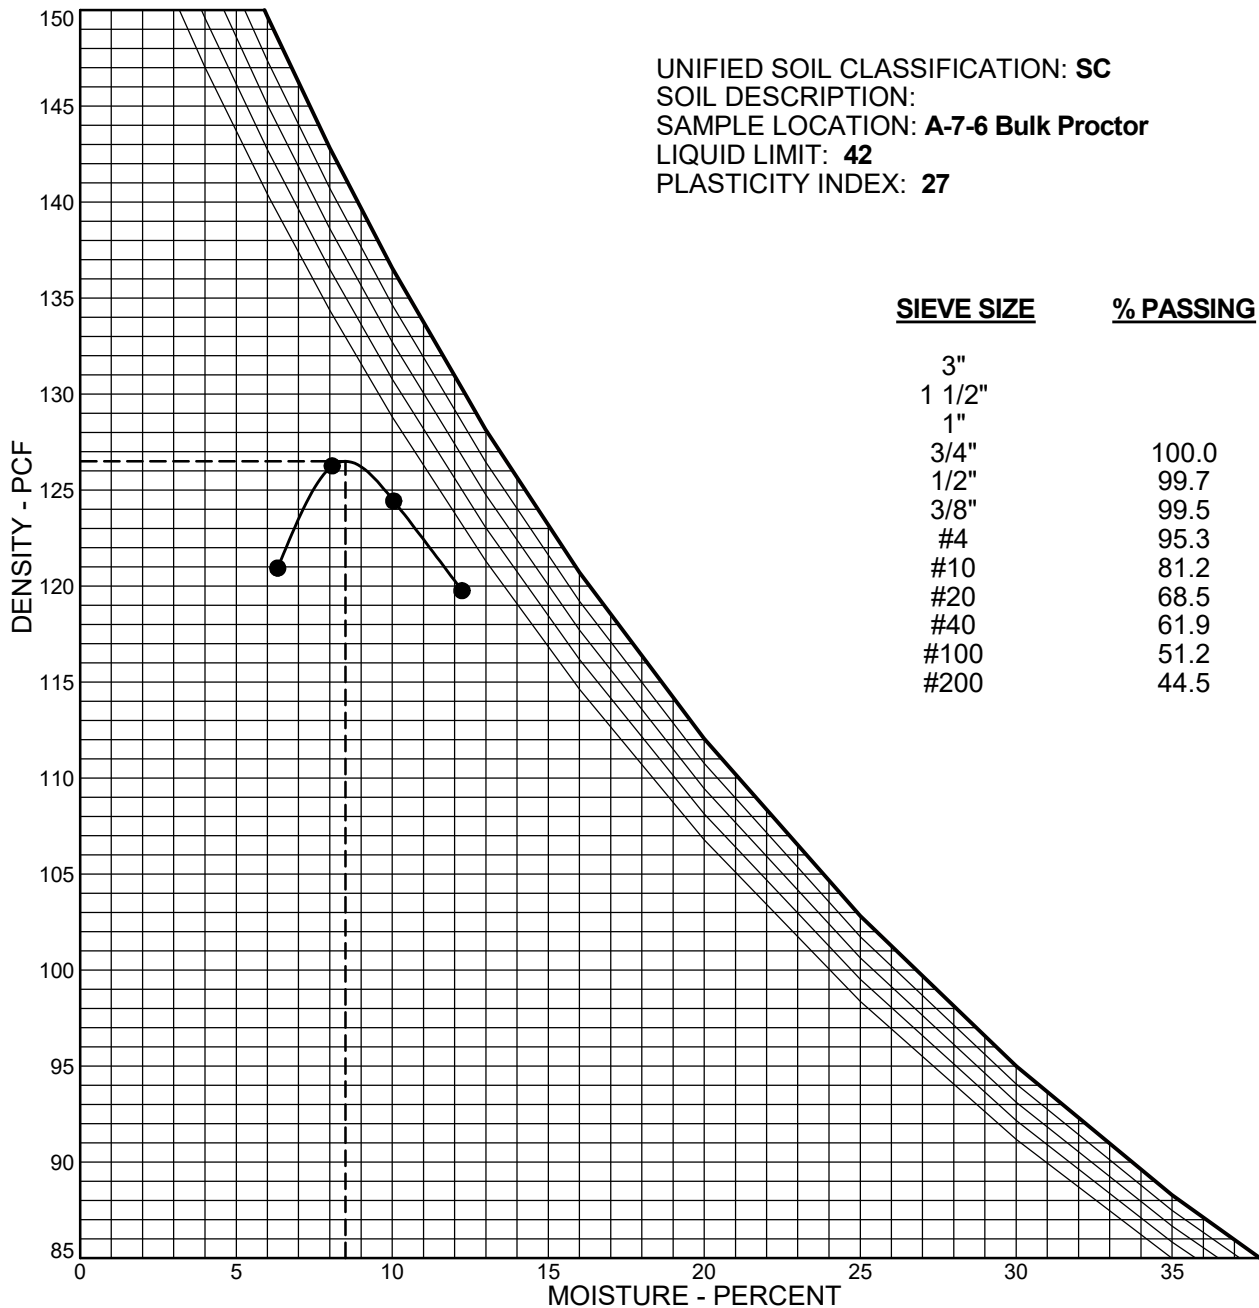
MOISTURE-DENSITY RELATION CURVE

LIQUID LIMIT: 42

PLASTICITY INDEX: 27

DESIGNATION **ASTM D-1557A**
MAX. DRY DENSITY **126.6 pcf**
OPTIMUM MOISTURE **8.5 %**
FRACTION USED **#4**
MOLD VOLUME **0.0333 cu.ft.**

A composite bulk sample from the TB-6 and TB-8 Test Borings, a composite A-7-6 soil, was tested to determine its moisture-density relationship curve in accordance with ASTM D1557 (Modified Proctor compaction test). The results are presented below:

A combined bulk sample of A-7-6 soil was tested to determine the optimum moisture-density relationship in accordance with ASTM D-698 (Standard Proctor compaction test). California Bearing Ratio, CBR tests were performed at varying densities with moisture content near optimum. At 95% of the maximum Standard Proctor density, the CBR of the bulk sample was 11.1. The Moisture-Density Relation Curve is presented in Figure 12. The CBR Test Results are presented in Figures 13 and 14.

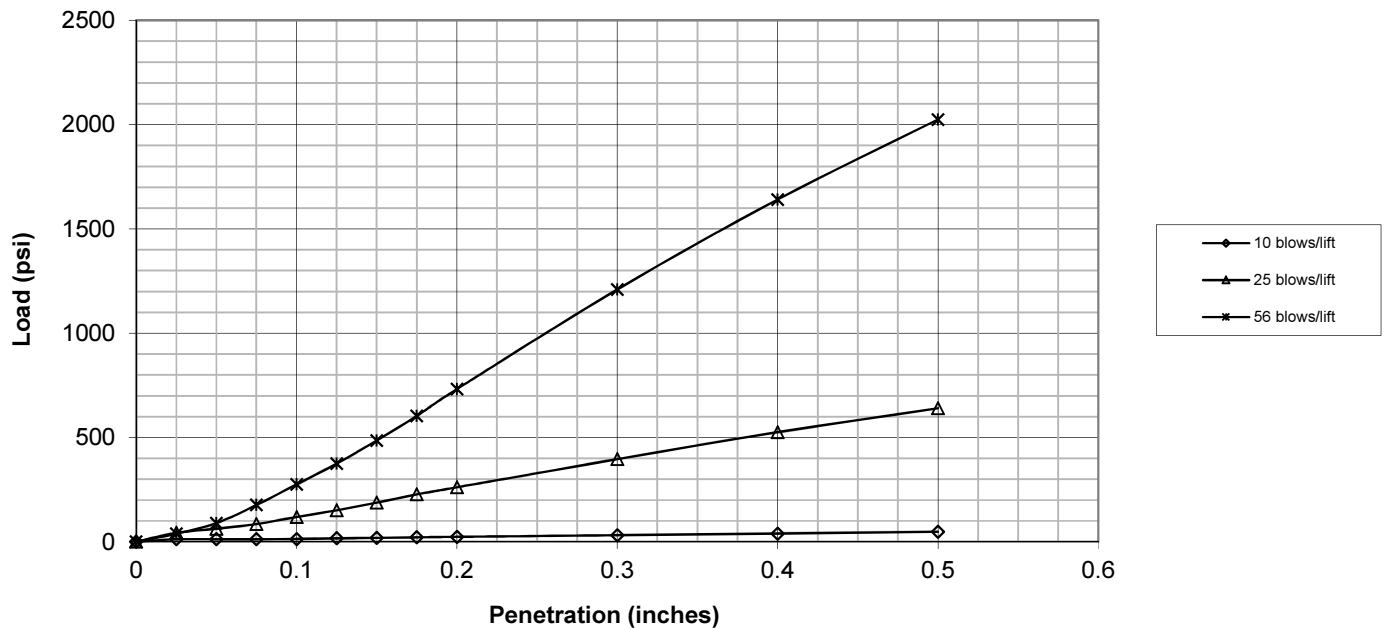
Project: Copper Chase at Sterling Ranch, Filing No. 1, Phase II
 Job No.: 193596
 AASHTO Classification: A-7-6
 Sample Number: CBR
 Sample Location: Combined Bulk Sample
 Soil Description: Clayey Sand

10 blows/lift	25 blows/lift	56 blows/lift
Penetration (in)	Load (psi)	Load (psi)	Load (psi)
0.000	0.0	0.0	0.0
0.025	11.8	42.3	38.3
0.050	11.8	62.1	89.7
0.075	11.8	85.0	176.0
0.100	13.1	118.6	275.1
0.125	16.5	150.8	374.2
0.150	18.5	187.5	485.4
0.175	21.2	227.1	603.3
0.200	23.5	261.0	732.0
0.300	31.2	395.7	1209.4
0.400	39.0	525.4	1641.0
0.500	47.4	640.0	2024.7

Corrected Penetration (in)	Corrected Load (psi)
10 blows/lift	0.100	1.3
25 blows/lift	0.100	11.9
56 blows/lift	0.100	27.5

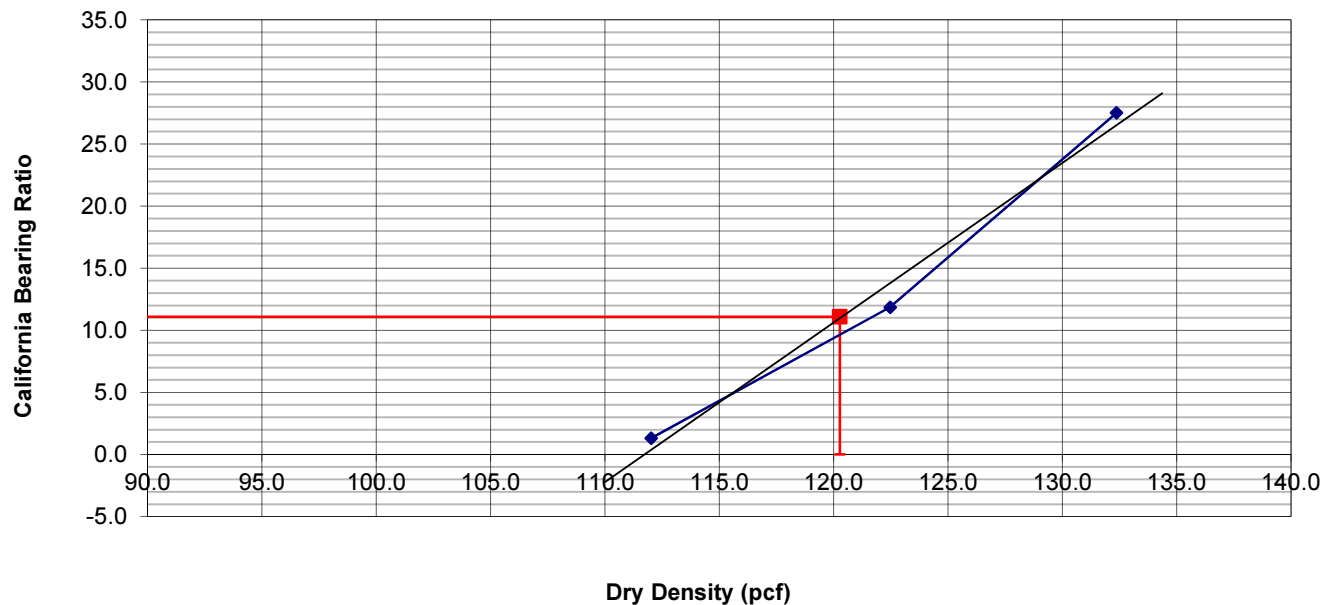
Project: Copper Chase at Sterling Ranch, Filing No. 1, Phase II
 Job No.: 193596
 AASHTO Classification" A-7-6
 Sample Number: CBR
 Sample Location: Combined Bulk Sample
 Soil Description: Clayey Sand

10 blows/lift	25 blows/lift	56 blows/lift
Corrected California Bearing Ratio	1.3	11.9	27.5
Dry Density (pcf)	112.0	122.5	132.4
Percent Compaction	88	97	105
Percent Moisture After Soaking	13.0	10.7	10.4
Percent Expansion (+) / Compression (-)	0.0%	0.1%	0.2%
Surcharge Weight (lbs)	12.60	12.60	12.60

California Bearing Ratio	11.1
Dry Density (pcf)	126.6
Percent Compaction	95%
Target Dry Density	120.3
Compaction Test Method	ASTM D-1557
Condition of sample	Soaked

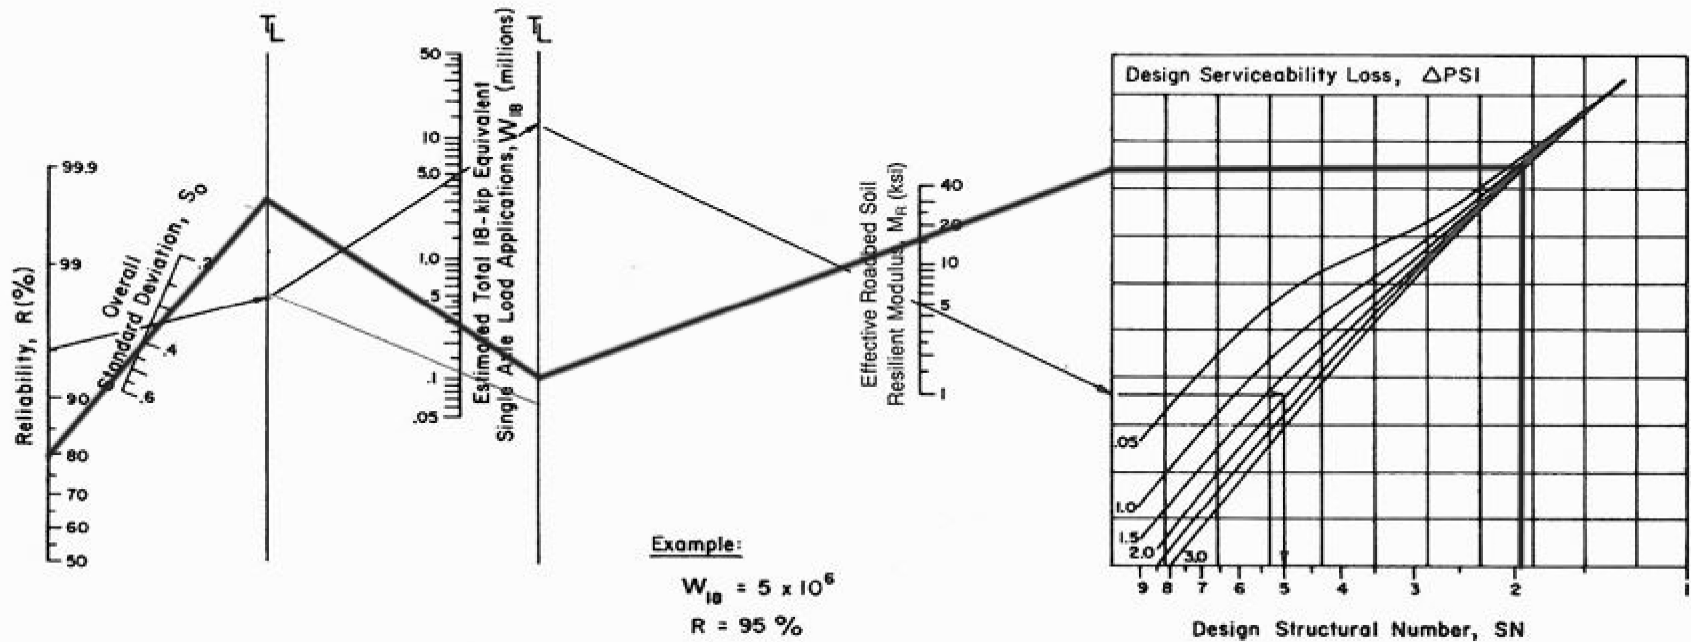
NOMOGRAPH SOLVES:

$$\log_{10} \frac{W}{18} = Z_R * S_o + 9.36 * \log_{10} (SN+1) - 0.20 + \frac{\log_{10} \left[\frac{\Delta \text{ PSI}}{4.2 - 1.5} \right]}{0.40 + \frac{1094}{(SN+1)^{5.19}}} + 2.32 * \log_{10} M_R - 8.07$$

Example:

$$W_{18} = 5 \times 10^6$$

1993 AASHTO Empirical Equation for Flexible Pavements
