PAVEMENT DESIGN REPORT

**Copper Chase at Sterling Ranch, Filing No. 1
Phase 1
El Paso County, Colorado**

JOB NO. 193596

February 26, 2024

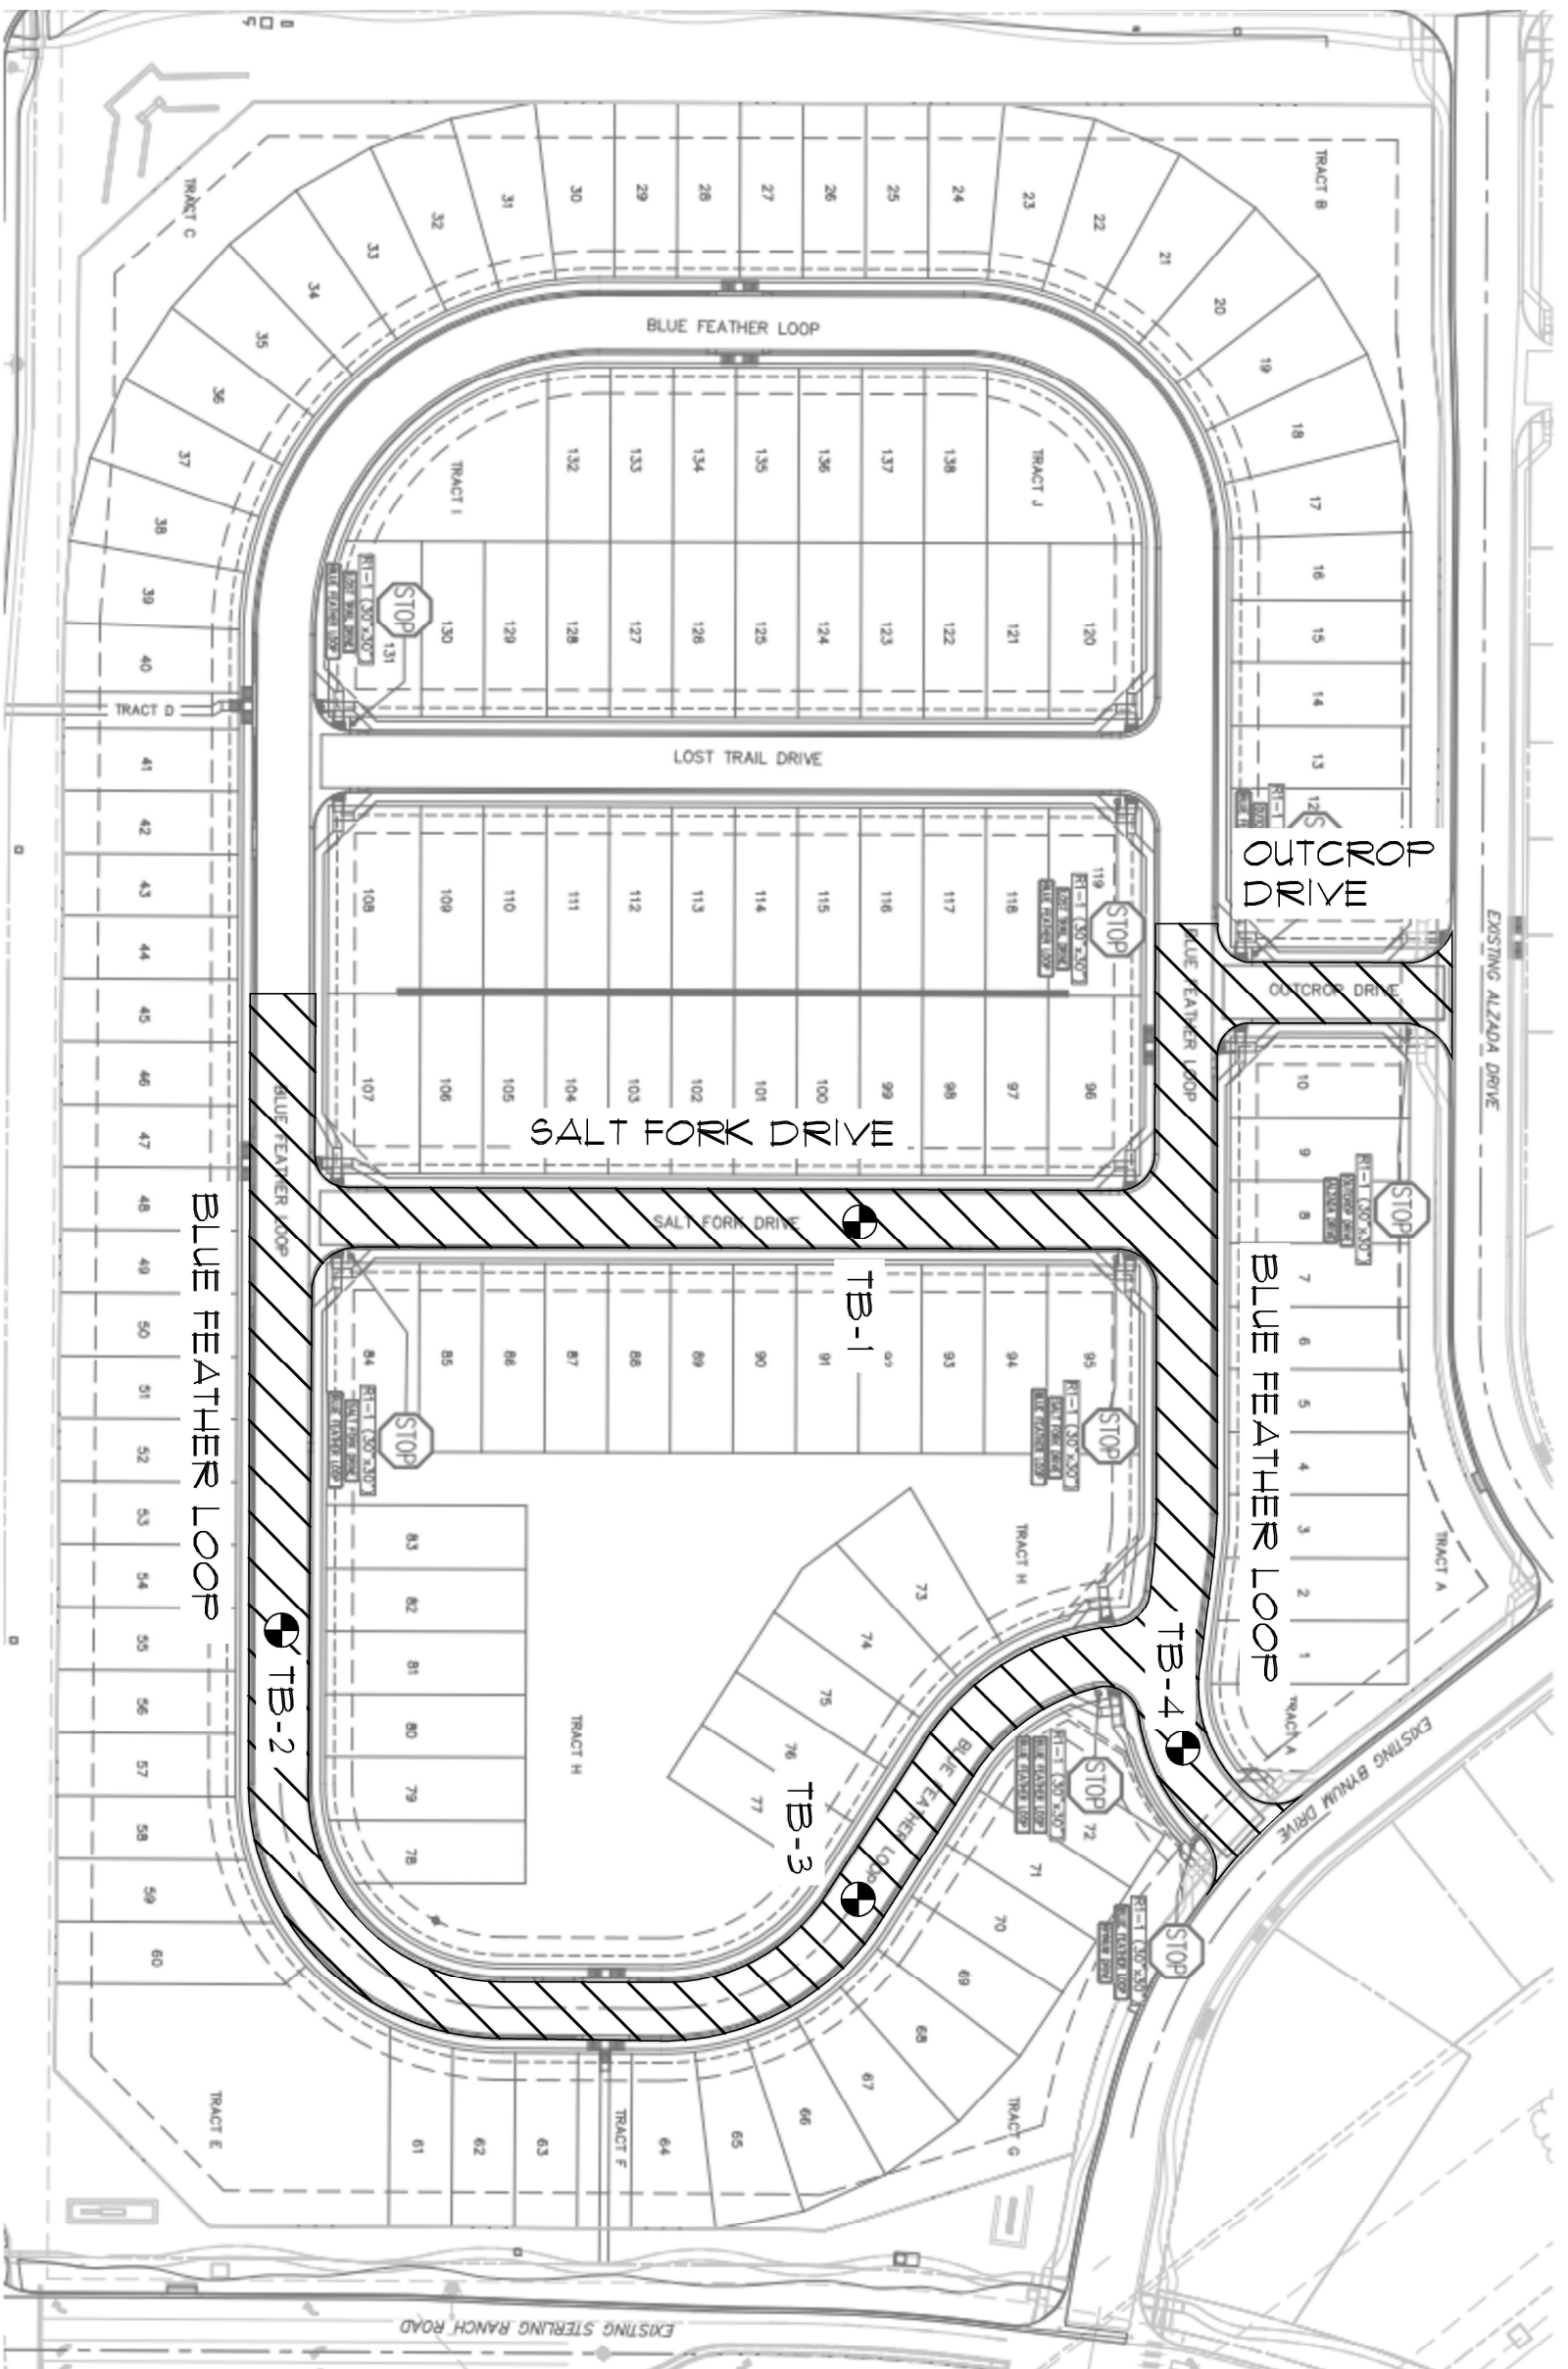
INDICATES AREAS INCLUDED IN THIS REPORT

The proposed streets included in this investigation are shown on Figure 2.1 and 2.2. The streets considered herein are classified as Urban Local.

The subsurface conditions on the site were investigated by drilling four exploratory test borings. The approximate locations of the test borings are presented in the Test Boring Location Plan, Figure 2.1.

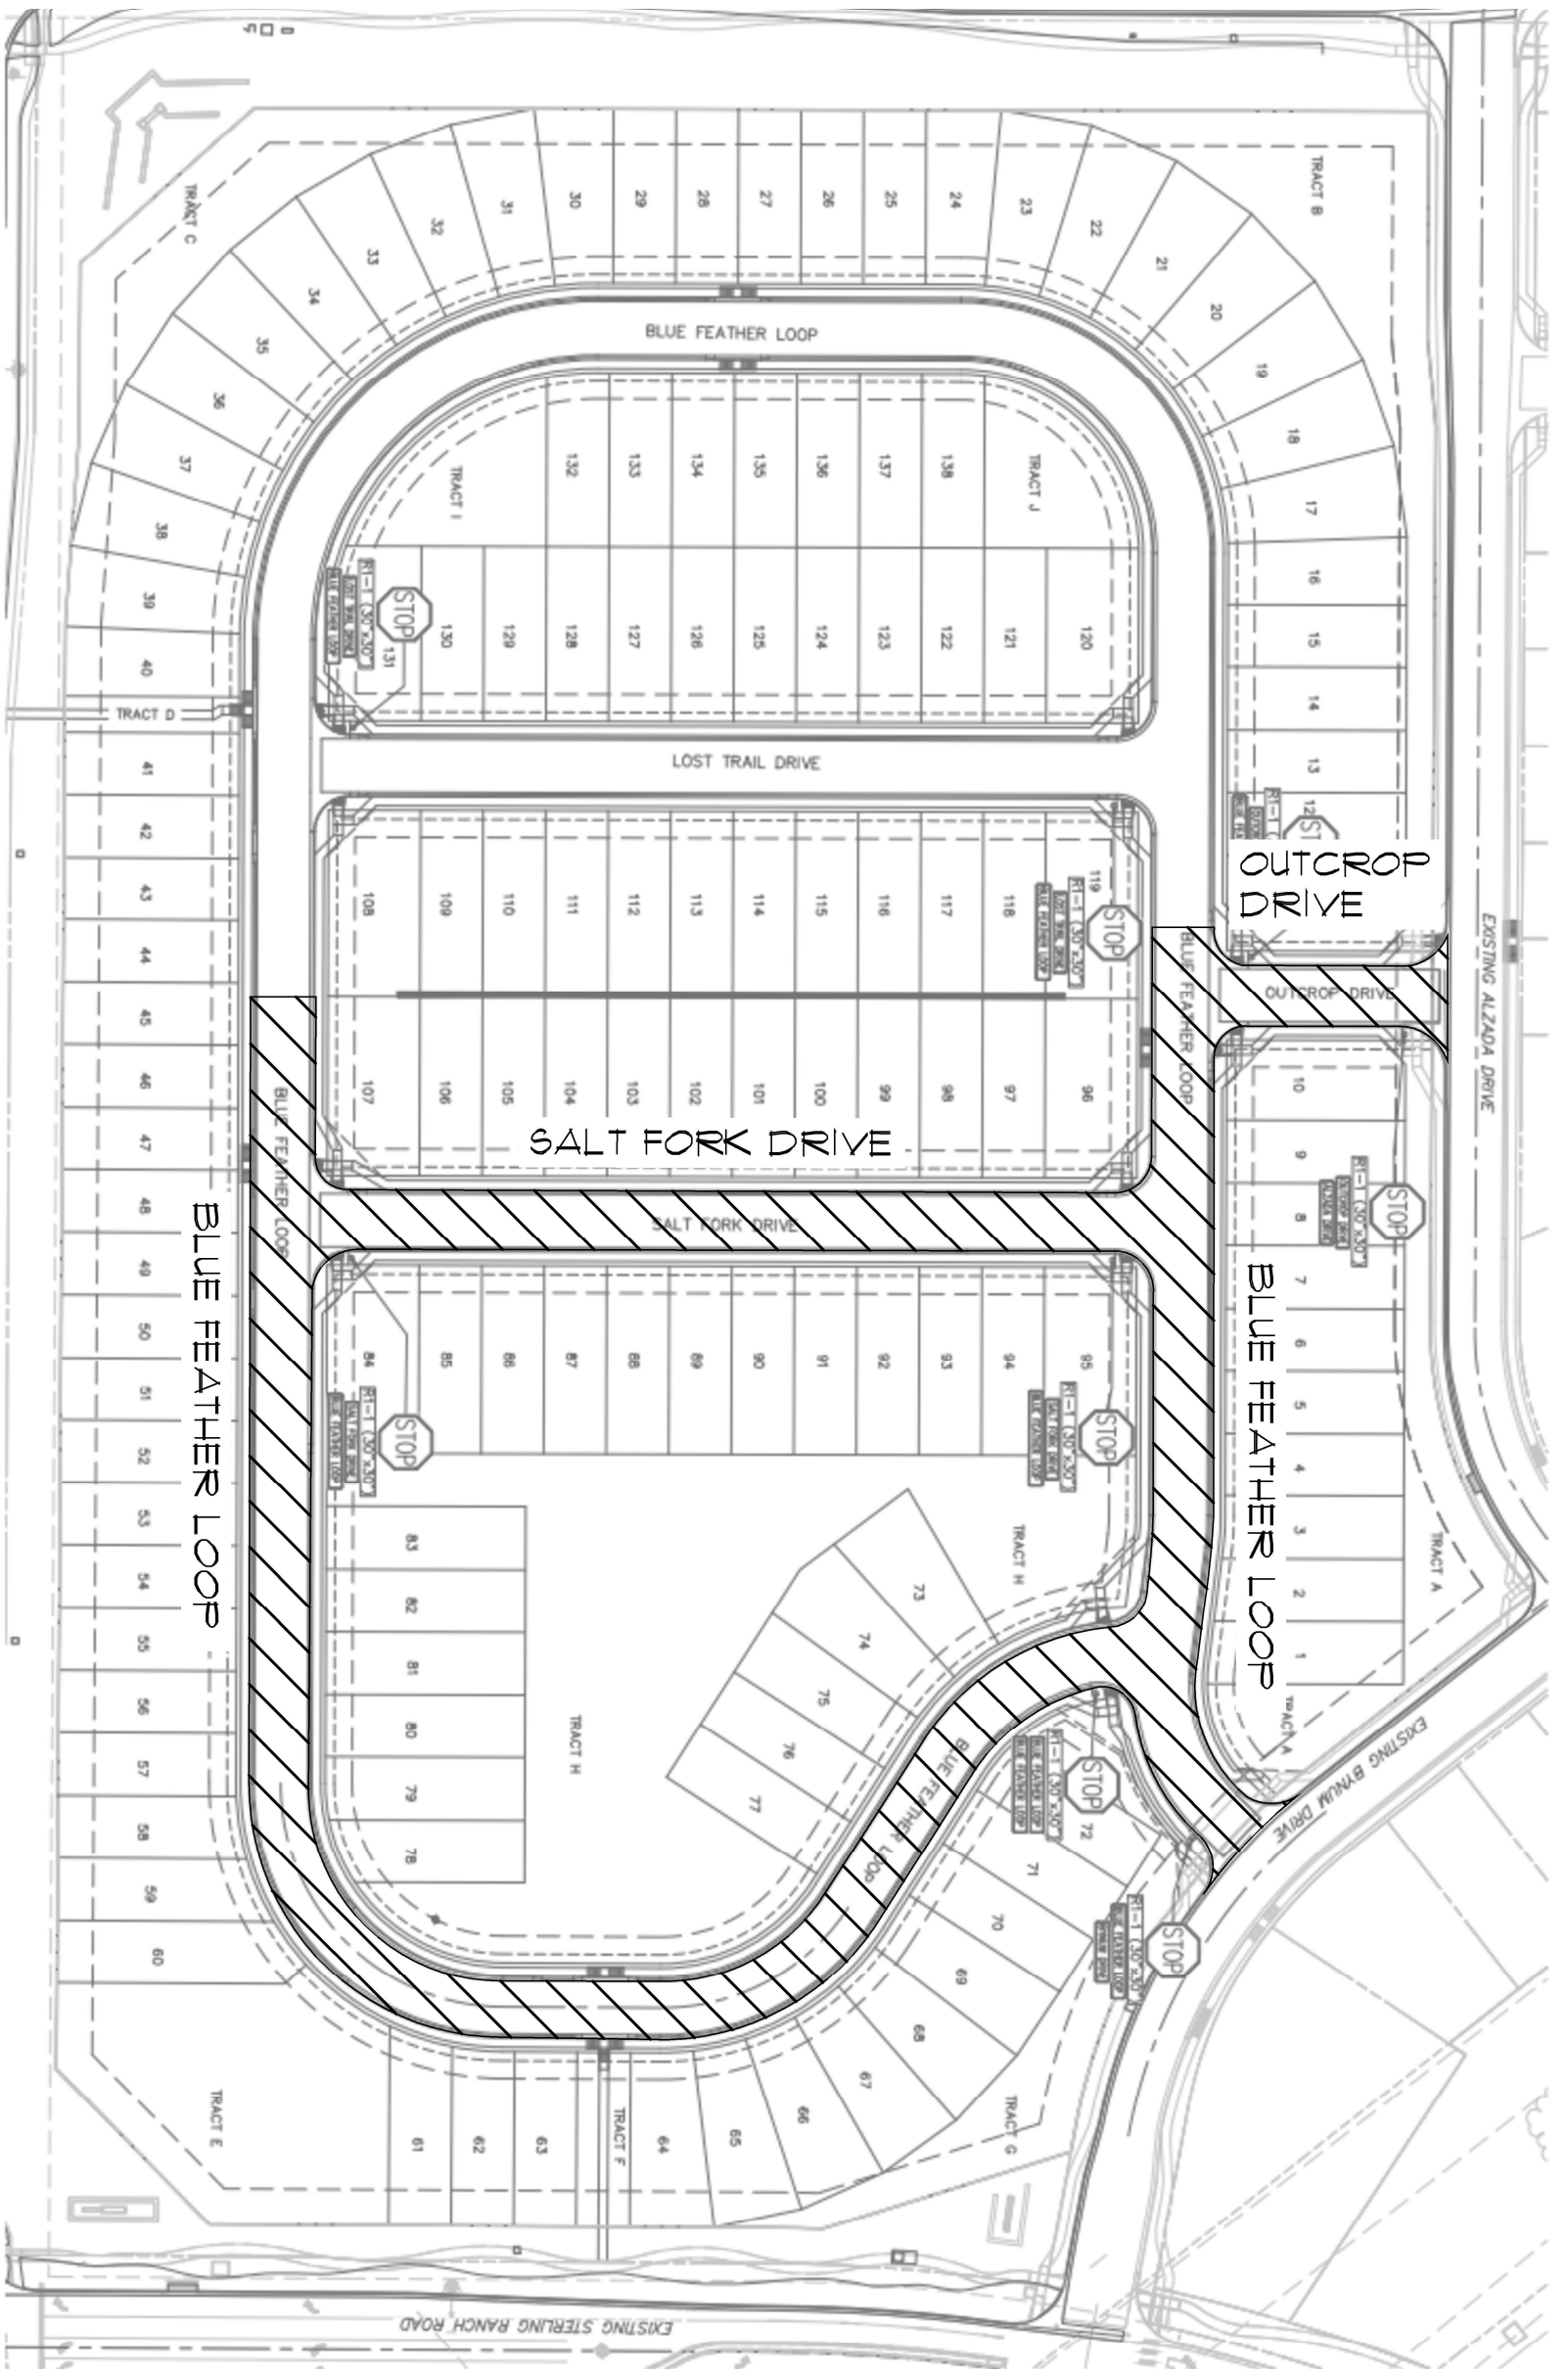
SHEET No. FIG-2.2	PAVEMENT RECOMMENDATIONS
	ENGINEER
	DRAWN BY: NM
	CHECKED BY: TM
ISSUED: 2-26-2024

6.5" HMA
OVER
10.75" ABC

Based on the design calculations, the recommended pavement section is presented below and on Figure 2.2

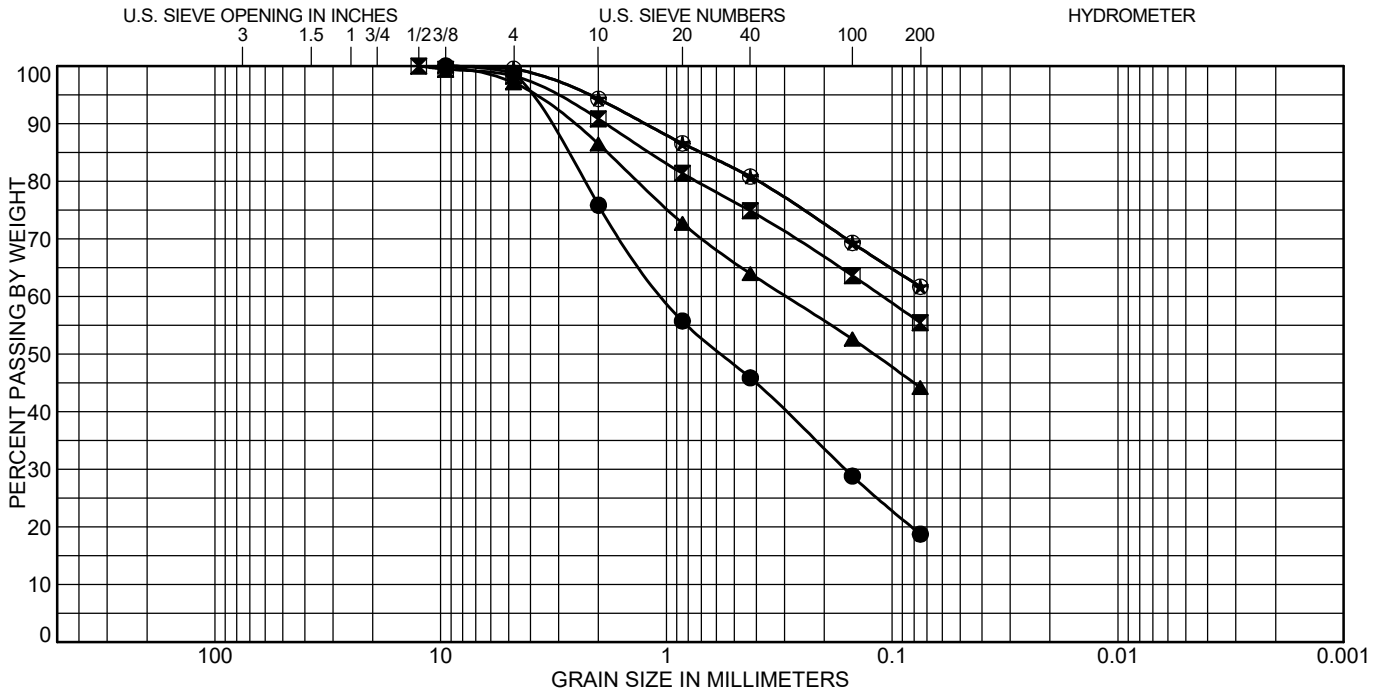
COBBLES	GRAVEL		SAND			SILT OR CLAY
	coarse	fine	coarse	medium	fine

Test Boring	Depth (ft)	Classification	LL	PL	PI
● 3	2.0	CLAYEY SAND(SC)	37	22	15
☒ 4	0.0	SANDY LEAN CLAY(CL)	36	19	17
▲ 4	2.0	CLAYEY SAND(SC)	38	23	15
★ A-6 Proctor	0.0	SANDY LEAN CLAY(CL)	36	14	22
⊙ Combined	0.0	SANDY LEAN CLAY(CL)	38	20	18

The moisture content for the recovered samples was obtained in the laboratory. Grain-size analysis and Atterberg Limits tests were performed on selected samples for purposes of classification and to develop pertinent engineering properties. A Summary of Laboratory Test Results is presented in Figure 6. Soil Classification Data are presented in Figures 7 and 8. Swell/Consolidation test results are presented in Figure 9.

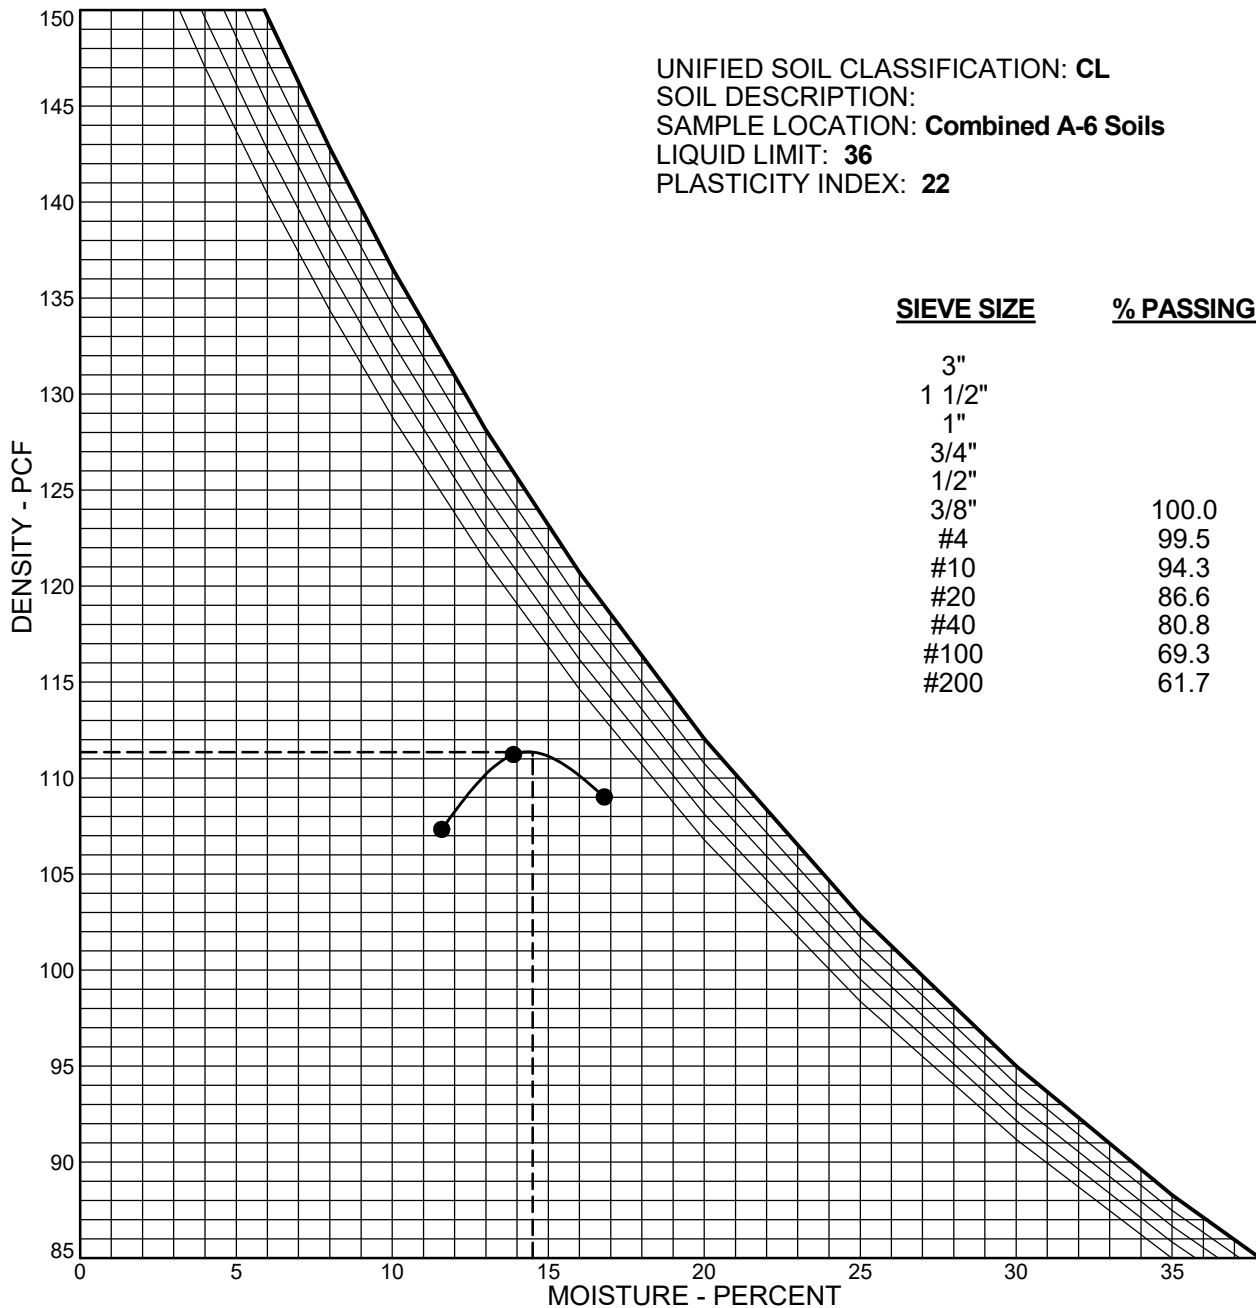
MOISTURE-DENSITY RELATION CURVE

UNIFIED SOIL CLASSIFICATION: CL
SOIL DESCRIPTION:
SAMPLE LOCATION: Combined A-6 Soils
LIQUID LIMIT: 36
PLASTICITY INDEX: 22

DESIGNATION **ASTM D-698**
MAX. DRY DENSITY **111.4 pcf**
OPTIMUM MOISTURE **14.5 %**
FRACTION USED **-4**
MOLD VOLUME **0.0333 cu.ft.**

A combined bulk sample of A-6 soil was tested to determine the optimum moisture-density relationship in accordance with ASTM D-698 (Standard Proctor compaction test). California Bearing Ratio, CBR tests were performed at varying densities with moisture content near optimum. At 95% of the maximum Standard Proctor density, the CBR of the bulk sample was 1.24. The Moisture-Density Relation Curve is presented in Figure 10. The CBR Test Results are presented in Figures 11 and 12.

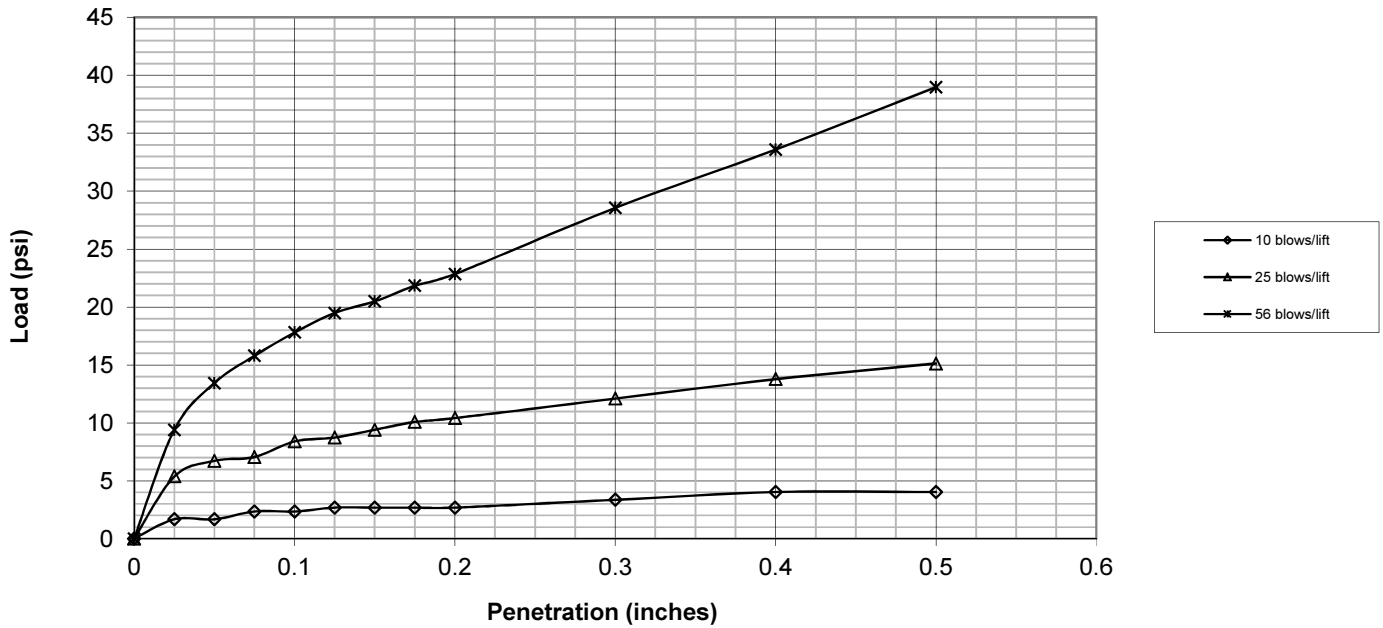
Project: **Copper Chase at Sterling Ranch, Filing No. 1**
 Job No.: **193596**
 AASHTO Classification: **A-6**
 Sample Number: **CBR**
 Sample Location: **Combined Bulk Sample**
 Soil Description: **Sandy Clay**

Penetration (in)	10 blows/lift	25 blows/lift	56 blows/lift
	Load (psi)	Load (psi)	Load (psi)
0.000	0.0	0.0	0.0
0.025	1.7	5.4	9.4
0.050	1.7	6.7	13.4
0.075	2.4	7.1	15.8
0.100	2.4	8.4	17.8
0.125	2.7	8.7	19.5
0.150	2.7	9.4	20.5
0.175	2.7	10.1	21.8
0.200	2.7	10.4	22.8
0.300	3.4	12.1	28.6
0.400	4.0	13.8	33.6
0.500	4.0	15.1	39.0

Corrected Penetration (in)	Corrected Load (psi)
10 blows/lift	0.100	0.2
25 blows/lift	0.100	0.8
56 blows/lift	0.100	1.8
