PAVEMENT DESIGN REPORT

**Copper Chase at Sterling Ranch, Filing No. 1
Phase 1
El Paso County, Colorado**

JOB NO. 193596

**February 26, 2024
REV: March 8, 2024**

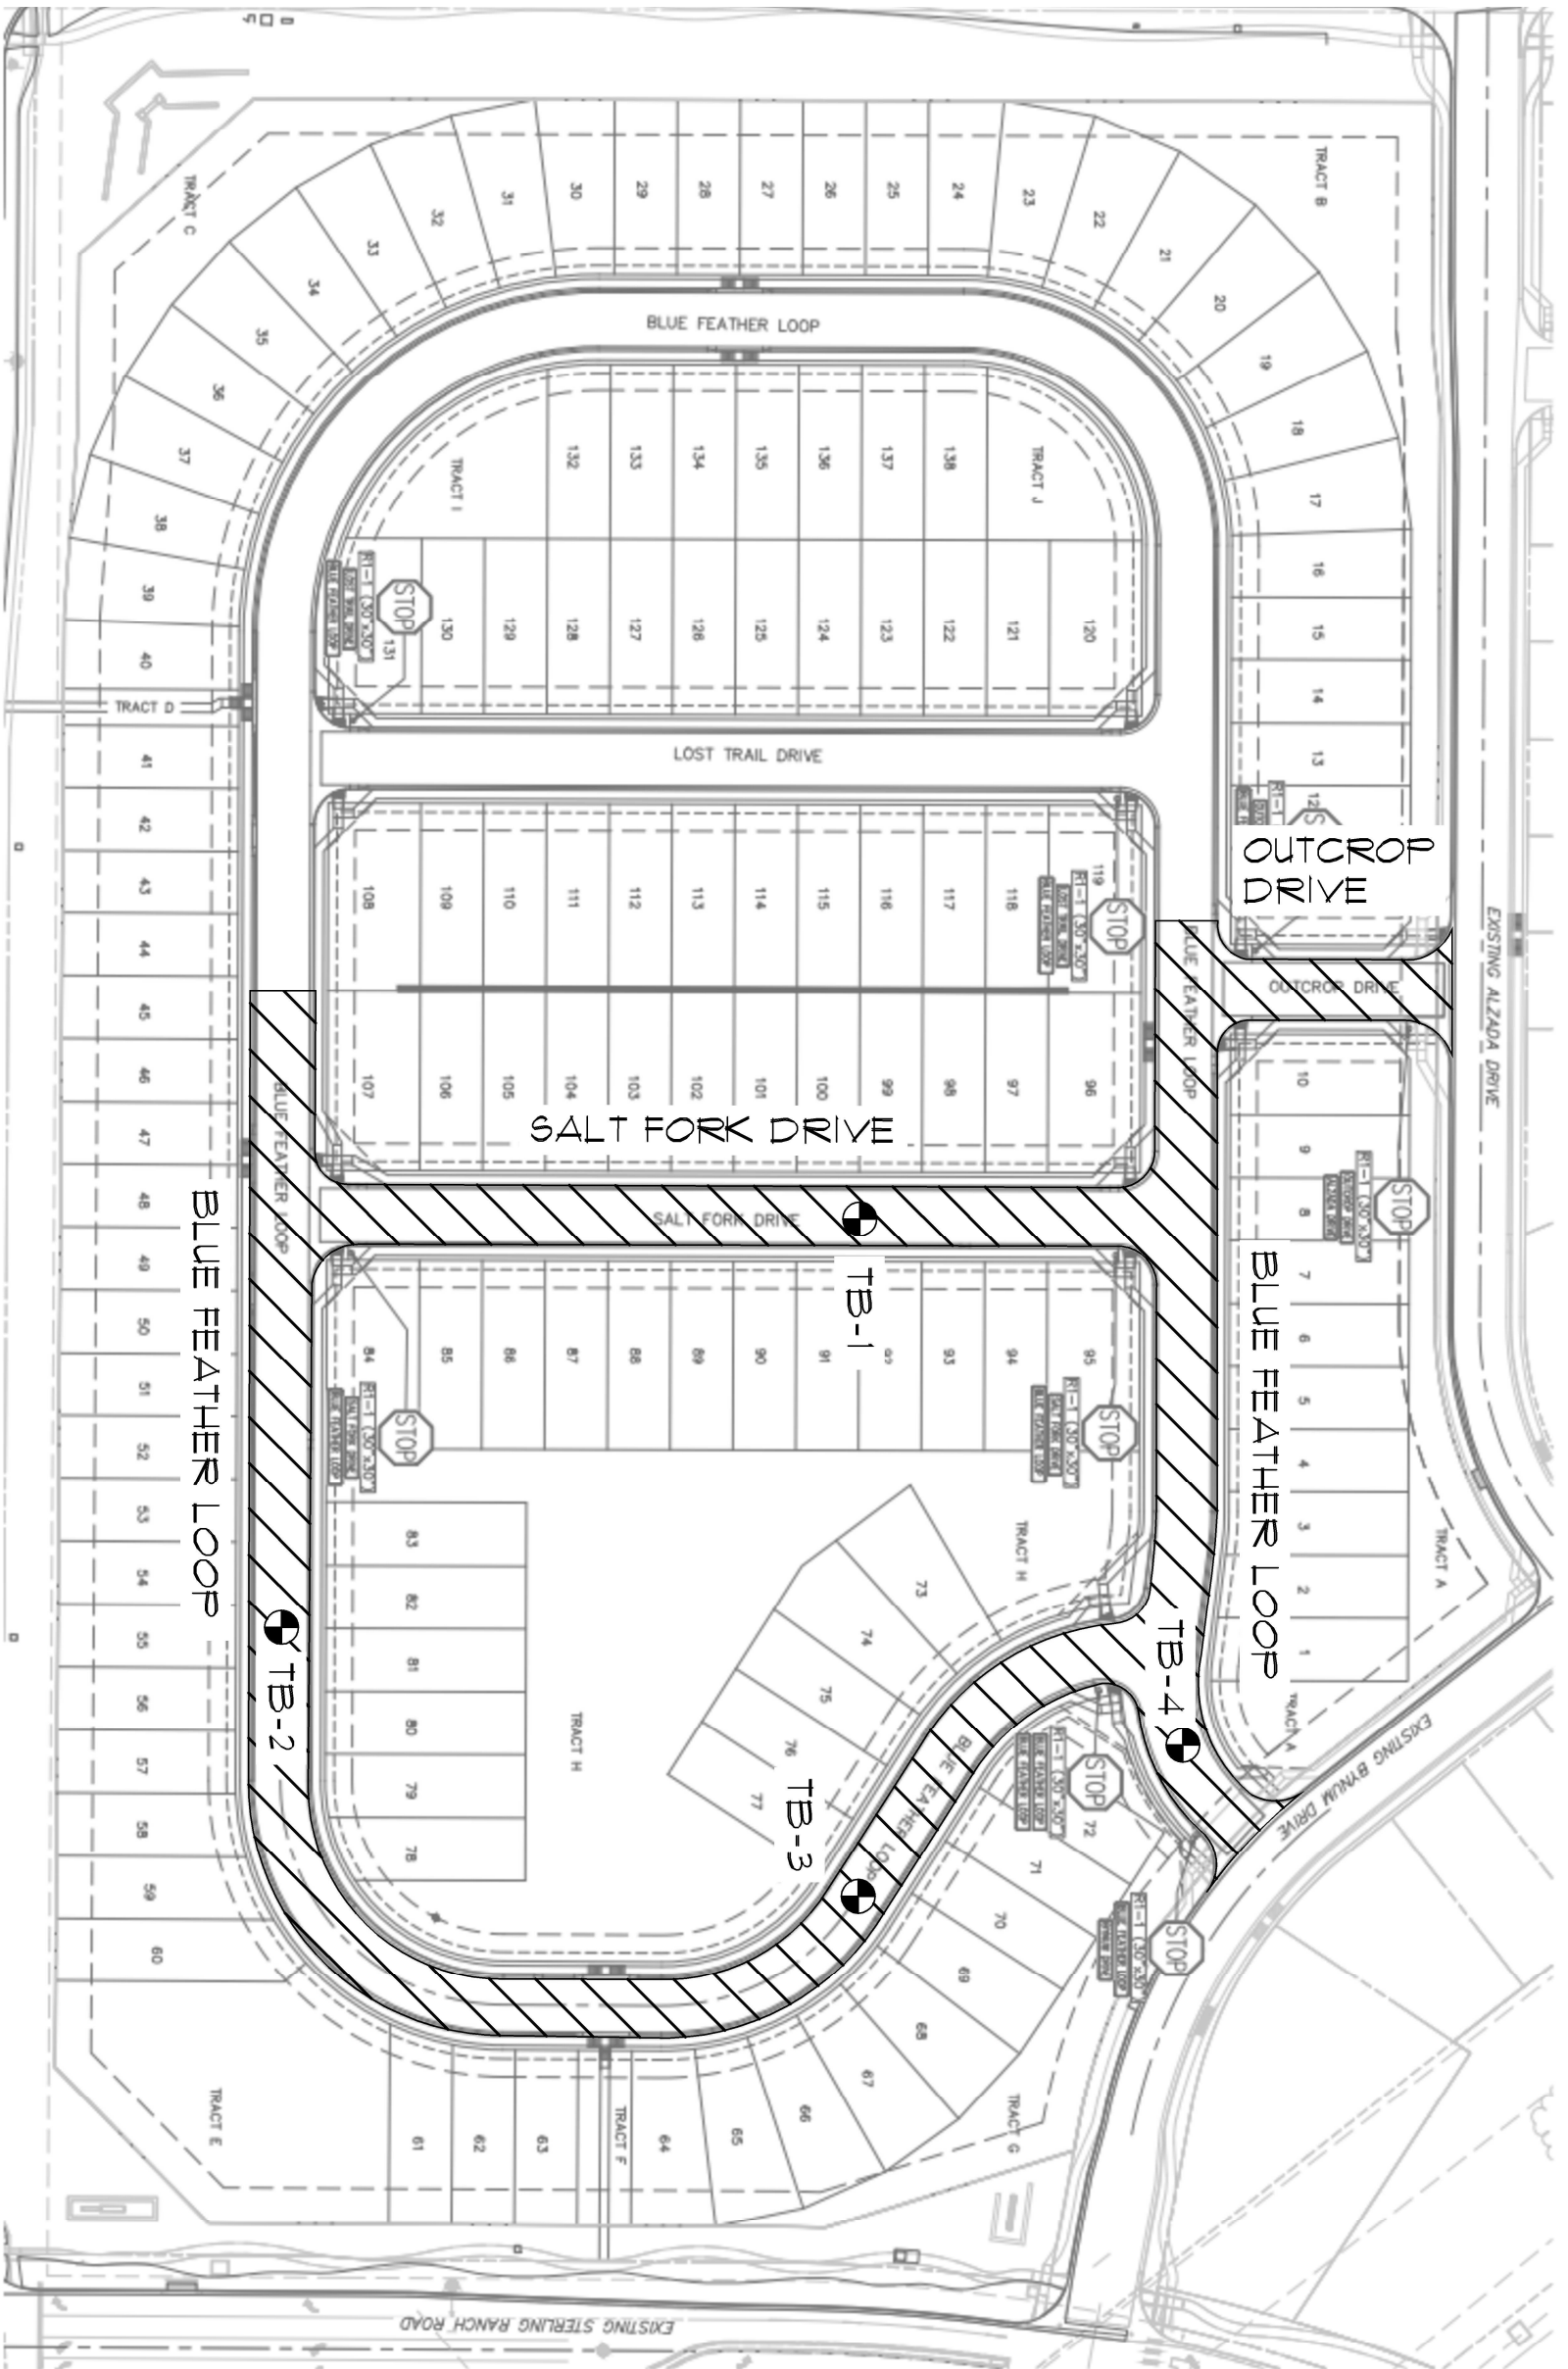
SHEET No.
FIG-2.1

INDICATES AREAS INCLUDED IN THIS REPORT

TEST BORING
 LOCATION PLAN

The proposed streets included in this investigation are shown on Figure 2.1 and 2.2. The streets considered herein are classified as Urban Local.

The subsurface conditions on the site were investigated by drilling four exploratory test borings. The approximate locations of the test borings are presented in the Test Boring Location Plan, Figure 2.1.

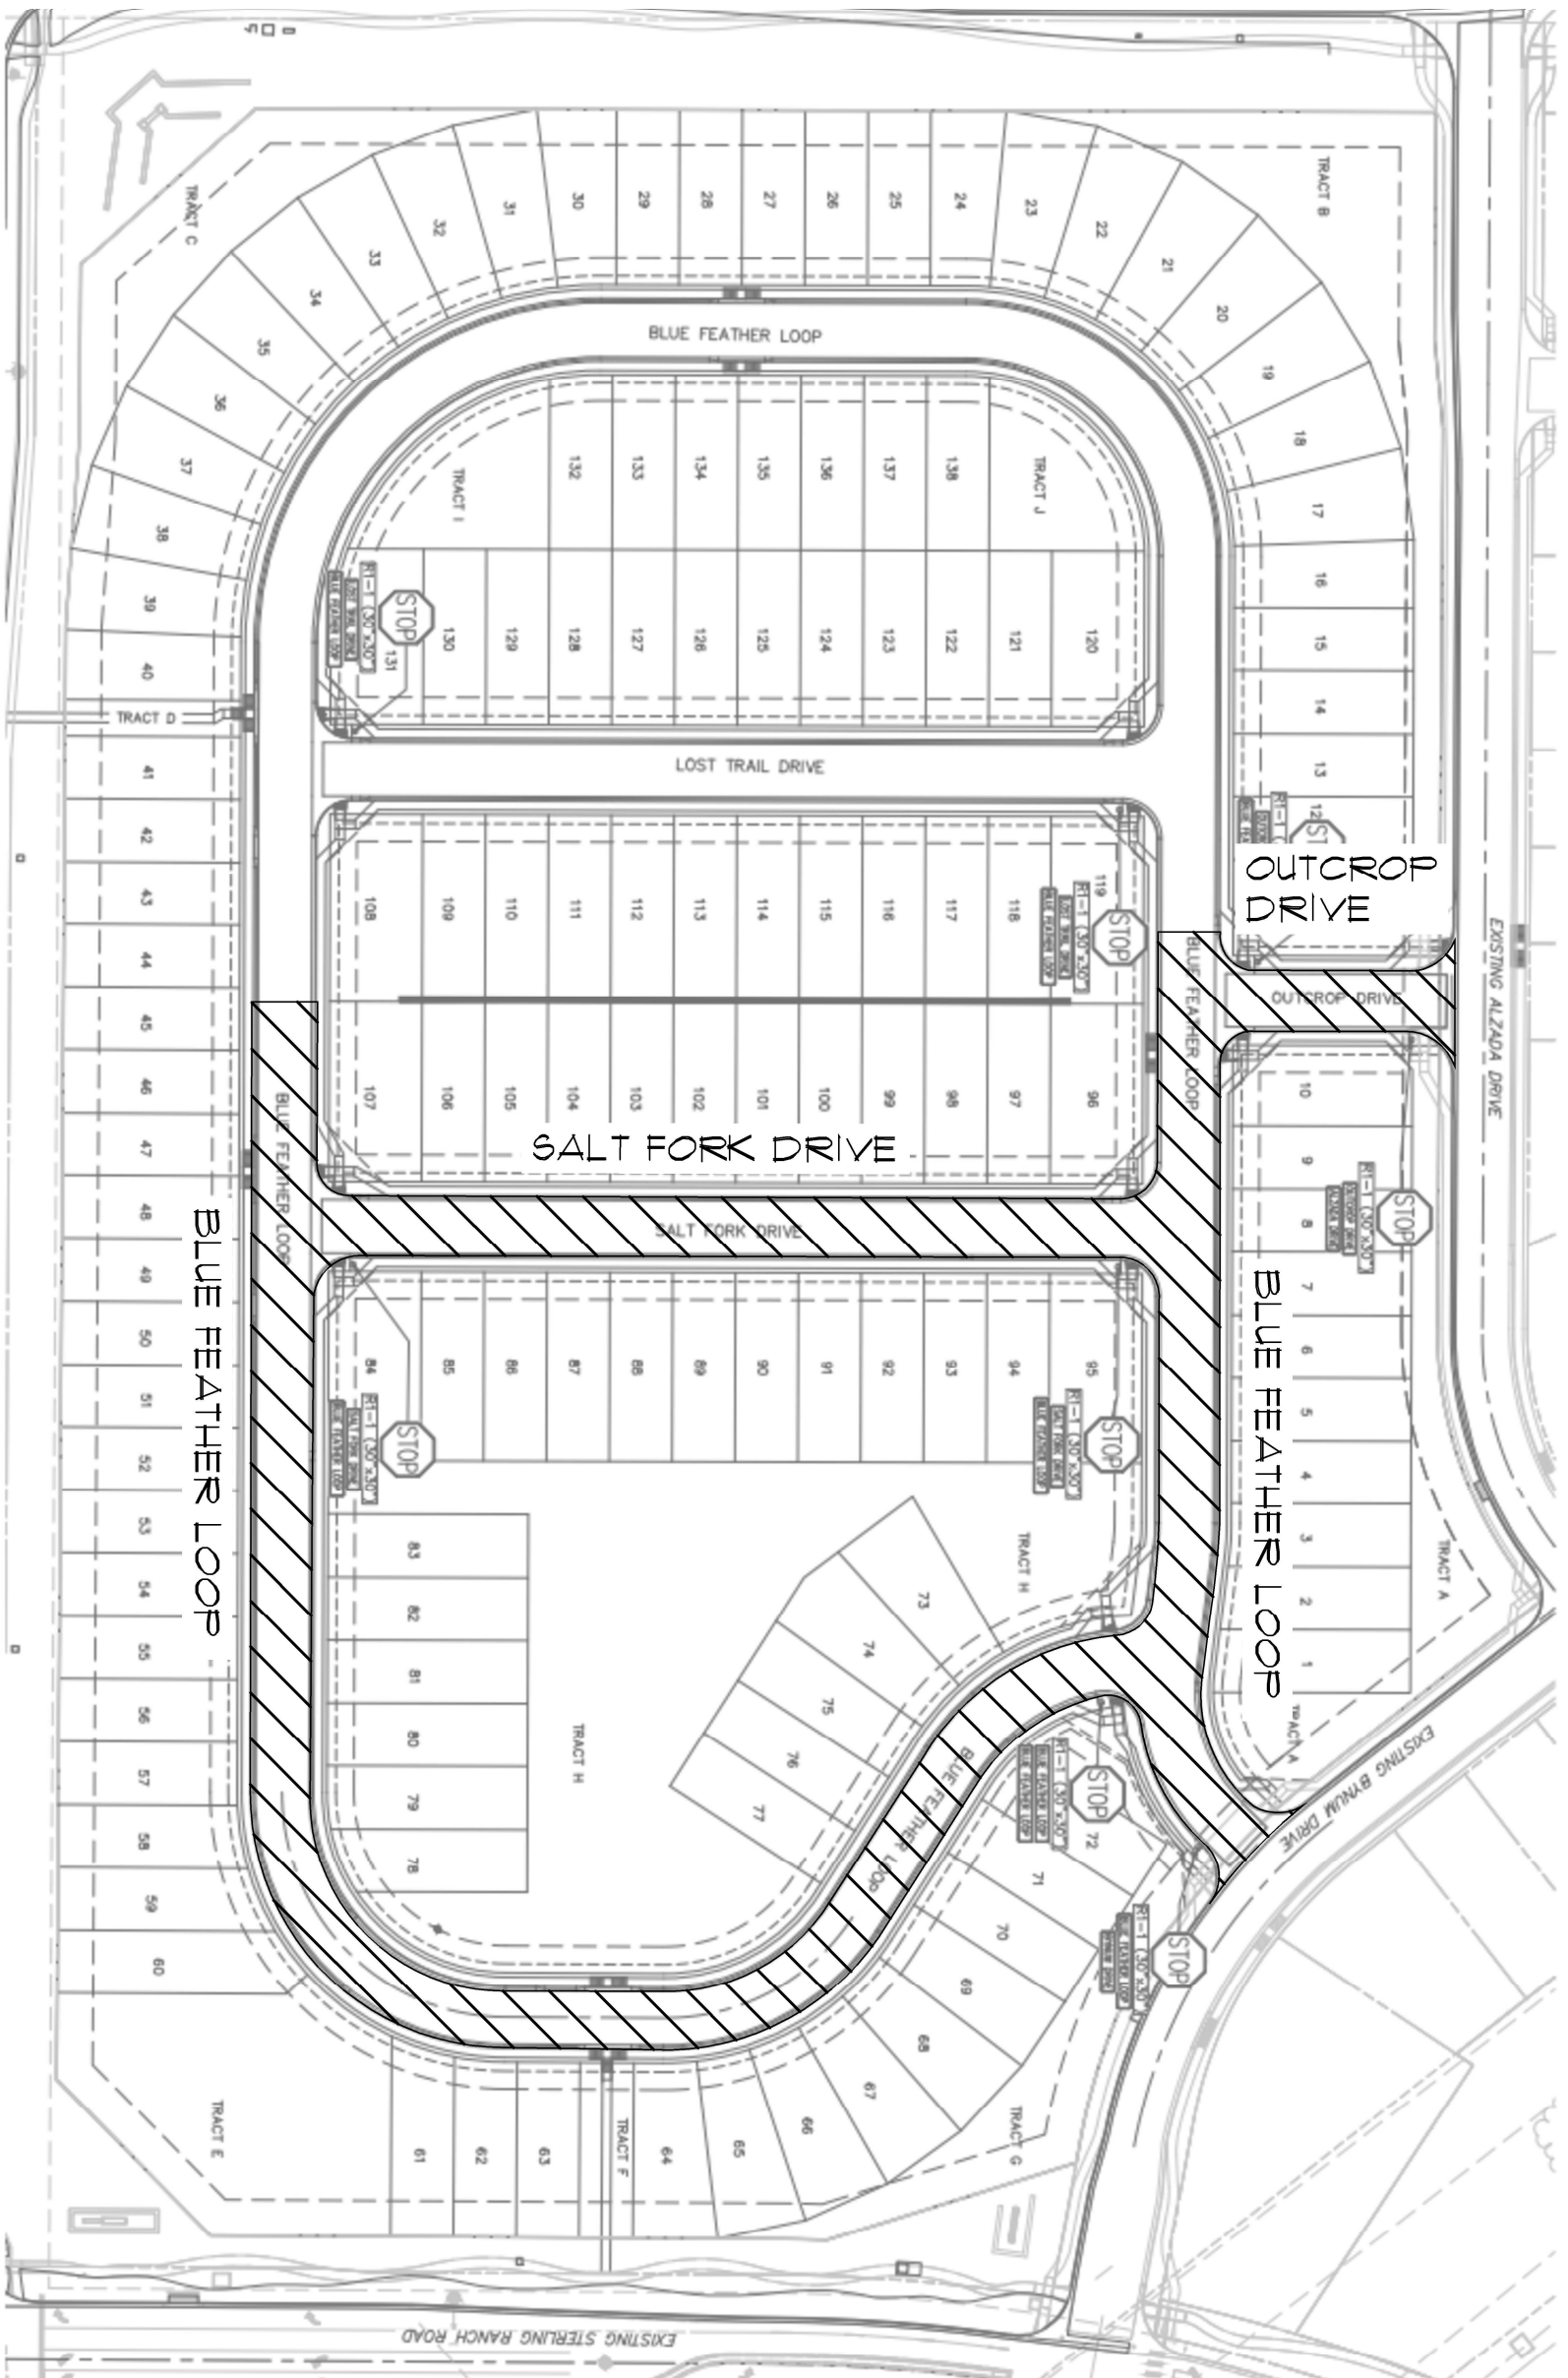
| | FIG-2.2 |

Urban Local: Outcrop Drive,
Salt Fork Drive, and Blue
Feather Loop
ESAL - 292,000

| ENGINEERS DRAWN BY: NM CHECKED BY: TM (SQUEL) 2-26-2024 REVISION: 2-28-2024 | PAVEMENT RECOMMENDATIONS |

Based on the design calculations, the recommended pavement section is presented below and on Figure 2.2

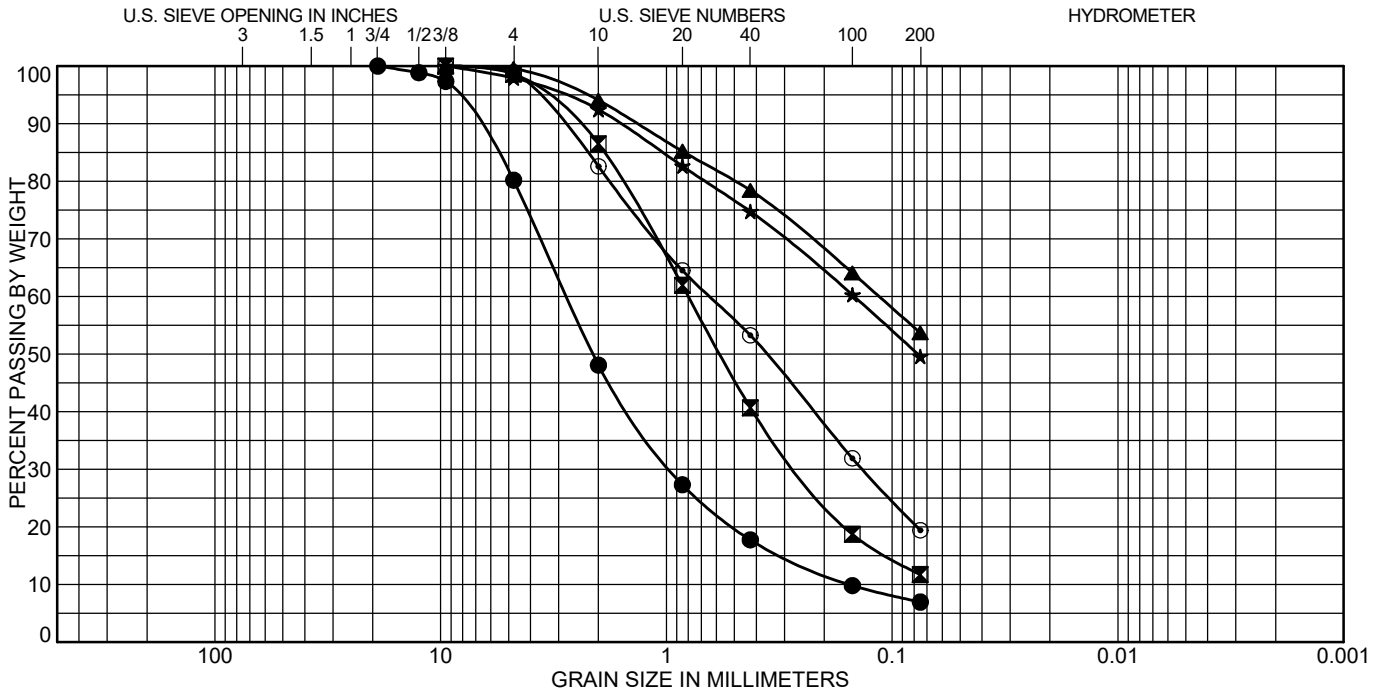
FIGURE No. 7

| COBBLES | GRAVEL | | SAND | | | SILT OR CLAY |

The moisture content for the recovered samples was obtained in the laboratory. Grain-size analysis and Atterberg Limits tests were performed on selected samples for purposes of classification and to develop pertinent engineering properties. A Summary of Laboratory Test Results is presented in Figure 6. Soil Classification Data are presented in Figures 7 and 8. Swell/Consolidation test results are presented in Figure 9.

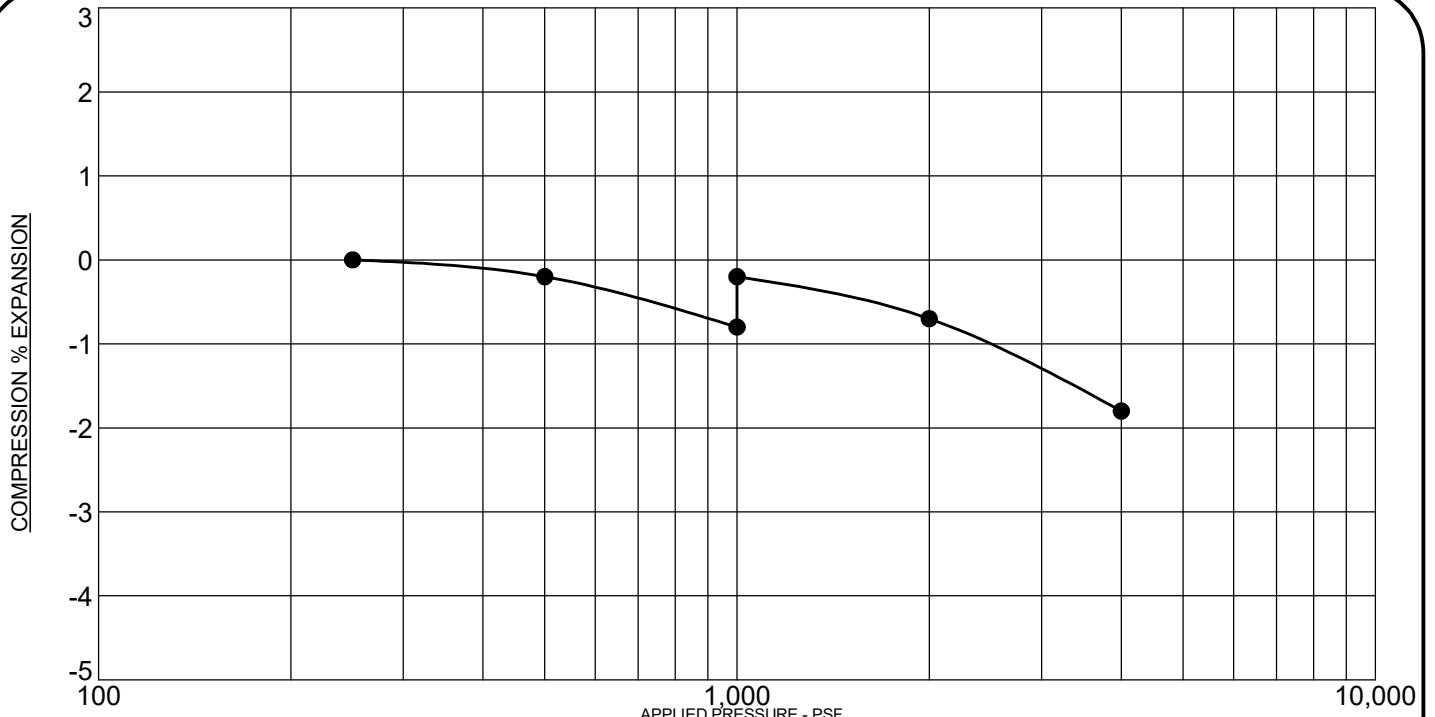
PROJECT: Copper Chase at Sterling Ranch, Filing No. 1, El Paso County, Colorado
 SAMPLE DESCRIPTION: CLAYEY SANDSTONE
 NOTE: SAMPLE WAS INUNDATED WITH WATER AT 1,000 PSF

SAMPLE LOCATION: 4 @ 2 FT
 NATURAL DRY UNIT WEIGHT: 121.2 PCF
 NATURAL MOISTURE CONTENT: 7.9%
 PERCENT SWELL/COMPRESSION: 0.6

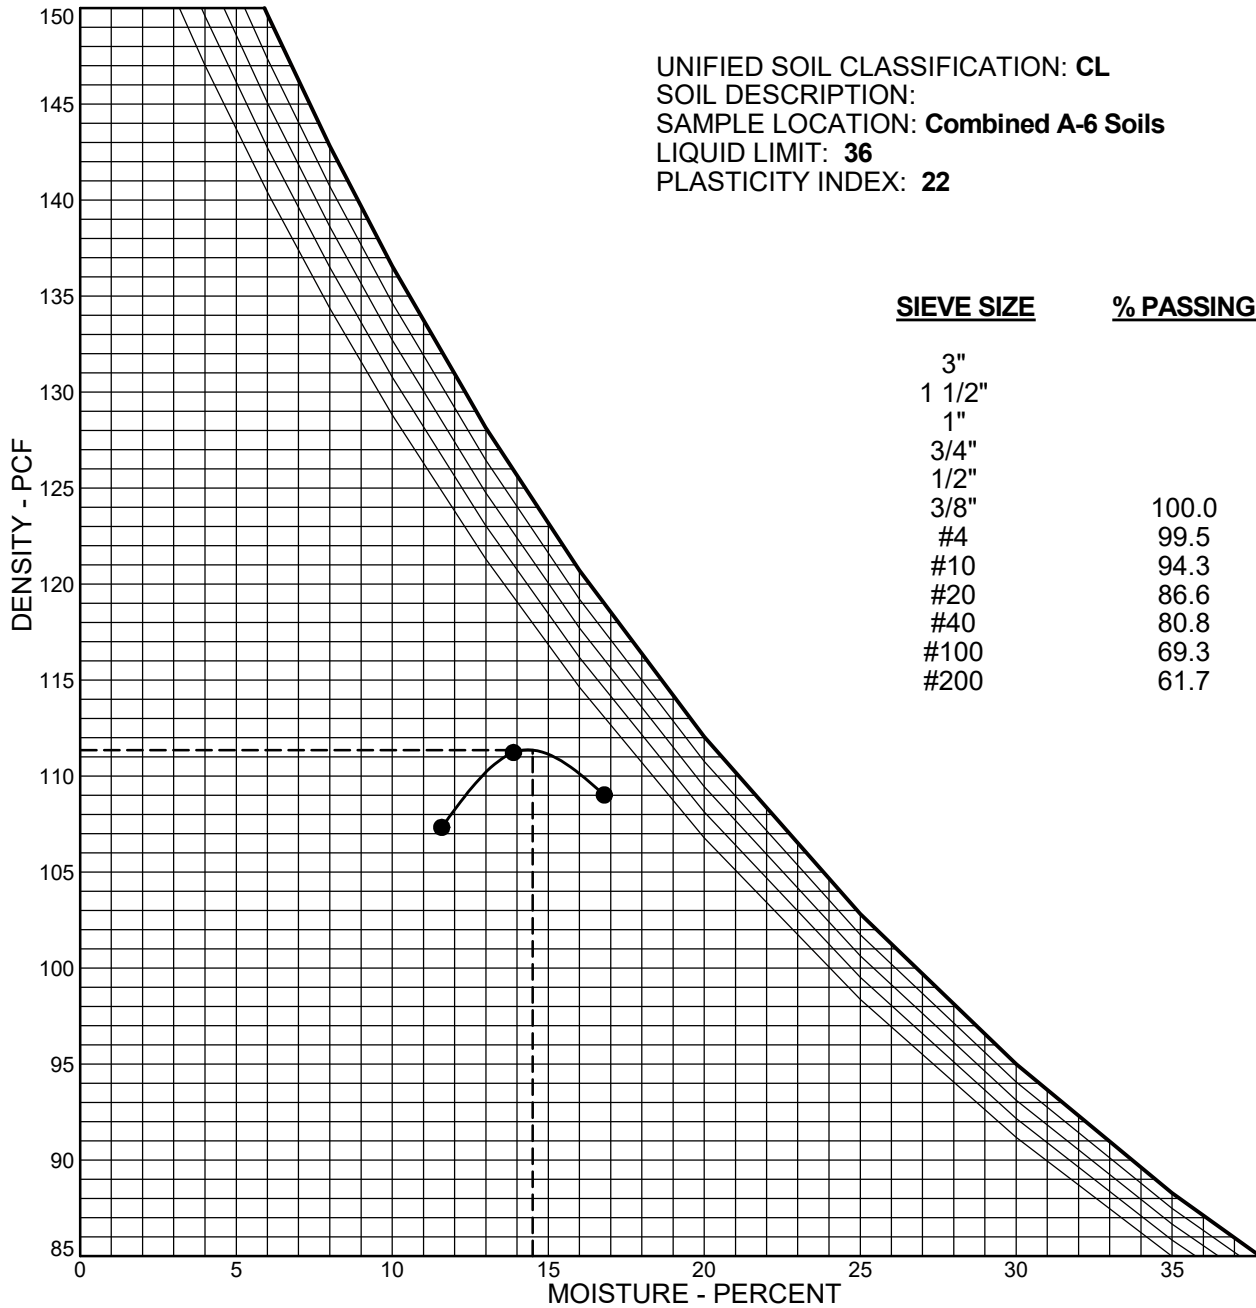
MOISTURE-DENSITY RELATION CURVE

UNIFIED SOIL CLASSIFICATION: CL
SOIL DESCRIPTION:
SAMPLE LOCATION: Combined A-6 Soils
LIQUID LIMIT: 36
PLASTICITY INDEX: 22

DESIGNATION **ASTM D-698**
MAX. DRY DENSITY **111.4 pcf**
OPTIMUM MOISTURE **14.5 %**
FRACTION USED **-4**
MOLD VOLUME **0.0333 cu.ft.**

NOTE: ZERO AIR VOIDS CURVES PLOTTED FOR:
Gs = 2.60
Gs = 2.65
Gs = 2.70
Gs = 2.75
Gs = 2.80

A combined bulk sample of A-6 soil was tested to determine the optimum moisture-density relationship in accordance with ASTM D-698 (Standard Proctor compaction test). California Bearing Ratio, CBR tests were performed at varying densities with moisture content near optimum. At 95% of the maximum Standard Proctor density, the CBR of the bulk sample was 1.24. The Moisture-Density Relation Curve is presented in Figure 10. The CBR Test Results are presented in Figures 11 and 12.

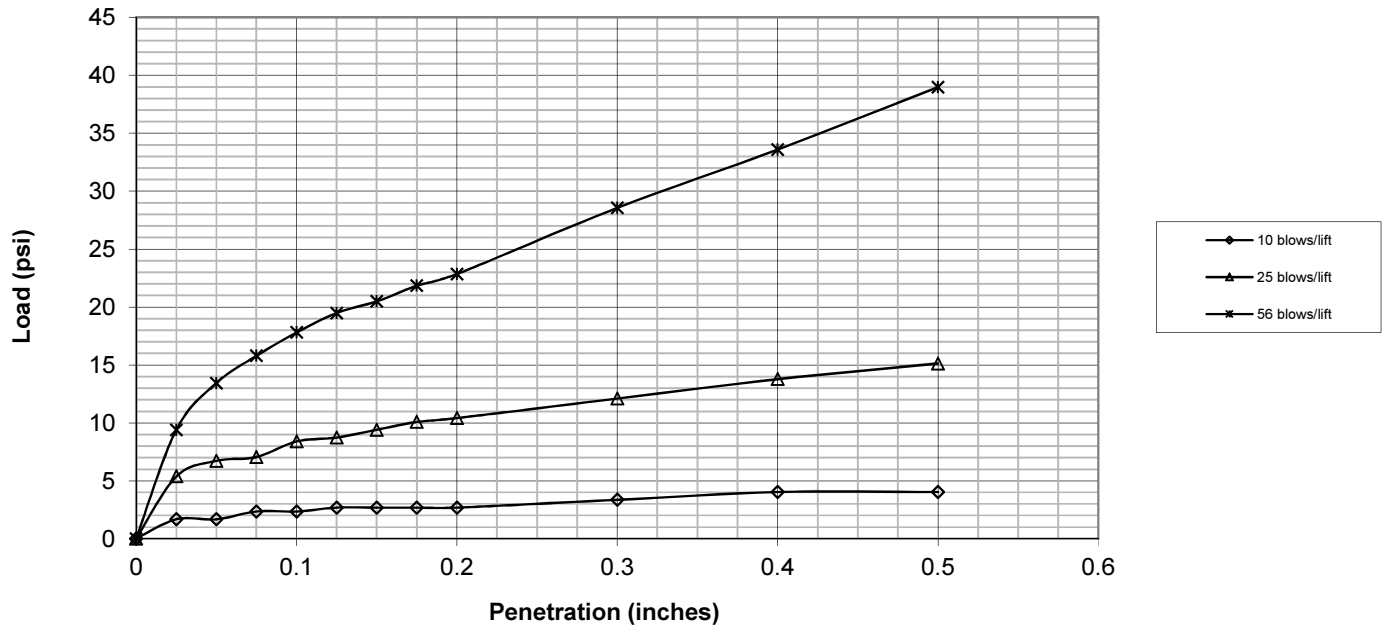
| | Corrected Penetration (in) | Corrected Load (psi) |

| | 10 blows/lift | 25 blows/lift | 56 blows/lift |
|---|---|---|---|
| Percent Expansion (+) / Compression (-) | 0.1% | 3.7% | 2.7% |
| Surcharge Weight (lbs) | 12.60 | 12.60 | 12.60 |

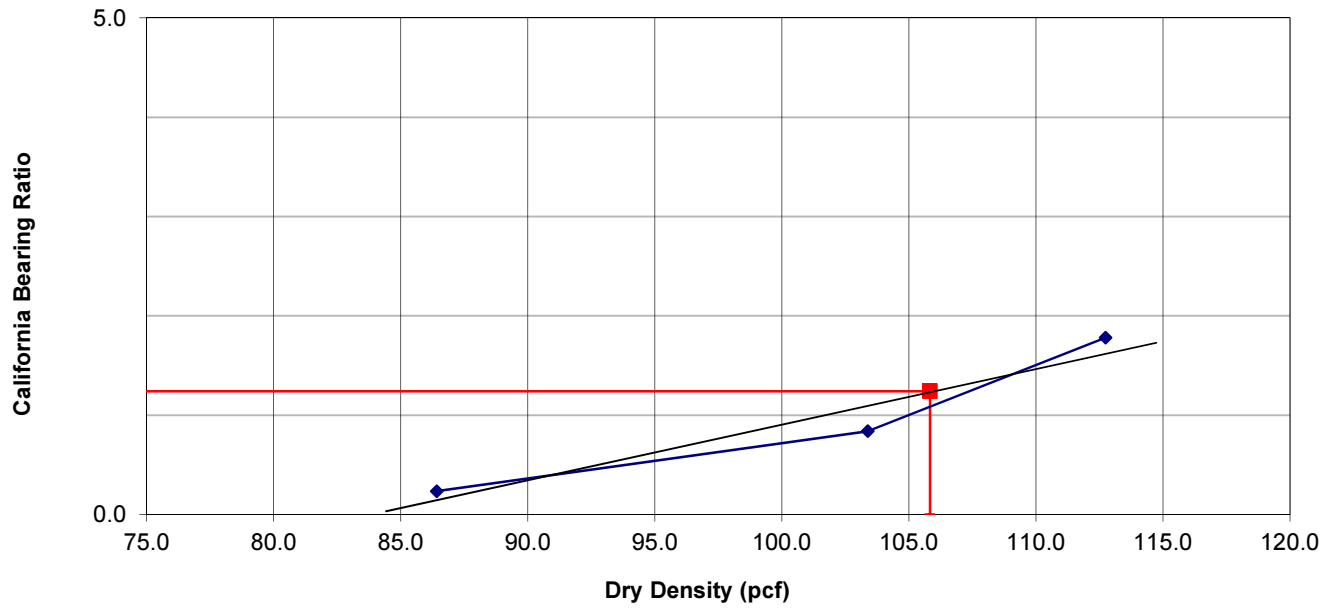
| California Bearing Ratio | 1.24 |
| Dry Density (pcf) | 111.4 |

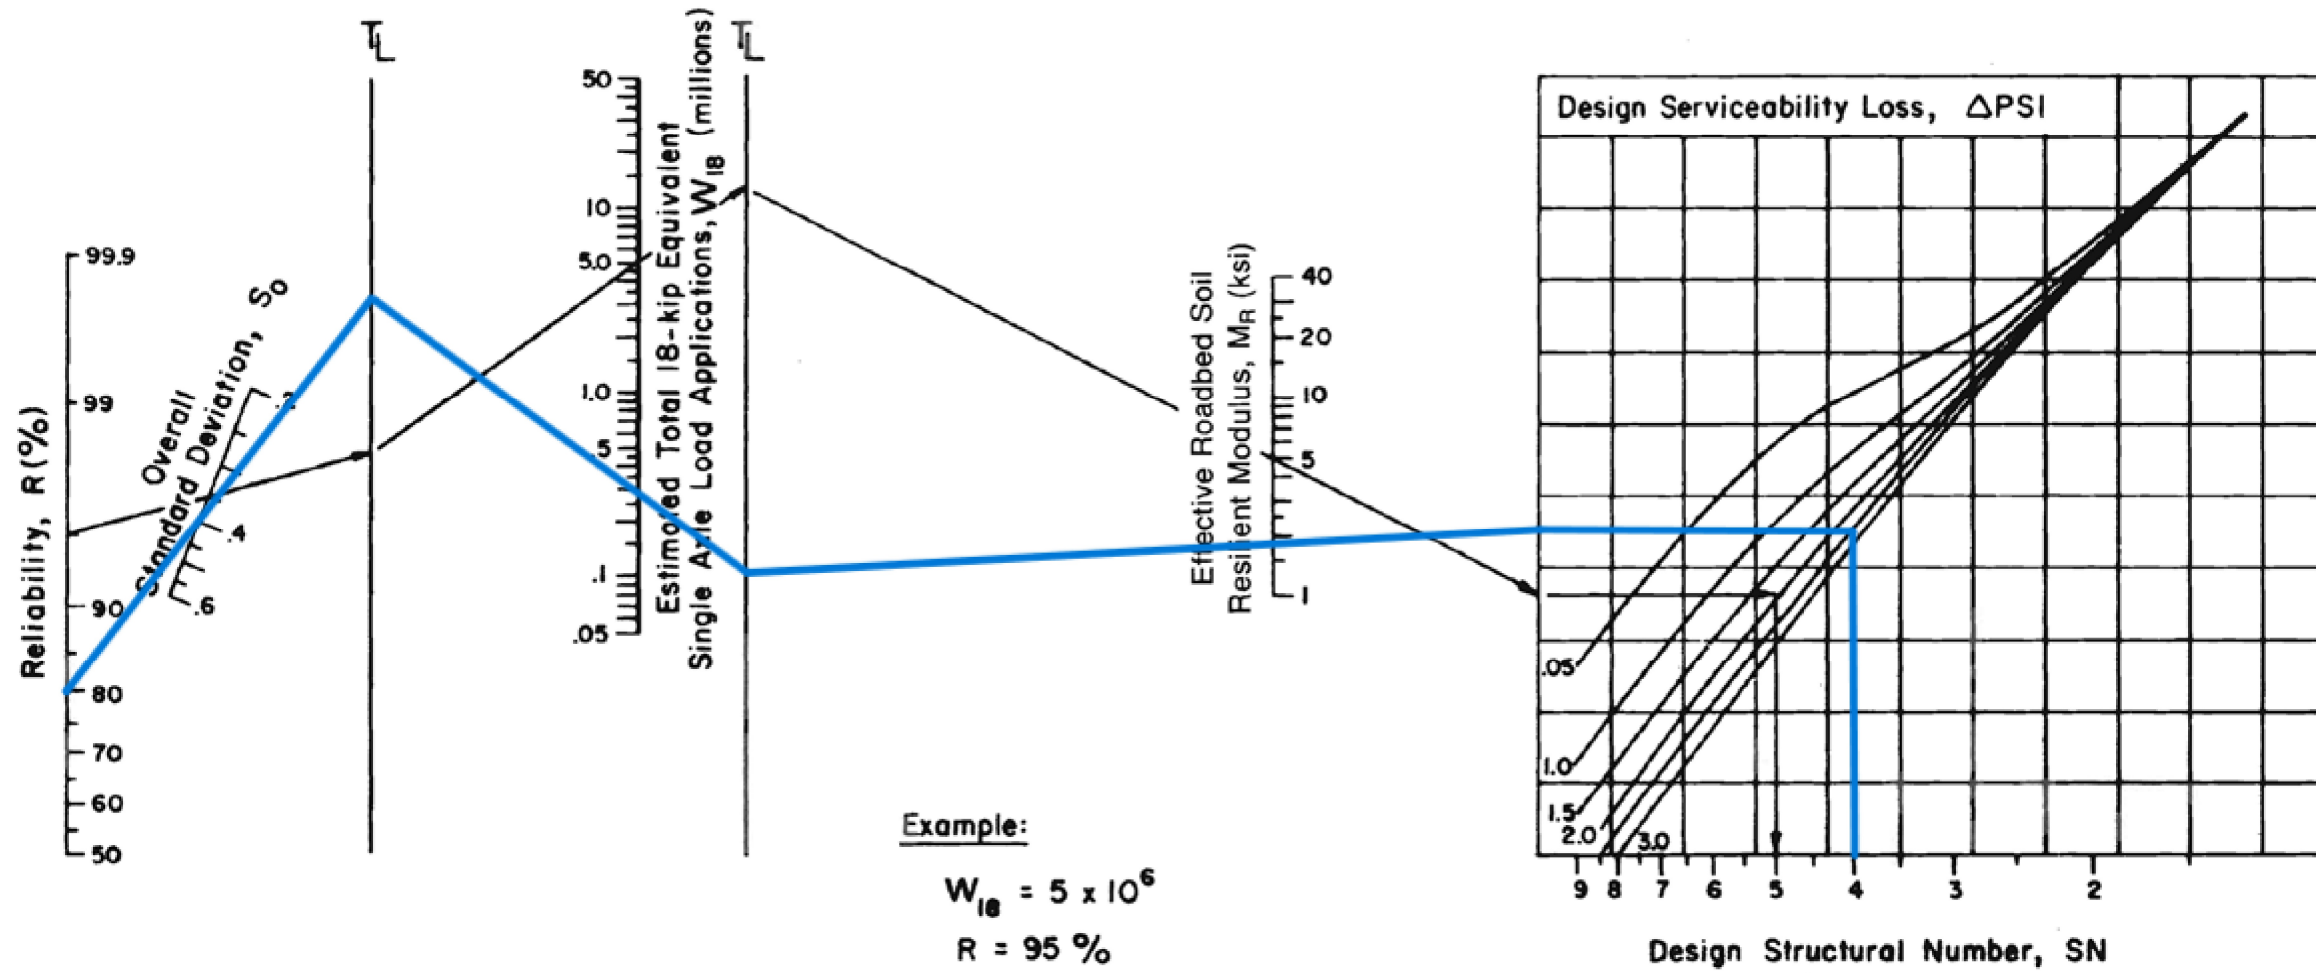
This is the nomograph for this project. Using the parameters presented in our report results in a Structural Number of approximately 4.0. Our calculated SN was 4.04.

Example:

- W₁₈ = 5 x 10⁶
- R = 95 %
- S_o = 0.35
- M_R = 5000 psi
- ΔPSI = 1.9
- Solution: SN = 5.0

$$\log_{10} \frac{W}{18} = z_R * S_o + 9.36 * \log_{10} (SN+1) - 0.20 + \frac{\log_{10} \left[\frac{\Delta PSI}{4.2 - 1.5} \right]}{0.40 + \frac{1094}{(SN+1)^{5.19}}} + 2.32 * \log_{10} M_R - 8.07$$
