ENTECH
ENGINEERING, INC.

**SOIL, GEOLOGY, AND GEOLOGIC HAZARD STUDY
WINSOME SUBDIVISION – FILING NO. 2
A PORTION OF PARCEL NO. 51000-00-493
17480 MERIDIAN ROAD NORTH
EL PASO COUNTY, COLORADO**

January 26, 2021

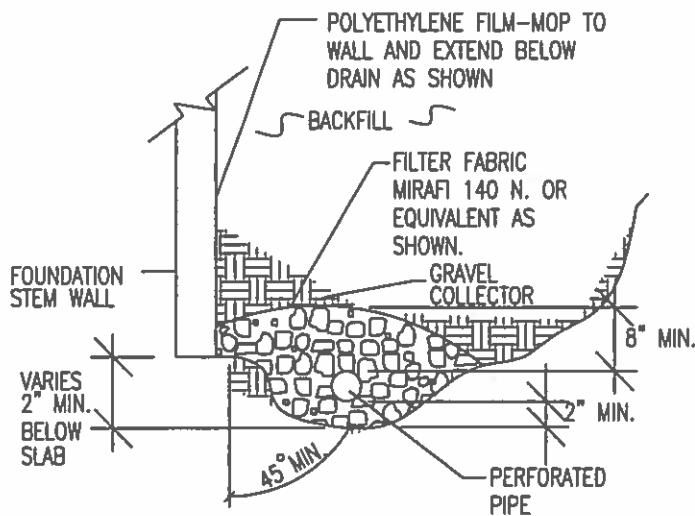
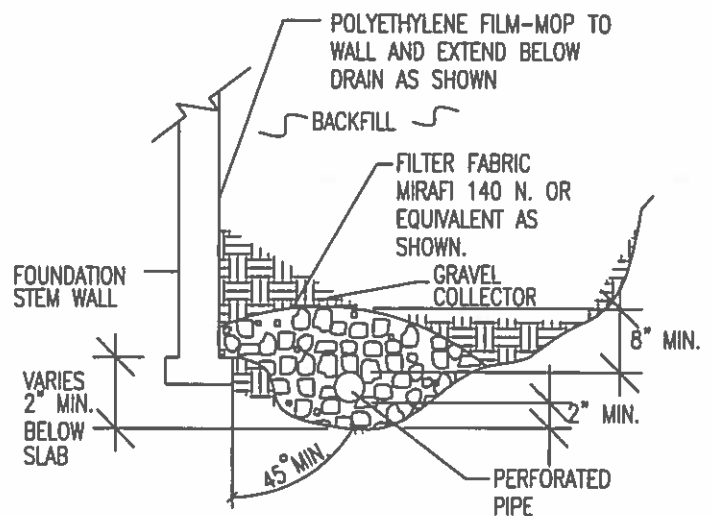
-GRAVEL SIZE IS RELATED TO DIAMETER OF PIPE PERFORATIONS-85% GRAVEL GREATER THAN 2x PERFORATION DIAMETER.

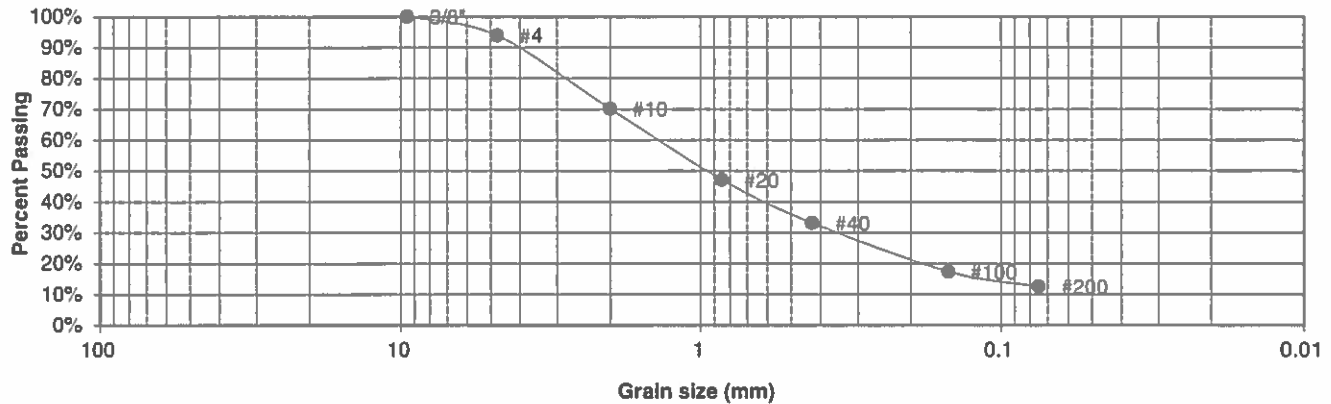
<u>UNIFIED CLASSIFICATION</u>	SM	<u>CLIENT</u>	WINSOME, LLC
<u>SOIL TYPE #</u>	1	<u>PROJECT</u>	HODGEN AND MERIDIAN
<u>TEST BORING #</u>	1	<u>JOB NO.</u>	202508
<u>DEPTH (FT)</u>	2-3	<u>TEST BY</u>	BL

Sieve Analysis Grain Size Distribution

<u>U.S. Sieve #</u>	<u>Percent Finer</u>
3"	
1 1/2"	
3/4"	
1/2"	
3/8"	100.0%
4	93.9%
10	70.1%
20	47.1%
40	33.1%
100	17.3%
200	12.5%

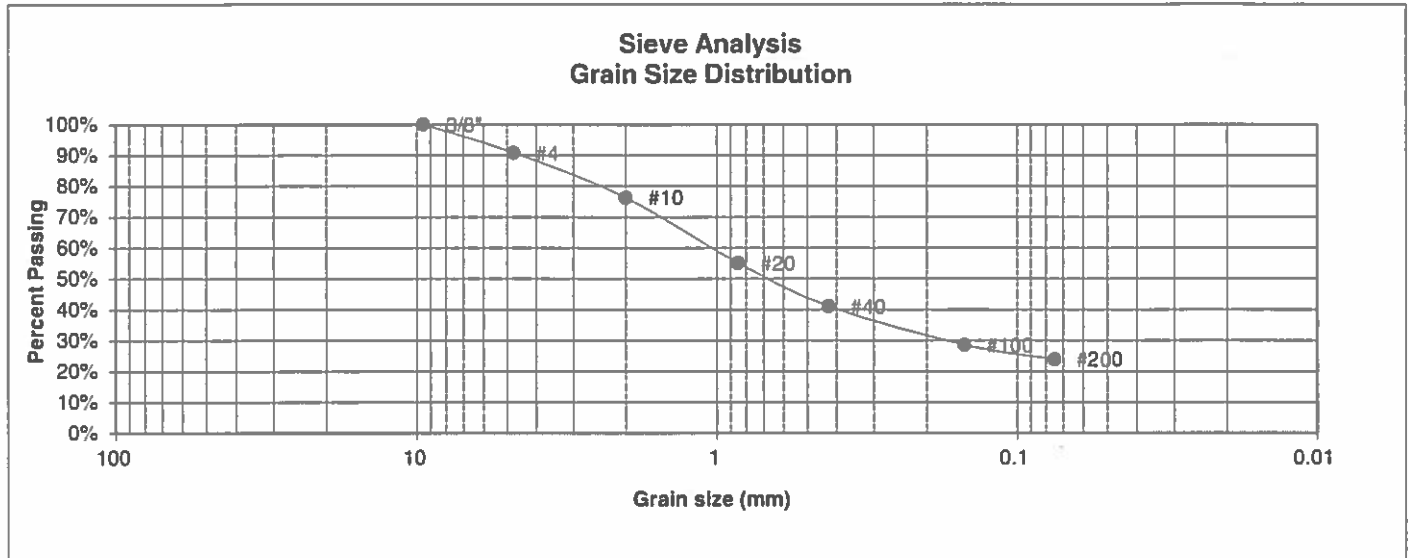
UNIFIED CLASSIFICATION	SM	CLIENT	WINSOME, LLC
SOIL TYPE #	2	PROJECT	HODGEN AND MERIDIAN
TEST BORING #	1	JOB NO.	202508
DEPTH (FT)	15	TEST BY	BL

<u>U.S. Sieve #</u>	<u>Percent Finer</u>
3"	
1 1/2"	
3/4"	
1/2"	
3/8"	100.0%
4	90.8%
10	76.2%
20	55.1%
40	41.1%
100	28.5%
200	23.9%

<u>Atterberg Limits</u>	
Plastic Limit	NP
Liquid Limit	NV
Plastic Index	NP

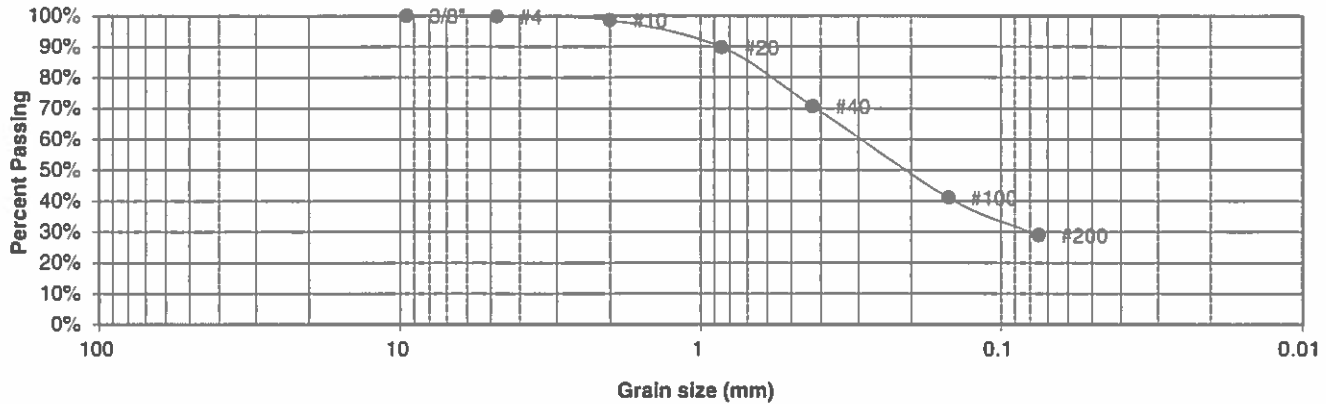
FIG NO.:
C-4

CLIENT	WINSOME, LLC
PROJECT	HODGEN AND MERIDIAN
JOB NO.	202508
TEST BY	BL

Sieve Analysis Grain Size Distribution

U.S. Sieve #	Percent Finer
3"	
1 1/2"	
3/4"	
1/2"	
3/8"	100.0%
4	99.8%
10	98.6%
20	89.7%
40	70.7%
100	41.0%
200	29.0%

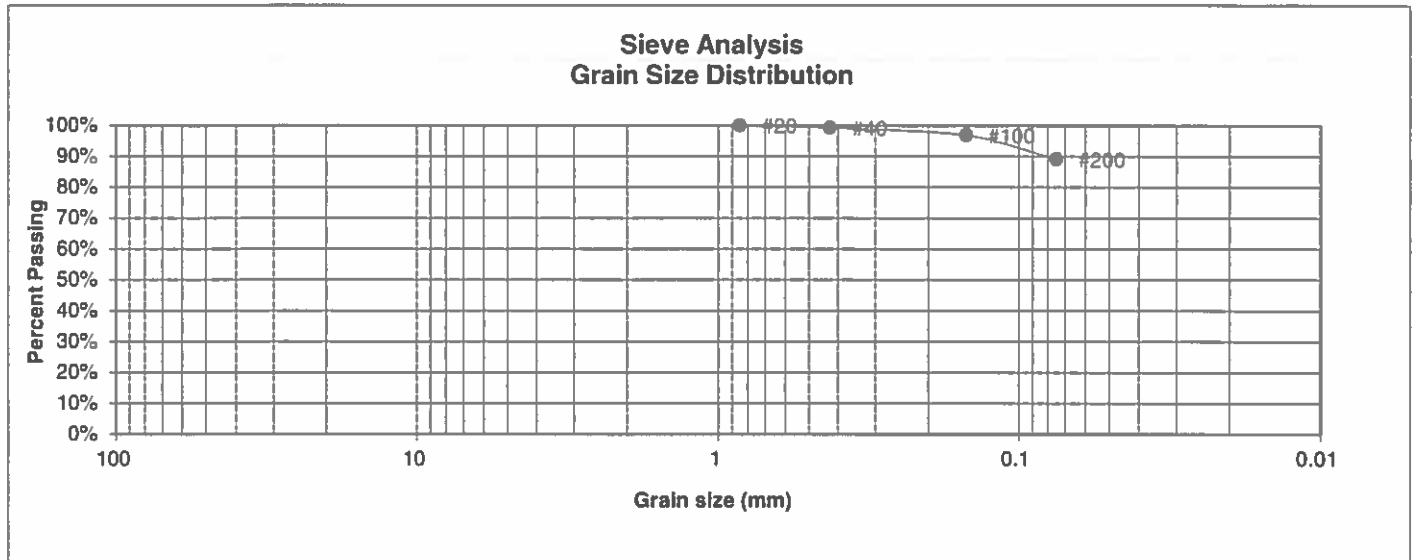
FIG NO.:
C-5

<u>UNIFIED CLASSIFICATION</u>	CL	<u>CLIENT</u>	WINSOME, LLC
<u>SOIL TYPE #</u>	3	<u>PROJECT</u>	HODGEN AND MERIDIAN
<u>TEST BORING #</u>	2	<u>JOB NO.</u>	202508
<u>DEPTH (FT)</u>	5	<u>TEST BY</u>	BL

<u>U.S. Sieve #</u>	<u>Percent Finer</u>
3"	
1 1/2"	
3/4"	
1/2"	
3/8"	
4	
10	
20	100.0%
40	99.2%
100	96.9%
200	89.1%

<u>Swell</u>	
Moisture at start	13.8%
Moisture at finish	21.3%
Moisture increase	7.5%
Initial dry density (pcf)	104
Swell (psf)	850

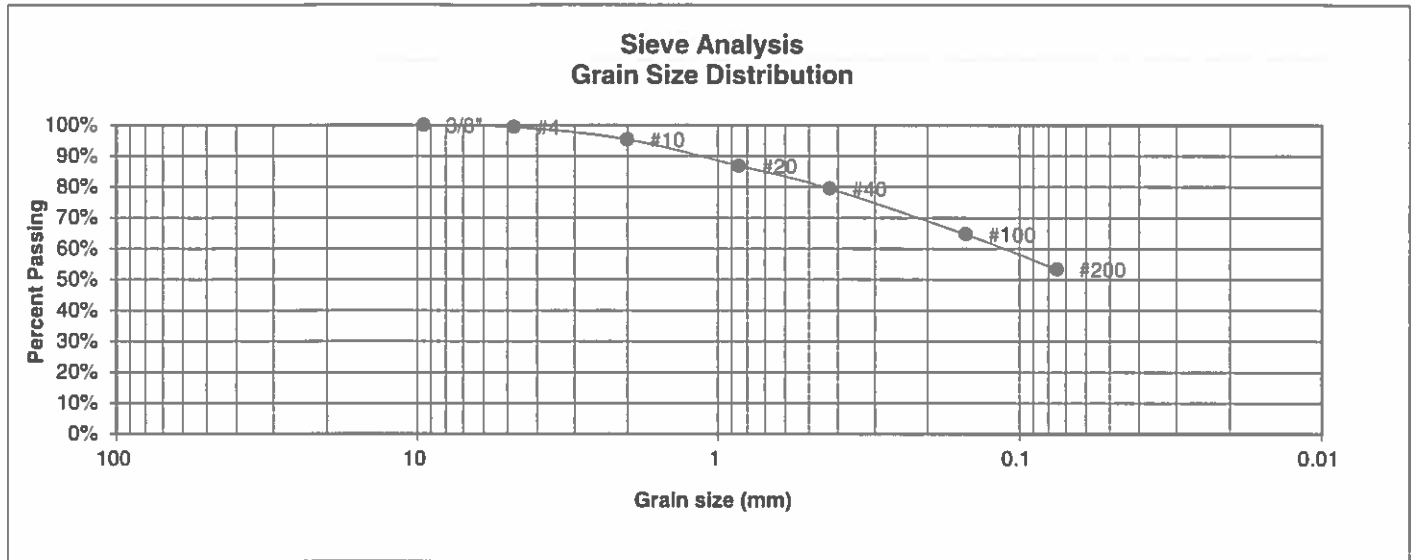
<u>UNIFIED CLASSIFICATION</u>	CL	<u>CLIENT</u>	WINSOME, LLC
<u>SOIL TYPE #</u>	3	<u>PROJECT</u>	HODGEN AND MERIDIAN
<u>TEST BORING #</u>	4	<u>JOB NO.</u>	202508
<u>DEPTH (FT)</u>	20	<u>TEST BY</u>	BL

<u>U.S. Sieve #</u>	<u>Percent Finer</u>
3"	
1 1/2"	
3/4"	
1/2"	
3/8"	100.0%
4	99.4%
10	95.4%
20	86.8%
40	79.4%
100	64.7%
200	53.3%

<u>Atterberg Limits</u>	
Plastic Limit	16
Liquid Limit	29
Plastic Index	13

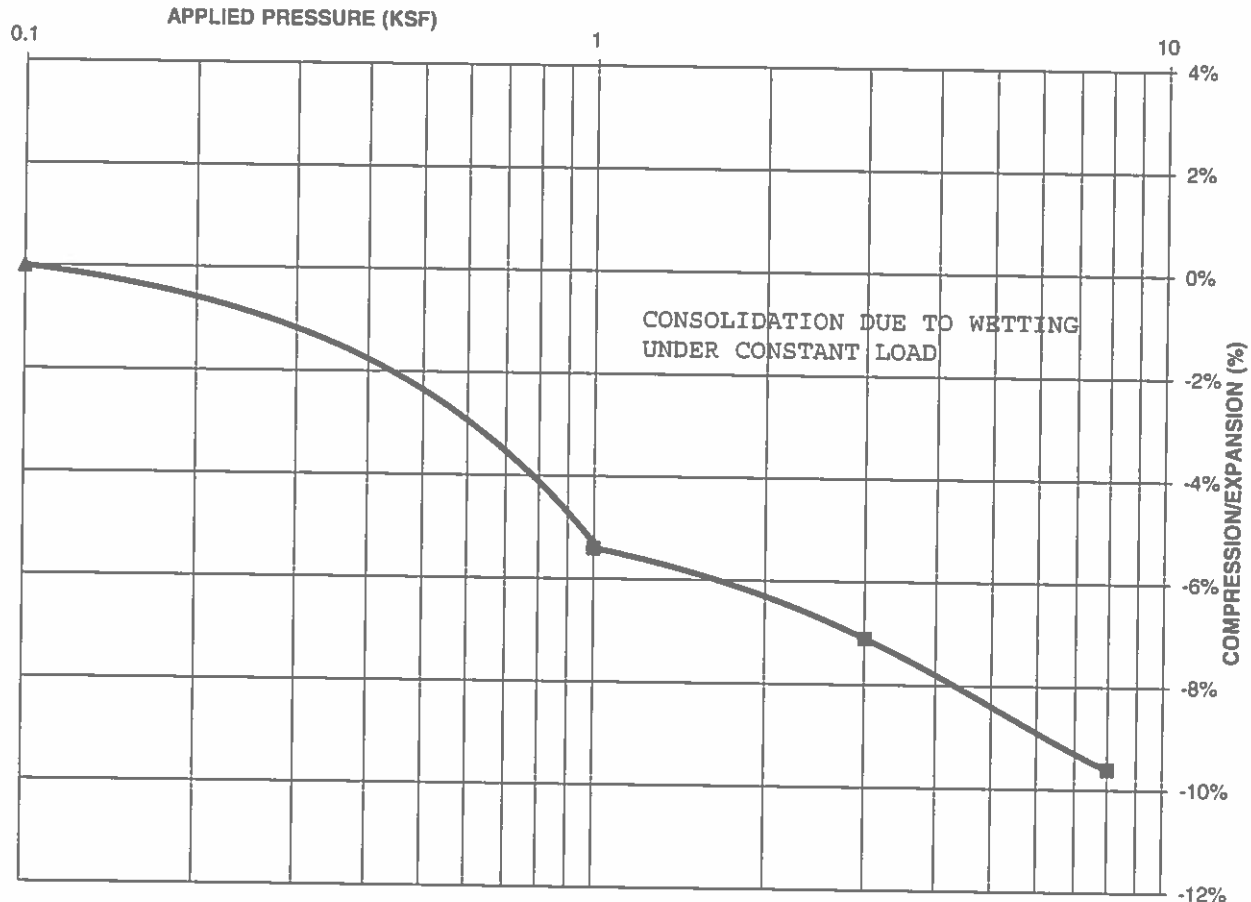
TEST BORING #	4	DEPTH(ft)	20
DESCRIPTION	CL	SOIL TYPE	3
NATURAL UNIT DRY WEIGHT (PCF)	107		
NATURAL MOISTURE CONTENT	21.8%		
SWELL/CONSOLIDATION (%)	-0.1%

SWELL CONSOLIDATION
