**SOIL, GEOLOGY, AND GEOLOGIC HAZARD STUDY  
WINSOME SUBDIVISION – FILING NO. 2  
A PORTION OF PARCEL NO. 51000-00-493  
17480 MERIDIAN ROAD NORTH  
EL PASO COUNTY, COLORADO**

January 26, 2021  
Revised June 25, 2021

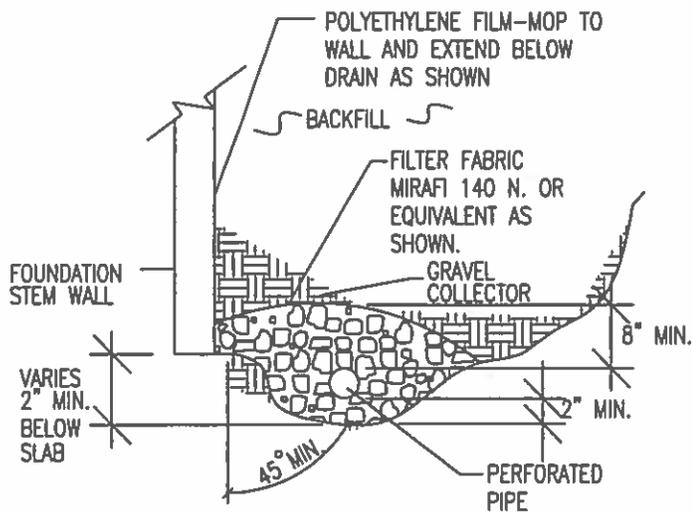
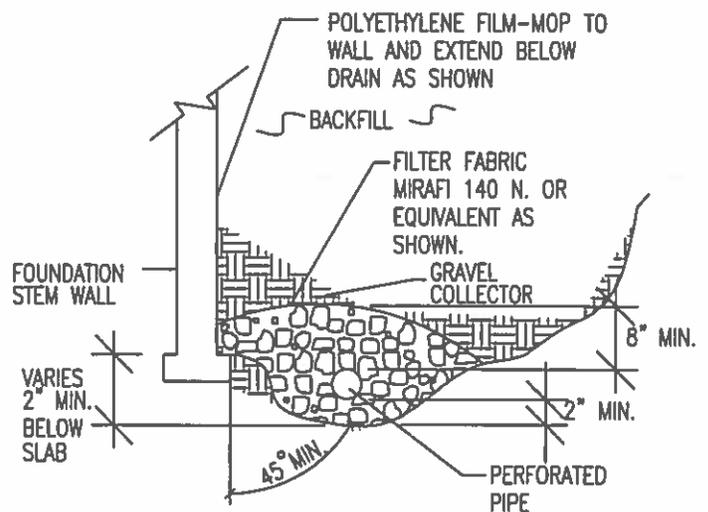
NOTES:

-GRAVEL SIZE IS RELATED TO DIAMETER OF PIPE PERFORATIONS-85% GRAVEL GREATER THAN 2x PERFORATION DIAMETER.

- Figure 1: Vicinity Map
- Figure 2: USGS Map
- Figure 3: Site Plan/Testing Location Map
- Figure 4: Soil Survey Map
- Figure 5: Eastonville Quadrangle Geology Map
- Figure 6: Geology Map/Engineering Geology
- Figure 7: Floodplain Map
- Figure 8: Typical Perimeter Drain Details

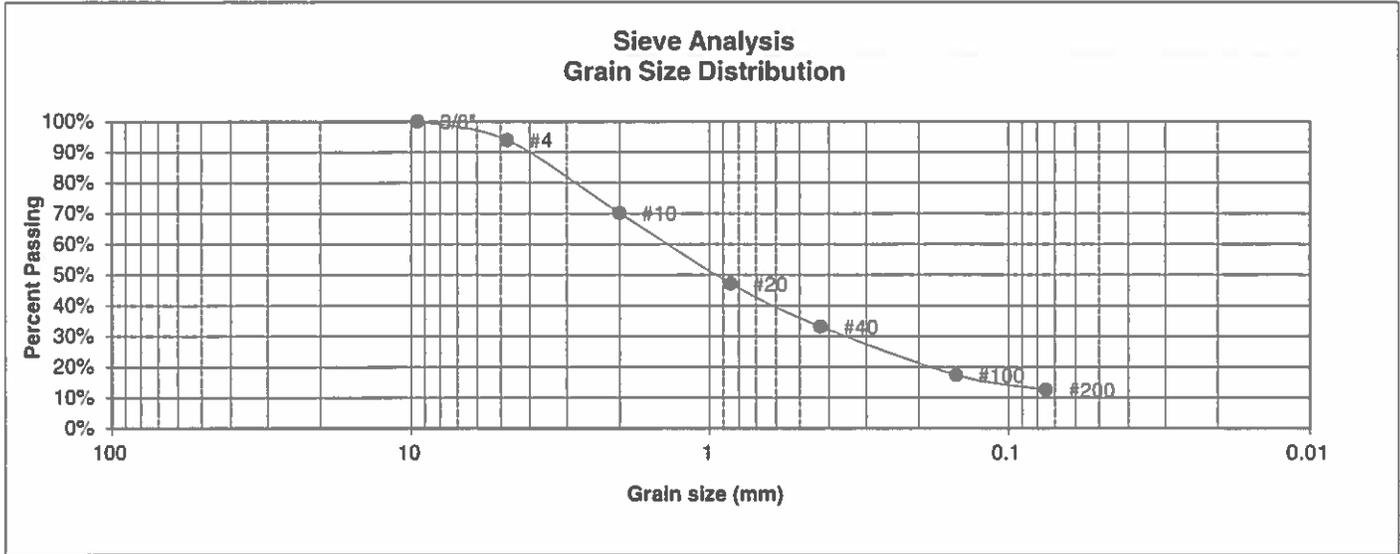
FIG NO:  
C-1

<b>UNIFIED CLASSIFICATION</b>	SM	<b>CLIENT</b>	WINSOME, LLC
<b>SOIL TYPE #</b>	1	<b>PROJECT</b>	HODGEN AND MERIDIAN
<b>TEST BORING #</b>	1	<b>JOB NO.</b>	202508
<b>DEPTH (FT)</b>	2-3	<b>TEST BY</b>	BL

U.S. Sieve #	Percent Finer
3"	
1 1/2"	
3/4"	
1/2"	
3/8"	100.0%
4	93.9%
10	70.1%
20	47.1%
40	33.1%
100	17.3%
200	12.5%

Soil Type 1 is a slightly silty to silty sand (SM-SW, SM). This material was encountered in all of the test borings. The sand was encountered at the existing surface and extended to depths ranging from 1 to 19 feet, and to the termination of Test Boring No. 3 from the previous investigation (20 feet). These soils were encountered at loose to dense states and at dry to moist conditions. Samples tested had 7 to 26 percent of the soil sized particles passing the No. 200 Sieve. Atterberg Limits Testing resulted in the sand being non-plastic.

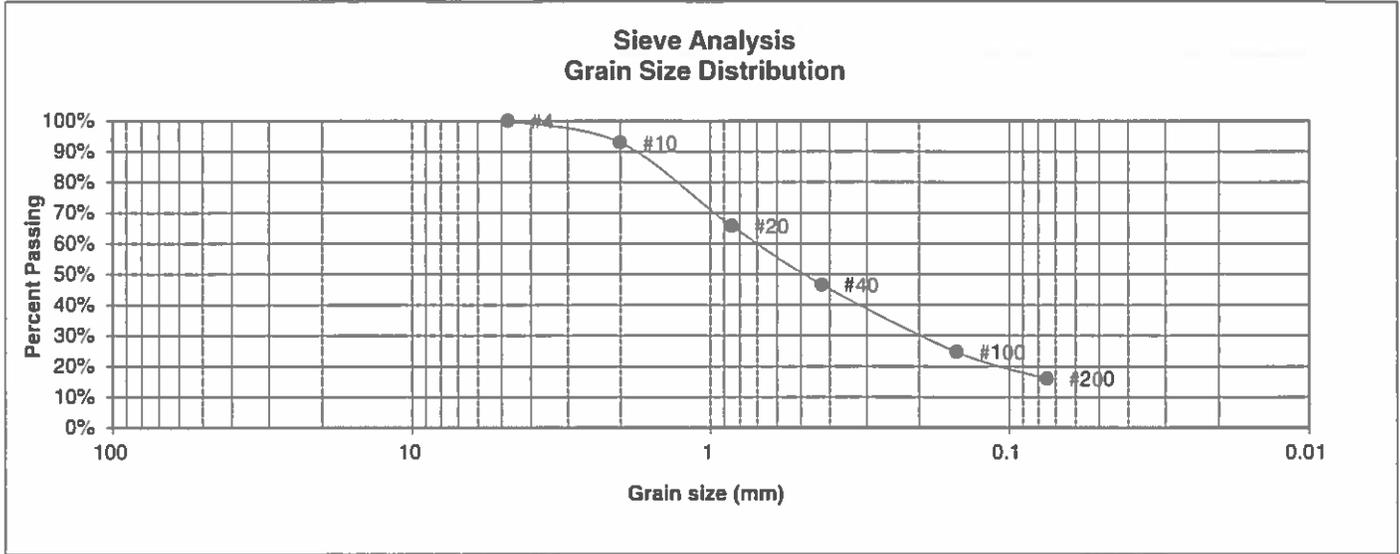
FIG NO.:  
C-2

<b>UNIFIED CLASSIFICATION</b>	SM	<b>CLIENT</b>	WINSOME, LLC
<b>SOIL TYPE #</b>	1	<b>PROJECT</b>	HODGEN AND MERIDIAN
<b>TEST BORING #</b>	4	<b>JOB NO.</b>	202508
<b>DEPTH (FT)</b>	5	<b>TEST BY</b>	BL

U.S. Sieve #	Percent Finer
3"	
1 1/2"	
3/4"	
1/2"	
3/8"	
4	100.0%
10	92.9%
20	65.7%
40	46.6%
100	24.7%
200	15.9%

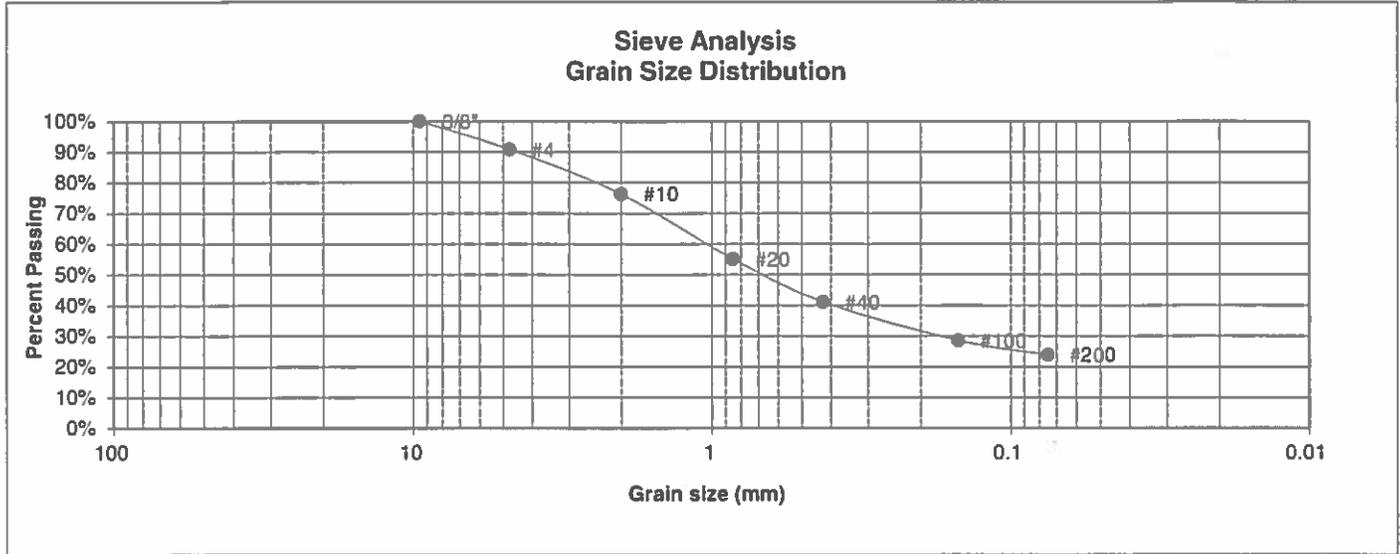
FIG NO.:  
C-3

<b>UNIFIED CLASSIFICATION</b>	SM	<b>CLIENT</b>	WINSOME, LLC
<b>SOIL TYPE #</b>	2	<b>PROJECT</b>	HODGEN AND MERIDIAN
<b>TEST BORING #</b>	1	<b>JOB NO.</b>	202508
<b>DEPTH (FT)</b>	15	<b>TEST BY</b>	BL

U.S. Sieve #	Percent Finer
3"	
1 1/2"	
3/4"	
1/2"	
3/8"	100.0%
4	90.8%
10	76.2%
20	55.1%
40	41.1%
100	28.5%
200	23.9%

Atterberg Limits	
Plastic Limit	NP
Liquid Limit	NV
Plastic Index	NP

Soil Type 2 is a silty to clayey sandstone (SM, SM-SW, SC). This material was encountered in all of the recent test borings, and Test Boring No. 4 from the previous investigation. The sandstone was encountered at dense to very dense states and moist conditions. Samples tested had 10 to 29 percent of the soil sized particles passing the No. 200 sieve. Highly expansive clayey sandstone and claystone are commonly interbedded in the sandstone in the area.

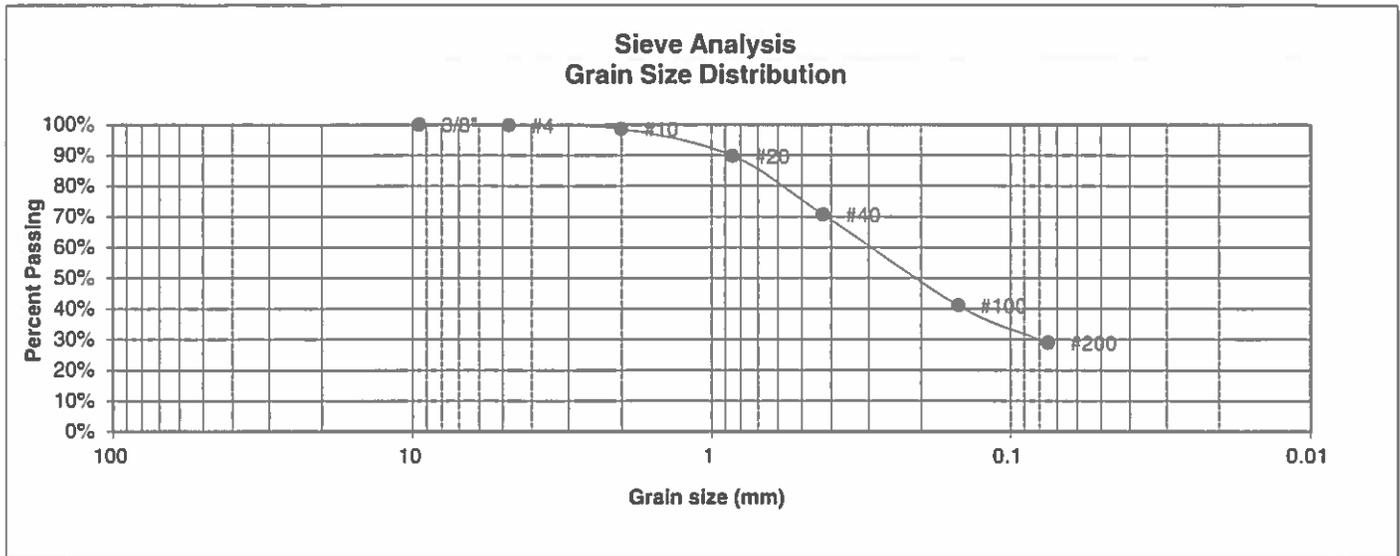
FIG NO.:  
C-4

<b>UNIFIED CLASSIFICATION</b>	SM	<b>CLIENT</b>	WINSOME, LLC
<b>SOIL TYPE #</b>	2	<b>PROJECT</b>	HODGEN AND MERIDIAN
<b>TEST BORING #</b>	3	<b>JOB NO.</b>	202508
<b>DEPTH (FT)</b>	2-3	<b>TEST BY</b>	BL

U.S. Sieve #	Percent Finer
3"	
1 1/2"	
3/4"	
1/2"	
3/8"	100.0%
4	99.8%
10	98.6%
20	89.7%
40	70.7%
100	41.0%
200	29.0%

Atterberg Limits	
Plastic Limit	NP
Liquid Limit	NV
Plastic Index	NP

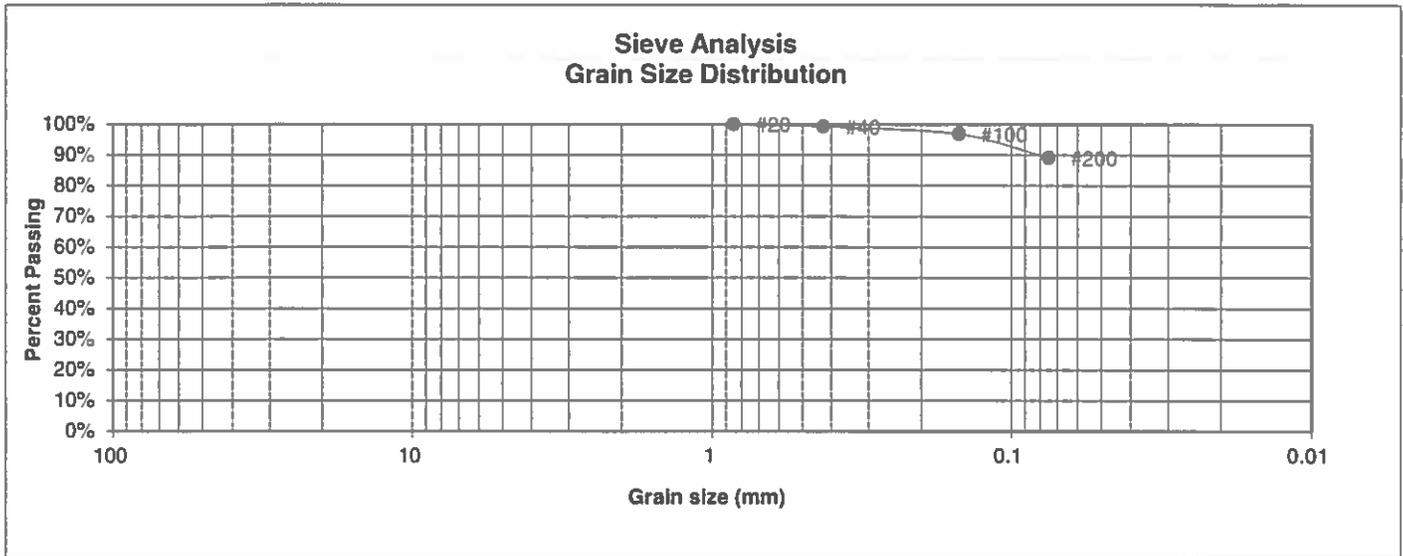
FIG NO:  
C-5

<b>UNIFIED CLASSIFICATION</b>	CL	<b>CLIENT</b>	WINSOME, LLC
<b>SOIL TYPE #</b>	3	<b>PROJECT</b>	HODGEN AND MERIDIAN
<b>TEST BORING #</b>	2	<b>JOB NO.</b>	202508
<b>DEPTH (FT)</b>	5	<b>TEST BY</b>	BL

U.S. Sieve #	Percent Finer
3"	
1 1/2"	
3/4"	
1/2"	
3/8"	
4	
10	
20	100.0%
40	99.2%
100	96.9%
200	89.1%

Soil Type 3 is a sandy claystone (CL). This material was encountered Test Boring No. 1 at 14 feet bgs and extended to the termination of the boring (20 feet). The claystone was encountered at hard consistencies and moist conditions. Samples tested had 74 percent of the soil sized particles passing the No. 200 sieve. Swell/Consolidation Testing resulted in a volume change of 0.9 percent, indicating a low to moderate expansion potential, and a consolidation of 0.1 percent.

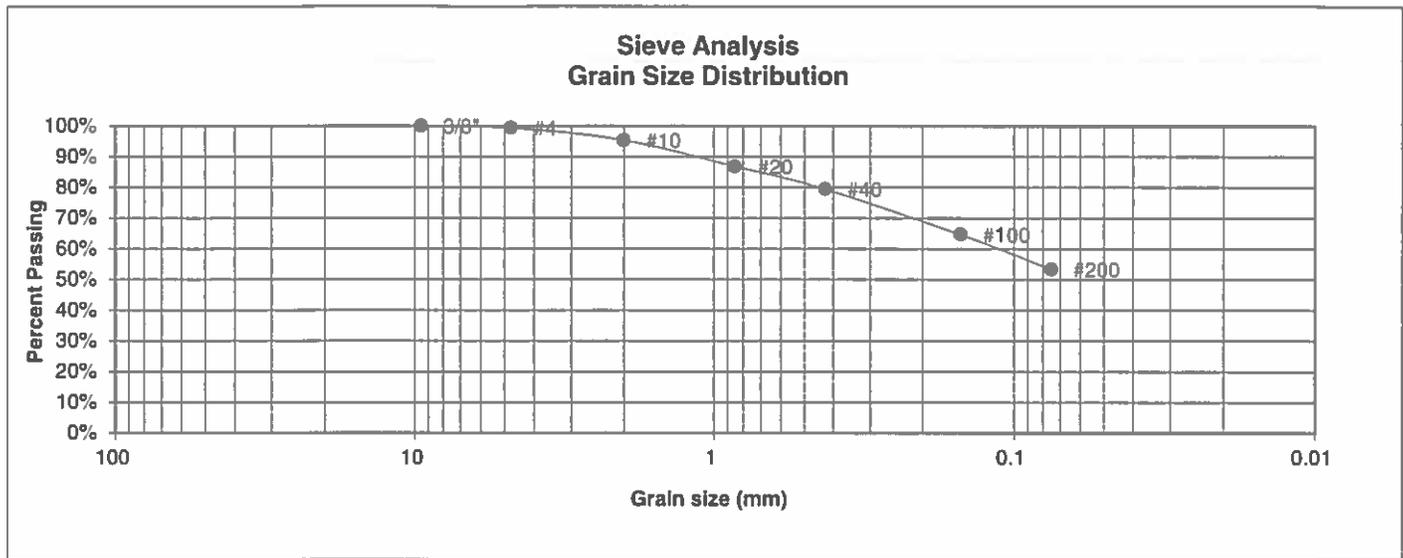
<b>UNIFIED CLASSIFICATION</b>	CL	<b>CLIENT</b>	WINSOME, LLC
<b>SOIL TYPE #</b>	3	<b>PROJECT</b>	HODGEN AND MERIDIAN
<b>TEST BORING #</b>	4	<b>JOB NO.</b>	202508
<b>DEPTH (FT)</b>	20	<b>TEST BY</b>	BL

U.S. Sieve #	Percent Finer
3"	
1 1/2"	
3/4"	
1/2"	
3/8"	100.0%
4	99.4%
10	95.4%
20	86.8%
40	79.4%
100	64.7%
200	53.3%

Atterberg Limits	
Plastic Limit	16
Liquid Limit	29
Plastic Index	13

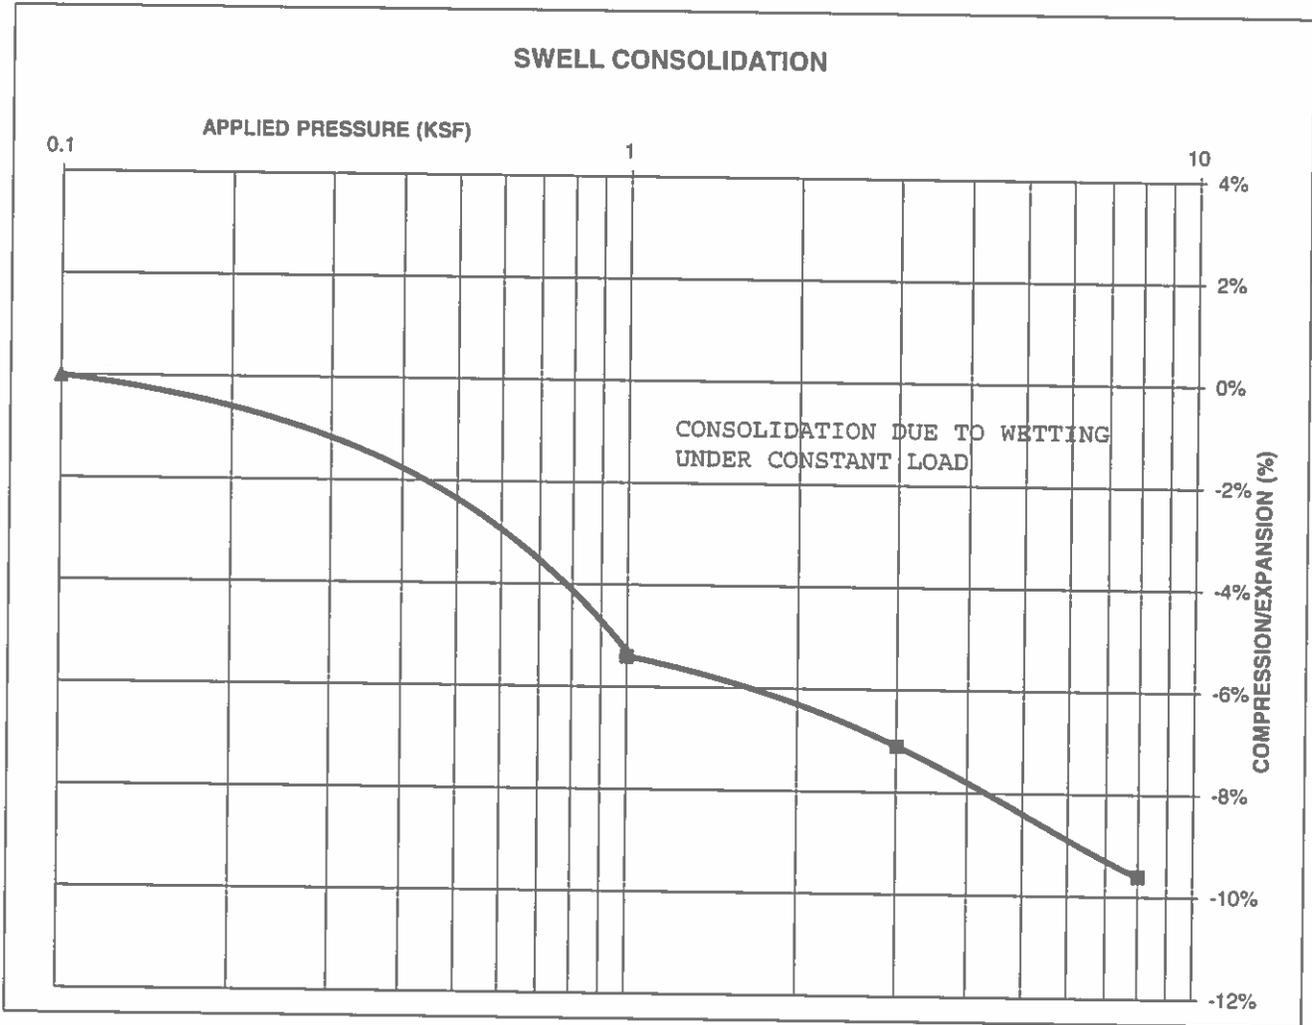
TEST BORING #	4	DEPTH(ft)	20
DESCRIPTION	CL	SOIL TYPE	3
NATURAL UNIT DRY WEIGHT (PCF)			107
NATURAL MOISTURE CONTENT			21.8%
SWELL/CONSOLIDATION (%)			-0.1%
