**From:** Hunyadi - DNR, John  
**Sent:** Tuesday, October 08, 2019 1:06 PM  
**To:** Charles Cothern  
**Cc:** Cothern, Charles; Durham, Charlene  
**Subject:** Re: The Gardens at North Carefree Detention Pond Breach Analysis

Attached is a breach analysis for two detention ponds under design for a subdivision being processed in El Paso County.

**ESTIMATION OF DAM BREACH PARAMETERS  
USING THE MACDONALD & LANGRIDGE-MONOPOLIS OR WASHINGTON STATE METHODS  
WITH ALL FAILURE TIMES ESTIMATED BY WASHINGTON STATE METHOD**

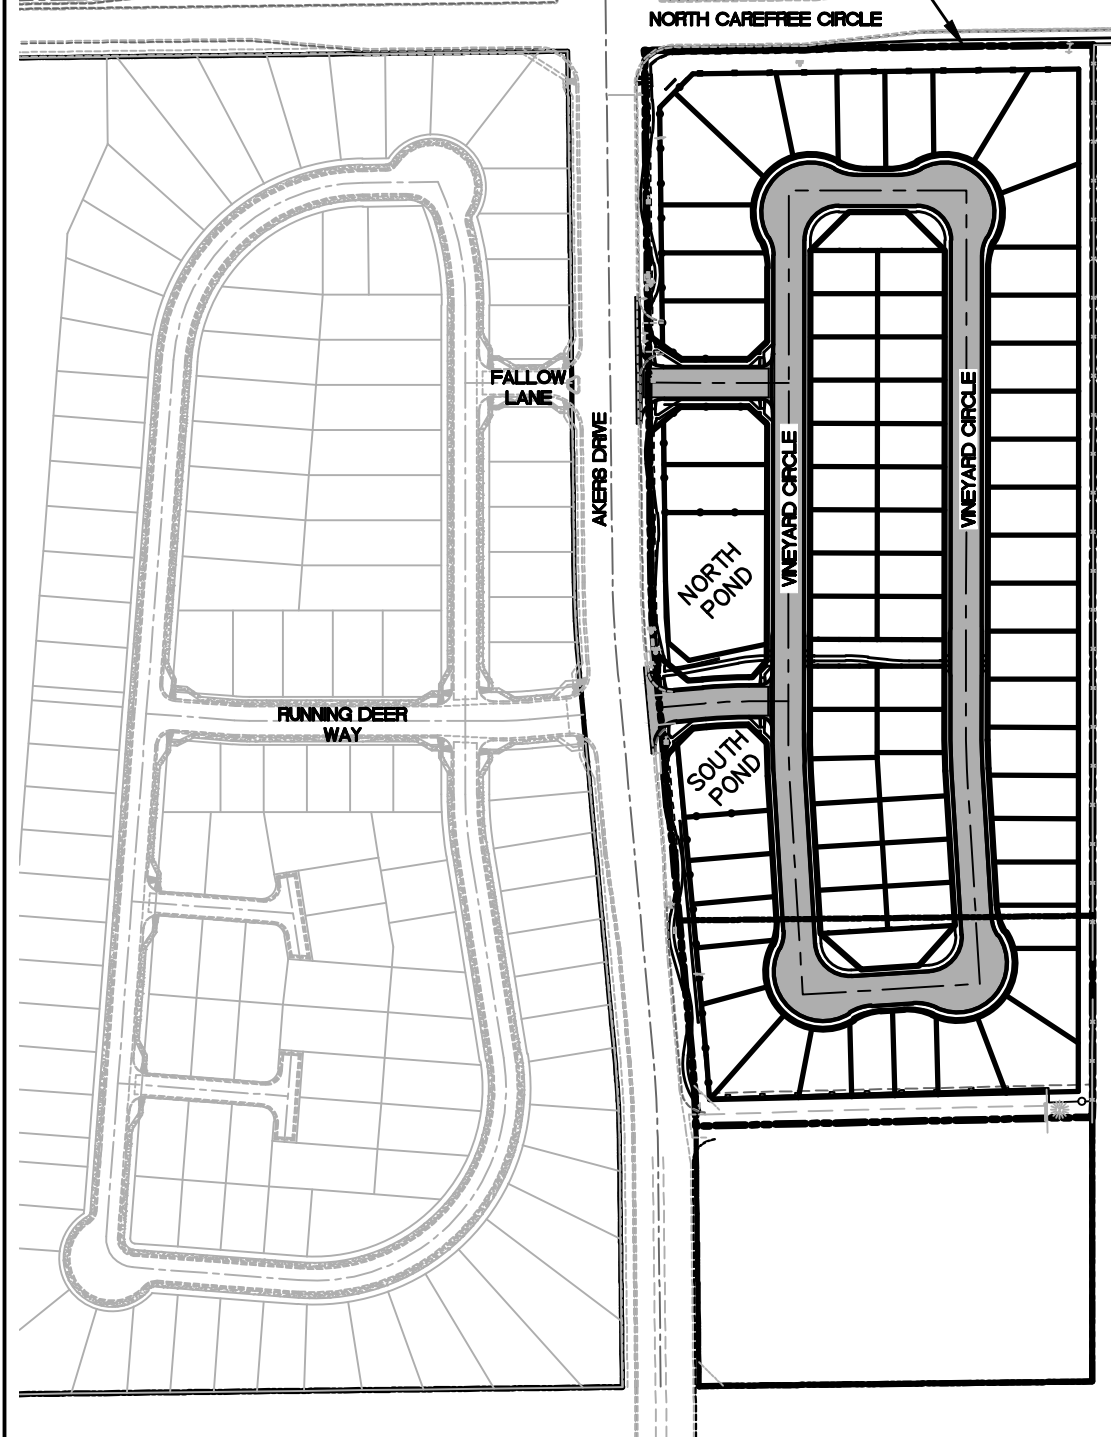
GARDENS AT NORTH CAREFREE BOUNDARY

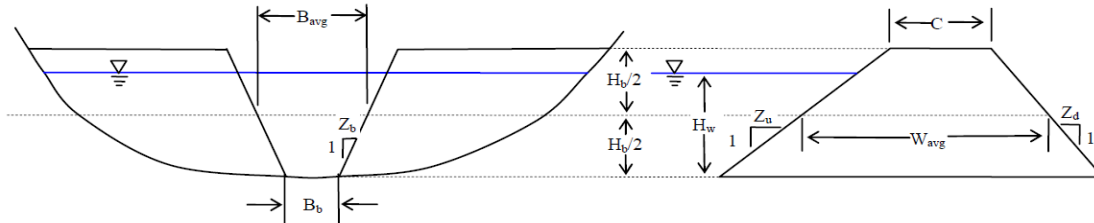
**Figure 1- Breach Variable Definition Sketch**

Height of water over base elevation of breach ( $H_w$ ) =	<b>5.9</b>	Feet
Volume of water stored in reservoir at time of failure ( $V_w$ ) =	<b>0.9</b>	Acre-Feet
Reservoir Surface Area at $H_w$ ( $A_s$ ) =	<b>0.3</b>	Acres
Crest width of dam ( $C$ ) =	<b>9.0</b>	Feet
Height of breach from dam crest to base elevation of breach ( $H_b$ ) =	<b>7.8</b>	Feet
Slope of upstream dam face ( $Z_u$ ) =	<b>4.0</b>	Z(H):1(V)
Slope of downstream dam face ( $Z_d$ ) =	<b>3.0</b>	Z(H):1(V)
Breach side-slope ratio ( $Z_b$ ) =	<b>0.1</b>	Z(H):1(V)
Piping Orifice Coefficient ( $C_p$ ) =	<b>0.61</b>	Used To Calculate Peak Discharge Through Piping Hole
Dam Size Class:	<b>Minor</b>	Assumes Full Reservoir At Time of Breach

*Piping Hole Width (D) =	<b>2.6</b>	Feet
Volume Eroded in Piping Hole =	<b>14</b>	Cubic Yards
Estimated Peak Discharge Through Pipe =	<b>71</b>	Cubic Feet Per Second

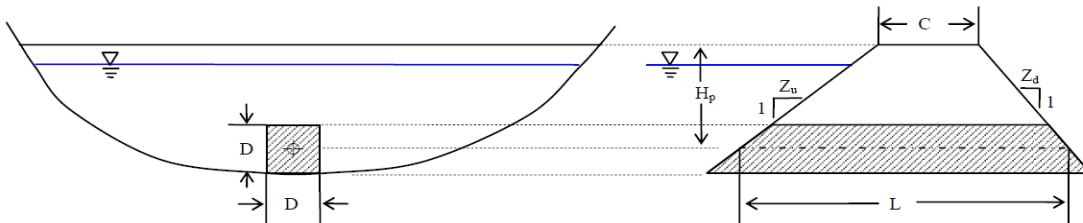
**Figure 2 - Piping Hole Variable Definition Sketch**

**Reservoir Evacuation May Occur Prior to Full Breach Development - Piping Hole Characteristics calculated below.**

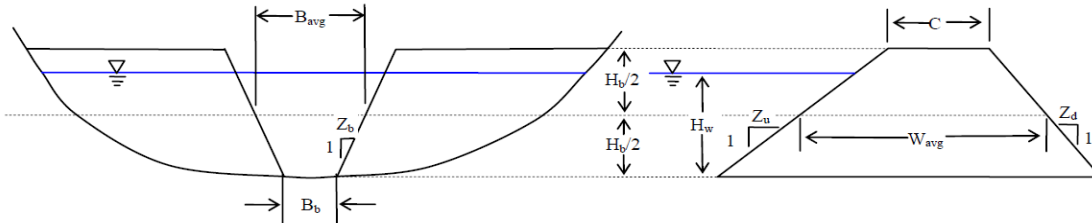
**Figure 1- Breach Variable Definition Sketch**

Height of water over base elevation of breach ( $H_w$ ) =	<b>6.4</b>	Feet
Volume of water stored in reservoir at time of failure ( $V_w$ ) =	<b>0.4</b>	Acre-Feet
Reservoir Surface Area at $H_w$ ( $A_s$ ) =	<b>0.1</b>	Acres
Crest width of dam ( $C$ ) =	<b>7.0</b>	Feet
Height of breach from dam crest to base elevation of breach ( $H_b$ ) =	<b>8.1</b>	Feet
Slope of upstream dam face ( $Z_u$ ) =	<b>3.0</b>	Z(H):1(V)
Slope of downstream dam face ( $Z_d$ ) =	<b>3.0</b>	Z(H):1(V)
Breach side-slope ratio ( $Z_b$ ) =	<b>0.1</b>	Z(H):1(V)
Piping Orifice Coefficient ( $C_p$ ) =	<b>0.61</b>	Used To Calculate Peak Discharge Through Piping Hole
Dam Size Class:	<b>Minor</b>	Assumes Full Reservoir At Time of Breach

*Piping Hole Width (D) =	<b>2.1</b>	Feet
Volume Eroded in Piping Hole =	<b>8</b>	Cubic Yards
Estimated Peak Discharge Through Pipe =	<b>50</b>	Cubic Feet Per Second

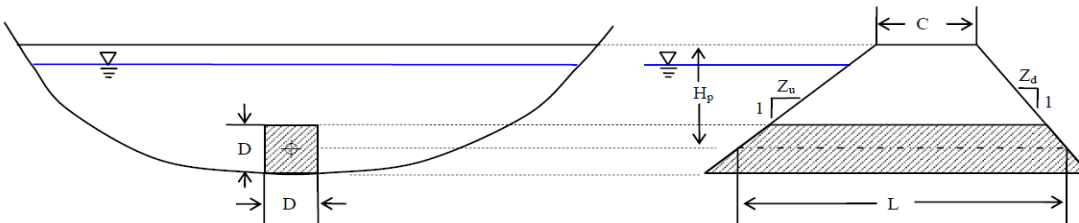
**Figure 2 - Piping Hole Variable Definition Sketch**

**Reservoir Evacuation May Occur Prior to Full Breach Development - Piping Hole Characteristics calculated below.**
