Private Detention Pond (PDB)
BMP's for Operations & Maintenance

The proposed Northcrest Center Development includes an Extended Detention Basin (EDB) Detention Pond. In El Paso County, property owners are responsible for implementing stormwater best management practices (BMPs). The Drainage Criteria Manual, Volume 2, requires that the County take measures to protect the quality of stormwater from sediment and other contaminants, requires sub-dividers, developers, landowners, and owners of facilities located in the County's rights-of-way or easements to provide adequate permanent stormwater quality BMPs with new developments or significant redevelopment. The development application process with El Paso County addresses BMPs to ensure proper functioning and to limit any potential on-site impacts or impacts to adjacent properties.

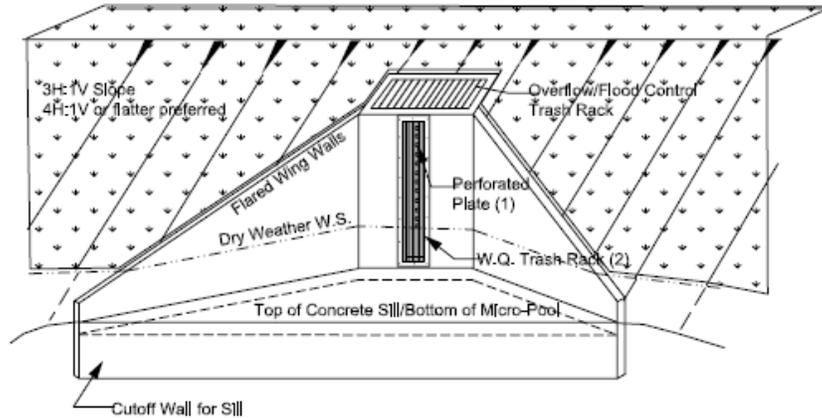
Notes:

- (1) Mounted to the back of the headwall
- (2) Mounted to the front of the headwall

Control structures/flow restrictors are located on the outlet pipe of a detention system. The control structure is typically a concrete catch basin with a riser. The control structure reduces the discharge rate of stormwater from a detention facility. The flow is regulated by a combination of orifices (holes with specifically sized diameters) and weirs (plates with rectangular or vee shaped notch).
