ENTECH
ENGINEERING, INC.

**SOILS AND GEOLOGY STUDY
STERLING RANCH EAST – FILING NO. 6
EL PASO COUNTY, COLORADO**

March 26, 2026

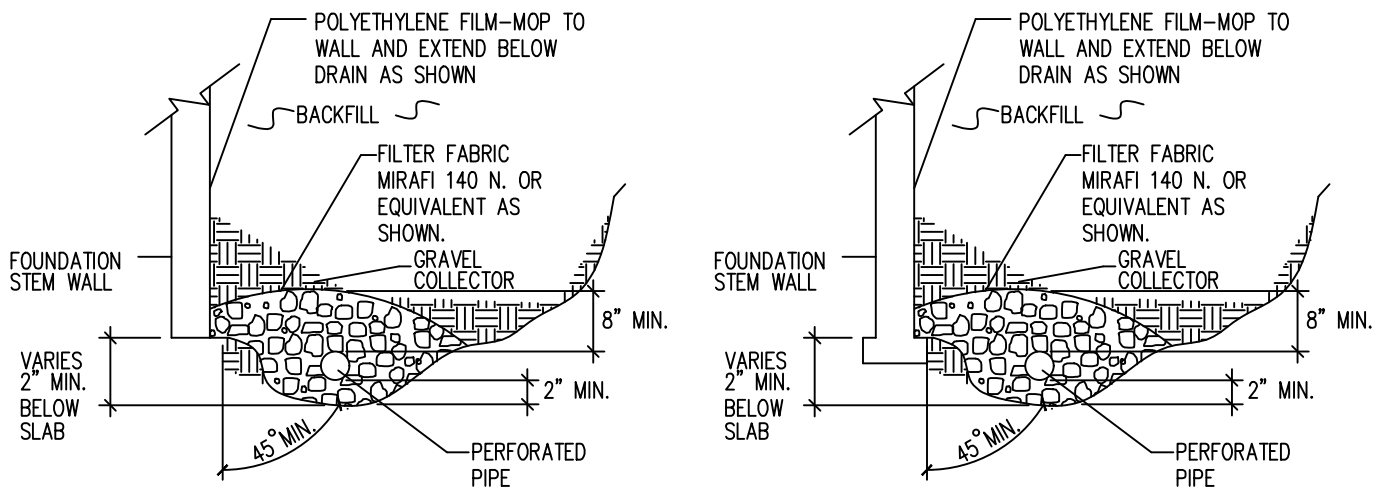
FIG. 10

-GRAVEL SIZE IS RELATED TO DIAMETER OF PIPE PERFORATIONS-85% GRAVEL GREATER THAN 2x PERFORATION DIAMETER.

Mitigation: Foundations must have a minimum 30-inch depth for frost protection. In areas where high subsurface moisture conditions are anticipated periodically, subsurface drains are recommended to help prevent the intrusion of water into areas below grade. Fill added to these areas further raise foundations above groundwater levels. Foundations should be kept a minimum of 3 feet above groundwater levels. Areas may experience higher groundwater levels during period of higher precipitation where water can flow through permeable sands on top of less permeable bedrock materials. Subsurface perimeter drains are recommended for portions of structures which will have useable space located below the finished ground surface, typical perimeter drain details are shown in Figure 10. Shallow groundwater conditions are not anticipated for majority of the filing, however, if areas of shallow groundwater are encountered, underslab drains or interceptor drains may be necessary. Typical drain details are shown in Figures 11 and 12. It is anticipated that the potential seasonally shallow groundwater areas will be mitigated with site grading. Specific recommendations should be made after additional investigation and site grading has been completed.

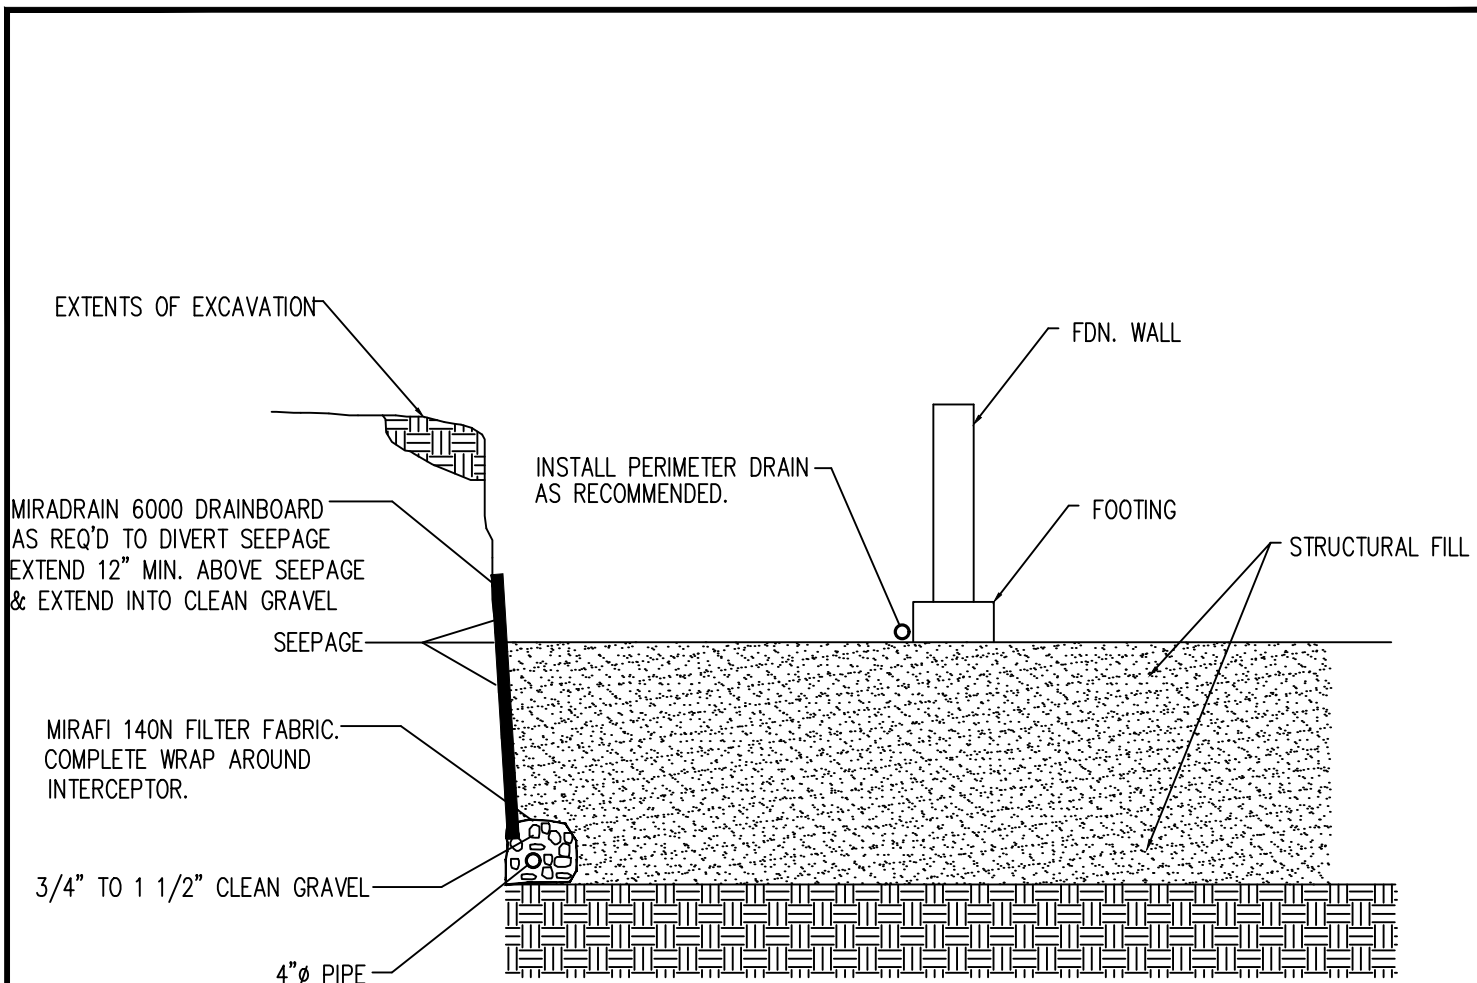
INTERCEPTOR DRAIN DETAIL

NOTE:
 EXTEND INTERCEPTOR DRAIN TO UNDERDRAIN OR TO SUMP.
 BENCH DRAIN INTO NATIVE SOILS 12 INCHES MINIMUM.

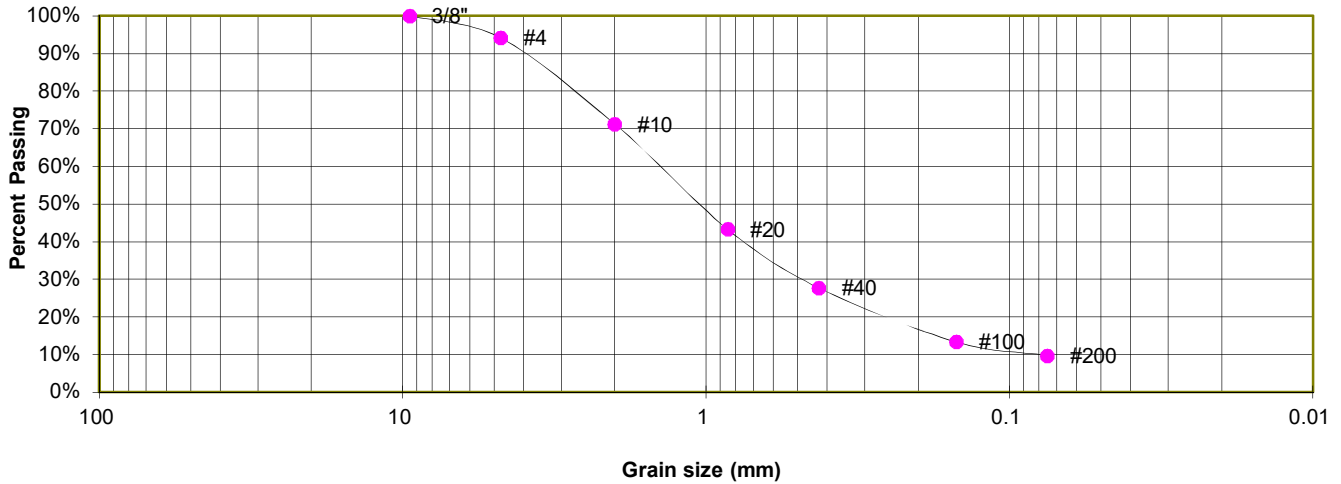
GRAIN SIZE ANALYSIS

SOIL DESCRIPTION SAND, WITH SILT
SOIL TYPE 1

U.S. Sieve #	Percent Finer
3"	
1 1/2"	
3/4"	
1/2"	
3/8"	100.0%
4	94.1%
10	71.3%
20	43.3%
40	27.7%
100	13.4%
200	9.7%

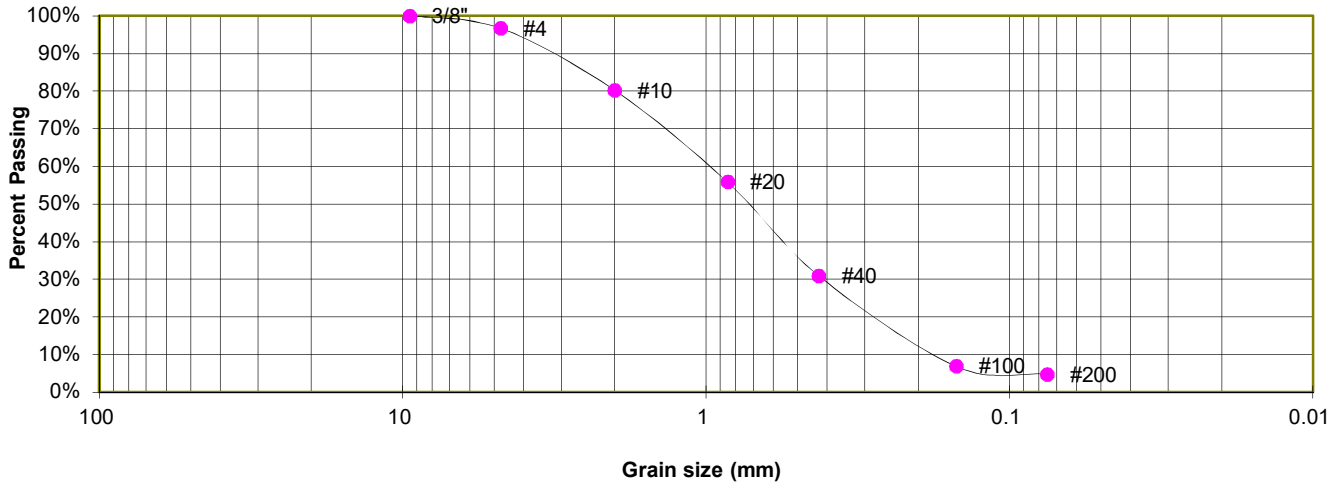
GRAIN SIZE ANALYSIS

SOIL DESCRIPTION SAND, SLIGHTLY SILTY
SOIL TYPE 1

U.S. Sieve #	Percent Finer
3"	
1 1/2"	
3/4"	
1/2"	
3/8"	100.0%
4	96.7%
10	80.2%
20	55.8%
40	30.9%
100	6.9%
200	4.8%

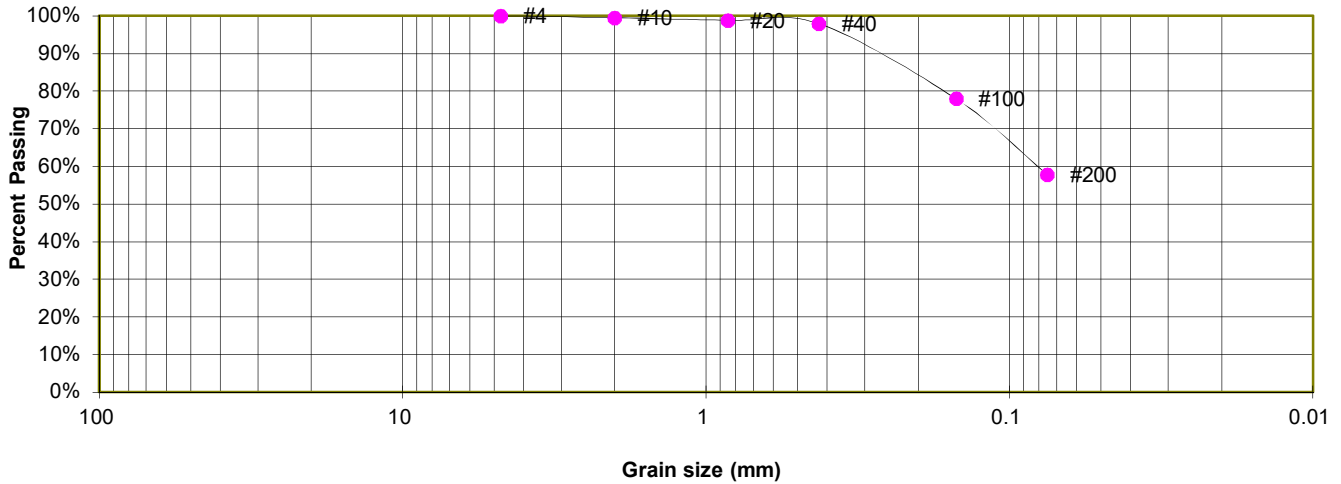
GRAIN SIZE ANALYSIS

SOIL DESCRIPTION CLAY, SANDY
 SOIL TYPE 2

U.S. Sieve #	Percent Finer
3"	
1 1/2"	
3/4"	
1/2"	
3/8"	
4	100.0%
10	99.5%
20	98.8%
40	97.9%
100	78.0%
200	57.8%

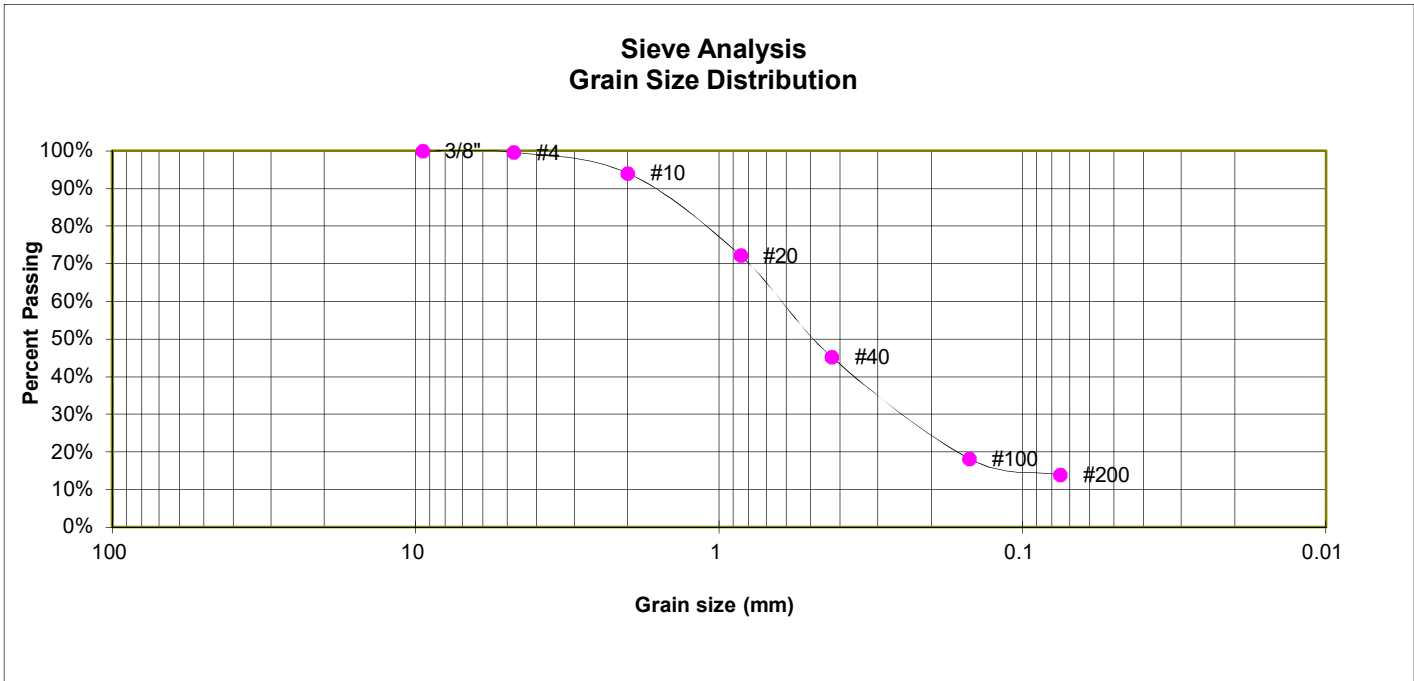
GRAIN SIZE ANALYSIS

TEST BORING 3
 DEPTH (FT) 15

SOIL DESCRIPTION SANDSTONE (SAND, SILTY)
 SOIL TYPE 3

U.S. Sieve #	Percent Finer
3"	
1 1/2"	
3/4"	
1/2"	
3/8"	100.0%
4	99.7%
10	94.1%
20	72.2%
40	45.2%
100	18.2%
200	13.9%

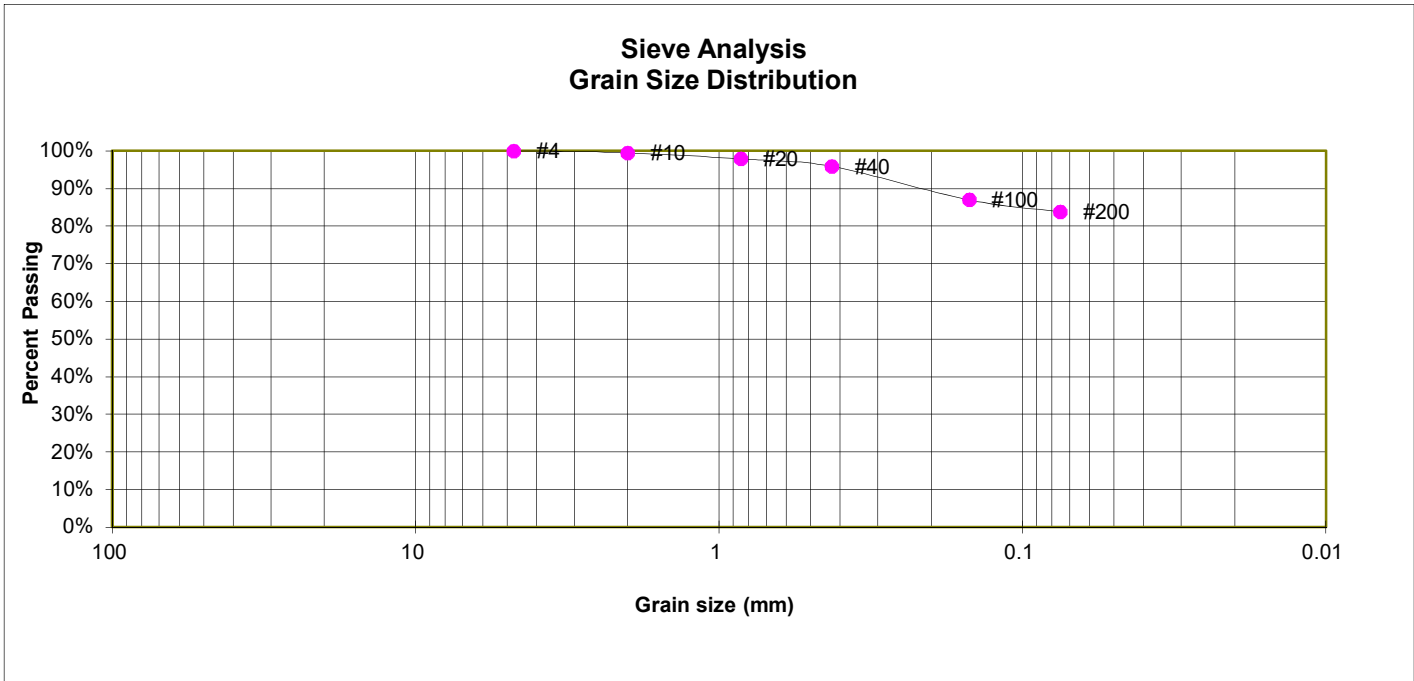
GRAIN SIZE ANALYSIS

TEST BORING 1
 DEPTH (FT) 20

SOIL DESCRIPTION CLAYSTONE (CLAY, WITH SAND)
 SOIL TYPE 4

U.S. Sieve #	Percent Finer
3"	
1 1/2"	
3/4"	
1/2"	
3/8"	
4	100.0%
10	99.5%
20	97.9%
40	95.9%
100	87.0%
200	83.8%

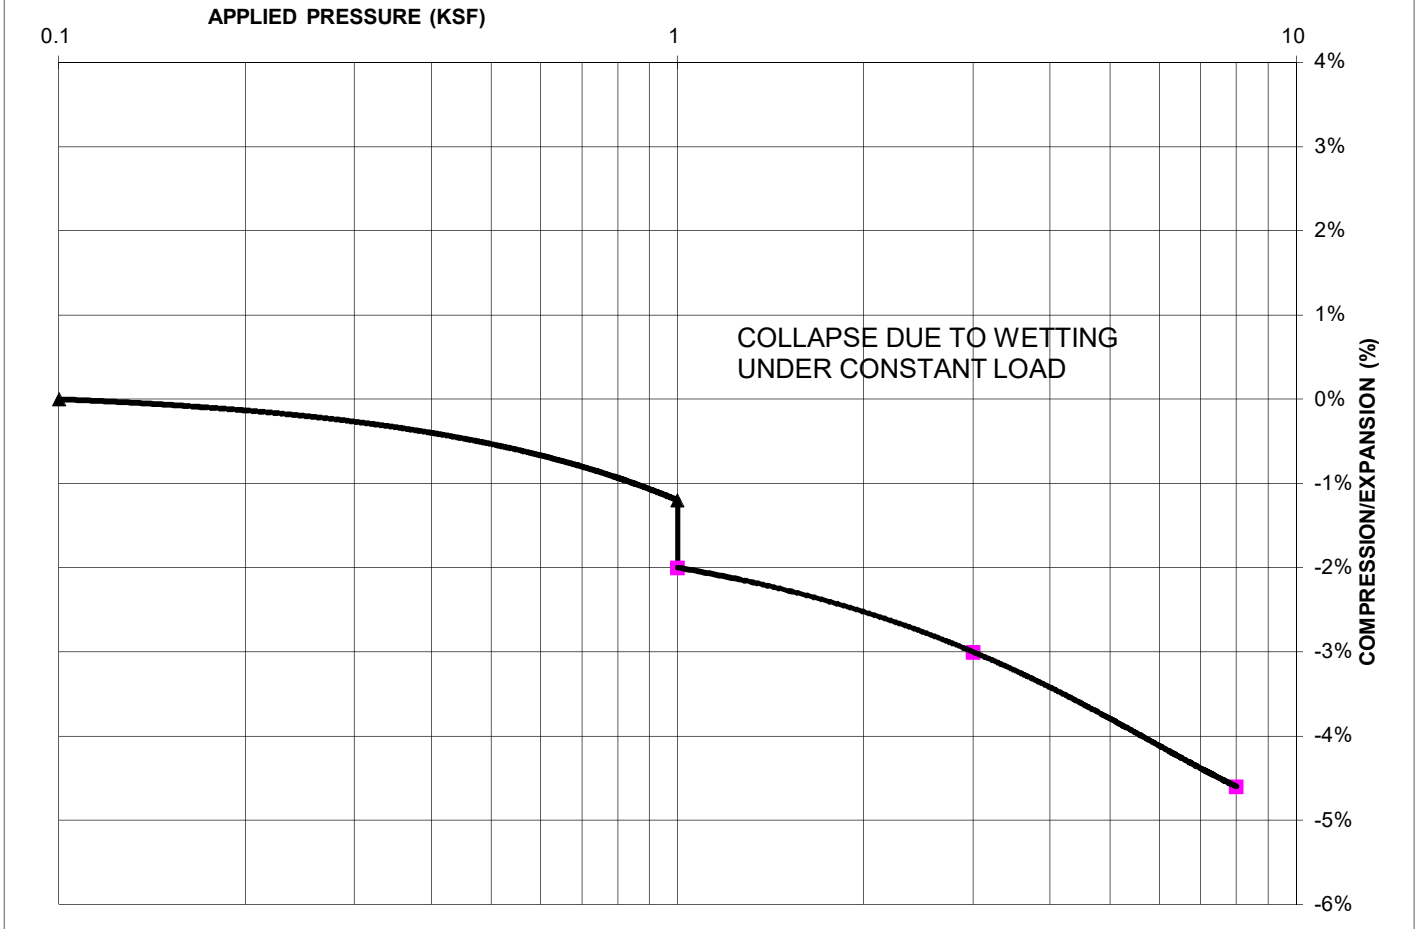
SWELL/COLLAPSE TEST RESULTS

SOIL DESCRIPTION CLAY, SANDY
SOIL TYPE 2

NATURAL UNIT DRY WEIGHT (PCF): 124
NATURAL MOISTURE CONTENT: 10.3%
SWELL/COLLAPSE (%): -0.8%
