Stormwater Management Facility Operation and Maintenance (O&M) Plan Template

Sterling Ranch Recycling Facility

***2/9/2024
PCD Project No. SF2325 & PPR2341***

STERLING RANCH RECYCLING FACILITY PROPOSED DRAINAGE MAP

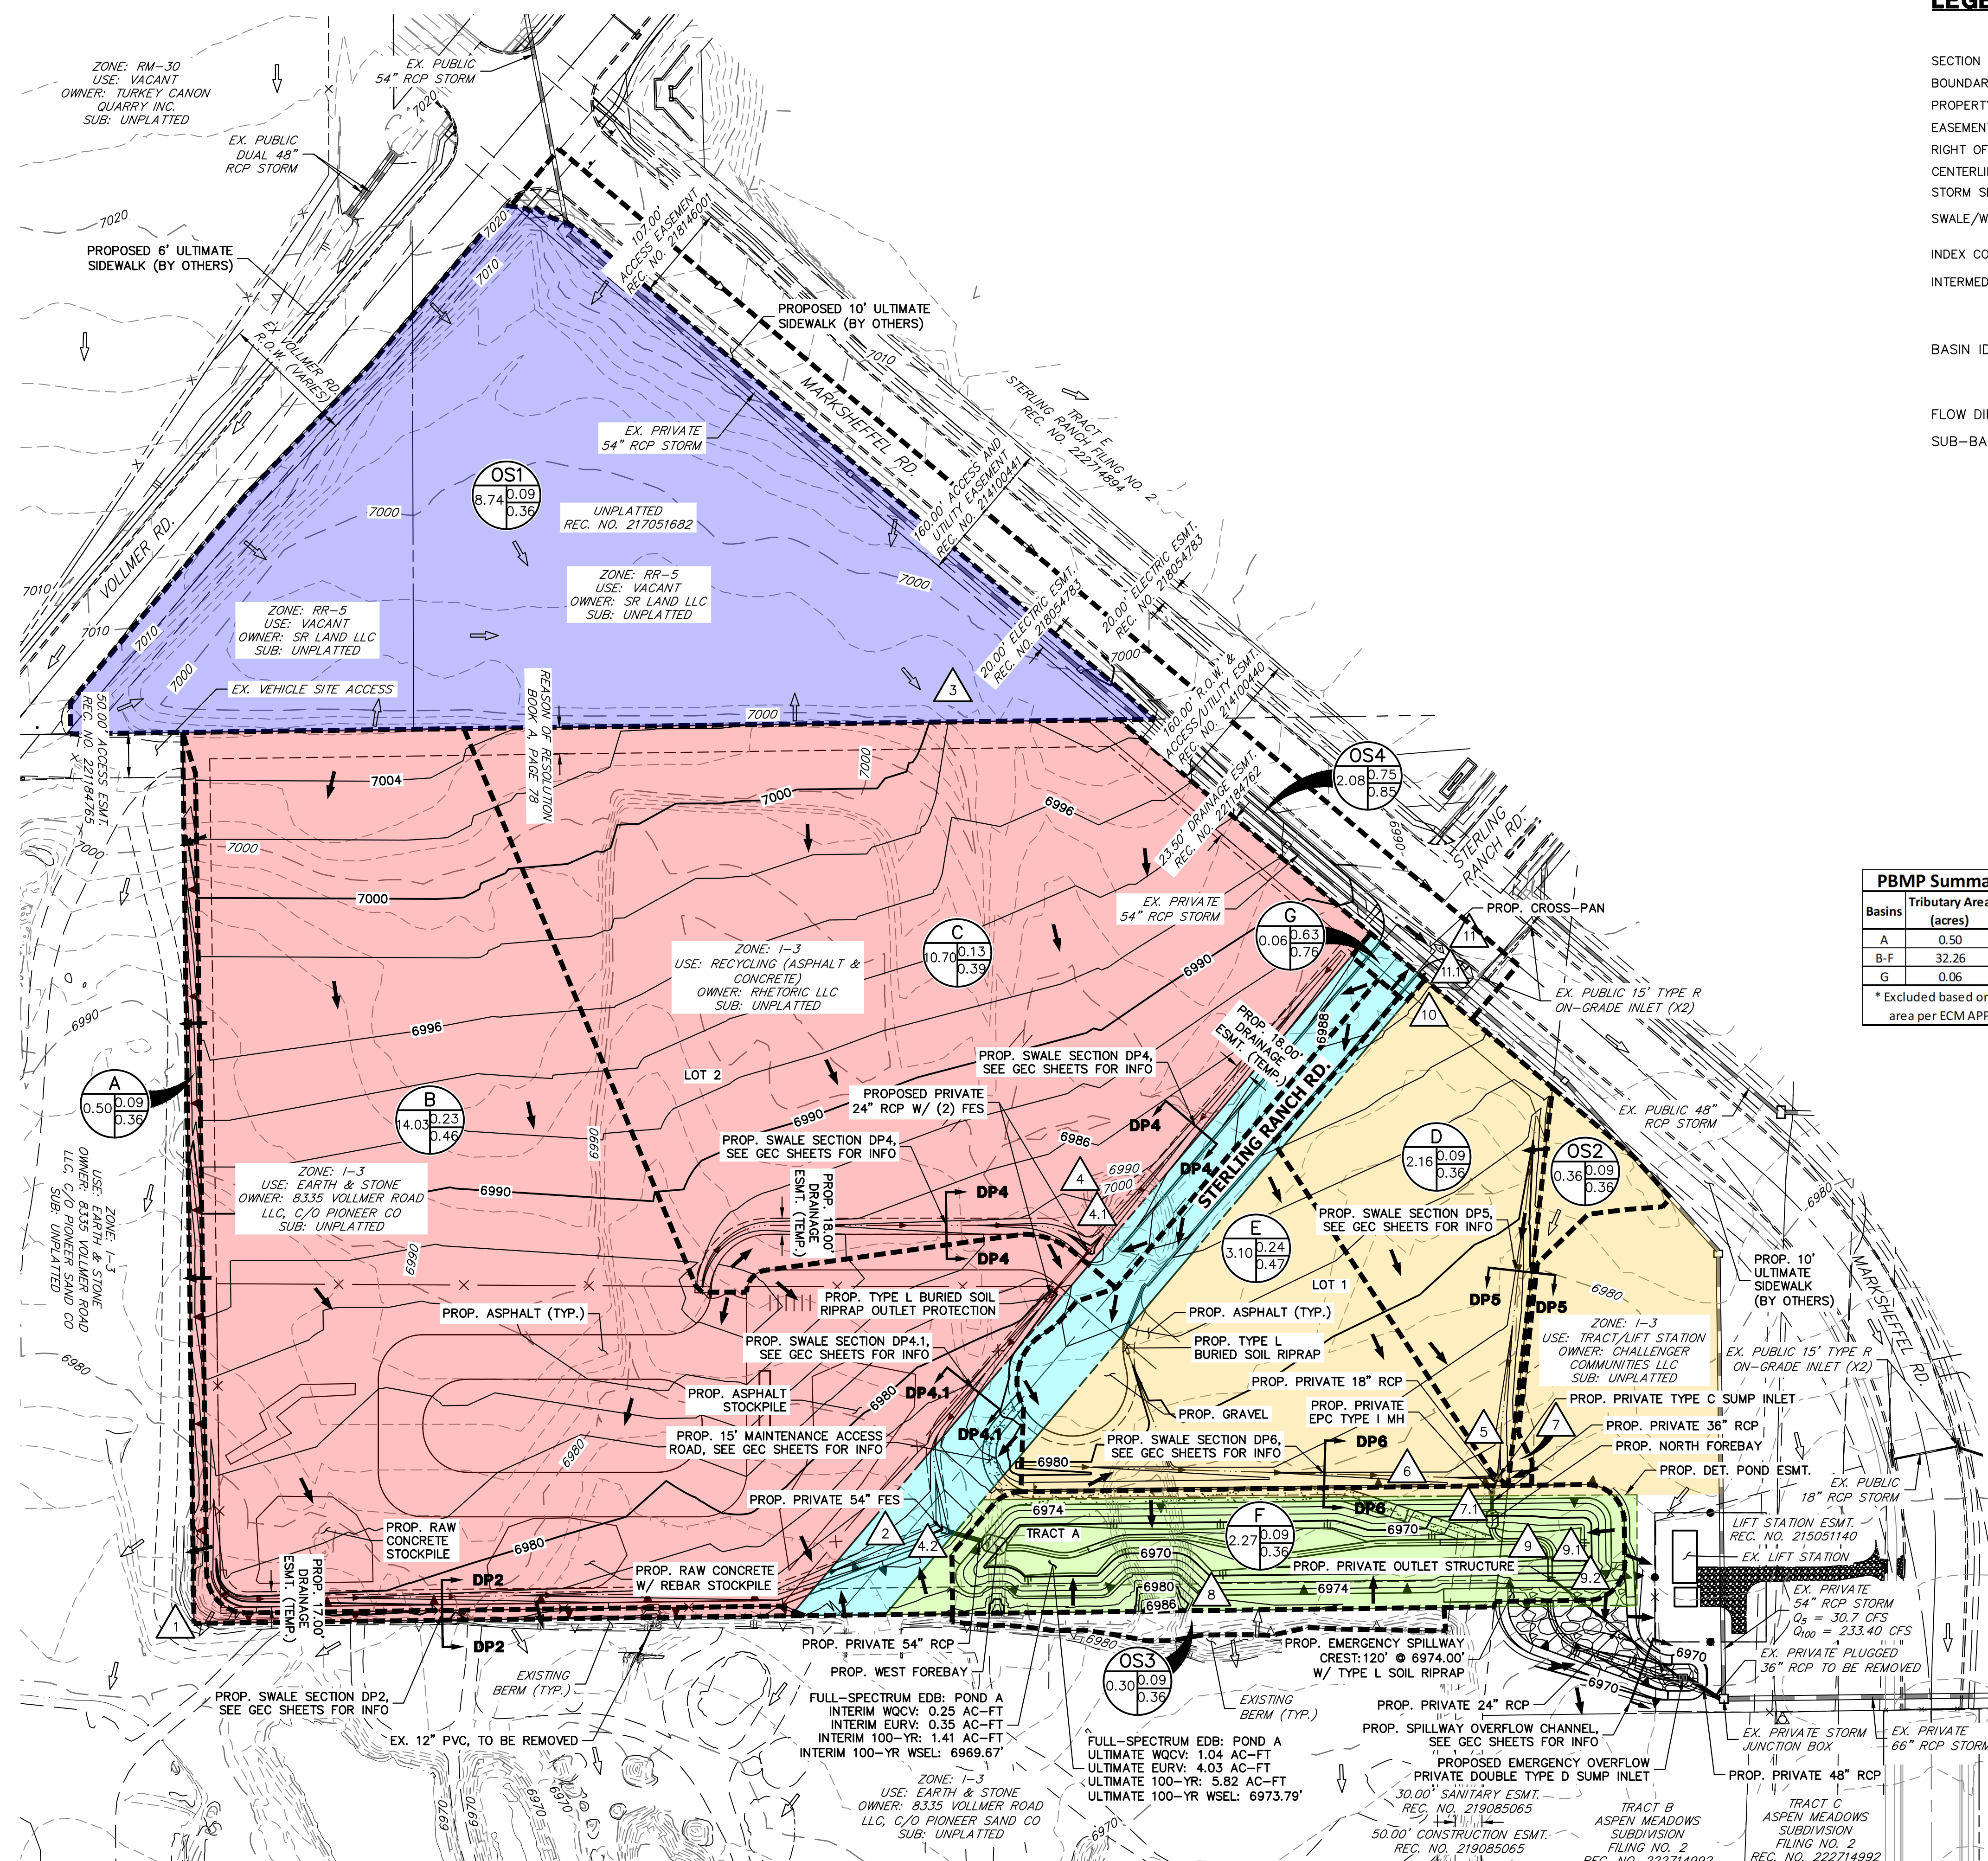
Basins	Tributary Area (acres)	PBMP
A	0.50	Excluded*
B-F	32.26	Pond A
G	0.06	Excluded*

DP	Q5		Q100	
	Total	Total	Total	Total
1	0.3	1.6		
2	7.4	25.1		
3	1.4	9.2		
4	3.4	17.7		
4.1	3.7	21.1		
4.2	9.3	40.1		
5	0.5	3.7		
6	2.2	7.1		
7	0.1	0.7		
7.1	2.8	11.2		
8	0.2	1.0		
9	0.6	4.4		
9.1	11.4	49.4		
9.2	0.1	8.3		
10	0.2	0.4		
11	6.7	12.8		
11.1	6.9	13.1
