Stormwater Management Facility Operation and Maintenance (O&M) Plan Template

Sterling Ranch Recycling Facility

***07/31/2023
PCD Project No. SF-23-XXX***

PROPOSED DRAINAGE MAP

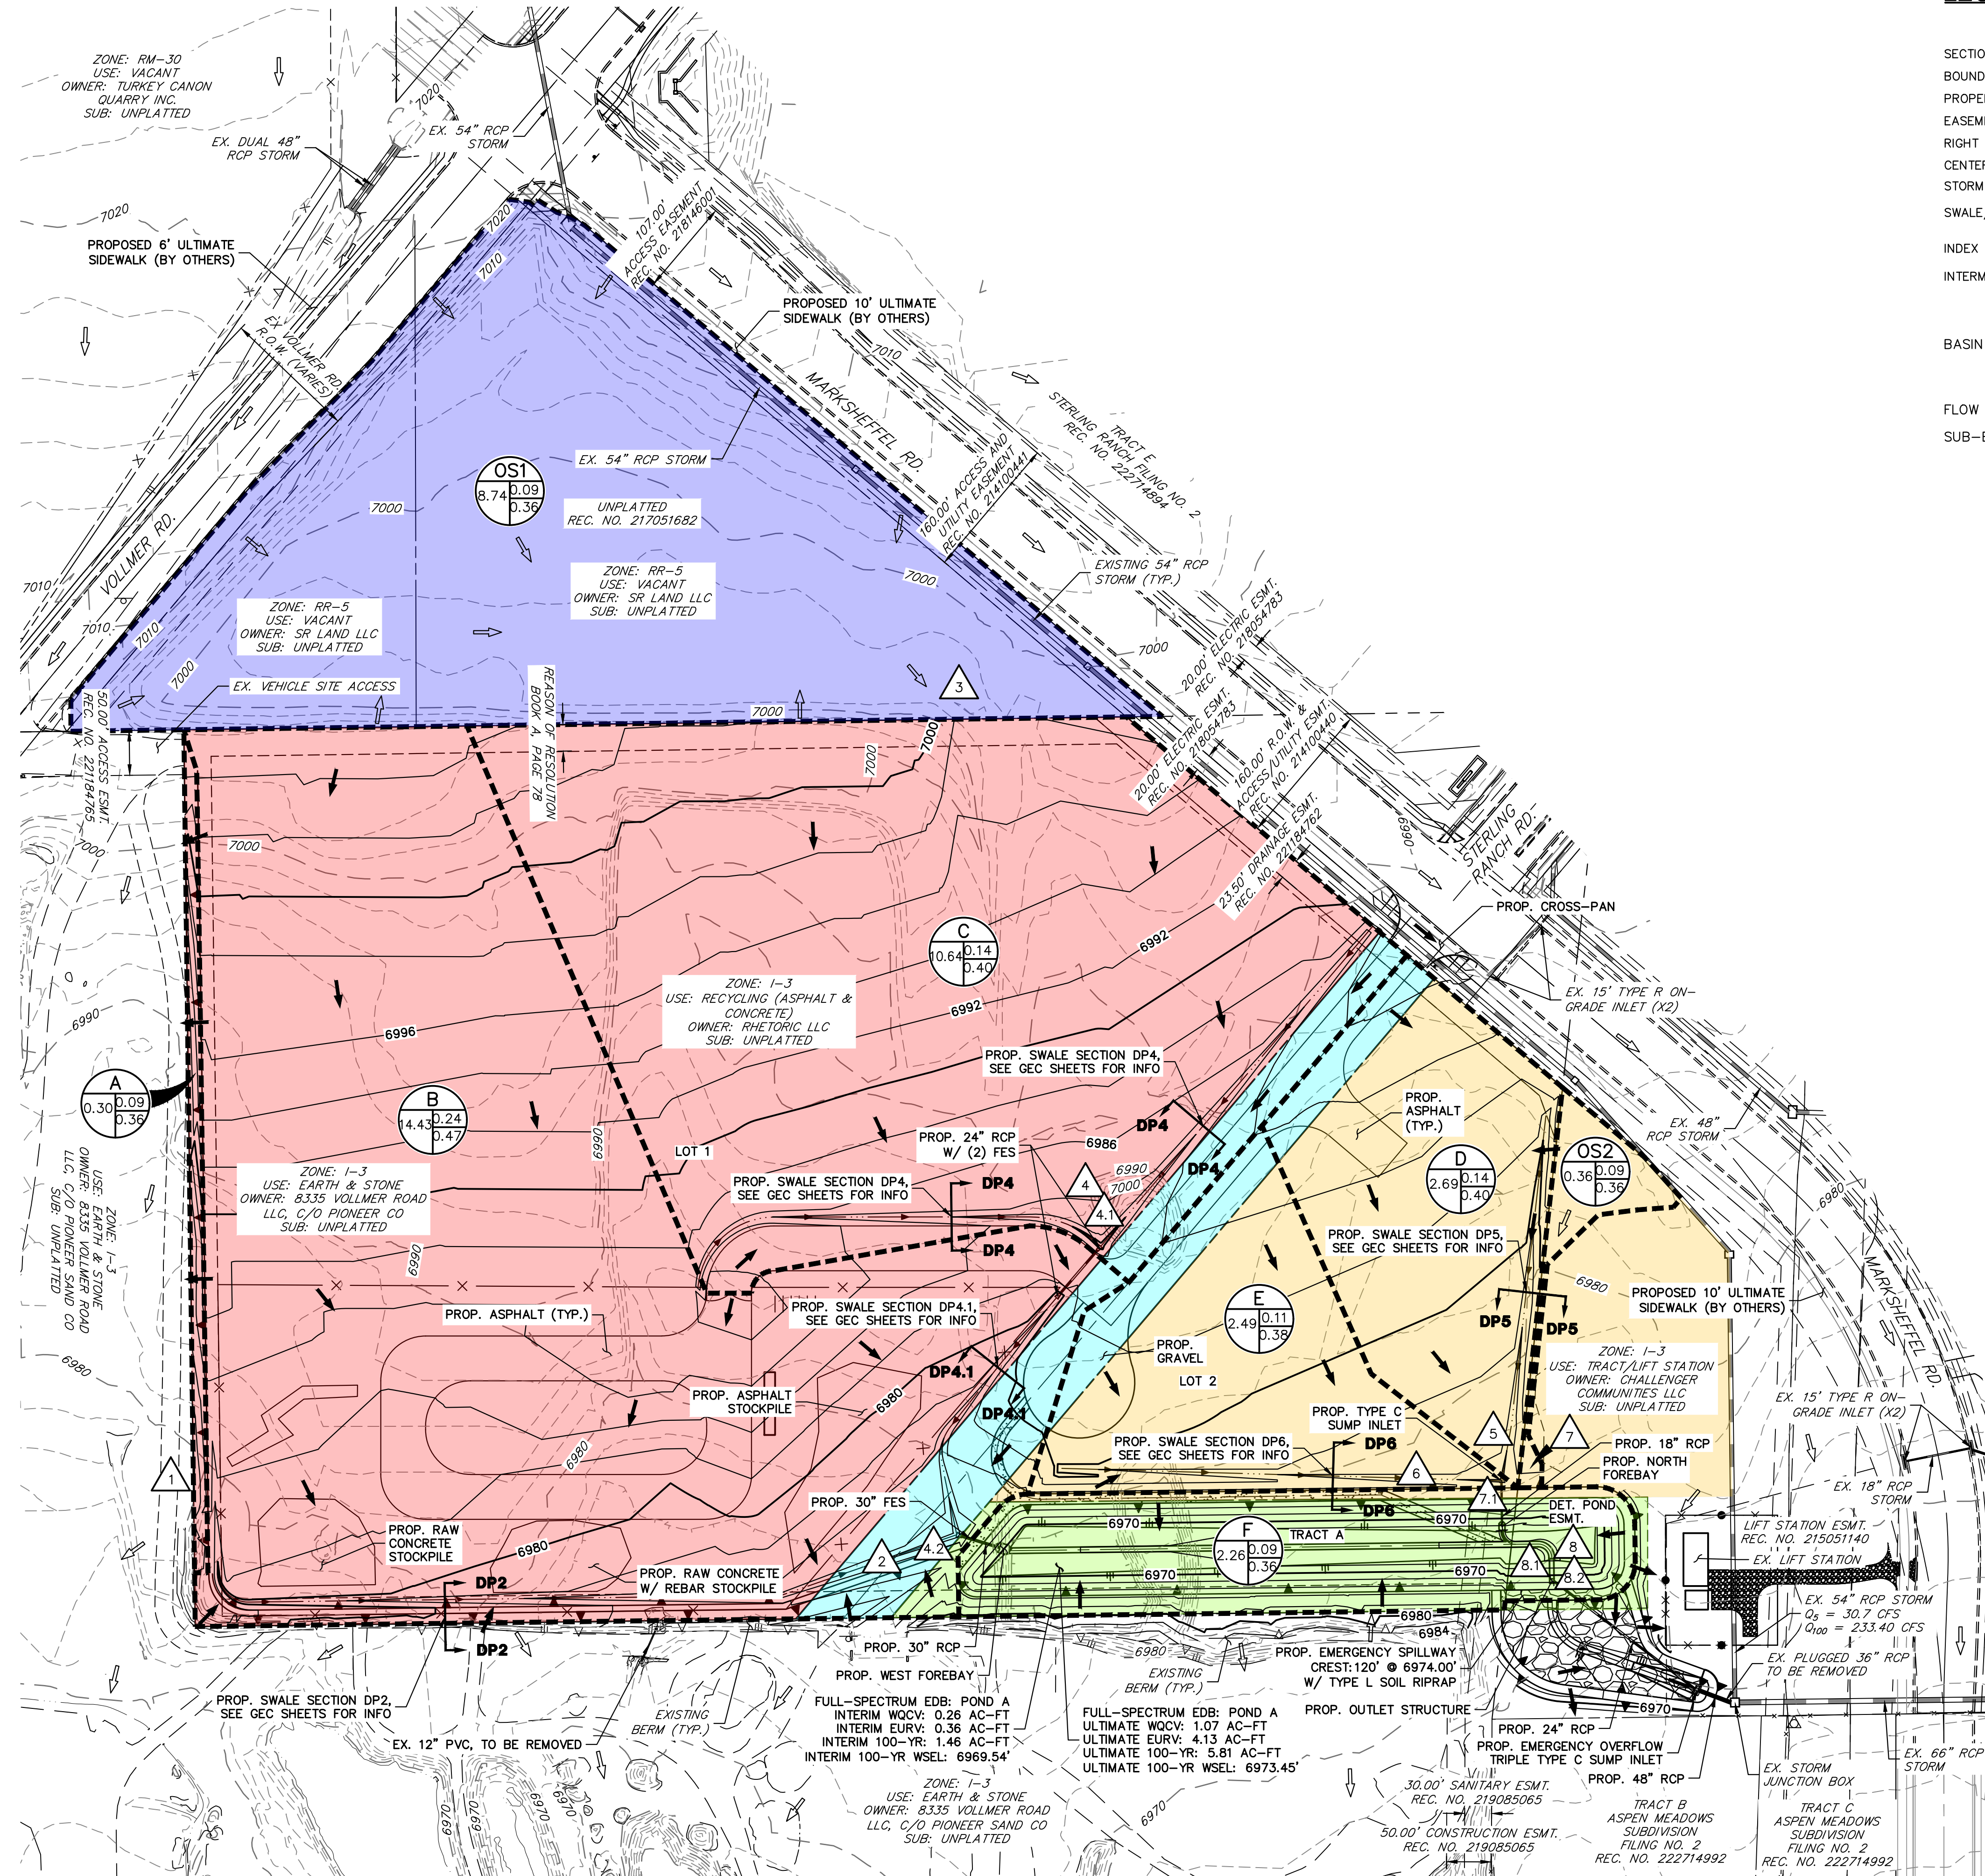
STERLING RANCH RECYCLING FACILITY

Tributary Sub-basin	Area (acres)	Percent Impervious	C _s	C ₁₀₀	t _c (min)	Q _s (cfs)	Q ₁₀₀ (cfs)
A	0.30	2%	0.09	0.36	5.0	0.2	1.0
B	14.43	20%	0.24	0.47	34.0	7.8	26.0
C	10.64	7%	0.13	0.39	28.7	3.5	17.7
D	2.69	12%	0.17	0.42	21.9	1.4	5.6
E	2.49	13%	0.17	0.42	20.9	1.3	5.3
F	2.26	2%	0.09	0.36	18.5	0.6	4.4
OS1	9.42	2%	0.09	0.36	49.4	1.5	9.8
OS2	0.36	2%	0.09	0.36	16.5	0.1	0.7

DP	Q ₅		Q ₁₀₀	
	Total	Total	Total	Total
1	0.2	1.0		
2	7.8	26.0		
3	1.5	9.8		
4	3.5	17.7		
4.1	3.9	21.9		
4.2	9.7	41.5		
5	1.4	5.6		
6	1.3	5.3		
7	0.1	0.7		
7.1	2.7	11.4		
8	0.6	4.4		
8.1	11.7	50.5		
8.2	0.1	0.7
