SOIL AND GEOLOGY STUDY

Center Ice View
Driftwood Estates, Filing No. 1
El Paso County, Colorado

JOB NO. 194552

January 11, 2024

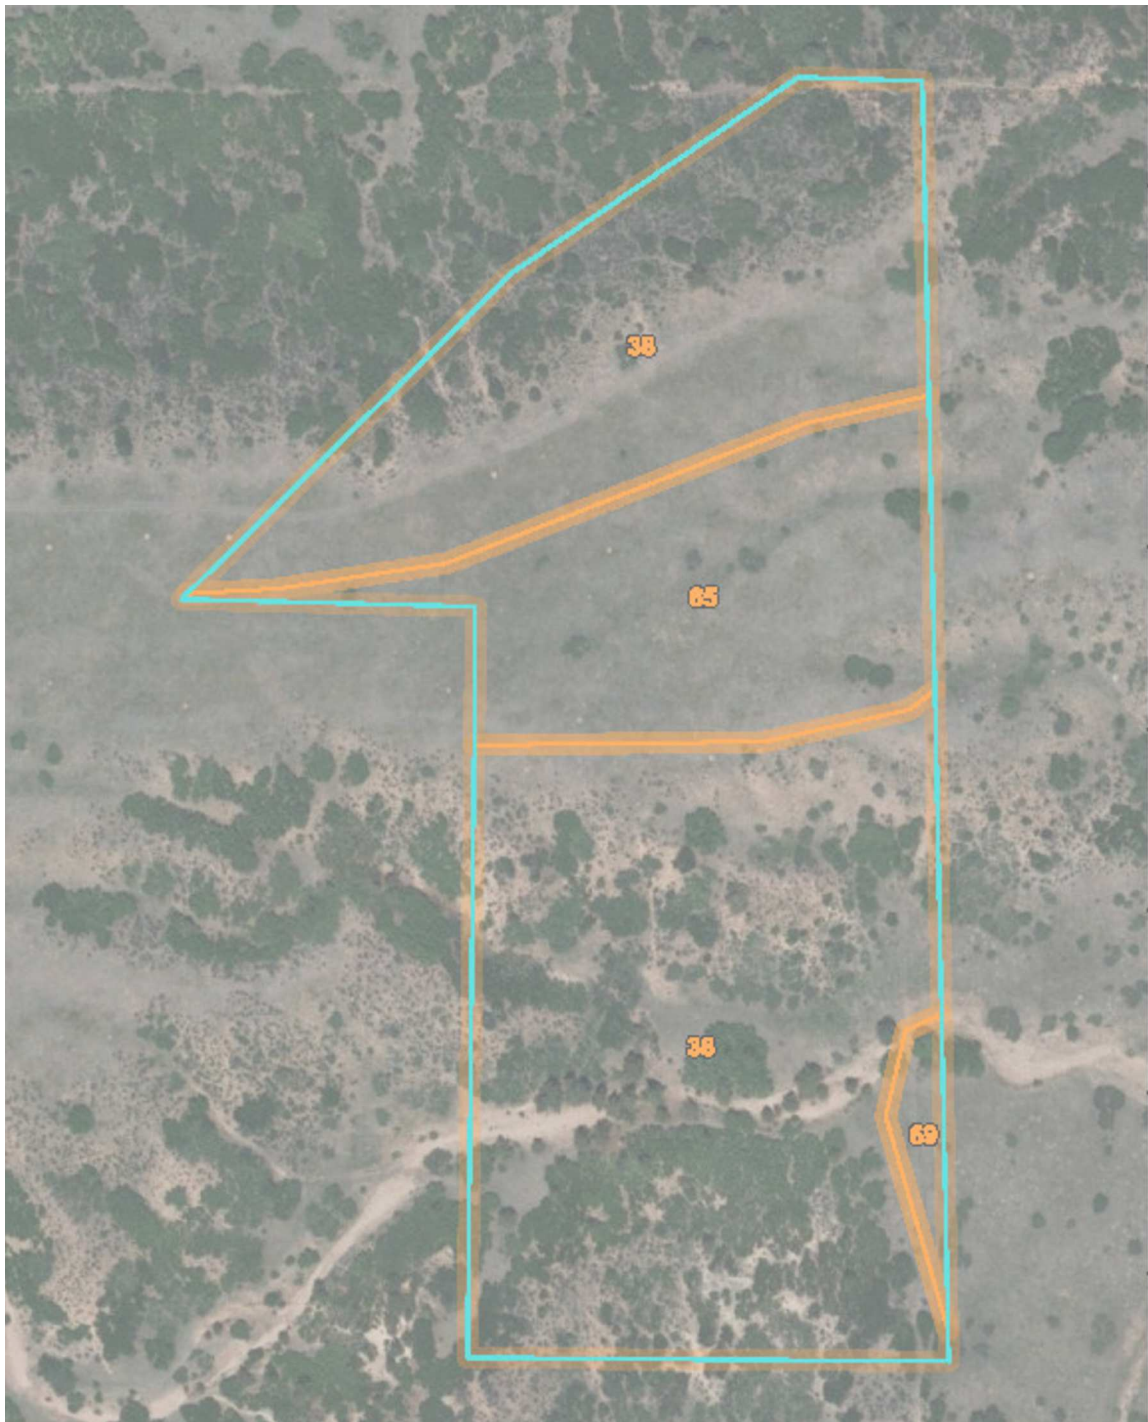
FIG No. 4

38 - Jarre - Tecolote complex with 8 to 65 percent slopes

65 - Perrypark gravelly sandy loam, 3 to 9 percent slopes

The USDA Soil Survey Map is presented in Figure 4.

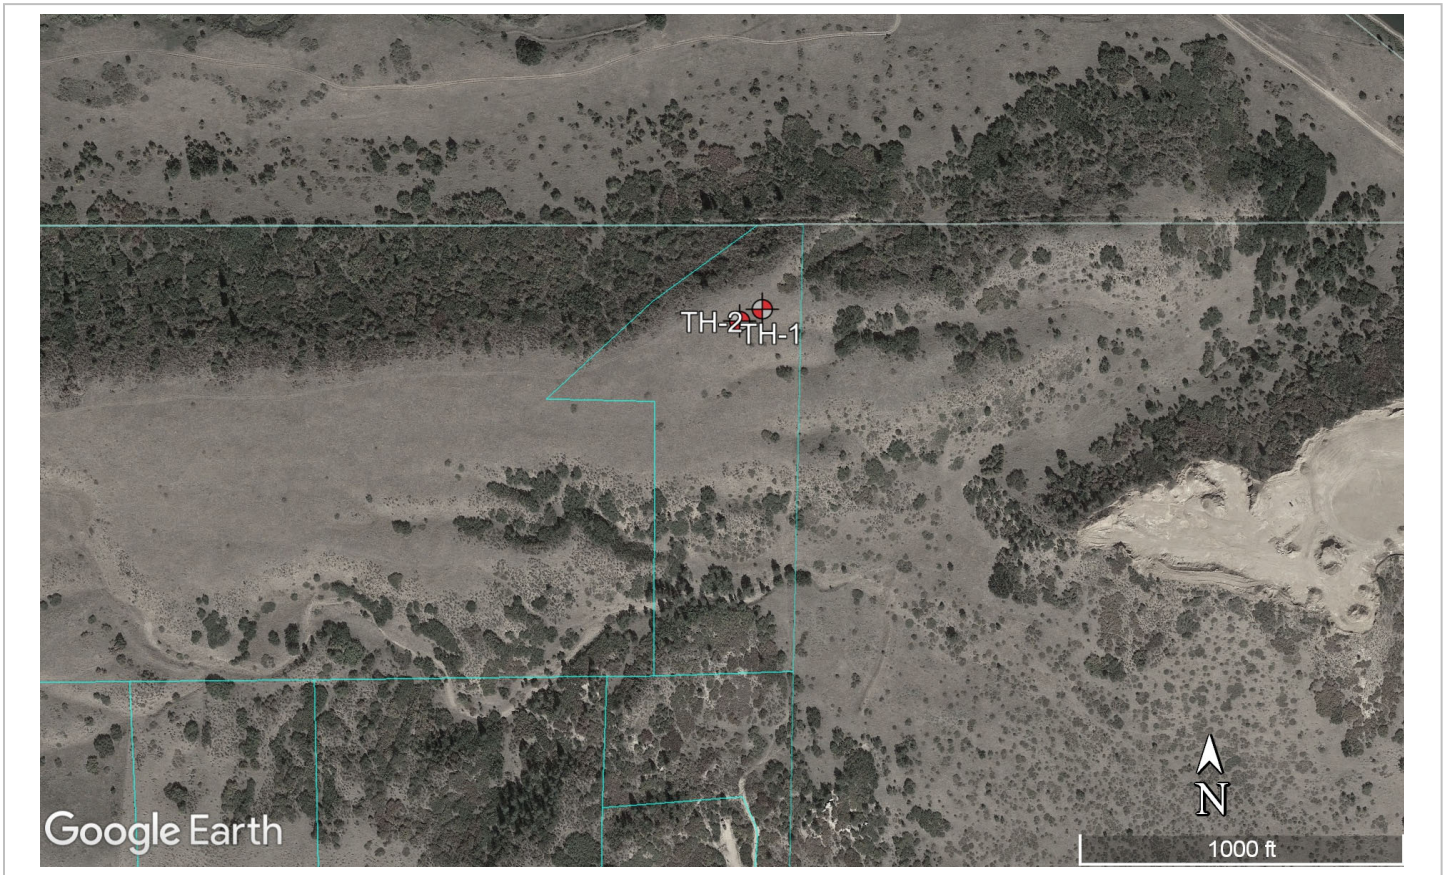
Coordinates

Bore Hole	Latitude	Longitude
TH-1	39.055751	-104.887556
TH-2	39.055844	-104.887326

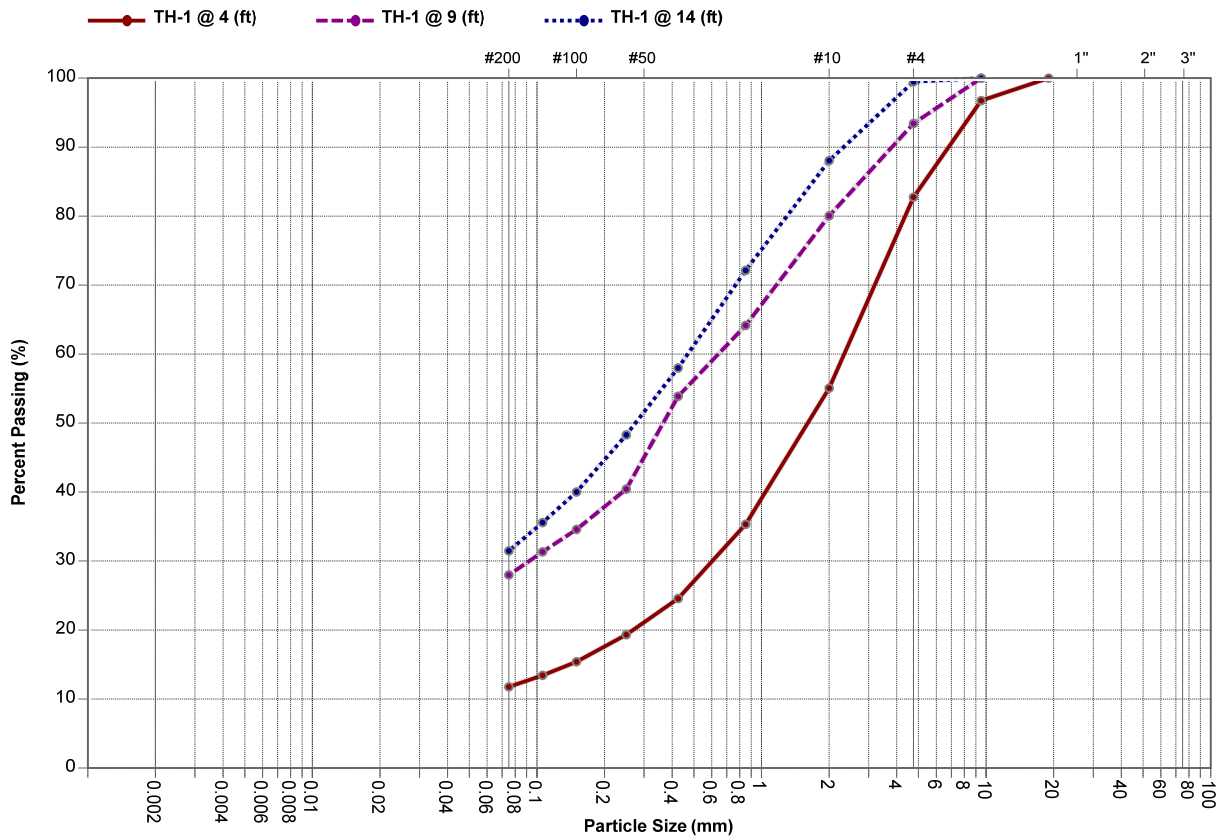
ASTM D6913

Particle Distribution (%)

Clay	Silt	Sand	Gravel	Cobble
	11.8	71	17.3	-
	28	65.4	6.6	-
	31.5	68	0.5	-

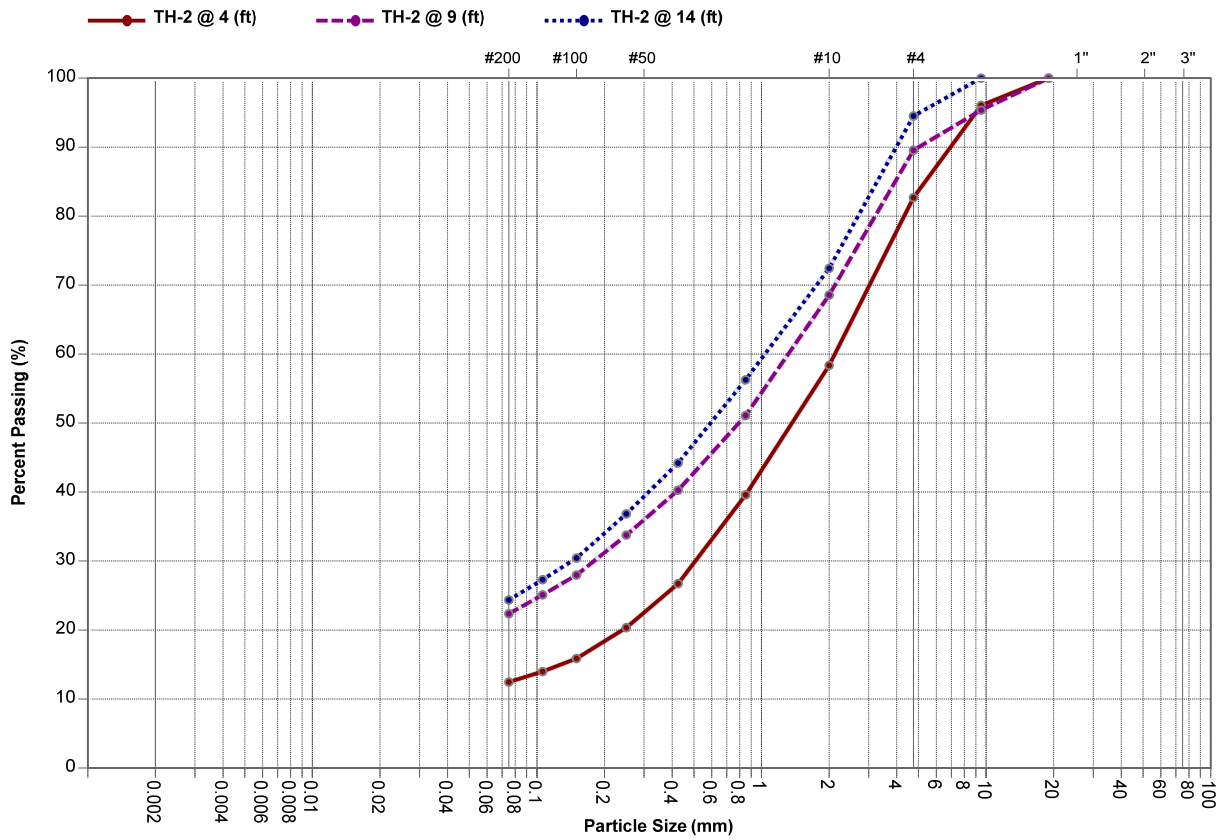
ASTM D6913

Particle Distribution (%)

Clay	Silt	Sand	Gravel	Cobble
-	12.4	70.2	17.3	0.1
-	22.4	67.2	10.5	-
-	24.4	70.1	5.5	-

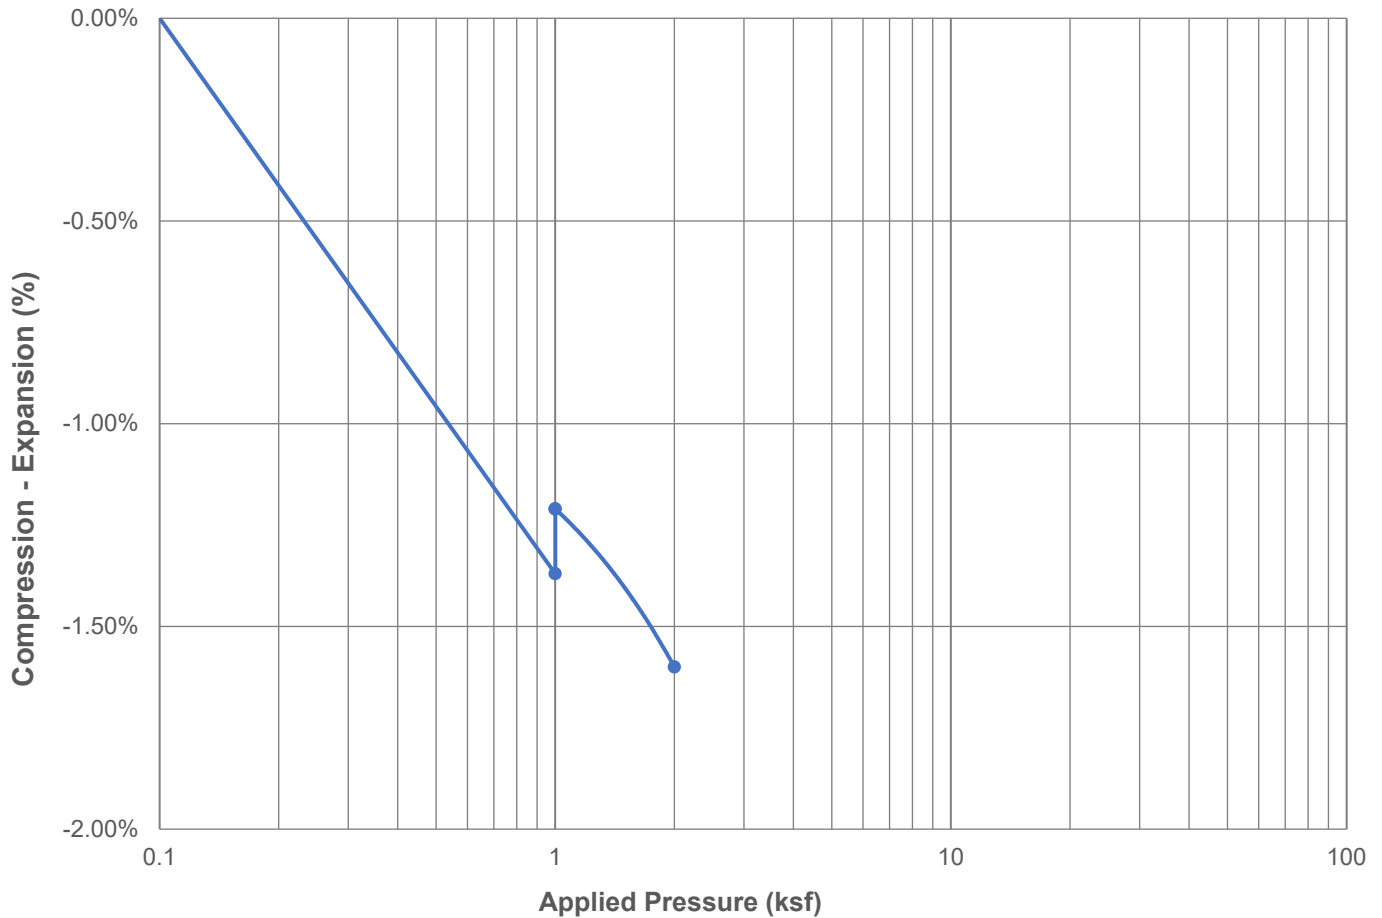
Borehole: TH-1
 Sample Depth: 14 Ft
 Classification: SC
 Sample Type: Disturbed

Values

Applied Load (lbs)	Displacement (in)
0	0.0000
1,000	-0.0137
Add Water	-0.0121
2,000	-0.0160

Native Moisture:	6.84%
Post-Test Moisture:	10.85%
Expansion Potential:	0.16%
Deadload (psf):	1,400

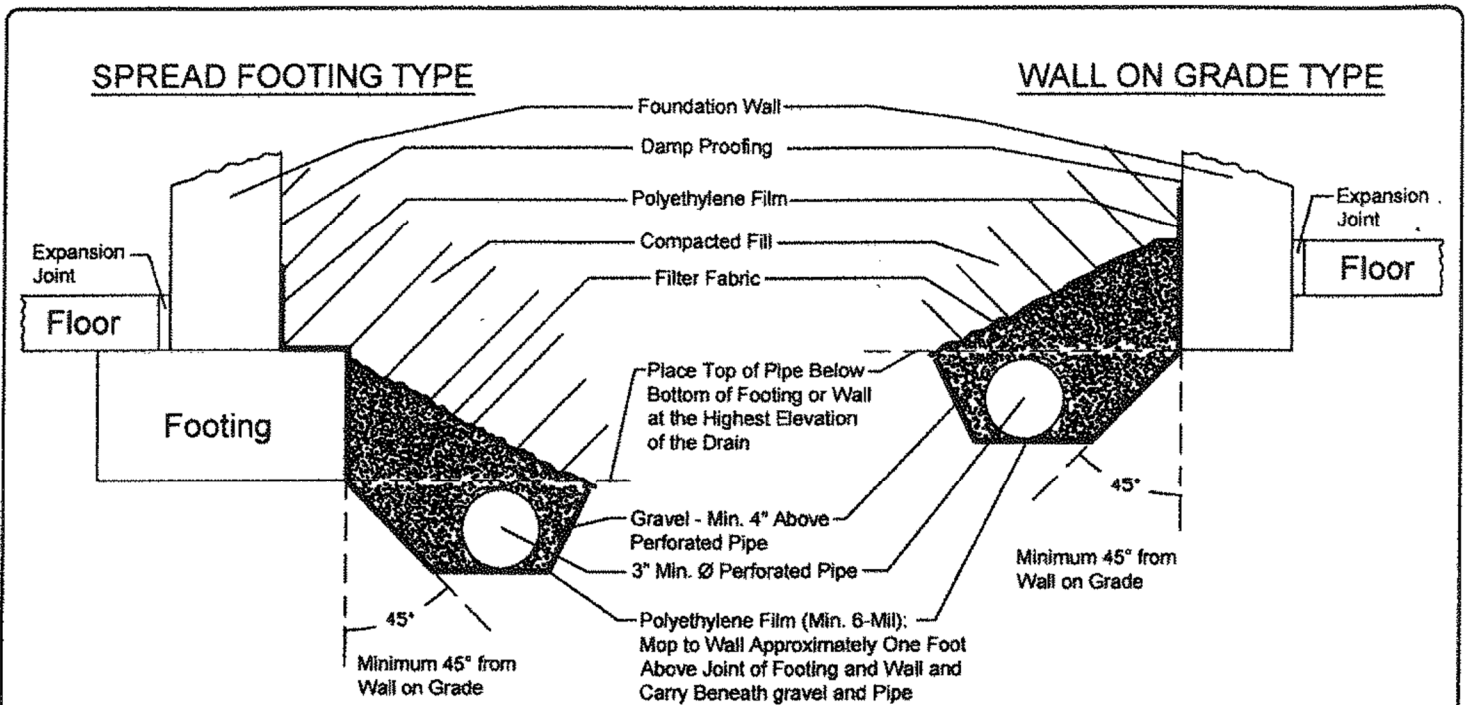
Exterior Drain Detail

1. Gravel to be Not More Than 1-1/2" and Not Less Than 1/2" Diameter.
2. Perforated Pipe Diameter Varies With Expected Seepage. 3"Ø and 4"Ø are Most Common. ABS and PVC are Most Common Materials for Pipe. We approve the use of an "EZ Flow Drainage System" by Infiltrator. All specifications in this drain detail are still applicable.

3. Pipe to be Laid out in a Minimum Slope of 1" in 10'.
4. Gravity Outfall is Desired if Possible. Portion of Pipe in Area Not Drained Shall be Non-Perforated. Daylight Must be Maintained Clear of Debris in Order to Function Properly.

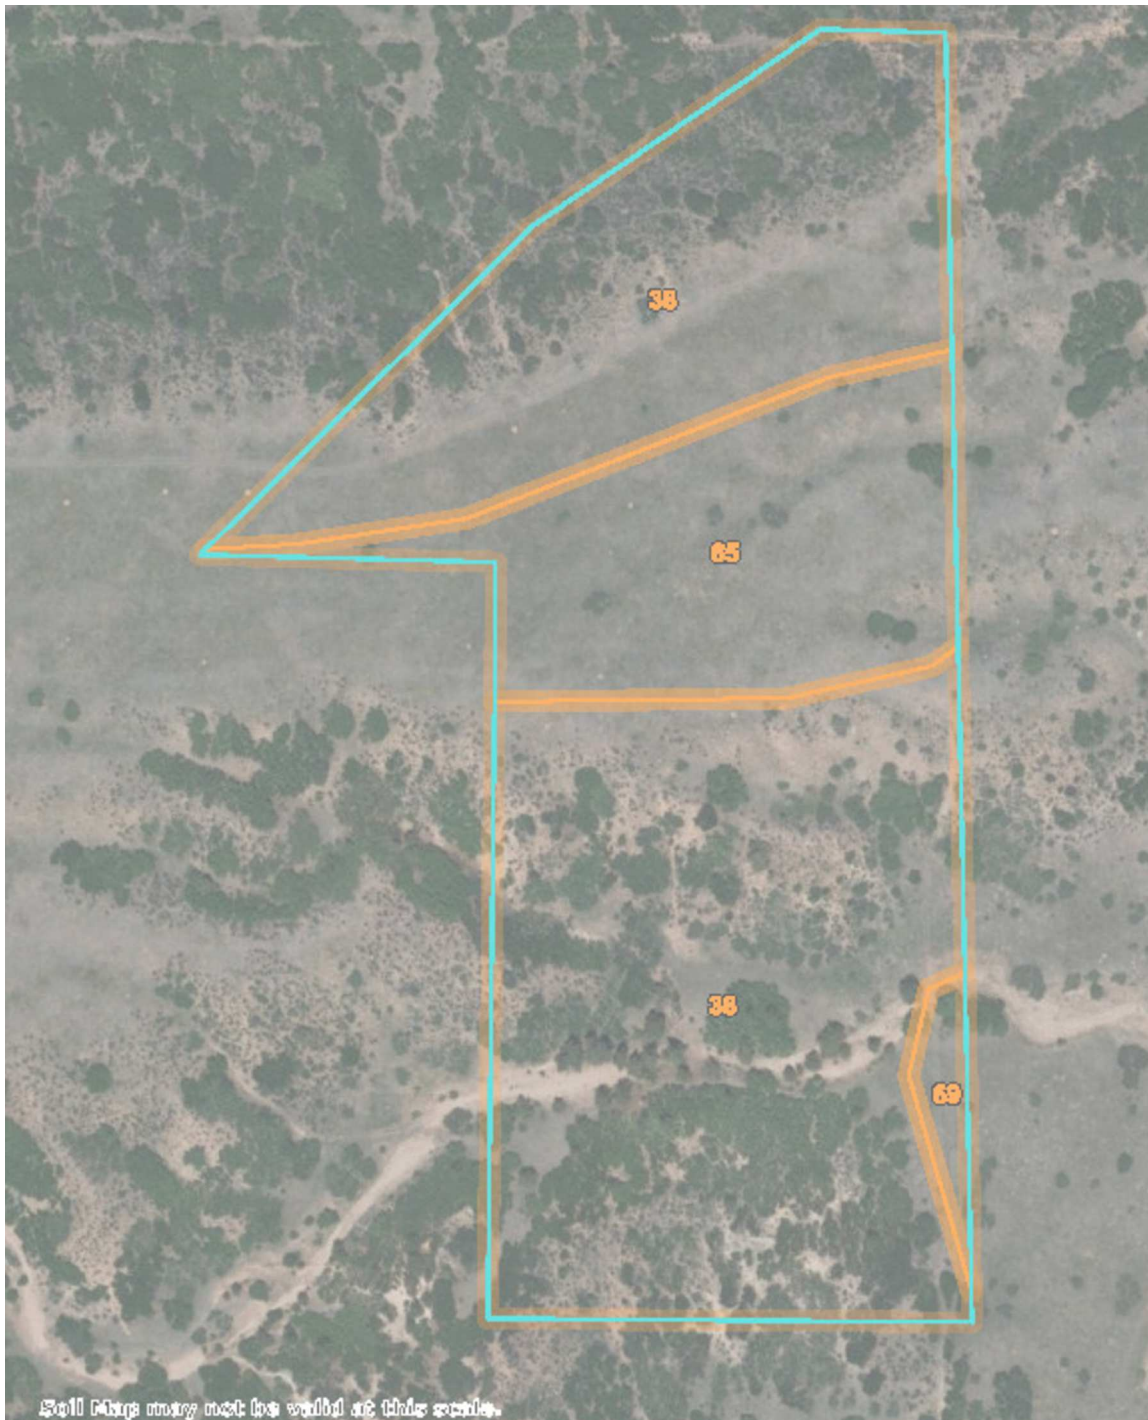
FIG No. 5

38 - Jarre - Tecolote complex with 8 to 65 percent slopes

65 - Perrypark gravelly sandy loam, 3 to 9 percent slopes

- 69 – Peyton-Pring complex, 8 to 15 percent slopes. This soil condition is located outside of the proposed OWTS locations and has been eliminated from this study. A USDA Soil Survey Map is presented in Figures 5.
