**ENTECH**  
ENGINEERING, INC.

**SOILS AND GEOLOGY STUDY  
MONUMENT RIDGE EAST  
MONUMENT HILL ROAD AND PALMER DIVIDE ROAD  
EL PASO COUNTY, COLORADO**

March 7, 2023  
Revised August 7, 2024

**PCD No. SP241**

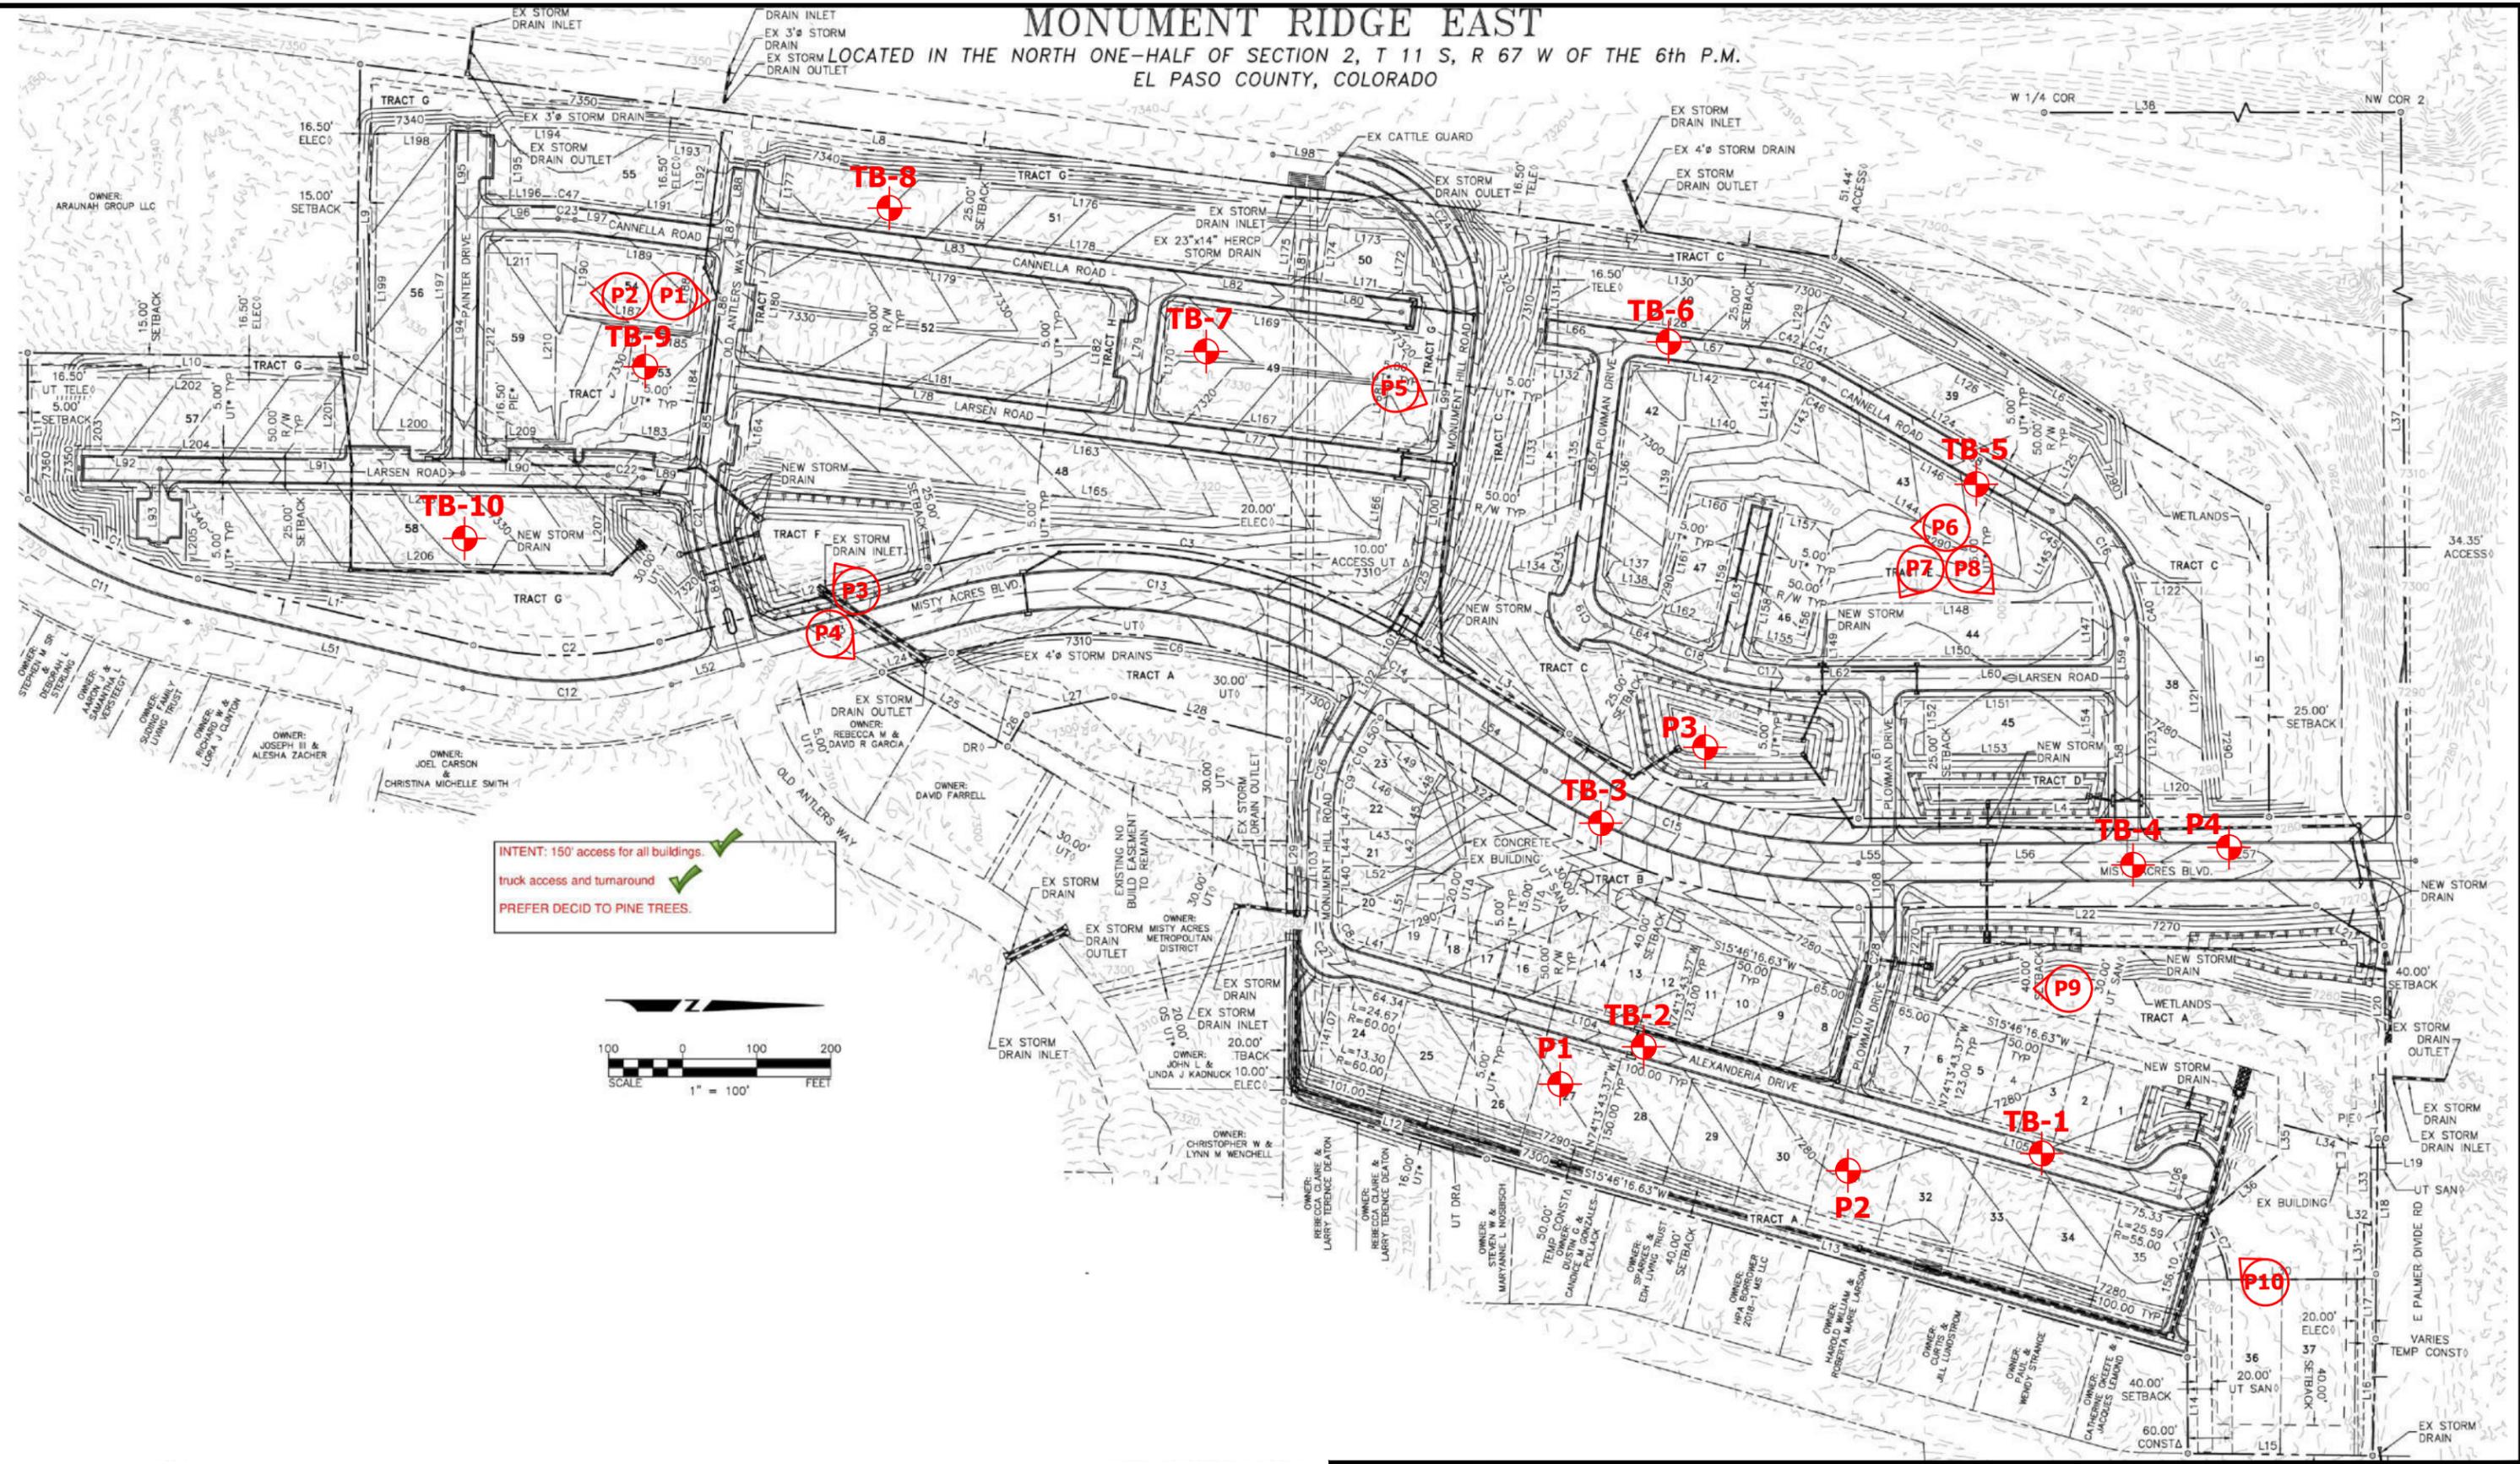
JOB NO.  
230248  
**FIG. 3**

- TB- APPROXIMATE TEST BORING LOCATION AND NUMBER**
- P- APPROXIMATE PIEZOMETER LOCATION AND NUMBER, GROUNDWATER DEPTH**

The topography of the site is generally gradually to moderately sloping to the east, west, and north along a drainage through the central portion of the site. Portions of the delineated wetlands indicated on Figure 3 were wet, however, flowing water was not observed. Several minor drainage swales were observed across the site. The drainages onsite flow in a northerly direction. The site is currently mostly undeveloped with an old farm house and barn located in the central portion of the site. Misty Acres Boulevard extends into the site and is partially paved. The site boundaries are indicated on the USGS Map, Figure 2. Previous land uses have included agricultural grazing and pasture land. The site contains primarily field grasses, weeds, scrub oak, and ponderosa pines. Site photographs, taken February 28, 2023, are included in Appendix A, and approximate locations are indicated on Figure 3.

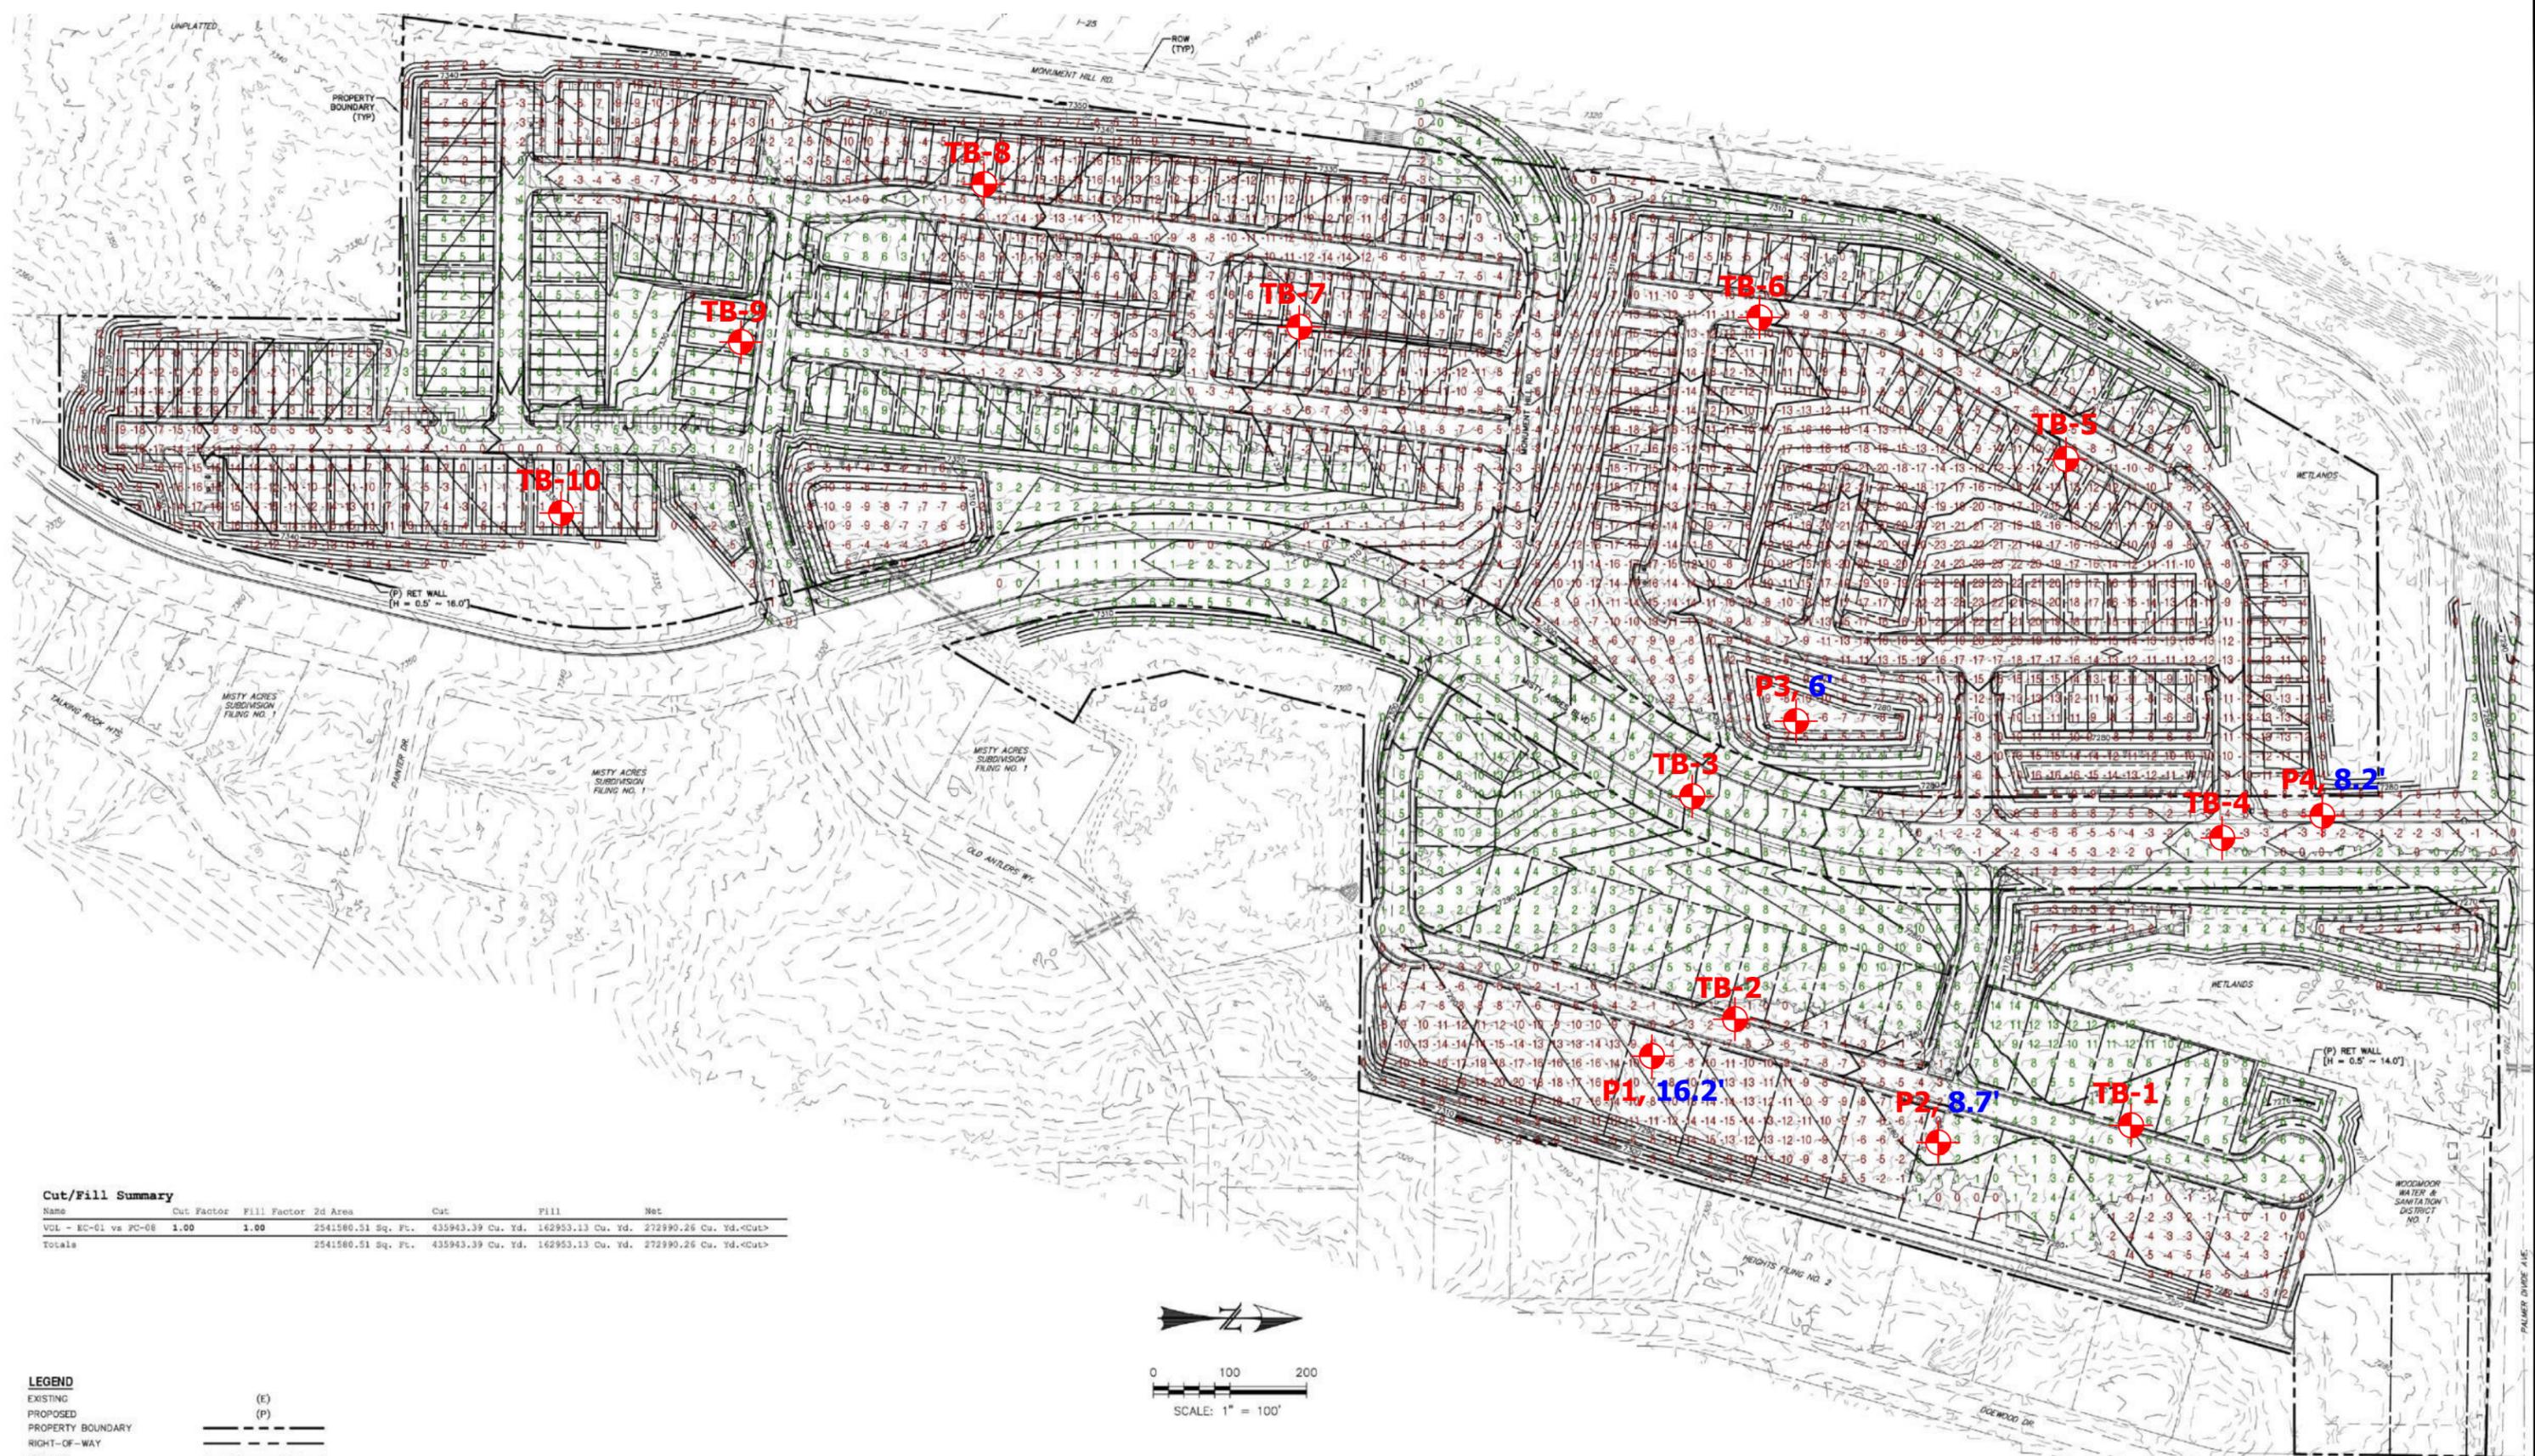
**FIG. 4**

**Cut/Fill Summary**

Name	Cut Factor	Fill Factor	2d Area	Cut	Fill	Net
VCL - EC-01 vs PC-08	1.00	1.00	2541580.51 Sq. Ft.	435943.39 Cu. Yd.	162953.13 Cu. Yd.	272990.26 Cu. Yd.<Cut>
<b>Totals</b>			2541580.51 Sq. Ft.	435943.39 Cu. Yd.	162953.13 Cu. Yd.	272990.26 Cu. Yd.<Cut>

**CUT/FILL EXHIBIT**  
 MONUMENT RIDGE EAST  
 MONUMENT RIDGE EAST, LLC

Total acreage involved in the proposed development is approximately 63 acres. The proposed site development consists of residential development consisting of duplex, three-plex, four-plex, single family lots, and other associated site improvements. Preliminary plans indicate significant grading will be performed to develop the site. An existing Woodmoor Water and Sanitation sewer main is located in the central and northern portions of the site. Proposed grading is shown on Figure 3, and the Cut/Fill Exhibit is presented on Figure 4. Significant cuts up to 20 feet or more are proposed across the site with the drainage area in the central portion of the site to be filled. Seven detention ponds and storm water drainage improvements are proposed across the site. Retaining walls are proposed in the southern and northern portions of the site varying in height from 0.5 to 16 feet.

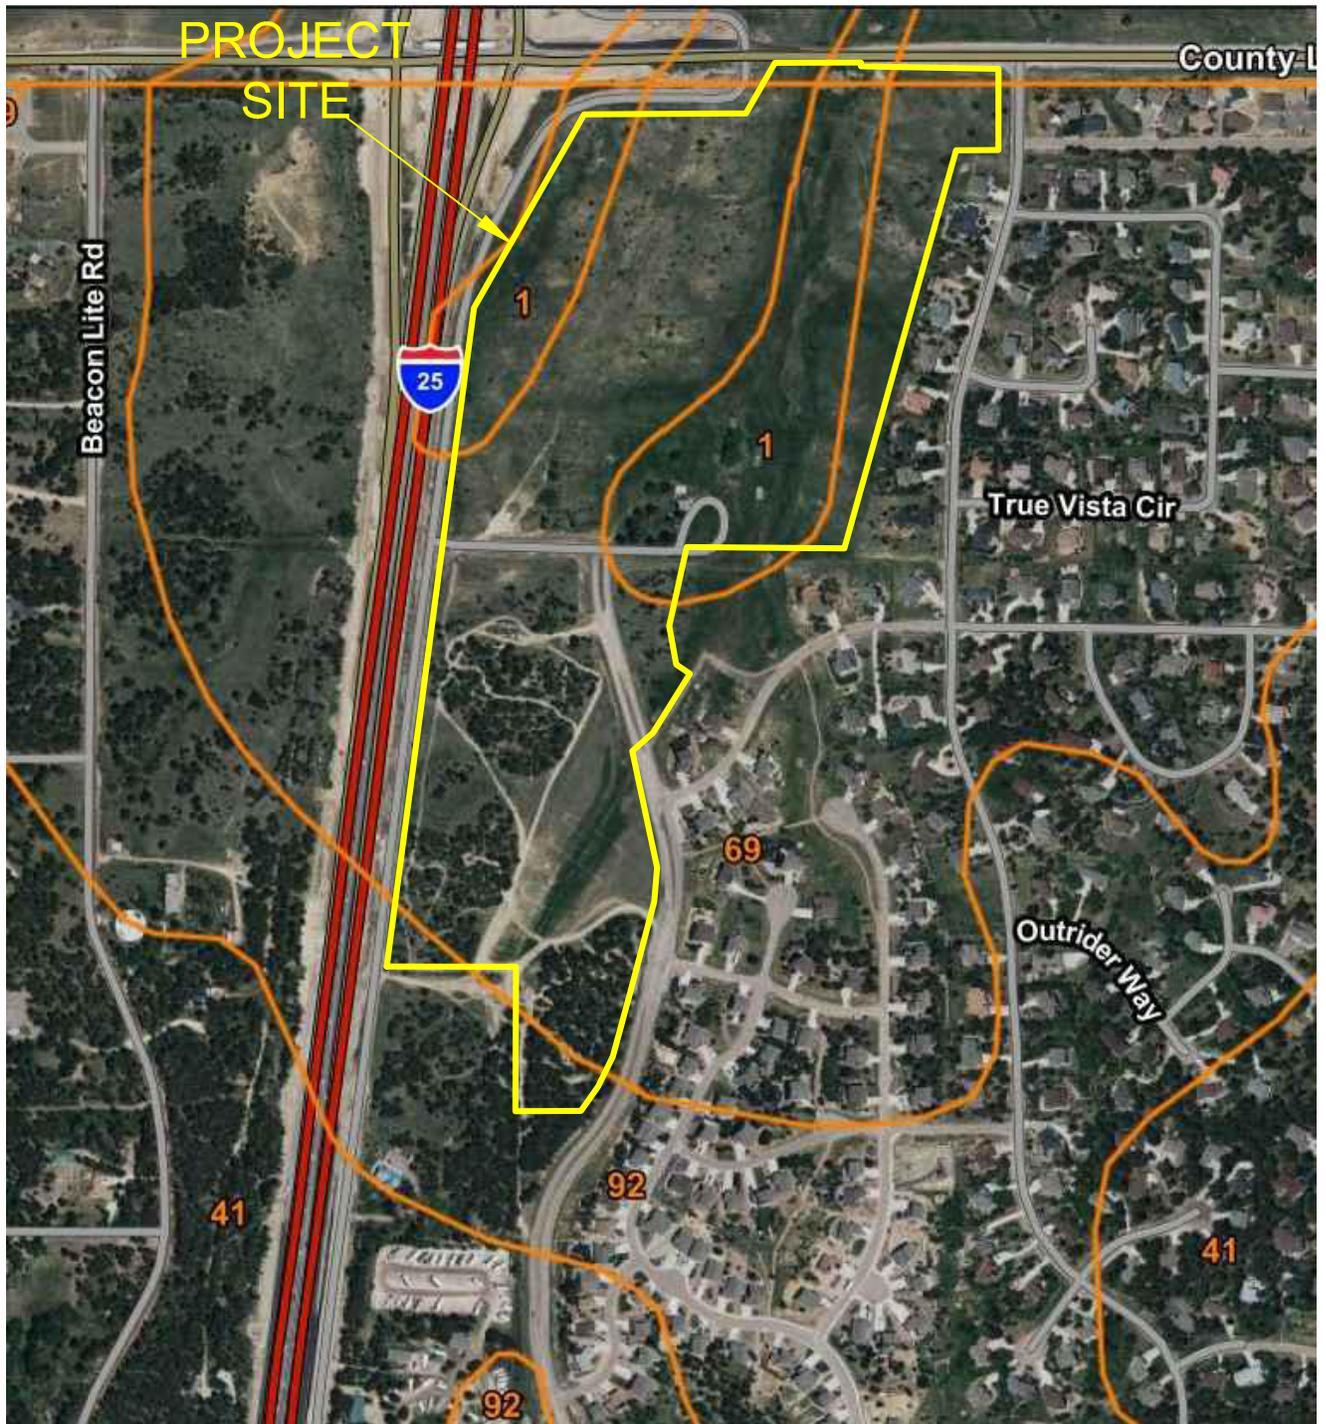
**FIG. 5**

**USDA SOIL MAP**  
MONUMENT RIDGE EAST  
MONUMENT RIDGE EAST, LLC

The Natural Resource Conservation Service (Reference 4), previously the Soil Conservation Service (Reference 5) has mapped one soil types on the site Figure 4. In general, the soils are classified as sandy loams. The soils are described as follows:

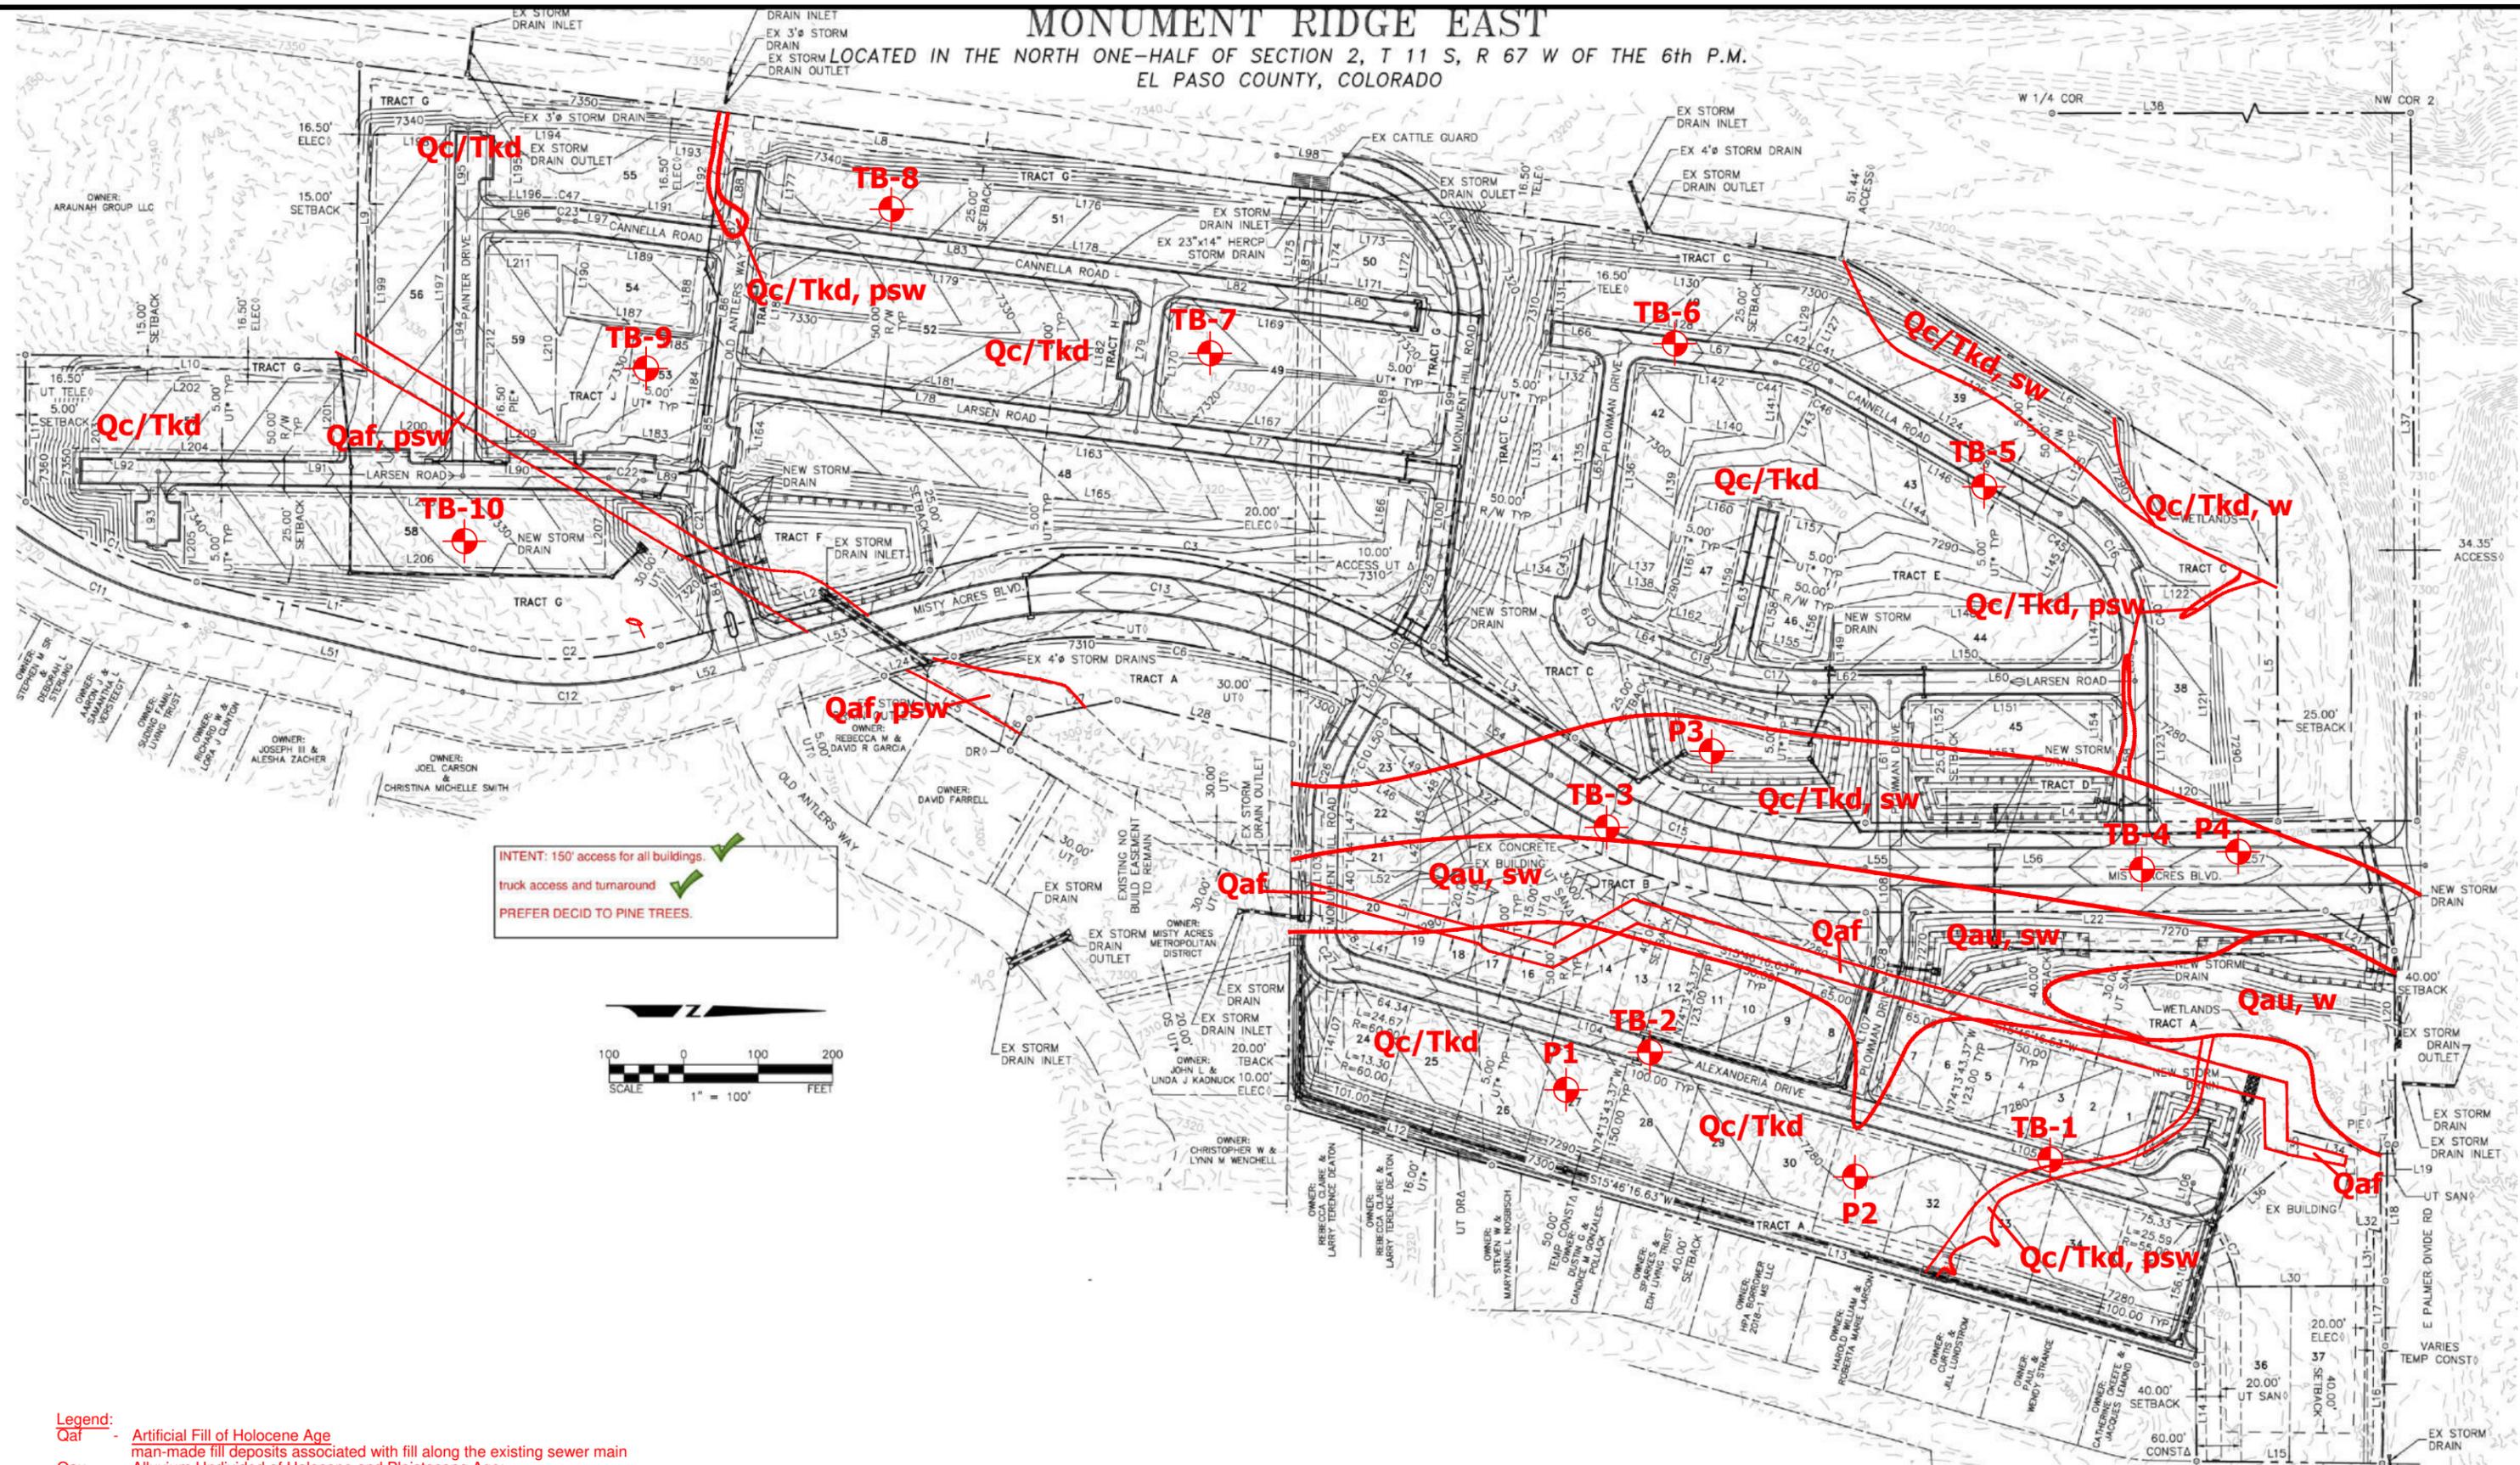
- Legend:**
- Qaf - Artificial Fill of Holocene Age  
man-made fill deposits associated with fill along the existing sewer main
  - Qau - Alluvium Undivided of Holocene and Pleistocene Age:  
sheetwash and channel deposited alluvium along active drainage way
  - QcTkd - Colluvium of Quaternary Age overlying Dawson Formation of Tertiary to Cretaceous Age:  
colluvial and residual soils overlying arkosic sandstone with interbedded fine-grained sandstone, siltstone and claystone
  - psw - potentially shallow groundwater area
  - sw - seasonally shallow groundwater area
  - w - standing water/wetlands

The Greenland and Monument Quadrangles Geology Map showing the site is presented in (Figure 5, References 6 and 7). The Geology/Engineering Geology Map prepared for the site is presented in Figure 6. Three mappable units were identified on this site which are described as follows:

The seasonally shallow groundwater and potentially seasonal shallow groundwater areas located on the site are shown on the Geology Map, Figure 7. Portions of these areas mapped with these hazards have been identified in the National Wetland Inventory as Freshwater Emergent Wetland habitats classified as PEM1C (Palustrine – P, Emergent – EM, Persistent – 1, Seasonally Flooded – C), Freshwater Forested/Shrub Wetland habitat classified as PSS1C (Palustrine – P, Scrub-Shrub – SS, Broad-Leaved Deciduous – 1), and Riverine habitat classified as R4SBC (Riverine – R, Intermittent – 4, Streambed – SB, Seasonally Flooded – C), (Figure 9, Reference 11). The jurisdictional and non-jurisdictional wetlands were previously delineated by WBS (Reference 12), and USACE Jurisdictional Determination letter (Reference 13) are included in Appendix E.

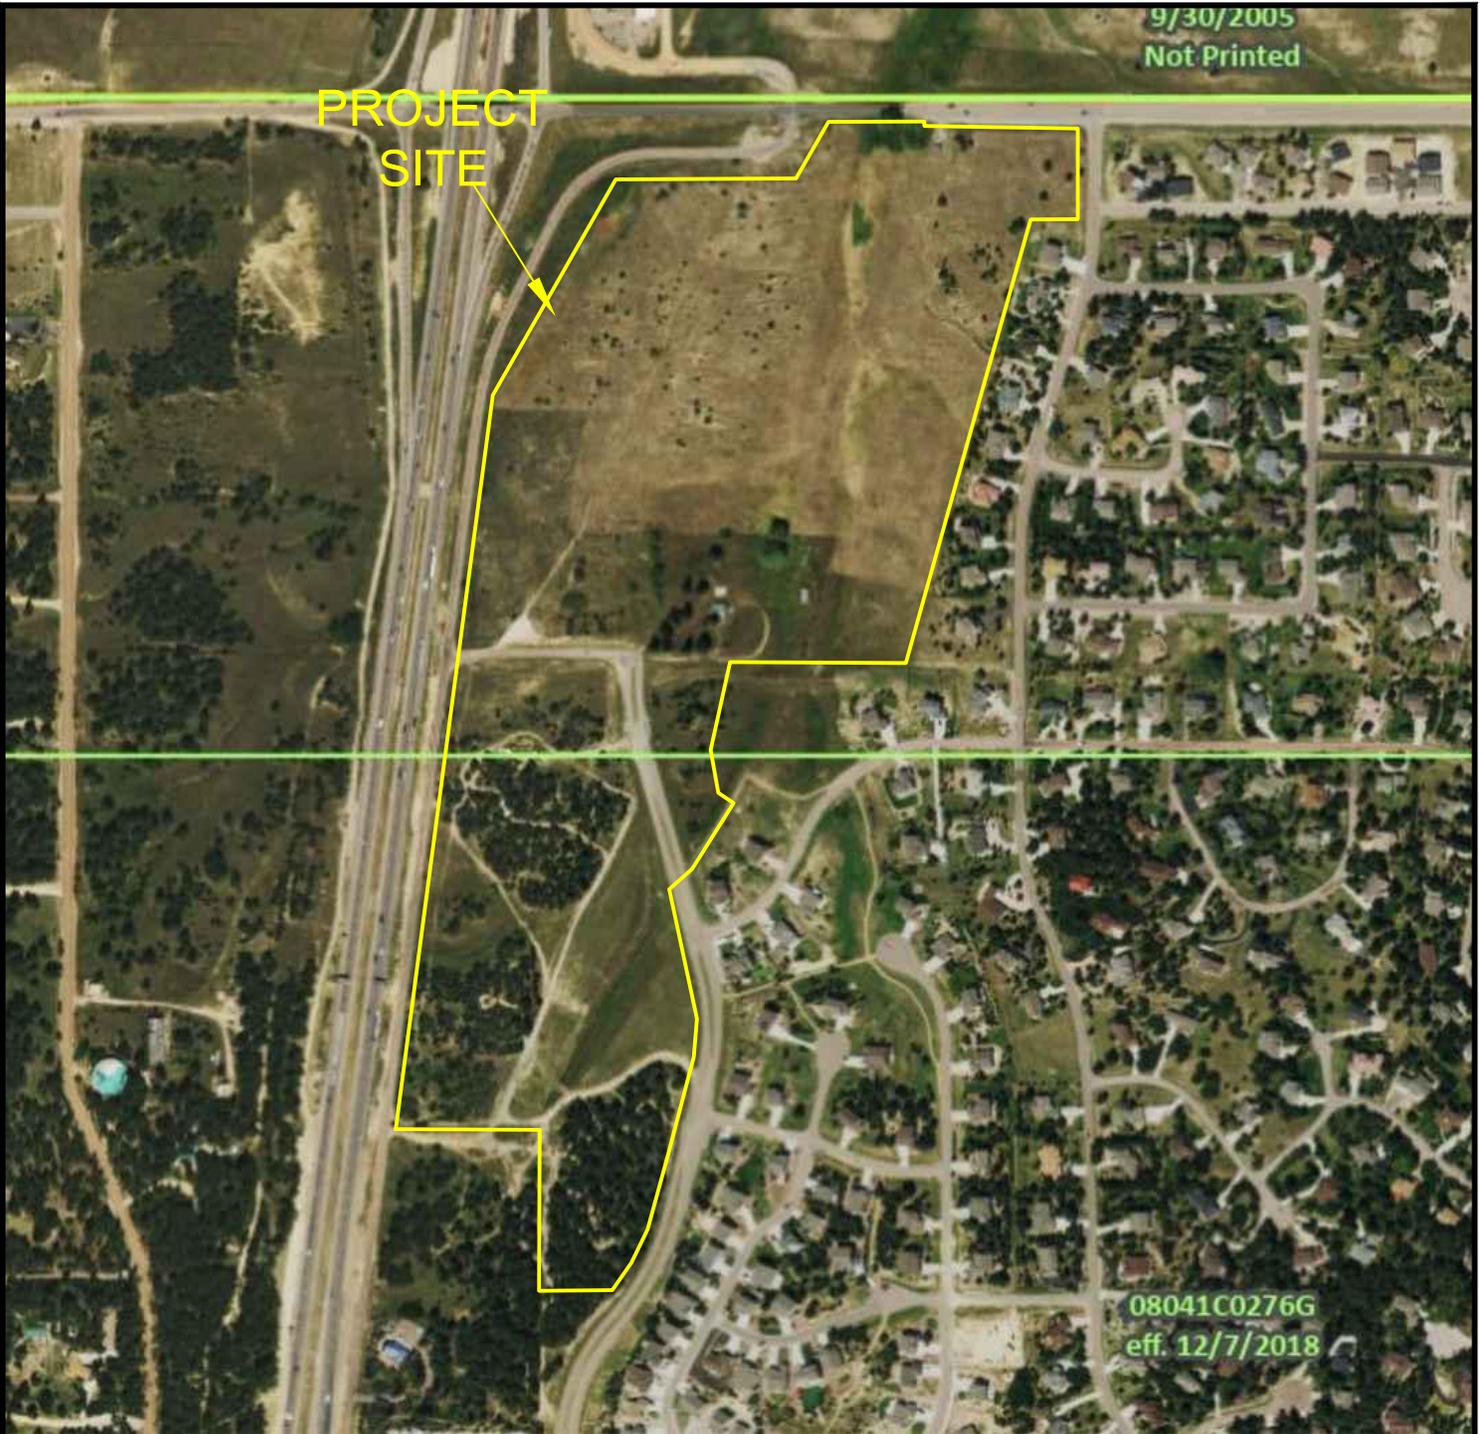
**FIG. 8**

08041C0276G  
eff. 12/7/2018

A drainage is located in the central portion of the site which flows in a northerly direction. The site is not mapped within any floodplain zones according to the FEMA Map Nos. 08041CO065G and 08041CO276G, dated December 7, 2018 (Figure 8, Reference 10). Wet areas were observed in the northern and northwestern portions of the site along the drainage in the delineated wetland areas. Additionally, areas of seasonal and potentially seasonal shallow groundwater were observed across the site. In these areas, we would anticipate the potential for periodically high subsurface moisture conditions and frost heave potential. These are low-lying areas along the central drainage and minor drainages across the site. Perched water conditions could be encountered across the entire site where water can flow within permeable sand layers overlying impermeable bedrock. Where perched water conditions are encountered, the mitigation recommendations for seasonal and potentially seasonal shallow groundwater should be followed. Foundations should maintain a minimum separation of 3 feet between the foundation grade and the maximum anticipated groundwater level. These areas are further discussed below.

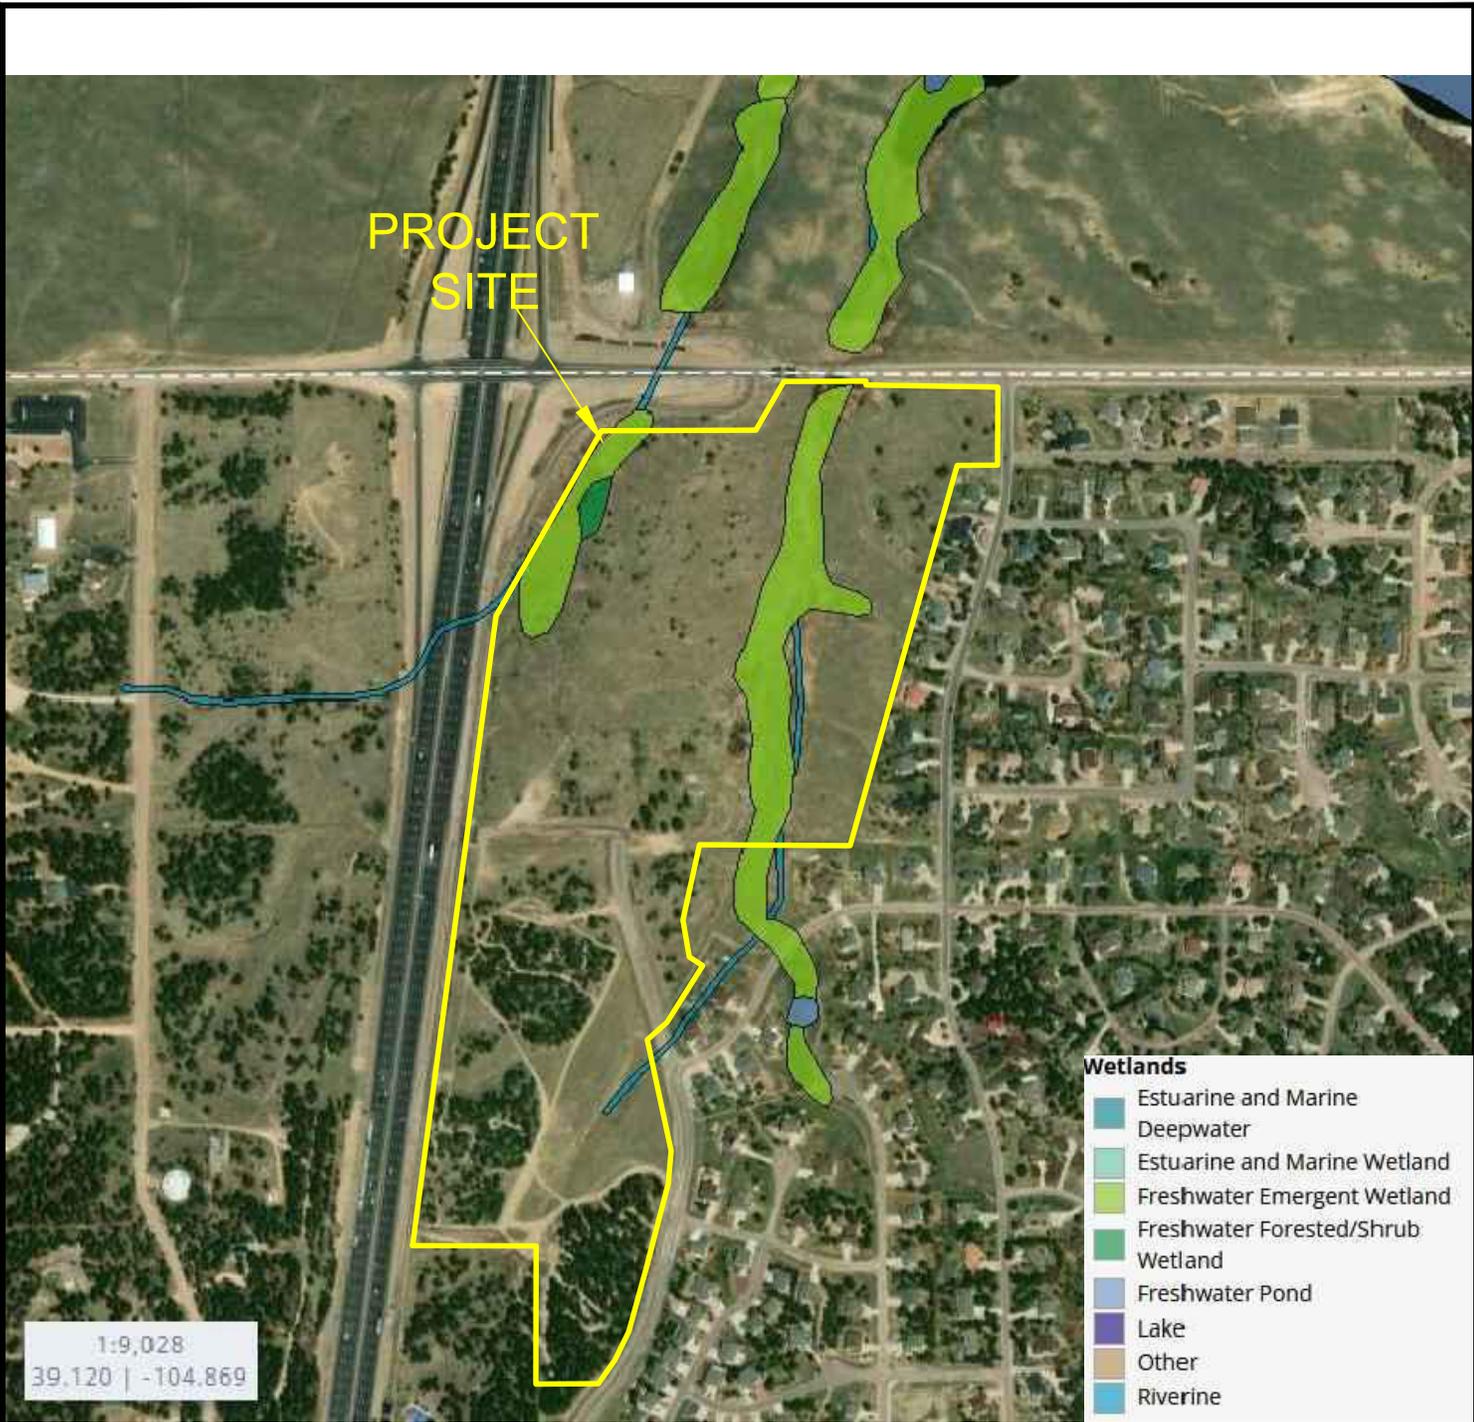
**FIG. 9**

**USFWS WETLANDS MAP**

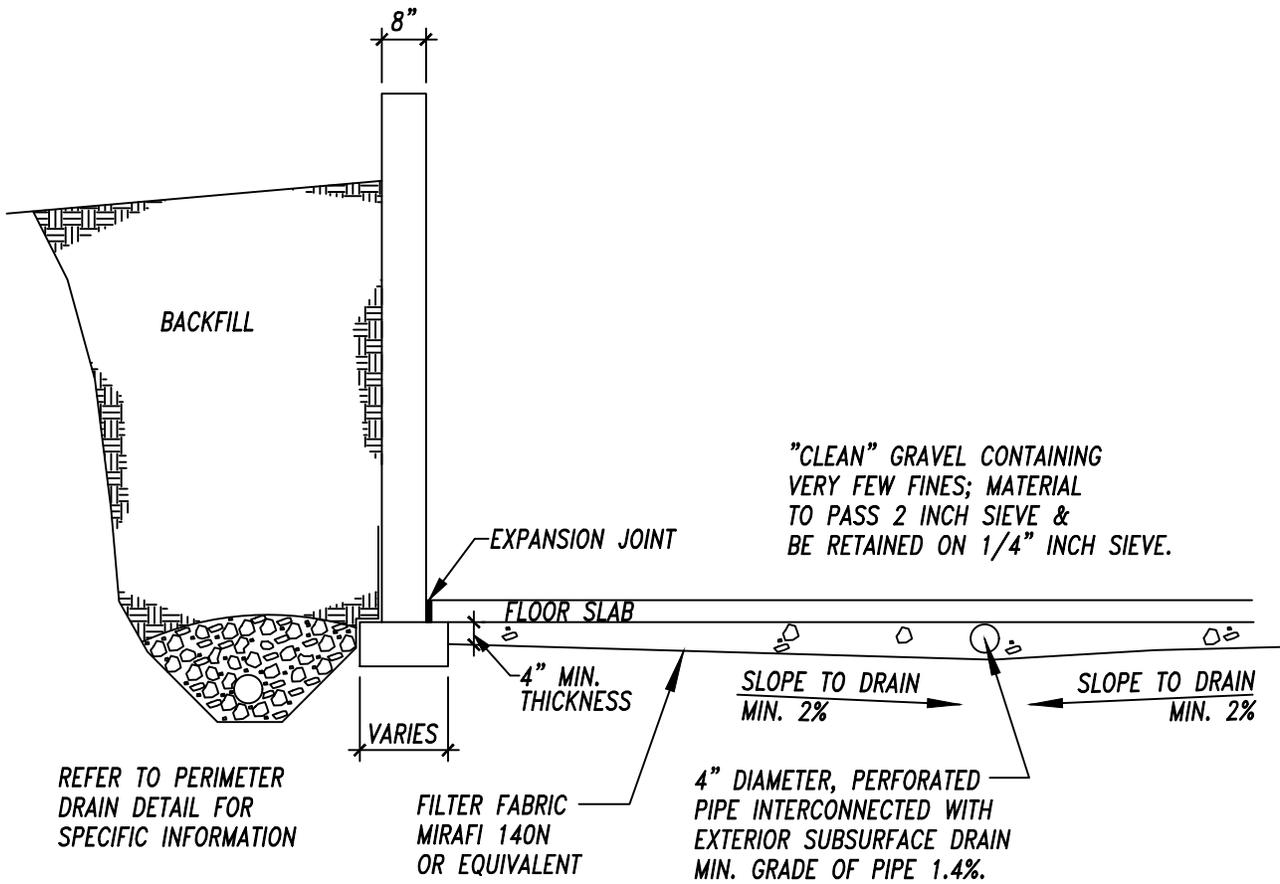
**FIG. 11**

**TYP. UNDERSLAB DRAINAGE LAYER  
(CAPILLARY BREAK)**  
MONUMENT RIDGE EAST  
MONUMENT RIDGE EAST, LLC

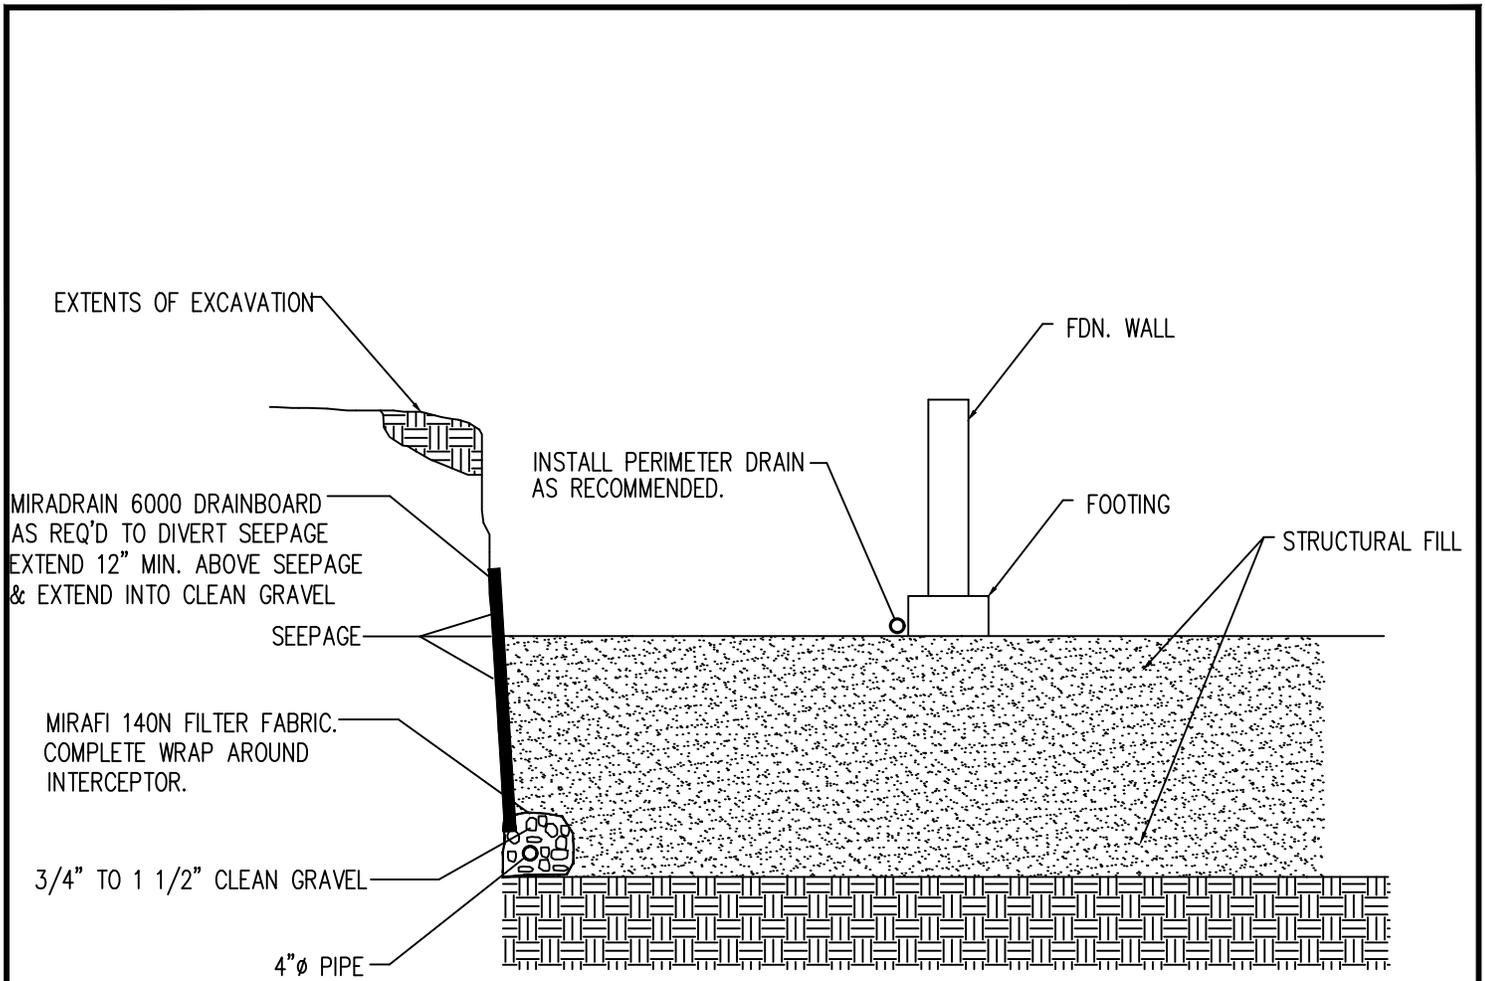
## INTERCEPTOR DRAIN DETAIL

NOTE:  
EXTEND INTERCEPTOR DRAIN TO UNDERDRAIN OR TO SUMP.  
BENCH DRAIN INTO NATIVE SOILS 12 INCHES MINIMUM.
