**ENTECH**  
ENGINEERING, INC.

**SOILS AND GEOLOGY STUDY  
MONUMENT RIDGE EAST  
MONUMENT HILL ROAD AND PALMER DIVIDE ROAD  
EL PASO COUNTY, COLORADO**

March 7, 2023  
Revised August 7, 2024

**PCD No. SP241**

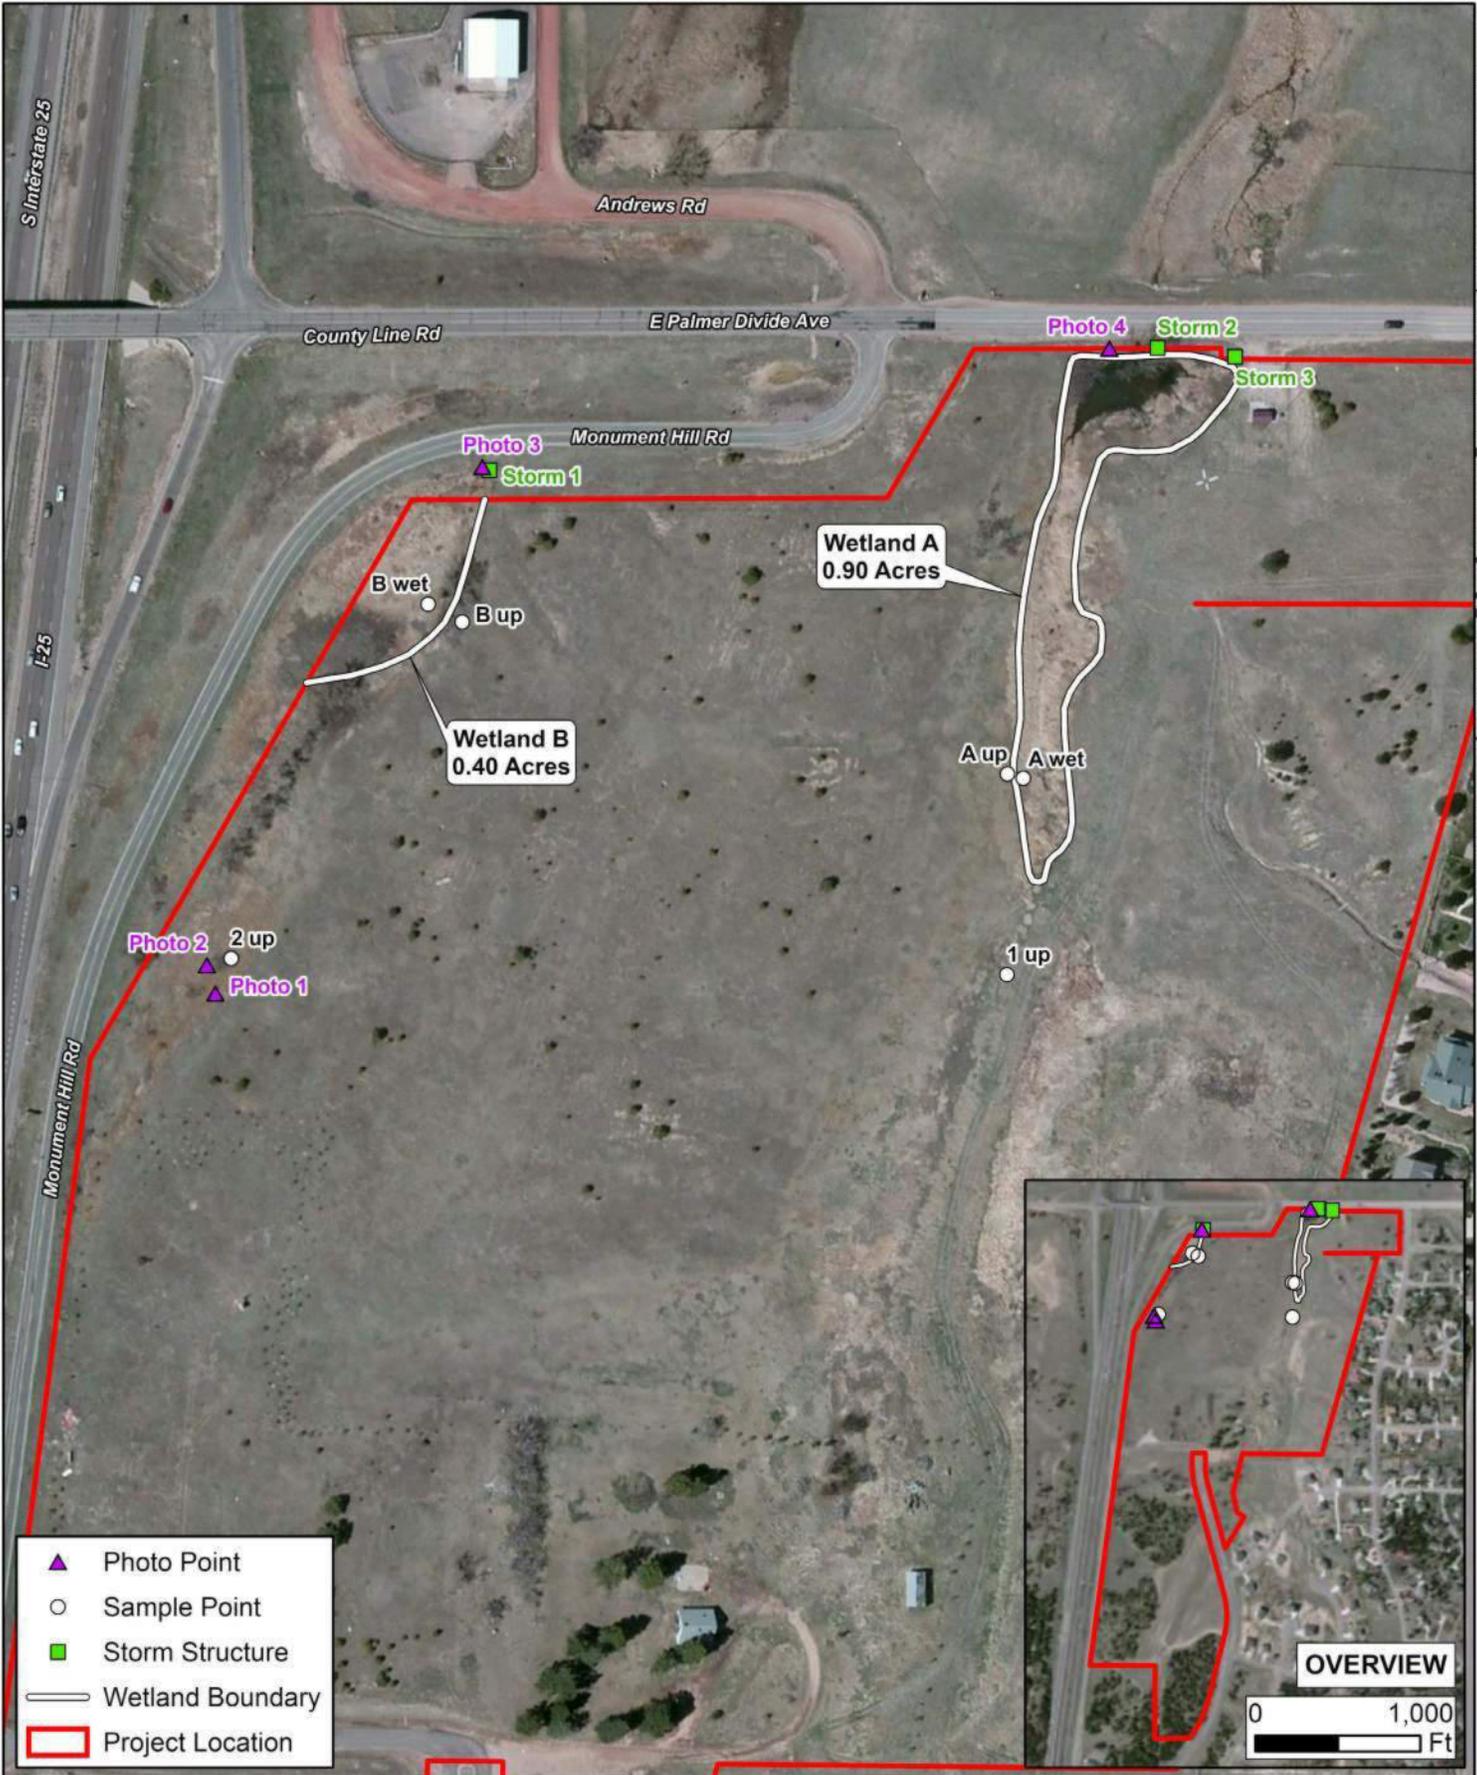
### Figure 6 - Wetland Boundary

Monument Ridge Development  
Woodmoor, Colorado

A Level 2 wetland delineation was performed on the site. A total of two (2) wetlands were identified and delineated in the preparation of this report, as summarized in **Table 1**. For a visual representation of the wetland locations and size, please see **Figure 6, Appendix B**. All potential wetland areas (mapped hydric soils, NWI signatures, and low depressional areas) were reviewed on-site and either delineated or determined to be upland.

Western Mountains, Valleys, and Coast Regional Supplement Routine Wetland Delineation data forms were used to record vegetation, hydrology, and soil characteristics at sample points in and adjacent to the wetlands (**Appendix B**). Sampling transects were taken along the wetland-upland boundary of the wetland. Transects and delineated wetland boundaries were field surveyed using a sub-meter accuracy hand-held GPS unit. Approximate sampling points and delineated wetland edges are shown on **Figure 6, Appendix B**. Pictures of each wetland can be found in **Appendix C**.

Wetland A is positioned in a sloped depression. The wetland is characterized as a seasonally flooded/shallow marsh wetland. The wetland boundary is outlined in **Figure 6, Appendix B**.

Wetland B is positioned in a sloped depression. The wetland is characterized as a seasonally flooded wetland. The wetland boundary is outlined in **Figure 6, Appendix B**.

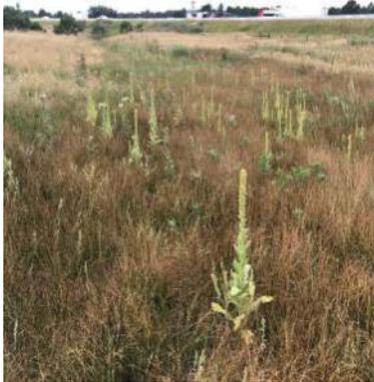
<p><b>Photo 1 – Sample Point 2 Up</b></p> <p>Date: 8/26/2021</p> <p>Direction Photo is Taken: Southwest</p> <p>Photo Location: Near Sample Point 2 Up</p>

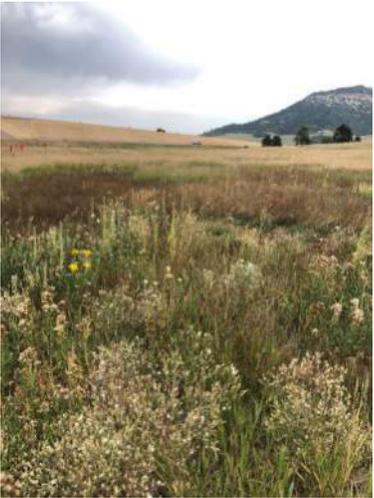
<p><b>Photo 2 – Sample Point 2 Up</b></p> <p>Date: 8/26/2021</p> <p>Direction Photo is Taken: Northeast</p> <p>Photo Location: Near Sample Point 2 Up</p>

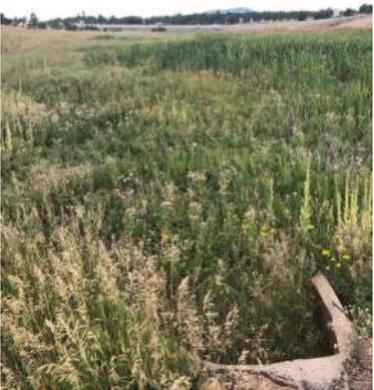
<p><b>Photo 3 – Wetland B</b></p> <p>Date: 8/26/2021</p> <p>Direction Photo is Taken: Southwest</p> <p>Photo Location: Looking at Wetland B, from Storm structure.</p>

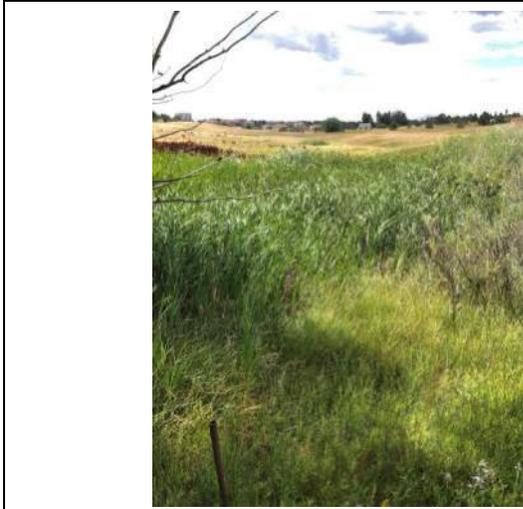
## Photo 4 – Wetland A

Date: 8/26/2021
