ENTECH
ENGINEERING, INC.

**SOILS AND GEOLOGY STUDY
MONUMENT RIDGE EAST
PARCEL NOS. 55092-00-002
MONUMENT HILL ROAD AND PALMER DIVIDE ROAD
EL PASO COUNTY, COLORADO**

March 7, 2023

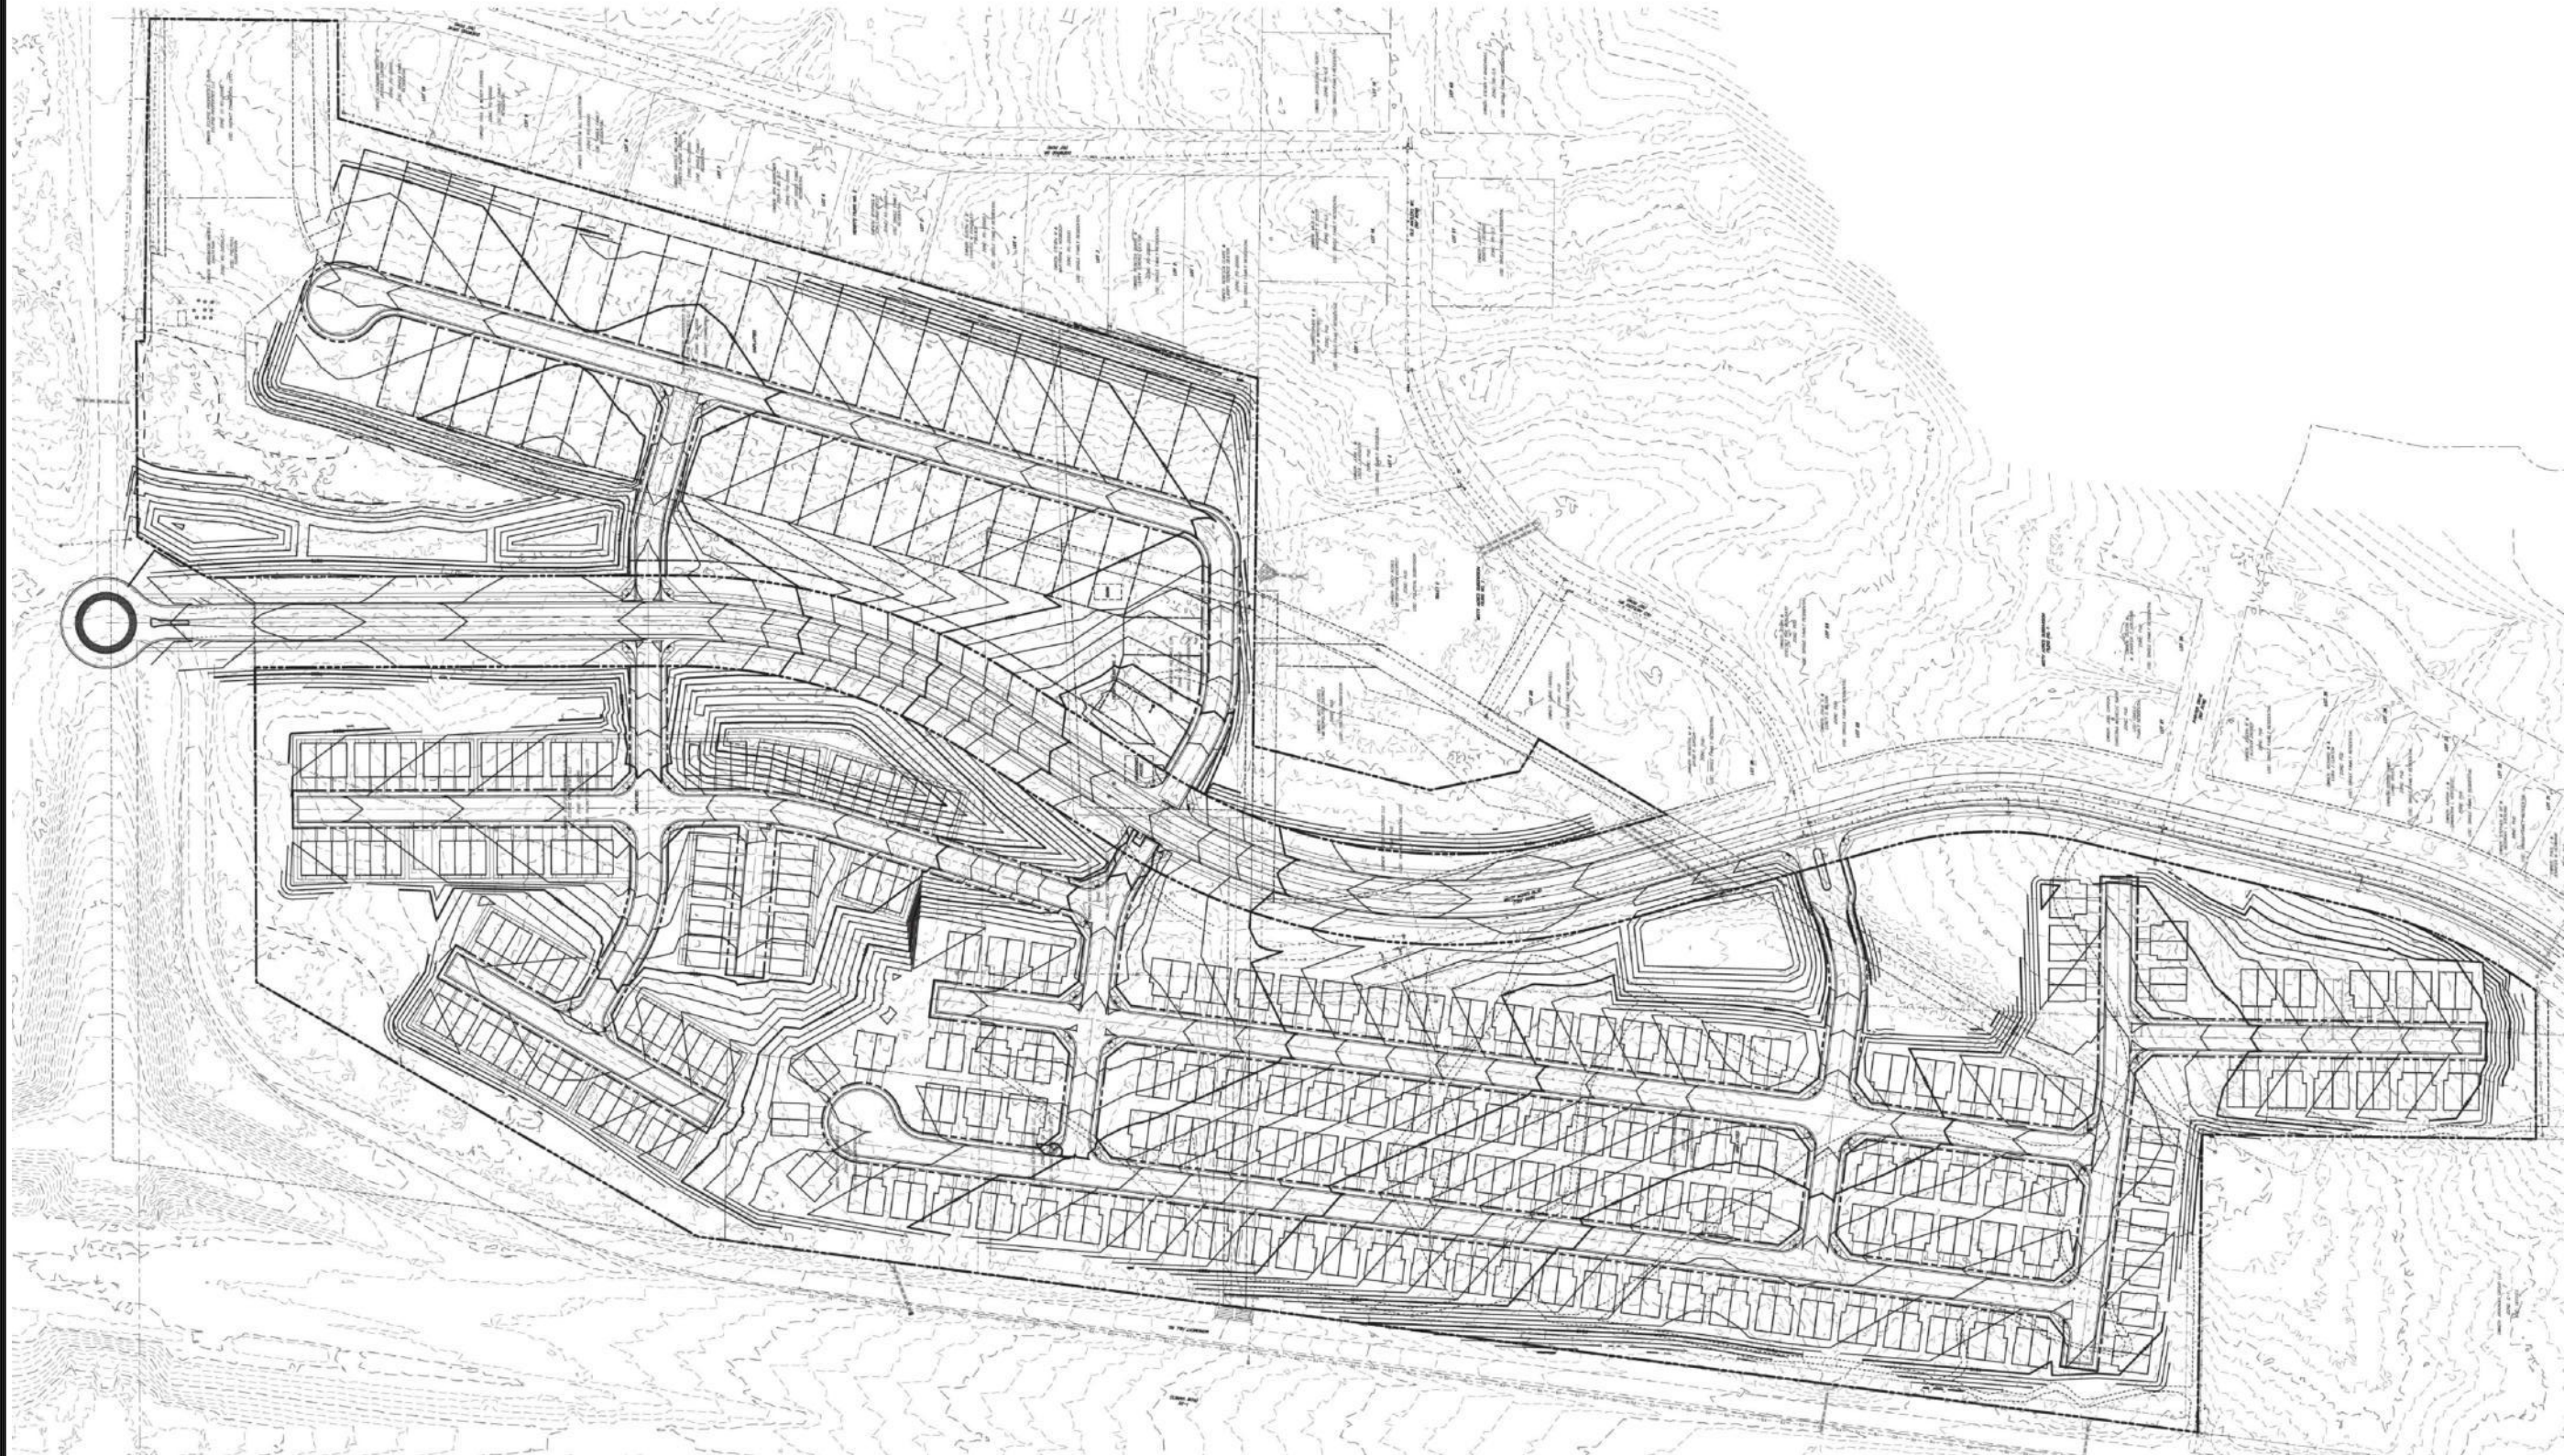
DRAWN L.L.L. CHECKED
DATE 3/1/23
SCALE AS SHOWN
JOB NO. 230248
FIGURE No. 4

PROPOSED GRADING PLAN
MONUMENT RIDGE EAST
MONUMENT HILL ROAD & PALMER DIVIDE ROAD
EL PASO COUNTY, CO.
FOR: MONUMENT RIDGE EAST, LLC

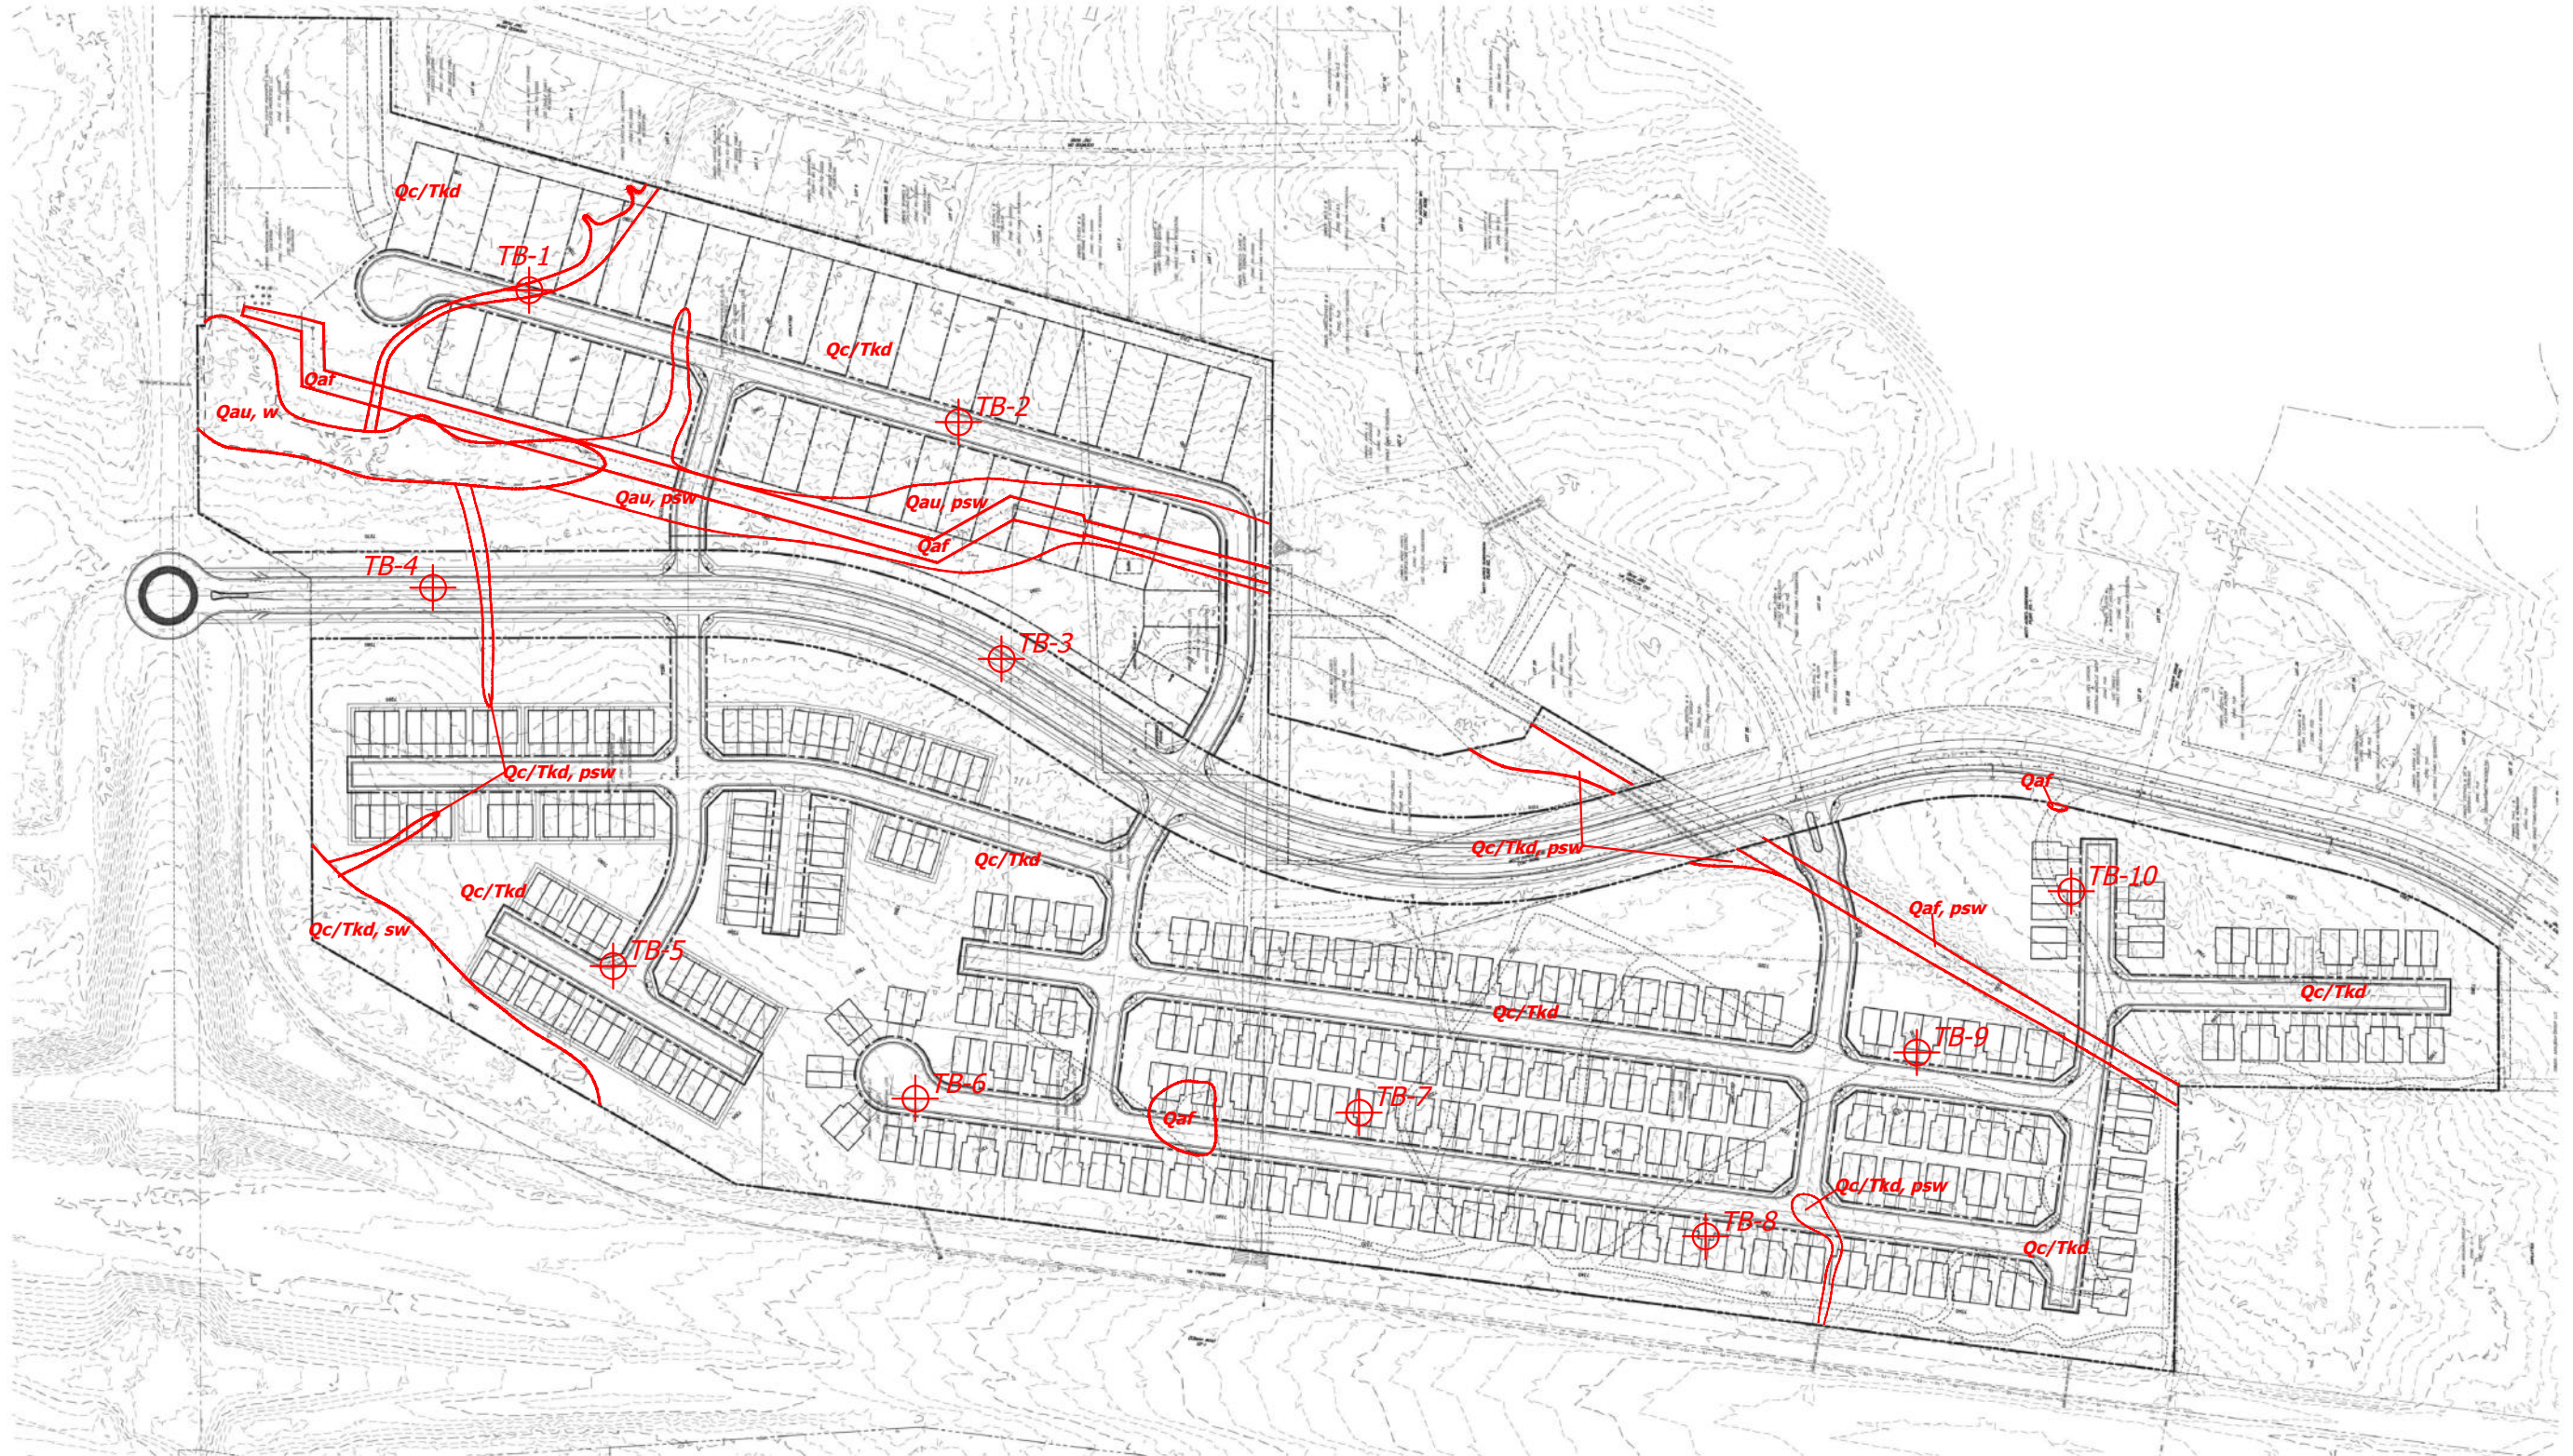
DRAWN
L.L.
CHECKED
DATE
3/1/23
SCALE
AS SHOWN
JOB NO.
230248
FIGURE No.
2

GEOLOGY/ENGINEERING GEOLOGY MAP
MONUMENT RIDGE EAST
MONUMENT HILL ROAD & PALMER DIVIDE ROAD
EL PASO COUNTY, CO.
FOR: MONUMENT RIDGE EAST, LLC

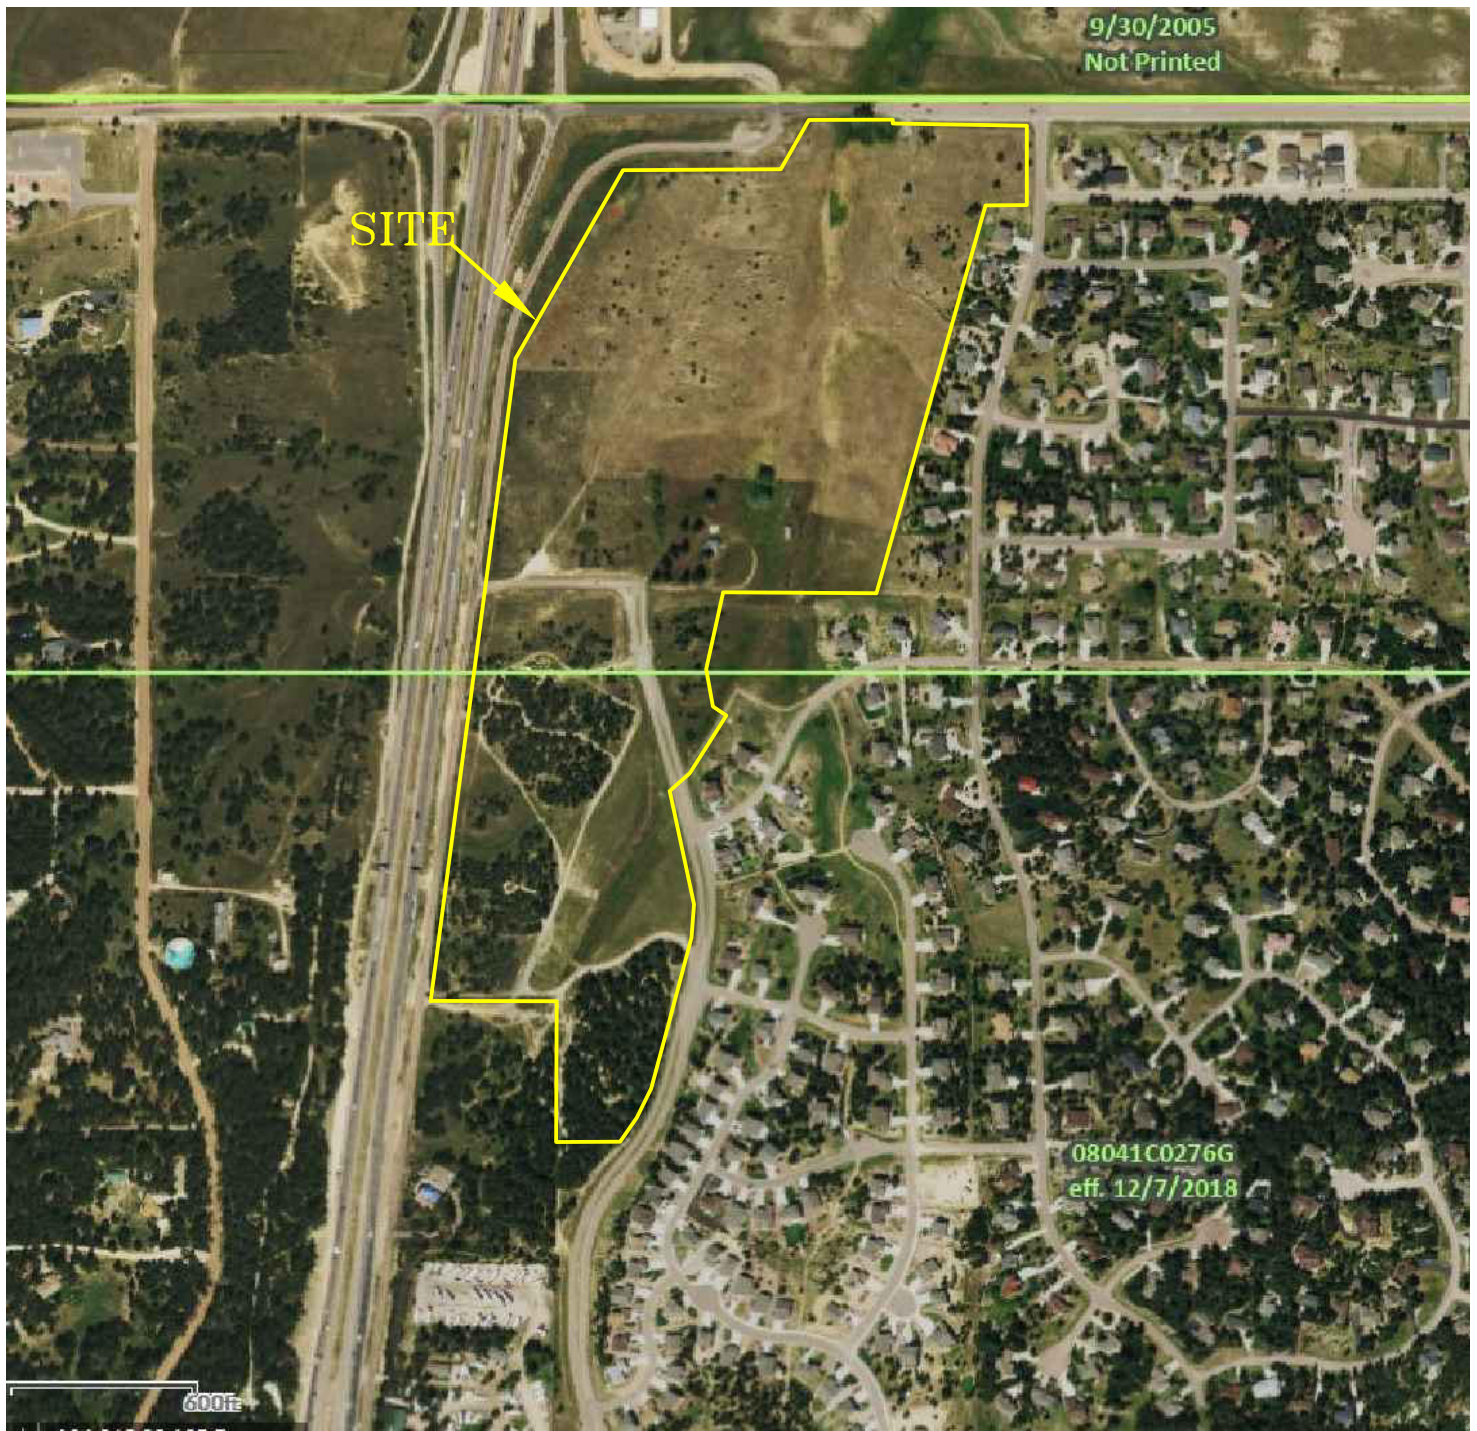
FIG NO.:
8

FEMA FLOODPLAIN MAP
HIGH FOREST ESTATES SUBDIVISION FIL. NO 1
8855 WALKER ROAD
EL PASO COUNTY, CO.
FOR: PAULA DONOHOO

A drainage is located in the central portion of the site and flows in a northerly direction. The site is not mapped within any floodplain zones according to the FEMA Map Nos. 08041CO065G and 08041CO276G, dated December 7, 2018 (Figure 8, Reference 9). Wet areas were observed in the northern portion of the site along the drainage in the area mapped as wetlands. Additionally, areas of seasonal and potentially seasonal shallow groundwater were observed across the site. In these areas, we would anticipate the potential for periodically high subsurface moisture conditions and frost heave potential. These are low-lying areas along the drainage and minor drainages across the site. Foundations should maintain a minimum separation of 3 feet between the foundation grade and the maximum anticipated groundwater level. Proposed grading plans indicate these areas will be filled and raised above the seasonally shallow and potentially seasonally shallow groundwater areas. **Additional investigation once grading has been completed to evaluate the groundwater levels is recommended.**

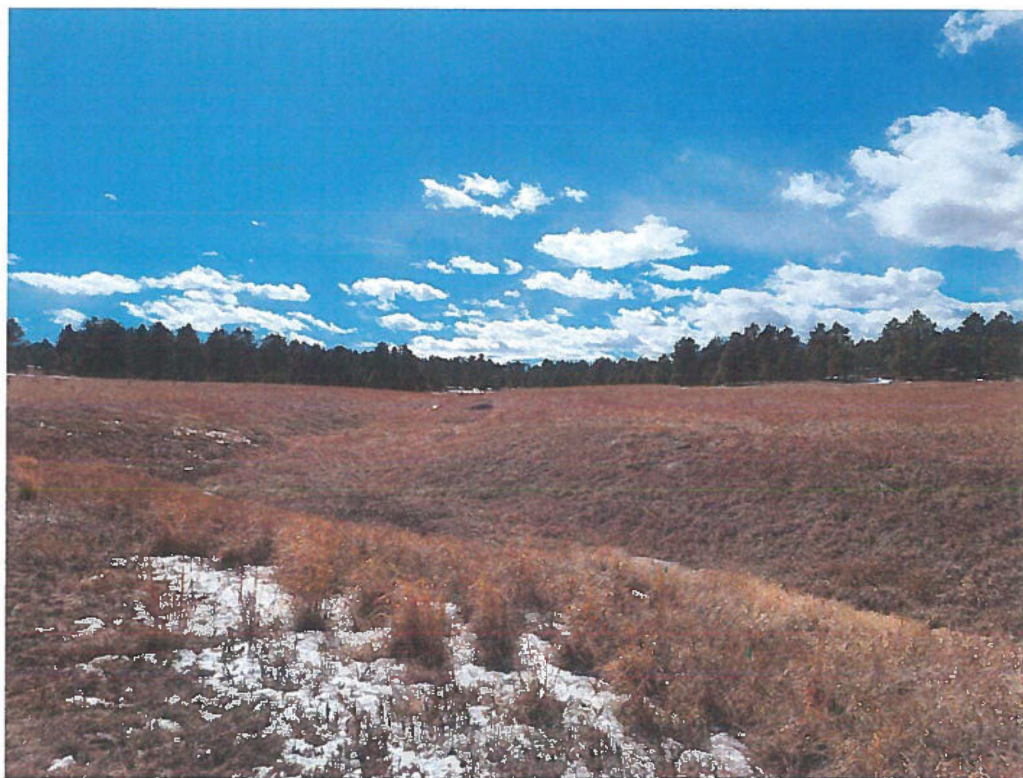
**Looking southwest
along drainage from
Misty Acres Boulevard
in the southern portion
of the site.**

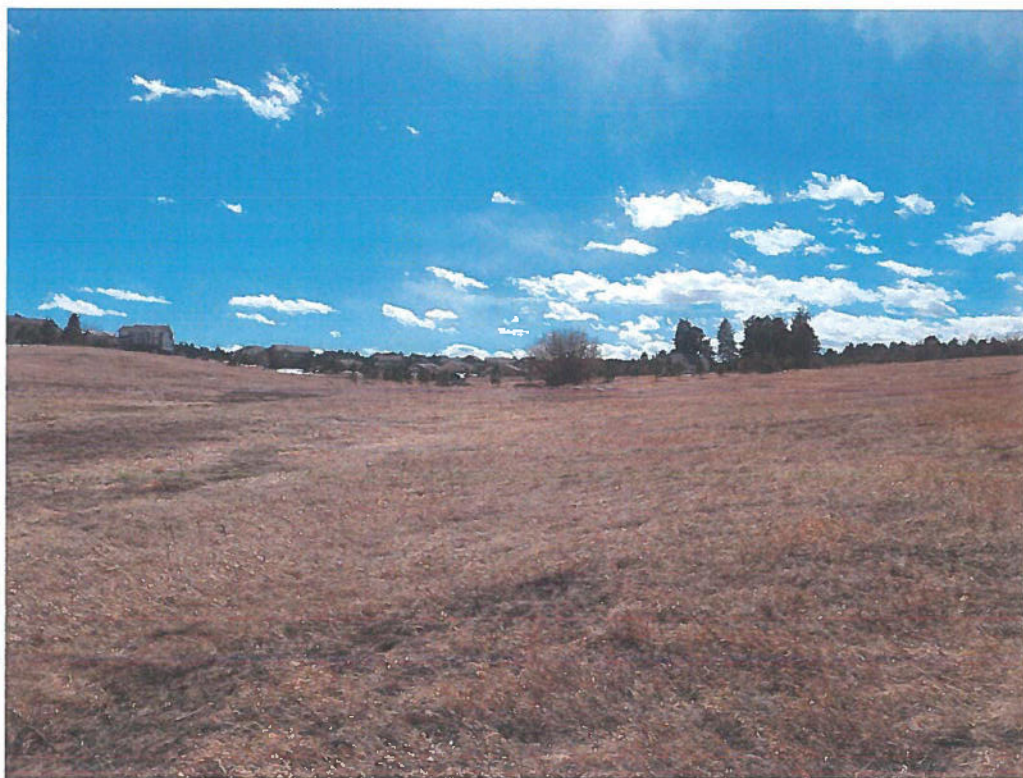
**Looking south along
drainage from the
north-central portion
of the site.**
