## **GEOLOGY AND SOILS STUDY**

**Creekside South at Lorson Ranch  
El Paso County, Colorado**

**JOB NO. 173922**

**February 27, 2020**

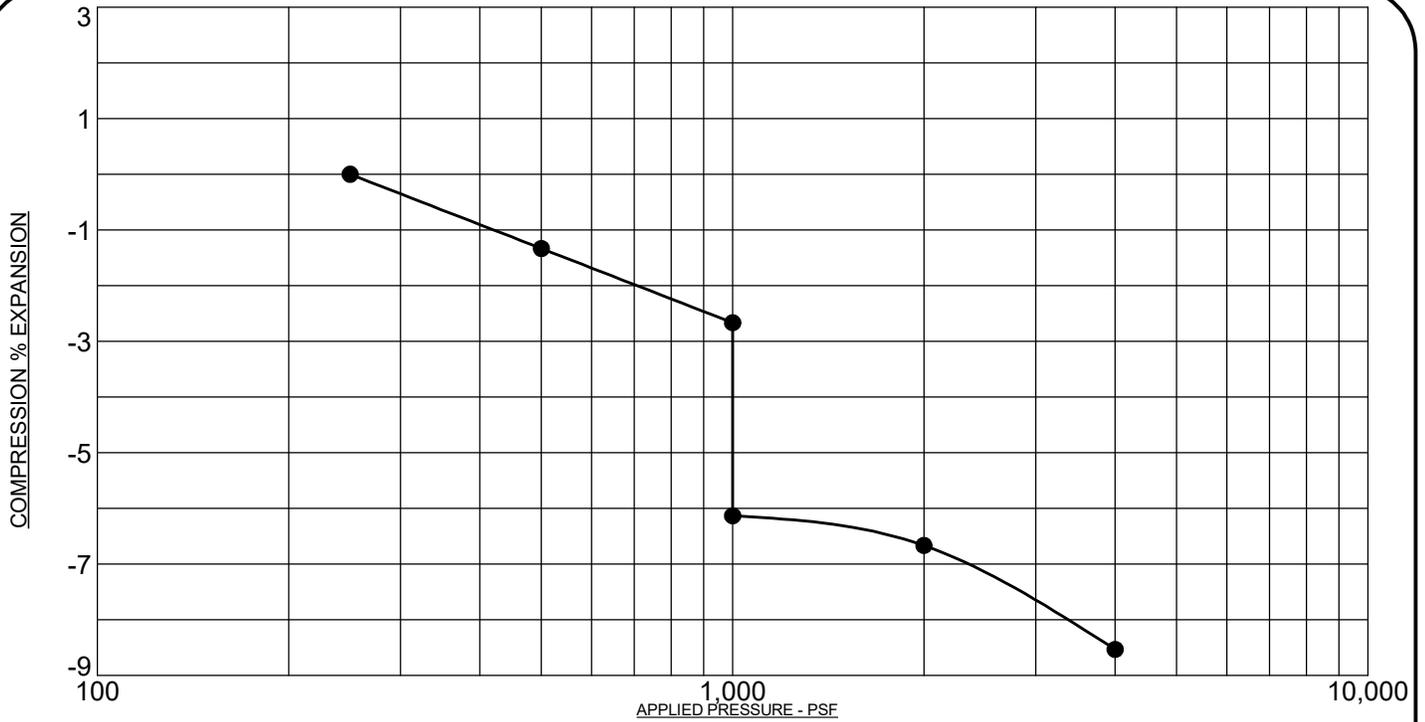
FIGURE No. 17

PROJECT: Creekside South, El Paso County, Colorado  
 SAMPLE DESCRIPTION: CLAY, SANDY  
 NOTE: SAMPLE WAS INUNDATED WITH WATER AT 1,000 PSF

SAMPLE LOCATION: 10 @ 4 FT  
 NATURAL DRY UNIT WEIGHT: 104.7 PCF  
 NATURAL MOISTURE CONTENT: 16.7%  
 PERCENT SWELL/COMPRESSION: - 3.5

SAMPLE LOCATION: 12 @ 9 FT  
 NATURAL DRY UNIT WEIGHT: 117.4 PCF  
 NATURAL MOISTURE CONTENT: 13.5%  
 PERCENT SWELL/COMPRESSION: 3.1

Soil laboratory testing was performed as part of this investigation. The laboratory tests included moisture content, dry density, grain-size analyses, Atterberg Limits and Swell/Consolidation tests. A Summary of Laboratory Test Results is presented in Figure 10. Soils Classification Data is presented in Figures 11 through 13. Swell/Consolidation Test Results are presented in Figures 14 through 17.

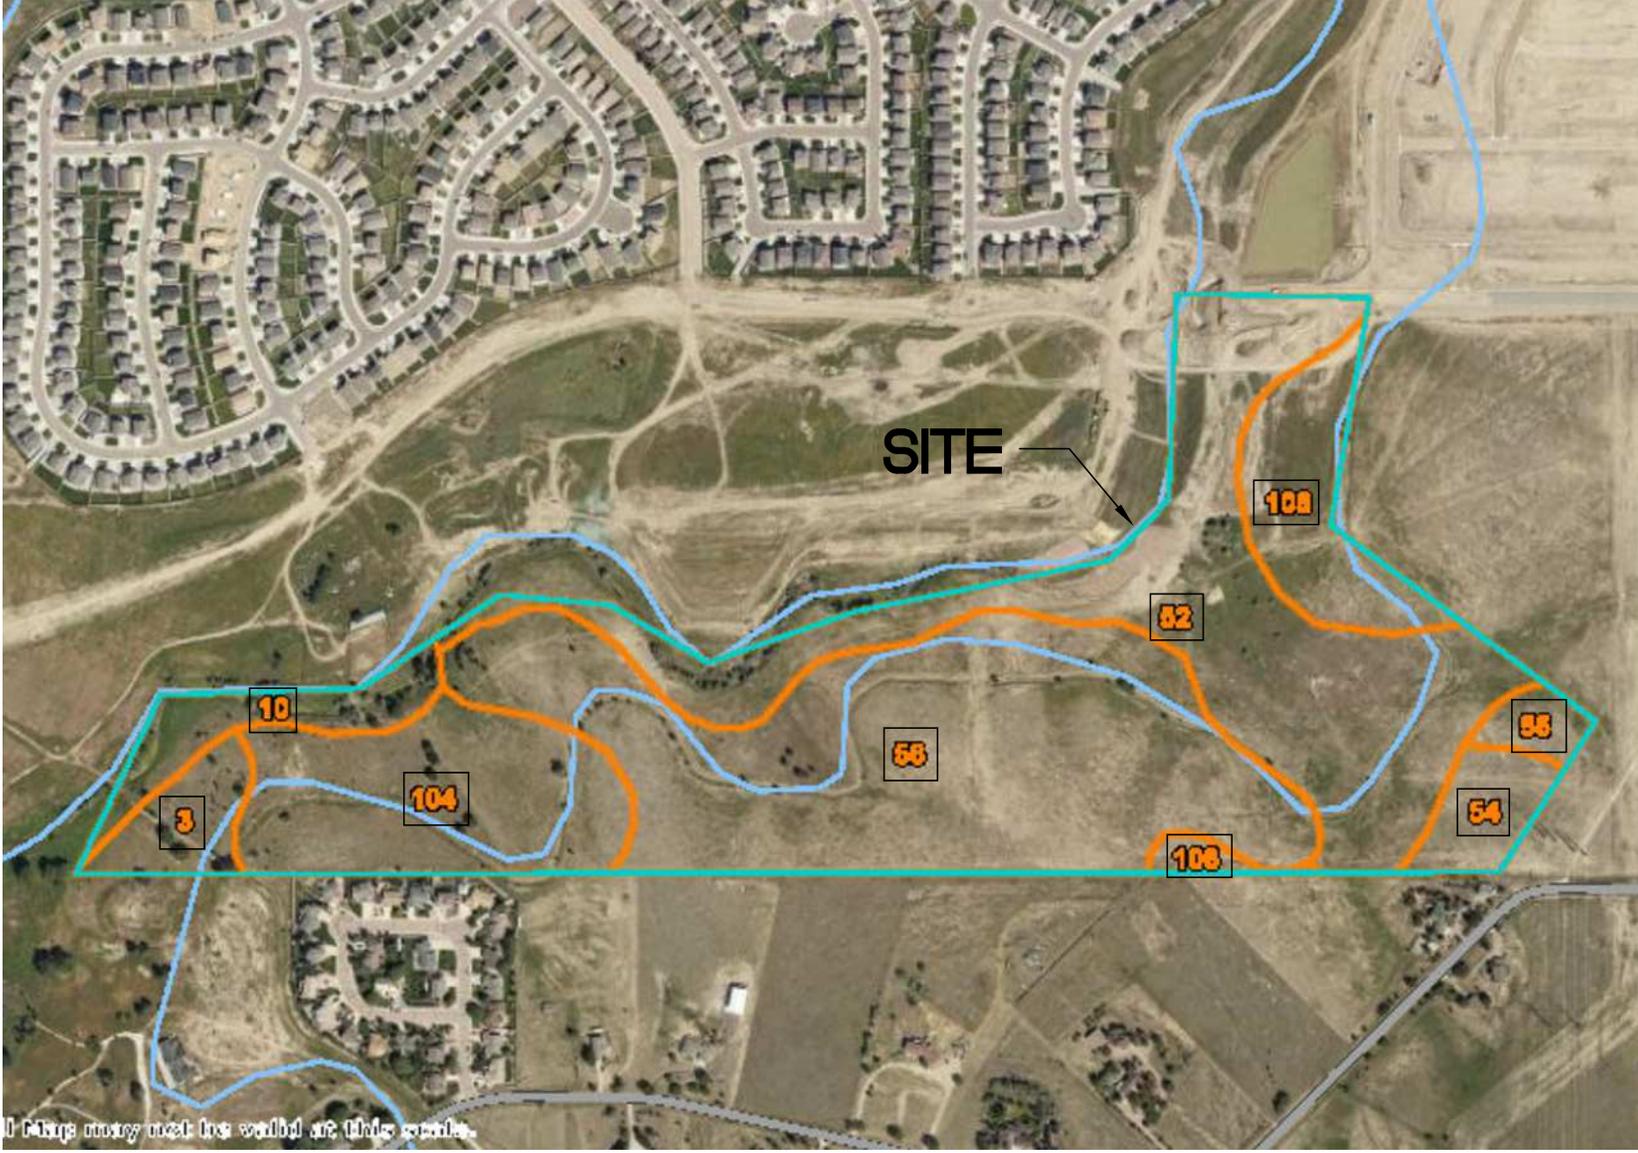
DESCRIPTIONS OF EACH USDA SOIL TYPE  
CAN BE FOUND IN SECTION 6.4 (U.S. SOILS  
CONSERVATION SERVICE) OF THE REPORT
