**SOIL, GEOLOGY, AND GEOLOGIC HAZARD
THE RETREAT AT TIMBER RIDGE
2.5+ ACRE LOTS
VOLLMER ROAD AND ARROYA LANE
EL PASO COUNTY, COLORADO**

Arroya Investments
P.O. Box 50223
Colorado Springs, Colorado 80949

April 12, 2017

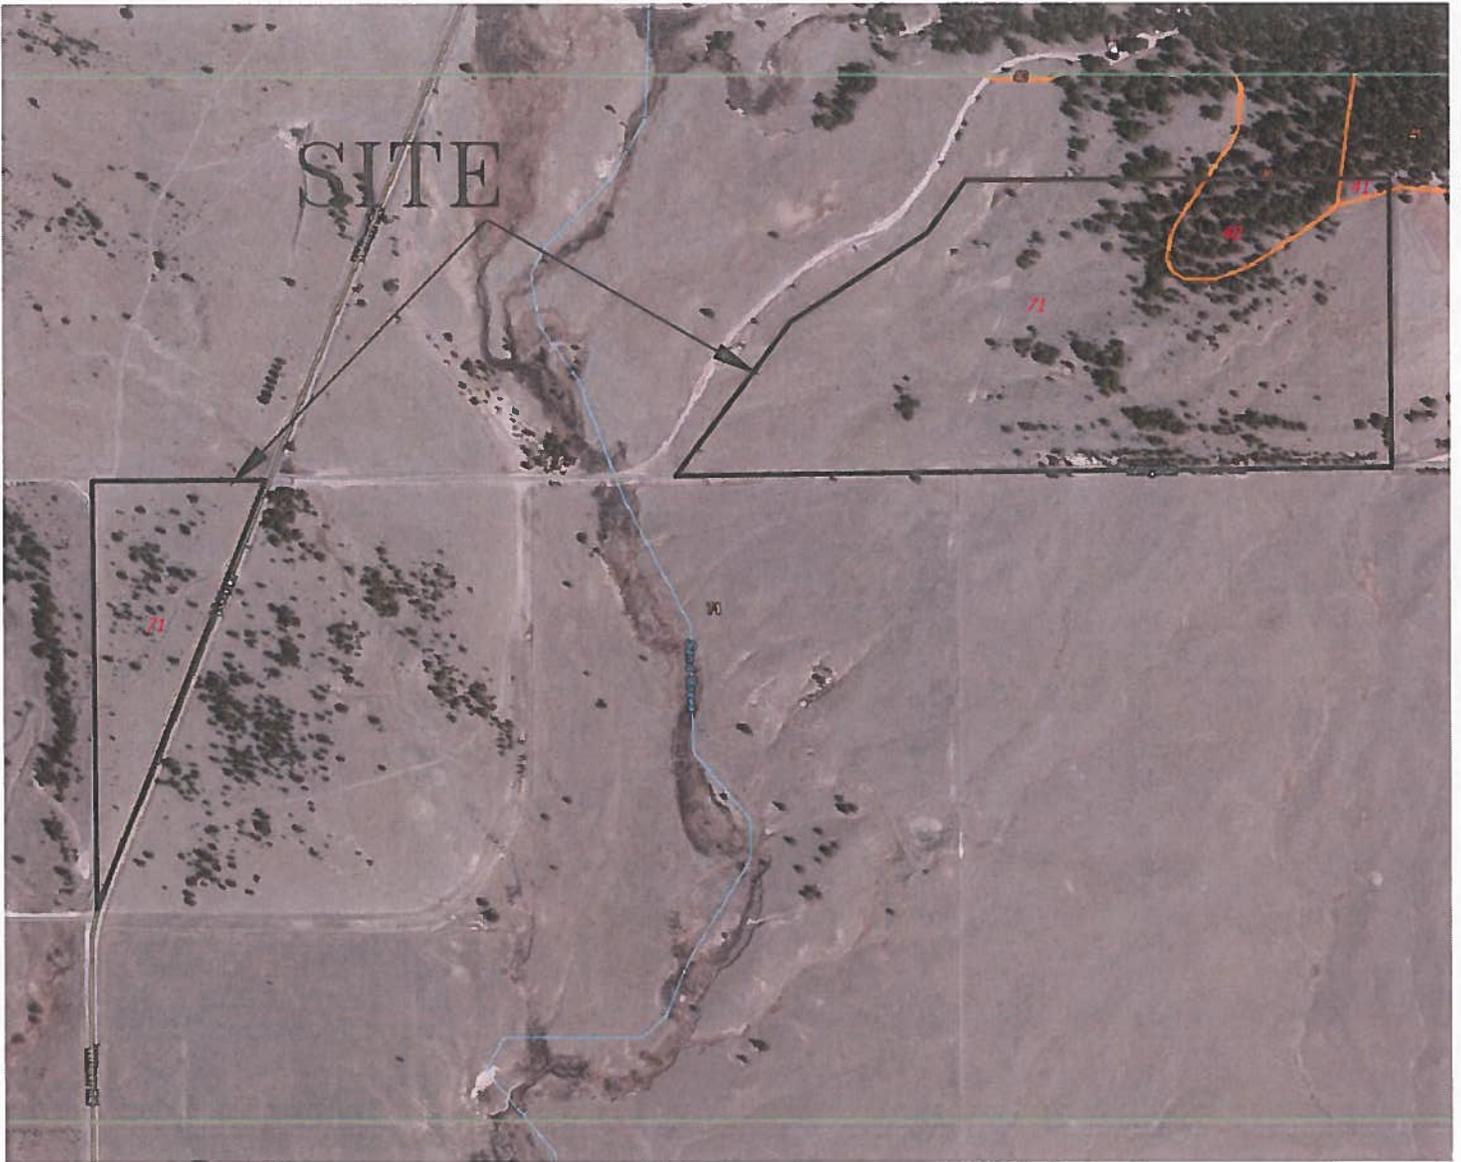
SOIL SURVEY MAP
THE RETREAT AT TIMBER RIDGE
VOLLMER ROAD AND ARROYA LANE
EL PASO COUNTY, CO.
FOR: ARROYA INVESTMENTS

FIG NO.:
 5

Complete descriptions of each soil type are presented in Appendix D. The soils have generally been described to have moderate to moderately rapid permeabilities. Possible hazards with soil erosion are present on the site. The erosion potential can be controlled with vegetation. The majority of the soils have been described to have slight to moderate erosion hazards.

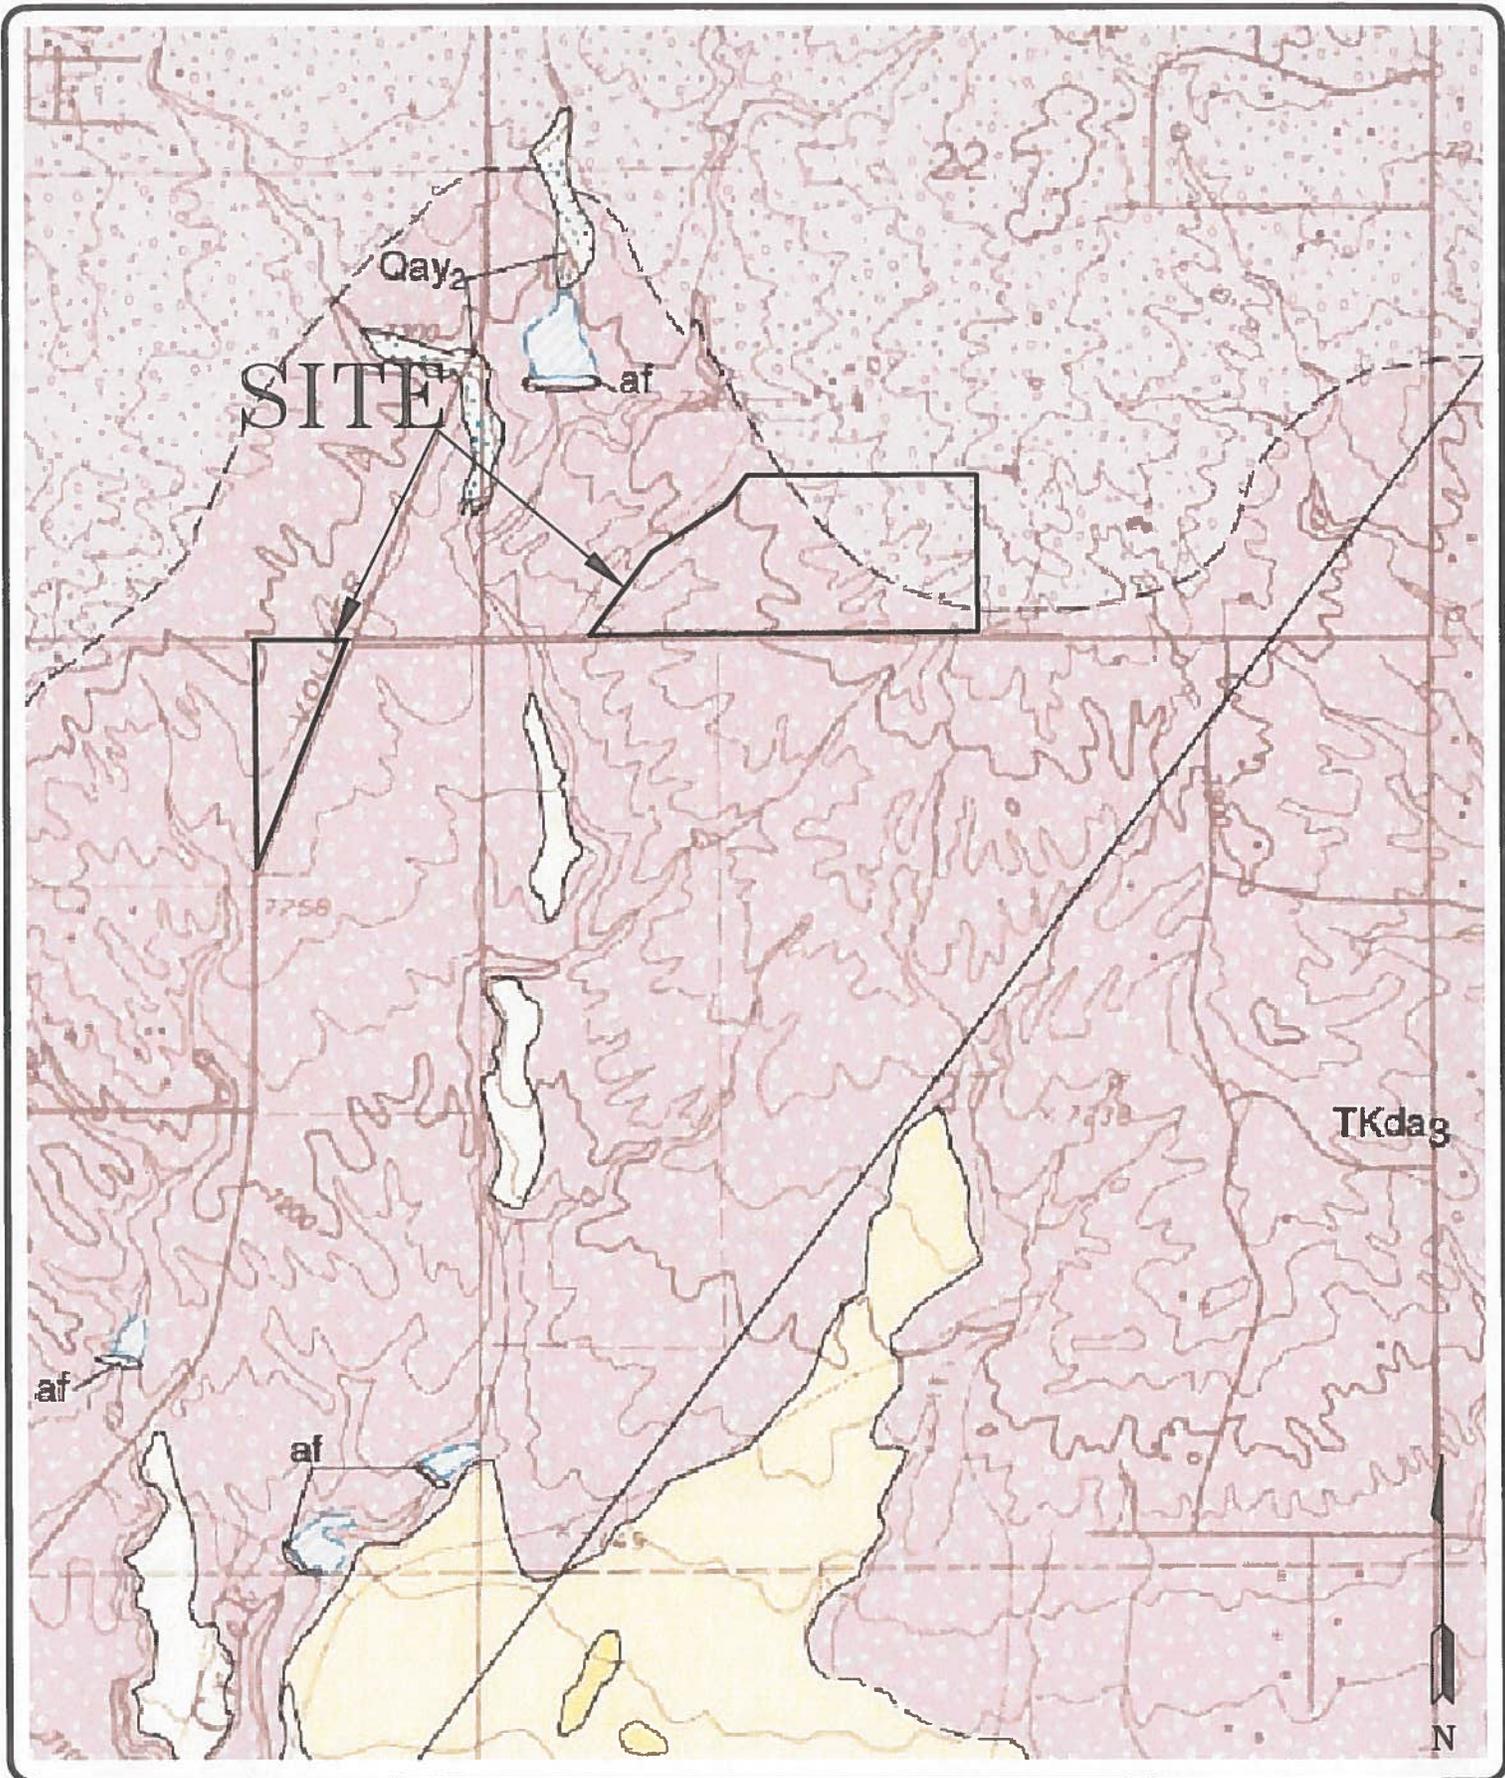
FALCON NW QUADRANGLE GEOLOGY MAP
THE RETREAT AT TIMBER RIDGE
VOLLMER ROAD AND ARROYA LANE
EL PASO COUNTY, CO.
FOR: ARROYA INVESTMENTS

FIG NO.:
6

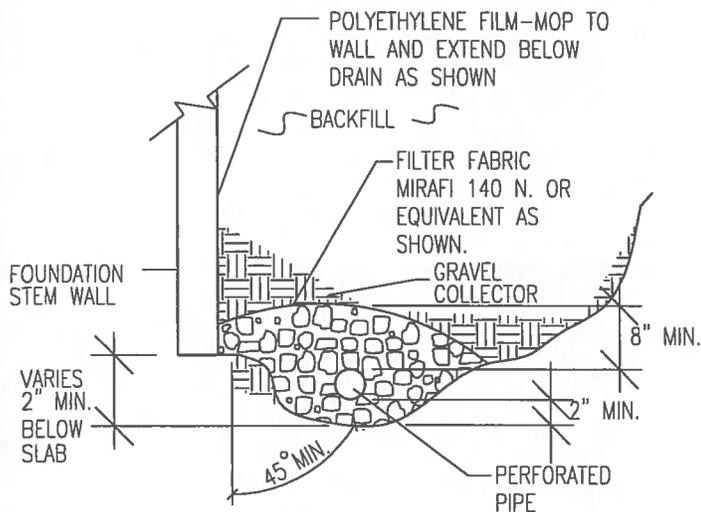
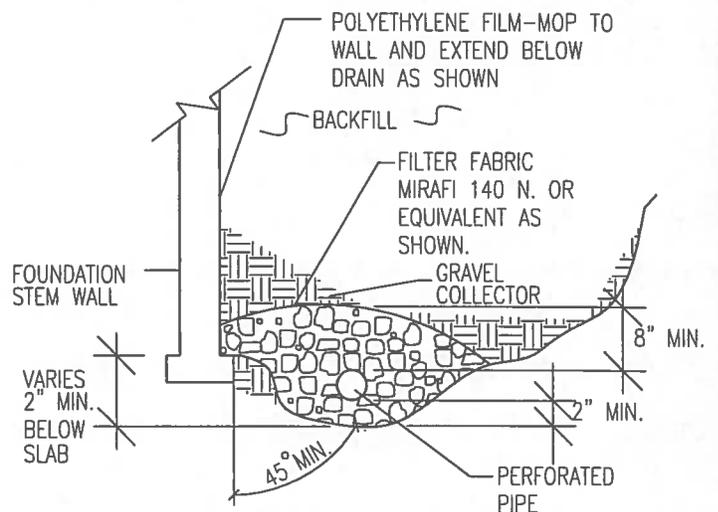
9

-GRAVEL SIZE IS RELATED TO DIAMETER OF PIPE PERFORATIONS-85% GRAVEL GREATER THAN 2x PERFORATION DIAMETER.

Mitigation: Foundations must have a minimum 30-inch depth for frost protection. In areas where high subsurface moisture conditions are anticipated periodically, subsurface perimeter drains are recommended to help prevent the intrusion of water into areas below grade. Typical drain details are presented in Figure 9. Any grading in these areas should be done to direct surface flow around construction to avoid areas of ponded water. Structures should not block drainages. All organic material should be completely removed prior to any fill placement. Finished floor levels must be located a minimum of one foot above floodplain levels.

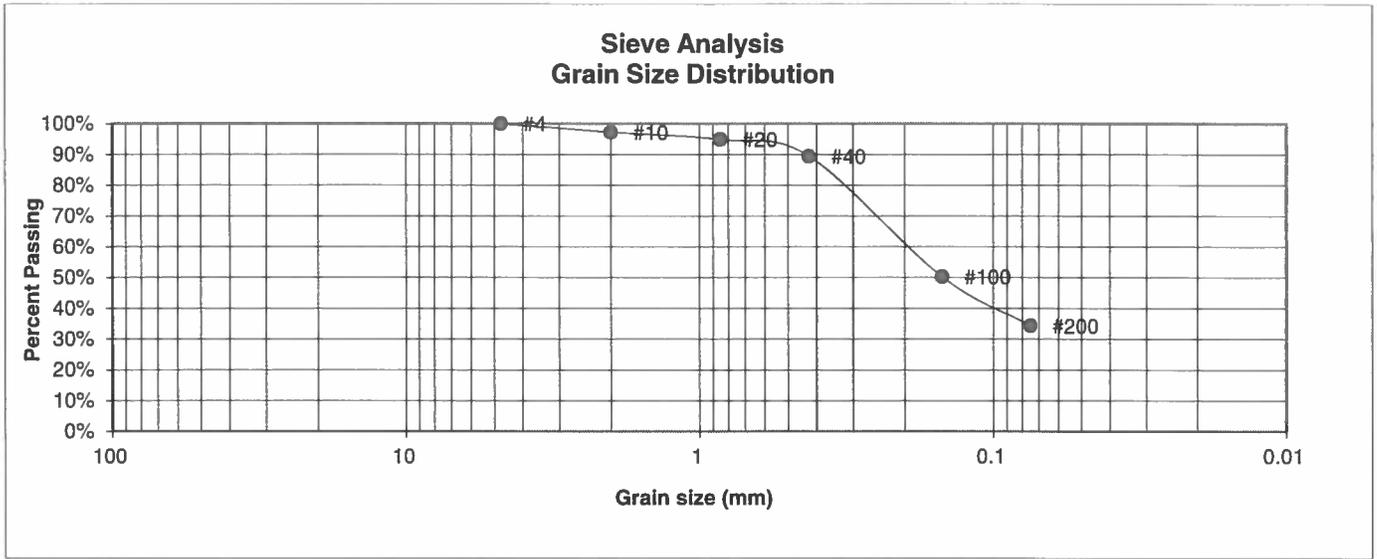
BORING NO.	1	<u>UNIFIED CLASSIFICATION</u>	SC	<u>TEST BY</u>	BL
DEPTH(ft)	2-3	<u>AASHTO CLASSIFICATION</u>		<u>JOB NO.</u>	170209
CLIENT	ARROYA INVESTMENTS				
PROJECT	THE RETREAT AT TIMBER RIDGE

U.S. Sieve #	Percent Finer
3"	
1 1/2"	
3/4"	
1/2"	
3/8"	
4	100.0%
10	97.2%
20	94.9%
40	89.5%
100	50.3%
200	34.3%

Soil Type 1 clayey to very clayey sand and silty to slightly silty sand (SC, SM, SM-SW), encountered in both of Test Borings and all of the test pits at the existing ground surface and extending to depths ranging from 1 foot to 14 feet bgs. These soils were encountered at loose to dense states and at moist conditions. The majority of the soils were encountered and medium dense states. Samples tested had 11 to 34 percent passing the No. 200 Sieve.

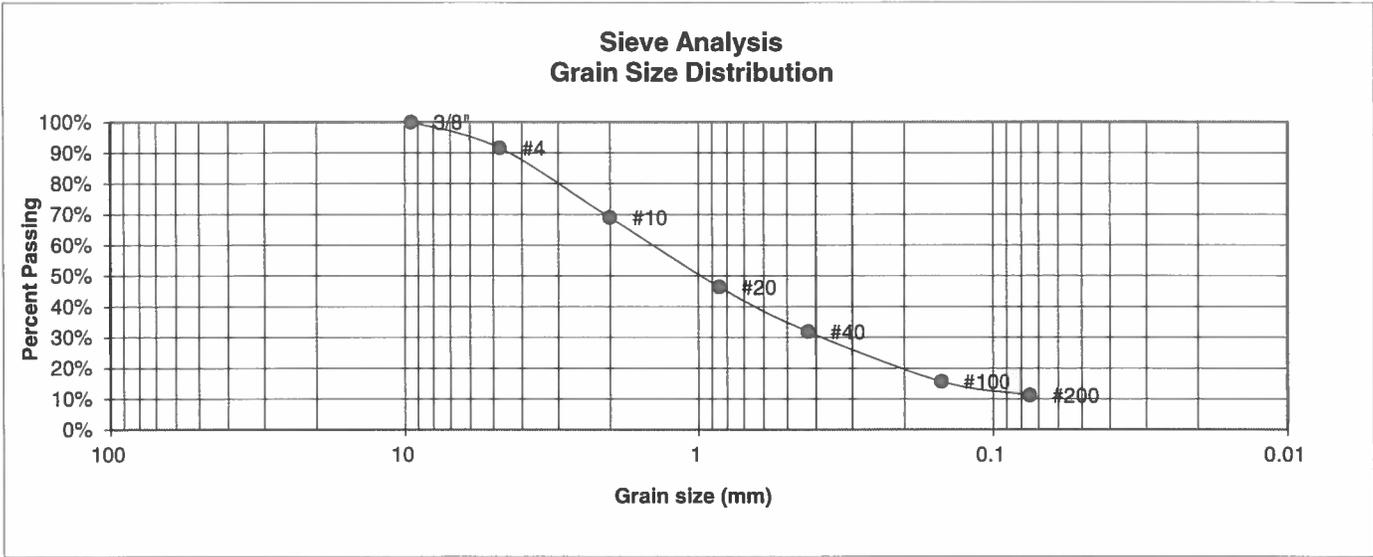
FIG NO.:
C-2

BORING NO.	2	<u>UNIFIED CLASSIFICATION</u>	SM-SW	<u>TEST BY</u>	BL
DEPTH(ft)	2-3	<u>AASHTO CLASSIFICATION</u>		<u>JOB NO.</u>	170209
CLIENT	ARROYA INVESTMENTS				
PROJECT	THE RETREAT AT TIMBER RIDGE

U.S. Sieve #	Percent Finer
3"	
1 1/2"	
3/4"	
1/2"	
3/8"	100.0%
4	91.6%
10	69.0%
20	46.4%
40	31.9%
100	15.7%
200	11.2%

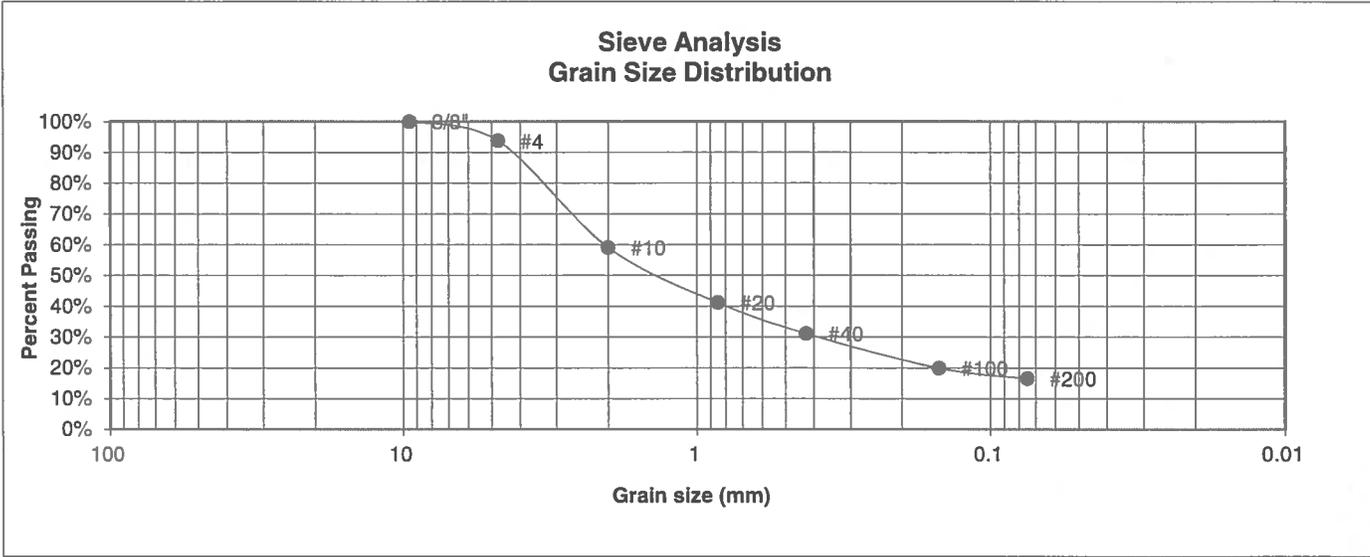
JOB NO.:
170209
FIG NO.:
C-3

BORING NO.	TP-3	UNIFIED CLASSIFICATION	SM	TEST BY	BL
DEPTH(ft)	4-5	AASHTO CLASSIFICATION		JOB NO.	170209
CLIENT	ARROYA INVESTMENTS				
PROJECT	THE RETREAT AT TIMBER RIDGE

U.S. Sieve #	Percent Finer
3"	
1 1/2"	
3/4"	
1/2"	
3/8"	100.0%
4	93.7%
10	59.1%
20	41.1%
40	31.1%
100	19.9%
200	16.4%

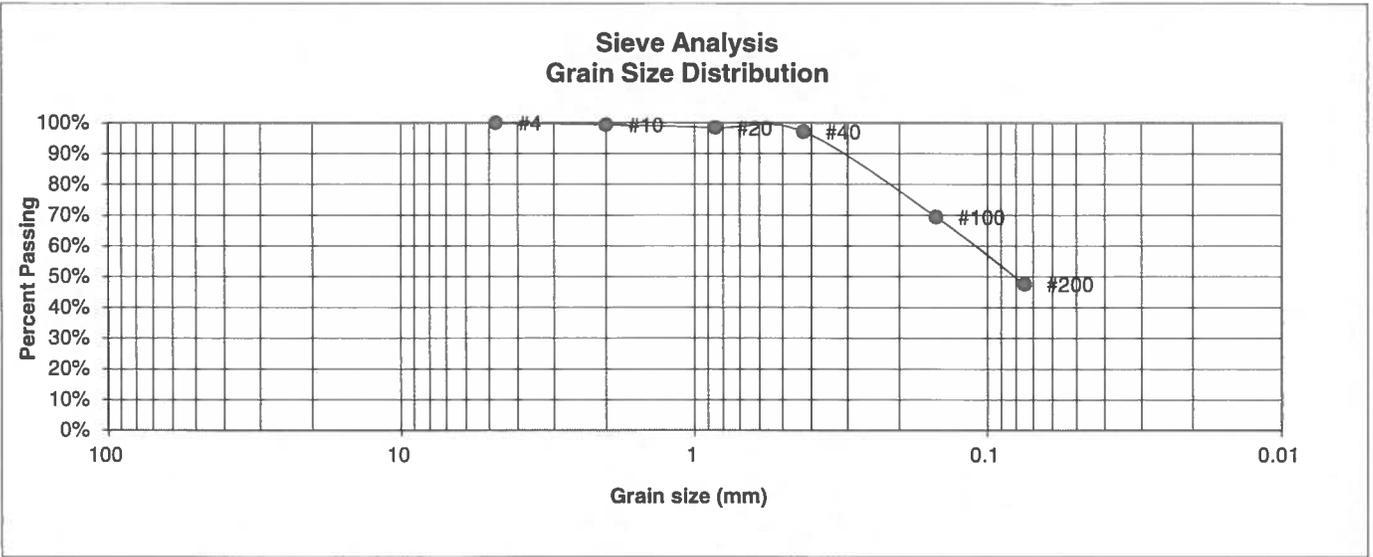
C-4

BORING NO.	1	UNIFIED CLASSIFICATION	SC	TEST BY	BL
DEPTH(ft)	5	AASHTO CLASSIFICATION		JOB NO.	170209
CLIENT	ARROYA INVESTMENTS				
PROJECT	THE RETREAT AT TIMBER RIDGE

U.S. Sieve #	Percent Finer
3"	
1 1/2"	
3/4"	
1/2"	
3/8"	
4	100.0%
10	99.4%
20	98.4%
40	97.1%
100	69.4%
200	47.6%

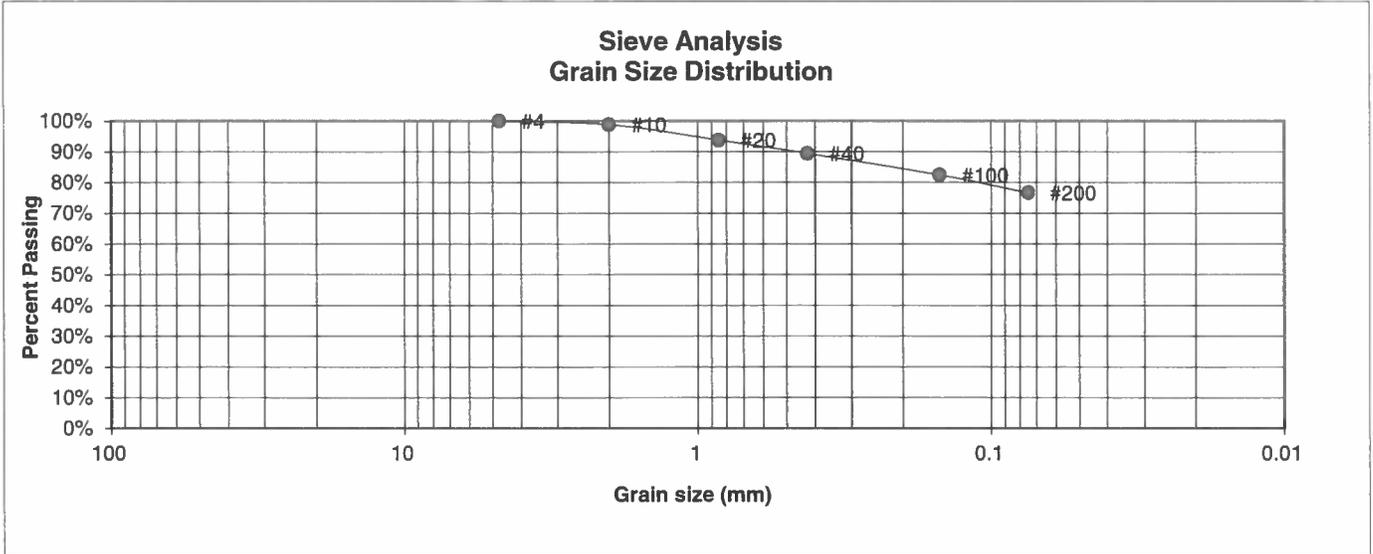
JOB NO.:
170209
FIG NO.:
C-5

BORING NO.	TP-2	UNIFIED CLASSIFICATION	CL	TEST BY	BL
DEPTH(ft)	5-6	AASHTO CLASSIFICATION		JOB NO.	170209
CLIENT	ARROYA INVESTMENTS				
PROJECT	THE RETREAT AT TIMBER RIDGE

U.S. Sieve #	Percent Finer
3"	
1 1/2"	
3/4"	
1/2"	
3/8"	
4	100.0%
10	98.9%
20	93.8%
40	89.4%
100	82.4%
200	76.6%

Soil Type 3 sandy claystone and siltstone (CL, MH), encountered in Test Pit Nos. 2 and 3 at depths ranging from 5 to 6.5 feet and extended to the termination test pit (8 feet). The claystone and siltstone were encountered at hard consistencies and at moist conditions. Samples tested had 60 to 77 percent passing the No. 200 Sieve. FHA Swell Testing resulted in an expansion pressure of 1280 psf, which is in the moderate expansion range.

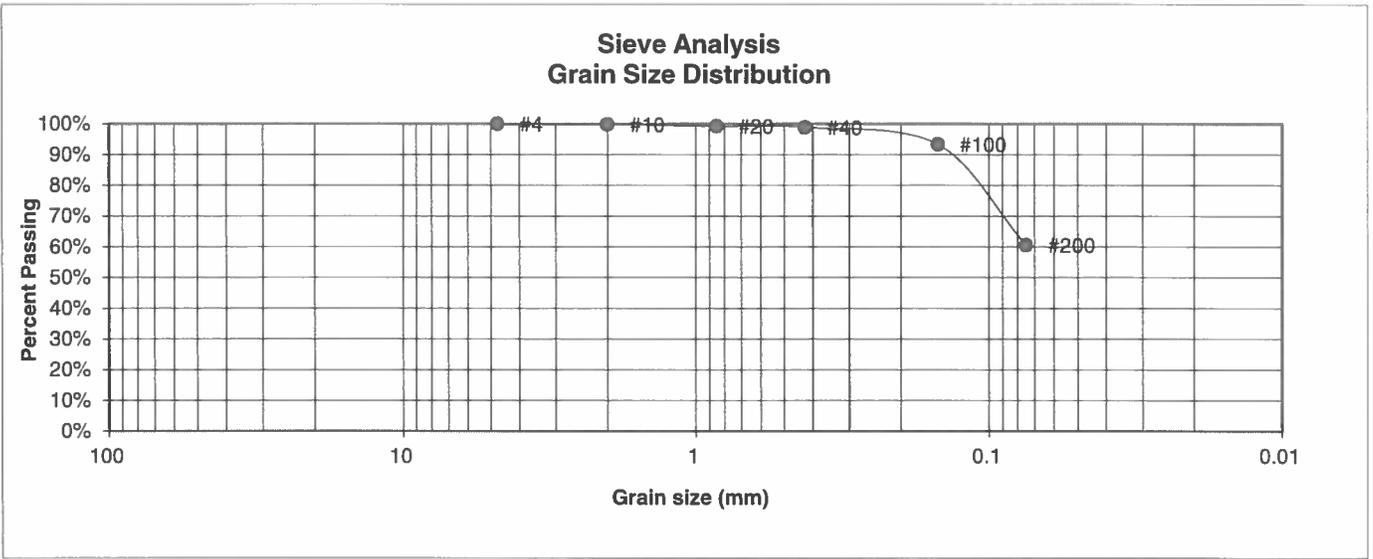
BORING NO.	TP-3	UNIFIED CLASSIFICATION	CL	TEST BY	BL
DEPTH(ft)	6-8	AASHTO CLASSIFICATION		JOB NO.	170209
CLIENT	ARROYA INVESTMENTS				
PROJECT	THE RETREAT AT TIMBER RIDGE

U.S. Sieve #	Percent Finer
3"	
1 1/2"	
3/4"	
1/2"	
3/8"	
4	100.0%
10	99.8%
20	99.3%
40	98.9%
100	93.3%
200	60.6%

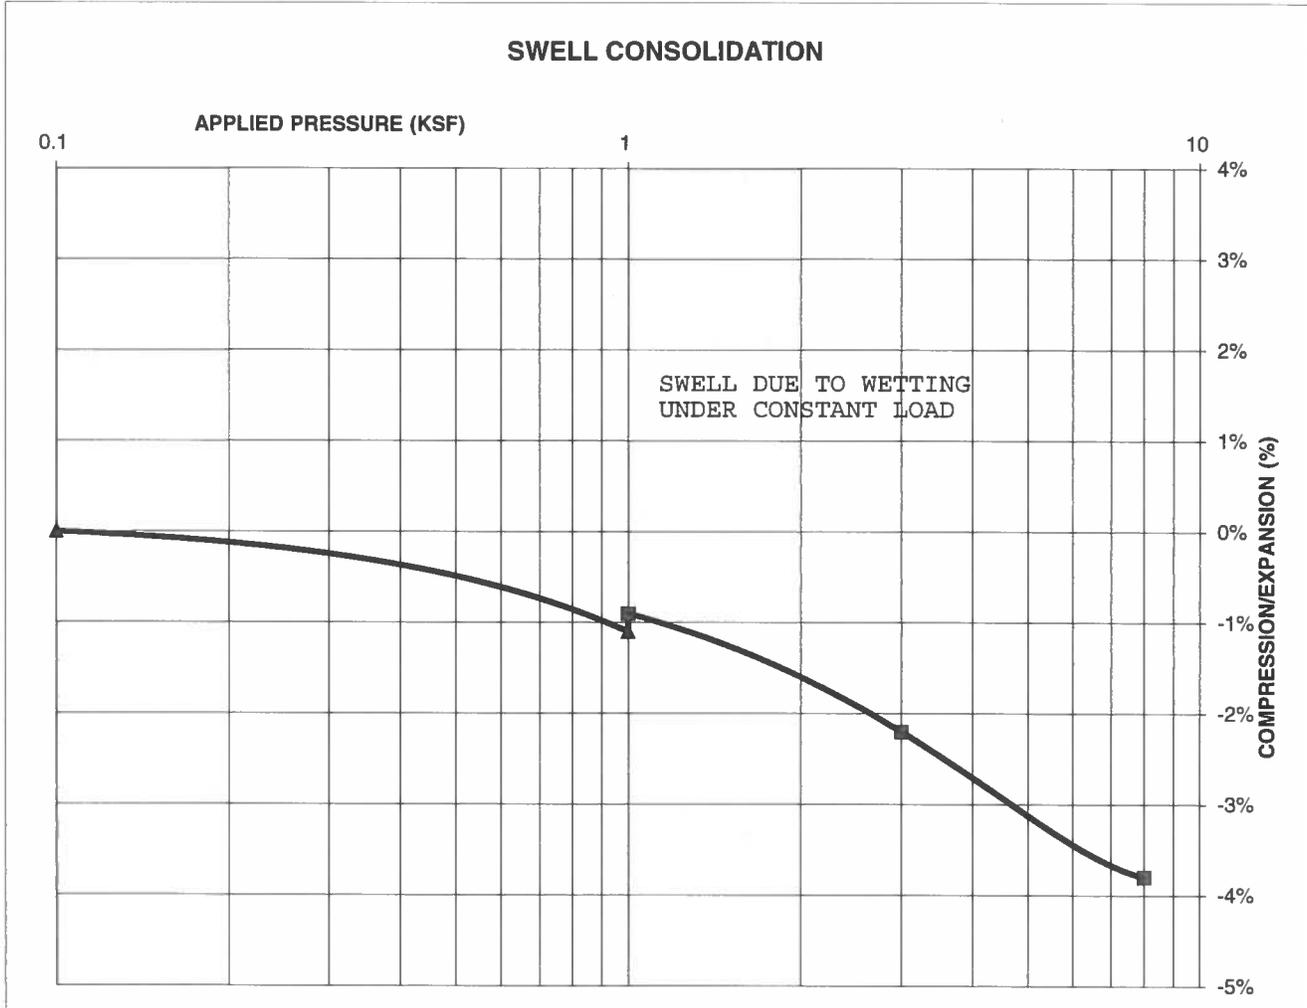
SAMPLE FROM:	1	DEPTH(ft)	5
DESCRIPTION	SAND, VERY CLAYEY		
NATURAL UNIT DRY WEIGHT (PCF)	108		
NATURAL MOISTURE CONTENT	14.9%		
SWELL/CONSOLIDATION (%)	0.2%

JOB NO. 170209
 CLIENT ARROYA INVESTMENTS
 PROJECT THE RETREAT AT TIMBER RIDGE

Soil Type 2 silty sandstone and clayey to very clayey sandstone (SM, SC), encountered in both of Test Borings and all of the Test Pits at depths ranging from 1 foot to 14 feet bgs and extending to the termination of the test borings (15 feet). The sandstone was encountered at dense to very dense states and at moist conditions. Samples tested had 48 percent passing the No. 200 Sieve. Swell/Consolidation Testing on a sample of the very clayey sandstone resulted in a swell of 0.2 percent, which is in the low expansion range.
