**ENTECH**  
ENGINEERING, INC.

**SOIL, GEOLOGY, AND GEOLOGIC HAZARD STUDY  
STERLING RANCH FILING NO. 5  
PARCEL 16  
EL PASO COUNTY, COLORADO**

November 22, 2022  
Revised December 1, 2023

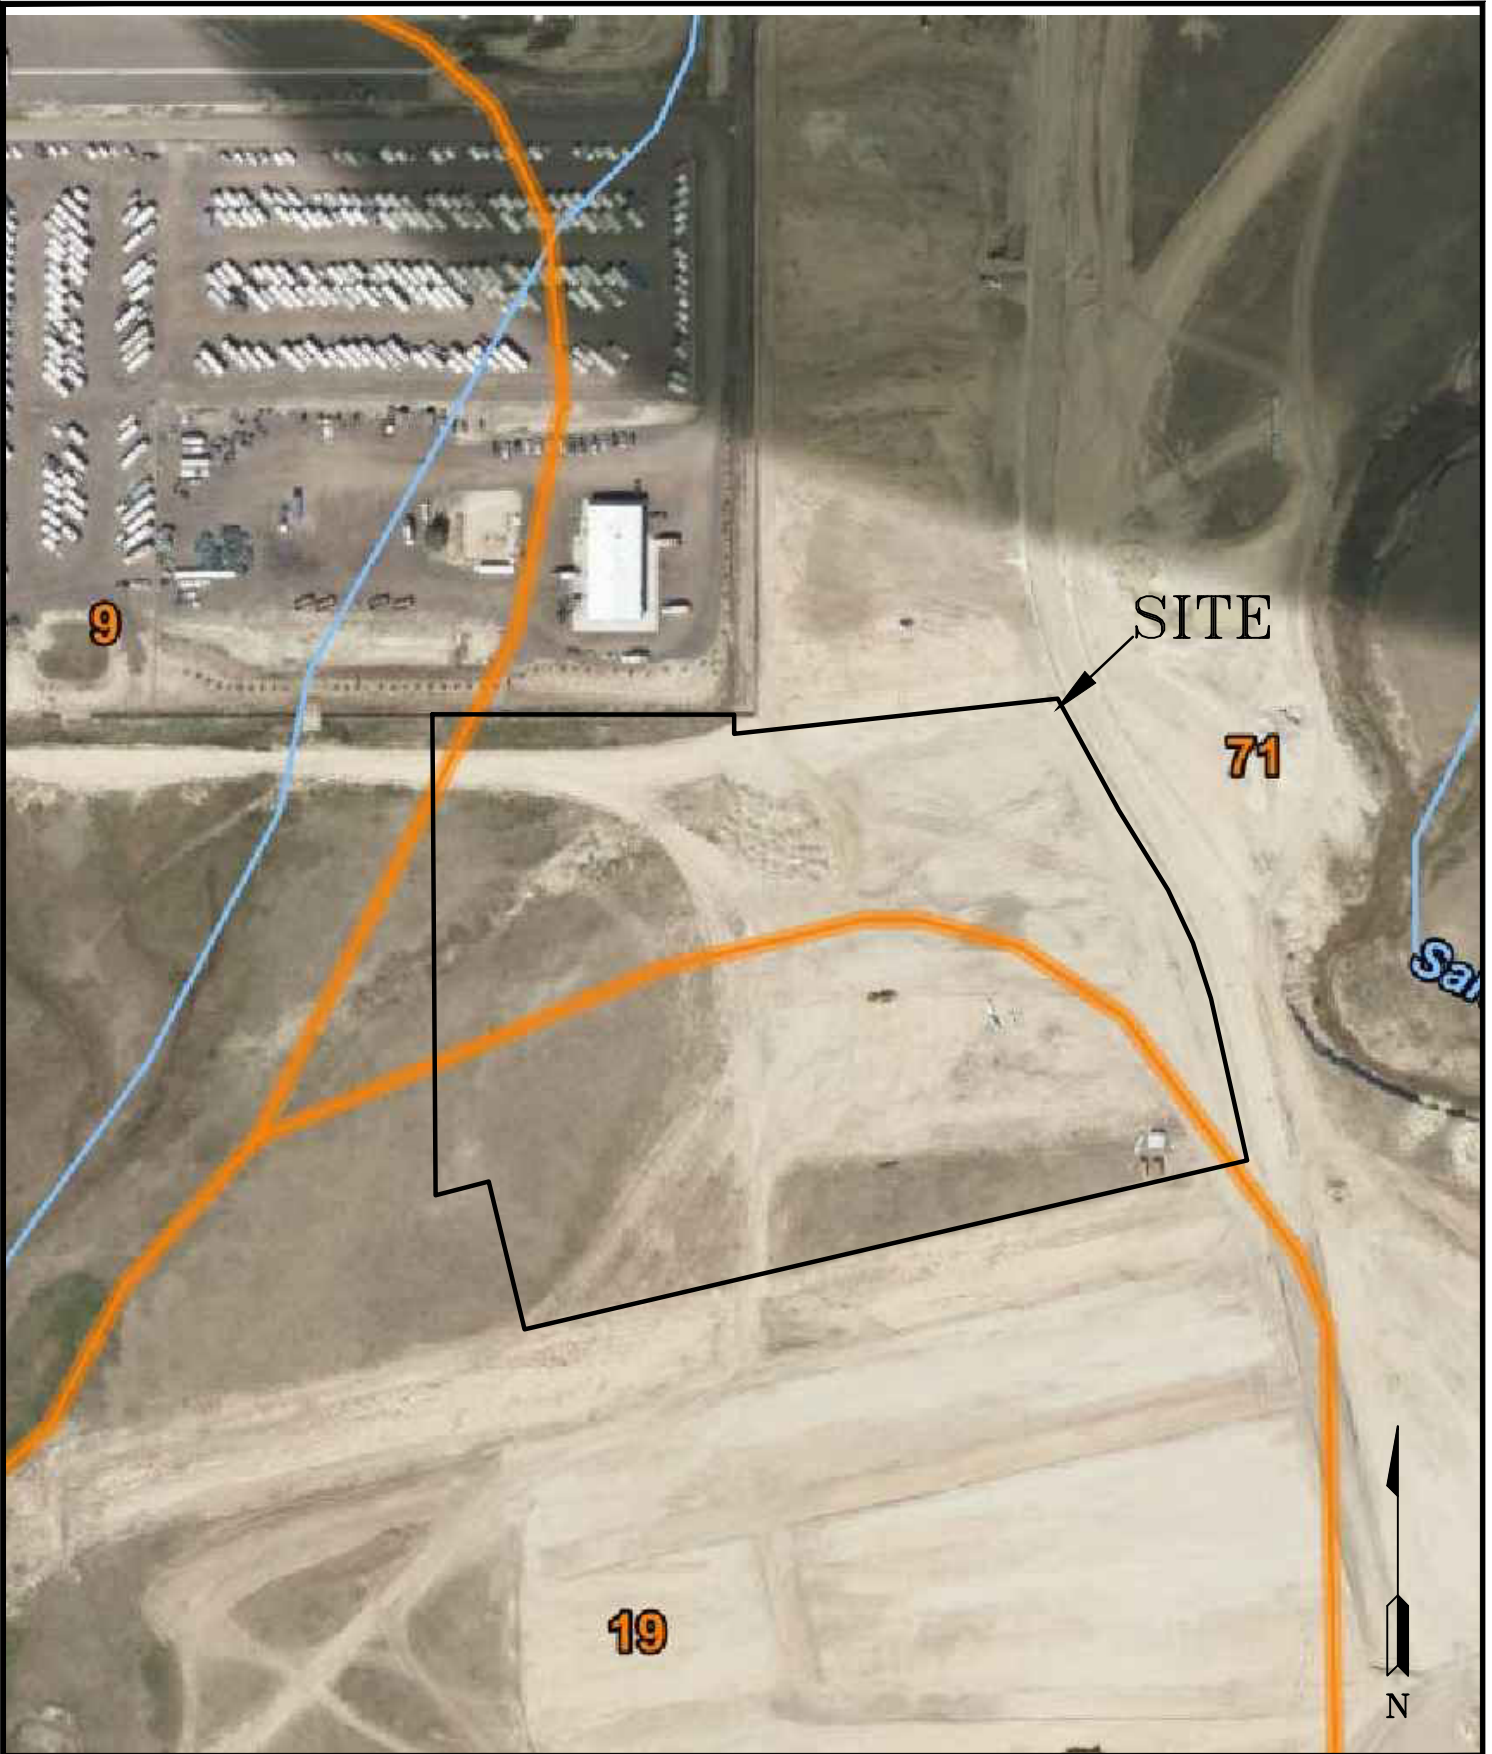
**FIG. 5**

**SOIL SURVEY MAP**  
STERLING RANCH FILING NO. 5  
PARCEL 16  
COLORADO SPRINGS, CO  
FOR: CLASSIC SRJ

The Natural Resources Conservation Service (Reference 1), previously the Soil Conservation Service (Reference 2) has mapped three soil types on the site (Figure 5). In general, the soils consist of loamy sand. Soils are described as follows:

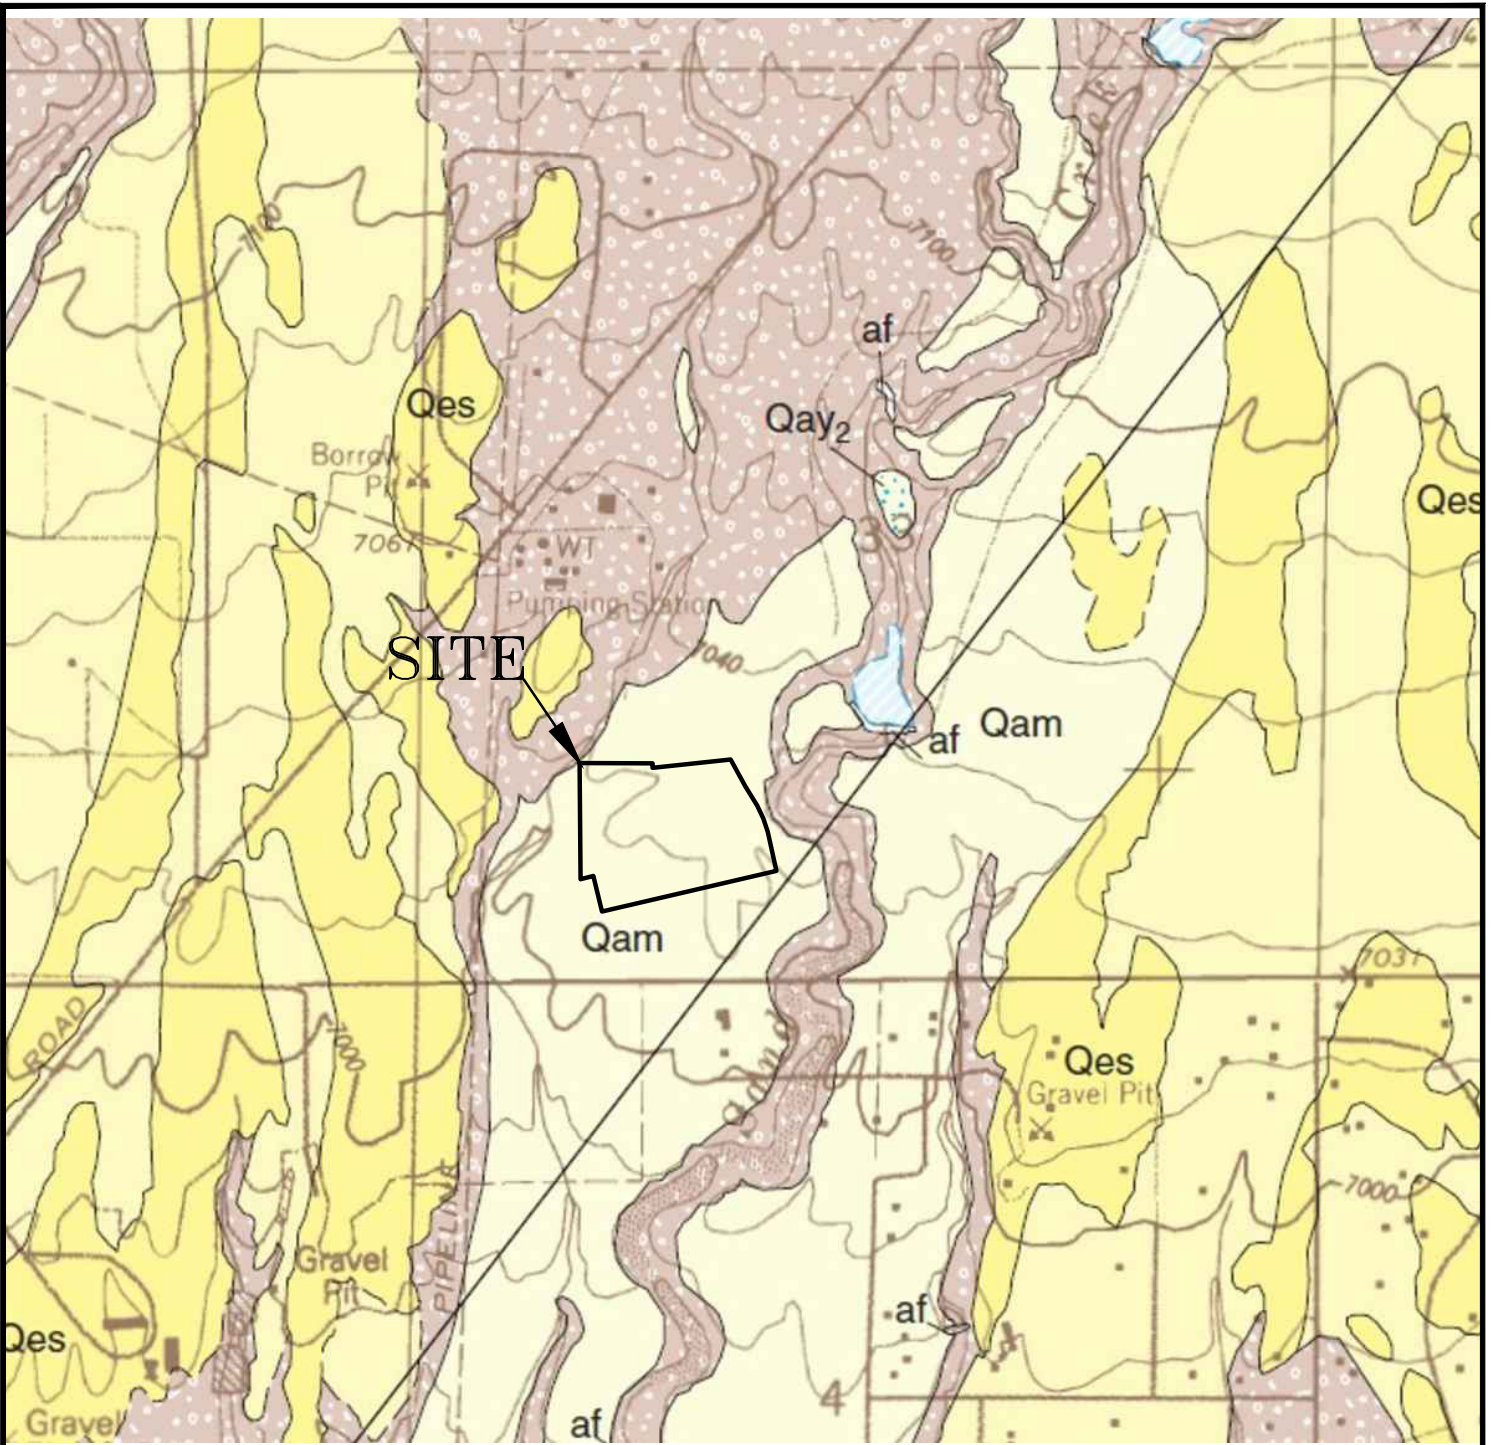
**FIG. 6**

**FALCON NW QUADRANGLE GEOLOGIC MAP**  
 STERLING RANCH FILING NO. 5  
 PARCEL 16  
 COLORADO SPRINGS, CO  
 FOR: CLASSIC SRJ

The Falcon NW Quadrangle Geologic Map showing the site is presented in Figure 6 (Reference 7). The Geology Map prepared for the site is presented in Figure 7. One mappable unit was identified on this site, which is described as follows:

**Qb Broadway Alluvium of Pleistocene Age:** These materials consist of stream terrace deposits. The Broadway Alluvium typically consists of silty to clayey gravelly sands. This deposit is usually highly stratified and may contain lenses of silt, clay or cobbles. This unit correlates to the Middle Alluvium on the Falcon NW Geologic Map (Figure 6).

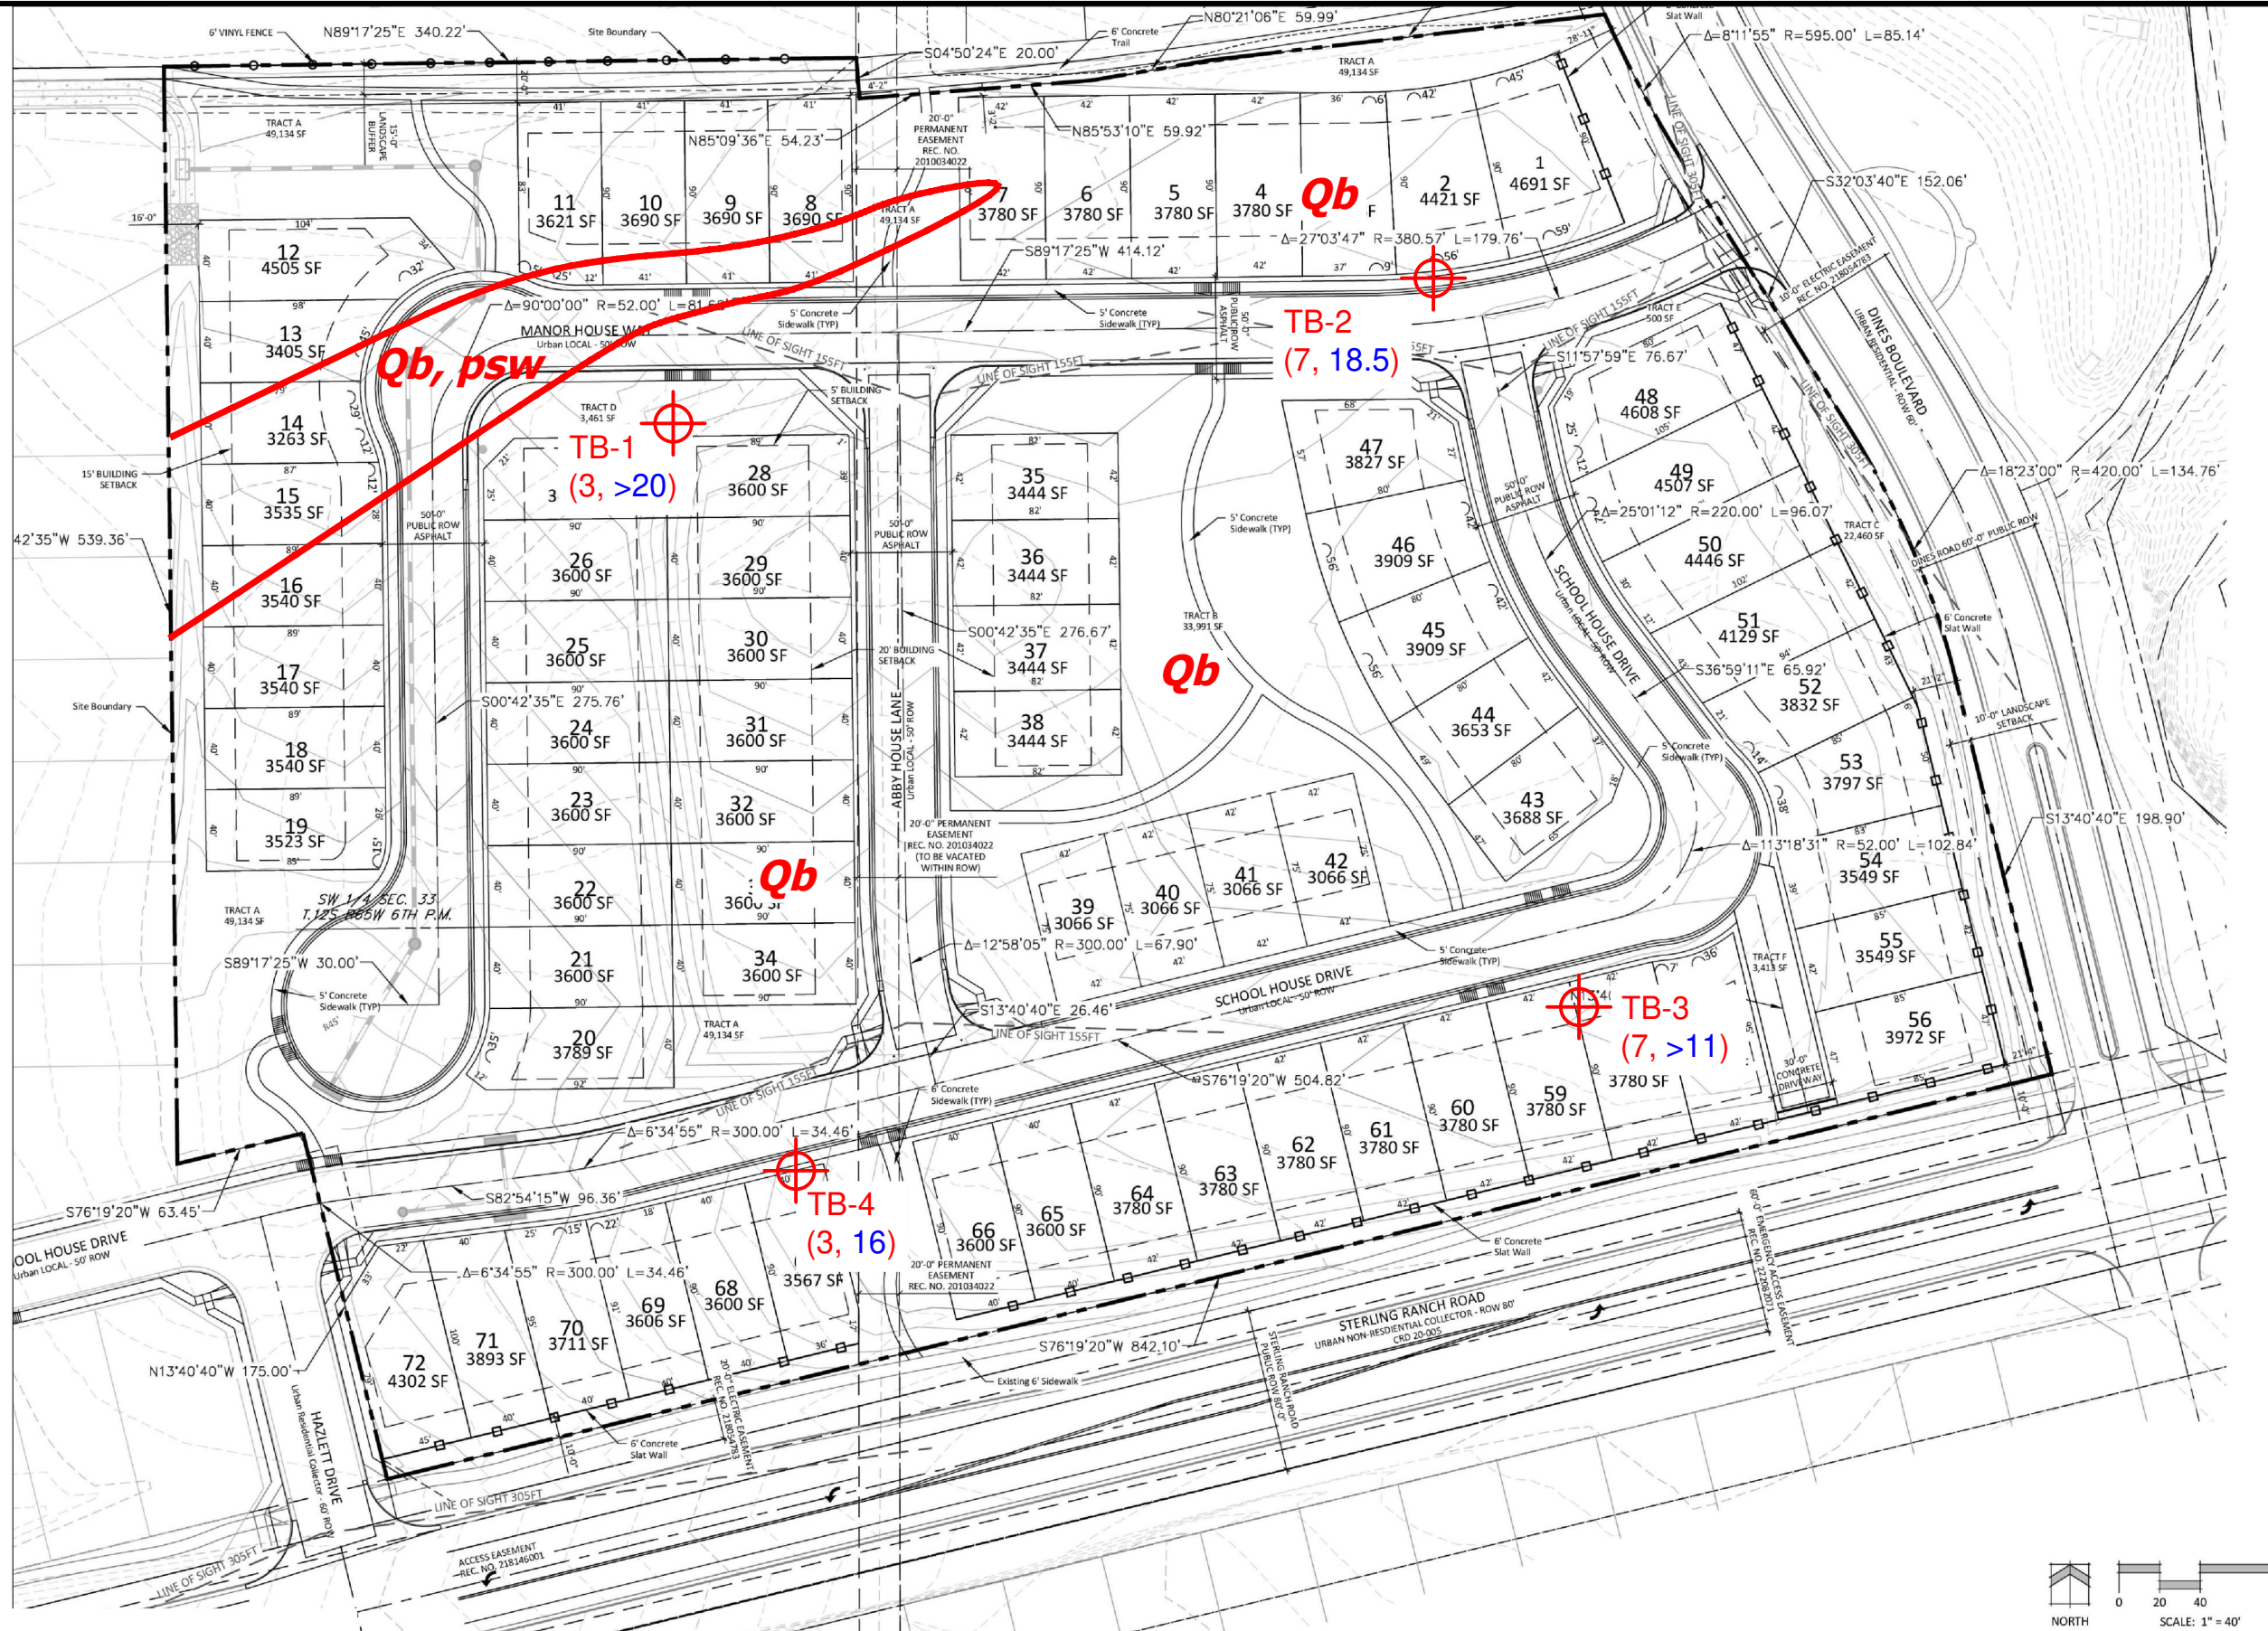
JOB NO.  
 222159  
**FIG. 7**

- Legend:**
- Qb* - *Broadway Alluvium of Quaternary Age; water deposited sand, terrace deposits*
  - psw* - *potentially seasoned shallow groundwater area*
  - TB** - **APPROXIMATE TEST BORING LOCATION AND NUMBER (DEPTH OF BEDROCK, DEPTH OF WATER)**

**GEOLOGY/ ENGINEERING GEOLOGY MAP**  
 STERLING RANCH FILING NO. 5  
 PARCEL 16  
 COLORADO SPRINGS, CO  
 FOR: CLASSIC SRJ

As mentioned previously, detailed mapping has been performed on this site to produce an Engineering Geology Map (Figure 7). This map shows the location of various geologic conditions of which the developers and planners should be cognizant during the planning, design and construction stages of the project. The hazards identified on this site include potentially expansive soils, potentially seasonal shallow groundwater areas, and shallow bedrock. The following hazards have been addressed:

An area of potentially seasonal shallow groundwater has been mapped in the drainage swale located in the northwestern of the site. According to the proposed grading plan, the drainage from the northeastern portion of Filing No. 4 will be collected and piped along the west side of the site to a temporary detention pond. Lots that may be impacted include Lot Nos. 7 – 9 and 13 – 17. Typical drain details are presented in Figures 9 through 11. This area will be regraded and drainage piped to the existing storm sewer, however, structures immediately adjacent to the drainage area may experience higher water levels during periods of high moisture. It should be noted that groundwater was not encountered to 20 feet adjacent to this area. Additionally, shallow groundwater was encountered west of the site after precipitation events due to runoff from the north that backed up in permeable sands overlying the bedrock.

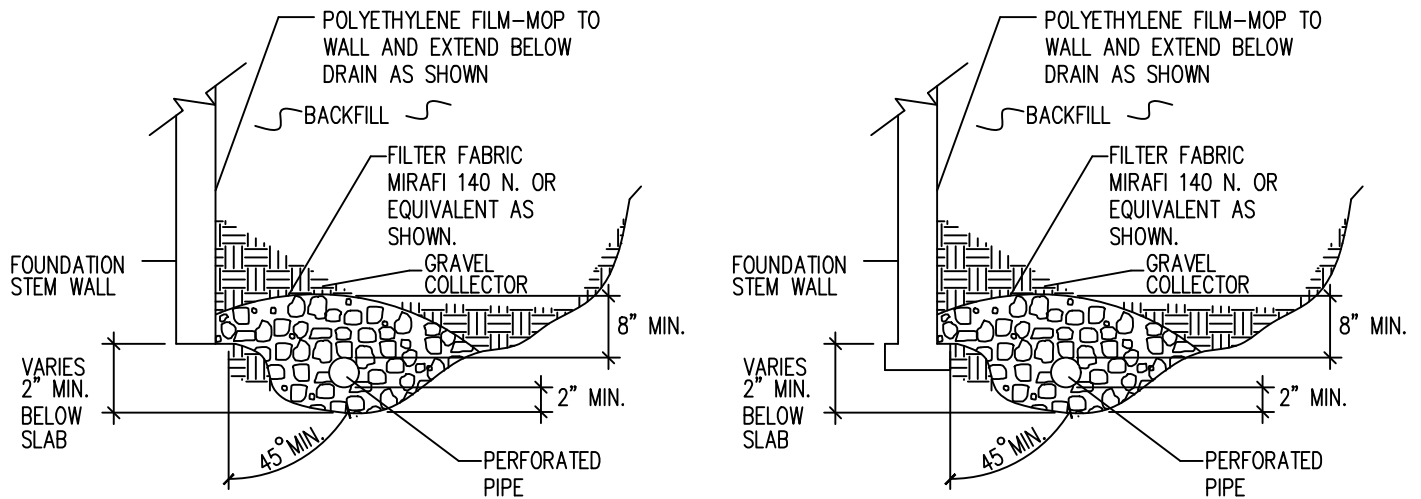
**FIG. 9**

NOTES:

-GRAVEL SIZE IS RELATED TO DIAMETER OF PIPE PERFORATIONS-85% GRAVEL GREATER THAN 2x PERFORATION DIAMETER.

permeable sands on top of less permeable bedrock materials. **Subsurface perimeter drains may be necessary to prevent the intrusion of water into areas below grade.** Typical drain details are presented in Figure 9. Where shallow groundwater is encountered, **underslab drains or interceptor drains may be necessary.** Typical drain details are presented in Figure 10 and 11. **Where basements are considered, interceptor and underslab drains may be necessary.** Structures should not block drainages. Swales should be created to intercept surface runoff and carry it safely around and away from structures. Additional investigation, after grading is completed, is recommended to provide final foundation and subsurface drain recommendations.

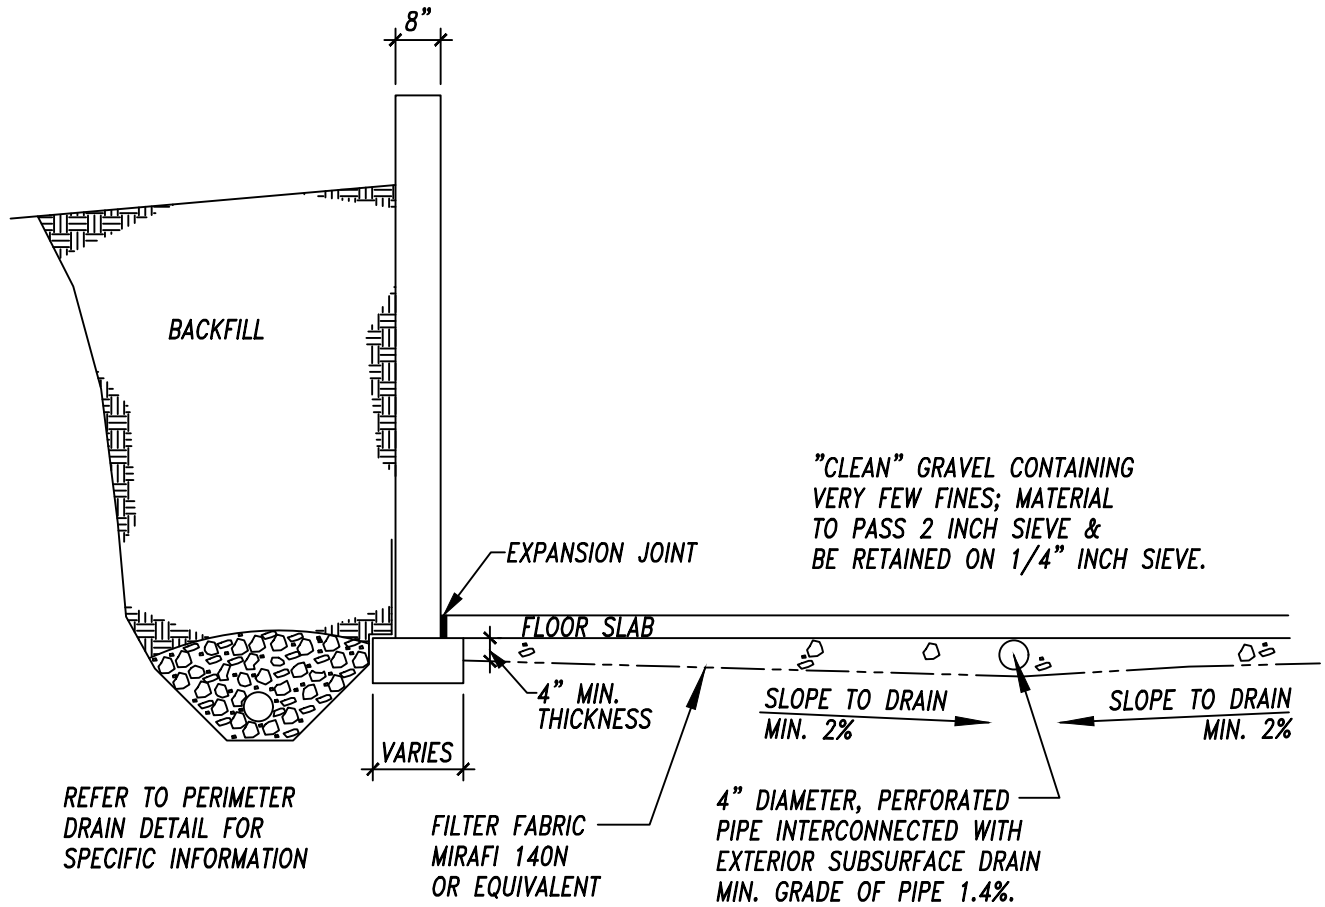
**FIG. 10**

**UNDERSLAB DRAINAGE LAYER**  
 STERLING RANCH FILING NO. 5  
 PARCEL 16  
 COLORADO SPRINGS, CO  
 FOR: CLASSIC SRJ

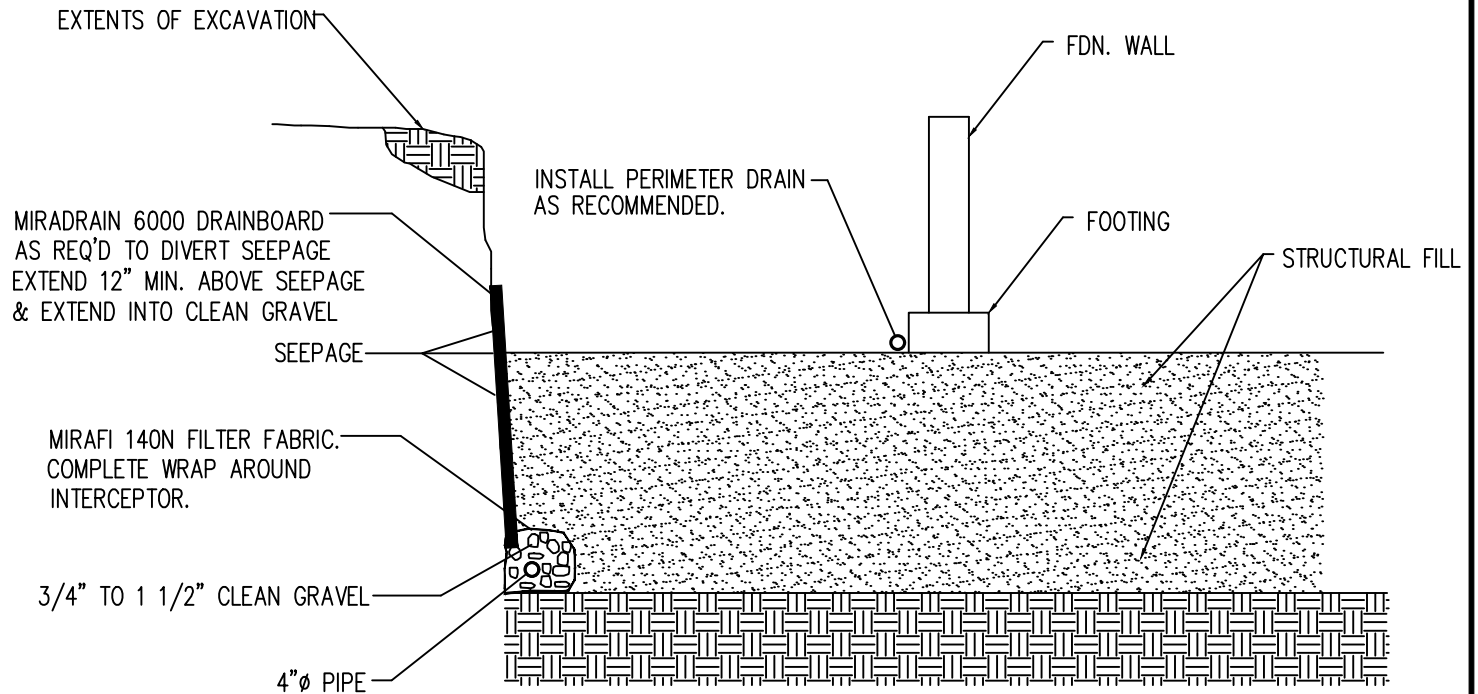
**FIG. 11**

NOTE:  
 EXTEND INTERCEPTOR DRAIN TO UNDERDRAIN OR TO SUMP.  
 BENCH DRAIN INTO NATIVE SOILS 12 INCHES MINIMUM.

## INTERCEPTOR DRAIN DETAIL

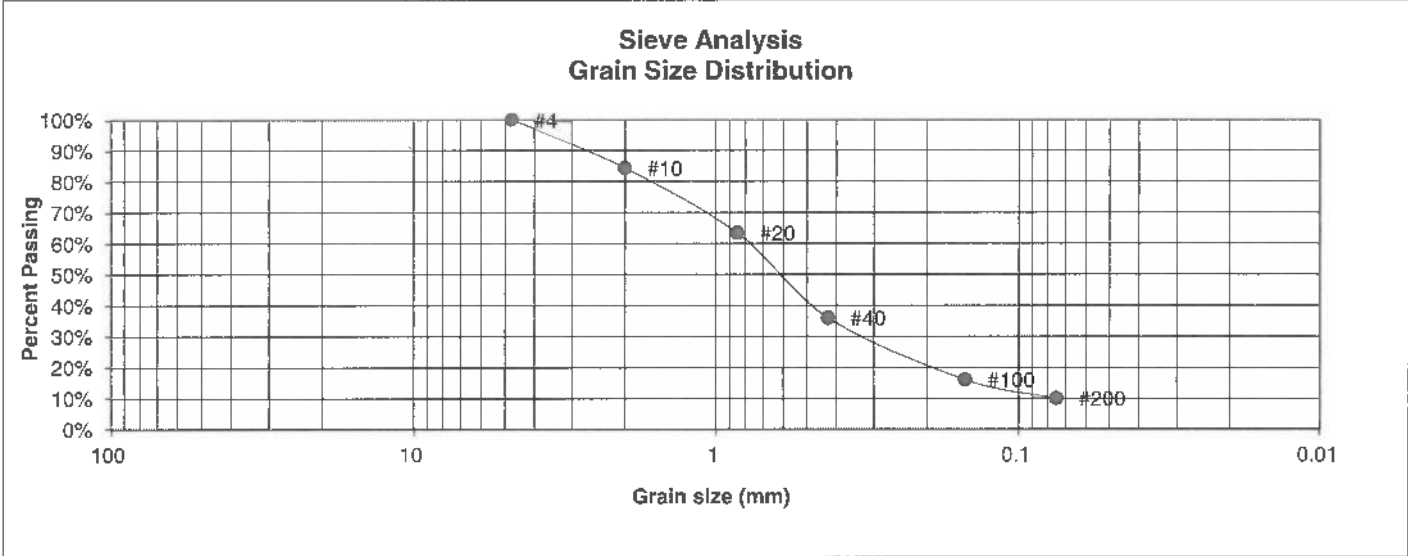
FIG NO.:  
C-1

UNIFIED CLASSIFICATION	SM-SW	CLIENT	CLASSIC SRJ
SOIL TYPE #	1	PROJECT	DINES BLVD. & STERLING RANCH
TEST BORING #	1	JOB NO.	222159
DEPTH (FT)	2-3	TEST BY	BL

U.S. Sieve #	Percent Finer
3"	
1 1/2"	
3/4"	
1/2"	
3/8"	
4	100.0%
10	84.3%
20	63.4%
40	36.0%
100	16.0%
200	10.0%

Atterberg Limits	
Plastic Limit	NP
Liquid Limit	NV
Plastic Index	NP
Swell	
Moisture at start	
Moisture at finish	
Moisture increase	
Initial dry density (pcf)	
Swell (psf)

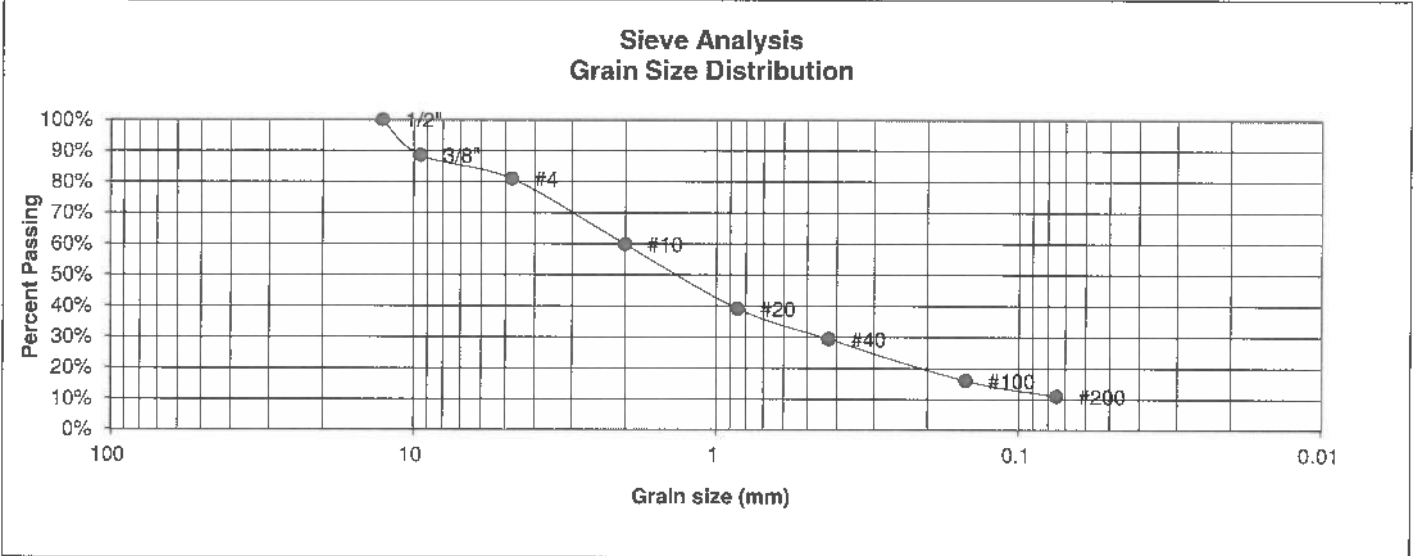
FIG NO.:  
C-2

<u>UNIFIED CLASSIFICATION</u>	SM-SW	<u>CLIENT</u>	CLASSIC SRJ
<u>SOIL TYPE #</u>	1	<u>PROJECT</u>	DINES BLVD. & STERLING RANCH
<u>TEST BORING #</u>	3	<u>JOB NO.</u>	222159
<u>DEPTH (FT)</u>	5	<u>TEST BY</u>	BL

<u>U.S. Sieve #</u>	<u>Percent Finer</u>	<u>Atterberg Limits</u>
3"		Plastic Limit
1 1/2"		Liquid Limit
3/4"		Plastic Index
1/2"	100.0%	
3/8"	88.5%	
4	80.9%	<u>Swell</u>
10	59.8%	Moisture at start
20	39.1%	Moisture at finish
40	29.4%	Moisture increase
100	16.0%	Initial dry density (pcf)
200	11.0%	Swell (psf)

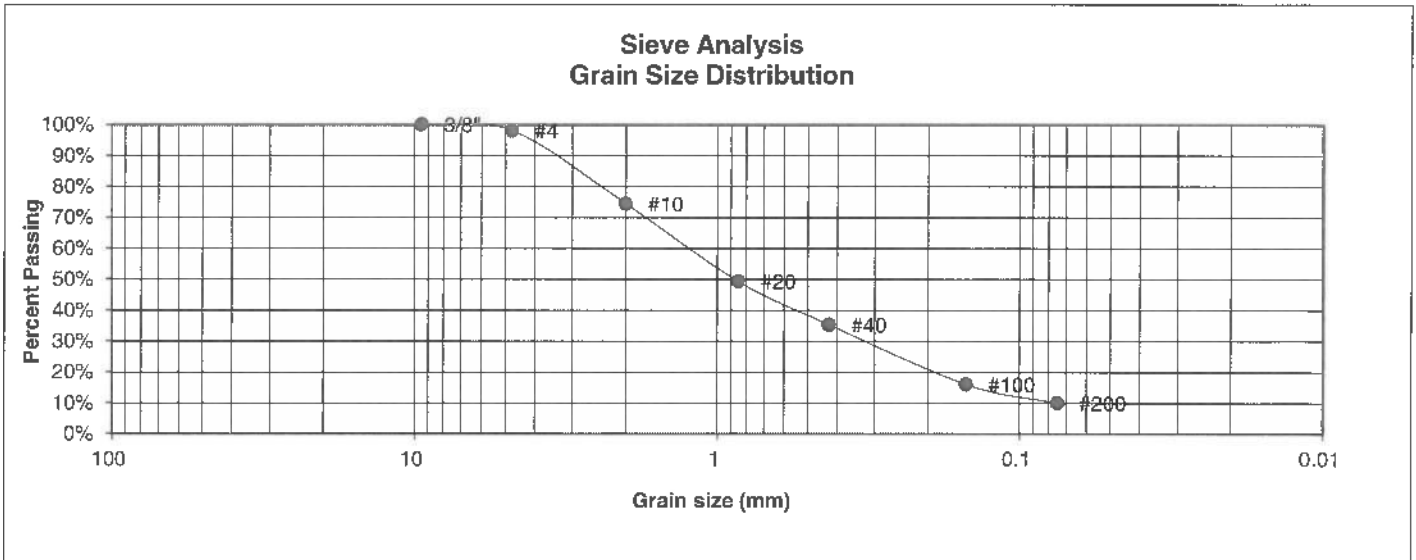
FIG NO.:  
*4-3*

UNIFIED CLASSIFICATION	SM-SW	CLIENT	CLASSIC SRJ
SOIL TYPE #	2	PROJECT	DINES BLVD. & STERLING RANCH
TEST BORING #	2	JOB NO.	222159
DEPTH (FT)	10	TEST BY	BL

U.S. Sieve #	Percent Finer
3"	
1 1/2"	
3/4"	
1/2"	
3/8"	100.0%
4	98.1%
10	74.4%
20	49.4%
40	35.4%
100	16.1%
200	10.1%

Atterberg Limits  
 Plastic Limit  
 Liquid Limit  
 Plastic Index

Swell  
 Moisture at start  
 Moisture at finish  
 Moisture increase  
 Initial dry density (pcf)  
 Swell (psf)

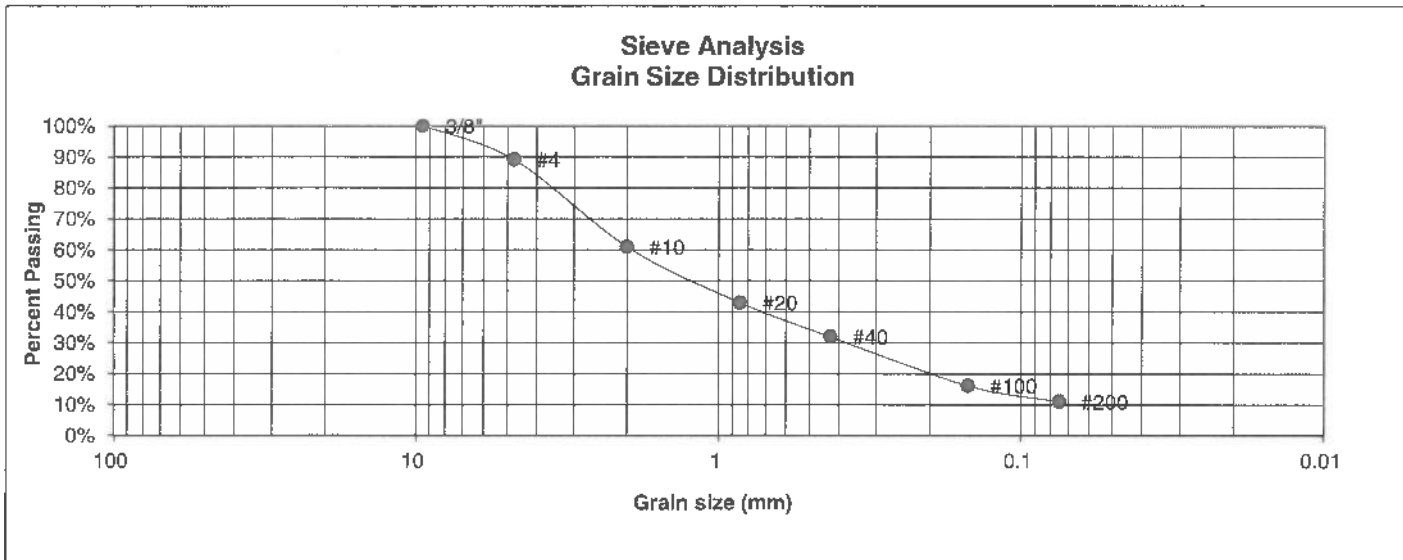
<b>UNIFIED CLASSIFICATION</b>	SM-SW	<b>CLIENT</b>	CLASSIC SRJ
<b>SOIL TYPE #</b>	2	<b>PROJECT</b>	DINES BLVD. & STERLING RANCH
<b>TEST BORING #</b>	4	<b>JOB NO.</b>	222159
<b>DEPTH (FT)</b>	15	<b>TEST BY</b>	BL

U.S. Sieve #	Percent Finer
3"	
1 1/2"	
3/4"	
1/2"	
3/8"	100.0%
4	89.1%
10	61.0%
20	42.9%
40	31.9%
100	16.2%
200	11.0%

**Atterberg Limits**  
 Plastic Limit  
 Liquid Limit  
 Plastic Index

**Swell**  
 Moisture at start  
 Moisture at finish  
 Moisture increase  
 Initial dry density (pcf)  
 Swell (psf)
