# SOIL AND GEOLOGY STUDY

# Graupner Subdivison Tanner Road El Paso County, Colorado

**JOB NO. 192447**

May 2, 2023

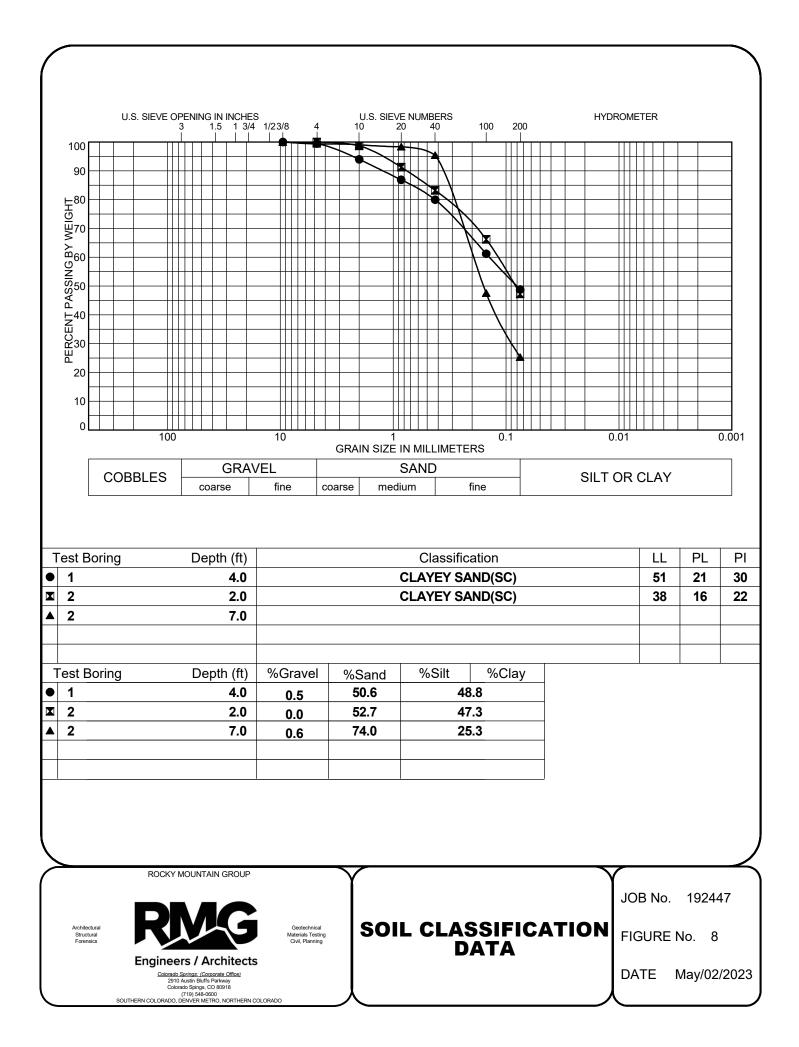
JOB No. 192447 FIGURE No. 7 PAGE 1 OF 1 DATE May/02/2023

Test Boring No.	Depth	Water Content (%)	Dry Density (pcf)	Liquid Limit	Plasticity Index	% Retained No.4 Sieve	% Passing No. 200 Sieve	Load at Saturation (psf)	% Swell/ Collapse	USCS Classification
1	4.0	19.8		51	30	0.5	48.8			SC
1	9.0	13.5								
1	14.0	9.3								
1	19.0	11.0								
2	2.0	9.1		38	22	0.0	47.3			SC
2	7.0	12.0				0.6	25.3			
2	14.0	17.9								
2	19.0	8.8

# SUMMARY OF LABORATORY TEST RESULTS

Soil laboratory testing was performed as part of this investigation. Laboratory testing included moisture content, grain-size analysis and Atterberg Limits. A Summary of Laboratory Test Results is presented in Figure 7. Soil Classification Data is presented in Figure 8.

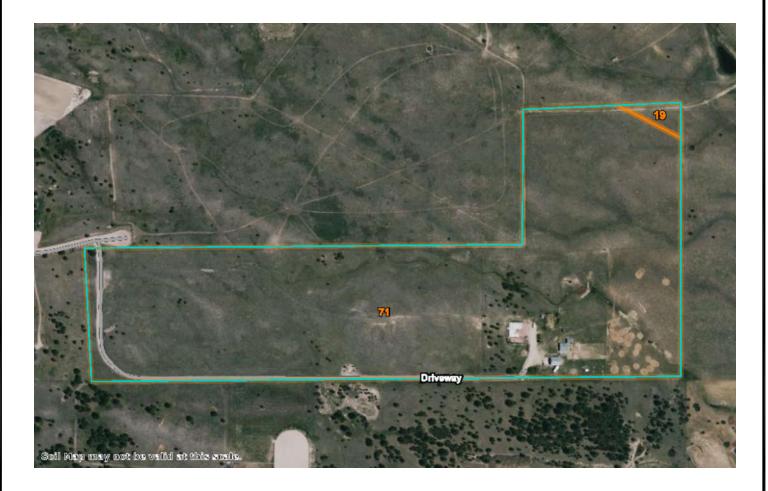
11 - PRING COURSE SANDY LOAM, 3 TO 8 PERCENT SLOPES 19 - COLUMBINE GRAVELLY SAND LOAM, Ø TO 3 PERCENT SLOPES

A USDA Soil Survey Map is presented in Figure 6.

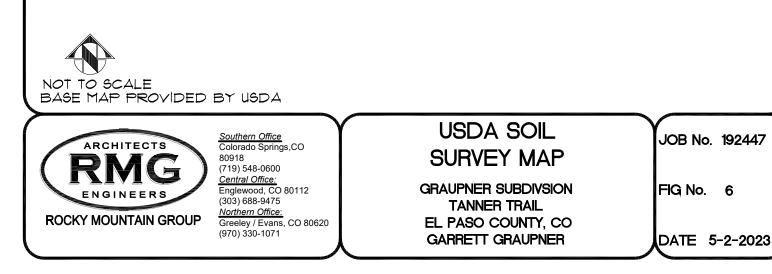
11 - PRING COURSE SANDY LOAM, 3 TO 8 PERCENT SLOPES 19 - COLUMBINE GRAVELLY SAND LOAM, Ø TO 3 PERCENT SLOPES
