## **SOILS AND GEOLOGY STUDY**

**The Ridge at Lorson Ranch  
El Paso County, Colorado**

**JOB NO. 175706**

**March 22, 2021**

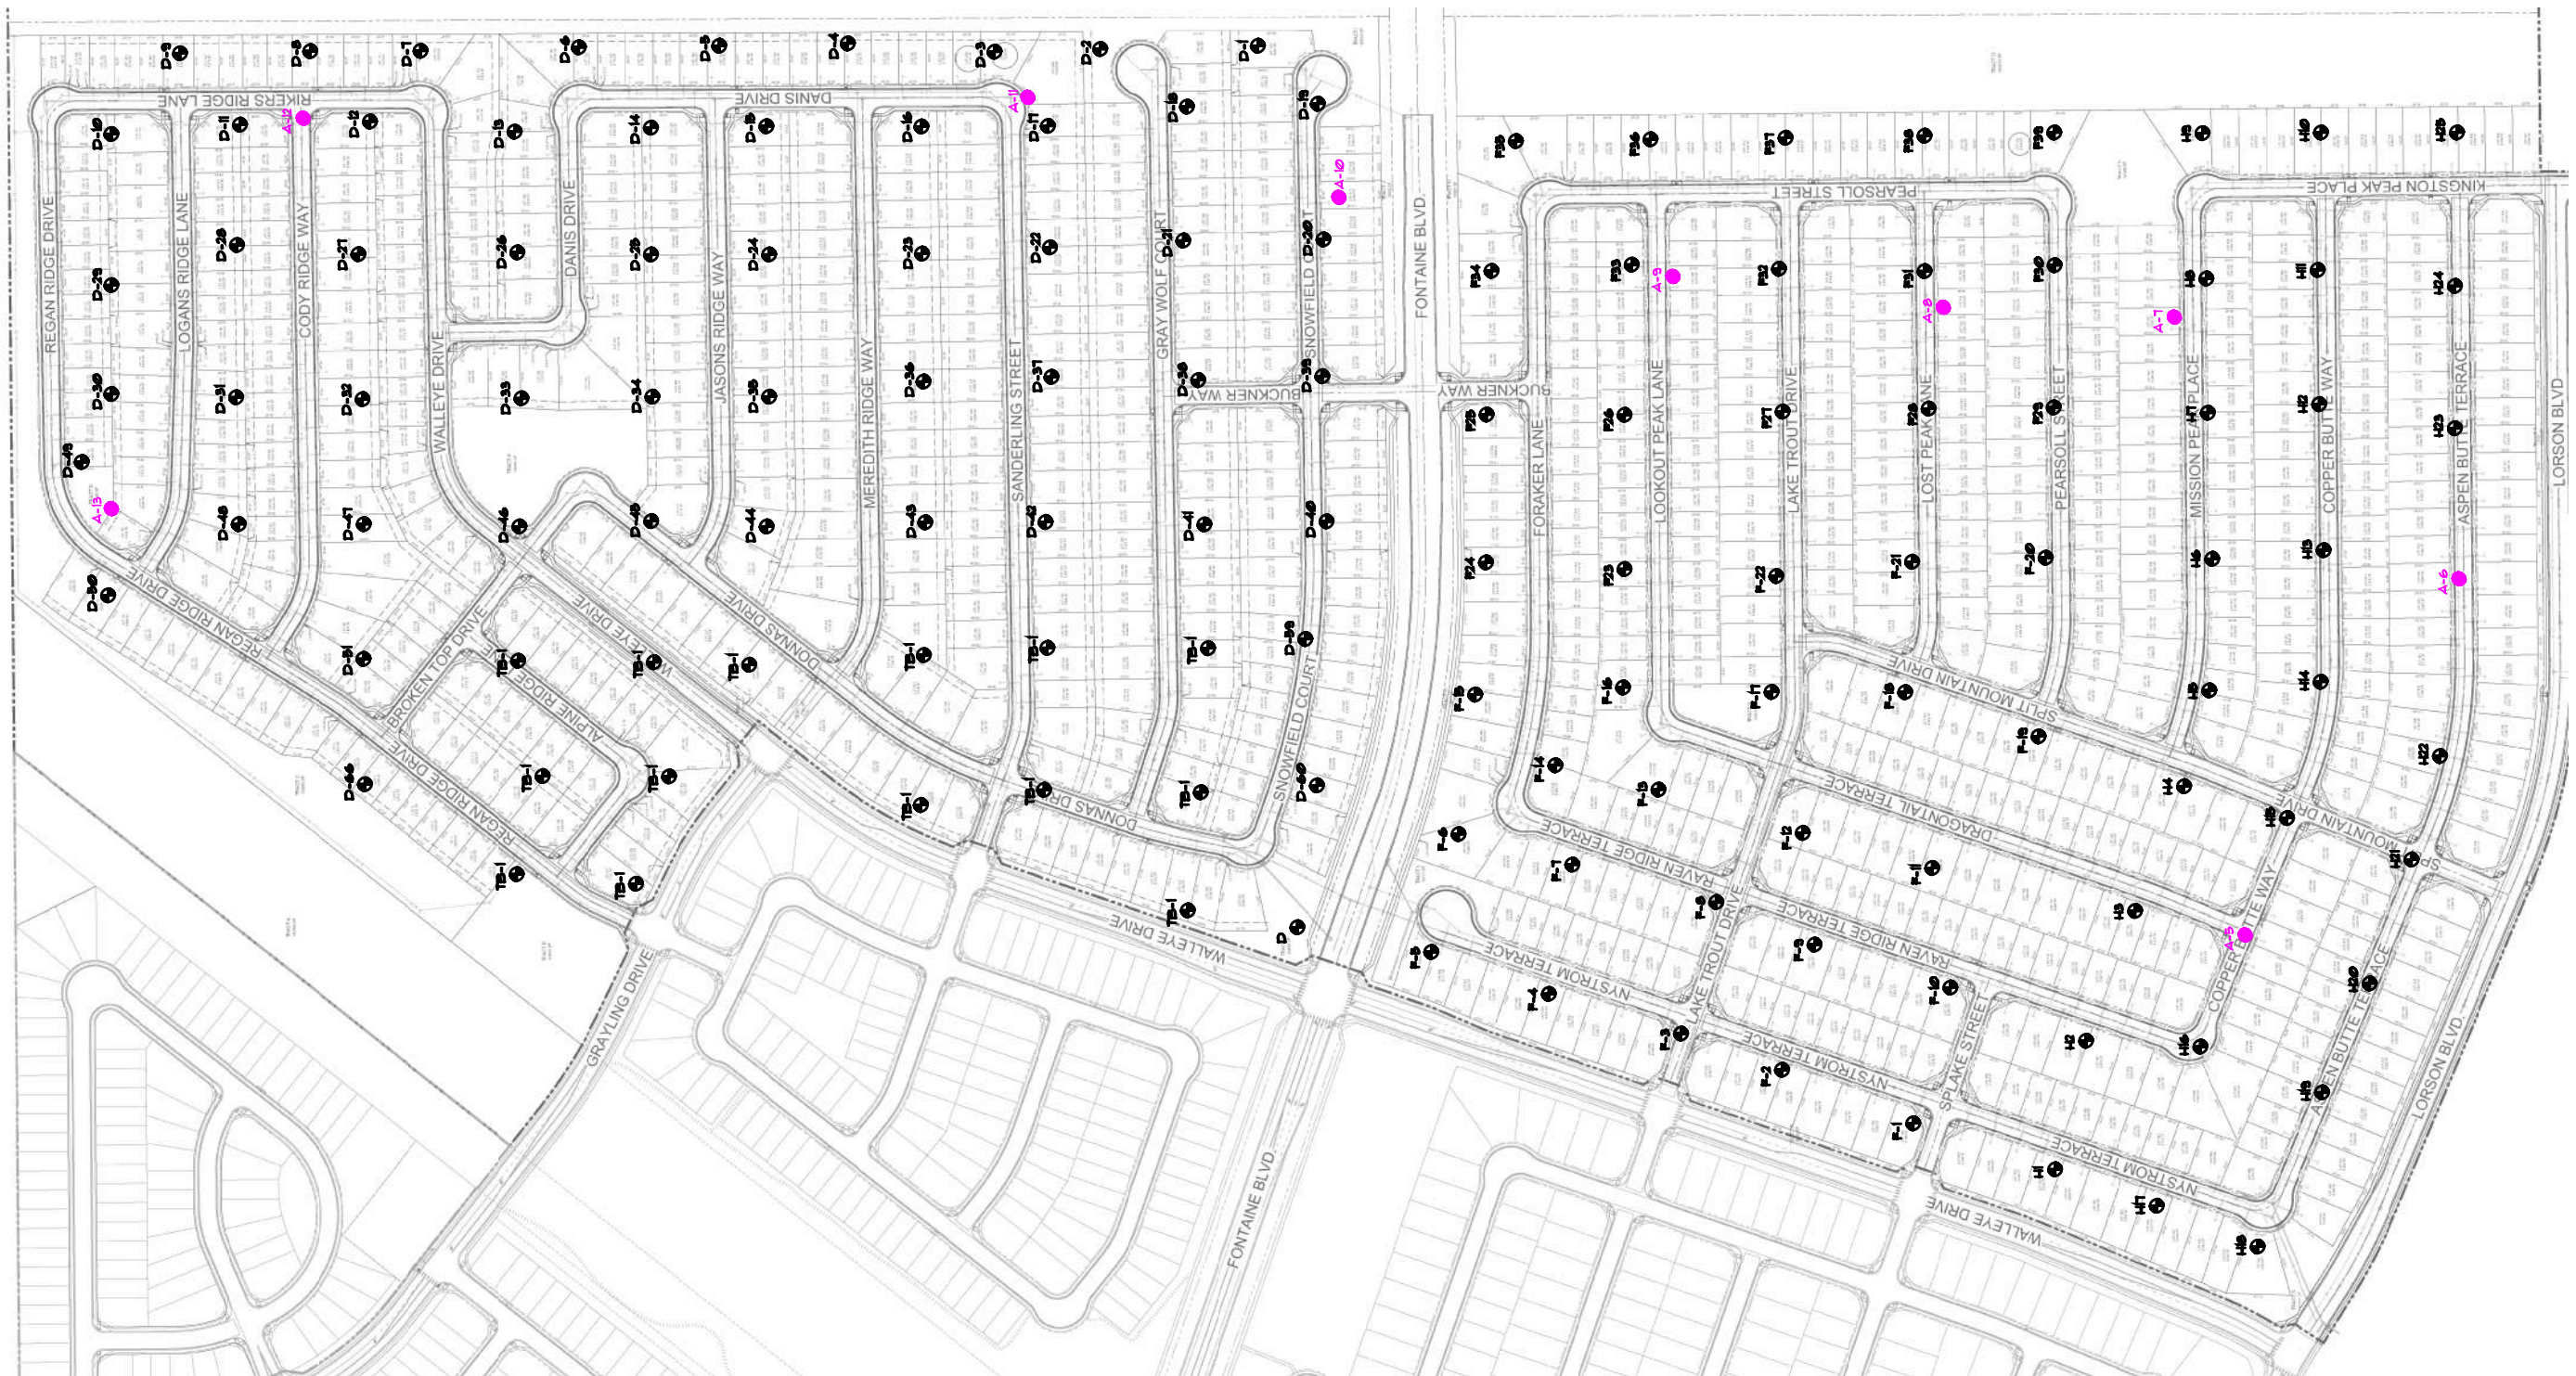
PROPOSED LOT LAYOUT  
 WITH TEST BORINGS  
 LOCATIONS

⬤ DENOTES APPROXIMATE LOCATION OF TEST BORINGS PERFORMED FOR THIS INVESTIGATION

● DENOTES APPROXIMATE LOCATION OF PRELIMINARY TEST BORINGS TO DETERMINE THE DEPTH OF BEDROCK

The subsurface conditions within the property were explored by drilling 134 exploratory test borings to depths of approximately 10 to 25 feet below the existing ground surface. Of the 134 exploratory test borings, 13 (labeled A-1 through A-13) were drilled as preliminary borings to determine the depth of bedrock prior to this investigation. The number of borings is in excess of the minimum one test boring per 10 acres of development up to 100 acres and one additional boring for every 25 acres of development above 100 acres as required by the ECM, Section C.3.3.

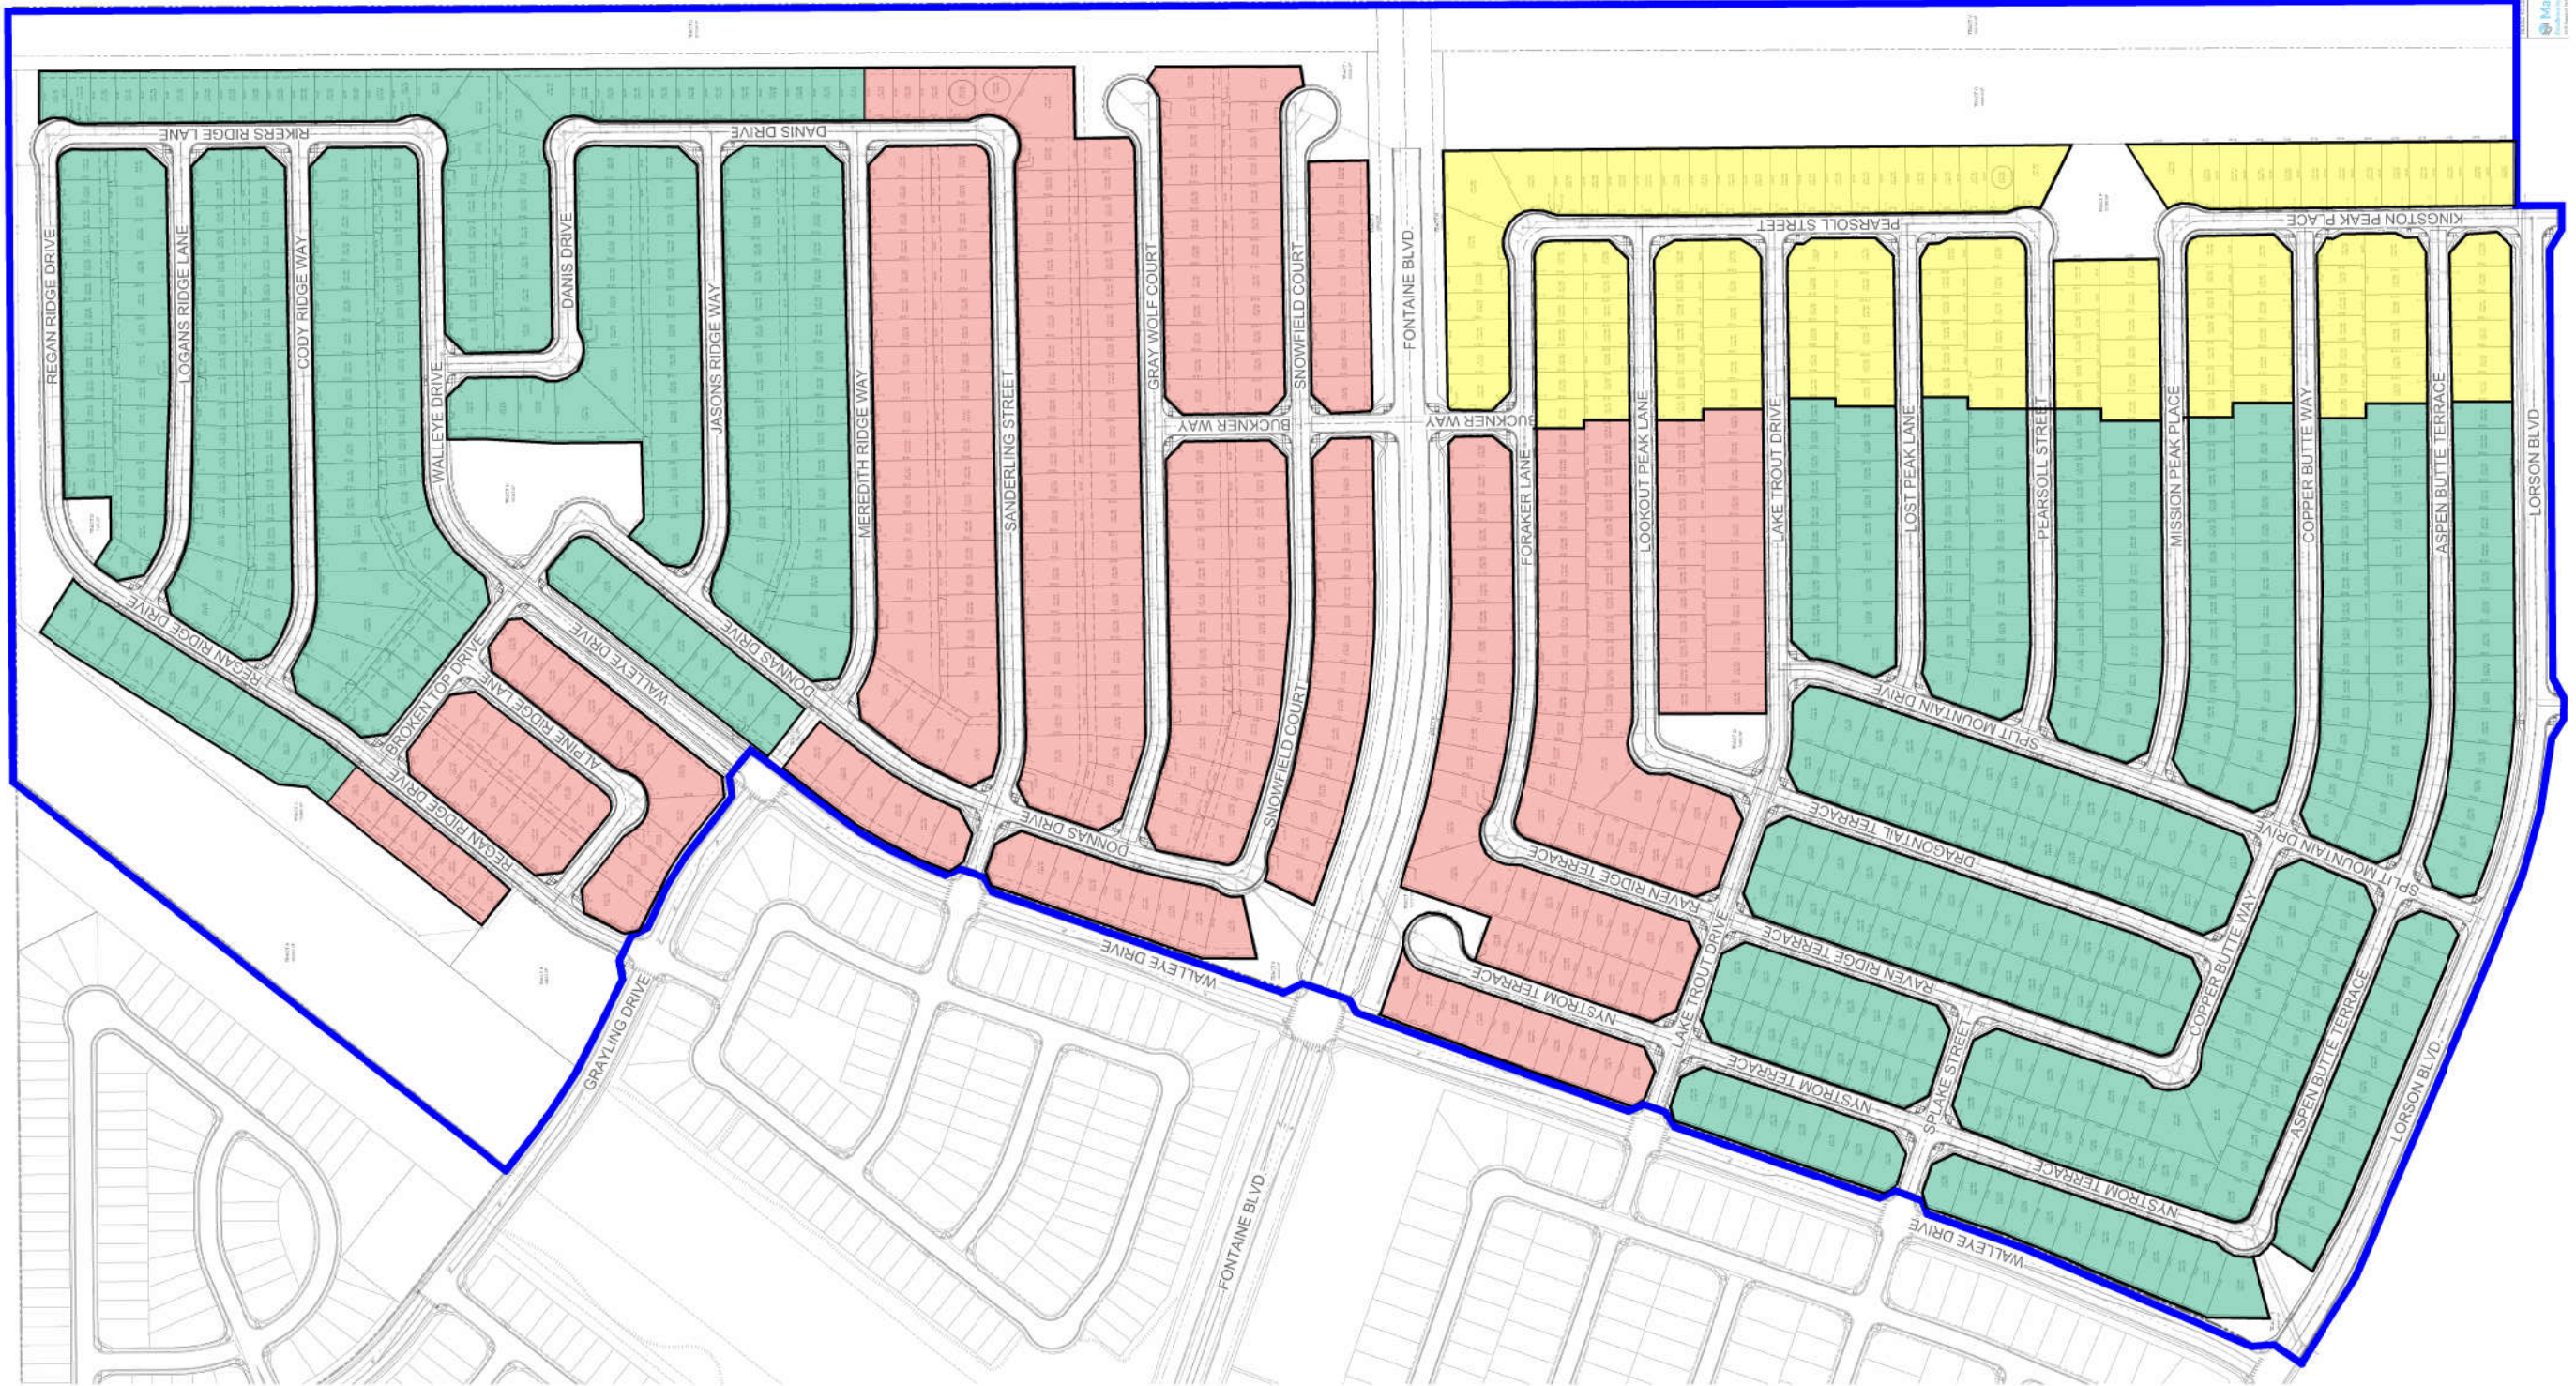
**SUBEXCAVATION TO:**  
**6 FEET BELOW AND 6 FEET**  
**(LATERALLY) BEYOND SPREAD**  
**FOOTING FOUNDATION COMPONENTS**  
**OR**  
**5 FEET BELOW AND 5 FEET**  
**(LATERALLY) BEYOND FT SLAB**  
**FOUNDATION COMPONENTS**

Our subexcavation recommendations are presented in Section **13.0 Subexcavation and Replacement** of this report and the attached Figure 3, Subexcavation Recommendations.

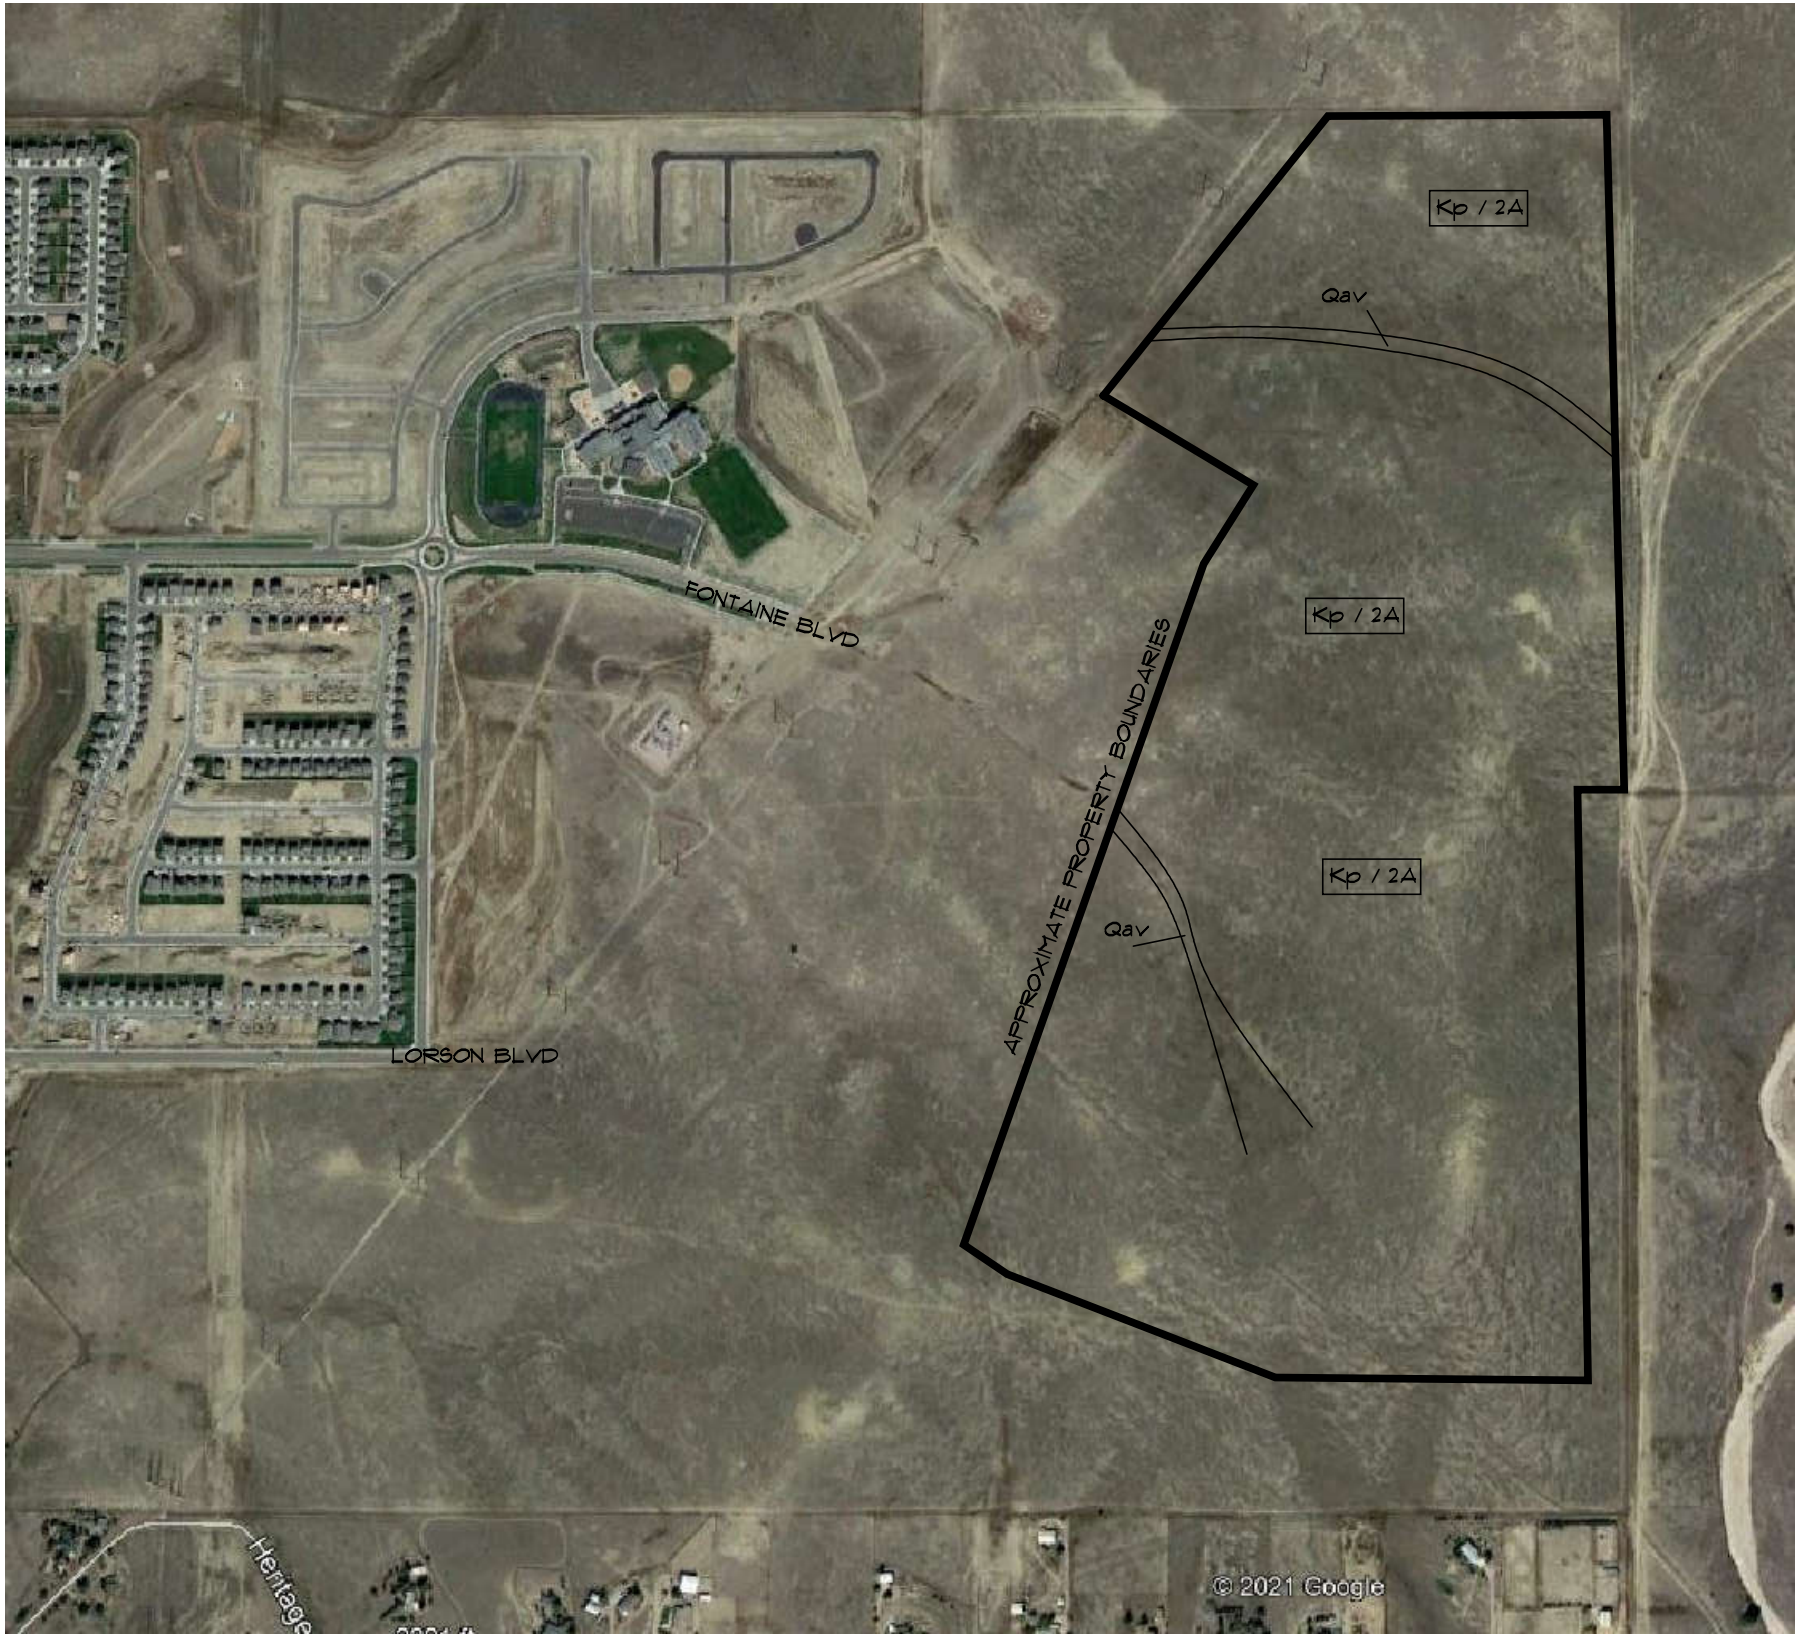
FIG-143

*Qav - Valley-fill alluvium (Holocene)* - unsorted to poorly sorted, weakly stratified, sandy to silty clay deposited as valley fill in broad drainage swales on low hillsides of the central and eastern parts of the quadrangle where underlain by Pierre Shale

Based on our field observations, the USDA map, and the Geologic Map of the Fountain Quadrangle, an interpreted geologic map of significant surficial deposits and features was mapped for the site. The identified geologic conditions affecting the development are presented in the Engineering and Geology Map, Figure 143.

The engineering geology is presented in the Engineering and Geology Map, Figure 143.

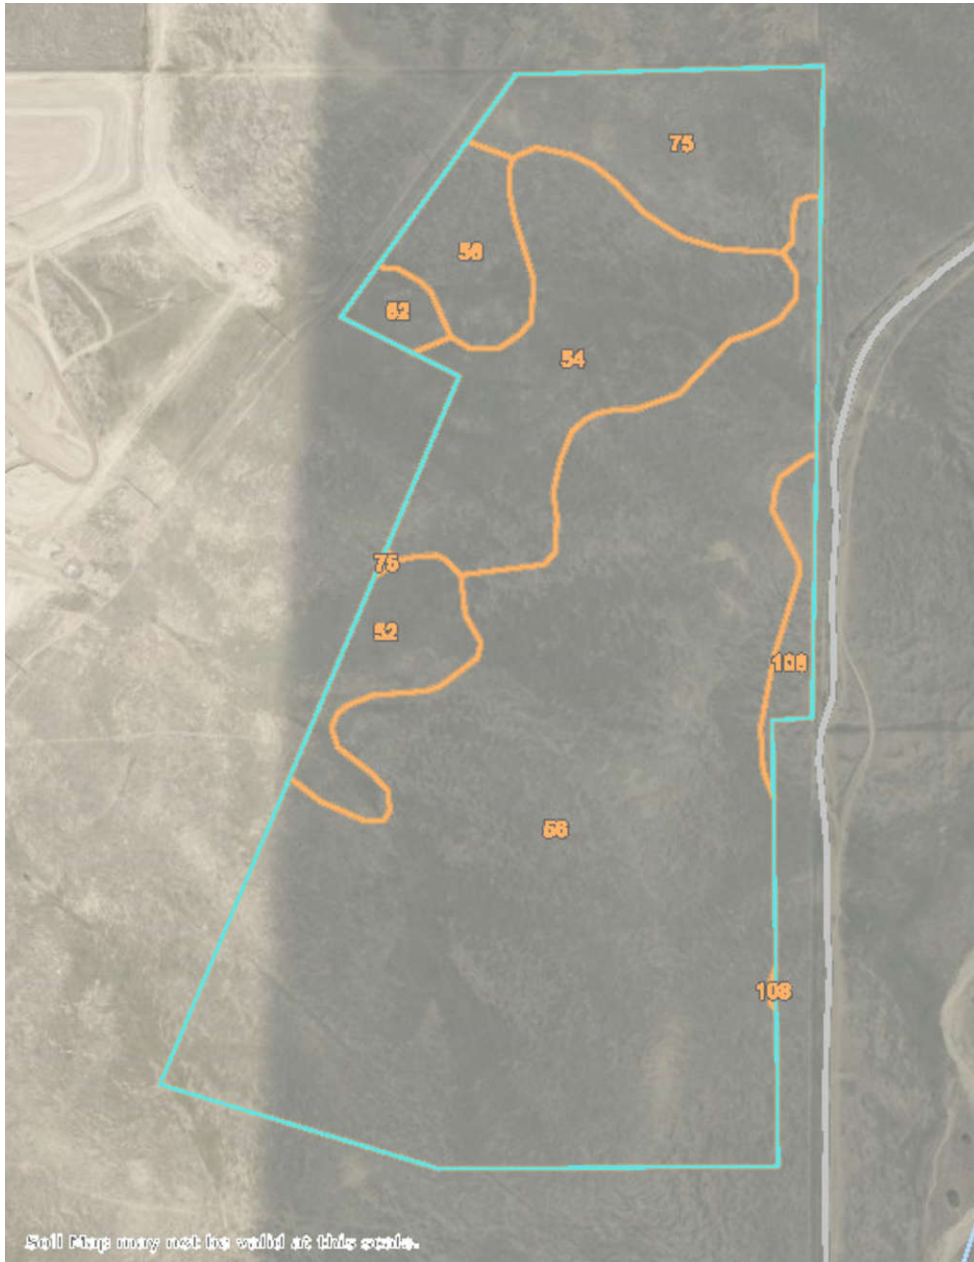
FIG No. 144

Soil Map may not be valid at this scale.

The USDA Soils Survey Map is presented in Figure 144.
