***WASTEWATER DISPOSAL REPORT***

***WINSOME FILING NO. 3***

WASTEWATER DISPOSAL REPORT

**SOIL, GEOLOGY, AND GEOLOGIC HAZARD STUDY  
WINSOME SUBDIVISION – FILING NO. 3  
PORTIONS OF PARCEL NOS. 51000-00-497 & 51000-00-510  
17480 MERIDIAN ROAD NORTH  
EL PASO COUNTY, COLORADO**

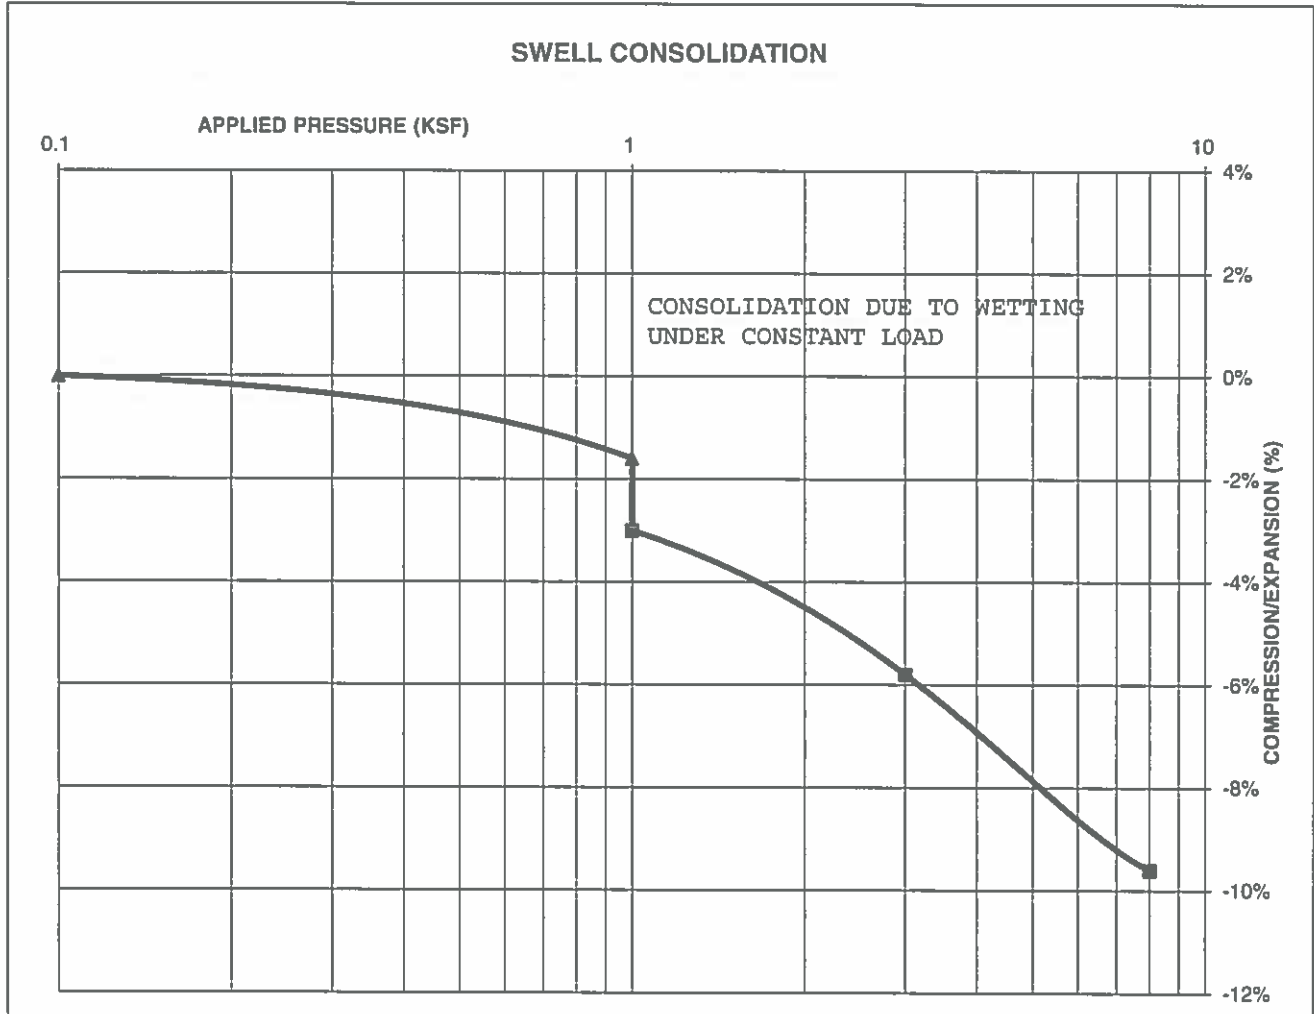
TEST BORING #	1	DEPTH(ft)	2-3
DESCRIPTION	SC	SOIL TYPE	2
NATURAL UNIT DRY WEIGHT (PCF)			106
NATURAL MOISTURE CONTENT			9.1%
SWELL/CONSOLIDATION (%)			-1.4%
